Building and Timber Pest Inspection Report

Inspection Date: Thu, 12 Feb 2026

Property Address: 18 Old Bamarang Rd, Mundamia NSW
2540, Australia

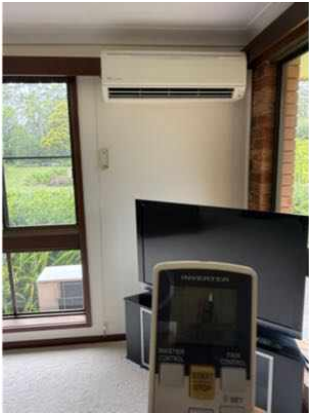
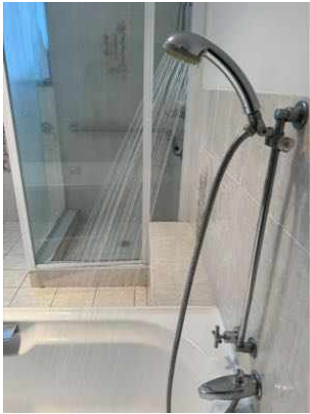
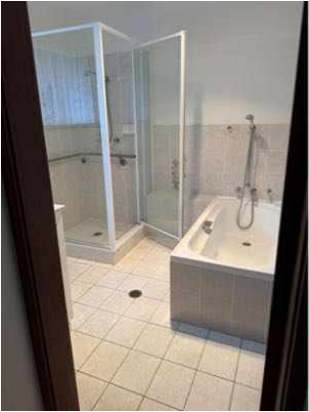
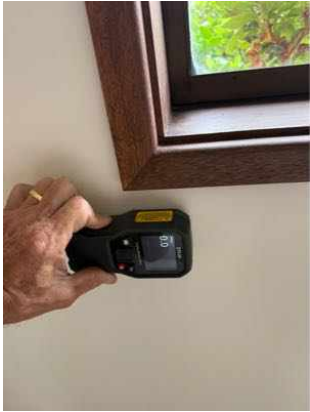
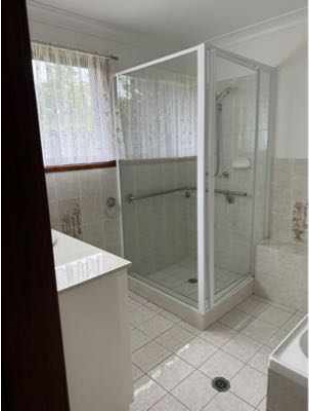
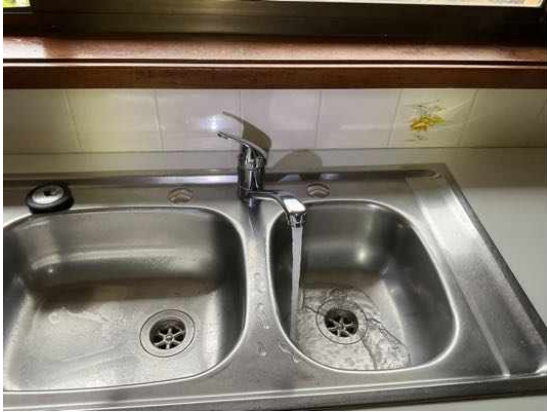
Building: Building 1
Location: All Internal Areas
Finding: Additional Photos
Information: Additional photos are provided for your general reference
