## Building Inspection Report

Inspection Date: Mon, 2 Mar 2026

Property Address: 18 Bowser Cres, Wangaratta VIC 3677,  
Australia

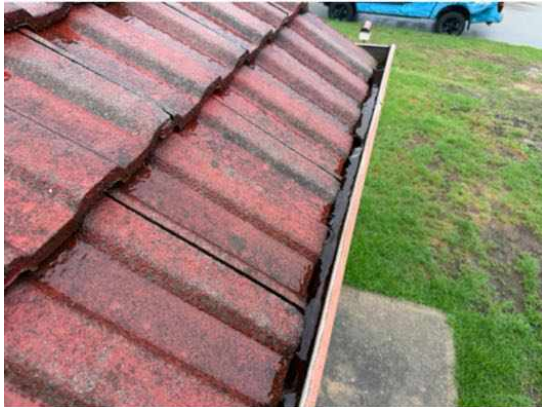
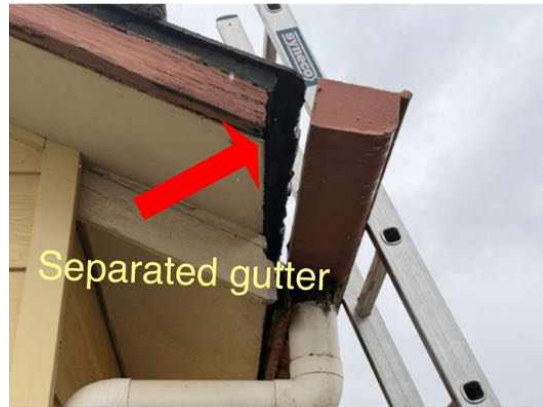
#### Defects 3.01

Building: Main Building  
Location: Roof Plumbing  
Finding: Roof Plumbing - Water pooling & Leaking  
Information: Areas of water pooling & leaking were identified to areas of the gutters & down-pipes. Water pooling of the gutters can lead to deterioration of the roof plumbing over time, if neglected. Water was found to be overflowing from the gutters, and areas of the gutters have pulled away from the roof & were sagging.

A licensed roof plumber should be engaged promptly, to provide further advice & remedial works where necessary.

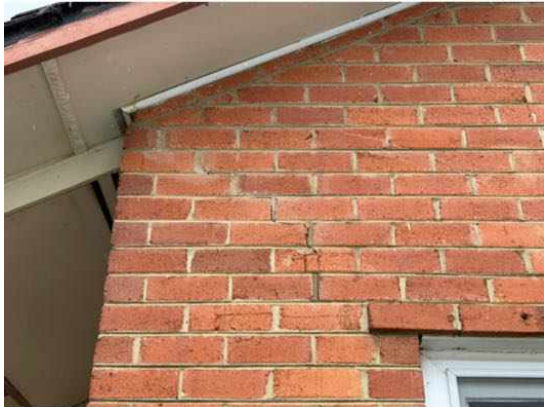
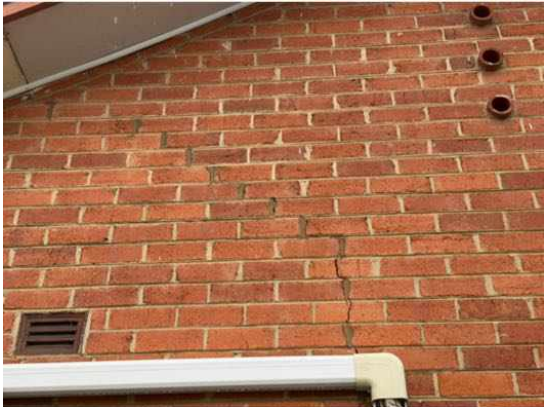
### Defects 3.04

Building:	Main Building
Location:	External Brickwork
Finding:	Brickwork - Step cracking
Information:	Step cracking was identified to areas of the brickwork at the time of inspection. Step cracking, has a variety of possible causes. However, the most common is movement of adjacent footings. Step cracking is a relatively common defect, and is most likely to occur adjacent to windows, doors and other openings.

The client should monitor the cracking. Should the step cracking lengthen, widen or become more numerous, the client should contact a structural engineer promptly, to provide further advice.

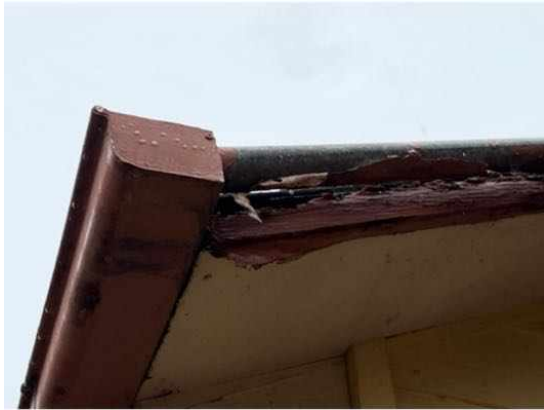
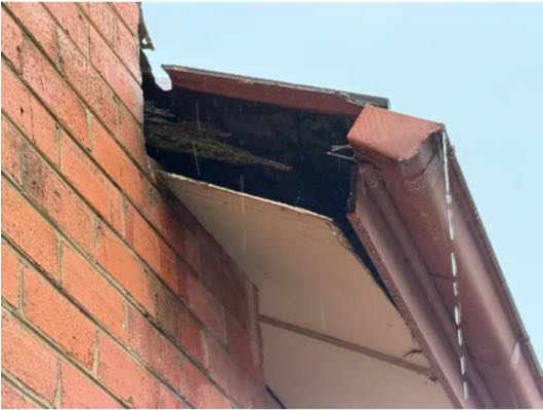
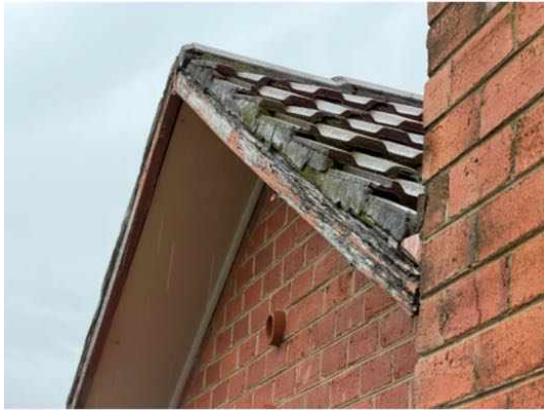
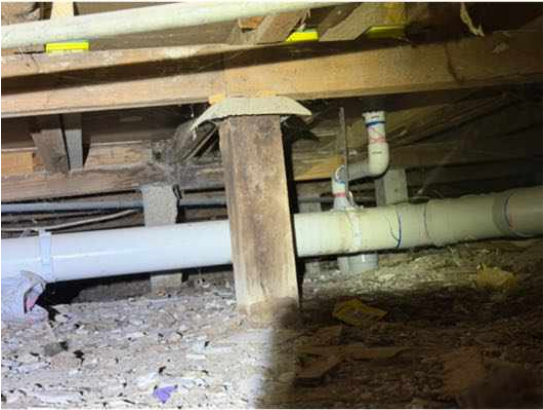
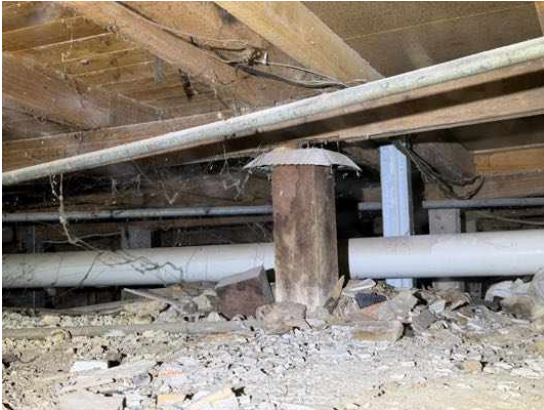
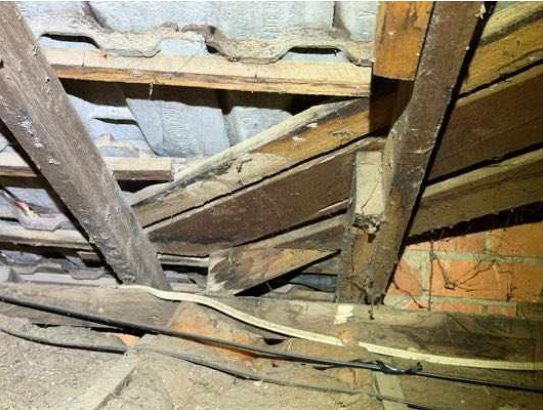
**Defects 3.08**

Building: Main Building  
Location: Fascia's, External Trims, Roof Framing, Stumps  
Finding: Fungal decay & weathering  
Information: Areas of fungal decay (wood rot) & weathering were identified at but not limited to areas of the fascia's, roof framing, timber stumps, and external trims.

For areas of fungal decay, the client should engage a licensed carpenter in the short term, to replace affected materials. For areas of general weathering, it is advised the client engage a licensed painter to apply protective sealant or coating to these areas.

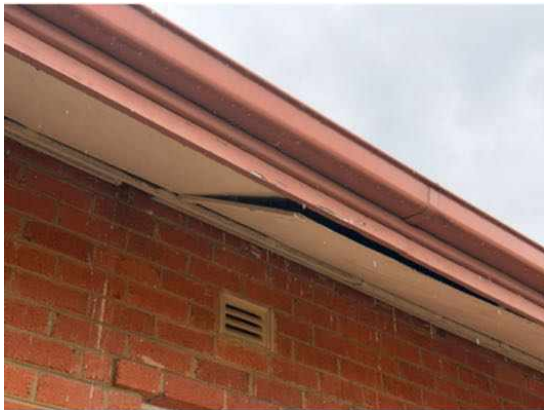
### Defects 3.11

Building:	Main Building
Location:	Interior Ceilings, Eaves
Finding:	Ceiling & Eaves - Sagging
Information:	Sections of the internal ceilings & eaves were found to be sagging at the time of inspection. Causes of ceiling and eaves sagging include fixings (e.g. nails or glue) that have become loose and require re-fixing.

Where sagging has occurred, works such as re-gluing of ceiling sheets and installing additional fixings may be required. Such works may be performed by relevant tradespeople, such as plasterers or licensed carpenters.

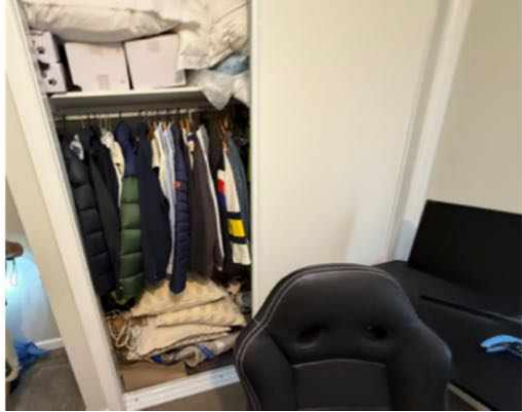
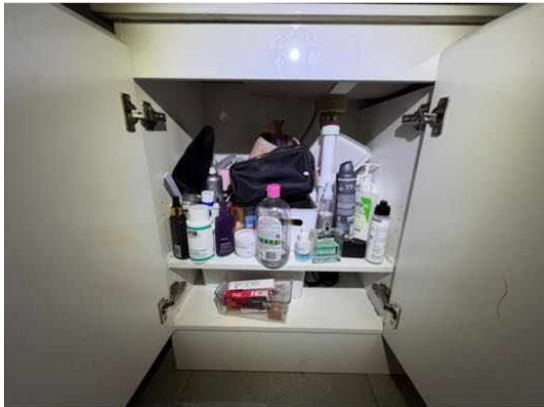
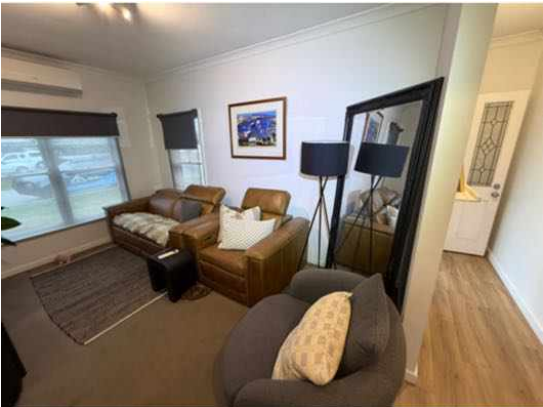
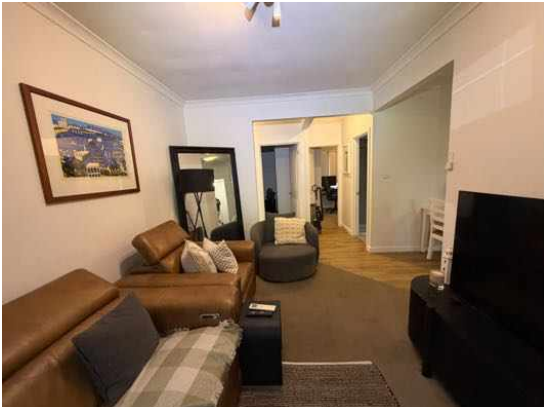
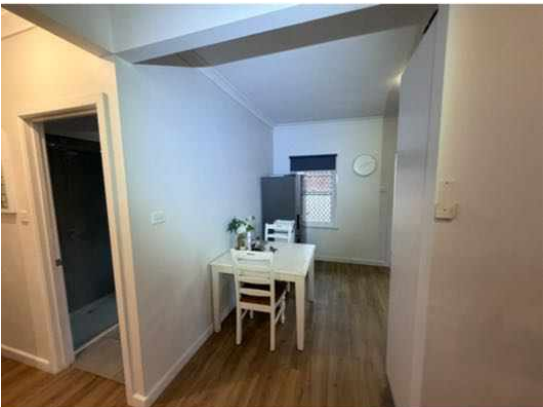
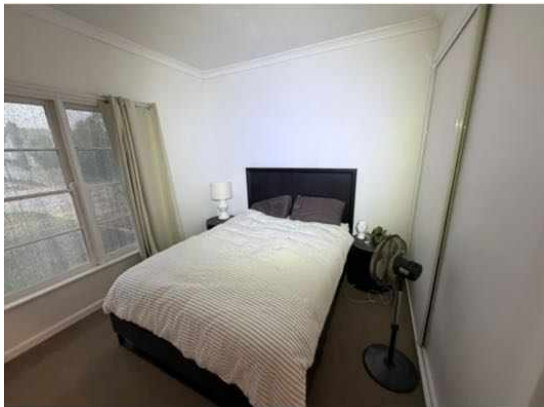
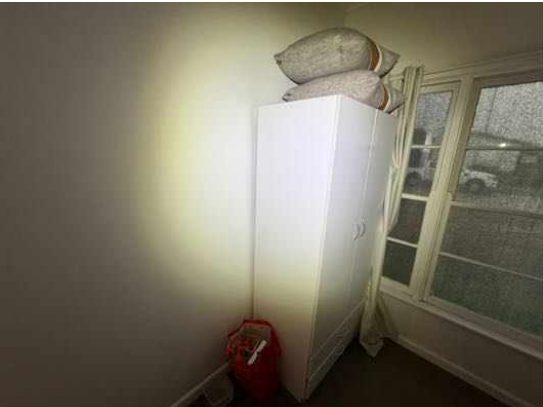
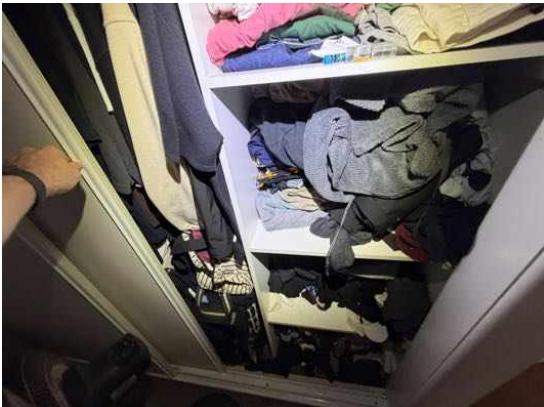
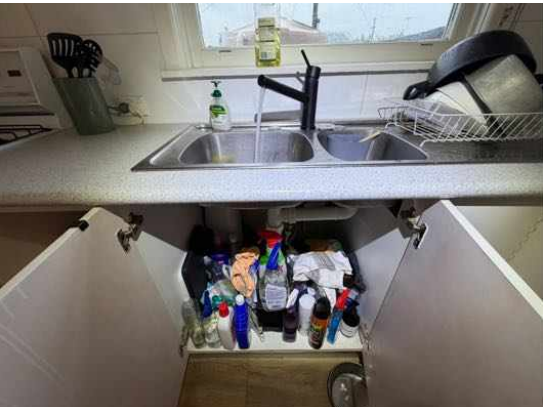
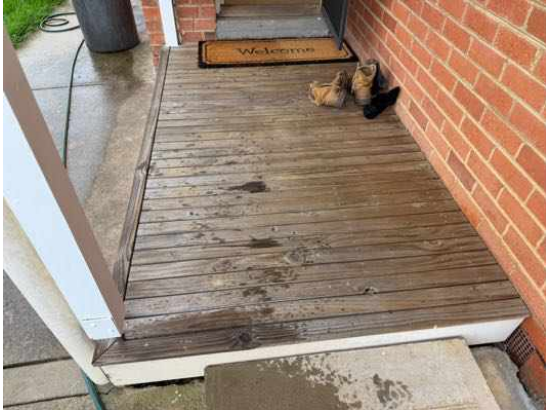
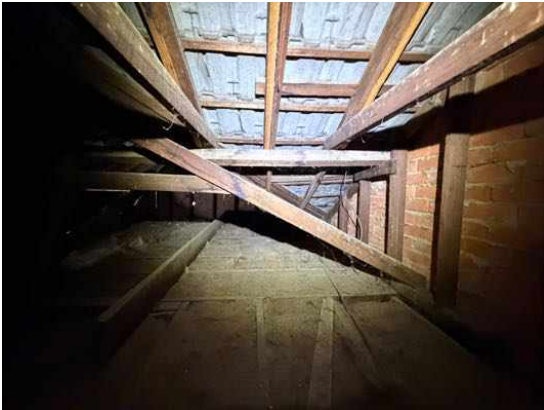
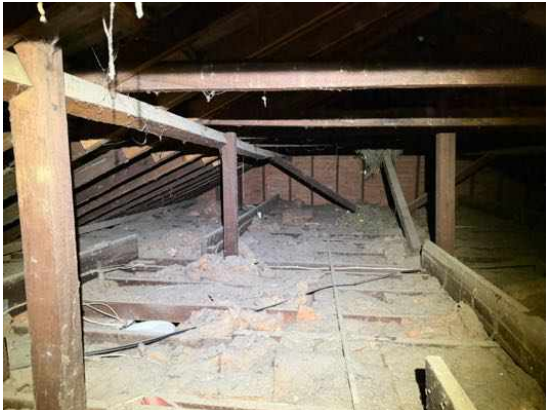
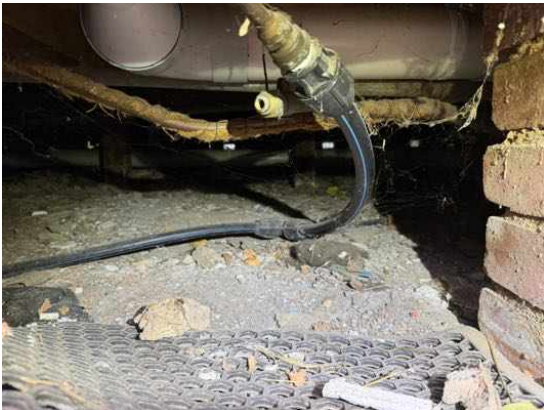
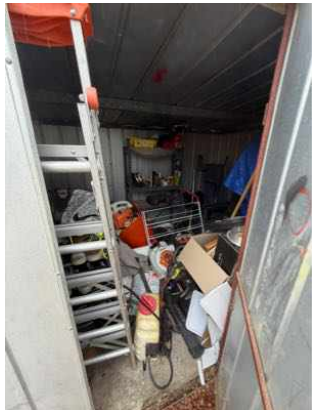
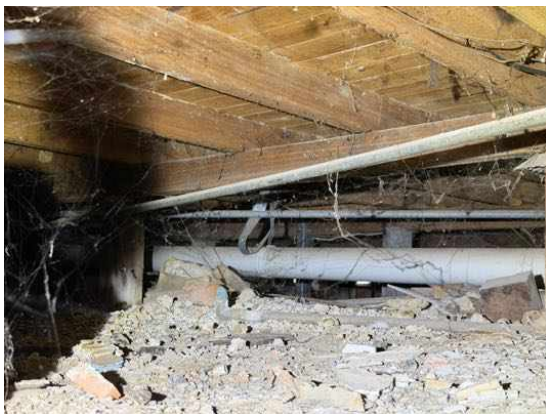
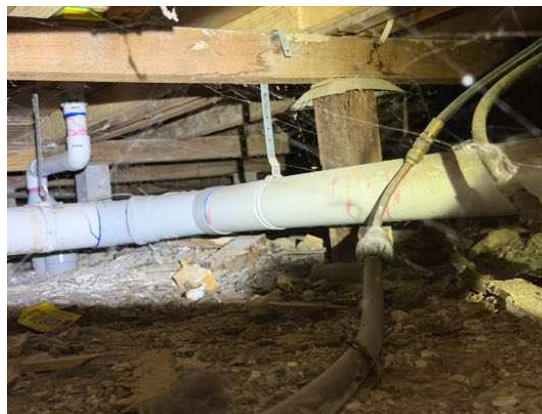
#### Noted Item

Building: Main Building  
Location: All Areas  
Finding: Additional Photos - Obstructions and Limitations  
Information: These photographs are an indication of the obstructions and limitations which impeded full inspection of the property at the time of inspection. These obstructions can hide an array of defects and should be removed to allow full inspection to be carried out. A re-inspection is recommended once the areas are made accessible.
