Building and Timber Pest Inspection Report

Inspection Date: Wed, 18 Feb 2026

Property Address: 2/12 Murrumbidgee Ave, Sylvania Waters
NSW 2224, Australia

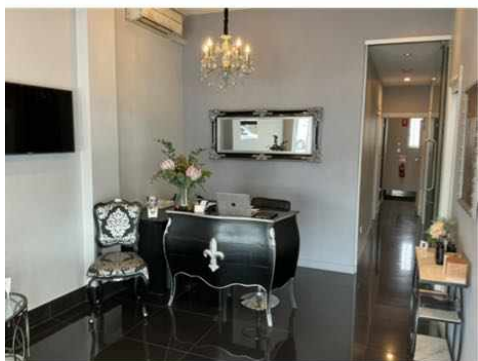
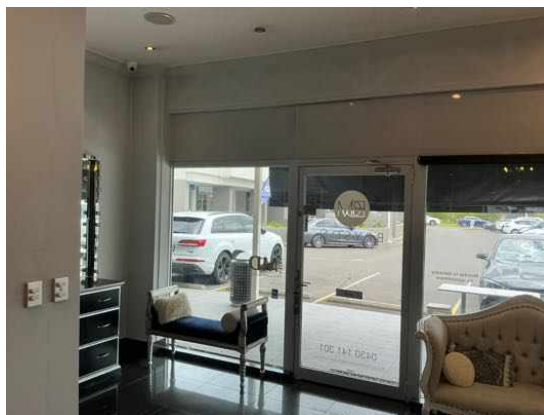
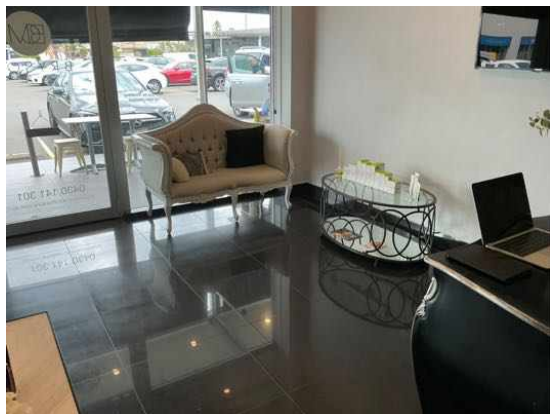
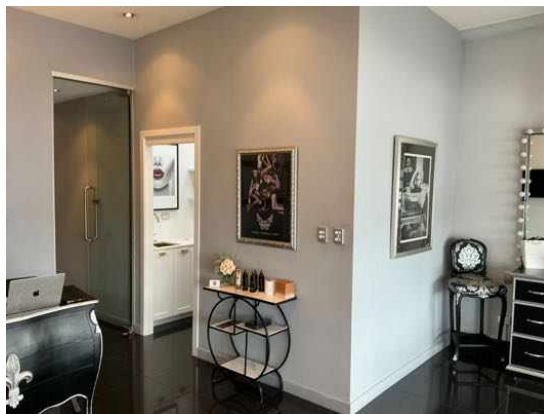
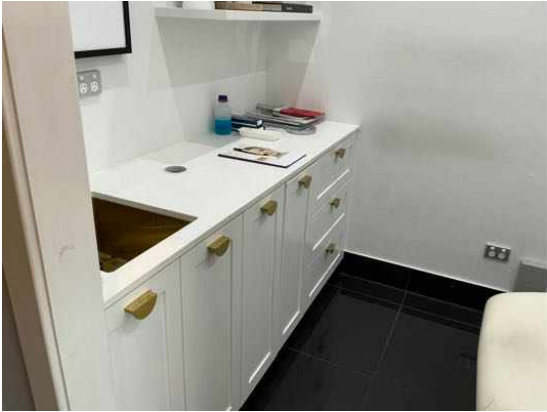
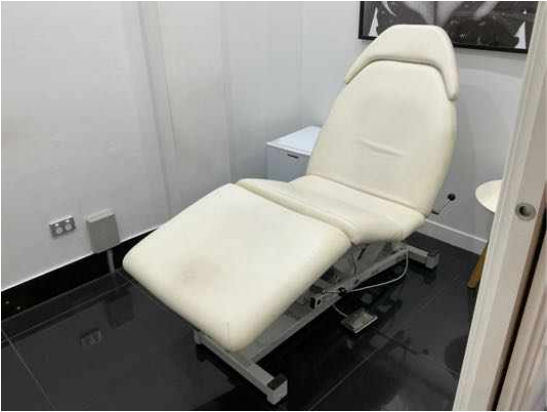
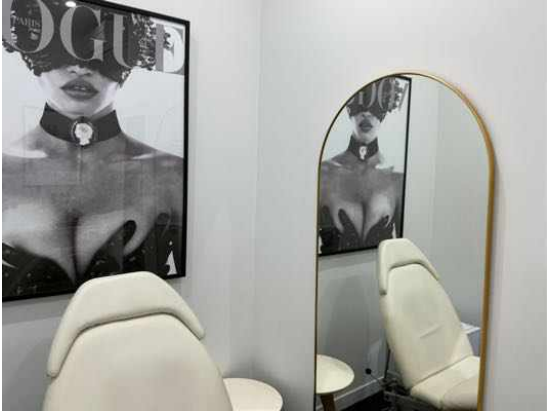
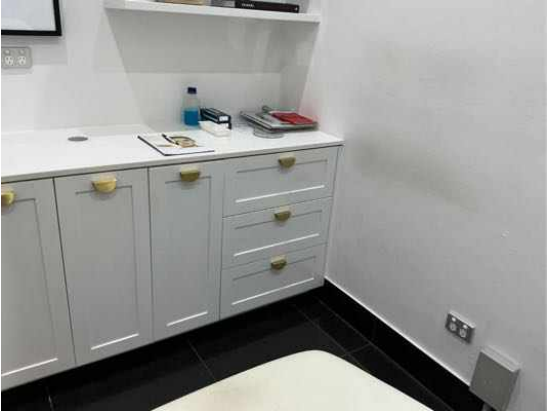
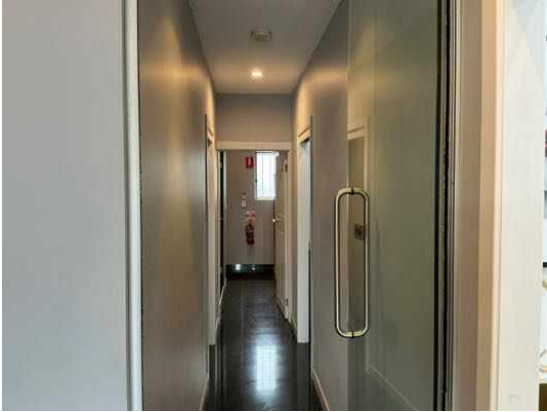
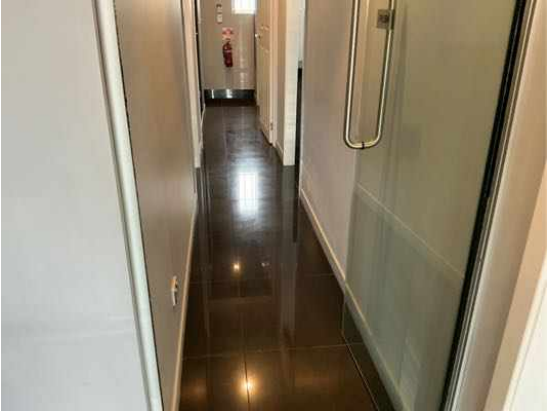
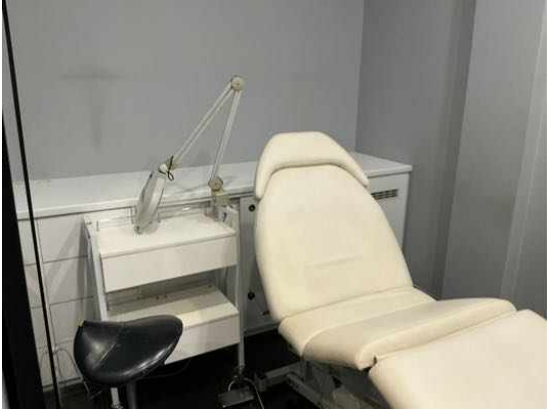
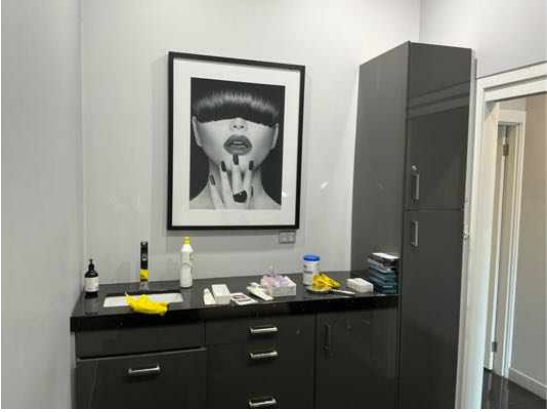
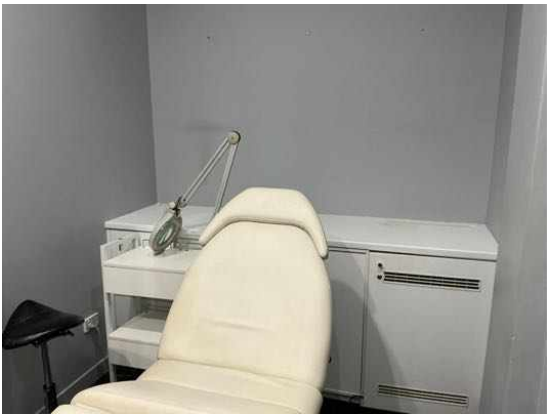
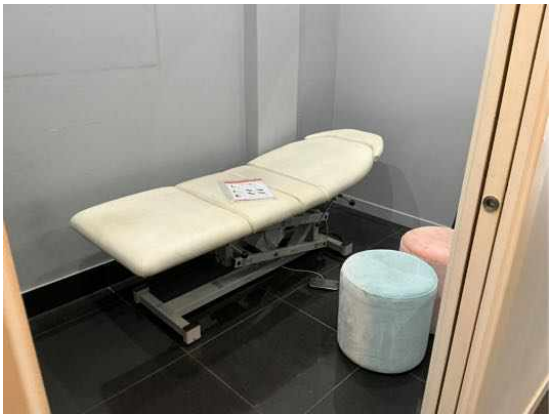
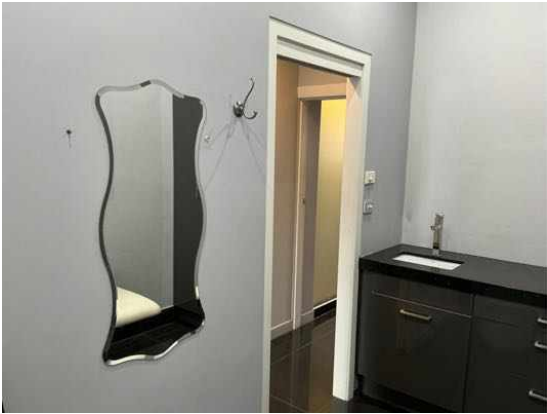
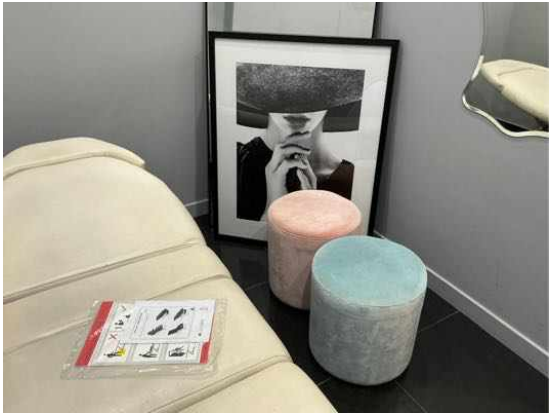
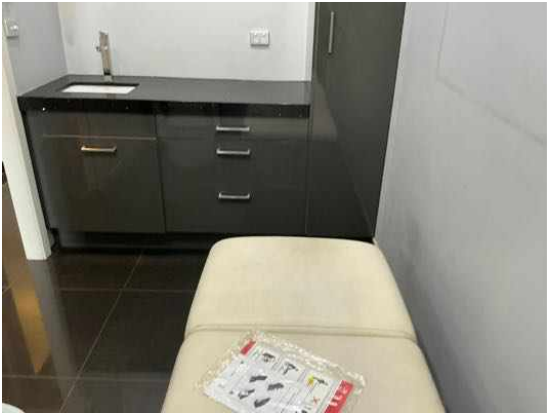
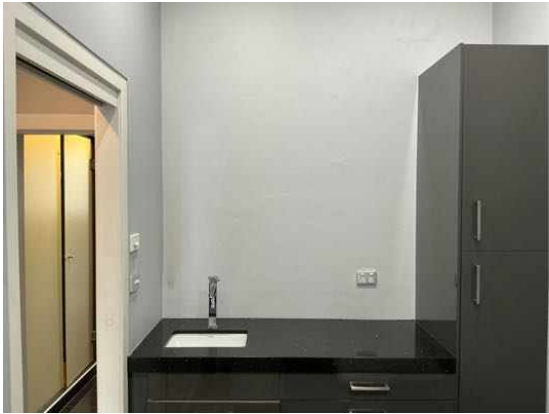
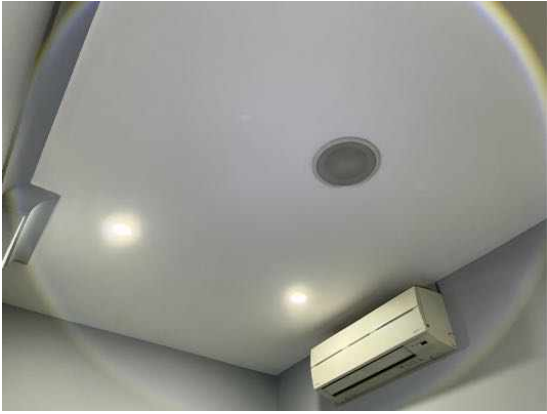
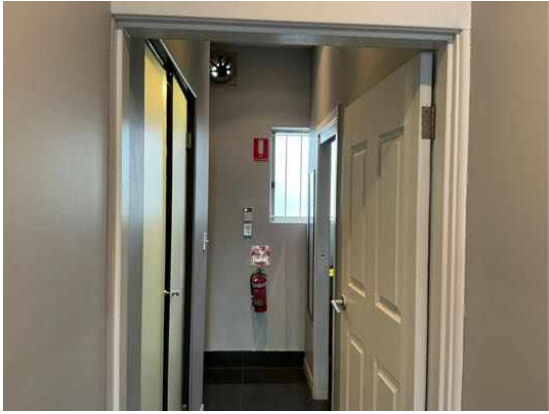
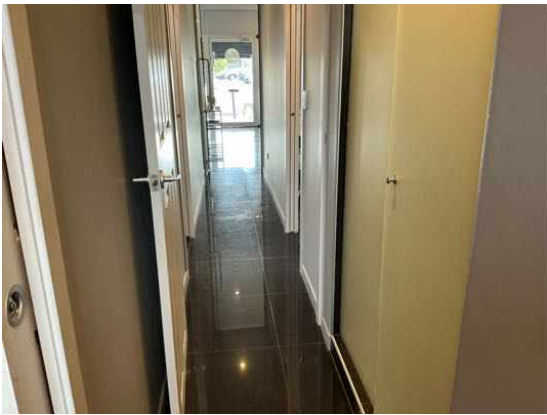
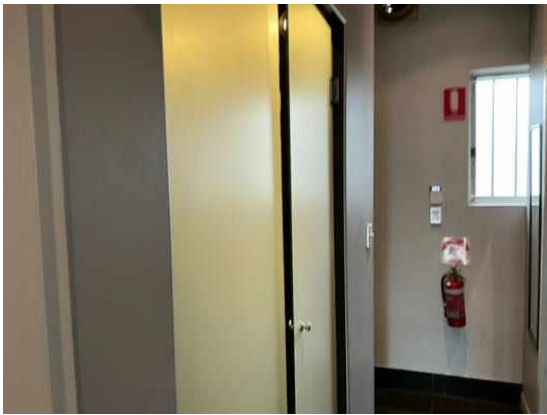
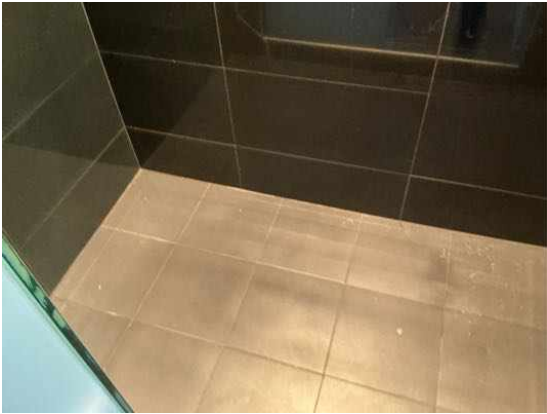
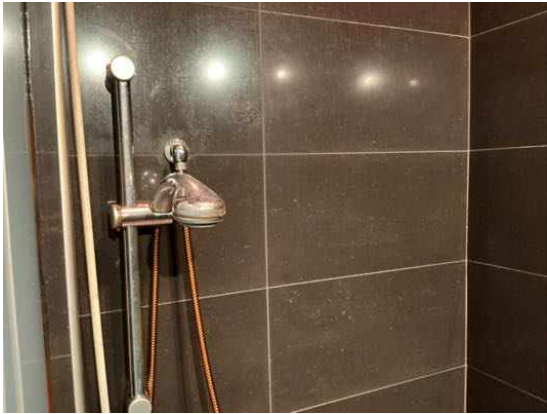
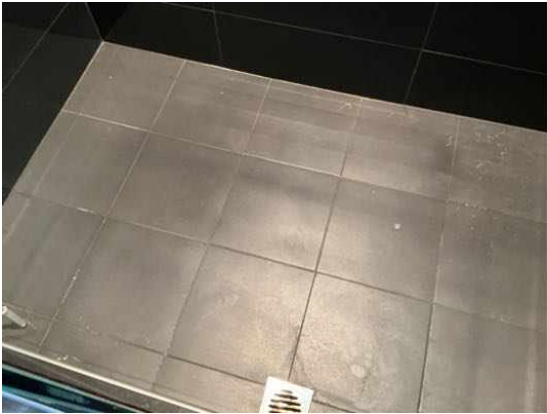
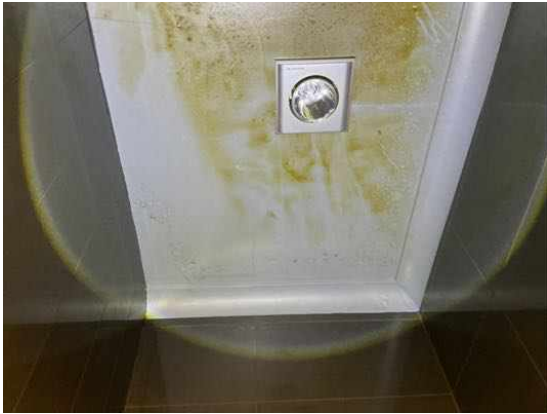
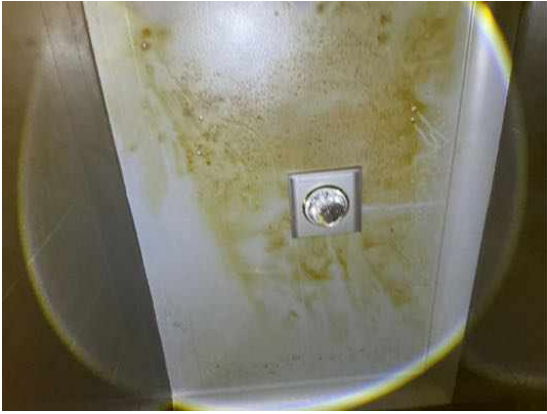
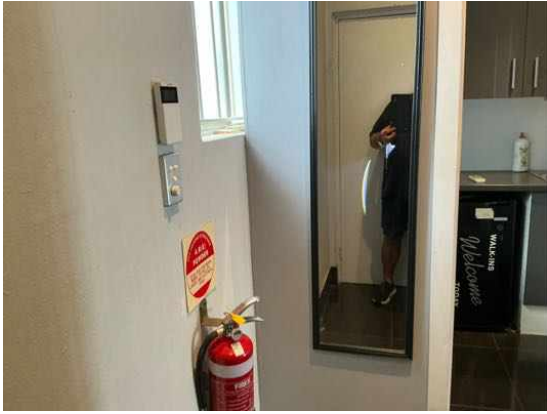
Noted Item

Building: Main Building
Location: All Areas- internal
Finding: Additional Photos - Obstructions and Limitations
Information: These photographs are an indication of the obstructions and limitations which impeded full inspection of the property at the time of inspection. These obstructions can hide an array of defects and should be removed to allow full inspection to be carried out. A re-inspection is recommended once the areas are made accessible.

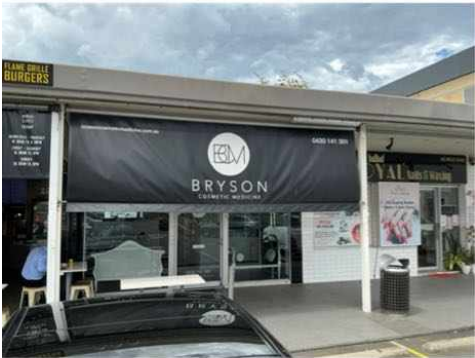
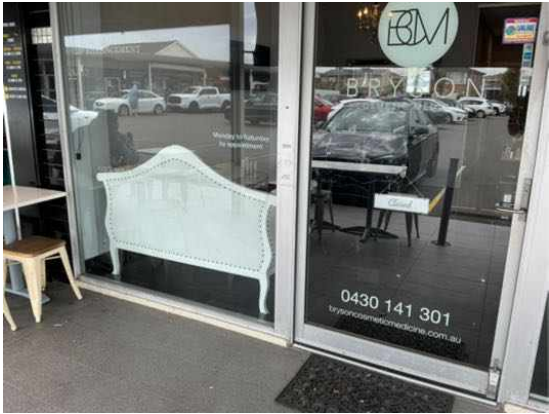
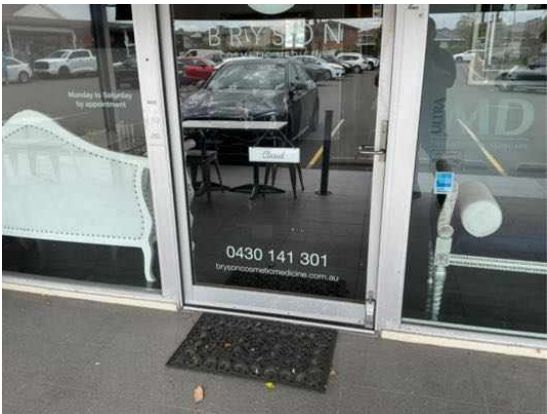
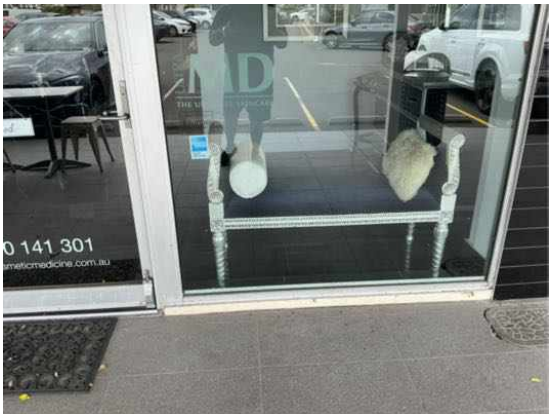
Building: Main Building
Location: All Areas- external
Finding: Additional Photos - Obstructions and Limitations
Information: These photographs are an indication of the obstructions and limitations which impeded full inspection of the property at the time of inspection. These obstructions can hide an array of defects and should be removed to allow full inspection to be carried out. A re-inspection is recommended once the areas are made accessible.
