# Building and Timber Pest Inspection Report

Inspection Date: Wed, 1 Apr 2026

Property Address: 98 Willan Dr, Cartwright NSW 2168,  
Australia

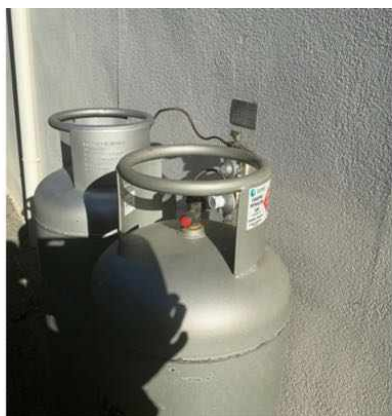
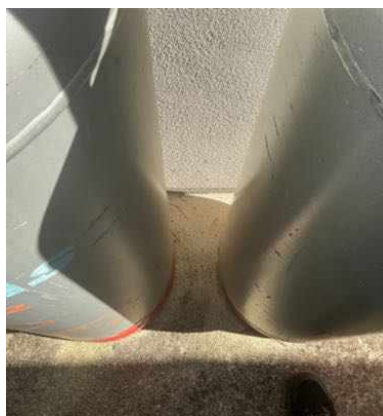
#### Finding 1.01

Building:	Main Building
Location:	All External Areas
Finding:	Gas Cylinders - Installation
Information:	The gas cylinders are currently unrestrained, which does not comply with AS/NZS 1596:2014, Clause 6.9.3, requiring all cylinders to be securely restrained to prevent tipping, falling, or movement. Unrestrained cylinders pose a significant safety risk due to the potential for valve damage and gas leakage. This is considered a major safety non-compliance, and immediate rectification by installing compliant restraints such as chains or brackets is recommended.

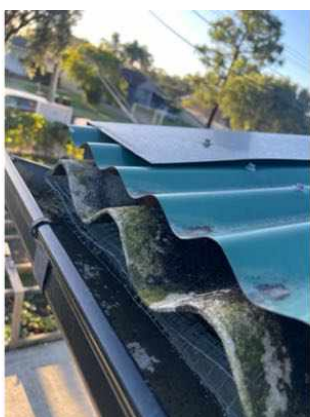
Building:	Main Building
Location:	Roof Exterior
Finding:	Roof overlay installation - Refer to 3.2
Information:	Roof overlay installations may conceal defects within the original roof covering, including deterioration, leaks, or structural issues. They may also increase roof loading and reduce ventilation, potentially contributing to condensation and moisture-related deterioration over time. Access for inspection and maintenance of the original roof covering is also restricted. Internal areas showed signs of moisture, including paint

The presence of internal moisture in conjunction with the roof overlay increases the likelihood of concealed defects within the roof structure or waterproofing system, which could not be confirmed at the time of inspection due to the non-invasive nature and access limitations.

Further investigation by a licensed roofing contractor and/or plumber is recommended to determine the source of moisture and assess any concealed damage. If left unaddressed, this condition may result in progressive deterioration and potentially significant repair costs.

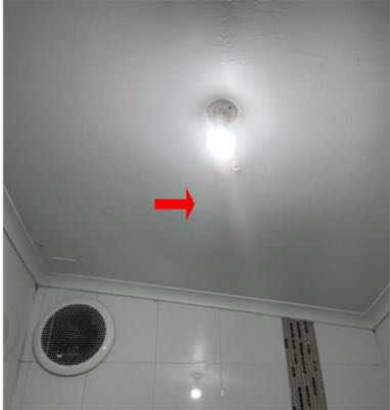
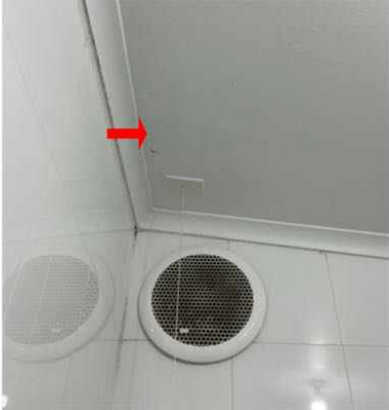
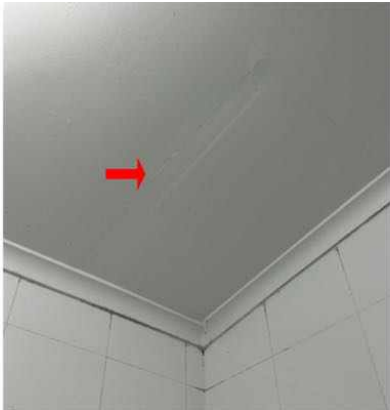
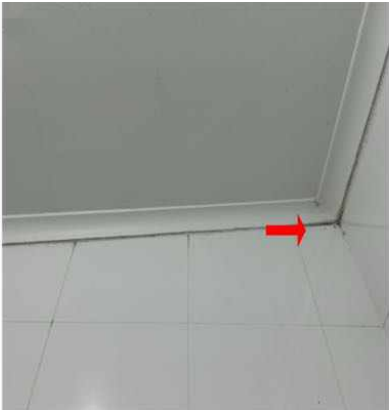
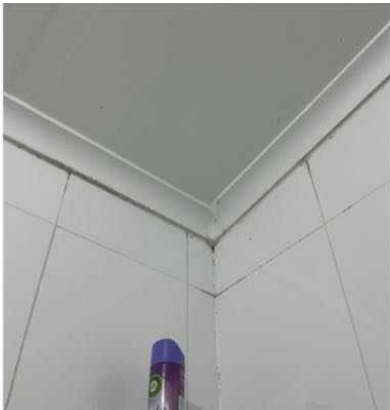
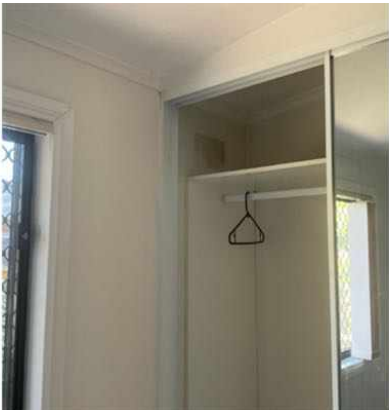
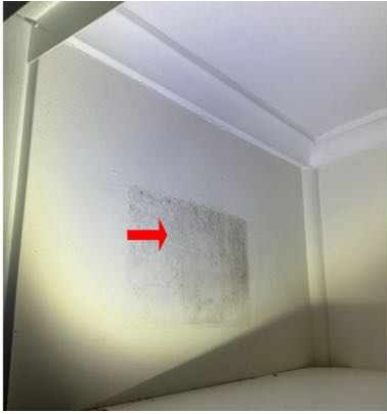
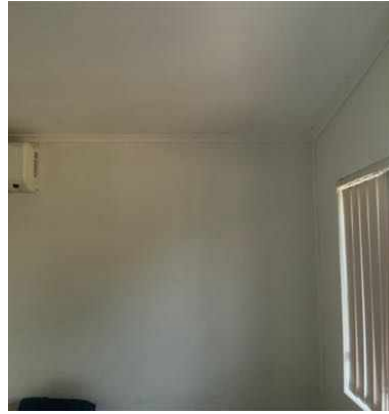
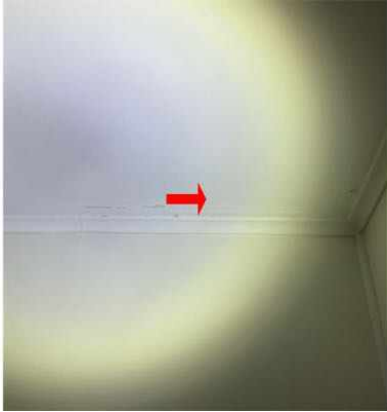
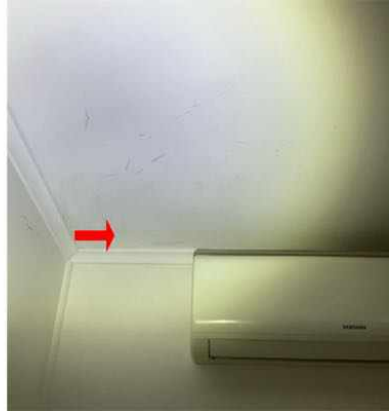
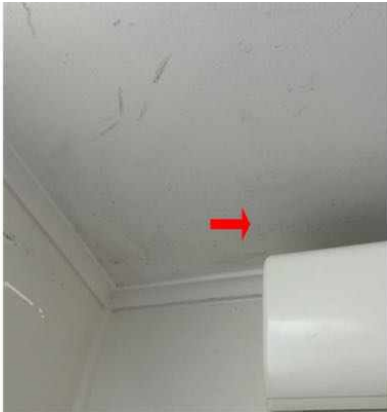
### Finding 3.02

Building:	Main Building
Location:	All Internal Areas - Bathroom , bedroom side, bedroom front
Finding:	Painted surface - Bubbling and mould
Information:	Sections of paint in this area was found to have bubbled and deteriorated. Paint bubbling is generally an indication of excessive moisture in the area, that is currently hidden by the painted surface.

The presence of excessive moisture can have major implications on associated building elements if left unattended. While only seemingly minor at this stage, the

damage cannot be determined due to the paint obstructing any further inspection of the damage.

It is highly advised that the affected paint be cleaned to allow a further, more invasive inspection by a licensed plumber. Failure to act on this defect may necessitate major works in the future.

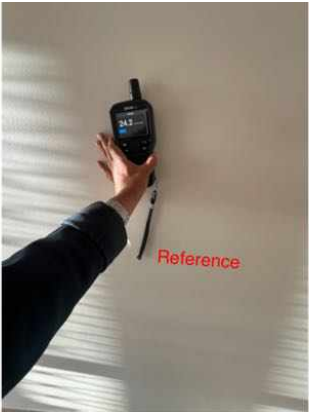
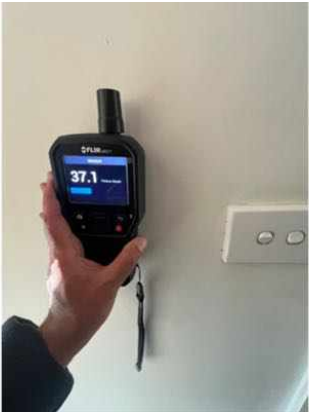
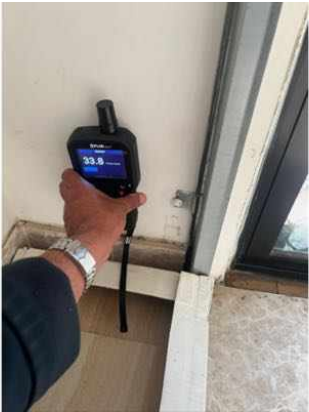
### Finding 3.03

Building:	Main Building
Location:	All Internal Areas - Front , Side, lounge , Garage
Finding:	Elevated Moisture – Further Investigation Recommended
Information:	Elevated moisture readings were detected in several locations, with some areas also showing minor signs of dampness while others did not present visible surface issues, although no significant structural damage was evident at the time of inspection, dampness can contribute to deterioration if left unaddressed. Inspector was not able to inspect the external wall due to space constraints. A further investigation by a licensed plumber or waterproofing specialist is recommended to confirm the source and ensure no concealed issues are developing.

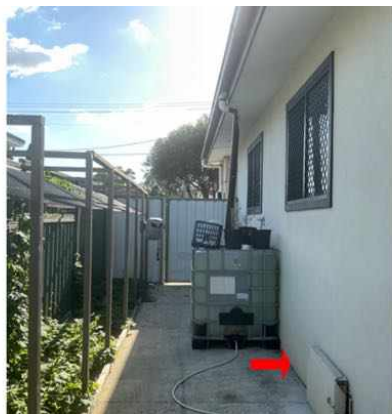
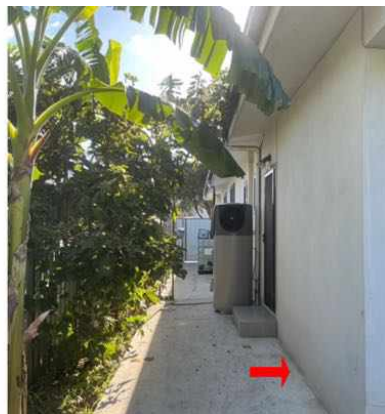
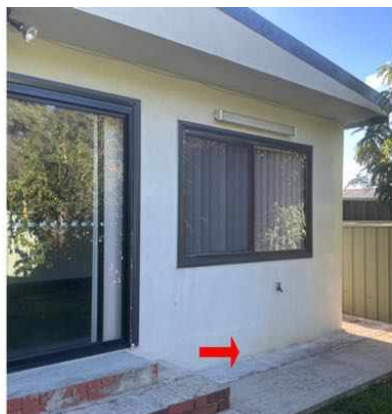
### Finding 3.05

Building:	Main Building
Location:	All External Areas
Finding:	External Slab-to-Cladding– Moisture Bridging Risk
Information:	The external concrete path/apron appears to be finished hard against the wall cladding with minimal or no visible clearance at the base. This configuration may allow moisture bridging and capillary transfer to the lower wall elements, particularly during heavy rainfall or ponding events, and can contribute to deterioration of sealants, coatings, and lower cladding edges over time. While no active water ingress was observed at the time of inspection, the detailing limits drainage and drying at the wall base. Ongoing monitoring and maintenance of joints and clearances is recommended to reduce long-term moisture-related risks.

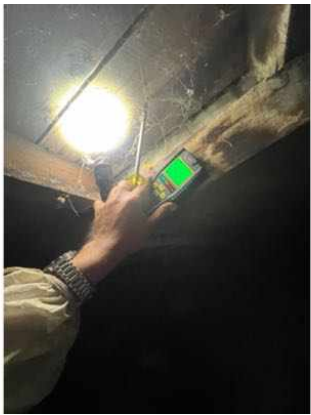
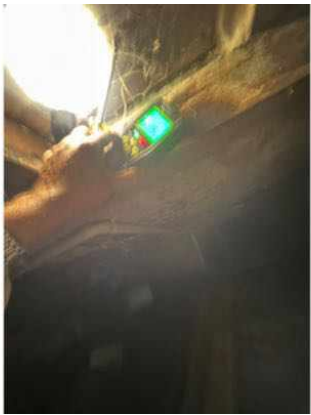
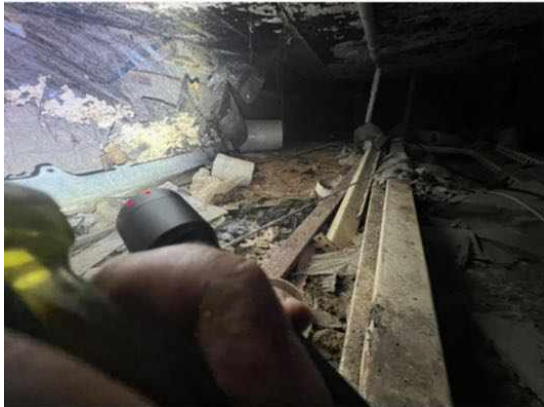
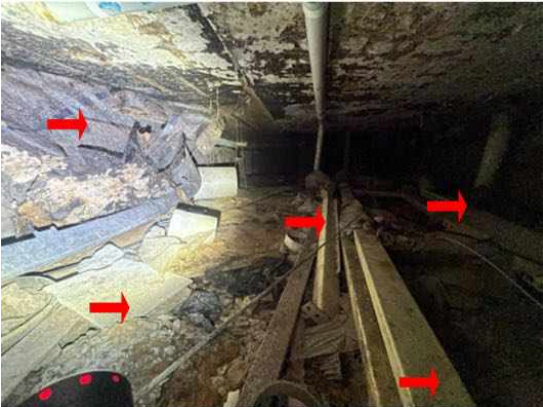
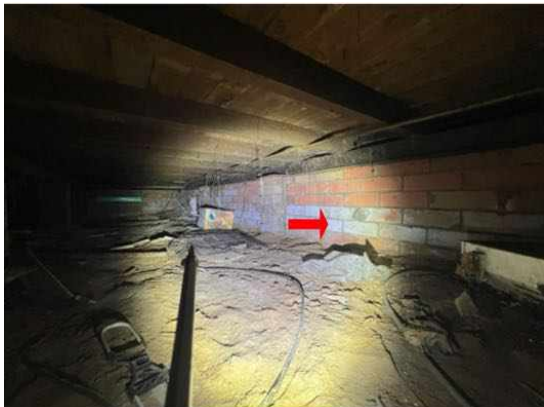
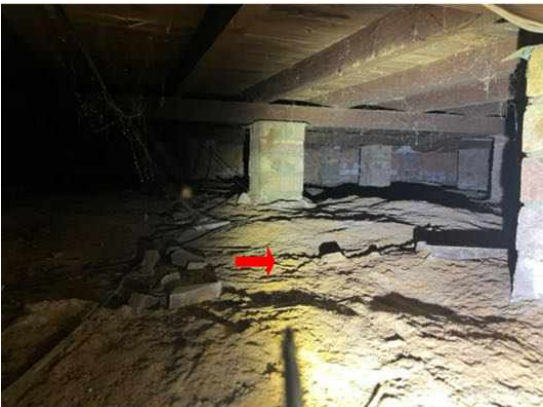
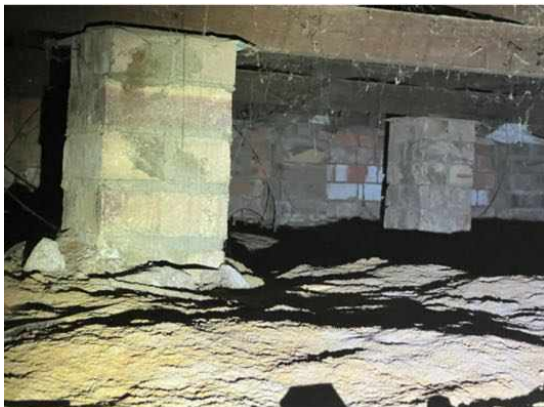
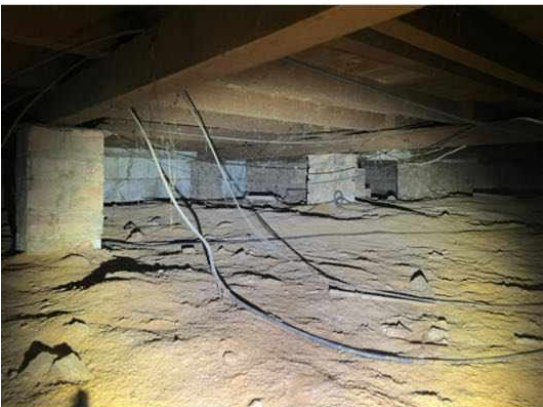
### Finding 3.06

Building:	Main Building
Location:	Subfloor
Finding:	Subfloor Moisture , Efflorescence and excessive debris
Information:	Debris , efflorescence and visible damp staining were observed along the lower brickwork within the subfloor, indicating active or historic rising damp.

The presence of salt deposits and discolouration suggests that moisture is migrating through the masonry via capillary action, likely due to inadequate subfloor drainage or ventilation

These conditions may contribute to further degradation of mortar joints, promote mould growth, and increase the risk of timber pest activity if left unaddressed. Elevated moisture was also noted in the subfloor timbers along with moisture staining to some areas.

The area should be further assessed by a damp remediation specialist, and improvements to subfloor ventilation and moisture control are recommended

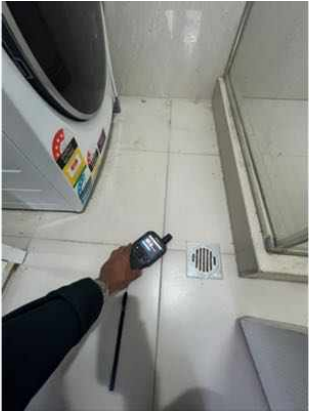
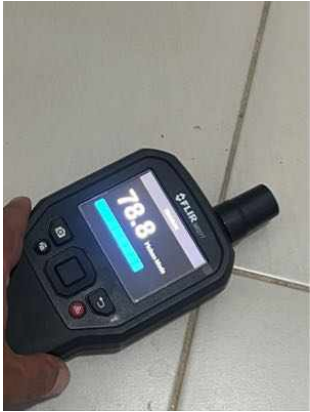
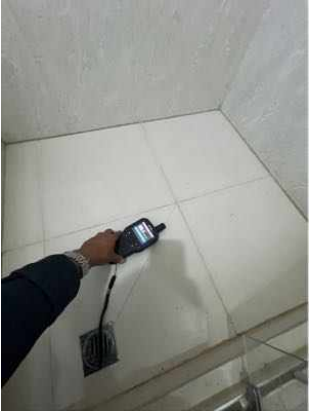
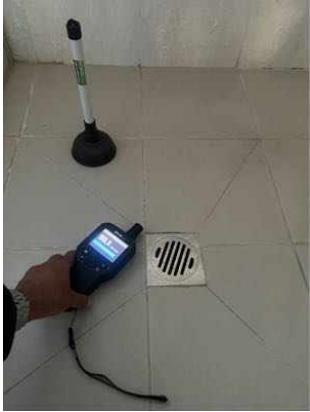
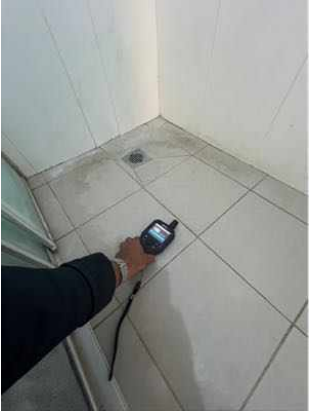
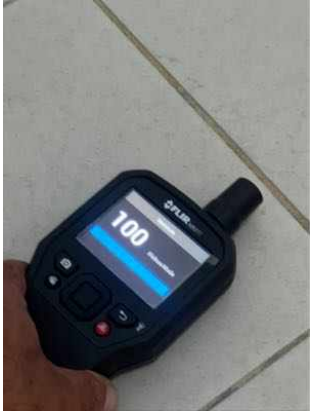
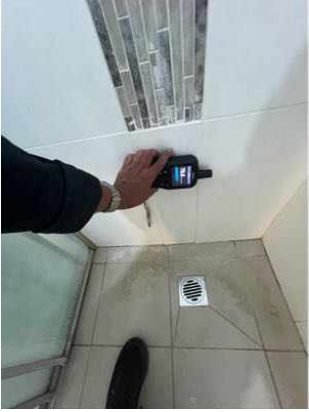
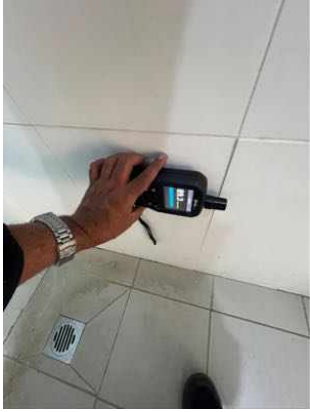
### Finding 3.07

Building:	Main Building
Location:	Bathrooms
Finding:	Elevated Moisture Bathroom
Information:	Elevated moisture levels were detected to tiled surfaces in bathroom/shower areas. Persistent moisture ingress can lead to concealed damage, including timber rot and mould growth.

Elevated moisture readings in tiled wet areas can occur from normal shower use, age/deterioration of waterproofing membranes, plumbing leaks or moisture absorption through grout lines. While no damage was visible, elevated readings may indicate moisture retention behind tiles, which can be a conducive condition for future deterioration if not monitored.

Monitor the area over time for signs of drumming, efflorescence, tile movement, or grout deterioration. Further inspection by a licensed waterproofing is recommended (e.g., pressure testing, membrane assessment).

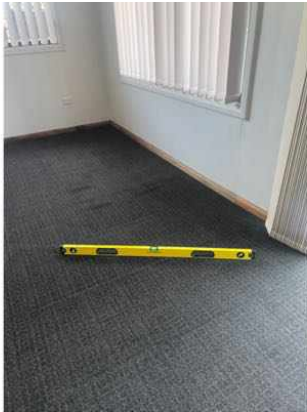
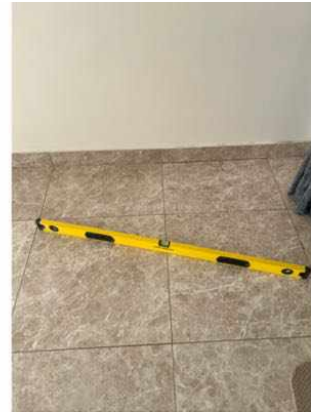
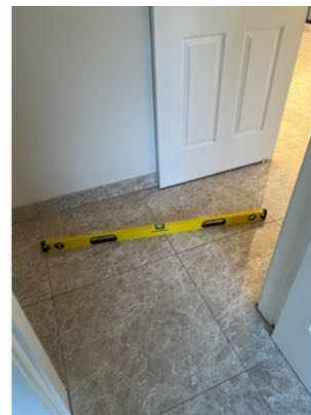
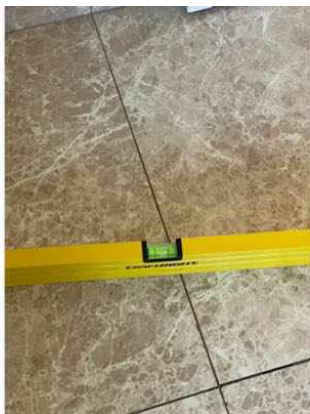
Building: Main Building  
Location: All Internal Areas - lounge , hallway , kitchen , rear lounge  
Finding: Flooring - Uneven to some areas  
Information: The internal flooring in this area is out of level and uneven. Uneven flooring is likely to indicate minor defects such as expected movement of the foundations of the property, but may also indicate subsidence of the associated subfloor stumps.

It is advised that the flooring be closely monitored to identify any further movement. Where flooring remains relatively unchanged for an extended period of time (i.e. several months), it is likely that this defect has been caused by expected movement of the foundations of the property.

However, where flooring is uneven further, potentially invasive inspection of the subfloor structures and stumps in this area is required. In this case, works to repair are likely to be required, and would be carried out by a registered builder specialising in re-stumping.

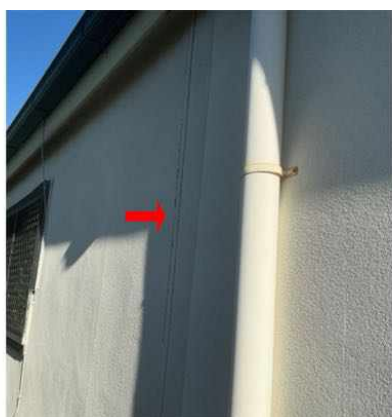
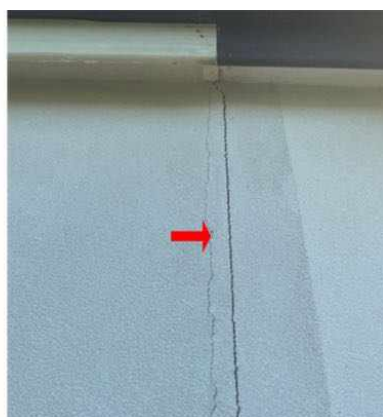
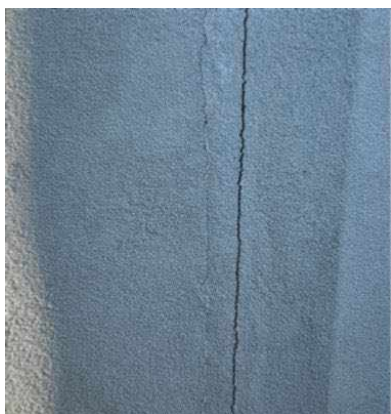
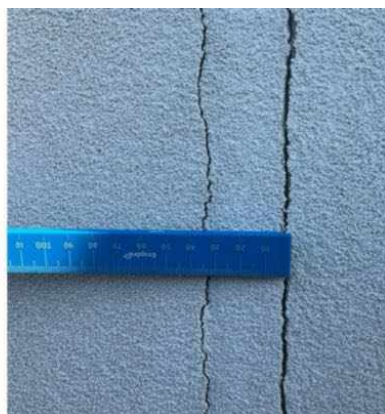
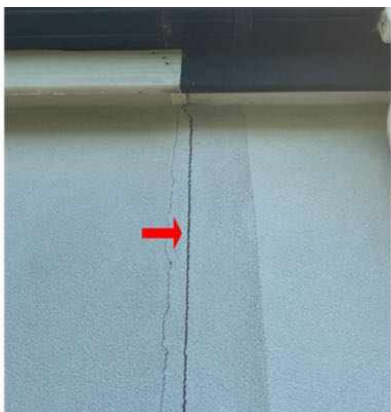
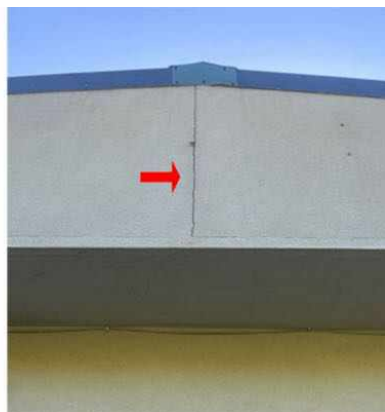
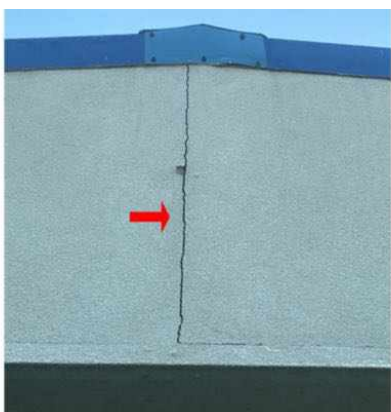
### Finding 3.09

Building:	Main Building
Location:	All External Areas
Finding:	Cracks to render - Category 2
Information:	It has been observed that cracking to internal rendered surfaces has occurred. The degree of damage falls within Category 2, described as noticeable cracks which are easily filled. Cracking of this size are generally less than 5mm in width.

Category 2 damage is required to be monitored for a period of 12 months. After the monitoring period, a crack rated at Category 2 or above is considered a defect requiring rectification, such cracking may also allow moisture ingress over time if left unsealed.

Sealing and maintenance of the coating system is recommended to maintain weatherproofing performance.

Always contact your building inspector should cracks widen, lengthen, or become more numerous.

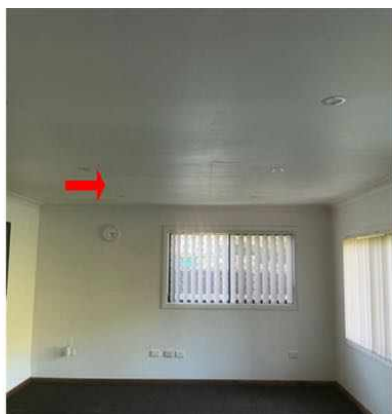
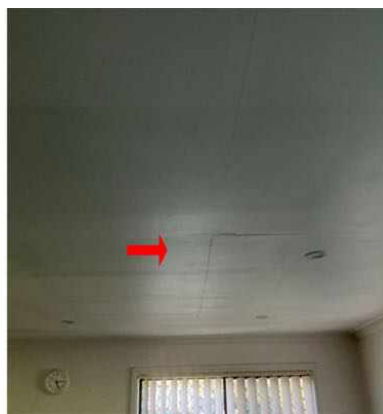
### Finding 3.10

Building:	Main Building
Location:	All Internal Areas - Rear lounge
Finding:	Ceiling - Sagging
Information:	Sections of the ceiling were found to be sagging at the time of inspection. Sagging to the fixed ceiling structure generally indicates that the building materials have swollen, due to contact with water, or that fixings (e.g. nails or glue) have become loose and require reattachment.

Where minor sagging is evident, comparatively minor works, such as re-gluing of ceiling sheets, may be required. Such works may be performed by relevant tradespeople, such as plasterers and painters. Where excessive moisture has caused

the roofing structure to swell and sag, the source of the water leak should primarily be identified prior to any remedial works being performed.

In some cases, sagging ceiling linings may also indicate that there are structural issues, causing surfaces to warp, twist or sag. Where sagging appears to be major, appointment of a structural engineer is advised to further inspect the property and identify the source and rectification works required.

The appropriate action should be taken by the client as soon as possible to ensure that any potential further damage is limited.

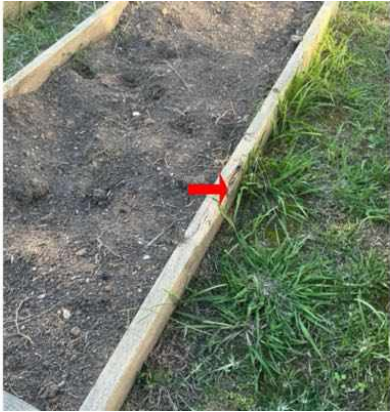
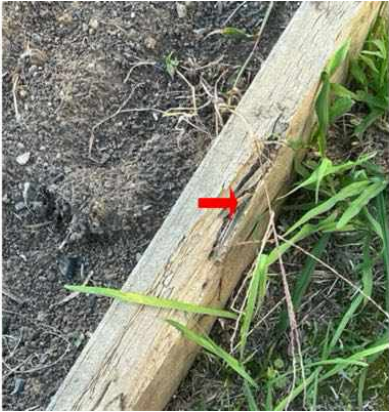
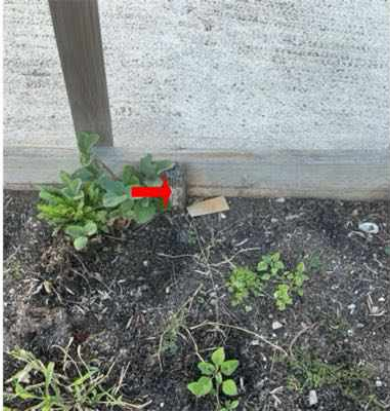
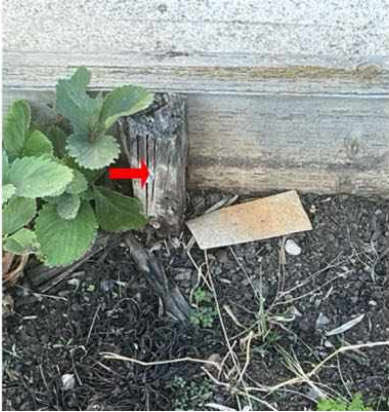
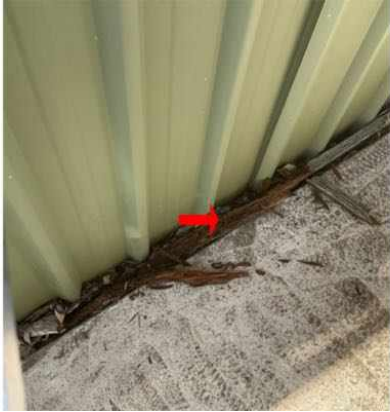
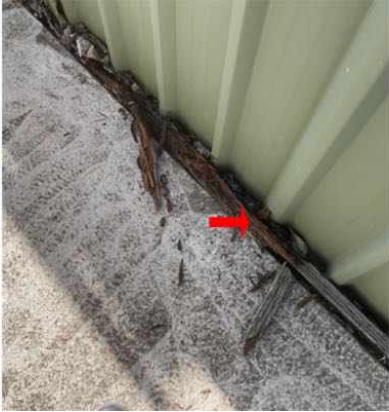
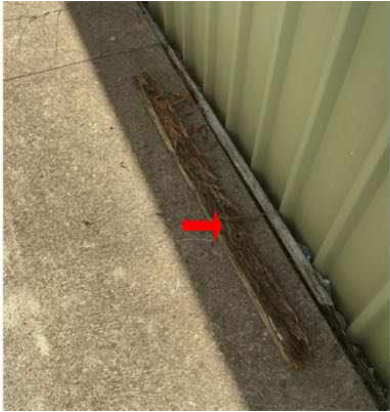
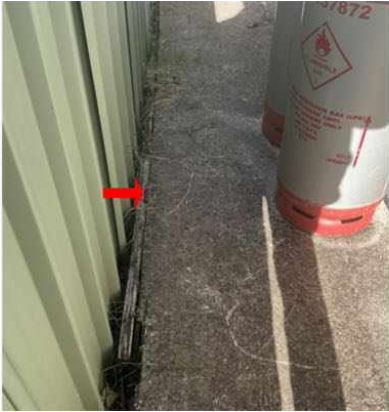
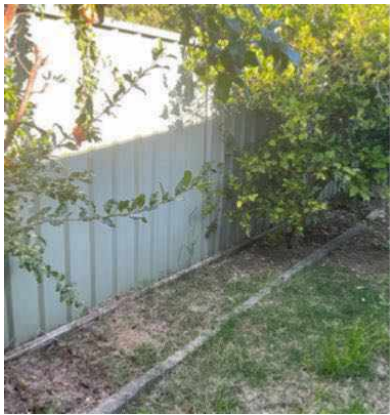
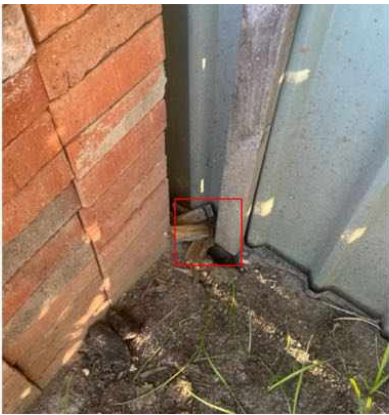
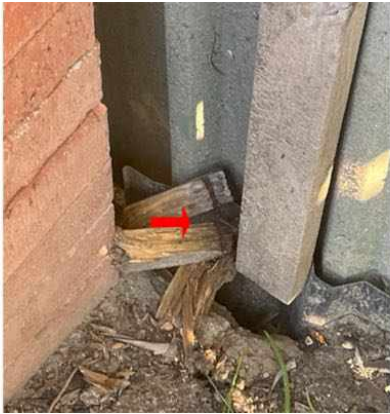
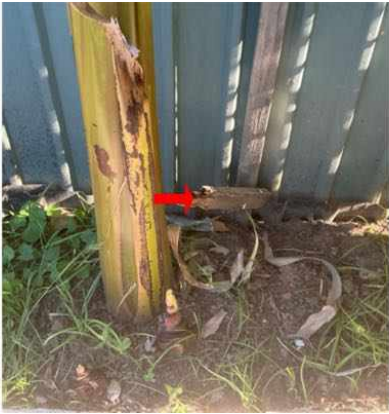
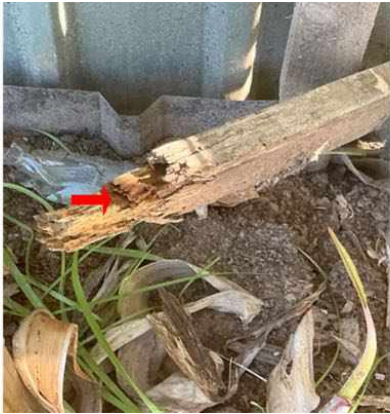
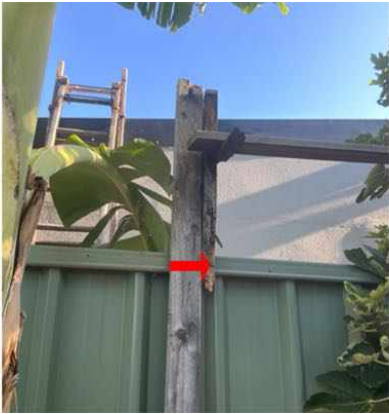
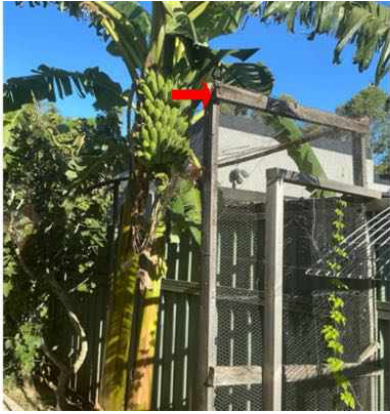
Building:	Main Building
Location:	All External Areas
Finding:	Wood rot to some areas
Information:	This building element shows evidence of wood rot. Wood rot, also known as Fungal Decay, occurs when timbers and other cellulose building materials are exposed to damp conditions on an ongoing basis. This could be the result of exposure to weathering over a prolonged period of time, or the attraction of excessive moisture from other abutting building materials. Contributing factors also include poor air ventilation in the area.

Wood rot is often associated with general damp problems and is evidenced by a 'musty' smell or mould and mildew occurring on surfaces. If left unmanaged, damp conditions can lead to further health problems and the decay of timbers will continue.

Early intervention and regular maintenance, particularly of exterior timbers, will prolong the useful life of these building elements. Prior to any works being performed, the cause of the moisture that has created the visible wood rot should be identified and addressed in a suitable manner. Replacement of affected timbers may then be a necessary step in protecting surrounding building elements from such deterioration.

A qualified plumber may be appointed to assess the cause of excessive moisture and to provide advice on any remedial works as required. A qualified carpenter or registered builder may also be required to replace affected building materials.

Even though Liverpool termite activity was not visible. A further invasive inspection by a licensed termite technician its also highly recommended to eliminate possibility of potential termite activity.

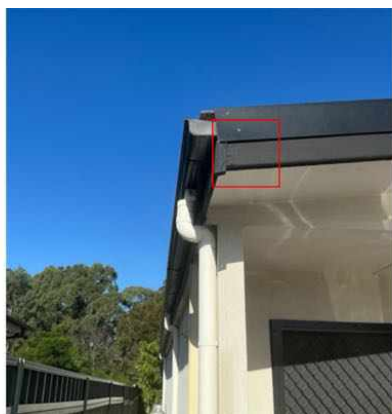
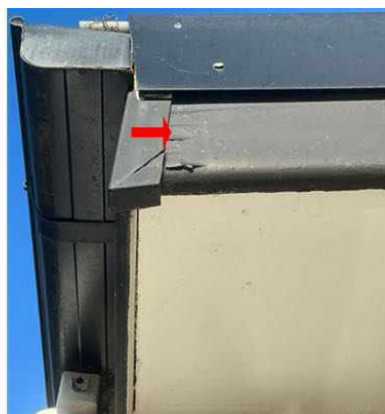
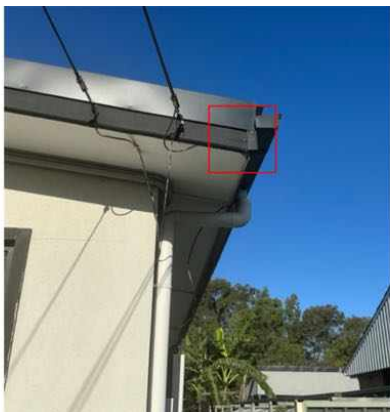
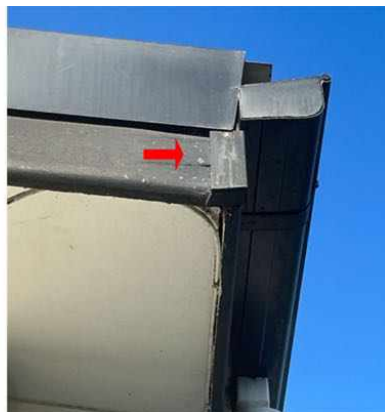
Finding 3.13

Building:	Main Building
Location:	All External Areas
Finding:	Fascias - Wood rot
Information:	Wood rot was found to be affecting fascias and barges in this area, evidenced by the presence of mould on the surface in some areas. Wood rot, also known as Fungal Decay, occurs when timbers and other cellulose building materials are exposed to damp conditions on an ongoing basis.

It is likely that this wood rot has developed as a result of faults in the roof plumbing, creating excessive moisture in this areas. Frequent exposure to rain and other weather conditions also make fascias and barges susceptible to accelerated deterioration.

Early intervention and regular maintenance will prolong the useful life of these building elements. Prior to any works being performed, the cause of the moisture that has created the visible wood rot should be identified and addressed in a suitable manner.

It is advised that a roof plumber be appointed to inspect all roof plumbing and subsequently identify the cause of the wood rot. Replacement of affected fascias and barges may then be a necessary step in protecting surrounding building elements from such deterioration.

A qualified plumber may be appointed to assess the cause of excessive moisture and to provide advice on any remedial works as required. A qualified carpenter or registered builder may also be required to replace affected building materials.

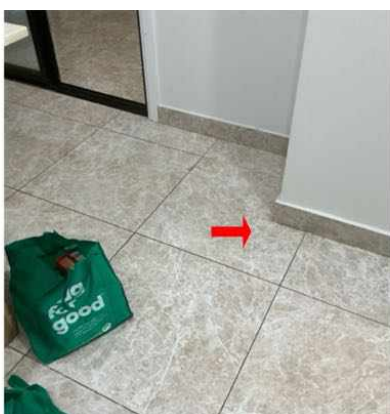
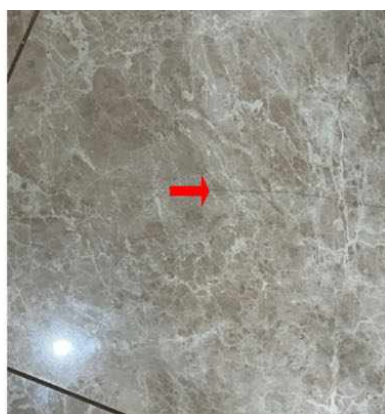
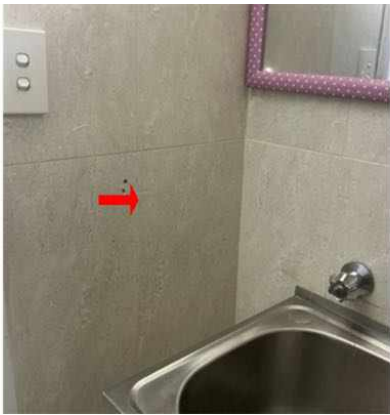
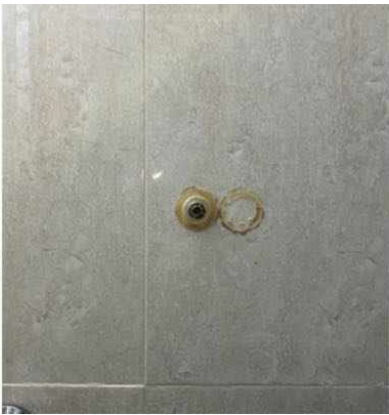
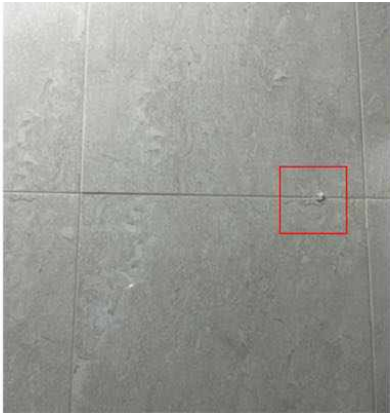
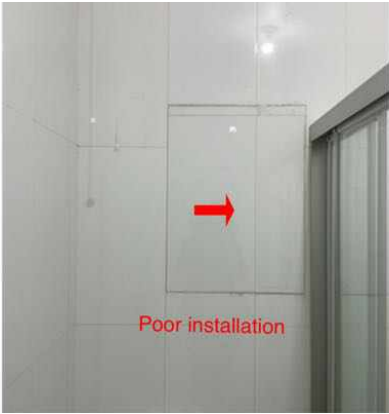
### Finding 3.14

Building:	Main Building
Location:	All Internal Areas
Finding:	Tiles - Cracked or damaged and poor installation to some areas
Information:	Cracking was evident to the tiling in this area at the time of inspection. While the cracking appears to be minor, this area is frequently exposed to water, allowing potential for water penetration into adjoining sections of walls or flooring.

If left unmanaged, water penetration to these areas may lead to subsequent water damage, which is likely necessitate repair work to affected building elements.

A tiling contractor should be appointed to ensure that no further water damage occurs. The re-application of silicone and grouting throughout remaining tile work is also advised, to further protect the area against water penetration.

Where water penetration has led to water damage, appointment of a relevant tradesperson may be required to repair damaged building elements.

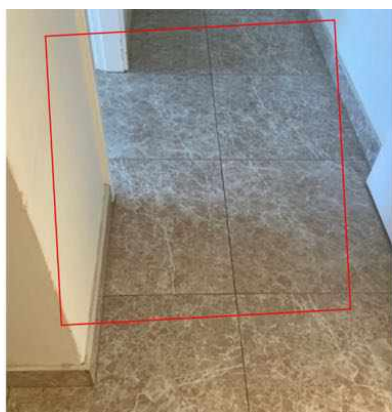
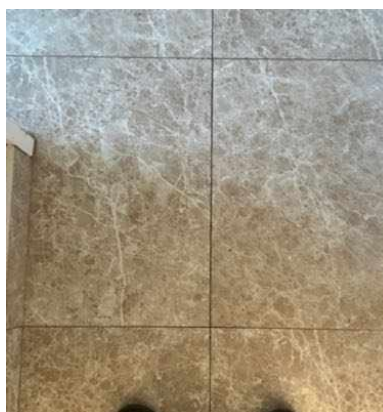
Building:	Main Building
Location:	Hallway
Finding:	Tiles - Drummy
Information:	Drummy tiled areas were identified at the time of inspection. The term 'drummy' refers to tiles that have become detached from their fixing, despite otherwise being in relatively good condition. Such defects are generally caused by physical or moisture damage to the area. Drummy tiled areas may also be a direct result of poor workmanship during the construction process.

Tiled areas may swell and shrink with changes in air humidity if the area has sustained moisture damage. Any exposure to moisture is capable of causing tiled areas to become drummy and/or cracked over a prolonged period of time. Drummy tiled areas generally require removal and replacement of affected tiles, with adequate sealant and grouting.

Specialist trades are available for these types of services. A registered builder may be required to undertake works if damage is extensive or if secondary building defects have resulted. Otherwise, it is advised that a tiling contractor be appointed to perform works as necessary. Immediate action is recommended to ensure that no further damage is sustained in the affected area.

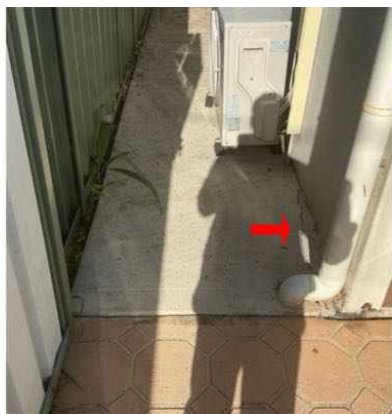
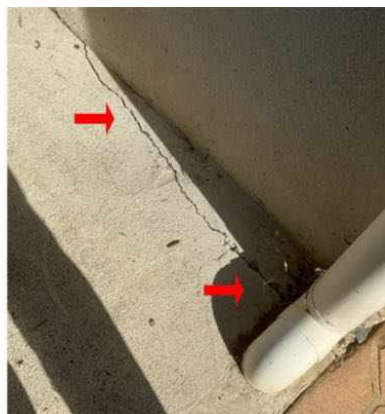
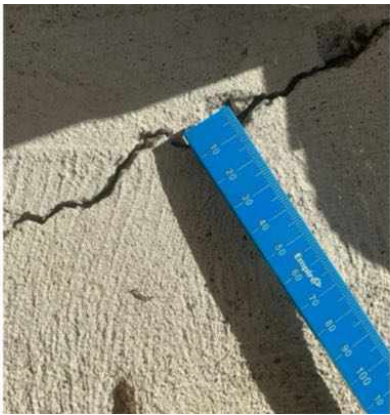
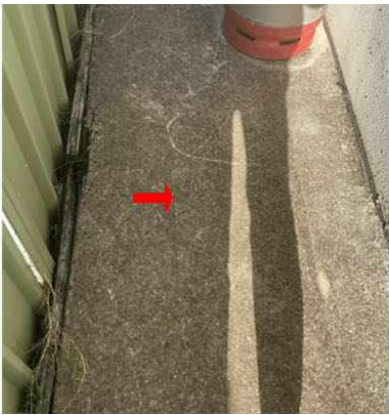
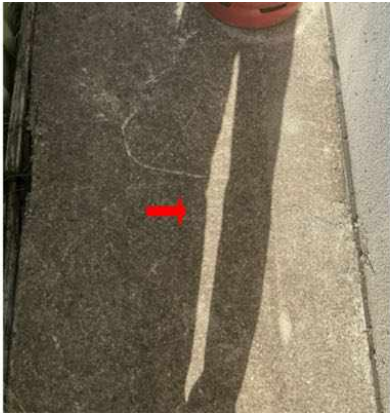
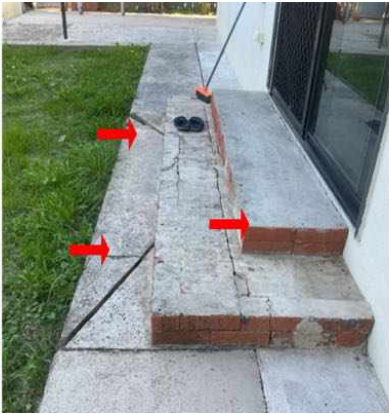
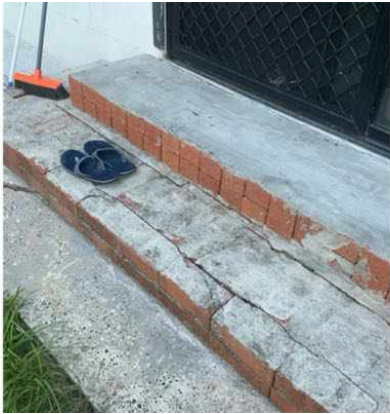
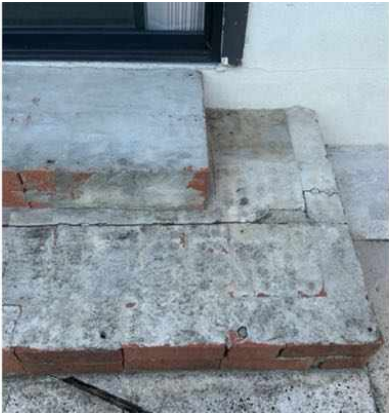
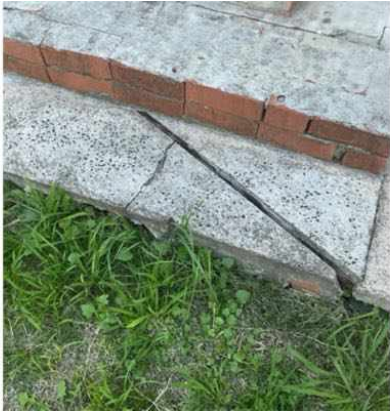
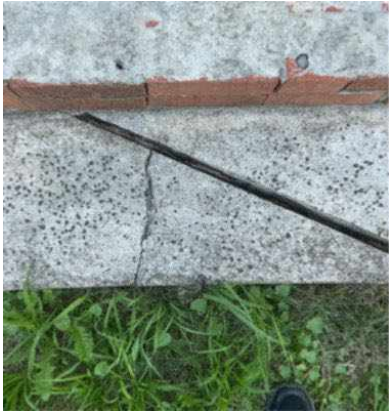
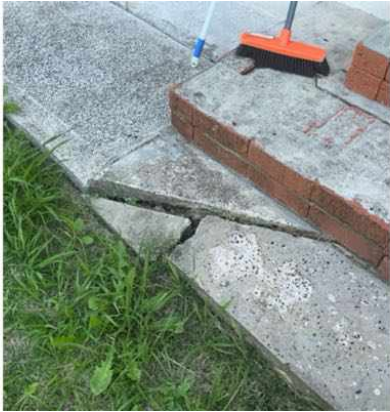
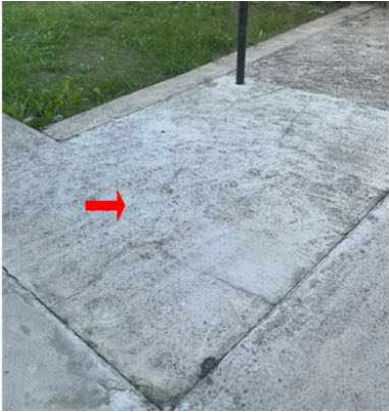
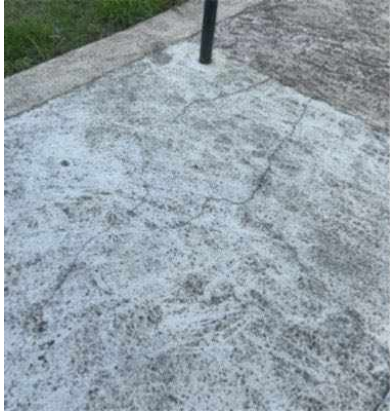
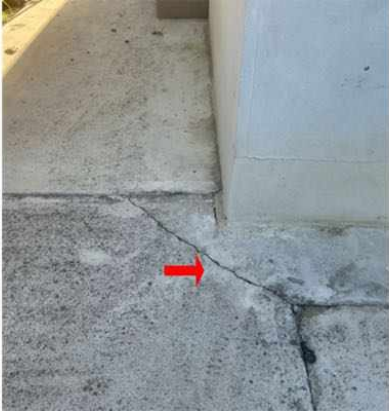
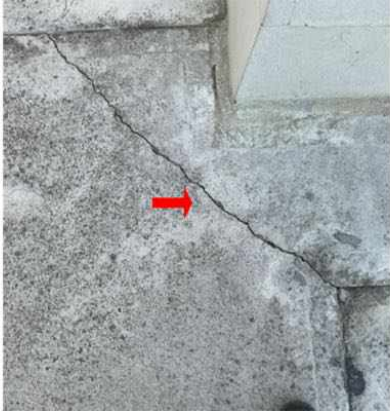
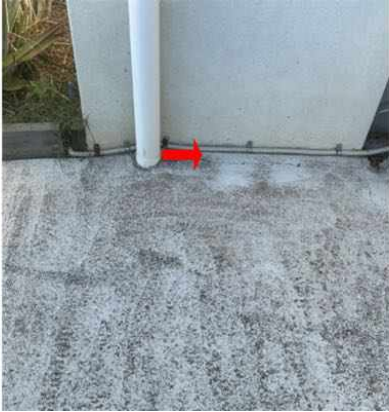
Building:	Main Building
Location:	All External Areas
Finding:	Cracking - External Concrete Paving Damage Category 4 - Gaps in Slab (4mm - 10mm +) to some areas
Information:	Gaps in the slab were identified in external concrete paving. Gaps in the slab are significant and are likely to lead to the development of safety hazards and secondary defects if left unmanaged, such as the creation of a trip hazard.

General age and expected deterioration of the paved areas is a common cause of this type of cracking. However, expansion and contraction of the slab may also have occurred due to environmental factors. Such factors include variable moisture and weather conditions, the presence of trees and their roots having a settling or lifting affect on the soil, or the effect of load bearing, e.g. heavy vehicles over a sustained period of time.

Cracking to this degree may also be due to poor original installation of the concrete. Factors such as poor compaction of the sub surface and/or inadequate reinforcing of the slab may create cracking and other secondary defects. Gaps in the concrete paving may also have a more significant structural cause, such as subsidence of soils.

Where gaps in the concrete paving are adjacent to structural elements of the building, the advice of a Structural Engineer is advisable before undertaking repairs. Significant repair and likely replacement of the concrete paving is probable.

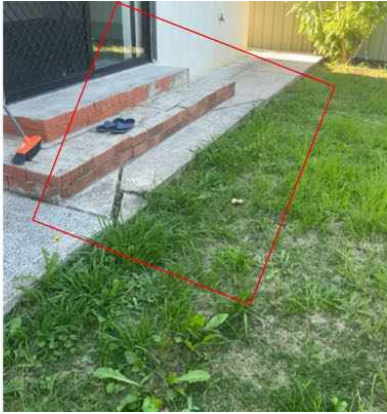
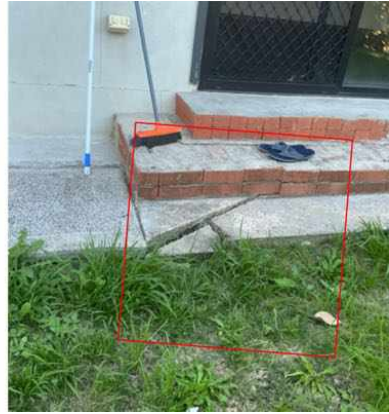
**Finding 3.18**

Building: Main Building  
Location: All External Areas  
Finding: Paving - Uneven to some areas  
Information: Sections of the external paved area are uneven, creating a potential trip hazard. It appears as though the area has been subject to rough installation, or that paving sections have lifted due to movements in the foundation of the property.

Where paving creates a trip hazard, personal injury may ensue if due caution is not taken by all persons within this area.

Re-paving of the area is required as soon as possible to remedy this situation. Further

consultation with a specialist concreter is advised.

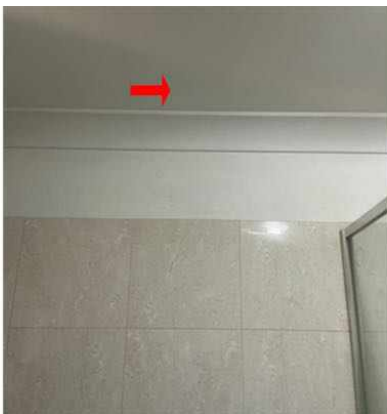
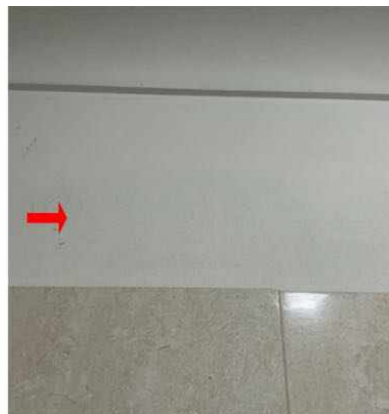
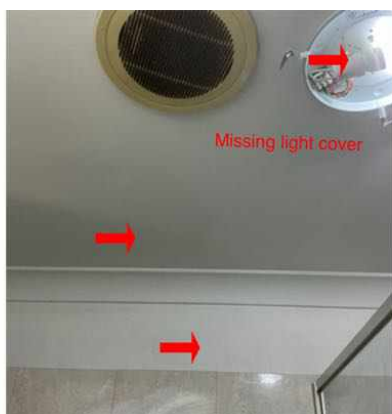
### Finding 3.19

Finding: Water Staining - Humidity or Ventilation

Information: The ceiling surface shows faint darkened spotting or shadowing, commonly consistent with surface mould or humidity-related staining, often found in bathroom or wet area ceilings with insufficient ventilation. While there is no visible sagging or major water damage, the pattern suggests prolonged moisture exposure, possibly due to steam accumulation or minor condensation issues. According to AS 4349.1–2007 (Appendix C), this would be classified as a minor defect unless further deterioration or active leaks are found. Recommend improving mechanical or natural ventilation, cleaning the surface with mould treatment, and monitoring for recurrence.

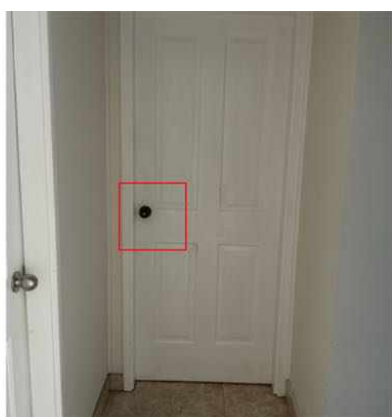
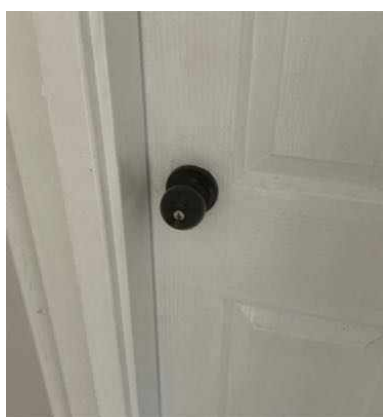
### Finding 3.20

Building:	Main Building
Location:	Bedroom - Side
Finding:	Doors - Binding/Jamming
Information:	Binding and/or jamming of several doors throughout the property were evident during standard operation. This defect inhibits the functionality of affected doors as well as creating potential for secondary defects to associated building elements, such as damage to the floor covering.

A door that binds to flooring or to the associated door frame may have several causes, ranging from minor defects, such as poor installation of the door or deteriorated hinges, through to major structural issues, such as damage to subfloor structures.

Where door binding/jamming appears to indicate major structural issues, a registered builder specialising in re-stumping should be appointed to provide an estimate on the cost of rectification.

For minor causes, a qualified carpenter or general handyperson should be appointed to perform minor rectification works at client discretion.
