# Building and Timber Pest Inspection Report

Inspection Date: Wed, 1 Apr 2026

Property Address: 98 Willan Dr, Cartwright NSW 2168,  
Australia

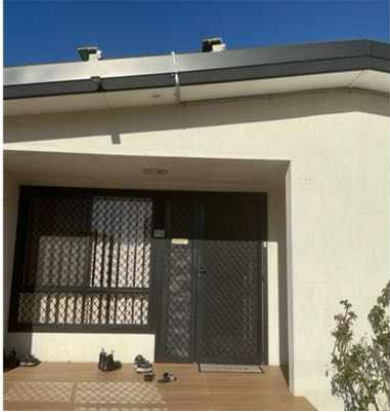
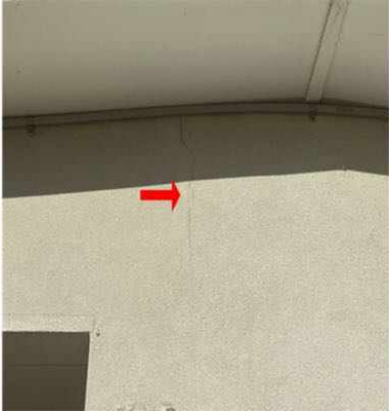
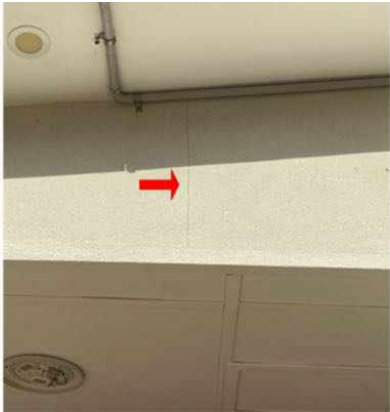
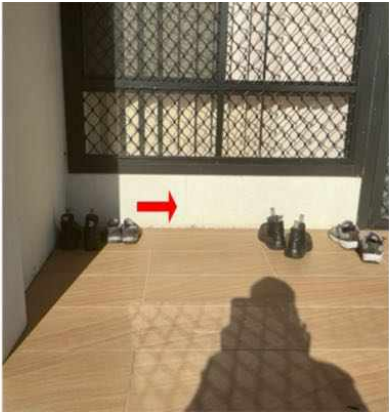
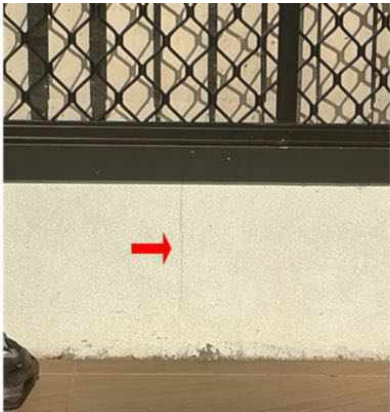
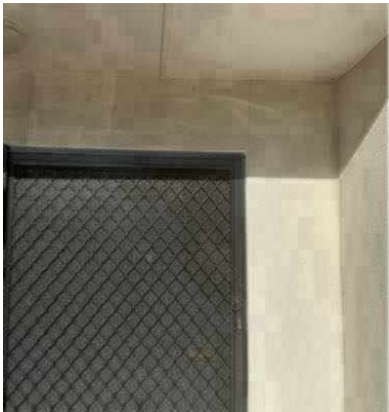
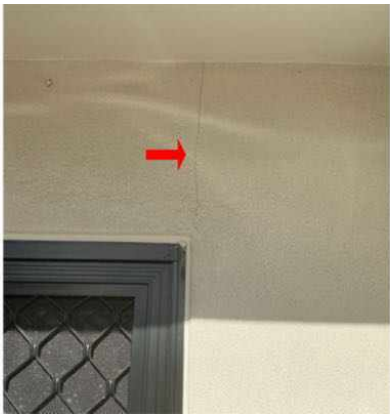
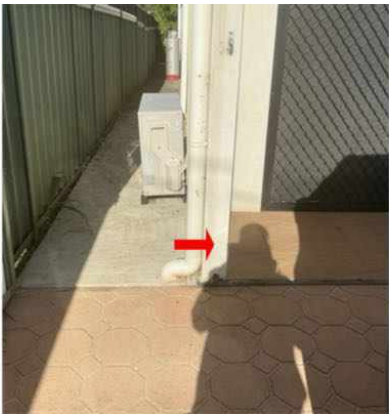
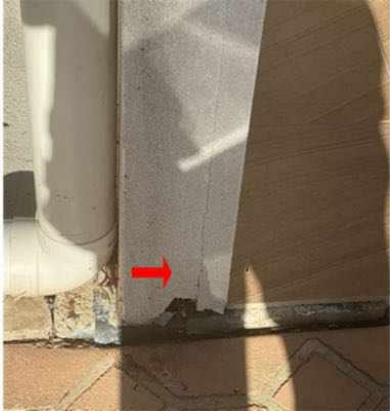
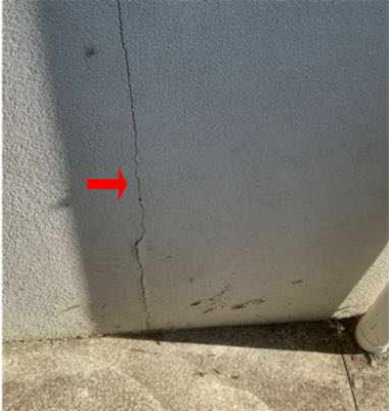
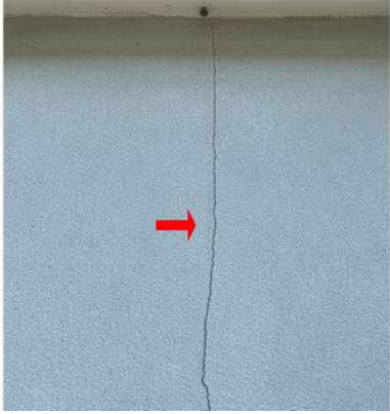
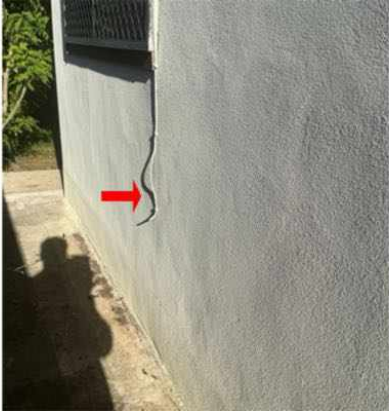
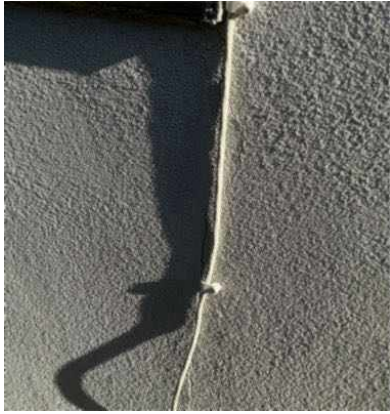
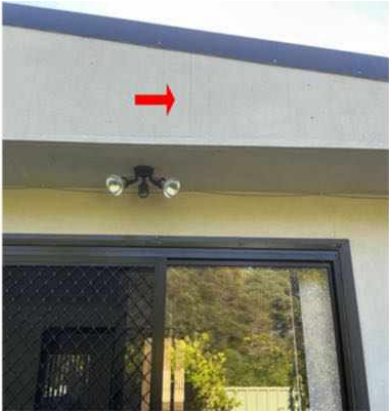
### Finding 3.21

Building: Main Building  
Location: All External Areas  
Finding: Cracks to render - Category 1  
Information: Minor hairline cracking was observed to the lightweight cladding/rendered surface. While typical of this type of construction, such cracking may allow moisture ingress over time if left unsealed. Sealing and maintenance of the coating system is recommended to maintain weatherproofing performance.

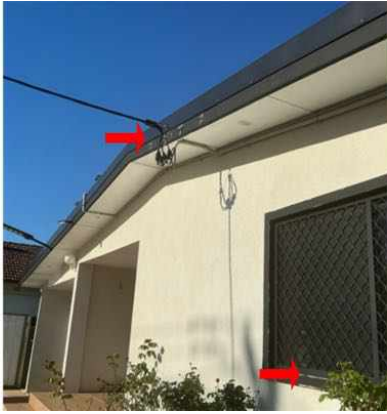
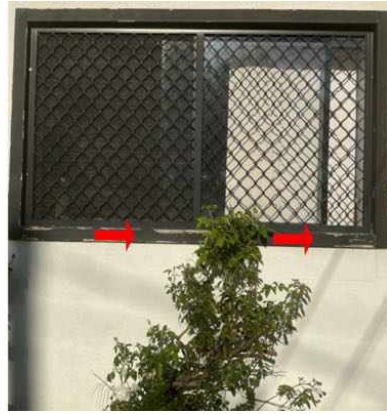
### Finding 3.22

Building:	Main Building
Location:	All External Areas
Finding:	External painting deteriorated to some areas
Information:	Whilst incomplete or missing paint finish is generally an appearance defect, it can also lead to the development of secondary building defects over time. Incomplete areas of paint finish expose the area to moisture, potentially accelerating the deterioration of underlying building materials.

Degraded paint finishes should be sanded back, filled, leveled and painted, as applicable. Where inadequate or missing paint protection has led to the deterioration of the associated building element, repair and/or replacement of this building element may be required.

A painting contractor should be appointed as soon as possible to perform necessary works to aid the appearance of the affected area and to ensure the area is protected against further deterioration. Alternatively, the homeowner following manufacturer instructions may perform these works.

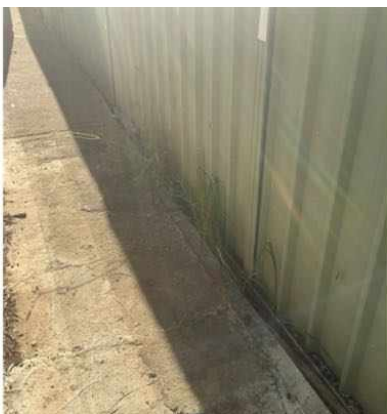
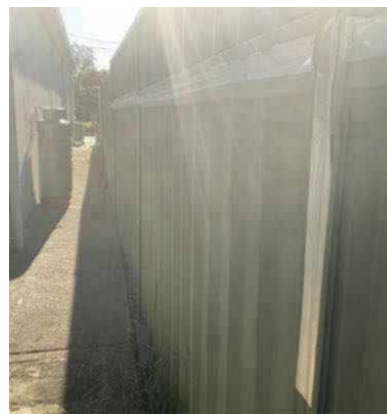
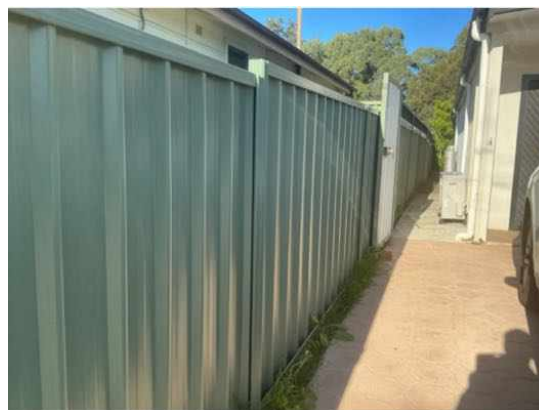
### Finding 3.23

Building:	Main Building
Location:	All External Areas
Finding:	Site drainage - Inadequate to some areas
Information:	The site drainage in this area was found to be inadequate at the time of inspection, creating potential for subsequent water damage to associated building elements.

It is important that water does not lie against the base of walls; surrounding paths and ground levels should be sloped to drain water away from walls. Downpipes should not discharge stormwater onto lower walls or plinths. Stormwater should be carried away by large, regularly cleaned drains. Ground levels may need to be lowered to expose a buried DPC.

Where site drainage is inadequate, installation of an Agricultural (Aggie) Drain may be required. A qualified plumber should be appointed to further inspect the property and perform any remedial works as necessary. Water damage and secondary defects are likely to occur if left unmanaged.

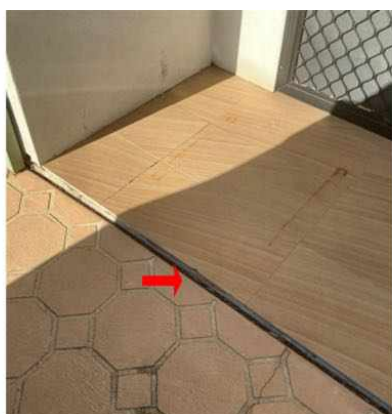
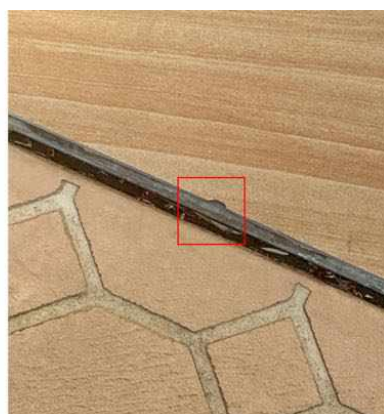
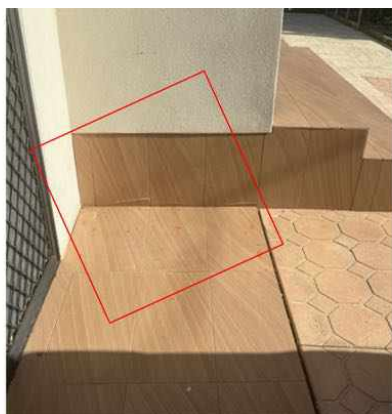
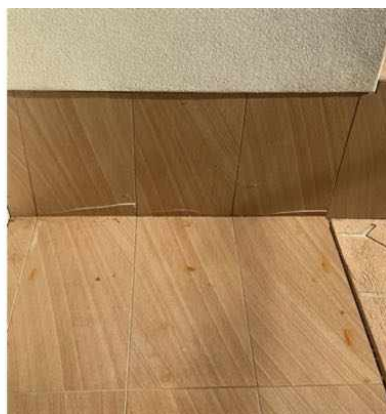
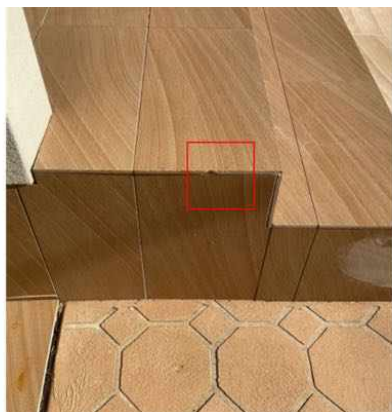
### Finding 3.24

Finding: Tiles - Cracked or damaged to some areas

Information: Cracking was evident to the tiling in this area at the time of inspection. While the cracking appears to be minor, this area is frequently exposed to water, allowing potential for water penetration into adjoining sections of walls or flooring.

If left unmanaged, water penetration to these areas may lead to subsequent water damage, which is likely necessitate repair work to affected building elements.

A tiling contractor should be appointed to ensure that no further water damage occurs. The re-application of silicone and grouting throughout remaining tile work is also advised, to further protect the area against water penetration.

Where water penetration has led to water damage, appointment of a relevant tradesperson may be required to repair damaged building elements.

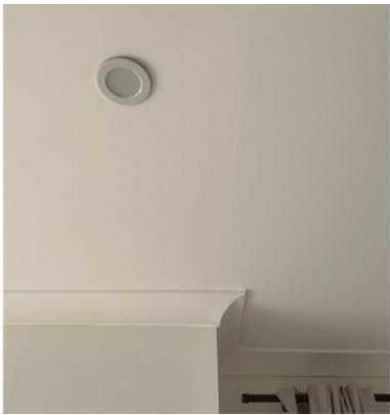
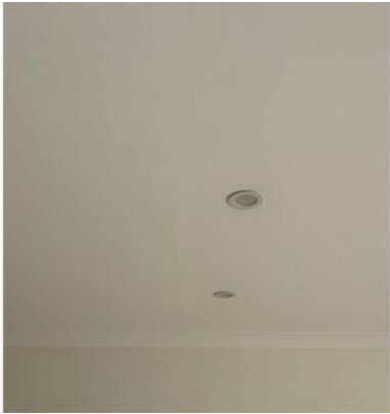
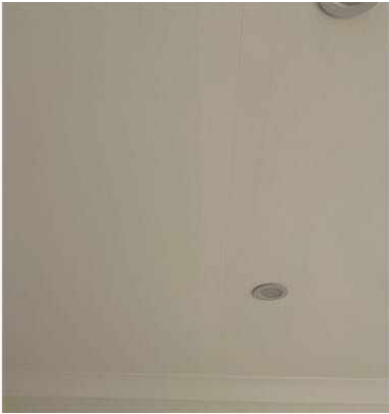
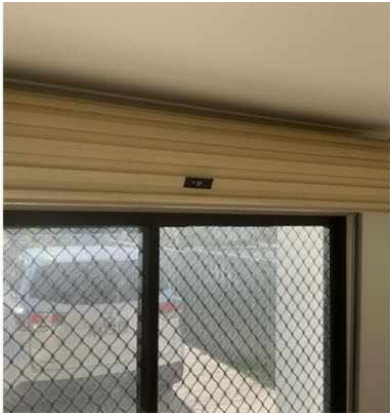
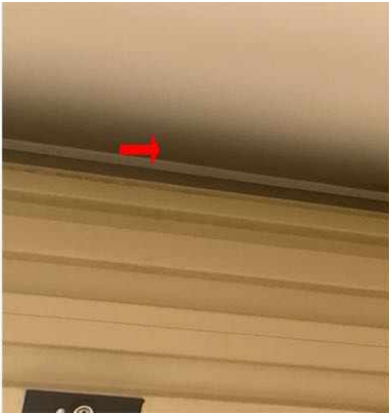
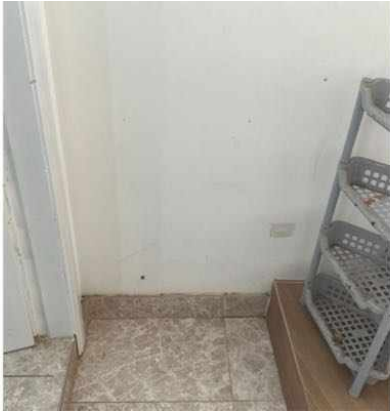
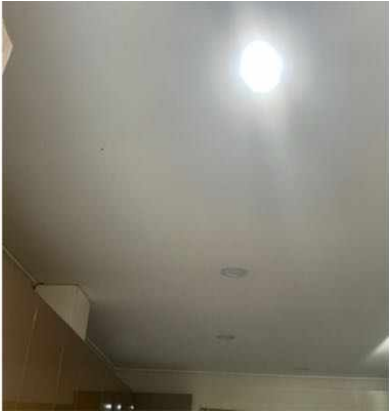
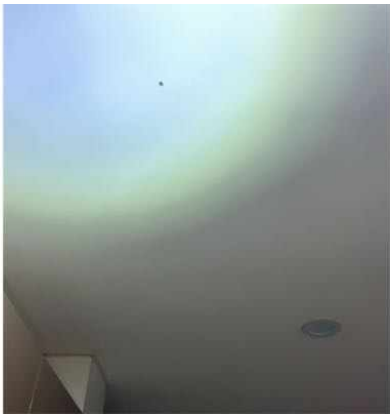
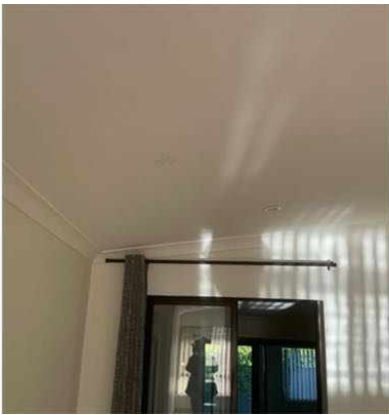
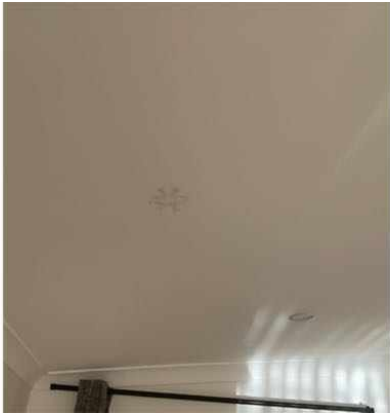
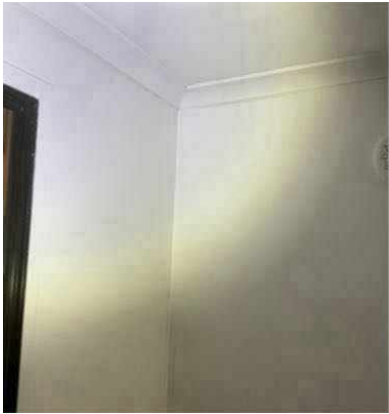
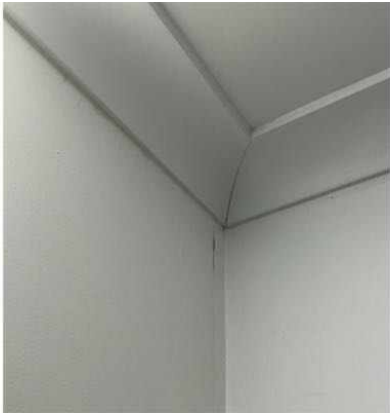
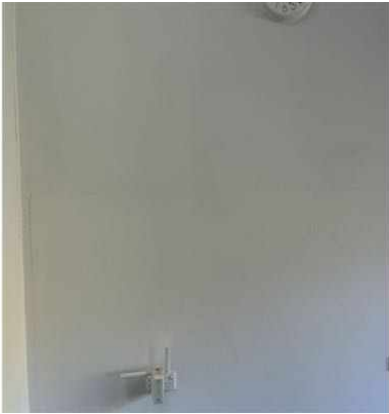
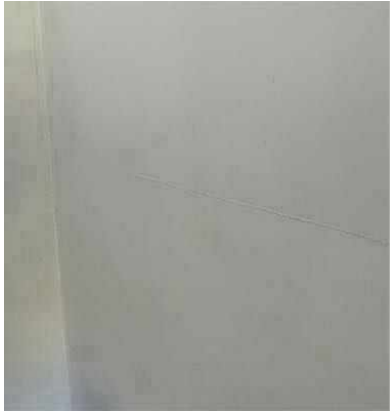
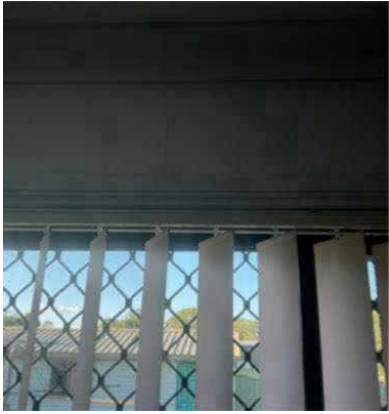
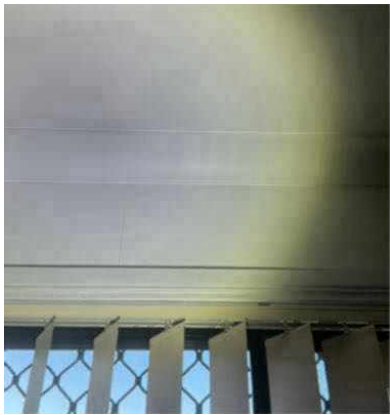
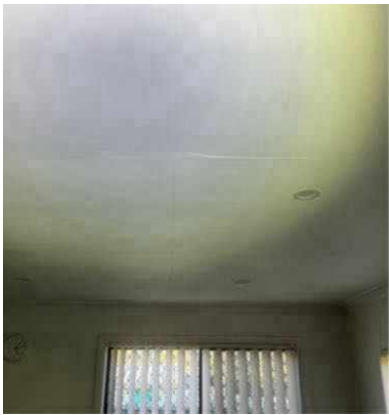
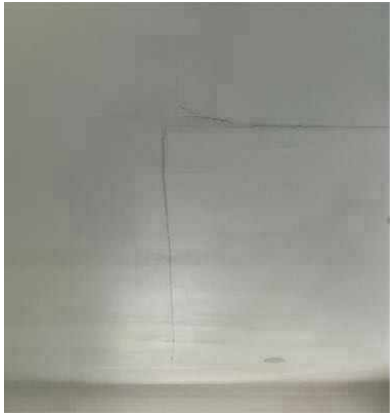
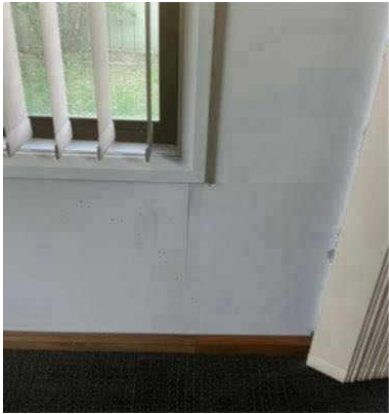
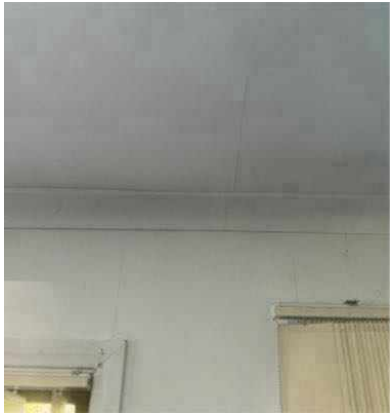
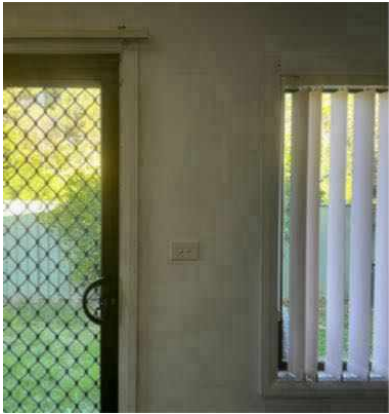
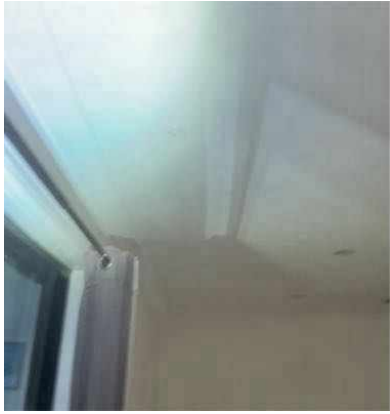
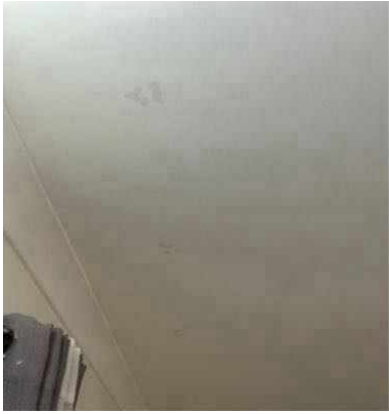
### Finding 3.25

Building:	Main Building
Location:	All Internal Areas
Finding:	Paint Finish & Hairline Cracking - To some areas
Information:	The paint finish in this area was identified as being incomplete at the time of inspection including some hairline minor cracking.

Whilst incomplete or missing paint and minor cracking and imperfections in finish is generally an appearance defect, it can also lead to the development of secondary building defects over time. Incomplete areas of paint finish expose the area to moisture, potentially accelerating the deterioration of underlying building materials.

Incomplete paint finishes should be sanded back, filled, leveled and painted, as applicable. Where inadequate or missing paint protection has led to the deterioration of the associated building element, repair and/or replacement of this building element may be required.

A painting contractor should be appointed as soon as possible to perform necessary works to aid the appearance of the affected area and to ensure the area is protected against further deterioration. Alternatively, the homeowner following manufacturer instructions may perform these works.

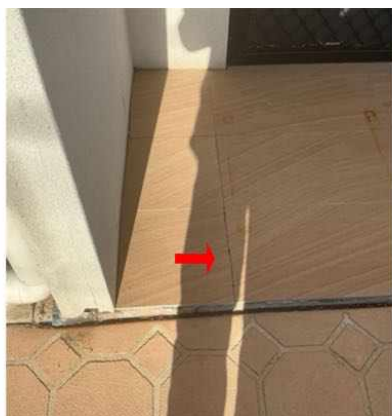
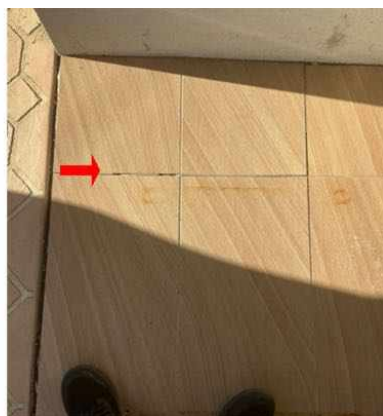
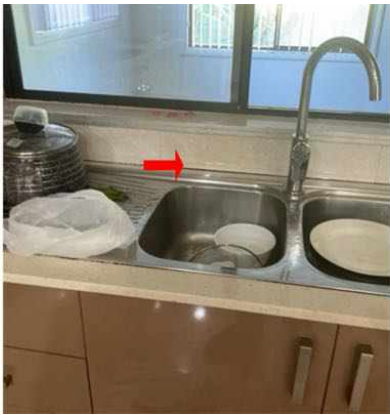
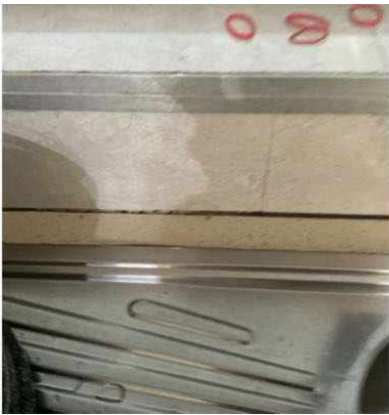
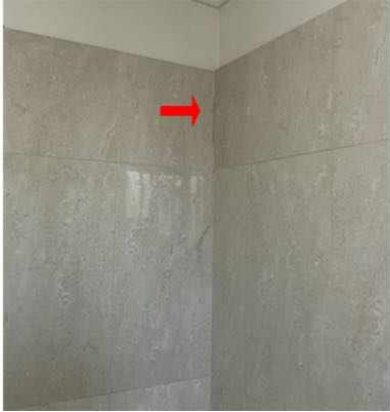
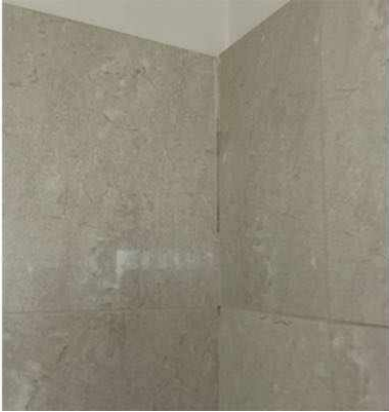
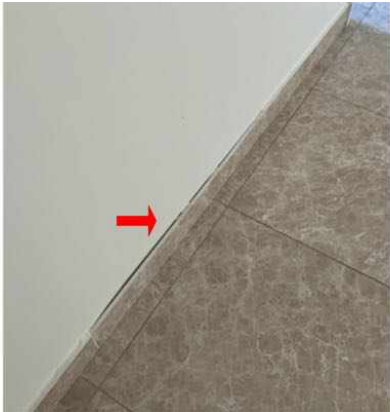
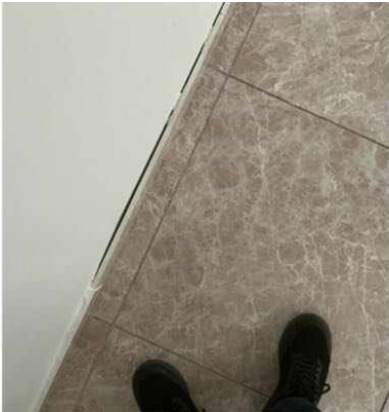
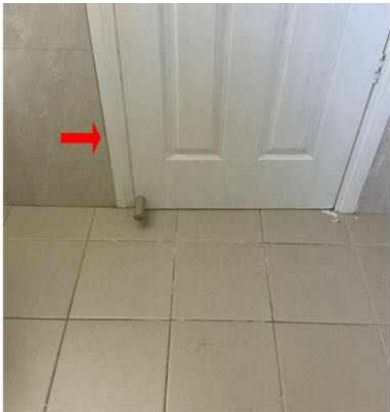
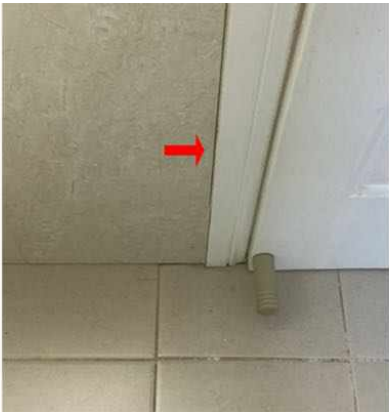
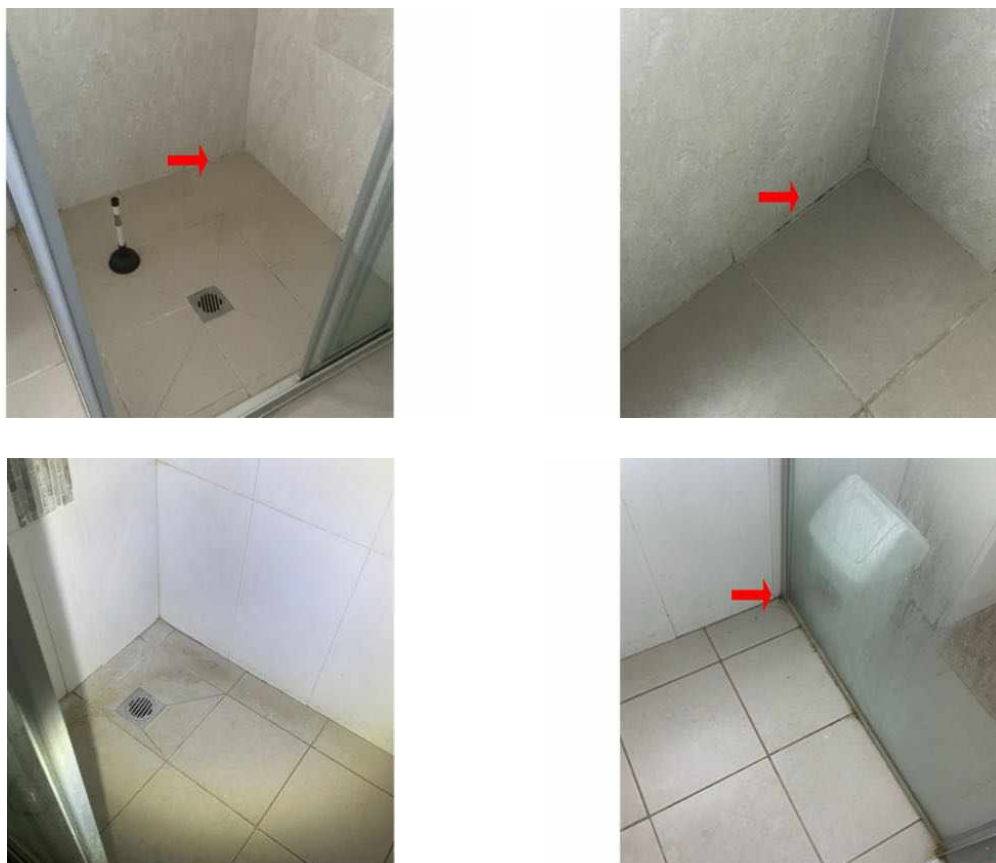
Finding 3.26

Building:	Main Building
Location:	All Internal Areas
Finding:	Sealant and grouting - Missing or degraded to some areas
Information:	It was noted on inspection that sealant or grout is degraded. There is also evidence of poor workmanship and excessive use of sealant. Silicone should never be used as a first line of defence against waterproofing. Further inspection by a licensed waterproofing contractor is highly recommended.

Different materials and floor areas move at different rates, generally causing cracking to grout or sealant at this point. A flexible sealant is required to allow for expected expansion and contraction, while keeping the joint water tight and protective of all associated building materials.

There appears to be excessive mould to the sealant and grout which will likely require scraping out and replacement.

Flexible and mould resistant materials should be applied to affected areas to prevent any subsequent water damage that is likely to occur. Regular maintenance and replacement of damage or missing or damaged sealant and grout is highly recommended to the wet areas, as this is a regular wear and tear defect. Sealant and grouting in areas that come into regular contact with water should be maintained for the long term care of your property.

A sealant specialist or tiling contractor should be appointed to complete these works as soon as possible.

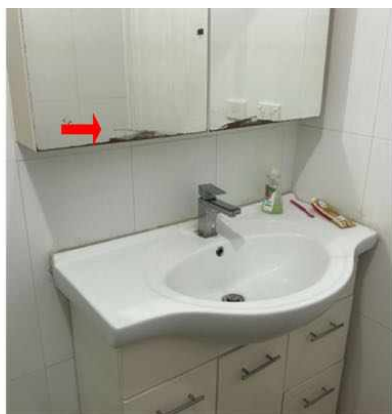
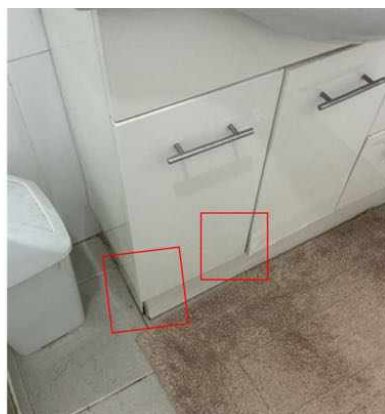
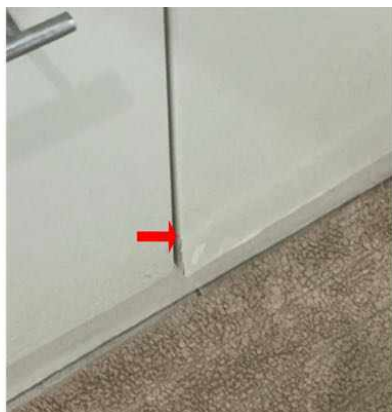
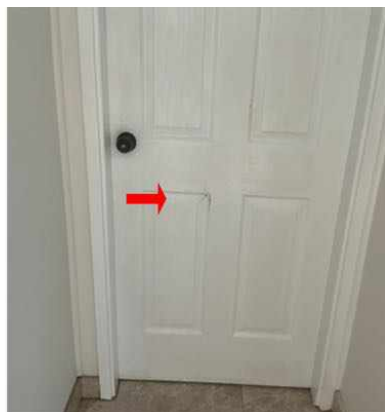
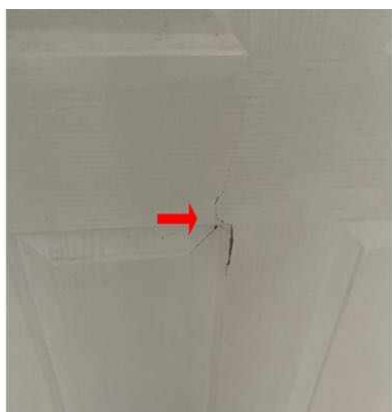
### Finding 3.27

Building:	Main Building
Location:	All Internal Areas
Finding:	Building element - Damaged - Vanity moisture damaged , mirror desilvering bathroom , door damaged bedroom
Information:	Breakage occurs generally when the building materials have either aged and decayed, or as a result of damage (accidental or deliberate).

Repair and/or replacement of broken elements is advised to ensure that additional secondary defects do not arise as a consequence. Such works are necessary, as all building elements play a key role in the operation and function of the overall structure and its performance.

A relevant tradesperson should be appointed to repair or replace the affected building element prior to any subsequent damage being caused.

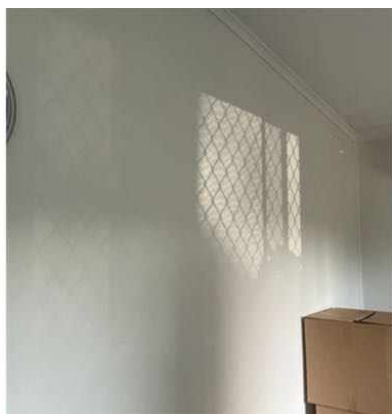
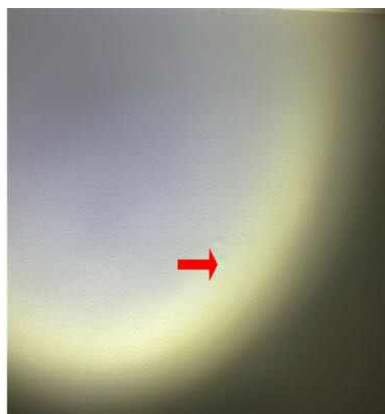
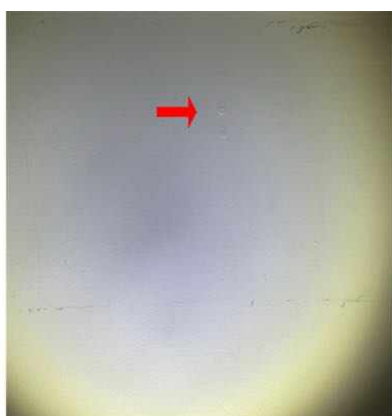
### Finding 3.28

Building:	Main Building
Location:	All Internal Areas
Finding:	Ceiling nails - Popping To some areas
Information:	Numerous popped nails were identified in the internal ceiling at the time of inspection. Nails and screws hold simply by the friction between them and the surface they are applied to. Over time, the nails and screws can back out, which is often a result of general ageing and deterioration of the building structure.

If left unmanaged, the ceiling sheets may become loose and unstable, increasing the rate of deterioration of the internal ceiling and creating potential for the development of secondary defects.

Re-fastening of popped nails will help to maintain the stability of the internal ceiling and associated building elements. Such minor works will also help to improve the appearance of the affected area and secure the ceiling sheets, so as to prevent the onset of ceiling sagging. These works should be performed by a qualified carpenter or plasterer at client discretion.

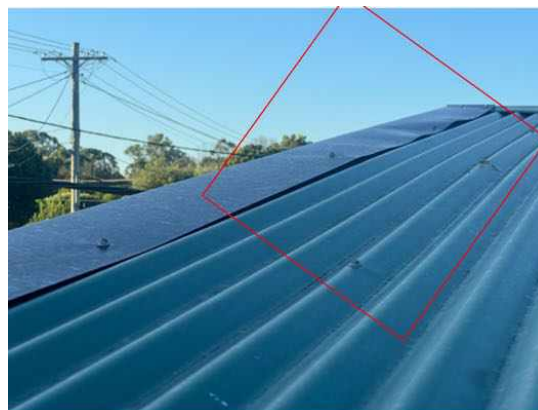
### Finding 3.30

Building:	Main Building
Location:	Roof Exterior
Finding:	Flashing defective - Lifting to some areas
Information:	The metal flashing at the wall junction appears inadequately installed, with visible gaps and lifting and reliance on surface sealant rather than a properly chased and continuous detail. The junction does not appear fully weather-tight, increasing the risk of moisture ingress into the wall cavity or roof structure over time. Defective flashing installation can lead to concealed deterioration if not addressed. Recommend assessment and rectification by a qualified roofing contractor to ensure compliant and effective weatherproofing.

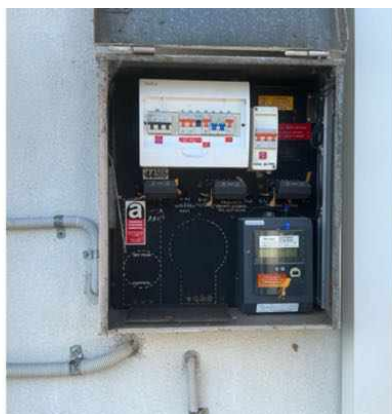
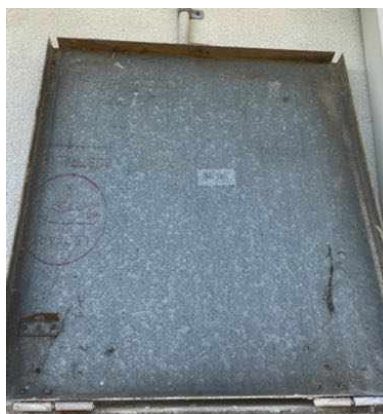
Building:	Main Building
Location:	All External Areas
Finding:	Termite Management System - no evidence of a chemical installation
Information:	The application of a post-construction chemical termite barrier is highly recommended for all properties, particularly if live termite activity has been found on the site previously. Such barriers are highly effective in preventing termite attack on any timber

A durable notice should be placed in the switchboard unit to indicate current termite barriers. At the time of inspection, it appeared as though no termite management system has been installed, with no evidence to suggest preventative works taking place.

The client may consider gaining further advice from a pest controller as to the costs and procedures involved with this application. It is recommended that obtaining such advice be a short-term priority.

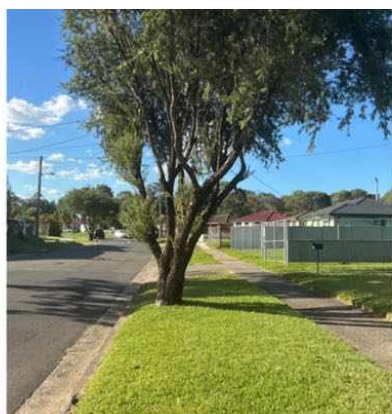
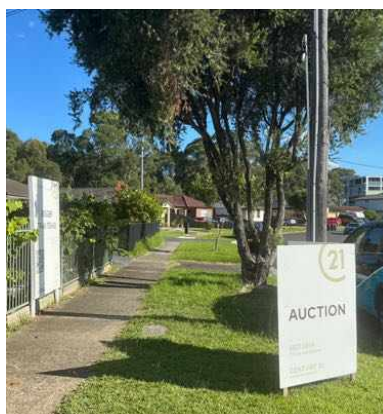
### Finding 6.02

Building:	Main Building
Location:	All External Areas
Finding:	Trees within 50m
Information:	Trees within 50m of the property can be conducive to termite activity. It is recommended an invasive inspection of all trees with 50m to the property be carried out by a qualified pest control expert.

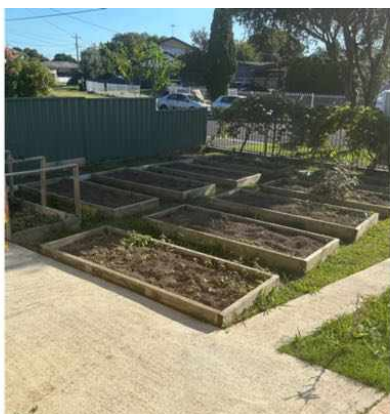
### Finding 6.03

Location: All External Areas  
 Finding: In ground contact - Timber to some areas  
 Information: Any timbers in direct ground contact provide opportunity for concealed termite entry and are likely to be subject to premature rot and decay as the soil retains moisture or damp conditions against the timbers.

Remove untreated timber that is in direct contact with external grounds. Consider replacement with more durable materials i.e. treated timber or non timber elements. Frequent pest inspections are advised to readily identify any termite activity in these areas.

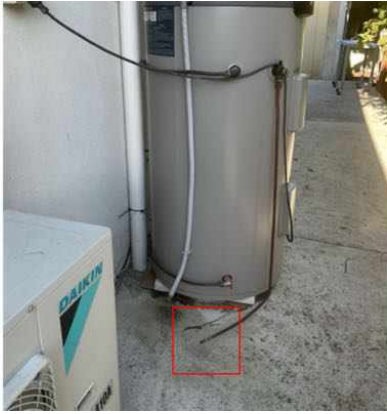
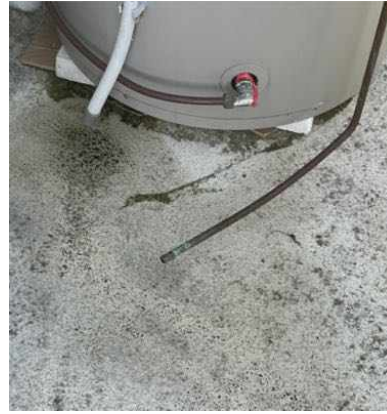
#### Finding 6.04

Building: Main Building  
 Location: All External Areas  
 Finding: HWS Overflow - Not Connected  
 Information: The Hot Water System (HWS) overflow was found to be disconnected from storm water drainage and is creating excessive moisture in the surrounding area.

These damp conditions can lead to secondary defects such as rot, rust or corrosion of associated building elements, the formation of fungal decay, or even the creation of potential slip hazards. When coupled with poor site drainage, pooling of water may also attract termite activity to this area.

It is highly recommended that a licensed plumber be appointed to connect the HWS overflow in order to prevent such an environment from being created. These minor works should be carried out as soon as possible.

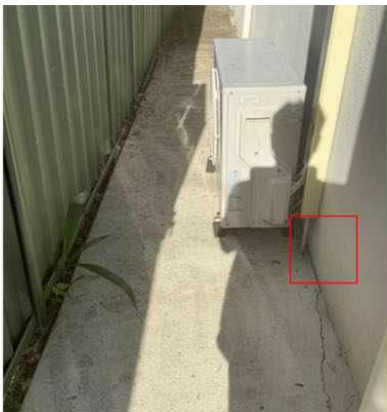
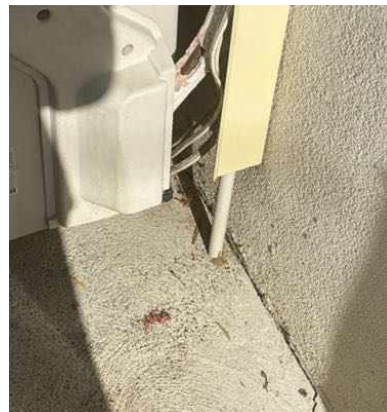
### Finding 6.05

Building:	Main Building
Location:	All External Areas
Finding:	Air conditioner - Disconnected overflow
Information:	The Air Conditioner (A/C) overflow was found to be disconnected from storm water drainage and is creating excessive moisture in the surrounding area.

Such leaking creates an environment which is conducive to an array of defects, including water damage to associated building elements and the attraction of termite or timber pest infestation.

It is highly recommended that a licensed plumber be appointed to connect the A/C overflow in order to prevent such an environment from being created. These minor works should be carried out as soon as possible.

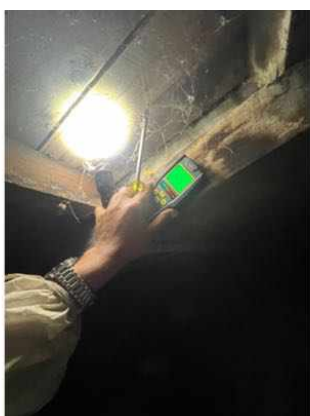
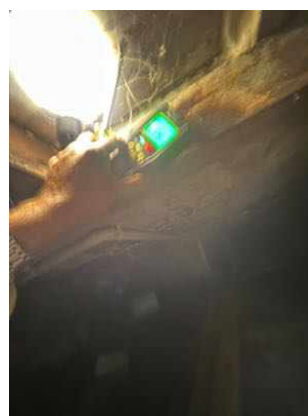
### Finding 6.06

Building:	Main Building
Location:	Subfloor
Finding:	Elevated moisture - identified
Information:	Elevated moisture can attract termites and produce conditions that promote fungal growth and wood decay.

Elevated moisture is generally caused by deteriorated, inadequate or missing roof drainage, leaking plumbing pipes or fixtures, poorly plumbed HWS overflows or condenser units and poor site drainage.

If mould growth has been found there may be environmental biological or health issues involved. In these cases an appropriately qualified inspector should also be contacted.

Prior to any remedial works being performed a qualified plumber should be appointed to further inspect the property and to identify the cause of the excessive moisture. Works to remove affected building elements may then be necessary and should be performed by an appropriate tradesperson.

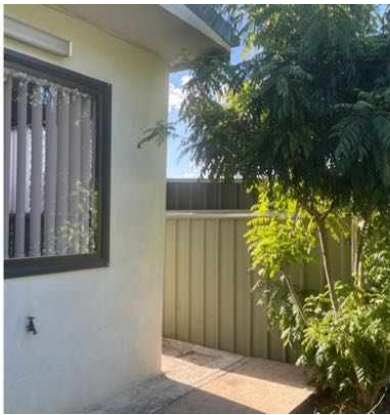
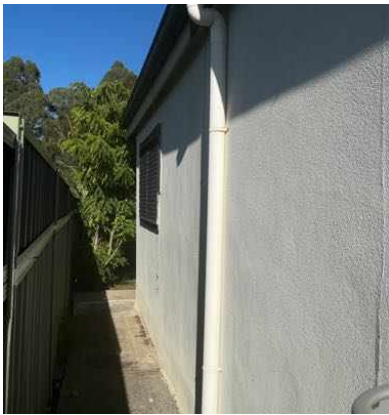
**Finding 6.08**

Building: Main Building  
Location: Subfloor  
Finding: Subfloor ventilation - Inadequate  
Information: Adequate subfloor ventilation aids in preventing excessive moisture wood rot and termite activity by ensuring a dry subfloor environment.

Where ventilation is substandard it is usually caused by factors such as failure to install adequate vents during construction subsequent building works or earth and vegetation covering over vents low subfloor clearance and items or debris in the subfloor restricting airflow.

Subfloor ventilation can be improved in most cases by addressing the causes such as exposing subfloor vents installing additional new vents installing mechanical (forced airflow) ventilation and removing debris from the subfloor.

A registered builder should be appointed as soon as possible to perform these works as necessary.

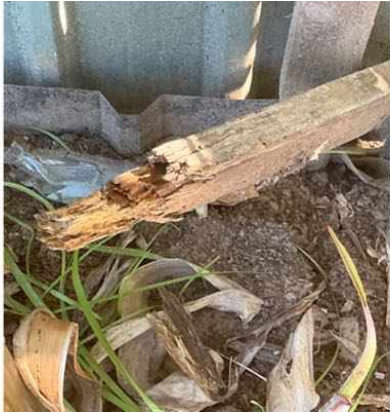
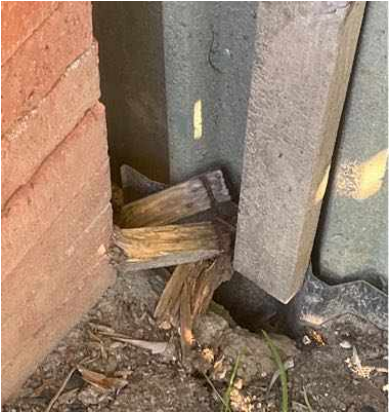
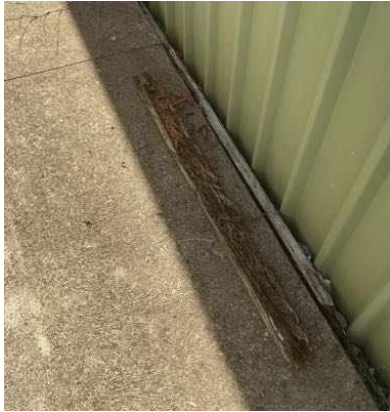
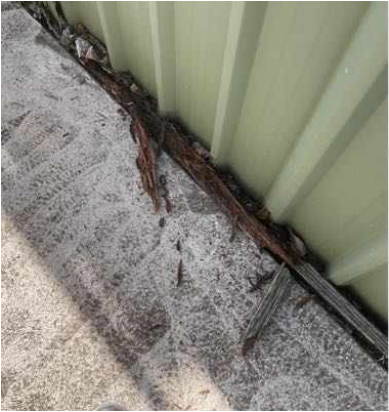
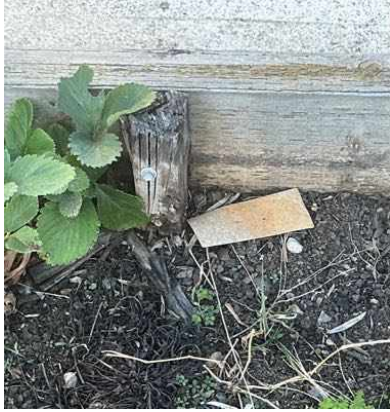
### Finding 7.01

Building:	Main Building
Location:	All External Areas
Finding:	Fungal decay - present
Information:	Fungal decay also known as wood decay or wood rot generally refers to the deterioration of timber elements when in contact with excessive levels of moisture for a prolonged period of time.

The development of fungal decay is accelerated by temperatures in the range of 5degreeC to 40degreeC as well as the presence of oxygen. Generally fungal decay develops on timber elements that are in use in an external environment which are exposed to rain penetration.

In this case although the affected timber element is in a decaying state the extent of any visible damage appears to be localised to a specific area and is yet to spread to other parts of the building element or affect adjoining structures. The fungal decay is therefore likely to be of a relatively superficial nature with minimal impact on the structural integrity or tensile strength of the timber element.

A further invasive inspection by a licensed timber pest technician is highly

recommended to check for concealed activity.

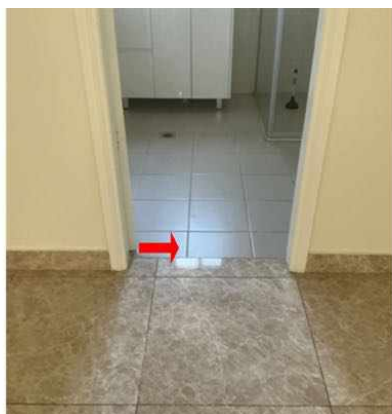
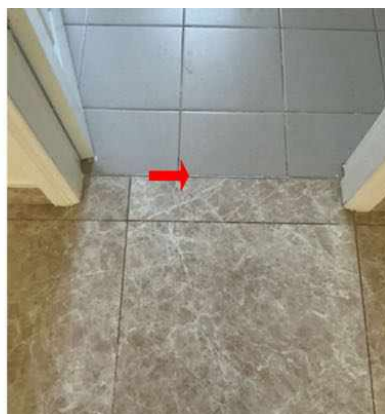
#### Noted Item

Building: Main Building  
 Location: All Internal Areas  
 Finding: Bathroom & external floor threshold  
 Information: The bathroom floor is at the same level as the adjoining timber flooring. This configuration is typical in modern apartments and is permitted where compliant waterproofing and floor falls are provided. No evidence of moisture damage was observed at the time of inspection; however, waterproofing performance cannot be confirmed without invasive inspection.

Care should be taken to avoid excessive water migration beyond the bathroom during use.

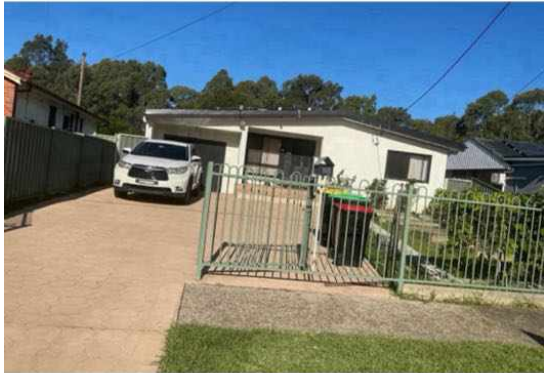
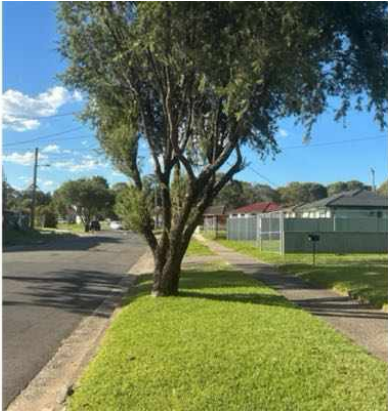
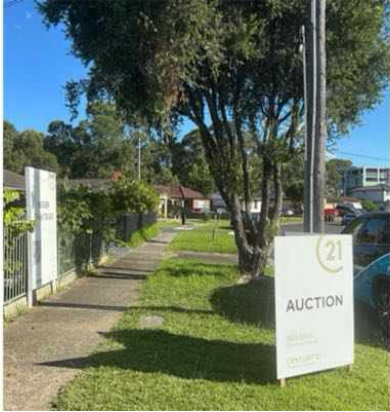
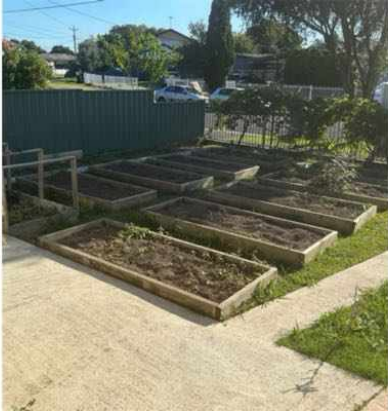
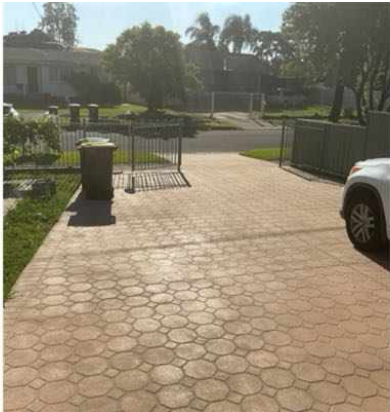
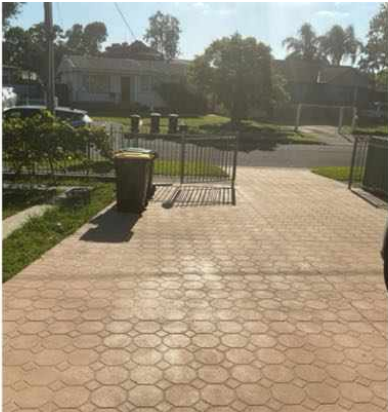
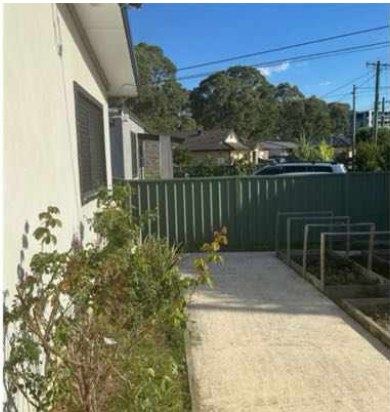
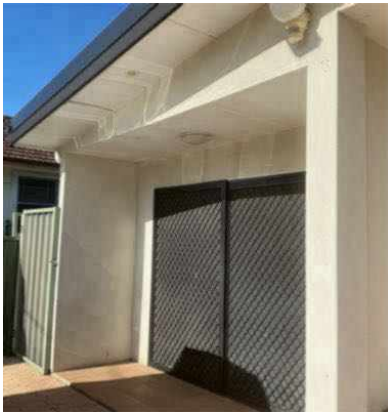
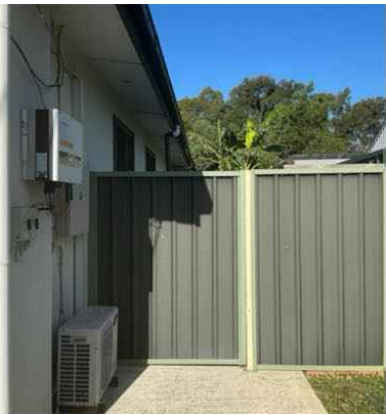
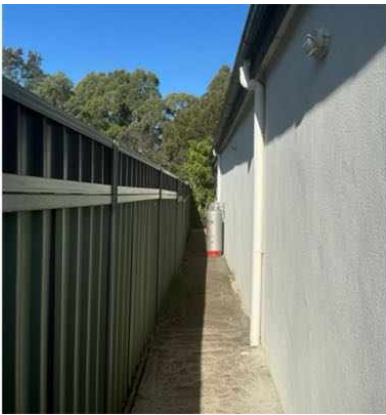
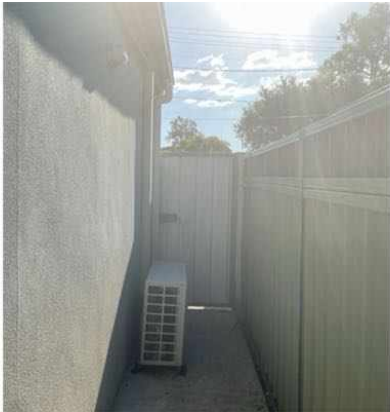
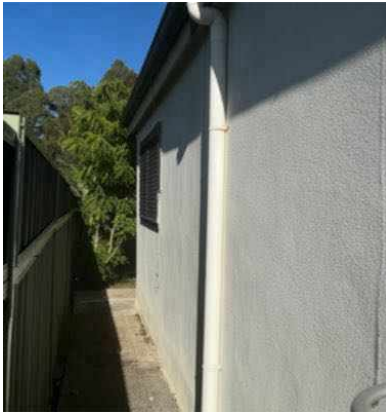
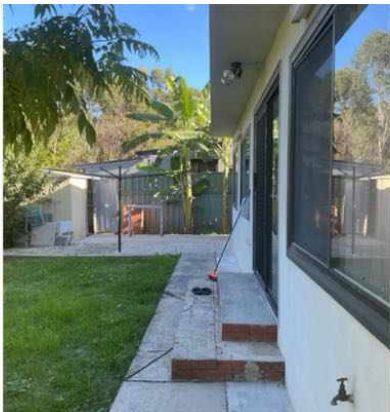
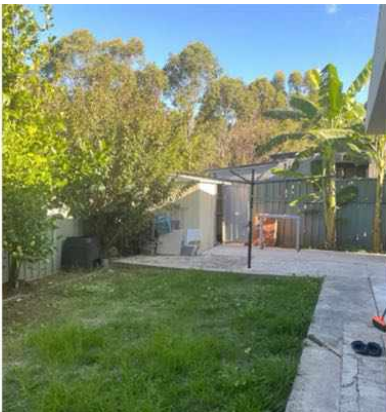
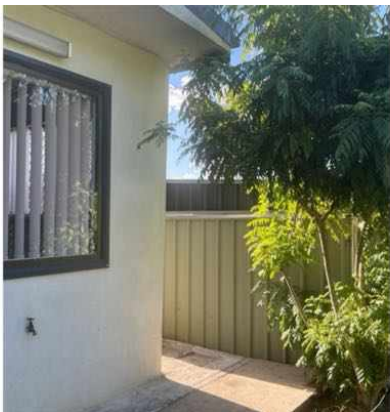
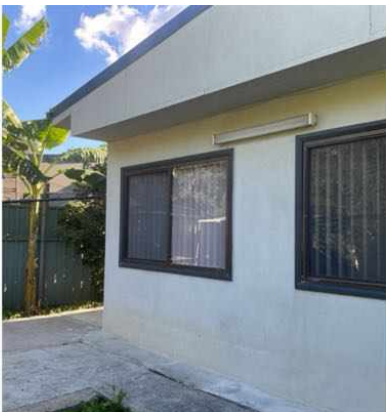
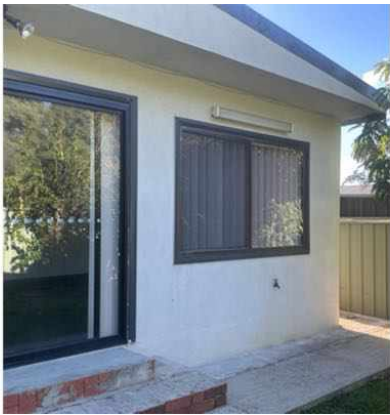
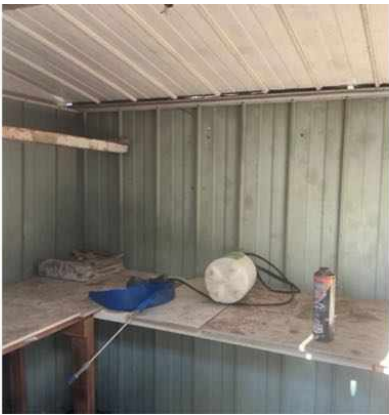
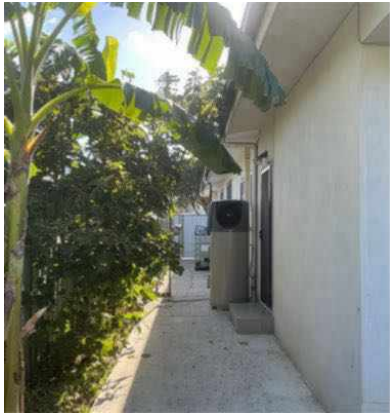
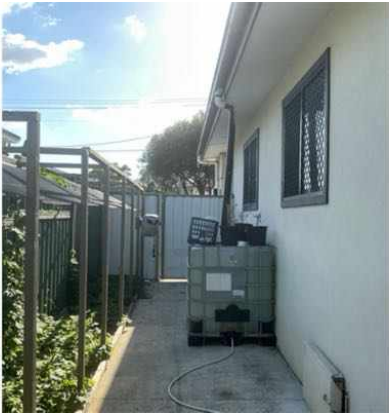
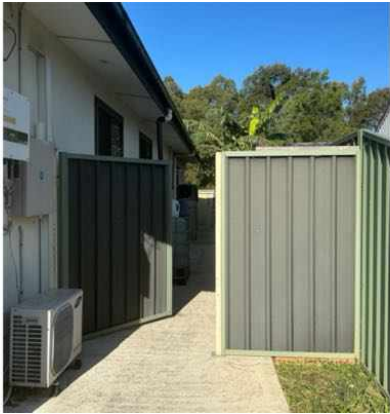
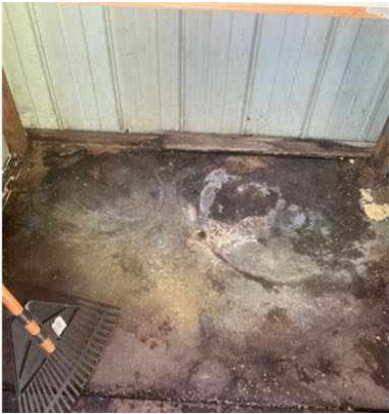
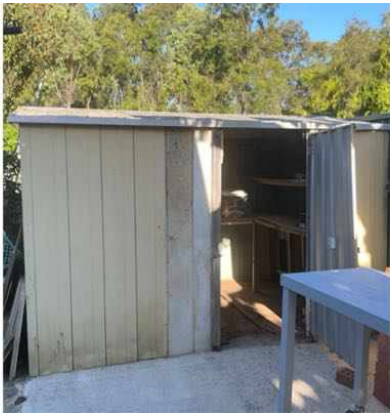
#### Noted Item

Building: Main Building  
 Location: All External Areas  
 Finding: Additional Photos - Obstructions and Limitations  
 Information: These photographs are an indication of the obstructions and limitations which impeded full inspection of the property at the time of inspection. These obstructions can hide an array of defects and should be removed to allow full inspection to be carried out. A re-inspection is recommended once the areas are made accessible.
