# Building and Timber Pest Inspection Report

Inspection Date: Wed, 1 Apr 2026

Property Address: 98 Willan Dr, Cartwright NSW 2168,  
Australia

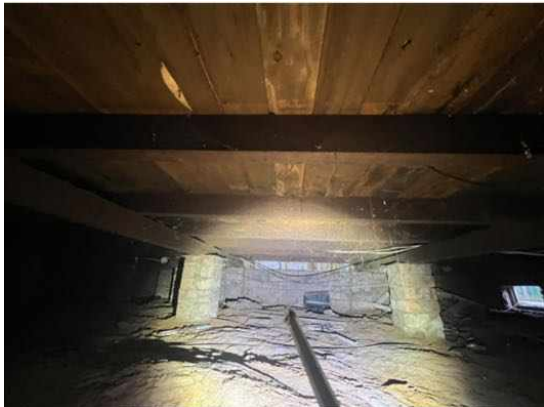
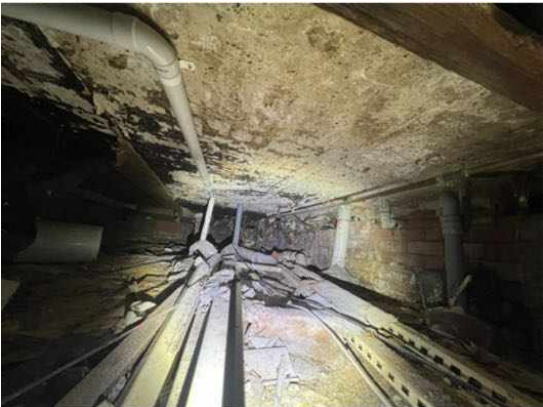
Building: Main Building  
Location: Subfloor  
Finding: Additional Photos - Obstructions and Limitations  
Information: These photographs are an indication of the obstructions and limitations which impeded full inspection of the property at the time of inspection. These obstructions can hide an array of defects and should be removed to allow full inspection to be carried out. A re-inspection is recommended once the areas are made accessible.
