Building and Timber Pest Inspection Report

Inspection Date: Thu, 26 Mar 2026

Property Address: 7/18 Liverpool Rd, Croydon NSW 2132, Australia

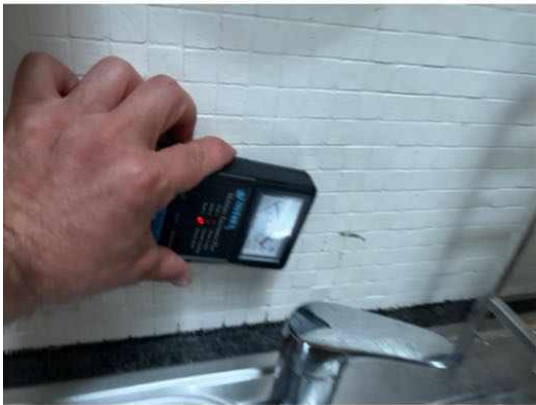
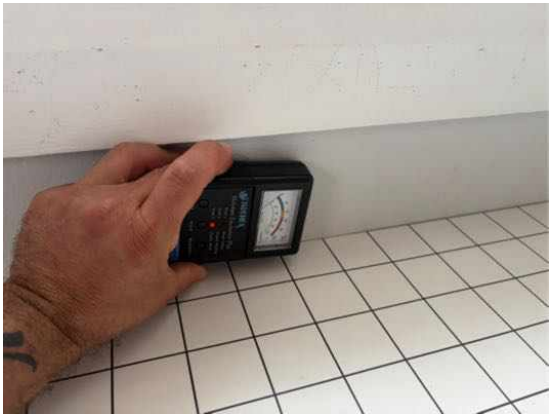
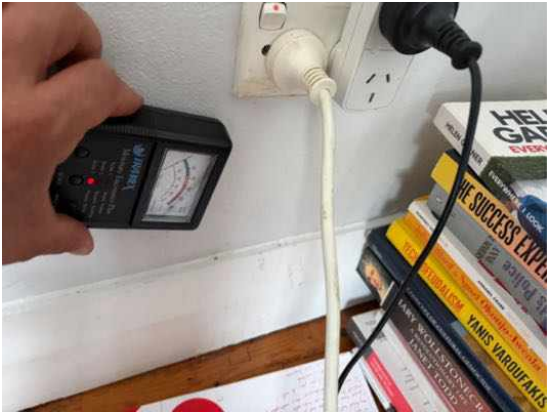
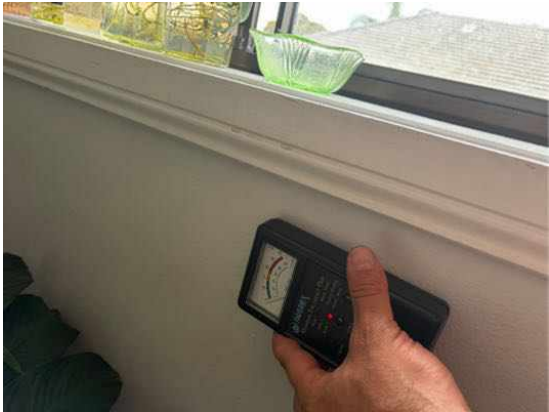
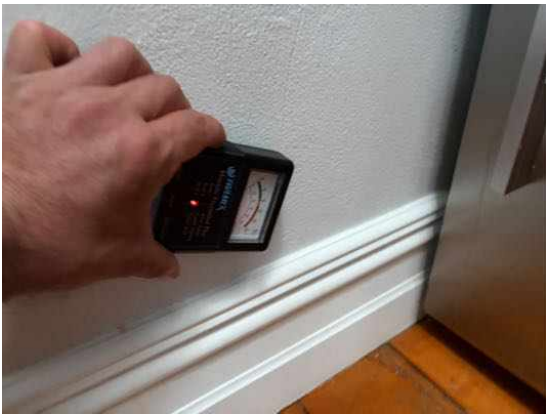
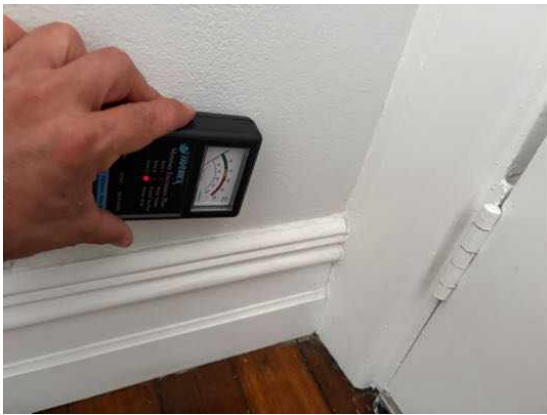
Building: Main Building
Location: All Areas
Finding: Moisture metre
Information: During the inspection the property was checked for moisture using a moisture metre.

This is for information only.

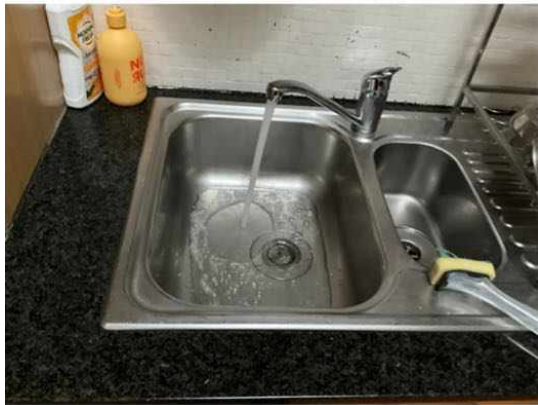
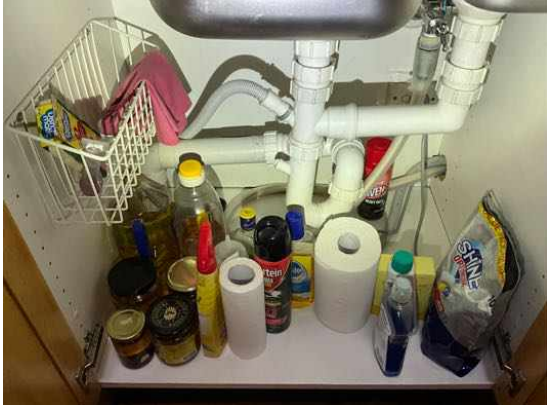
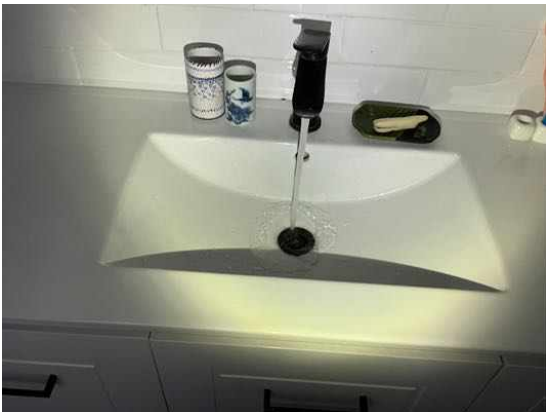
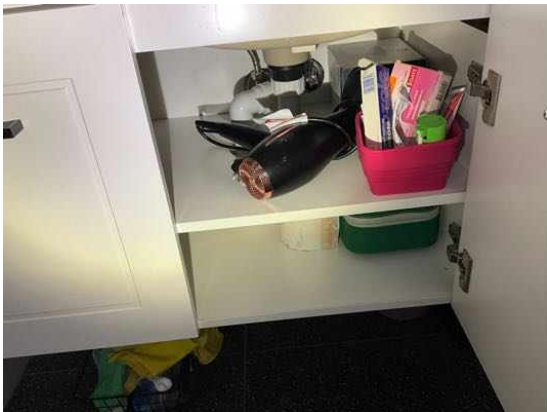
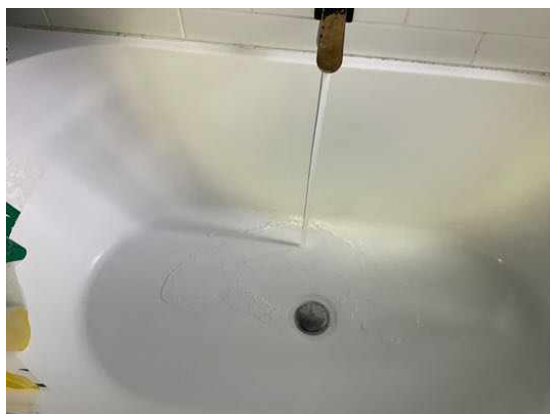
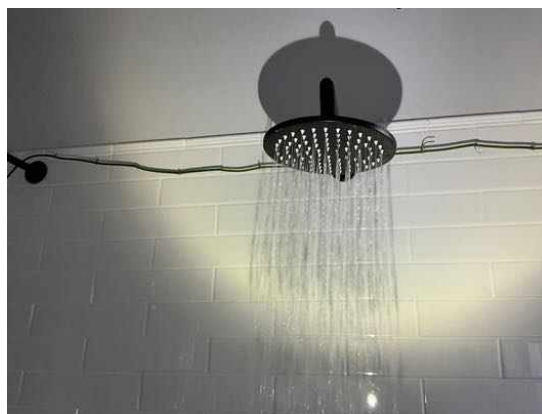
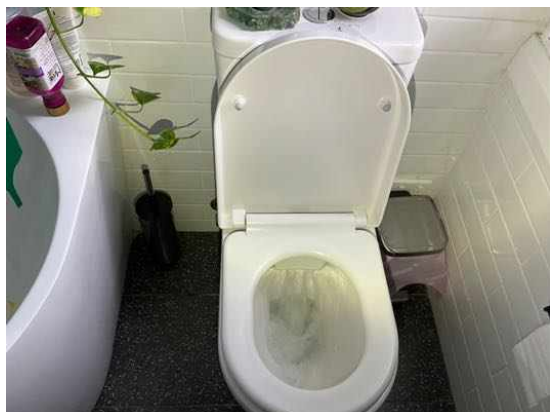
Building: Main Building
Location: All Wet Areas
Finding: Additional Photos
Information:

Additional photos are provided for your general reference.

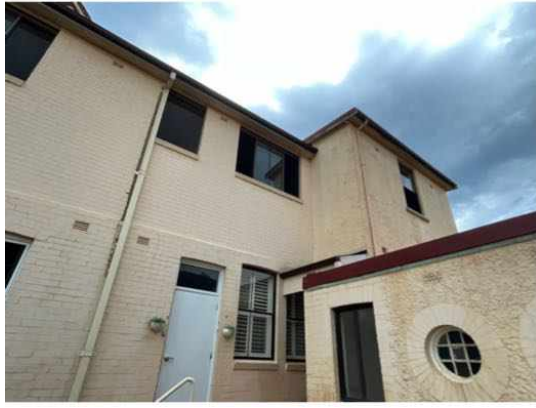
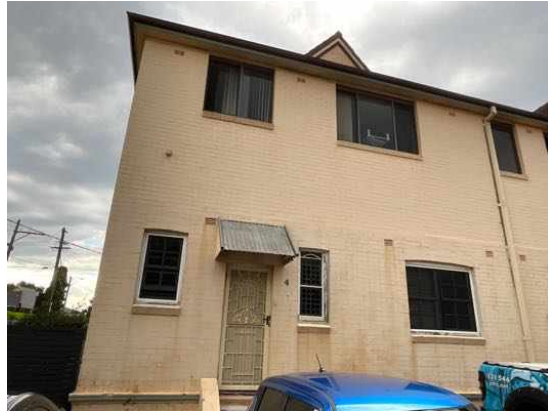
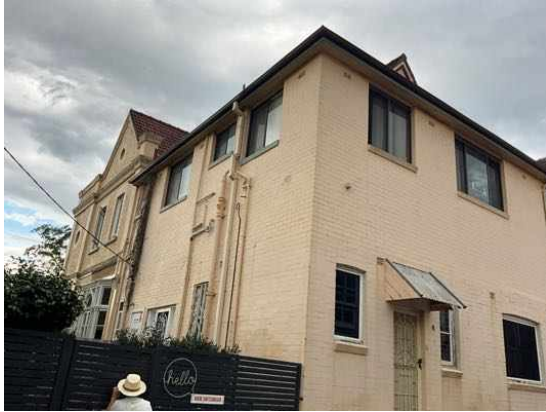
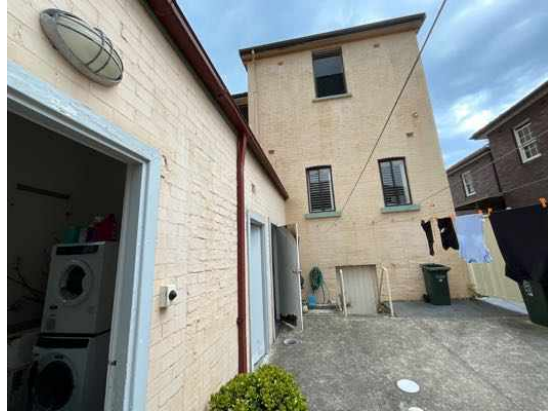
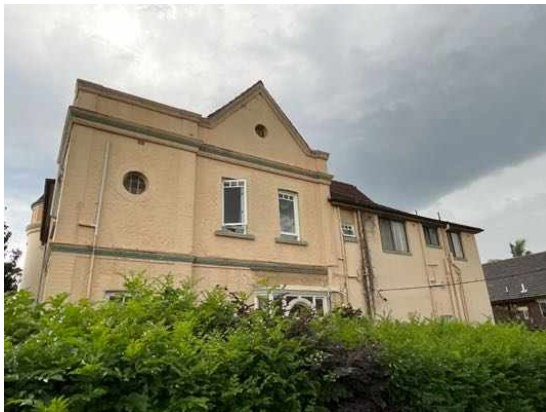
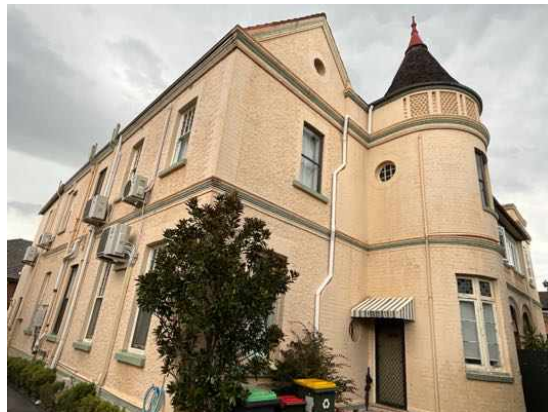
Building:	Main Building
Location:	Exterior
Finding:	Additional Photos
Information:	Additional photos are provided for your general reference.

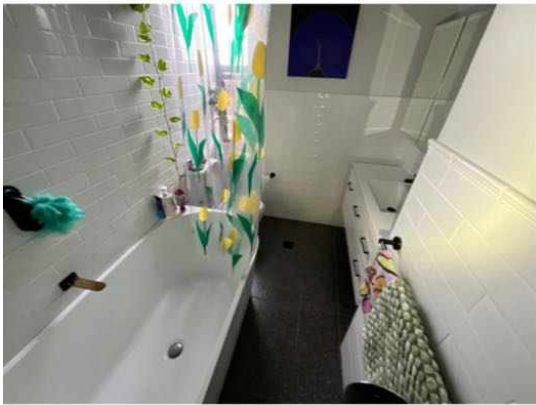
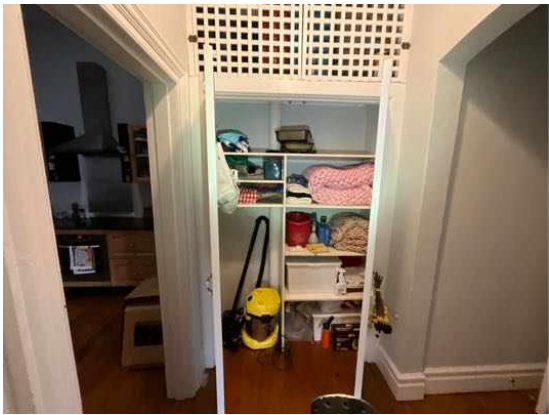
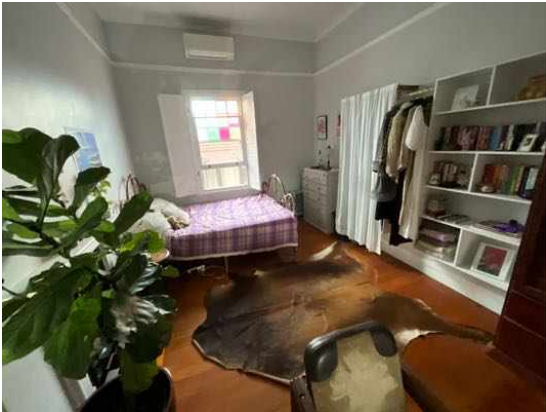
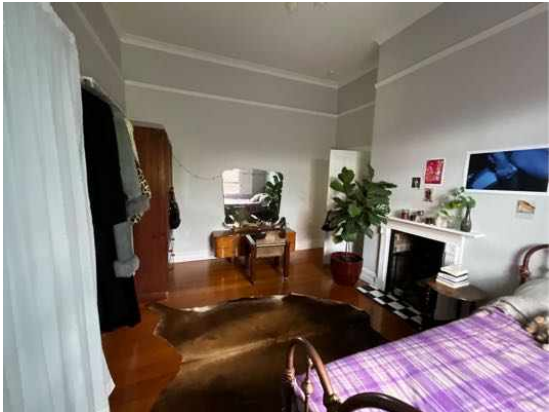
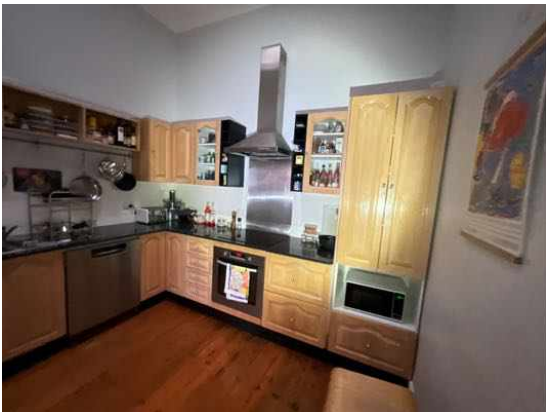
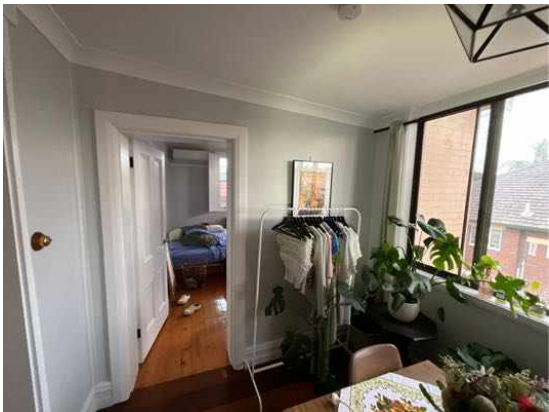
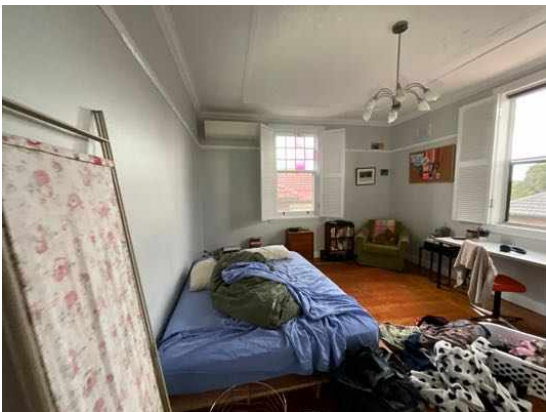
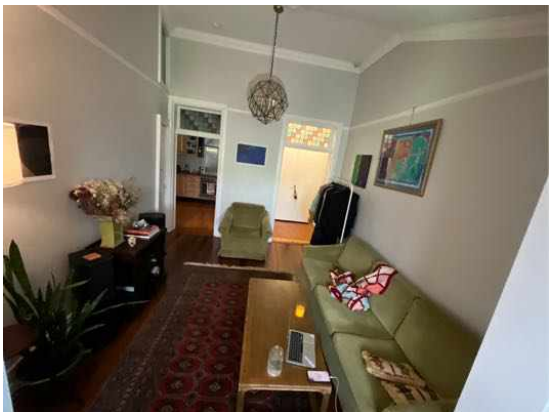
Building: Main Building
 Location: All Areas
 Finding: Additional Photos - Obstructions and Limitations
 Information:

These photographs are an indication of the obstructions and limitations which impeded full inspection of the property at the time of inspection. These obstructions can hide an array of defects and should be removed to allow full inspection to be carried out. A re-inspection is recommended once the areas are made accessible.
