# Building and Timber Pest Inspection Report

Inspection Date: Wed, 4 Feb 2026

Property Address: 1/375 Lawrence St, Wodonga VIC 3690,  
Australia

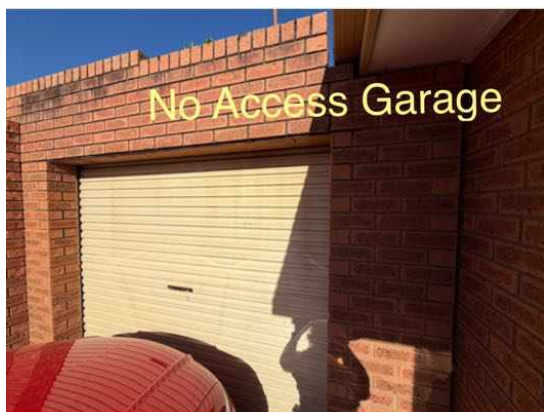
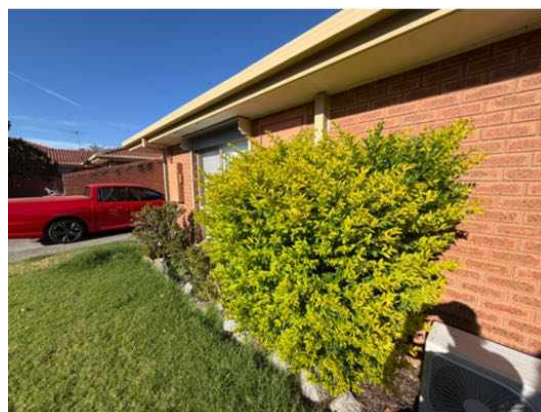
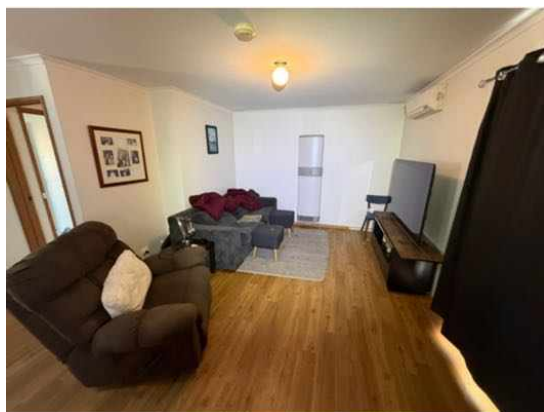
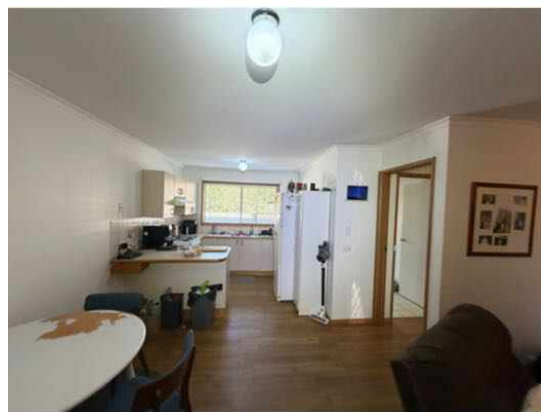
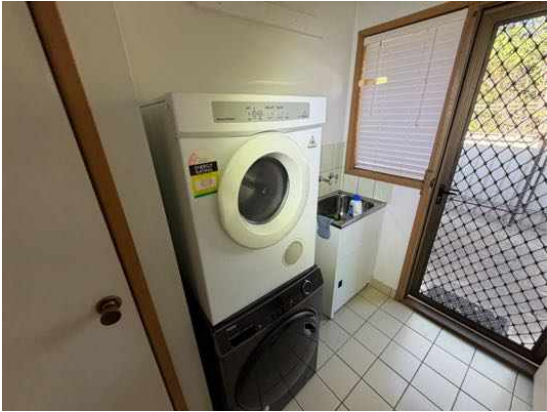
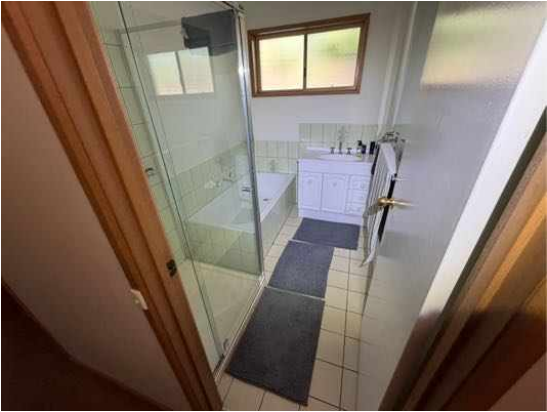
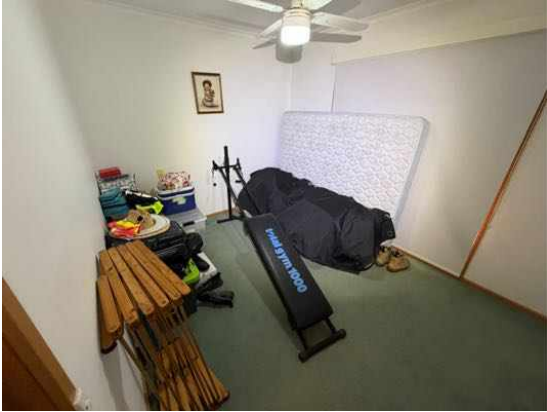
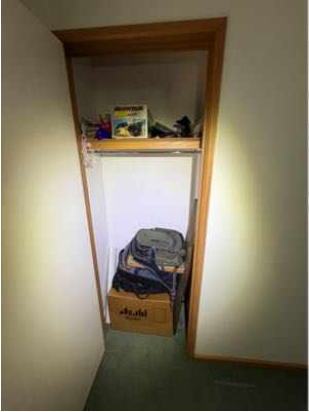
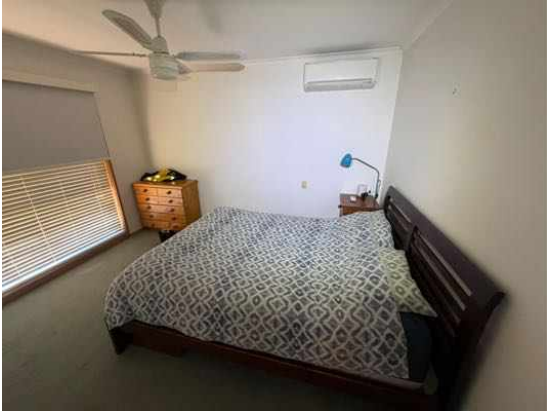
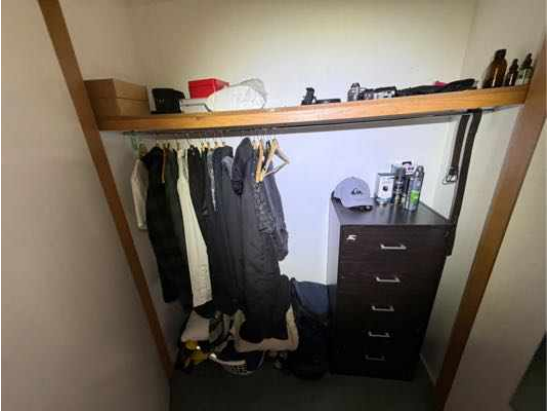
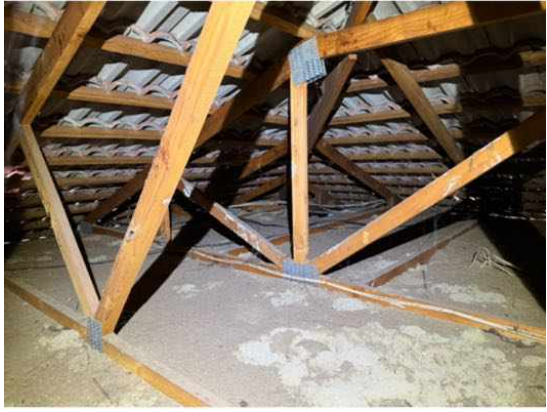
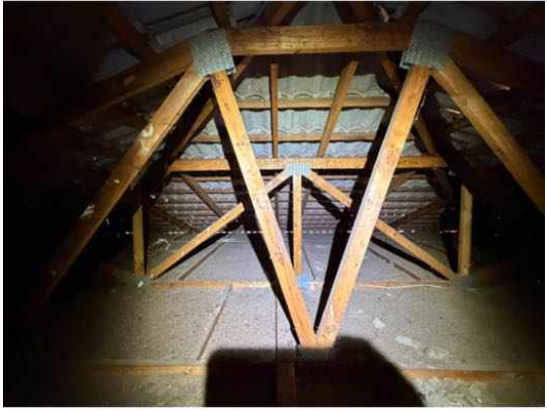
Building: Main Building  
Location: All Areas  
Finding: Additional Photos - Obstructions and Limitations  
Information: These photographs are an indication of the obstructions and limitations which impeded full inspection of the property at the time of inspection. These obstructions can hide an array of defects and should be removed to allow full inspection to be carried out. A re-inspection is recommended once the areas are made accessible.
