Building and Timber Pest Inspection Report

Inspection Date: Tue, 7 Apr 2026

Property Address: 167 Oxford St, Cambridge Park NSW 2747,
Australia

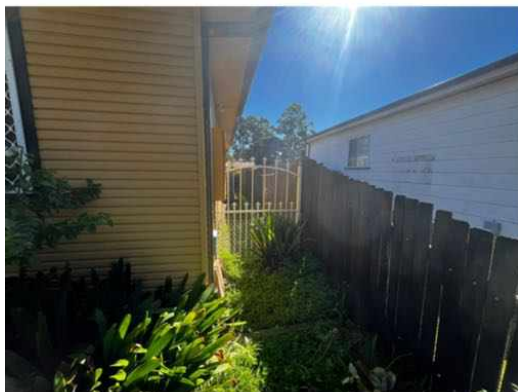
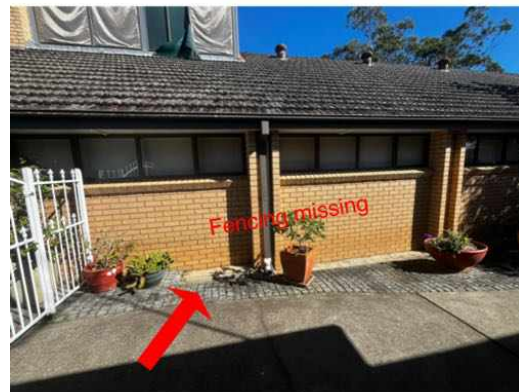
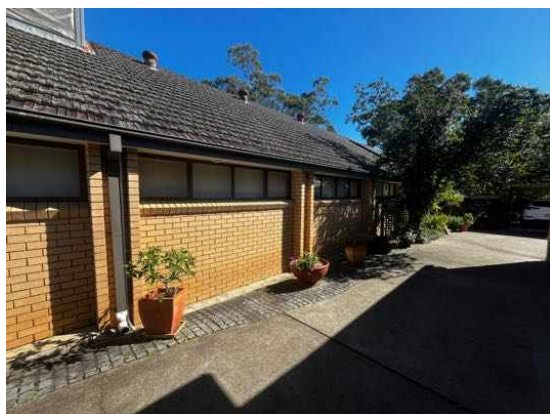
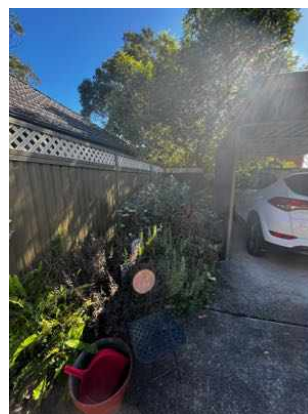
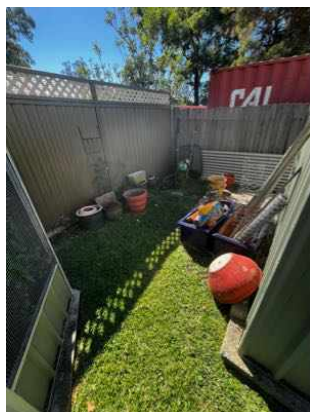
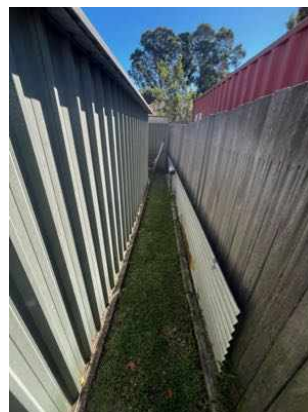
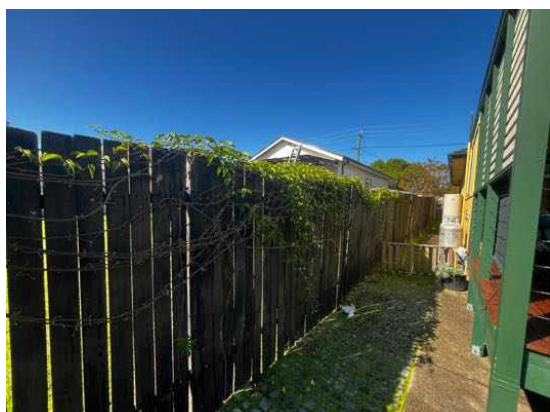
Building: Main Building
Location: Yard Fencing
Finding: Perimeter Fencing - Timber fence/ Colourbond Fence
Information: For your information photos taken at the time of inspection - During the inspection the Colourbond fence was inspected and found minor defects/ dents, deterioration but the fence at the back of the property Timber fence inspected. The timber fence on the right side of the property was also deteriorated.

A fencing should be provided for the safety of the property and other disputes.

Please consult a surveyor to inspect and verify the same.

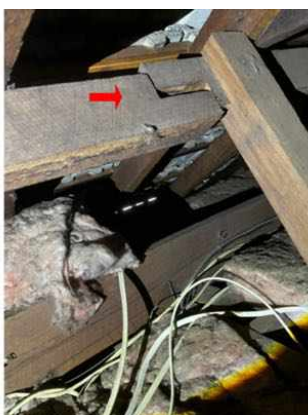
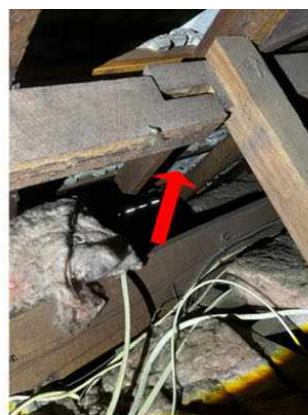
Finding 2.04

Building:	Main Building
Location:	Roof
Finding:	Roof structure - Connections (Sagging)
Information:	The roofing structure was found to be sagging in certain sections at the time of inspection. Upon closer inspection within the ceiling void, it is suspected that the sagging is a direct result of inadequate connections, which appear to have deteriorated over a prolonged period of time.

Sagging roof structures are likely to create strain on associated building elements, creating potential for secondary damage. The roof is also unlikely to have sufficient support, which will lead to further sagging if left unmanaged.

It is critical to ensure that the fastenings holding important roof elements together remain structurally sound (i.e. not corroded) and tightly fastened. Any failure in fastenings can lead to movement of roof members, which is likely to result in an uneven or sagged appearance of the roof exterior. Improper nailing at the point where the ceiling joist connects to the bottom of the rafter may also cause sagging.

Remedial works are highly advised and should be performed by a registered builder or roofing contractor as soon as possible.

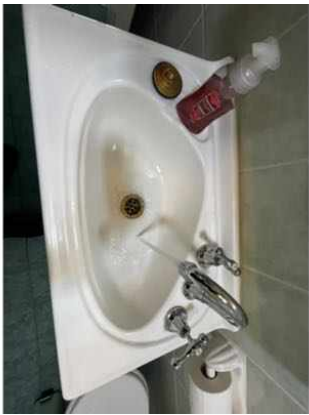
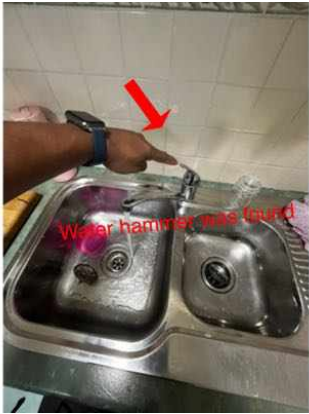
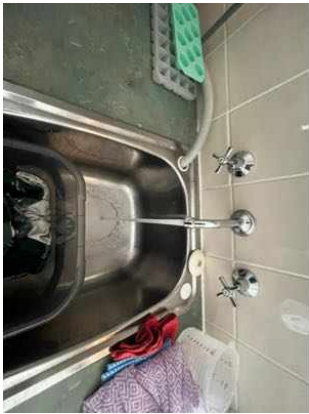
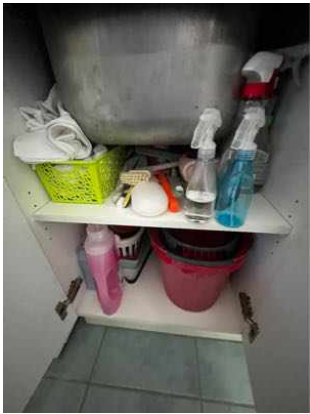
Building: Main Building
 Location: All Areas
 Finding: Cabinetry Plumbing - Kitchen/ Pantry cum Laundry
 Information: Upon Inspection of the Kitchen and the Pantry/ Laundry and BBQ Kitchen all cupboards where sinks and basins with drainage plumbing were inspected and no evidence of leaks were present at the time of inspection.

Water hammer was found when taps turned on and off at the premises.

For your information only no remedial works are required at the time of inspection.

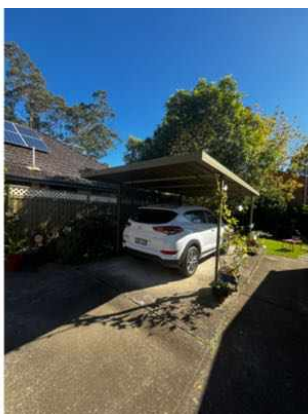
Finding 3.02

Building:	Main Building
Location:	All External Areas
Finding:	Gutters - Water pooling
Information:	Water pooling happens in sections of the roof guttering and floor guttering too.. This is generally a secondary defect caused by blocked or partially blocked gutters. Such blockages and subsequent water pooling are likely to lead to rust and water damage to associated structures if left unattended.

The Gutter running at the back of the house roofline was not connected to a downpipe or a continues gutter from the colourbond roof. Hence water pouring from the gutter - show evidence.

Any areas of guttering that shows evidence of water pooling should be checked for partial or full blockages and any secondary damage that may have occurred as a result. Depending on the extent of the damage, building elements may require repair and/or replacement to ensure adequate roof drainage and function of exterior plumbing system.

A roofing plumber should be appointed as soon as possible to rectify this issue. It is highly advised that all gutters be maintained on a frequent basis to ensure the condition of roof plumbing.

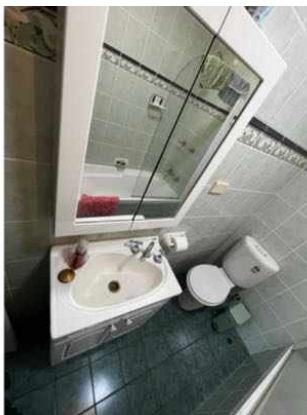
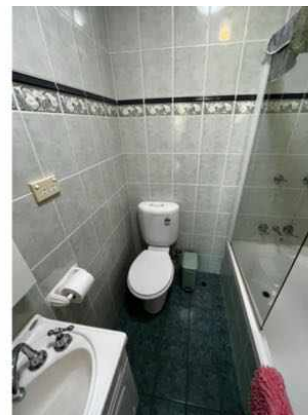
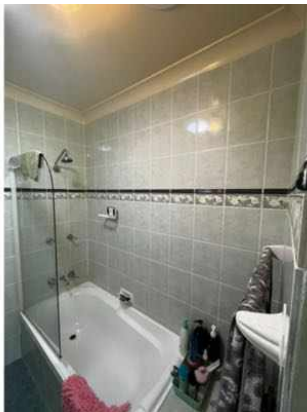
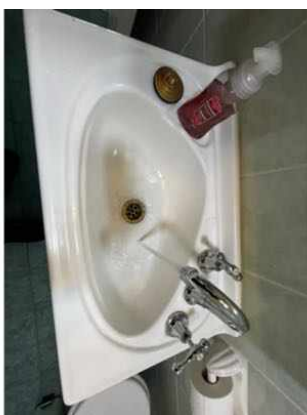
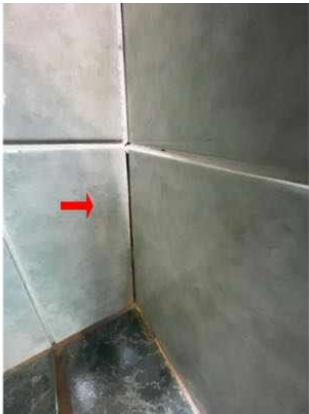
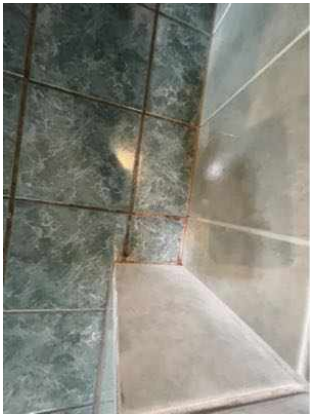
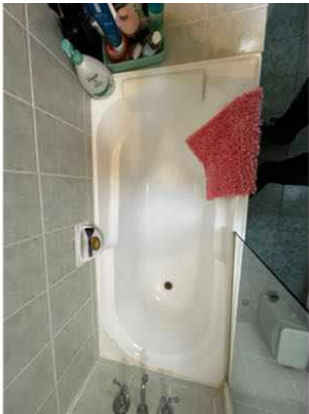
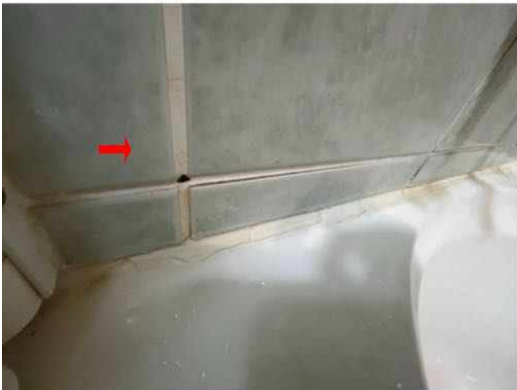
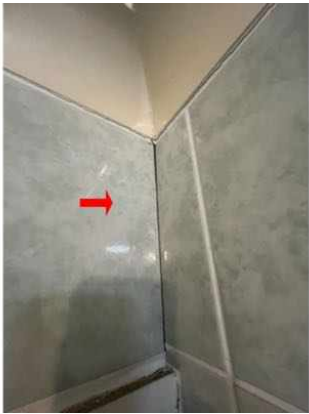
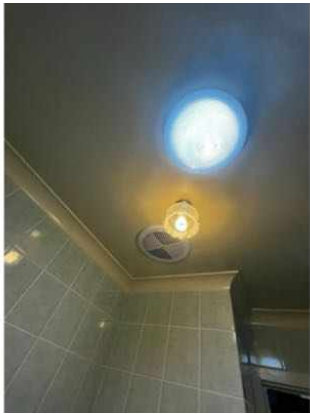
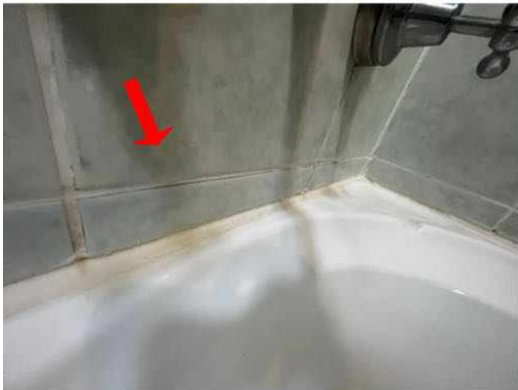
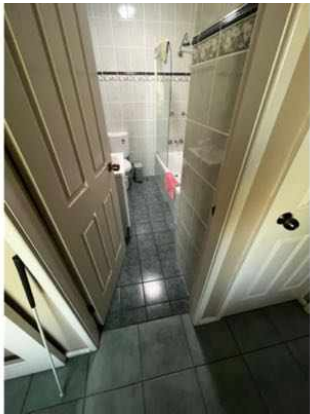
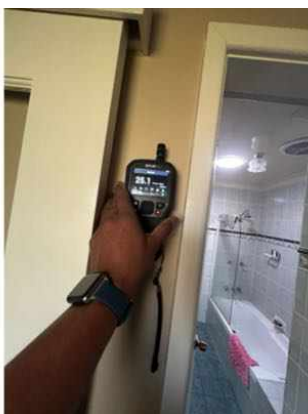
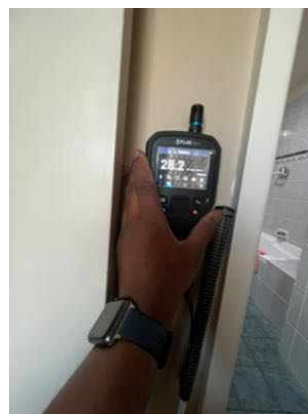
Finding 3.03

Building:	Main Building
Location:	Bathroom
Finding:	Sealant and grouting - Missing or damaged
Information:	It was noted on inspection that sealant or grout is degraded to the tiled shower alcove and or other areas of the bathroom.

Different materials and floor areas move at different rates, generally causing cracking to grout or sealant at this point. A flexible sealant is required to allow for expected expansion and contraction, while keeping the joint water tight and protective of all associated building materials.

There appears to be excessive mould to the sealant and grout which will likely require scraping out and replacement.

Flexible and mould resistant materials should be applied to affected areas to prevent any subsequent water damage that is likely to occur. Regular maintenance and replacement of damage or missing or damaged sealant and grout is highly recommended to the wet areas, as this is a regular wear and tear defect. Sealant and grouting in areas that come into regular contact with water should be maintained for the long term care of your property.

A sealant specialist or tiling contractor should be appointed to complete these works as soon as possible

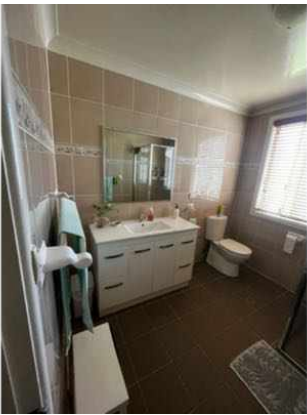
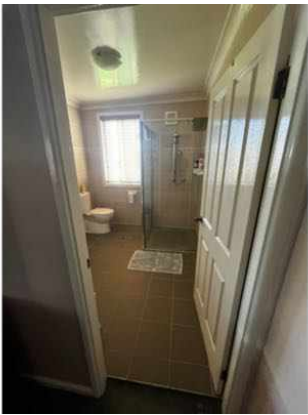
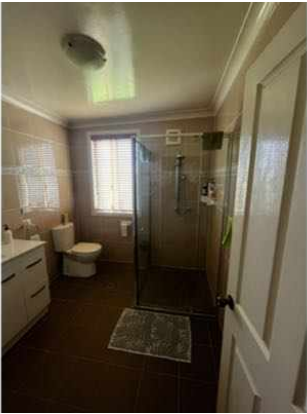
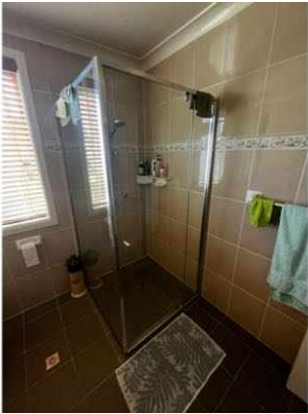
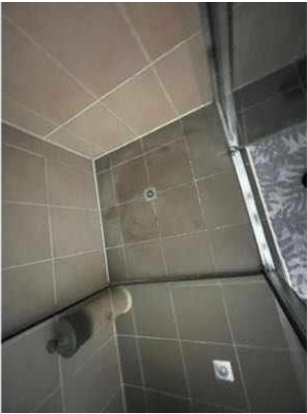
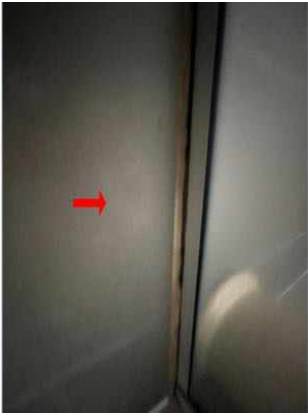
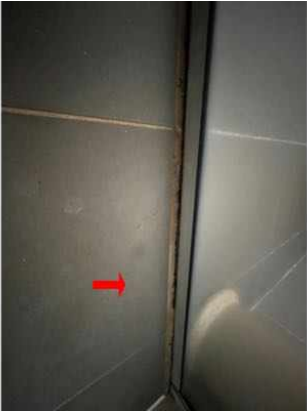
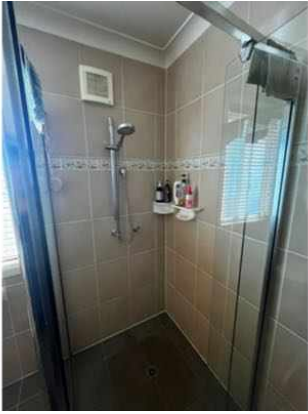
Finding 3.04

Building:	Main Building
Location:	Bathroom -2
Finding:	Sealant and grouting - Missing or damaged
Information:	It was noted on inspection that sealant or grout is degraded to the tiled shower alcove and or other areas of the bathroom.

Different materials and floor areas move at different rates, generally causing cracking to grout or sealant at this point. A flexible sealant is required to allow for expected expansion and contraction, while keeping the joint water tight and protective of all associated building materials.

There appears to be excessive mould to the sealant and grout which will likely require scraping out and replacement.

Flexible and mould resistant materials should be applied to affected areas to prevent any subsequent water damage that is likely to occur. Regular maintenance and replacement of damage or missing or damaged sealant and grout is highly recommended to the wet areas, as this is a regular wear and tear defect. Sealant and grouting in areas that come into regular contact with water should be maintained for the long term care of your property.

A sealant specialist or tiling contractor should be appointed to complete these works as soon as possible

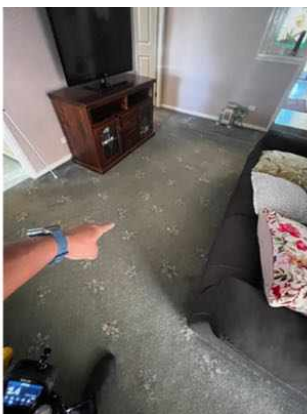
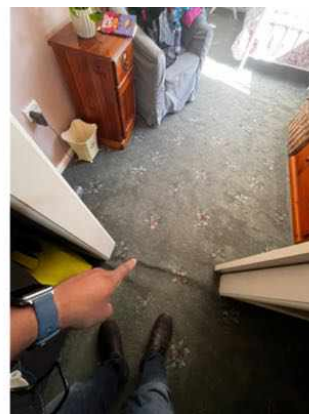
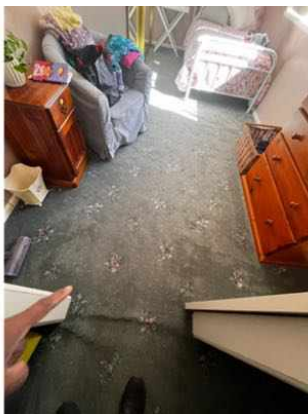
Finding 3.05

Building:	Main Building
Location:	Second Rumpus
Finding:	Carpet - Deteriorated
Information:	Sections of the carpet floor covering in this area appeared to be deteriorated.

Replacement of the affected carpet is required to ensure the safety of the area. Where required, remedial works should be undertaken to any associated walls and flooring showing deterioration.

A carpet specialist can be consulted to remedy the situation.

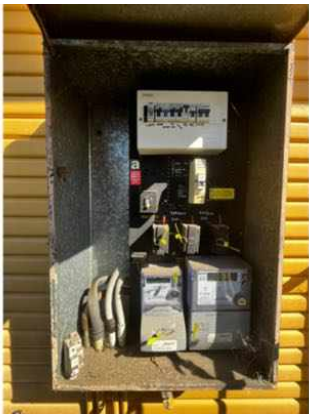
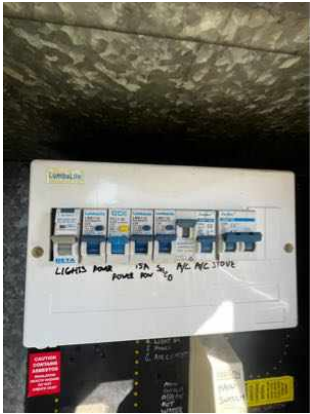
Building:	Main Building
Location:	Electrical Switchboard
Finding:	Termite Management System - no evidence of a chemical installation no Durable Notice
Information:	The application of a post-construction chemical termite barrier is highly recommended for all properties, particularly if live termite activity has been found on the site previously. Such barriers are highly effective in preventing termite attack on any timber building elements throughout the property.

A durable notice should be placed in the switchboard unit to indicate current termite barriers. At the time of inspection, it appeared as though no termite management system has been installed, with no evidence to suggest preventative works taking place.

The client may consider gaining further advice from a pest controller as to the costs and procedures involved with this application. It is recommended that obtaining such advice be a short-term priority.

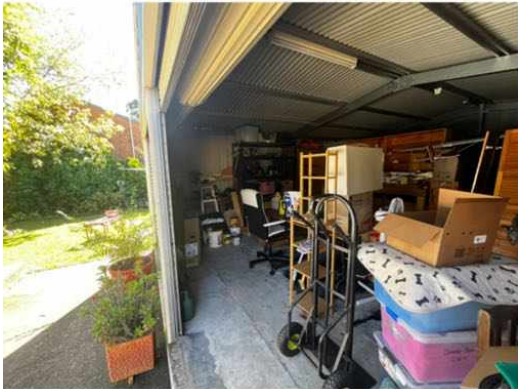
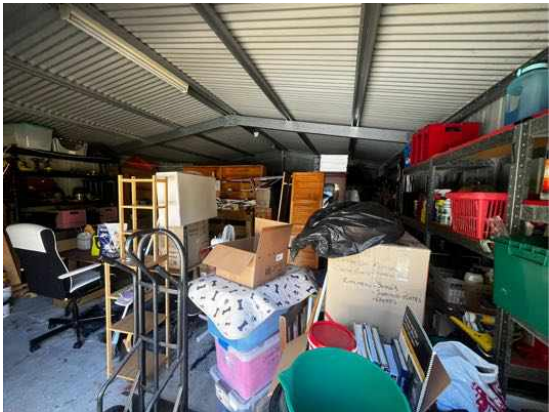
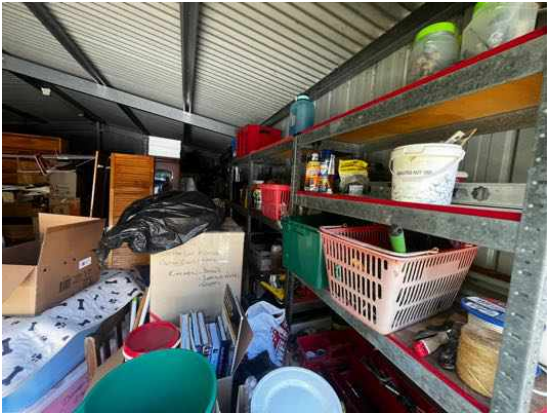
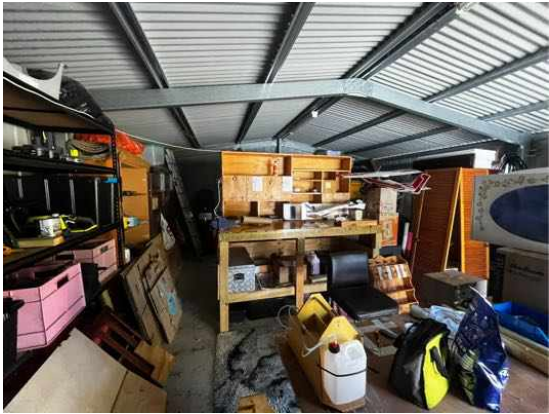
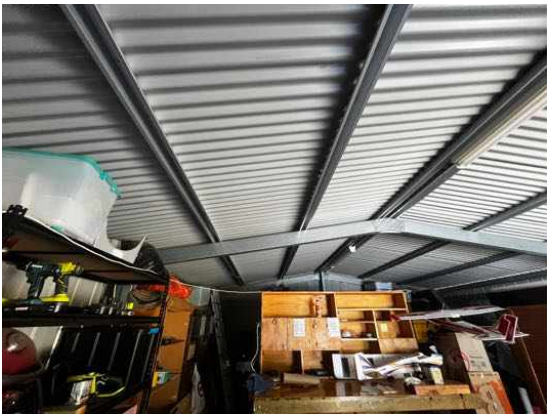
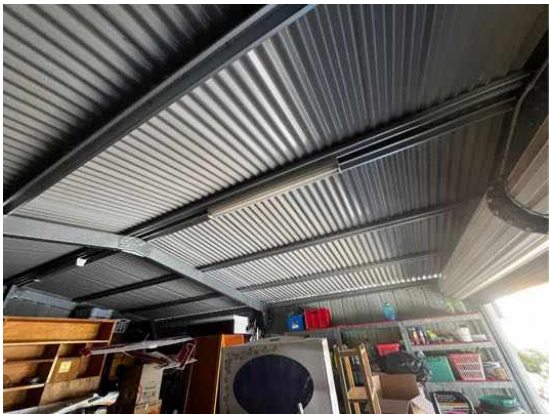
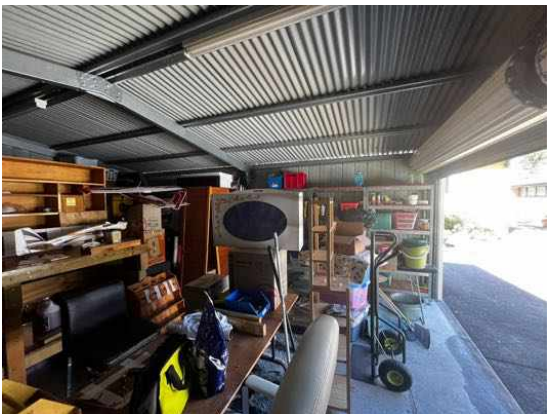
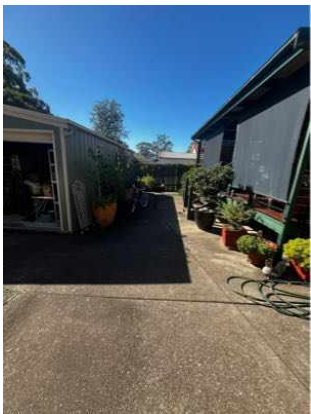
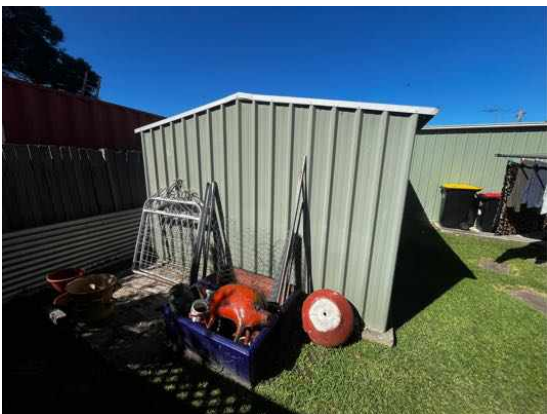
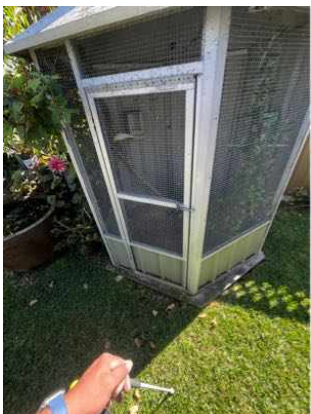
Finding 6.02

Building: Main Building
 Location: Storage Shed 1-2
 Finding: Stored items/ furniture - Limits Inspection
 Information: There are stored items too close to the external walls and throughout cupboards and other items in the toilet/bathroom area and this limits the ability to inspect further

Request you to remove hindered items and clear the inspectable area as required. If needed another inspection may be scheduled.

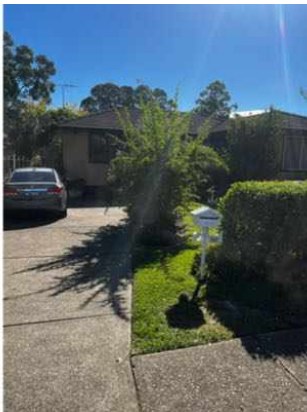
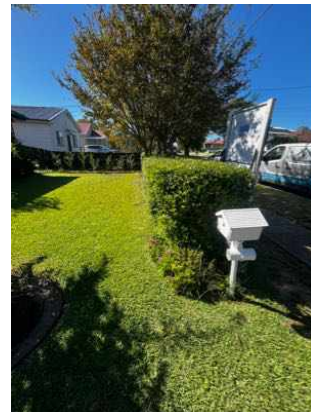
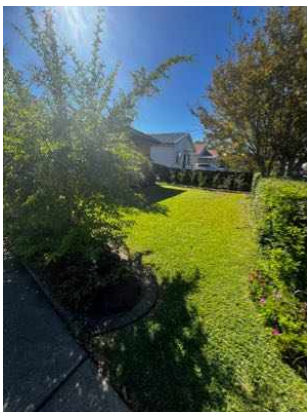
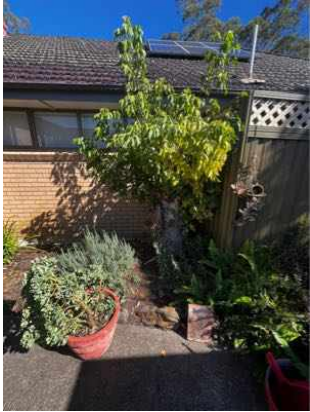
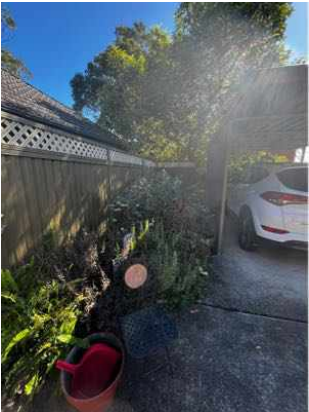
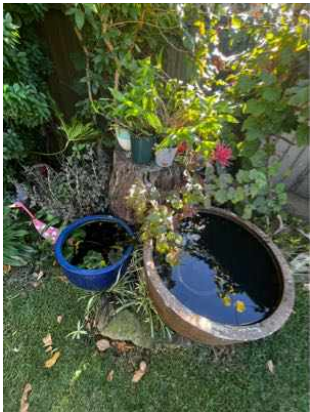
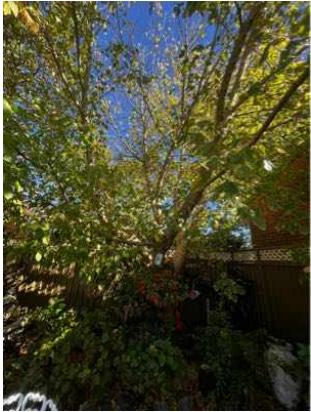
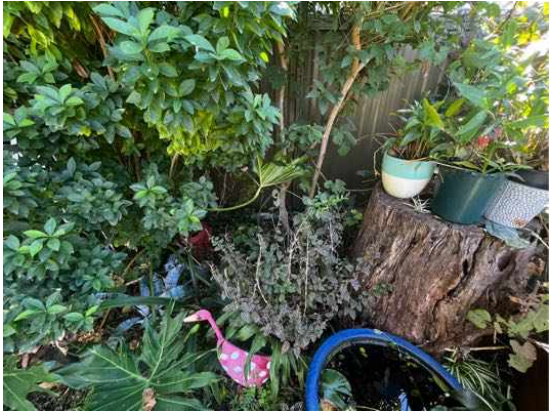
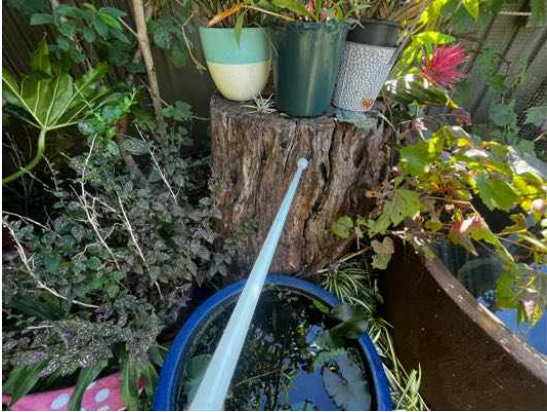
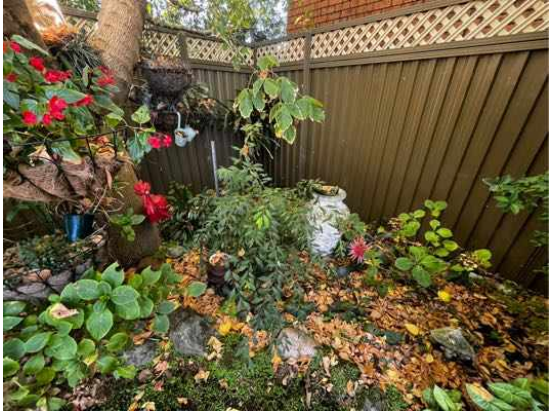
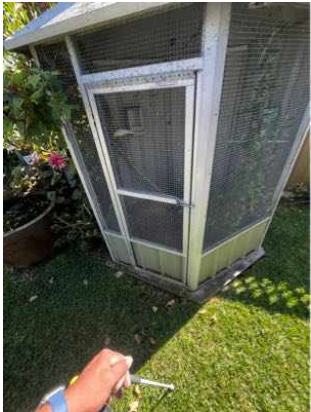
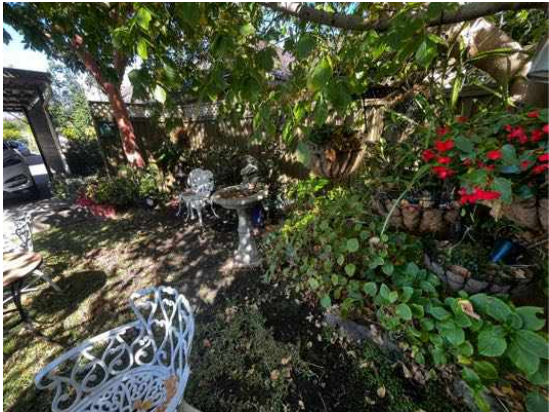
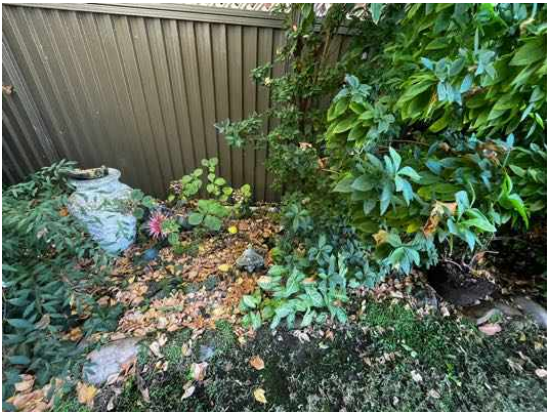
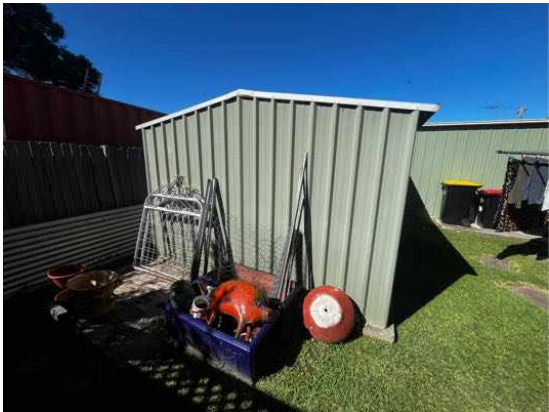
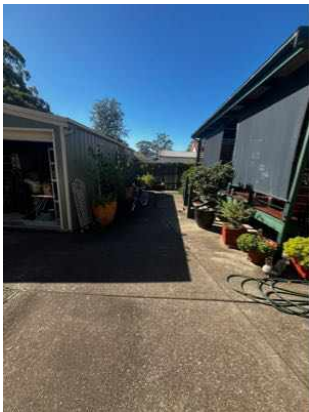
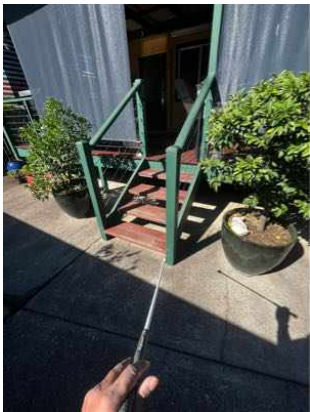
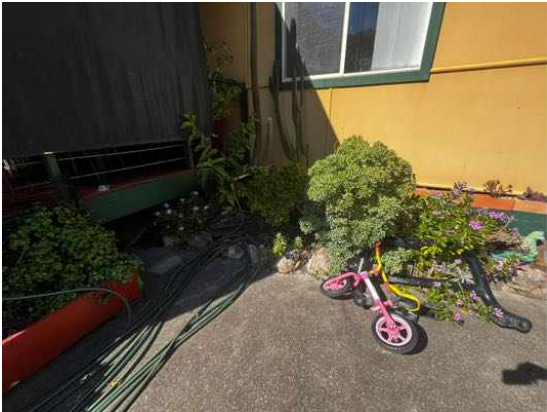
Finding 6.03

Building:	Main Building
Location:	All External Areas
Finding:	Limited Inspection Area - Alfresco area, Steps, Shed surround, split level at the back of the property.
Information:	There is limited to no access near the alfresco area, storage area at the time of inspection and Part of the Left side of the house.

The risk of termite activity may be present. As they are likely to come into contact with weather conditions or excessive moisture wood rot is likely to develop on timbers that are not treated.

It is highly recommended that any stored timbers be immediately removed from areas in which they may attract any termite / timber pest attack. Minimisation of risk / prevention of termite attack is far more adequate than dealing with the presence of termite activity.

These obstructions can hide an array of defects and should be removed to allow full inspection to be carried out. A re-inspection is recommended once the areas are made accessible.

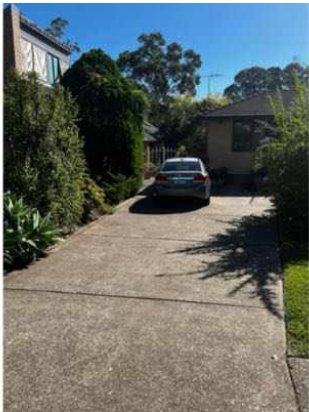
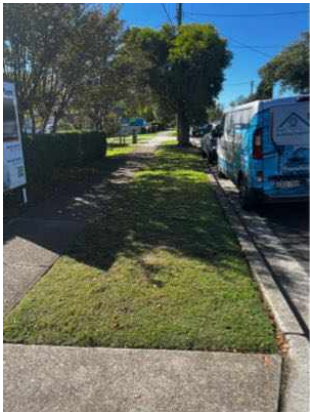
Finding 6.04

Building: Main Building
Location: All External Areas
Finding: Large Trees/ Stumps within 30 meters of the house
Information: There are a number of large trees/ stumps within 30meters of the house which may contain natural termite activity. It is important to monitor these areas to ensure no natural activity is allowed to progress into the main house.

Regular inspections are recommended. Consider test drilling Trees.

A pest controller can be contacted to carry out such testing at owners discretion.

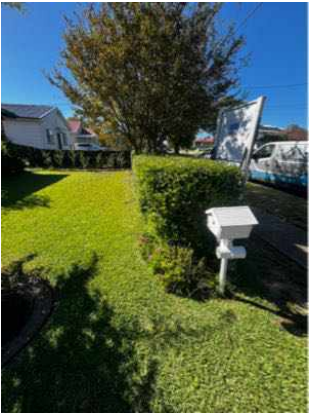
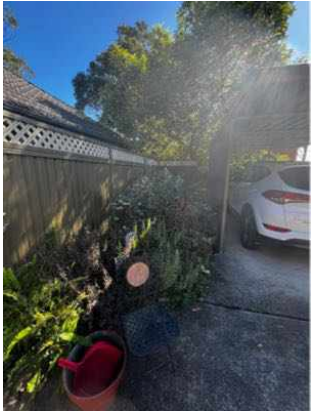
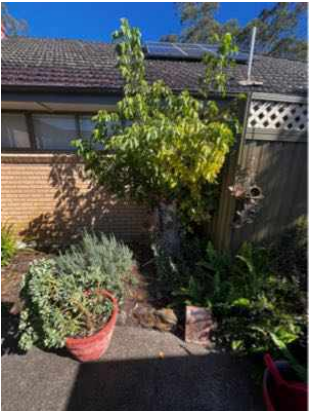
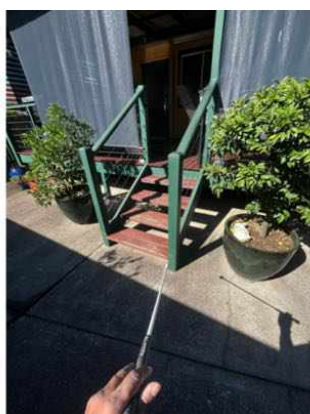
Finding 6.05

Building: Main Building
Location: Yard
Finding: Building materials in direct ground contact - conducive to termites
Information: Where timber elements are in direct contact with the ground and consequently moisture or dampness they become conducive to termite activity. Whether timber is used as a building element part of a fencing structure or stored as an unused item they can provide an environment that is attractive to termite infestation.

When met with excessive moisture timber begins to decay and develop wood rot. Any timbers that are in direct contact with external grounds especially if left untreated or non-durable also provide ingress for subterranean termites into that particular element.

The removal of any such materials that may be conducive to termite activity should be removed as soon as possible to minimise the risk of termite attack.

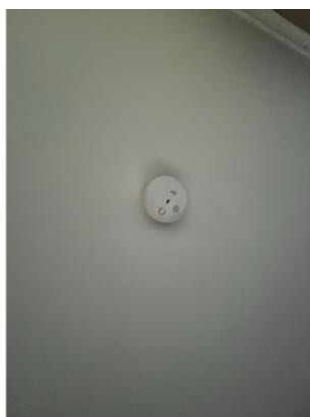
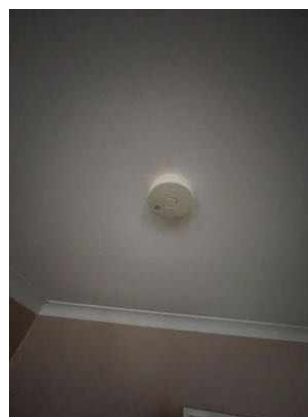
Building: Main Building
Location: All Internal Areas
Finding: Smoke Detector and Alarms
Information: Reporting on Smoke Detectors or Alarms, including hard wired smoke detection systems and their legislative requirements, is outside the Scope of this Report.

Additionally, it is advised that all smoke detectors be tested by the homeowner on a monthly basis.

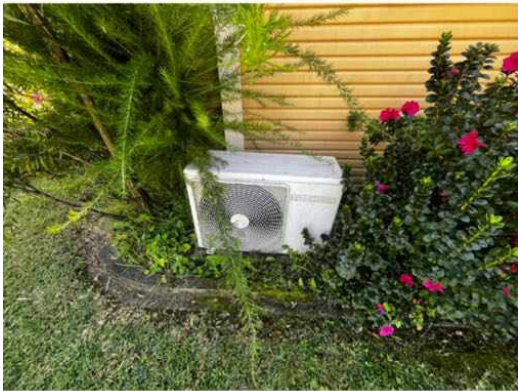
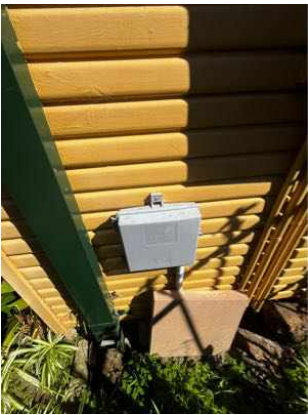
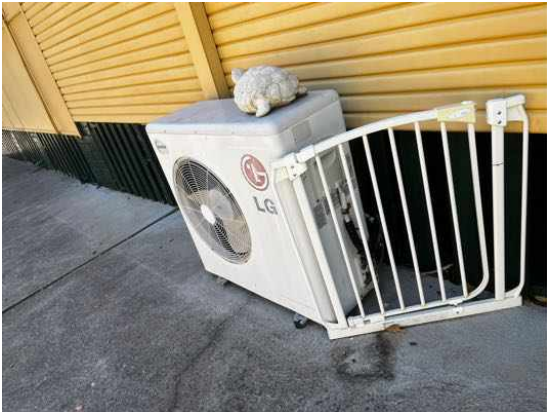
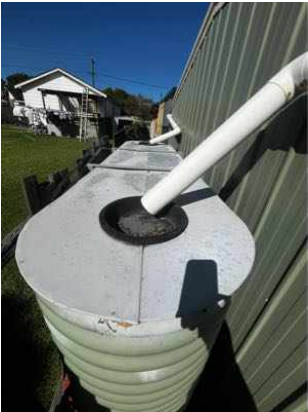
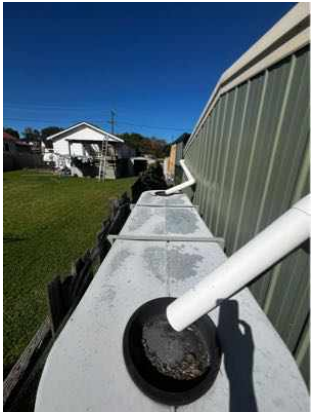
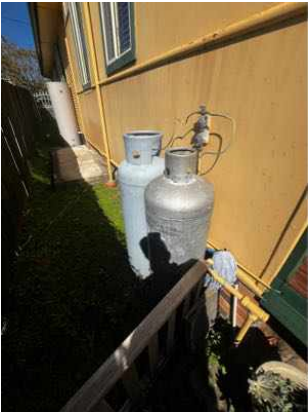
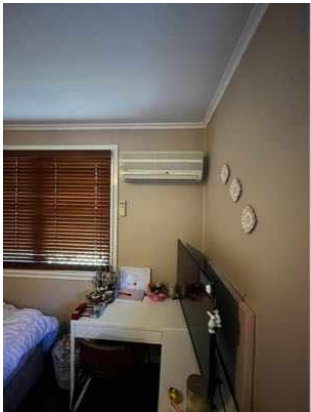
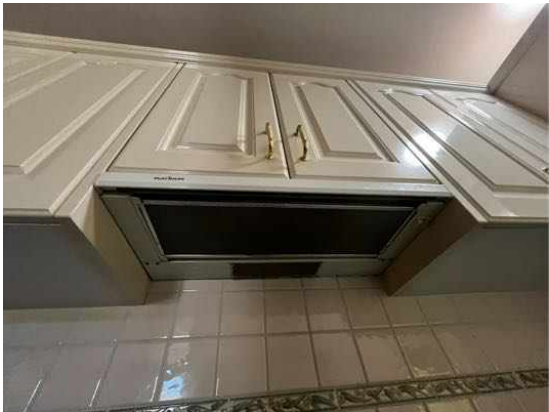
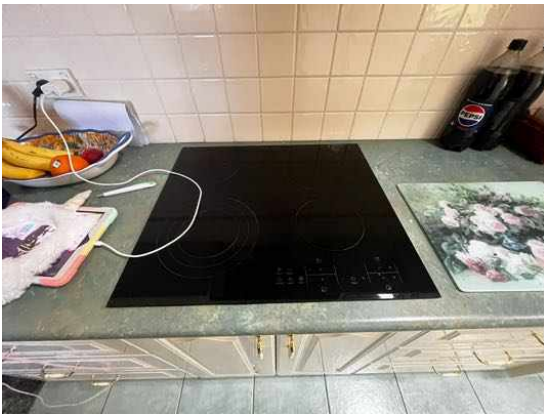
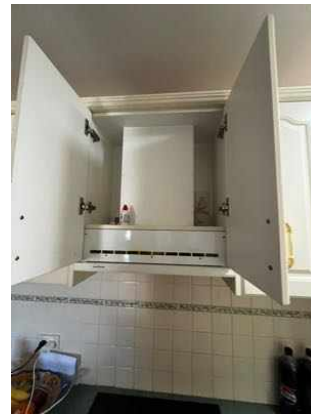
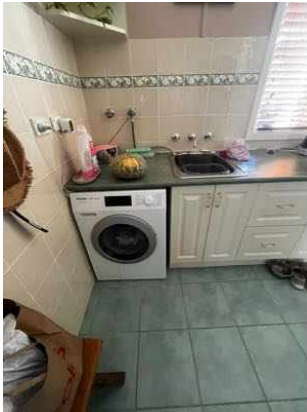
Building:	Main Building
Location:	Kitchen/ Laundry Bathroom
Finding:	Plumbing/electrical/gas/aircon/appliances/pool equipment/fire safety etc
Information:	Plumbing and electrical inspections are outside the scope of the building inspection and must be conducted by a Licensed and registered Trades person.

It is highly recommended that the client makes immediate arrangements to have the gas appliances checked by a licensed gas plumber to ensure that the appliances are working safely and efficiently.

We recommend all other installations be checked also.

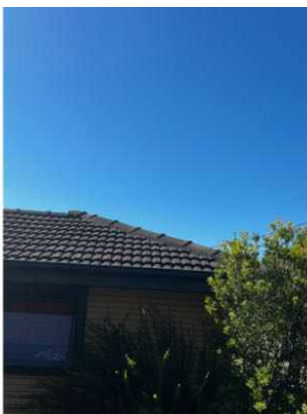
Building: Main Building
Location: Roof Exterior
Finding: Roof tiles - Weathered
Information: Upon inspection of the exterior roofing, the majority of roof tiles were considered to be in a fair condition. While weathering of the tiles is consistent with the age of the property, maintenance works are required.

Consult a roofer if assistance required.
