Building and Timber Pest Inspection Report

Inspection Date: Tue, 7 Apr 2026

Property Address: 167 Oxford St, Cambridge Park NSW 2747,
Australia

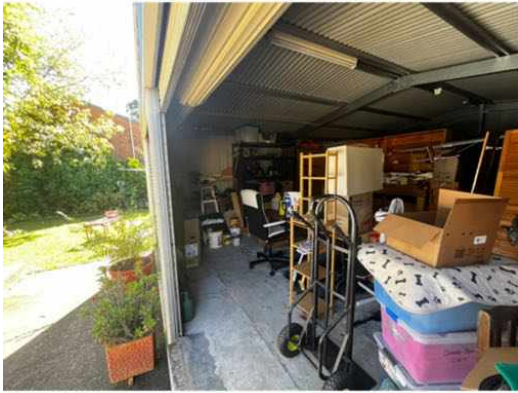
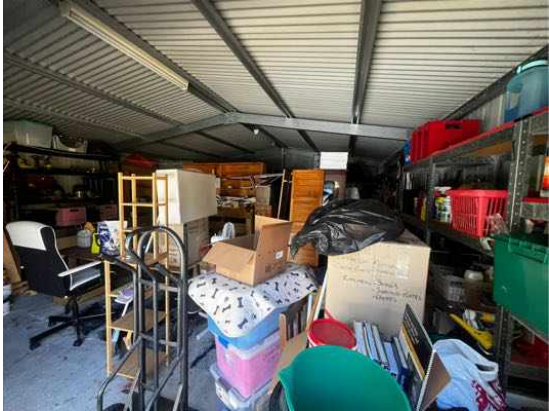
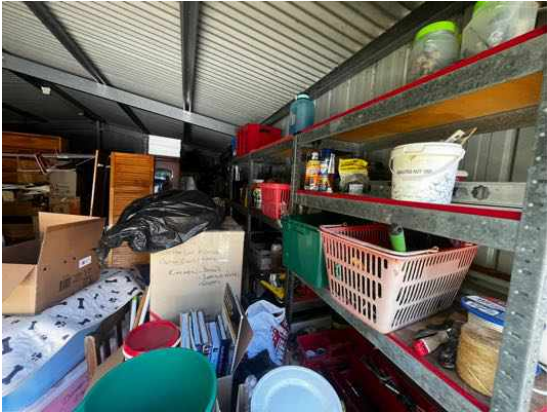
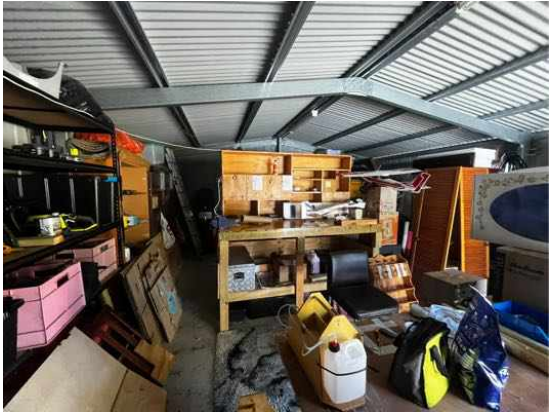
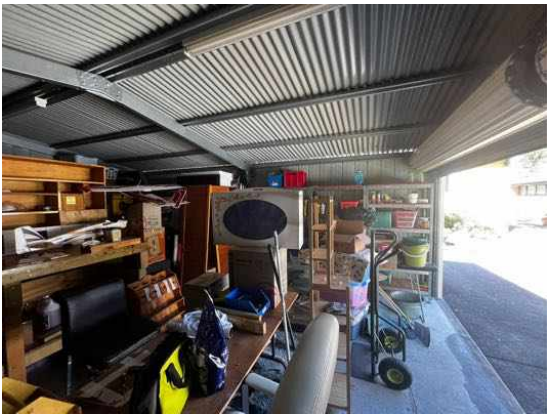
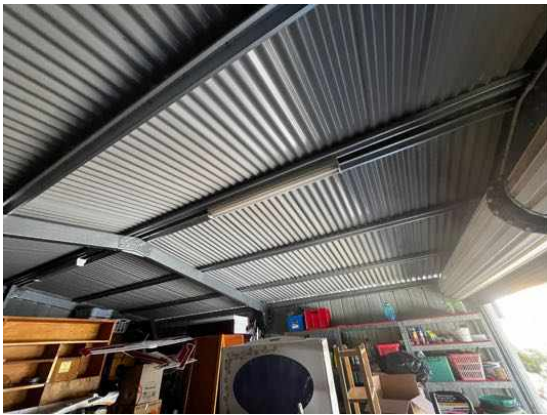
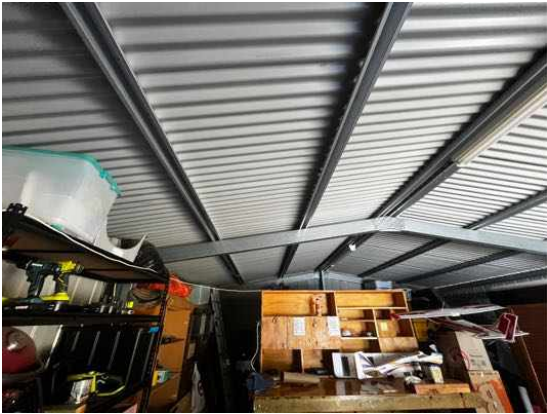
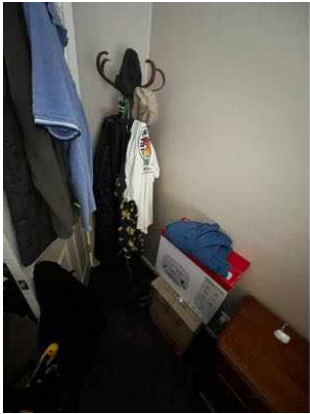
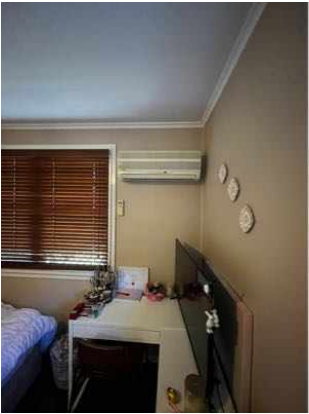
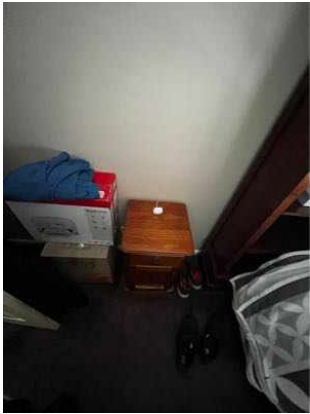
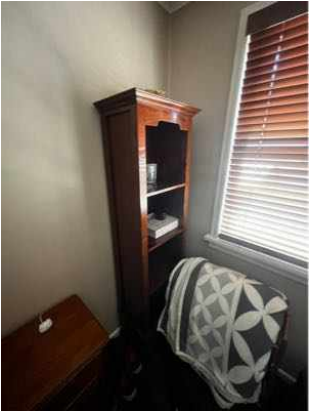
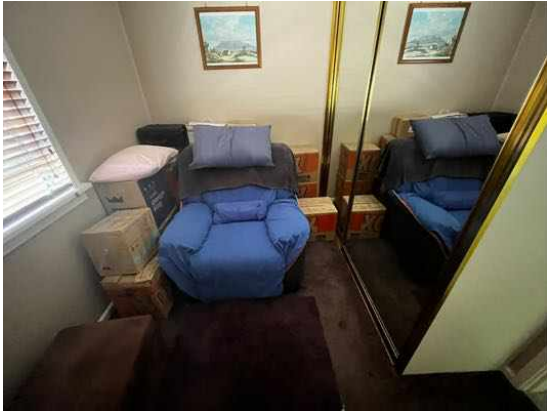
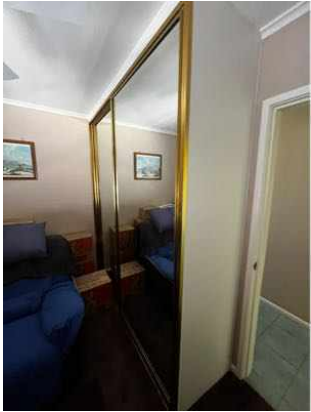
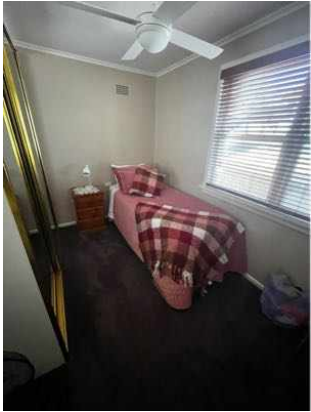
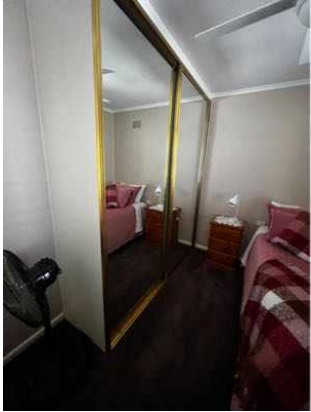
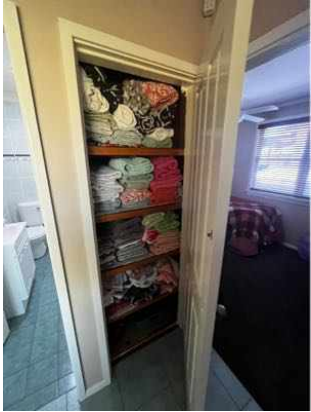
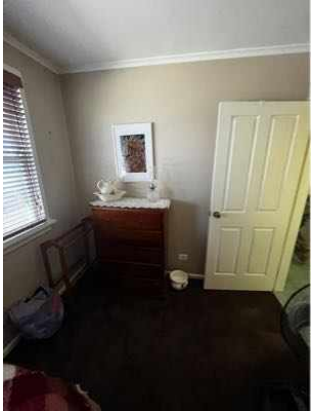
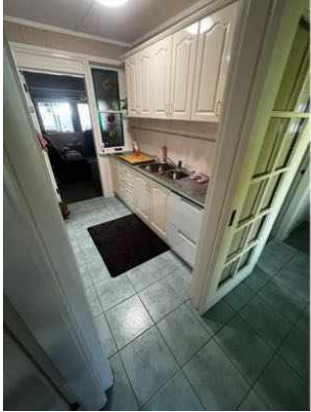
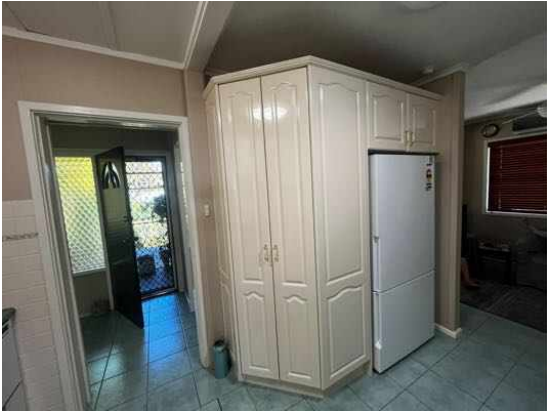
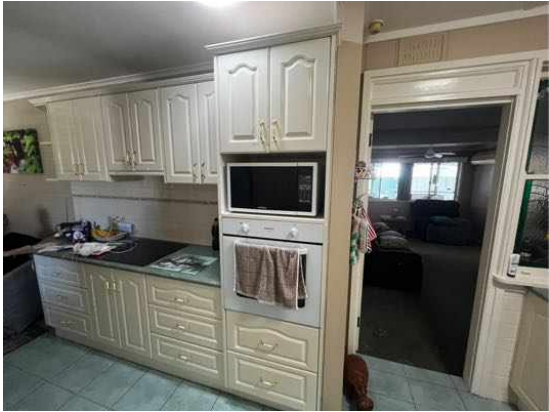
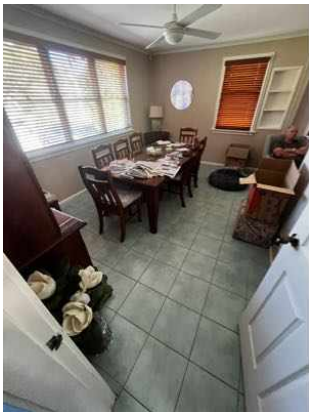
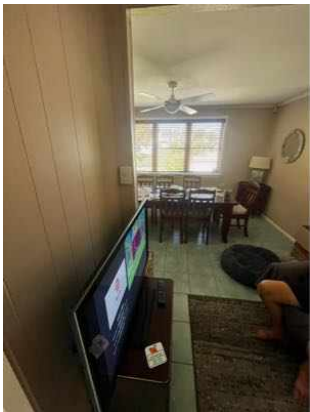
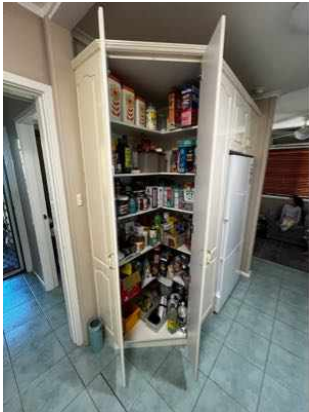
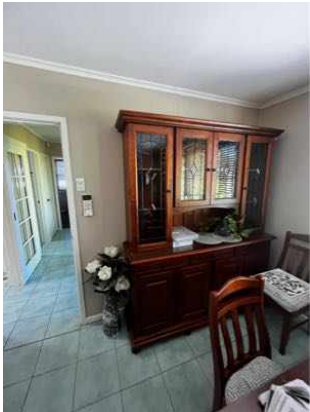
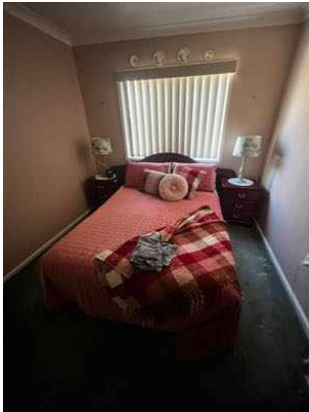
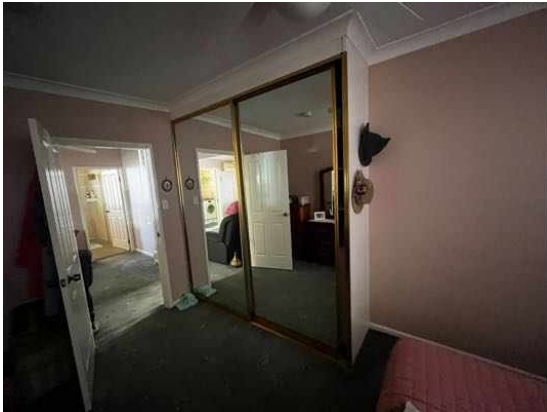
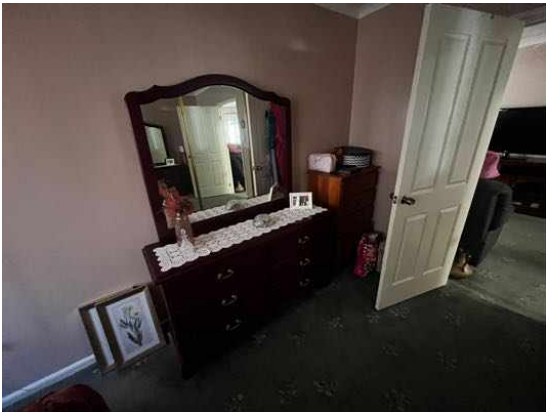
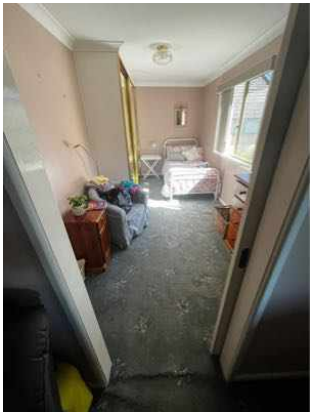
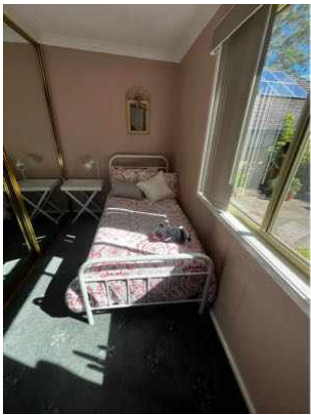
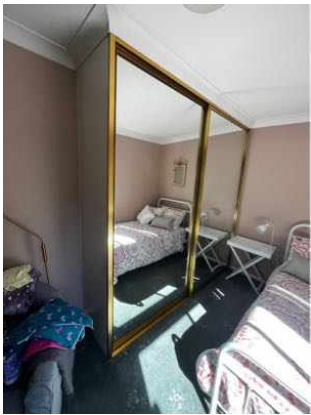
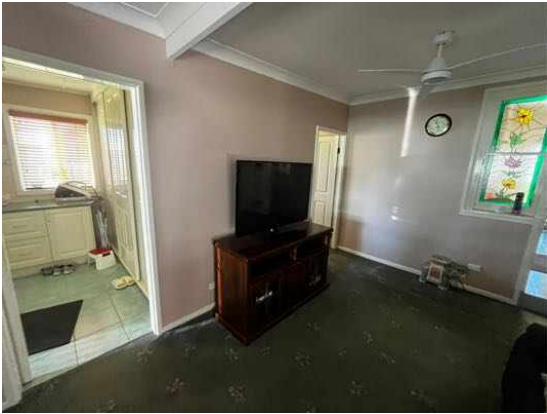
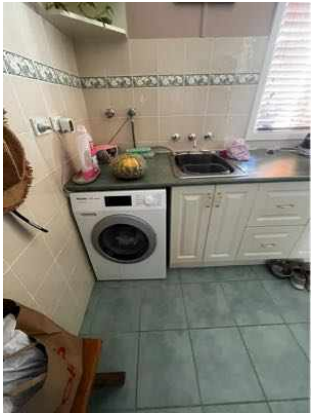
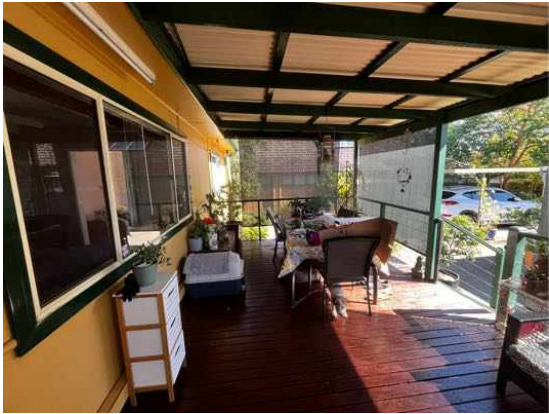
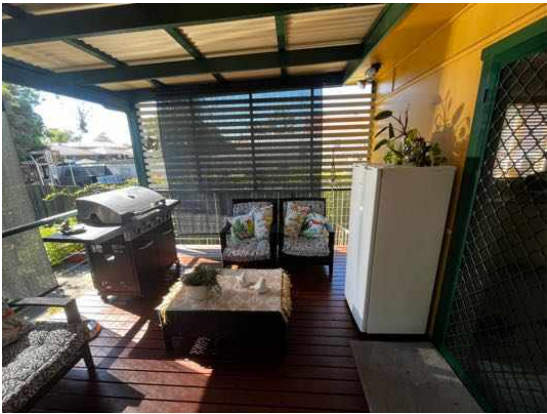
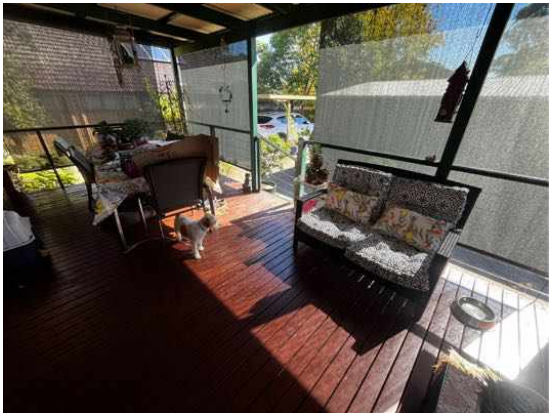
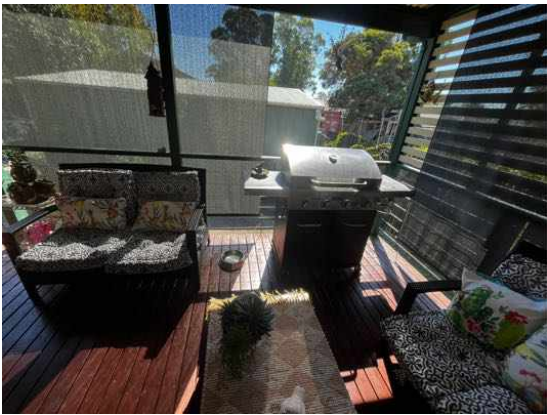
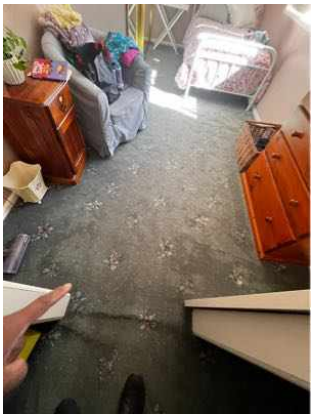
Noted Item

Building: Studio
 Location: All Areas
 Finding: Additional Photos - Obstructions and Limitations
 Information: These photographs are an indication of the obstructions and limitations which impeded full inspection of the property at the time of inspection inside the studio.

These obstructions can hide an array of defects and should be removed to allow full inspection to be carried out. A re-inspection is recommended once the areas are made accessible.
