# Building and Timber Pest Inspection Report

Inspection Date: Thu, 22 Jan 2026

Property Address: 20 Mountain View Parade, Maudsland QLD  
4210, Australia

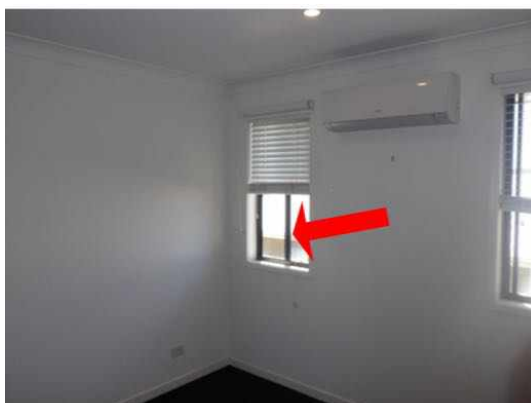
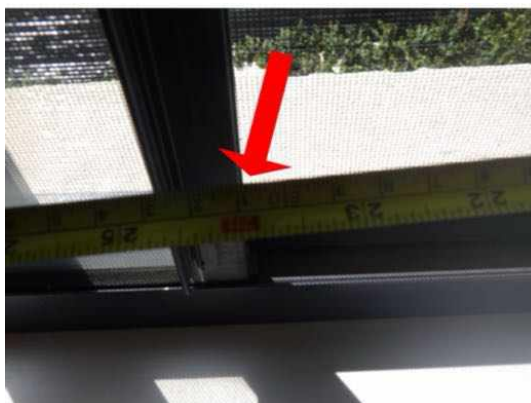
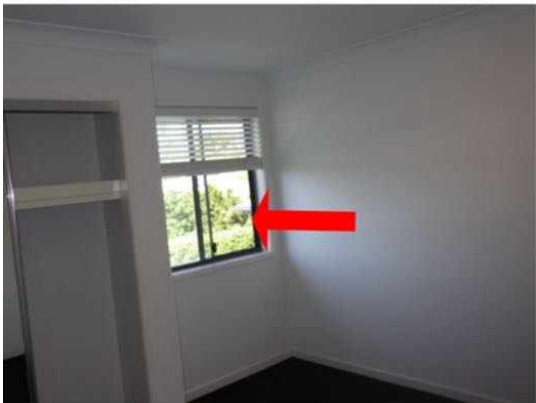
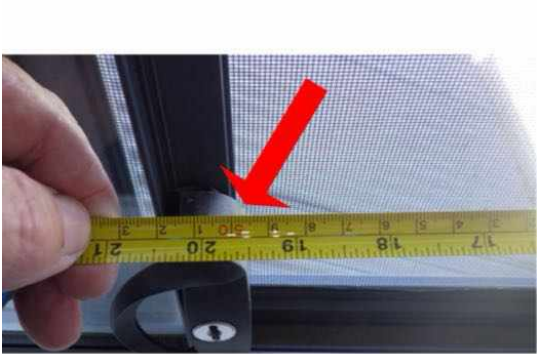
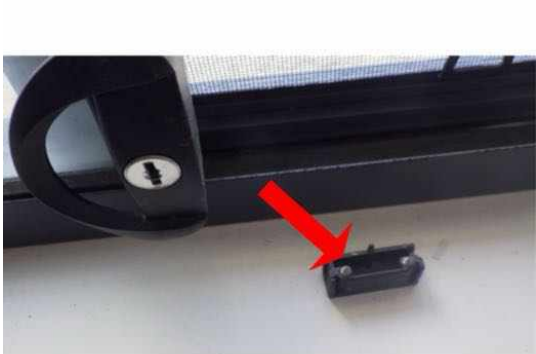
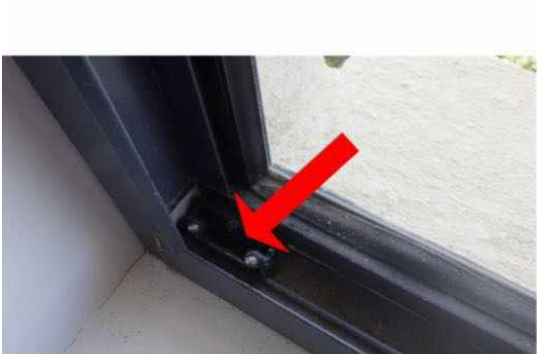
Information: It was noted that the windows of the upper level bedrooms are less than 1.7m from the floor and have a fall greater than 2m on the exterior from the sill and as such are required to only open upto 125mm or have security grills fitted.

At the time of inspection it was observed, previously installed safety catches have been removed.

This is noted as a safety concern and this regulation may not have been in place at the time of construction.

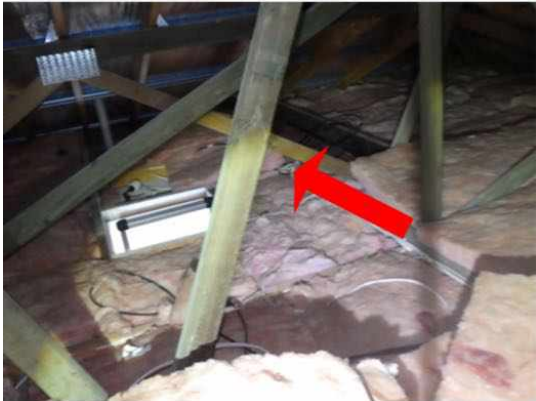
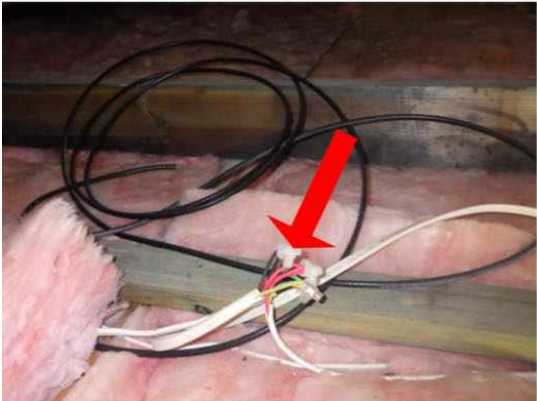
**Finding 1.02**

Building: Main Building  
Location: Attic > Front  
Finding: Electrical cables exposed  
Information: Exposed electrical cabling connections were identified in the upper level roof space area. Exposed electrical cabling or connections represents a potential safety hazard including for fire and personal contact. Any areas of unsheathed electric cables and/or exposed connections should be enclosed in an approved electrical junction box.

A licensed electrician should be engaged as a matter of priority to undertake rectification work.

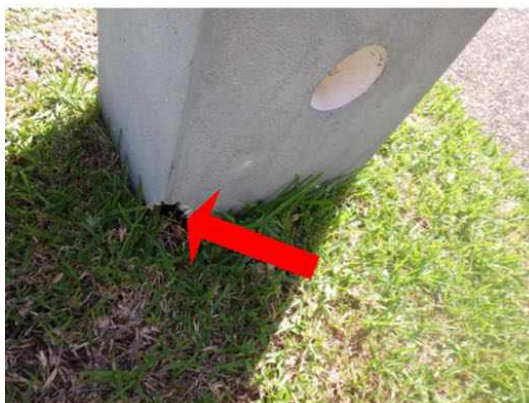
### Finding 3.01

Building:	Main Building
Location:	Yard - Front > Centre
Finding:	Mailbox
Information:	At the time of inspection the mailbox to the front of the property showed signs of damage. The damage appears consistent with impact at some time.
	A general handy man could be engaged to repair or replace the damaged mailbox.

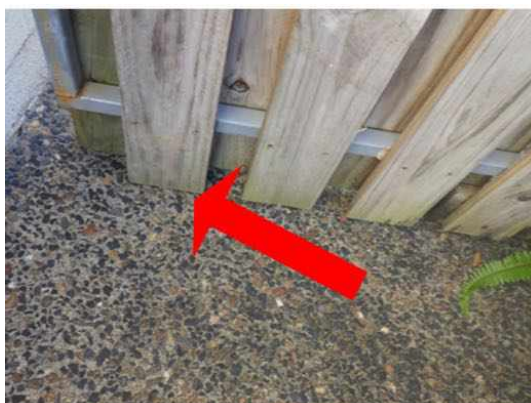
### Finding 3.02

Building:	Main Building
Location:	Yard - Side > Front Left
Finding:	Gate - Sticking/ jamming
Information:	At the time of inspection the gate to the left side of the property was sticking or jamming on the concrete footpath, during standard operation.
	A fencing contractor or general handyman could be engaged to adjust or repair the gate as required.

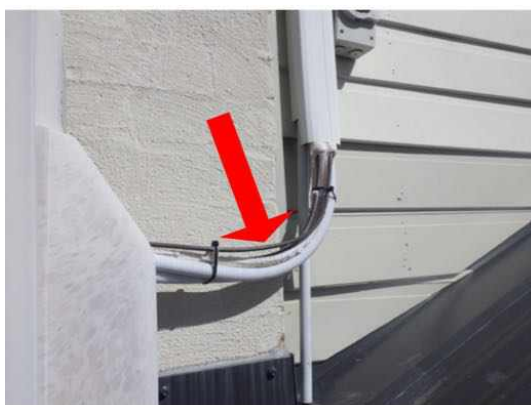
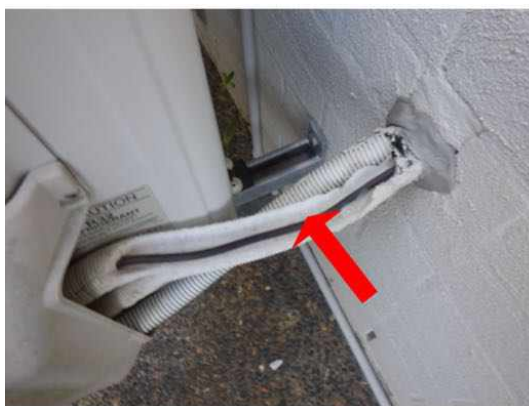
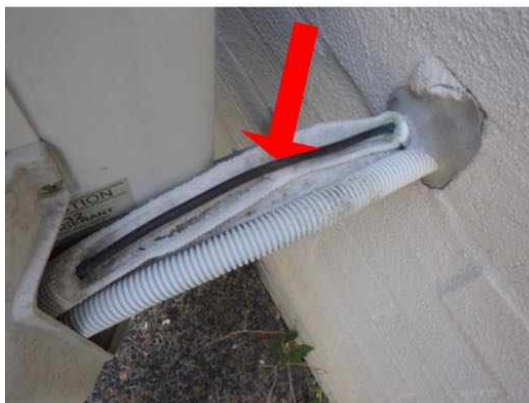
### Finding 3.03

Building: Main Building  
Location: Exterior walls > Front Right, Centre Left  
Finding: Pipework - Insulation deteriorated  
Information: At the time of inspection sections of the air conditioning units pipe work insulation showed evidence of damage and deterioration. It is suspected that this deterioration has developed as a result of excessive exposure to weather, including UV exposure in daylight. Deteriorated insulation reduces the effectiveness of the material in helping to maintain the desired temperature and work most efficiently.

If left in an exposed position, it is likely that the deterioration will continue and worsen over time, potentially resulting in secondary building defects as well as a further loss in insulating properties.

Some areas of replacement of pipe insulation is likely to be required. Further preventative measures to remove or protect the material from future exposure are also advisable. Consultation with a licensed air conditioning installer is advised to gain quotes for the repair and/or replacement of deteriorated insulation.

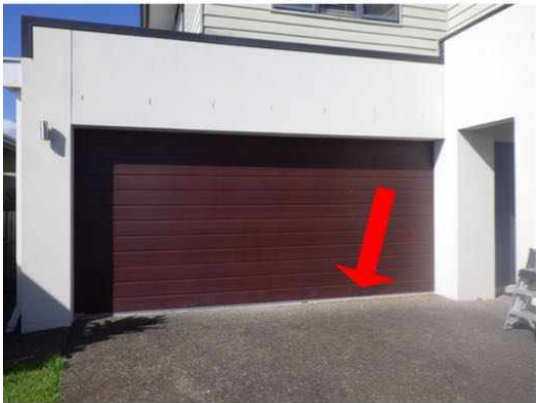
### Finding 3.04

Building:	Main Building
Location:	Garage > Front
Finding:	Garage door - dent
Information:	The garage door has dent likely to have resulted from impact damage be it accidental or deliberate impact at sometime.

Repair and/or replacement of the garage door would improve the condition of the garage but certainly not an urgent item

A qualified sectional door installer or supplier could be engaged to check out the operation and overall condition of the door to determine if repair is an option.

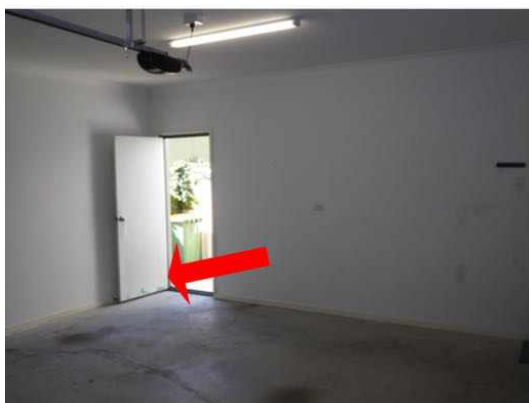
**Finding 3.05**

Building: Main Building  
Location: Garage > Rear Left  
Finding: Painted surface - Deteriorated  
Information: At the time of inspection sections of paint to the garage area exterior door were found to have deteriorated. Deteriorated paint is generally an indication of exposure to moisture or poor workmanship.

The presence of excessive moisture can have implications on painted areas and associated building elements if left unattended. While only seemingly minor at this stage, the cause of the damage is assumed to be from continual weather exposure.

It is advised that the affected paint work be rectified by a qualified painter.

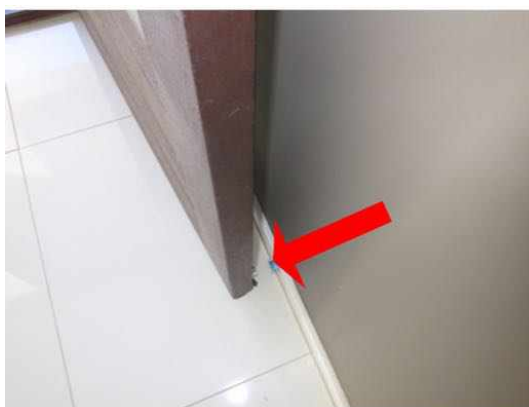
### Finding 3.06

Building:	Main Building
Location:	Entry > Front Left
Finding:	Door stop - Missing
Information:	The entry door stop is missing or is inadequate to stop the door handle from damaging the wall.

Re-installation or replacement of the door stop is advised to prevent any subsequent damage to the wall linings or associated structures.

A general handyman may be appointed to perform these works at client discretion.

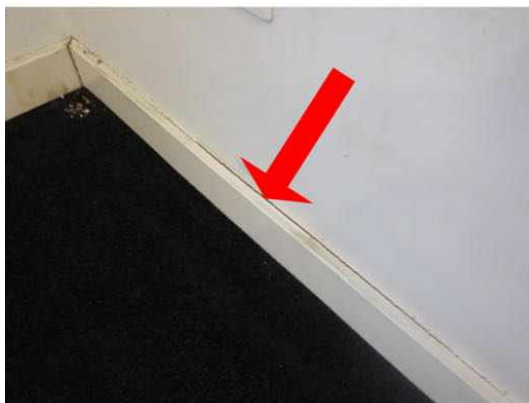
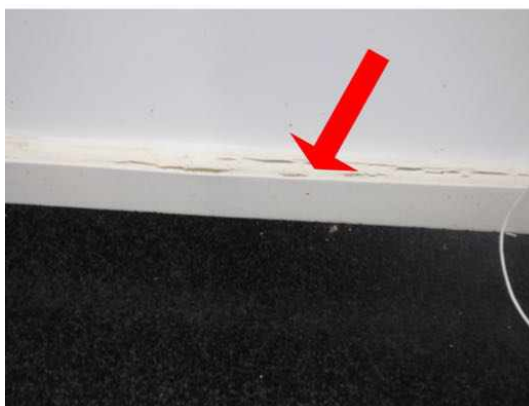
### Finding 3.07

Building:	Main Building
Location:	Lounge Room > Front, Centre
Finding:	Skirting Damaged
Information:	At the time of inspection the MDF timber skirting in the lounge room showed signs of damage or deterioration. The deterioration appears consistent with moisture exposure.

A qualified carpenter or general handyman could be engaged to replace the skirtings as required.

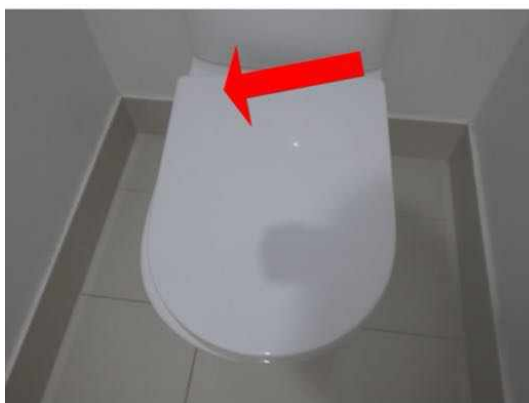
### Finding 3.08

Building:	Main Building
Location:	Powder Room > Centre
Finding:	Toilet seat - Loose
Information:	The toilet seat in the powder room was found to be loose at the time of inspection. It is suspected that this defect has developed due to general wear and tear.

If left unmanaged, the toilet seat could deteriorate further, leading to destabilisation and the potential for water leaks to the toilet pan area.

It is recommended that the seat be repaired by a licensed plumbing or general handyman.

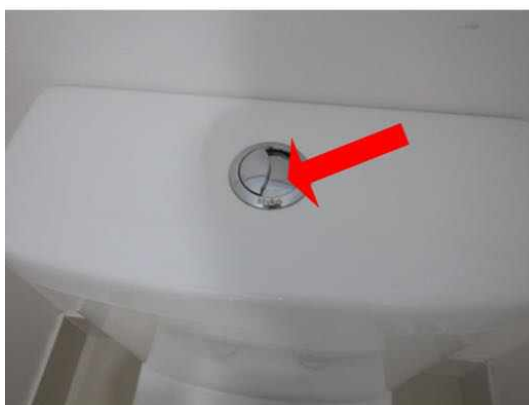
### Finding 3.09

Building: Main Building  
 Location: Powder Room > Centre,Rear  
 Finding: Cistern  
 Information: At the time of inspection the WC toilet cistern right side flush button did not activate water flow during standard operation.

A qualified plumber could be engaged to undertake repair work on the toilet cistern.

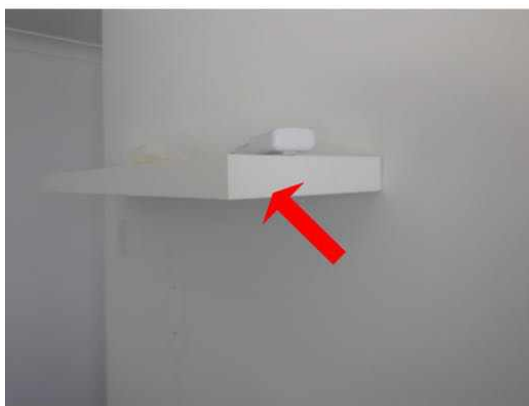
### Finding 3.10

Building: Main Building  
 Location: Rumpus Room > Front Left  
 Finding: Shelving  
 Information: At the time of inspection the wall hung shelf in the rumpus room showed signs of movement or separation.

The shelving may have been previously overloaded.

A qualified carpenter or general handyman could be appointed to undertake repairs at the clients discretion.

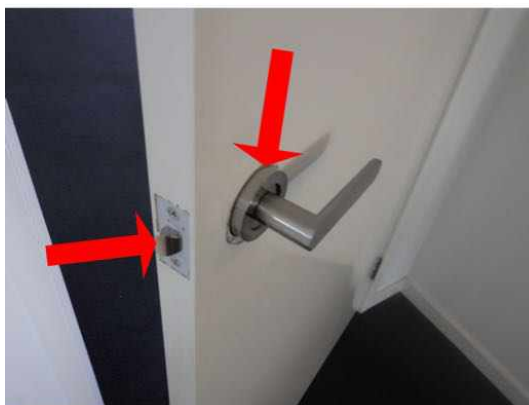
### Finding 3.11

Building: Main Building  
 Location: Bedroom - Master > Front  
 Finding: Door Handle  
 Information: At the time of inspection it was noted that the door handle latch set, to the main bedroom door has been installed the opposite way to which it would normally operate. The latch set mechanism should be removed, rotated 180 degrees and re-installed. Additionally it appears the door handle has been replaced at some time, with the new door handle passage set back plate being too small for the door handle cut out.

The client could engage a general handyman to reverse the latch set and/or replace the door handle.

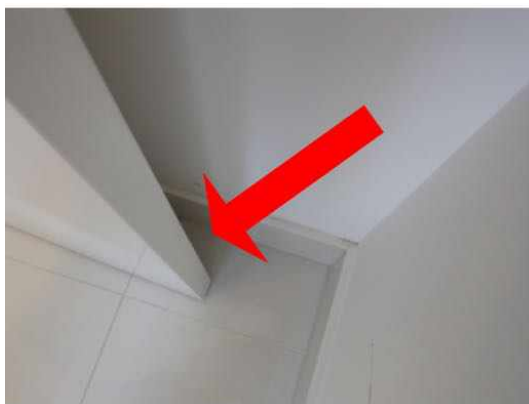
### Finding 3.12

Building: Main Building  
 Location: Ensuite - WC > Front Left  
 Finding: Door stop - Missing  
 Information: The ensuite WC area door stop is missing or is inadequate to stop the door handle from damaging the wall.

Re-installation or replacement of the door stop is advised to prevent any subsequent damage to the wall linings or associated structures.

A general handyman may be appointed to perform these works at client discretion.

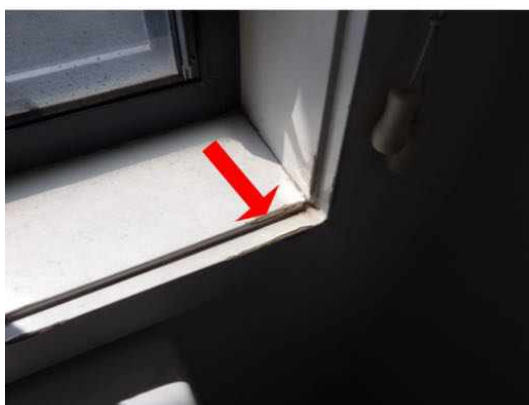
### Finding 3.13

Building: Main Building  
 Location: Ensuite - WC > Rear  
 Finding: Architraves Damaged  
 Information: At the time of inspection the ensuite WC area window MDF timber architraves showed signs of minor damage or deterioration. The deterioration appears consistent with moisture exposure.

A qualified carpenter or general handyman could be engaged to repair or replace the timber architraves as required.

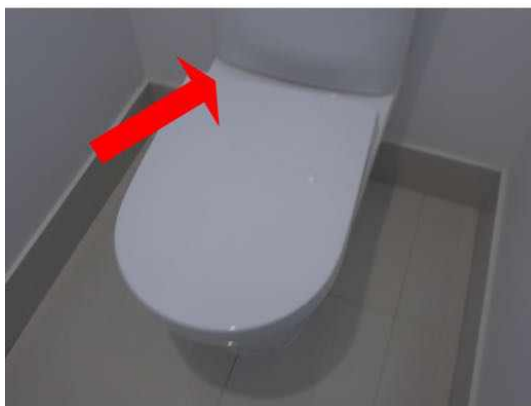
### Finding 3.14

Building: Main Building  
 Location: Toilet (WC) > Centre  
 Finding: Toilet seat - Loose  
 Information: The WC area toilet seat was found to be loose at the time of inspection. It is

suspected that this defect has developed due to general wear and tear.

If left unmanaged, the toilet seat could deteriorate further, leading to destabilisation and the potential for water leaks to the toilet pan area.

It is recommended that the seat be repaired by a licensed plumbing or general handyman.

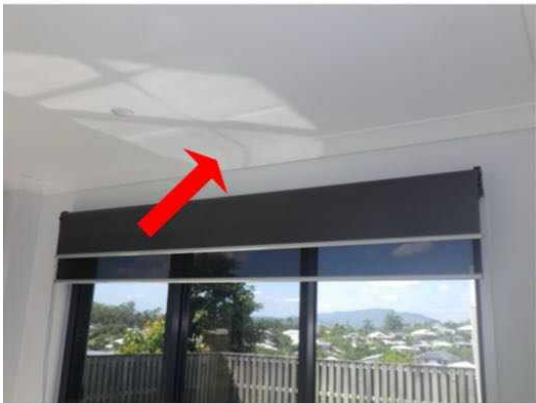
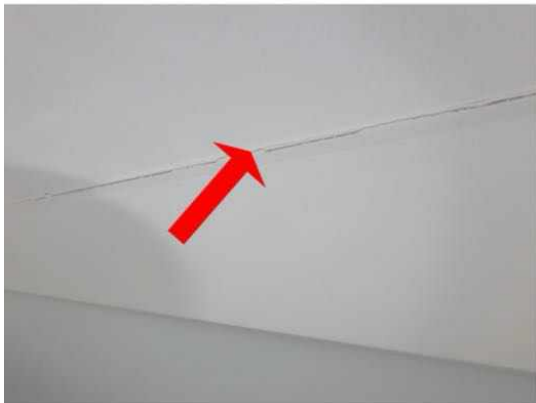
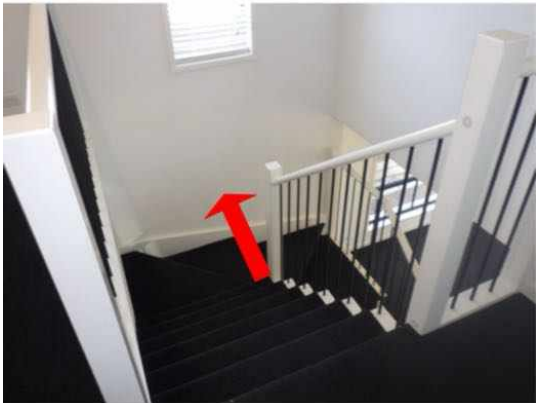
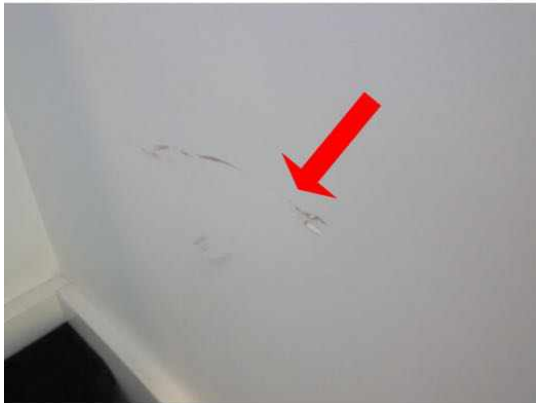
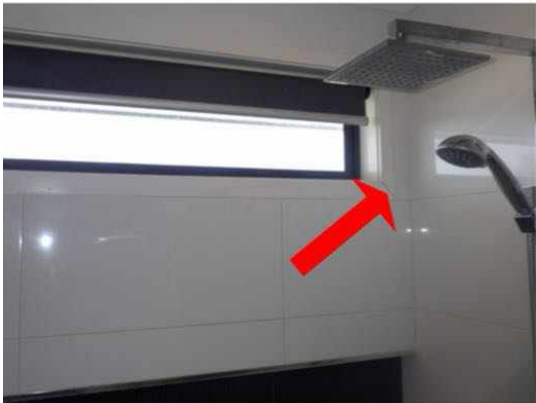
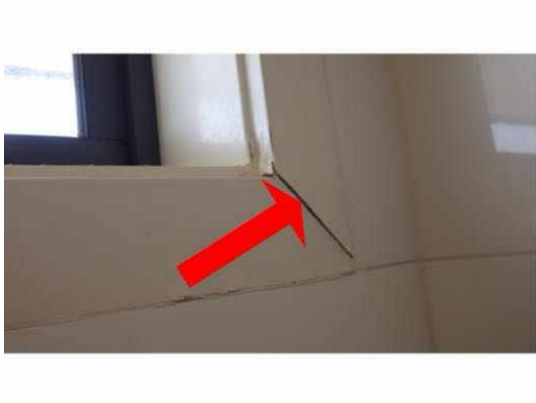
### Finding 3.15

Building:	Main Building
Location:	Internal Areas > Existing
Finding:	Wear and Tear
Information:	At the time of inspection the building interior showed signs of minor cracking and/or scuffing to walls, ceilings, cornices and timber trims (as per example photos).

The level of damage appears consistent with the removal of previous fixtures or fittings, general deterioration and/or wear and tear.

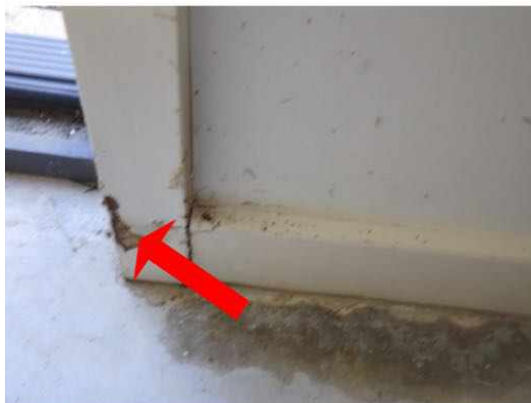
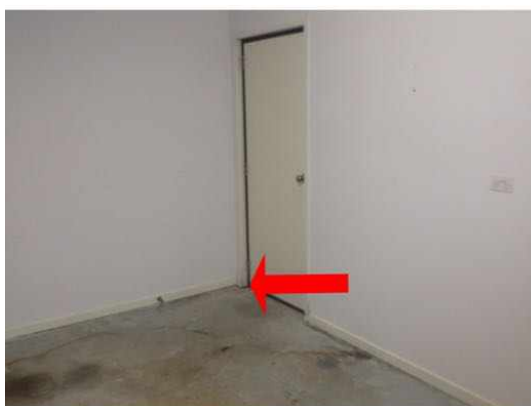
### Finding 3.17

Building:	Main Building
Location:	Garage > Rear Left
Finding:	Wood Rot
Information:	At the time of inspection an area of the timber architraves and skirting board to the garage area external door frame showed signs of wood rot. The wood rot damage appears to be caused from moisture exposure.

The client could engage a qualified carpenter or general handyman to undertake repair work.

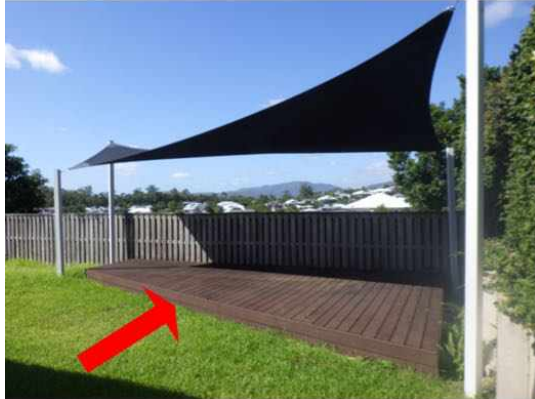
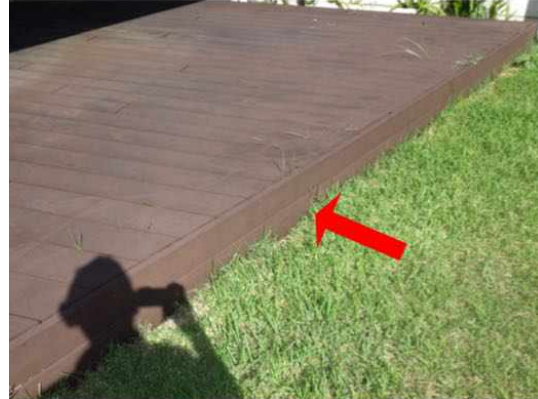
Building: Main Building  
 Location: Yard - Back > Rear Right  
 Finding: Deck - In ground contact  
 Information: At the time of inspection it was noted the timber deck area to the rear of the property is in direct contact with the finished ground level.

and are likely to be subject to premature rot and decay as the soil retains moisture or damp conditions against the timbers.

Frequent pest inspections are highly advised to readily identify any termite activity in these areas.

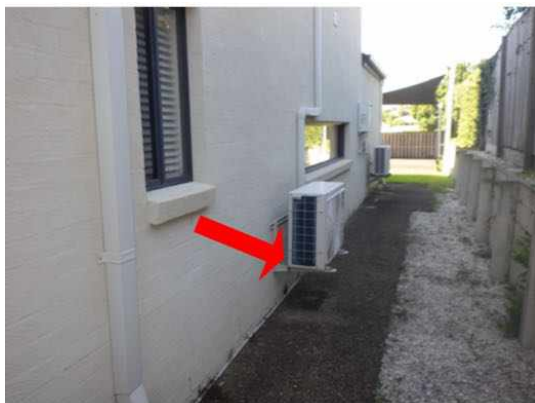
### Finding 6.02

Building:	Main Building
Location:	Exterior walls > Centre Right
Finding:	Overflows - Not plumbed for drainage
Information:	The air conditioning unit overflows are not plumbed or connected to suitable drainage, which can result in the surrounding areas becoming excessively damp. These damp conditions can lead to secondary defects such as rot, rust or corrosion of associated building elements, the formation of fungal decay, or even the creation of potential slip hazards. When coupled with poor site drainage, pooling of water may also attract termite activity to this area. It is highly recommended that a qualified plumber be appointed to install adequate drainage to the overflows. These works will ensure that the areas remain dry and free of any secondary defects.

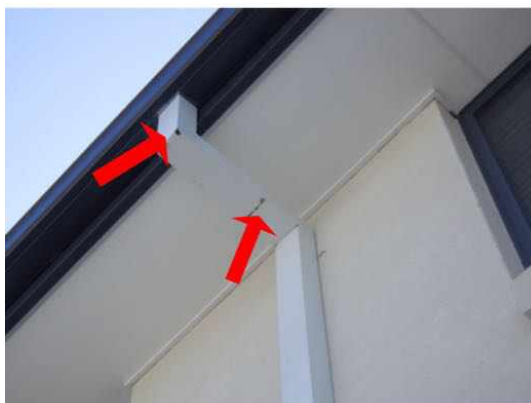
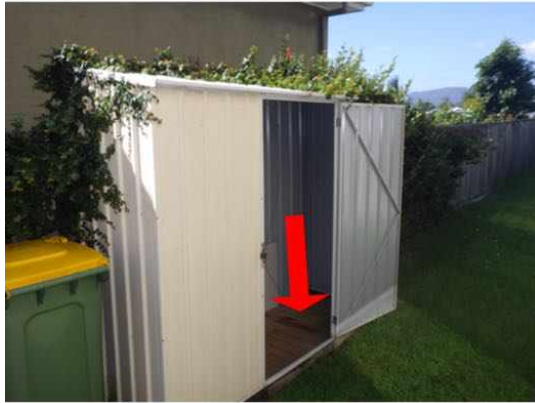
**Finding 6.04**

Building: Main Building  
 Location: Shed > Ground Level  
 Finding: Timber - In ground contact  
 Information: At the time of inspection it was noted the timber floor to the garden shed on the left side of the property is in direct contact with the finished ground level.

Any timbers in direct ground contact provide opportunity for concealed termite entry and are likely to be subject to premature rot and decay as the soil retains moisture or damp conditions against the timbers.

Frequent pest inspections are highly advised to readily identify any termite activity in these areas.

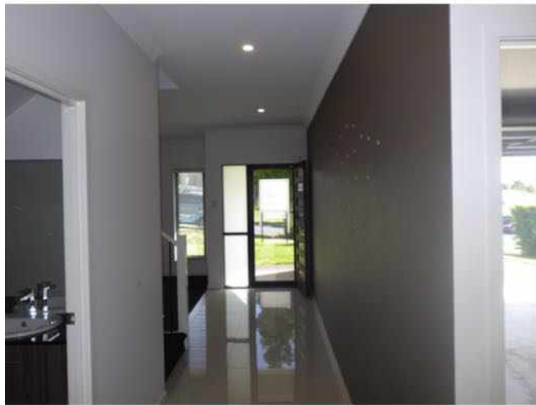
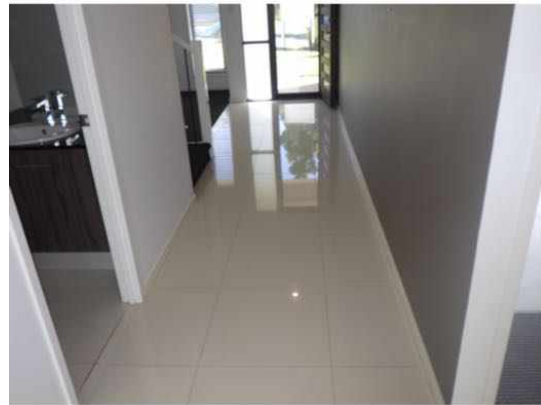
Building: Main Building  
Location: Hallway  
Finding: No obvious defect  
Information: No obvious defects found at the time of inspection.

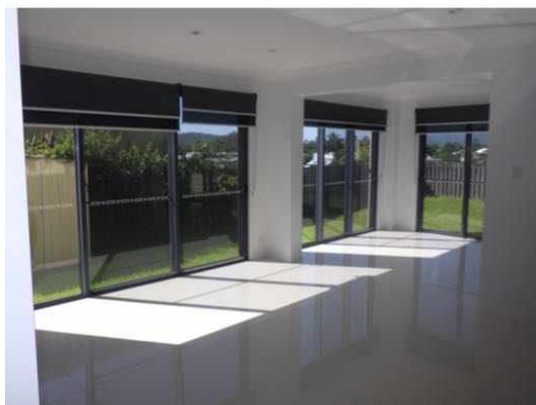
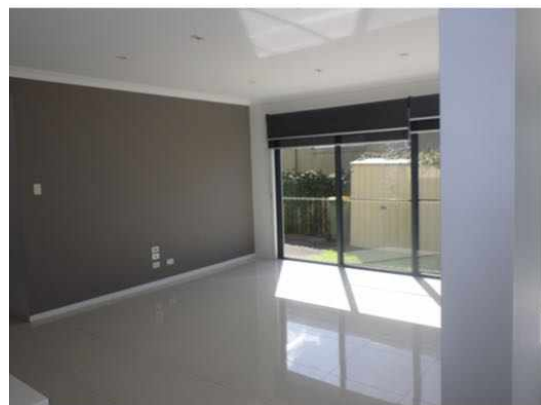
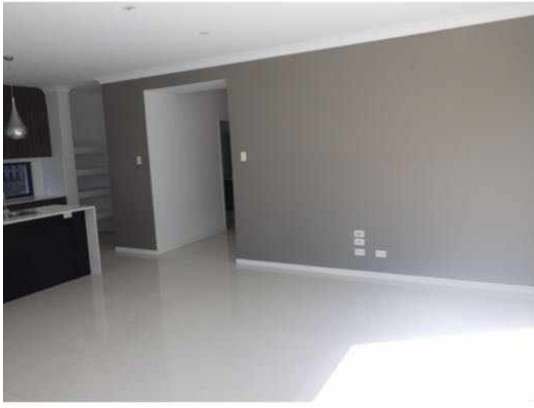
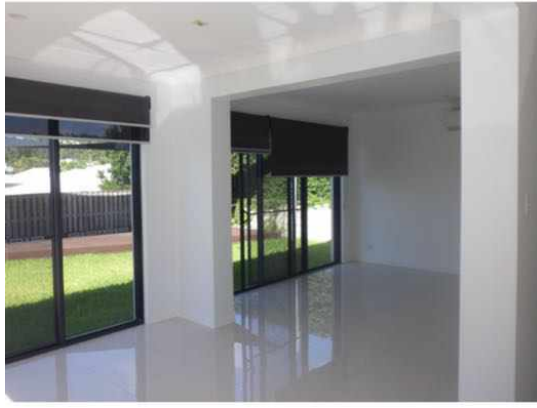
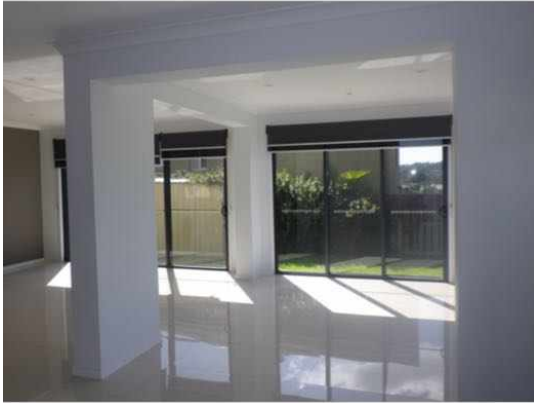
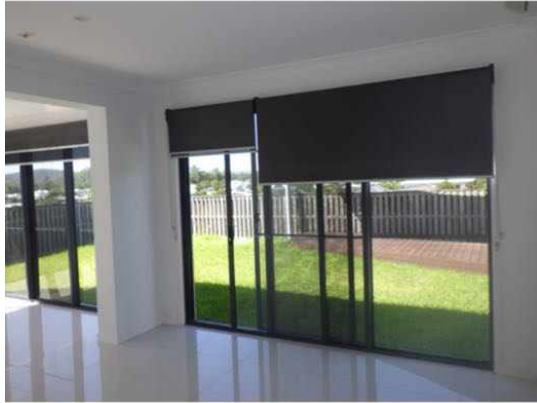
Building: Main Building  
Location: Living Room  
Finding: No obvious defect  
Information: No obvious defects found at the time of inspection.

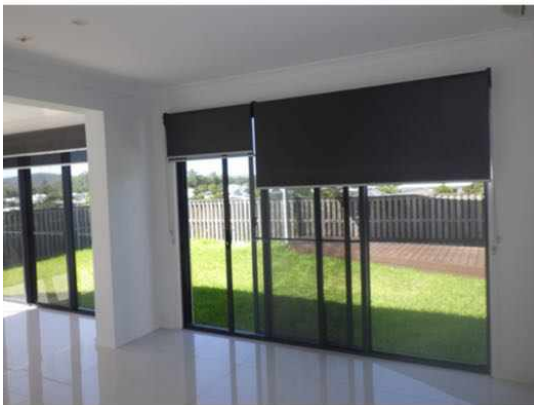
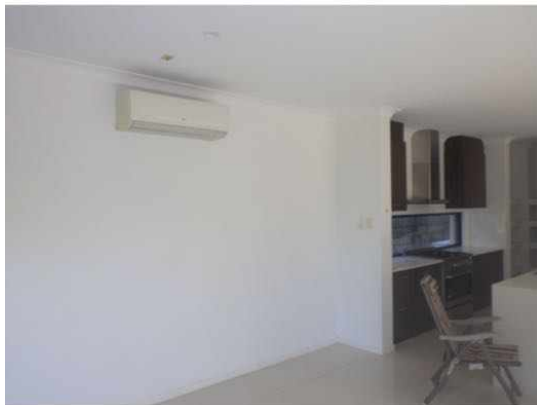
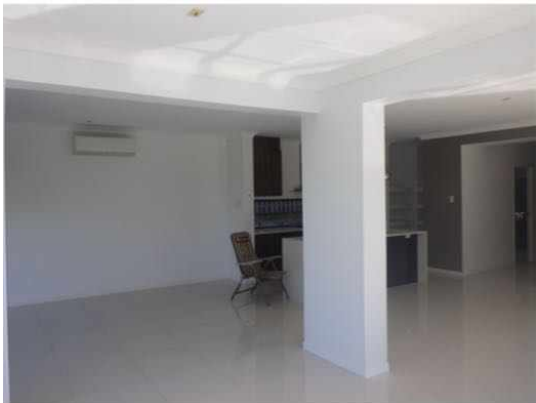
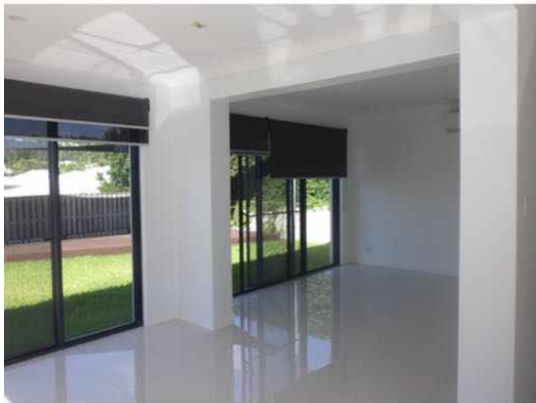
Building: Main Building  
Location: Dining Room  
Finding: No obvious defect  
Information: No obvious defects found at the time of inspection.

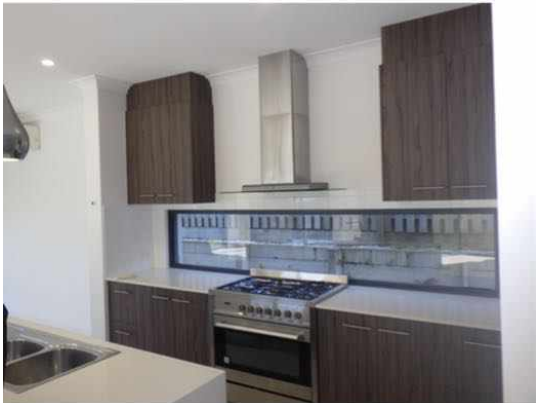
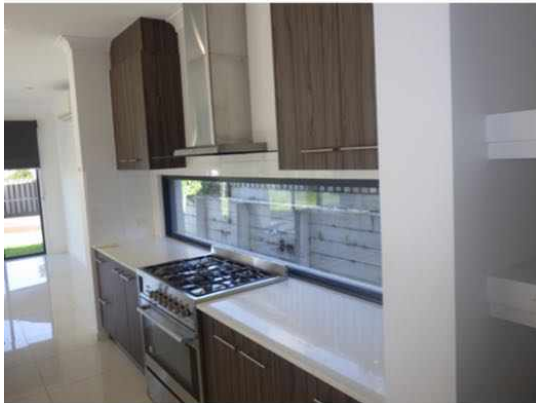
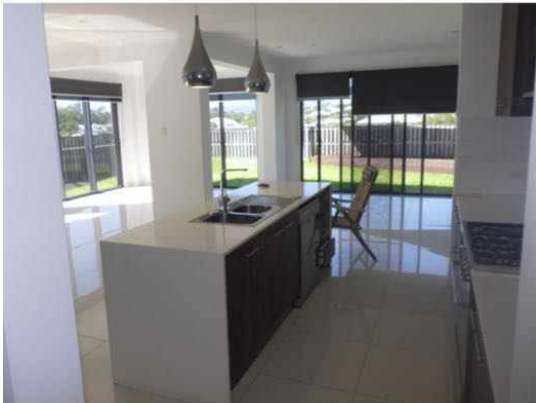
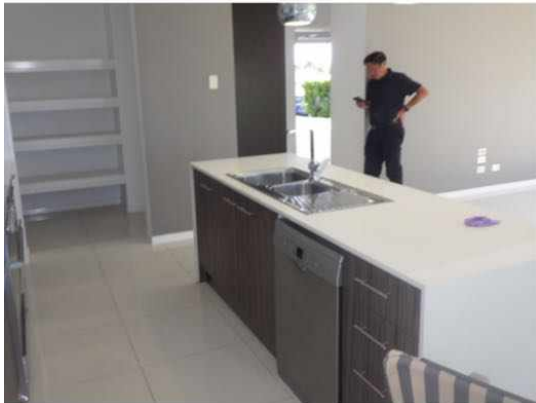
Building: Main Building  
 Location: Kitchen  
 Finding: No obvious defect  
 Information: No obvious defects found at the time of inspection.

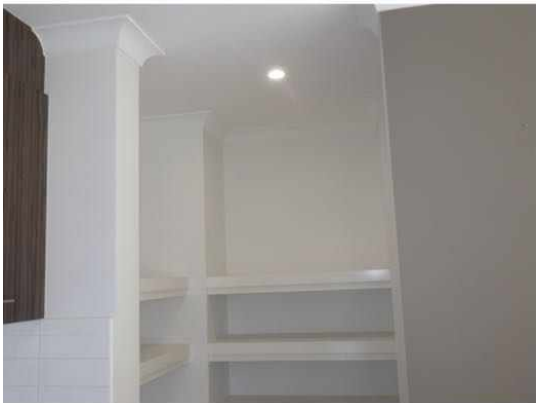
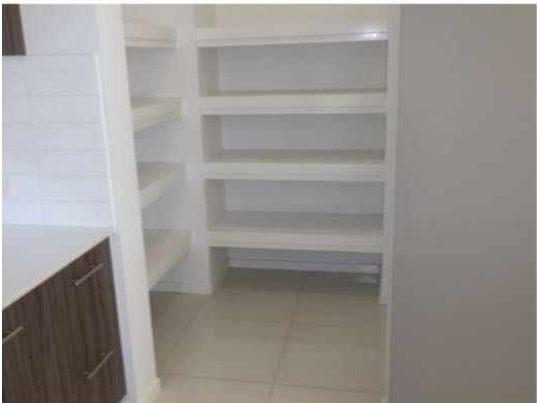
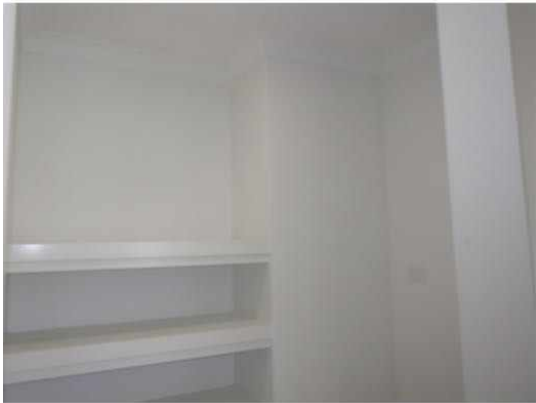
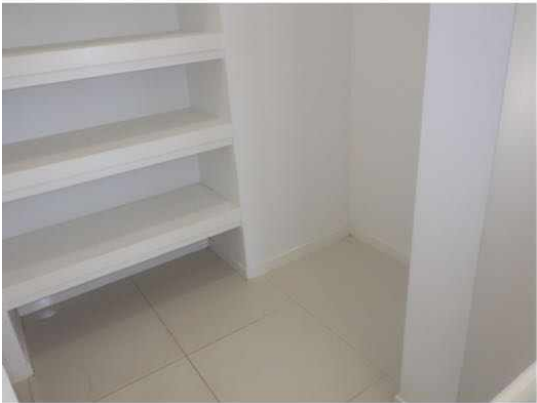
Building: Main Building  
 Location: Pantry - Walk In  
 Finding: No obvious defect

Information: No obvious defects found at the time of inspection.

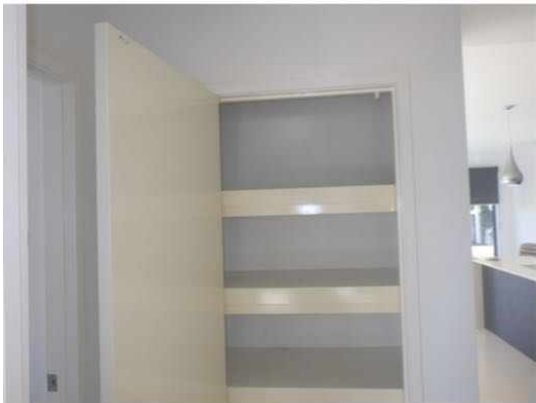
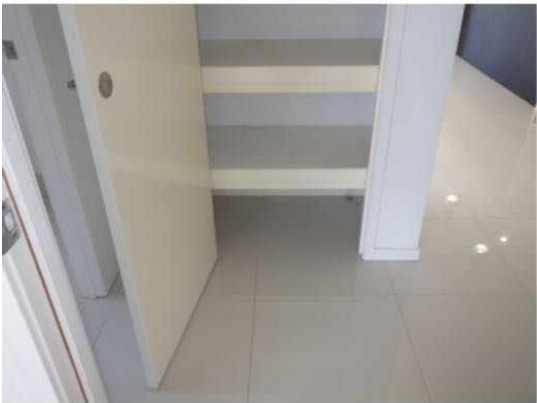
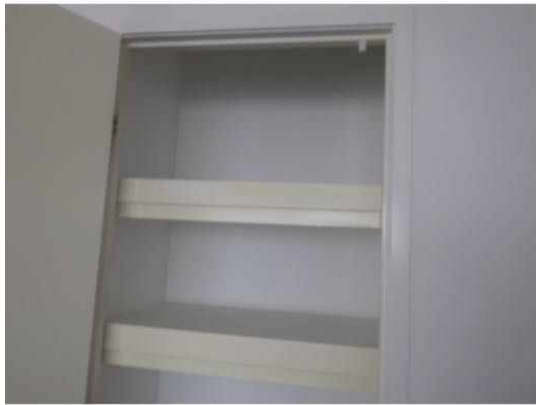
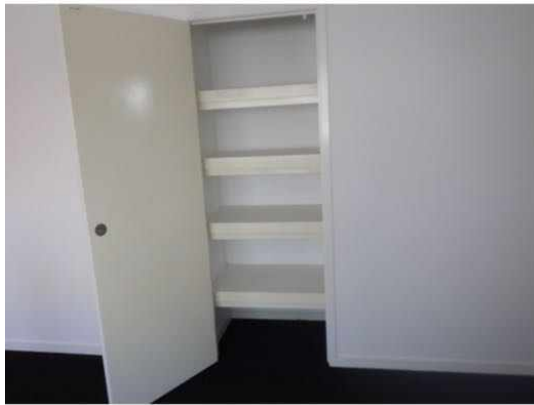
Building: Main Building  
Location: Linen Cupboards  
Finding: No obvious defect  
Information: No obvious defects found at the time of inspection.

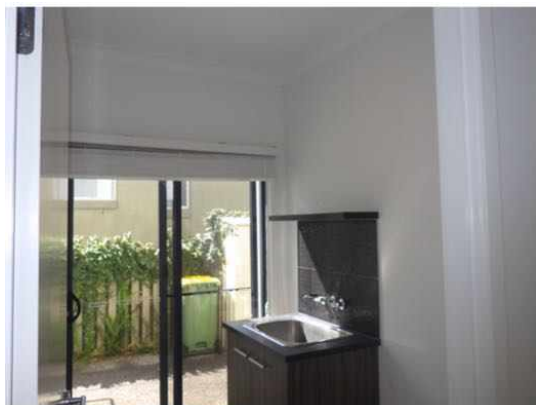
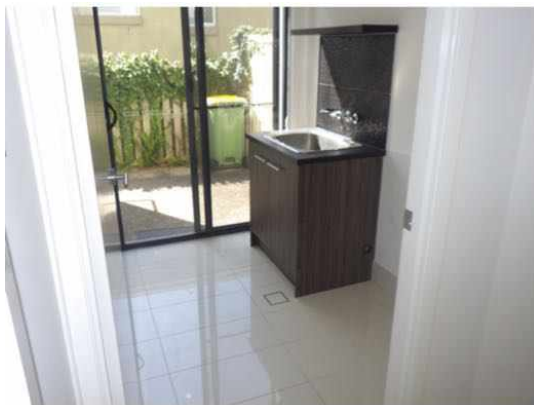
Building: Main Building  
Location: Laundry  
Finding: No obvious defect  
Information: No obvious defects found at the time of inspection.

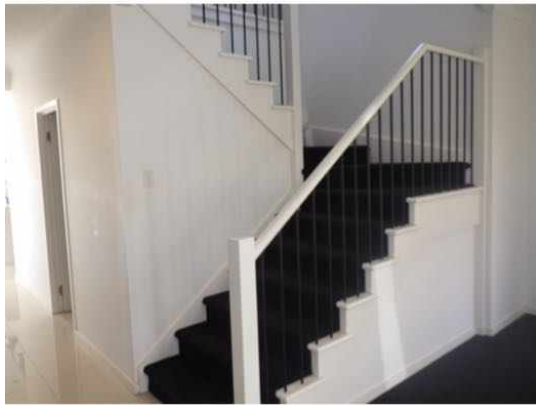
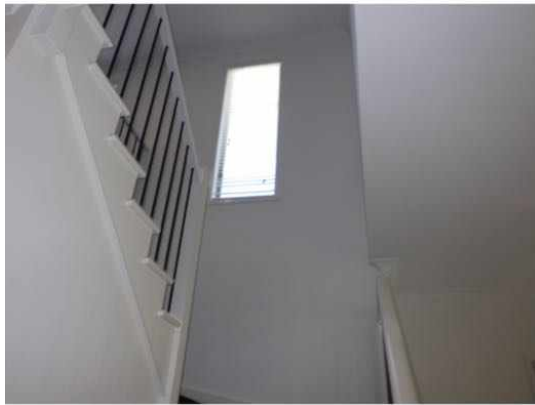
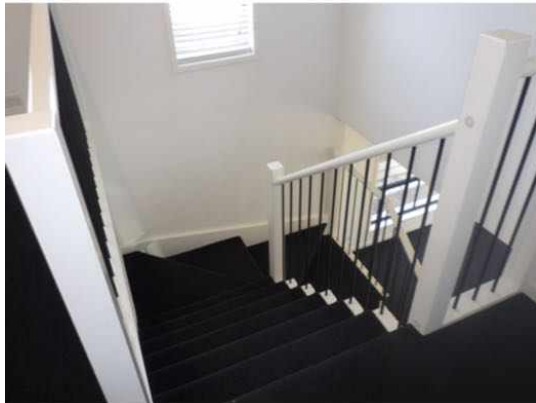
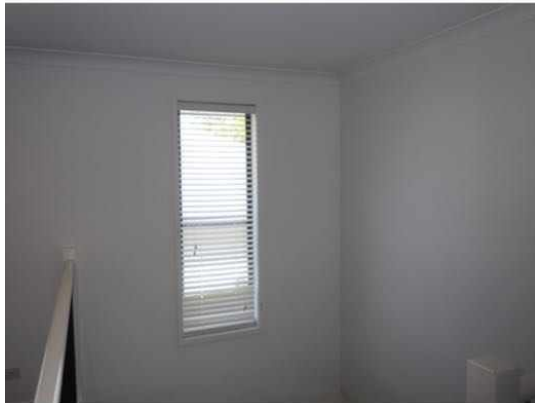
Building: Main Building  
Location: Stairs - Internal  
Finding: No obvious defect  
Information: No obvious defects found at the time of inspection.

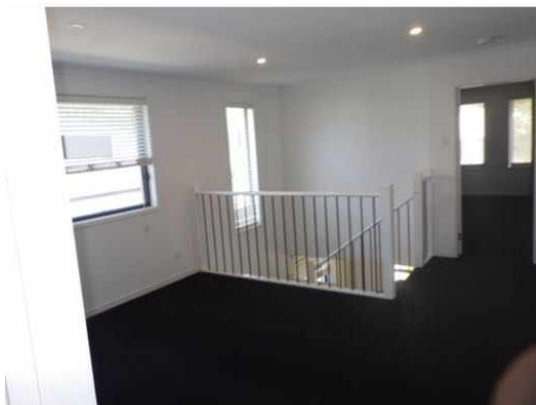
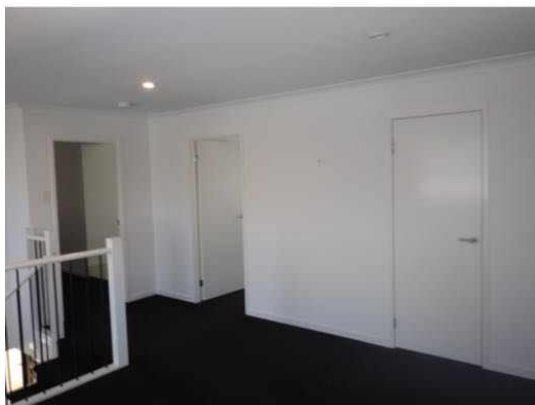
Building: Main Building  
Location: Rumpus Room  
Finding: Additional Photos  
Information: Additional photos are provided for your general reference

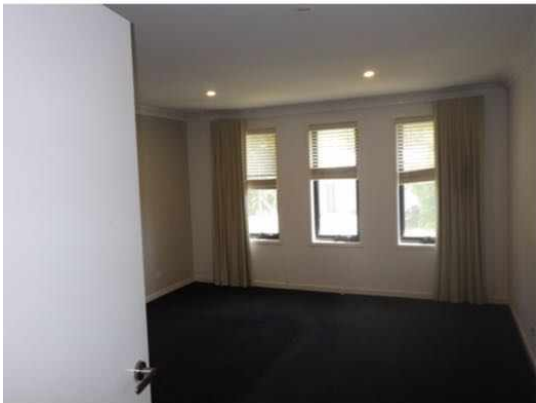
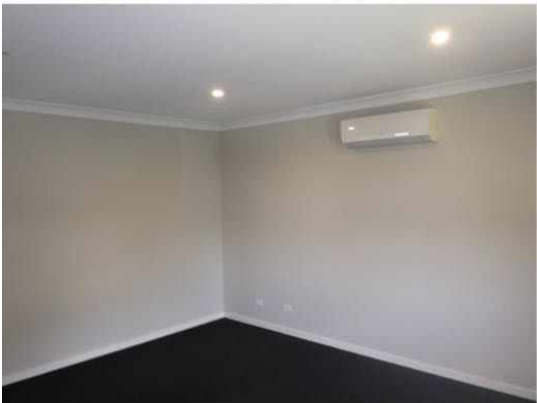
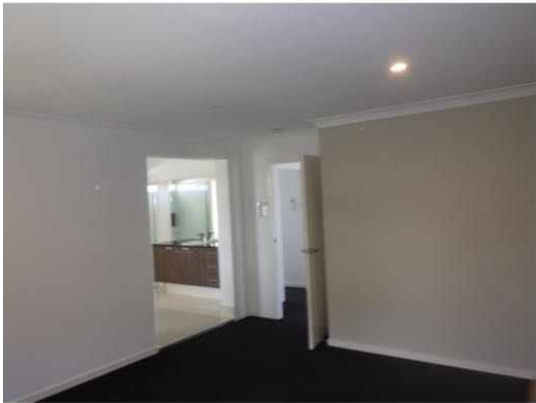
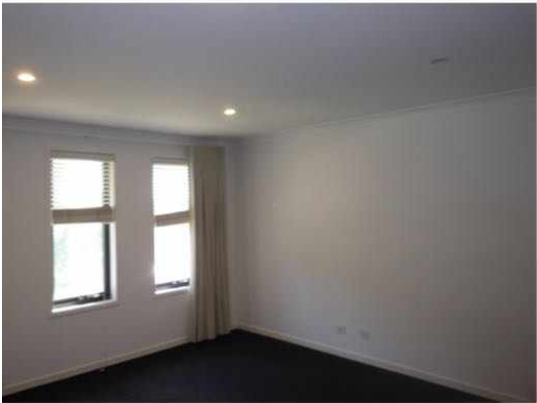
Building: Main Building  
Location: Bedroom - Master  
Finding: Additional Photos

Information: Additional photos are provided for your general reference

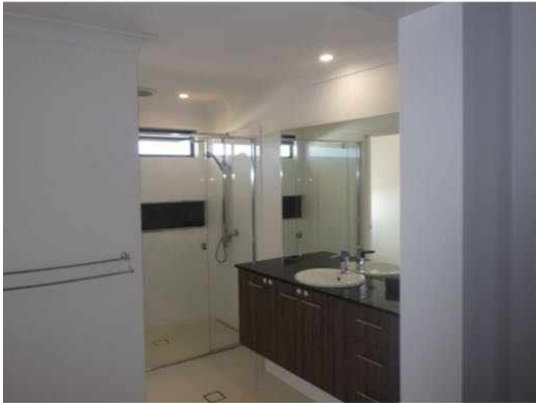
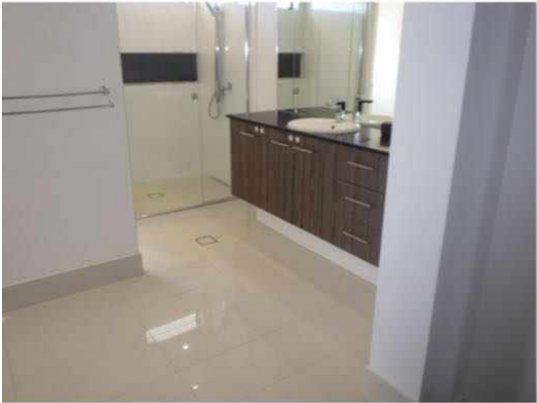
Building: Main Building  
Location: Ensuite  
Finding: No obvious defect  
Information: No obvious defects found at the time of inspection.

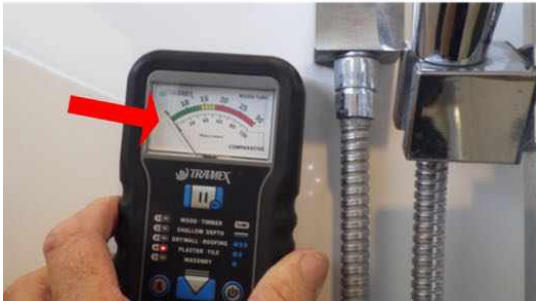
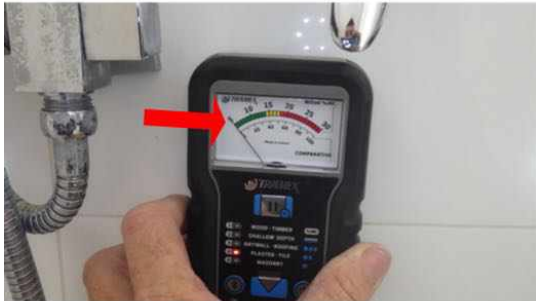
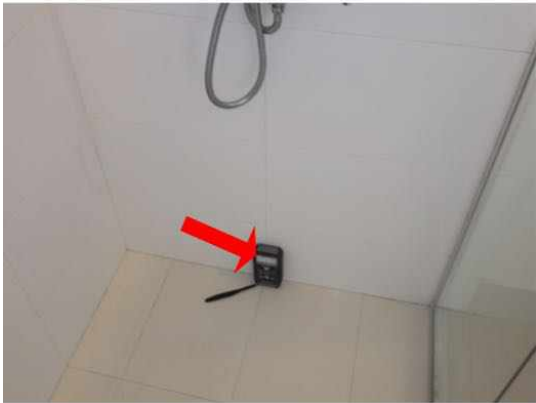
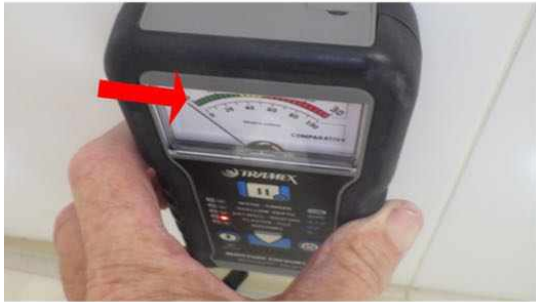
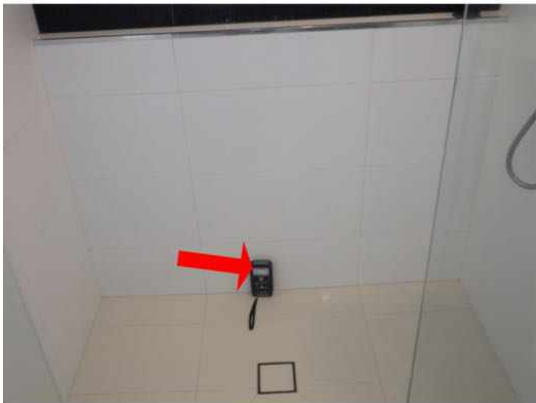
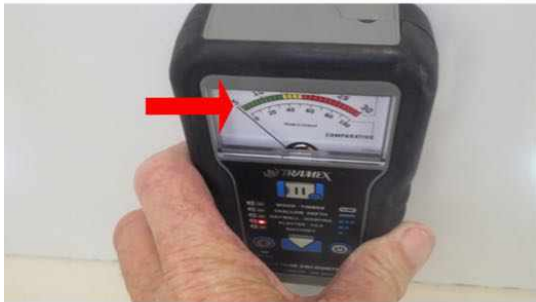
Location: Ensuite > Rear Right  
Finding: Moisture Level Readings  
Information: At the time of inspection the ensuite shower cubicle areas checked with the Tramex Moisture Meter returned low - normal moisture level readings.

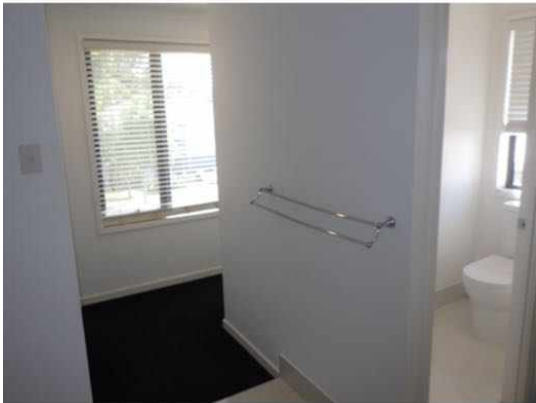
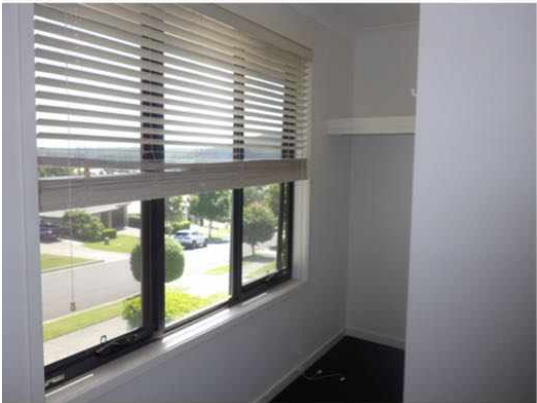
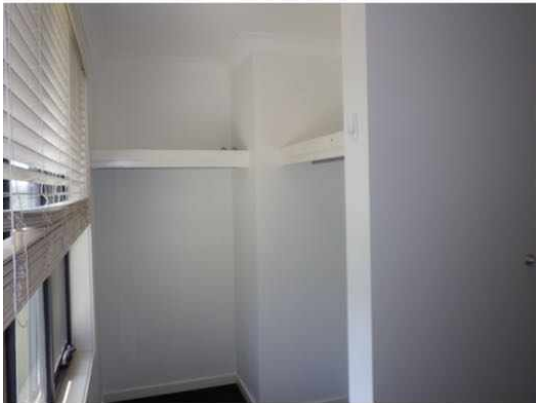
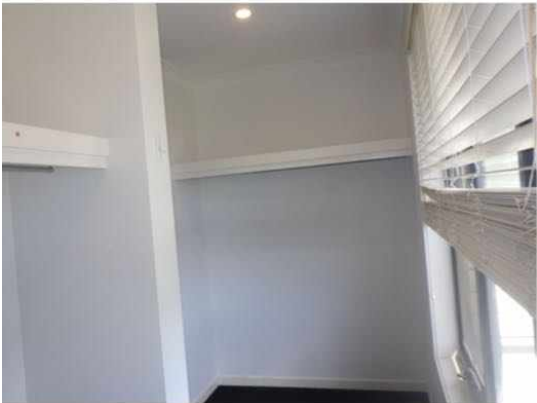
Building: Main Building  
Location: Walk In Robe  
Finding: No obvious defect  
Information: No obvious defects found at the time of inspection.

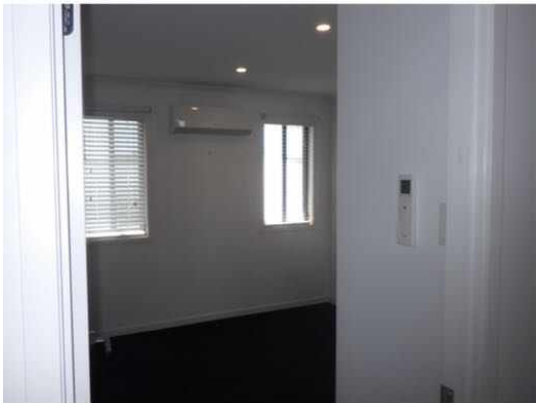
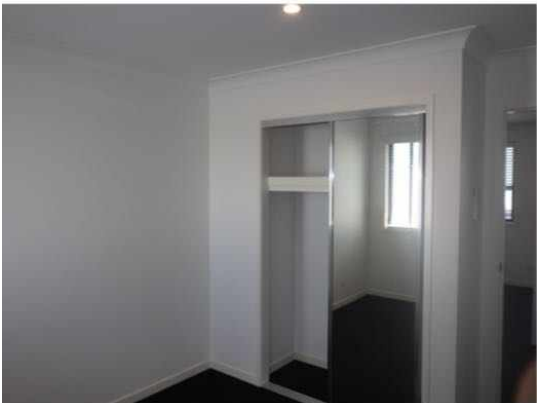
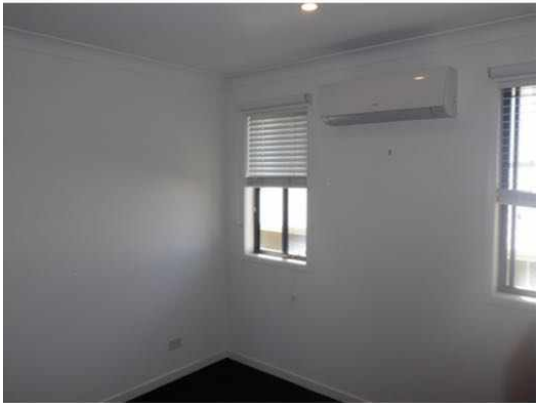
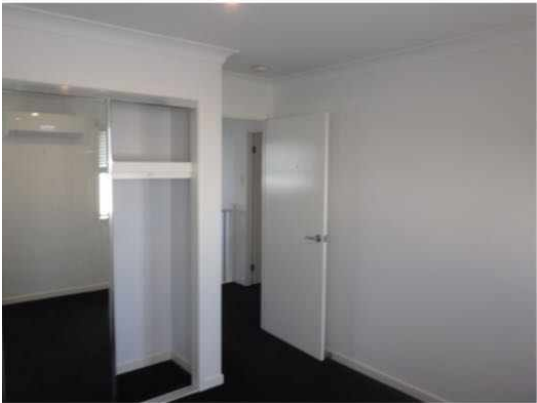
Building: Main Building  
Location: Bedroom 2  
Finding: Additional Photos

Information: Additional photos are provided for your general reference
