# Building and Timber Pest Inspection Report

Inspection Date: Thu, 22 Jan 2026

Property Address: 20 Mountain View Parade, Maudsland QLD  
4210, Australia

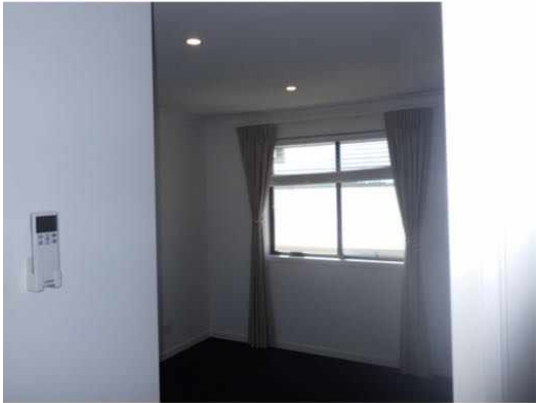
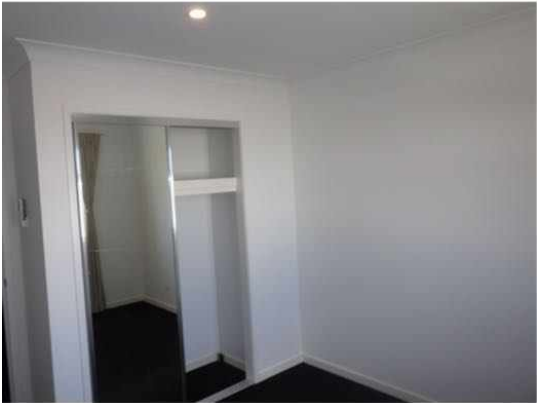
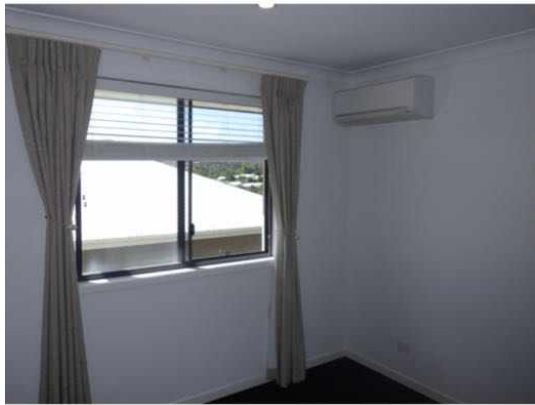
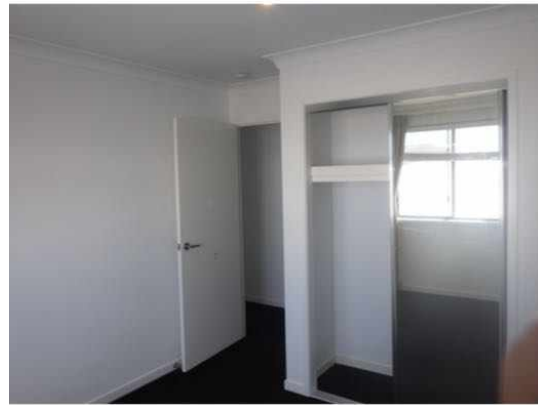
Building: Main Building  
Location: Bedroom 3  
Finding: Additional Photos  
Information: Additional photos are provided for your general reference

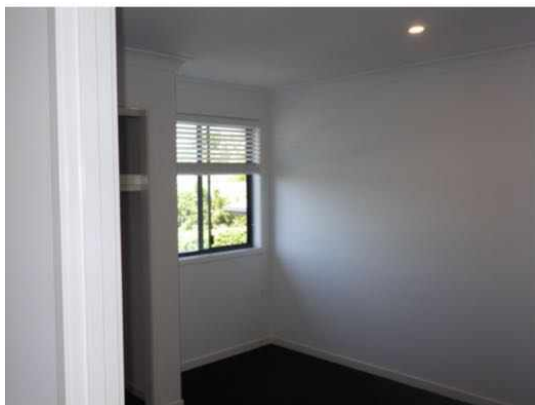
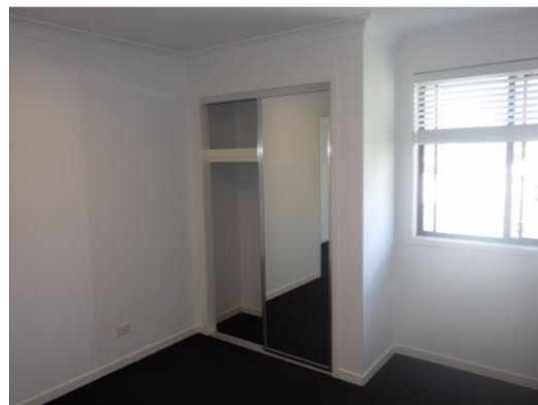
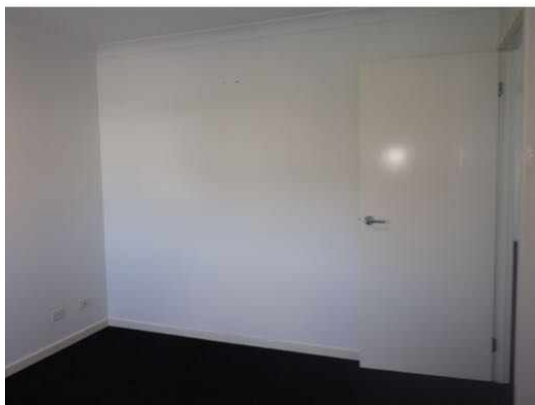
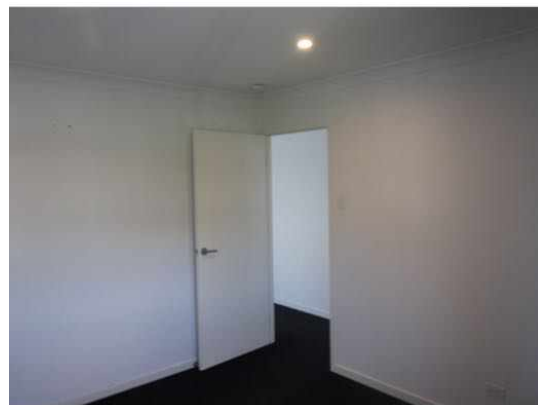
Building: Main Building  
Location: Bedroom 4  
Finding: Additional Photos  
Information: Additional photos are provided for your general reference

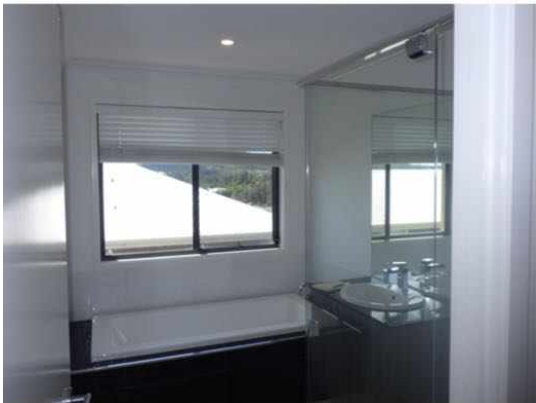
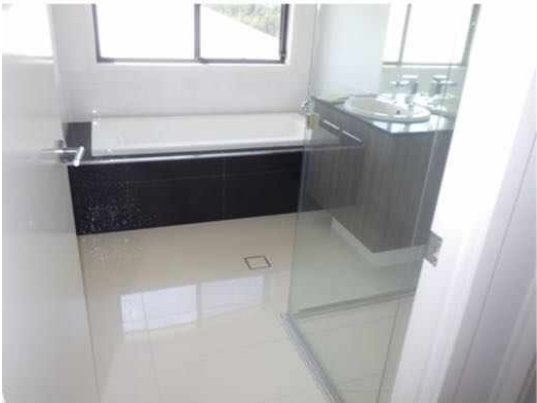
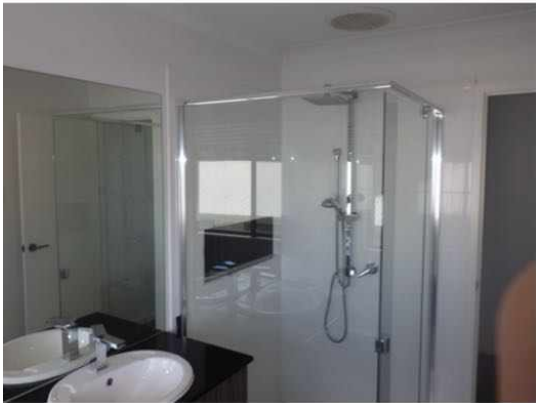
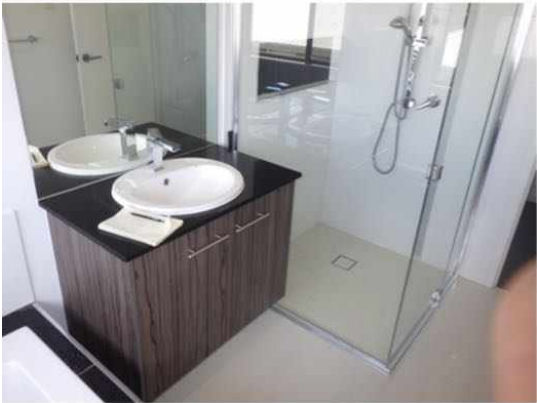
Building: Main Building  
Location: Bathroom  
Finding: No obvious defect

Information: No obvious defects found at the time of inspection.

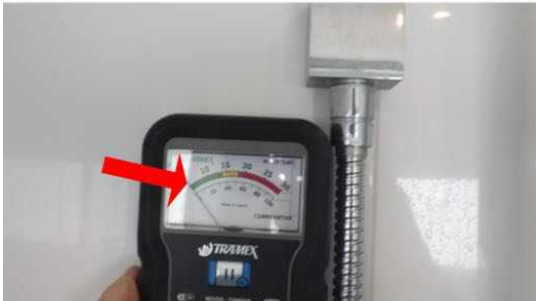
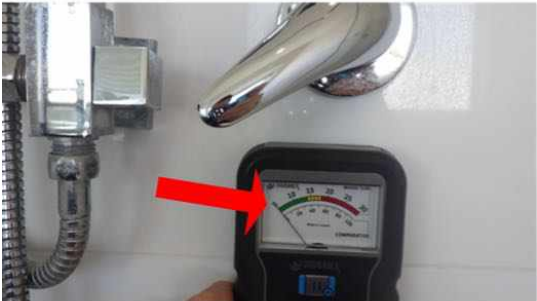
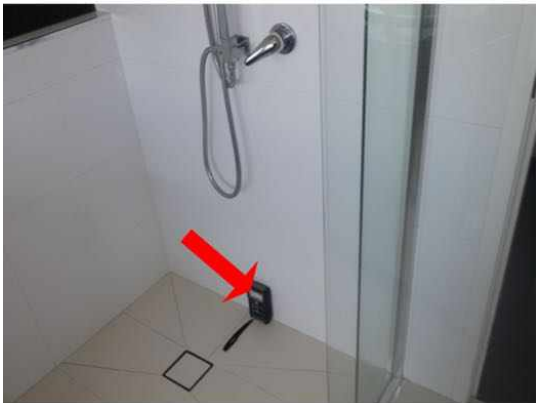
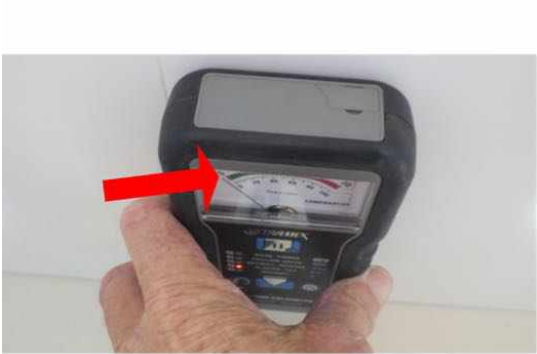
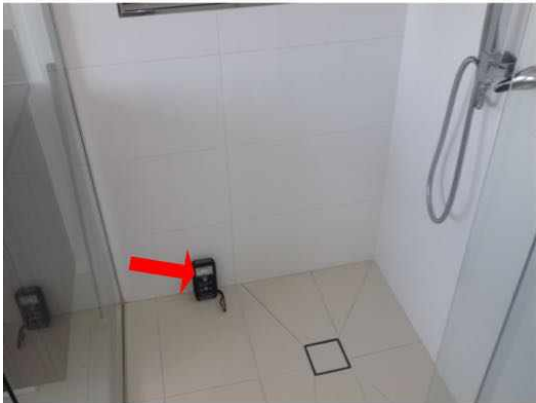
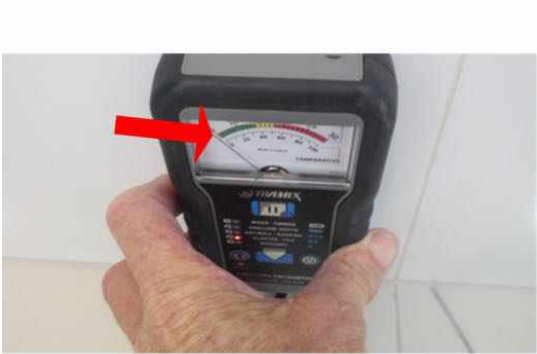
Building: Main Building  
Location: Bathroom > Front Right  
Finding: Moisture Level Readings  
Information: At the time of inspection the bathroom shower cubicle areas checked with the Tramex Moisture Meter returned low - normal moisture level readings.

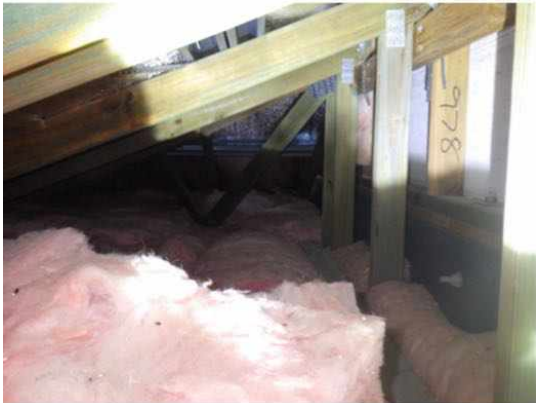
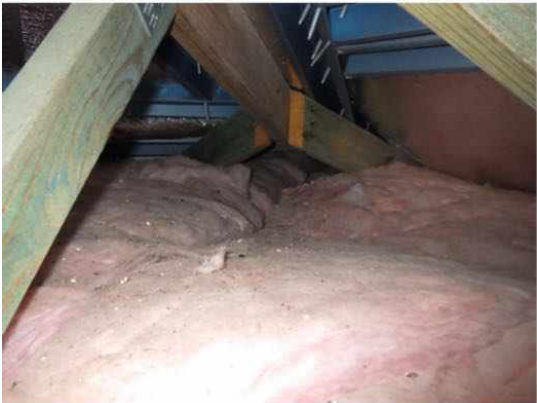
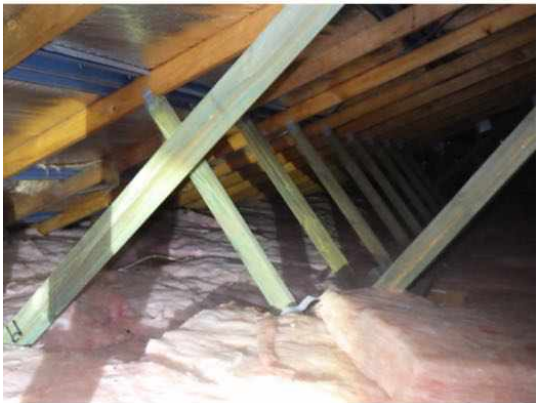
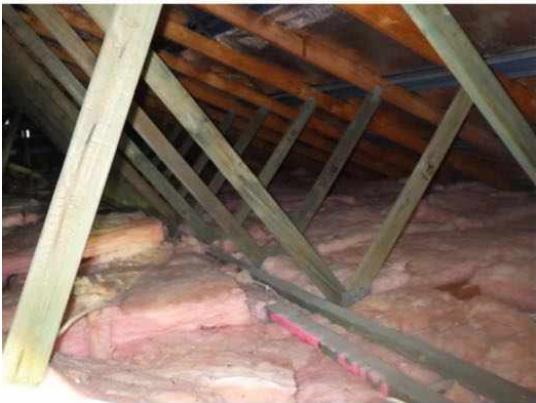
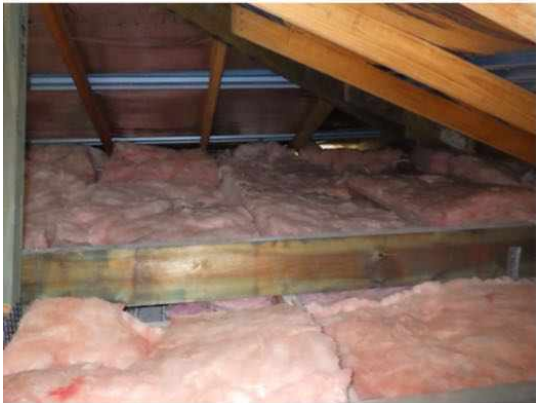
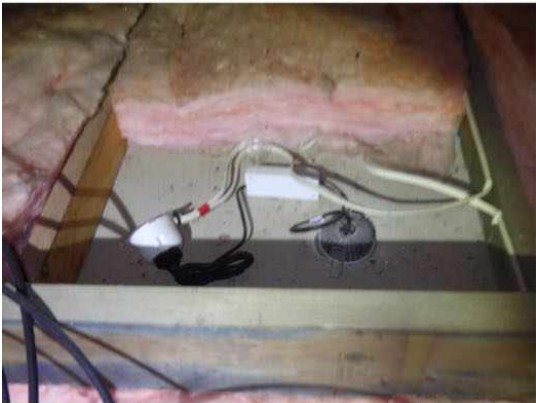
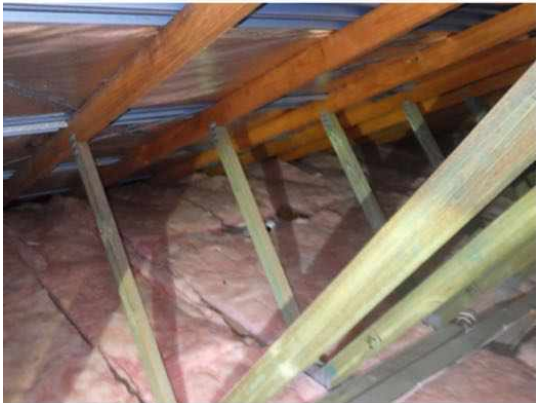
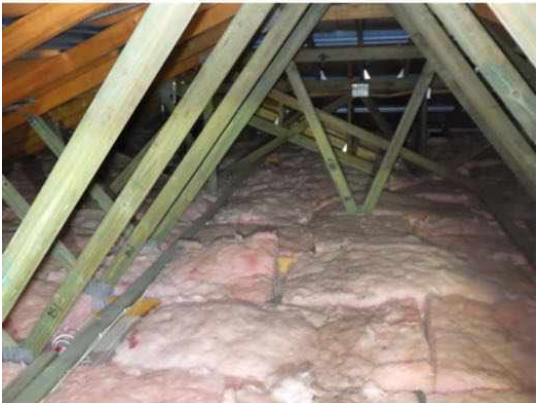
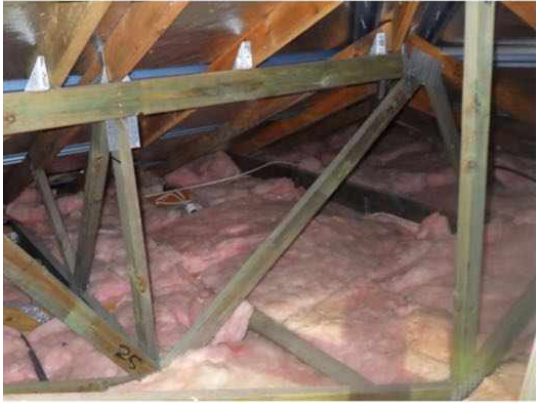
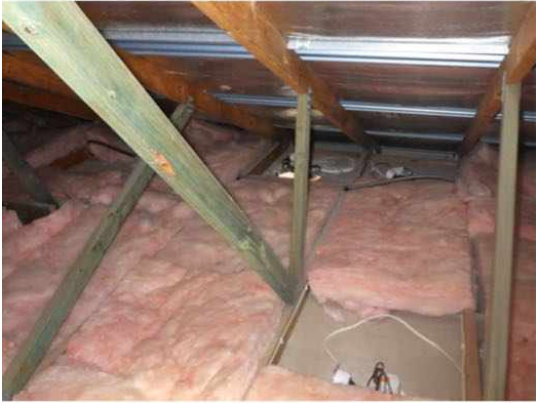
Building: Main Building  
Location: Attic  
Finding: Additional Photos  
Information: Additional photos are provided for your general reference

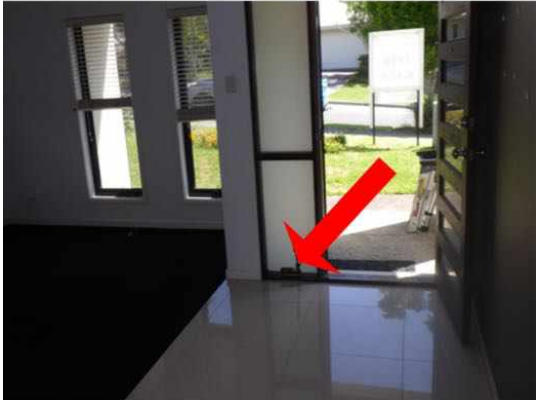
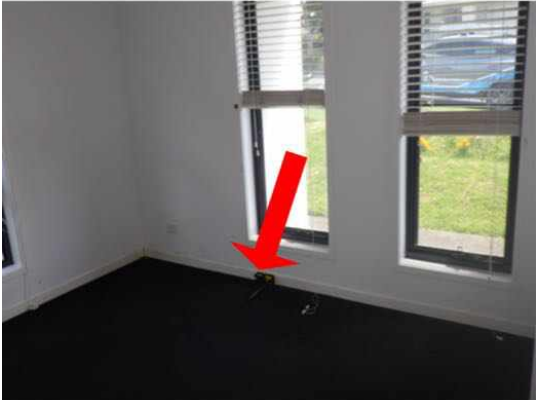
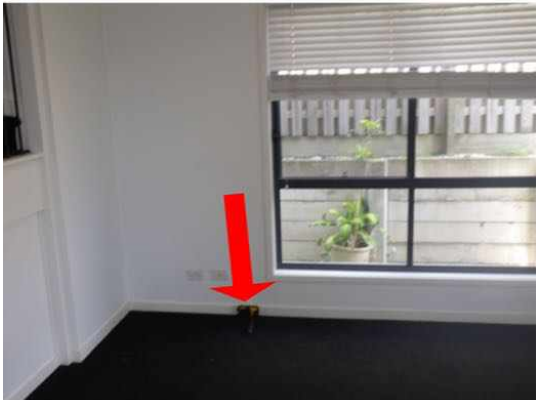
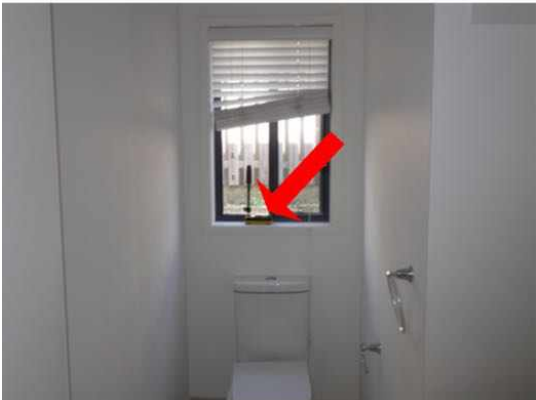
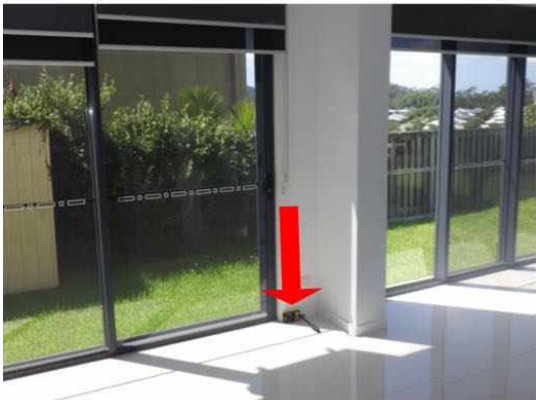
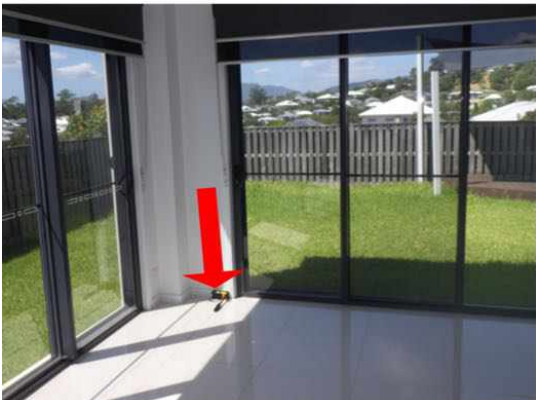
Building: Main Building  
Location: Internal Areas  
Finding: Termitracker  
Information: The termitracker itracker was positioned randomly to internal wall, timber skirting and window frame areas checking for signs of termite activity.

No activity was recorded at the time of inspection.

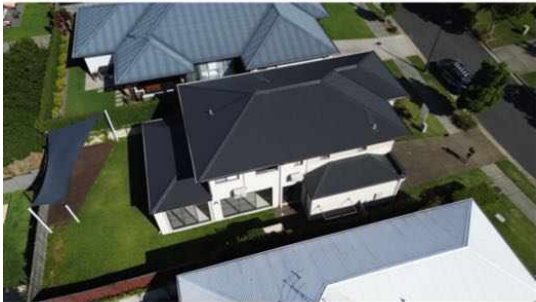
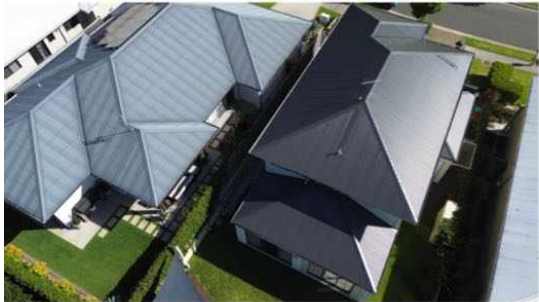
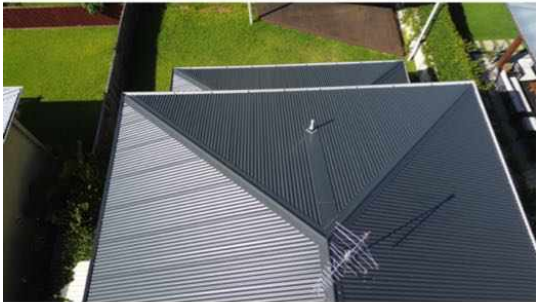
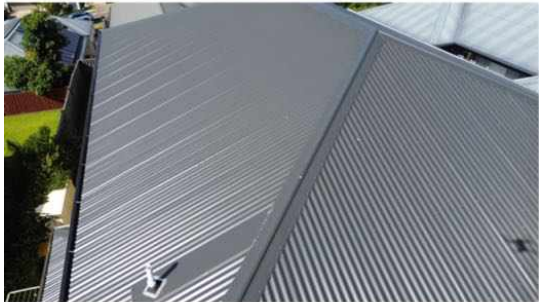
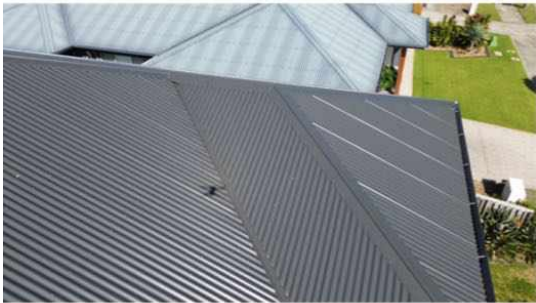
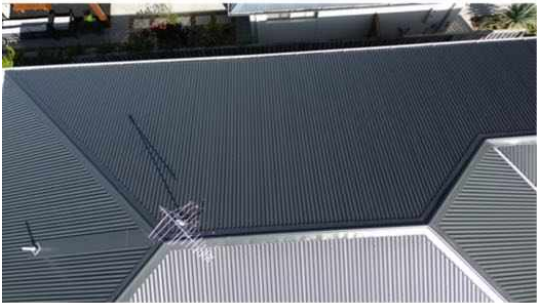
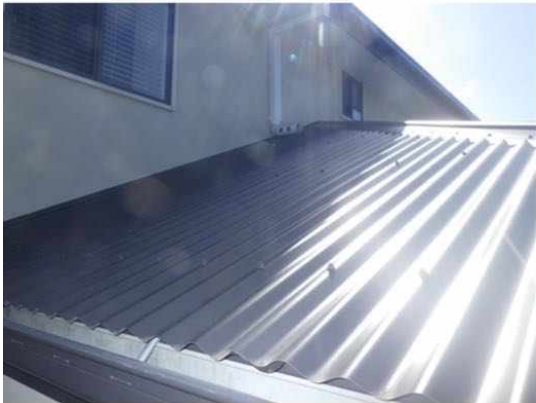
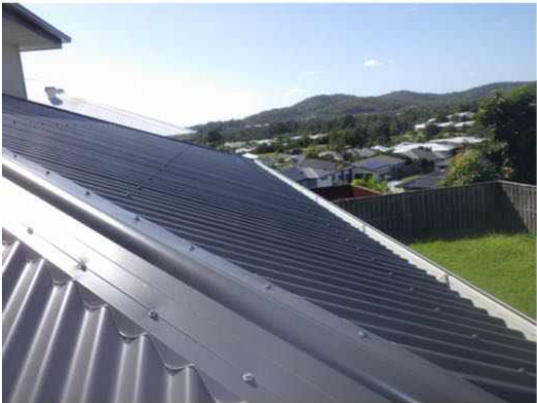
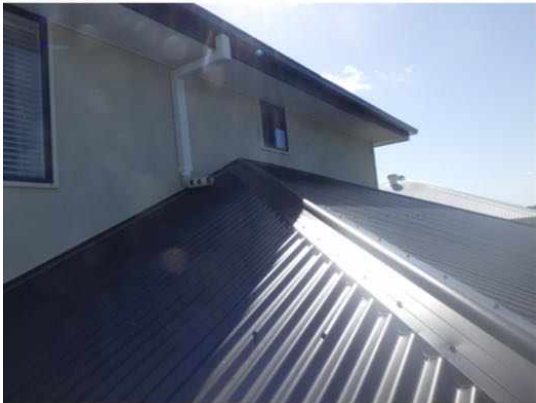
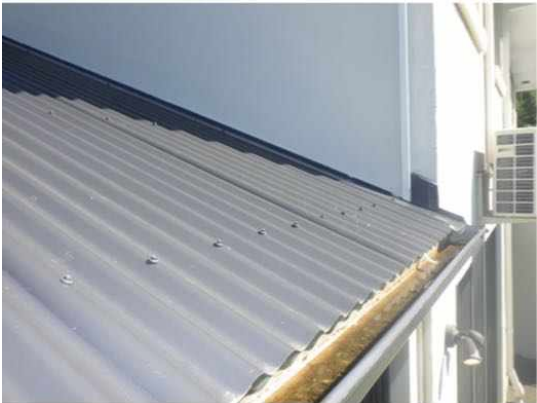
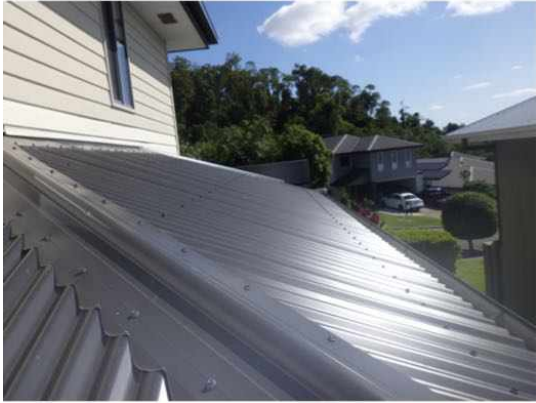
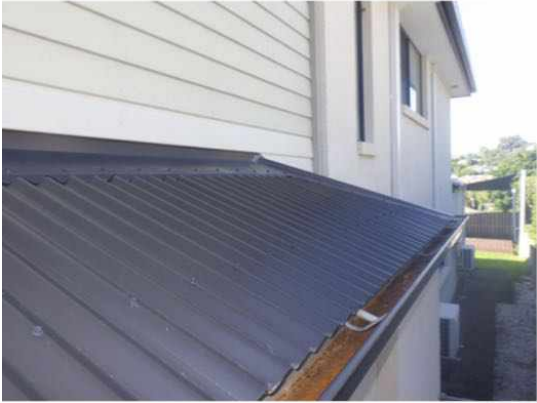
Building: Main Building  
Location: Roof Exterior  
Finding: Roof Photos  
Information: Roof area photos were taken manually and with the DJI Mini 3 Drone flown over the roof at the time of inspection.

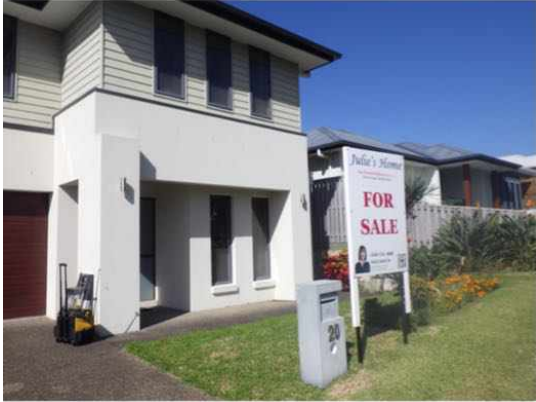
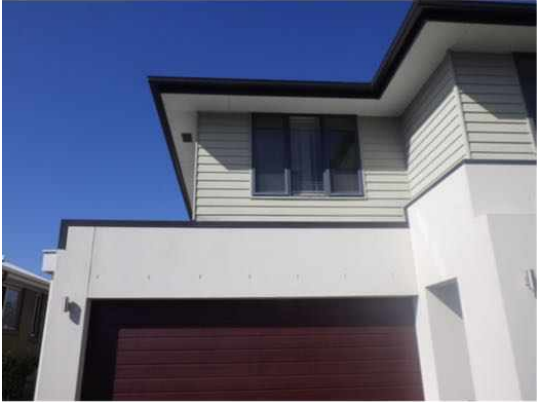
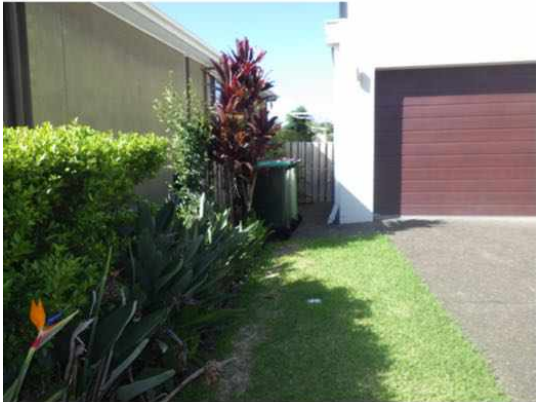
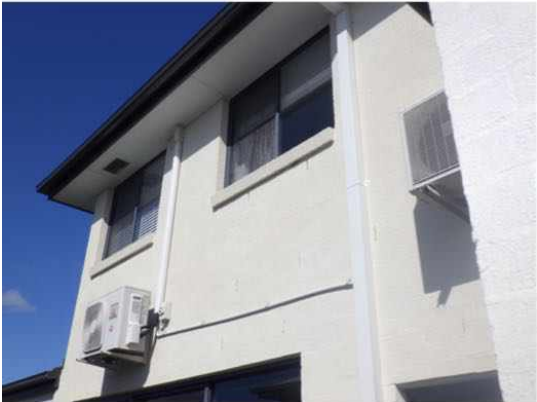
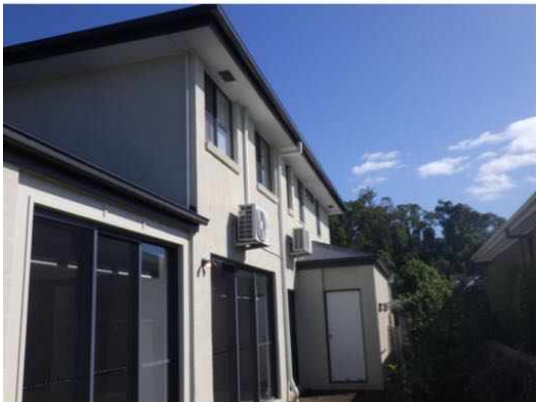
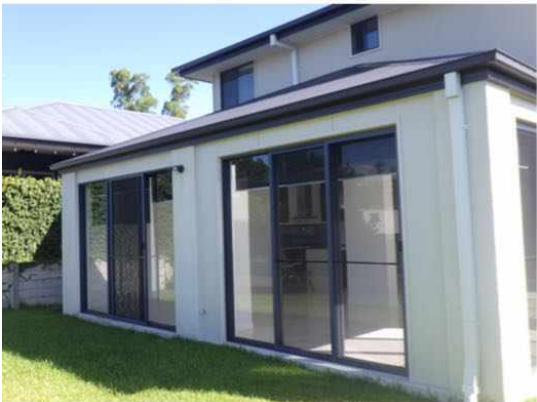
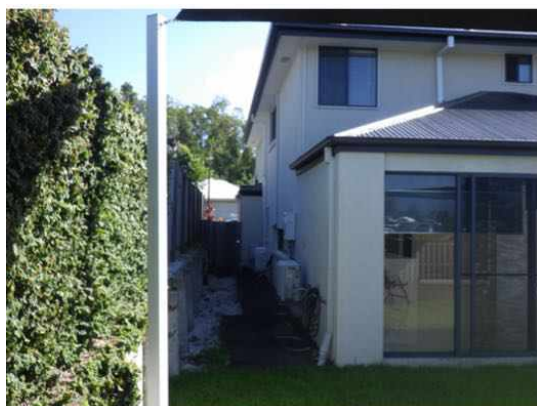
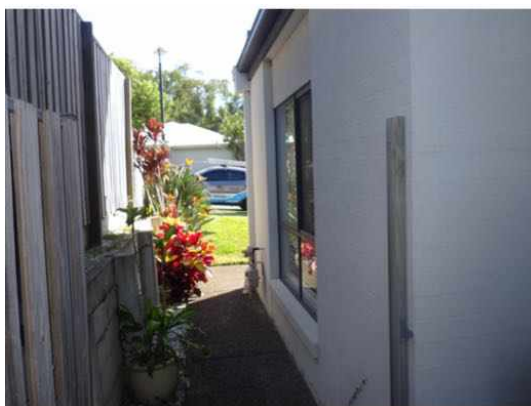
Building: Main Building  
Location: External Areas  
Finding: Additional Photos  
Information: Additional photos are provided for your general reference

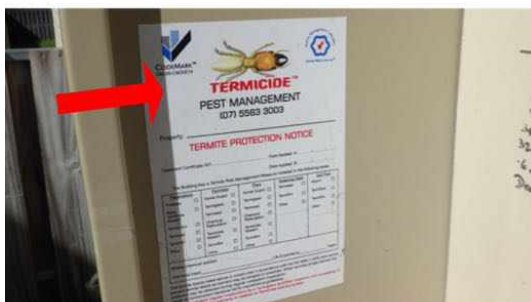
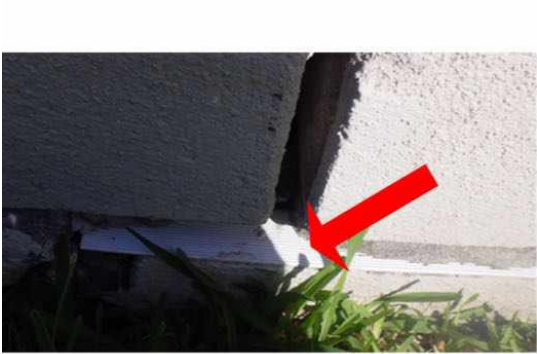
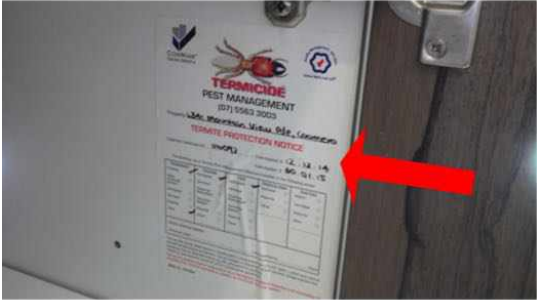
In this instance evidence of a previously installed physical barrier was observed, along with a durable notice inside the electrical meter box and the kitchen area under sink cabinetry (dated 30/01/2015). This system requires regular annual inspections.

No evidence of regular or annual inspections was found.

Where a Termite Management System has been identified you should refer to the type of barrier date of installation warranty conditions and any documentation provided by a builder or past owner.
