Building Inspection Report

Inspection Date: Mon, 12 Jan 2026

Property Address: 10 Feathertop Wy, Nar Nar Goon North VIC
3812, Australia

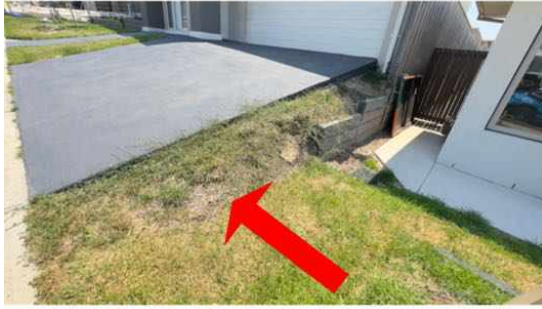
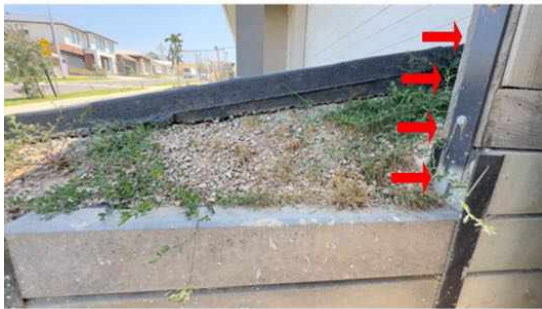
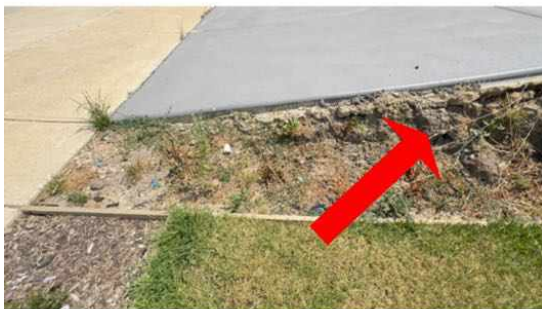
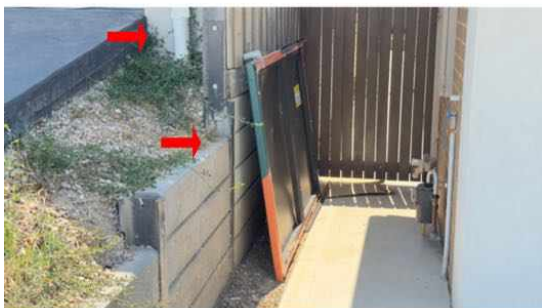
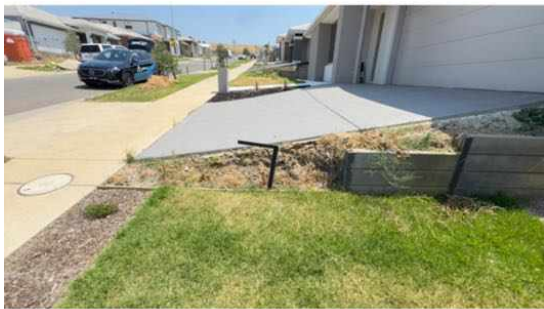
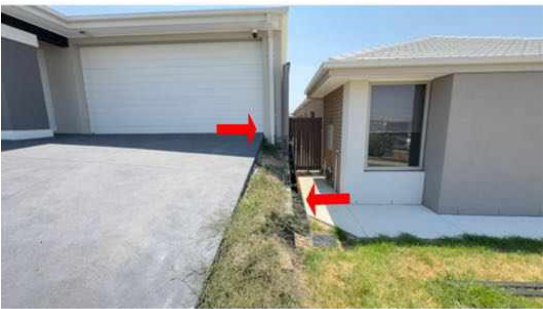
Defects 2.01

Building: Main Building
 Location: Yard - Front > All Areas
 Finding: Retaining Wall Masonry - Missing & Inadequate Height - Retaining Walls
 Information: Sections of the retaining wall were observed to be missing and / or at an inadequate height in these areas. This can compromise the structural function of the retaining walls, reducing its ability to restrain soil and manage ground loads. This condition may lead to soil movement, erosion, drainage issues, and potential instability of adjoining ground or structures.

The defect is likely attributable to substandard construction.

A suitably qualified licensed builder or structural engineer should be engaged immediately to assess the retaining walls along all boundaries of the property and specify what appropriate remedial works are required. Repairs or reconstruction should be carried out as soon as practicable to reinstate structural performance, manage soil retention, and reduce the risk of further ground movement or damage to nearby structures.

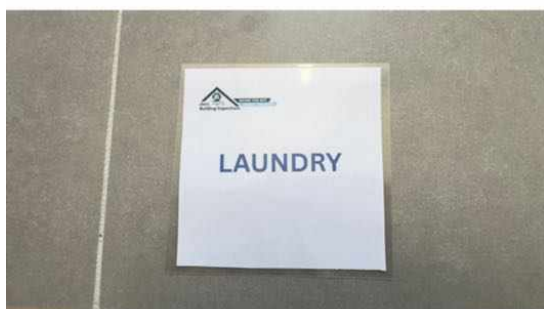
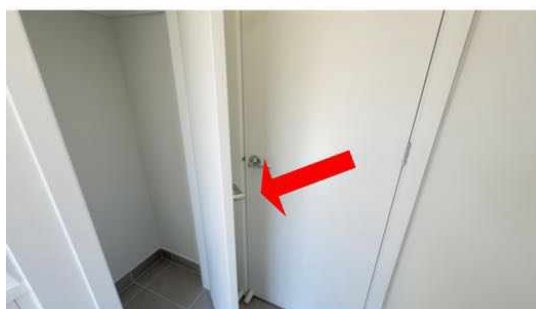
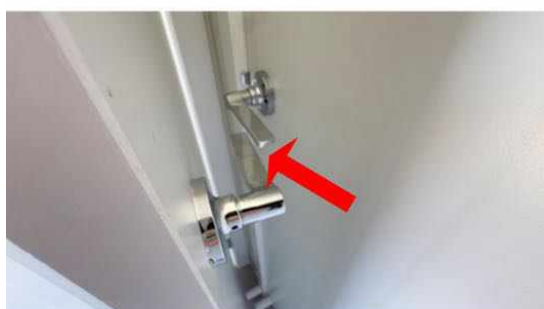
Defects 3.01

Building:	Main Building
Location:	Laundry >
Finding:	Doors - Inadequate Door Stops
Information:	The inspection identified inadequate door stops in this area. Inadequate door stops can lead to damage to walls or doors and may impair the proper operation of the doors.

The inadequate door stop may be due to an oversight by the builder.

It is recommended that a qualified carpenter or competent handyman be engaged promptly to install an adequate door stop. Correct installation will protect doors and walls and ensure proper door functionality.

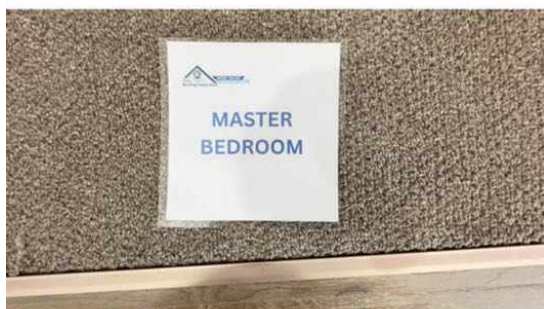
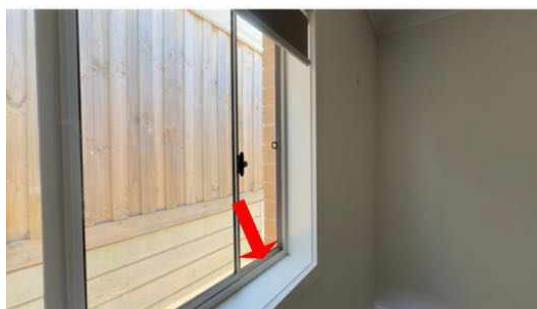
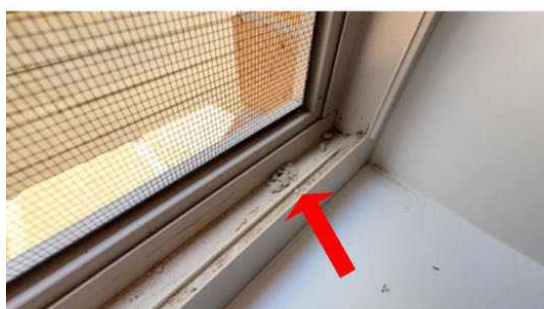
Defects 3.02

Building:	Main Building
Location:	Bedroom - Master >
Finding:	Windows - Stiff To Open
Information:	Windows were observed to be stiff to open in this area. The stiffness can make the

window difficult to operate, reduce usability, and may increase the risk of damage if force is applied.

Possible causes include misalignment, worn hardware, or buildup of debris.

It is recommended that the building owners engage a window specialist or registered builder immediately to assess the window and adjust, repair, or service it to restore smooth operation.

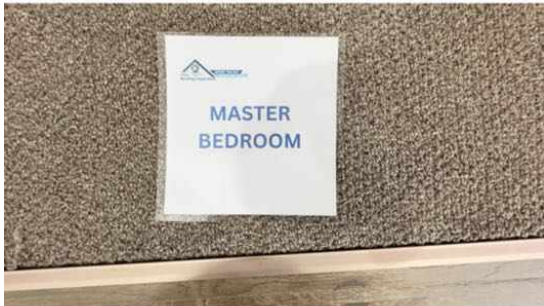
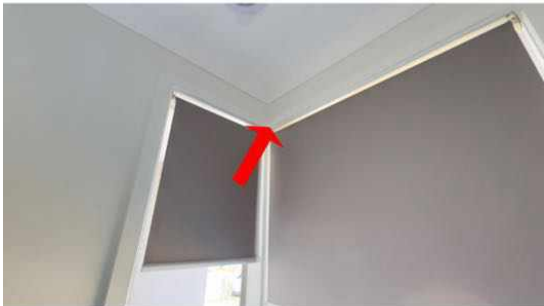
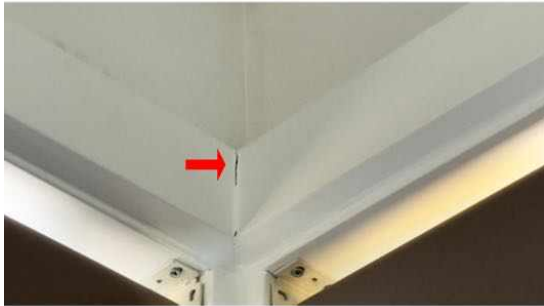
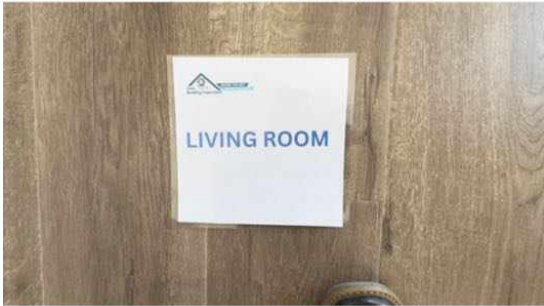
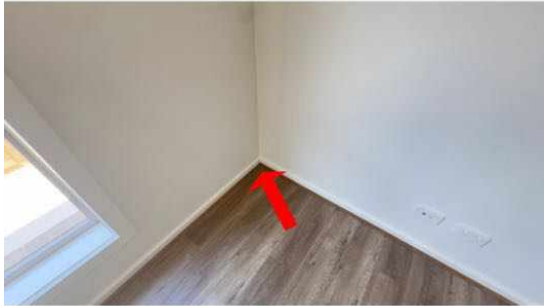
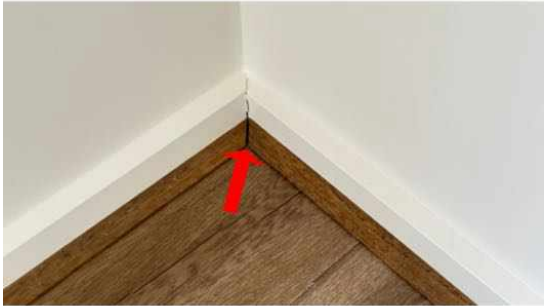
Defects 3.03

Building:	Main Building
Location:	All Areas
Finding:	Walls - Minor Plaster Cracking
Information:	Cracking was observed in this area. While generally cosmetic in nature, plaster cracks can result from minor building movement, seasonal expansion and contraction, or poor jointing and finishing at the time of construction.

Possible causes may include normal building settlement and movement, seasonal expansion and contraction of building materials and or poor installation or finishing of plasterboard joints.

Cracking should be monitored over time to assess whether movement is ongoing. Where cracking is purely cosmetic, patching and repainting may be undertaken as

part of routine maintenance by a qualified plasterer or painter.

If cracks widen, reoccur after repairs, or appear in conjunction with other structural signs, further investigation by a registered builder or structural engineer is recommended immediately.

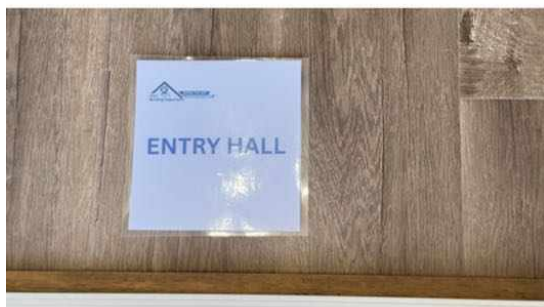
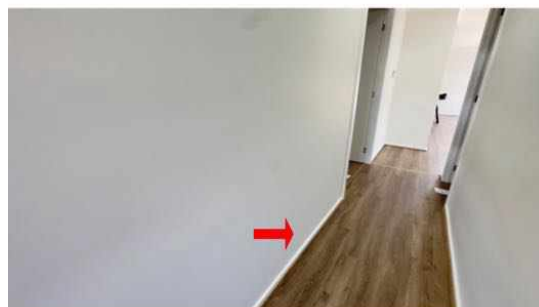
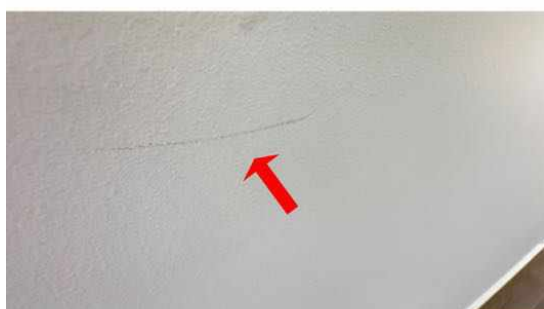
Defects 3.04

Building: Main Building
Location: Entry Hall
Finding: Walls - Paint Finishes Discolouration
Information: The walls were inspected for paint condition, and discolouration was observed in this area.

While primarily a cosmetic issue, the affected paint may indicate age-related wear, poor surface preparation, or previous repairs.

When practical, a qualified painter should be engaged to prepare and repaint the affected areas. Addressing paint deterioration will improve the appearance of the ceilings and help protect the surfaces from further wear.

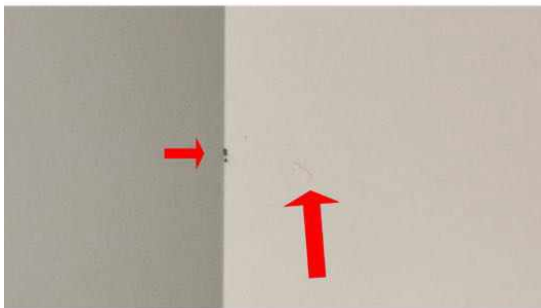
Defects 3.05

Building:	Main Building
Location:	Bedroom - Master >
Finding:	Walls - Plaster Walls Damaged
Information:	Minor damage to plaster wall surfaces was observed in this area, including small dents, chips, and surface imperfections. This type of damage is commonly associated with general wear and tear, minor impact, or movement over time.

While the damage is not considered structural in nature, it detracts from the overall presentation and finish of the property. Ongoing deterioration may occur if left unattended.

A suitably qualified plasterer or competent handyman should be engaged, at the client's discretion, to carry out minor patching, sanding, and repainting as required to

restore the affected areas to an acceptable standard.

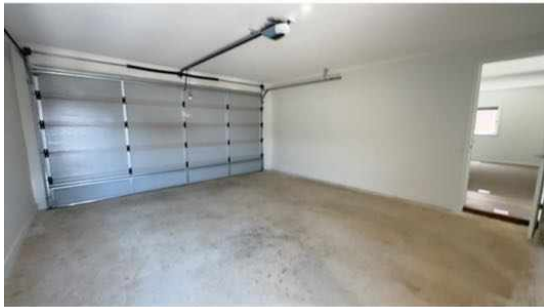
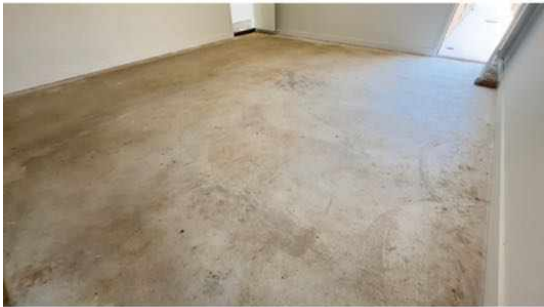
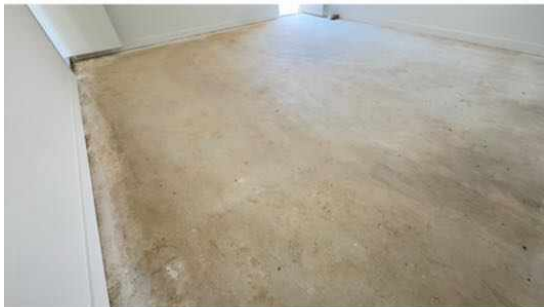
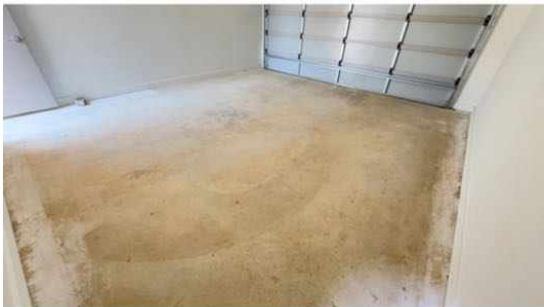
Defects 3.06

Building:	Main Building
Location:	Garage
Finding:	Concrete - Discolouration
Information:	Concrete surfaces were visually inspected and discolouration was observed in this area. Discolouration may affect the aesthetic appearance of the surface and could indicate exposure to environmental factors, staining, and wear.

Possible causes include weathering, sun exposure, water staining, or contact with chemicals or organic matter.

A qualified cleaning specialist should be engaged when practical to clean or treat the affected areas. Prompt attention will improve appearance and maintain the surface condition.

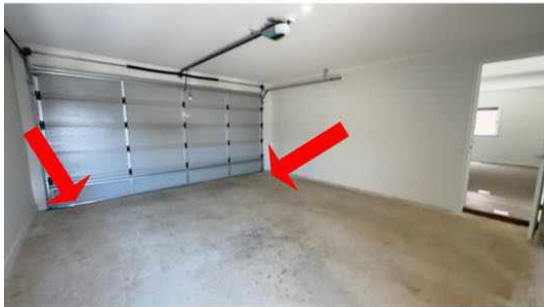
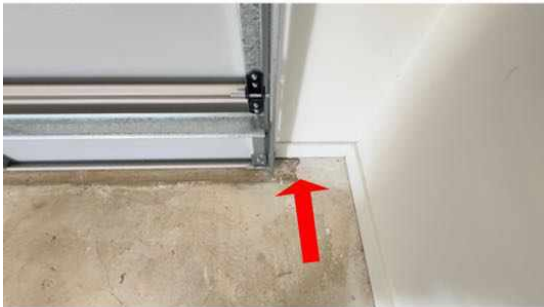
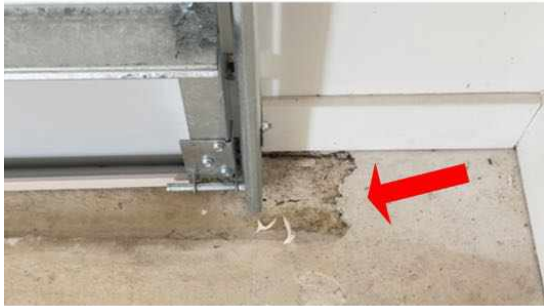
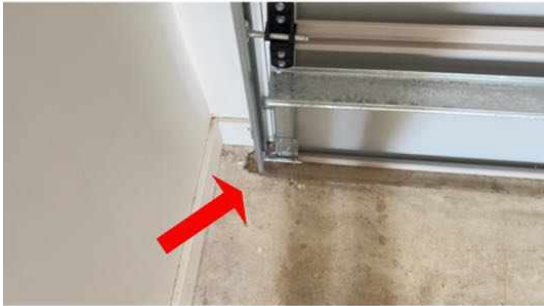
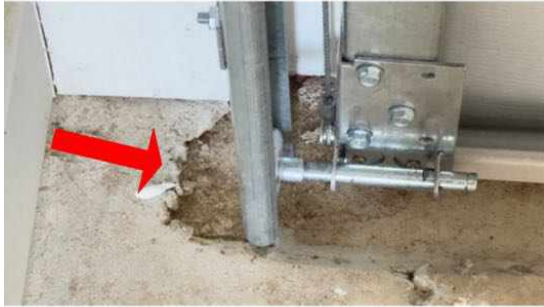
Defects 3.07

Building: Main Building
Location: Garage >
Finding: Concrete - Damaged Surfaces
Information: Concrete Surfaces were visually inspected in this area. Damaged surfaces were observed, including chipping, spalling and surface abrasion.

Damaged concrete surfaces can reduce durability, aesthetic appearance, and may increase susceptibility to further deterioration over time. Possible causes include age-related wear, impact, weathering, or substandard original construction.

A qualified concreter should be engaged when practical to repair or resurface affected

areas. Prompt attention will restore a smooth surface, improve durability, and maintain presentation.

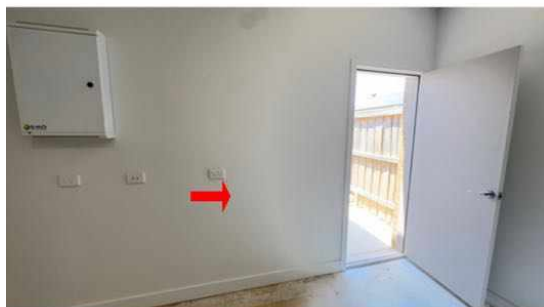
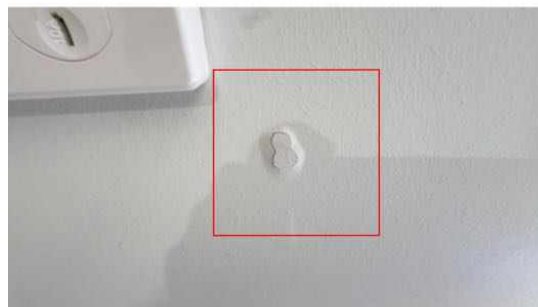
Defects 3.08

Building: Main Building
Location: Garage
Finding: Walls - Nails Popping
Information: The walls were inspected and evidence of nail popping (where nails or screws have worked loose) was observed. This is generally a cosmetic issue, although repeated occurrences may indicate minor movement of the framing or shrinkage of materials.

Possible causes include timber framing shrinkage or seasonal expansion/contraction, slight building settlement causing movement of fixings or inadequate or failing fixings during original construction.

A licensed plastering contractor should be engaged immediately to reset or replace loose fasteners, patch affected areas, and repaint as required. Although nail popping does not typically affect structural integrity, addressing it will maintain wall appearance and prevent further minor damage.

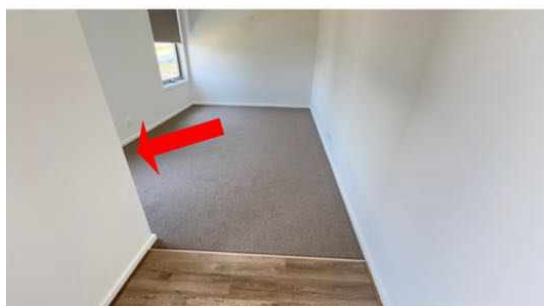
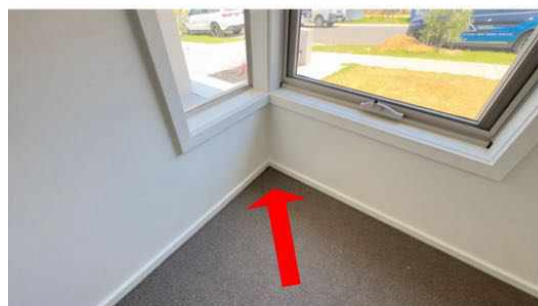
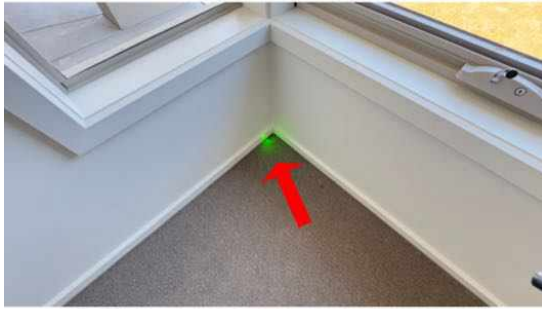
Defects 3.09

Building:	Main Building
Location:	Bedroom - Master
Finding:	Floors - Carpet Damaged
Information:	The carpet was inspected and found to be damaged in this area, with signs of burning. Damaged carpet can reduce comfort, detract from the appearance of the space, and, over time, expose the subfloor to additional wear or moisture.

This condition may result from everyday use or accidental impact.

A qualified flooring installer should be engaged when practical to clean, repair and or replace the affected carpet. Timely attention will restore visual appeal, comfort, and the longevity of the flooring.

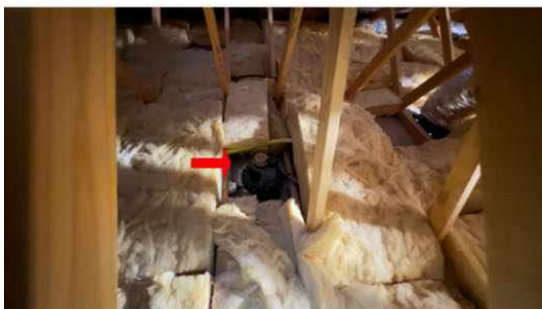
Defects 3.10

Information: The exhaust fans in the roof void are not ducted to the atmosphere. The issue is observed where fan outlets discharge directly into the roof space instead of venting outside.

This has likely occurred due to incomplete installation or missing ducting. Unducted fans may cause moisture buildup, condensation, and potential damage to insulation, ceiling linings, or timber, increasing the risk of mould growth and structural deterioration.

A licensed HVAC technician or licensed roof plumber is required to install proper ducting to vent the exhaust fans to the atmosphere. This should be rectified immediately to prevent moisture-related damage and maintain the performance of the ventilation system.

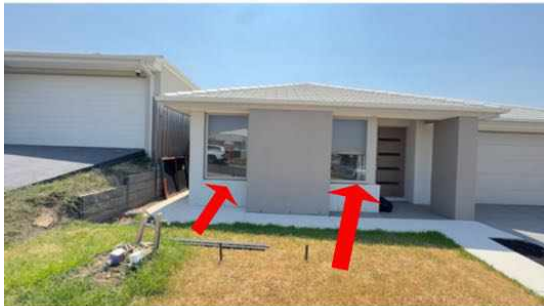
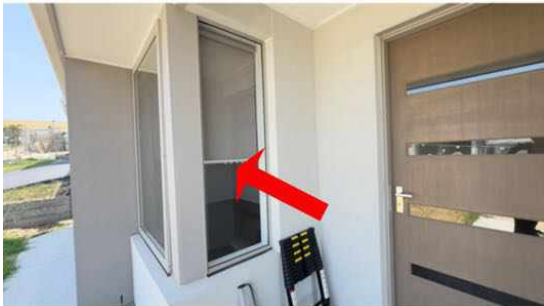
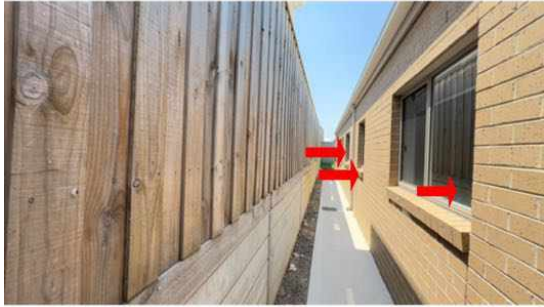
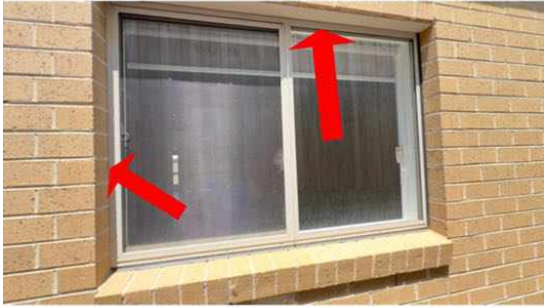
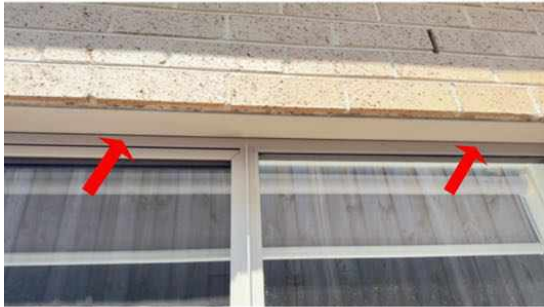
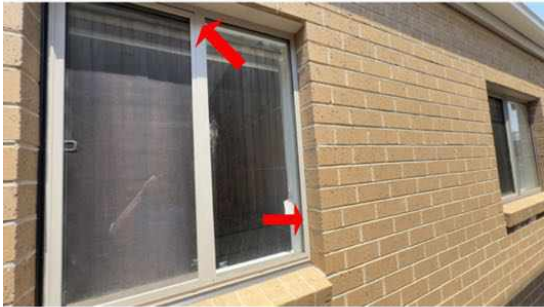
Defects 3.12

Building: Main Building
Location: All External Areas >
Finding: Windows - All External Frames Not Sealed
Information: All external window frames were observed to be inadequately sealed at the time of inspection. Unsealed or poorly sealed window frames can allow water penetration, air leakage, and pest ingress, which may lead to deterioration of surrounding wall materials, internal moisture damage, and reduced thermal efficiency.

This condition is likely due to substandard workmanship or deterioration of sealants over time.

A suitably qualified tradesperson should be engaged to install appropriate external-grade sealant to all affected window frames. Rectification should be carried out as soon as practicable to maintain weatherproofing, prevent moisture ingress, and protect adjoining building elements.

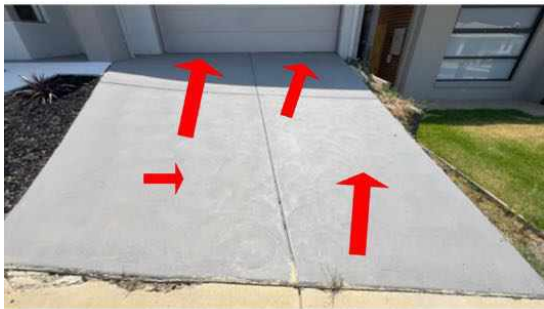
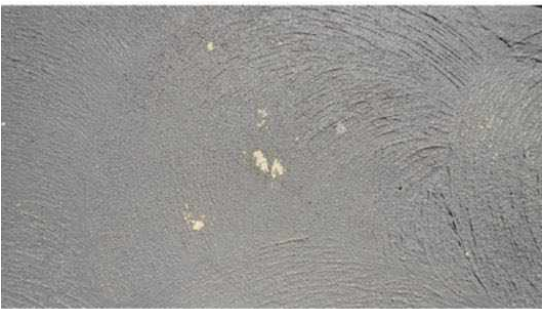
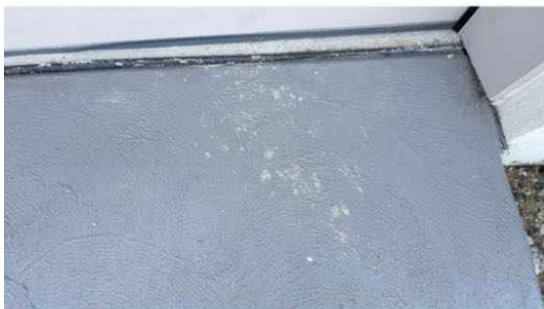
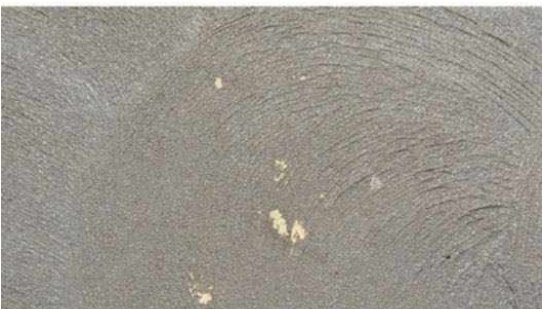
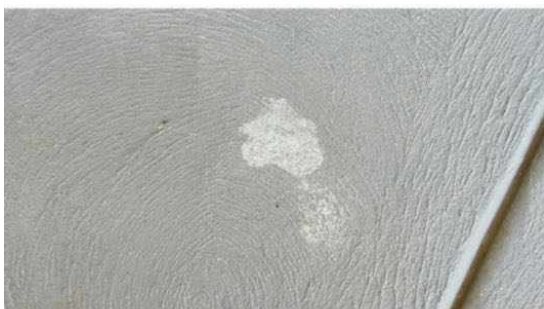
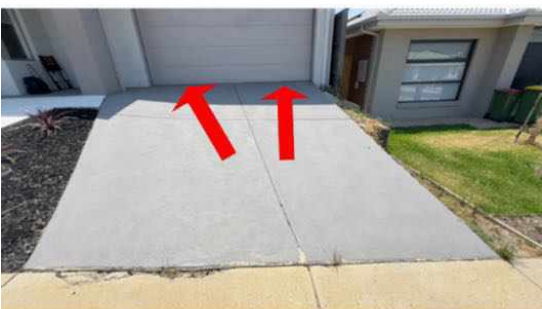
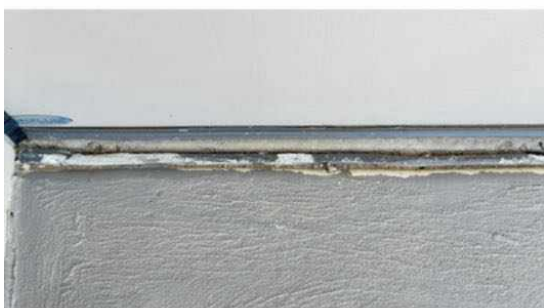
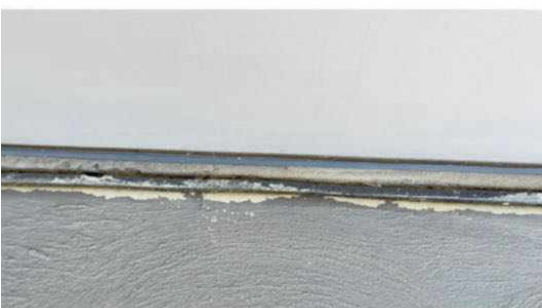
Defects 3.13

Building: Main Building
Location: Driveway
Finding: Concrete - Poor Surface Finish
Information: Concrete surfaces were visually inspected and poor surface finishing was observed in this area, including rough textures, uneven troweling and inconsistent concrete painted surface profiles.

While primarily cosmetic, these defects reduce aesthetic appeal, and increase susceptibility to surface wear or deterioration over time. This condition may be caused by rushed or substandard finishing during construction, inadequate curing, or poor quality concrete mix.

A qualified concreter should be engaged when practical to treat affected areas. Prompt attention will improve appearance, durability, and long-term performance of the driveway.

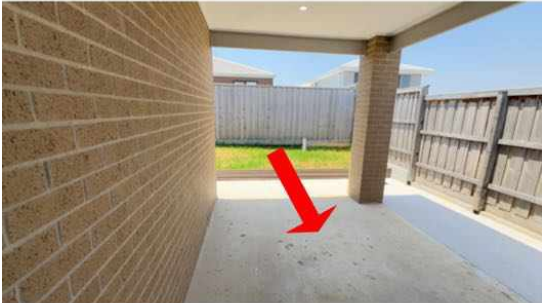
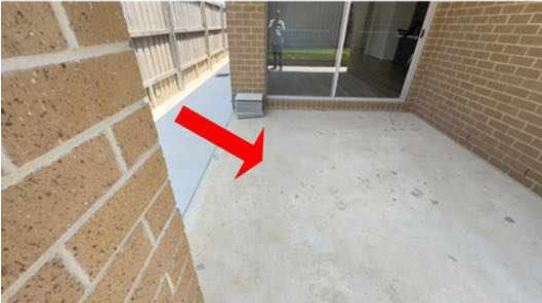
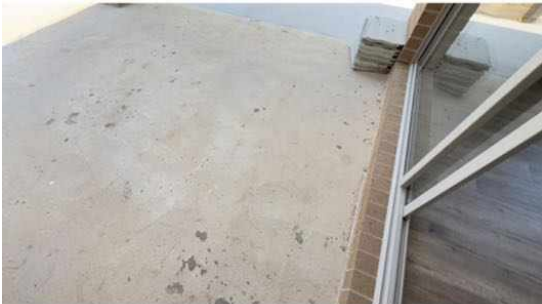
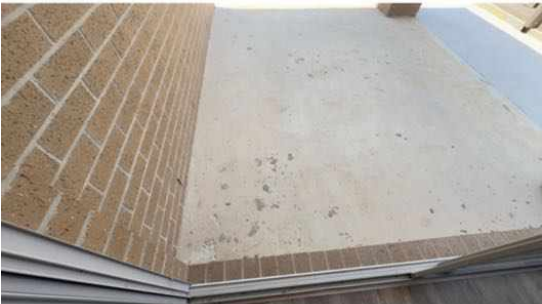
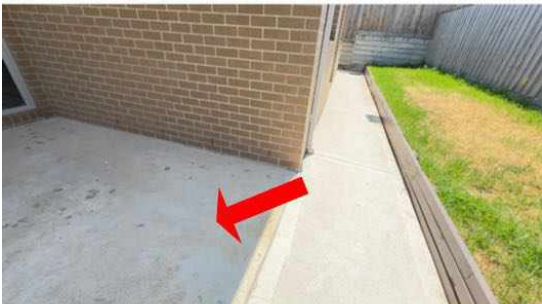
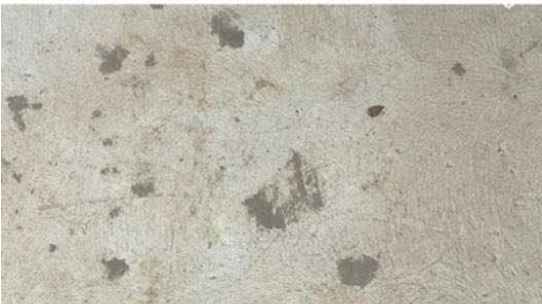
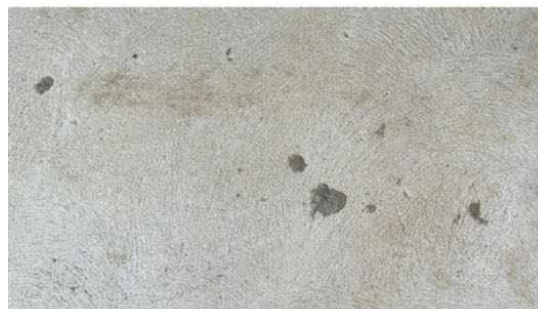
Defects 3.14

Building: Main Building
Location: Yard - Back
Finding: Concrete - Poor Surface Finish
Information: Concrete surfaces were visually inspected and poor surface finishing was observed in this area, including rough textures, uneven troweling and inconsistent concrete surface profiles.

While primarily cosmetic, these defects may allow water pooling, reduce aesthetic appeal, and increase susceptibility to surface wear or deterioration over time. This condition may be caused by rushed or substandard finishing during construction, inadequate curing, or poor quality concrete mix.

A qualified concreter should be engaged when practical to grind, resurface, or treat affected areas. Prompt attention will improve appearance, durability, and long-term performance of the driveway.

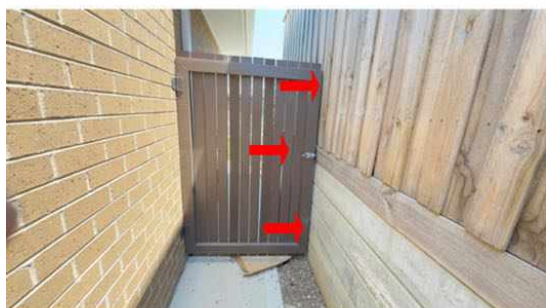
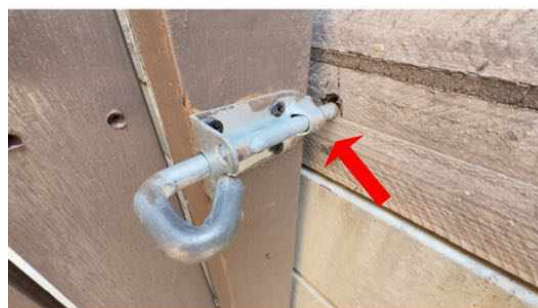
Defects 3.15

Building:	Main Building
Location:	Inside of the Fencing Side Gate >
Finding:	Gates - Gate Binding
Information:	Binding or jamming of the gate was observed in this area. This affects functionality and may cause secondary damage to surrounding building elements.

Binding can result from minor issues, including poor installation, worn hinges, or misalignment.

When practical, a qualified carpenter should be engaged to inspect and carry out necessary repairs.

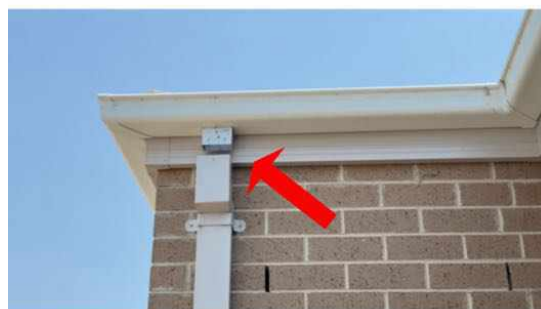
Defects 3.16

Building:	Main Building
Location:	Side Of House >
Finding:	Roof Plumbing - Downpipes Not Connected To Storm Water
Information:	Downpipes in this area are not connected to the stormwater drainage system, allowing water to discharge directly onto surrounding ground.

This has likely occurred due to missing connections, poor installation, or design oversight. Uncontrolled water discharge may cause erosion, pooling, water ingress

near the building, and potential damage to landscaping, paving, or foundations.

A licensed roof plumber is required to inspect and connect the downpipes to the stormwater system in this area. This should be rectified immediately to ensure proper drainage and prevent potential water damage.

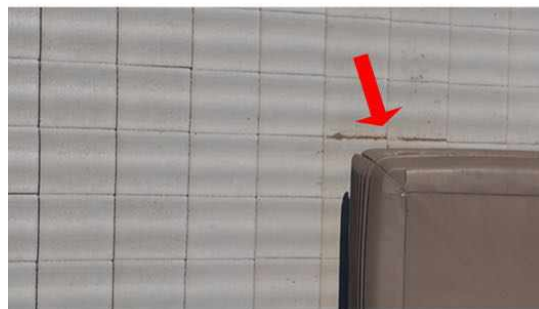
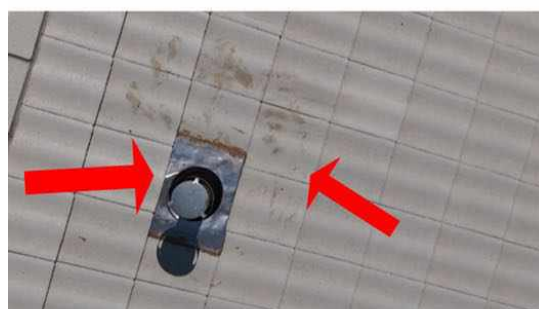
Defects 3.17

Building:	Main Building
Location:	Roof Exterior
Finding:	Roof Plumbing - Roof Tiles Discolouration
Information:	Roof tiles in this area were observed to exhibit surface discolouration at the time of inspection. The discolouration appears to be cosmetic in nature and is likely the result of residue or staining left behind from previous trade works that were not adequately cleaned upon completion.

While this condition does not appear to affect the immediate performance of the roof covering, it detracts from the overall presentation and, if left untreated, may contribute to long-term staining or accelerated surface deterioration.

A suitably qualified roof maintenance contractor or cleaning specialist should be engaged immediately to clean the affected tiles using appropriate methods. This will improve the appearance of the roof and assist in maintaining the longevity of the roofing materials.

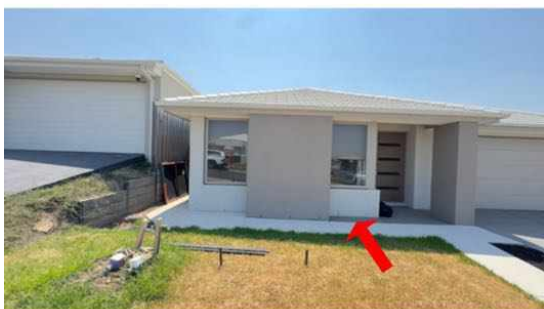
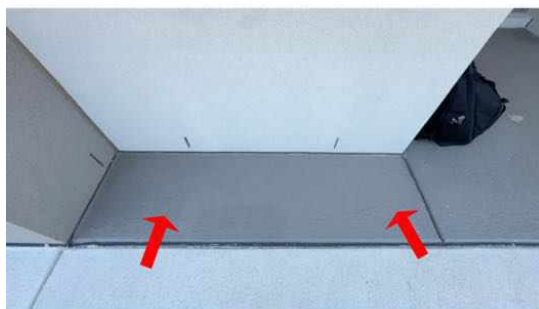
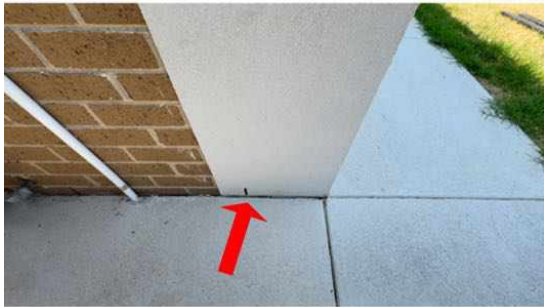
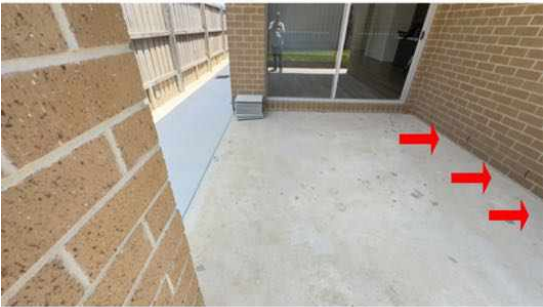
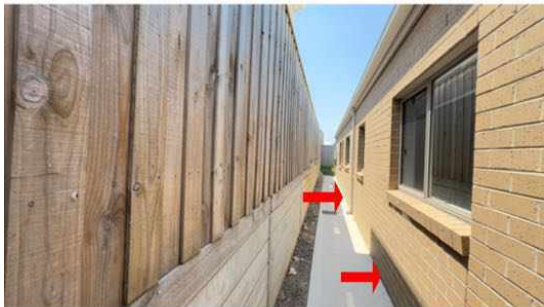
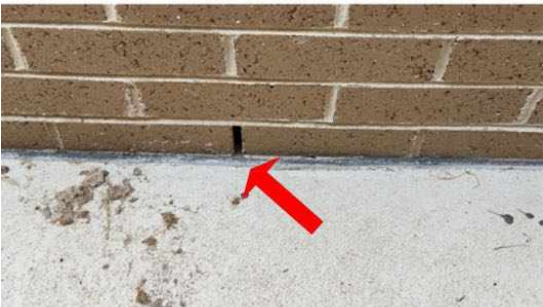
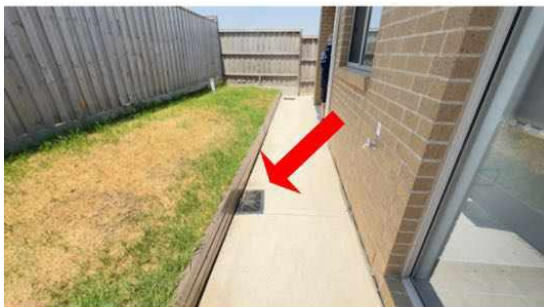
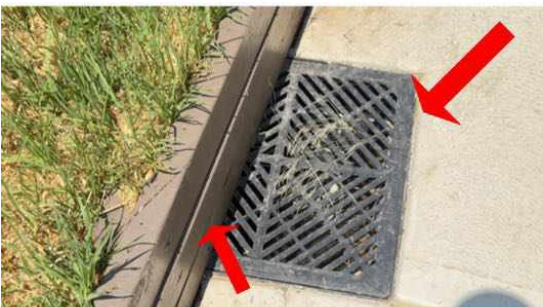
Defects 3.19

Finding: Site Drainage - Inadequate

Information: The overall site drainage was observed to be inadequate at the time of inspection. Poor drainage can cause water to pond near external walls, increasing the risk of rising damp, foundation movement, timber decay, and deterioration of associated building elements.

Ground levels should slope away from the dwelling to direct water from walls and footings. Downpipes must be properly connected to the stormwater system and should not discharge directly onto walls, paving, or plinths. Stormwater should be directed away from the property through adequately sized and maintained drains. Where ground levels are too high and cover the damp-proof course (DPC), lowering the levels may be necessary to expose the DPC and allow effective drainage.

A licensed plumber should be engaged promptly to investigate and recommend suitable remedial works, which may include the installation of an agricultural (aggie) drain or other site drainage improvements. Immediate action is strongly recommended, as inadequate drainage can lead to progressive water damage and secondary building defects over time.

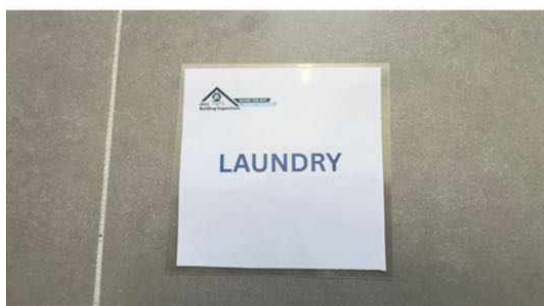
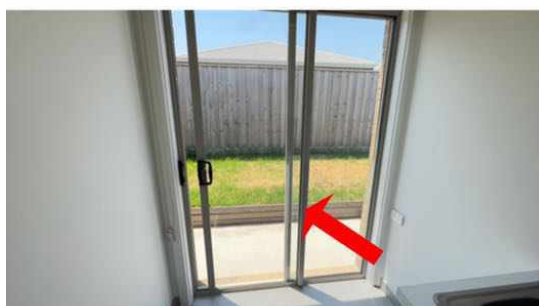
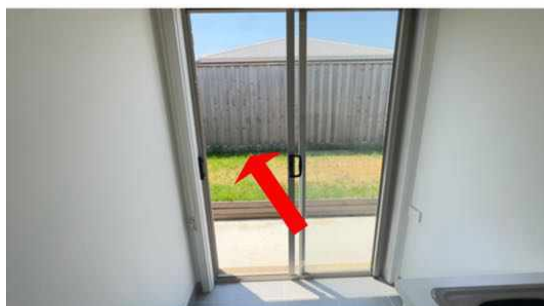
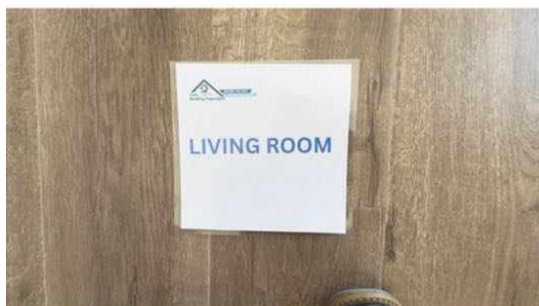
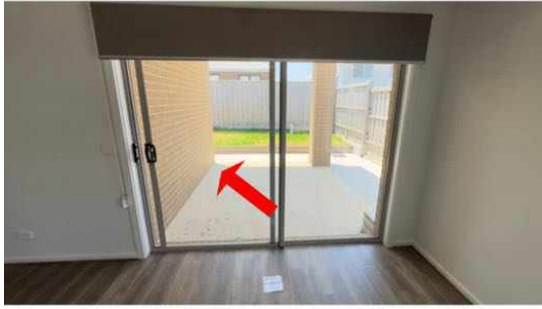
Building: Main Building
Location: All Areas
Finding: Flyscreens - Missing
Information: At the time of inspection, flyscreens were observed to be missing from the windows in this area. It could not be determined whether the flyscreens were never installed or were removed after installation.

The absence of this building element detracts from the functional performance of the windows. Missing flyscreens increase the risk of insect and pest ingress into the adjoining rooms and reduce the overall amenity of the property.

It is recommended that all missing flyscreens be installed or replaced to restore the intended function of the windows and improve occupant comfort. A suitably qualified handyman may be engaged to carry out these works at the client's discretion.

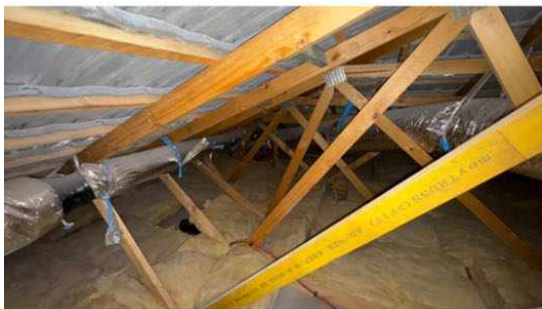
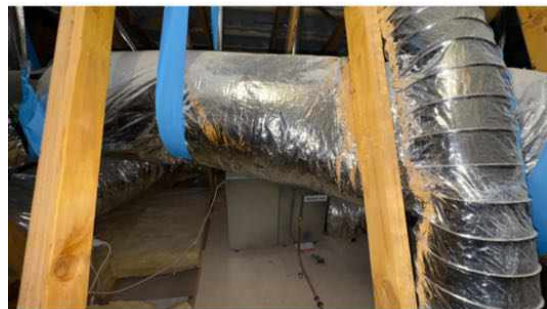
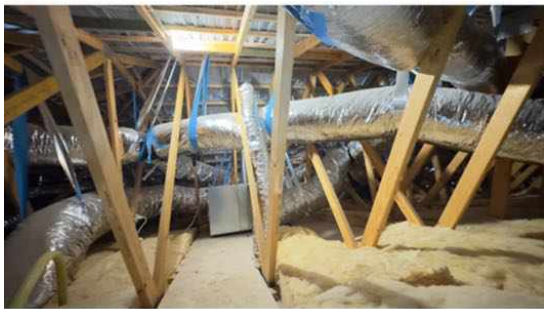
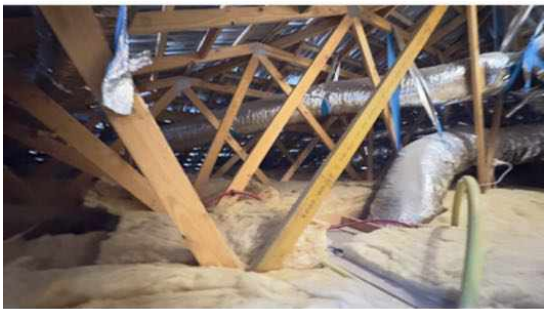
Building: Main Building
 Location: Roof Void
 Finding: Roof Void - Limited Access
 Information: Limited access to the roof void was present due to facts including but not limited to, limited access, insulation, Air condition Unit & ducting, obstructions or placement of insulation and or sarking, for this reason complete access to the roof void was not possible.

NOTE: Unless all insulation is removed from the roof space a full inspection is never possible, timber pest or termite activity and/or damage may not be visible.

A visual inspection was carried out from accessible areas only, recommend installing another access hatch in a more accessible area for a re-inspection.

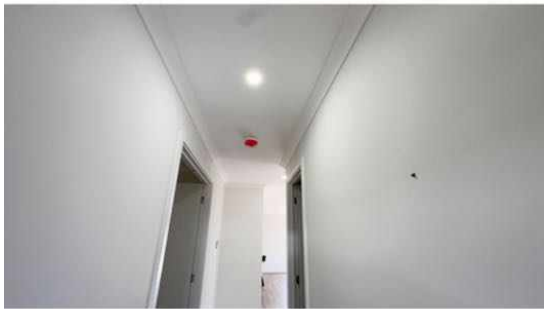
Building: Main Building
Location: All Internal Areas
Finding: Smoke Detectors - Advisory
Information:

During the inspection, smoke detectors were noted for advisory purposes only. The operation, age, type, and compliance of smoke detectors could not be fully verified as part of this inspection.

Smoke detectors are critical life-safety devices, and non-compliant, outdated, or non-operational units may not provide adequate warning in the event of a fire.

It is recommended that a licensed electrician be engaged immediately to test, service, and upgrade smoke detectors as required to ensure correct operation and compliance with current safety requirements.

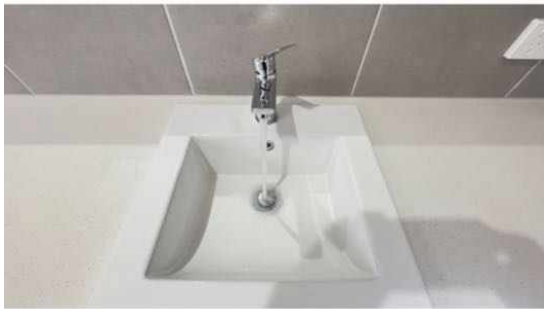
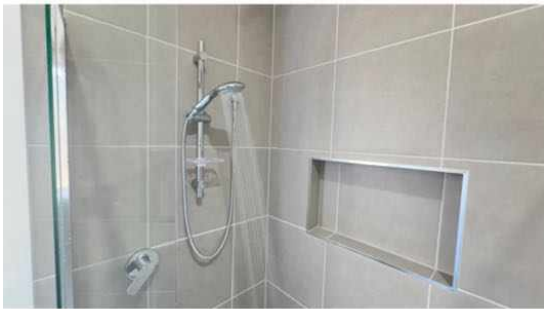
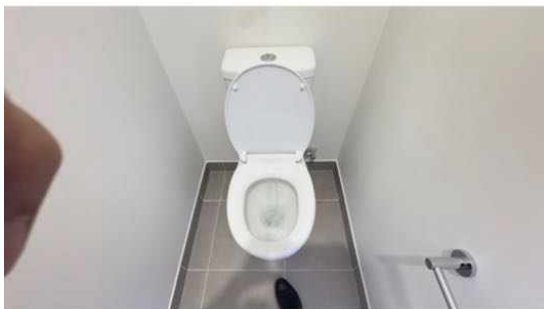
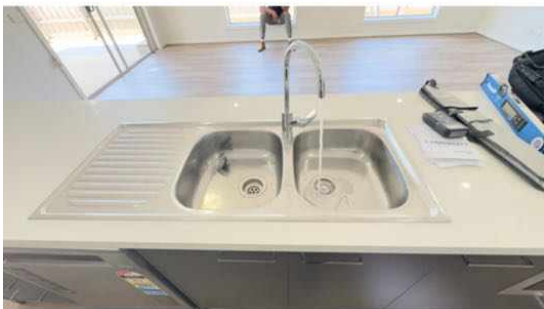
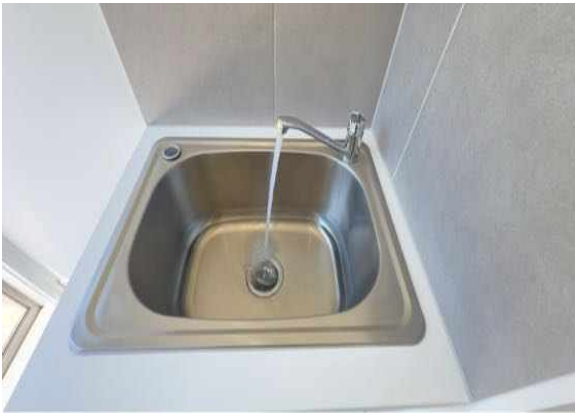
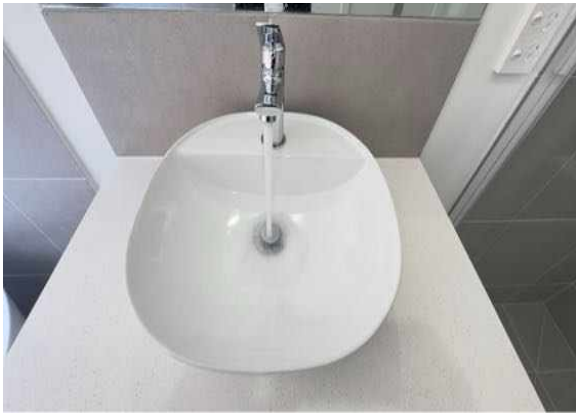
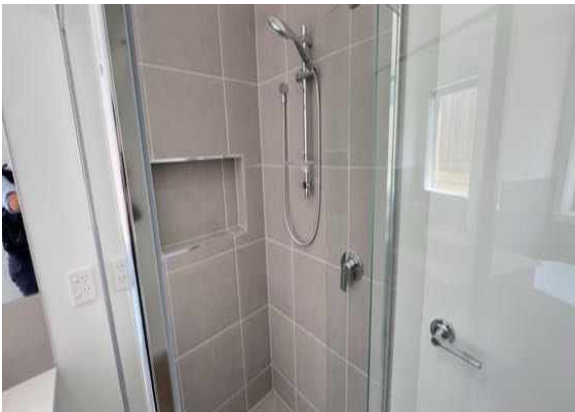
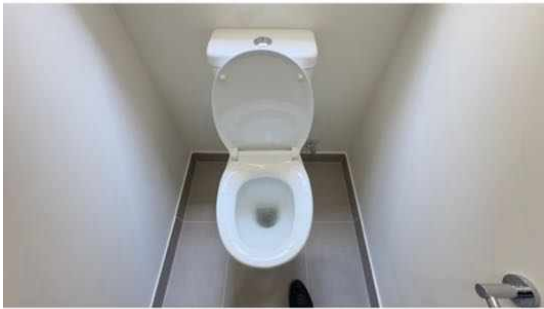
Noted Item

Building: Main Building
 Location: All Internal Areas
 Finding: Water Supply & Drainage - Shower, Basins, Toilets, & Plumbing Fixtures
 Information: The shower recess was tested, and no visible water penetration to surrounding areas was observed at the time of inspection, except where noted as a separate defect elsewhere in this report. Water appeared to flow freely toward the floor waste. Moisture detected to the shower walls is documented separately in the report. The shower floor waste appeared clear during inspection.

Flushing the toilet revealed no visible leaks, and the fixture appeared to operate normally unless otherwise noted as a separate defect. No water damage was observed to the vanity unit unless specifically stated elsewhere in the report. Basins, bathtubs, laundry tubs, vanities, and sinks were tested and inspected with no evidence of leaks, blockages, or drainage issues at the time of inspection unless otherwise noted. All internal taps and shower heads were tested with no leaks observed, unless documented as a separate defect.

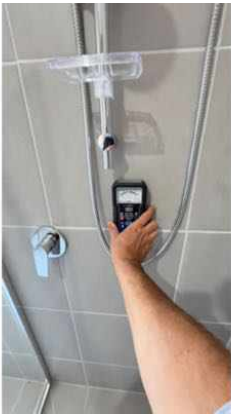
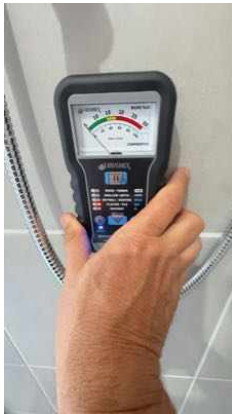
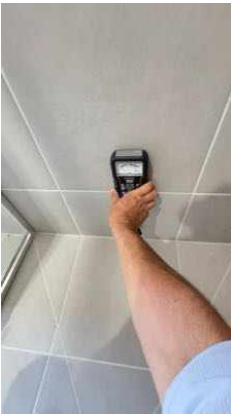
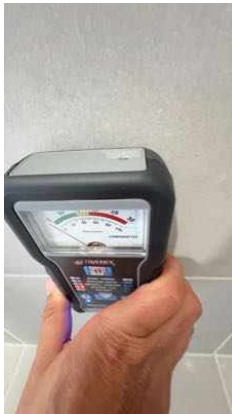
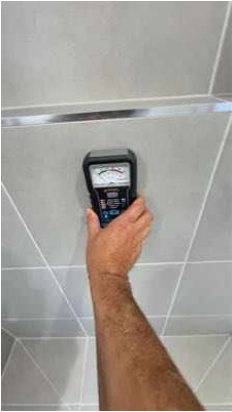
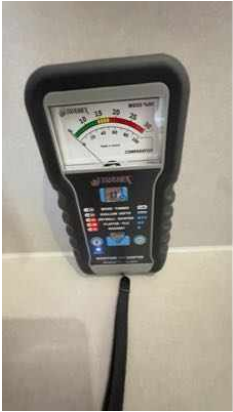
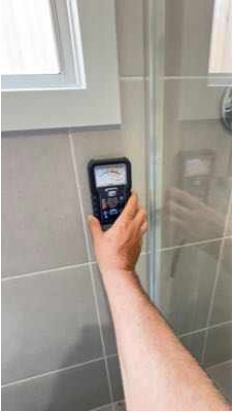
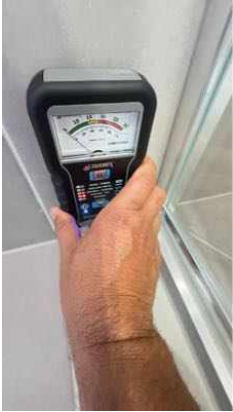
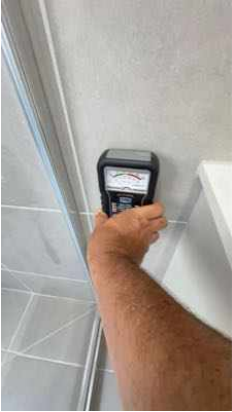
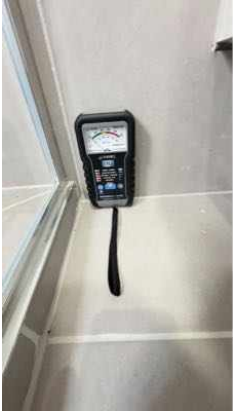
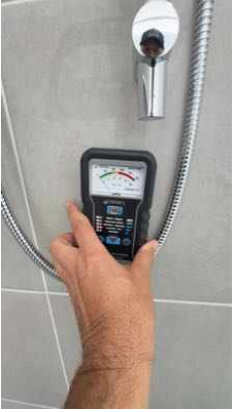
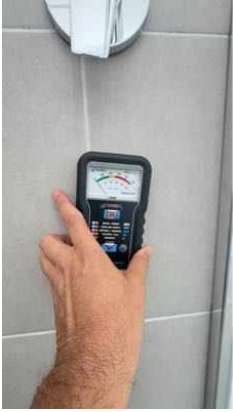
Noted Item

Building: Main Building
Location: All Areas Interior & Exterior
Finding: Moisture Levels - Advisory - No Elevated Moisture Levels Present
Information: At the time of inspection, no elevated moisture levels were detected in these areas. Moisture readings were taken (using a Tramex Moisture Meter) and non-invasive testing methods and reflect conditions present at the time of inspection only. This item is noted for advisory purposes and should not be relied upon as a guarantee that moisture issues are not present elsewhere or may not occur in the future.

It is important to note that moisture levels can fluctuate due to weather conditions, plumbing usage, seasonal changes, or intermittent leaks. Concealed moisture within wall cavities, subfloor areas, or other inaccessible locations may not be detected during a visual or limited moisture assessment.

Ongoing monitoring of the property is recommended, and further investigation by a qualified tradesperson should be considered if signs of water ingress, dampness, staining, mould growth, or material deterioration become apparent.

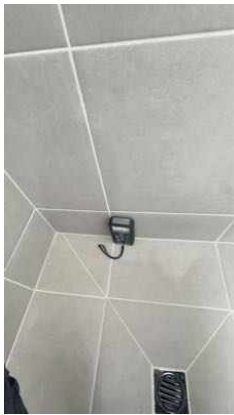
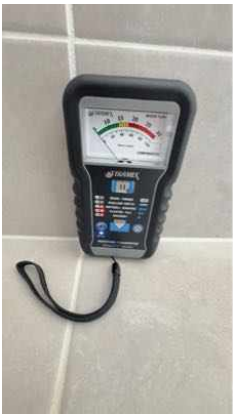
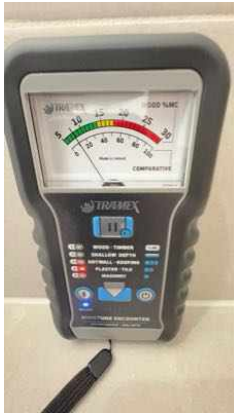
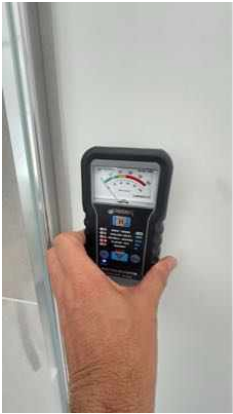
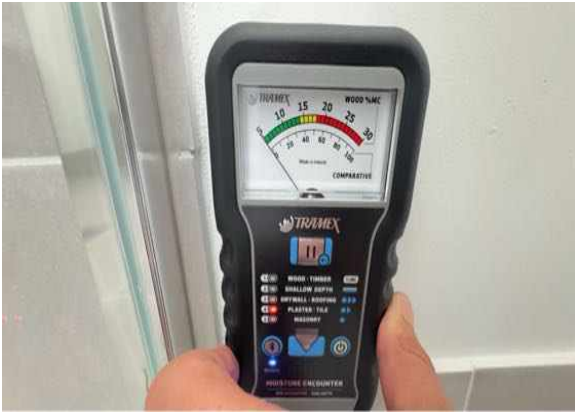
Noted Item

Finding: Thermal Scanning & Diagnostic - Advisory - No Elevated Moisture Levels Present

Information: During the inspection, a thermal imaging camera was utilised as a non-invasive diagnostic tool to assist in identifying potential irregularities associated with moisture ingress, heat loss, insulation deficiencies, or concealed building defects. Thermal imaging detects surface temperature variations that may indicate abnormal conditions within building elements.
