Building Inspection Report

Inspection Date: Mon, 12 Jan 2026

Property Address: 10 Feathertop Wy, Nar Nar Goon North VIC
3812, Australia

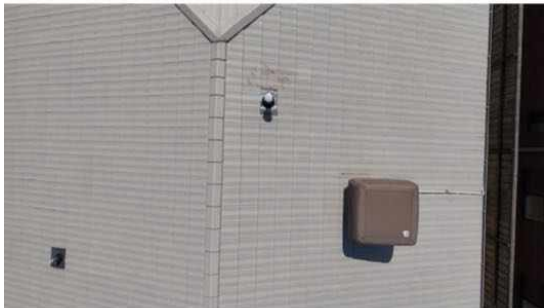
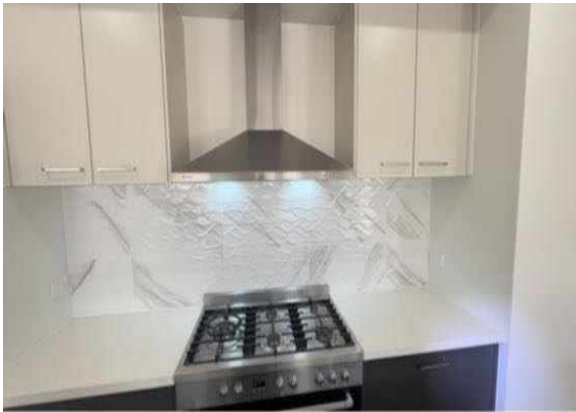
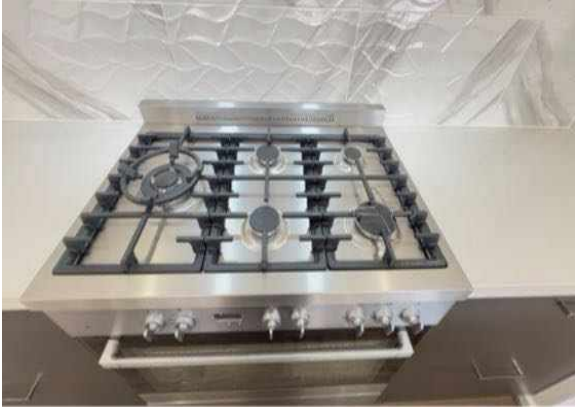
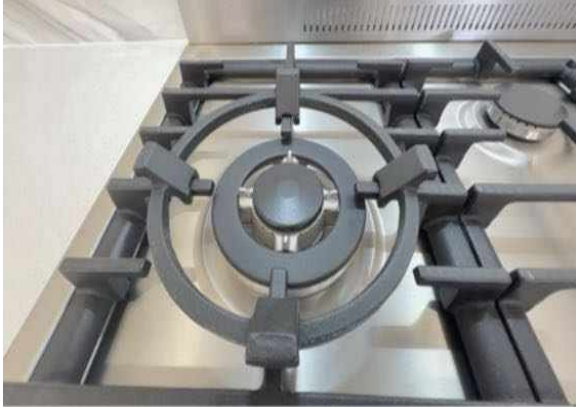
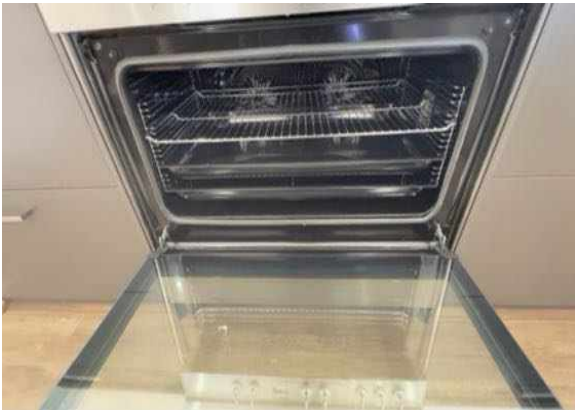
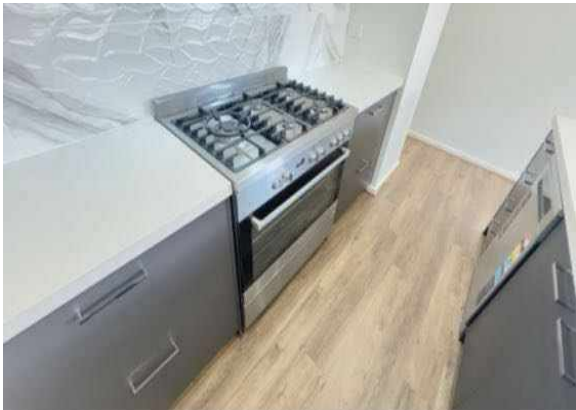
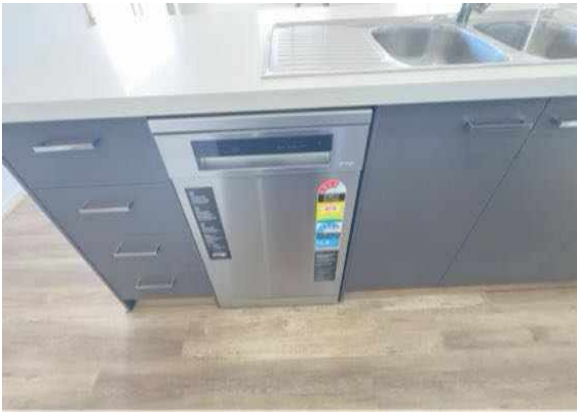
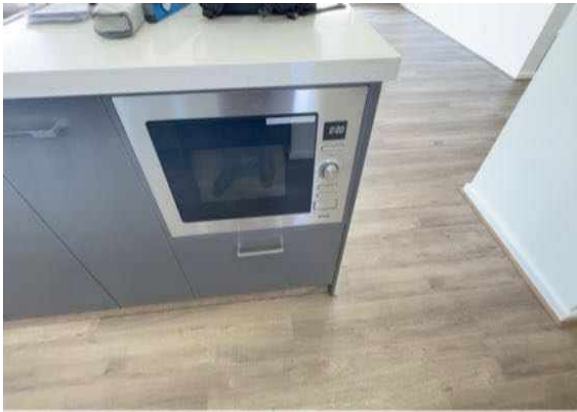
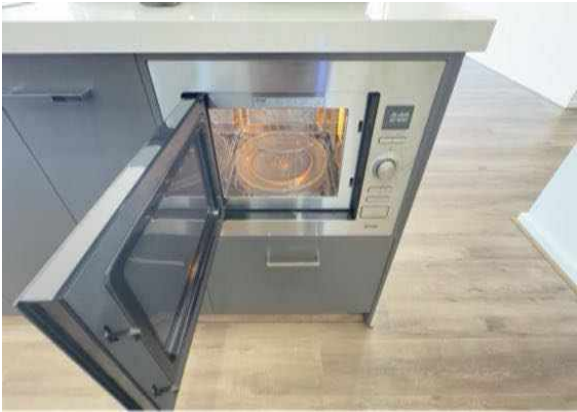
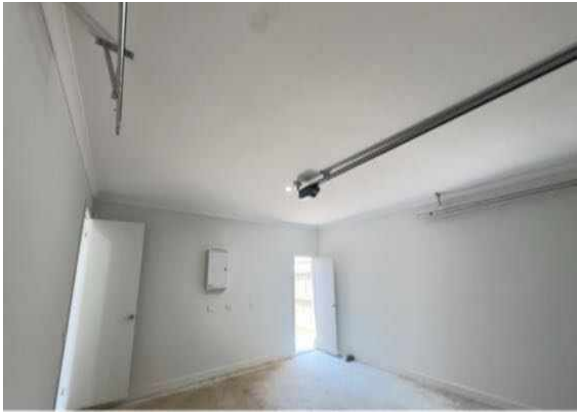
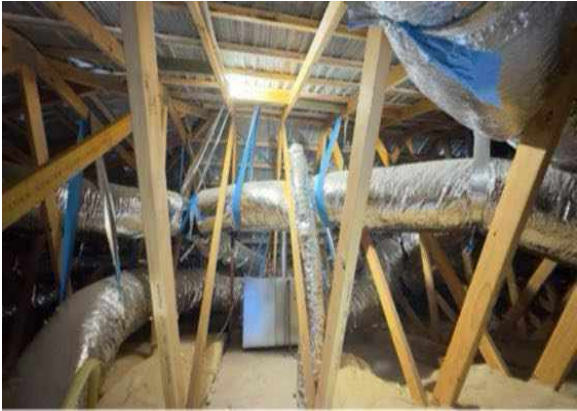
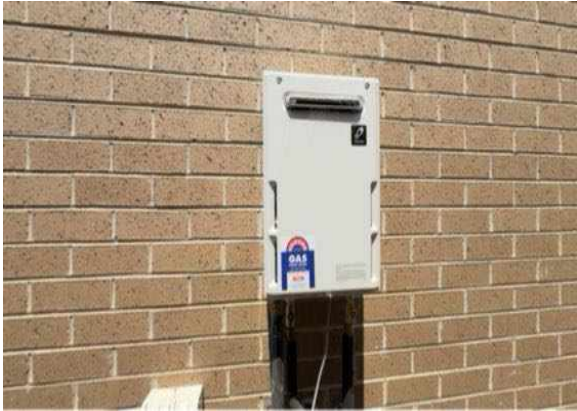
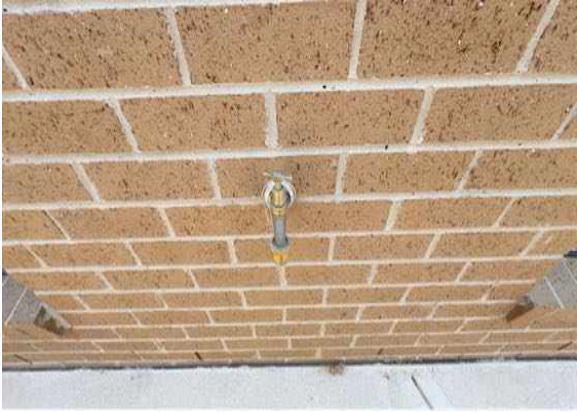
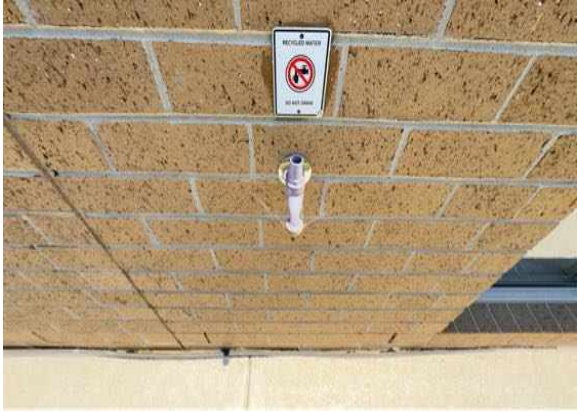
Noted Item

Building:	Main Building
Location:	All Areas, Interior & Exterior
Finding:	Appliances, Heating & Cooling Systems, Mechanical Systems, Plumbing, Electrical, Fireplaces - Advisory
Information:	The inspection did not include testing, operation, safety, or assessment of any installed or portable appliances or mechanical systems. This includes, but is not limited to, ovens, cooktops, microwaves, rangehoods, dishwashers, ducted vacuum systems, air-conditioning units, heating systems, hot water services, ceiling fans, exhaust fans, intercoms, security systems, fireplaces, and solid fuel heaters.

Appliances may be worn, damaged, or malfunctioning. Electrical or gas appliances can pose serious safety hazards if incorrectly installed or maintained.

Service, repair, or replace equipment as necessary, particularly where service history or warranty coverage is unknown.

Inspect any water, gas, or electrical connections associated with appliances to ensure safety and compliance.

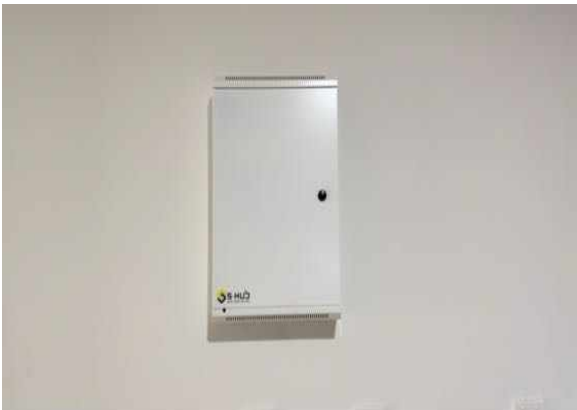
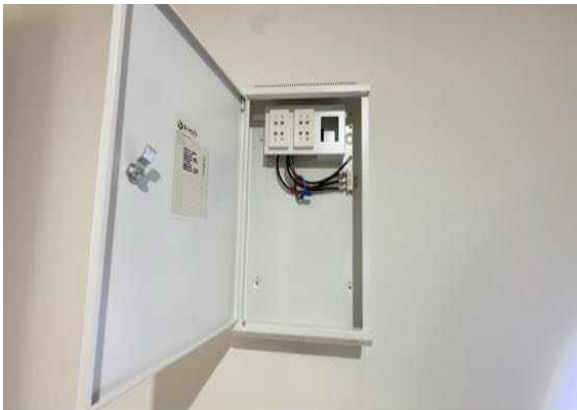
Noted Item

Building: Main Building

For full compliance and safety verification, a licensed electrician should be engaged to inspect the switchboard, test all circuits, and ensure all components are functioning correctly. This will help maintain electrical safety and prevent potential hazards.

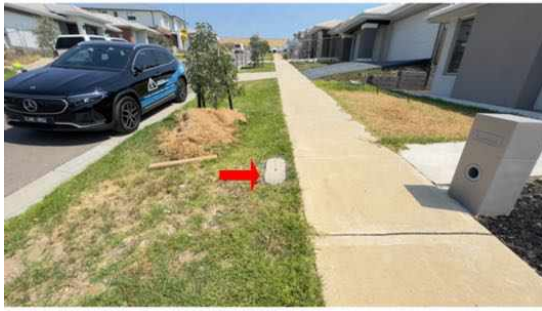
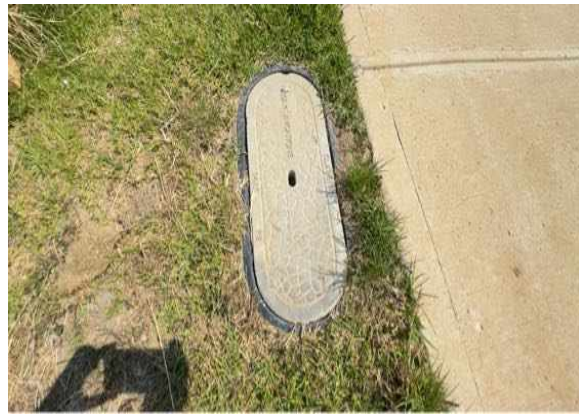
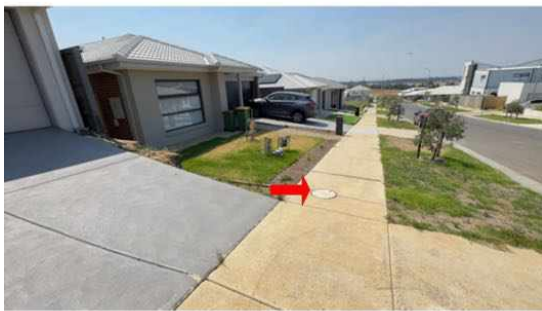
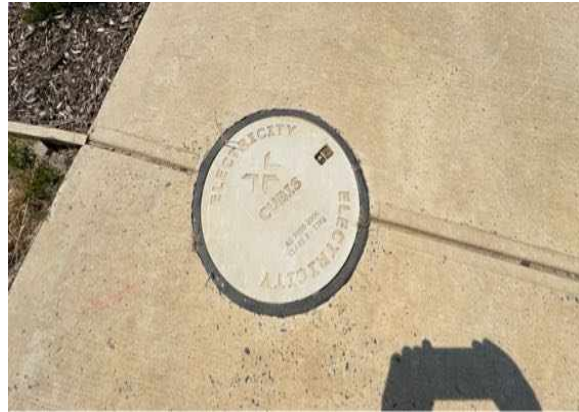
During the inspection, minor cracking, surface wear, or uneven sections were observed on footpaths or crossovers. Some accessible metal components, such as street signage or grates, showed signs of rust or deterioration. Debris accumulation and vegetation encroachment were also noted around council infrastructure. Access or visibility was limited to certain council-owned assets.

These areas should be monitored, and for detailed assessment, maintenance, or compliance verification, the relevant local council authority should be contacted immediately. Regular monitoring of adjacent council assets is recommended to ensure ongoing safety and proper maintenance.

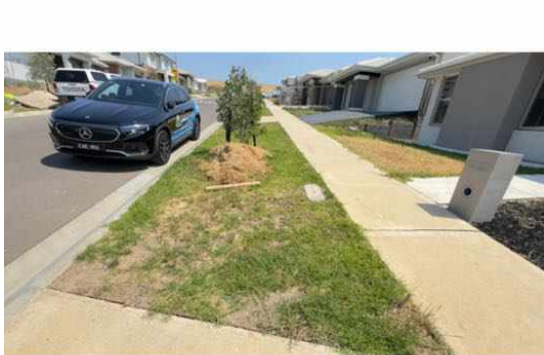
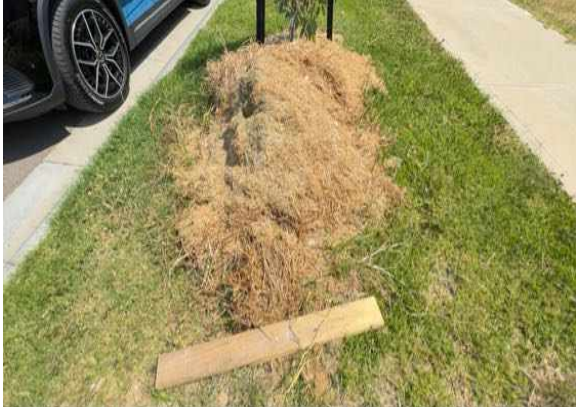
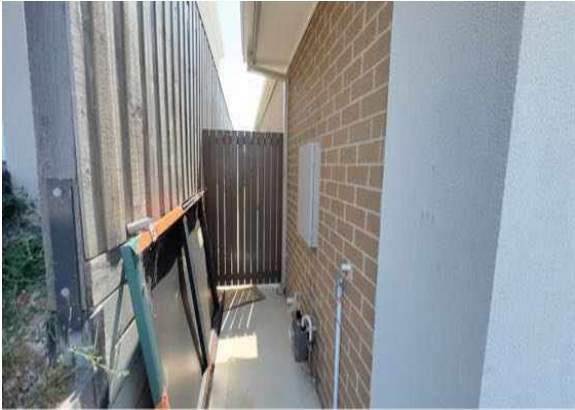
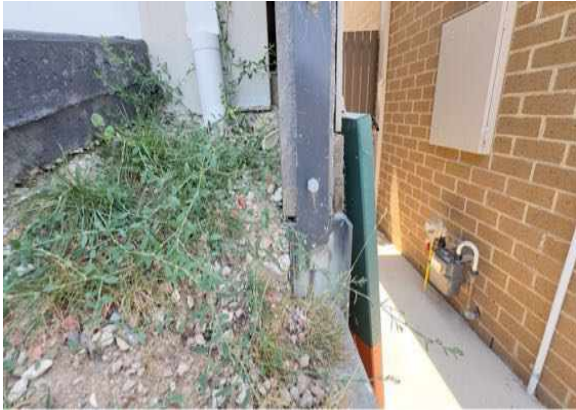
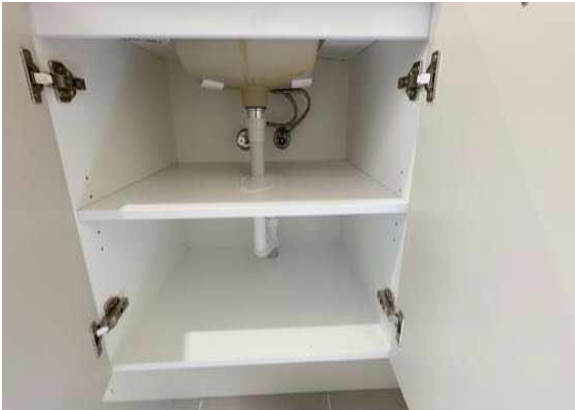
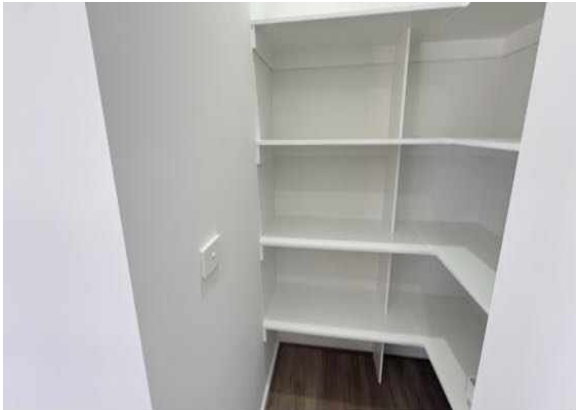
Building: Main Building
 Location: All Areas
 Finding: Additional Photos - Obstructions & Limitations
 Information: These photographs provide evidence of obstructions and restrictions that prevented full access to certain areas of the property at the time of inspection. Such obstructions may include stored goods, furniture, floor coverings, stored building materials, dense vegetation, vehicles, or fixed finishes.

Because these areas could not be visually assessed, no comment can be made on their condition within this report.

It is strongly recommended that obstructions be removed and concealed areas made fully accessible immediately. A re-inspection should then be carried out to allow a complete assessment of the property's condition. This is particularly important prior to purchase, as defects in concealed areas can carry significant rectification costs.
