Building and Timber Pest Inspection Report

Inspection Date: Thu, 9 Apr 2026

Property Address: 2/110 Ford St, Ivanhoe VIC 3079, Australia

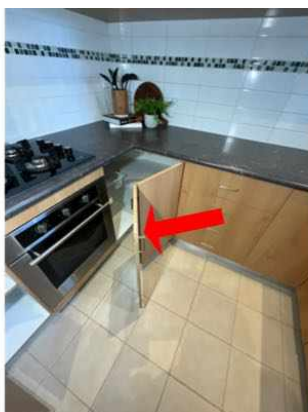
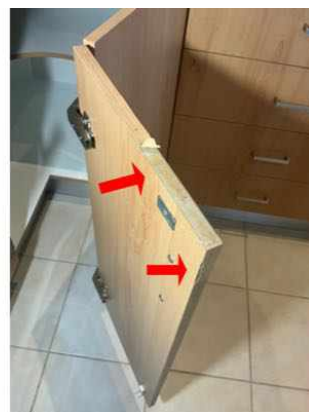
Finding: Damage to the kitchen cupboards - edging peeling off

Information: Evidence of damage was identified to the kitchen cupboards at the time of inspection. It appears that the edging on the cupboards were peeling off.

The cupboard doors may be re edged. Failing that , replacement of the cupboard doors may need to be undertaken.

A kitchen specialist or competent handyman may be engaged to inspect the damaged areas and repair or replace any items where necessary.

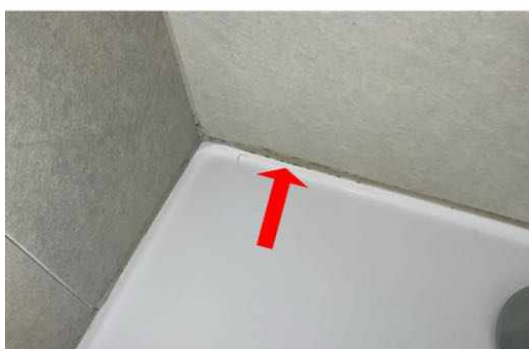
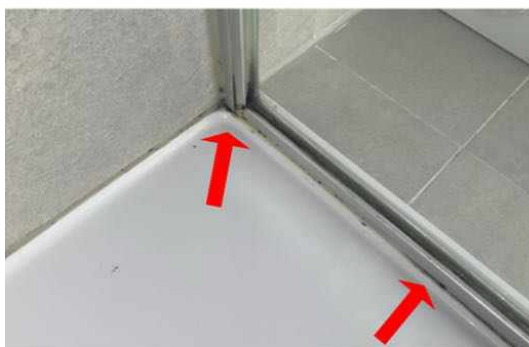
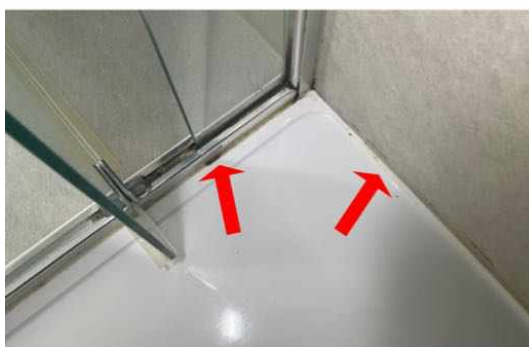
Finding 3.03

Finding: Sealant - Degraded and mouldy within shower area

Information: Sealant is degraded / mouldy in the shower area. Sealant is used to protect gaps and crevices in building materials to ensure that they are water-tight and prevent water penetration to the associated structures.

Failure to do so may lead to further deterioration of the sealant which in turn may lead to water damage to the surrounding area.

Where sealant is damaged or mouldy, the area should be cleaned of mould. Should this not be effective and the sealant be damaged, a tiling contractor should be appointed to scrape out and re-apply any silicone where necessary.

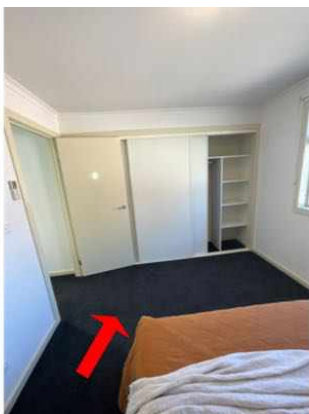
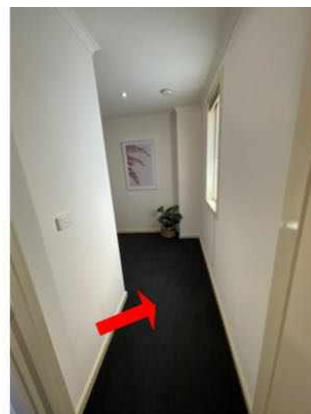
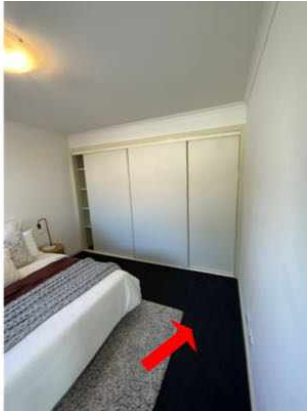
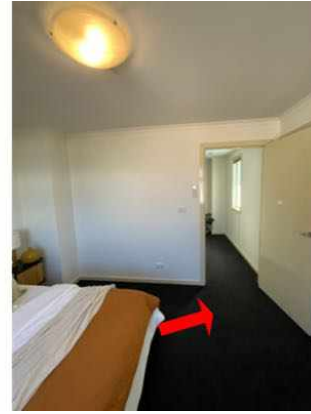
Creaking floors generally indicate that the fixings for the flooring may be coming loose slightly.

The area should be monitored for any changes or unevenness. Should this occur, consultation with a registered builder should be undertaken to determine the cause. The potential resolution may involve regluing and screwing the floor down through to replacement of subfloor support structures.

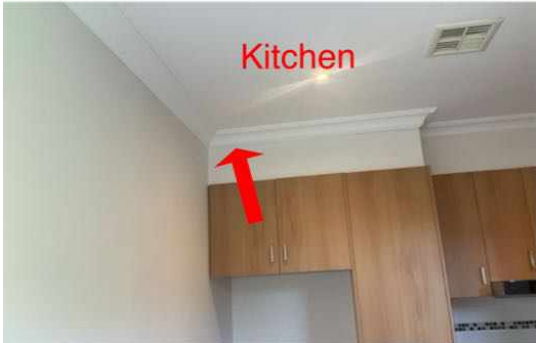
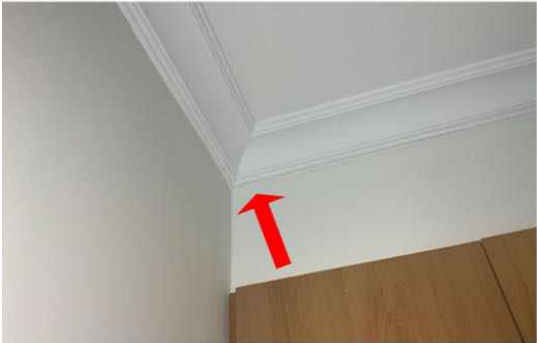
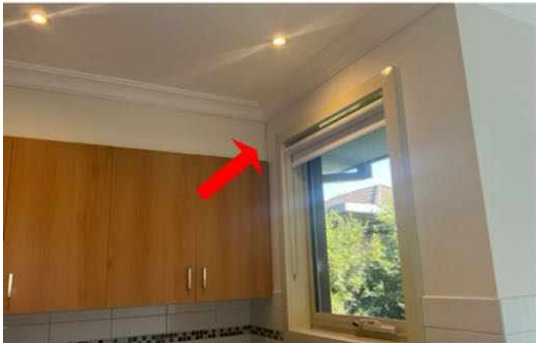
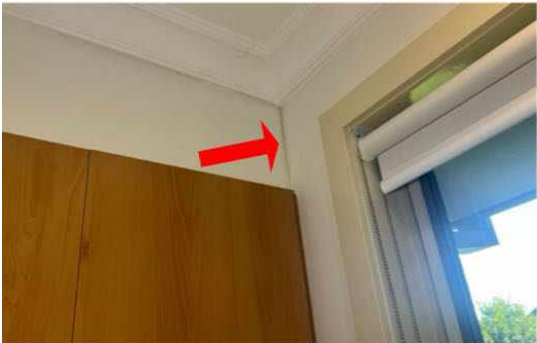
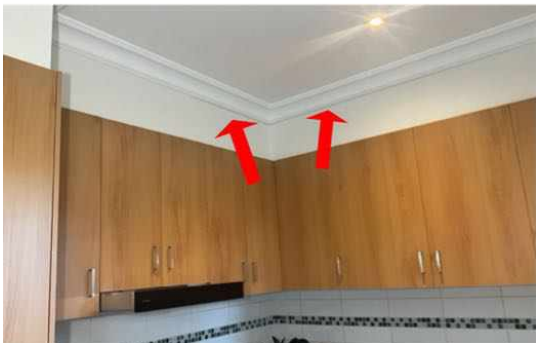
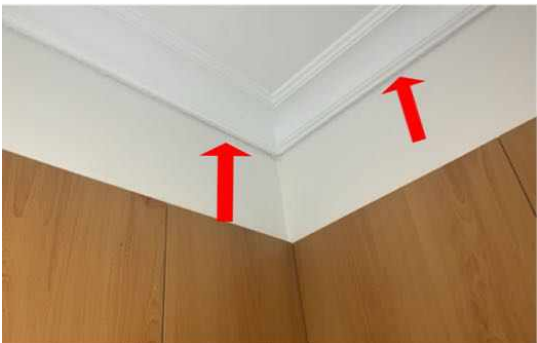
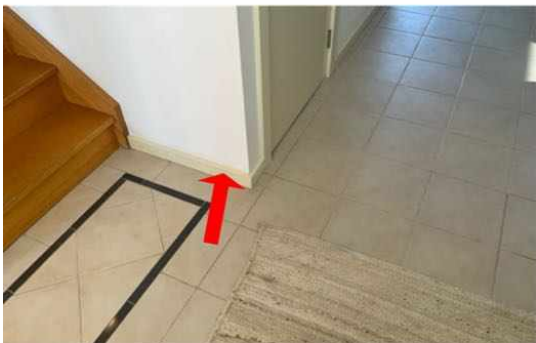
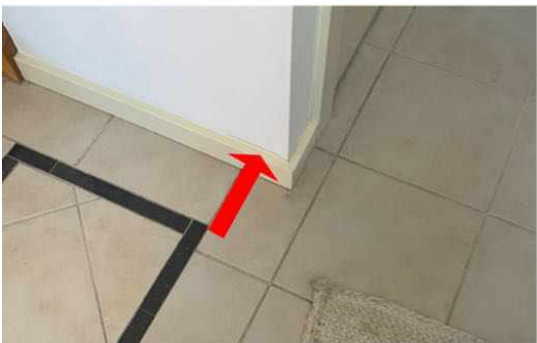
Finding 3.08

Building:	
Location:	All Areas
Finding:	Cracking - fine
Information:	Some fine cracking was noted throughout the property.

Although fine cracks are quite noticeable, they are often only considered to be an appearance defect, and usually do not indicate any structural damage. Generally, the cause of a fine crack is indicative of a separation between building materials and finishes (e.g. paint, plaster, etc.) along joins.

Note: photos included are indicative of fine cracking noted at the the time of inspection. Other fine cracks may be present but not recorded here.

Cracking of this nature can generally be repaired with minor sanding, filling and/or repainting. Such works should be performed by a qualified painter or a general handyman.

Monitoring of all cracking should be conducted frequently. Always contact a building inspector should cracks widen, lengthen, or become more numerous.

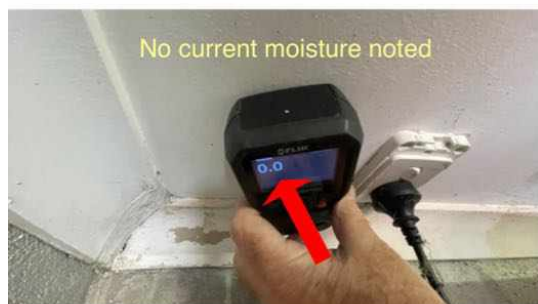
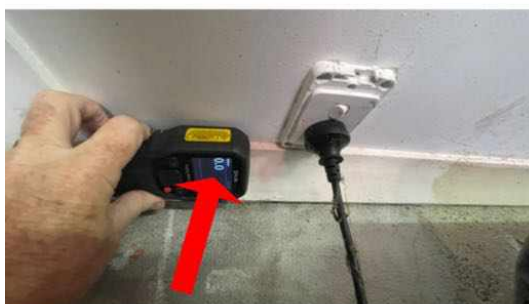
Finding 3.09

Building:
Location: Garage
Finding: Ceiling - suspected moisture damage and staining
Information: At the time of inspection some suspected moisture damage and staining was noted to the ceiling within the garage.

Please note: whilst no current moisture was noted in the area at the time of inspection, this doesn't mean that no future leaking may occur. The area should be monitored for any further changes and action taken as above.

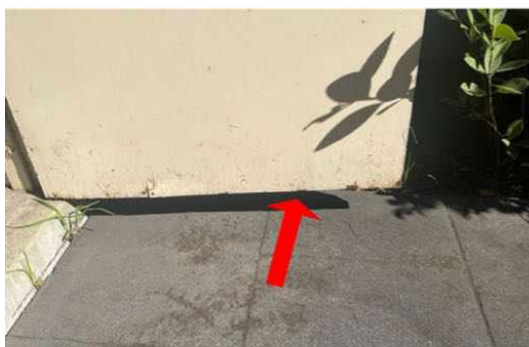
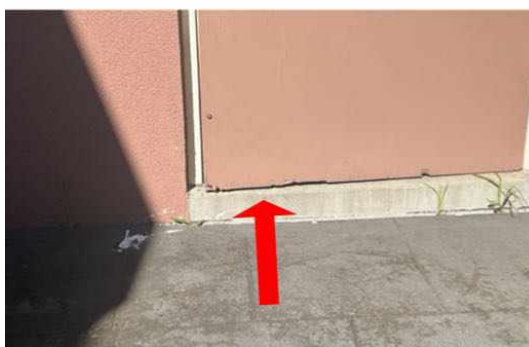
Finding 3.13

Finding: Door showing signs of damage to the base

A suitably qualified handyman or painter should be engaged to remove doors, repair any damage, paint the door including top and bottom and rehang them.

If the door cannot be repaired, a new door may be required.

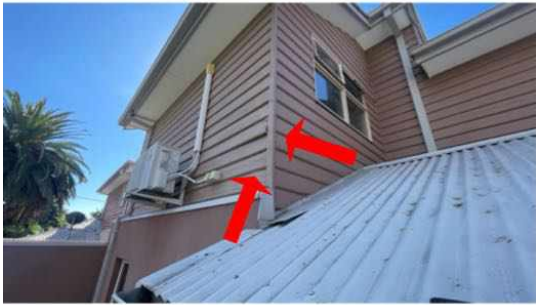
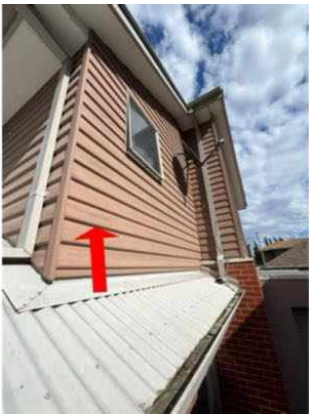
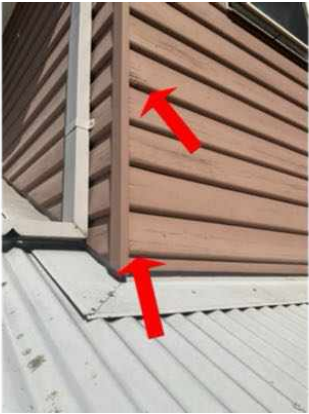
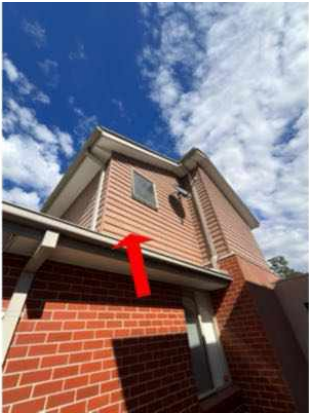
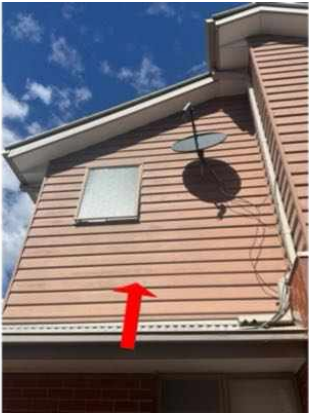
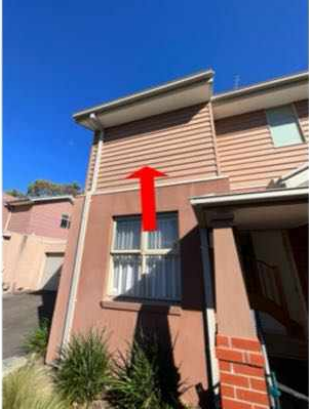
Finding 3.14

Weatherboards are sealed and protected by paint and other sealants. When these sealants deteriorate over time, they allow water penetration to the weatherboards, causing moisture damage and possible wood rot. If left unmanaged, the wood rot is likely to develop further, possibly necessitating major repair or replacement works in the long-term future.

To maintain the condition of the external wall cladding, any severely affected weatherboards should be repaired as a priority. Where weatherboards have rotted due to excessive moisture other than rain penetration, the cause of the moisture should be identified immediately by a licensed plumber. A qualified carpenter should be appointed to repair and replace rotting weatherboards.

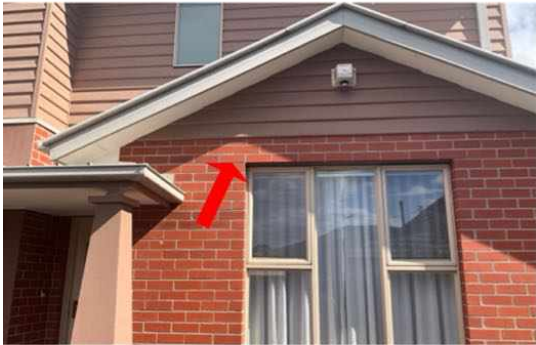
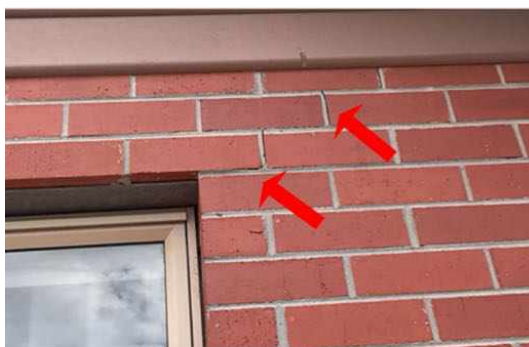
Finding: Brickwork - Cracking [Fine]

Information: Although fine cracks are quite noticeable, they are often only considered to be an appearance defect and usually do not indicate any major structural damage. Generally, the cause of a fine crack is indicative of a separation between brickwork and mortar throughout the structure, but single bricks may also show cracks of this nature.

It is highly recommended that the cracking been monitored for a period of time to determine any further movements. Should no further movement occur, cracking of this nature can be repaired with minor filling and should be conducted via qualified bricklayer

Always contact a building inspector should cracks widen lengthen or become more numerous.

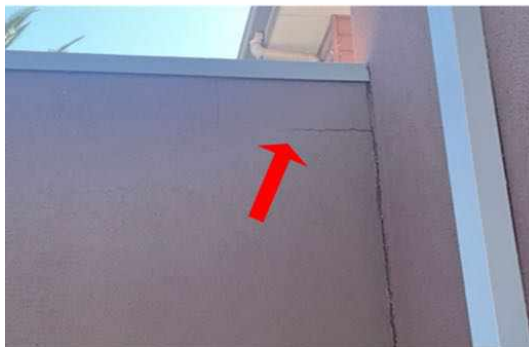
Finding 3.16

Finding: Rendered wall - noticeable cracking

Information: Noticeable cracking to the rendered wall was identified at the time of inspection.

This type of cracking is often consistent with general movement of the foundations of the property and is not considered a major structural defect.

Whilst it is more of an appearance issue, repairs may be required as failure to act may allow moisture to enter the crack and cause secondary damage to other building elements.

Consultation with a suitably qualified renderer should be sought to determine costs involved with any repairs necessary.

Should cracks increase in size or number, speak with your building inspector for further advice.

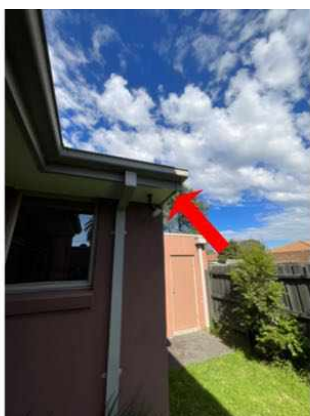
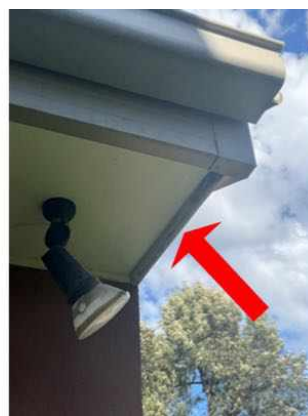
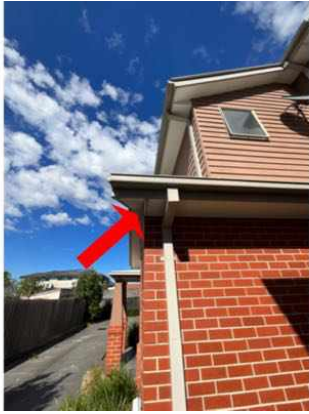
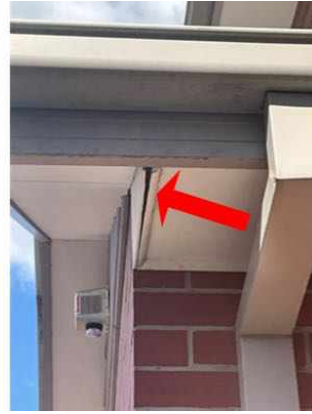
Finding 3.17

Finding: Beads - Damaged

Information: Beading acts (like cornice or skirtings) to cover the intersection or joins of building materials. It was noted at the time of inspection that beading in this area has come loose. This deterioration is suspected to have been caused by general ageing and frequent exposure to weather, which is expected in a building of this age and condition.

Beading is important in weatherproofing the surrounding building elements and preventing termite or pest ingress. Furthermore, beading works to protect the joins of building materials, which are more susceptible to deterioration and decay.

Repair or replacement of the beading is advised to ensure the protection and longevity of any associated building elements. Such works may be performed by a general handyperson or qualified carpenter.

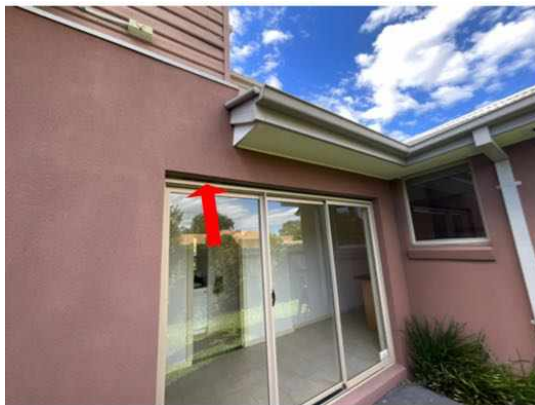
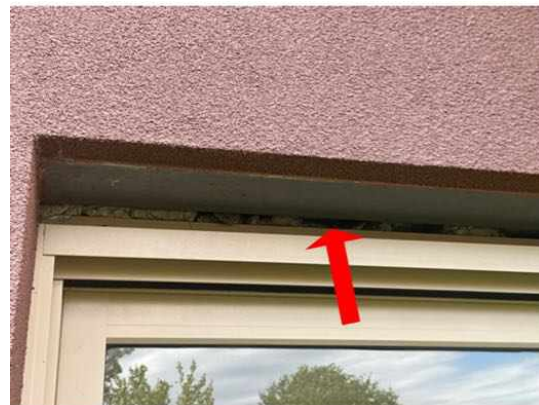
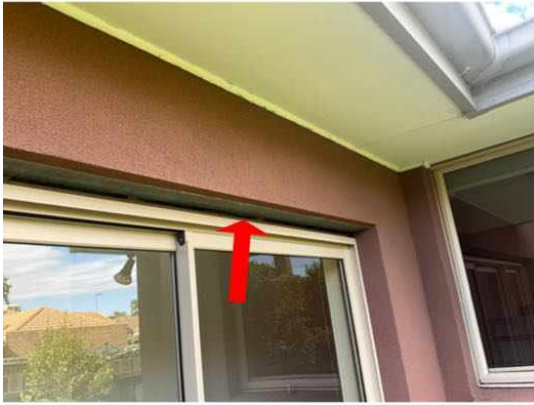
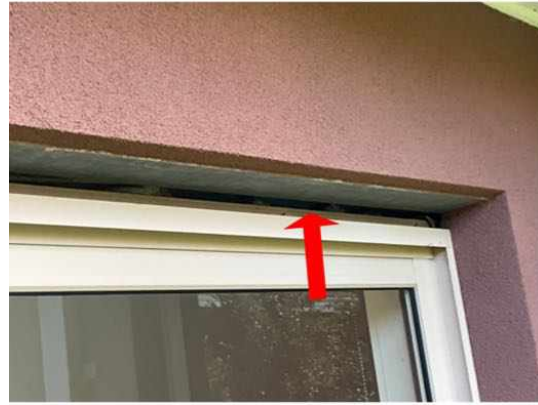
Finding 3.18

Information: A gap was identified above the external door frame at the rear of the property. Where gaps around frames are evident, it may allow moisture to get into the cavity of the brickwork and cause secondary damage. Pest ingress may also be possible.

The gap around the frame should be sealed to prevent this occurring.

A competent handyman or registered builder should be engaged to perform remedial works to restore the frame to a weathertight condition.

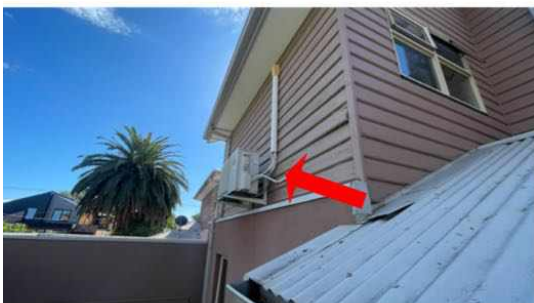
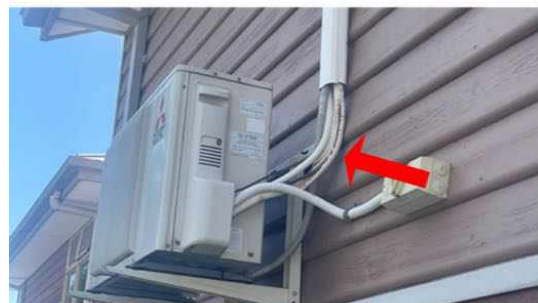
Finding 3.19

Finding: Pipework - Insulation deteriorated

Information: Sections of the pipe insulation show evidence of damage and deterioration. It is suspected that this deterioration has developed as a result of excessive exposure to weather, including UV exposure in daylight. Deteriorated insulation reduces the effectiveness of the material in helping to maintain the desired temperature and work most efficiently.

If left in an exposed position, it is likely that the deterioration will continue and worsen over time, potentially resulting in secondary building defects as well as a further loss in insulating properties.

Some areas of replacement of pipe insulation is likely to be required. Further preventative measures to remove or protect the material from future exposure are also advisable. Consultation with a licensed plumber is advised to gain quotes for the repair and/or replacement of deteriorated insulation.

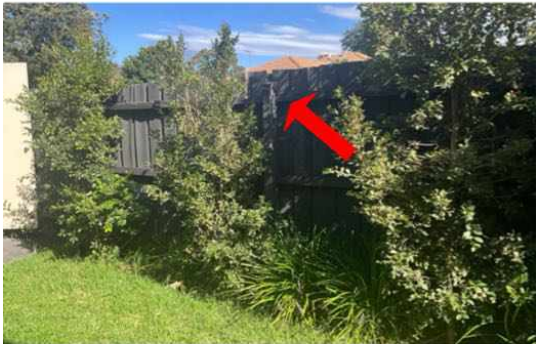
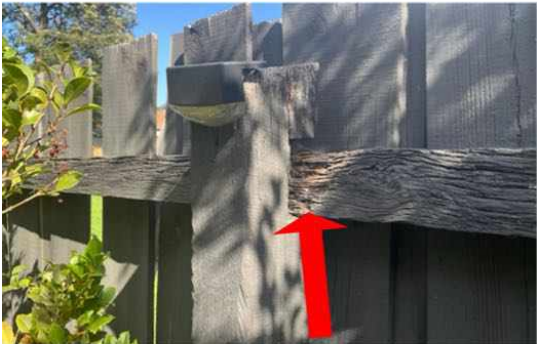
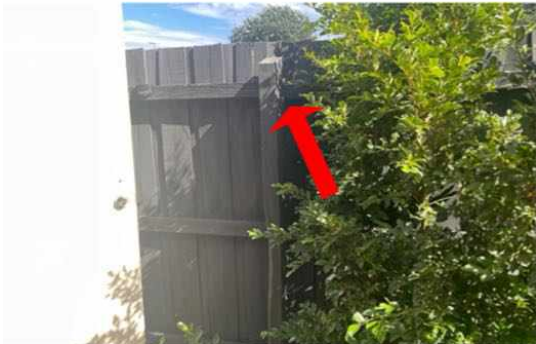
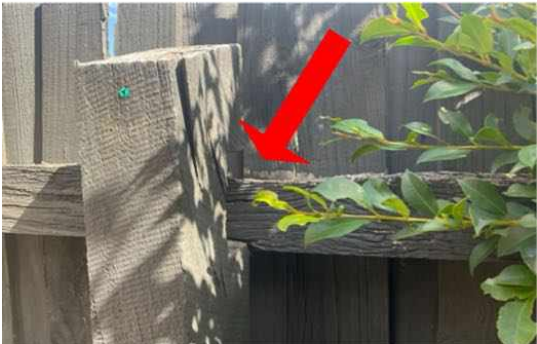
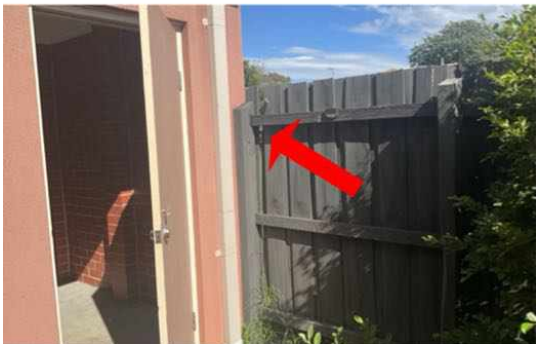
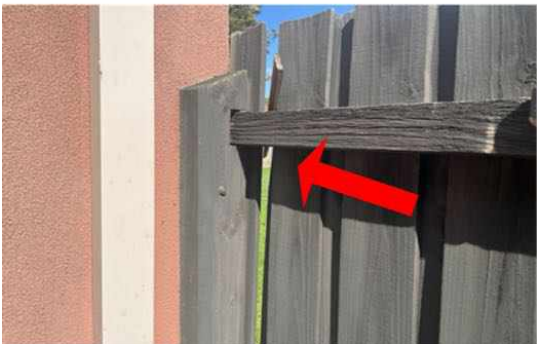
Finding 3.20

Finding: Fencing - Deteriorated

Information: It was noted at the time of inspection that sections of the fencing throughout the property have deteriorated. Typically fencing deteriorates due to age and or wear, rot and or rust which is generally expected for a structure of this age, due to prolonged exposure to weather conditions. Sometimes inadequate installation or maintenance can be to blame.

If left unattended, it is likely that further damage will occur. It is suspected that repair and replacement of several elements of the fencing will be required.

A licensed fencing contractor should be appointed to provide further advice and perform rectification works as necessary.

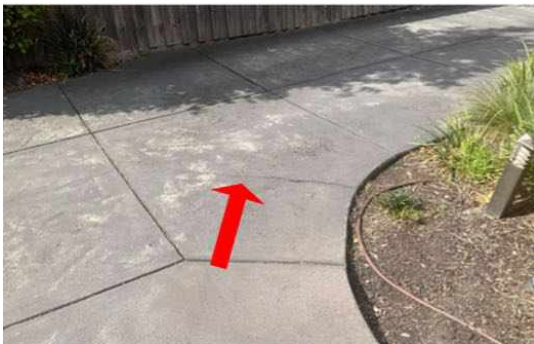
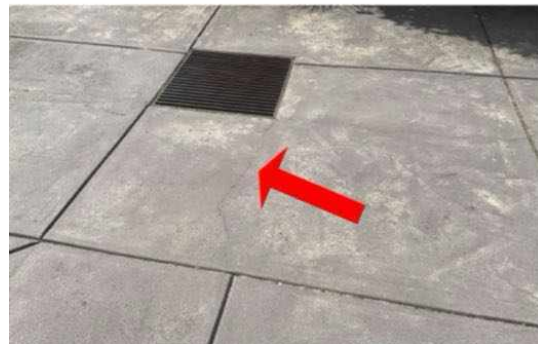
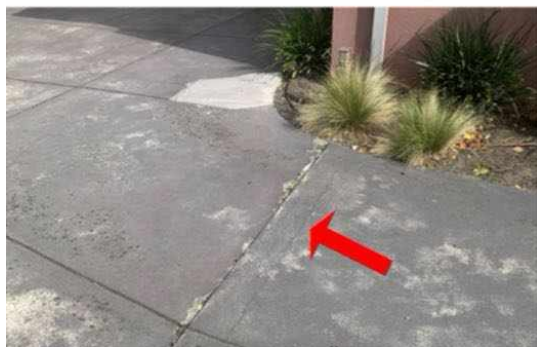
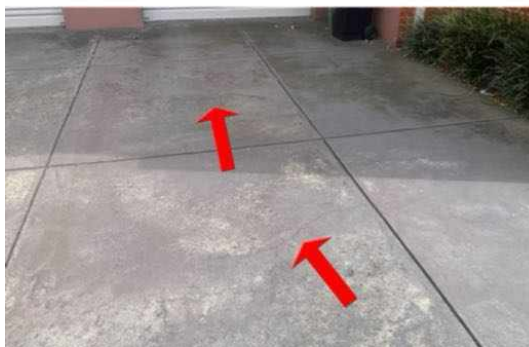
Monitoring of all cracking should be conducted frequently. Always contact a building inspector should cracks widen, lengthen, or become more numerous.

Please note: the driveway may be covered by any owners corporation. Further enquiries should be made to determine if this is the case.

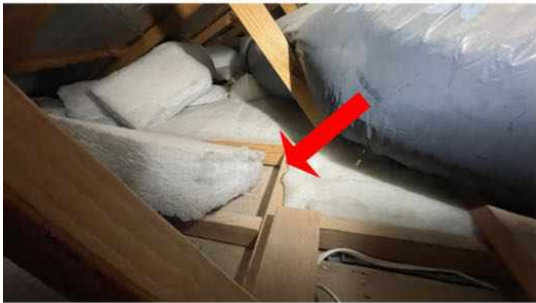
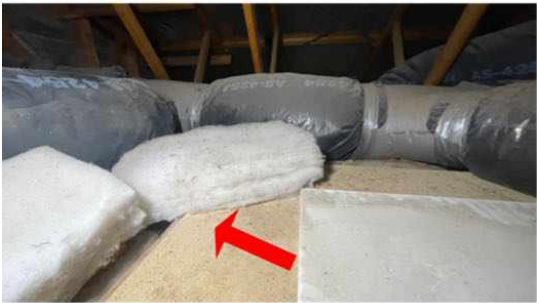
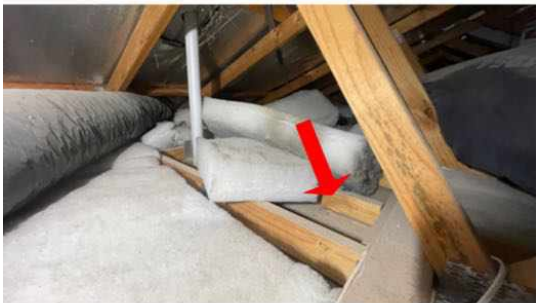
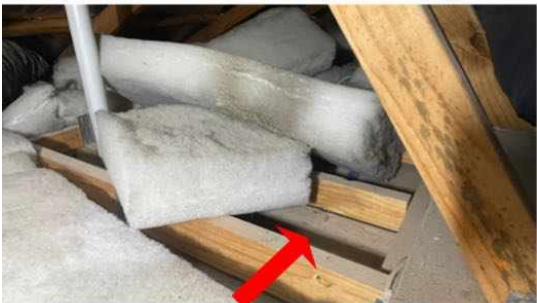
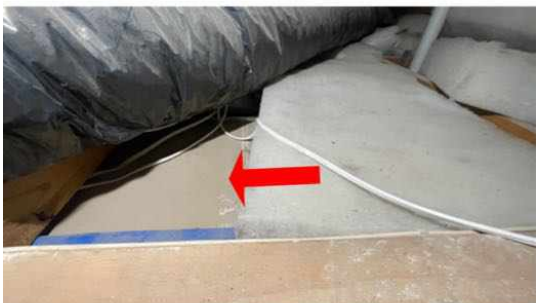
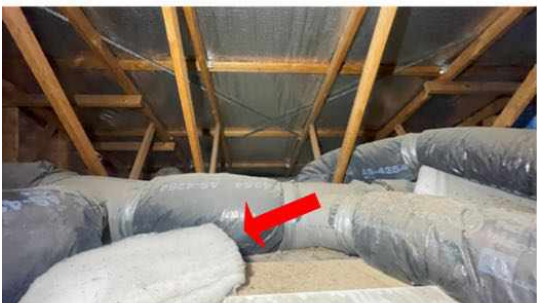
Finding 3.22

Information: At the time of inspection, it was noted that whilst there appeared to be a generally good coverage of insulation, there were some areas which had little or no insulation. It appeared that some sections of the insulation has been moved from its original placement.

It is suspected this insulation may have been moved for some reason and has failed to be put back. This uneven coverage can reduce the effectiveness of the insulation.

Caution should be exercised when accessing the roof void. You should be aware there is a potential for electric shock if contact is made with any exposed or faulty electrical wiring within the roof void.

An insulation contractor should be engaged to replace insulation back to its original position and install new insulation if necessary.

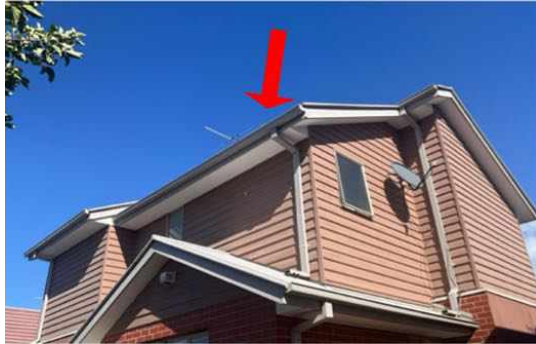
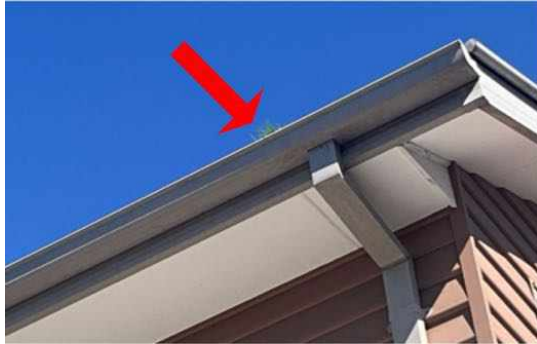
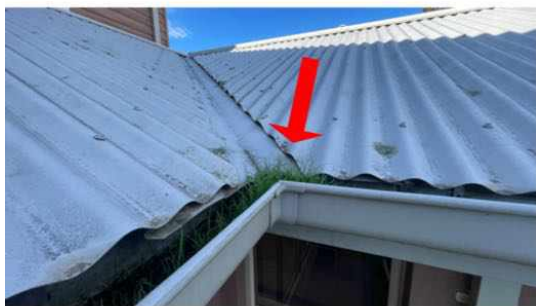
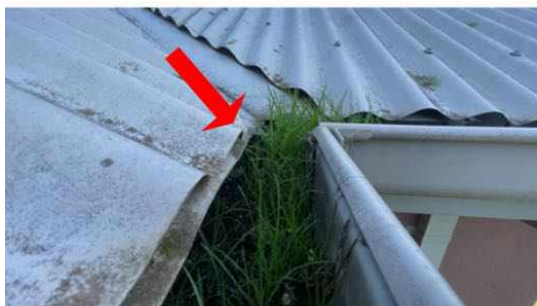
Finding 3.23

Blocked gutters are likely to lead to high levels of moisture in the affected areas. Such moisture will not only cause rust and decay of the associated building materials, but can also provide conditions that are conducive to termite and timber pest activity.

Blockages in gutters should therefore be removed immediately to ensure dry conditions are maintained.

It is highly advised that blocked gutters be cleared by the homeowner or a general handyperson as a matter of urgency. Failure to do so may result in moisture entering the property causing more significant damage.

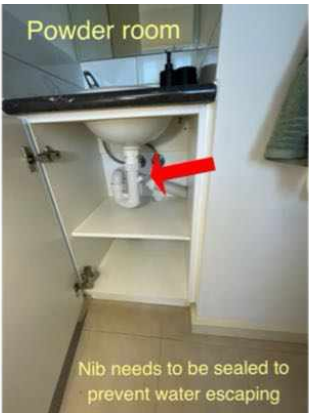
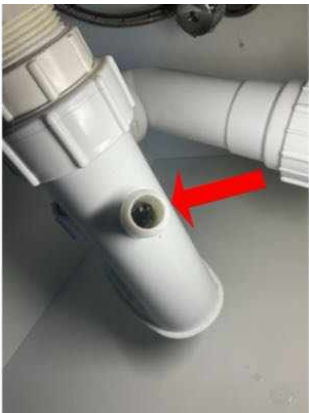
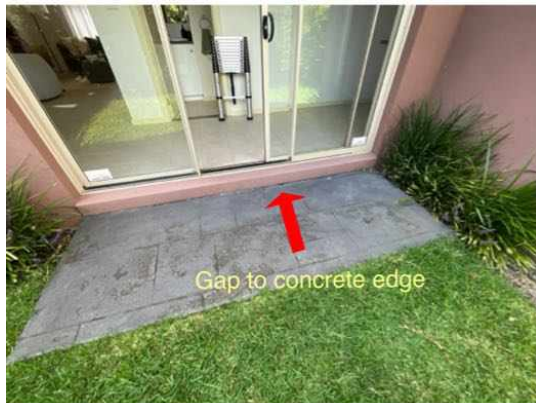
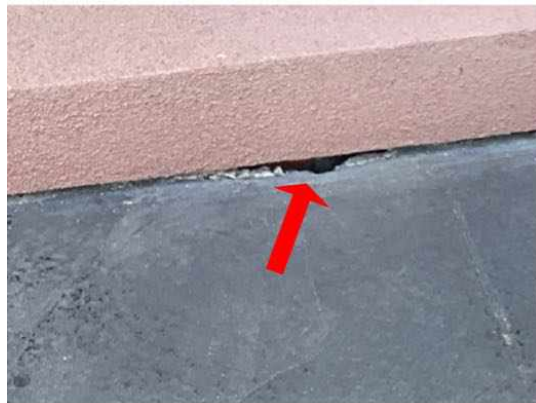
Finding 3.24

Building:
Location: All Areas
Finding: Additional Photos - minor defects

Information: Additional photos are provided for your general reference. Arrows have been included where necessary to highlight areas of importance.

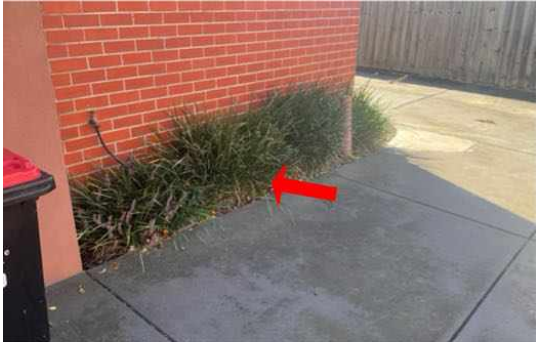
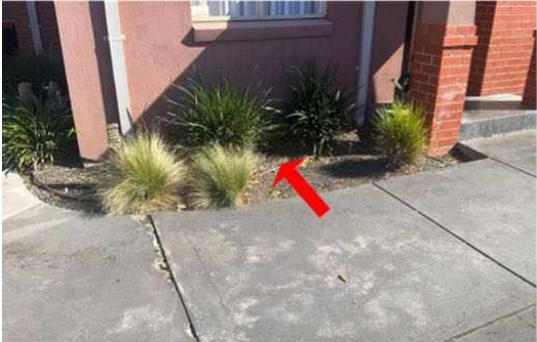
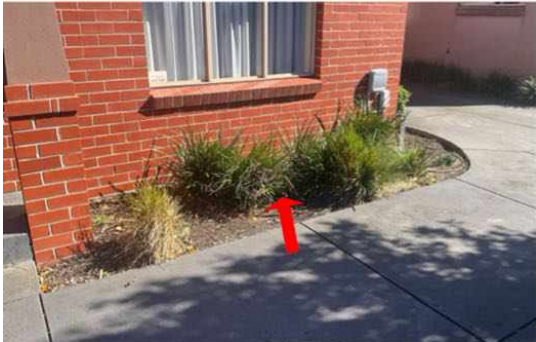
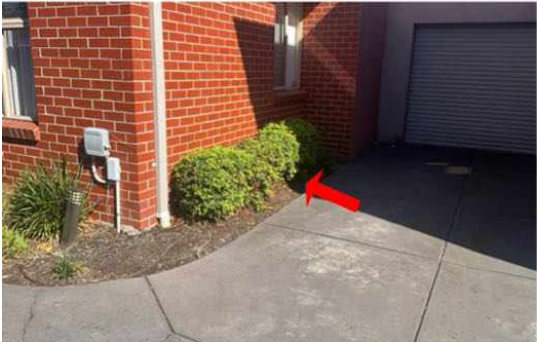
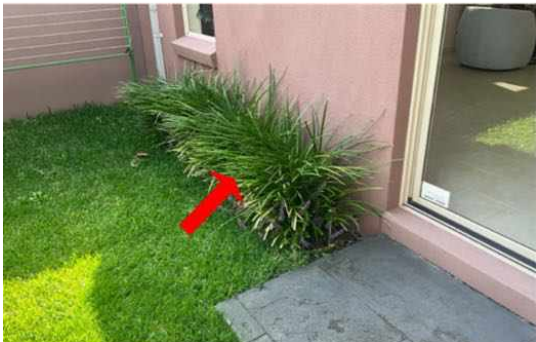
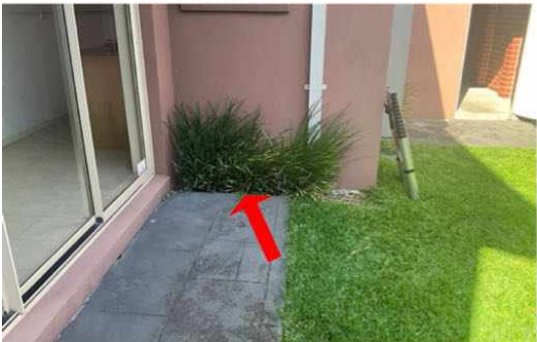
Finding: Garden Beds - Conditions Conducive to Termites

Information: Garden beds were found to be evident around and against the property. These garden beds can include untreated timber, and with a combination of moisture from rainfall and hosing, can make conditions conducive to termite activity and termite ingress.

The removal and replanting of species that do not provide "cover" or cutting back of existing vegetation will assist greatly in preventing this from occurring.

The removal of any such materials that may be conducive to termite activity should be carried out as soon as possible to minimize the risk of potential termite attack.

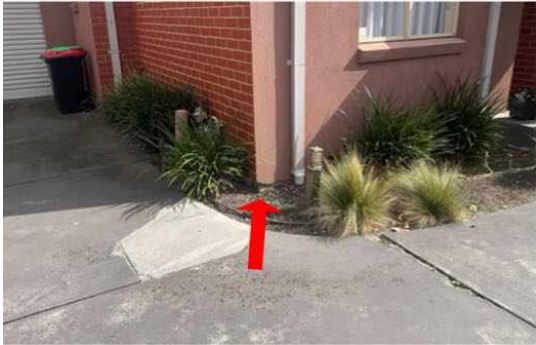
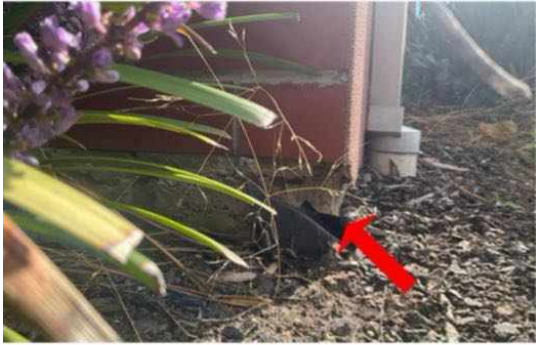
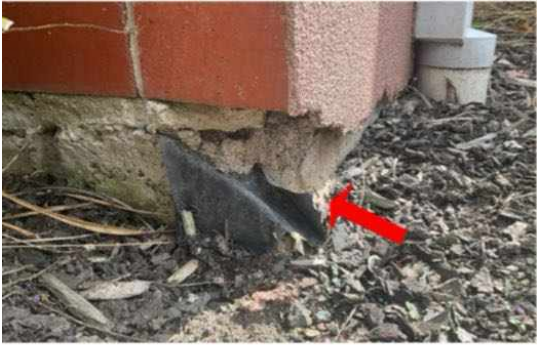
The area should be monitored for any cracking of brickwork or subsidence in the area. Should this occur, a structural engineer should be engaged to inspect the area and provide the right corrective action to ensure the slab is adequate.

Such measures could include reinforcing the area underneath the corner brickwork so as to provide adequate support for the brickwork.

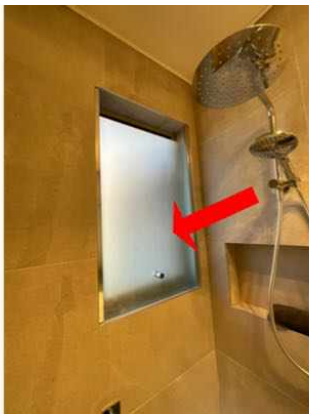
Building:
 Location: Ensuite
 Finding: Additional Photos for your information - sliding glass window
 Information: It was noted at the time of inspection that the ensuite shower had a glass sliding window in front of the wind out window. This sliding window was stiff and difficult to open. It also did not stay open on the way up - it was reliant on the window sitting on a lip within the frame.

As it did not stay up by itself, it may fall down and smash which would pose a safety hazard.

Caution should be taken in the area.

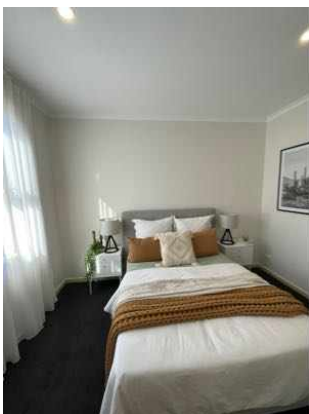
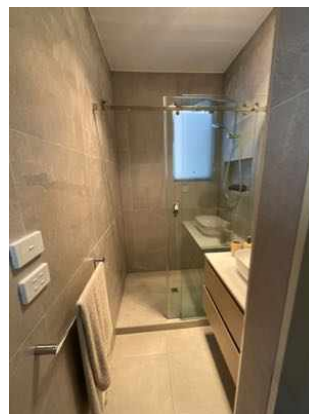
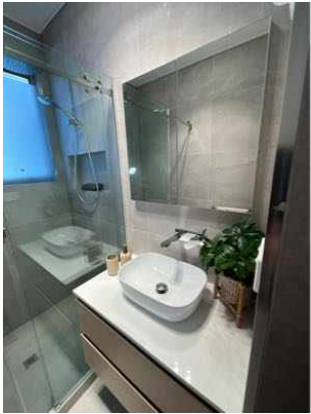
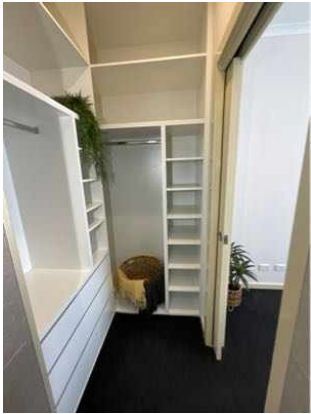
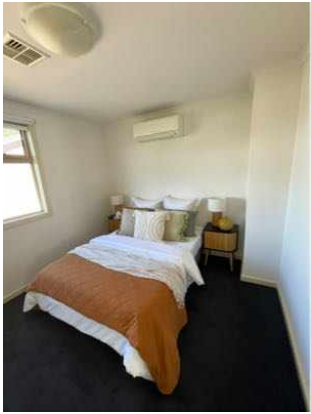
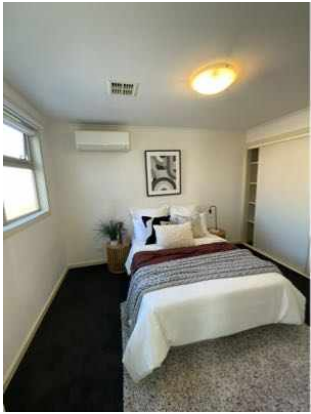
Building:
 Location: All Areas
 Finding: Additional Photos - Obstructions and Limitations
 Information: These photographs are an indication of the obstructions and limitations which impeded full inspection of the property at the time of inspection. These obstructions can hide an array of defects and should be removed to allow full inspection to be carried out. A re-inspection is recommended once the areas are made accessible.
