Building Inspection Report

Inspection Date: Mon, 2 Mar 2026

Property Address: 6 Chagall Parade, Clyde North VIC 3978,
Australia

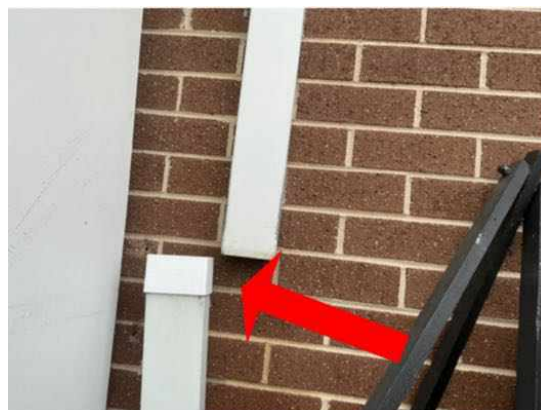
Defects 3.01

At the time of inspection, the downpipe located in the side yard directly behind the garage was found to be completely disconnected. The pipe has separated from its connection point, resulting in rainwater from the associated gutter discharging directly adjacent to the external wall and surrounding ground surface.

Uncontrolled discharge of roof water in this manner may lead to saturation of the footing area, increased risk of moisture ingress to the building envelope, potential foundation movement, and conditions conducive to timber pest activity. Ongoing water concentration at the base of the wall can also contribute to premature deterioration of external finishes and structural elements.

This defect requires immediate attention. A qualified plumber should be engaged without delay to reconnect and properly secure the downpipe and ensure it is effectively connected to an appropriate stormwater drainage system.

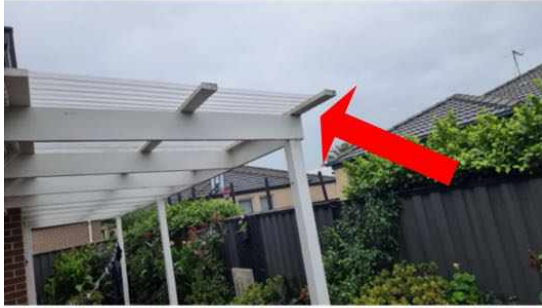
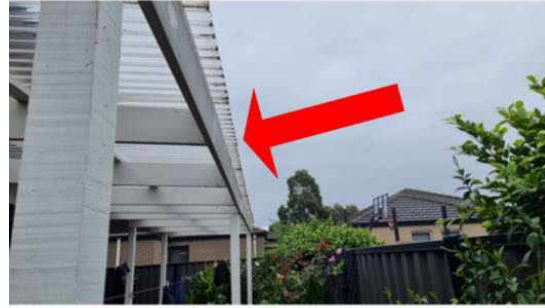
Defects 3.02

Building: Main Building
 Location: Alfresco
 Finding: Absence of Gutters and Downpipes – Alfresco / Patio Roof - urgent attention needed
 Information:

At the time of inspection, the roof structure over the rear alfresco/patio area was observed to be installed without any guttering or downpipe system. As a result, rainwater discharges directly from the roof edges onto the surrounding ground surface.

Uncontrolled roof water discharge may lead to water pooling adjacent to the dwelling, soil saturation, surface erosion, and potential moisture ingress to nearby structural elements. Prolonged moisture accumulation around the perimeter of the building may also create conditions conducive to termite activity and contribute to premature deterioration of external finishes and footings.

A qualified roofing contractor should be engaged without delay to install an

appropriate guttering and downpipe system to effectively collect and direct stormwater to a suitable drainage point in accordance with standard building practices.

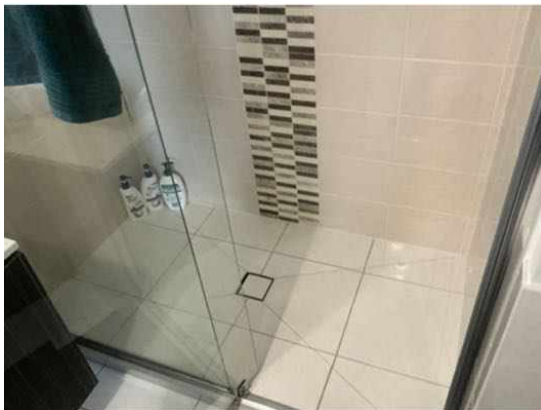
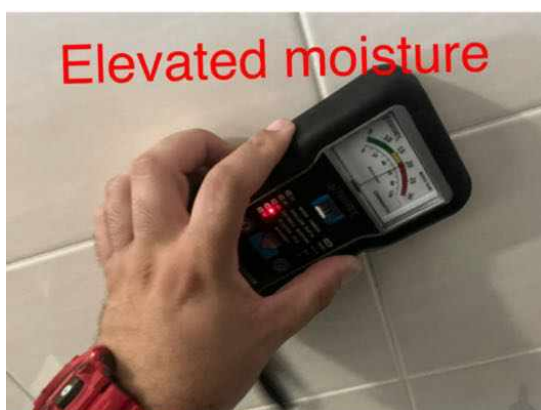
Defects 3.06

Building:	Main Building
Location:	Ensuite - Master
Finding:	Shower - Damp
Information:	Damp is evident to the lower 300mm of wall to the shower alcove. This defect is quite common, and is suspected to have been caused by moisture permeating through the grouting in this area, which shows evidence of deterioration. Leaking pipes within the adjoining wall is also a possible cause.

Unmanaged damp in the shower recess is likely to facilitate the formation and development of mould and fungi growth, decaying associated building materials and compromising their structural integrity. It is important to address damp conditions, as the World Health Organisation notes that excess moisture leads - on almost all indoor materials - to growth of microbes such as moulds, fungi and bacteria, which subsequently emit spores and other matter into the indoor air. Exposure to these contaminants is associated with a wide range of respiratory and other health-related problems.

Consultation with a qualified plumber or bathroom specialist is advised immediately to identify the cause of damp and to perform remedial works as required. Where excessive mould growth is present, further inspection by a specialist environmental health inspector should also be considered.

Always ensure that sealant and grout is in good condition to prevent any moisture issues occurring in the future.

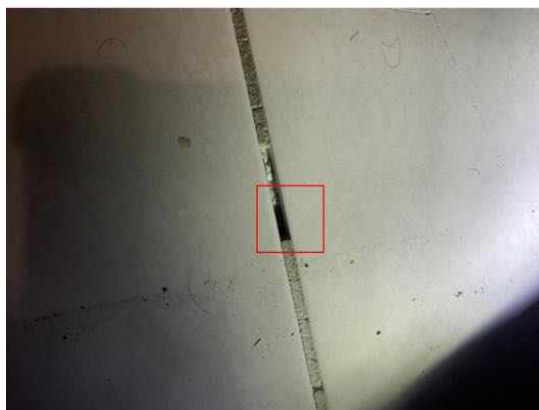
Defects 3.07

Finding: Sealant and grouting - Deteriorated

Information: It was noted on inspection that sealant or grout is degraded to the tiled shower alcove and or other areas of the bathroom.

Different materials and floor areas move at different rates, generally causing cracking to grout or sealant at this point. A flexible sealant is required to allow for expected expansion and contraction, while keeping the joint water tight and protective of all associated building materials.

Flexible and mould resistant materials should be applied to affected areas to prevent any subsequent water damage that is likely to occur. Regular maintenance and replacement of damage or missing or damaged sealant and grout is highly recommended to the wet areas, as this is a regular wear and tear defect. Sealant and grouting in areas that come into regular contact with water should be maintained for the long term care of your property.

A sealant specialist or tiling contractor should be appointed to complete these works as soon as possible

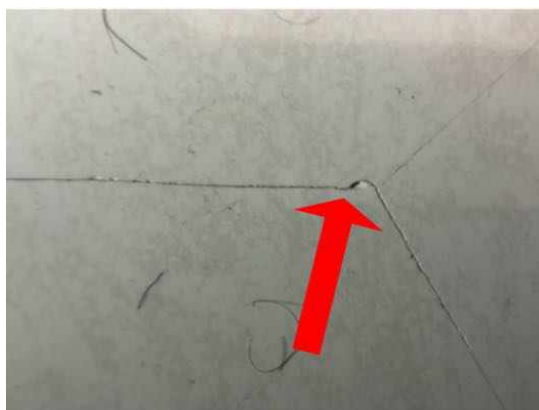
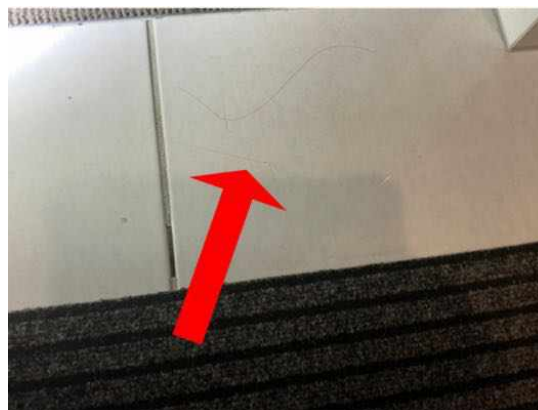
Defects 3.08

Building: Main Building
 Location: Ensuite - Master
 Finding: Broken Floor Tiles – En-Suite Bathroom
 Information:

Multiple floor tiles within the en-suite bathroom were observed to be broken at the time of inspection. The damage appears localised to several tiles; however, the affected areas present visible deterioration to the finished floor surface.

Broken tiles may allow moisture penetration through joints and cracks, potentially affecting the tile bedding and underlying timber frame . If not addressed, this may result in further tile loosening or deterioration of the substrate over time.

A qualified tiler should be consulted to remove and replace the damaged tiles. During rectification, the underlying substrate and waterproofing should be checked to ensure they remain intact and serviceable.

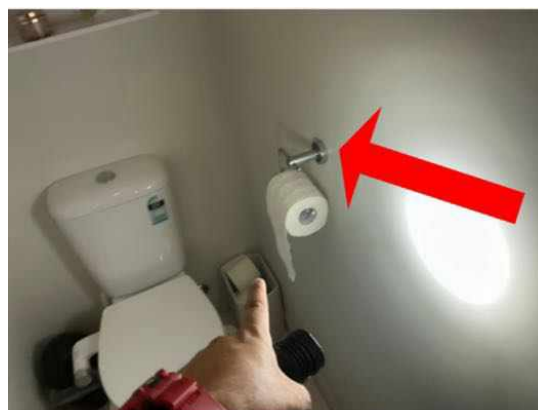
Defects 3.10

Building: Main Building
 Location: Ensuite - Master
 Finding: Toilet roll holder - Loose
 Information: The toilet roll holder was found to be loose at the time of inspection. While not a major operational defect, function can deteriorate if the problem is left unmanaged.

It is advised that the homeowner performs remedial works to re-attach the toilet roll holder to its original fixing. A general handyperson may be required to perform these works.

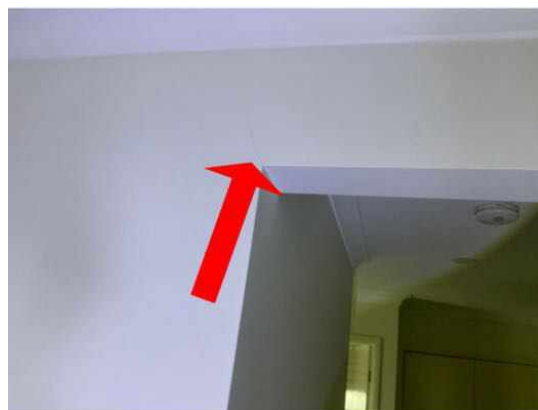
Defects 3.11

Building: Main Building
 Location: Living Room
 Finding: Minor Crack to Internal Plaster Wall
 Information:

A minor crack was observed to the plaster wall adjacent to an internal opening at the time of inspection. The crack was small in width and limited in extent, with no indication of significant structural distress.

Such cracking is commonly associated with normal building movement, minor settlement, or material shrinkage over time. In its current condition, the crack appears cosmetic in nature.

If rectification is desired for appearance purposes, the affected area may be filled, sanded, and repainted by a qualified painter or plasterer to restore a uniform finish.

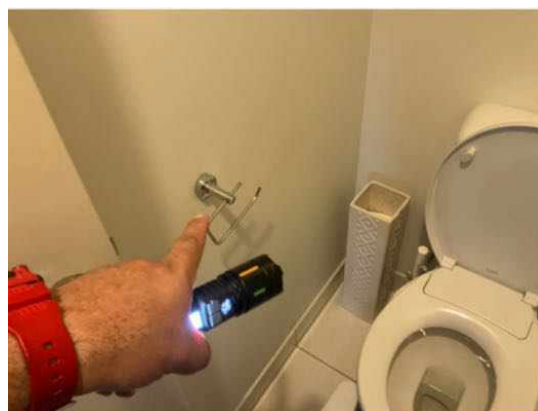
Defects 3.12

Building:	Main Building
Location:	Toilet (WC) - Upstairs
Finding:	Toilet roll holder - Loose
Information:	The toilet roll holder was found to be loose at the time of inspection. While not a major operational defect, function can deteriorate if the problem is left unmanaged.

It is advised that the homeowner performs remedial works to re-attach the toilet roll holder to its original fixing. A general handyperson may be required to perform these works.

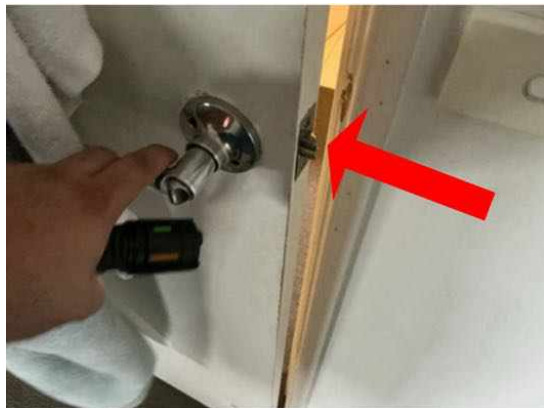
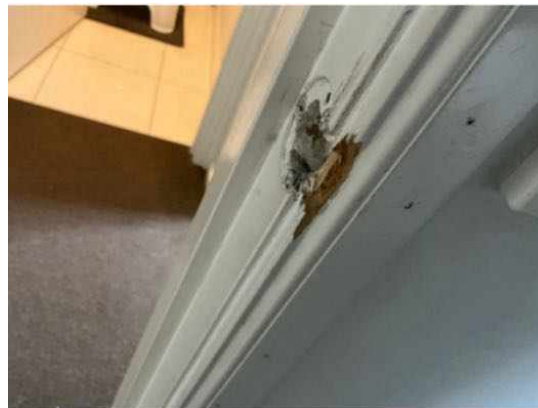
Defects 3.13

Building:	Main Building
Location:	Bedroom 4
Finding:	Missing Striker Plate – Bedroom 4 Door
Information:

At the time of inspection, the door to Bedroom 4 was found to be missing the striker plate to the door jamb. As a result, the door latch is unable to properly engage, and the door does not open and close as intended.

The absence of the striker plate prevents secure latching of the door and may lead to misalignment, unnecessary wear to the latch mechanism, and reduced functionality of

the door assembly.

A qualified carpenter or handyman should be engaged to supply and install a suitable striker plate and adjust the door hardware as required to ensure proper alignment and secure operation of the door.

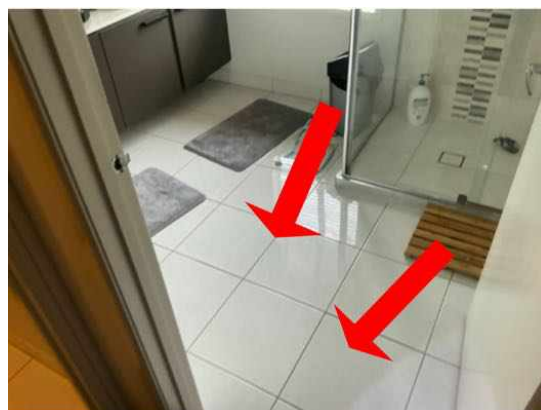
Defects 3.14

Information: At the time of inspection, the floor tiles within the second bathroom were found to exhibit movement underfoot. In particular, sections near the entry area felt slightly bouncy, and minor movement of individual tiles was noticeable when pressure was applied. This condition is consistent with possible inadequate fixing of the flooring substrate to the underlying joists, resulting in deflection and subsequent movement of the tiled finish.

Ongoing substrate movement can lead to progressive grout cracking, tile loosening, and potential compromise of the timber-framing over time. If not rectified, further tile deterioration or debonding may occur.

A flooring specialist or qualified tiler should be consulted to assess the extent of

substrate movement and recommend appropriate rectification measures. This may involve securing the flooring sheets to the supporting structure and reinstating the tiled surface as required to provide a stable and durable finish.

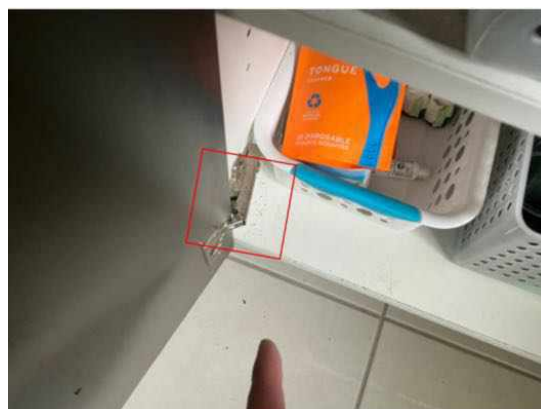
Defects 3.15

Building: Main Building
 Location: Bathroom 2
 Finding: Loose Vanity Cabinet Hinges – Bathroom 2
 Information:

At the time of inspection, the vanity cabinet door hinges within Bathroom 2 were found to be loose. The fixings appear to have loosened over time, resulting in minor movement and misalignment of the cabinet doors.

Loose hinges may affect the proper operation of the doors and, if left unattended, may lead to further wear to the hinge hardware or damage to the cabinet carcass.

A qualified carpenter or handyman should be engaged to resecure and tighten the hinges and adjust the cabinet doors as required to ensure correct alignment and smooth operation.

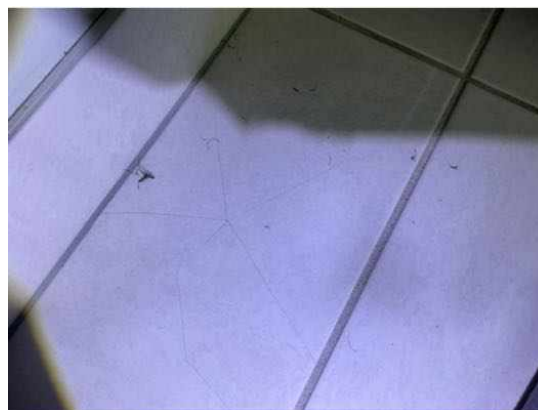
Defects 3.16

Building: Main Building
 Location: Bathroom 2
 Finding: Cracked / Broken Tiles – Bathroom 2
 Information:

At the time of inspection, several tiles within Bathroom 2 were observed to be cracked or broken. The damage appears localised to individual tiles; however, the affected areas present visible deterioration to the tiled surface.

A qualified tiler should be consulted to carefully remove and replace the damaged tiles. During rectification, the underlying substrate and waterproofing should be checked to ensure they remain intact and serviceable.

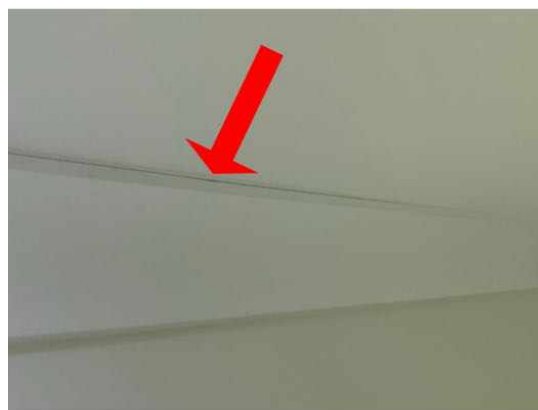
Defects 3.17

Building: Main Building
 Location: Bathroom 2
 Finding: Minor Sag / Gap to Cornice – Bathroom 2
 Information:

Such gaps commonly occur due to normal building movement, minor settlement, or material shrinkage over time. In its current condition, the issue appears to be minor and predominantly cosmetic in nature.

If rectification is desired, a qualified plasterer may be engaged to assess the affected section and undertake filling and re-finishing as required to restore a uniform appearance.

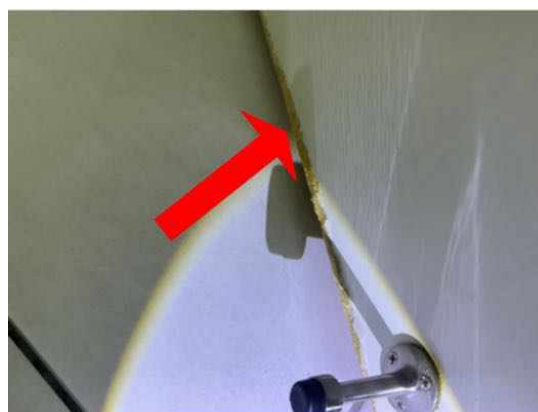
Defects 3.18

Building: Main Building
 Location: Bathroom 2
 Finding: Minor Moisture Damage to Bottom of Bathroom Door
 Information:

Prolonged exposure to moisture can cause swelling, paint deterioration, or minor timber fibre breakdown at the base of internal doors, particularly in wet areas. In its current condition, the issue appears minor and primarily cosmetic.

If rectification is desired for appearance purposes, the affected section may be lightly sanded, sealed, and repainted. Care should also be taken to ensure adequate ventilation within the bathroom to minimise ongoing moisture exposure.

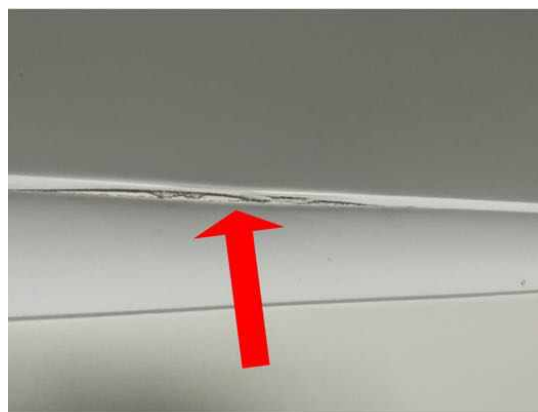
Defects 3.21

Cornice damage may occur due to previous impact, movement, or historical moisture exposure. While moisture readings were within an average range at the time of testing, the visible damage warrants further review to determine the underlying cause and prevent potential recurrence.

A qualified plasterer should be engaged to investigate the cause of the damage and carry out appropriate rectification works, including repair or replacement of the affected cornice section as required.

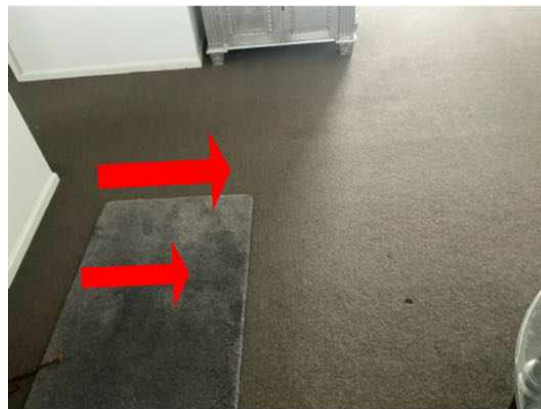
Defects 3.22

Building: Main Building
 Location: Living Room
 Finding: Localised Squeaking to Upper-Level Flooring – Living Area
 Information:

Squeaking to upper-level floors commonly occurs where flooring sheets are not adequately secured to the underlying joists, resulting in minor movement and friction between materials. This movement may develop over time due to settlement, shrinkage, or loosening of fixings.

If rectification is desired, a qualified carpenter or flooring specialist should be consulted to assess the affected area and secure the flooring sheets to the underlying joists as required to minimise movement and associated noise.

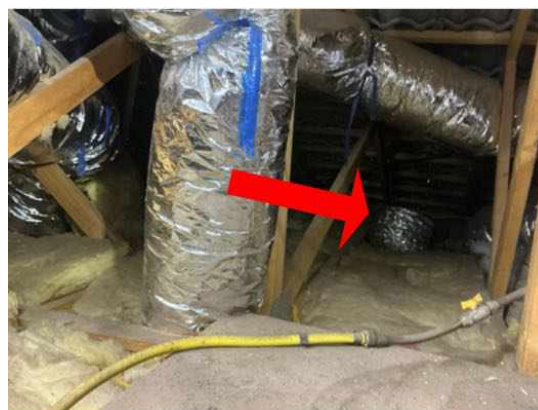
Defects 3.24

Loose or unsupported ducting within the roof cavity may indicate incomplete installation, redundant material left in place, or potential inefficiency within the mechanical ventilation or heating/cooling system. Regardless of its intended purpose, ducting should be properly secured and appropriately terminated to prevent performance issues or unintended discharge into the roof void.

A licensed HVAC technician should be engaged to review the ducting within the roof space, confirm its purpose, and ensure all ductwork is correctly installed, supported, and functioning as intended.

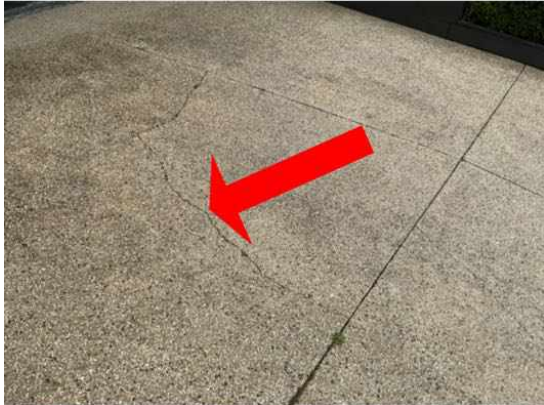
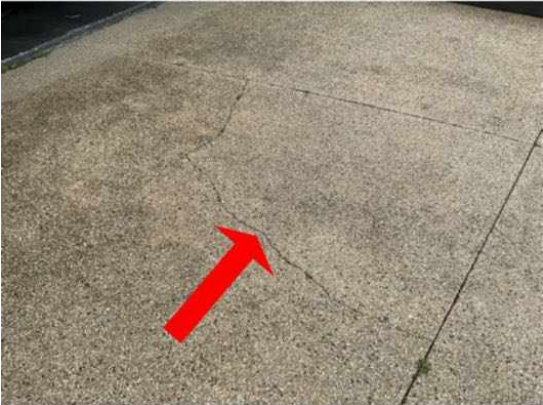
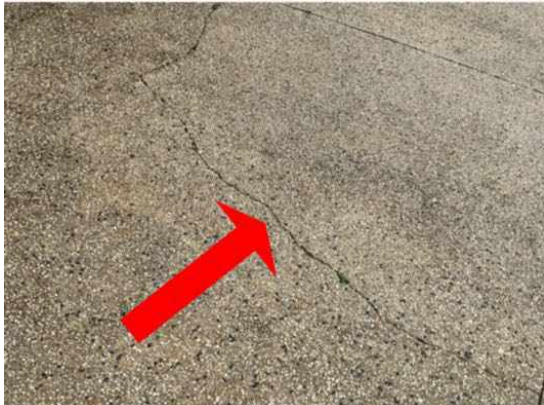
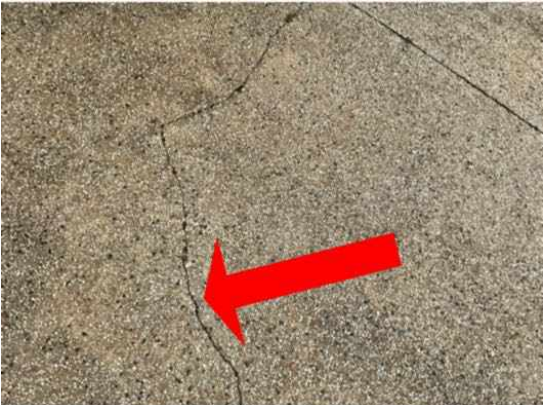
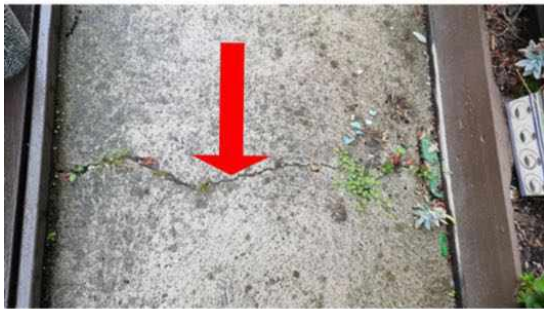
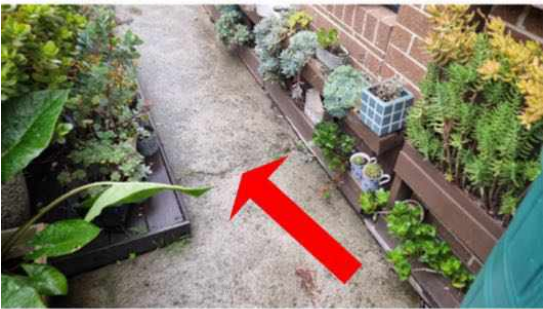
Defects 3.25

as poor compaction of the sub surface and/or inadequate reinforcing of the slab may create cracking and other secondary defects.

Monitoring of all cracking should be conducted frequently. Always contact a building inspector should cracks widen, lengthen, or become more numerous.

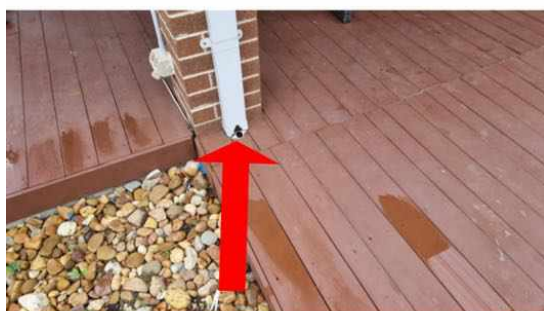
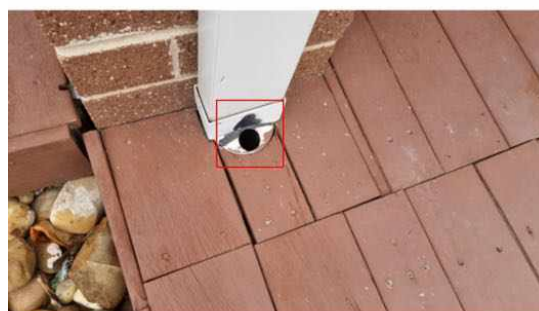
Defects 3.26

Building: Main Building
Location: Exterior walls - rear
Finding: Open Stormwater Downpipe Outlet – Rear Exterior
Information:

An open outlet at the base of a downpipe may allow uncontrolled discharge of stormwater into the immediate surrounding area. This can contribute to localised water accumulation, saturation of adjacent materials, potential deterioration of nearby building elements, and conditions conducive to timber pest activity. Additionally, debris entry into the pipe system may occur where openings are left unsealed.

A qualified plumber should be engaged to assess the affected downpipe and install an appropriate fitting, cover, or connection to ensure proper stormwater discharge to an approved drainage point.

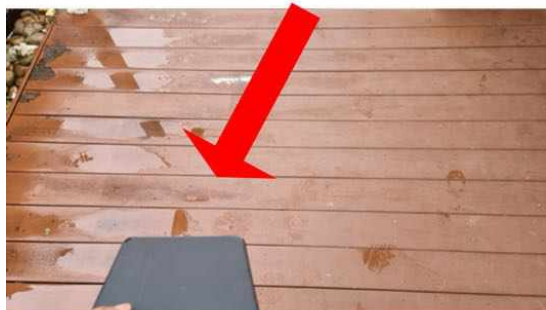
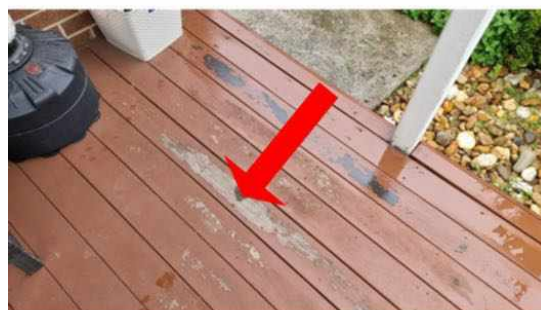
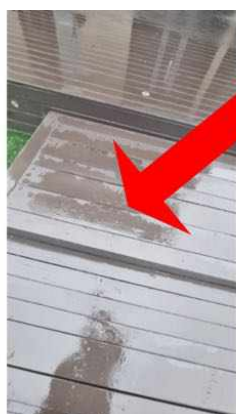
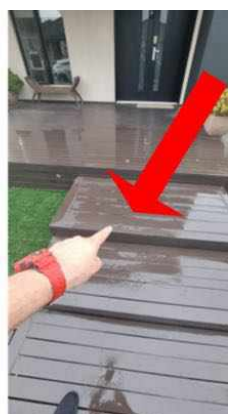
Defects 3.27

Building:	Main Building
Location:	All External Areas
Finding:	Localised Deflection to Decking – Front and Rear
Information:

A qualified carpenter should be engaged without delay to remove the affected decking boards and undertake a thorough inspection of the underlying joists, bearers, and

support members. Any timber found to be deteriorated or structurally compromised should be replaced, and the decking reinstated to ensure adequate support and long-term performance.

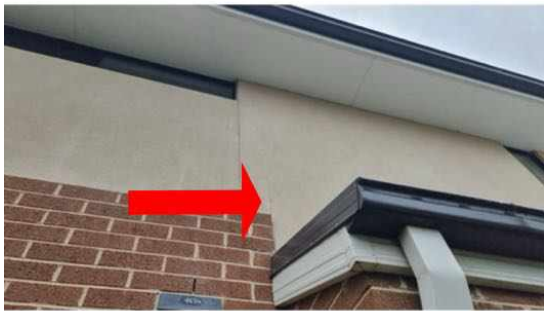
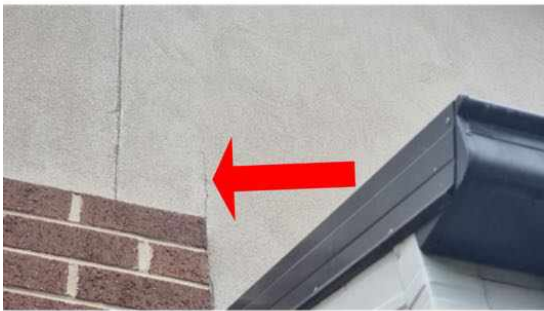
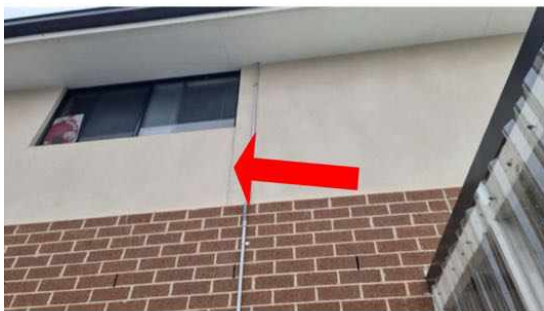
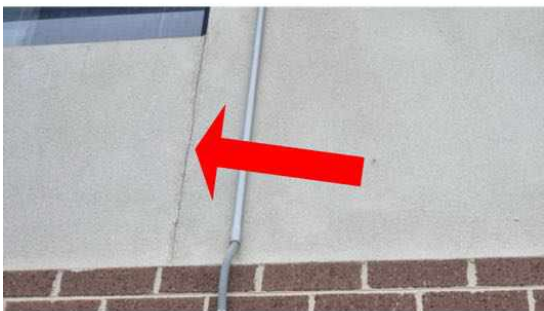
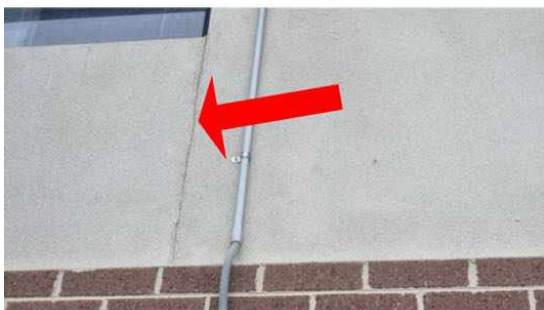
Defects 3.28

Building:	Main Building
Location:	All External Areas
Finding:	Cracking and Open Expansion Joints – Level 1 Cladding
Information:

Upon visual inspection of the Level 1 cladding, a minor crack was observed to the rendered surface along the side elevation. In addition, sections along the left-hand side elevation were noted where the expansion joints have opened, resulting in visible gaps within the cladding system.

Open expansion joints and cracks in rendered cladding may permit moisture ingress into the wall cavity if left unsealed. Over time, water penetration can contribute to deterioration of internal framing elements, insulation, and internal finishes, as well as promote mould growth or further movement-related cracking.

It is recommended that a qualified caulking specialist be engaged as a matter of urgency to seal all identified cracks and open expansion joints with an appropriate flexible sealant. All affected areas should be properly prepared and sealed to restore weather tightness and prevent moisture ingress into the building envelope.

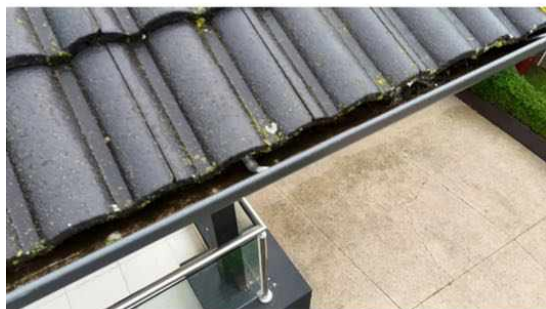
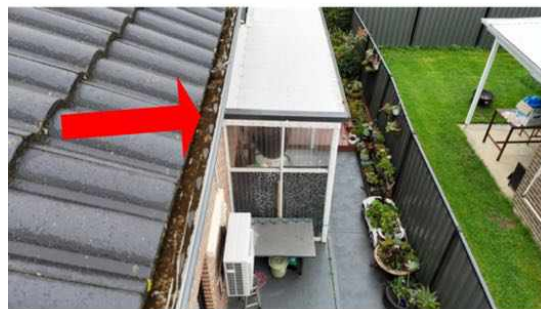
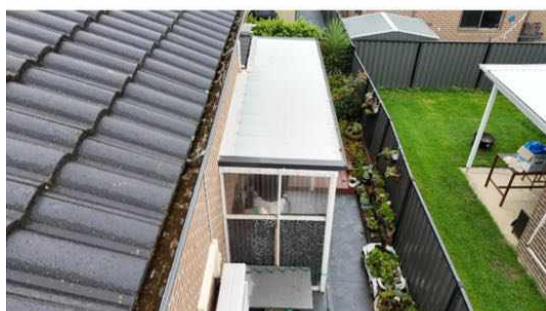
Defects 3.29

Building: Main Building
Location: Gutters
Finding: Gutters - Water pooling
Information: Water was found to be pooling in sections of the roof guttering. This is generally a secondary defect caused by blocked or partially blocked gutters. Such blockages and subsequent water pooling are likely to lead to rust and water damage to associated structures if left unattended.

partial or full blockages and any secondary damage that may have occurred as a result. Depending on the extent of the damage, building elements may require repair and/or replacement to ensure adequate roof drainage and function of exterior plumbing system.

A roofing plumber should be appointed as soon as possible to rectify this issue. It is highly advised that all gutters be maintained on a frequent basis to ensure the condition of roof plumbing.

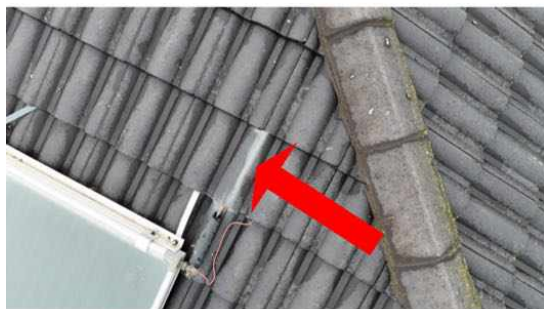
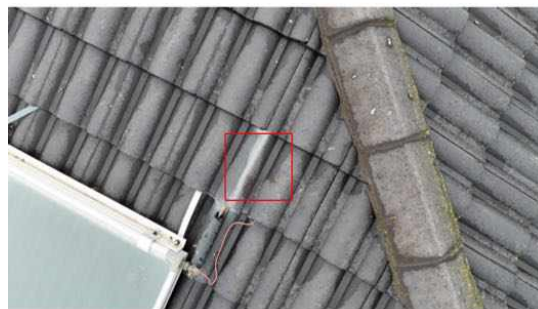
Defects 3.31

Building: Main Building
Location: Roof Exterior
Finding: Broken and Improperly Repaired Roof Tile
Information:

At the time of inspection, one roof tile was observed to be cracked and previously repaired using a silicone-based sealant. The repair appears to be a temporary measure rather than a permanent solution, and the integrity of the tile remains compromised.

Silicone patching does not restore the structural performance or long-term weather resistance of a damaged roof tile. Over time, such repairs may fail, potentially allowing water ingress into the roof cavity and contributing to deterioration of sarking, battens, or internal ceiling finishes.

A qualified roofing contractor should be engaged to remove and replace the damaged tile with a new tile of matching profile and specification to ensure proper weatherproofing and long-term performance of the roof covering.

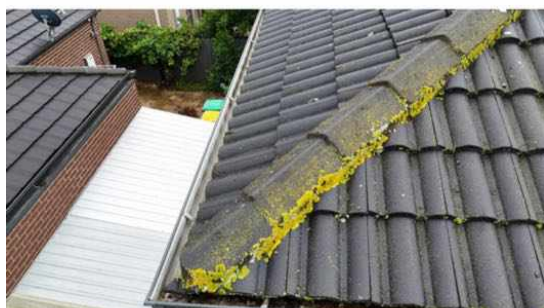
Defects 3.32

Building: Main Building
 Location: Roof Exterior
 Finding: Moss / Lichen Growth to Roof Tiles and Ridge Capping
 Information:

At the time of inspection, significant moss and lichen growth was observed along the ridge capping and adjacent roof tiles. The biological growth was widespread in sections and appears to have developed over time due to prolonged moisture retention on the roof surface.

Accumulation of moss and lichen can impede proper water runoff, retain moisture against the tile surface, and contribute to gradual deterioration of the roof covering and ridge mortar. Over time, this may increase the risk of tile displacement, mortar breakdown, and potential water ingress into the roof cavity if left unmanaged.

A qualified roofing contractor should be engaged to safely clean the affected roof areas using appropriate methods. Following cleaning, the condition of the ridge capping and pointing should be assessed, and any deteriorated mortar or flexible pointing repaired as required to ensure ongoing weather tightness and durability of the roof covering.

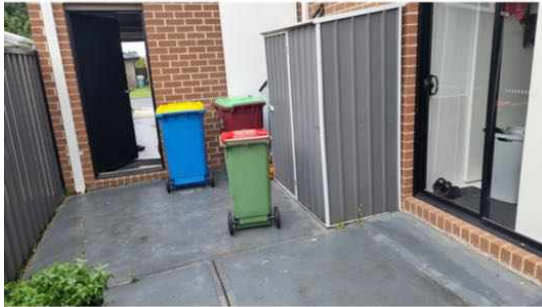
Noted Item

Building: Main Building
 Location: All External Areas
 Finding: Obstructions and Limitations - Exterior
 Information: These photographs are an indication of the obstructions and limitations which impeded the inspection of the external areas of the property at the time of inspection.

These obstructions can hide an array of defects and should be removed to allow full inspection to be carried out. A re-inspection is recommended once the areas are made accessible.
