Building and Timber Pest Inspection Report

Inspection Date: Wed, 1 Apr 2026

Property Address: 3/8A Clydesdale Drive, Upper Coomera
QLD 4209

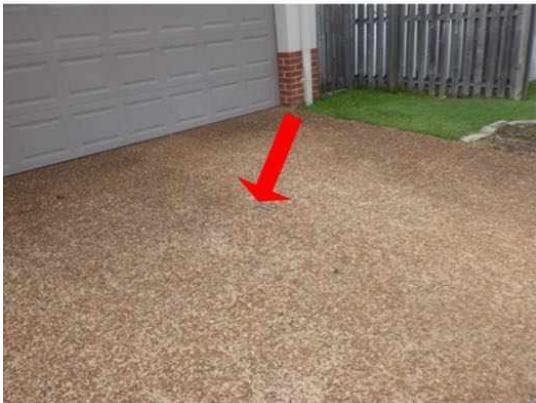
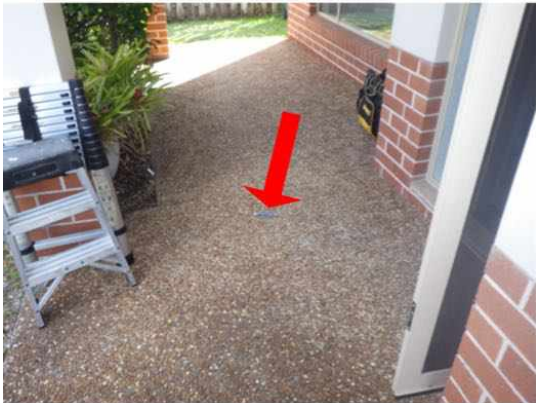
Building: Main Building
Location: Driveway > Ground Level
Finding: Cracking in concrete slab - Category 1
Information: Cracking coded as Category 1 was identified in the driveway and footpaths concrete slabs. A Category 1 crack is described as a fine but noticeable crack, with the slab at an otherwise reasonable level.

To be considered Category 1, the approximate width of the crack is less than 1.0mm, or a less than 10mm change in offset when a 3m straight edge is placed over the defect.

Category 1 cracks should be monitored for a period of 12 months. At the end of the monitoring period, identified cracks that are rated greater than Category 2 are considered defects, and require rectification.

Monitoring of all cracking should be conducted frequently. Always contact a building inspector should cracks widen, lengthen, or become more numerous.

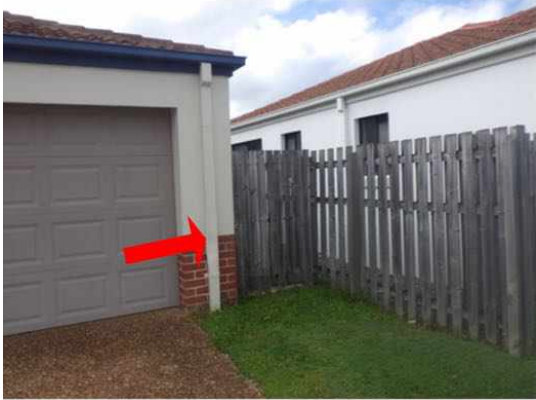
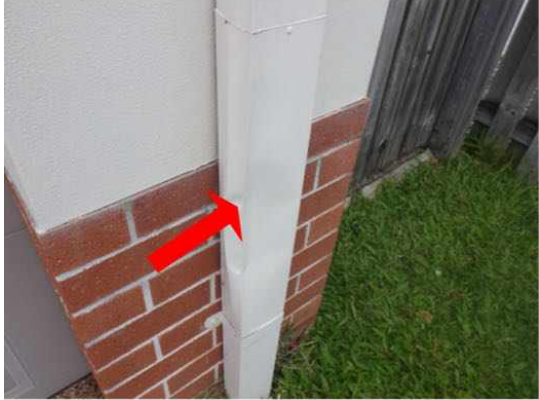
Finding 3.02

Building: Main Building
 Location: Exterior walls - front > Front Right
 Finding: Stormwater pipe - Damaged
 Information: The down pipe to the front right side exterior wall of the building has suffered damage. The level of damage appears consistent with impact.

A licensed plumber or general handyman could be appointed to repair/replace the down pipe at the clients discretion.

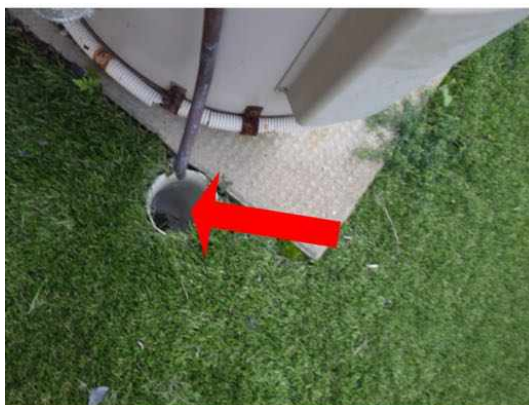
Finding 3.03

Building: Main Building
 Location: Exterior walls - right side > Centre Right
 Finding: Stormwater Grate
 Information: The stormwater grate cap to the hot water service overflow pipe on the right side of the building was missing at the time of inspection.

It is recommended that a general handyman be appointed to replace the stormwater line grate cap as necessary, to help prevent any potential stormwater line blockages.

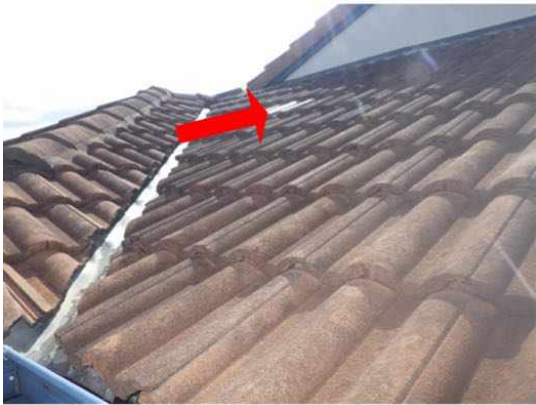
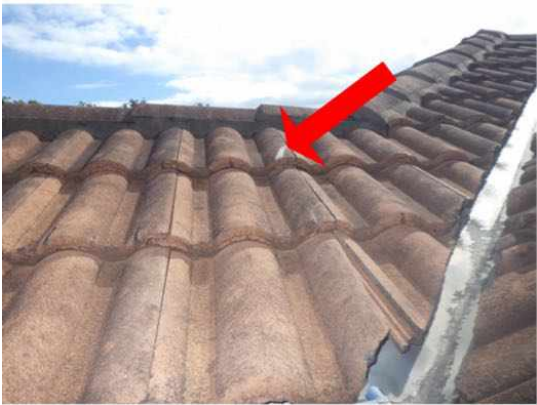
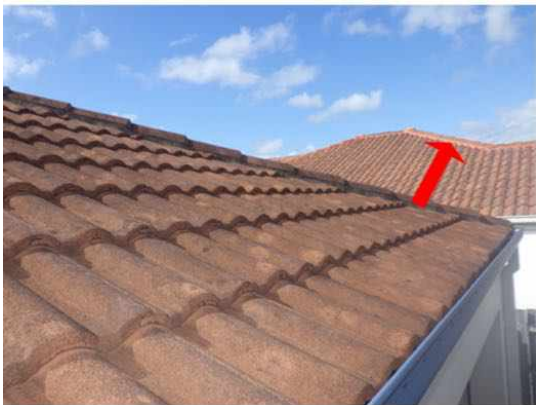
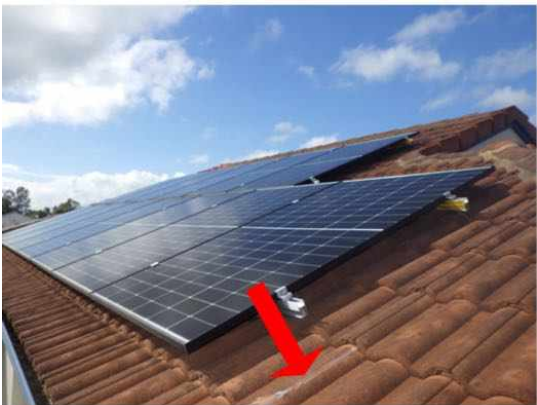
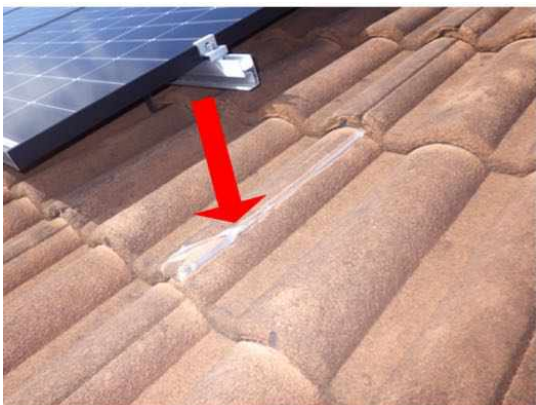
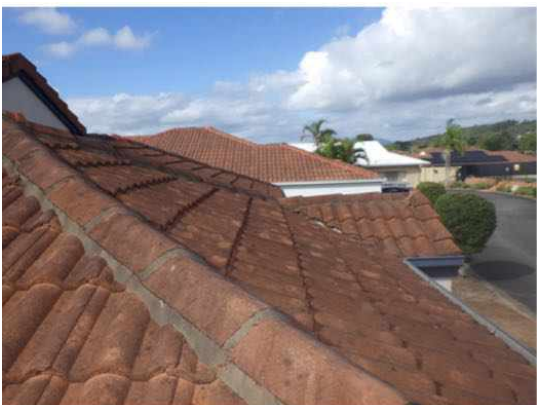
Finding 3.04

Building: Main Building
 Location: Roof Exterior > Existing
 Finding: Roof tiles - Weathered
 Information: Upon inspection of the exterior roofing, the majority of roof tiles were considered to be in a fair condition, with evidence of minor cracking and previous repair work to roof areas. While weathering of the tiles is consistent with the age of the property, maintenance works will likely be required.

Re-pointing and re-sealing the roof tiles should be considered by the client to help preserve and extend the life span of the tiles.

The client should consult a roofing contractor to gain advice on costs of any remedial works that may be required in the short to medium term. Remedial works are likely to increase the longevity of the exterior roofing structure.

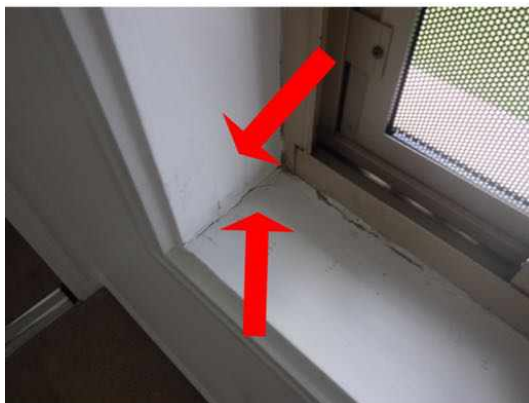
Finding 3.10

Information: The aluminium sliding window in bedroom 2 was stiff to operate at the time of the inspection. Windows provide ventilation to the adjoining area and should be at a fully operational level to ensure user comfort. Restricted function of the window may also pose as a potential safety hazard if required for emergency egress from the building.

Generally, factors such as general age of the building element and a lack of maintenance are the usual causes for this type of defect.

An aluminium window service agent will be required to repair the affected windows.

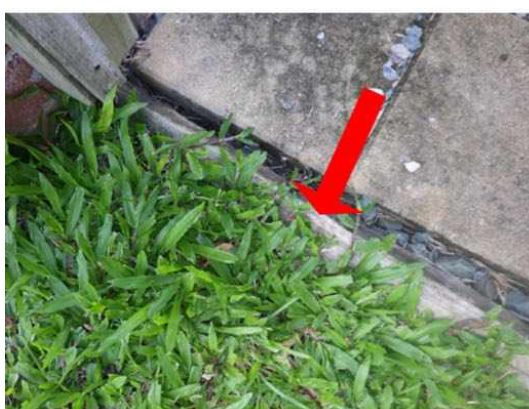
Any timbers in direct ground contact provide opportunity for concealed termite activity and are likely to be subject to premature rot and decay as the soil retains moisture or damp conditions against the timbers.

Removal of any untreated timber or tree stumps which are in direct contact with external ground is recommended. Frequent pest inspections are advised to readily identify any termite activity in these areas.

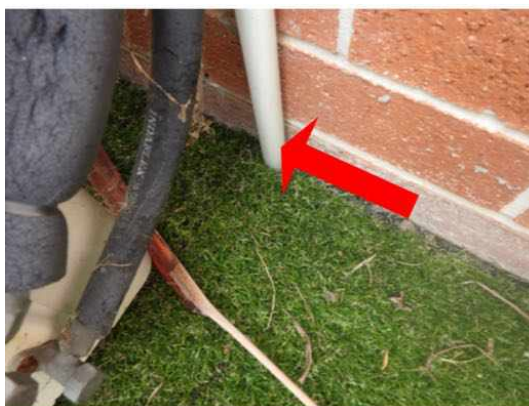
Finding 6.02

Building: Main Building
 Location: Exterior walls - left side > Centre Left
 Finding: Overflow - Not plumbed for drainage
 Information: The air conditioning unit overflow on the left side of the property is not plumbed or connected to suitable drainage, which can result in the surrounding area becoming excessively damp. These damp conditions can lead to secondary defects such as rot, rust or corrosion of associated building elements, the formation of fungal decay, or even the creation of potential slip hazards. When coupled with poor site drainage, pooling of water may also attract termite activity to this area. It is highly recommended that a qualified plumber be appointed to install adequate drainage to the overflow. These works will ensure that the area remains dry and free of any secondary defects.

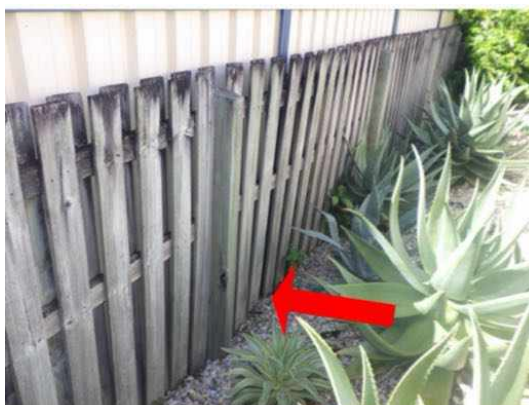
Finding 6.03

Building: Main Building
 Location: Yard - Back & Sides > Ground Level
 Finding: In ground contact
 Information: It was noted that the garden beds and finished ground levels cover the base of the timber fence palings (as per example photos).

Any timbers in direct ground contact provide opportunity for concealed termite entry and are likely to be subject to premature rot and decay as the soil retains moisture or damp conditions against the timbers.

Frequent pest inspections are advised to readily identify any termite activity in these areas.

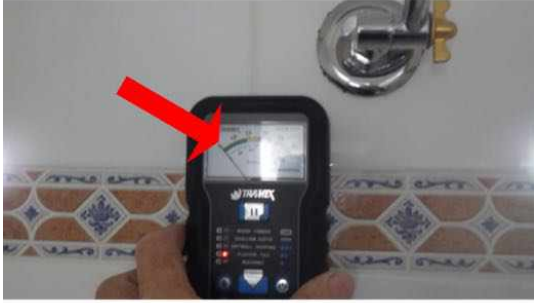
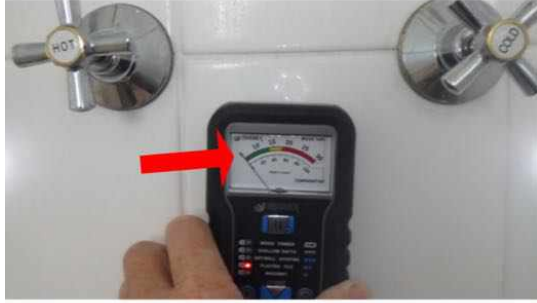
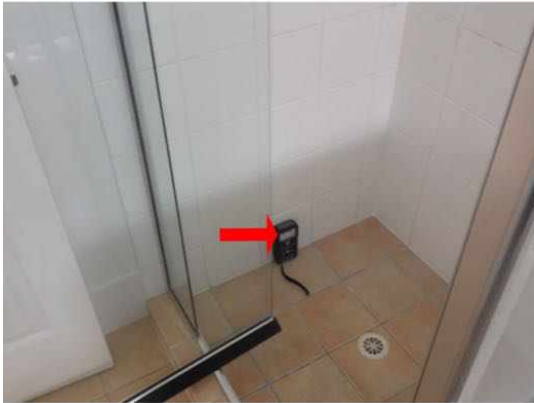
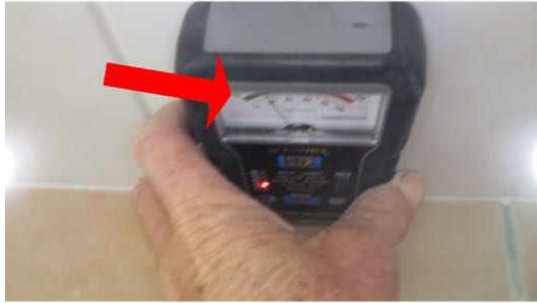
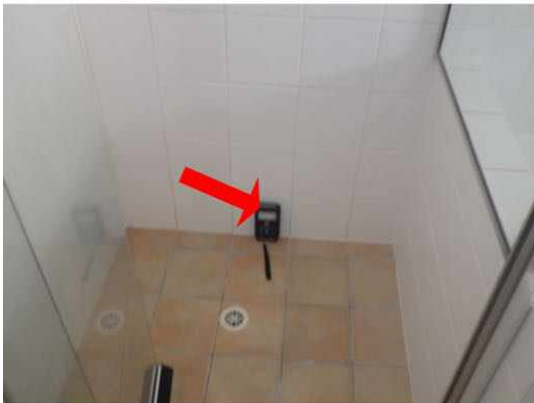
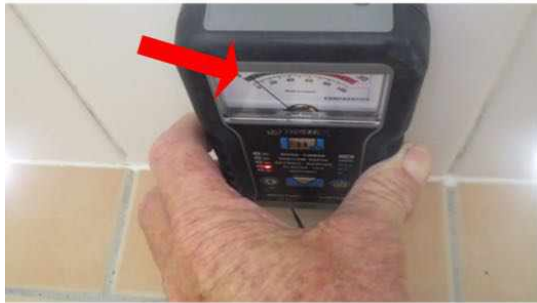
Finding: Moisture Level Readings

Information: At the time of inspection the bathroom shower cubicle areas checked with the Tramex Moisture Meter returned low - normal moisture level readings.

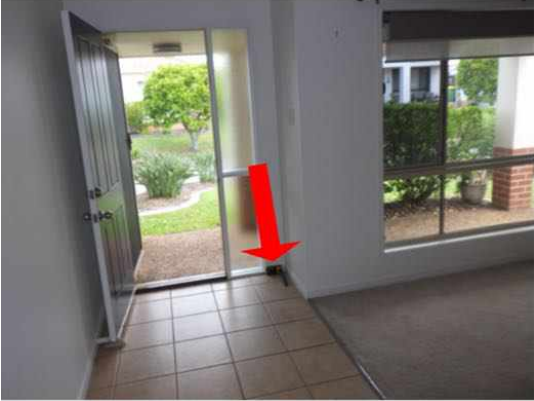
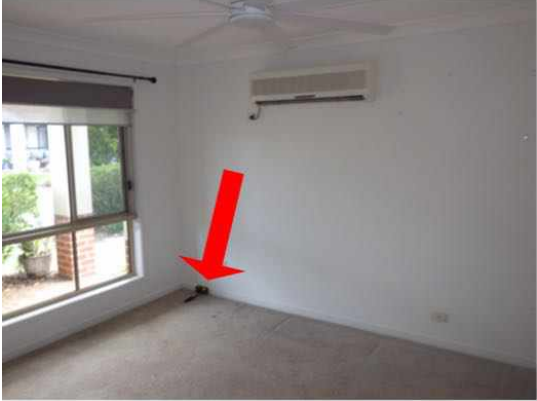
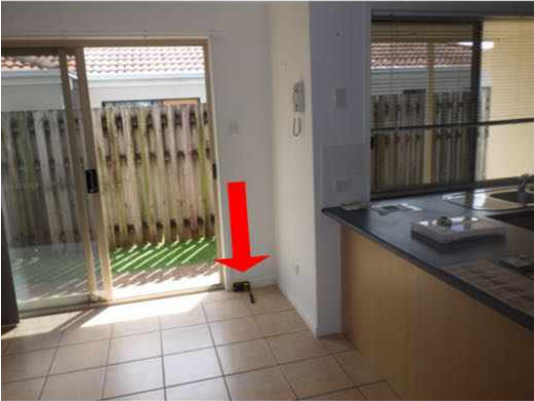
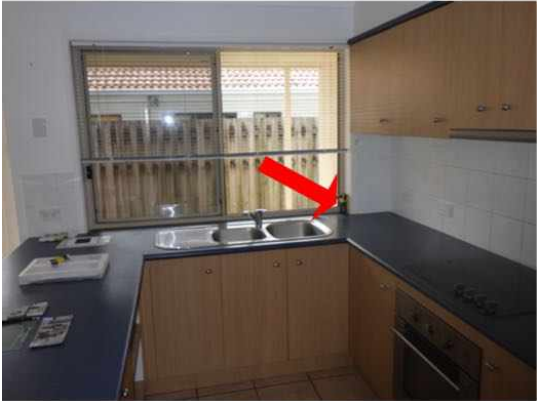
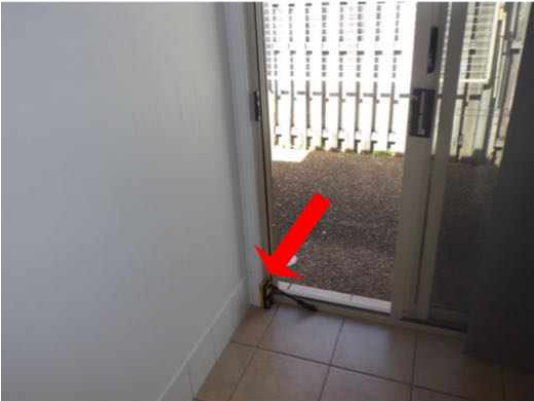
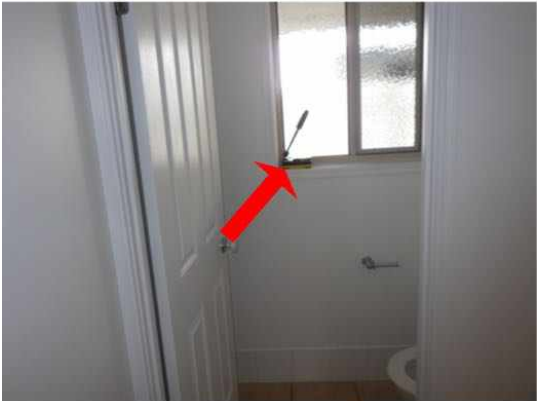
Building: Main Building
Location: Internal Areas > Existing
Finding: Termitracker
Information: The termitracker itracker was positioned randomly to internal wall, timber skirting and window frame areas checking for signs of termite activity.

No activity was recorded at the time of inspection.

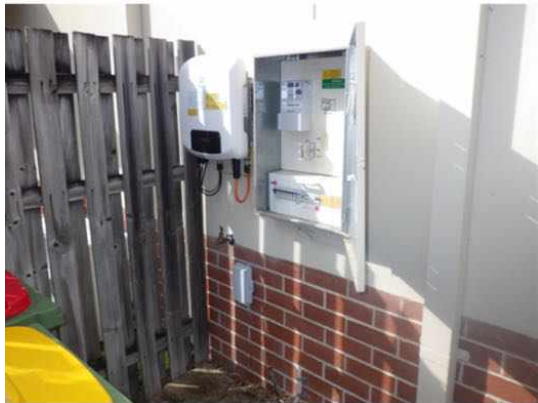
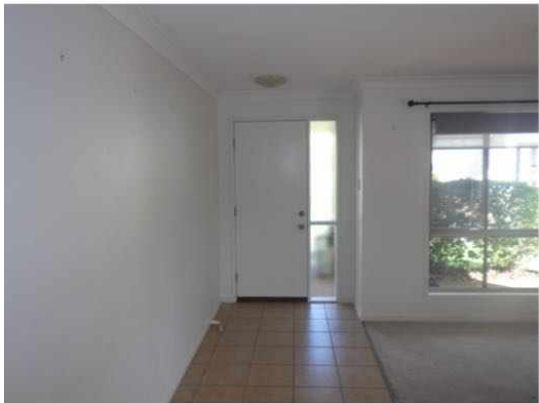
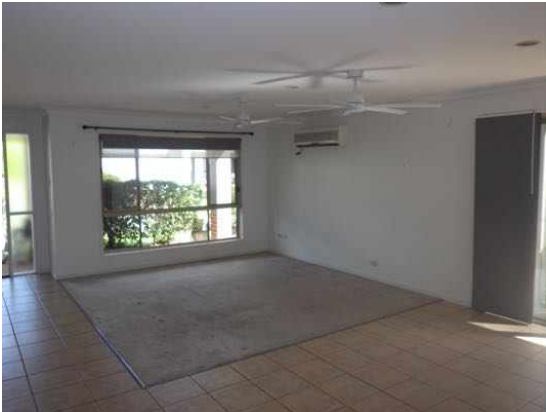
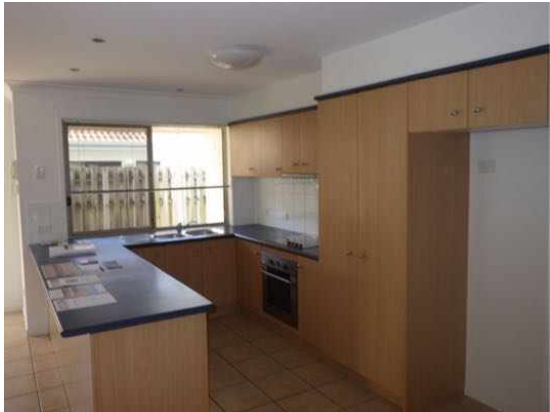
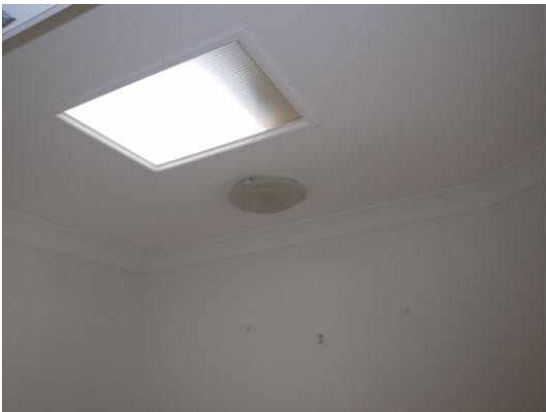
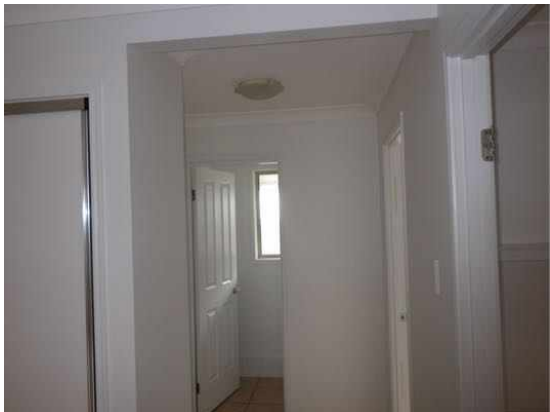
Building: Main Building
 Location: Internal Areas > Existing
 Finding: Electricity
 Information: At the time of inspection no electrical fixtures, fittings or appliances were able to be checked as there was no electricity supply to the property.

It is recommended the client seeks confirmation from the seller or sellers agent, all appliances, and electrical fittings and fixtures are operating and functioning as intended before the time of sale.

Alternatively a licensed electrician could be engaged to check all appliances and electrical fixtures at the clients discretion.

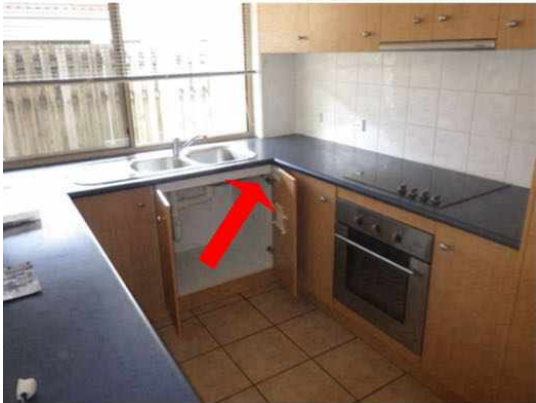
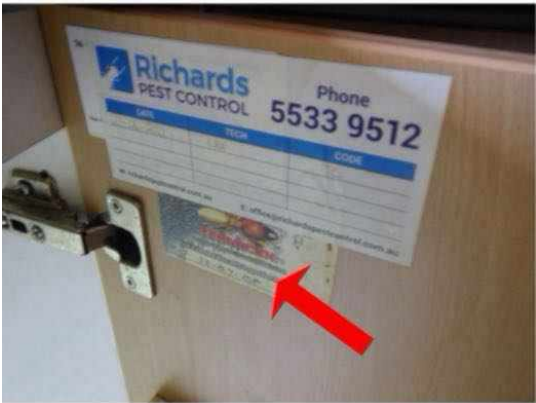
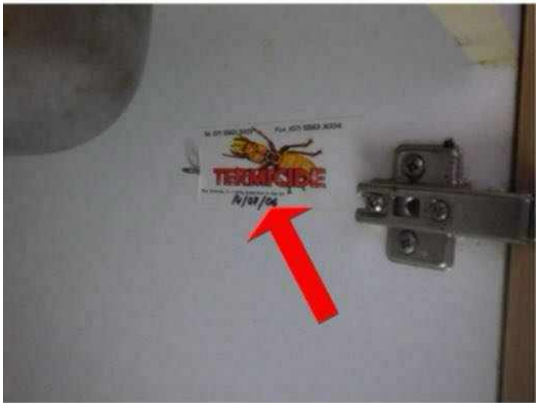
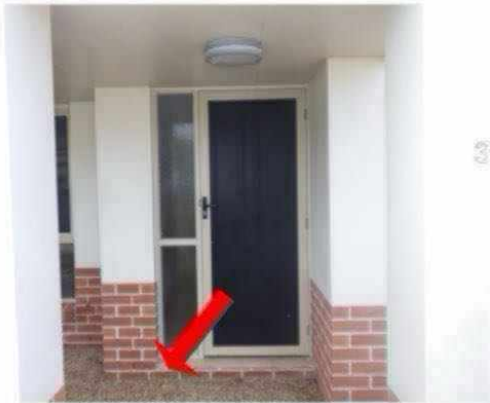
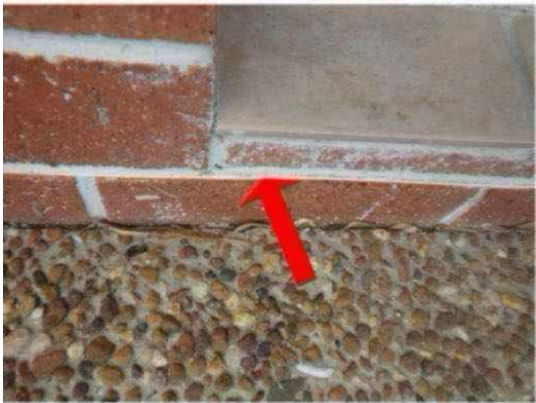
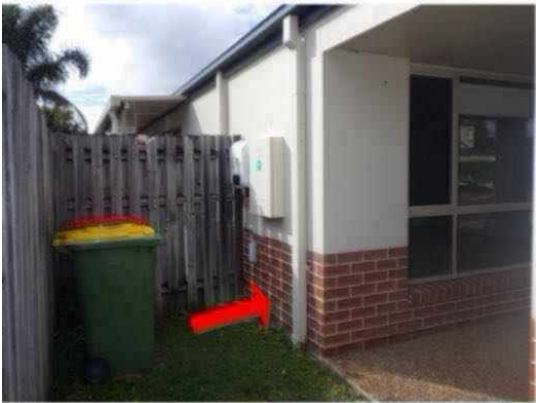
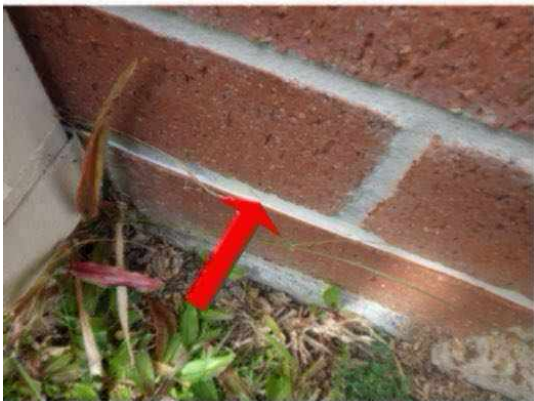
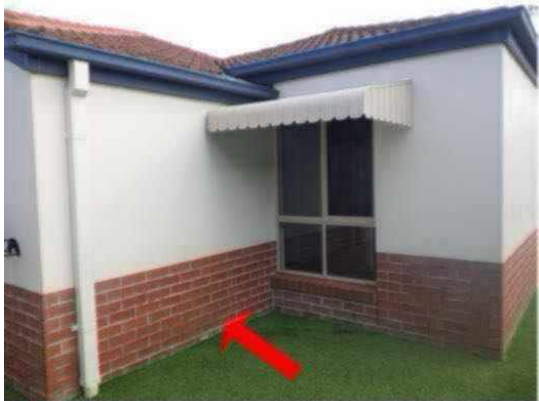
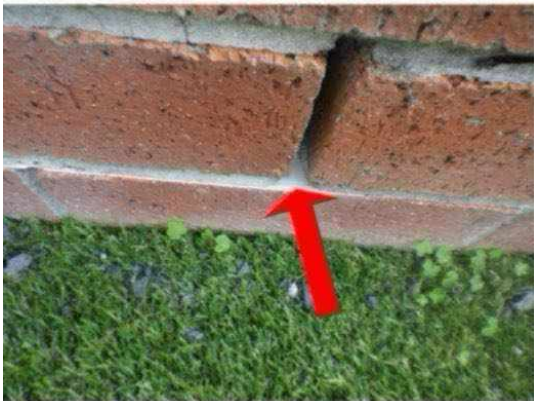
Noted Item

The following items were noted as - Evidence of a previous termite management program

In this instance no durable notice was found inside the electrical meter box (although it may have deteriorated to an unreadable stage) but evidence of a previously installed physical barrier was observed, along with previous inspection notices inside the kitchen area under sink cabinetry, last dated 12/07/2008. This system requires regular annual inspections.

No evidence of regular or annual inspections was found.

of barrier date of installation warranty conditions and any documentation provided by a past owner (if possible).

Alternatively the building complex body corporate managers may provide or have relevant information on any existing termite barrier and/or the barrier installation company details.
