Building Inspection Report

Inspection Date: Tue, 24 Mar 2026

Property Address: 15 Kinedana St, Eden Hills SA 5050,
Australia

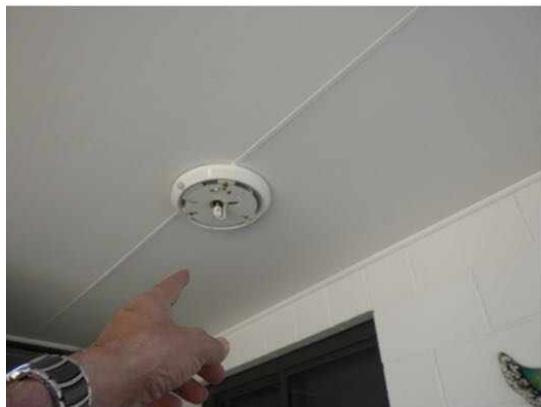
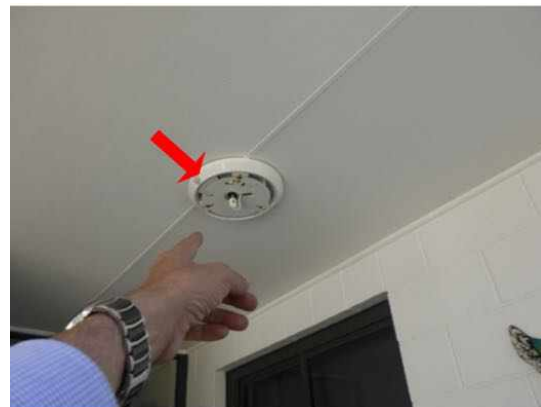
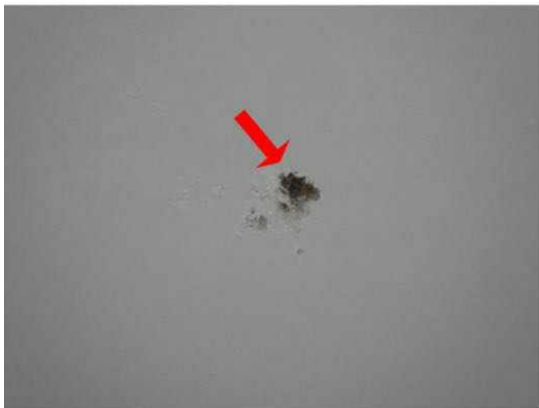
Defects 1.01

Building:	Building 1
Location:	All Areas
Finding:	Electrical fitting - Broken / Missing / Exposed
Information:	At the time of inspection it was electrical fitting in this entry area, internal area was found to be broken & exposed. Apart from that at the time of inspection it was also noticed that electrical fittings were missing from this master bedroom area.

Breakage occurs generally when the building materials have aged and decayed, but may also be indicative of impact damage to the building element (accidental or deliberate).

Left unmanaged, the fitting is unlikely to cause further damage to surrounding building elements. However, the broken fitting does expose electrical works, and may create a safety hazard if there is potential contact with persons in the area.

Repair and/or replacement of the broken fitting is advised. A Licensed electrician should be appointed to repair/replace the fitting immediately.

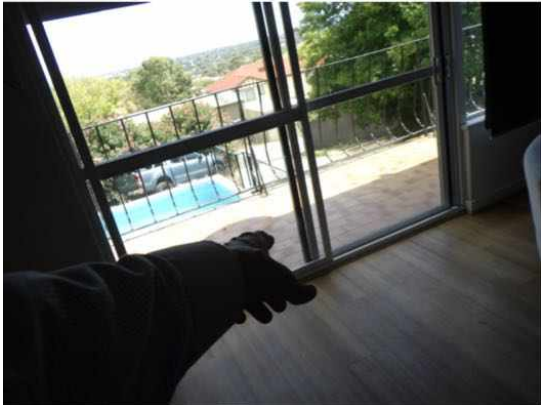
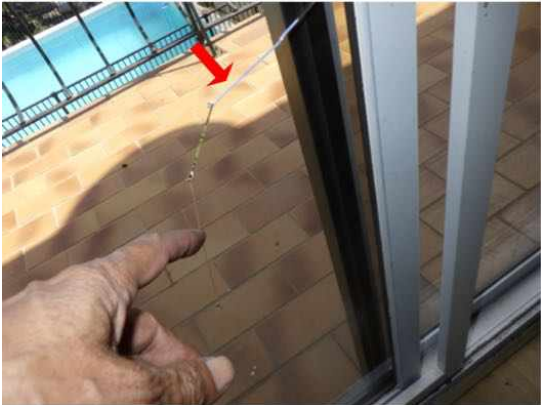
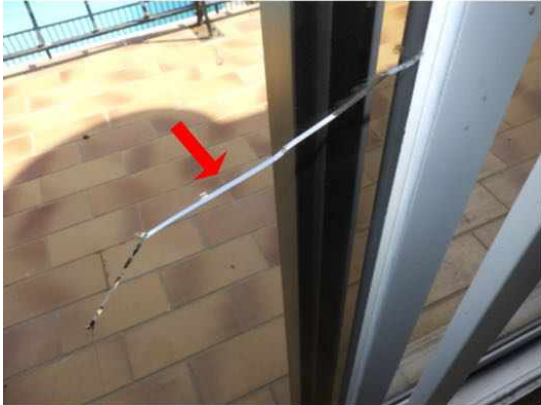
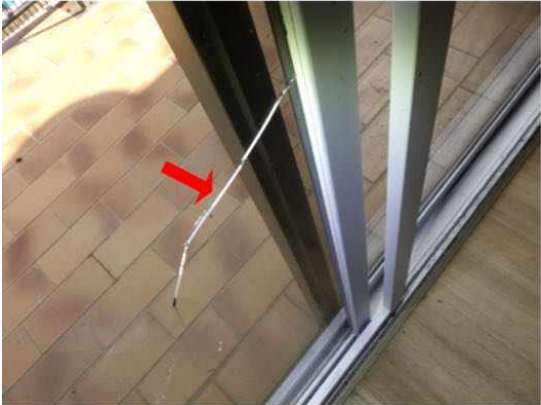
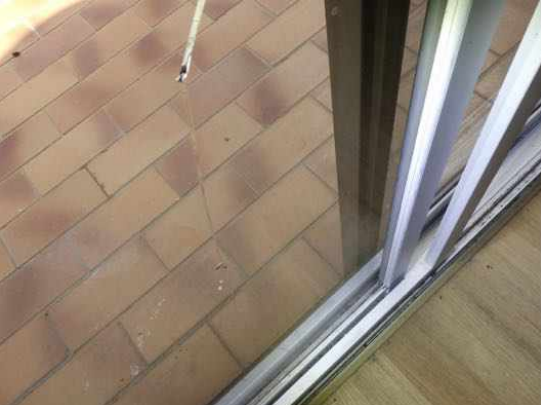
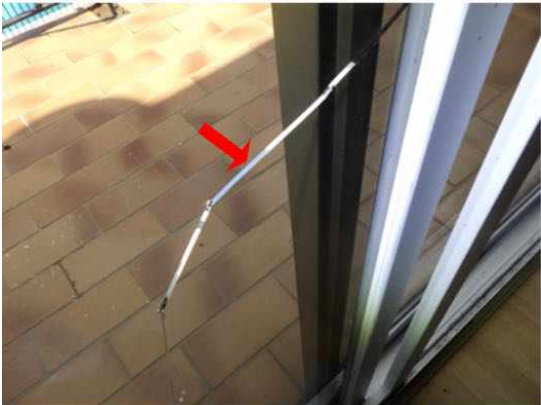
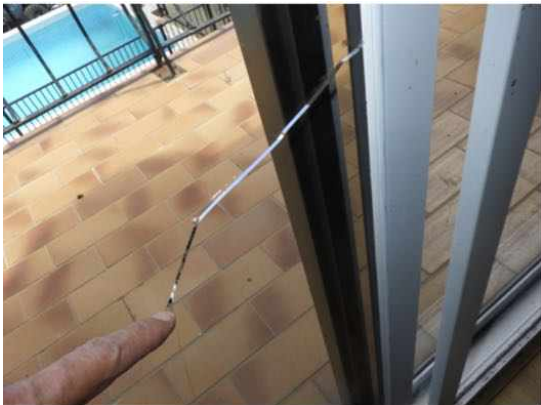
Defects 1.02

Building:	Building 1
Location:	All External Areas
Finding:	Sliding door assembly - Glass Cracked
Information:	Cracks were identified in the sliding door frame assembly in this area. Cracking in sliding door glass is generally the result of impact damage, and is likely to develop further when left unmanaged.

The likelihood of this sliding door pane further cracking and shattering is increased exponentially, providing a safety hazard in the area. The cracked glass also impairs the weather tightness of the building, creating potential for minor water leaks.

A qualified glazier is required to repair the sliding door glass as soon as possible. Depending on the extent of the cracking, replacement of the sliding door may be required. Please be advised that any persons coming into contact with the cracked window should do so with due caution to avoid any personal injury that may ensue.

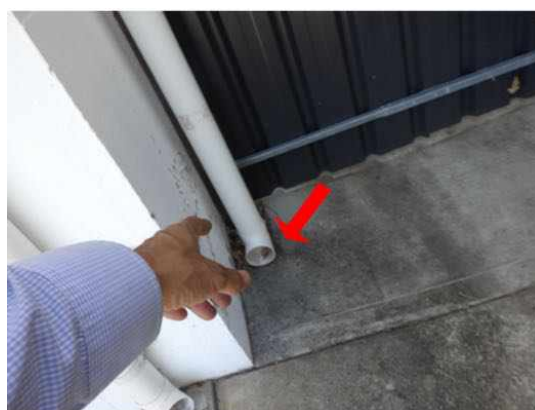
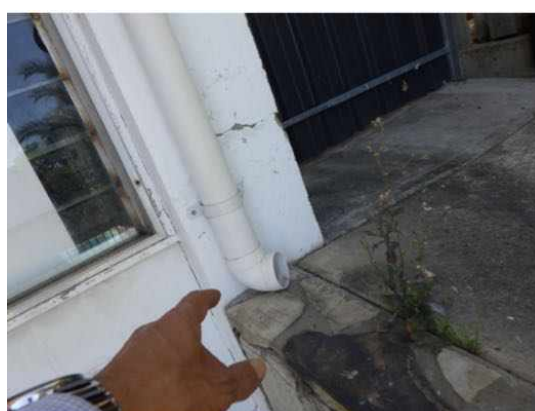
Defects 2.01

Building:	Building 1
Location:	All External Areas
Finding:	Site drainage - Inadequate
Information:	The site drainage in this area was found to be inadequate at the time of inspection, creating potential for subsequent water damage to associated building elements.

It is important that water does not lie against the base of walls; surrounding paths and ground levels should be sloped to drain water away from walls. Downpipes should not discharge stormwater onto lower walls or plinths. Stormwater should be carried away by large, regularly cleaned drains. Ground levels may need to be lowered to expose a buried DPC.

Where site drainage is inadequate, installation of an Agricultural (Aggie) Drain may be required. A qualified plumber should be appointed as soon as possible to further inspect the property and perform any remedial works as necessary. Water damage and secondary defects are likely to occur if left unmanaged.

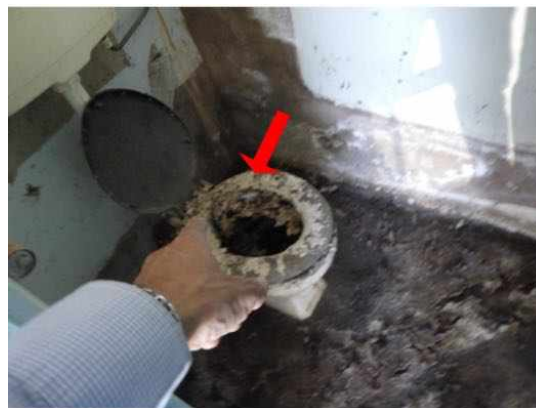
Defects 2.02

Building:	Building 1
Location:	All External Areas
Finding:	External rear area - Toilet assembly - Blocked
Information:	At the time of inspection it was noticed that toilet assembly is blocked in this sub floor area. Blockages prevent building elements from operating as intended, detracting from the overall function of the affected building elements. Additionally, the lack of general maintenance may lead to the development of more significant defects, such as damage to surrounding building materials.

Blockages should be removed and addressed promptly, as they will lead to the development of secondary building defects. The blockage should be removed as the primary rectification works. Secondly, check for any secondary or concealed damage, and then attempt to address the cause of the blockage to prevent recurrence or any water damage to associated structures.

Depending on the location of the blockage and the building elements affected, a licensed plumber may be required to perform necessary remedial works.

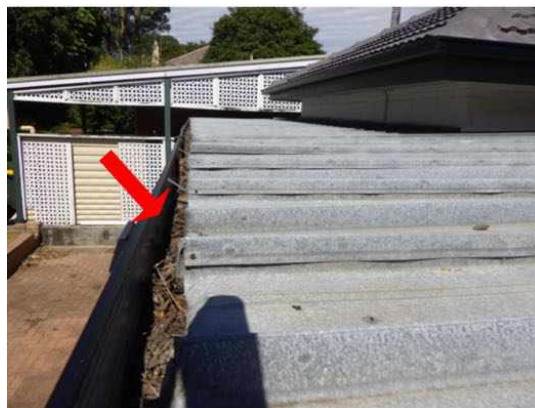
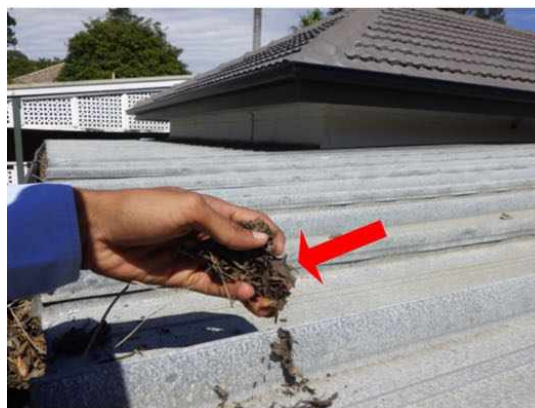
Defects 3.01

Blocked gutters are likely to lead to high levels of moisture in the affected areas. Such moisture will not only cause rust and decay of the associated building materials, but can also provide conditions that are conducive to termite and timber pest activity. Blockages in gutters should therefore be removed immediately to ensure dry conditions are maintained.

Consult a Licensed Plumber for further specific advice on remedial works that may be required. In the interim, it is highly advised that blocked gutters be removed by the homeowner or a general handyperson as a matter of urgency.

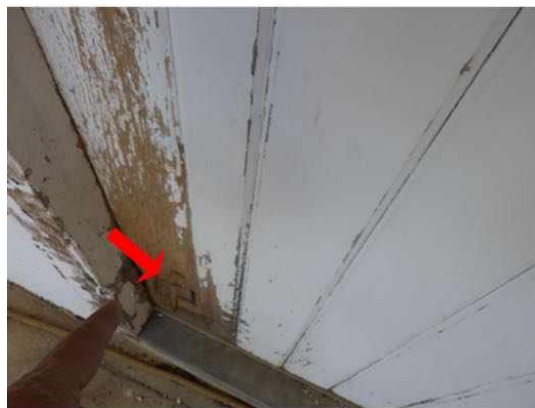
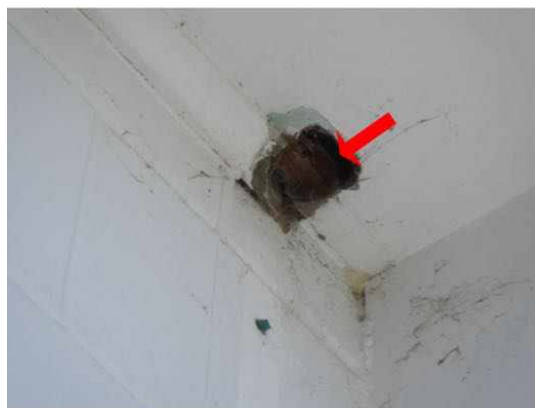
Defects 3.02

Building:	Building 1
Location:	All External Areas
Finding:	Building element - Damaged
Information:	At the time of inspection it was noticed few sections of buildings elements were damaged around the property. Breakage occurs generally when the building materials have either aged and decayed, or as a result of damage (accidental or deliberate).

Repair and/or replacement of broken elements is advised to ensure that additional secondary defects do not arise as a consequence. Such works are necessary, as all building elements play a key role in the operation and function of the overall structure and its performance.

A relevant tradesperson should be appointed to repair or replace the affected building element prior to any subsequent damage being caused.

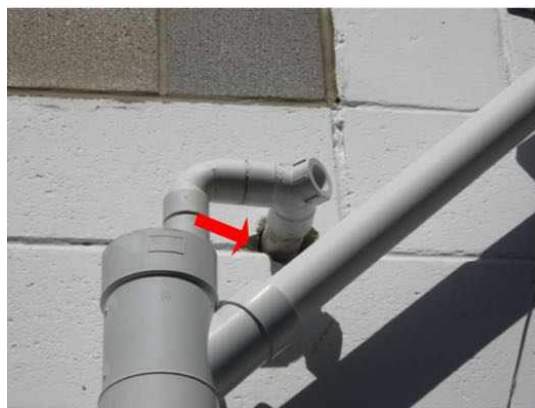
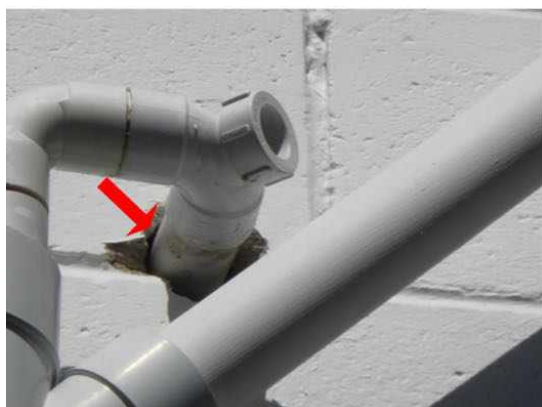
Defects 3.03

Building:	Building 1
Location:	All External Areas
Finding:	External walls - Holes
Information:	Significant holes were identified around pipe penetrations in this wall section. It is suspected that the installation of this pipework was completed to a substandard level of workmanship or is incomplete.

Gaps and holes around pipework makes the area susceptible to insect and vermin ingress, as well as allowing water penetration to the cavity wall. As such, associated building elements are likely to deteriorate at an accelerated rate, and major implications are expected if holes around the pipework are left unmanaged.

All excessive holes, gaps or cracks should be adequately filled by a suitable sealant or trimmings as soon as possible to prevent any further damage. Such works may be conducted by a general handyperson or licensed plumber.

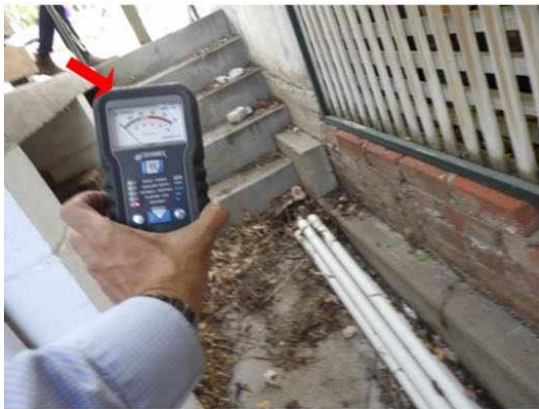
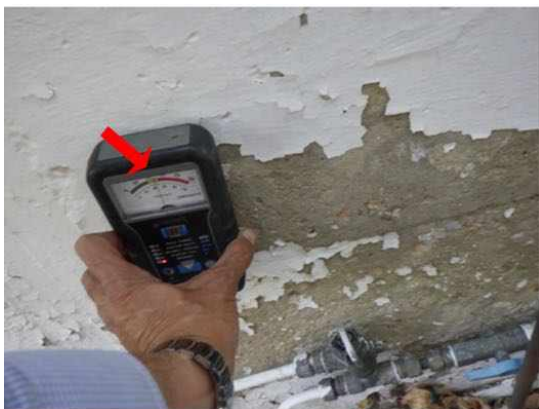
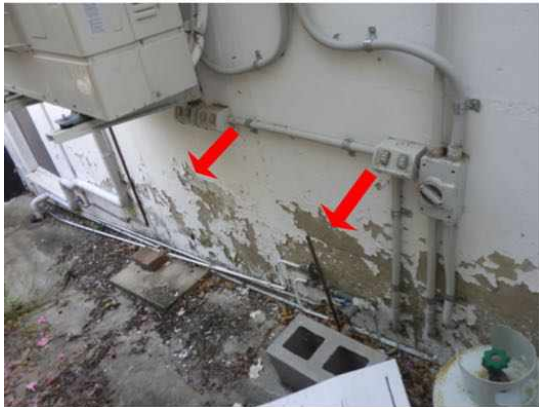
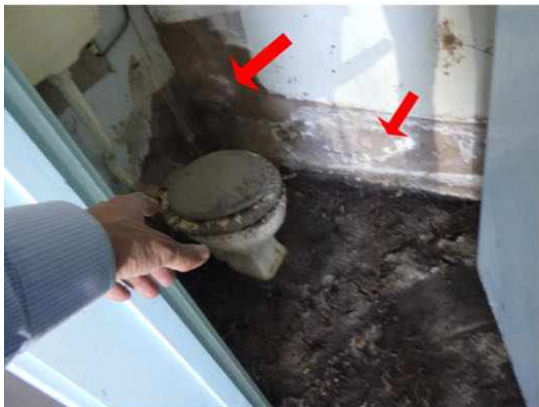
Defects 3.04

Building:	Building 1
Location:	All External Areas
Finding:	External Walls - Damp
Information:	At the time of inspection it was noticed that mild moisture readings were noted in few external wall sections around the property.

Damp (or structural damp) refers to the presence of unwanted moisture in the structure of a building, either as the result of intrusion from outside, or condensation from within the structure. Generally, structural damp is caused by rain penetration, rising damp, and leaks from plumbing pipes.

Unmanaged damp facilitates the formation and development of mould, fungi growth and wood rot, decaying associated building materials and compromising their structural integrity. Damage to finishes is also likely to occur, including lifting, bubbling, peeling and staining of paint, plaster and wallpaper.

The first step in addressing damp is to diagnose the cause. The identified cause should be addressed first prior to repairing the appearance and other defects which have resulted from the rising damp. If the original cause is not resolved, further cases of damp are likely to ensue, resulting in secondary defects.

Consultation with a qualified plumber is advised immediately to identify the cause of damp and perform remedial works as required. Where excessive mould growth is present, further inspection by a specialist environmental health inspector should also be considered.

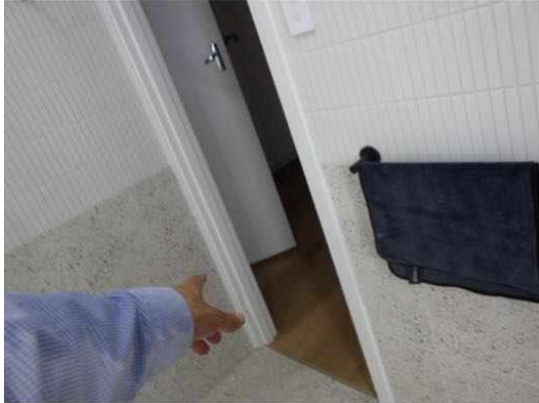
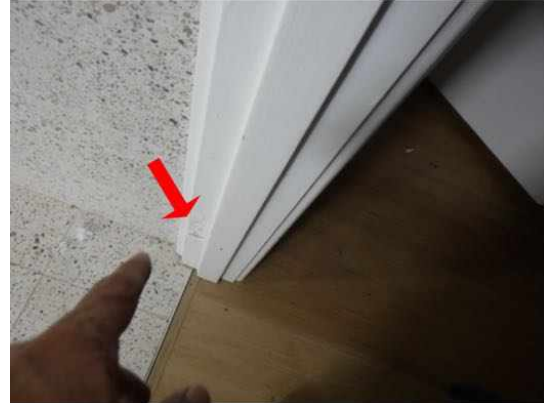
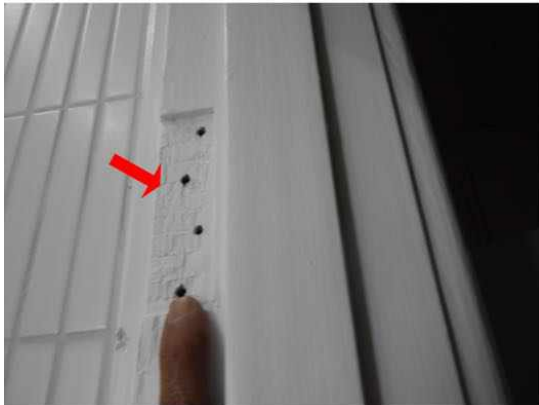
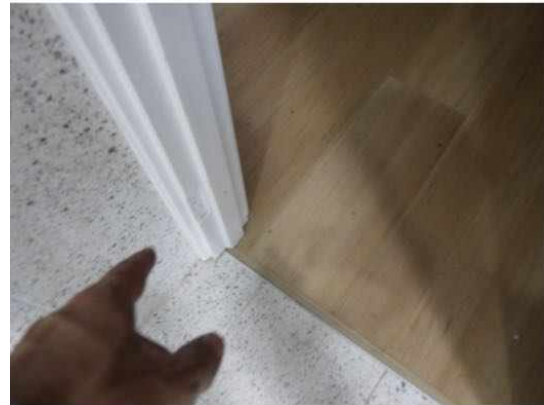
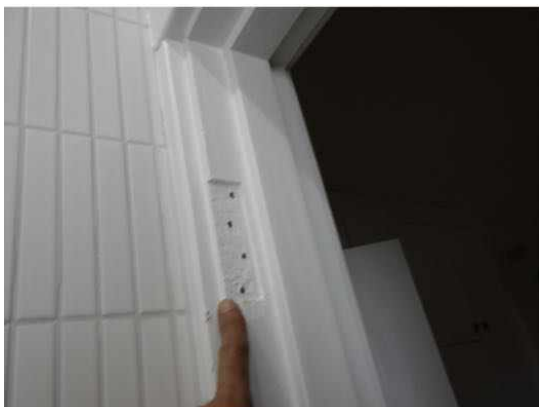
Defects 3.05

Building: Building 1
 Location: Bathroom - Ensuite
 Finding: Bathroom - Ensuite - Door - Missing
 Information: At the the time of inspection it was noticed that door is missing from this bathroom - ensuite area.

Replacement of any missing building element should be conducted as soon as

possible to ensure that no damage or functional issues occur to associated building materials.

The appropriate tradesperson should be appointed as soon as possible to replace the missing building element.

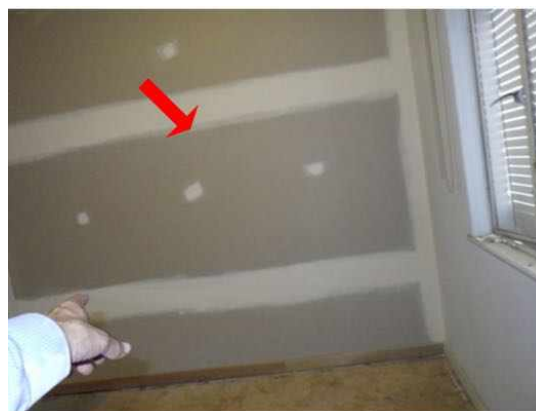
Defects 3.06

Building:	Building 1
Location:	All Internal Areas
Finding:	Internal Walls - Paint finish - Incomplete
Information:	The paint finish in this bedroom area internal wall was identified as being incomplete at

Whilst incomplete or missing paint finish is generally an appearance defect, it can also lead to the development of secondary building defects over time. Incomplete areas of paint finish expose the area to moisture, potentially accelerating the deterioration of underlying building materials.

Incomplete paint finishes should be sanded back, filled, leveled and painted, as applicable. Where inadequate or missing paint protection has led to the deterioration of the associated building element, repair and/or replacement of this building element may be required.

A painting contractor should be appointed as soon as possible to perform necessary works to aid the appearance of the affected area and to ensure the area is protected against further deterioration. Alternatively, the homeowner following manufacturer instructions may perform these works.

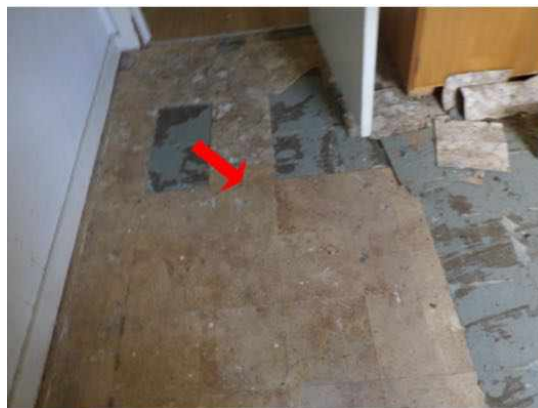
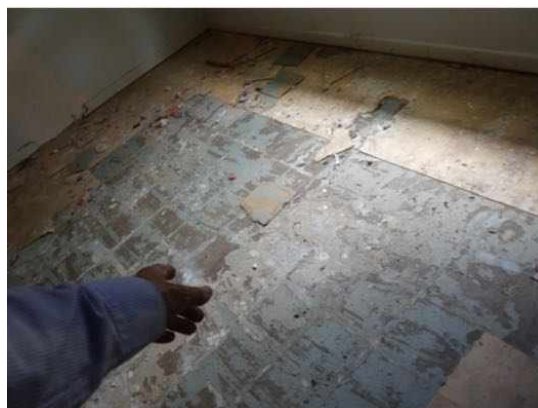
Defects 3.07

Building:	Building 1
Location:	All Internal Areas
Finding:	Carpet - Missing/ Not installed
Information:	At the time of inspection it was noticed that carpet is missing / not installed in this bedrooms area. Although some building elements may seem irrelevant or unnecessary, all building elements play a key role in the operation and function of the overall structure and its performance.

Replacement of any missing building element should be conducted as soon as possible to ensure that no damage or functional issues occur to associated building materials.

The appropriate tradesperson should be appointed as soon as possible to replace the missing building element.

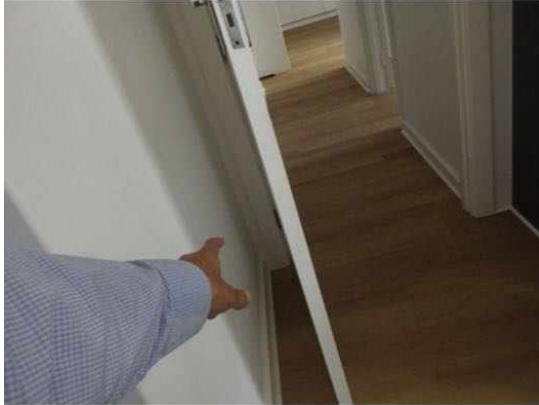
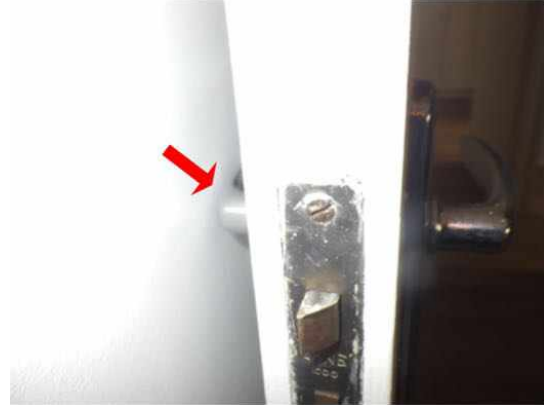
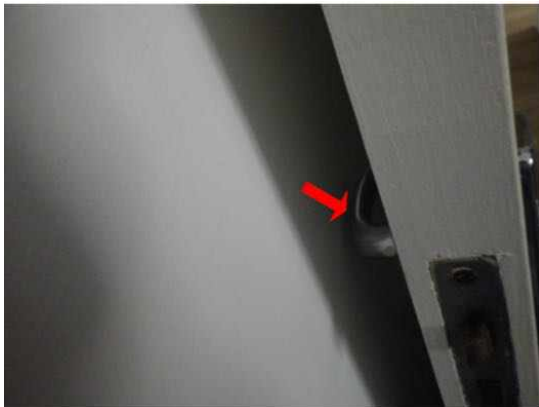
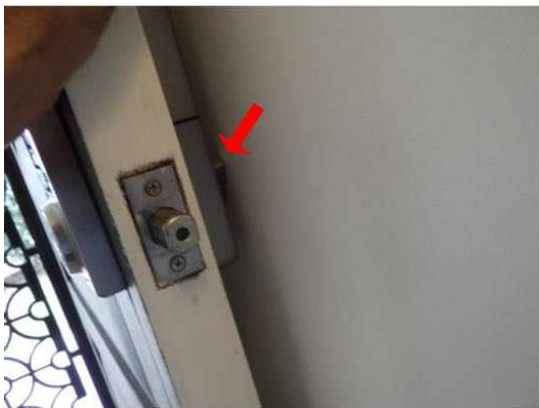
Defects 3.08

Building:	Building 1
Location:	All Internal Areas
Finding:	Door stop - Missing
Information:	The door stop is missing or is inadequate to stop the door handle from damaging the wall. Although some building elements may seem irrelevant or unnecessary, all building elements play a key role in the operation and function of the overall structure and its performance.

Re-installation or replacement of the door stop is advised as soon as possible to prevent any subsequent damage to the door or associated structures. A general handyman may be appointed to perform these works at client discretion.

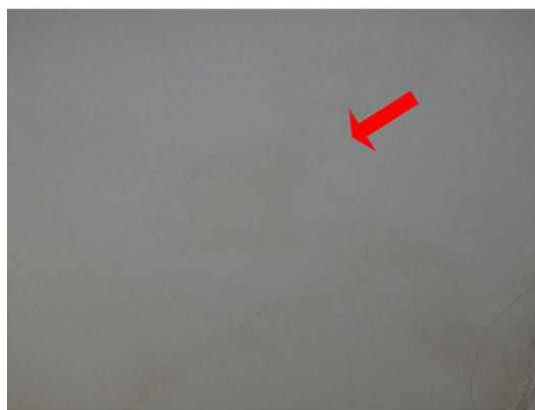
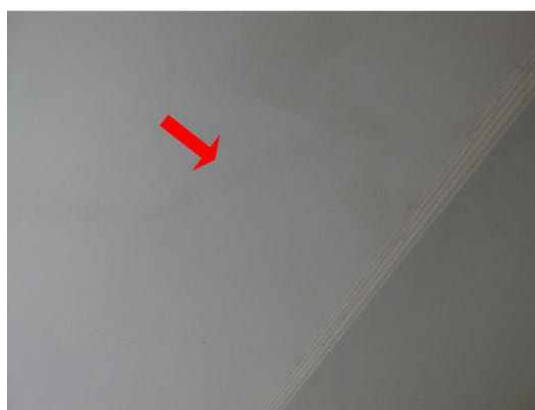
Defects 3.09

Building:	Building 1
Location:	All Internal Areas
Finding:	Ceiling - Water stained
Information:	Water staining to ceiling linings in this bedroom-3 area was evident at the time of inspection. Water staining indicates that surfaces have been exposed to excessive moisture over time. The minerals and other elements in the water lead to staining, which may graduate to corrosion and deterioration if left unmanaged.

While mostly an appearance defect, water staining can be indicative of more serious

defects, which may be currently concealed by interior ceilings.

Where water staining is active, a licensed plumber must be consulted to identify the cause of the staining and to provide advice on any reparation works that may be required. Replacement of any damaged structures is advised.

Conversely, where water staining is old and inactive, affected building materials may be repaired or replaced at client discretion.

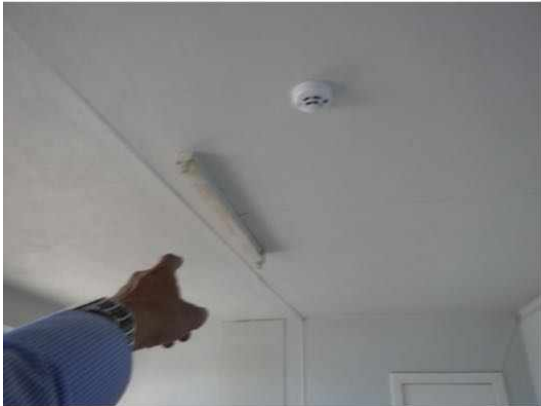
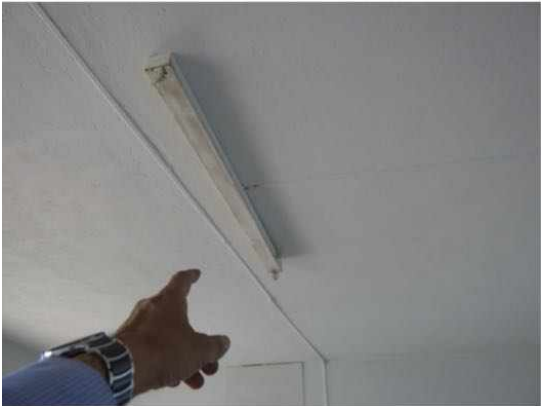
Defects 3.10

Building:	Building 1
Location:	All Internal Areas
Finding:	Fluorescent light - Missing
Information:	At the time of inspection it was noticed that fluorescent light was missing in this area. Although some building elements may seem irrelevant or unnecessary, all building elements play a key role in the operation and function of the overall structure and its performance.

Replacement of any missing building element should be conducted as soon as possible to ensure that no damage or functional issues occur to associated building materials.

The appropriate tradesperson should be appointed as soon as possible to replace the

missing building element.

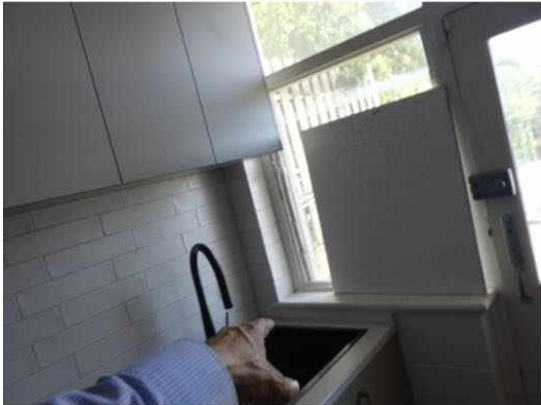
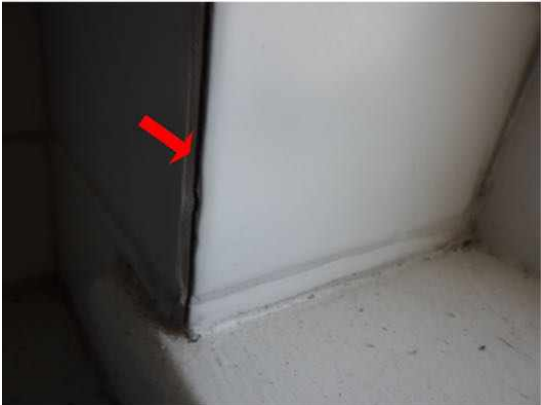
Defects 3.11

Building: Building 1
 Location: All Internal Areas
 Finding: Grout - Missing/ Deteriorated
 Information: Grout is missing/ deteriorated in this laundry area. Grout is used to protect gaps and crevices in building materials to ensure that they are water-tight and prevent water penetration to the associated structures.

Where grout is missing, a tiling contractor should be appointed immediately to apply grout and re-apply any silicone where necessary. Failure to do so is likely to lead to water damage to the surrounding area.

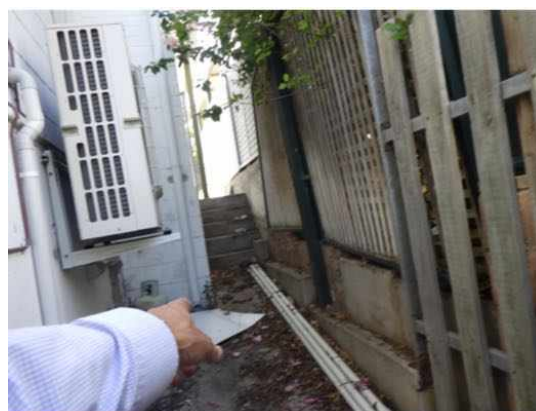
Noted Item

Building:	Building 1
Location:	All External Areas >
Finding:	Termite Management System - No evidence of a chemical installation
Information:	The application of a post-construction chemical termite barrier is highly recommended for all properties, particularly if live termite activity has been found on the site previously. Such barriers are highly effective in preventing termite attack on any timber building elements throughout the property.

A durable notice should be placed in the switchboard unit to indicate current termite barriers. At the time of inspection, it appeared as though no termite management system has been installed, with no evidence to suggest preventative works taking place.

The client may consider gaining further advice from a pest controller as to the costs and procedures involved with this application. It is recommended that obtaining such advice be a short-term priority.

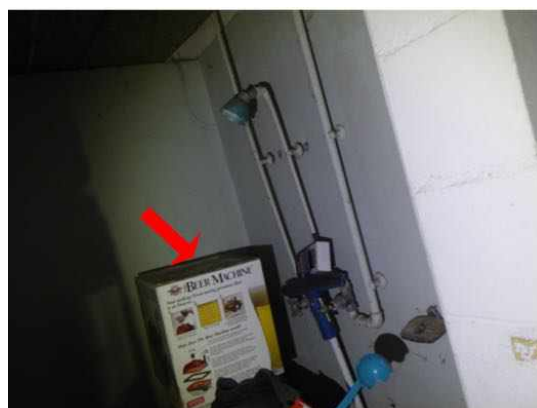
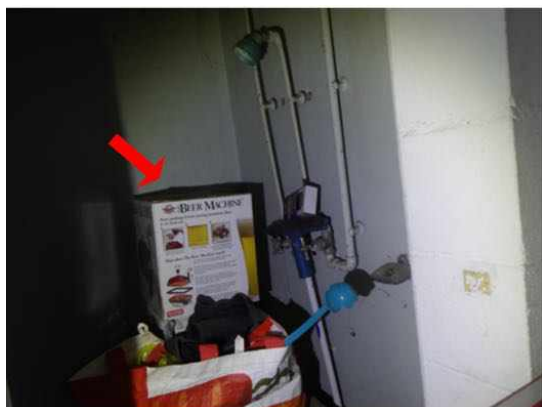
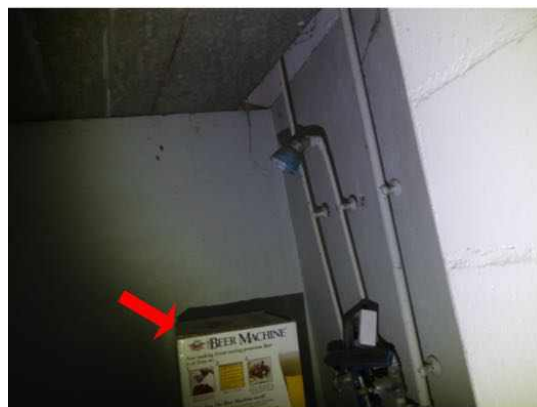
Noted Item

Building: Building 1
Location: All External Areas
Finding: External Area - Shower area- Obstructions and Limitations
Information: At the time of inspection it was noticed that shower area is blocked with stored materials in the external sub floor area. These photographs are an indication of the obstructions and limitations which impeded full inspection of the property at the time of inspection. These obstructions can hide an array of defects and should be removed to allow full inspection to be carried out. A re-inspection is recommended once the areas are made accessible.

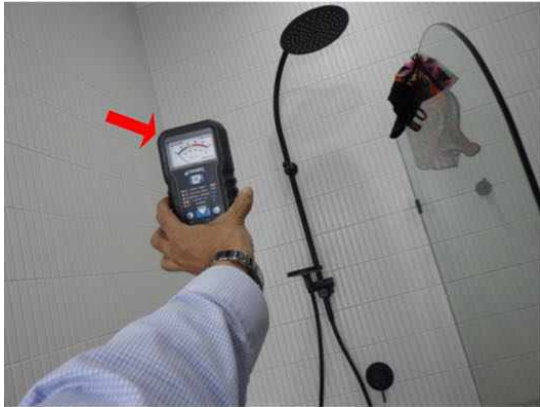
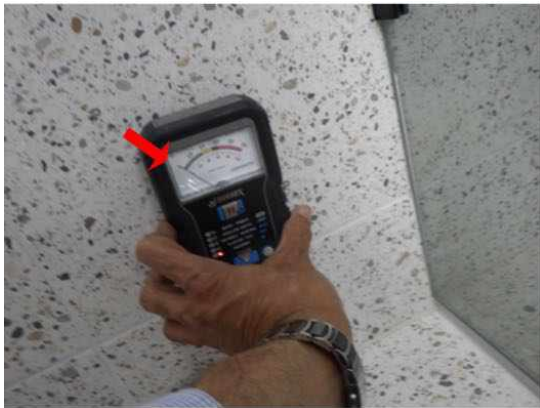
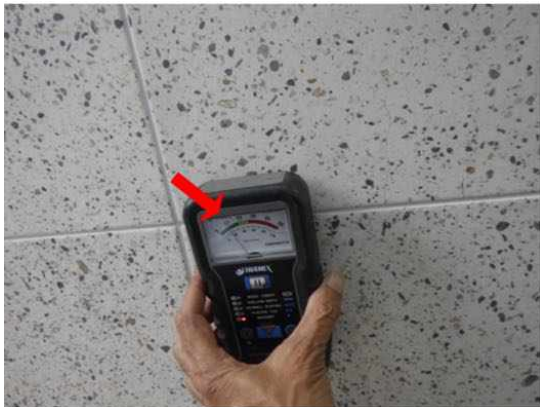
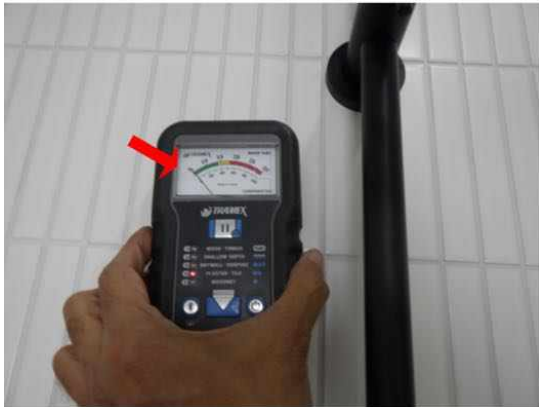
Noted Item

Building: Building 1
Location: Bathroom-Ensuite
Finding: Shower Alcove - No Damp
Information: At the time of inspection it was noticed that damp is not evident to the shower alcove.

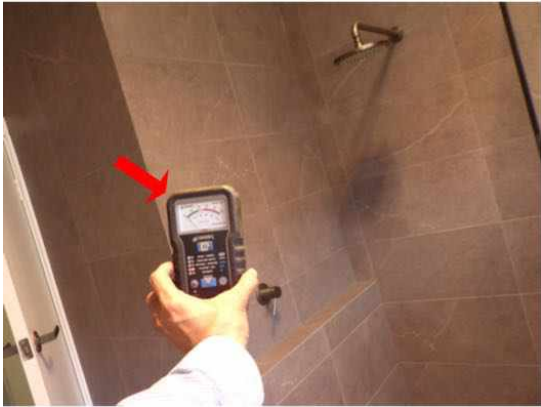
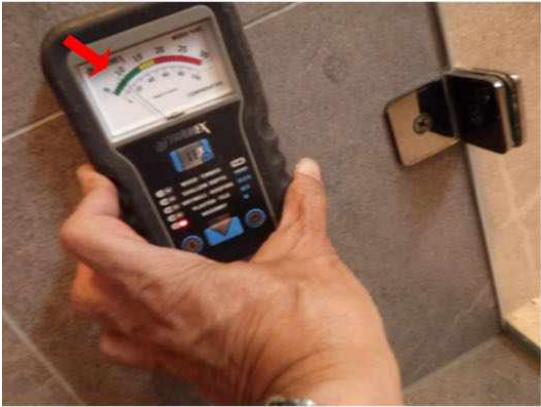
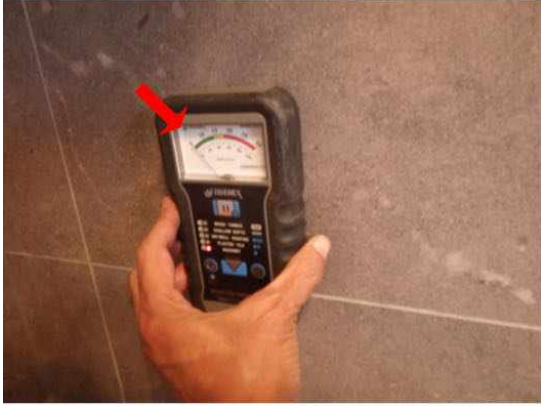
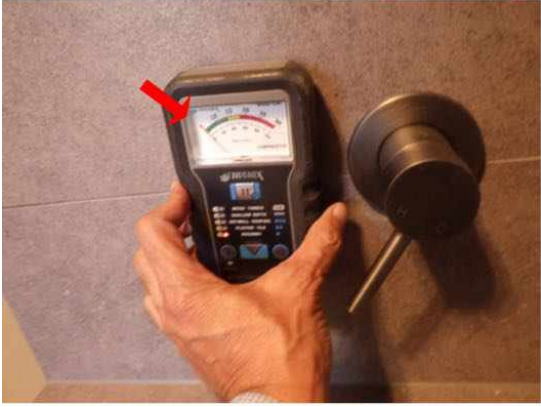
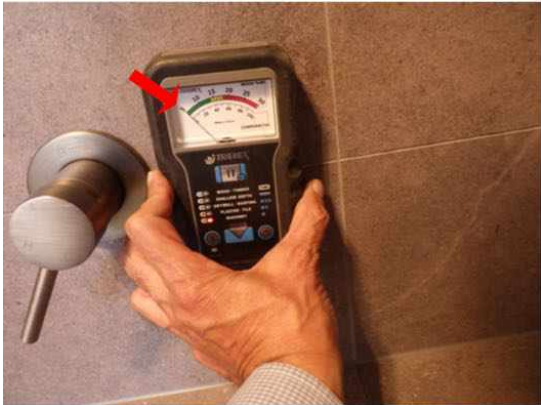
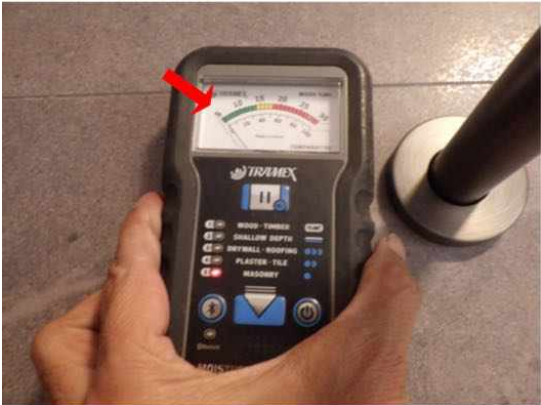
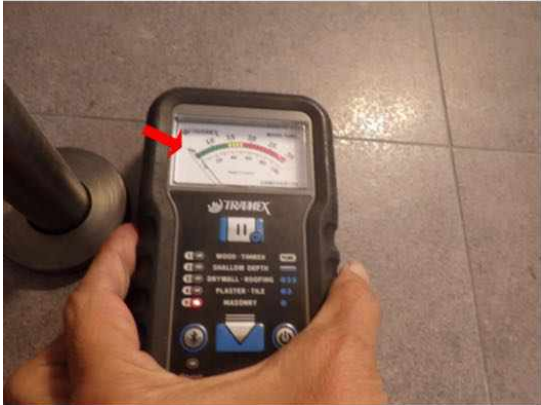
Noted Item

Building: Building 1
 Location: Bathroom 2
 Finding: Shower Alcove - No Damp
 Information: At the time of inspection it was noticed that damp is not evident to the shower alcove.

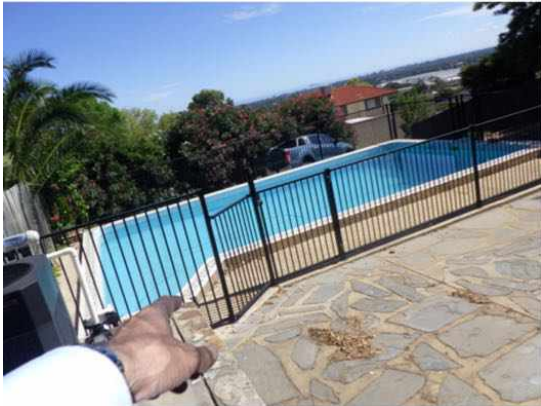
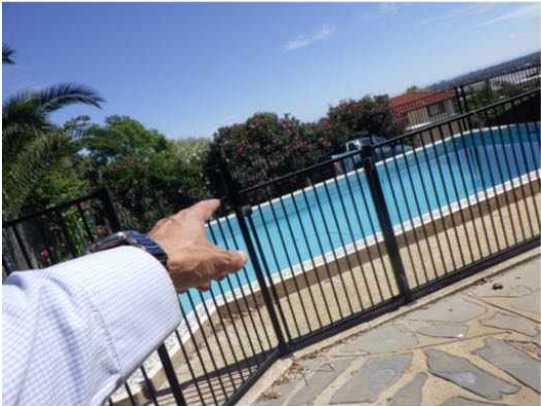
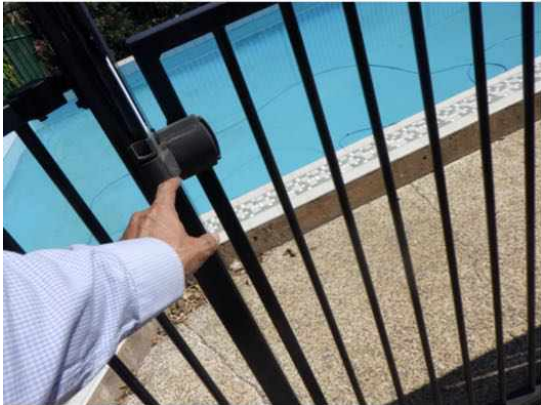
Noted Item

Building: Building 1
Location: All External Areas
Finding: Pool fencing - Inspection required
Information: Assessment of the pool area is required. Pool fencing needs to comply with Australian Standards.

Please note that this inspection does not cover pool fencing and other pool fittings and fixtures. It is highly advised that a specialist be appointed to inspect the pool and surrounding area and provide advice on rectification works that may be required.

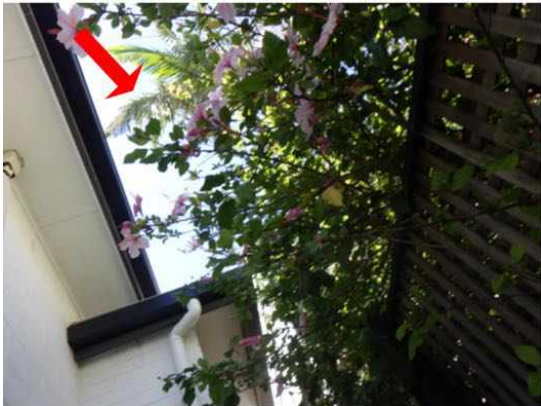
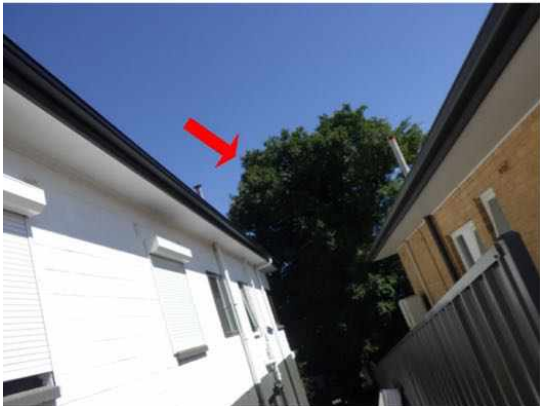
Noted Item

Building: Building 1
 Location: All External Areas
 Finding: Trees - Overhanging and filling gutters
 Information: Overhanging trees often result in excessive amounts of leaf debris accumulating in gutters.

Gutters are a critical part of the building's management of storm water and rain. It is therefore important that they be kept clear to prevent secondary damage to associated building elements, including exterior and interior walls, ceiling linings and any adjoining building elements. Where gutters are blocked, pooling of rainwater is likely to occur, fast-tracking rust and corrosion of the roof plumbing elements.

It is highly advised that all overhanging tree branches be removed as soon as possible to prevent any further damage. Repair and/or replacement of sections of damaged guttering may also be required where the extent of the damage necessitates.

Such works should be performed by the homeowner; however, appointment of a landscape contractor or an arborist may be required. Consultation with a licensed roof plumber is required where guttering has been damaged.

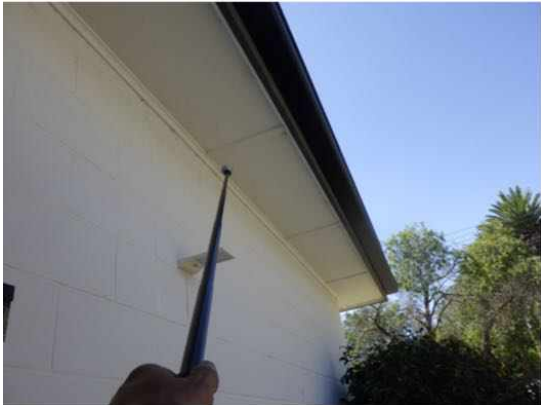
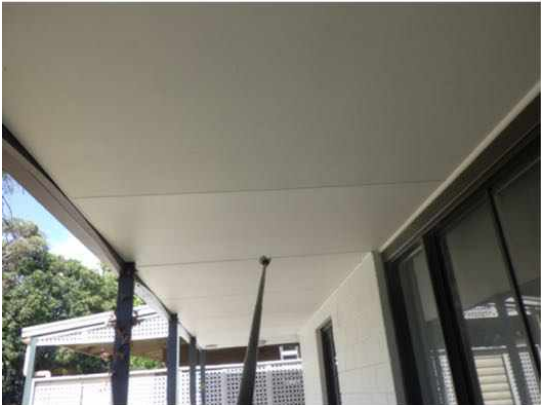
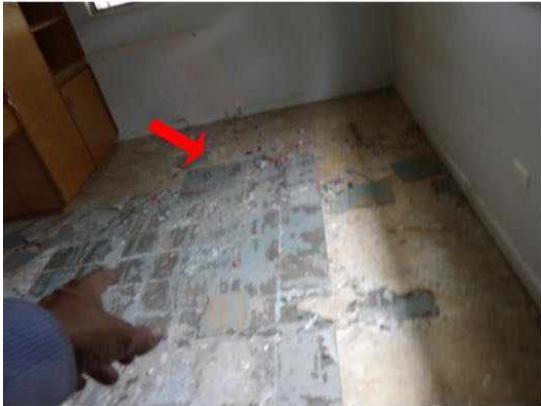
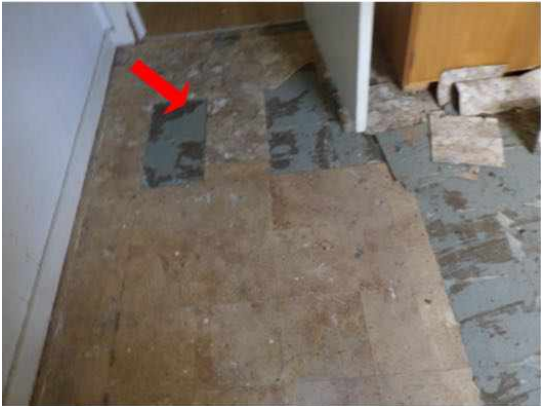
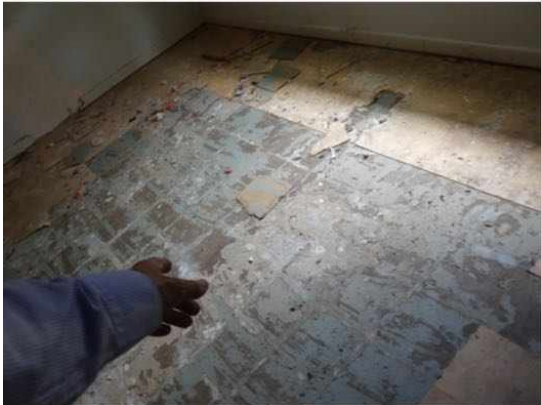
Noted Item

Building: Building 1
Location: All Areas
Finding: Asbestos - Suspected ACM Identified on Site
Information: Reporting on Asbestos is outside the Scope of this Report. This suspected defect is highlighted as a caution only. We suspect, based on our experience in the building industry, that there is a higher risk of the identified building element containing asbestos.

As Asbestos Reporting is outside the scope of this report, we advise that you consider a separate Asbestos Inspection and Condition Audit, which can include the taking of samples for definitive confirmation of the presence of Asbestos.

In the interim, the client is advised to act with caution, especially when considering any damage to building materials general wear and tear renovations extensions demolition and general maintenance activities due to the suspected presence of Asbestos.

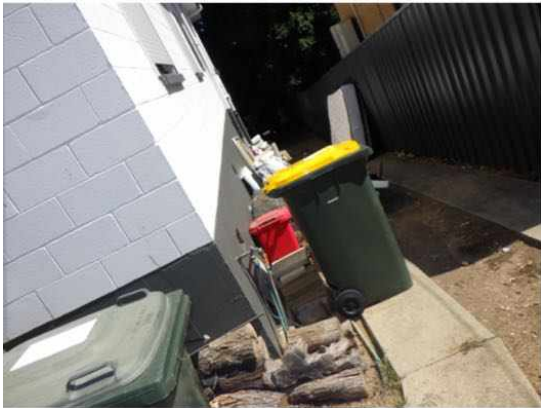
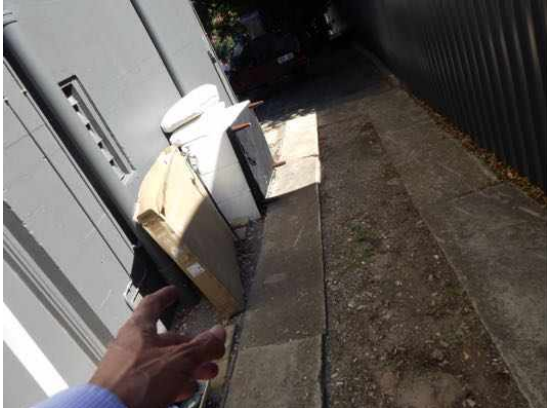
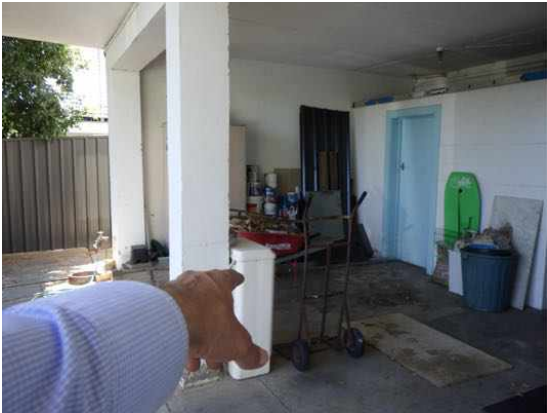
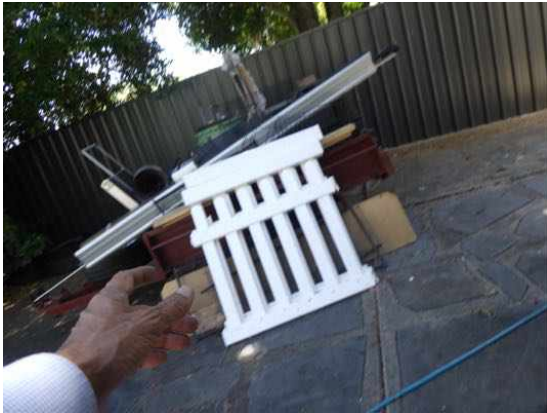
Noted Item

Building: Building 1
Location: All Areas
Finding: Additional Photos - Obstructions and Limitations
Information: These photographs are an indication of the obstructions and limitations which impeded full inspection of the property at the time of inspection. These obstructions can hide an array of defects and should be removed to allow full inspection to be carried out. A re-inspection is recommended once the areas are made accessible.
