Building Inspection Report

Inspection Date: Tue, 24 Mar 2026

Property Address: 15 Kinedana St, Eden Hills SA 5050,
Australia

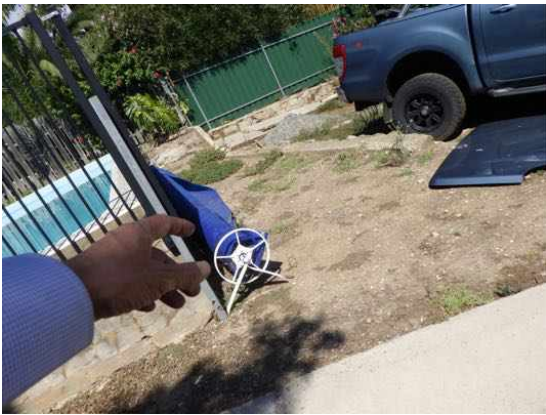
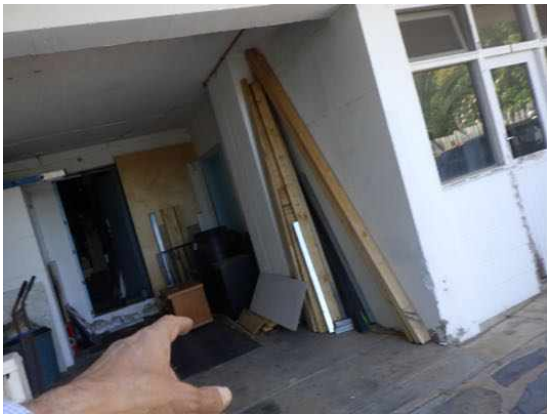
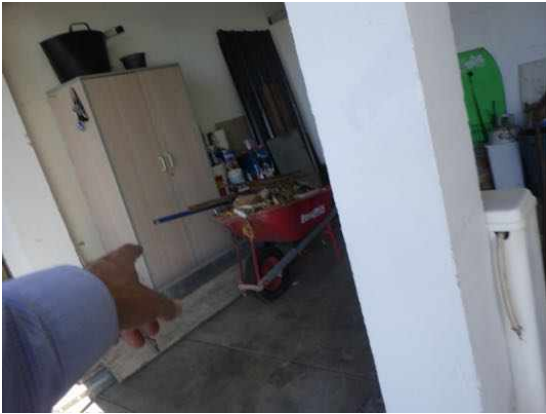
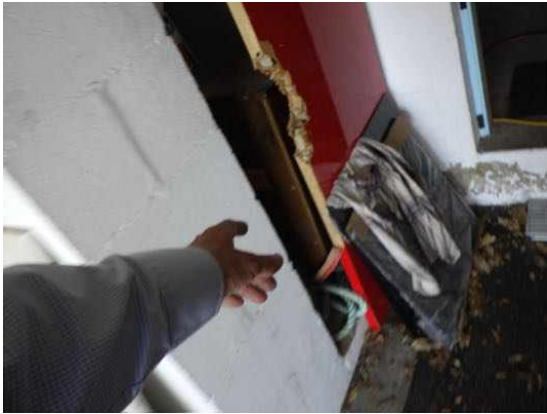
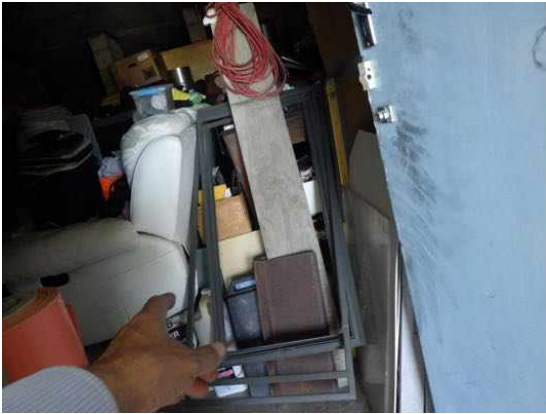
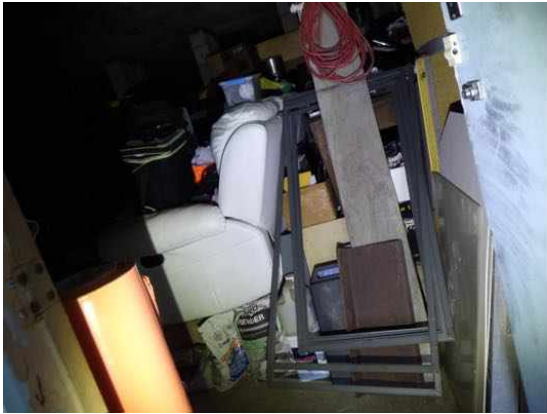
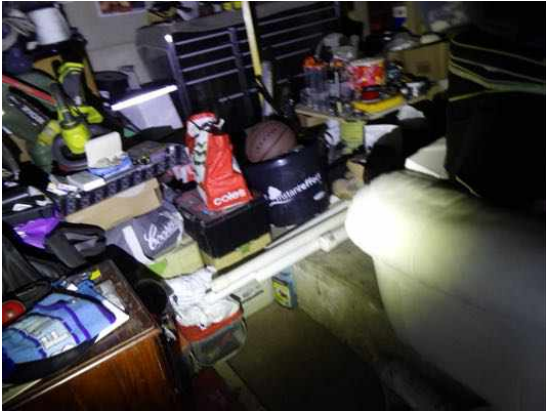
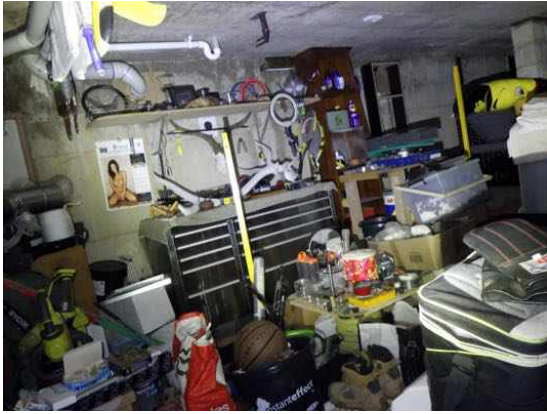
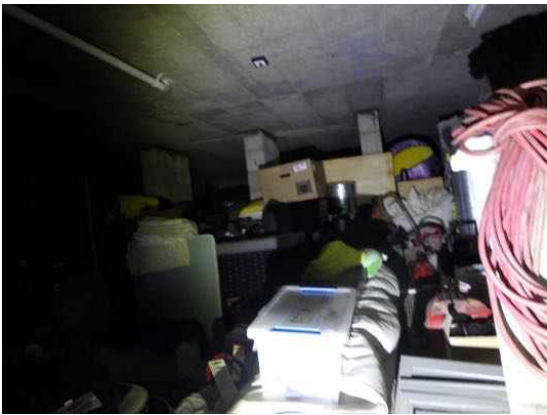
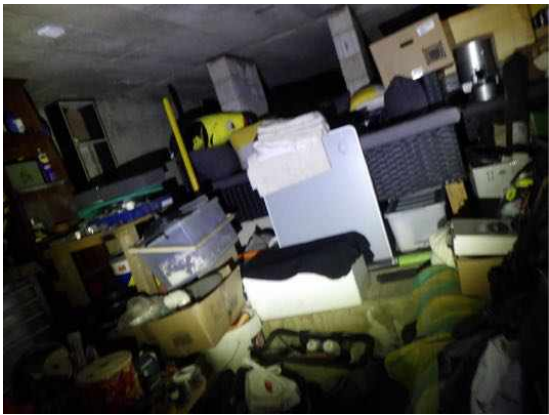
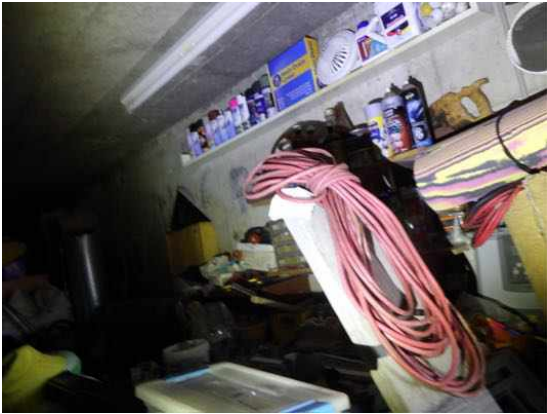
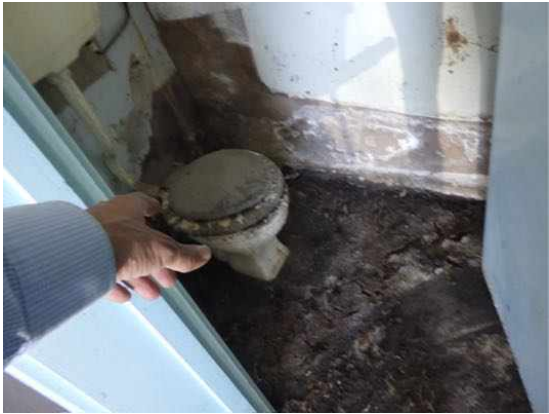
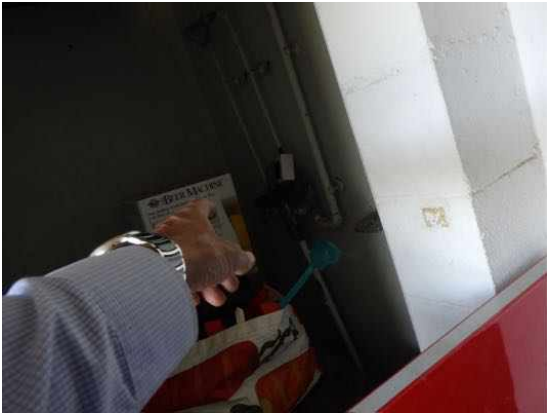
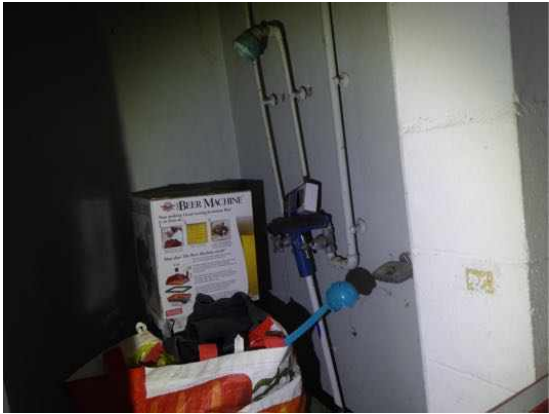
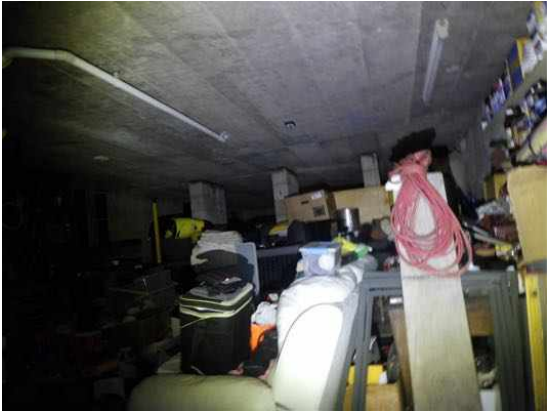
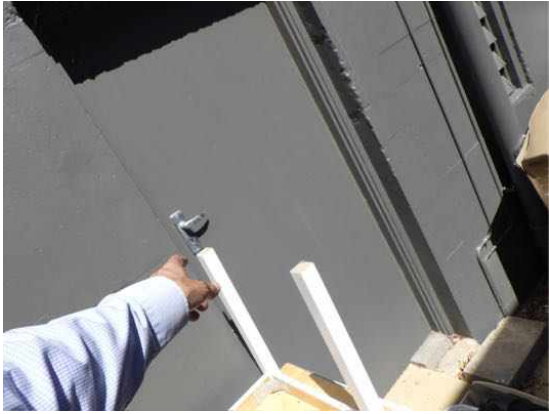
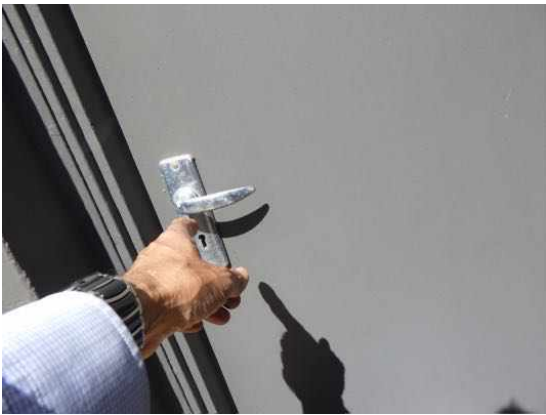
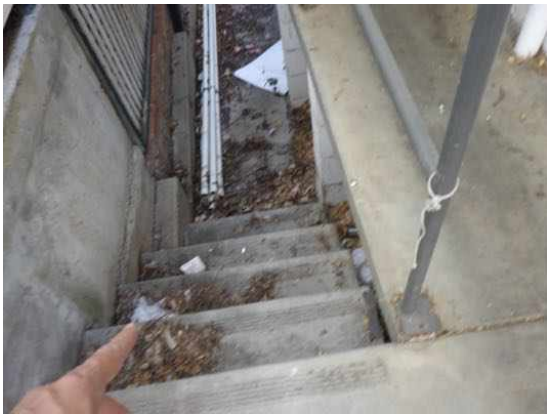
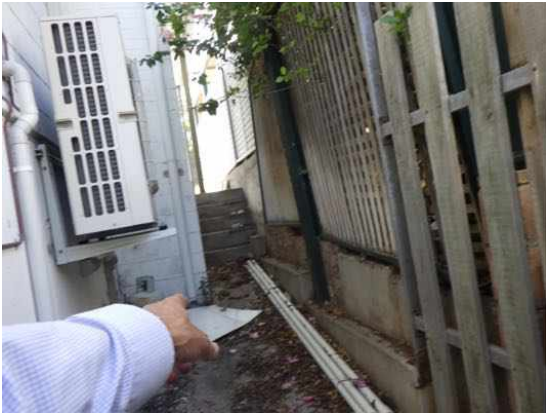
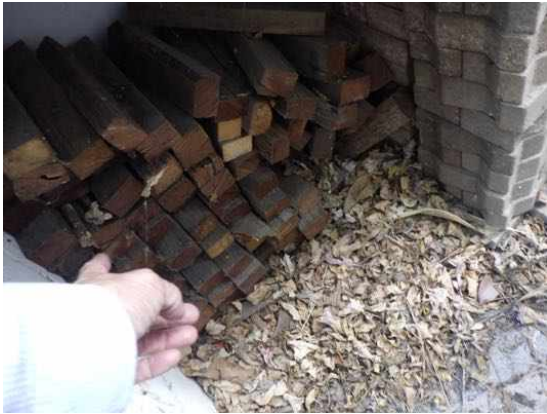
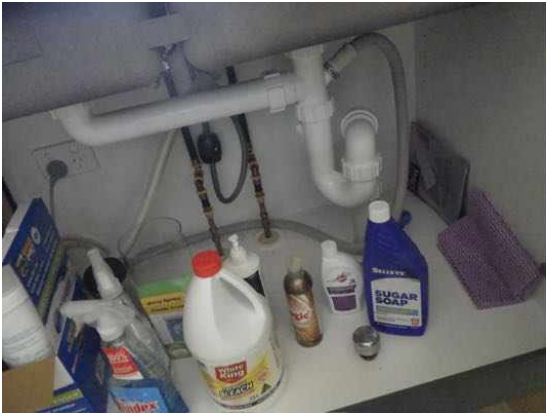
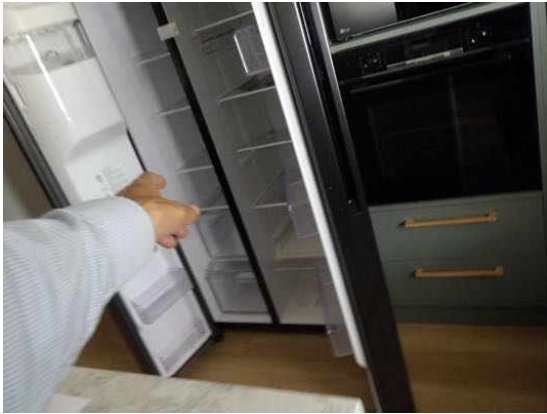
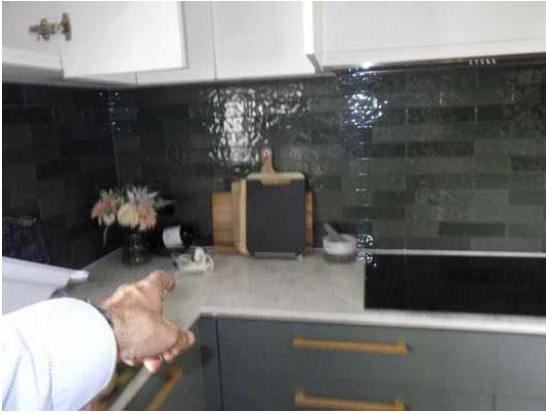
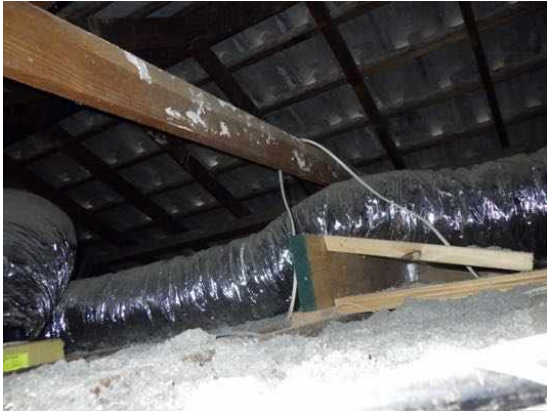
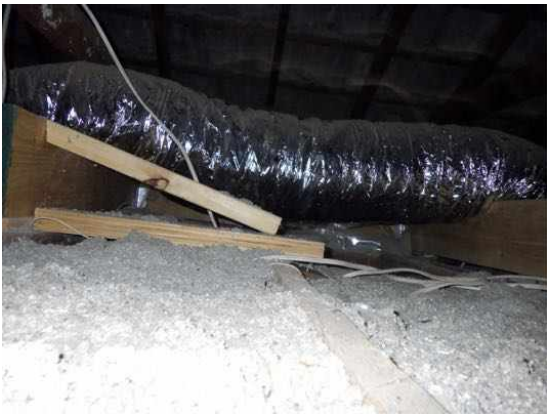
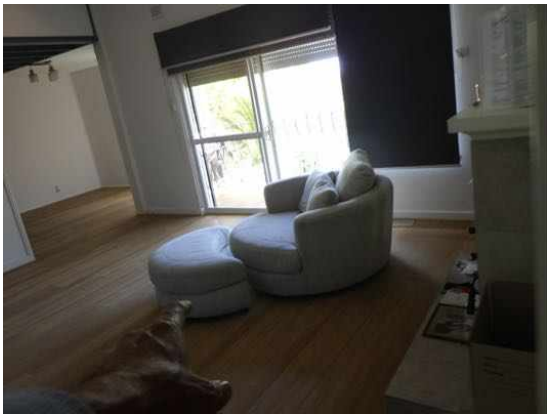
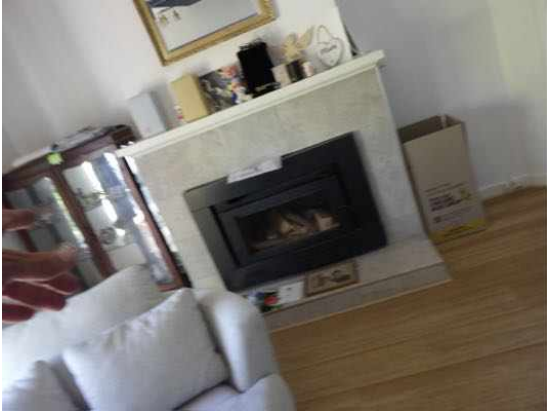
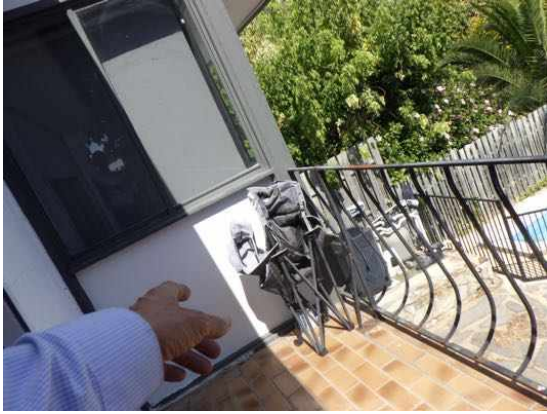
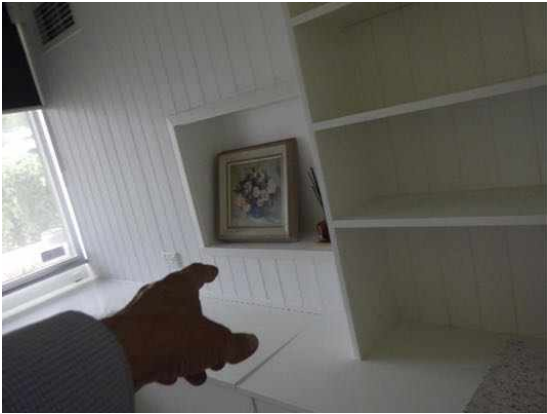
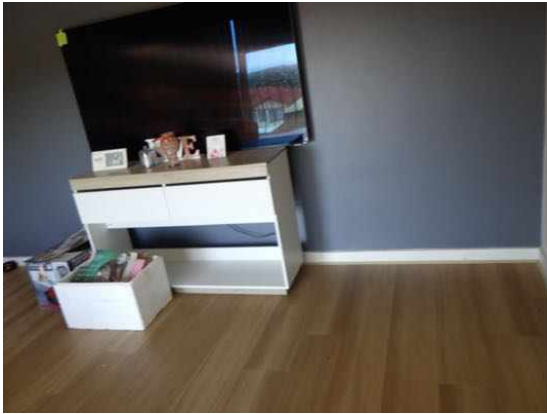
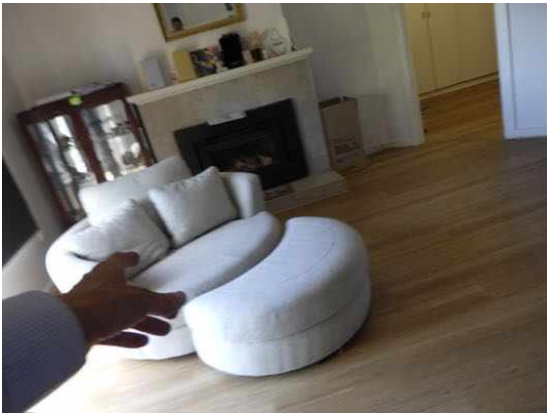
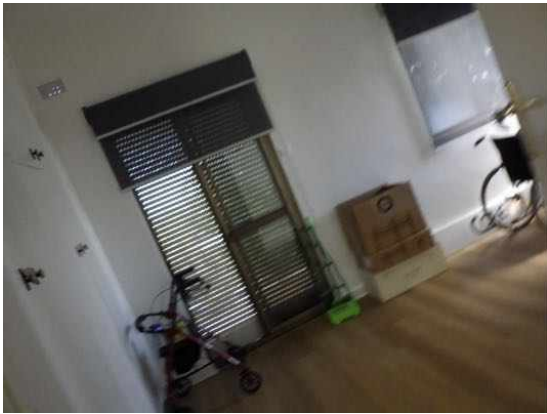
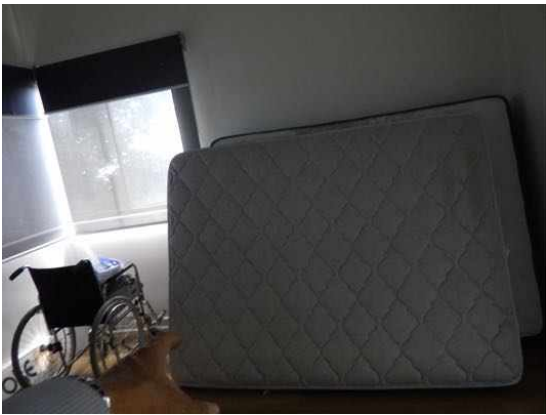
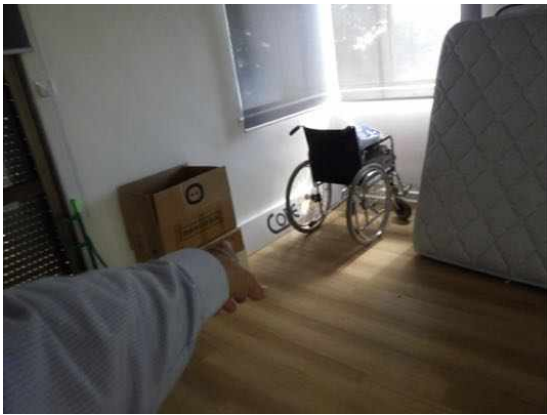
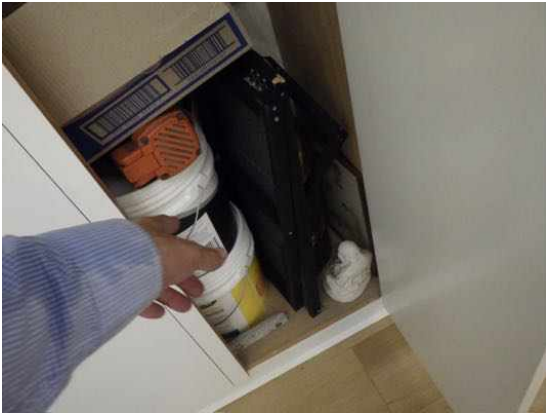
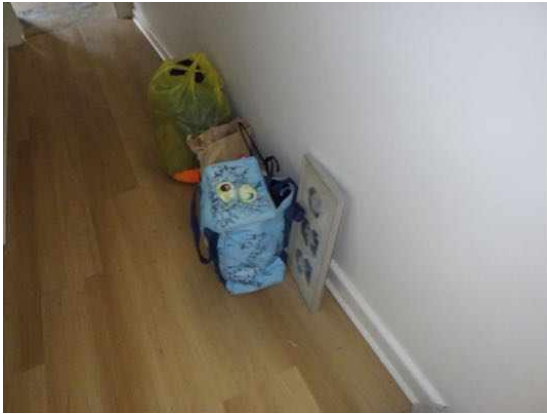
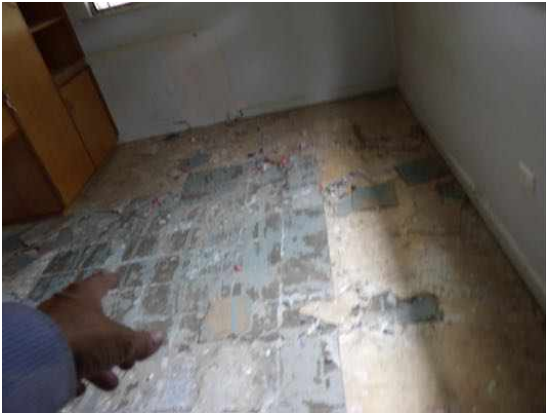
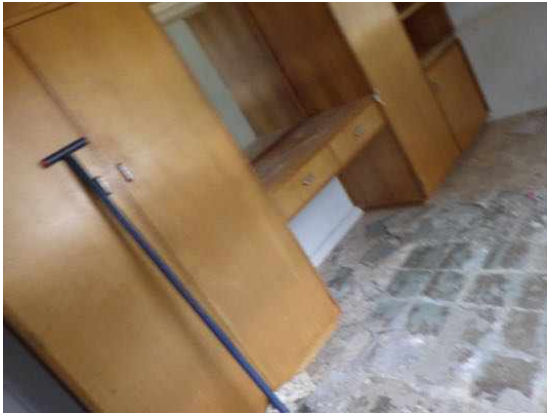
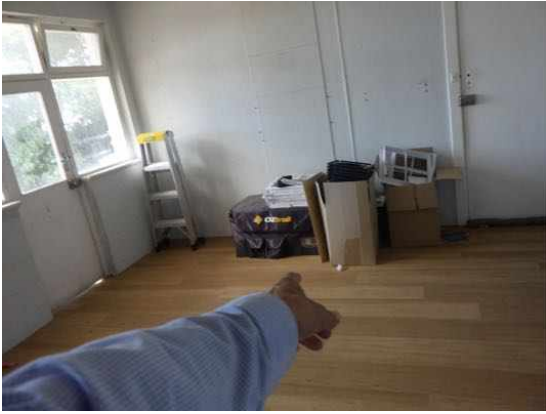
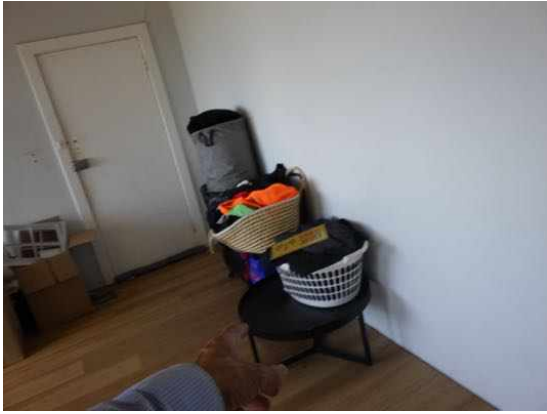
Noted Item

Building: Building 1
Location: All Areas
Finding: Additional Photos - Obstructions and Limitations
Information: These photographs are an indication of the obstructions and limitations which impeded full inspection of the property at the time of inspection. These obstructions can hide an array of defects and should be removed to allow full inspection to be carried out. A re-inspection is recommended once the areas are made accessible.

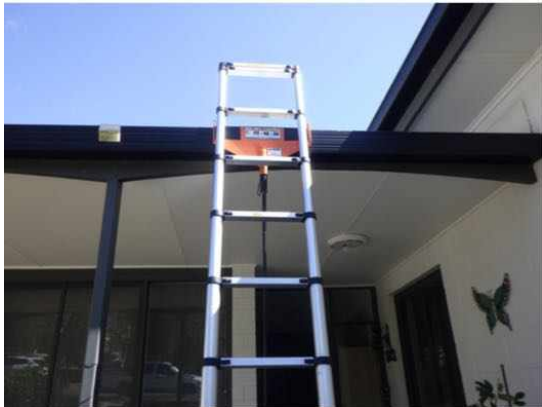
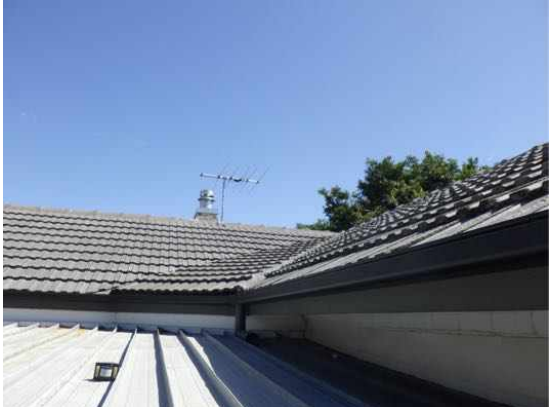
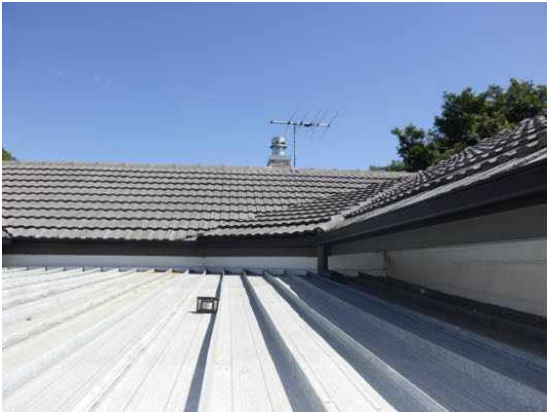
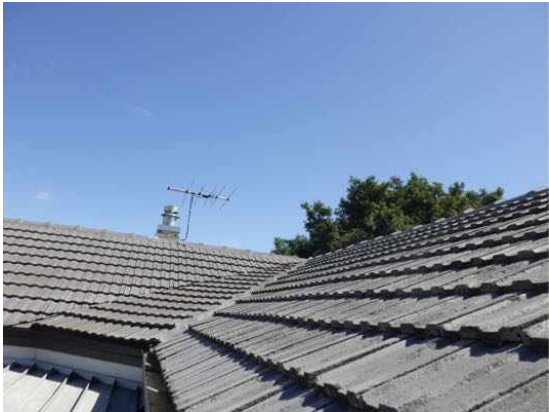
Building: Building 1
Location: All Areas
Finding: Additional Photos
Information: Additional photos are provided for your general reference
