## Building and Timber Pest Inspection Report

Inspection Date: Fri, 13 Feb 2026

Property Address: 34 Catherine Cres, BLAXLAND, NSW, 2774,  
Australia

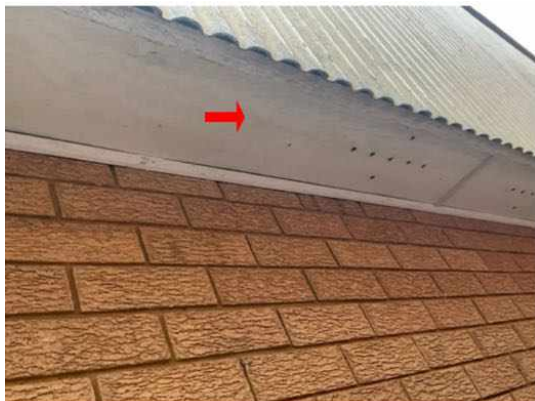
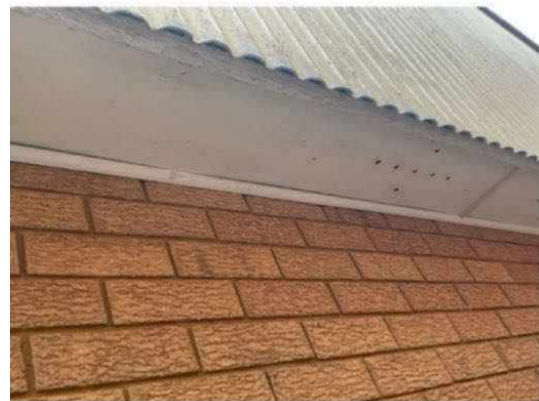
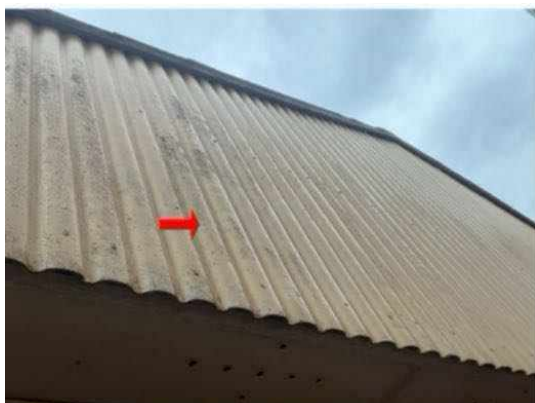
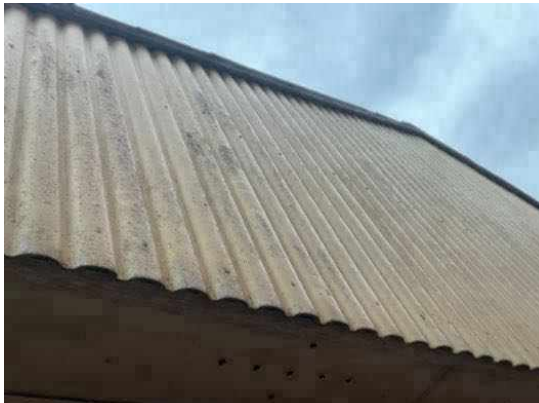
Building:	Main Building
Location:	All Areas
Finding:	Asbestos - Suspected ACM Identified on Site
Information:	Reporting on Asbestos is outside the Scope of this Report. This suspected defect is highlighted as a caution only. We suspect, based on our experience in the building industry, that there is a higher risk of the identified building element containing asbestos.

As Asbestos Reporting is outside the scope of this report, we advise that you consider a separate Asbestos Inspection and Condition Audit, which can include the taking of samples for definitive confirmation of the presence of Asbestos.

In the interim, the client is advised to act with caution, especially when considering any damage to building materials general wear and tear renovations extensions demolition and general maintenance activities due to the suspected presence of Asbestos.

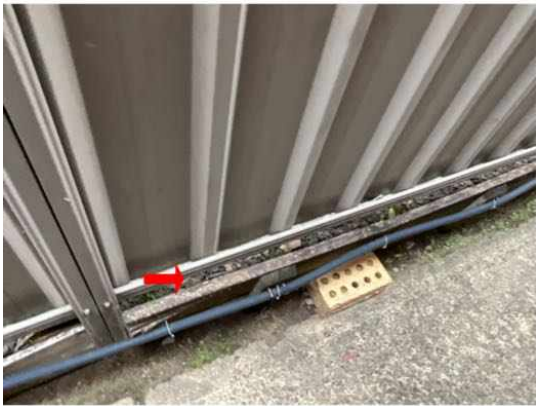
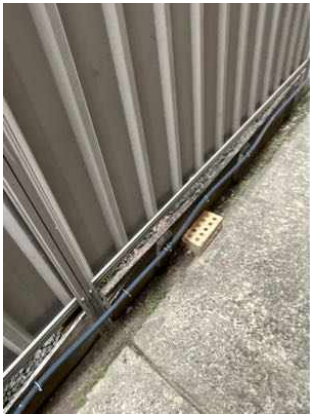
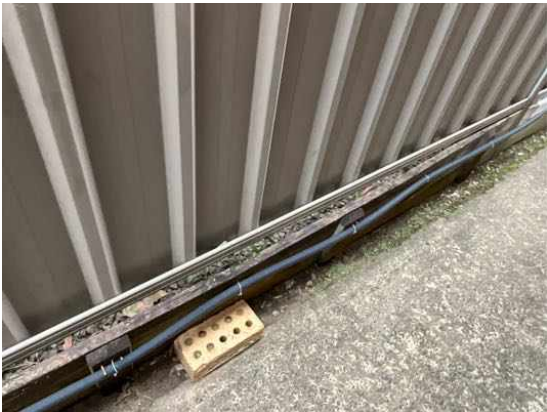
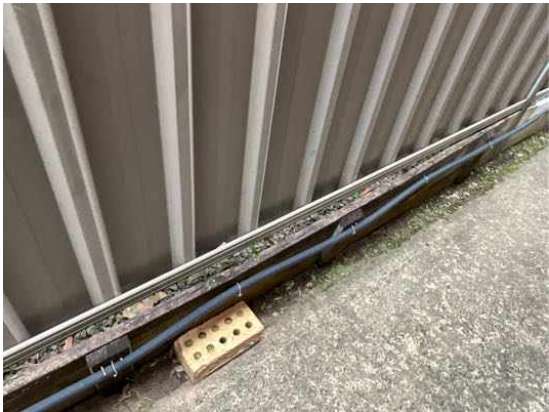
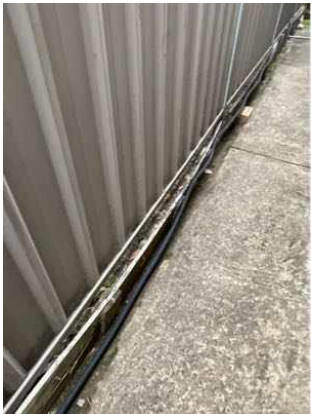
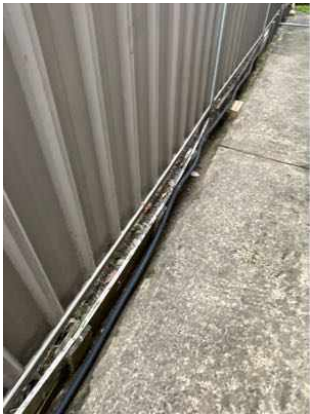
Building: Main Building  
 Location: All Areas  
 Finding: Detoriated fence  
 Information: The fence along the property boundary has deteriorated significantly, showing signs of rot, rust, and structural weakness. Several sections are leaning or have become detached, compromising the integrity of the fence and its ability to perform its intended function.

The deteriorated fence poses multiple risks:

1. **Safety Hazard:** The unstable fence may collapse, posing a risk of injury to residents, visitors, and passersby.
2. **Security Concern:** The compromised fence may allow unauthorized access to the property, increasing the risk of theft, vandalism, or trespassing.
3. **Property Damage:** Falling sections of the fence could damage nearby structures, plants, or other property features.
4. **Legal Liability:** If the fence were to fail and cause injury or damage to neighboring properties, the property owner may be held liable.

- **Licensed Fencing Contractor:** A professional fencing contractor should be hired to assess the extent of the damage and either repair or replace the deteriorated sections.
- **Handyman Services:** For minor repairs, a qualified handyman could be engaged to reinforce or repair specific sections of the fence.
- **Landscaper (if the fence is part of a larger garden feature):** If the fence is integrated into the landscape design, a landscaper with experience in fencing could be involved in the repair or replacement process.

It's important to ensure that whoever is hired is experienced and qualified to ensure the fence is restored to a safe and functional condition, compliant with local

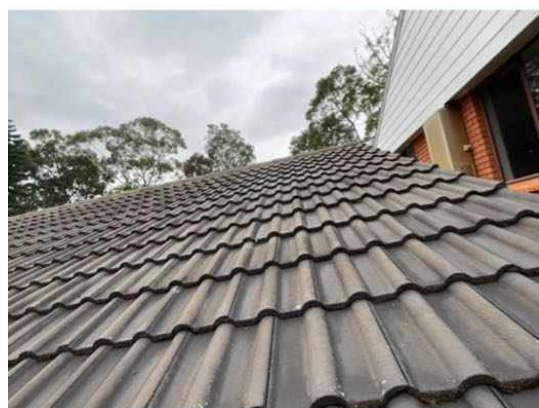
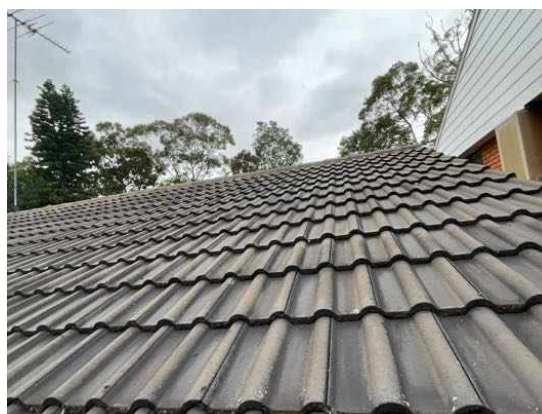
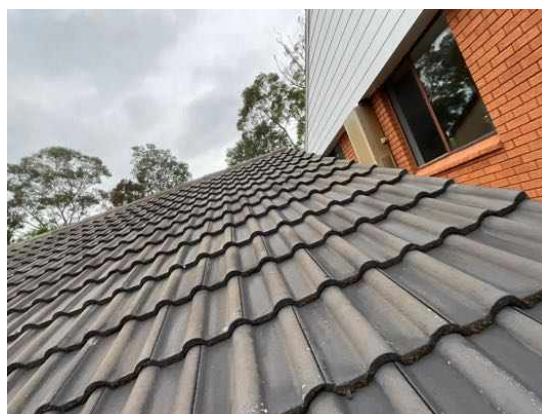
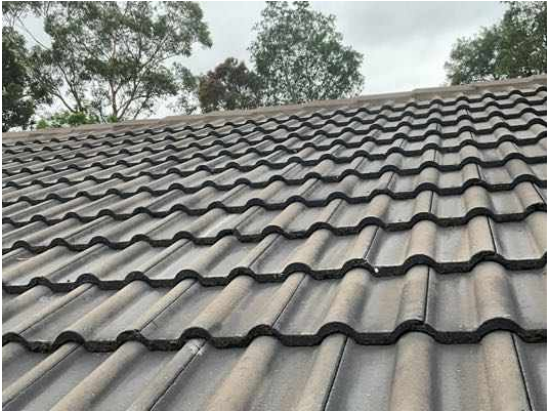
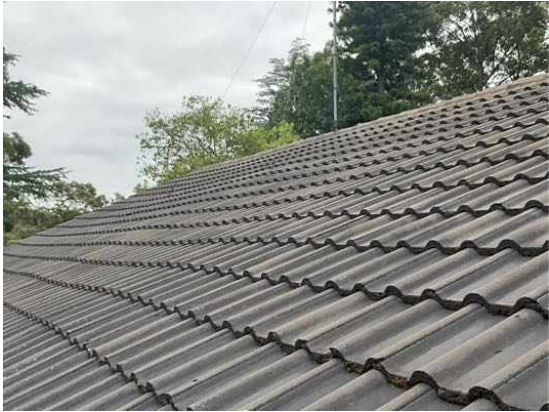
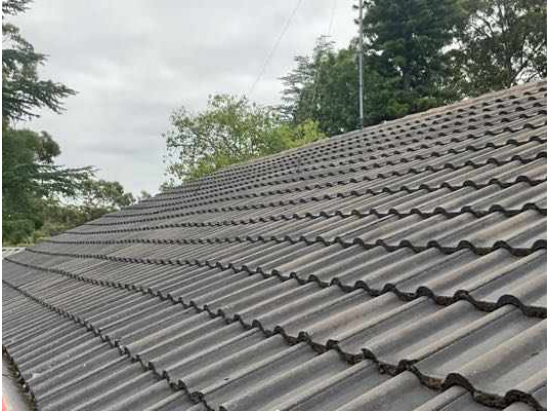
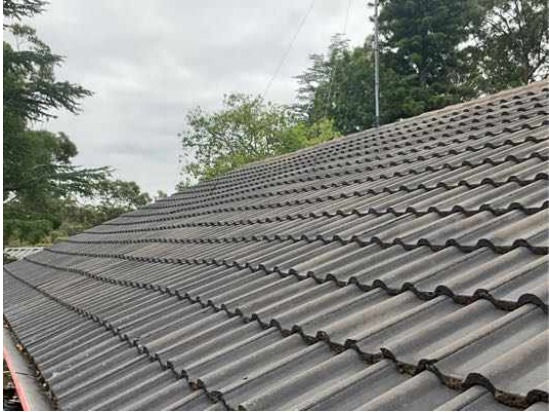
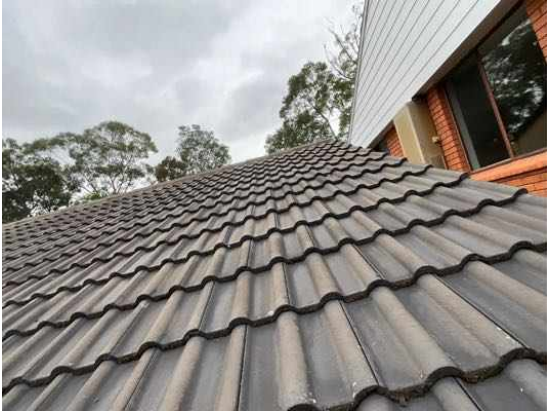
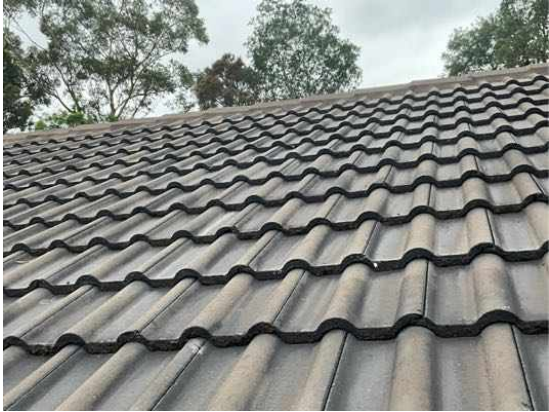
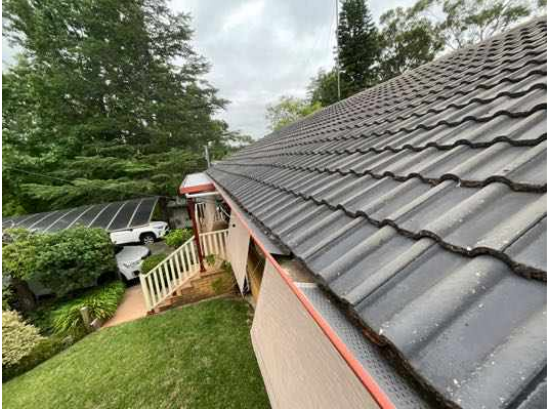
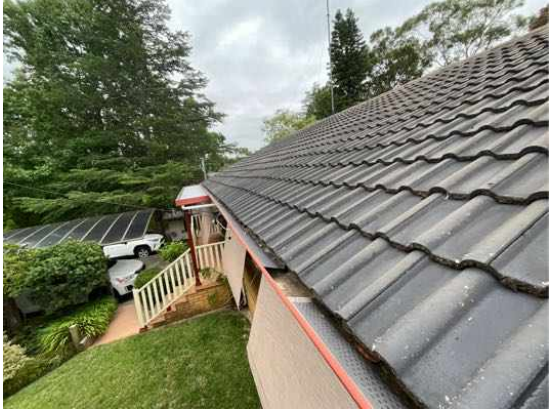
### Finding 3.02

Information: Inspection of the roof revealed widespread weathering to the tiled roof surface. The tiles show loss of surface finish, colour fading, and age-related deterioration typical of older roof coverings. Although no significant cracking was noted, weathering can lead to increased porosity, reduced water-shedding capability, and a higher risk of future cracking or displacement during adverse weather conditions.

A licensed roofer should be engaged to undertake a closer inspection, carry out routine maintenance, and replace any tiles that may be compromised. Ongoing monitoring is recommended due to the age and condition of the roof covering.

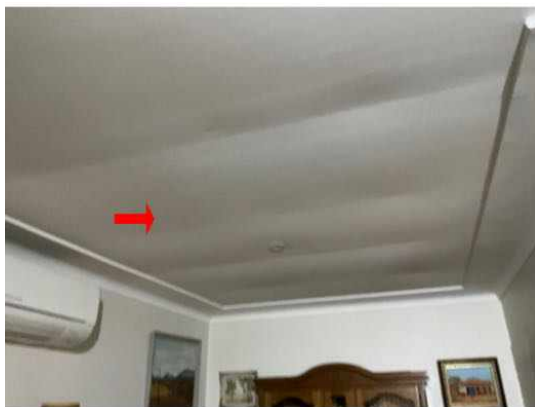
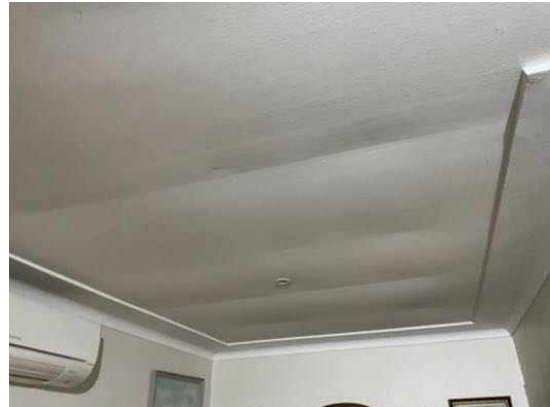
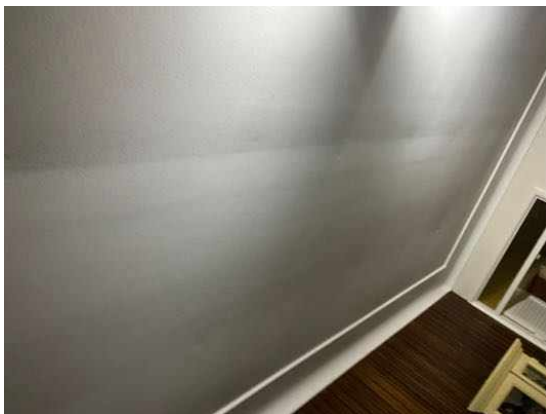
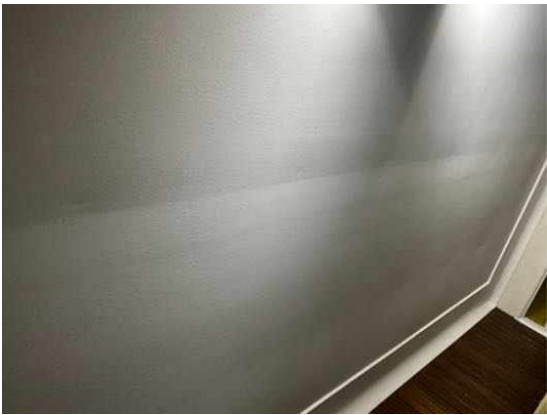
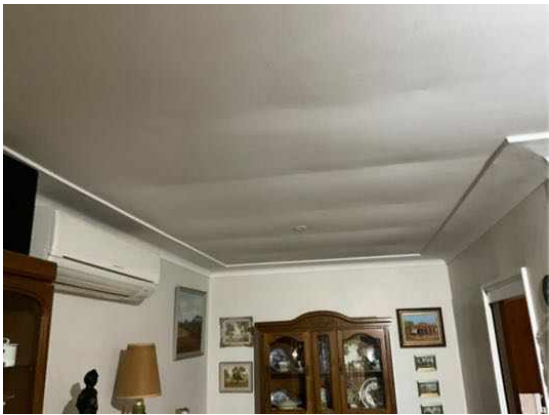
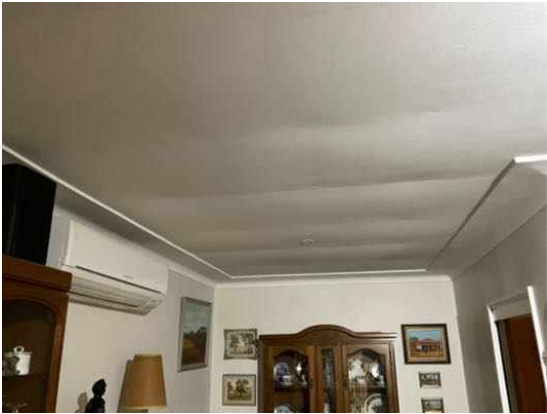
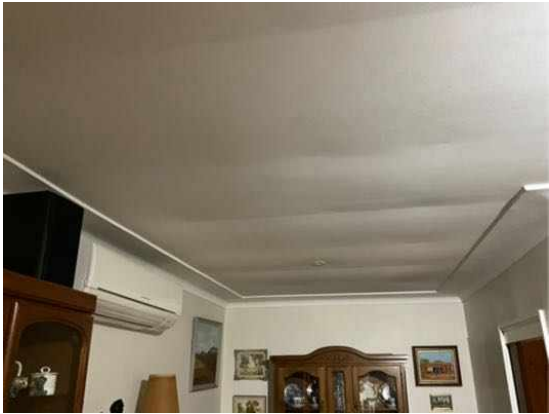
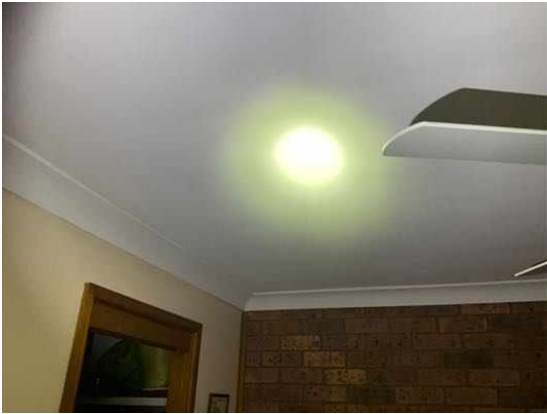
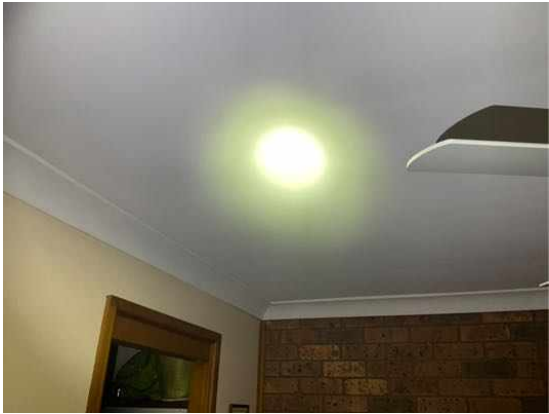
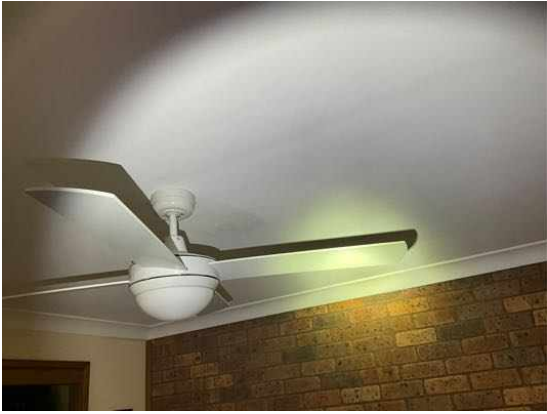
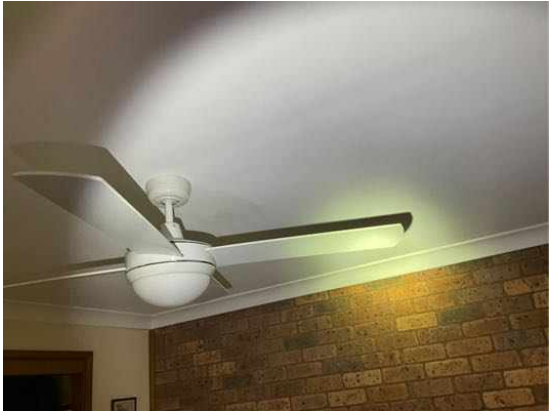
Finding 3.03

Building: Main Building  
Location: All Areas  
Finding: Sagging ceiling  
Information: The ceiling exhibits noticeable sagging, characterized by visible dips or bulges in the surface.

Risk: Sagging ceilings pose several risks, including potential collapse or detachment of ceiling materials, which can lead to property damage and serious injuries to occupants. Additionally, sagging ceilings may indicate underlying structural issues, such as water damage or compromised support beams, which could worsen over time if left unaddressed.

A qualified and licensed Builder or structural engineer should be consulted to assess the extent of the sagging and identify the underlying cause. Depending on the severity and cause, repairs may involve reinforcing support structures, addressing water damage, or replacing damaged ceiling materials to ensure safety and structural integrity.

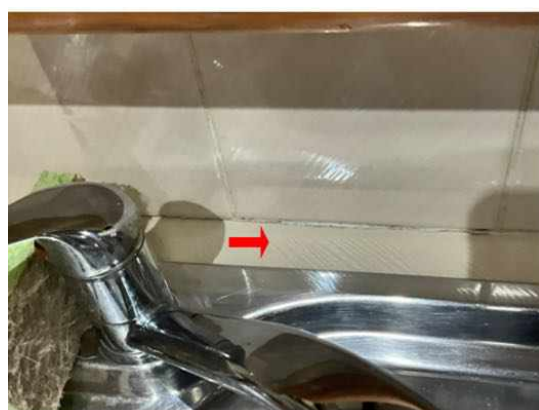
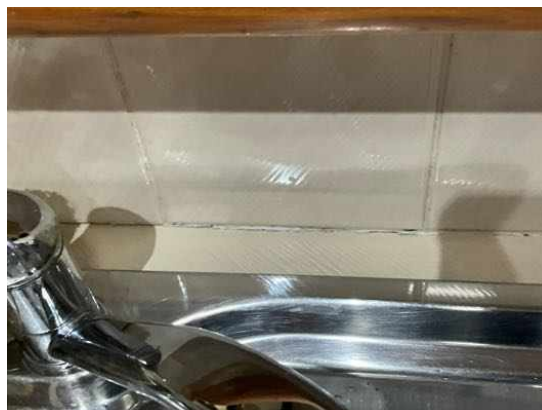
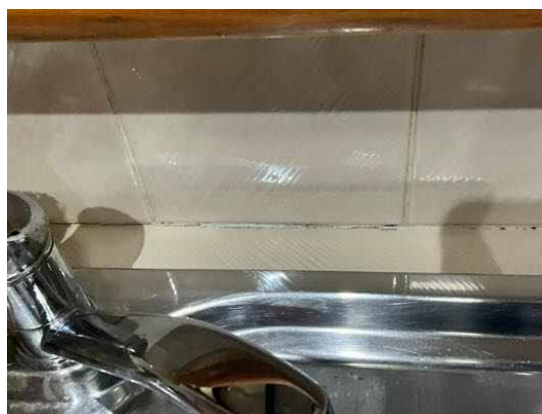
Finding 3.04

Building: Main Building  
 Location: Kitchen  
 Finding: Silicone Sealant - Deteriorated Around Basin  
 Information: The silicone seal around the basin has deteriorated, with visible gaps and discolouration noted along the edges.

Water penetration through the deteriorated seal may cause damage to surrounding surfaces, promote mould growth, and lead to deterioration of adjacent materials.

A licensed plumber or qualified handyman should remove the old sealant and reapply a sanitary-grade silicone to ensure watertight protection.

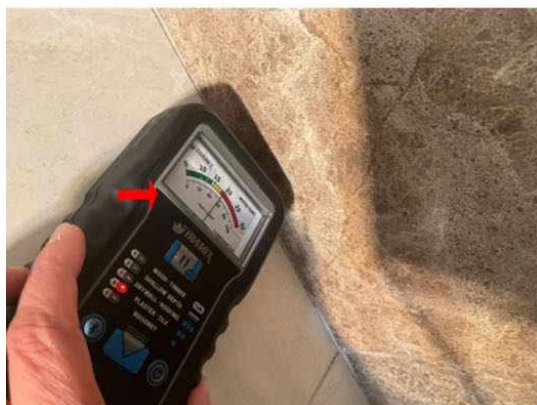
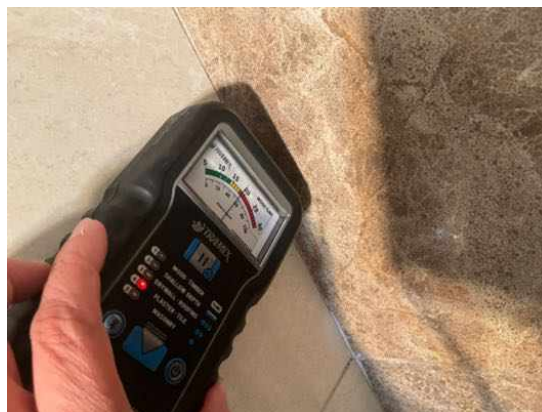
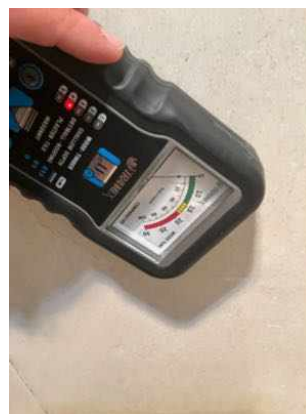
### Finding 3.05

Building: Main Building  
 Location: Bathroom  
 Finding: Shower - Damp  
 Information: Damp is evident to the lower 300mm of wall to the shower alcove. This defect is quite common, and is suspected to have been caused by moisture permeating through the

grouting in this area, which shows evidence of deterioration. Leaking pipes within the adjoining wall is also a possible cause.

Unmanaged damp in the shower recess is likely to facilitate the formation and development of mould and fungi growth, decaying associated building materials and compromising their structural integrity. It is important to address damp conditions, as the World Health Organisation notes that excess moisture leads - on almost all indoor materials - to growth of microbes such as moulds, fungi and bacteria, which subsequently emit spores and other matter into the indoor air. Exposure to these contaminants is associated with a wide range of respiratory and other health-related problems.

Consultation with a qualified plumber or bathroom specialist is advised immediately to identify the cause of damp and to perform remedial works as required. Where excessive mould growth is present, further inspection by a specialist environmental health inspector should also be considered.

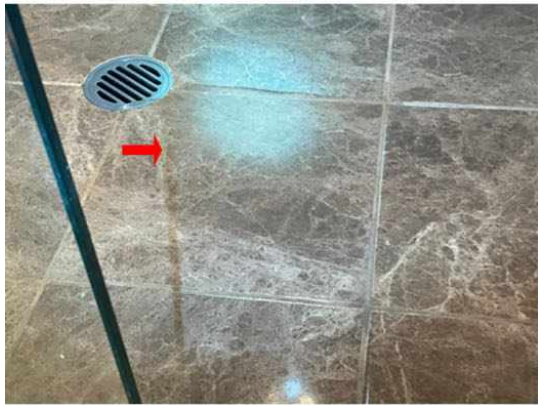
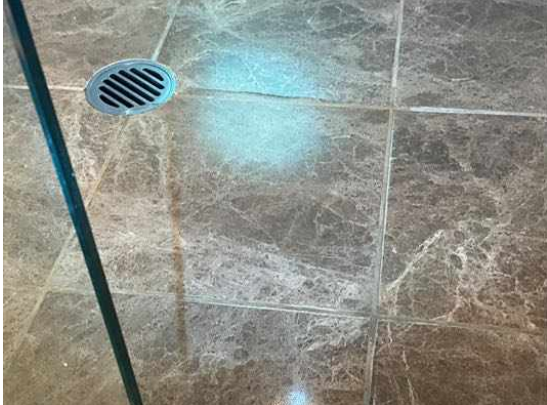
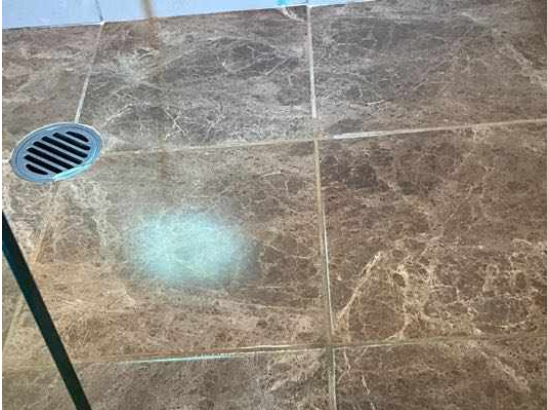
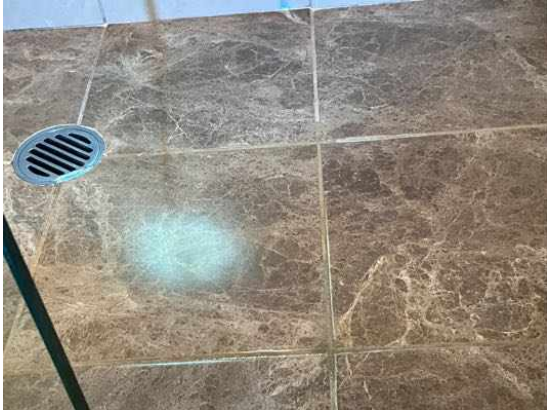
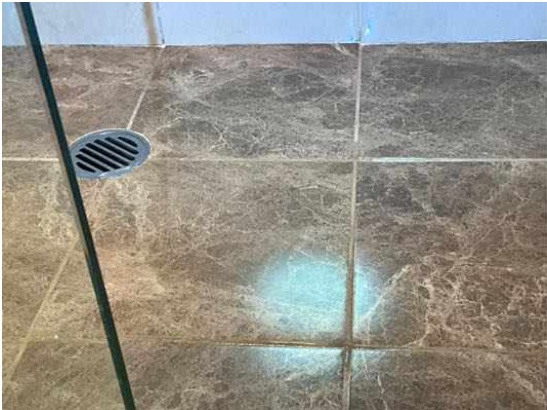
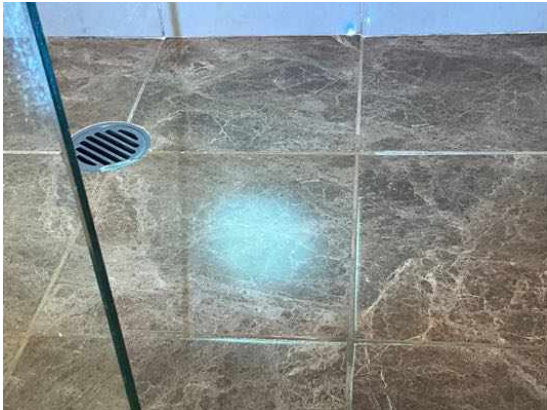
Building:	Main Building
Location:	Bathroom
Finding:	Shower base - Water pooling
Information:	Evidence of water pooling around the floor waste in the shower recess was noticed at the time of inspection. It is suspected that this excessive moisture is attributed to insufficient fall in the shower floor tiles.

This pooling is minor overall but is still considered unsatisfactory, as standard tiling practices would not permit this situation to occur. Pooling water around floor wastes can create a slip hazard in extreme cases and create conditions that are conducive to mould growth over time. Where left unmanaged, the degradation of sealant and grouting is also likely to occur, possibly necessitating further repair works.

Remedial works may involve some sections of tiling and flooring repair and replacement. A tiling contractor or bathroom specialist should be appointed to provide further advice on reparation options and to perform works as necessary.

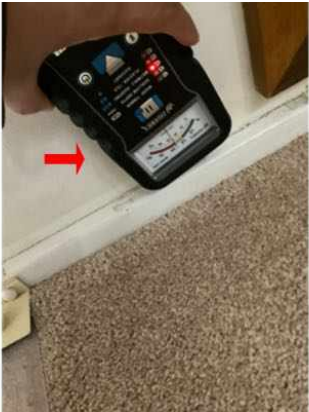
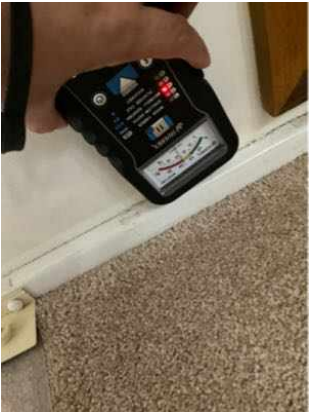
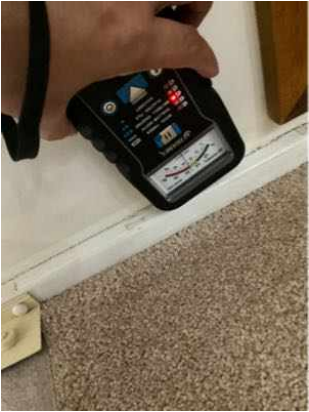
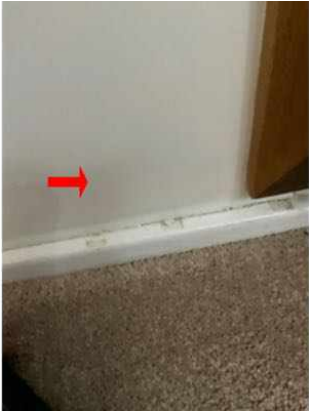
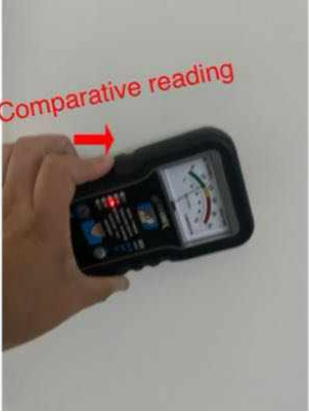
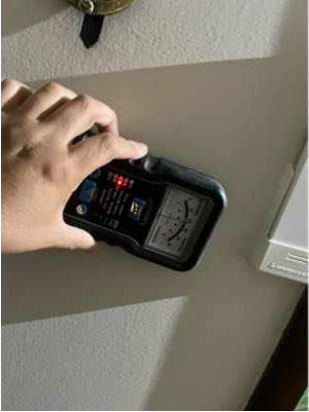
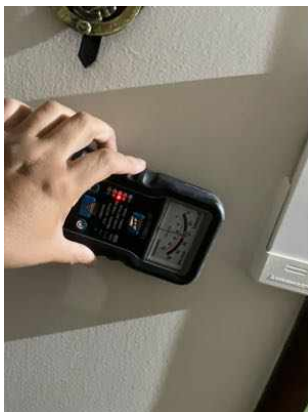
**Finding 3.08**

Building: Main Building  
Location: Living Room  
Finding: Evidence of excessive moisture - Drywall  
Information: Excessive moisture is present at the time of , indicating a potential water leakage issue within the wall.

The prolonged presence of moisture can lead to mold growth, deteriorate the structure, and create an environment conducive to health hazards. Additionally, it may compromise the adhesive holding the tiles, leading to their detachment.

A licensed plumber or a qualified contractor specializing in water damage remediation

should investigate the source of the moisture, fix any leaks, and address the damage. Additionally, replacing affected tiles and ensuring proper waterproofing are crucial to preventing future issues.

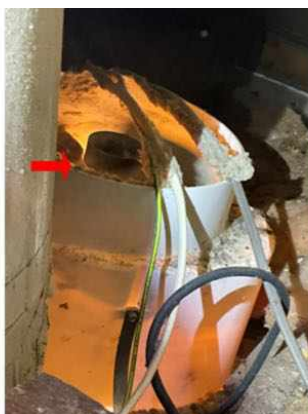
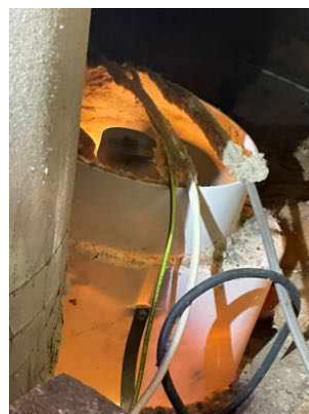
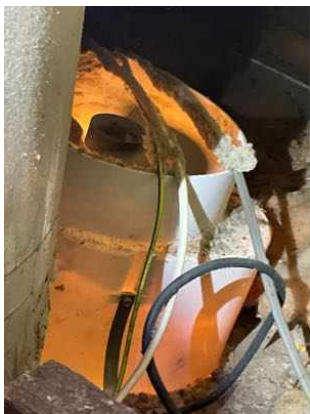
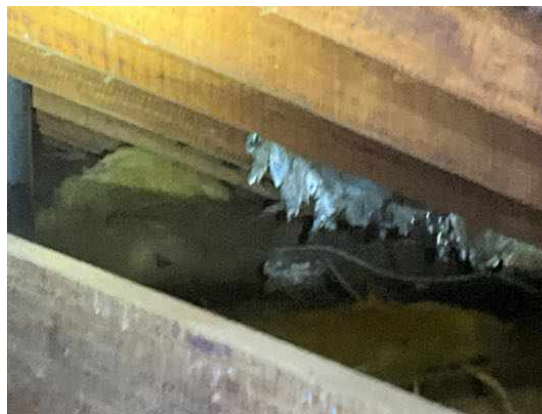
### Finding 3.09

Building:	Main Building
Location:	Roof Void
Finding:	Exhaust fan not vented out
Information:	The exhaust fan located within the roof void is not appropriately ducted to the external atmosphere and is currently discharging moist air directly into the roof space. This is considered a defect under AS 4349.1, as it does not meet the minimum standard of residential building performance expected under normal residential building practices.

This condition may lead to excessive condensation within the roof void, increasing the risk of mould growth, deterioration of insulation, timber decay, and overall reduced durability of building elements. It may also result in poor indoor air quality, potentially affecting occupant health.

It is recommended that the exhaust fan be modified by a licensed HVAC contractor or qualified builder, ensuring it is properly ducted to discharge externally in accordance with manufacturer specifications, the National Construction Code (NCC), and applicable Australian Standards.

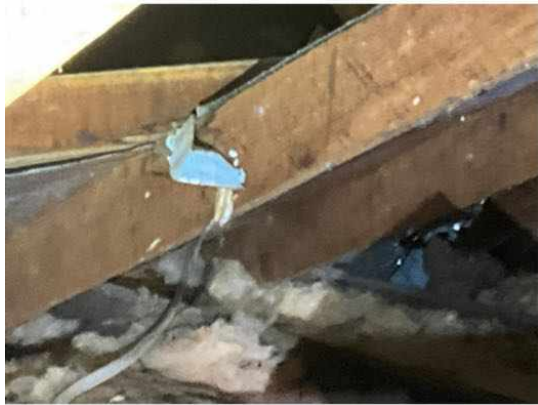
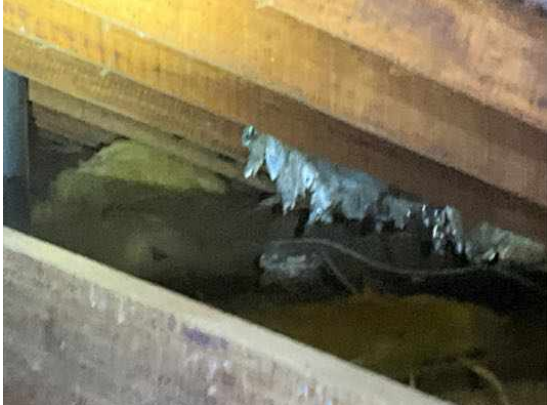
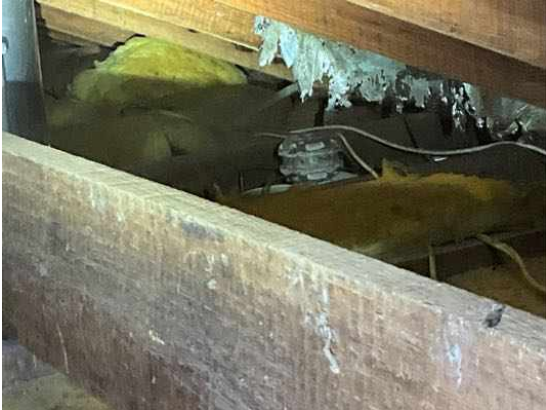
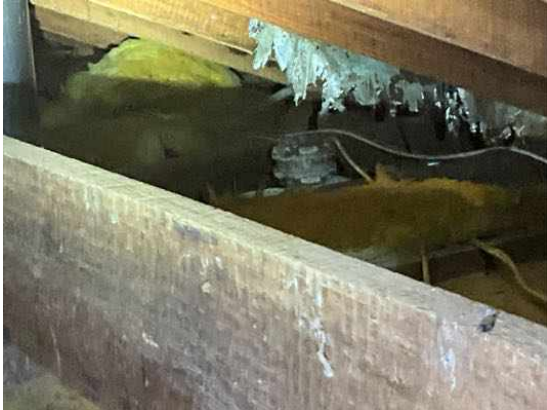
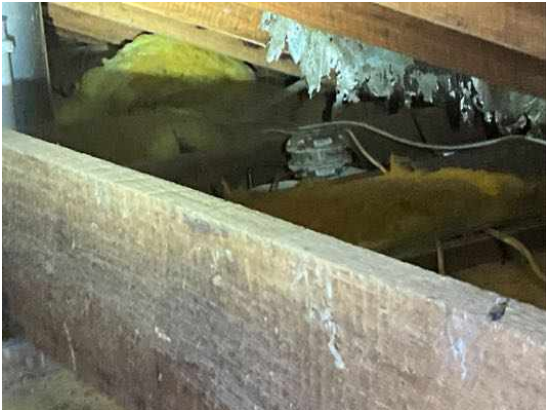
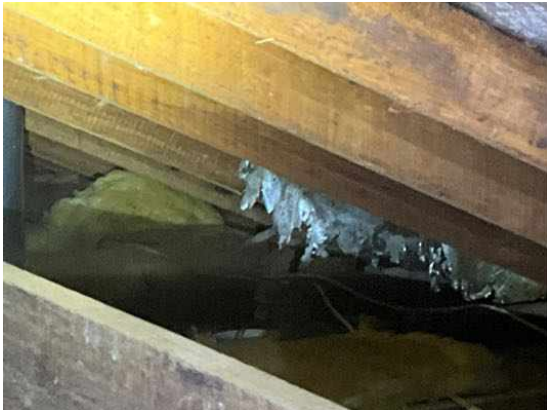
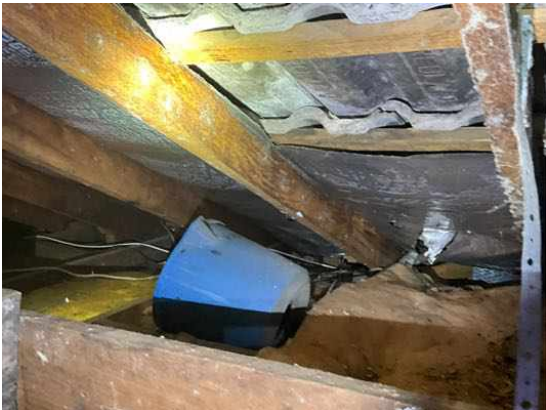
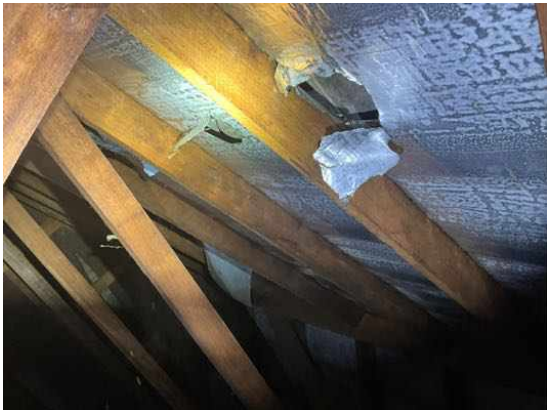
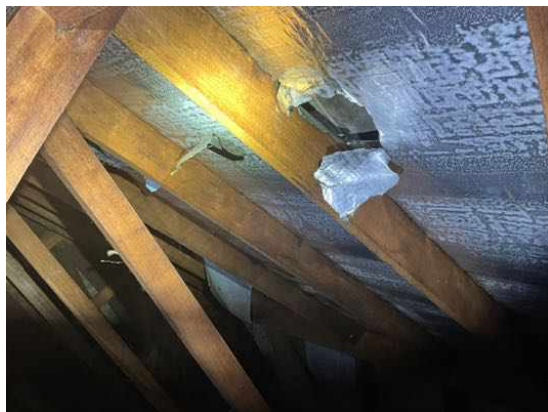
### Finding 3.10

Building:	Main Building
Location:	Roof Void
Finding:	Sarking - Damaged
Information:	Sarking, a laminated aluminium foil applied to the interior of the roof covering, assists in insulating the property and acting as a vapour-barrier to the roof void and, subsequently, to the household.

Where sarking is damaged, both insulation and moisture protection of the property are inhibited. This creates a loss of energy and thus negatively impacts the energy efficiency of the property, allowing potential for moisture ingress from condensation or leaking roof tiles.

It is important to repair any holes or damaged sections of sarking to ensure that the building material is fully functional. A registered builder or qualified carpenter should be consulted to provide further advice on this defect and to perform rectification works at client discretion.

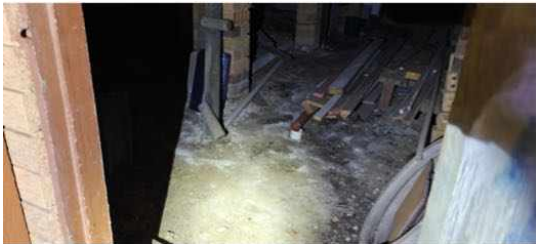
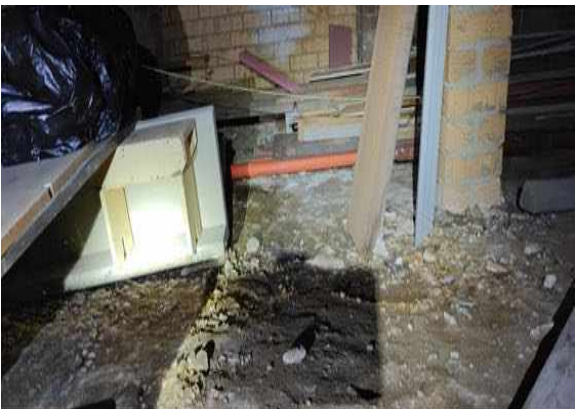
### Finding 3.11

Building: Main Building  
 Location: Subfloor  
 Finding: Subfloor - Site drainage - Inadequate  
 Information: The site exhibits poor drainage under the subfloor, leading to several critical issues. Water accumulates and does not properly drain away from the subfloor area, creating a hazardous condition.

1. Frequent water pooling and stagnation under the subfloor.
2. Risk of subfloor structural damage due to prolonged moisture exposure.
3. Potential for mold and mildew growth, compromising indoor air quality and a potential of Termite attack.
4. Safety hazard for occupants due to slippery surfaces and potential electrical hazards.

The poor site drainage under the subfloor poses a significant safety risk to the occupants, as it can lead to structural damage and health hazards.

This issue requires immediate attention and rectification. A licensed and experienced plumber or licensed builder specialising in drainage and foundation work should be engaged to assess the problem and implement necessary drainage solutions, such as improved grading, installation of drainage systems, and moisture barrier enhancements. Regular maintenance and inspections should also be scheduled to prevent future occurrences. Water damage and secondary defects are likely to occur if left unmanaged.

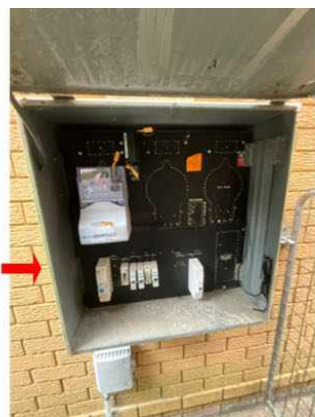
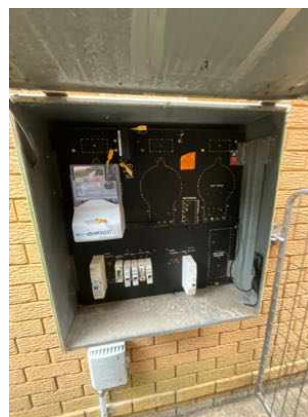
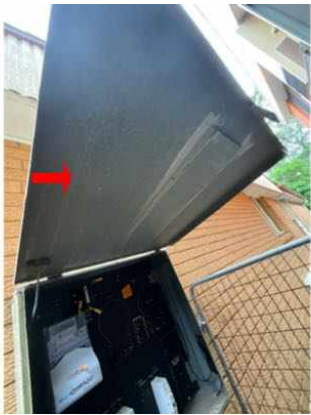
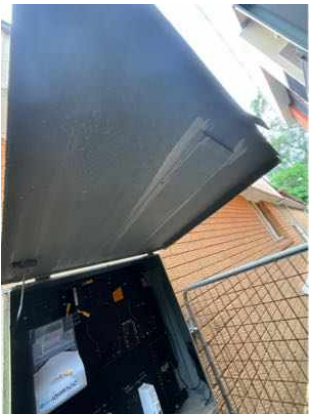
Building: Main Building  
Location: Exterior walls - right side  
Finding: No Evidence of Termite Management System - Durable notice / Legible Sticker  
Information: The application of a pre & post-construction chemical termite barrier is highly recommended for all properties. Such barriers are highly effective in preventing termite attack on any timber building elements throughout the property.

A durable notice was not placed in the switchboard unit to indicate current termite barriers is legible at the time of inspection.

Client must seek further information from the vendor or real estate agent if the conditions of termite management systems were maintained.

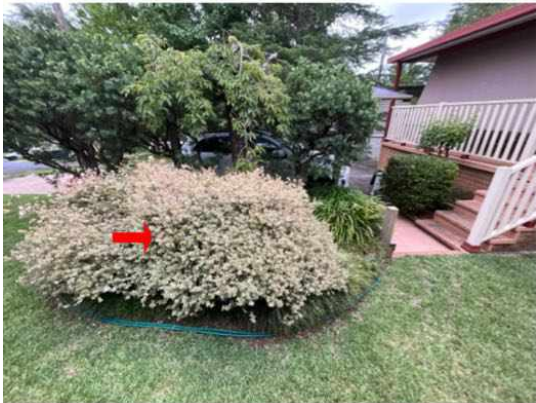
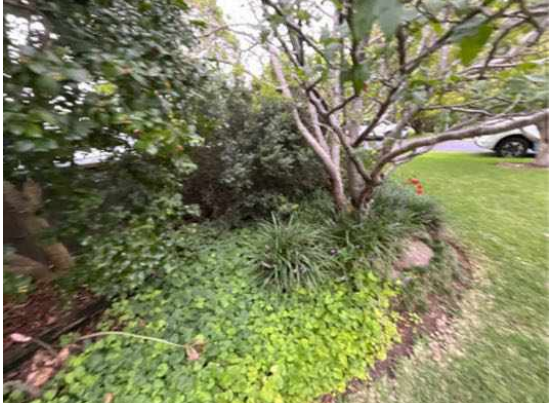
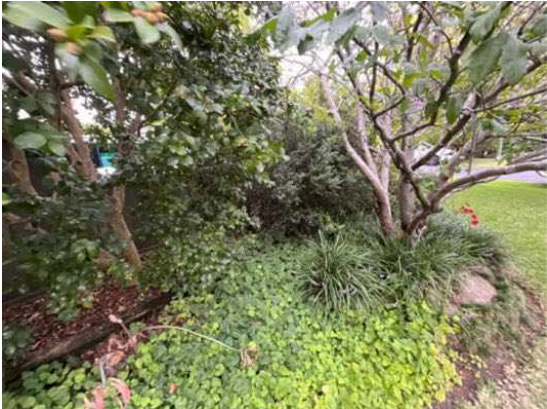
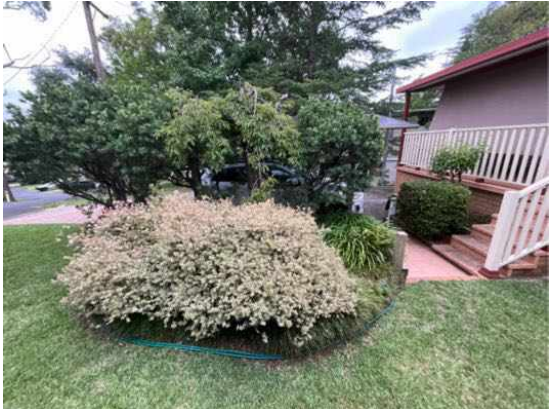
**Finding 6.02**

Finding: Dense vegetation around a property can increase the risk of termite infestation

Information: The presence of dense vegetation around a property can increase the risk of termite infestation, as it provides a conducive environment for them. To address this, consider maintaining a clear space between the vegetation and your home. If you suspect a termite issue, it's advisable to consult with a licensed pest control professional for inspection and treatment.

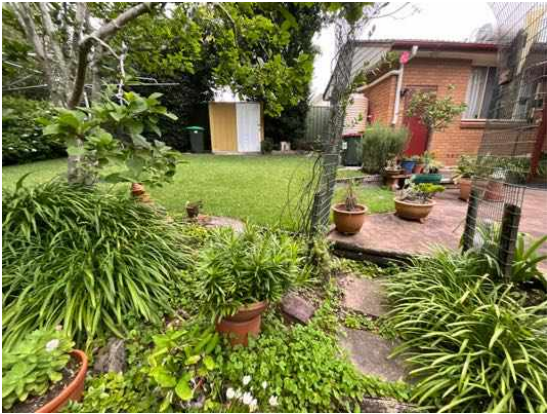
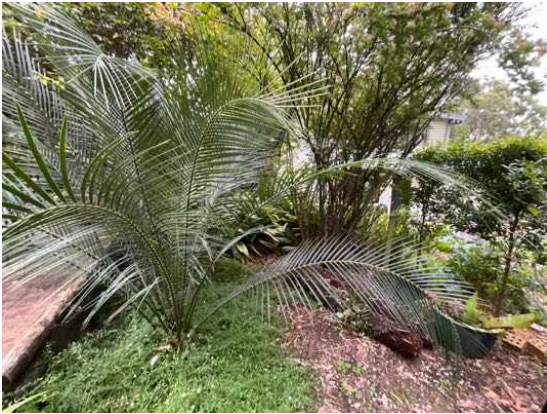
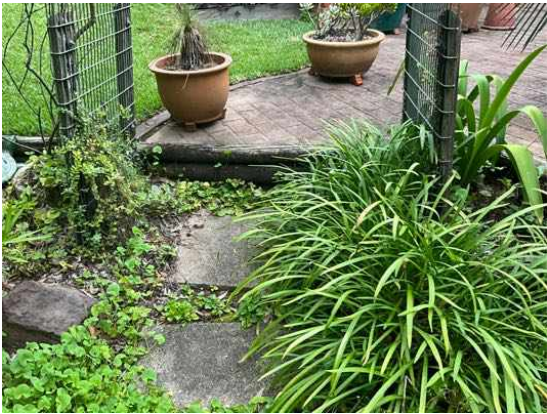
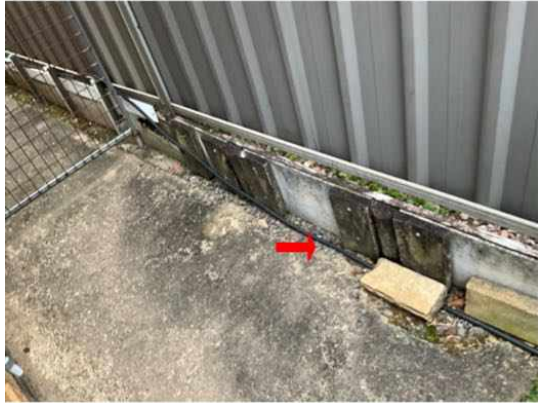
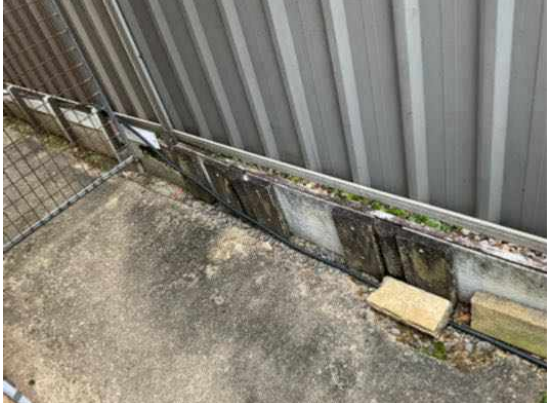
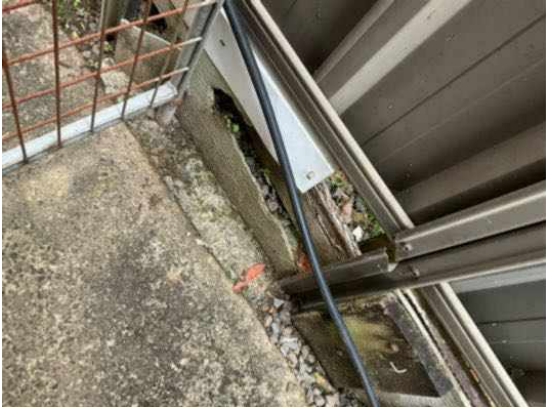
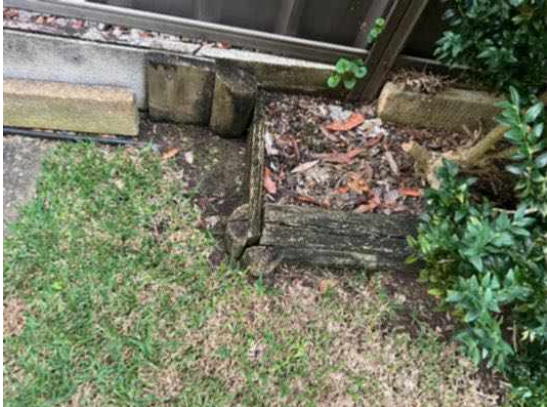
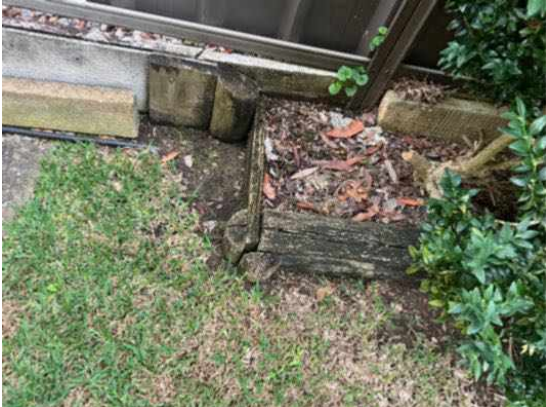
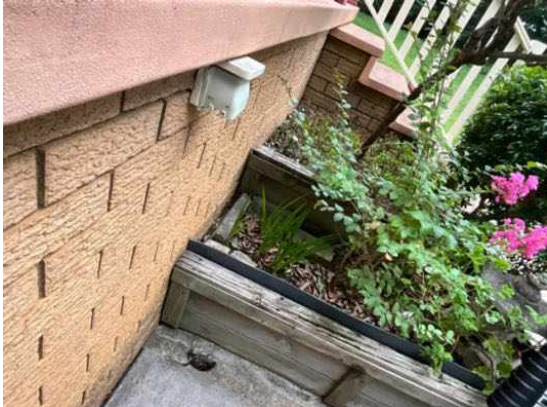
Finding 6.03

Building: Main Building  
Location: All Areas  
Finding: Timber on ground / conducive conditions to termite damage  
Information: Timber on the ground is indeed conducive to termite damage. Termites are known to thrive in moist environments, and wood in contact with soil or moisture is more susceptible to infestation.

To prevent this, it's important to keep timber elevated and away from direct ground contact. Regular inspections and proper termite control measures are also essential to protect your wooden structures from termite damage.

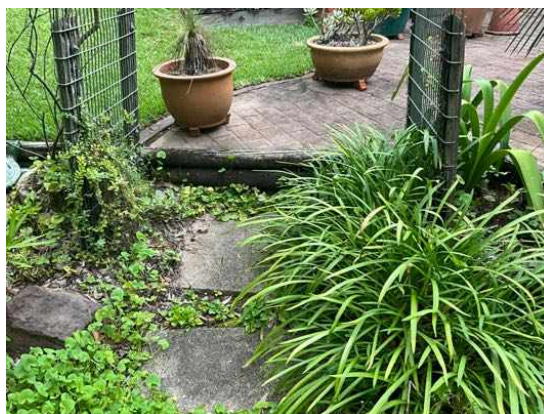
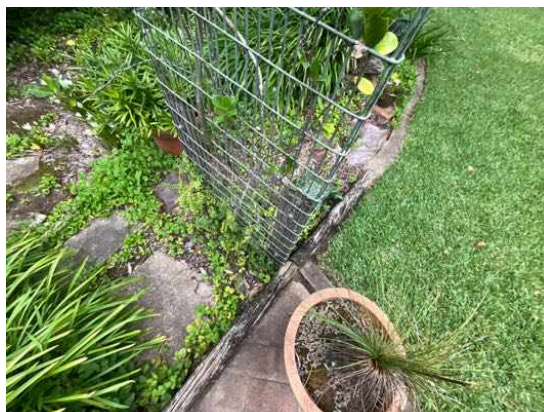
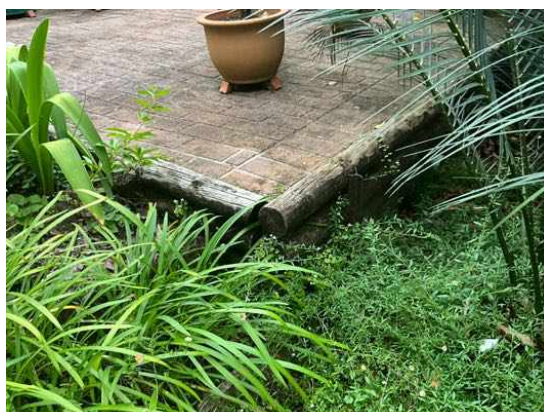
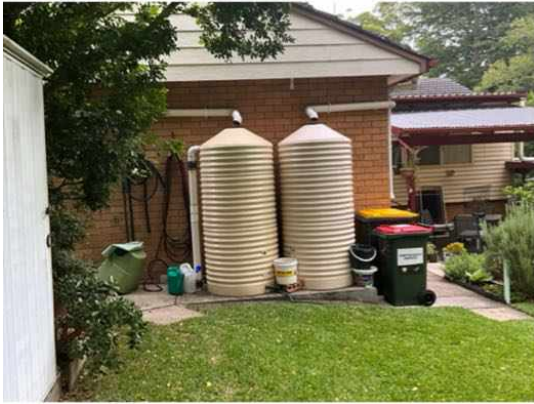
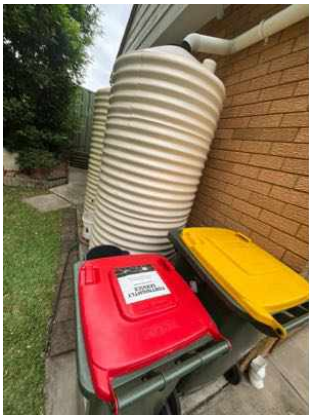
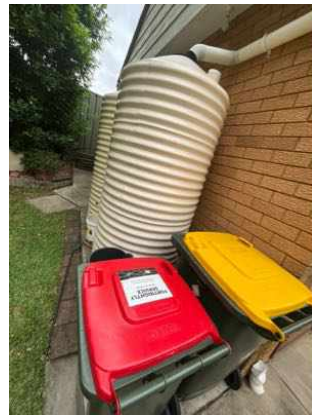
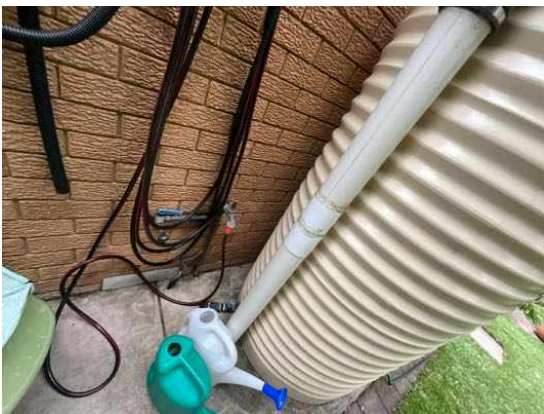
### Finding 6.04

Building: Main Building  
 Location: All Areas  
 Finding: Bridging or Obstruction Conducive environment for Termites  
 Information: Bridging of termite barriers occurs when termites bridge (usually by building a mud tunnel) a termite barrier or inspection zone or where termites have a passage, allowing them to bridge the barrier.

property in a concealed or undetected manner.

Recommended moving obstructions away from the external walls for further and future inspections.

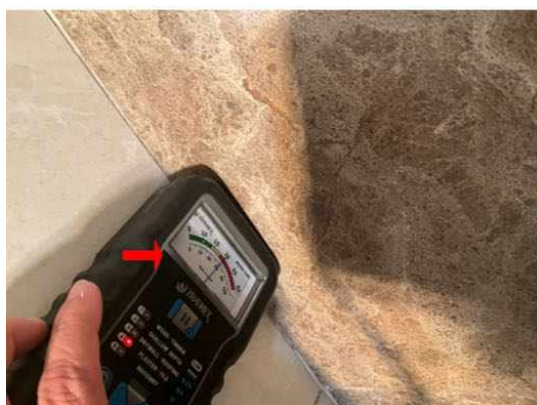
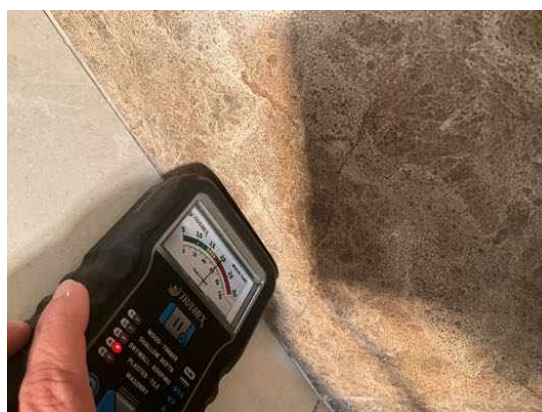
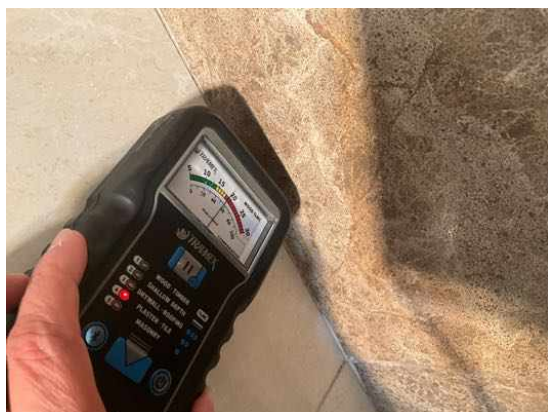
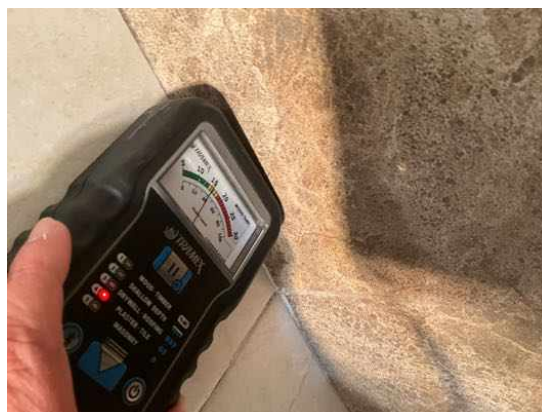
### Finding 6.05

Building:	Main Building
Location:	Bathroom
Finding:	Evidence of excessive moisture was present at the time of inspection
Information:	Excessive moisture is present behind the bathroom tiles, indicating a potential water leakage issue within the wall.

The prolonged presence of moisture can lead to mold growth, deteriorate the structure, and create an environment conducive to health hazards. Additionally, it may compromise the adhesive holding the tiles, leading to their detachment.

A licensed plumber or a qualified contractor specializing in water damage remediation should investigate the source of the moisture, fix any leaks, and address the damage. Additionally, replacing affected tiles and ensuring proper waterproofing are crucial to preventing future issues.
