## Building and Timber Pest Inspection Report

Inspection Date: Fri, 13 Feb 2026

Property Address: 34 Catherine Cres, BLAXLAND, NSW, 2774,  
Australia

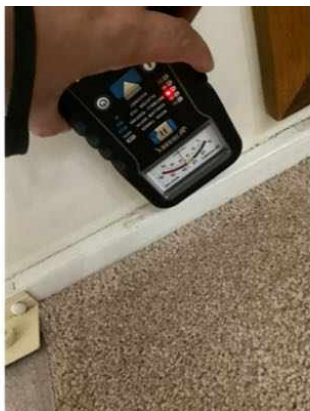
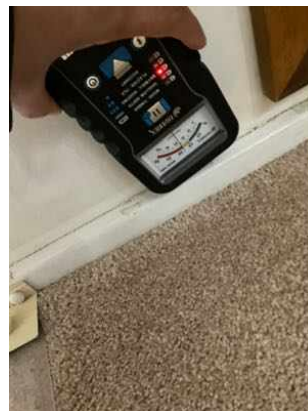
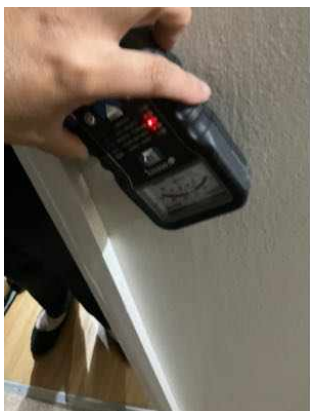
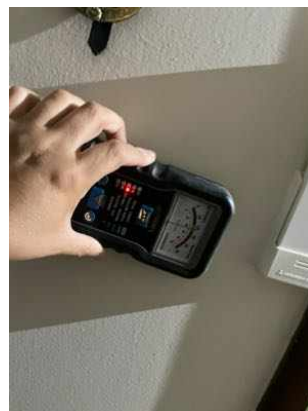
### Finding 6.06

Building:	Main Building
Location:	Living Room
Finding:	Excessive moisture - Conducive to Timber pest
Information:	Excessive moisture can attract termites and produce conditions that promote fungal growth and wood decay.

Excessive moisture is generally caused by deteriorated inadequate or missing roof drainage leaking plumbing pipes or fixtures poorly plumbed HWS overflows or condenser units and poor site drainage.

Prior to any remedial works being performed a qualified plumber should be appointed to further inspect the property and to identify the cause of the excessive moisture. Works to remove affected building elements may then be necessary and should be performed by an appropriate tradesperson.

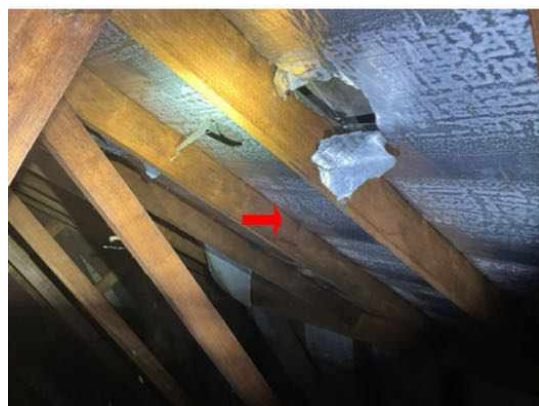
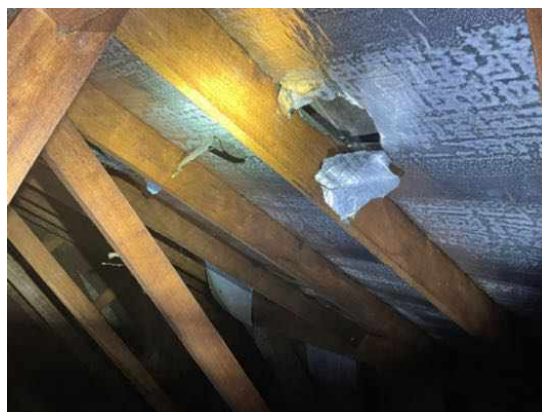
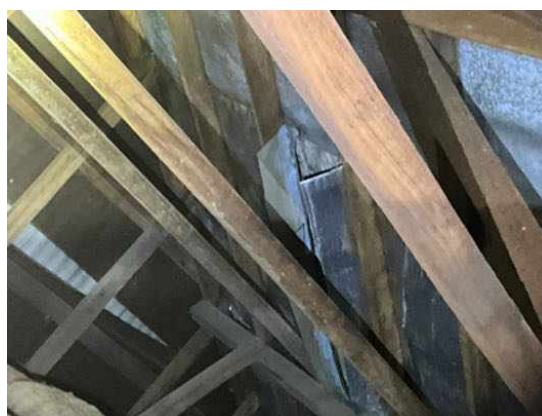
### Finding 6.07

Building:	Main Building
Location:	Roof Void
Finding:	Roof void exhibits conspicuous signs of excessive moisture
Information:	The roof void exhibits conspicuous signs of excessive moisture, evident through water staining within the sarking material.

Risk in Terms of Timber Pest: The excessive moisture within the roof void poses a significant risk for timber pests such as termites, as it creates an ideal environment for infestation and proliferation. The damp conditions promote wood decay, making the structure susceptible to damage by these pests.

A qualified roofing contractor and a professional pest control service specialized in timber pest management should be engaged to rectify the issue. They can assess the extent of moisture damage, address any underlying structural issues, and implement effective solutions to mitigate the risk of timber pest infestation.

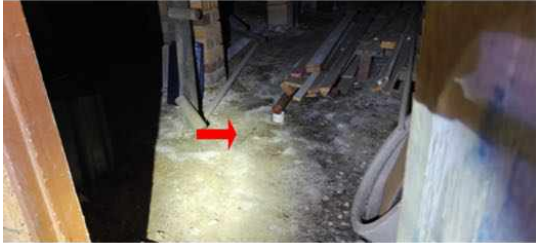
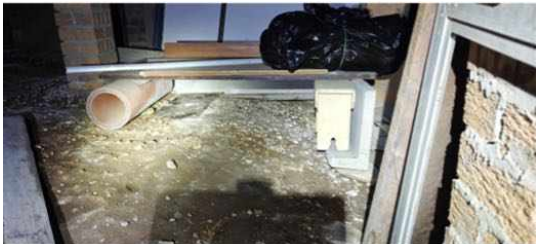
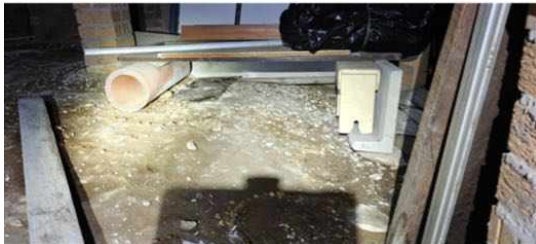
### Finding 6.08

Building:	Main Building
Location:	Subfloor
Finding:	Subfloor - poor ventilation, inadequate site drainage, water stains
Information:	The subfloor lacks adequate ventilation, suffers from inadequate site drainage, exhibits water stains, creating conducive conditions for timber pests such as termites.

Risk: The combination of poor ventilation, inadequate drainage, water stains significantly increases the risk of timber pest infestations. Termites are attracted to moist environments and can thrive in subfloors with high humidity levels and water damage. The lack of proper ventilation and drainage exacerbates moisture retention, providing an ideal habitat for timber pests to establish colonies and cause extensive damage to the subfloor structure. Additionally, water stains indicate previous or ongoing moisture issues, which further attract timber pests and contribute to the deterioration of timber materials.

A licensed pest control professional specializing in timber pest management should be consulted to assess the extent of the infestation and develop a comprehensive treatment plan. They can implement strategies to eliminate existing timber pests, such as termites and prevent future infestations by addressing underlying moisture issues. Additionally, a qualified plumber or builder may be needed to improve subfloor

ventilation, enhance site drainage, repair water-damaged areas. Regular inspections and maintenance are essential to ensure ongoing protection against timber pests and maintain the structural integrity of the subfloor.

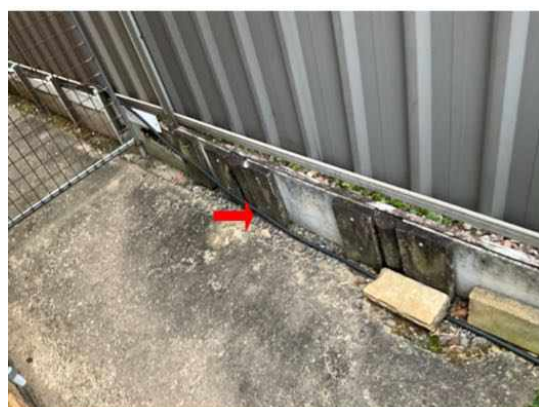
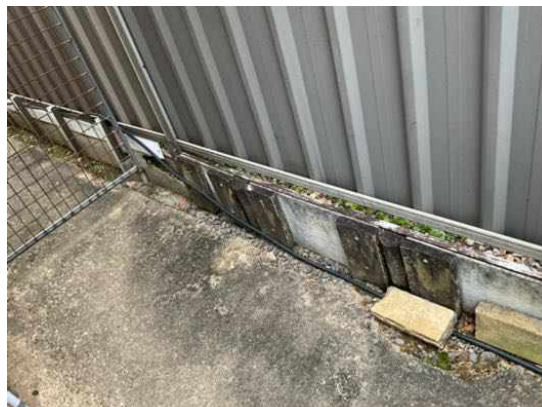
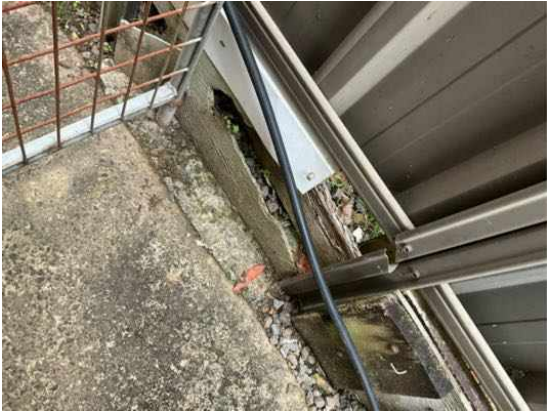
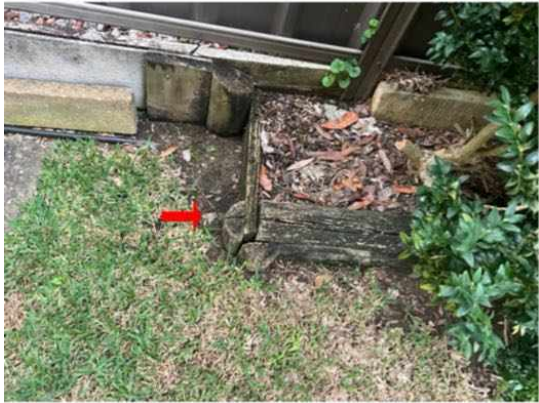
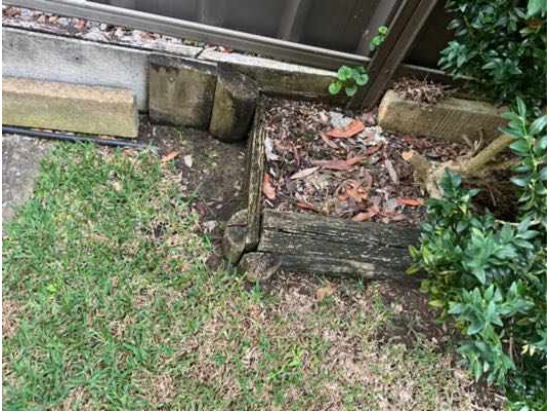
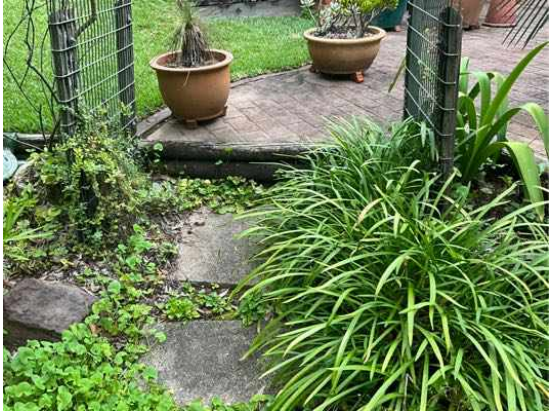
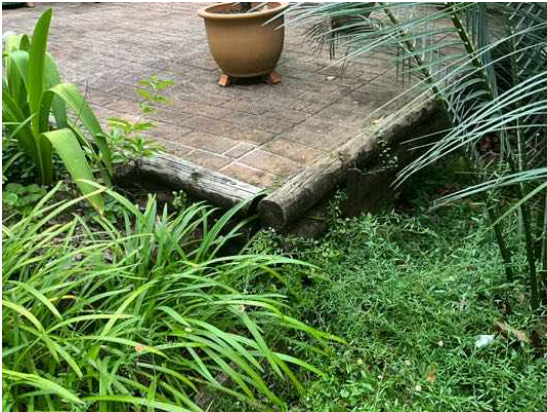
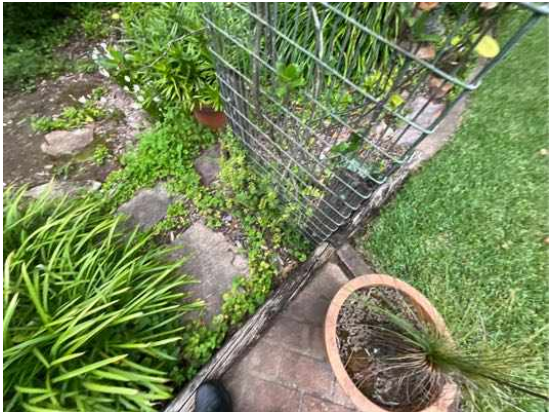
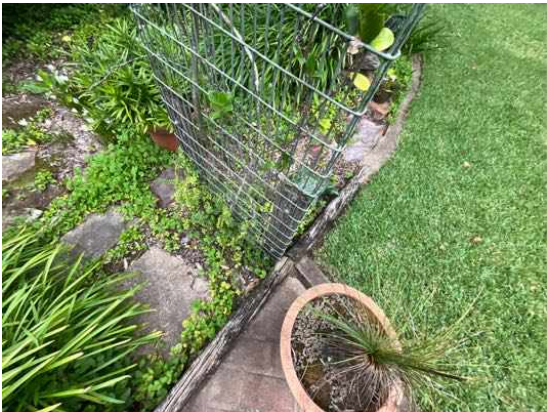
### Finding 7.01

Building:	Main Building
Location:	All Areas
Finding:	Wood rot
Information:	This building element shows evidence of wood rot. Wood rot, also known as Fungal Decay, occurs when timbers and other cellulose building materials are exposed to damp conditions on an ongoing basis. This could be the result of exposure to weathering over a prolonged period of time, or the attraction of excessive moisture from other abutting building materials. Contributing factors also include poor air ventilation in the area.

Wood rot is often associated with general damp problems and is evidenced by a 'musty' smell or mould and mildew occurring on surfaces. If left unmanaged, damp conditions can lead to further health problems and the decay of timbers will continue.

Early intervention and regular maintenance, particularly of exterior timbers, will prolong the useful life of these building elements. Prior to any works being performed, the cause of the moisture that has created the visible wood rot should be identified and addressed in a suitable manner. Replacement of affected timbers may then be a necessary step in protecting surrounding building elements from such deterioration.

A qualified plumber may be appointed to assess the cause of excessive moisture and to provide advice on any remedial works as required. A qualified carpenter or registered builder may also be required to replace affected building materials.

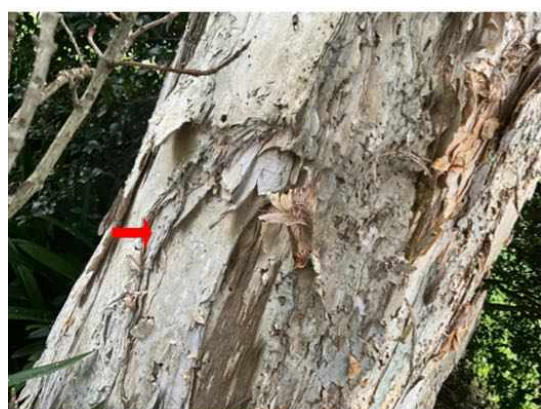
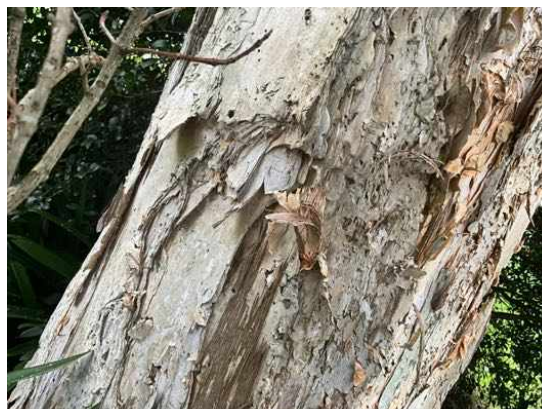
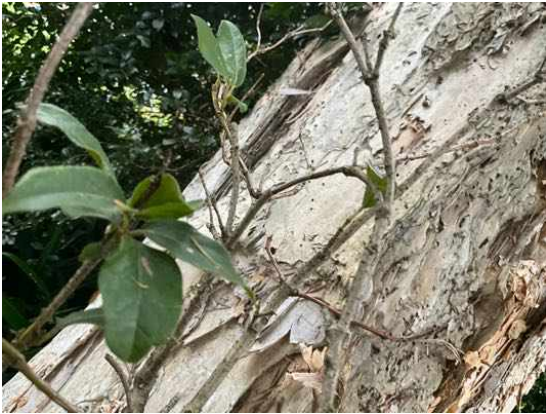
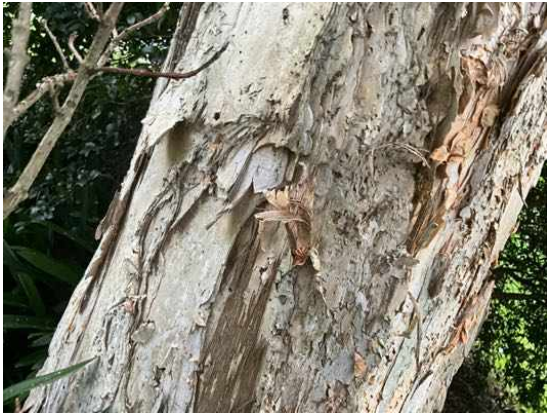
### Finding 8.01

Building: Main Building  
 Location: Yard - Back  
 Finding: Wood Borer Activity - Trees  
 Information: Numerous small to medium-sized exit holes and surface tunnelling marks were noted along the trunk and branches of a dead standing tree. The pattern and shape of the damage are consistent with wood borer infestation. No live activity was observed at the time of inspection, though damage is clearly evident.

- The tree maybe structurally compromised and may pose a fall or safety hazard, especially during wind events.
- Proximity to structures or power lines may increase the risk of damage or injury.
- Although native borers are not typically a threat to treated structural timbers, their presence indicates decay and weakened wood that could attract secondary pests.

- Engage a qualified arborist to assess the structural integrity of the tree and arrange for safe removal if required.
- If the tree is within falling distance of a building, fence, or utility infrastructure, urgent removal is recommended.
- Regular site monitoring is advised for surrounding trees to detect any early signs of similar pest activity.

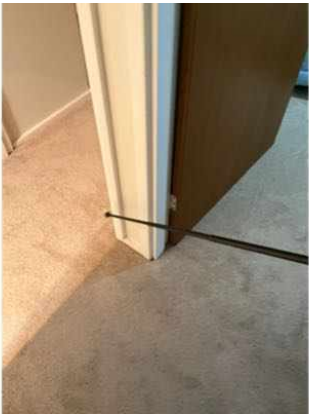
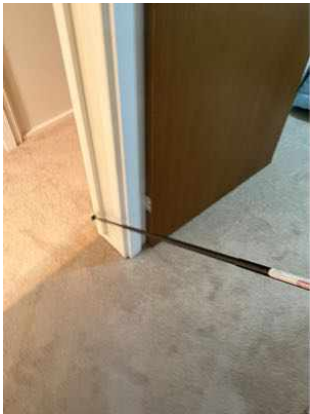
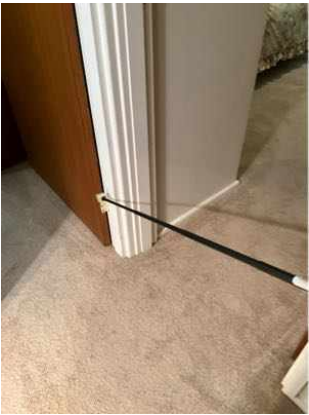
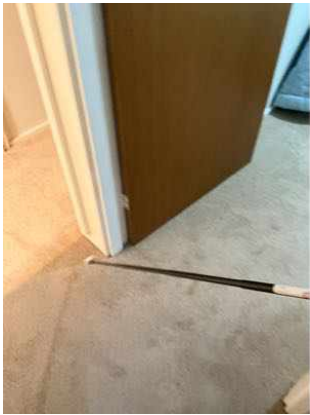
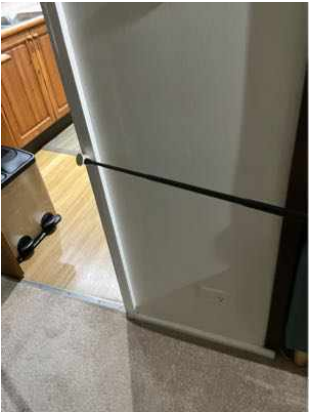
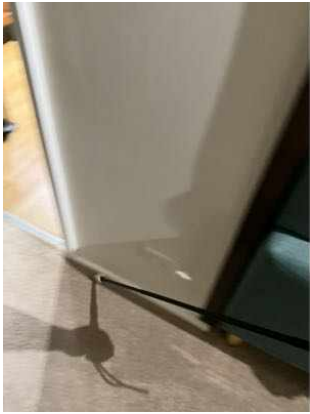
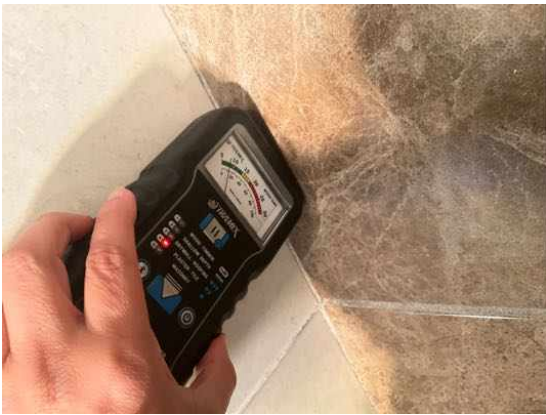
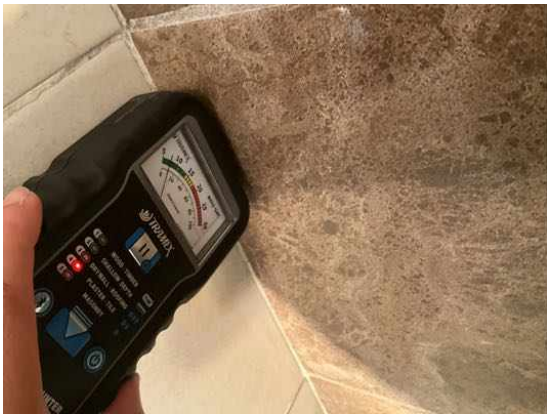
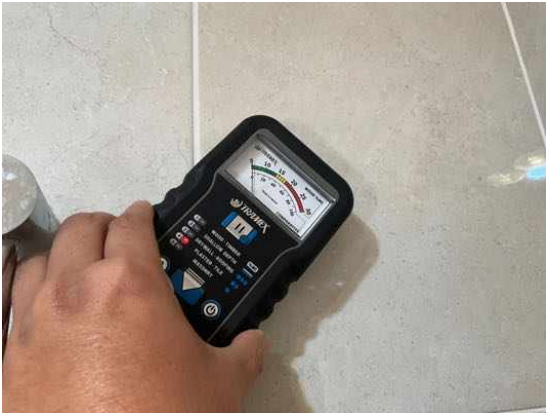
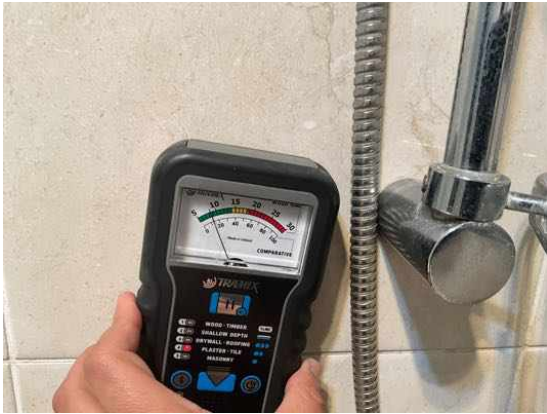
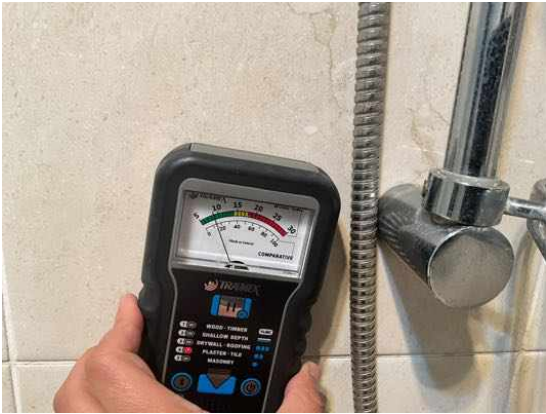
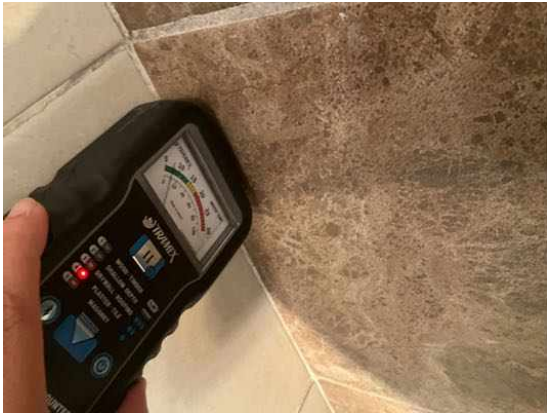
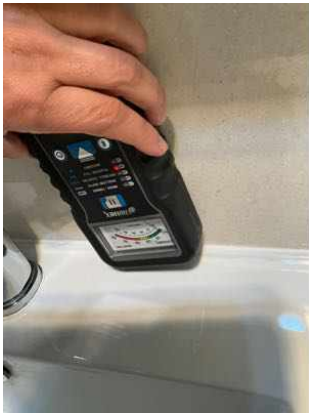
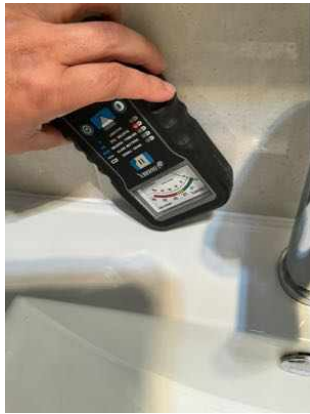
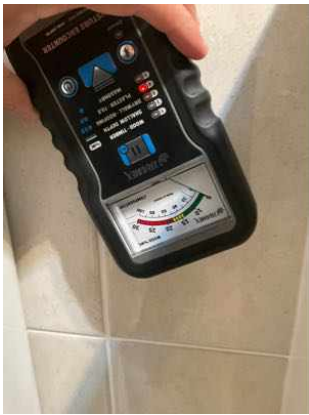
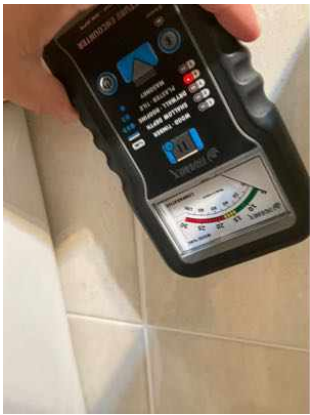
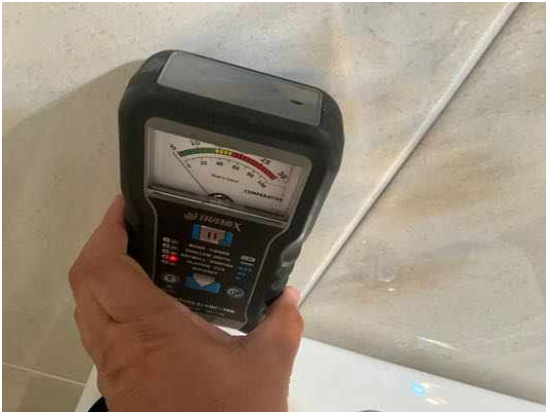
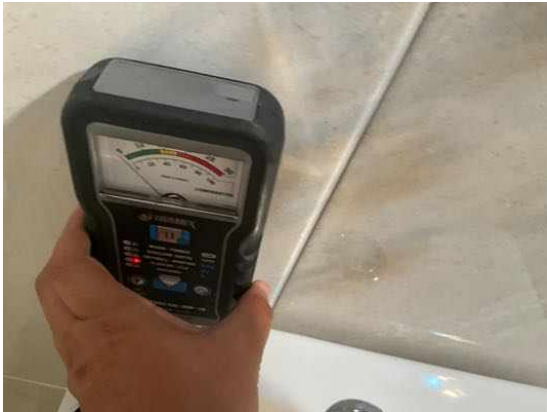
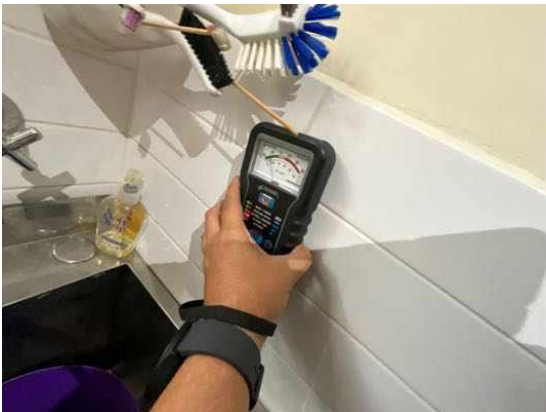
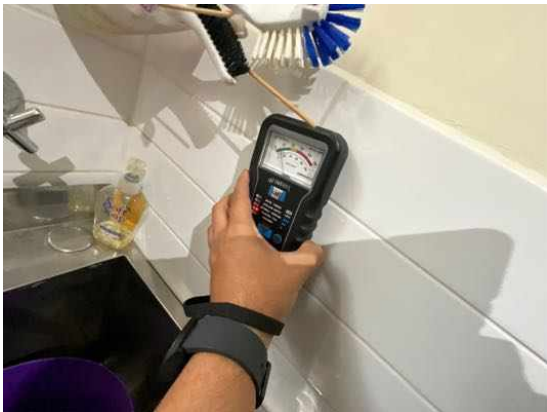
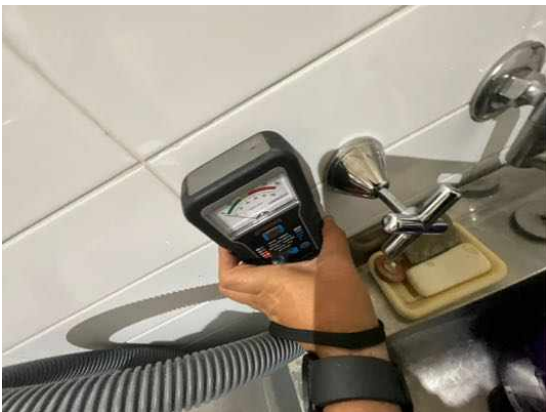
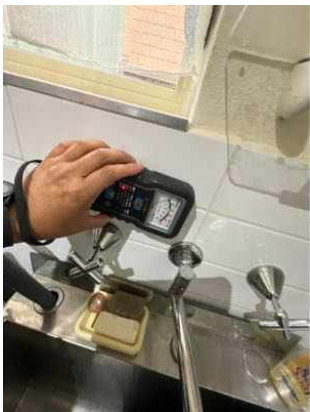
Building: Main Building  
Location: All Areas  
Finding: Additional Photos  
Information: Additional photos are provided for your general reference

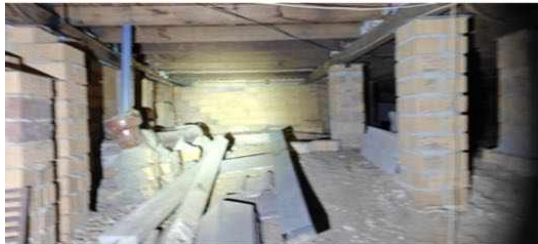
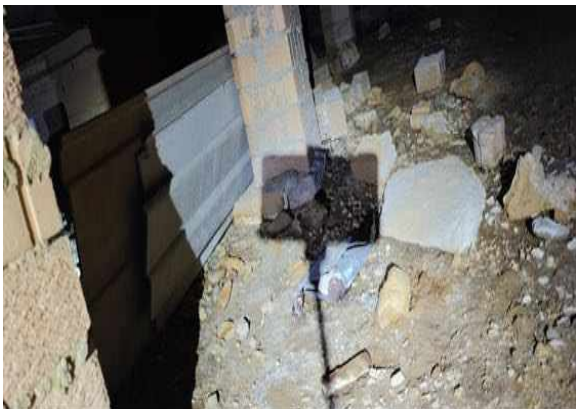
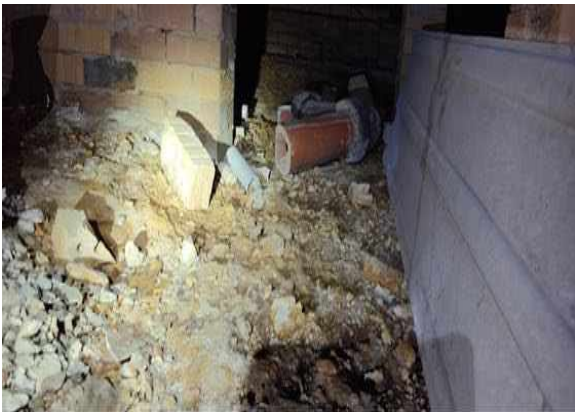
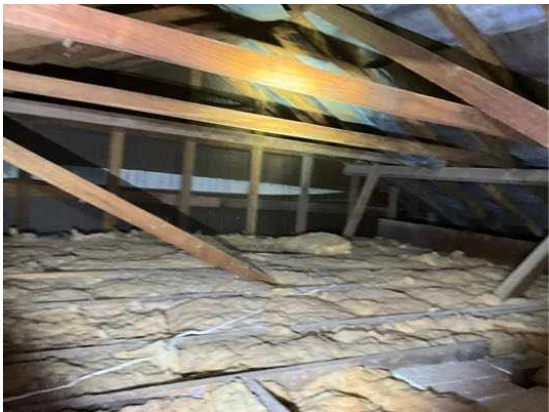
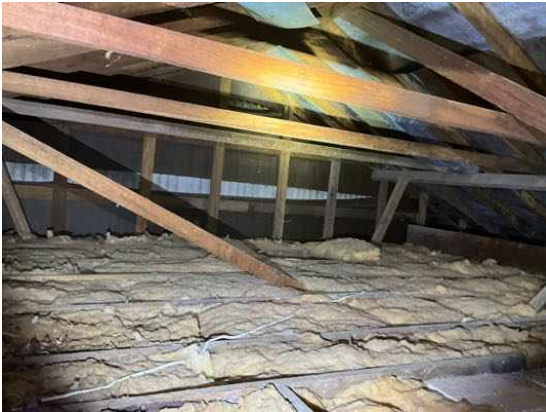
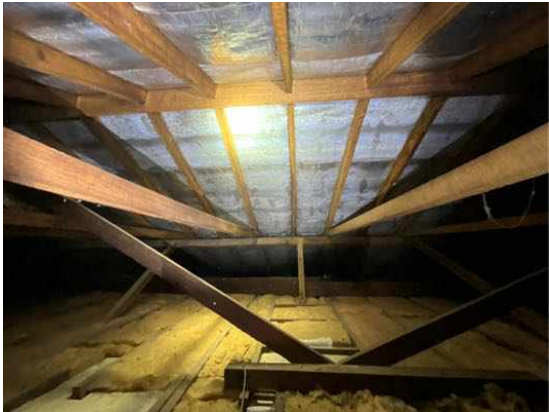
Building:	Main Building
Location:	All Areas
Finding:	Additional Photos - Obstructions and Limitations
Information:	These photographs are an indication of the obstructions and limitations which impeded full inspection of the property at the time of inspection. These obstructions can hide an array of defects and should be removed to allow full inspection to be carried out. A re-inspection is recommended once the areas are made accessible.
