Building Inspection Report

Inspection Date: Sat, 21 Feb 2026

Property Address: Unit 2/92 Roberts St, WEST FOOTSCRAY,
VIC, 3012, Australia

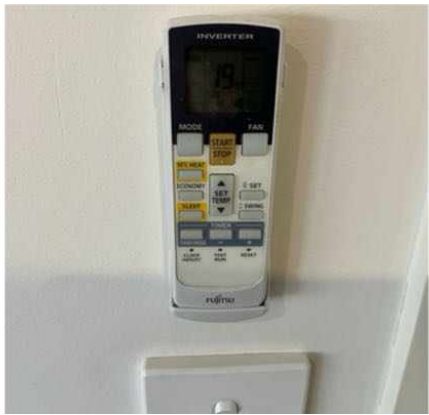
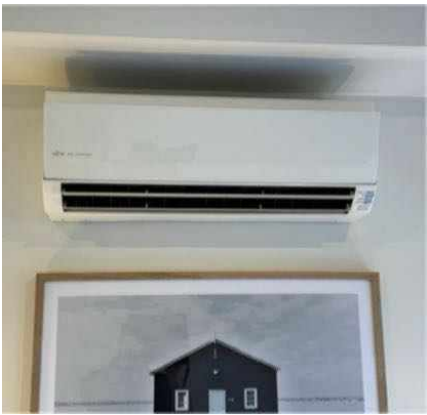
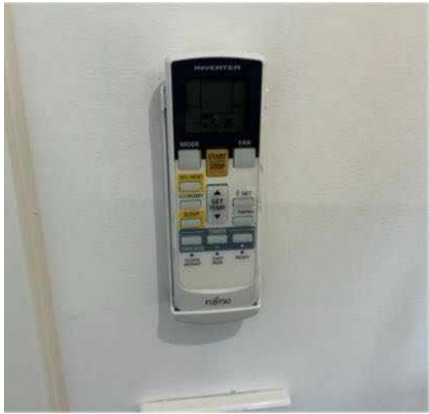
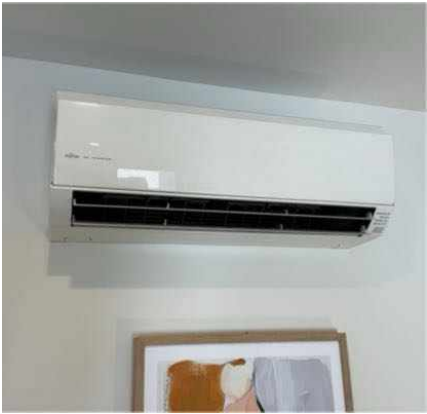
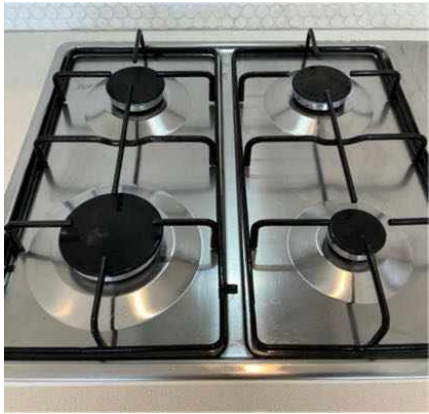
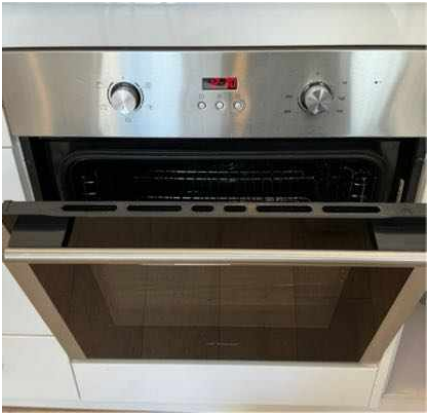
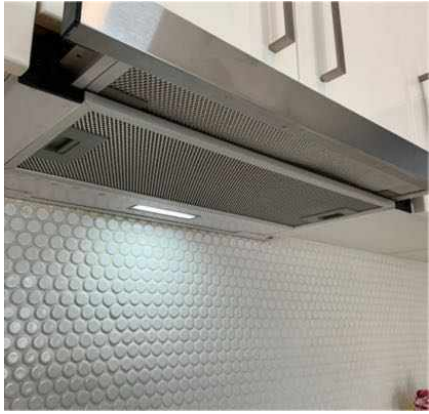
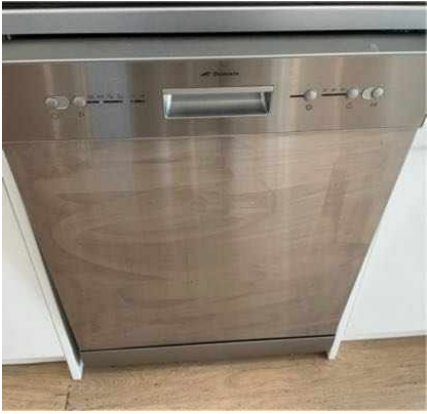
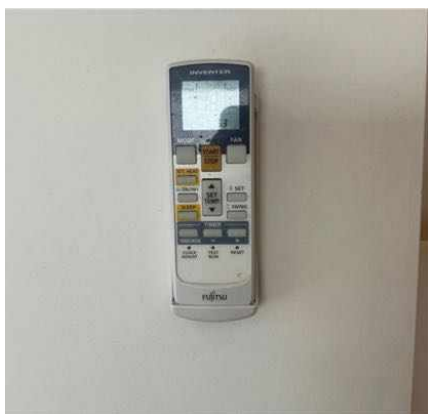
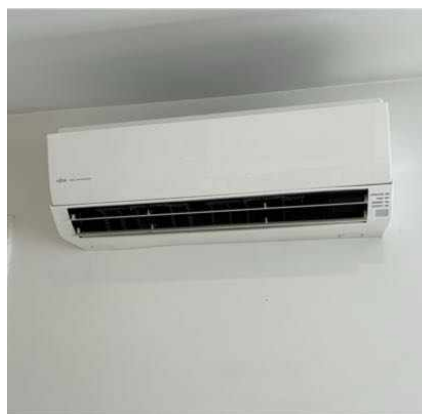
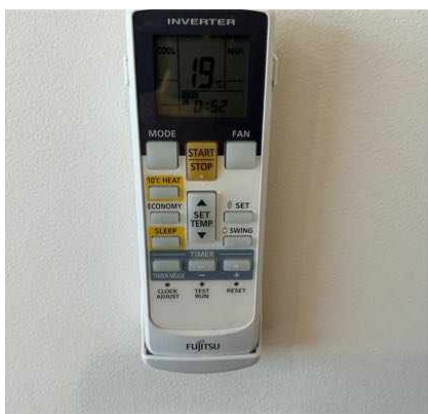
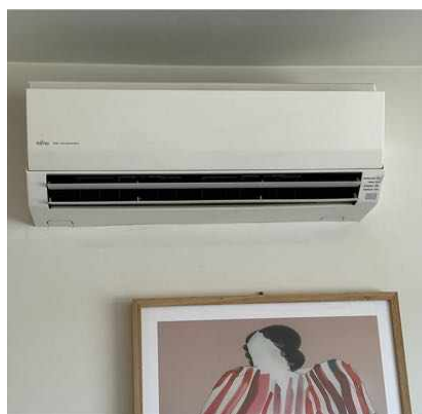
- Confirm inclusions with the sales contract to ensure all appliances and the reverse cycle air conditioner are covered.
- Retain user manuals and warranty information where available.
- Re-test all appliances and the air conditioning system upon settlement and prior to first use, as function may vary with time, load, or power supply conditions.
- Engage a licensed electrician or suitably qualified appliance or air conditioning technician to conduct a safety and performance check, particularly if installation dates, service history, or compliance documentation are unknown.

While the appliances and reverse cycle air conditioner were operational during the inspection, it should be noted that a full performance test was not conducted, and future performance or safety compliance cannot be guaranteed.
