# Building and Timber Pest Inspection Report

Inspection Date: Mon, 9 Mar 2026

Property Address: 143 St Killian St, White Hills VIC 3550,  
Australia

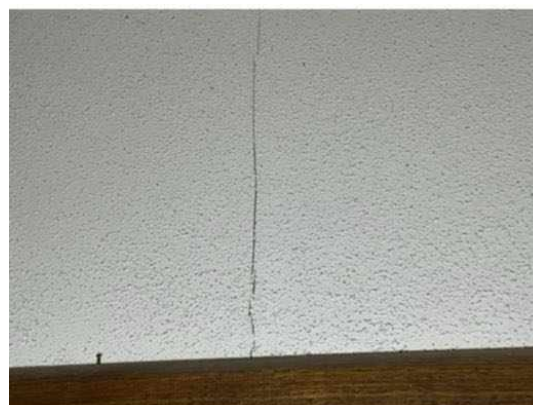
Building:	Building 1
Location:	Hall, bed 3
Finding:	Cracking - Damage Category 2 - Noticeable (up to 5mm)
Information:	Noticeable cracks are a common occurrence as a result of many primary defects. Such causes may include age, general wear and tear, expected building movement, general expansion/contraction of building materials in different weather conditions, and/or minor failings in the installation or application of building materials.

Noticeable cracks may result in minor sticking or jamming of associated doors and windows, which require easement. However, noticeable cracks are easily filled and repaired. A plasterer can be consulted to install an expansion joint at this point to allow for this movement during different weather conditions.

Monitoring of all cracking should be conducted frequently. Always contact a building inspector should cracks widen, lengthen, or become more numerous. Additionally, your building inspector should also be contacted if associated building elements such as doors and windows become more difficult to operate over time.

Relevant tradespeople, such as carpenters, painters and plasterers, should be appointed to perform remedial works, as deemed necessary.

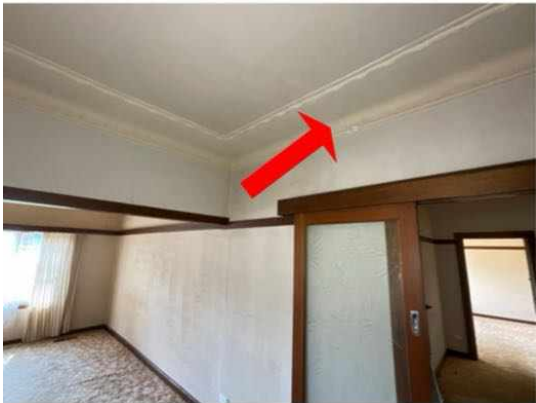
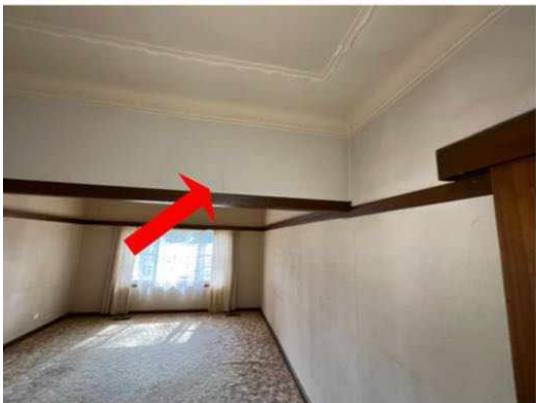
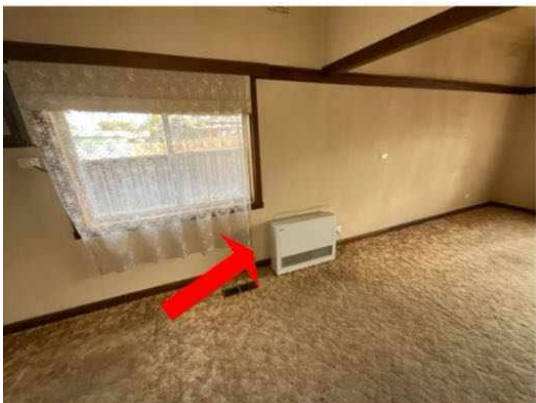
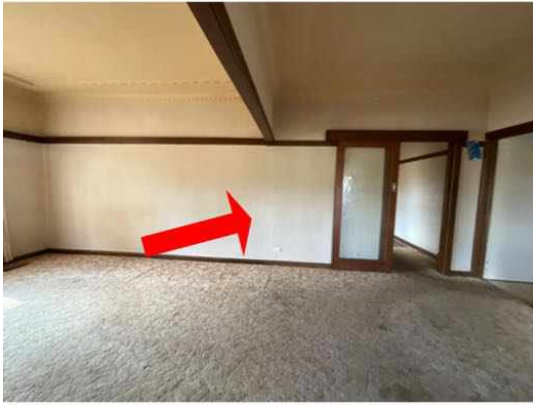
### Finding 3.05

Building:	Building 1
Location:	Living Room
Finding:	Cracking - Damage Category 1 - Fine (up to 1mm)
Information:	Although fine cracks are quite noticeable, they are often only considered to be an appearance defect, and usually do not indicate any structural damage. Generally, the cause of a fine crack is indicative of a separation between building materials and finishes (e.g. paint, plaster, etc.) along joins.

Cracking of this nature can generally be repaired with minor sanding, filling and/or repainting. Such works should be performed by a qualified painter or a general handyman.

Monitoring of all cracking should be conducted frequently. Always contact a building inspector should cracks widen, lengthen, or become more numerous.

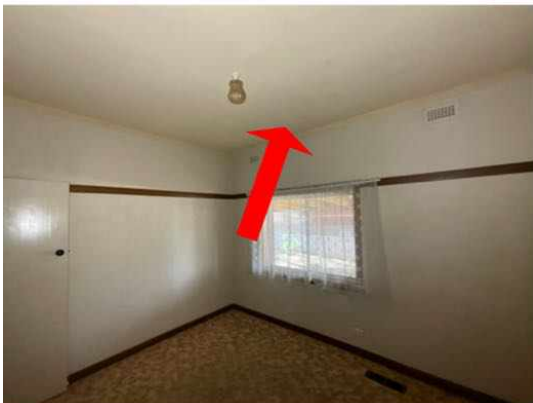
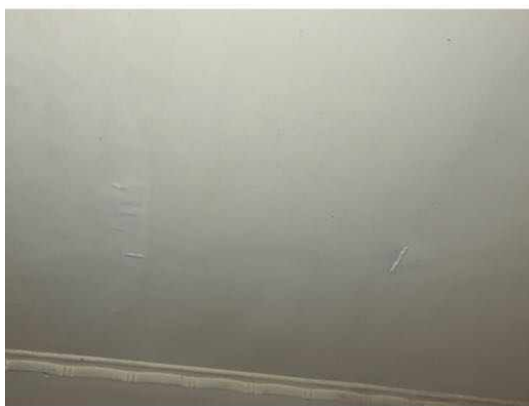
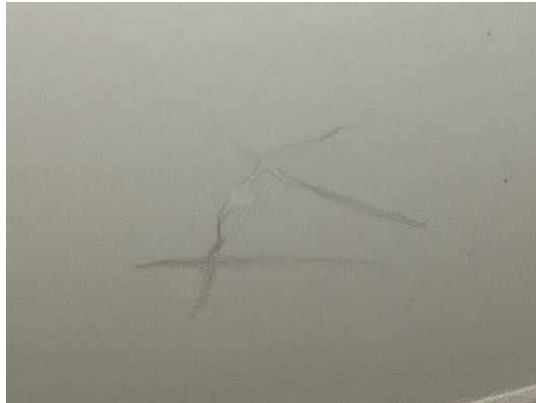
### Finding 3.06

Building: Building 1  
 Location: Bed 2, living room  
 Finding: Paint- Flaking  
 Information: Sections of paint in this area was found to have deteriorated. Paint flaking is generally an indication of excessive moisture in the area, that is currently hidden by the painted surface.

The presence of excessive moisture can have major implications on associated building elements if left unattended. While only seemingly minor at this stage, the damage cannot be determined due to the paint obstructing any further inspection of the damage.

A qualified Painter should be contacted at the Owner's discretion to re-paint the area.

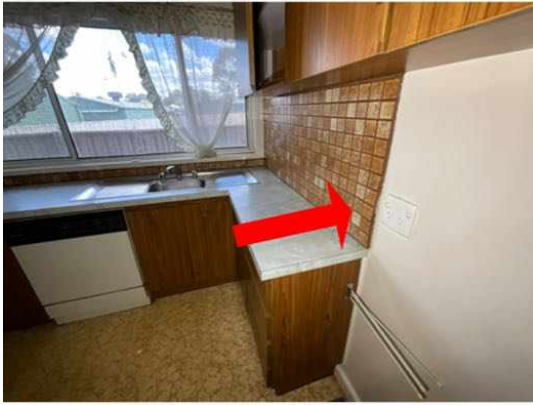
### Finding 3.07

Building:	Building 1
Location:	Kitchen
Finding:	Tiles - Drummy
Information:	Drummy tiled areas were identified at the time of inspection. The term 'drummy' refers to tiles that have become detached from their fixing, despite otherwise being in relatively good condition. Such defects are generally caused by physical or moisture damage to the area. Drummy tiled areas may also be a direct result of poor workmanship during the construction process.

Tiled areas may swell and shrink with changes in air humidity if the area has sustained moisture damage. Any exposure to moisture is capable of causing tiled areas to become drummy and/or cracked over a prolonged period of time. Drummy tiled areas generally require removal and replacement of affected tiles, with adequate sealant and grouting.

Specialist trades are available for these types of services. A registered builder may be required to undertake works if damage is extensive or if secondary building defects have resulted. Otherwise, it is advised that a tiling contractor be appointed to perform works as necessary. Immediate action is recommended to ensure that no further damage is sustained in the affected area.

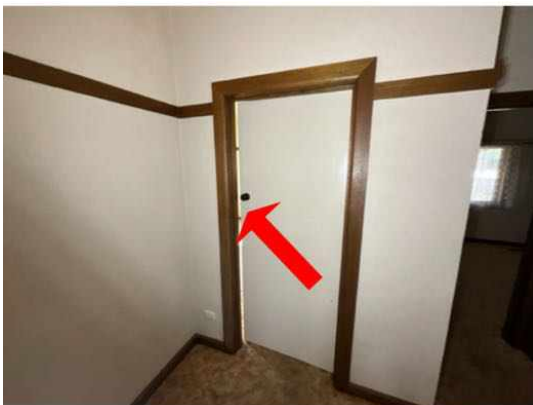
### Finding 3.08

Building: Building 1  
 Location: Bedroom 1,3  
 Finding: Door - Striker plate misaligned  
 Information: The striker plate to this door appears to have become misaligned and has consequently resulted in the door's operation being compromised.

This is a common defect and is expected in a property of this age, whether being due to substandard installation or general deterioration of the door hardware.

Readjustment of the striker plate is recommended at client discretion. Works such as these can be completed by a general handyman or qualified carpenter.

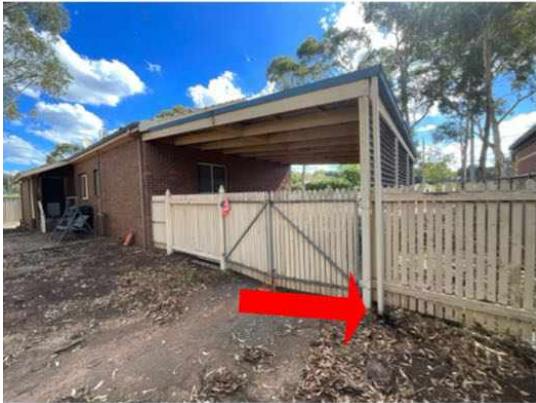
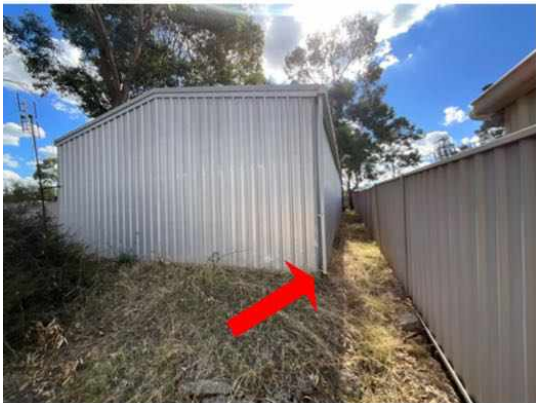
Where roof plumbing doesn't drain adequately, the area at the base perimeter can become excessively damp, potentially creating an environment that is susceptible to rust and corrosion of surrounding building elements, as well as attracting termites and other pests.

It is highly recommended that a plumber be appointed to further inspect the area and to install adequate drainage equipment where necessary.

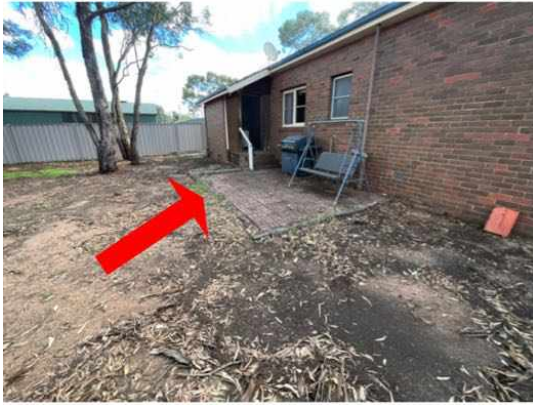
**Finding 6.03**

Building: Building 1  
Location: Yard - Side  
Finding: HWS Overflow - Not Connected  
Information: The Hot Water System (HWS) overflow was found to be disconnected from storm water drainage and is creating excessive moisture in the surrounding area.

These damp conditions can lead to secondary defects such as rot, rust or corrosion

of associated building elements, the formation of fungal decay, or even the creation of potential slip hazards. When coupled with poor site drainage, pooling of water may also attract termite activity to this area.

It is highly recommended that a licensed plumber be appointed to connect the HWS overflow in order to prevent such an environment from being created. These minor works should be carried out as soon as possible.

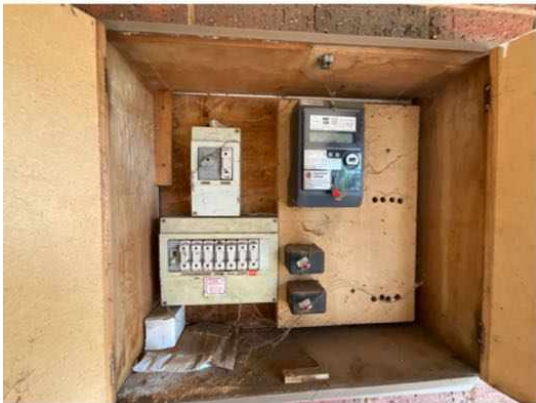
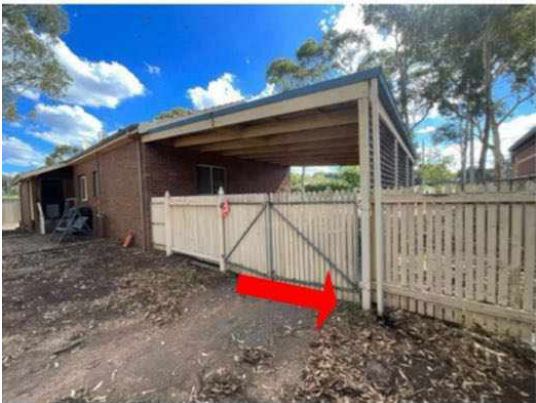
A durable notice should be placed in the switchboard unit to indicate current termite barriers. At the time of inspection, it appeared as though no termite management system has been installed, with no evidence to suggest preventative works taking place.

The client may consider gaining further advice from a pest controller as to the costs and procedures involved with this application. It is recommended that obtaining such advice be a short-term priority.

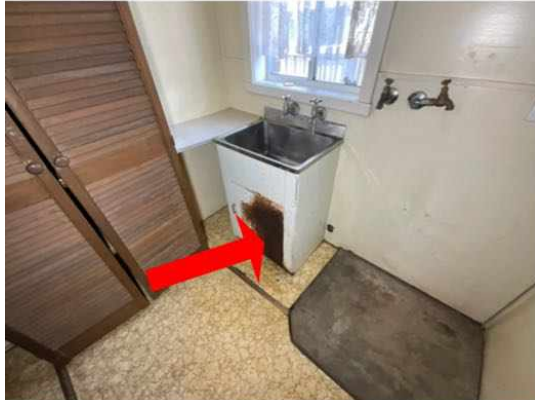
Building:	Building 1
Location:	Laundry
Finding:	Rust- metal component
Information:	The metal element in this area is rusted. This will further deteriorate if not addressed.

Appropriate trades should be contacted at the discretion of the client, to restore the area to improve utility.
