## Building Inspection Report

Inspection Date: Thu, 5 Mar 2026

Property Address: 6 Bellevue Ave, Old Reynella SA 5161,  
Australia

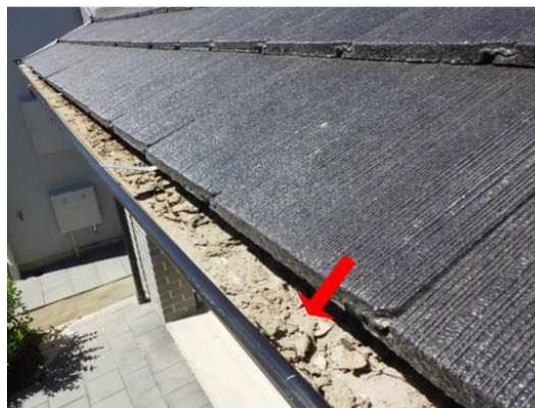
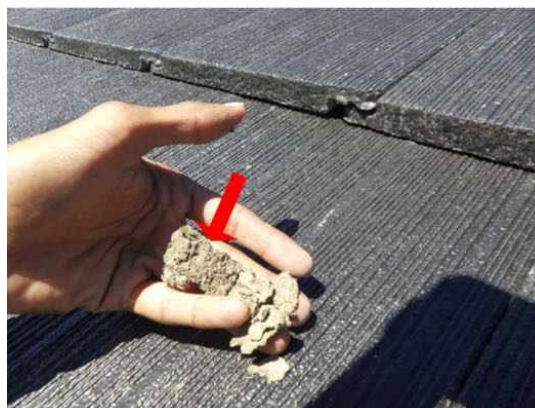
Blocked gutters are likely to lead to high levels of moisture in the affected areas. Such moisture will not only cause rust and decay of the associated building materials, but can also provide conditions that are conducive to termite and timber pest activity. Blockages in gutters should therefore be removed immediately to ensure dry conditions are maintained.

Consult a Licensed Plumber for further specific advice on remedial works that may be required. In the interim, it is highly advised that blocked gutters be removed by the homeowner or a general handyperson as a matter of urgency.

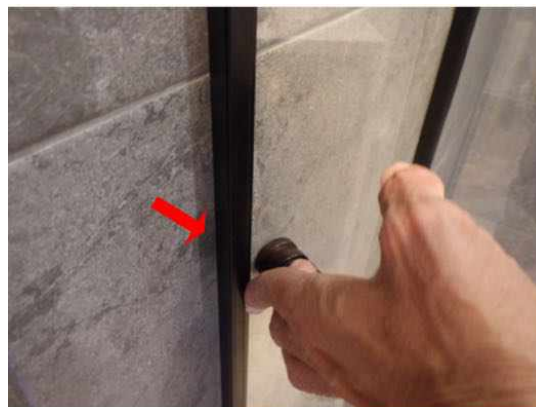
Building:	Building 1
Location:	Bathroom - Ensuite
Finding:	Shower screen touching - Internal wall tiles during standard operation
Information:	At the time of inspection it was noticed that shower screen door is touching the internal wall tiles and creating a potential safety hazard in the bathroom -ensuite area during standard operation and creating a potential safety hazard for the persons coming contact in this area.

It advised that builder should take appropriate measures to avoid/ reduce the impact of shower screen hitting during door operations.

A qualified glazier is required to repair the shower screen as soon as possible. Please be advised that any persons coming into contact with the shower screen should do so with due caution to avoid any personal injury that may ensue.

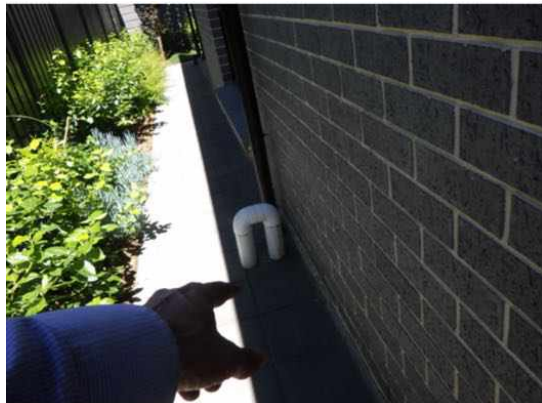
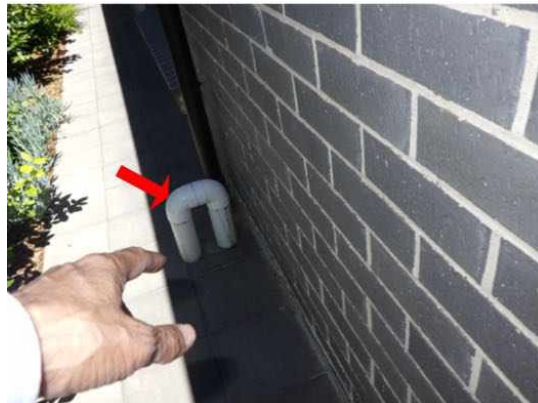
It is recommended that confirmation be obtained regarding the requirement for a

stormwater tank installation at this property. If required, the stormwater tank should be installed in accordance with relevant council regulations and approved building plans.

For further details, it is advised that enquiries be made with the real estate agent, the builder (if applicable), or the relevant local council or appropriate authorities.

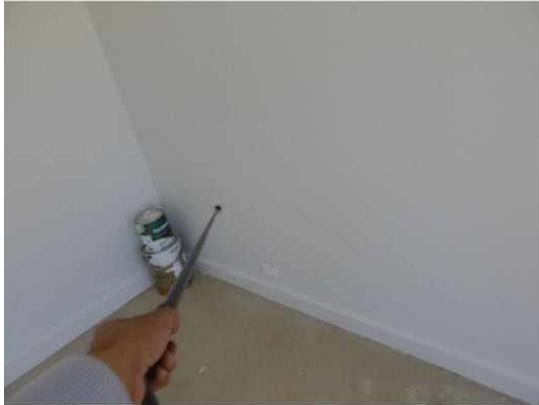
Building: Building 1  
 Location: All Internal Areas  
 Finding: Garage – Internal Access Doorway Restriction  
 Information: At the time of inspection, it was observed that access through the internal doorway between the garage and the house was restricted when entering the dwelling from the garage area. The doorway clearance appears limited, which may affect safe and convenient access between these areas.

For further details, it is advised that enquiries be made with the real estate agent, builder (if applicable), or the relevant authorities.

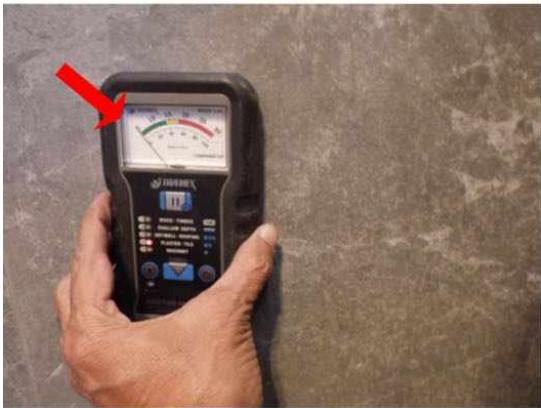
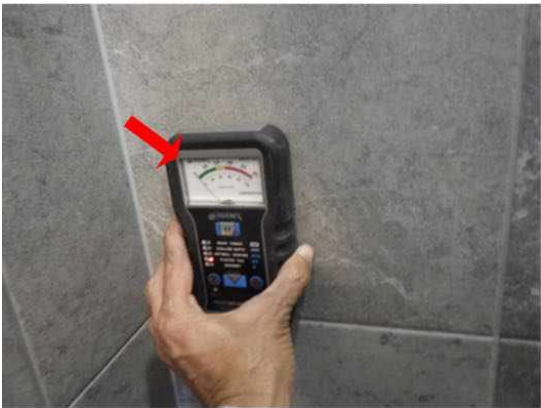
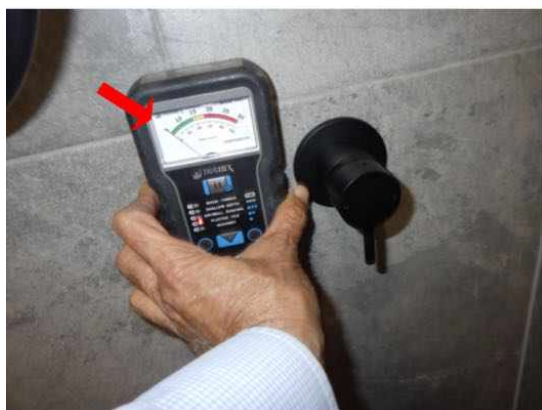
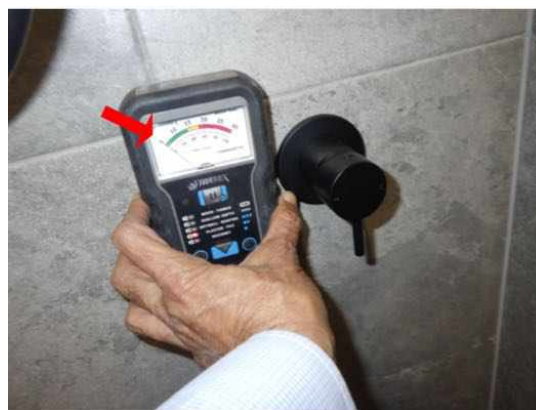
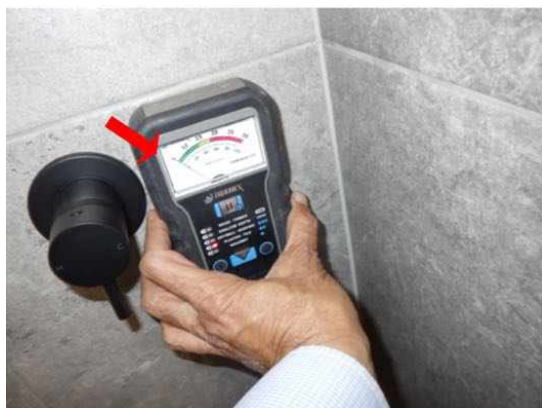
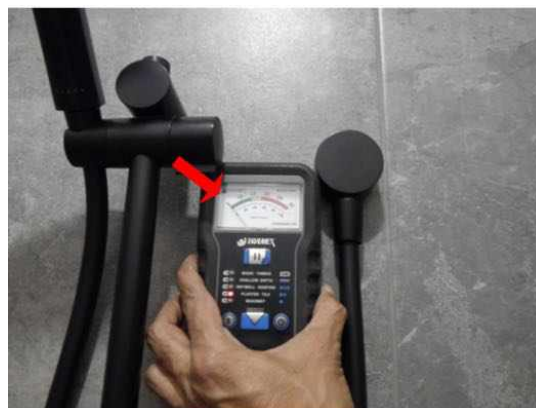
Building: Building 1  
Location: Bathroom-Ensuite  
Finding: Shower Alcove - No Damp  
Information: At the time of inspection it was noticed that damp is not evident to the shower alcove.

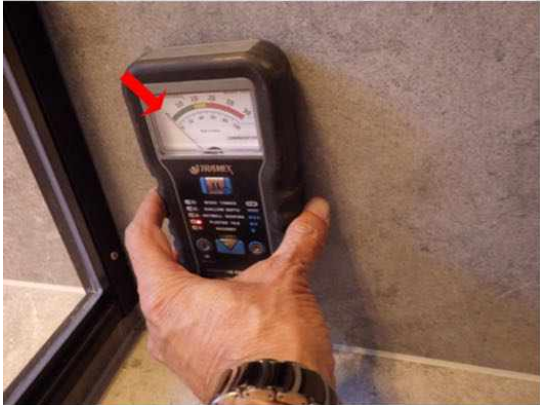
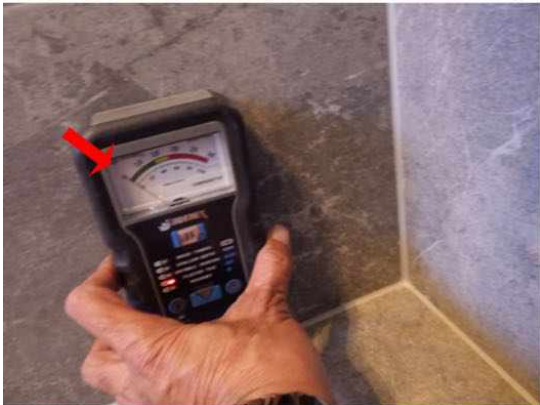
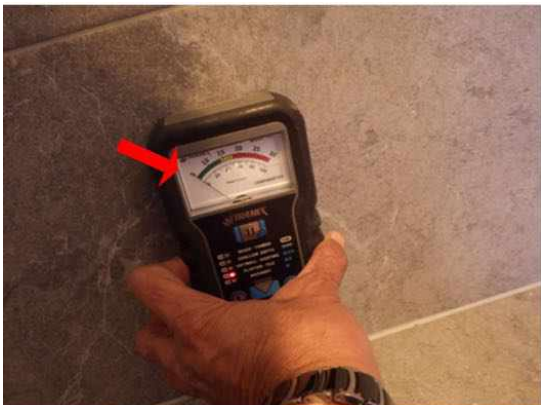
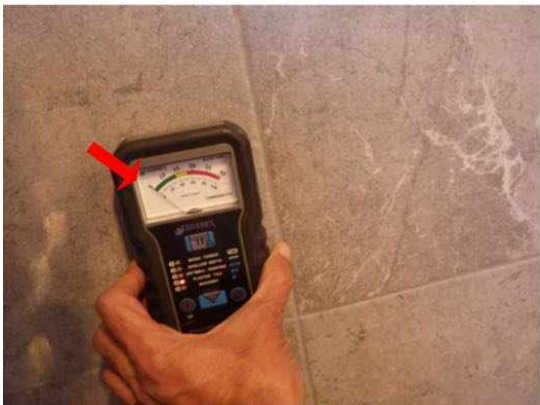
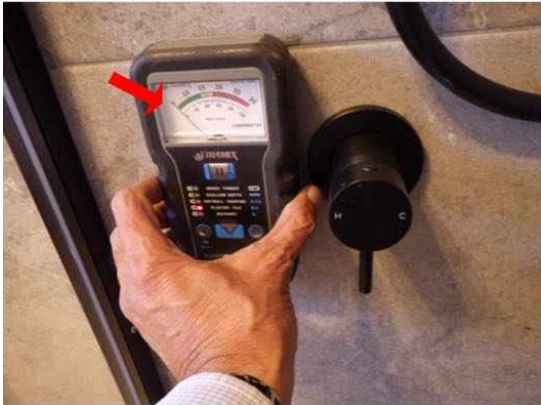
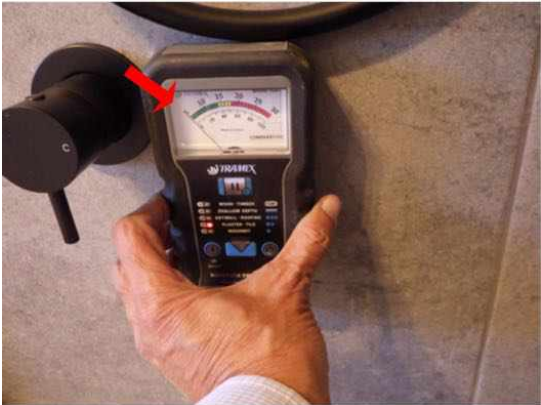
Building: Building 1  
 Location: Bathroom 2  
 Finding: Shower Alcove - No Damp  
 Information: At the time of inspection it was noticed that damp is not evident to the shower alcove.

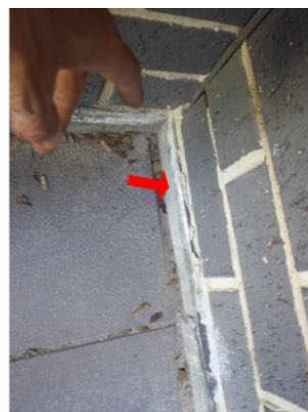
Building: Building 1  
 Location: All External Areas  
 Finding: Slab edge concrete - Efflorescence  
 Information: At the time of inspection it was noticed that efflorescence appears to be effecting the slab edge concrete in few sections around the property.

mortar between bricks or tiles. While detracting from the overall appearance of the affected area, efflorescence is not likely to develop into secondary damage if left unmanaged.

Generally, soluble salt deposits can be removed by dry brushing with a stiff-bristled brush. Repeated dry brushing is an ideal treatment for eliminating this forming of efflorescence. A cleaning contractor or general handyperson may be appointed to perform these works at the discretion of the client.

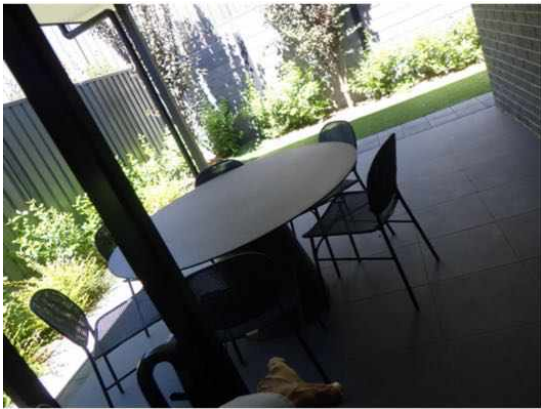
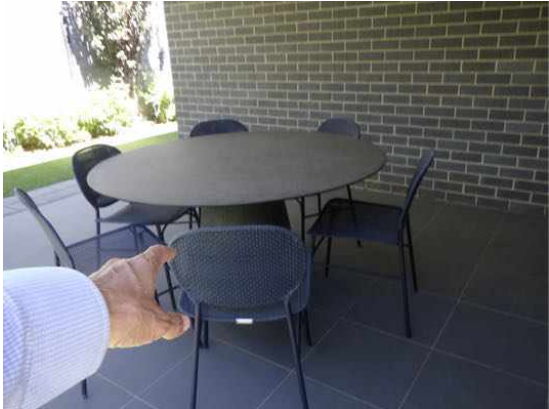
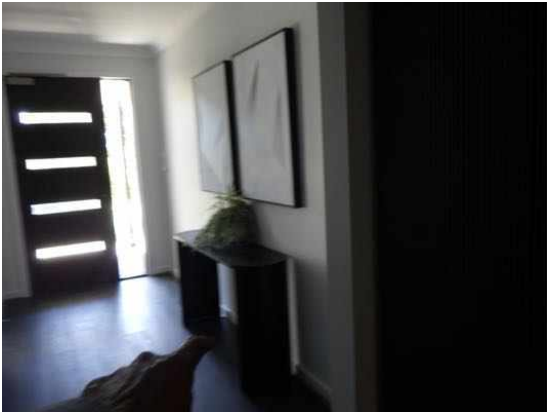
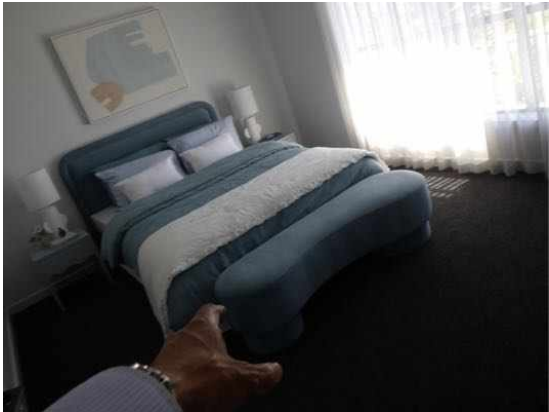
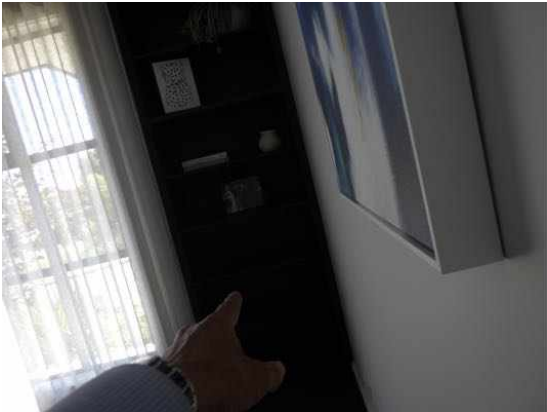
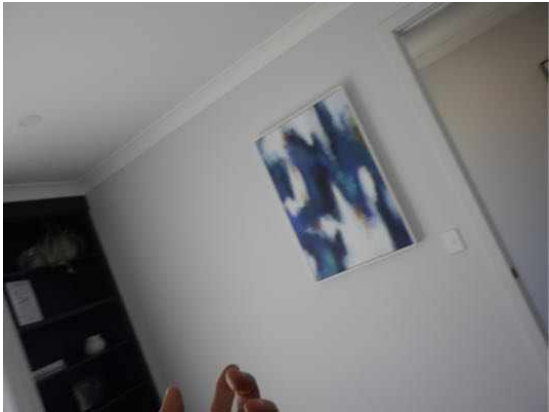
Building:	Building 1
Location:	All Areas
Finding:	Additional Photos - Obstructions and Limitations
Information:	These photographs are an indication of the obstructions and limitations which impeded full inspection of the property at the time of inspection. These obstructions can hide an array of defects and should be removed to allow full inspection to be carried out. A re-inspection is recommended once the areas are made accessible.

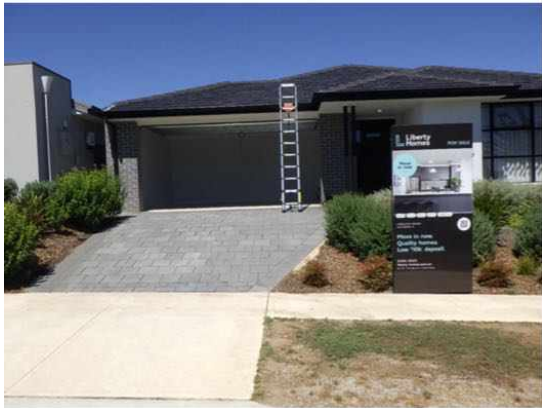
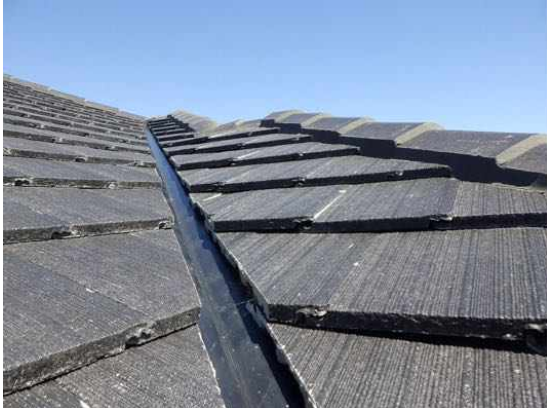
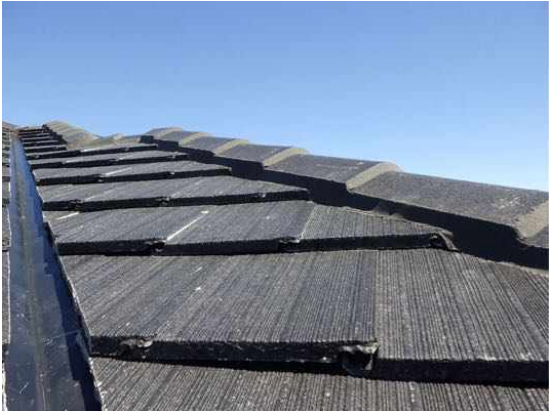
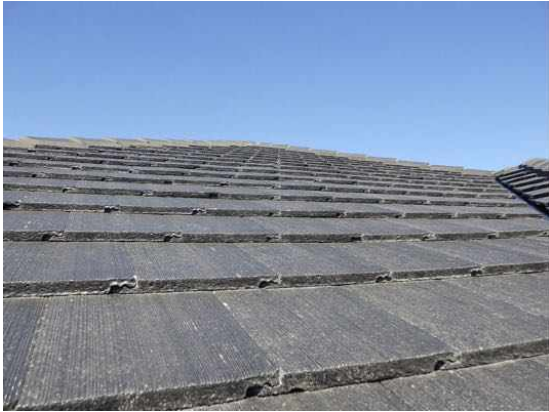
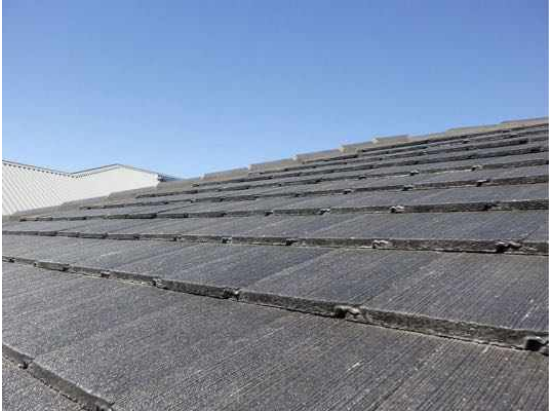
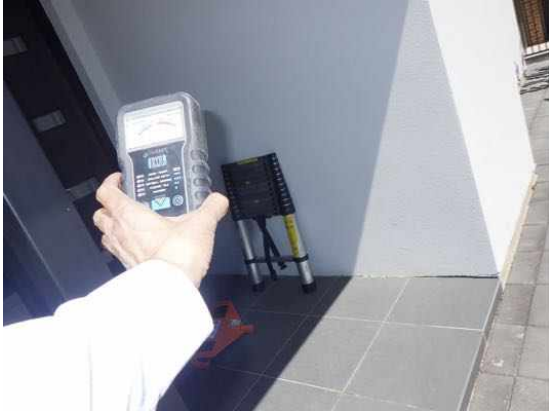
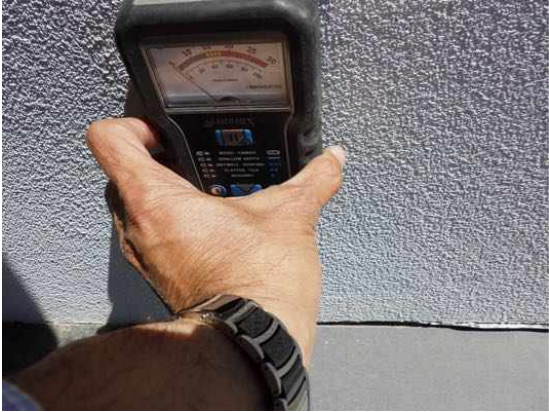
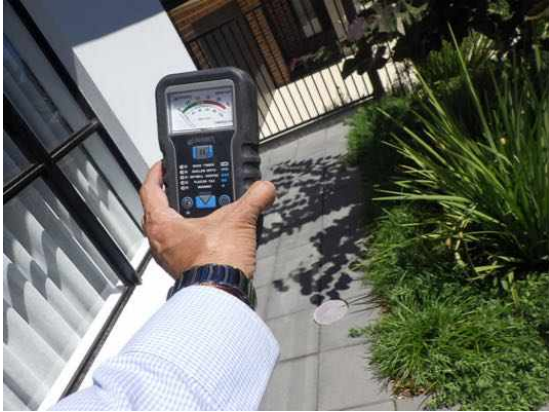
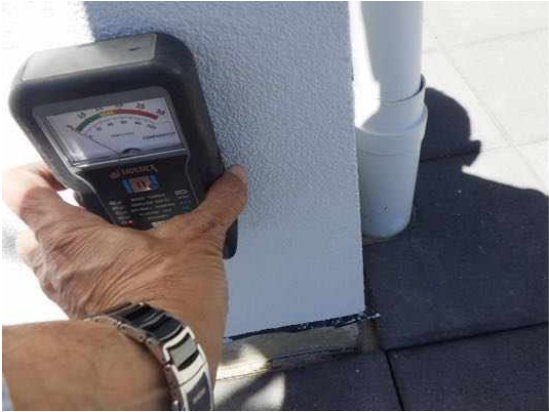
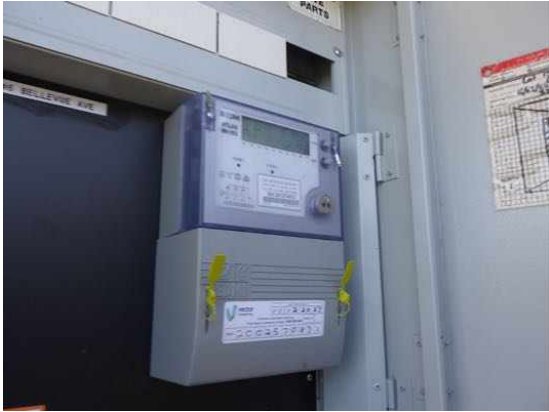
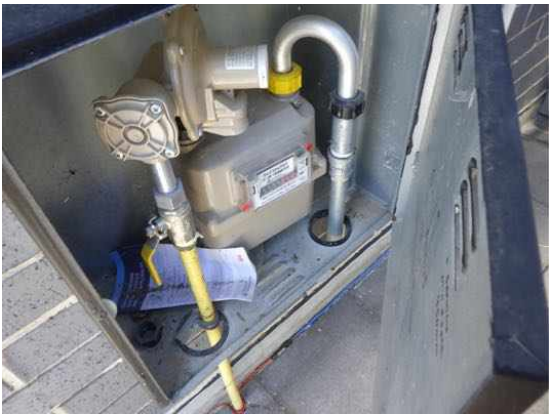
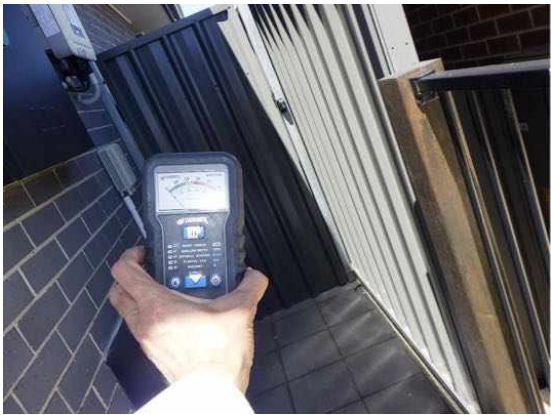
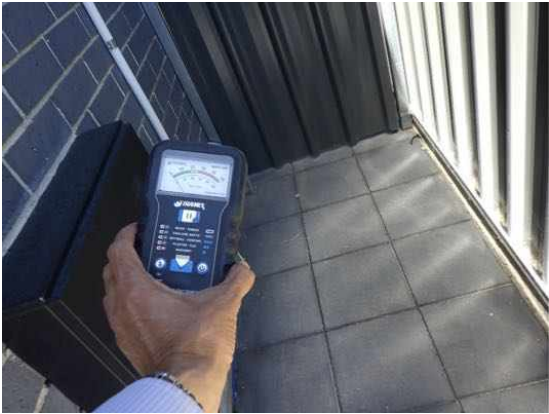
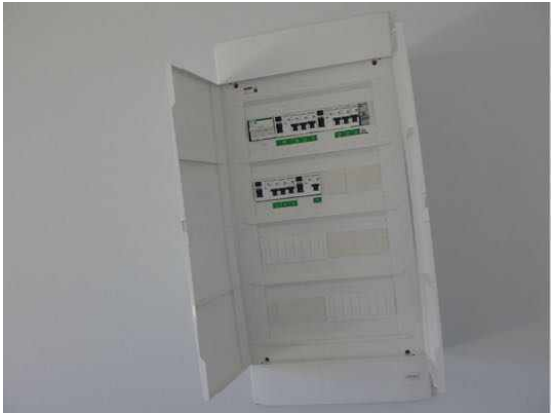
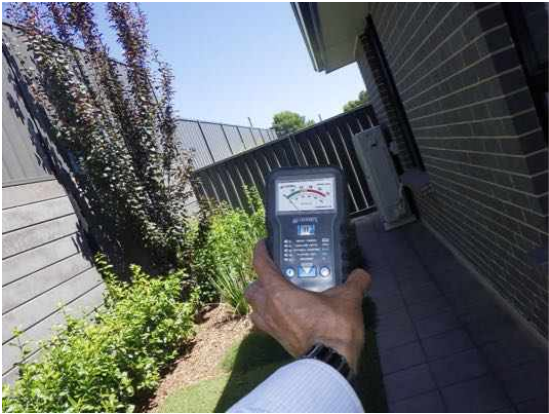
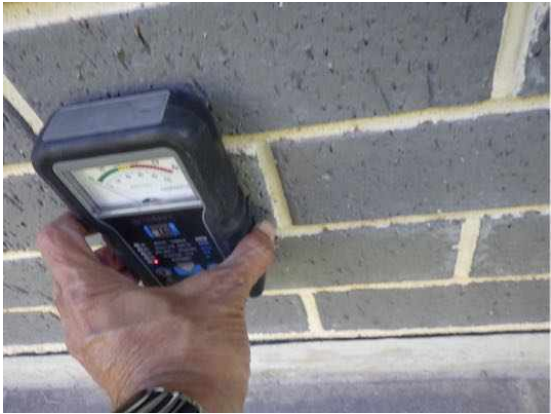
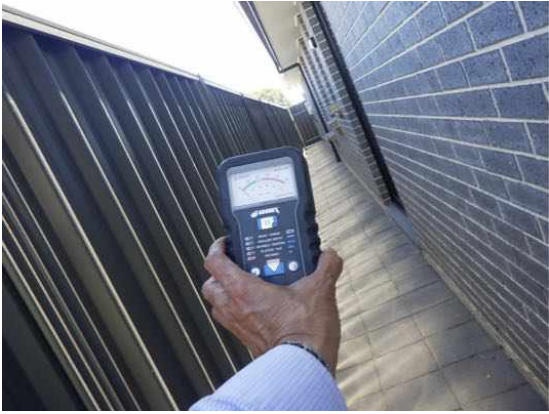
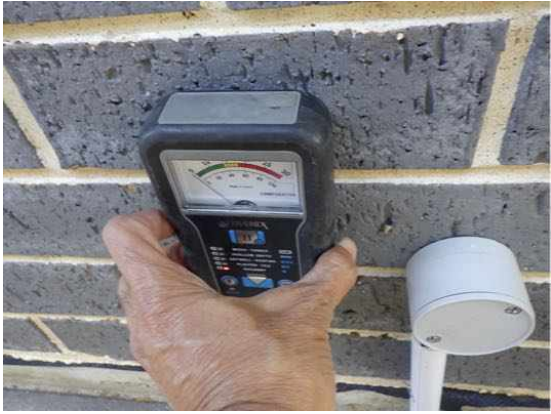
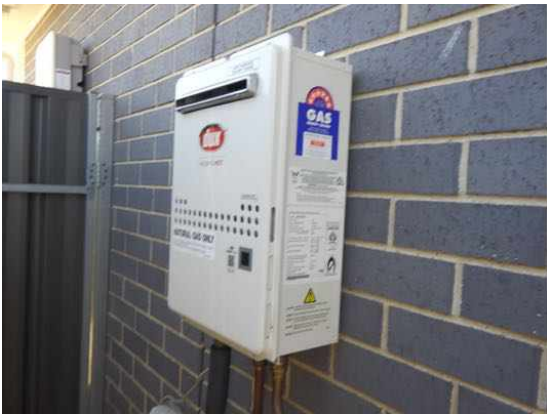
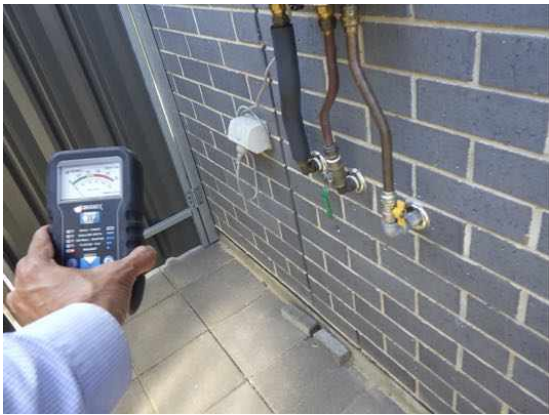
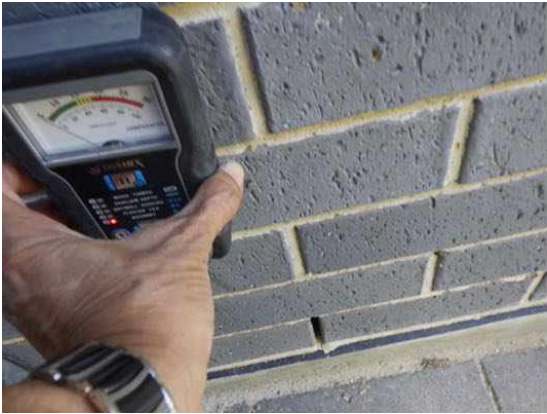
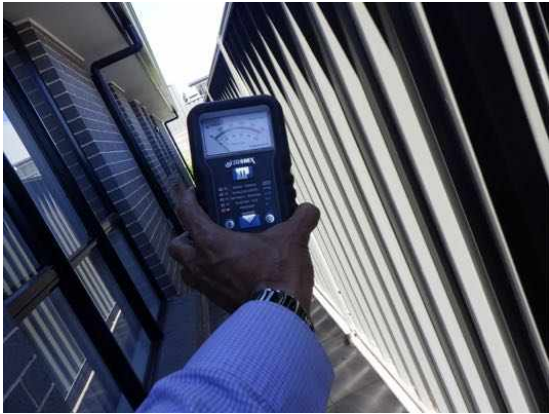
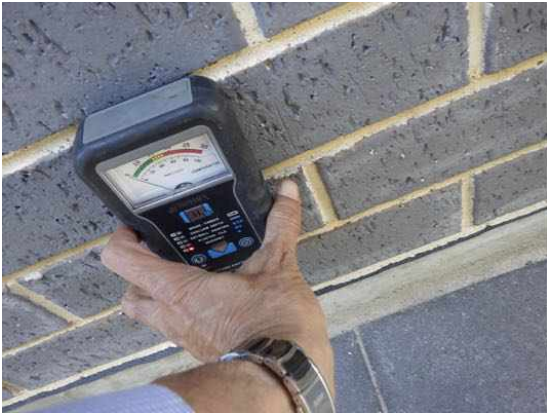
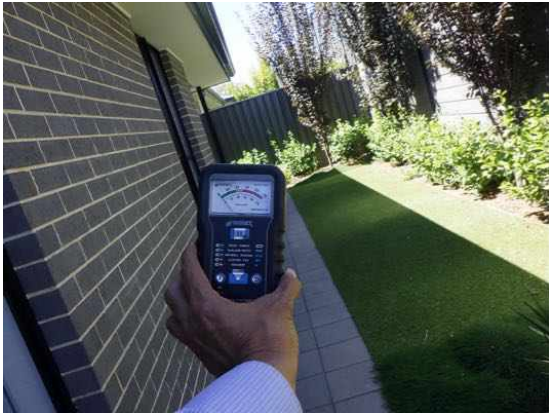
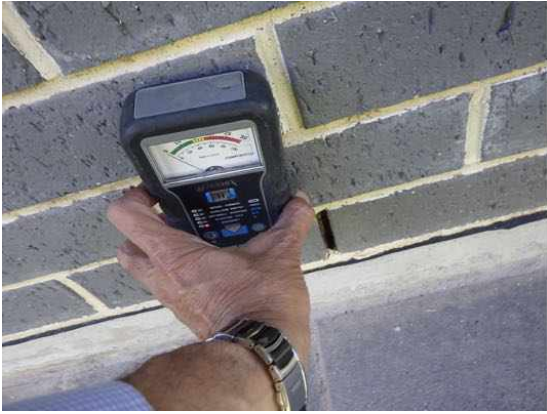
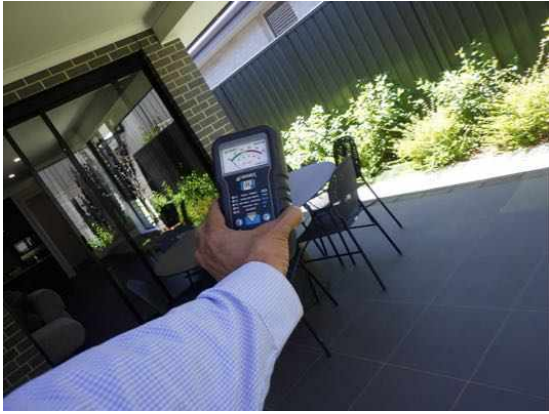
Building: Building 1  
Location: All Areas  
Finding: Additional Photos  
Information: Additional photos are provided for your general reference
