# Building and Timber Pest Inspection Report

Inspection Date: Mon, 23 Feb 2026

Property Address: 5/123 Anderson Rd, Albion VIC 3020,  
Australia

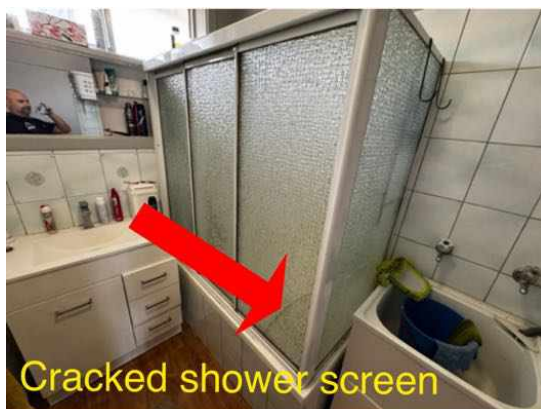
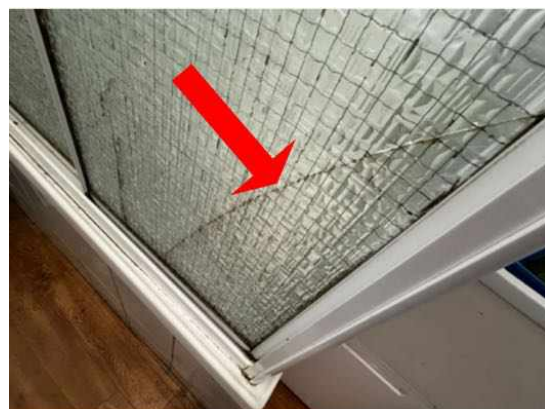
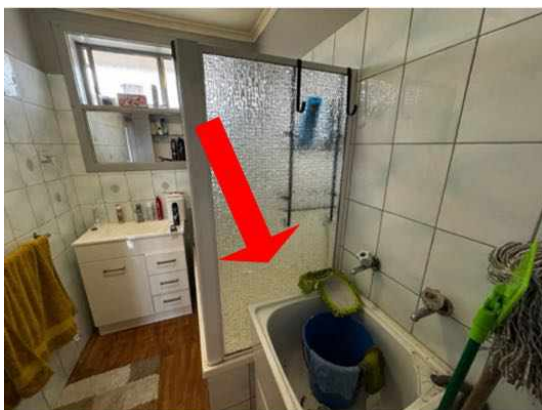
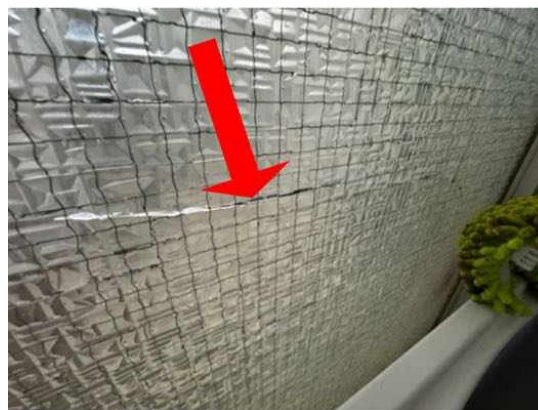
Building:	Main Building
Location:	Bathroom > Rear
Finding:	Cracked Shower Screen Glass – Safety Hazard
Information:	Two glass panels forming part of the shower screen were observed to be cracked at the time of inspection. Cracked glazing in wet areas presents a significant safety hazard, as the glass may shatter unexpectedly during normal use.

Given the suspected age of the building (50+ years), it is likely that the glass installed may not be compliant safety glazing. Older glass panels are often non-toughened and, if broken, can shatter into sharp shards capable of causing serious injury. The presence of existing cracks increases the likelihood of sudden failure.

This condition is considered a safety hazard.

It is recommended that the cracked shower screen panels be replaced by a qualified glazier as soon as practicable. Replacement glazing should comply with current safety glazing requirements for wet areas. The shower should be used with caution until rectification has been completed.

Immediate to short term due to safety risk.

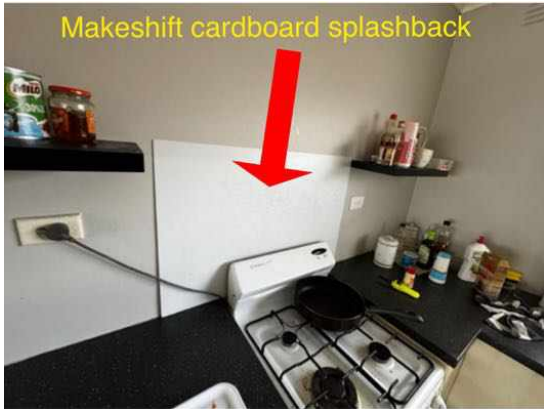
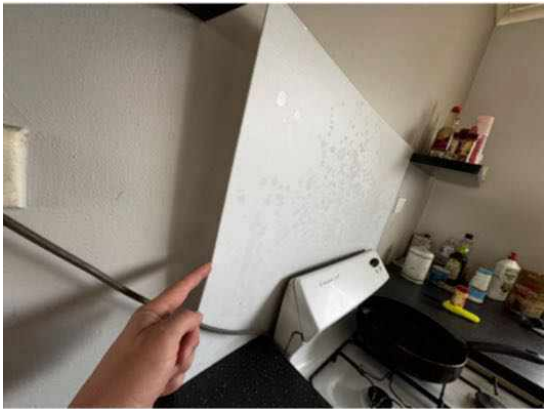
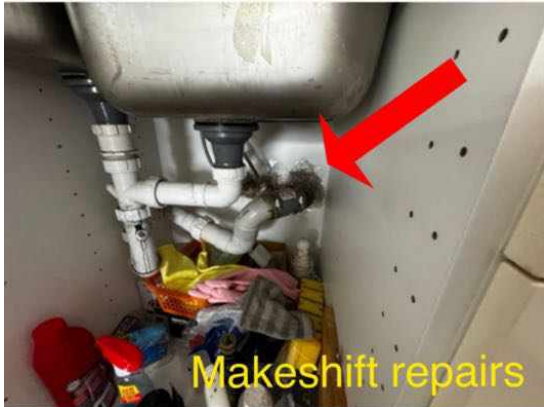
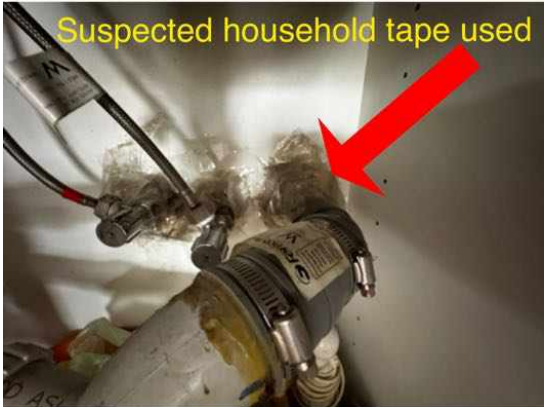
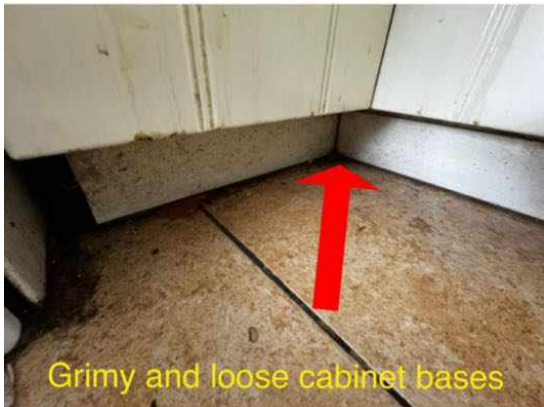
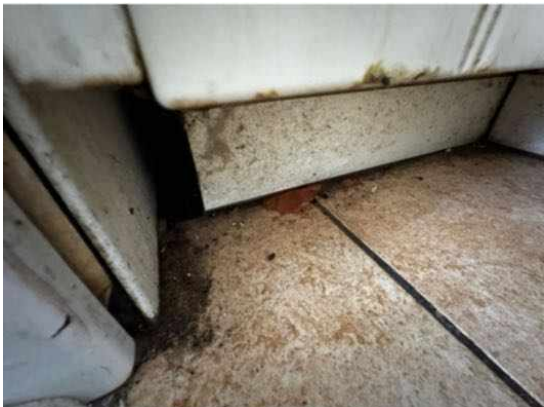
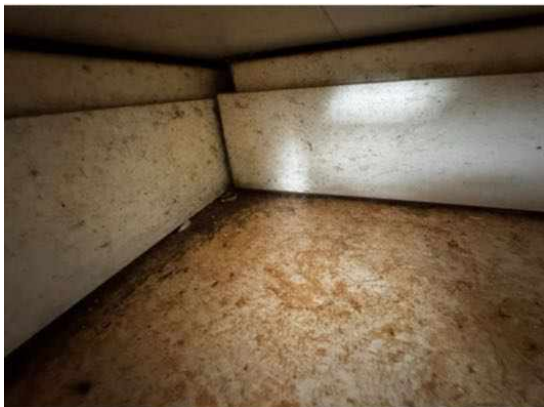
## Finding 1.02

Building:	Main Building
Location:	Kitchen > Rear Right
Finding:	Kitchen Defects – Makeshift Repairs and Deterioration
Information:	During the inspection of the kitchen area, a makeshift cardboard/plastic splashback was observed behind the cooktop. This appears to have been installed to prevent grease splashing onto the wall surface. Such materials are not suitable as a permanent splashback solution and may present a fire risk when located in close proximity to a heat source.

Under the kitchen sink, makeshift repairs were observed to plumbing penetrations. It is suspected that household tape has been used to patch gaps and openings around the pipe penetrations. This type of repair is substandard and not durable, and gaps around plumbing penetrations can allow moisture ingress, pest entry, and air movement into concealed wall cavities.

Grimy and loose cabinet bases were also observed beneath the kitchen cupboards. The condition suggests prolonged wear and possible past moisture exposure. Loose cabinetry components may further deteriorate if not properly secured and maintained.

It is recommended that a compliant, non-combustible splashback be installed behind the cooktop in accordance with current safety requirements. Plumbing penetrations under the sink should be properly sealed using suitable materials by a licensed plumber or qualified tradesperson. The cabinet bases should be cleaned, secured, and repaired or replaced where necessary to prevent further deterioration.

Rectification recommended in the short term, particularly for fire safety and moisture control concerns.

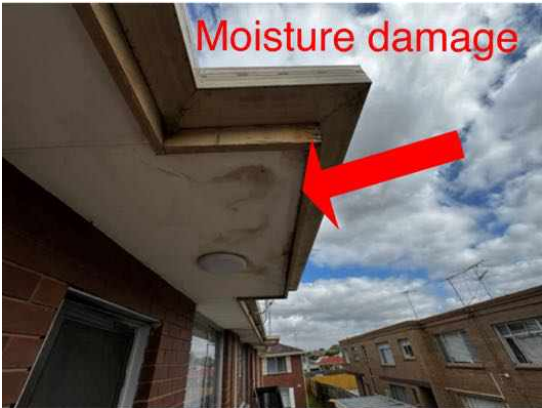
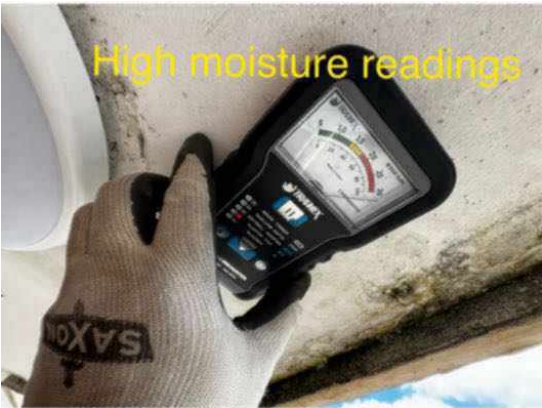
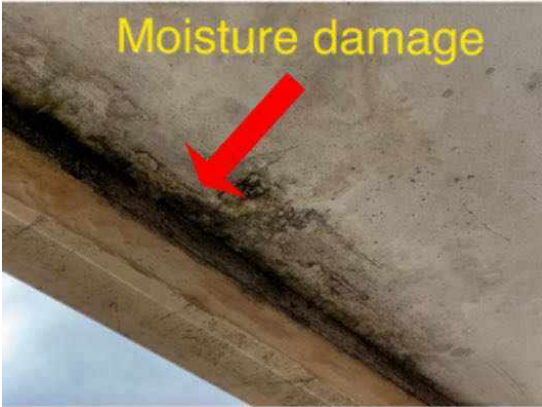
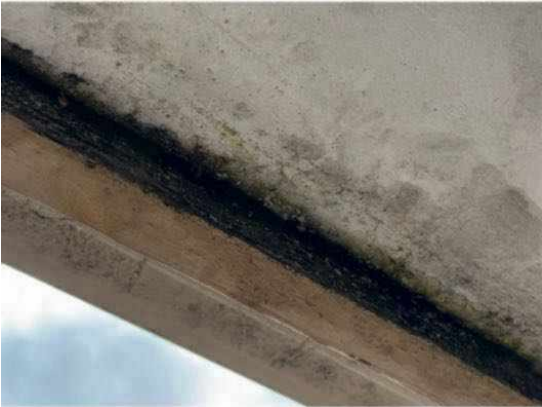
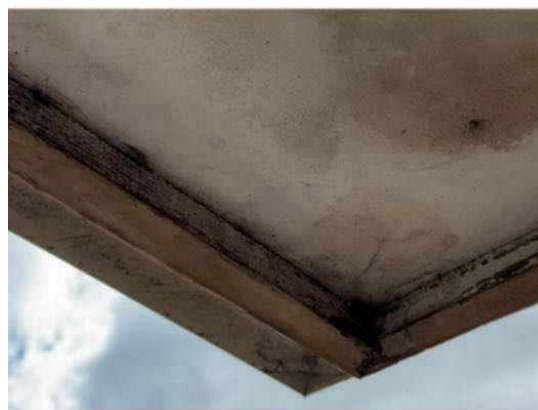
## Finding 2.02

Building:	Main Building
Location:	Entry eaves > Front
Finding:	Moisture Damage to Eave Lining – Suspected Roof Leak (Liability to Be Confirmed)
Information:	The eave lining directly in front of the entry door to Unit 5 was observed to have significant moisture damage, with visible timber decay and deterioration to associated timber elements. The condition is consistent with prolonged water exposure.

Further investigation and rectification recommended in the short term due to active high moisture readings and risk of ongoing deterioration.

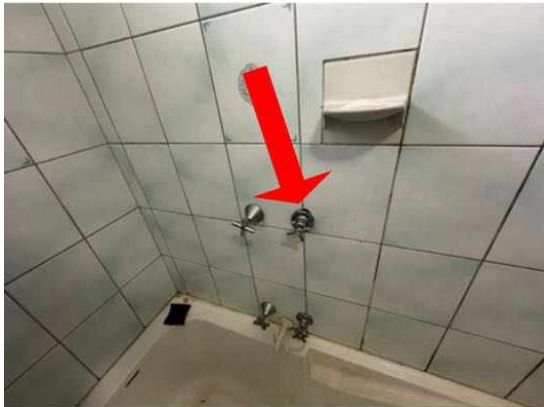
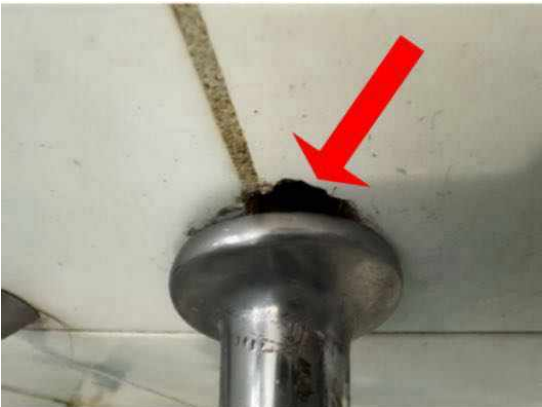
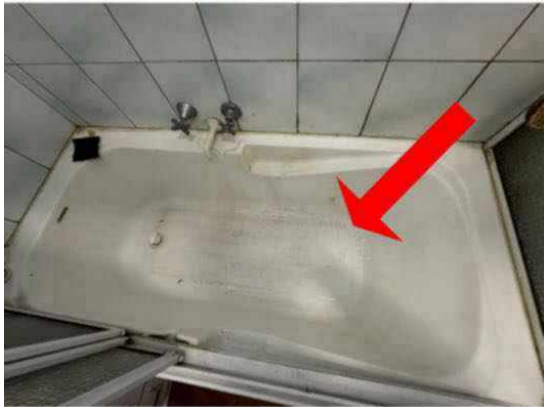
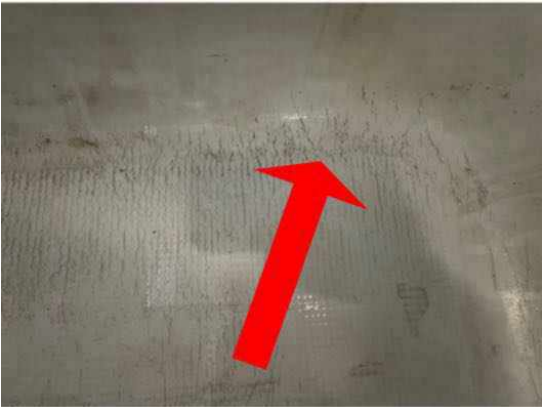
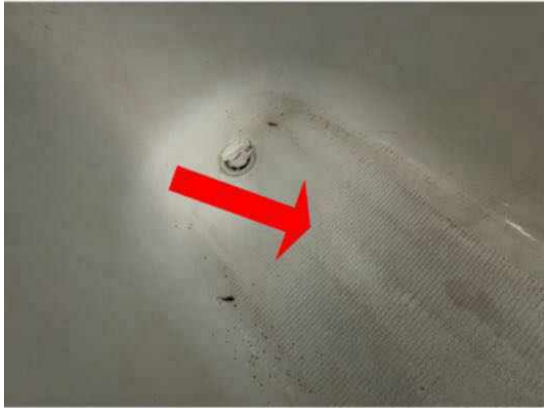
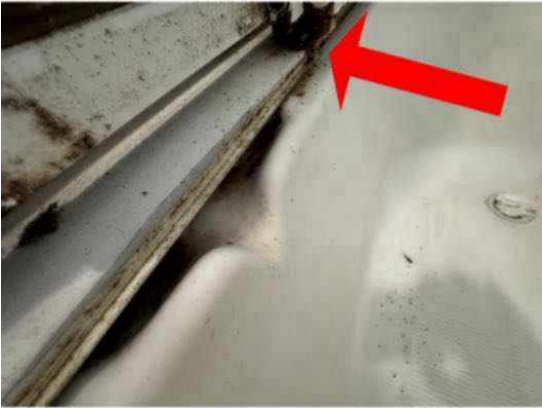
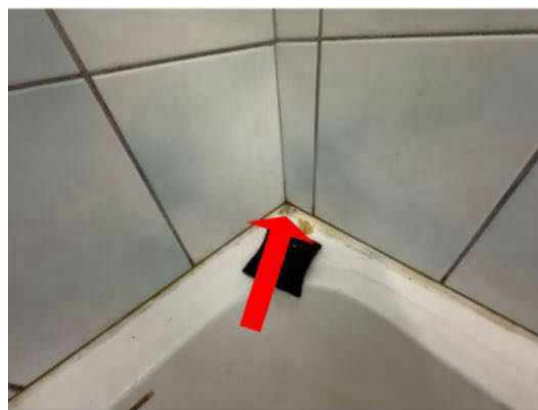
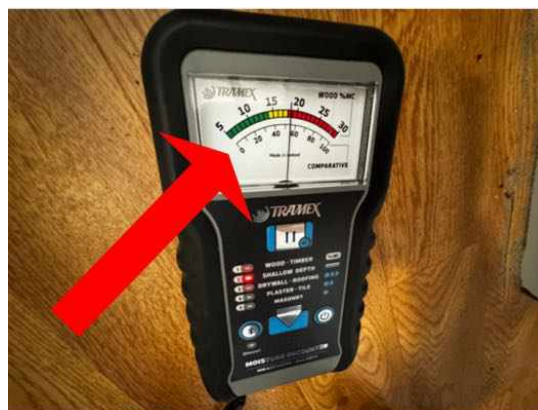
### Finding 2.03

**Building:** Main Building  
**Location:** Bathroom > Rear  
**Finding:** Bathroom Defects – Potential Water Ingress and Elevated Moisture  
**Information:** During the inspection of the bathroom area, a visible gap was observed around the shower plumbing penetration point. This gap presents a potential point of water ingress into the wall cavity, particularly during normal shower use. If left unsealed, moisture may enter concealed areas and contribute to timber decay, mould growth, and structural deterioration over time.

Further invasive investigation may be required if moisture levels persist or increase.

Immediate. Rectification and further investigation recommended due to elevated moisture readings and risk of concealed structural damage.

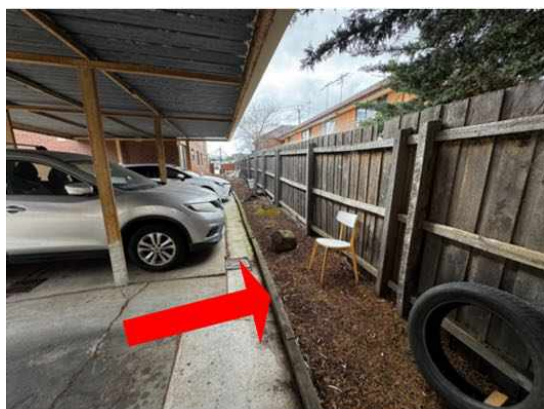
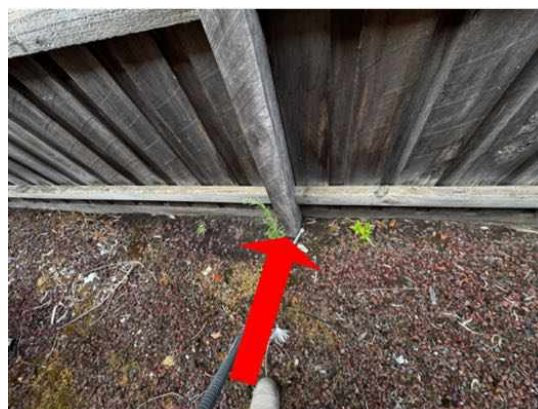
Building: Main Building  
 Location: Yard - side > Centre Left  
 Finding: Inground timber contact (TP)  
 Information: At the time of inspection, in-ground timber contact was observed to the side yard, including timber garden edging, and fence posts, all in direct contact with the ground. These timber elements are positioned within the soil zone and in close proximity to the building and associated structures.

In accordance with AS 3660.2, conditions that facilitate termite access or provide a direct food source are recognised as increasing the risk of termite activity to existing

buildings. Timber elements in direct contact with the ground are particularly vulnerable, as they can attract subterranean termites and support concealed foraging activity, potentially allowing termite colonies to establish and migrate toward nearby structures without early detection.

As a result, the presence of in-ground timber elements is considered to increase the risk of termite activity to the property. It is recommended that a licensed termite management or pest control contractor be engaged to assess these conditions and provide advice on appropriate risk mitigation measures, which may include removal or replacement of timber elements with non-susceptible materials, isolation of timber from soil contact, and integration of suitable termite management measures to suit the existing site conditions.

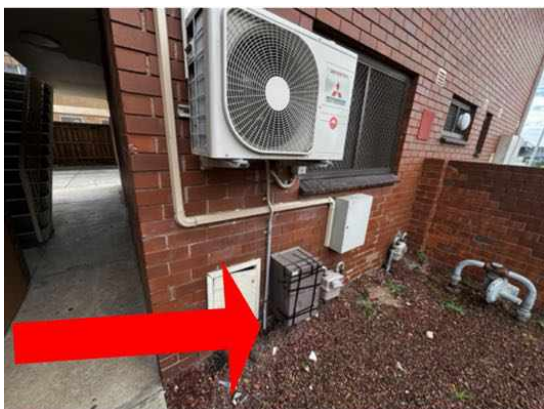
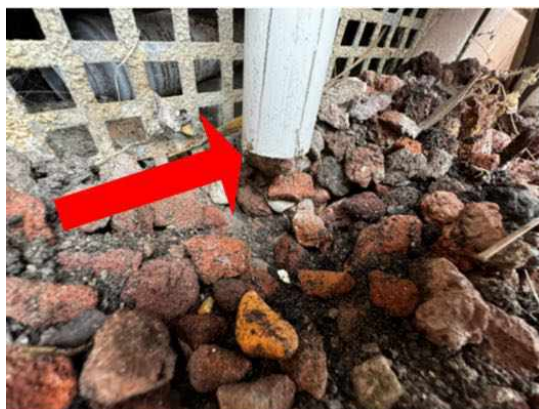
Building: Main Building  
 Location: Airconditioning discharge > Rear Left  
 Finding: Uncontrolled discharge from air conditioner unit (TP)  
 Information: At the time of inspection, the air conditioner unit located to the side of the building was observed to have an overflow pipe discharging directly onto the ground, rather than being connected to a suitable drainage system. This condition allows ongoing moisture to accumulate at the base of the building and surrounding soil.

Conditions that promote persistent dampness or poor drainage around a building are recognised as conducive to termite activity, as elevated moisture levels can attract subterranean termites and support concealed foraging activity. Uncontrolled discharge from hot water system overflows may therefore increase moisture-related deterioration and termite risk.

As a result, the discharge from the air conditioner unit overflow is considered to contribute to conditions conducive to termite activity. It is recommended that a licensed plumber be engaged to connect the overflow pipe to an appropriate drainage point, ensuring that water is not discharged directly onto the ground adjacent to the building, with further advice from a licensed termite management or pest control contractor where elevated termite risk is identified.

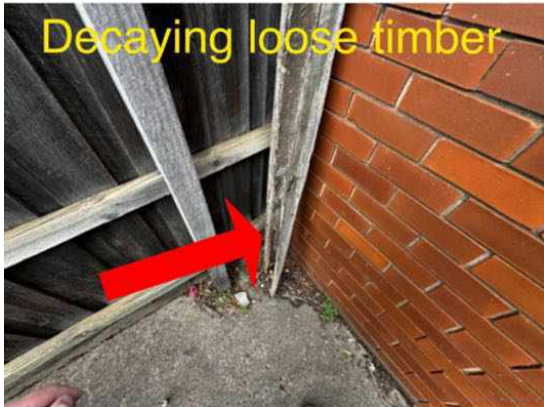
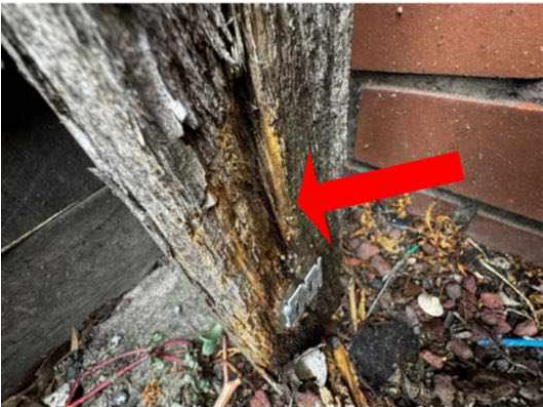
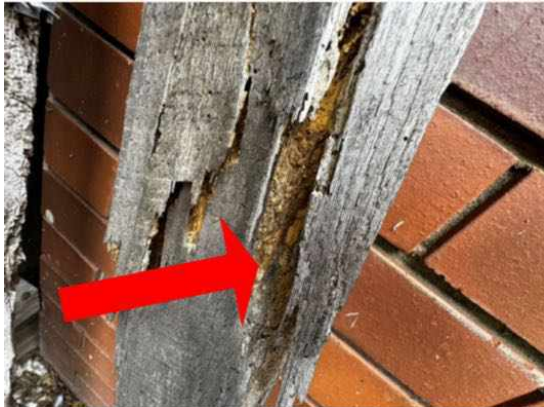
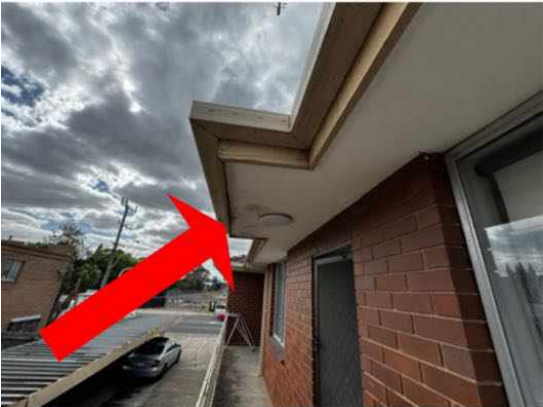
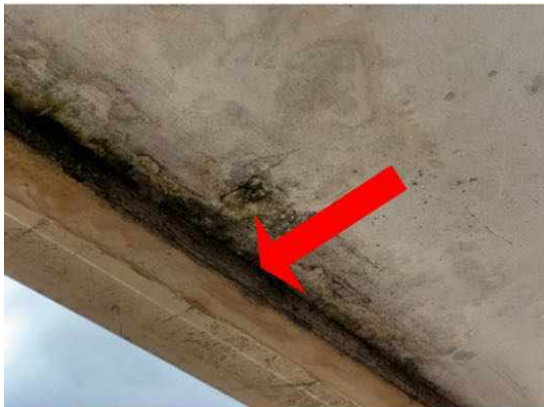
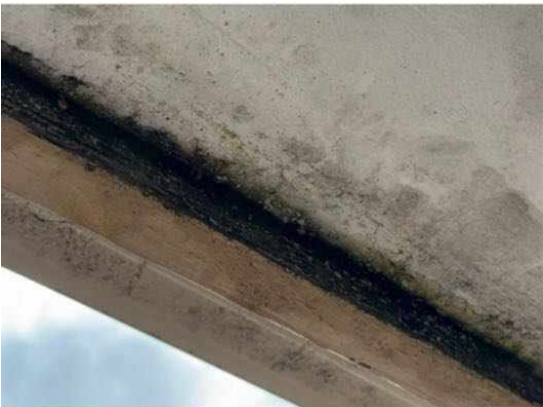
Building:	Main Building
Location:	Balcony, side yard > Centre Left, Level 1
Finding:	Timber decay & rot - Conducive conditions (TP)
Information:	During the inspection, several conducive conditions for termite and timber pest activity were observed in the common area adjacent to the unit. Timber decay and rot were identified in the side yard of the building. A rotting dead tree stump was present in the side yard, and loose timber elements in this area showed visible signs of fungal decay.

In addition, the eave lining directly in front of the unit entrance was observed to be visibly moisture damaged. Timber elements to the eave exhibited signs of timber decay and rot. Moisture testing undertaken in this area returned very high moisture readings, confirming the presence of excessive moisture. Prolonged moisture exposure significantly increases the likelihood of timber deterioration and creates conducive conditions for termite and timber pest activity.

These conditions represent elevated risk areas for potential termite and timber pest infestation, particularly given the suspected age of the building and the presence of decaying timber materials in close proximity to the structure.

It is recommended that all decayed timber materials, including the dead tree stump and loose timber debris, be removed from the side yard. The moisture-damaged eave lining and affected timber elements should be further investigated and repaired or replaced as required. The source of moisture contributing to the elevated readings should be identified and rectified. Ongoing monitoring for termite and timber pest activity is advised.

Rectification recommended in the short term due to high moisture levels and increased risk of termite and timber pest activity.

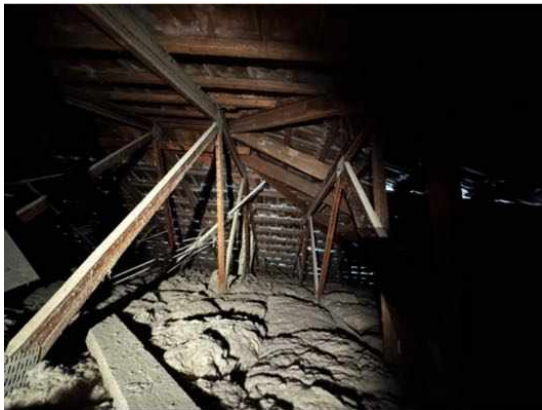
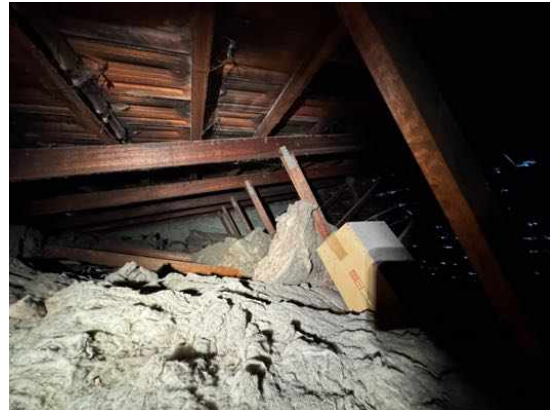
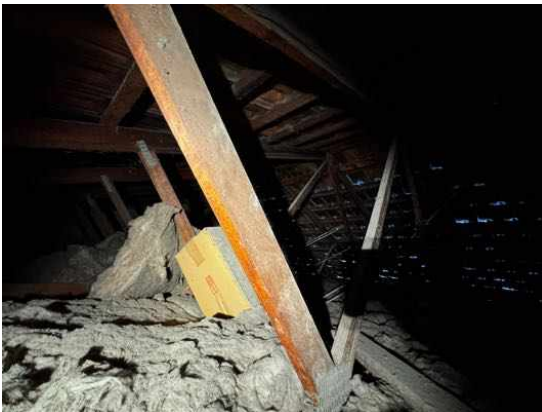
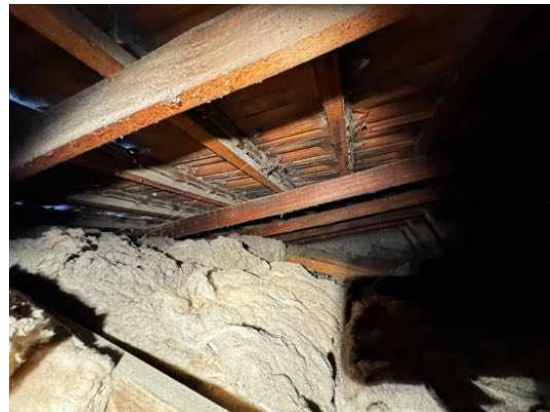
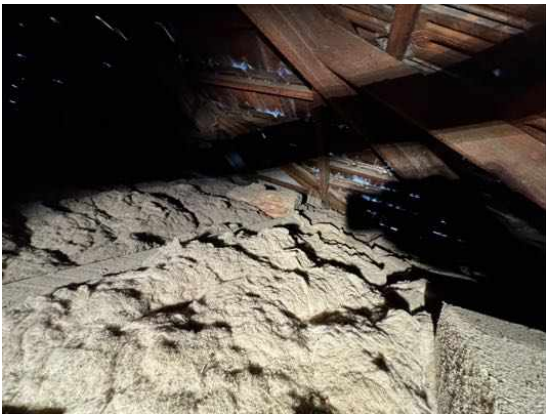
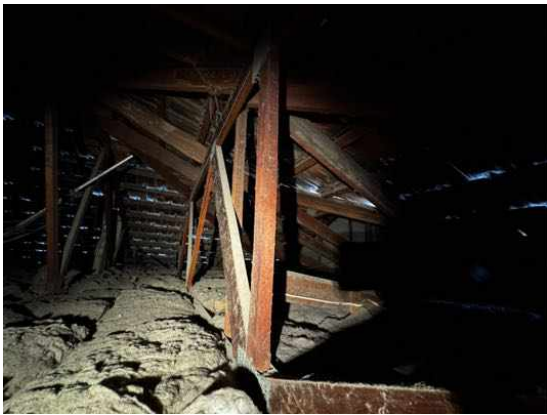
Building: Main Building  
Location: All Areas > All Areas  
Finding: Additional Photos - Obstructions and Limitations  
Information: These photographs are an indication of the obstructions and limitations which impeded full inspection of the property at the time of inspection. These obstructions can hide an array of defects and should be removed to allow full inspection to be carried out. A re-inspection is recommended once the areas are made accessible.

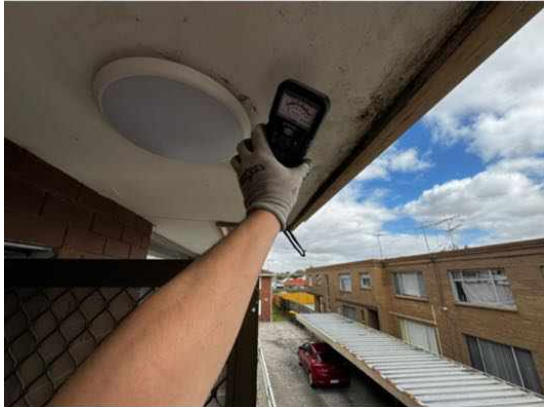
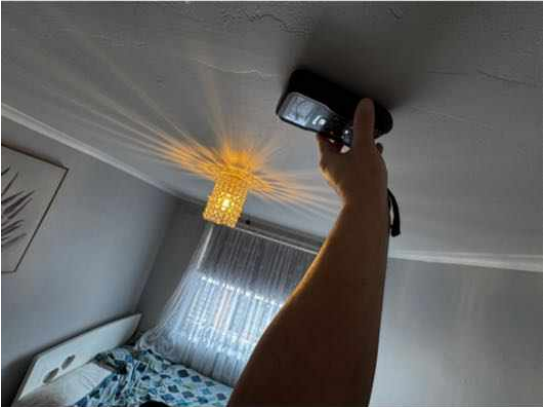
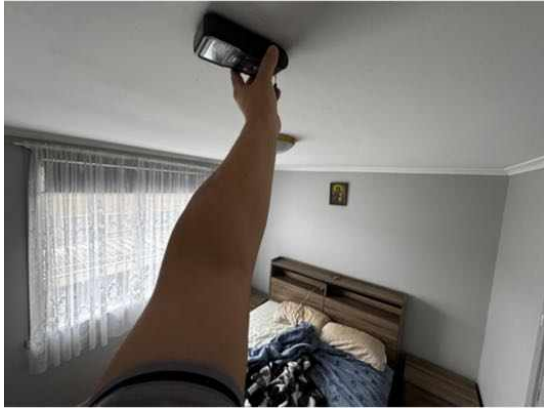
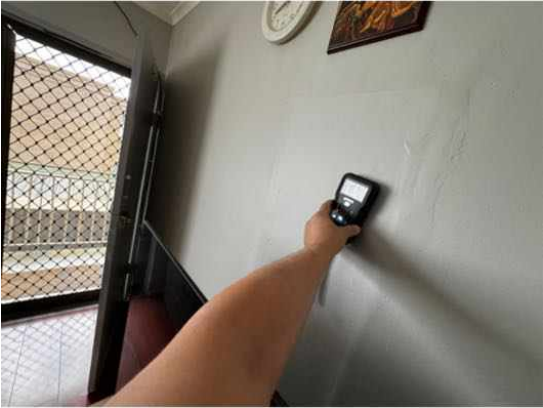
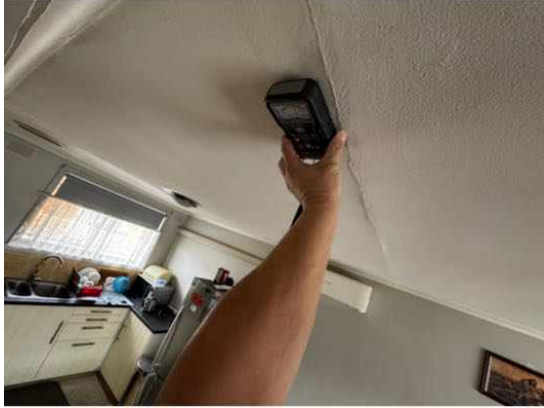
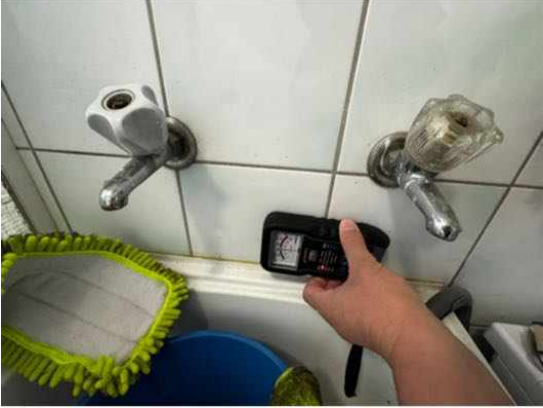
Building: Main Building  
 Location: All Areas > All Areas  
 Finding: Termite investigation techniques (TP)  
 Information: All accessible areas of the dwelling were inspected, with particular attention paid to wet areas, which were closely assessed for elevated moisture levels and temperature anomalies that may indicate conditions conducive to termite activity. No evidence of termite activity was identified within the interior of the dwelling at the time of inspection.

In an attempt to identify concealed or hidden timber pest activity, a range of inspection techniques were adopted. These included the use of a moisture meter to assess susceptible areas, sounding of timber elements using a handheld probing device, and visual assessment of materials for signs commonly associated with termite activity. These signs include moisture-related deterioration, deformation of timber, termite mud leads or bridging, and irregular or regular shaped holes within timber elements that may indicate pest-related damage.

It is noted that termite activity can generate increased moisture and localized temperature variations, and where such irregularities are detected, further investigation may be warranted. However, it is also acknowledged that certain obstructions, including floor coverings, wall linings, wall tiles, and fixed cabinetry such as bathroom fit-offs, can conceal termite activity and limit the effectiveness of visual inspection. As a result, the absence of visible evidence at the time of inspection does

not eliminate the possibility of concealed termite activity within inaccessible or obstructed areas of the building.

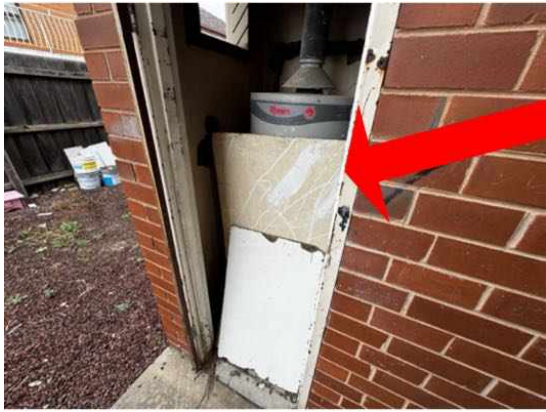
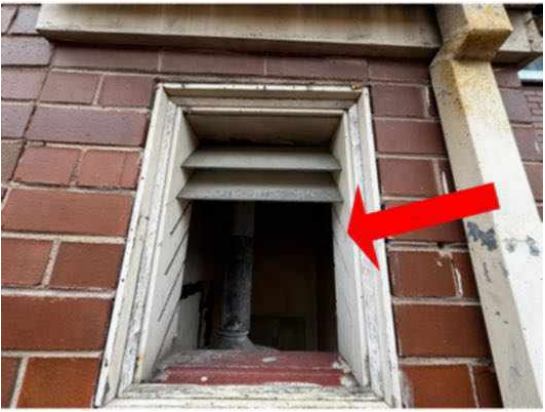
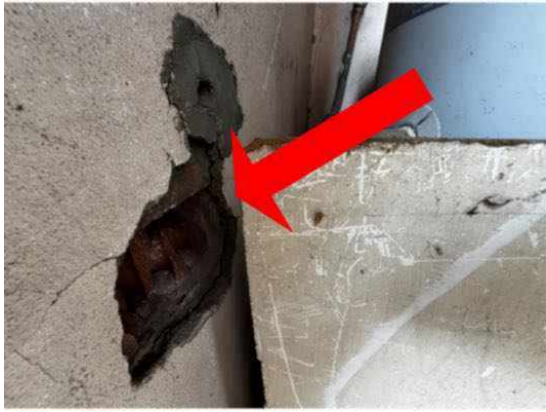
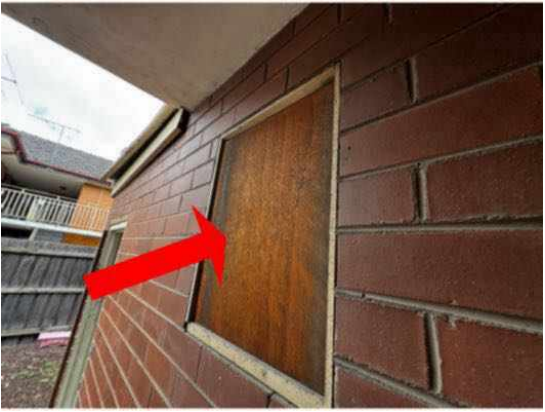
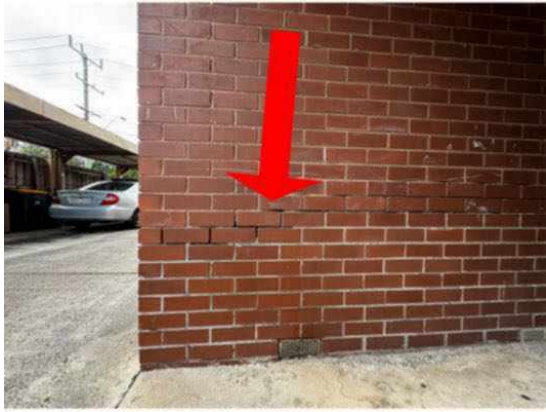
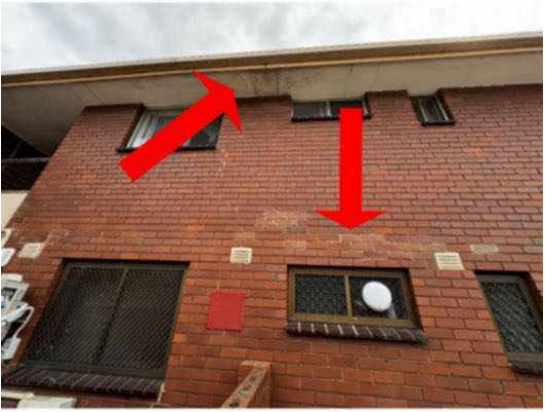
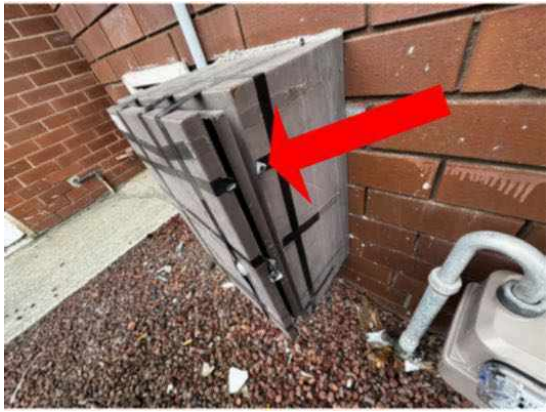
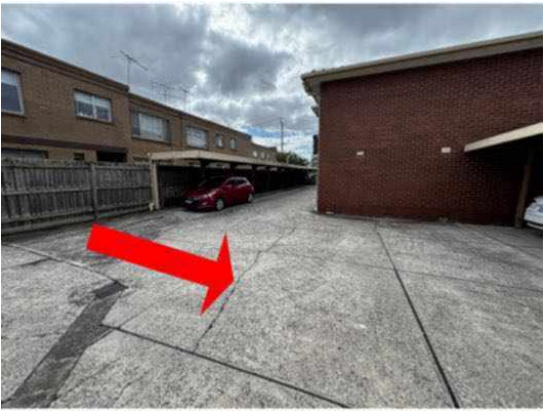
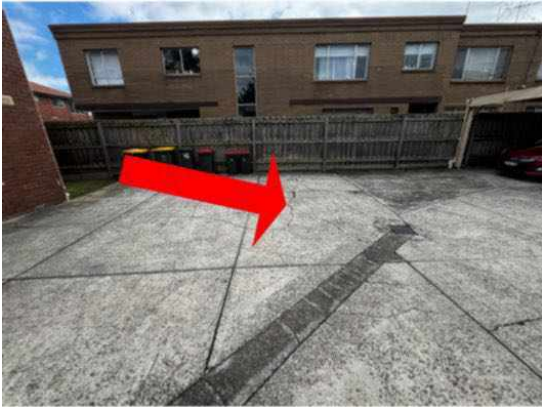
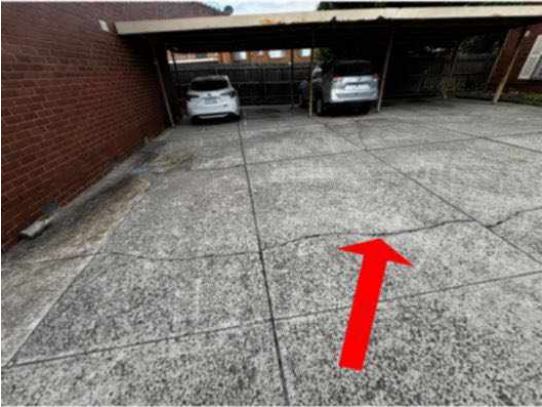
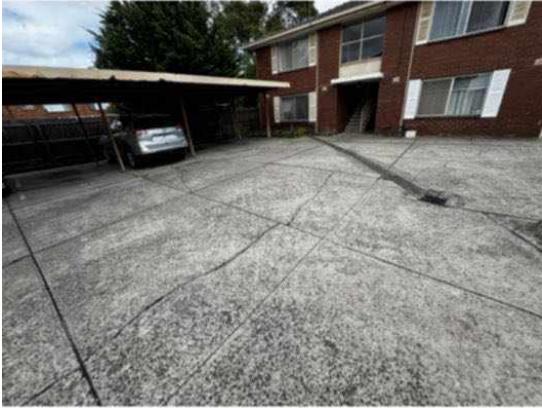
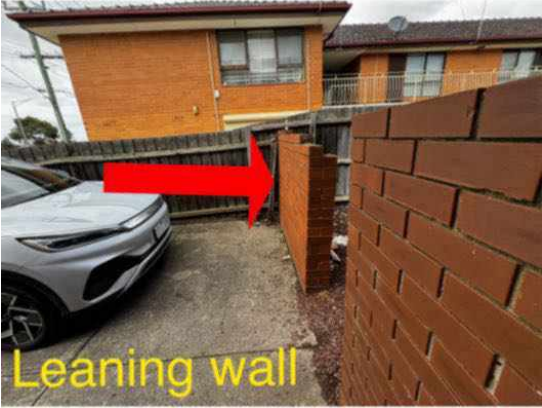
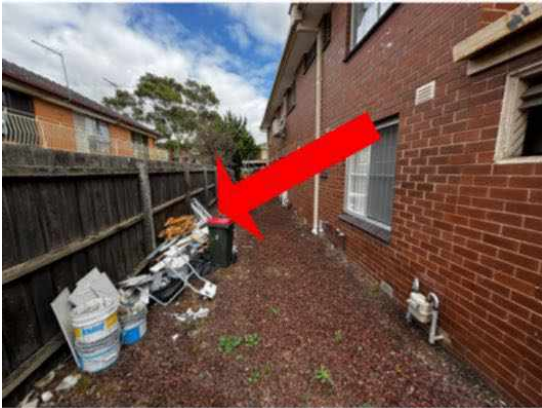
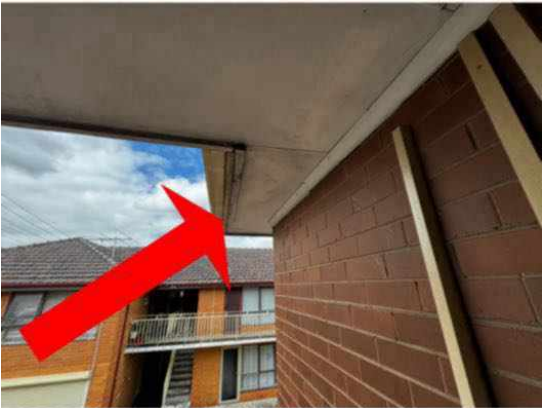
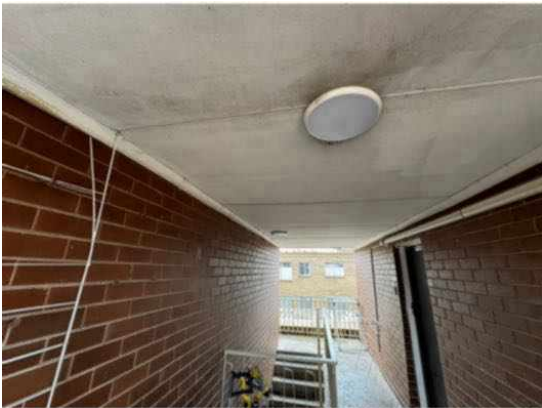
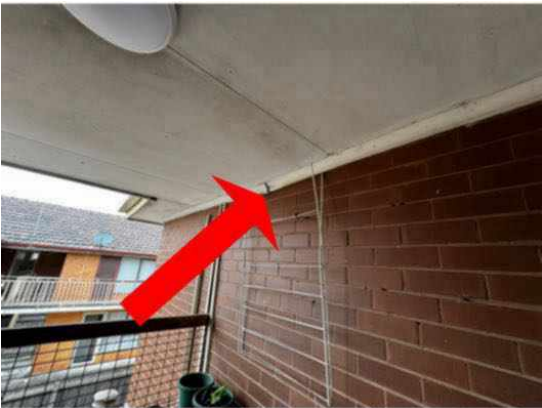
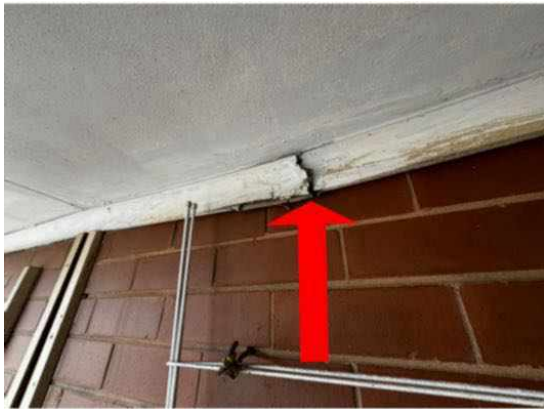
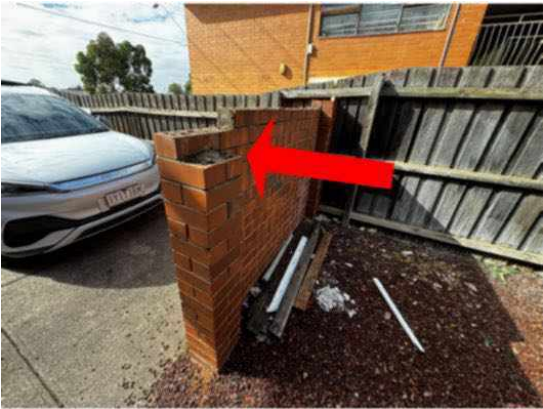
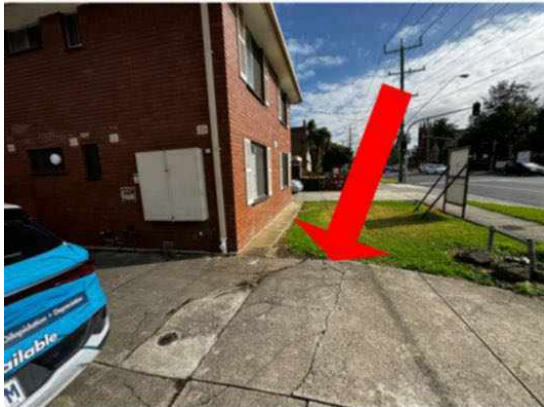
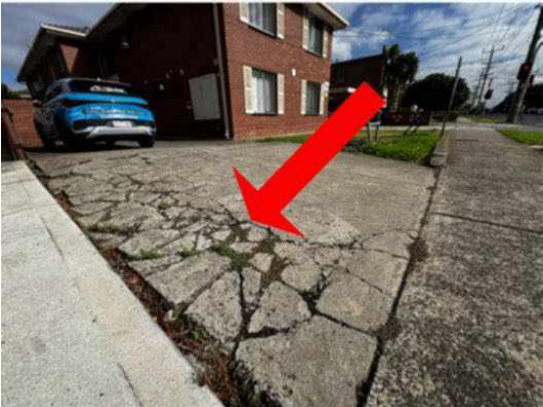
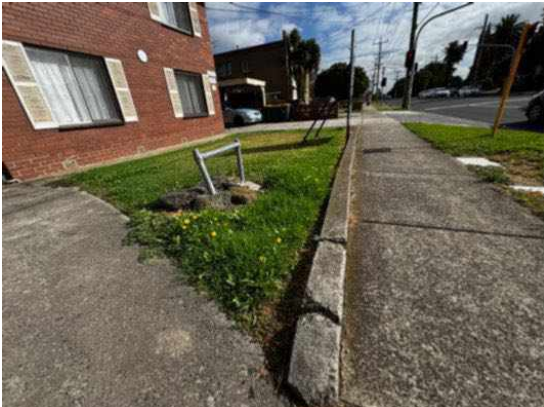
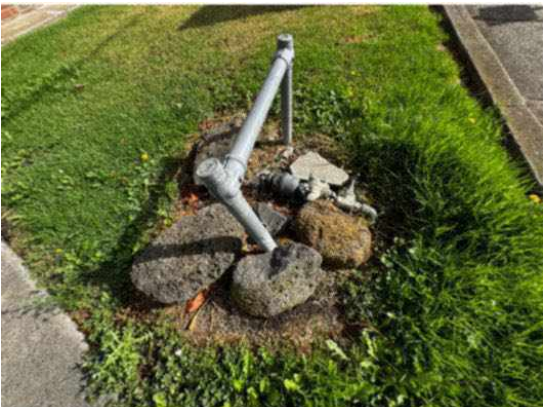
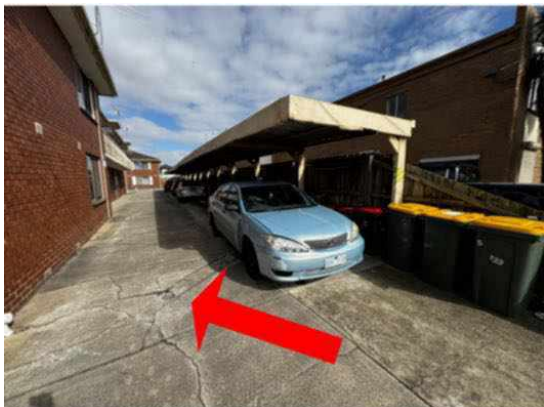
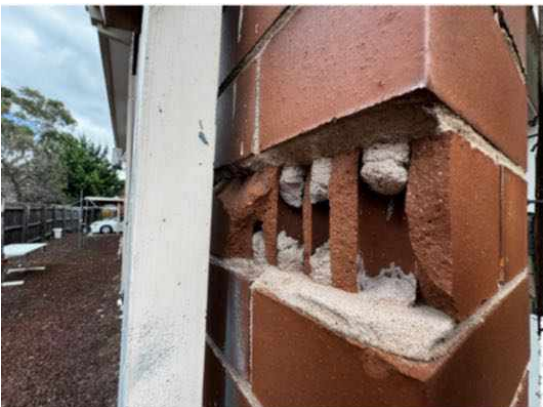
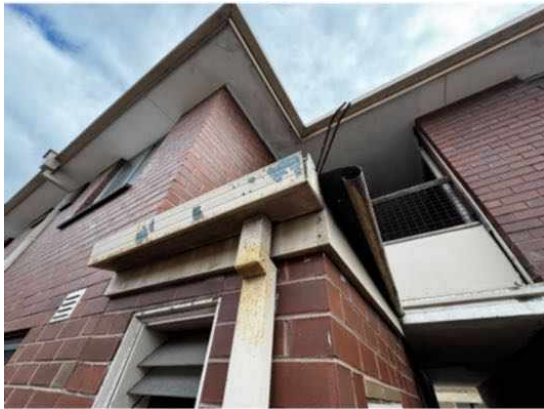
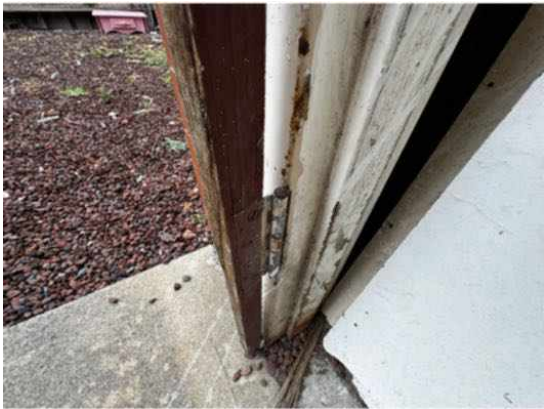
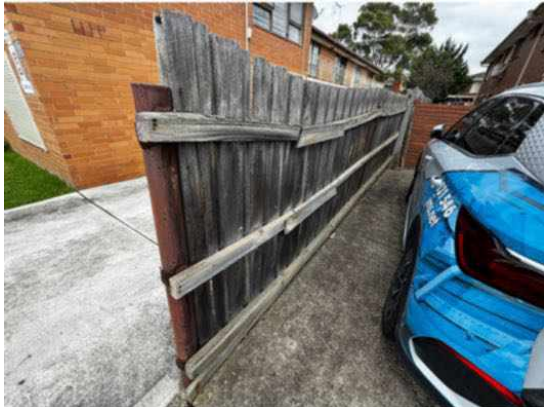
Building: Main Building  
 Location: Common Areas > All Areas  
 Finding: Common Areas – General Deterioration (Outside Scope – FYI Only)  
 Information: In accordance with AS 4349.1–2007, the inspection of common property areas in multi-unit developments is generally outside the scope of a standard pre-purchase building inspection. The primary focus of this inspection was the internal areas of the subject unit.

However, for your information only, the common areas of the building were observed to be in very poor condition at the time of inspection. These areas appeared unmaintained and generally unkept. Observed issues included broken doors, missing window louvres, boarded-up window openings, cracked and damaged brickwork, moisture-damaged eaves, visible makeshift repairs, major cracking to concrete driveway and paved areas, leaning brick walls, rubbish accumulation in yard areas, damaged and stained ceilings to common corridors, and deteriorated boundary fencing.

It is recommended that the body corporate or relevant property manager be notified of the general condition of the common areas and that appropriate maintenance and structural assessments be carried out where required.
