# Building and Timber Pest Inspection Report

Inspection Date: Thu, 8 Jan 2026

Property Address: 2 Warrener St, Nerang QLD 4211, Australia

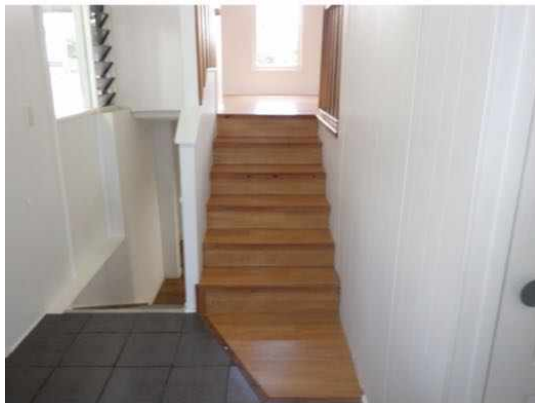
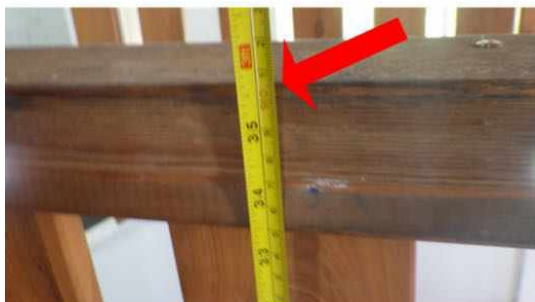
Building:	Main Building
Location:	Stairs - Internal > Existing
Finding:	Balustrade - Suspected Non-Compliance
Information:	The internal stair balustrade was measured and found to be (.905m high) less than the present building regulation requirement of 1000mm high.

Some changes to the building regulations are made to ensure the safety of all inhabitants and balustrades are definitely one of those crucial regulations.

A registered builder should be contacted to discuss possible rectification solutions.

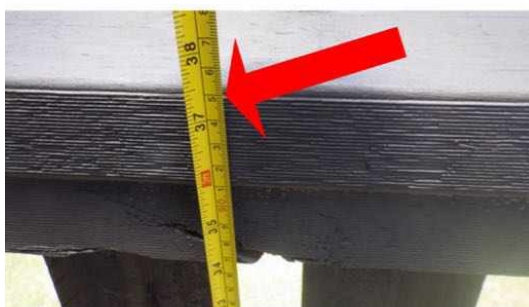
#### Finding 1.02

Building: Main Building  
 Location: Balcony > Existing  
 Finding: Balustrade - Suspected Non-Compliance  
 Information: The balcony area balustrade was measured and found to be (.950mm high) less than the present building regulation requirement of 1000mm high.

This defect creates a potential safety hazard and should be rectified to ensure the safety of the area and to meet present building standards and regulations.

A registered builder should be contacted to discuss possible rectification solutions.

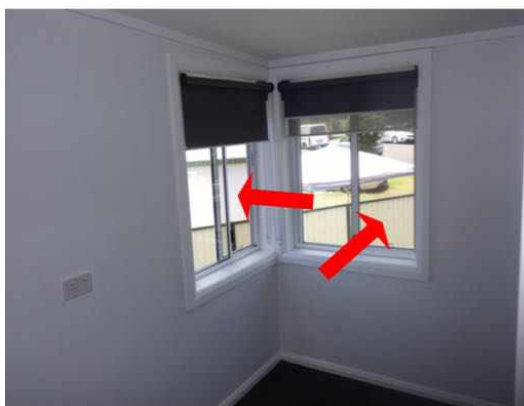
### Finding 1.03

Building: Main Building  
 Location: Bedroom 3 > Existing  
 Finding: Window safety  
 Information: It was noted that the windows of the upper level bedroom 3 are less than 1.7m from the floor and have a fall greater than 2m on the exterior from the sill and as such are required to only open upto 125mm or have security grills fitted.

This is noted as a safety concern and this regulation may not have been in place at the time of construction.

Windows are defective if they do not comply with provision 3.9.2.5 of Volume 2 of the BCA that requires that a window opening must have protection if the floor below the window in a bedroom is 2 m or more above the ground surface beneath.

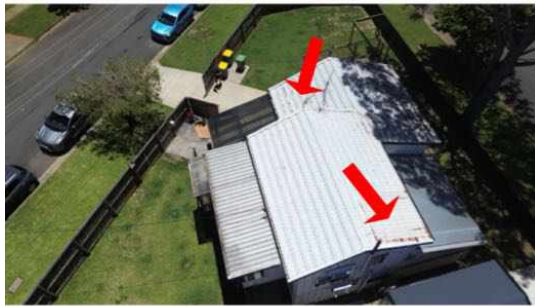
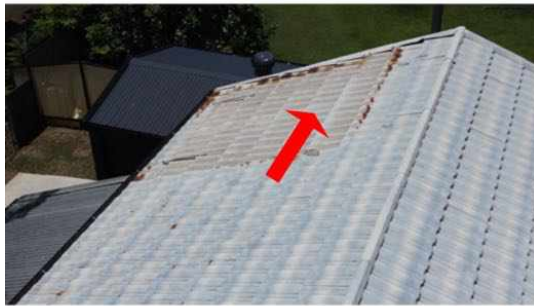
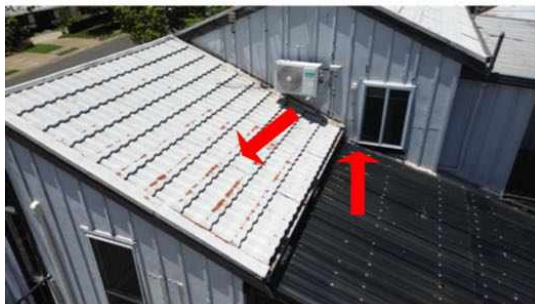
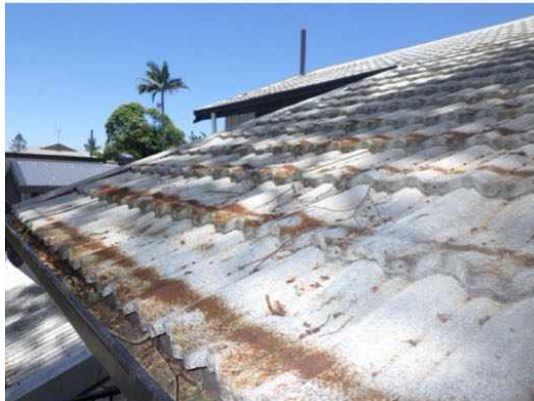
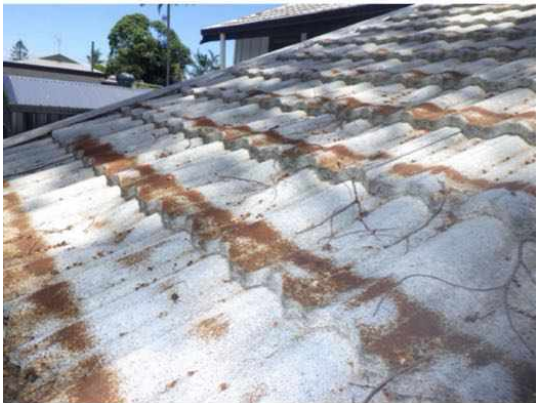
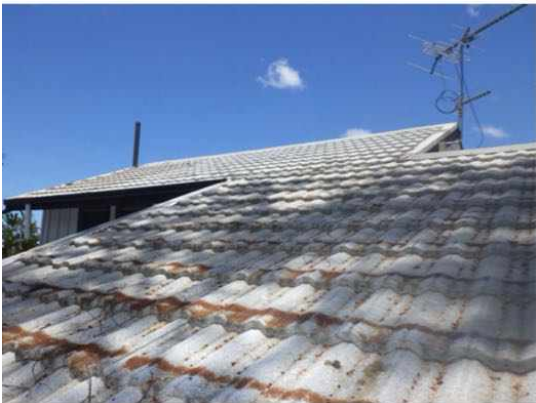
**Finding 2.01**

Building: Main Building  
Location: Roof Exterior > Existing  
Finding: Roof Tiles - Rusted  
Information: At the time of inspection it was observed that there is significant deterioration, damage and/or rusting to the decramastic type metal roof tiles exterior surface (as per example photos). Additionally it appears there has been substandard roof repairs, where colourbond roof sheeting has been installed directly on top of existing decramastic

Decramastic type roof coverings generally comprise numerous individual tiles, which join and overlap. These intersections are particularly prone to lift at the edge and consequently rust at these points.

If left unmanaged, these degrading joints can allow water ingress to the internal roofing structures, potentially leading to secondary damage of building elements. Accelerated deterioration of the roofing tiles and any associated building elements is also likely to occur.

A licensed roofing contractor should be appointed to assess the condition of, or damage to all the roofing coverings and to perform repair or replacement works as necessary.

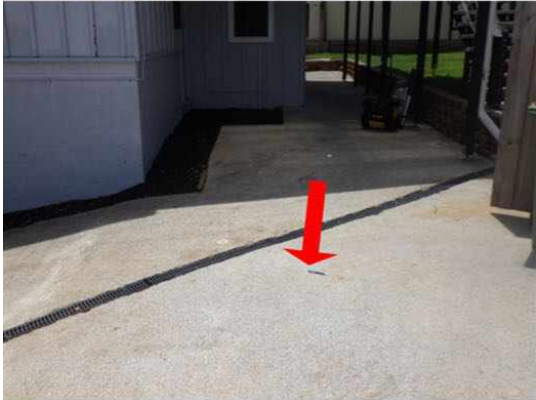
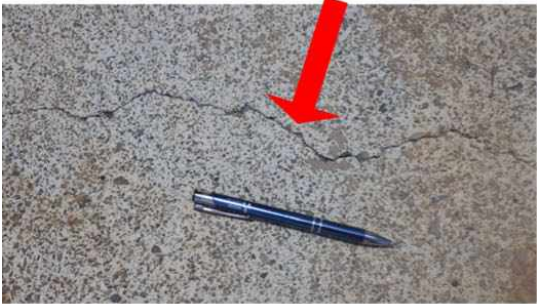
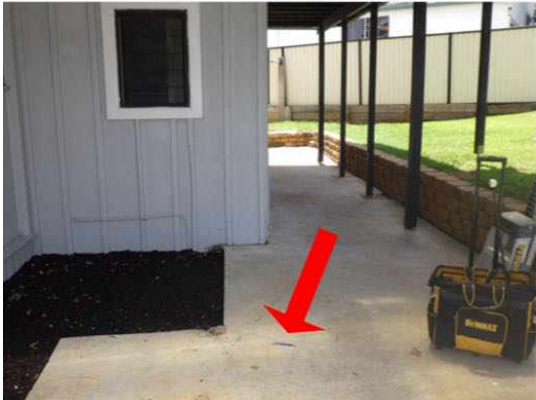
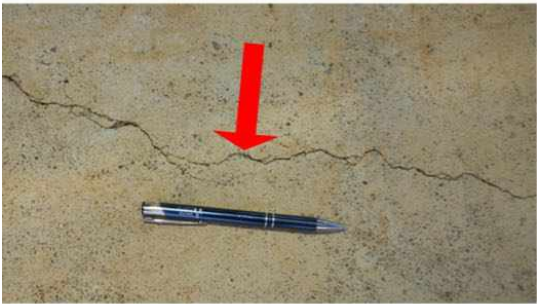
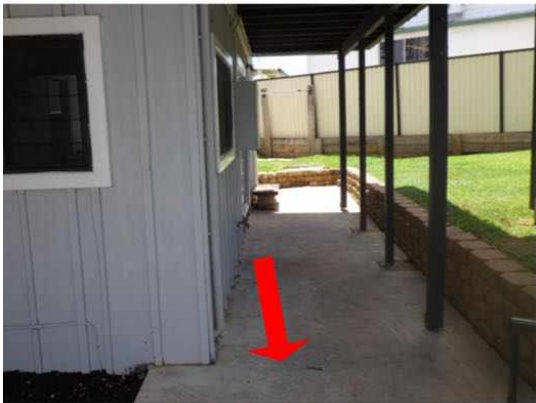
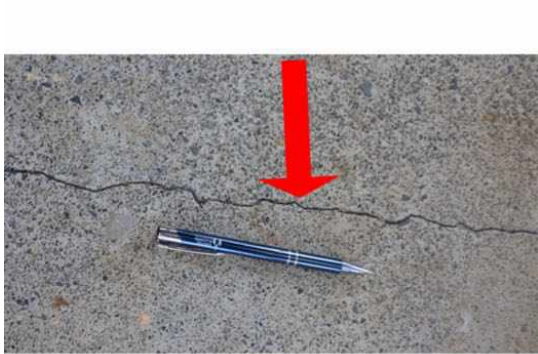
#### Finding 3.01

Building: Main Building  
Location: Driveway > Ground Level  
Finding: Cracking in concrete slab - Category 1  
Information: Cracking coded as Category 1 was identified in the driveway and/or footpaths concrete slab (as per example photos). A Category 1 crack is described as a fine but noticeable crack, with the slab at an otherwise reasonable level.

To be considered Category 1, the approximate width of the crack is less than 1.0mm, or a less than 10mm change in offset when a 3m straight edge is placed over the defect.

Category 1 cracks should be monitored for a period of 12 months. At the end of the monitoring period, identified cracks that are rated greater than Category 2 are considered defects, and require rectification.

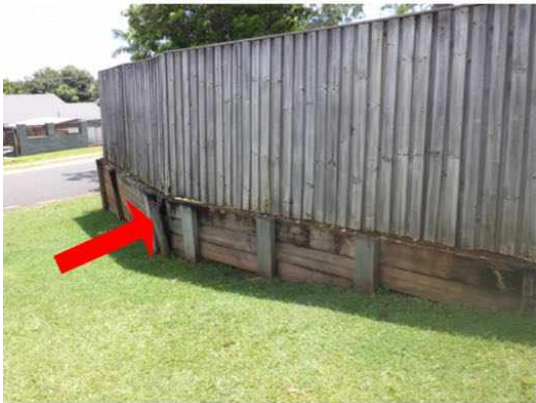
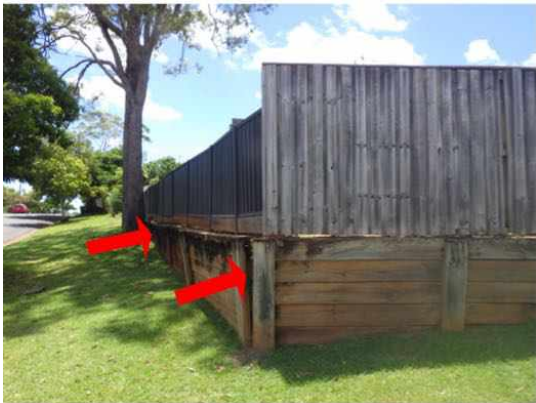
**Finding 3.02**

The timber retaining wall to the front left side of the property was found to be deteriorated at the time of inspection. Generally, deteriorated retaining walls are caused by poor material use or continuous exposure to weather conditions. However, deteriorated retaining walls may also be a result of substandard construction, poor site drainage or unmanaged stormwater flows.

If left unmanaged, the retaining wall may become a safety hazard. Where retaining walls further rot and decay, an environment is created that is conducive to termite and pest infestation.

A landscaper or retaining wall installer could be appointed to repair the wall, at the discretion of the client.

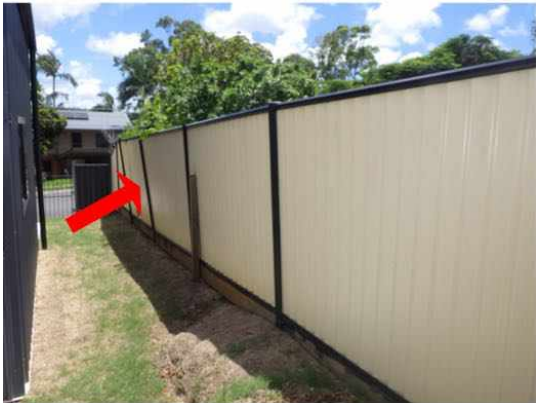
**Finding 3.03**

It was noted at the time of inspection that sections of the metal fencing to the right side of the property showed signs of impact damage and/or have deteriorated. Typically fencing deteriorates due to age and or wear, rot and or rust which is generally expected for a structure of this age, due to prolonged exposure to weather conditions. Sometimes inadequate installation or maintenance can be to blame.

It is suspected that repair of several elements of the fencing may be required.

A licensed fencing contractor could be appointed to provide further advice and perform rectification works as necessary.

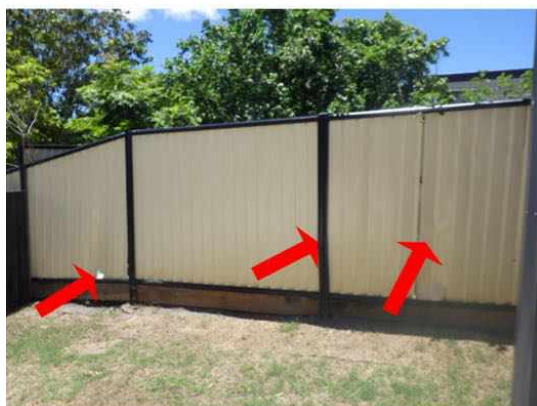
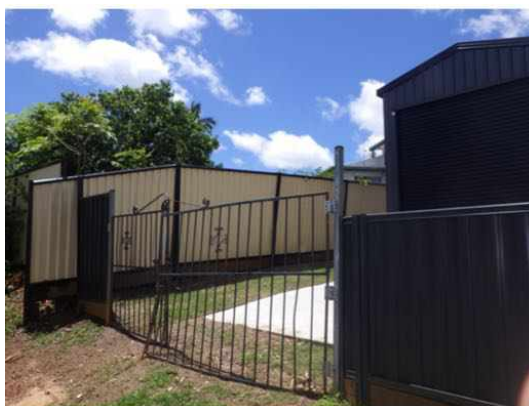
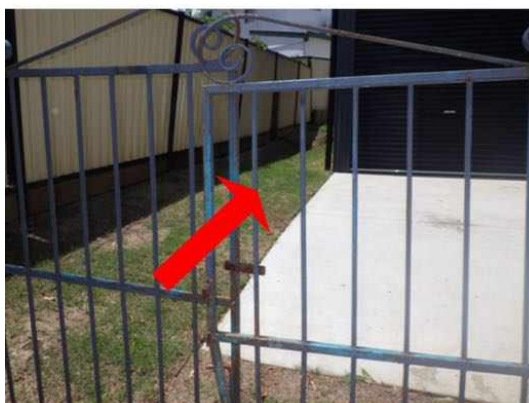
### Finding 3.04

Building:	Main Building
Location:	Yard - Back > Existing
Finding:	Gate - Sticking/ jamming
Information:	At the time of inspection the metal gates to the rear of the property were sticking or jamming during standard operation.

A fencing contractor or general handyman could be engaged to adjust or repair the gate as required.

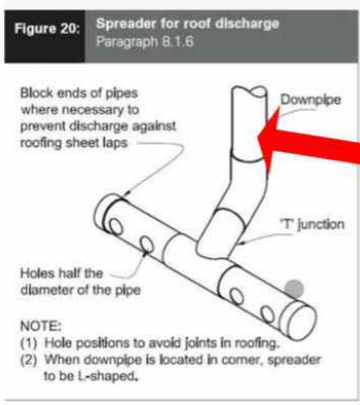
### Finding 3.05

Building:	Main Building
Location:	Roof Exterior > Rear Right
Finding:	Downpipe spreaders - Insufficient
Information:	The down pipe from the upper roof catchment area is not adequately installed onto the lower roof, the current installation allows for discharge water in a concentrated area which may cause roof leaks into the underlying areas, Downpipe spreaders which are not installed correctly are likely to result in excessively damp conditions against the exterior wall surfaces of the building.

The volume of water discharge should also be considered to ensure appropriate size spreaders are installed.

A registered roofing plumber could be engaged to inspect the area and advise on relevant works required.

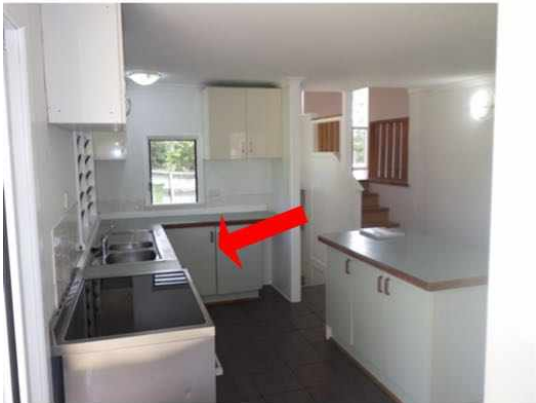
**Finding 3.06**

Building: Main Building  
 Location: Kitchen > Existing  
 Finding: Cabinetry - Deterioration  
 Information: At the time of inspection the kitchen cabinetry showed signs of deterioration (as per example photos). The level of damage appears consistent with exposure to moisture, previous alterations or general wear and tear.

A qualified cabinet maker or general handyman could be engaged to undertake repair works at the clients discretion.

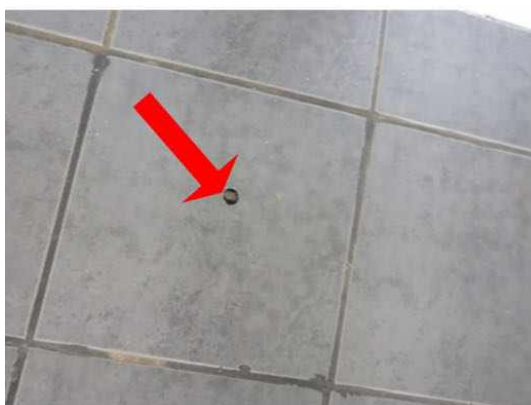
**Finding 3.08**

Building: Main Building  
 Location: Laundry > Front  
 Finding: Tile - Cracked  
 Information: Cracked tiles to the laundry floor area was identified at the time of inspection. Such defects are generally caused by impact. Cracked or broken tiled areas may also be a direct result of poor workmanship during the construction process.

A tiling contractor could be appointed to perform repair works at the clients discretion.

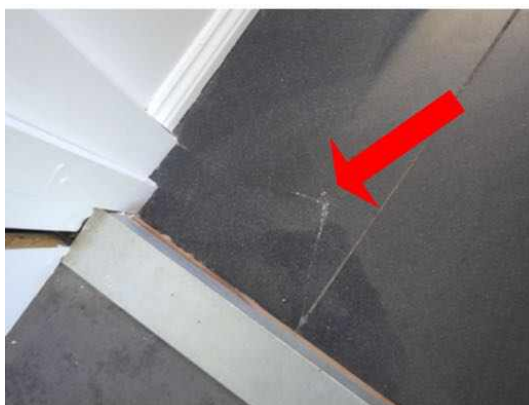
### Finding 3.09

Building: Main Building  
 Location: Laundry > Front  
 Finding: Grout - Missing  
 Information: Grout is missing from a section of floor tiles in the laundry area. Grout is used to protect gaps and crevices in building materials to ensure that they are water-tight and prevent water penetration to the associated structures.

Where grout is missing, a tiling contractor or general handyman should be appointed to apply grout and re-apply any silicone where necessary.

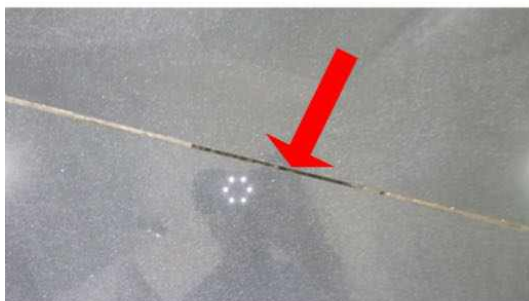
### Finding 3.10

Building:	Main Building
Location:	Laundry > Centre
Finding:	Cabinetry - Door jamming
Information:	Cupboard doors in the laundry area were found to be jamming at the time of inspection. To improve operation of the affected cupboard doors, a cabinet maker or general handyman may be appointed to make adjustments to the hinges of the affected door. Such works should be completed at discretion of the client.

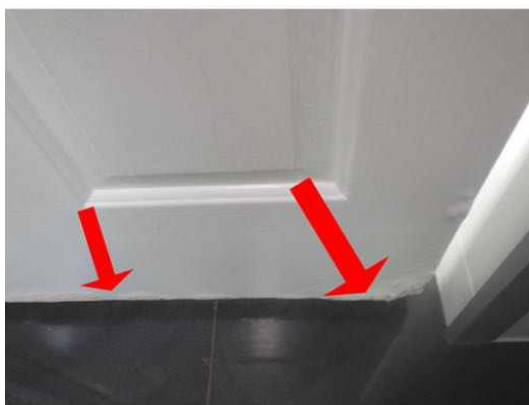
### Finding 3.15

Building:	Main Building
Location:	Bathroom > Front
Finding:	Door Guide
Information:	It was noted that the door guides to the bathroom area sliding door were missing at the time of inspection.

This is noted as a minor defect that you need to be aware of.

A licensed carpenter or general handyman could be engaged to adjust or replace the door guides at the clients discretion.

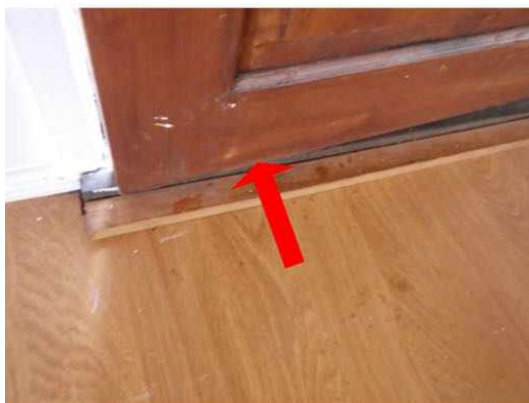
### Finding 3.22

Building:	Main Building
Location:	Living Room > Rear Right
Finding:	Timber paint deterioration.
Information:	The paint or protective coating to the living room timber exterior door has deteriorated. The deterioration appears consistent with general wear and tear along

with continual exposure to weather conditions.

A qualified painter could be engaged to undertake maintenance work on the exposed timber door surface at the clients discretion.

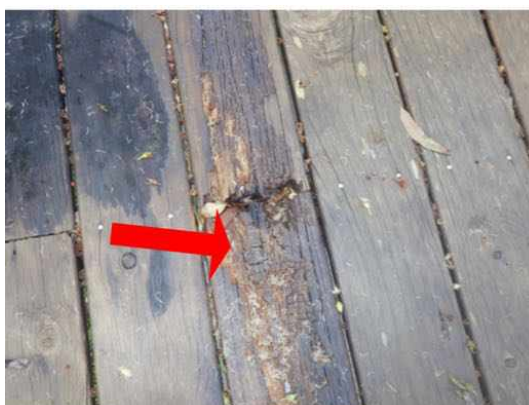
### Finding 3.24

Building:	Main Building
Location:	Deck > Existing
Finding:	Timber - exposed to weather
Information:	At the time of inspection the external timber deck showed signs of weathering.

External decking timbers that are frequently exposed to harsh weather conditions require adequate protection in order to maintain their condition. Where timbers have not been painted or treated adequately, general deterioration is likely to occur at an accelerated rate.

Adequate treatment of the balcony area decking timbers will be required by a painting contractor or general handyman.

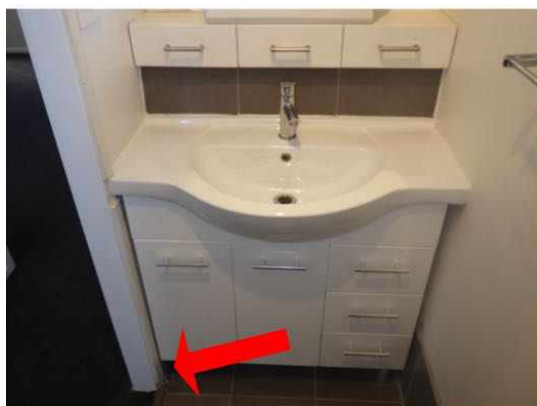
### Finding 3.33

Building:	Main Building
Location:	Bathroom 2 > Centre
Finding:	Basin - Pop up waste
Information:	The upper level bathroom basin pop up waste was damaged or missing at the time of inspection. It is advised that maintenance is carried out on the waste so as it functions as intended.

A handyman could be appointed to perform any remedial works where required.

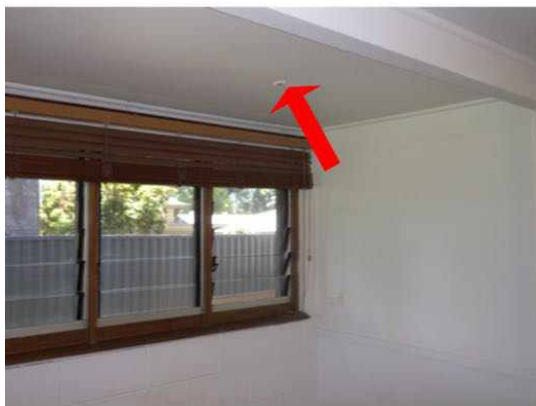
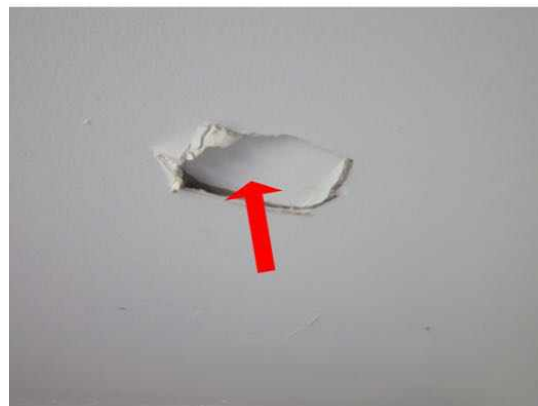
### Finding 3.36

Building:	Main Building
Location:	Utilities Room 1 > Centre
Finding:	Internal ceiling - Hole
Information:	Holes were identified in the utilities room 1 ceiling. It is suspected that the hole is the result of impact.

All excessive holes, gaps or cracks should be adequately filled by a suitable sealant or trimmings as soon as possible to prevent any further damage. Such works may be conducted by a general handyperson or licensed painter.

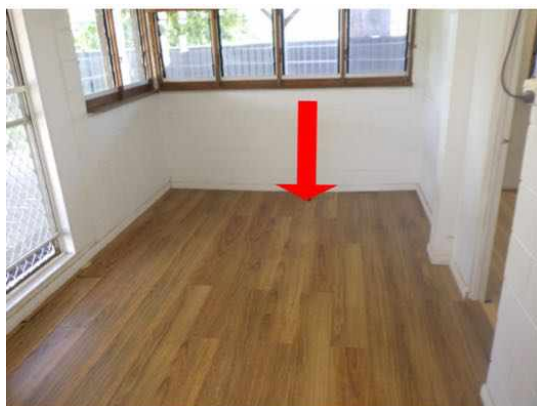
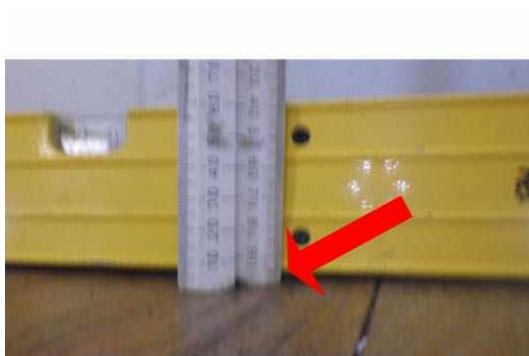
### Finding 3.37

Building:	Main Building
Location:	Utilities Room 1 > Ground Level
Finding:	Floor
Information:	At the time of inspection a section of the internal floor in the ground floor utilities room 1 area was noticeably dipped or uneven.

It is advised that a licensed builder is engaged to further investigate and/or to undertake rectification work on the floor area as required.

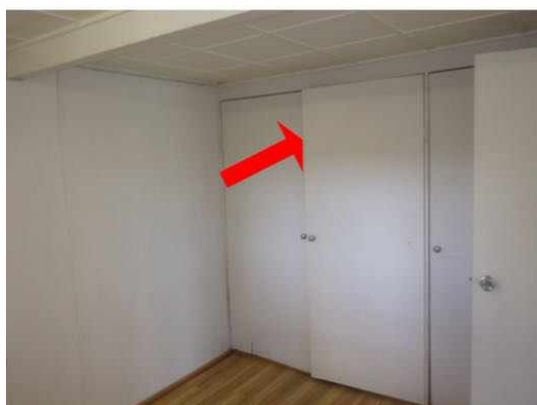
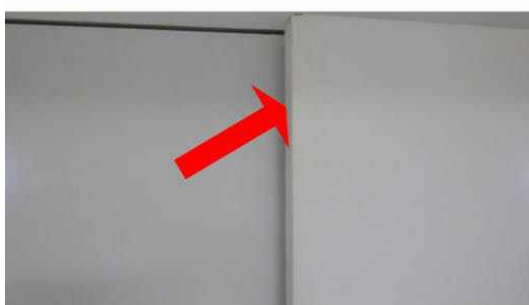
### Finding 3.38

Building: Main Building  
 Location: Utilities Room 2 > Rear Right  
 Finding: Door - Binding/Jamming  
 Information: Binding and/or jamming of the utilities room 2 robe doors was evident during standard operation. This defect inhibits the functionality of affected door as well as creating potential for secondary defects to associated building elements, such as damage to the door framing.

A door that binds to the associated door frame or sill may have several causes, such as poor installation of the door or deteriorated hinges.

A qualified carpenter or general handyperson could be appointed to perform minor rectification works at client discretion.

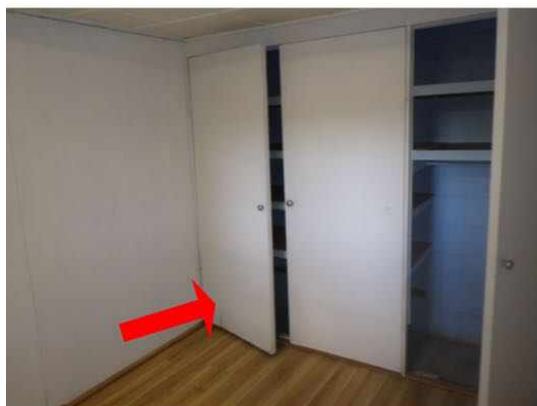
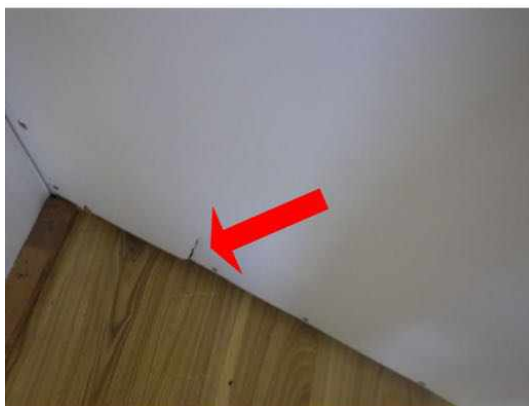
### Finding 3.39

Building: Main Building  
 Location: Utilities Room 2 > Rear Right  
 Finding: Damaged Door  
 Information: The utilities room 2 robe door has suffered damage to the front and/or back surface.

Damage occurs generally when the building materials have aged and decayed, but

appears to be indicative of impact damage.

A qualified carpenter or general handyman could be appointed to replace the door at the clients discretion.

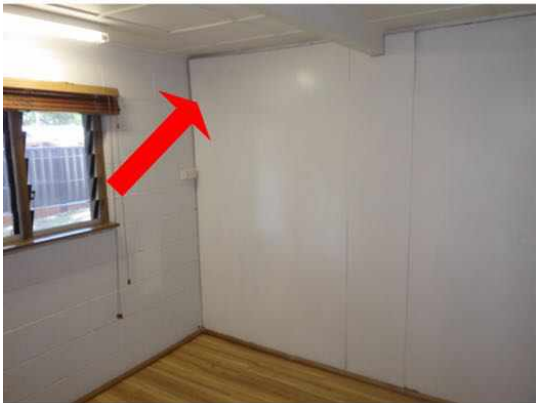
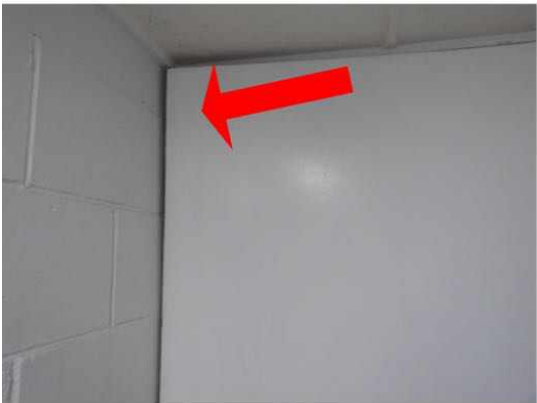
### Finding 3.40

Building: Main Building  
Location: Utilities Room 2 > Rear Left  
Finding: Wall Paneling - Deteriorated  
Information: It was noted at the time of inspection that a section of the interior wall paneling to the utilities room 2 area of the property have deteriorated. Typically wall paneling deteriorates due to age and or wear which is generally expected for a structure of this age. Sometimes inadequate installation or maintenance can be to blame.

The wall paneling is loose or detached from the wall framing which is suspected to have suffered some type of damage possibly from moisture or previous termite activity.

It is suspected that repair of several elements of the wall cladding and framing may be required.

A licensed builder or qualified carpenter should be engaged to investigate further and undertake repair work as required.

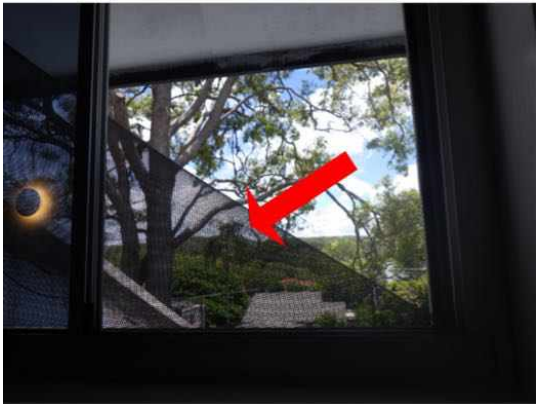
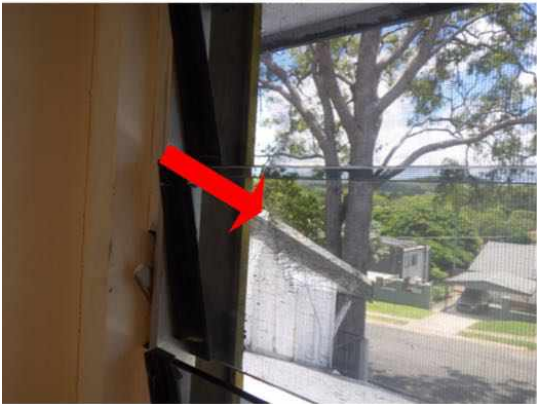
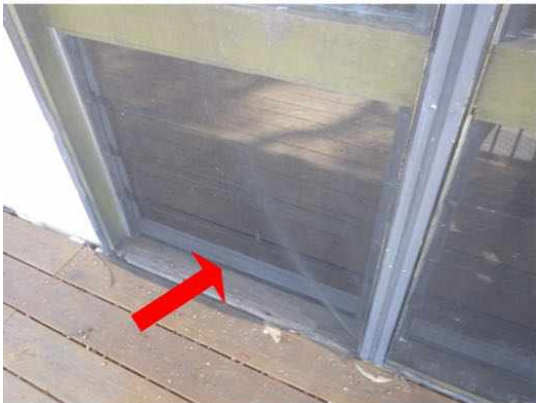
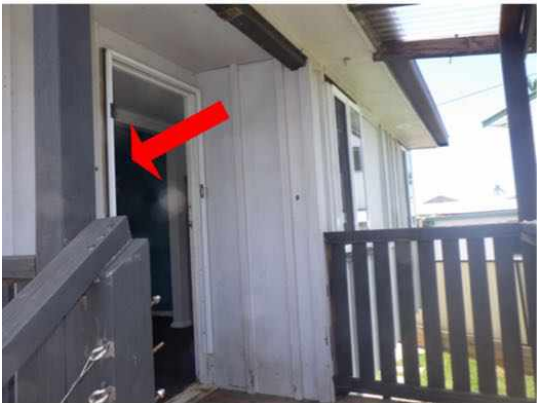
**Finding 3.41**

Building: Main Building  
Location: External Areas > Existing  
Finding: Insect Screens  
Information: At the time of inspection a number of insect screens or doors throughout the property were missing and/or showed signs of damage or general wear and tear (as per example photos).

A insect screen service agent or supplier could be consulted regarding repair or replacement of the damaged screens.

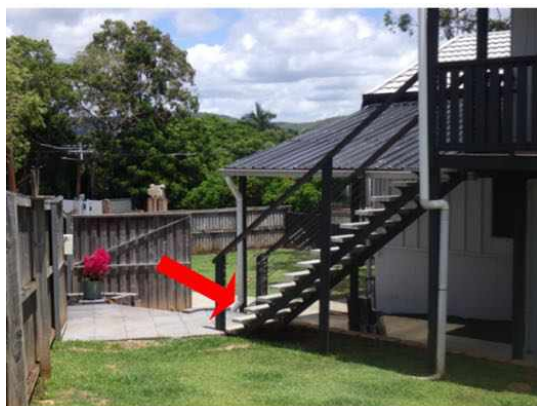
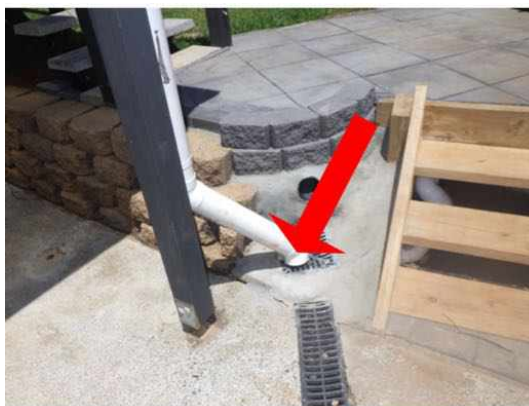
## Finding 6.02

Building:	Main Building
Location:	Yard - Front > Ground Level
Finding:	Stormwater downpipes
Information:	The down pipes to the front roof area of the property are not connected to the stormwater drainage on the site. This disconnection negatively impacts the functional capacity of the downpipes and the surrounding ground area.

Where roof plumbing doesn't drain as required, the area at the base perimeter can become excessively damp, potentially creating an environment that is susceptible to flooding and rust or corrosion of surrounding building elements, as well as attracting termites and other pests.

It is recommended that a licensed plumber be appointed to further inspect and to extend the down pipes to the properties stormwater line as necessary.

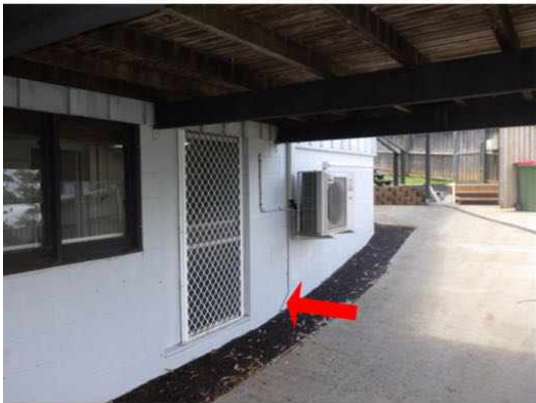
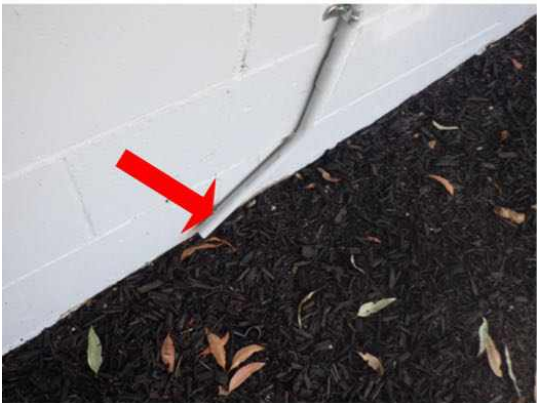
### Finding 6.03

Building:	Main Building
Location:	Exterior walls - left side > Centre
Finding:	Overflow - Not plumbed for drainage
Information:	The air conditioning unit overflow is not plumbed or connected to suitable drainage, which can result in the surrounding area becoming excessively damp. These damp conditions can lead to secondary defects such as rot, rust or corrosion of associated building elements, the formation of fungal decay, or even the creation of potential slip hazards. When coupled with poor site drainage, pooling of water may also attract termite activity to this area. It is highly recommended that a qualified plumber be appointed to install adequate drainage to the overflow. These works will ensure that the area remains dry and free of any secondary defects.

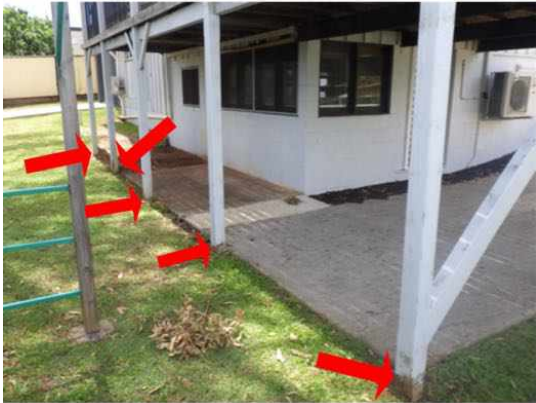
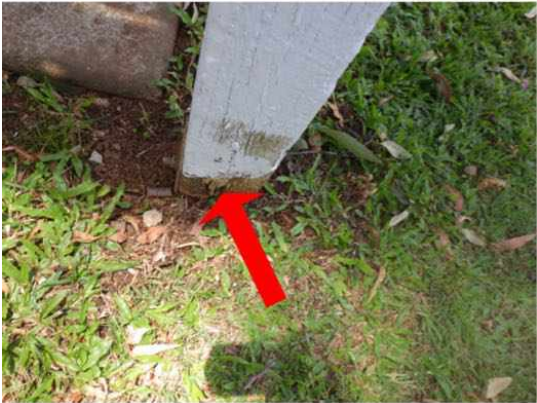
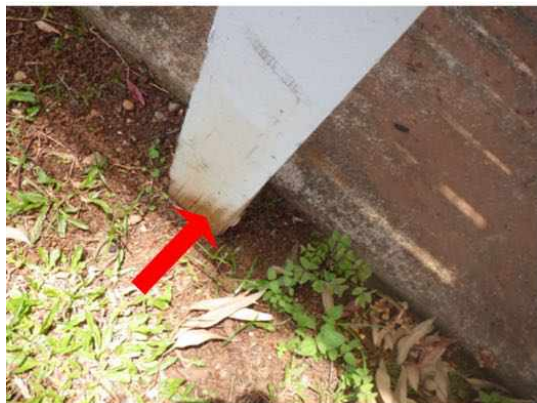
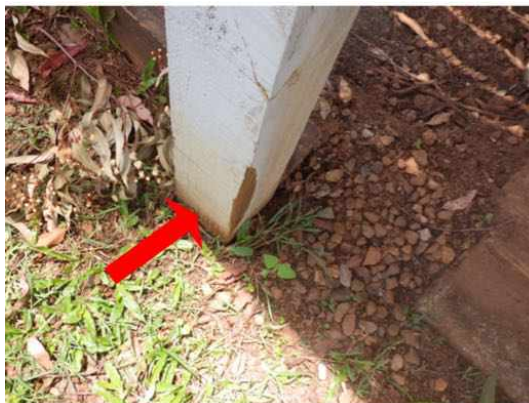
**Finding 6.04**

Building: Main Building  
Location: Deck > Ground Level  
Finding: In ground contact  
Information:

It was noted at the time of inspection, that the timber posts to the timber deck area at the rear of the property are in direct contact with the ground. The ground area directly around and under the bottom of the timber post should be cleared so as to provide a clear inspection zone to the post and support bracket. It is advised that this area be monitored very closely for signs of wood rot and or timber termite pest activity.

Any timbers in direct ground contact provide opportunity for concealed termite entry and are likely to be subject to premature rot and decay as the soil retains moisture or damp conditions against the timbers. Frequent pest inspections are advised to readily identify any termite activity in these areas.

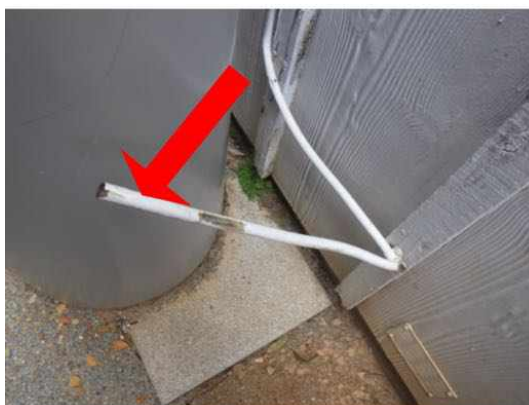
### Finding 6.05

Building:	Main Building
Location:	Exterior walls - right side > Centre
Finding:	Overflow - Not plumbed for drainage
Information:	The hot water system overflow is not plumbed or connected to suitable drainage, which can result in the surrounding area becoming excessively damp. These damp conditions can lead to secondary defects such as rot, rust or corrosion of associated building elements, the formation of fungal decay, or even the creation of potential slip hazards. When coupled with poor site drainage, pooling of water may also attract termite activity to this area. It is highly recommended that a qualified plumber be appointed to install adequate drainage to the overflow. These works will ensure that the area remains dry and free of any secondary defects.

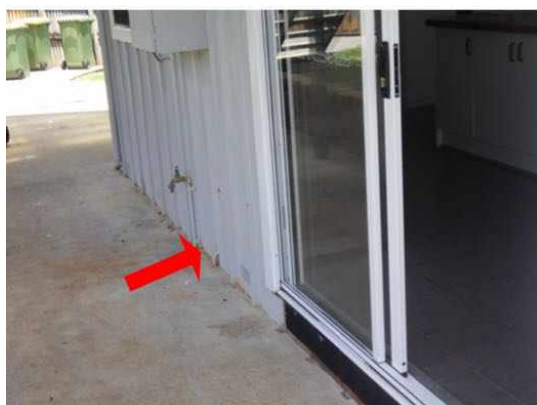
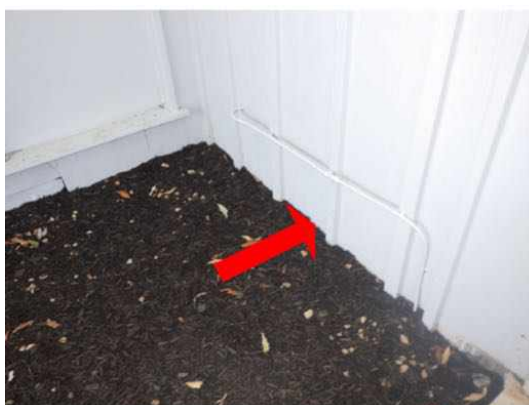
### Finding 6.06

Building:	Main Building
Location:	Exterior walls - front > Ground Level
Finding:	Slab Edge - Exposure
Information:	At the time of inspection the masonry wall cladding to the front of the property was found to be finished below concrete or ground level and does not achieve the 50mm separation required.

An inspection zone of 50mm in relation to the exposed slab edge between the bottom edge of the wall cladding and the perimeter paving or ground surface is required. This inspection zone should be maintained in order to force termites into the open where they can be detected more readily during regular inspections. The slab edge should not be concealed by anything that may prevent inspection of the area, including render, landscaping, soil, turf, paving, concrete, cladding or other structures. If the slab edge or weep hole line is not properly exposed, it is considered a high risk area of termite attack.

It is highly recommended that timber termite pest inspections be carried out every 6 - 12 months to aid protection of the property against infestation.

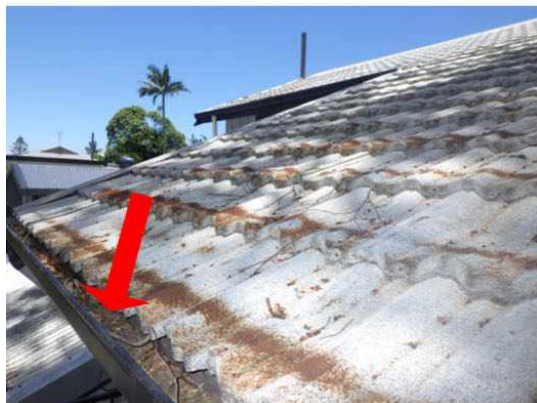
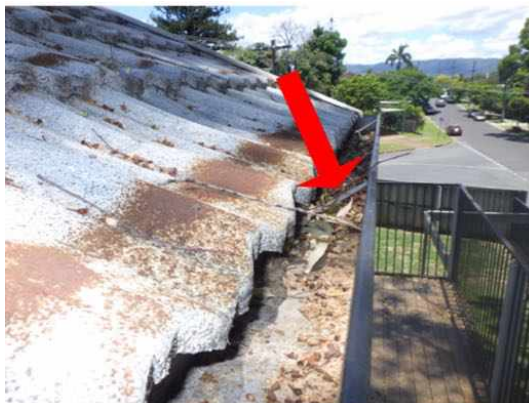
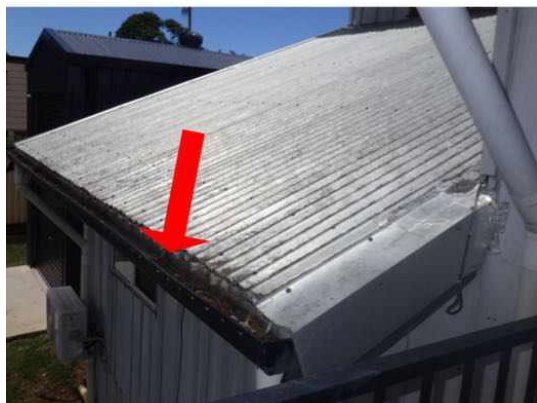
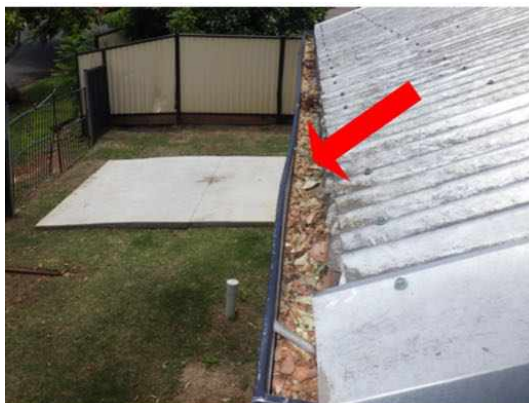
### Finding 6.07

Building:	Main Building
Location:	Roof Exterior > Rear
Finding:	Gutters - Leaves in gutters
Information:	At the time of inspection there was leaves and vegetation type debris in the roof gutters to the rear of the property.

Roof plumbing structures, such as guttering and downpipes, should be free of all debris to prevent blockages. Blockages of the guttering and downpipes will lead to pooling and accumulated water overflows, which is likely to subsequently flood eaves and exterior walls.

Blocked gutters are likely to lead to high levels of moisture in the affected areas. Such moisture will not only cause rust and decay of the associated building materials, but can also provide conditions that are conducive to termite and timber pest activity. Blockages in gutters should therefore be removed immediately to ensure dry conditions are maintained.

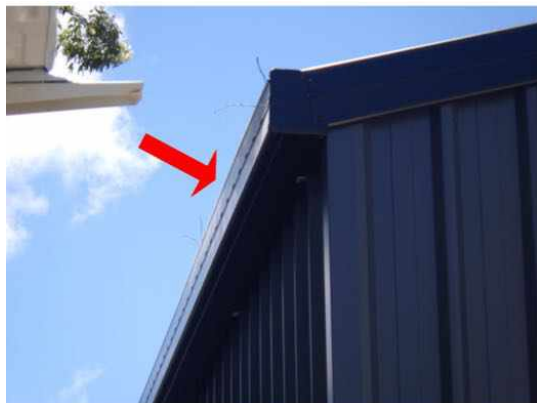
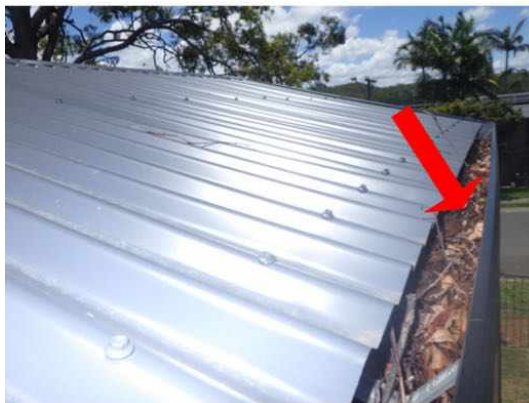
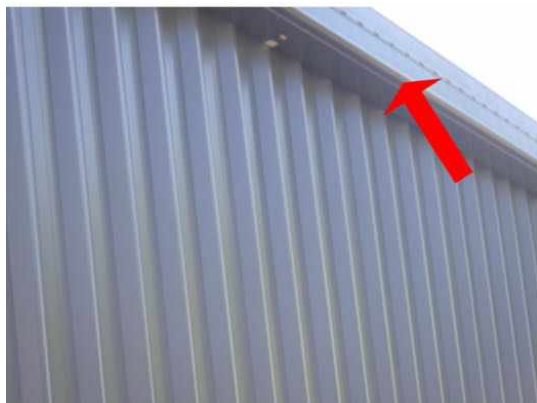
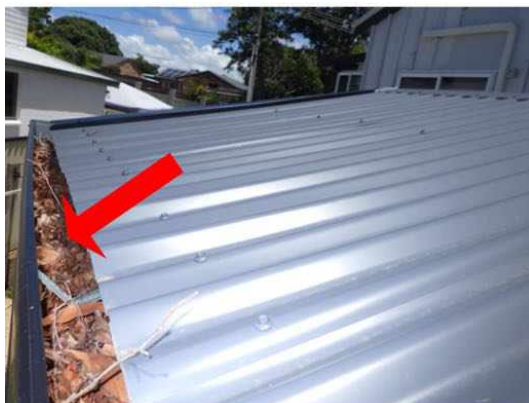
### Finding 6.08

Building:	Shed
Location:	Roof Exterior > Existing
Finding:	Gutters - Leaves in gutters
Information:	At the time of inspection there was leaves and vegetation type debris in the roof gutters of the shed on the right side of the property.

Roof plumbing structures, such as guttering and downpipes, should be free of all debris to prevent blockages. Blockages of the guttering and downpipes will lead to pooling and accumulated water overflows, which is likely to subsequently flood eaves and exterior walls.

Blocked gutters are likely to lead to high levels of moisture in the affected areas. Such moisture will not only cause rust and decay of the associated building materials, but can also provide conditions that are conducive to termite and timber pest activity. Blockages in gutters should therefore be removed immediately to ensure dry conditions are maintained.

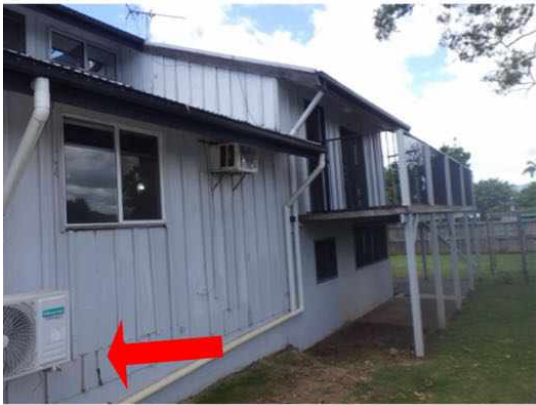
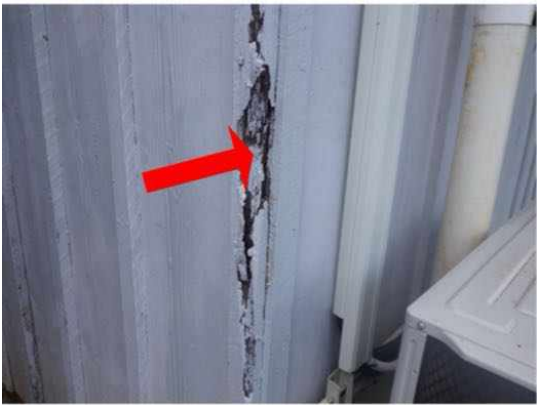
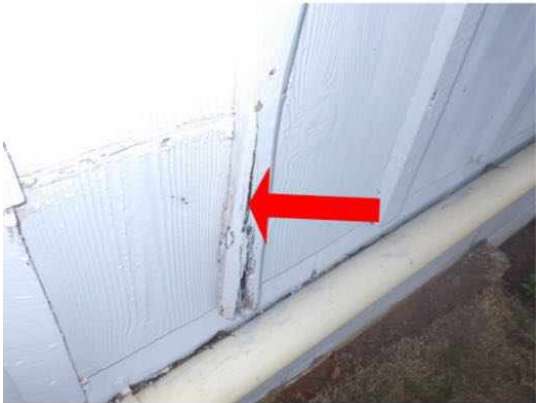
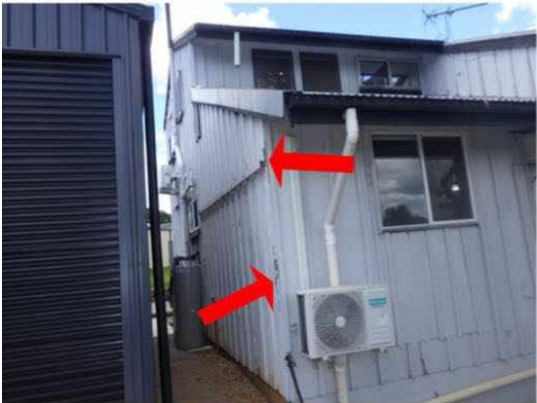
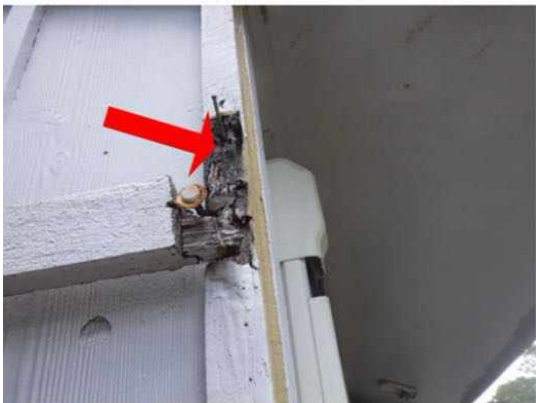
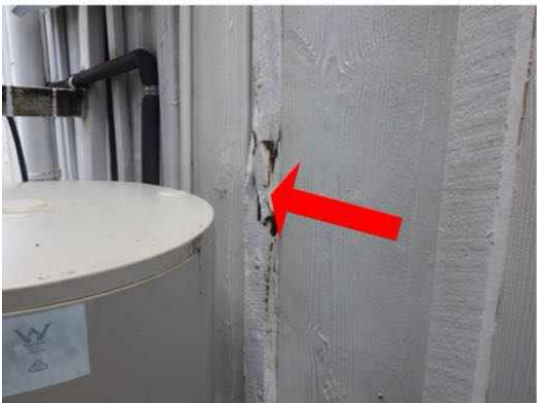
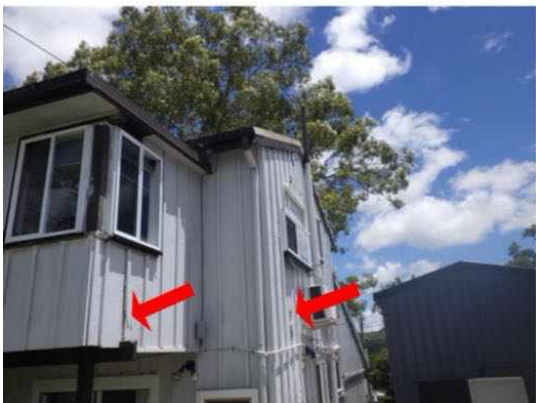
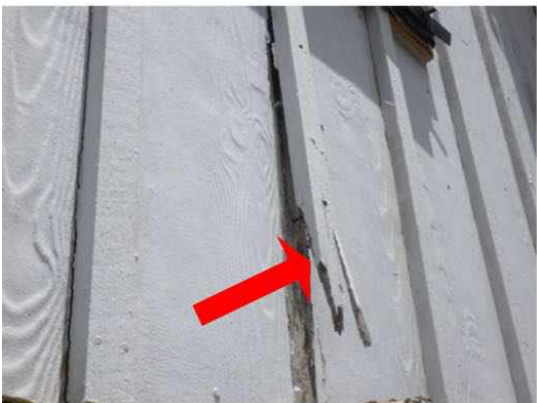
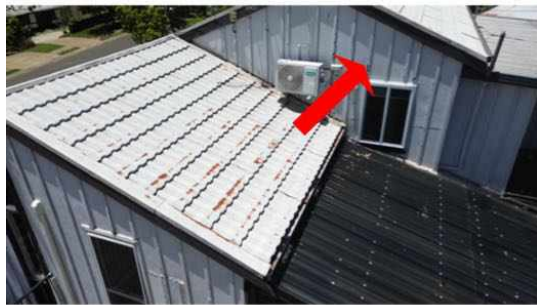
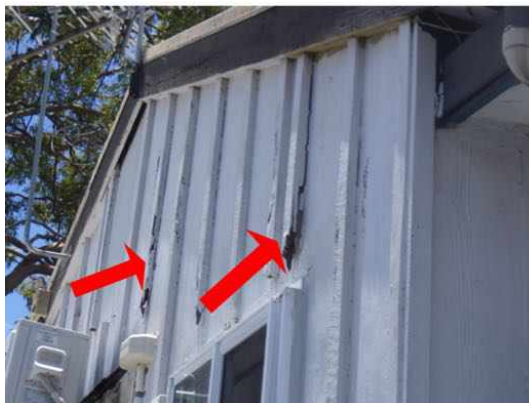
Building:	Main Building
Location:	Exterior walls > Existing
Finding:	Wood rot - timber battens.
Information:	The timber cover battens to the exterior wall cladding show evidence of significant wood rot in a number of areas (as per example photos). Wood rot, also known as Fungal Decay, occurs when timbers and other cellulose building materials are exposed to damp conditions on an ongoing basis. This could be the result of exposure to weathering over a prolonged period of time, or the attraction of excessive moisture from other abutting building materials. Contributing factors also include poor air ventilation.

A qualified builder or carpenter should be engaged to check all exposed timber members and undertake repair work as required.

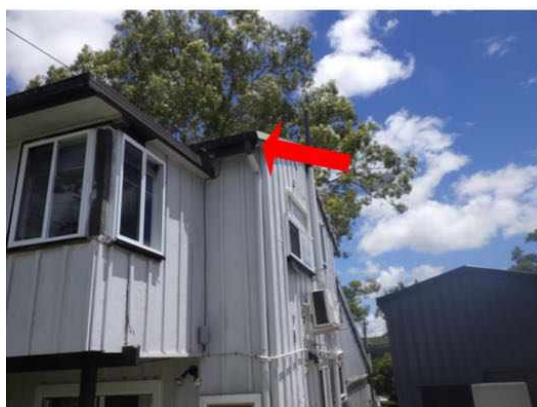
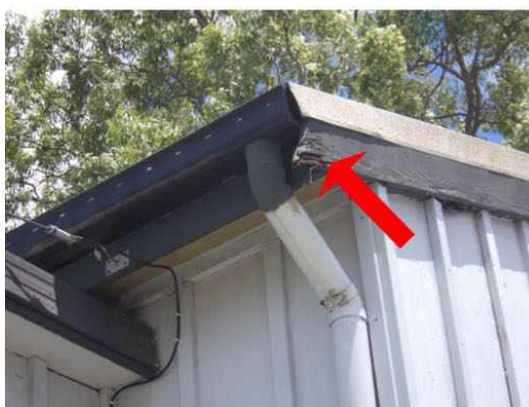
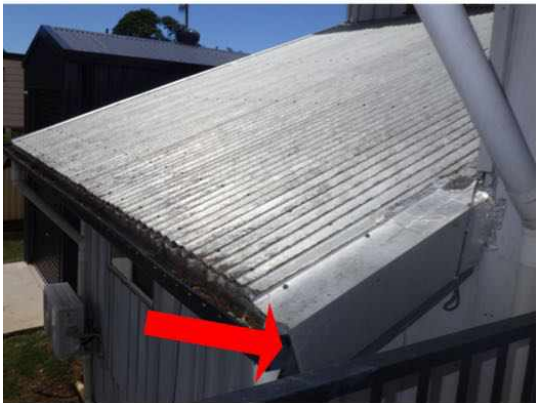
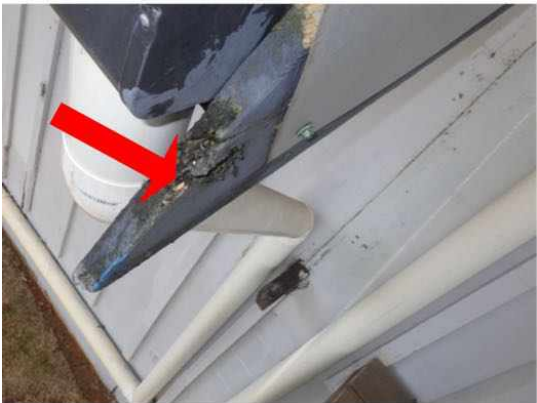
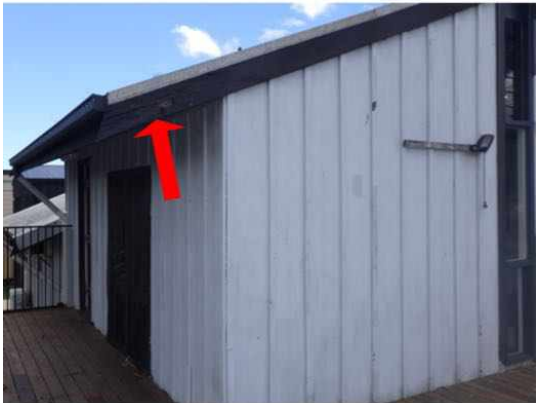
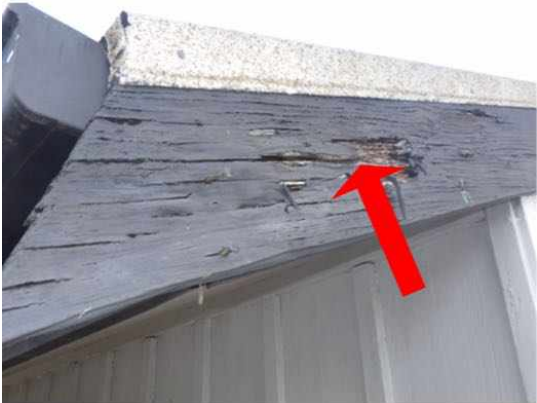
## Finding 7.02

Building:	Main Building
Location:	Eaves > Existing
Finding:	Fascias - Wood rot
Information:	At the time of inspection wood rot was found to be affecting fascias and barges in a number of areas (as per example photos). Wood rot, also known as Fungal Decay, occurs when timbers and other cellulose building materials are exposed to damp conditions on an ongoing basis.

Frequent exposure to rain and other weather conditions make fascias and barges susceptible to accelerated deterioration.

Early intervention and regular maintenance will prolong the useful life of these building elements. Prior to any works being performed, the cause of the moisture that has created the visible wood rot should be identified and addressed in a suitable manner.

A registered builder or qualified carpenter should be engaged to check the condition of all fascia's and barge boards and to replace affected fascia's as required.
