# Building and Timber Pest Inspection Report

Inspection Date: Thu, 8 Jan 2026

Property Address: 2 Warrener St, Nerang QLD 4211, Australia

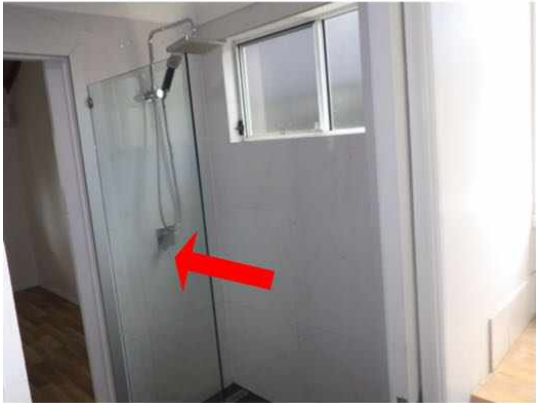
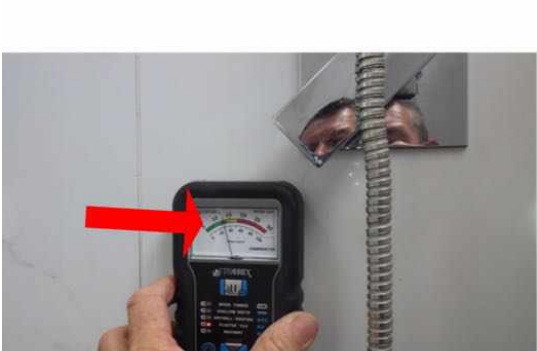
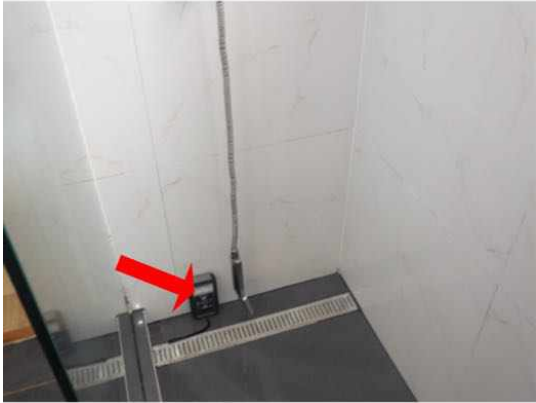
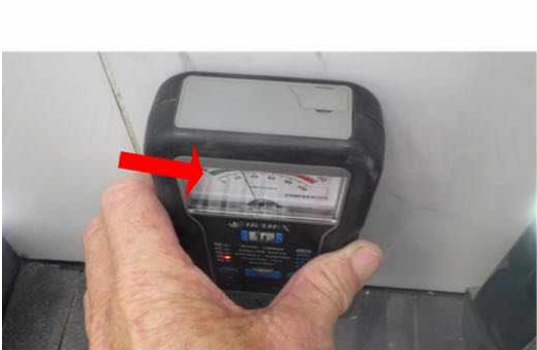
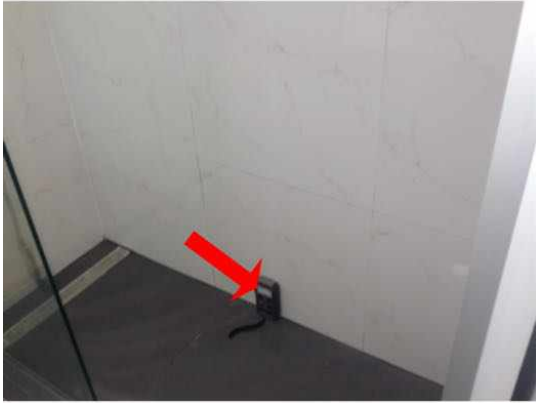
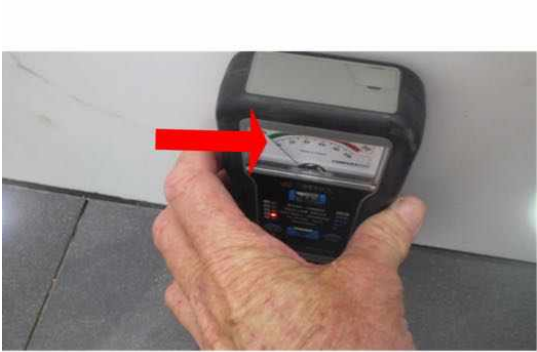
Building: Main Building  
Location: Bathroom > Centre Right  
Finding: Moisture Level Readings  
Information: At the time of inspection the ground floor bathroom shower cubicle areas checked with the Tramex Moisture Meter returned low - normal moisture level readings.

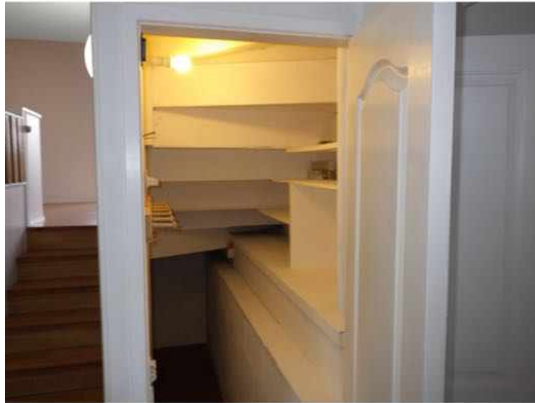
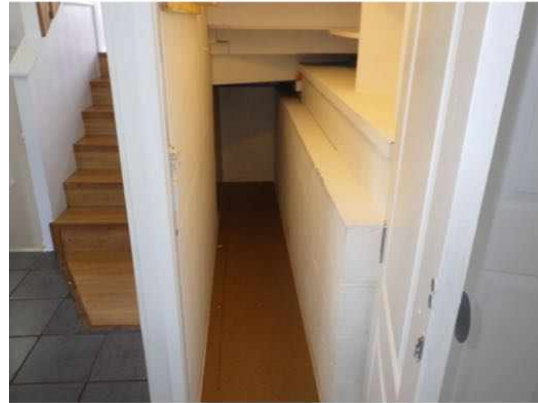
Building: Main Building  
Location: Under Stair Void or Storeroom  
Finding: No obvious defect  
Information: No obvious defects found at the time of inspection.

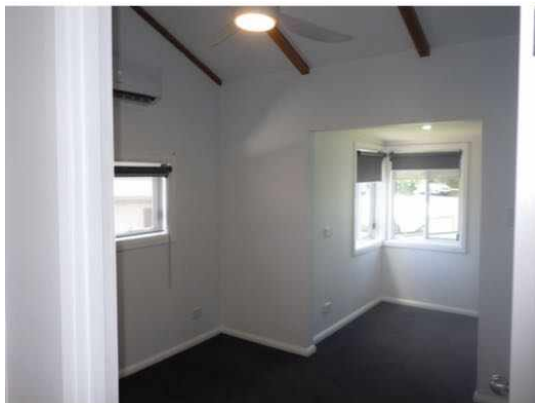
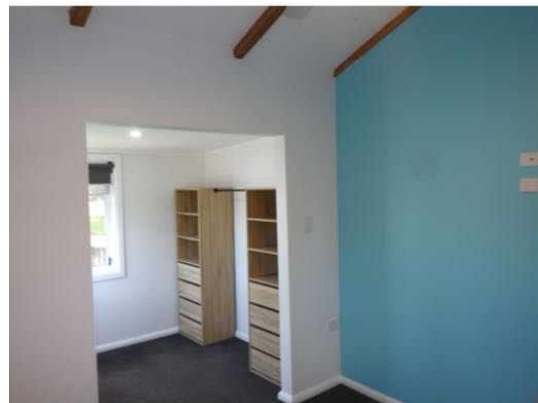
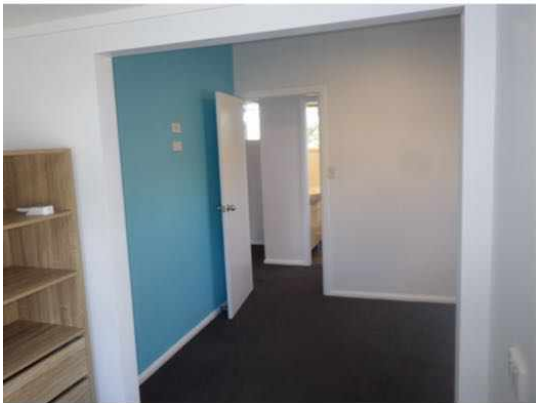
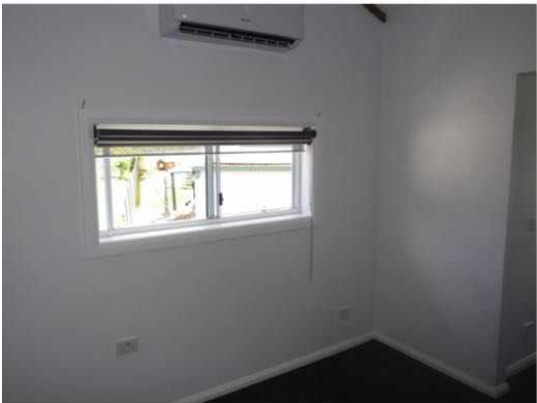
Building: Main Building  
Location: Bedroom 3  
Finding: No obvious defect  
Information: No obvious defects found at the time of inspection.

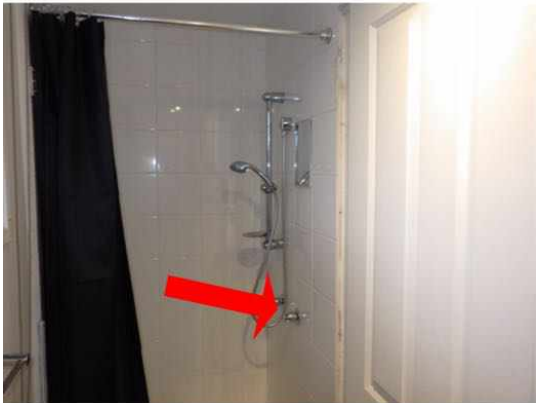
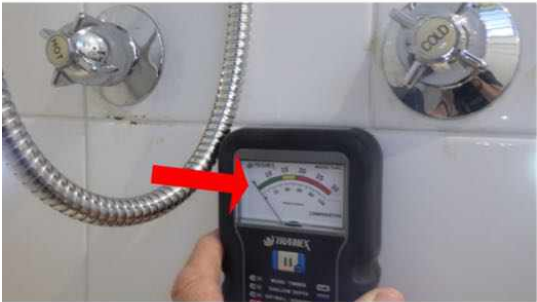
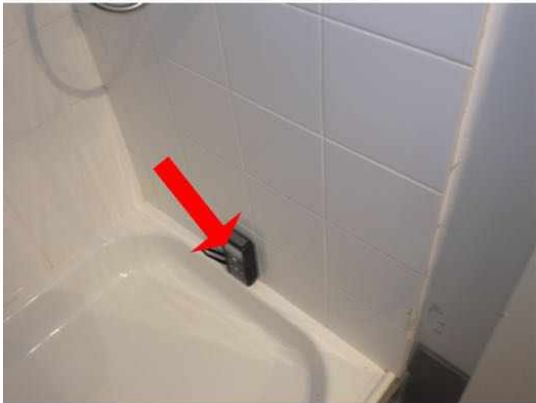
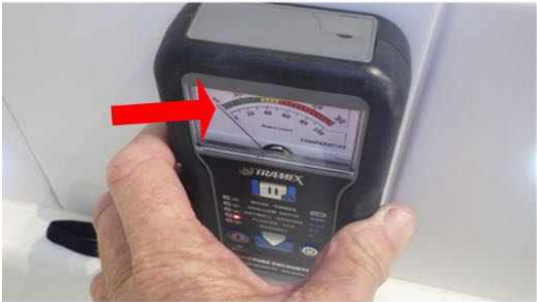
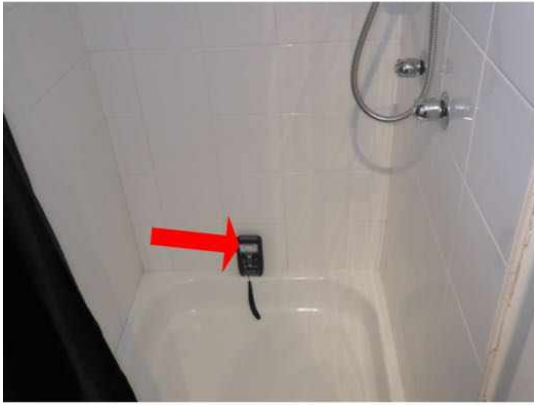
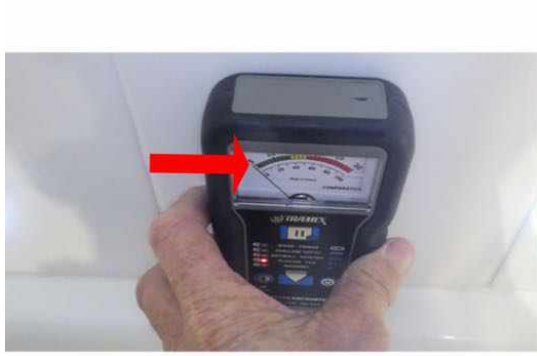
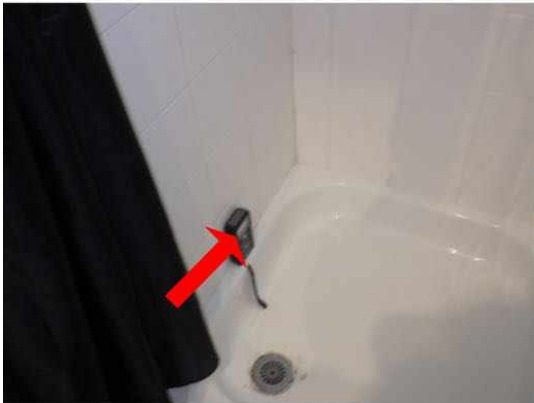
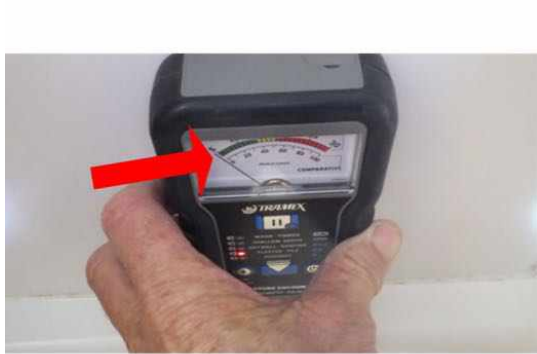
Building: Main Building  
Location: Bathroom 2 > Centre Right  
Finding: Moisture Level Readings  
Information: At the time of inspection the upper level bathroom 2 shower cubicle areas checked with the Tramex Moisture Meter returned low - normal moisture level readings.

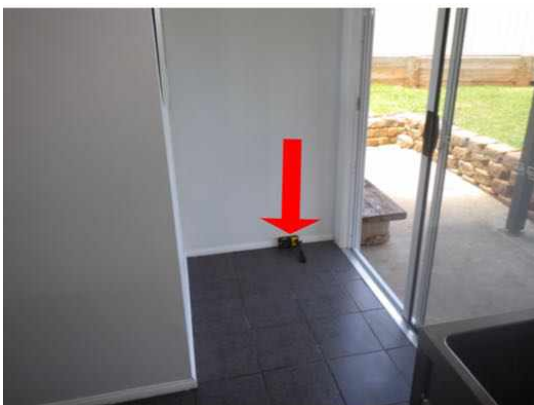
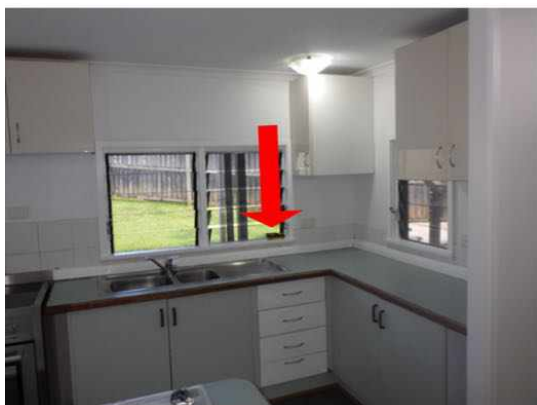
Building: Main Building  
Location: Internal Areas  
Finding: Termitracker  
Information: The termitracker itracker was positioned randomly to internal wall, timber skirting and window frame areas checking for signs of termite activity.

No activity was recorded at the time of inspection.

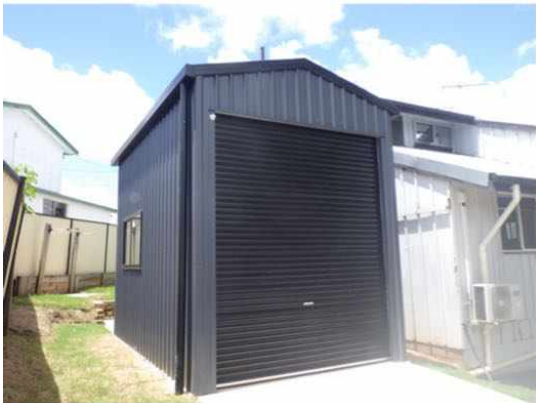
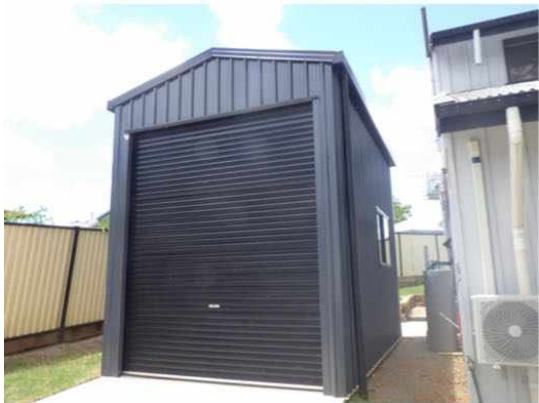
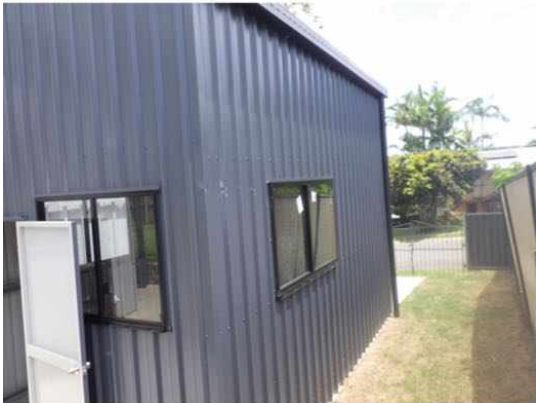
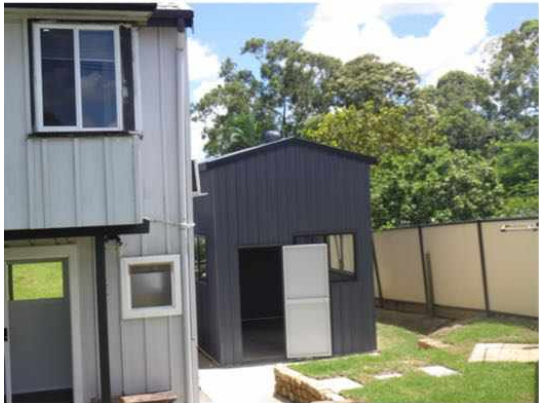
Building: Shed  
Location: External Areas > Existing  
Finding: No obvious defect  
Information: No obvious defects found at the time of inspection.

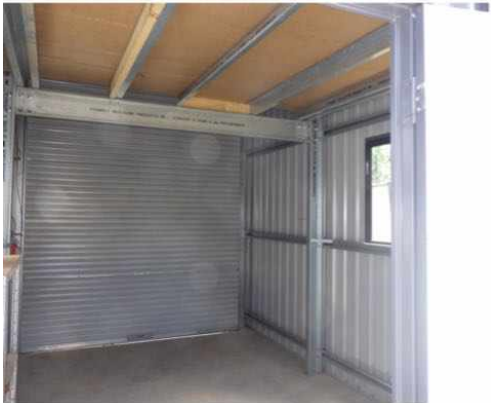
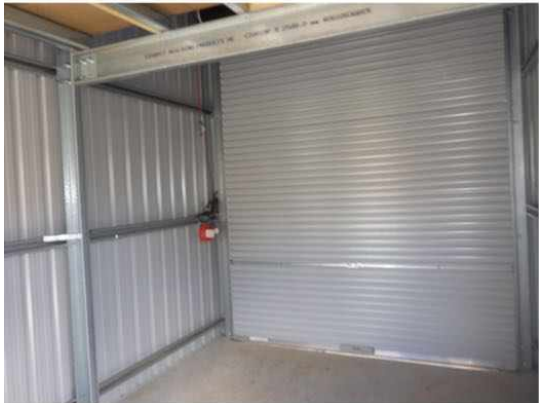
Building: Shed  
Location: Internal Areas  
Finding: No obvious defect  
Information: No obvious defects found at the time of inspection.
