Building and Timber Pest Inspection Report

Inspection Date: Tue, 27 Jan 2026

Property Address: 7/32 Shoalhaven Heads Rd, Shoalhaven Heads NSW 2535, Australia

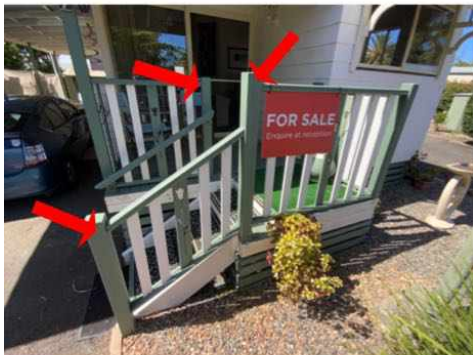
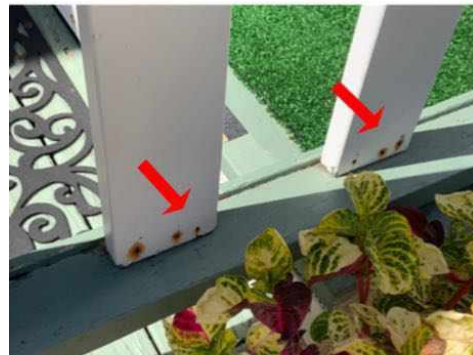
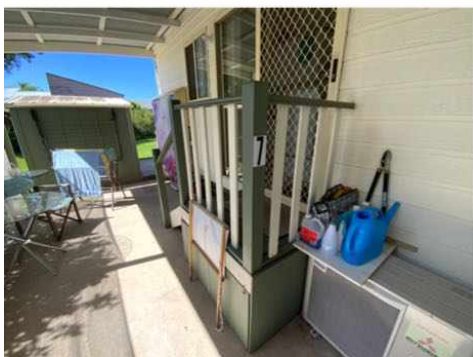
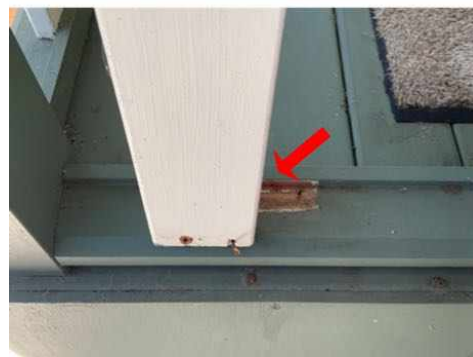
Building:	Main Building
Location:	Deck - Front
Finding:	Handrail - Damaged (Loose posts and pickets - substandard bracing and fixings) SAFETY HAZARD
Information:	Breakage occurs generally when the building materials have either aged and decayed, or as a result of damage (accidental or deliberate).

Repair and/or replacement of broken elements is advised to ensure that additional secondary defects do not arise as a consequence. Such works are necessary, as all building elements play a key role in the operation and function of the overall structure and its performance.

A relevant tradesperson should be appointed to repair or replace the affected building element prior to any subsequent damage being caused.

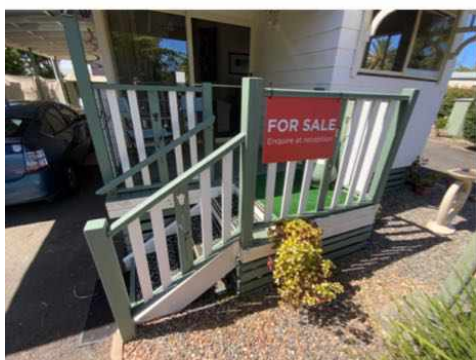
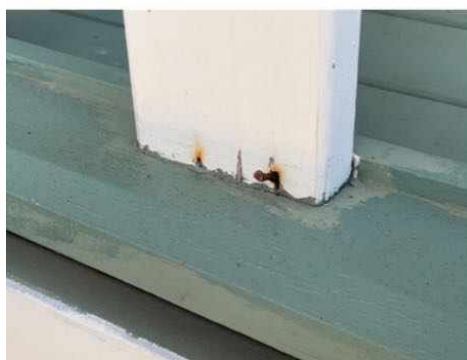
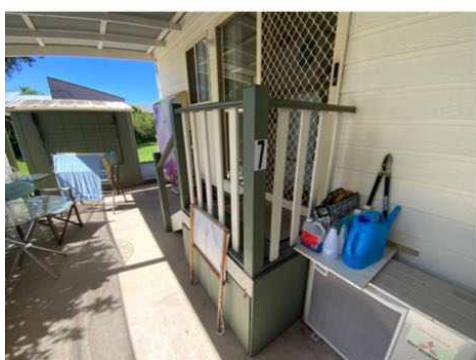
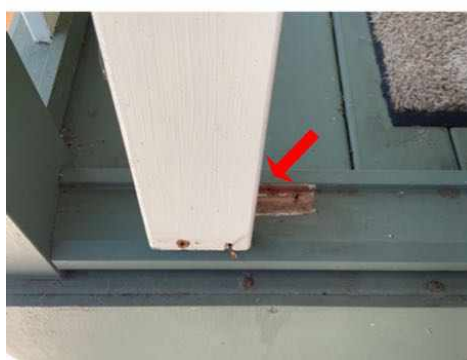
Finding 1.02

Building: Main Building
 Location: Deck - Front
 Finding: Handrail Fixings - Rusted or corroded
 Information: This building element shows evidence of rusting and corrosion, which is likely to have developed as a result of excessive exposure to moisture and or inadequate coatings.

As surface rust provides no protection to the underlying iron, the deteriorating condition is likely to worsen if not addressed in the short-term future.

Where possible, the use of galvanized (treated) metals or aluminium coated metals aid in rust prevention, as does regular general maintenance. Rust formation can be controlled with coatings, such as paint, that isolate the iron from the environment.

Rusting and corrosion should be managed by ideally removing or limiting the affected surface from exposure to moisture. A registered builder may be appointed to replace any building elements that have been severely affected by rust or water damage.

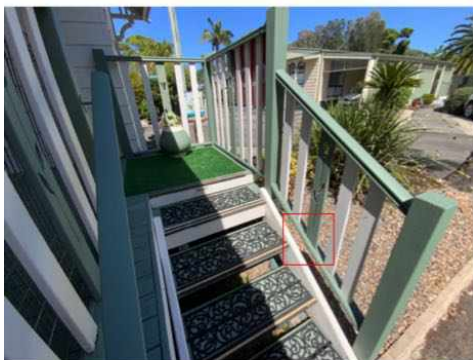
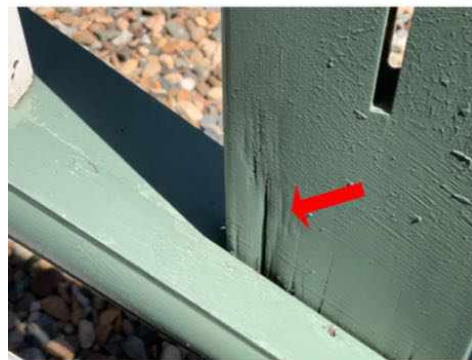
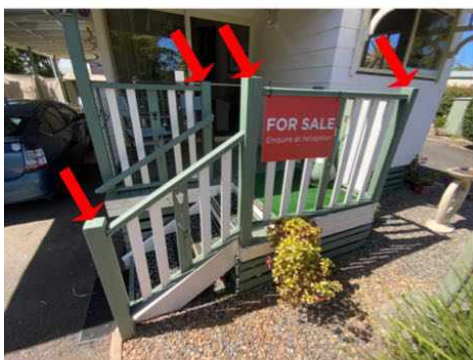
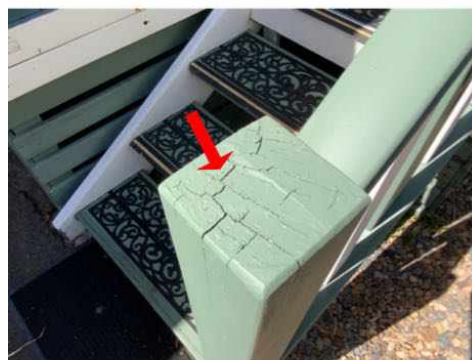
Finding 1.03

Building: Main Building
 Location: Deck - Front
 Finding: Wood rot to some timbers to the handrails
 Information: This building element shows evidence of wood rot. Wood rot, also known as Fungal

Decay, occurs when timbers and other cellulose building materials are exposed to damp conditions on an ongoing basis. This could be the result of exposure to weathering over a prolonged period of time, or the attraction of excessive moisture from other abutting building materials. Contributing factors also include poor air ventilation in the area.

Wood rot is often associated with general damp problems and is evidenced by a 'musty' smell or mould and mildew occurring on surfaces. If left unmanaged, damp conditions can lead to further health problems and the decay of timbers will continue.

Early intervention and regular maintenance, particularly of exterior timbers, will prolong the useful life of these building elements. Prior to any works being performed, the cause of the moisture that has created the visible wood rot should be identified and addressed in a suitable manner. Replacement of affected timbers may then be a necessary step in protecting surrounding building elements from such deterioration.

A qualified plumber may be appointed to assess the cause of excessive moisture and to provide advice on any remedial works as required. A qualified carpenter or registered builder may also be required to replace affected building materials.

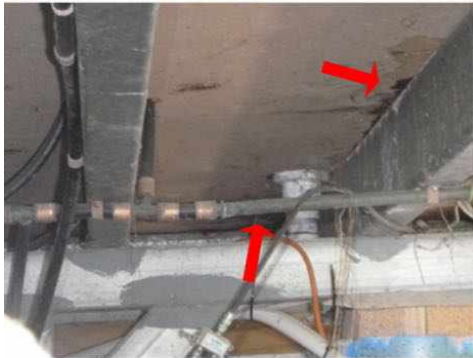
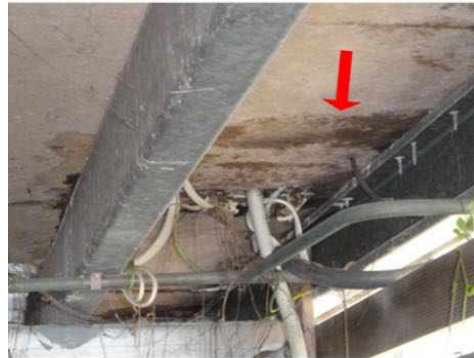
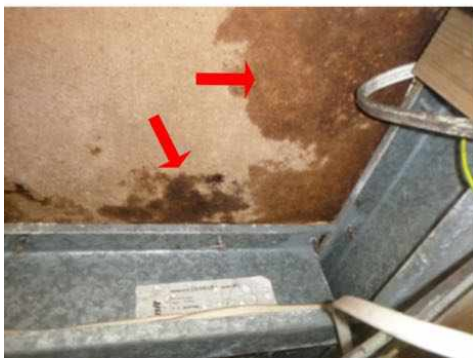
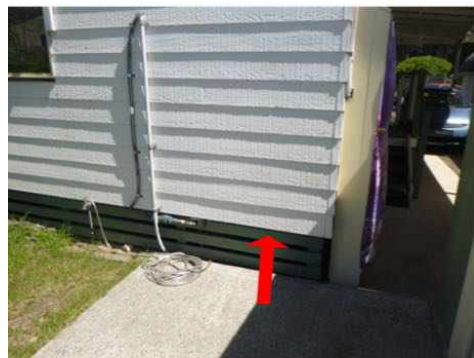
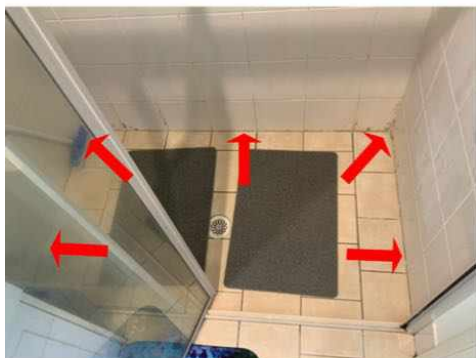
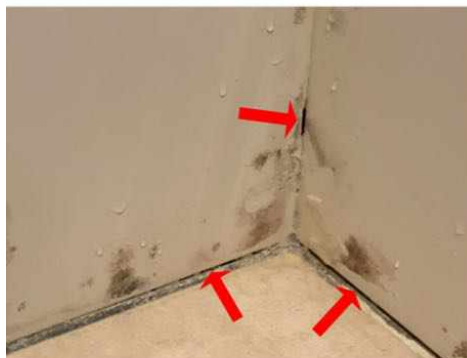
Finding 2.01

Building: Main Building
Location: Subfloor
Finding: Shower base - Leaking
Information: Leaking was evident to the shower base at the time of inspection. It is suspected that the leaking has occurred as a result of a failed waterproofing membrane, grouting and sealant to the shower base or general ageing of the building elements.

Leaking from the shower base, where left unattended, is likely to lead to water damage to adjoining flooring and walls. Such damage can lead to water damage and necessitate extensive remedial works being required. Active water leaks may also create an environment that is susceptible to the formation and development of mould.

Appointment of a tiling contractor or a sealant specialist company (like Megasealed or Tile Rescue) is required to repair or replace the shower base. Such works should be performed as soon as possible to ensure that no further damage occurs.

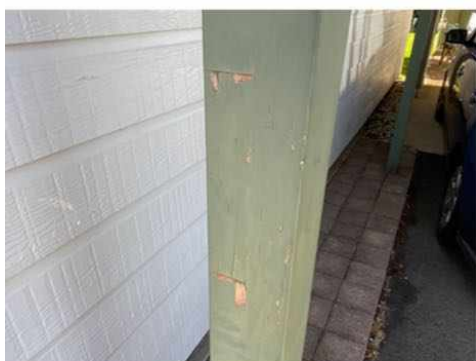
Finding 3.02

Building:	Main Building
Location:	All Areas
Finding:	External paint to timbers - deteriorated
Information:	Much of the external paintwork including but not limited to external timbers and trims have been neglected and require attention to prepare and re-paint.

Degraded paint finishes should be sanded back, filled, leveled and painted, as applicable. Where inadequate or missing paint protection has led to the deterioration of the associated building element, repair and/or replacement of this building element may be required.

A painting contractor should be appointed as soon as possible to perform necessary works to aid the appearance of the affected area and to ensure the area is protected against further deterioration. Alternatively, the homeowner following manufacturer instructions may perform these works.

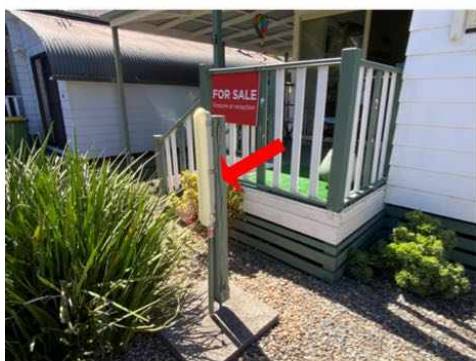
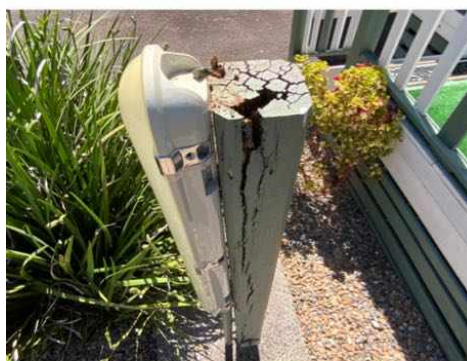
Finding 3.04

Building:	Main Building
Location:	Yard - Front
Finding:	Wood rot to light post
Information:	This building element shows evidence of wood rot. Wood rot, also known as Fungal Decay, occurs when timbers and other cellulose building materials are exposed to damp conditions on an ongoing basis. This could be the result of exposure to weathering over a prolonged period of time, or the attraction of excessive moisture from other abutting building materials. Contributing factors also include poor air ventilation in the area.

Early intervention and regular maintenance, particularly of exterior timbers, will prolong the useful life of these building elements. Prior to any works being performed, the cause of the moisture that has created the visible wood rot should be identified and addressed in a suitable manner. Replacement of affected timbers may then be a necessary step in protecting surrounding building elements from such deterioration.

A qualified plumber may be appointed to assess the cause of excessive moisture and to provide advice on any remedial works as required. A qualified carpenter or registered builder may also be required to replace affected building materials.

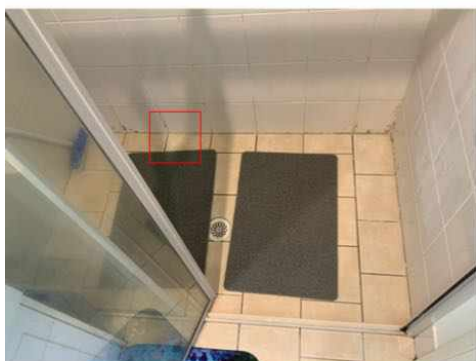
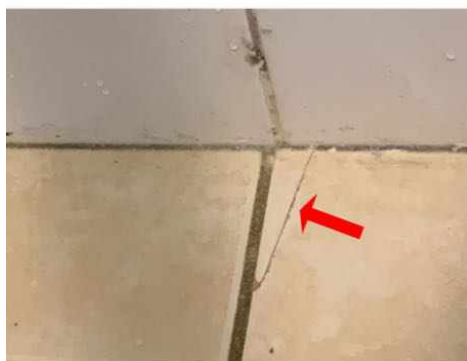
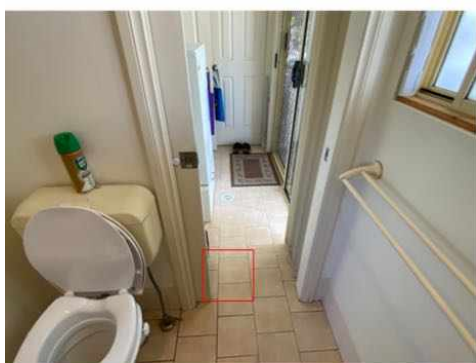
Finding 3.05

Building:	Main Building
Location:	Bathroom
Finding:	Tiles - Cracked or damaged
Information:	Cracking was evident to the tiling in this area at the time of inspection. While the cracking appears to be minor, this area is frequently exposed to water, allowing potential for water penetration into adjoining sections of walls or flooring.

damage, which is likely necessitate repair work to affected building elements.

A tiling contractor should be appointed to ensure that no further water damage occurs. The re-application of silicone and grouting throughout remaining tile work is also advised, to further protect the area against water penetration.

Where water penetration has led to water damage, appointment of a relevant tradesperson may be required to repair damaged building elements.

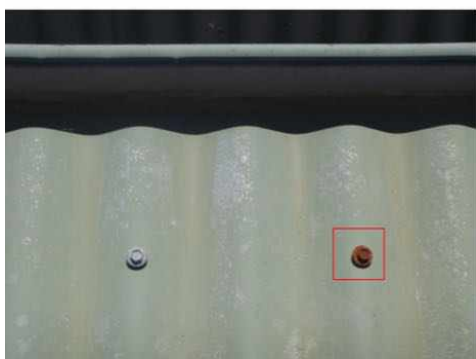
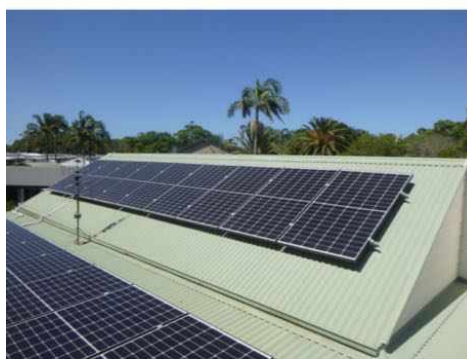
Finding 3.06

Building:	Main Building
Location:	Roof Exterior
Finding:	Building element - Rusted or corroded (Roofing screws to some areas)
Information:	This building element shows evidence of rusting and corrosion, which is likely to have developed as a result of excessive exposure to moisture and or inadequate coatings.

Where possible, the use of galvanized (treated) metals or aluminium coated metals aid in rust prevention, as does regular general maintenance. Rust formation can be controlled with coatings, such as paint, that isolate the iron from the environment.

Rusting and corrosion should be managed by ideally removing or limiting the affected surface from exposure to moisture. A registered builder may be appointed to replace any building elements that have been severely affected by rust or water damage.

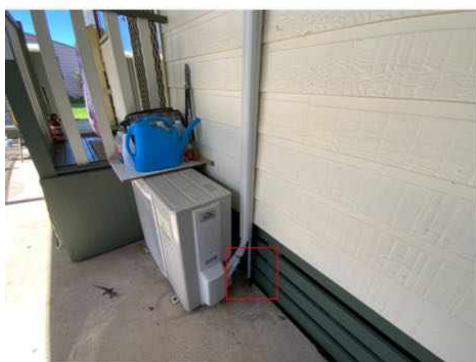
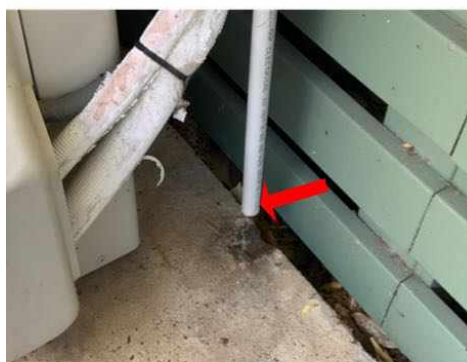
Building:	Main Building
Location:	All Areas
Finding:	Air conditioner - Disconnected overflow
Information:	The Air Conditioner (A/C) overflow was found to be disconnected from storm water drainage and is creating excessive moisture in the surrounding area.

Such leaking creates an environment which is conducive to an array of defects, including water damage to associated building elements and the attraction of termite or timber pest infestation.

It is highly recommended that a licensed plumber be appointed to connect the A/C overflow in order to prevent such an environment from being created. These minor works should be carried out as soon as possible.

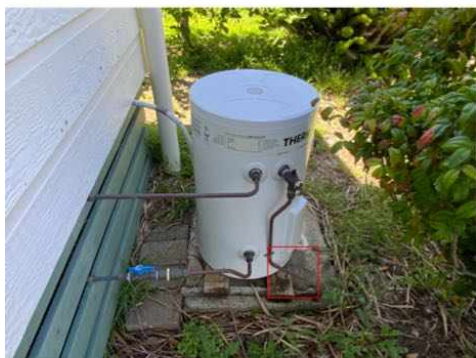
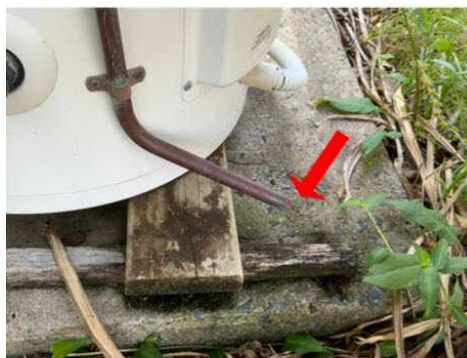
Finding 6.03

Building:	Main Building
Location:	All Areas
Finding:	HWS Overflow - Not Connected
Information:	The Hot Water System (HWS) overflow was found to be disconnected from storm water drainage and is creating excessive moisture in the surrounding area.

These damp conditions can lead to secondary defects such as rot, rust or corrosion of associated building elements, the formation of fungal decay, or even the creation of potential slip hazards. When coupled with poor site drainage, pooling of water may also attract termite activity to this area.

It is highly recommended that a licensed plumber be appointed to connect the HWS overflow in order to prevent such an environment from being created. These minor works should be carried out as soon as possible.

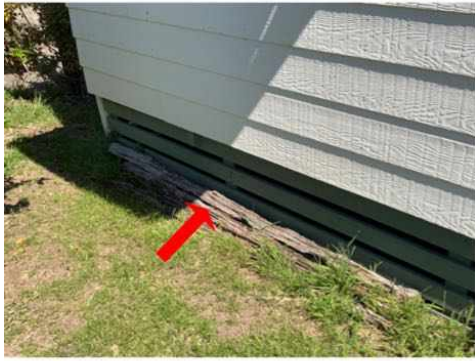
Finding 6.04

Building:	Main Building
Location:	All Areas
Finding:	Timber in ground contact
Information:	To reduce the risk of timber pest attack it is essential that timber used in a hazardous environment (e.g. in direct contact with the ground or frequently exposed to damp conditions) is of sufficient durability and/or is adequately preservative treated.

Untreated timbers in direct contact with the ground are likely to develop severe wood rot and/or fungal decay if left unattended creating attraction for subterranean termites to infest the timbers from surrounding areas.

If untreated or non-durable timbers are found to be in a hazardous environment it is highly advised that replacement of these building elements be performed as soon as possible to aid the protection of the property against termite / timber pest attack.

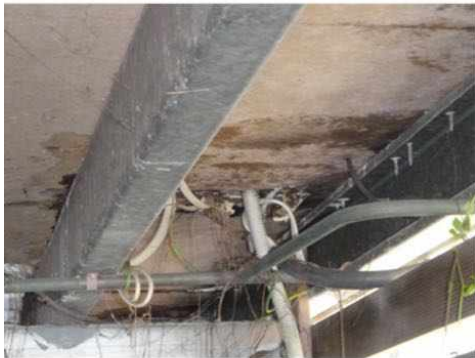
Finding 6.05

Building:	Main Building
Location:	Subfloor
Finding:	Evidence of excessive moisture was present at the time of inspection (Leaking Shower)
Information:	Excessive moisture can attract termites and produce conditions that promote termite attack fungal growth and wood decay.

Excessive moisture is generally caused by deteriorated inadequate or missing roof drainage, leaking plumbing pipes or fixtures, poorly plumbed HWS overflows or condenser units and poor site drainage.

It is highly recommended that all plumbing and drainage fixtures and fittings be maintained regularly in order to prevent excessive moisture being present in the external / internal property.

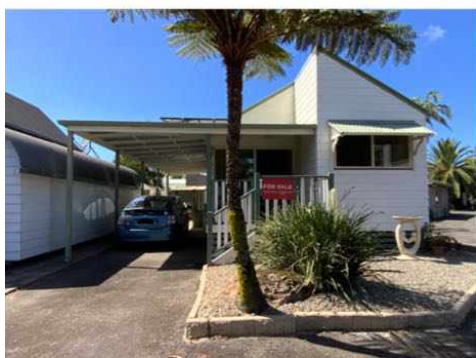
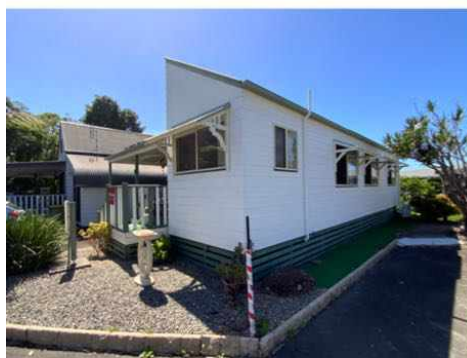
Finding 6.06

Building:	Main Building
Location:	All Areas
Finding:	Trees within 50m of the property
Information:	Trees within 50m of the property can be conducive to termite activity. It is recommended an invasive inspection of all trees with 50m to the property be carried out by a qualified pest control expert.

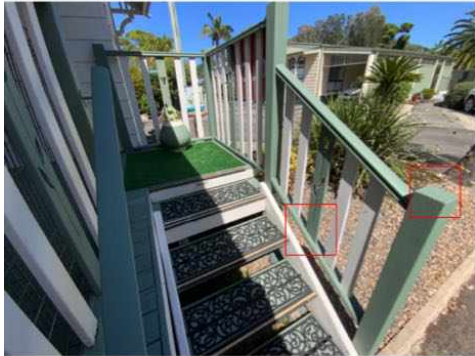
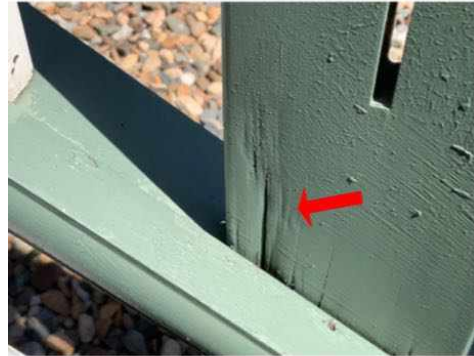
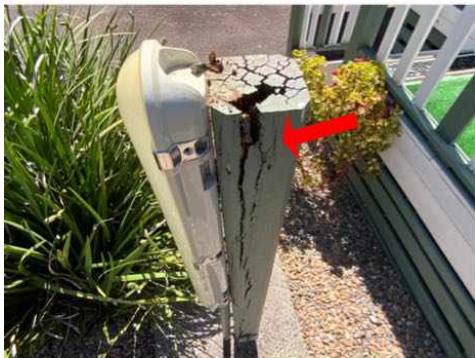
Finding 7.01

Building:	Main Building
Location:	All Areas
Finding:	Fungal decay - present (localised)
Information:	Fungal decay also known as wood decay or wood rot generally refers to the deterioration of timber elements when in contact with excessive levels of moisture for a prolonged period of time.

In this case although the affected timber element is in a decaying state the extent of any visible damage appears to be localised to a specific area and is yet to spread to other parts of the building element or affect adjoining structures. The fungal decay is therefore likely to be of a relatively superficial nature with minimal impact on the structural integrity or tensile strength of the timber element.

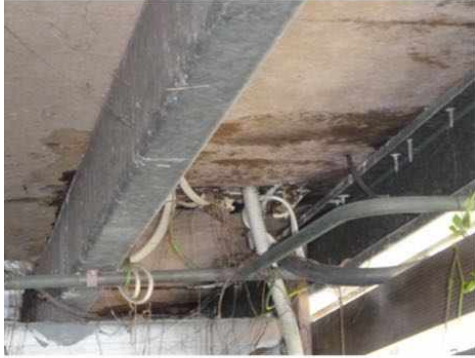
Finding 7.02

Building:	Main Building
Location:	Subfloor
Finding:	Fungal decay - present (Leaking Shower)
Information:	Fungal decay also known as wood decay or wood rot generally refers to the deterioration of timber elements when in contact with excessive levels of moisture for a prolonged period of time.

In this case although the affected timber element is in a decaying state the extent of

any visible damage appears to be localised to a specific area and is yet to spread to other parts of the building element or affect adjoining structures. The fungal decay is therefore likely to be of a relatively superficial nature with minimal impact on the structural integrity or tensile strength of the timber element.

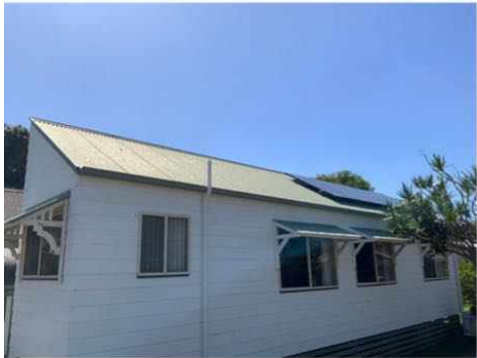
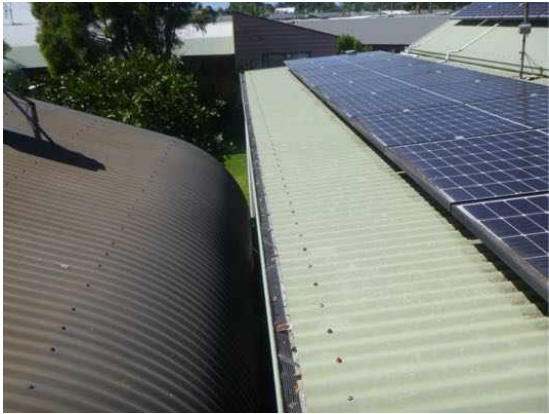
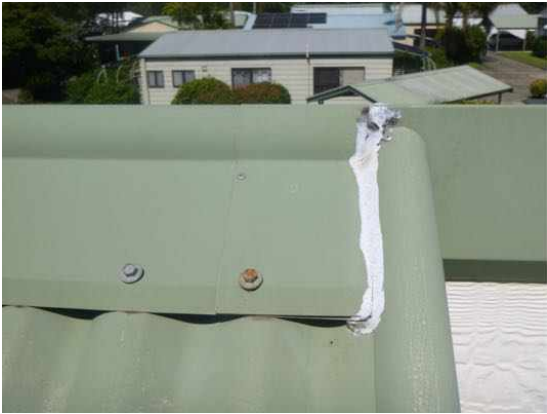
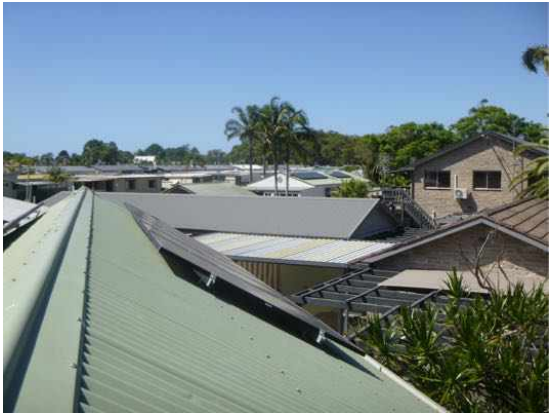
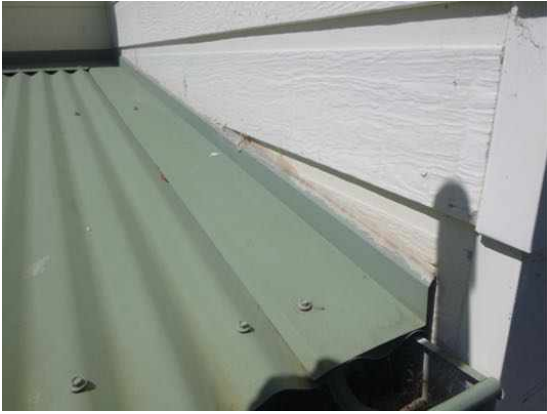
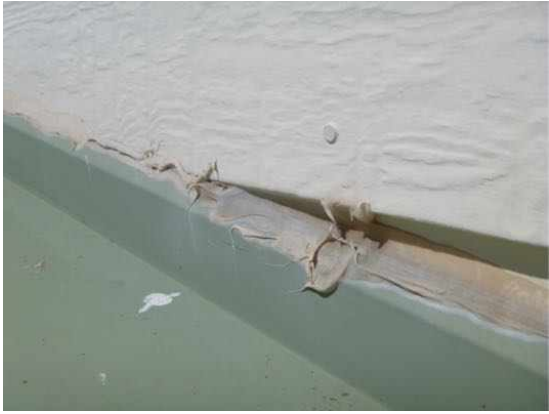
Building: Main Building
Location: Roof Exterior
Finding: Additional Photos - Obstructions and Limitations
Information: These photographs are an indication of the obstructions and limitations which impeded full inspection of the property at the time of inspection. These obstructions can hide an array of defects and should be removed to allow full inspection to be carried out. A re-inspection is recommended once the areas are made accessible.

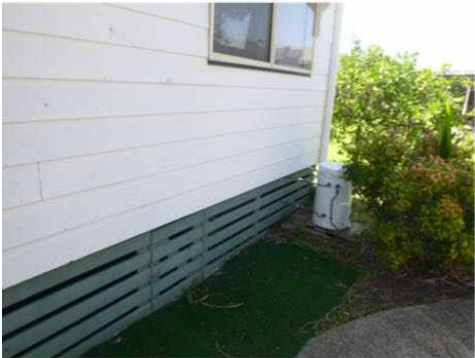
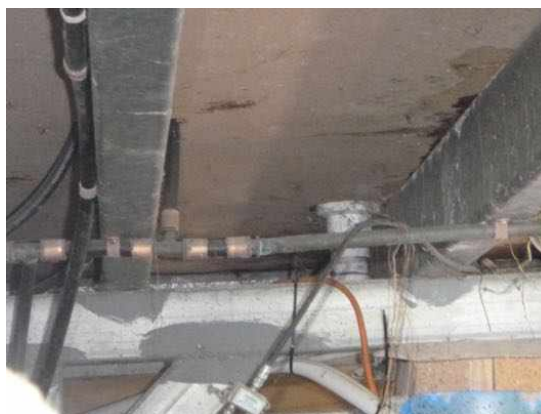
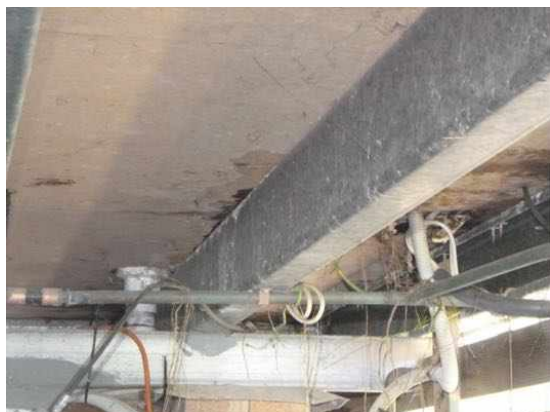
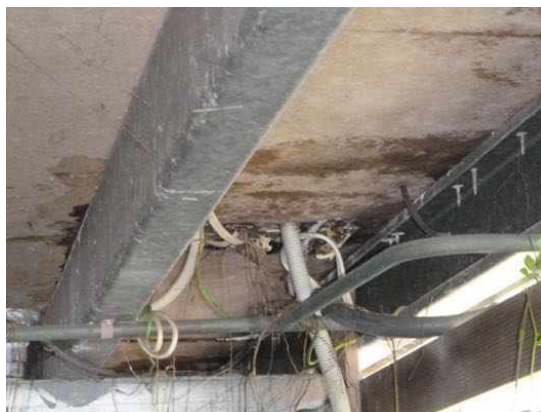
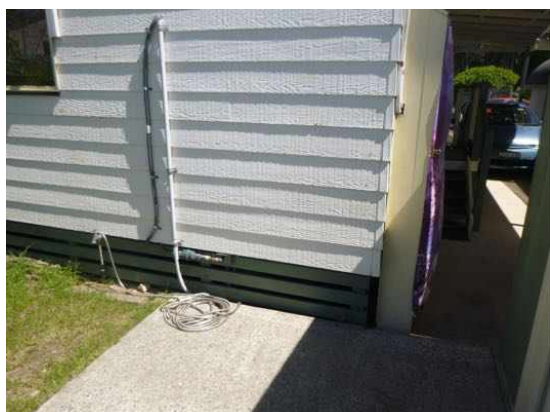
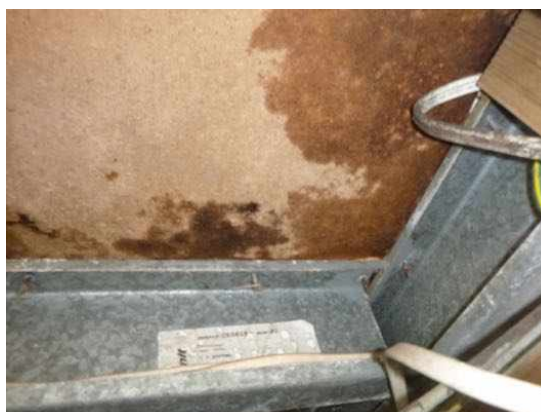
Building: Main Building
Location: Subfloor
Finding: Additional Photos - Obstructions and Limitations
Information: These photographs are an indication of the obstructions and limitations which impeded full inspection of the property at the time of inspection. These obstructions can hide an array of defects and should be removed to allow full inspection to be carried out. A re-inspection is recommended once the areas are made accessible.

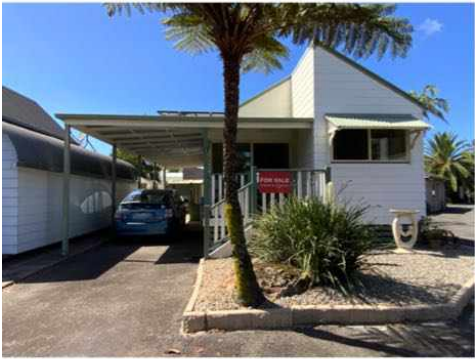
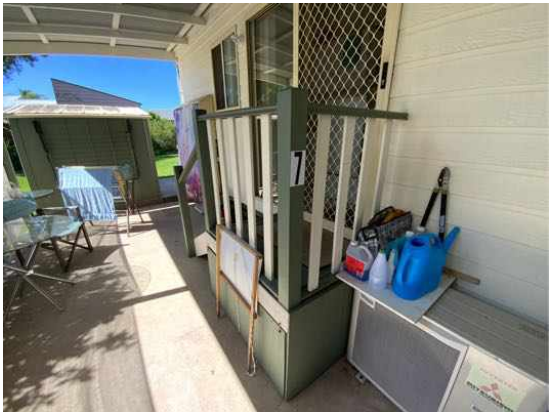
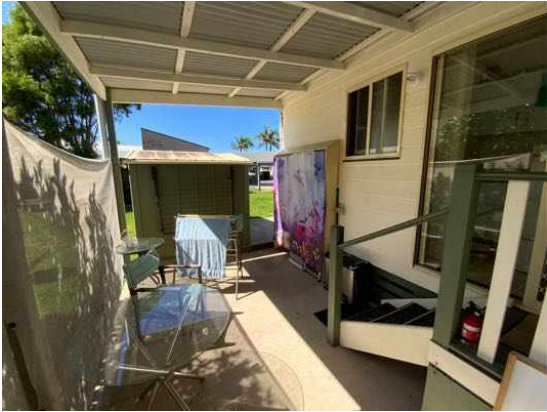
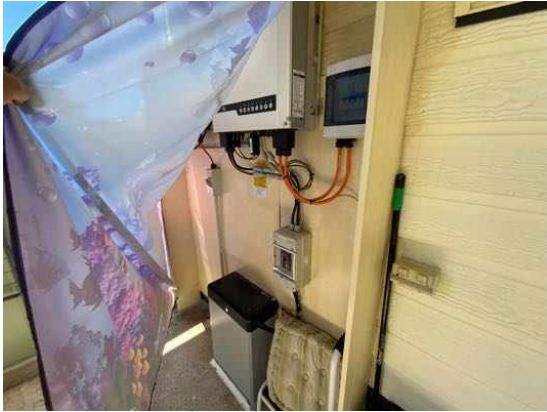
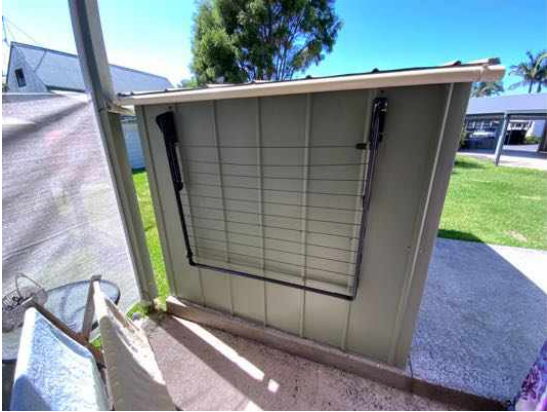
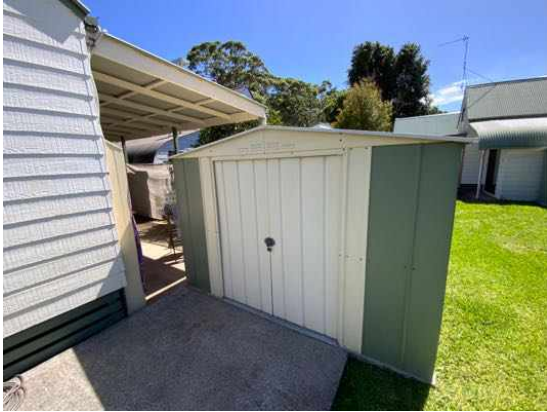
Building:	Main Building
Location:	All Areas
Finding:	Additional Photos - Obstructions and Limitations
Information:	These photographs are an indication of the obstructions and limitations which impeded full inspection of the property at the time of inspection. These obstructions can hide an array of defects and should be removed to allow full inspection to be carried out. A re-inspection is recommended once the areas are made accessible.

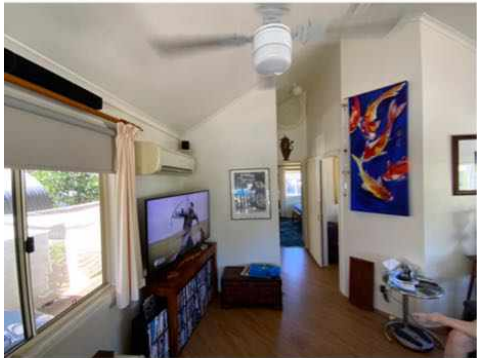
Building: Main Building
Location: All Areas
Finding: Additional Photos - Obstructions and Limitations
Information: These photographs are an indication of the obstructions and limitations which impeded full inspection of the property at the time of inspection. These obstructions can hide an array of defects and should be removed to allow full inspection to be carried out. A re-inspection is recommended once the areas are made accessible.

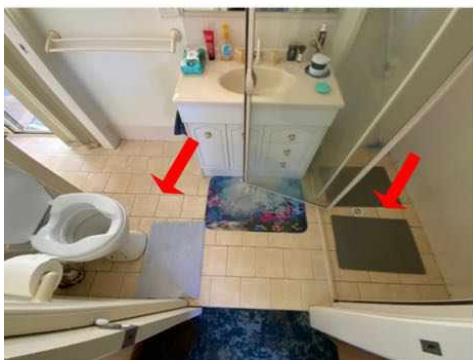
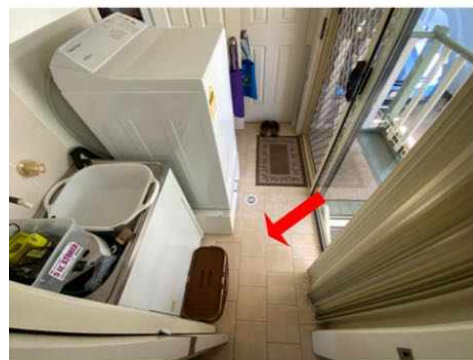
Building: Main Building
 Location: All Wet Areas
 Finding: Water Proofing Membranes - Information Only
 Information: Internal Water Proofing Membranes, are crucial in preventing water ingress into the property is important to know that the Membrane System used is to Australian Standards and has been installed correctly.

With older property's where this information is unavailable all wet areas should be monitored. Generally waterproofing certificates are only valid for approximately 7-8yrs. If any leaks, water staining, peeling or bubbling of the paint become evident to any adjacent walls or ceilings below a licensed builder or waterproofing specialist is recommended to investigate further.

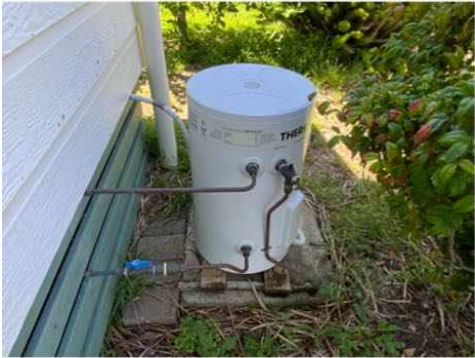
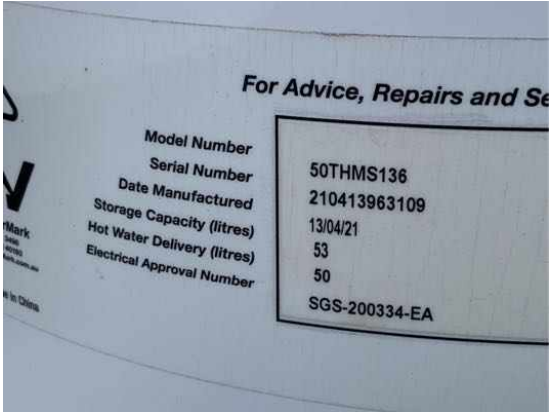
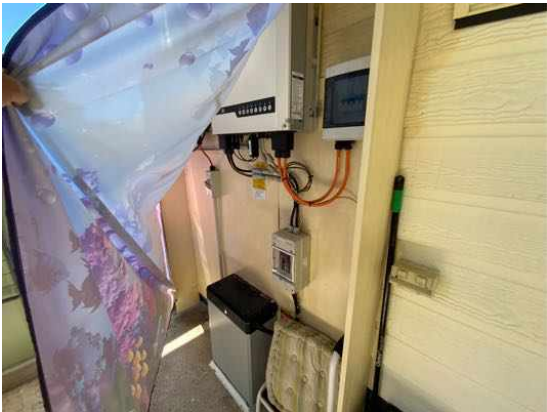
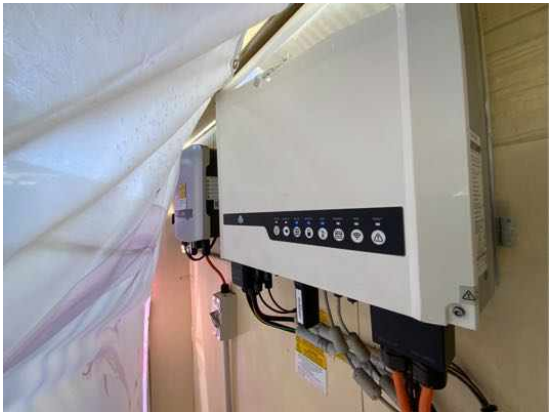
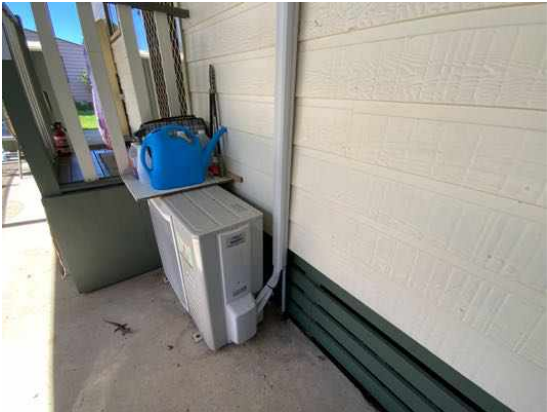
Building: Main Building
Location: All Areas
Finding: Additional Photos
Information:

Additional photos are provided for your general reference. Arrows have been included to highlight areas of importance. Please discuss these photos with your building consultant for clarification.
