# Building and Timber Pest Inspection Report

Inspection Date: Wed, 4 Feb 2026

Property Address: 30 Cornelius Place, Regentville NSW 2745

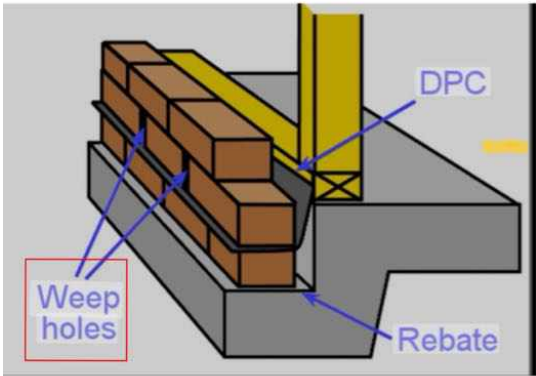
Finding 3.02

Building: Main Building  
Location: Exterior walls - left side  
Finding: Brickwork - Cracking.  
Information: Observation:

Cracking was noted in the external brickwork and appeared to be minor to moderate at the time of inspection.

Vertical cracking may indicate thermal movement, while other patterns could suggest more localised stress within the wall.

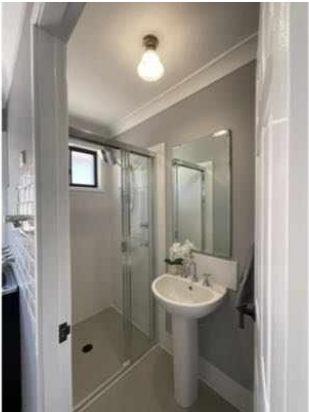
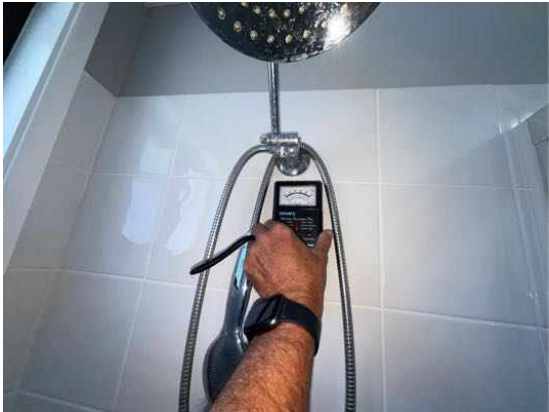
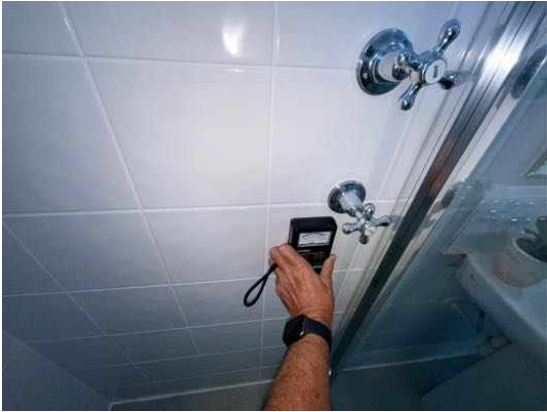
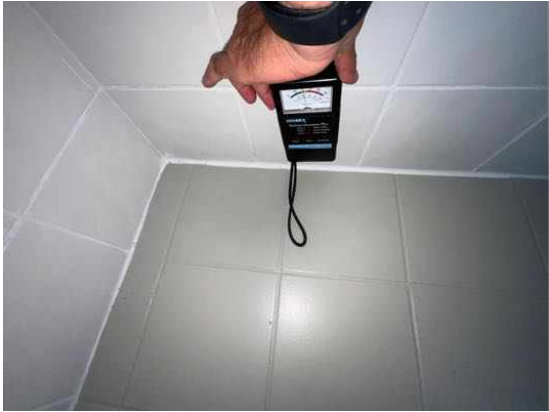
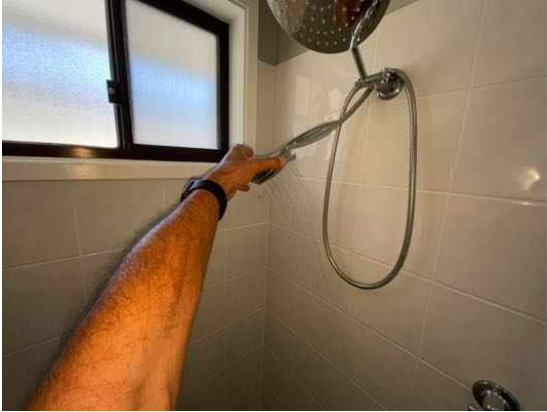
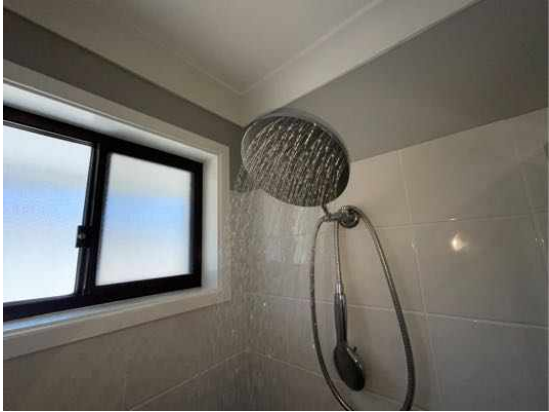
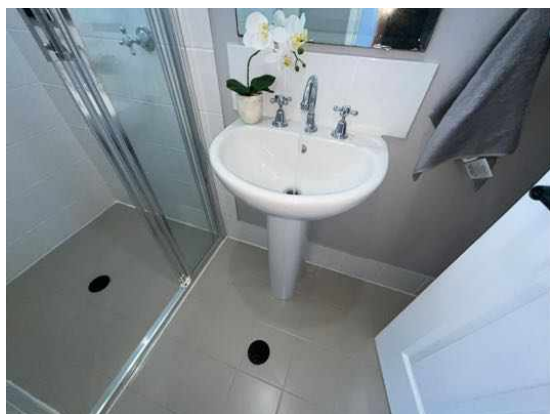
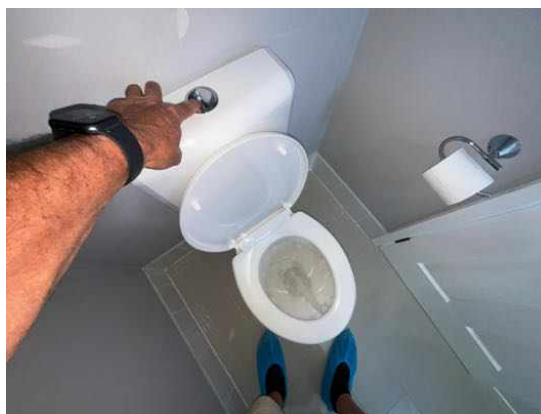
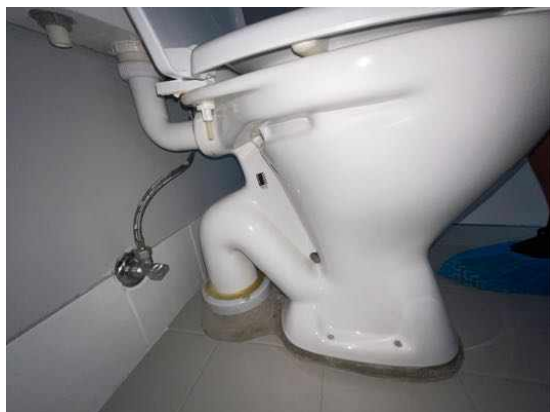
Building: Main Building  
 Location: Bathroom  
 Finding: Wet Areas - Bathroom(s) - Overall Condition & Recommendations.  
 Information: Overall Condition & Recommendations

It is not possible under the visual inspection criteria of a standard pre-purchase report to categorically determine if leaks are present. If a more detailed or accurate assessment is required, a special-purpose inspection should be undertaken.

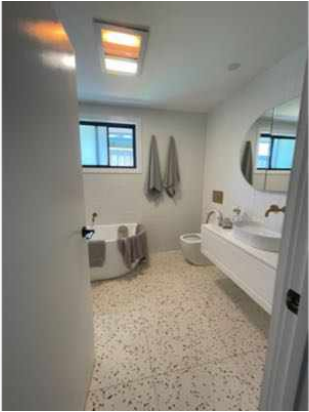
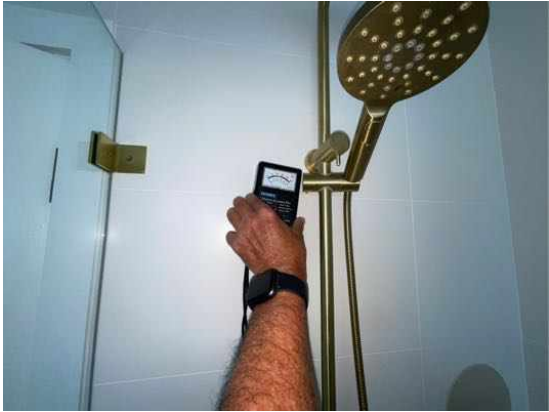
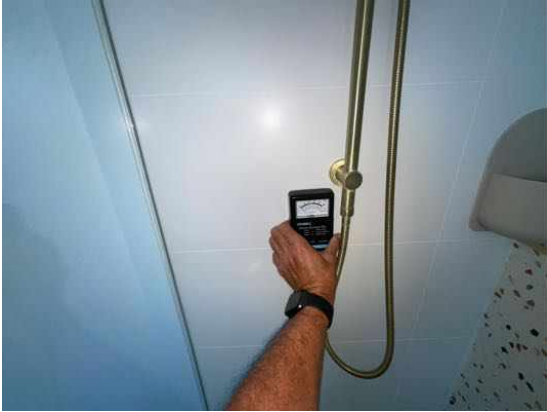
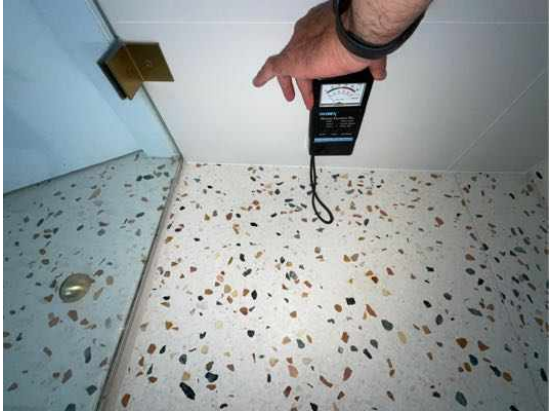
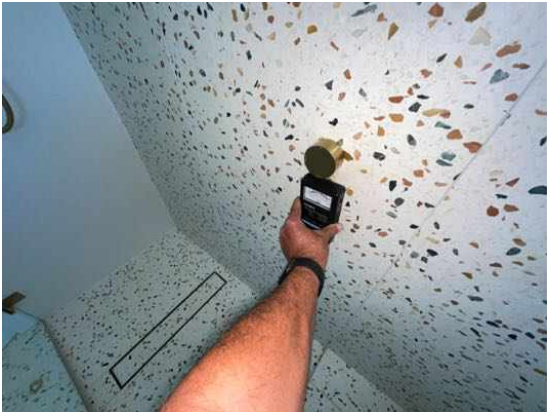
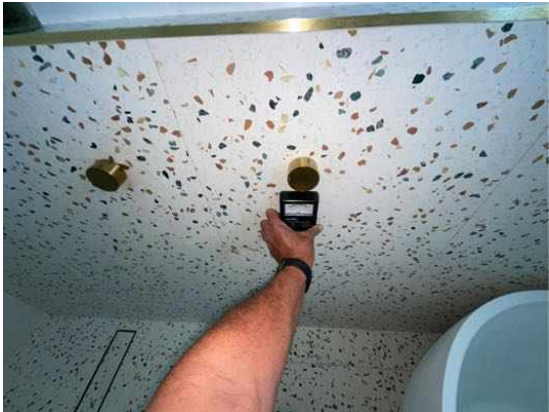
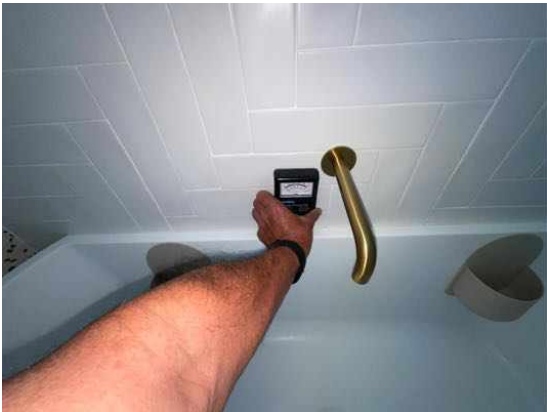
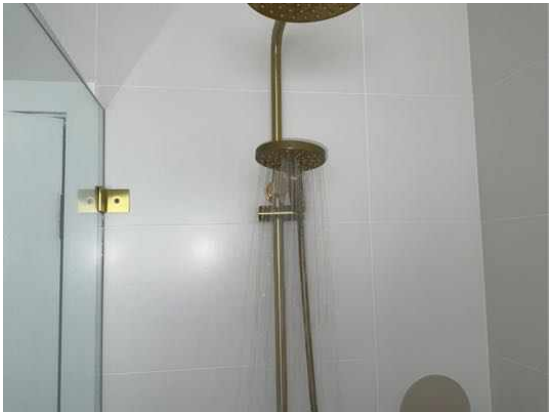
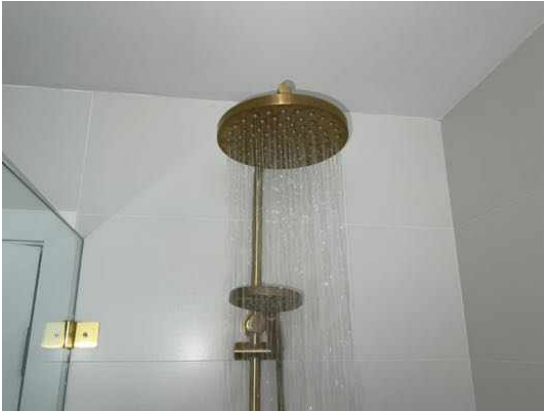
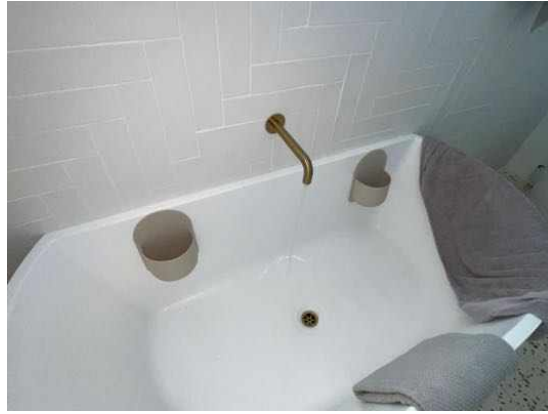
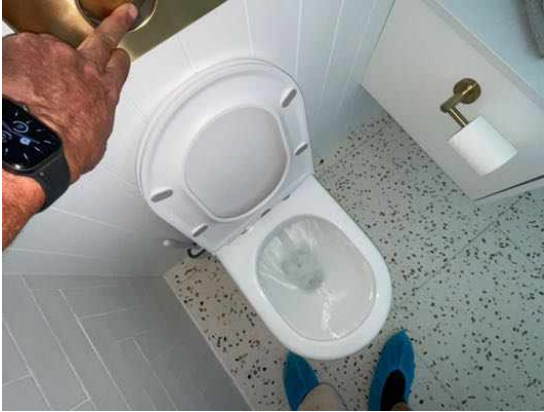
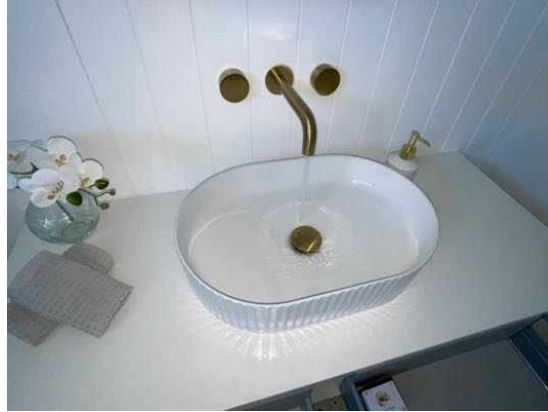
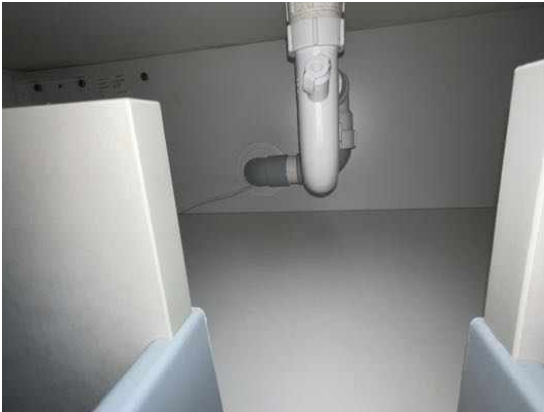
Building: Main Building  
 Location: All Areas  
 Finding: Water Pressure – Observation Only.  
 Information: During the inspection, water pressure appeared to be within a normal operating range based on a basic functional check. However, this observation was made without the use of pressure testing equipment and does not constitute an assessment by a licensed plumber.

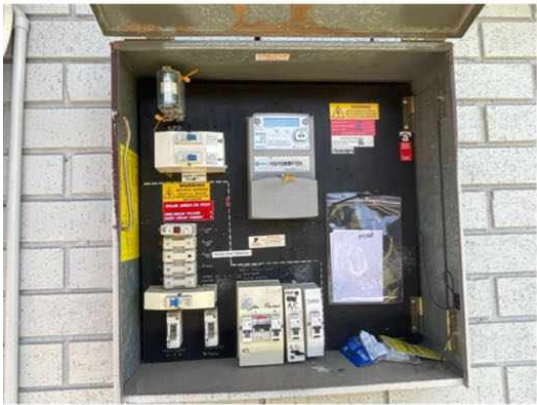
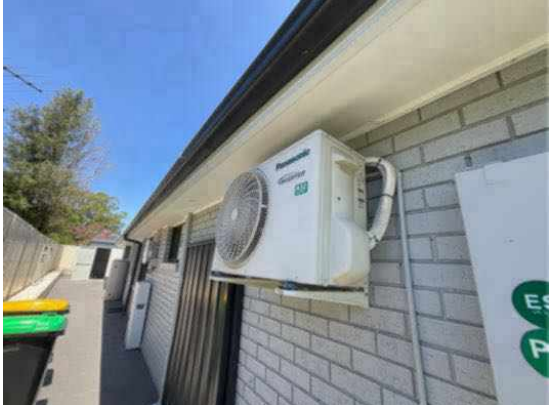
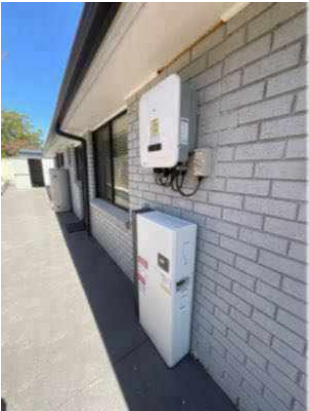
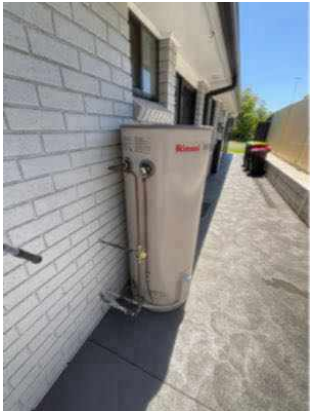
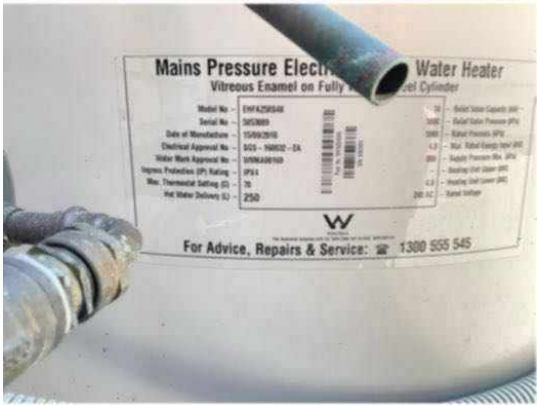
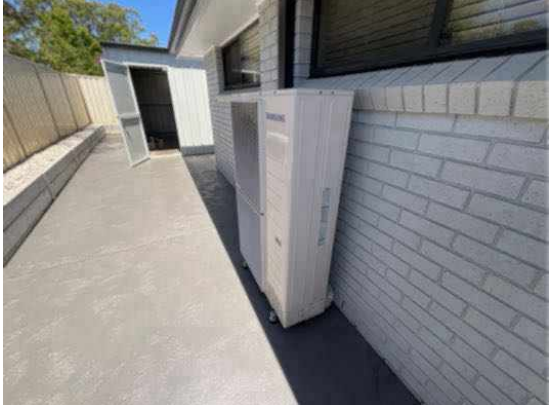
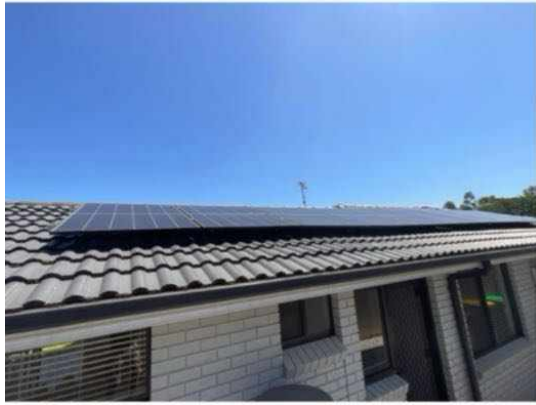
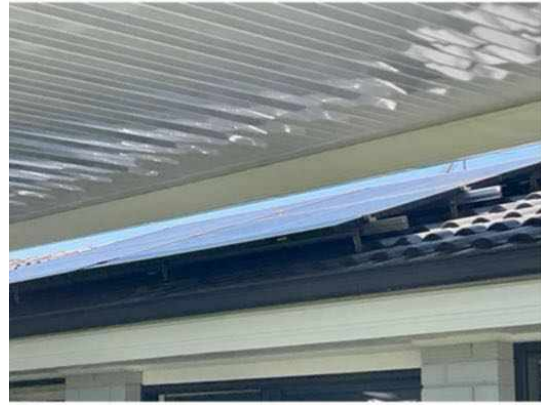
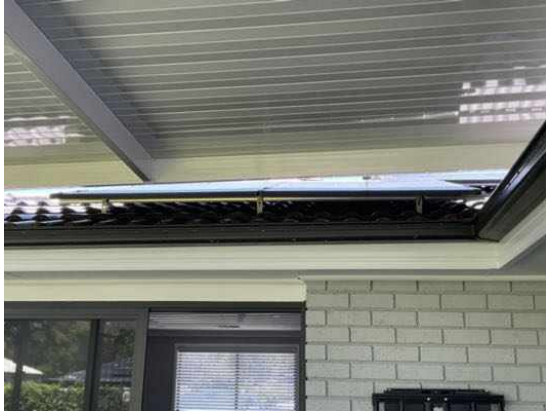
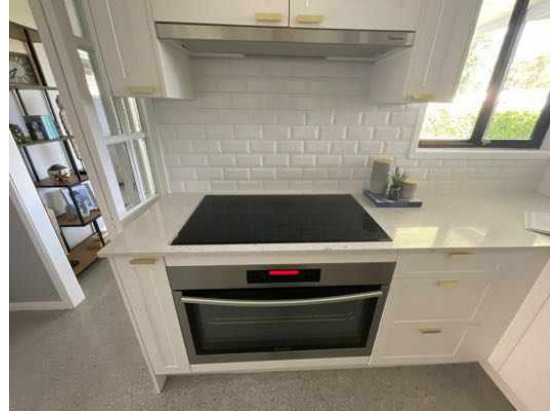
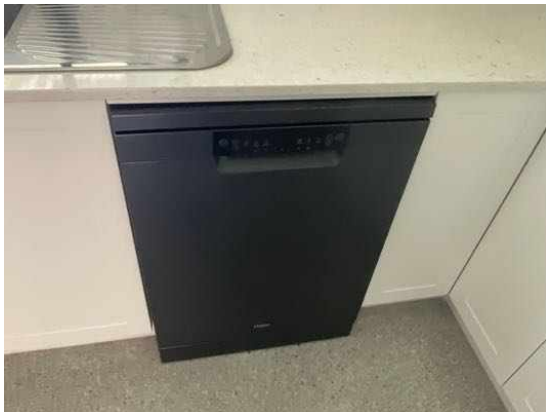
Building: Main Building  
 Location: All Areas  
 Finding: Plumbing, Electrical & Gas Installations – Scope and Recommendations.  
 Information: Plumbing and electrical inspections fall outside the scope of this building inspection and must be carried out by appropriately licensed and registered tradespersons.

Additional photos have been supplied with this report for your general reference.

- Any gas appliances (if applicable) must be inspected by a licensed gas plumber to confirm they are operating safely and efficiently.
- We also recommend that all other plumbing and electrical installations be thoroughly checked by qualified professionals to ensure they are functioning correctly and meet current safety and compliance standards.

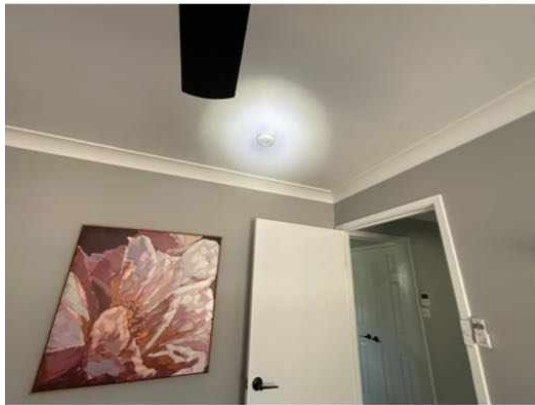
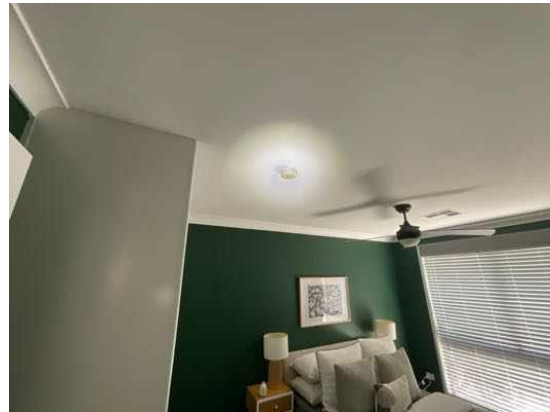
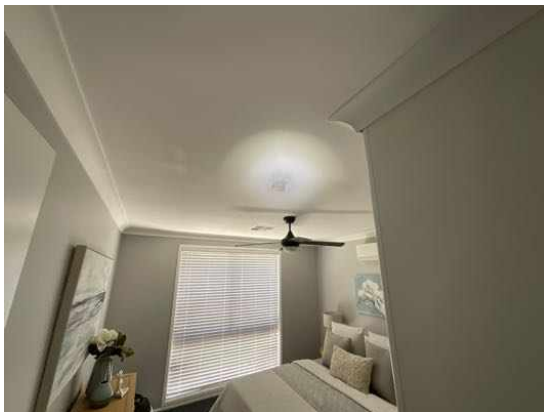
Building: Main Building  
Location: All Areas  
Finding: Smoke Detectors / Alarms.  
Information: Reporting on the presence, type, location, or compliance of smoke detectors or alarms, including hard-wired smoke detection systems and their legislative requirements, is outside the scope of this inspection report.

To ensure compliance and safety, further inspection and/or advisory services from a qualified specialist are recommended. These services can confirm the sufficiency, type, location, and functionality of all smoke detection devices within the property.

- All smoke detectors be tested monthly by the homeowner.
- All systems comply with the requirements of AS 3786 and any applicable state-based legislation.

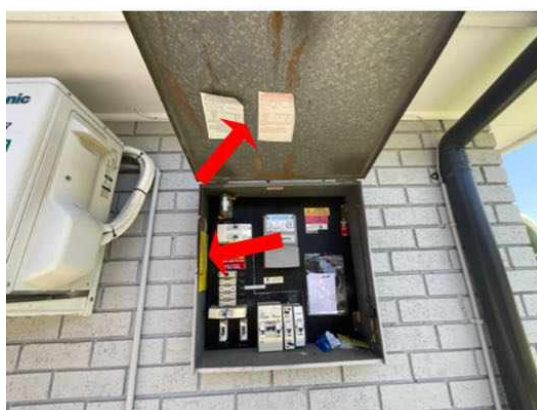
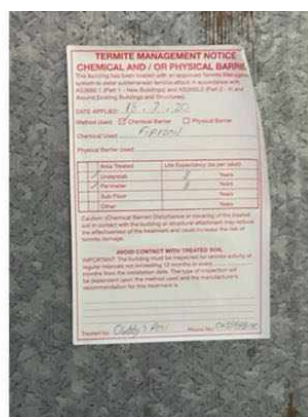
Building: Main Building  
 Location: All Areas  
 Finding: Termite Management System – Previous Barrier Noted..  
 Information: Observation:

At the time of inspection, evidence of a previous termite management system was noted, indicated by the presence of a durable notice affixed to the electrical switchboard.

- The installation of a termite management system is strongly recommended for all properties, particularly those with timber building elements. These systems provide a proactive defence against termite attack and are effective in minimising the risk of concealed termite entry and structural damage.

- The client is advised to contact the pest control provider listed on the durable notice (if identifiable) to obtain further information regarding:
- The type of system installed (e.g., chemical barrier, baiting system, or physical barrier)
- The installation date
- Any warranty conditions, service history, or ongoing maintenance requirements
- If no reliable information can be obtained, or if the existing system is found to be outdated or non-functional, it is recommended that a new termite management system be installed by a licensed pest control professional.
