Building and Timber Pest Inspection Report

Inspection Date: Tue, 17 Feb 2026

Property Address: 42 Tallwood Avenue, Glenmore Park NSW
2745

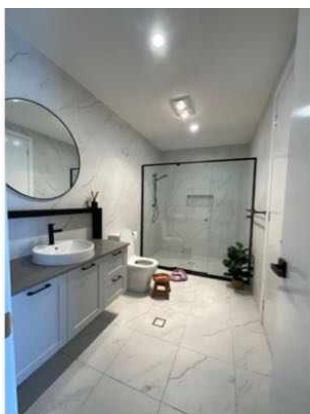
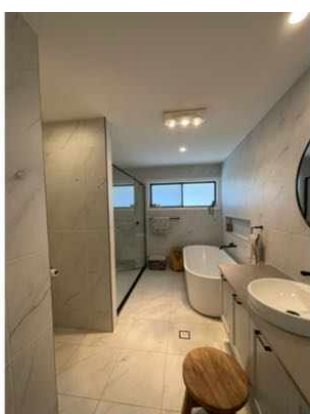
Building:	Main Building
Location:	Ensuite, Bathroom & Powder Room
Finding:	Minor Defect – Inadequate Fall to Shower Floor Waste.
Information:	Observation:

Minor water pooling was observed around the shower floor waste at the time of inspection. This condition appears to be due to insufficient fall in the shower floor tiling, resulting in incomplete drainage following use. The shower recess appeared dry prior to testing.

Although the extent of pooling is currently minor, the condition is considered unsatisfactory in accordance with accepted tiling and wet area installation standards. Prolonged water retention may contribute to:

- Localised slip hazards
- Mould and mildew development
- Premature deterioration of grout joints and flexible sealants
- Increased risk of moisture migration over time

Under the National Construction Code (NCC 2019 – SA 3.1 Performance Requirements for Wet Areas), bathroom floors must be installed to prevent the accumulation of water that may create unhealthy or hazardous conditions.

Rectification may involve regrading and retiling sections of the shower base to achieve adequate fall toward the floor waste. While not considered urgent at the time of inspection, corrective works are recommended to improve drainage performance and

reduce the risk of longer-term moisture-related deterioration.

Alternatively, the area may be monitored over time to determine whether the water fully dissipates after normal use. Should monitoring confirm that the area dries adequately and no ongoing issues develop, rectification may not be required. Any decision to proceed with remedial works remains at the Client's discretion.

If rectification is elected, a licensed tiler or bathroom renovation specialist should be engaged to assess and carry out the necessary works.

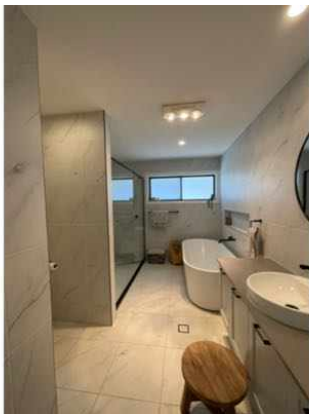
Building: Main Building
Location: Bathroom
Finding: Wet Areas - Bathroom(s) - Overall Condition & Recommendations.
Information: Overall Condition & Recommendations

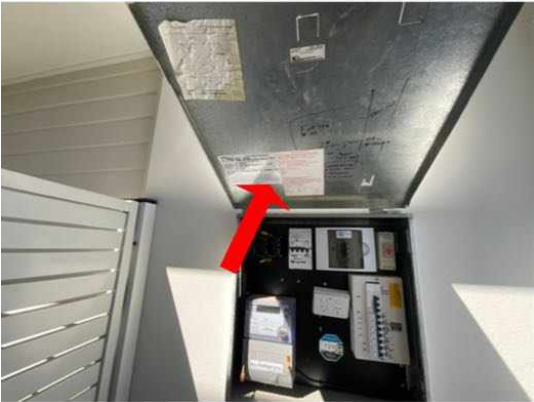
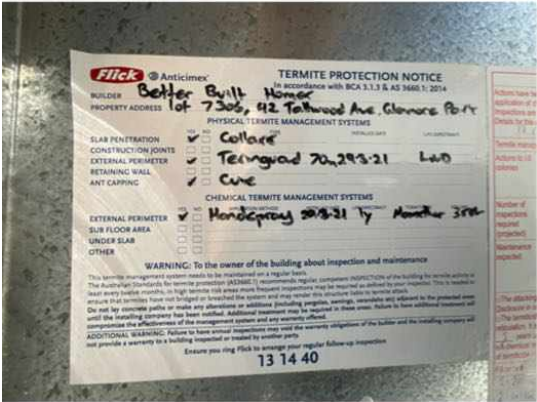
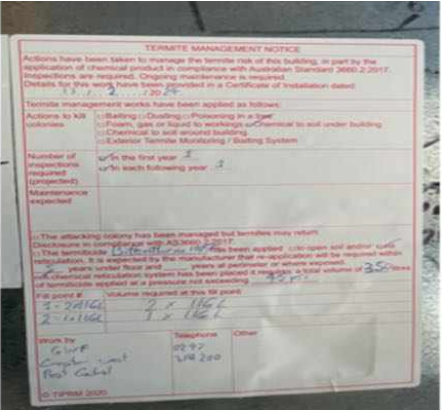
Building: Main Building
 Location: All Areas
 Finding: Termite Management System – Previous Barrier Noted..
 Information: Observation:

At the time of inspection, evidence of a previous termite management system was noted, indicated by the presence of a durable notice affixed to the electrical switchboard.

- The installation of a termite management system is strongly recommended for all properties, particularly those with timber building elements. These systems provide a proactive defence against termite attack and are effective in minimising the risk of concealed termite entry and structural damage.
- The client is advised to contact the pest control provider listed on the durable notice (if identifiable) to obtain further information regarding:
 - The type of system installed (e.g., chemical barrier, baiting system, or physical barrier)
 - The installation date
 - Any warranty conditions, service history, or ongoing maintenance requirements
 - If no reliable information can be obtained, or if the existing system is found to be outdated or non-functional, it is recommended that a new termite management system be installed by a licensed pest control professional.
