Building and Timber Pest Inspection Report

Inspection Date: Mon, 23 Mar 2026

Property Address: 1/89 Green St, Ivanhoe, VIC, 3079, Australia

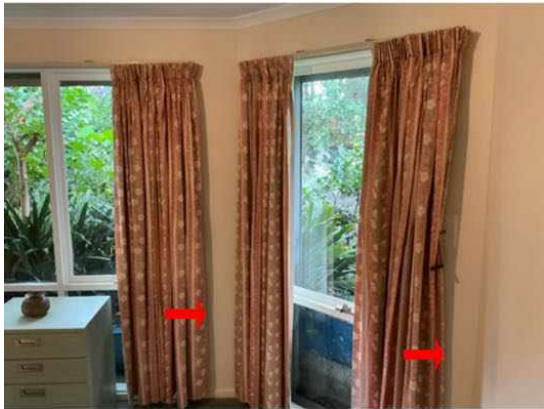
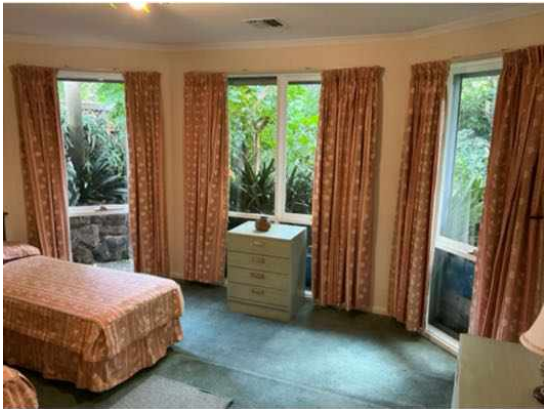
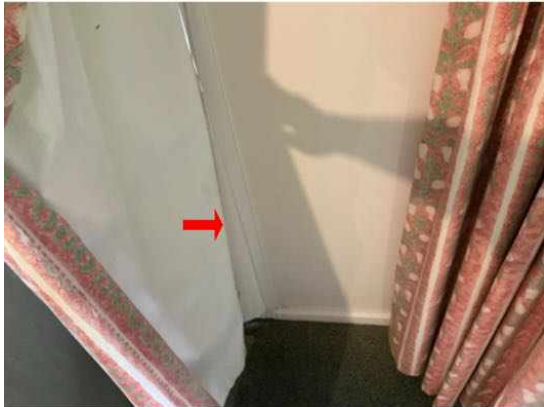
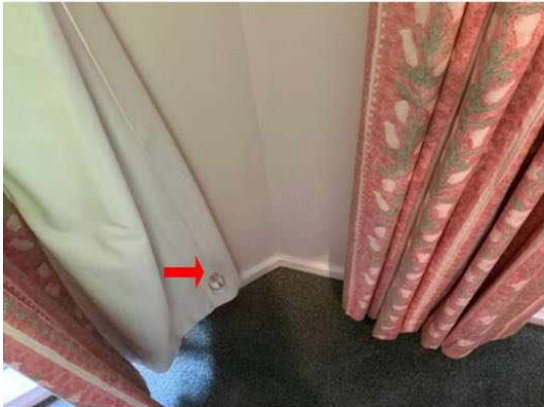
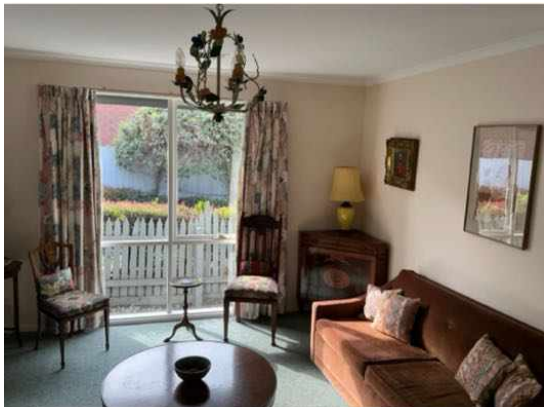
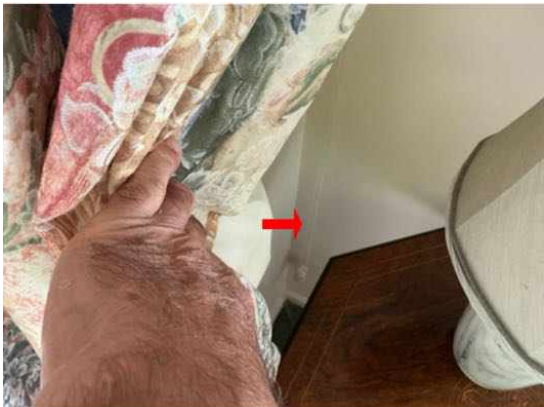
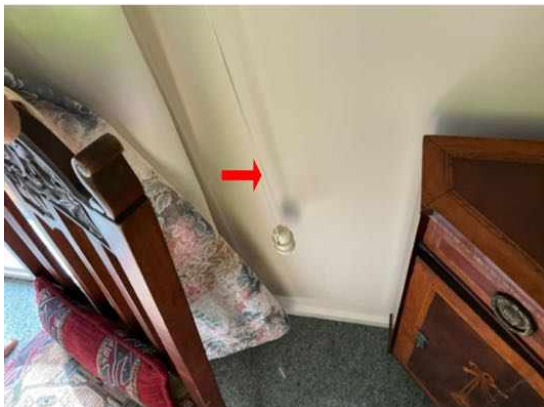
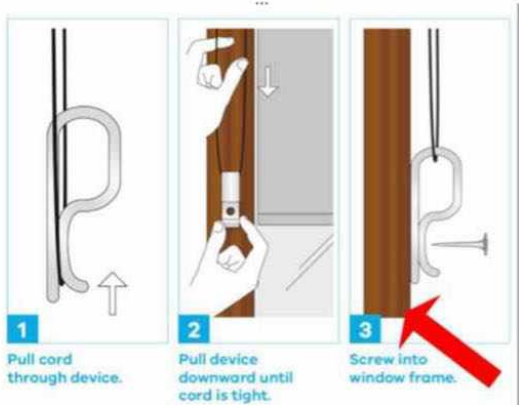
Building:	Main Building
Location:	Master Bedroom/ Lounge
Finding:	Curtain & Blind - Safety Cord
Information:	Looped curtain and blind cords pose a significant strangulation hazard for children as they can place the loop over their head and/or get tangled in the loose cords.

Check all the rooms in your house for any blinds or curtains with long cords that are either loose or looped. This includes any cords that are within children's reach at floor level or near furniture they can climb on.

Secure any loose or looped cords with cleats or tension devices – these can be purchased from your local curtain and blind retailer or hardware store. Do not put furniture such as cots, beds, highchairs, playpens, couches, chairs, tables or bookshelves near a window where children can reach the blind or curtain cord.

It is recommended that this defect be resolved immediately to avoid harm to occupants.

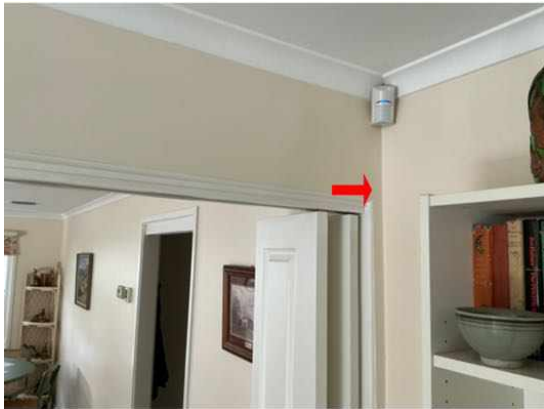
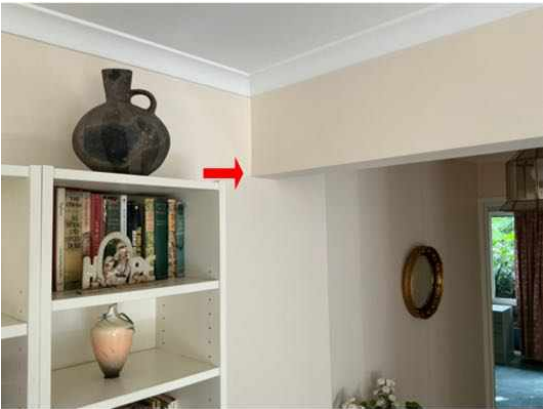
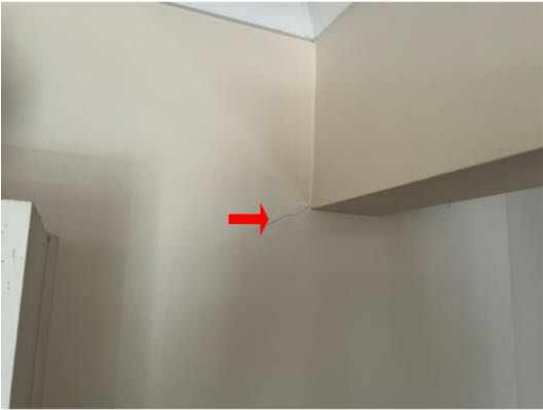
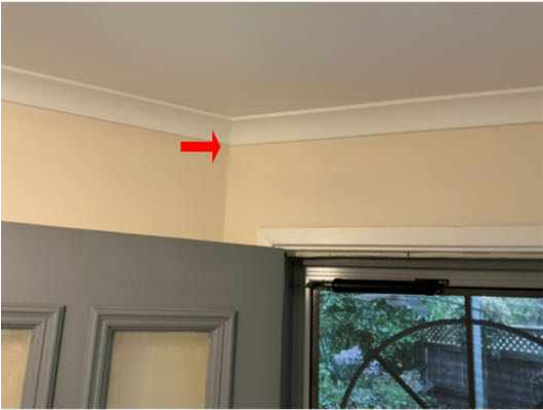
Building:	Main Building
Location:	All Areas
Finding:	Cracking - Damage Category 1 - Fine (up to 1mm)
Information:	Although fine cracks are quite noticeable, they are often only considered to be an appearance defect, and usually do not indicate any structural damage. Generally, the cause of a fine crack is indicative of a separation between building materials and finishes (e.g. paint, plaster, etc.) along joints.

In this instance client have indicate that these cracks become visible after roof leaks. However the leaks have been repaired, and hence no change in terms of sizes.

Cracking of this nature can generally be repaired with minor sanding, filling and/or repainting. Such works should be performed by a qualified Painter or a general Handyman.

Monitoring of all cracking should be conducted frequently. Always contact a Building Inspector should cracks widen, lengthen, or become more numerous.

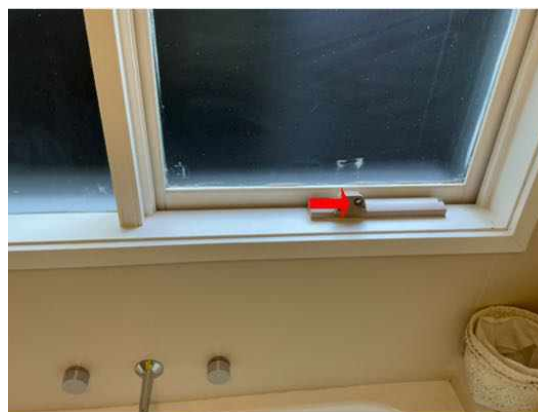
Finding 3.02

Building:	Main Building
Location:	Bathroom/Main
Finding:	Window - Missing handle
Information:	The handle to the window was missing at the time of the inspection. Absence of the handle limits the operation of the window and may pose as a safety risk.

Replacement of the handle should be conducted as soon as possible. A general handy person or qualified carpenter should be appointed to perform these works to improve the operational state of the affected window and improve the safety of the internal area.

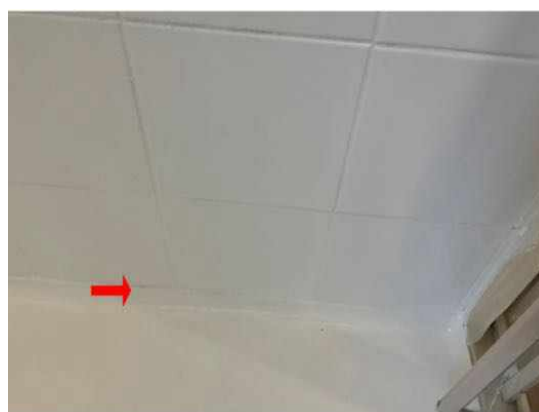
Finding 3.03

Building:	Main Building
Location:	Bathroom/Master
Finding:	Sealant and grouting - Missing or damaged
Information:	It was noted on inspection that sealant or grout is degraded to the tiled shower alcove and or other areas of the bathroom . A flexible sealant is required to allow for expected expansion and contraction, while keeping the joint water tight and protective of all associated building materials.

The lack of sealant between tiles can cause water damp to the wall behind it.

Regular maintenance and replacement of damage or missing or damaged sealant and grout is highly recommended to the wet areas, as this is a regular wear and tear defect. Sealant and grouting in areas that come into regular contact with water should be maintained for the long term care of your property.

Consultation with a sealant specialist is advised immediately to perform remedial works as required.

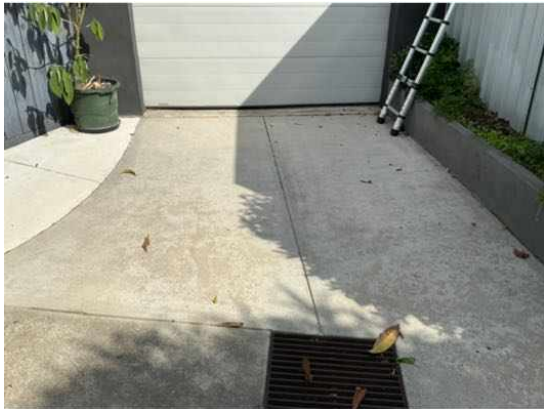
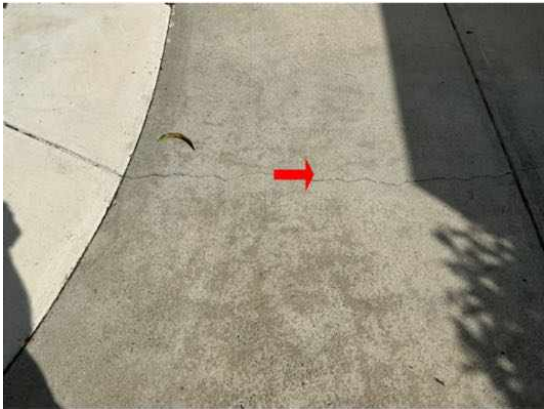
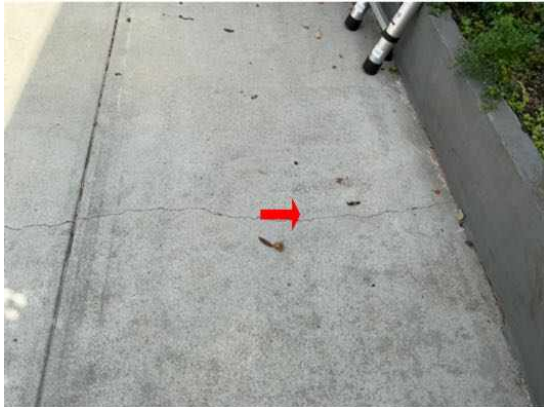
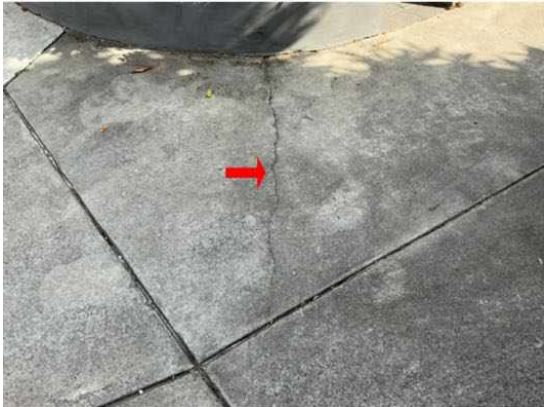
Finding 3.04

Building:	Out Building
Location:	Garage/Driveway
Finding:	Crack in pavement
Information:	Crack in the pavement has noted and it is To be considered Category 2, the approximate width of the crack is less than 2.0mm, or a change in offset of less than 15mm when a 3m straight edge is placed over the defect.

Category 2 cracks to pavement should be monitored for a period of 12 months. At the end of the monitoring period, cracks rated greater than Category 2 are considered defects that require rectification.

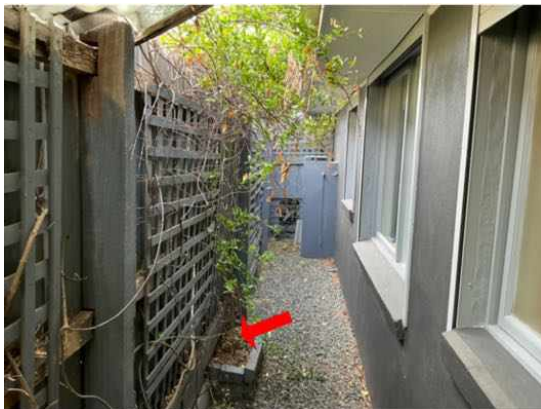
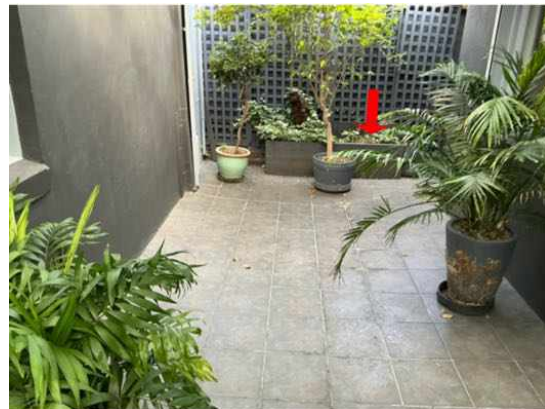
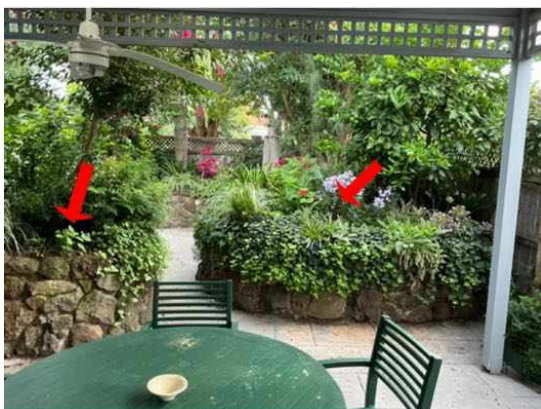
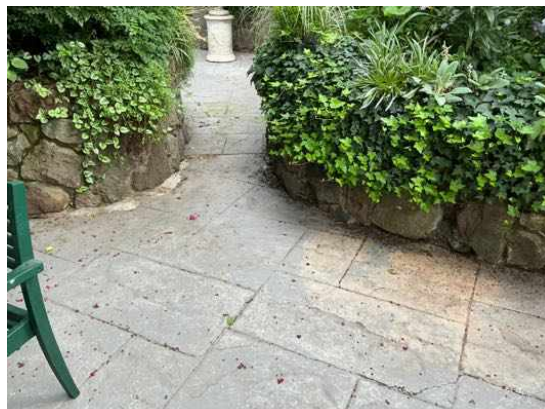
Garden beds can include untreated timber and a combination of moisture from watering, which produce conditions conducive to termite activity and ingress.

Further advice from a Timber Pest Technician is required to ensure appropriate Termite Management systems are implemented.

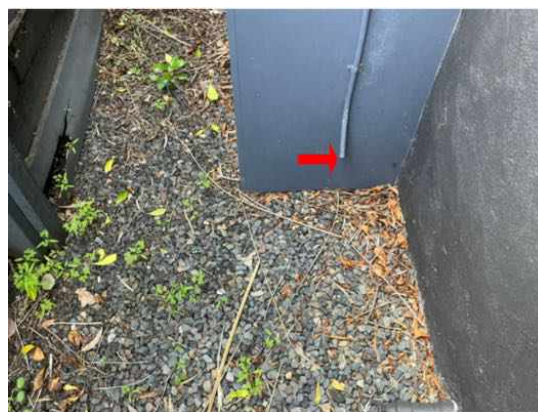
Finding 7.01

Building:	Main Building
Location:	All Areas
Finding:	Fencing - Wood rot
Information:	Wood rot was found to be affecting the fencing in this area, evidenced by the presence of mould on the surface in some areas. Wood rot, also known as Fungal Decay, occurs when timbers and other cellulose building materials are exposed to damp conditions on an ongoing basis.

It is likely that this wood rot has developed as a result of faults in the roof plumbing, creating excessive moisture in this areas. Frequent exposure to rain and other weather conditions also make fascias and barges susceptible to accelerated deterioration.

elements. Prior to any works being performed, the cause of the moisture that has created the visible wood rot should be identified and addressed in a suitable manner.

It is advised that a roof plumber be appointed to inspect all roof plumbing and subsequently identify the cause of the wood rot. Replacement of affected fascias and barges may then be a necessary step in protecting surrounding building elements from such deterioration.

A qualified plumber may be appointed to assess the cause of excessive moisture and to provide advice on any remedial works as required. A qualified carpenter or registered builder may also be required to replace affected building materials.

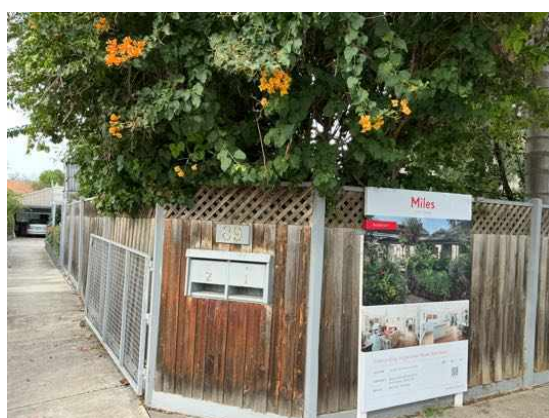
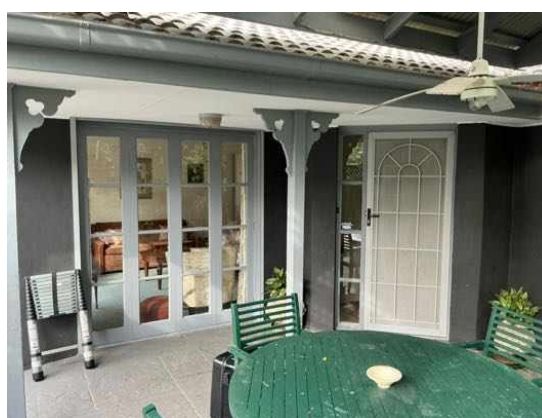
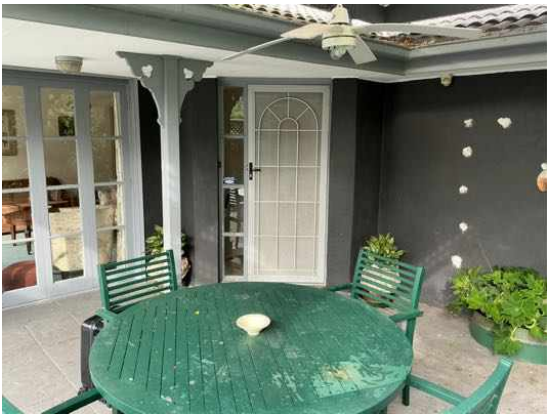
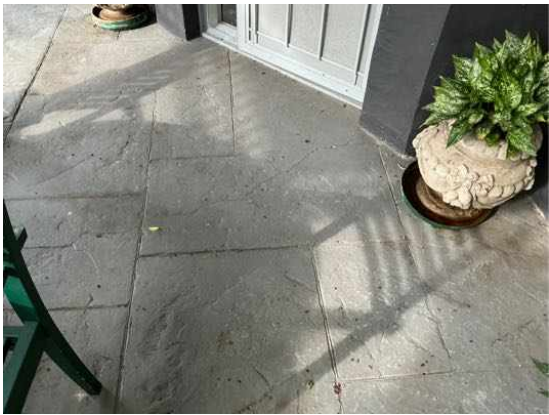
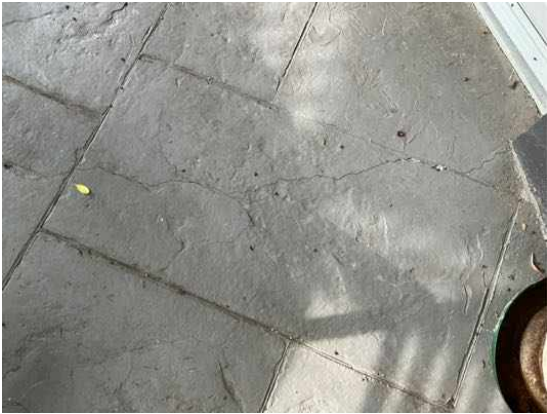
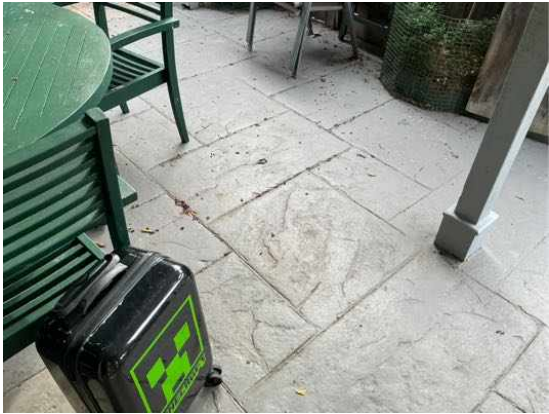
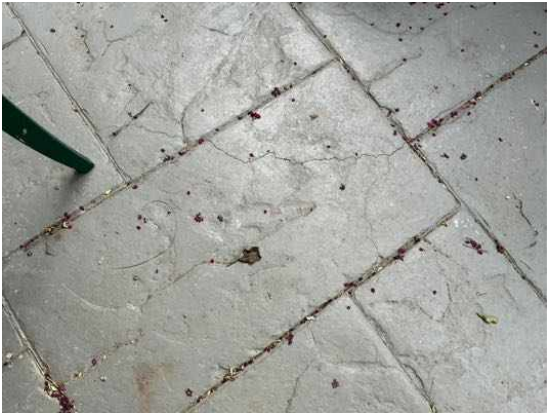
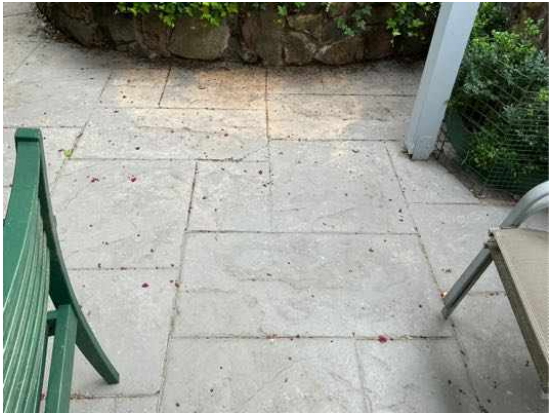
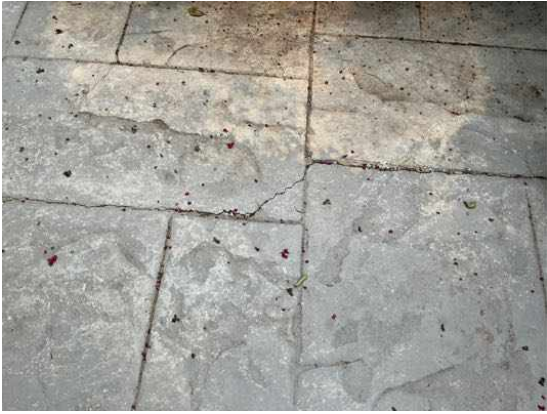
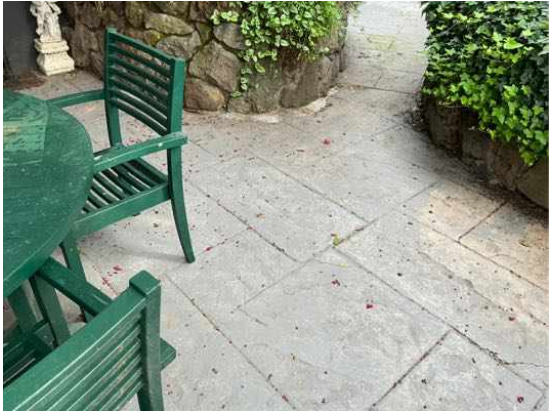
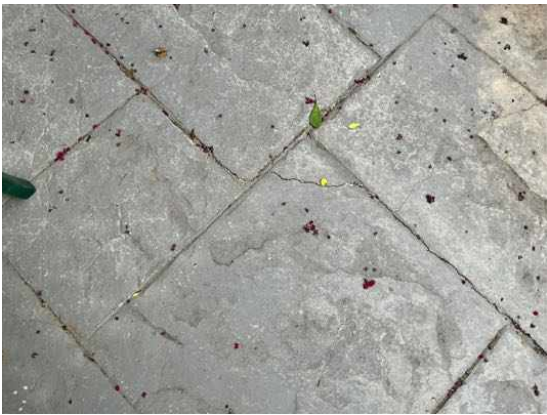
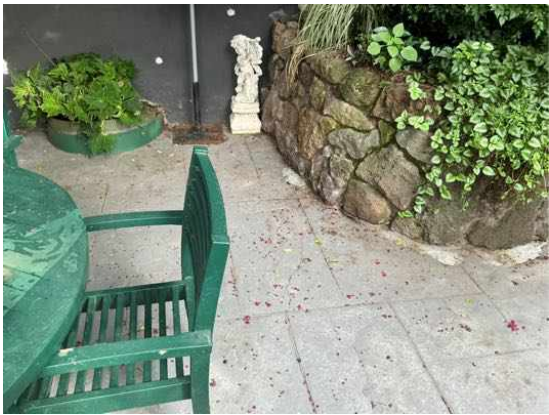
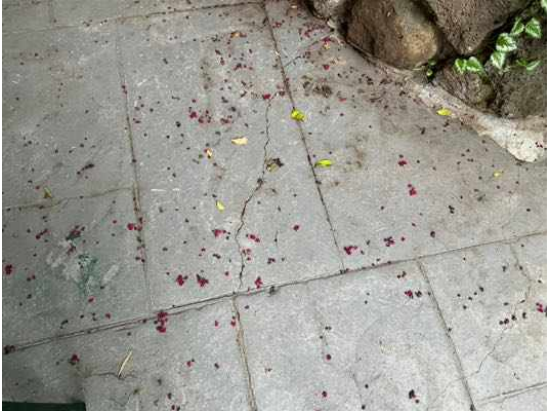
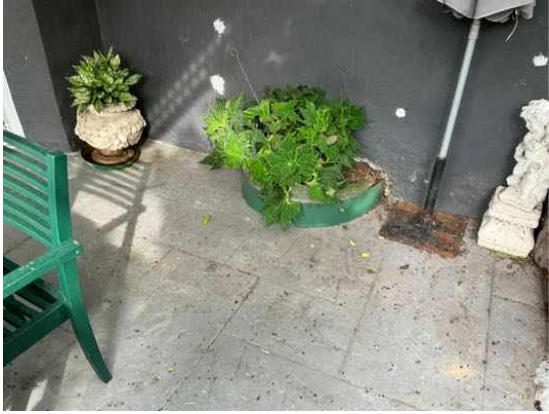
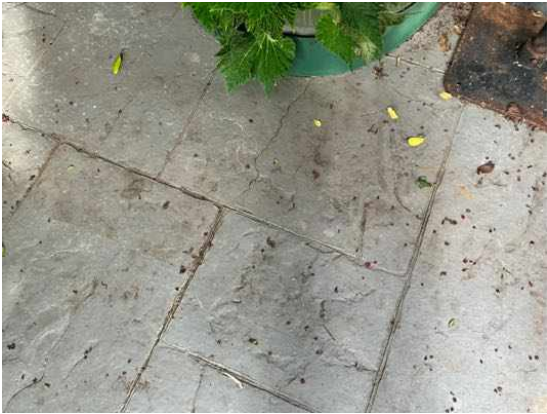
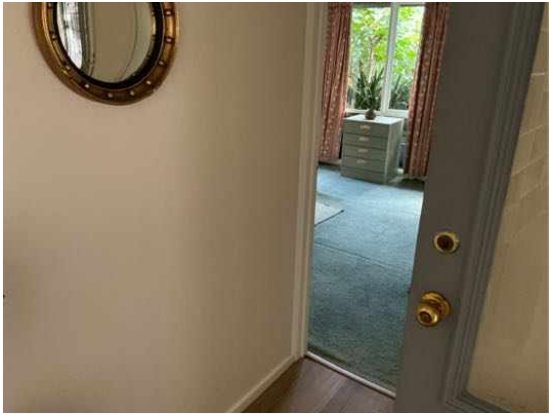
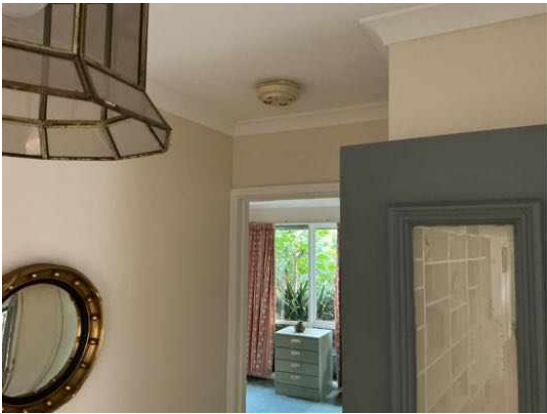
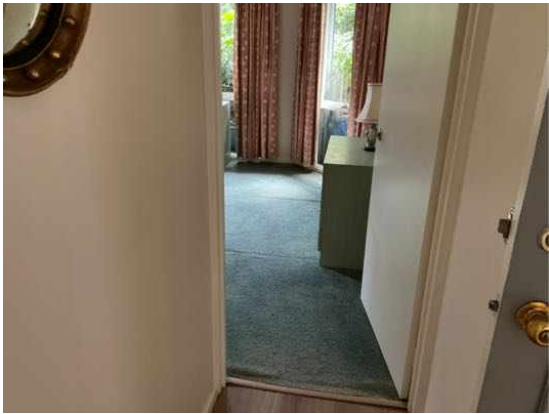
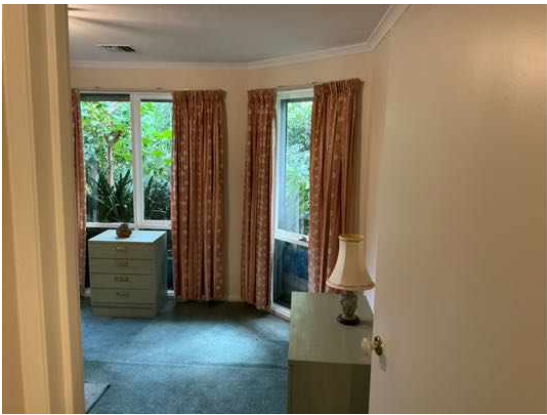
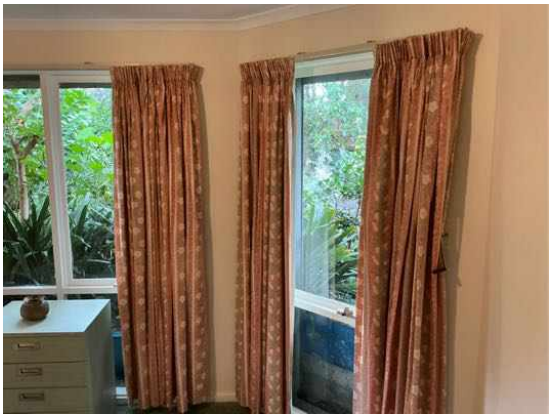
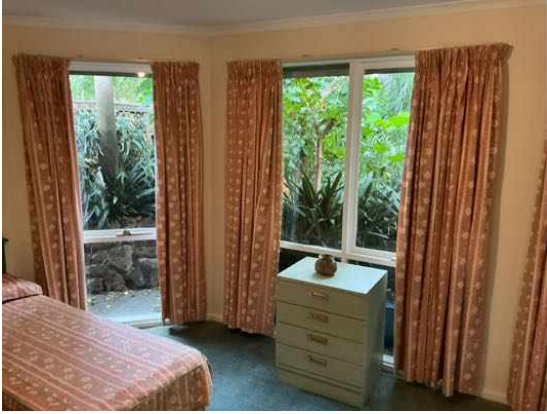
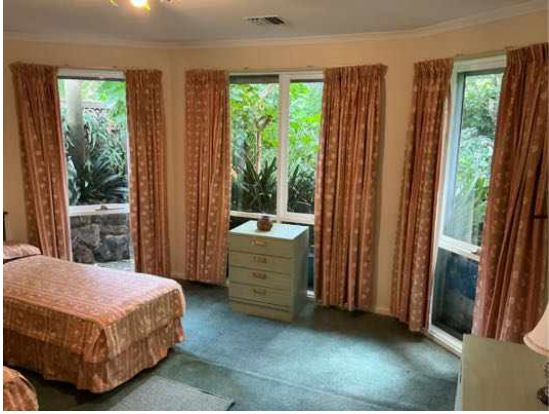
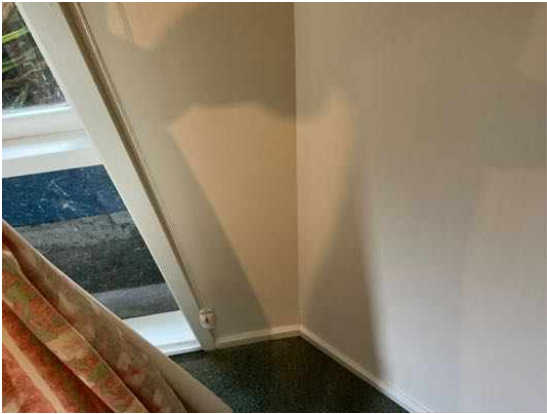
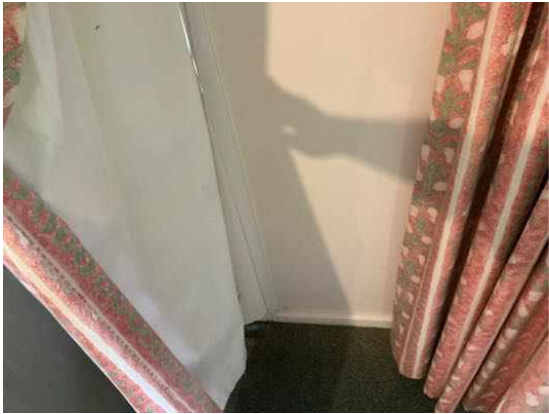
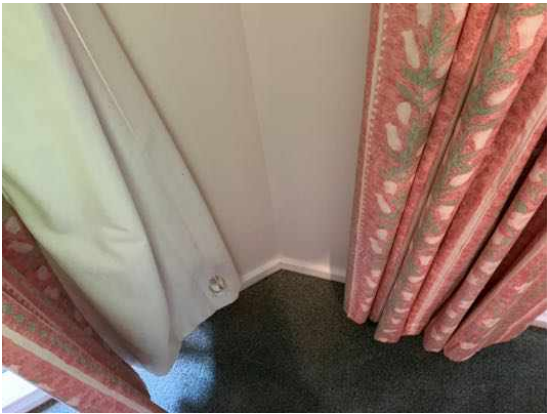
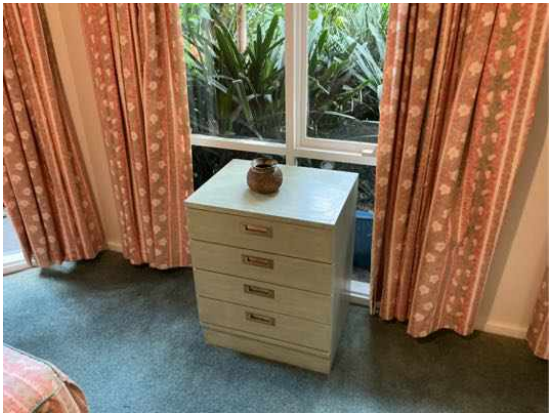
Building:	Main Building
Location:	All Areas
Finding:	Additional Photos - Obstructions and Limitations
Information:	These photographs are an indication of the obstructions and limitations which impeded full inspection of the property at the time of inspection. These obstructions can hide an array of defects and should be removed to allow full inspection to be carried out. A re-inspection is recommended once the areas are made accessible.

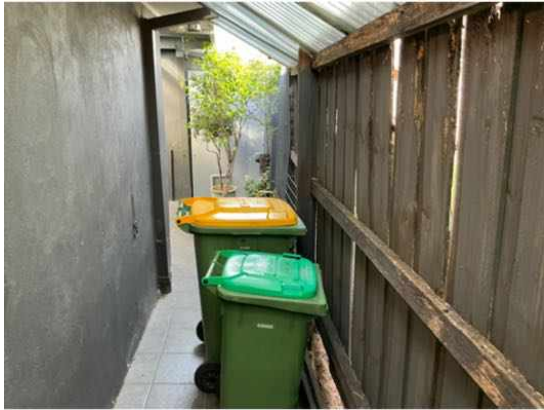
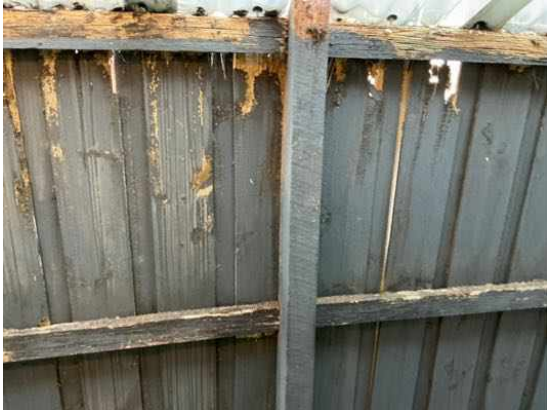
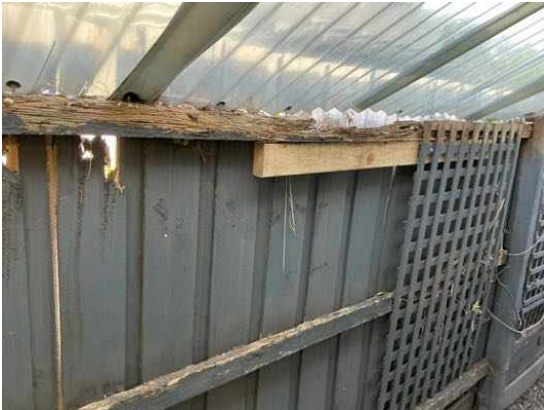
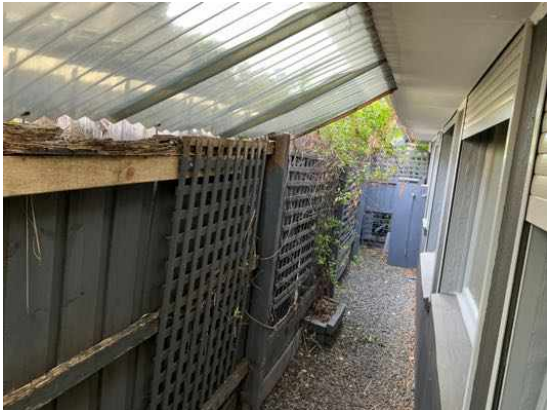
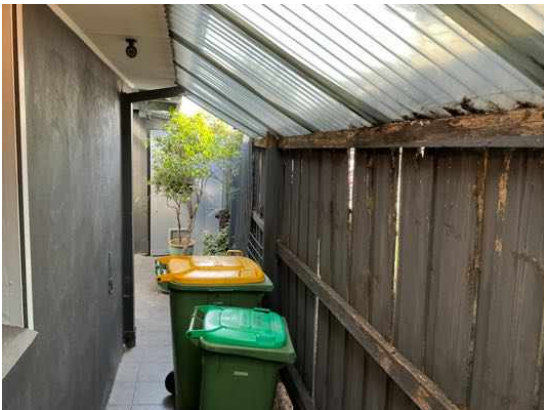
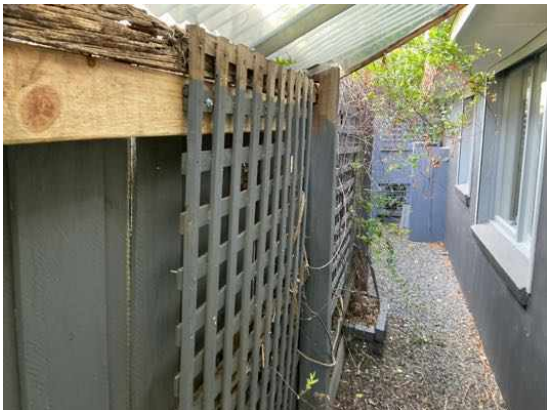
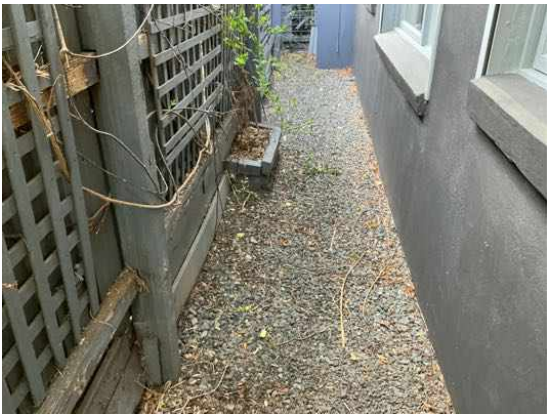
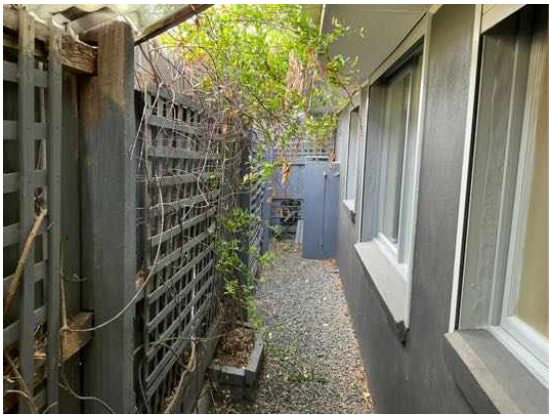
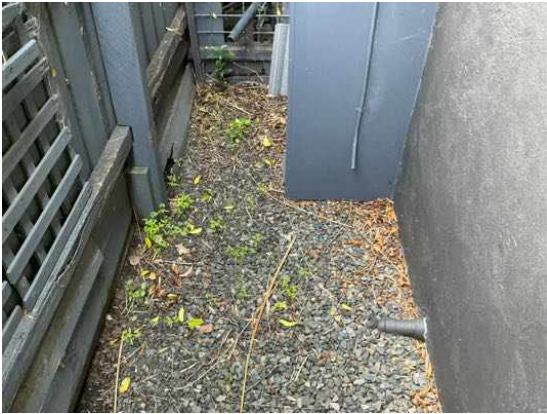
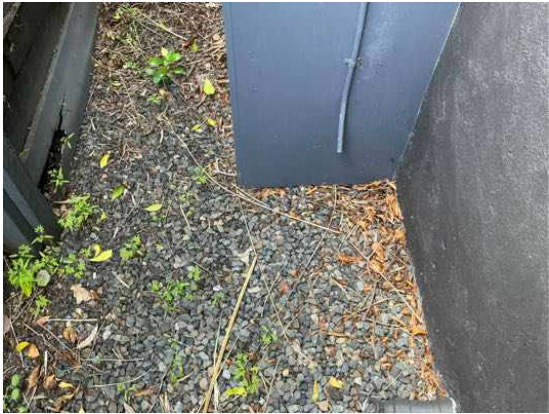
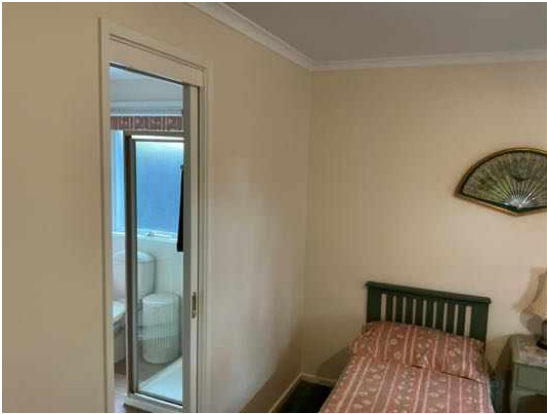
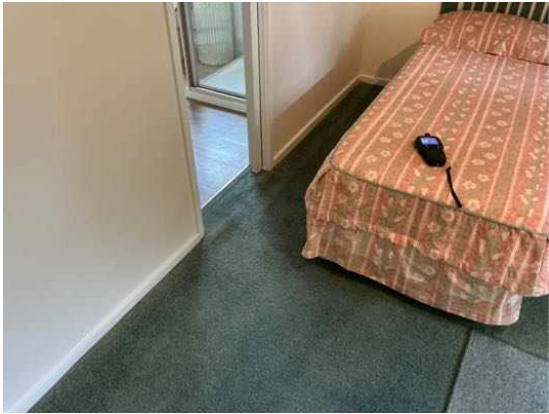
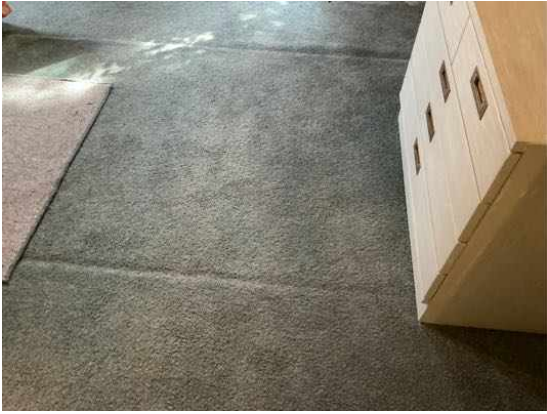
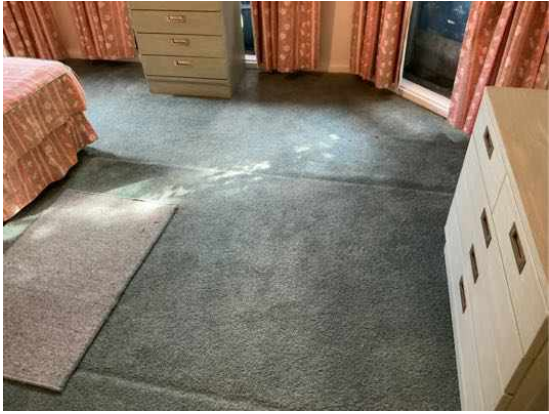
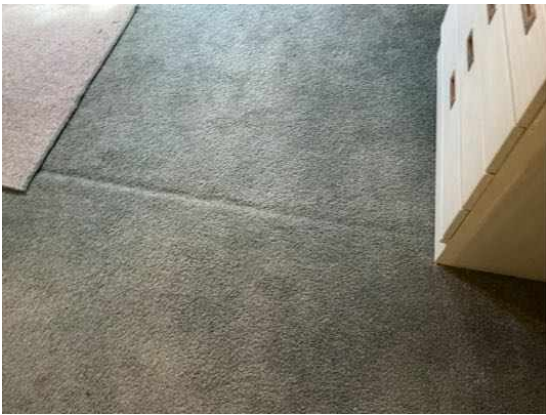
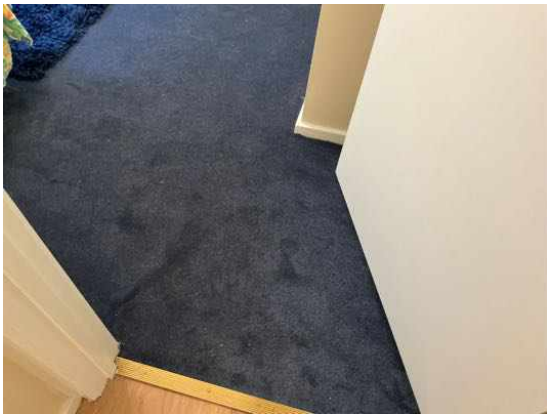
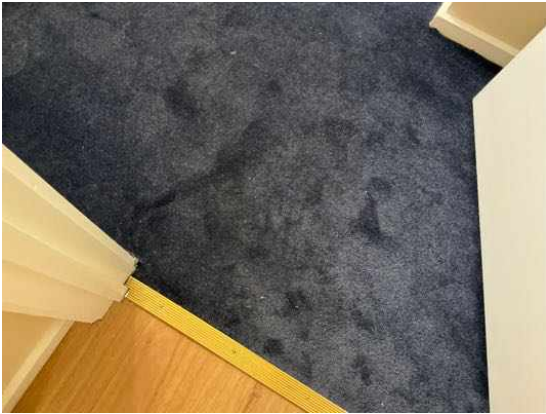
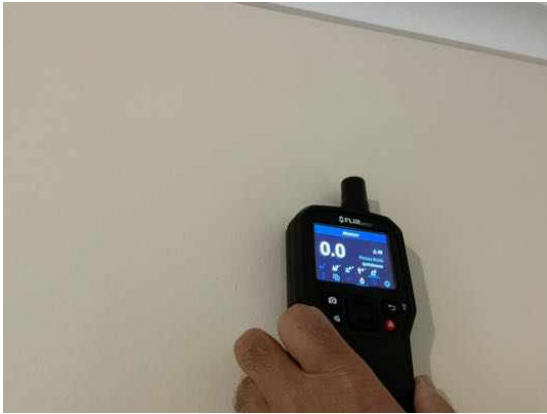
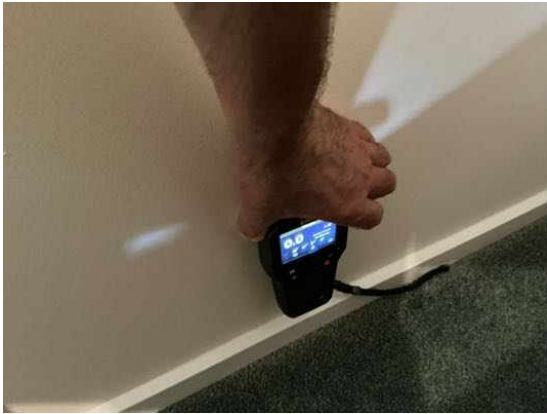
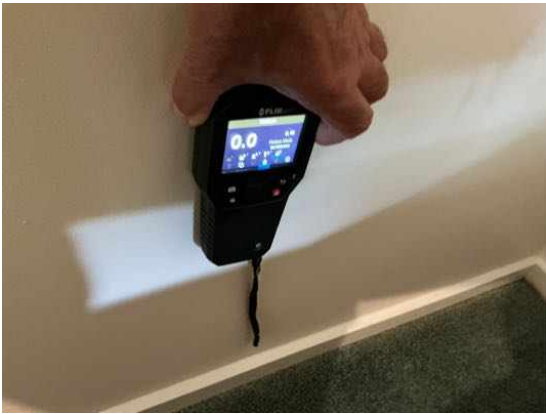
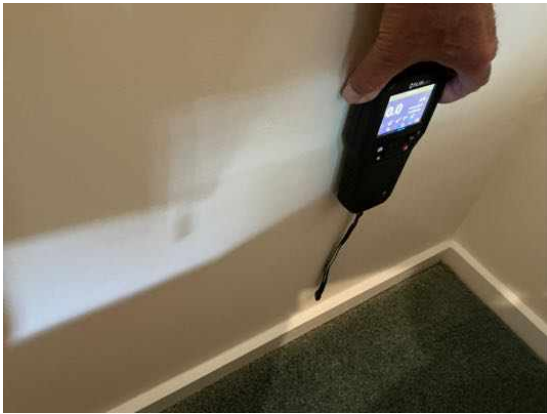
Building: Main Building
Location: All Areas
Finding: Additional Photos - Obstructions and Limitations
Information: These photographs are an indication of the obstructions and limitations which impeded full inspection of the property at the time of inspection. These obstructions can hide an array of defects and should be removed to allow full inspection to be carried out. A re-inspection is recommended once the areas are made accessible.
