Building and Timber Pest Inspection Report

Inspection Date: Thu, 29 Jan 2026

Property Address: 95 Brighton St, Riverstone NSW 2765,
Australia

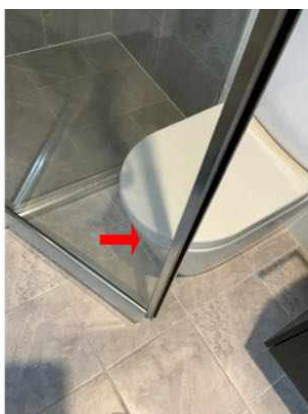
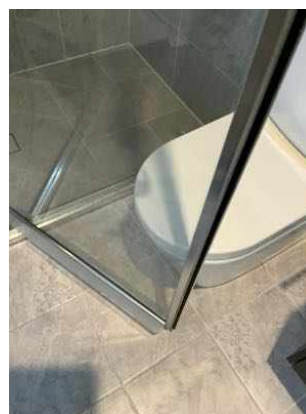
Building:	Main Building
Location:	Ensuite
Finding:	Shower screen - Hitting toilet
Information:	A safety hazard was identified in the bathroom of the property. The issue pertains to the shower screen, which, when fully opened, makes contact with the adjacent toilet. This situation poses an immediate risk to the safety and well-being of occupants due to the potential for accidents and injuries.

Collision between the shower screen and the toilet can cause injury to individuals using the bathroom, particularly if the shower screen shatters upon impact. The repeated contact between the shower screen and the toilet can also result in damage to both fixtures, leading to costly repairs or replacements.

This is to be addressed prior to handover.

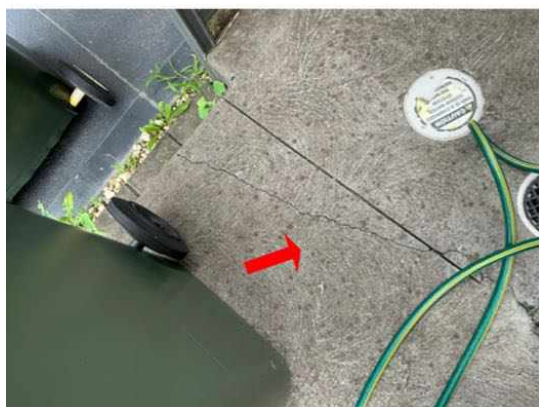
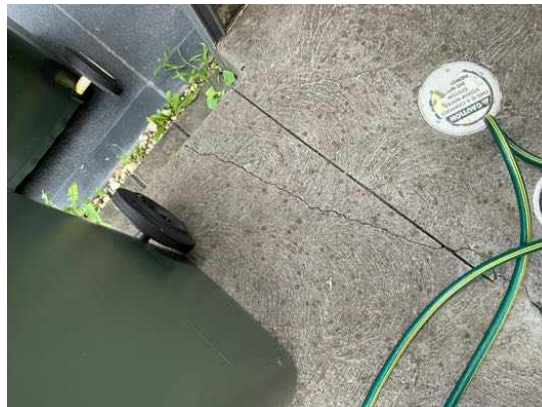
Building:	Main Building
Location:	Yard - Side
Finding:	Crack in concrete slab - Category 2
Information:	A crack coded as Category 2 was identified in the slab. A Category 2 crack is

described as a distinct crack, with the slab being noticeably curved or changed in level.

To be considered Category 2, the approximate width of the crack is less than 2.0mm, or a change in offset of less than 15mm when a 3m straight edge is placed over the defect.

Category 2 cracks to slabs should be monitored for a period of 12 months. At the end of the monitoring period, cracks rated greater than Category 2 are considered defects that require rectification.

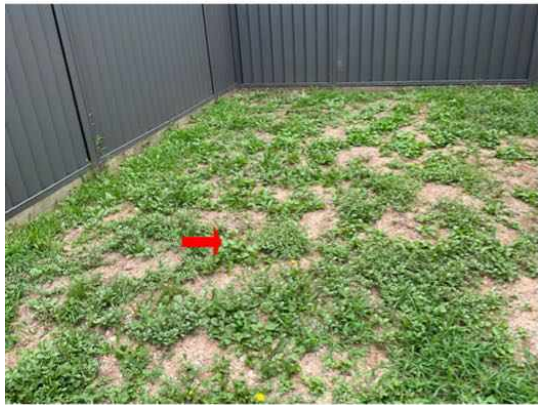
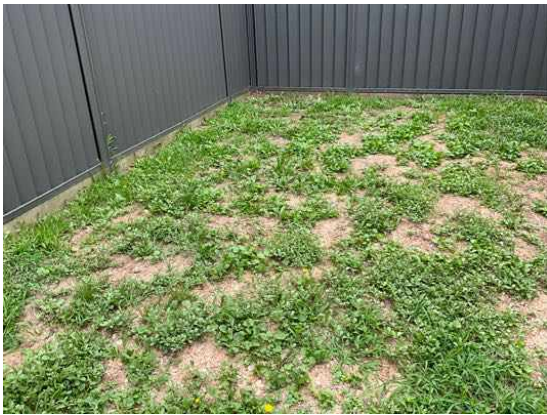
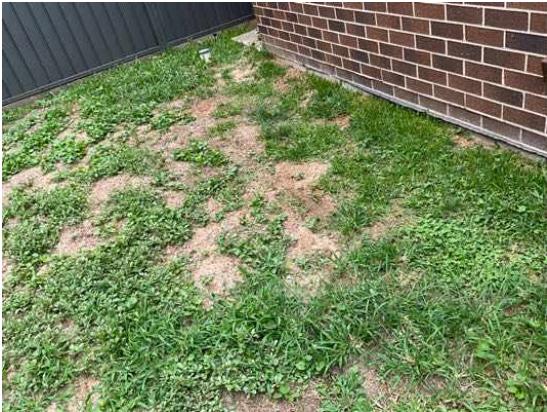
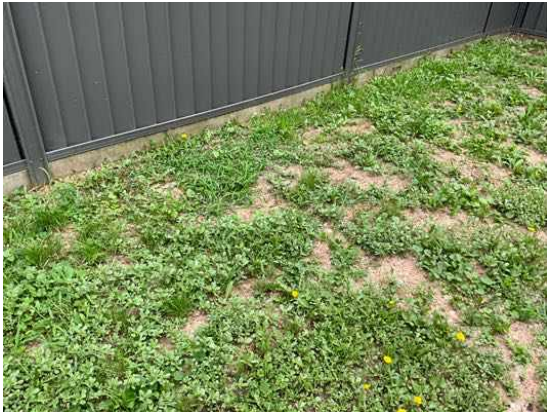
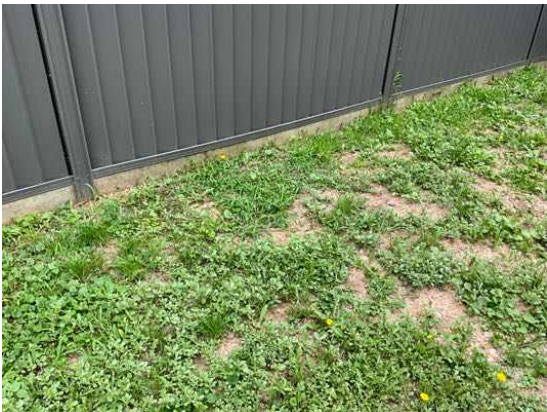
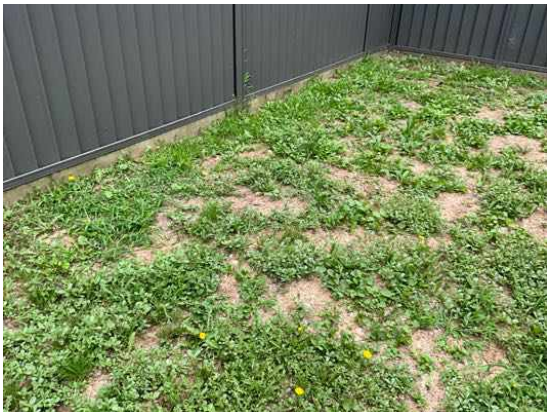
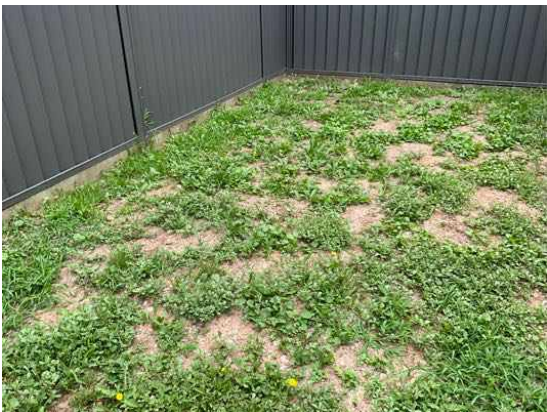
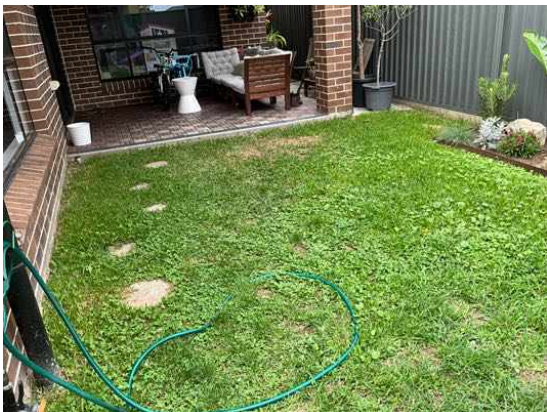
Finding 3.02

Building:	Main Building
Location:	Yard - Back
Finding:	Water pooling - poor surface drainage
Information:	Surface drainage

Surface water drainage is defective if it is not in accordance with the requirements of the Building Code of Australia.

Such water pooling also increases the risk of termite activity and the development of fungal decay in the area.

Consult a Licensed Plumber regarding the cost of potential site drainage rectification works.

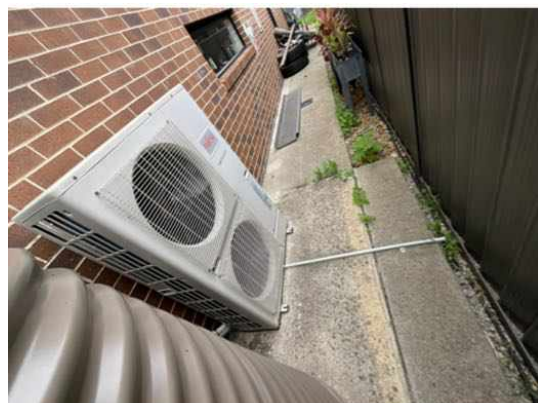
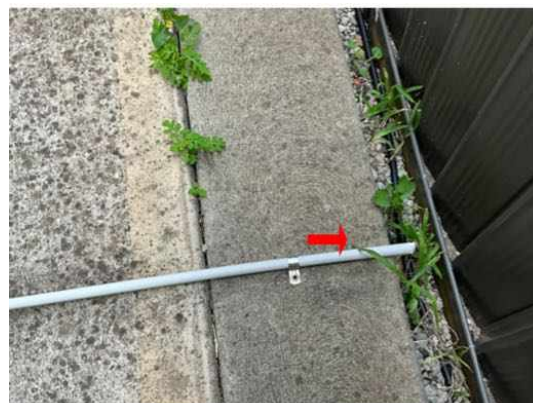
Finding 3.03

Building:	Main Building
Location:	Exterior walls - right side
Finding:	Air conditioner - Disconnected overflow
Information:	The Air Conditioner (A/C) overflow was found to be disconnected from storm water drainage and is creating excessive moisture in the surrounding area.

Such leaking creates an environment which is conducive to an array of defects, including water damage to associated building elements and the attraction of termite or timber pest infestation.

It is highly recommended that a licensed plumber be appointed to connect the A/C overflow in order to prevent such an environment from being created. These minor works should be carried out as soon as possible.

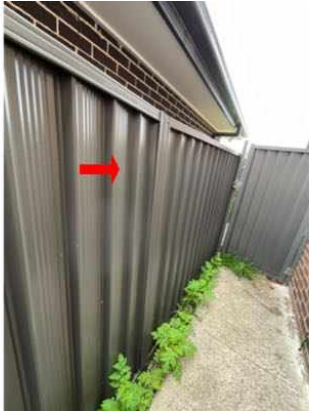
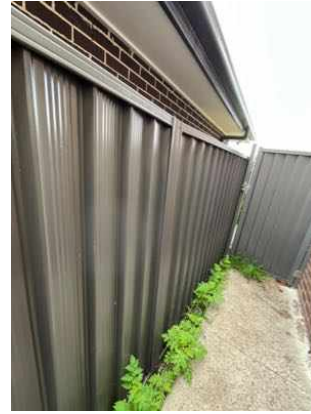
Finding 3.04

Building:	Main Building
Location:	Fencing
Finding:	Leaning fence
Information:	The fence is leaning, deviating from its vertical position, compromising its stability and aesthetic appeal.

The leaning fence poses a risk of collapse, potential property damage, and a security breach, diminishing its effectiveness as a barrier.

A skilled fencing contractor or handyman is needed to assess and rectify the leaning fence. Timely repair is crucial to restore the fence's stability and prevent further damage or safety hazards.

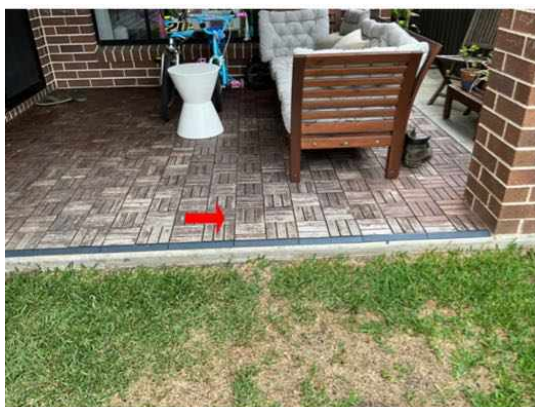
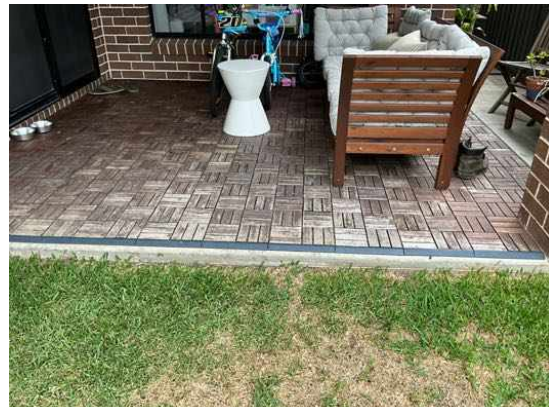
Finding 3.05

Building: Main Building

Information: External timbers that are frequently exposed to harsh weather conditions require adequate protection in order to maintain their condition. Where timbers have not been painted or treated adequately, general deterioration is likely to occur at an accelerated rate.

If left unattended, replacement of these timbers is likely to be necessary in the short-term future. Adequate treatment of these timbers is required as soon as possible by a painting contractor or general handyman.

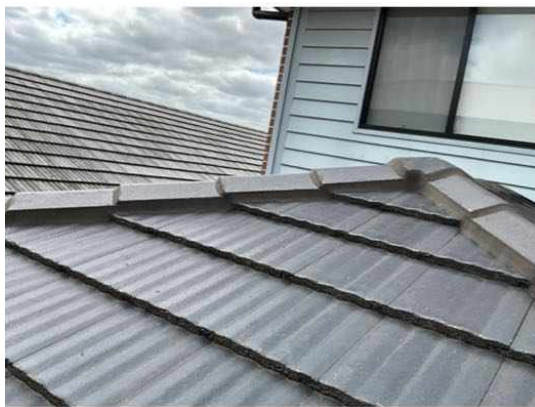
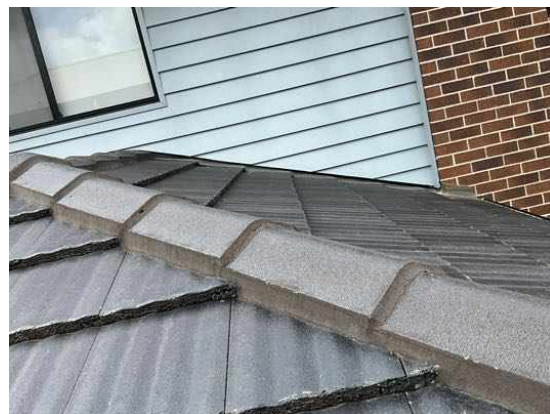
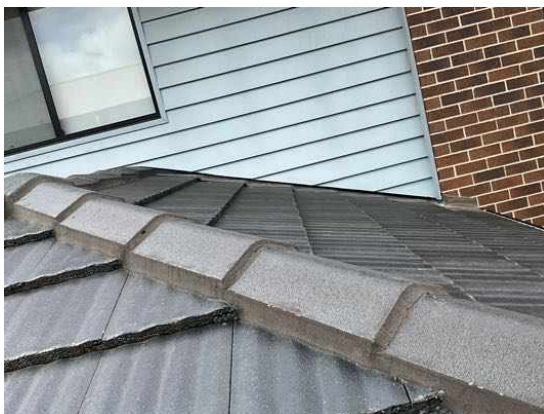
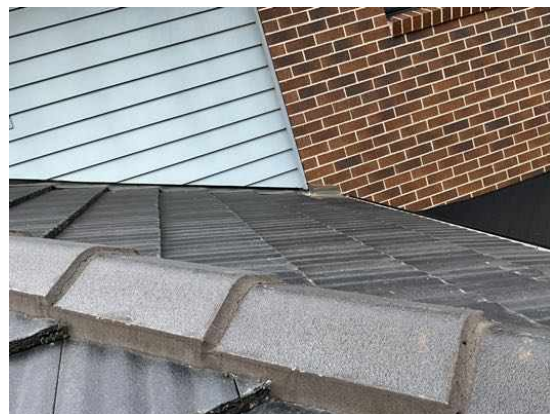
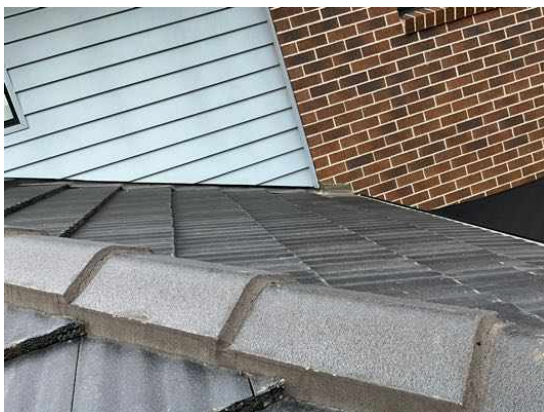
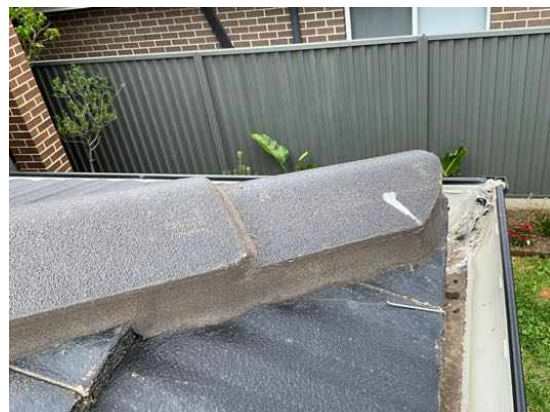
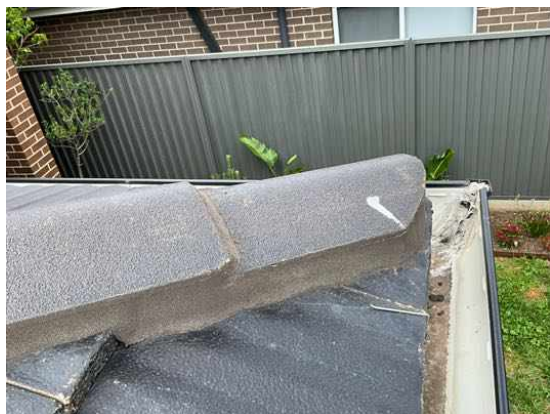
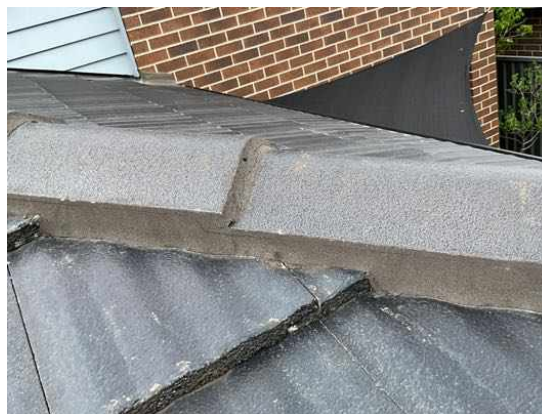
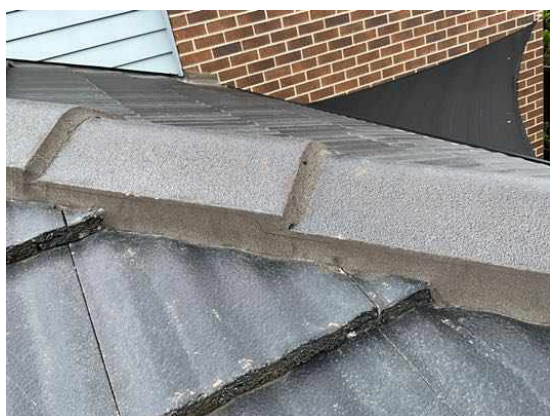
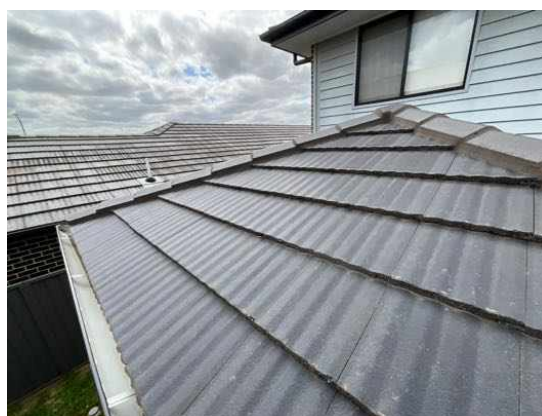
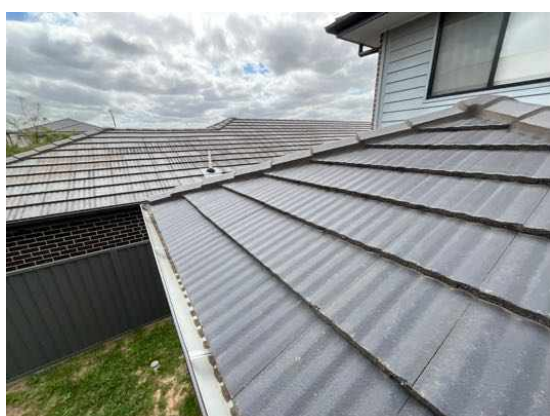
Finding 3.06

Building: Main Building
Location: Roof Exterior
Finding: Roof Weathered
Information:

Inspection of the roof revealed widespread weathering to the tiled roof surface. The tiles show loss of surface finish, colour fading, and age-related deterioration typical of older roof coverings. Although no significant cracking was noted, weathering can lead to increased porosity, reduced water-shedding capability, and a higher risk of future cracking or displacement during adverse weather conditions.

A licensed roofer should be engaged to undertake a closer inspection, carry out routine maintenance, and replace any tiles that may be compromised. Ongoing monitoring is recommended due to the age and condition of the roof covering.

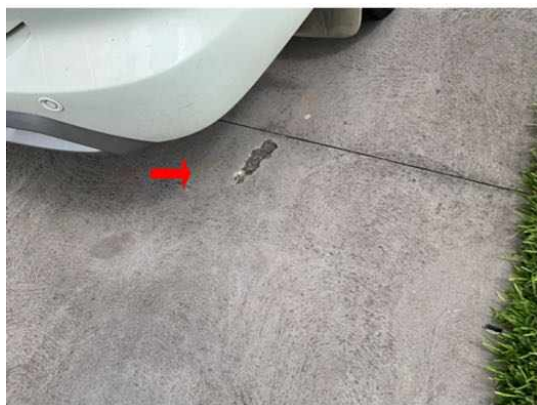
Finding 3.07

Building:	Main Building
Location:	Driveway
Finding:	Concrete damaged
Information:	The concrete pavement exhibits various forms of damage, including cracks, potholes, and spalling, compromising its integrity and smoothness.

Risk: Damaged concrete pavement poses several risks, including trip hazards, vehicle damage, and drainage issues. Cracks and potholes can cause pedestrians to trip and fall, leading to injuries, while vehicle damage may occur from driving over uneven surfaces. Additionally, poor drainage due to damaged pavement can result in water

accumulation, leading to erosion, flooding, and further deterioration of the pavement over time.

A professional concrete contractor or pavement repair company should be engaged to assess the extent of the damage and determine the appropriate repair method. Depending on the severity of the damage, repairs may involve patching, resurfacing, or replacing sections of the concrete pavement to restore functionality and safety. Additionally, measures may be taken to address underlying issues such as poor drainage to prevent future damage.

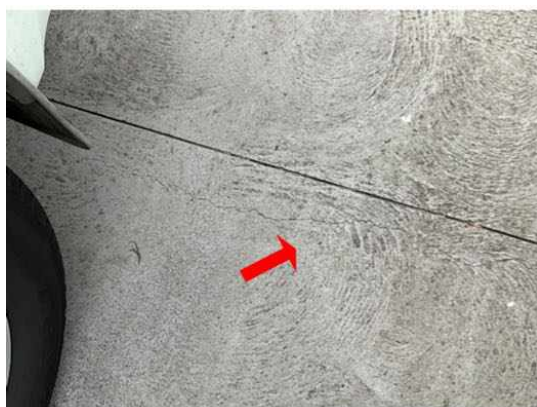
Finding 3.08

Building: Main Building
 Location: All Areas
 Finding: Crack in concrete slab - Category 0
 Information: A crack coded as Category 0 was identified in the slab. A Category 0 crack is described as a hairline crack, representing insignificant movement of slab from level.

The approximate width of the crack to be considered Category 0 is 0.3mm, or change in offset of less than 8mm when a 3m straight edge is placed over the defect.

No rectification is required at this time. However, all cracking should be monitored over a 12 month period to identify any further damage in the area.

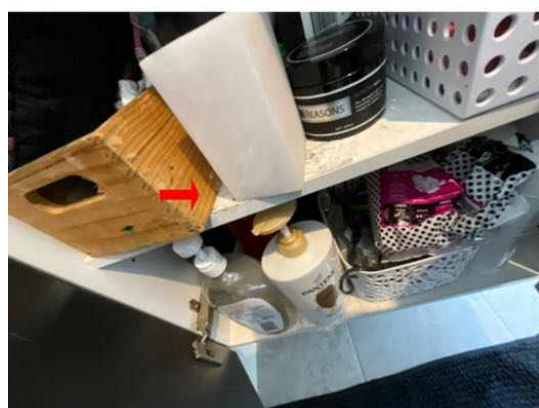
Finding 3.10

Building: Main Building
 Location: Bathroom downstairs
 Finding: Stains in Vanity
 Information: Defect: General Stains in the Vanity

Description: The vanity surface exhibits general stains that may be due to water exposure, soap scum, cosmetics, or other substances. These stains are unsightly and may indicate ongoing maintenance issues.

- Hygiene Concerns: Stains can harbor bacteria and germs, potentially compromising hygiene in the bathroom.
- Aesthetic Impact: Stains reduce the visual appeal of the bathroom, making it look unkempt and less inviting.
- Potential for Hidden Damage: Stains caused by water exposure could indicate underlying water damage that, if left untreated, may lead to more serious structural issues.
- Decreased Resale Value: An unappealing vanity can negatively affect the overall aesthetic and perceived value of the property.

- Clean the vanity using appropriate cleaning agents to remove stains.
- Inspect for any underlying issues, such as leaks or surface damage, and address them accordingly.
- Consider refinishing or replacing the vanity if stains are persistent and cannot be removed.

- Homeowner or Cleaning Service: For minor stains, thorough cleaning can often be done by the homeowner or a professional cleaning service using suitable cleaning products.
- Handyman: For more stubborn stains or minor repairs, a handyman can clean, repair, or refinish the vanity surface.
- General Contractor: If the stains indicate more serious damage or if a replacement is needed, a general contractor with experience in bathroom renovations can perform the necessary repairs or replacement of the vanity.

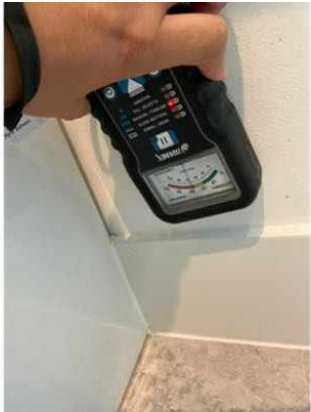
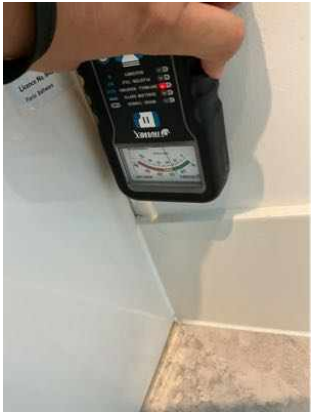
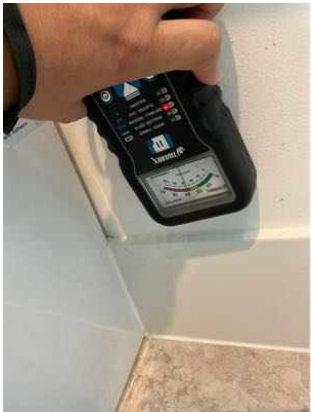
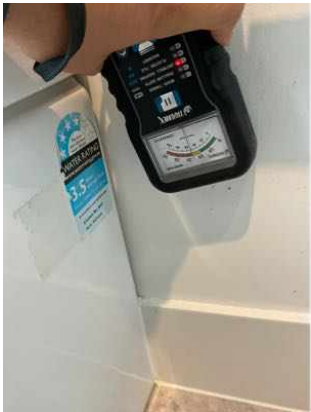
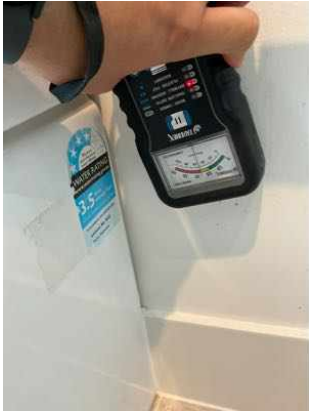
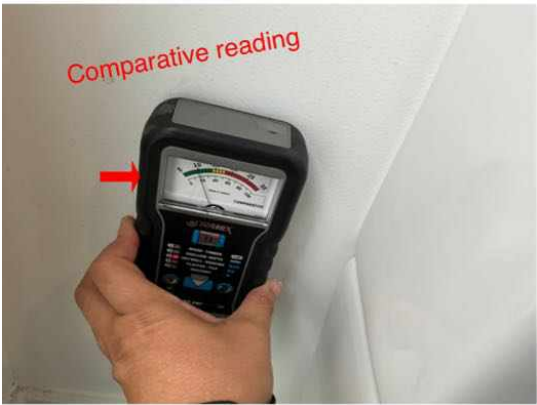
Finding 3.11

Building: Main Building
Location: Bathroom downstairs
Finding: Evidence of excessive moisture - Drywall
Information: Excessive moisture is present at the time of , indicating a potential water leakage issue within the wall.

The prolonged presence of moisture can lead to mold growth, deteriorate the structure, and create an environment conducive to health hazards. Additionally, it may compromise the adhesive holding the tiles, leading to their detachment.

A licensed plumber or a qualified contractor specializing in water damage remediation should investigate the source of the moisture, fix any leaks, and address the damage. Additionally, replacing affected tiles and ensuring proper waterproofing are crucial to preventing future issues.

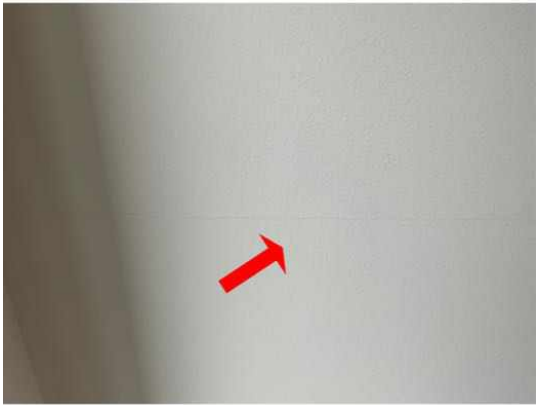
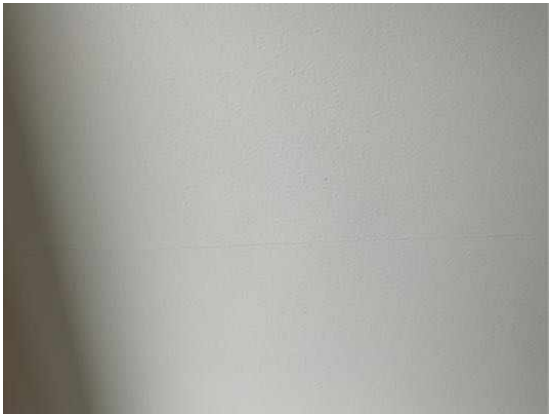
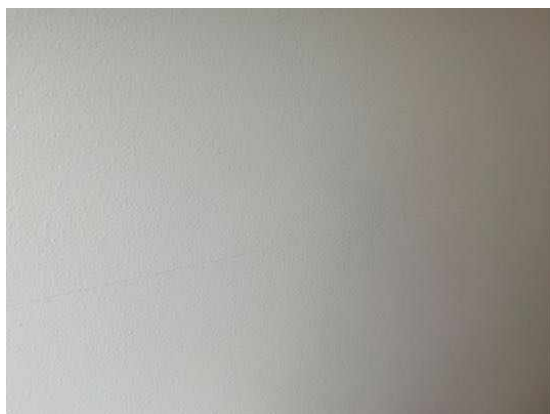
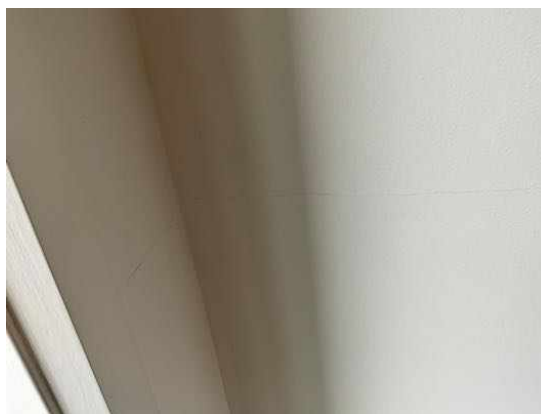
Finding 3.12

Building: Main Building
Location: Bathroom downstairs
Finding: Cracking - Damage Category 0 - Hairline (less than 1mm)
Information: Hairline cracks are very minor in nature and generally are only ever an appearance defect. While such cracking may be noticeable in some cases, it is quite common and does not indicate any structural damage.

Cracking of this nature can generally be repaired with minor sanding, filling and/or repainting. Such works should be performed by a qualified painter or a general handyman.

Monitoring of all cracking should be conducted frequently. Always contact a building inspector should cracks widen, lengthen, or become more numerous.

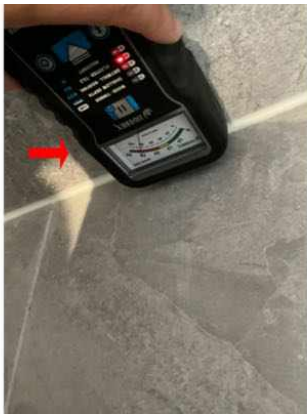
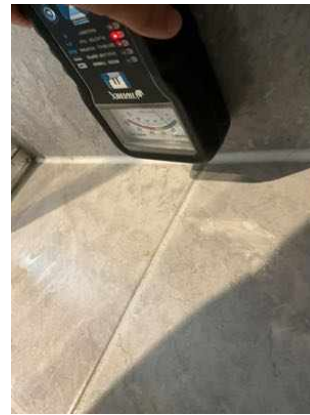
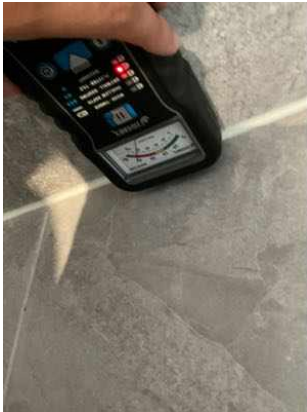
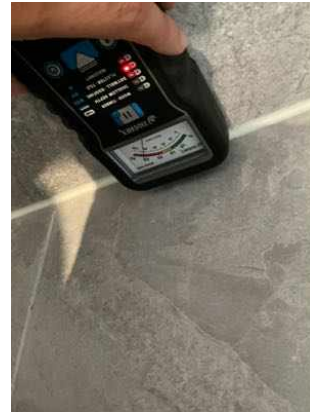
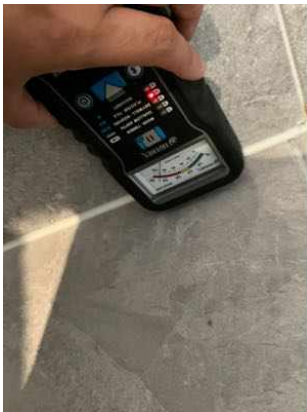
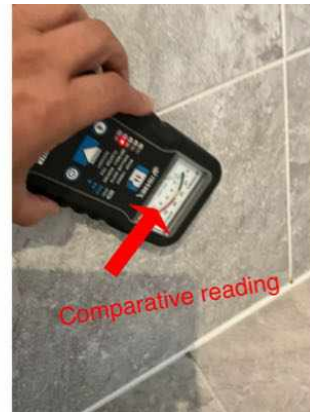
Finding 3.13

Building:	Main Building
Location:	Ensuite
Finding:	Shower - Damp
Information:	Damp is evident to the lower 300mm of wall to the shower alcove. This defect is quite common, and is suspected to have been caused by moisture permeating through the grouting in this area, which shows evidence of deterioration. Leaking pipes within the adjoining wall is also a possible cause.

Damp (or structural damp) refers to the presence of unwanted moisture in the structure of a building, either as the result of intrusion from outside, or condensation from within the structure. In the shower area, internal water leaks or other sources of excessive moisture are generally the cause of damp.

Unmanaged damp in the shower recess is likely to facilitate the formation and development of mould and fungi growth, decaying associated building materials and compromising their structural integrity. It is important to address damp conditions, as the World Health Organisation notes that excess moisture leads - on almost all indoor materials - to growth of microbes such as moulds, fungi and bacteria, which subsequently emit spores and other matter into the indoor air. Exposure to these contaminants is associated with a wide range of respiratory and other health-related problems.

Consultation with a qualified plumber or bathroom specialist is advised immediately to identify the cause of damp and to perform remedial works as required. Where excessive mould growth is present, further inspection by a specialist environmental health inspector should also be considered.

Always ensure that sealant and grout is in good condition to prevent any moisture issues occurring in the future.

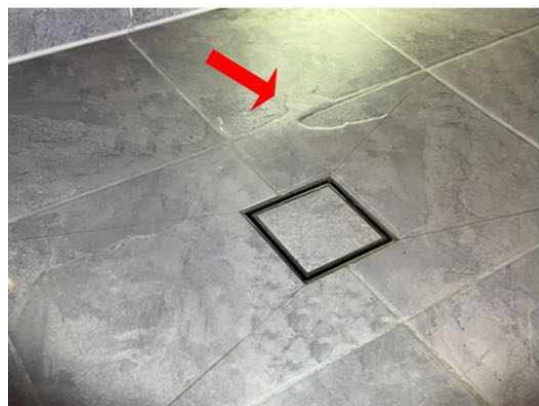
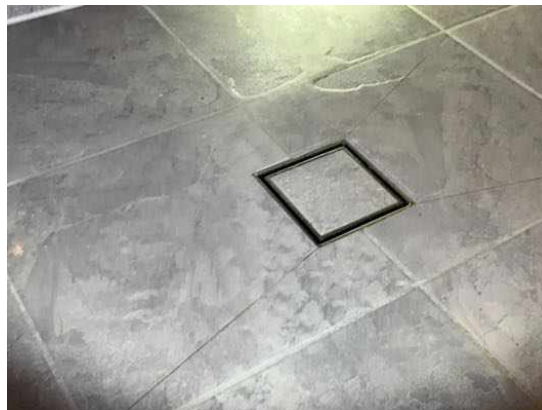
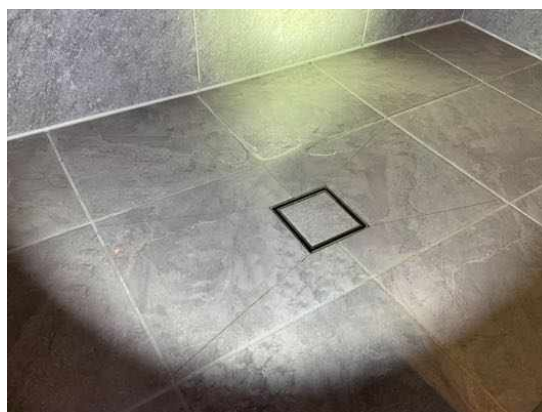
Finding 3.14

Building:	Main Building
Location:	Ensuite
Finding:	Shower base - Water pooling
Information:	Evidence of water pooling around the floor waste in the shower recess was noticed at the time of inspection. It is suspected that this excessive moisture is attributed to insufficient fall in the shower floor tiles.

This pooling is minor overall but is still considered unsatisfactory, as standard tiling practices would not permit this situation to occur. Pooling water around floor wastes can create a slip hazard in extreme cases and create conditions that are conducive to mould growth over time. Where left unmanaged, the degradation of sealant and

grouting is also likely to occur, possibly necessitating further repair works.

Remedial works may involve some sections of tiling and flooring repair and replacement. A tiling contractor or bathroom specialist should be appointed to provide further advice on reparation options and to perform works as necessary.

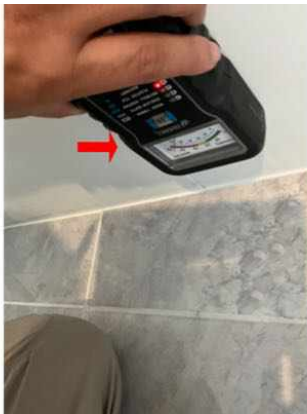
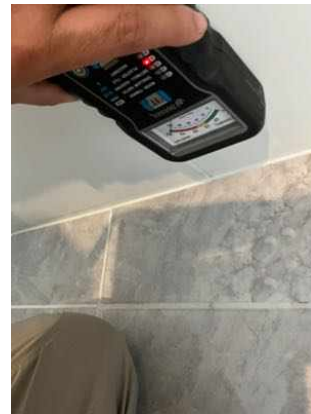
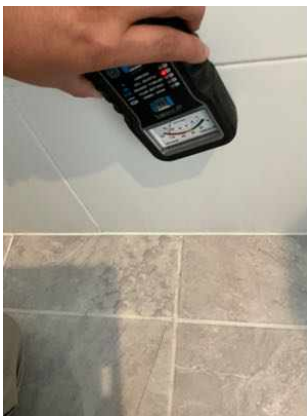
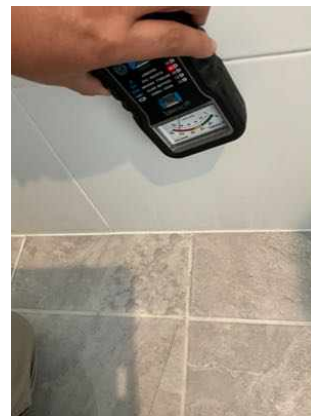
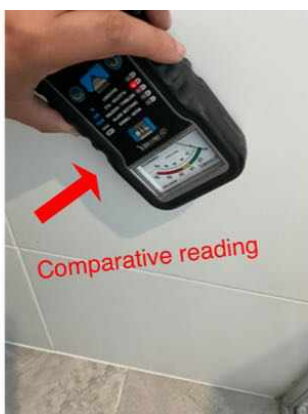
Finding 3.15

Building:	Main Building
Location:	Bathroom
Finding:	Shower - Damp
Information:	Damp is evident to the lower 300mm of wall to the shower alcove. This defect is quite common, and is suspected to have been caused by moisture permeating through the grouting in this area, which shows evidence of deterioration. Leaking pipes within the adjoining wall is also a possible cause.

Damp (or structural damp) refers to the presence of unwanted moisture in the structure of a building, either as the result of intrusion from outside, or condensation from within the structure. In the shower area, internal water leaks or other sources of excessive moisture are generally the cause of damp.

Unmanaged damp in the shower recess is likely to facilitate the formation and development of mould and fungi growth, decaying associated building materials and

compromising their structural integrity. It is important to address damp conditions, as the World Health Organisation notes that excess moisture leads - on almost all indoor materials - to growth of microbes such as moulds, fungi and bacteria, which subsequently emit spores and other matter into the indoor air. Exposure to these contaminants is associated with a wide range of respiratory and other health-related problems.

Consultation with a qualified plumber or bathroom specialist is advised immediately to identify the cause of damp and to perform remedial works as required. Where excessive mould growth is present, further inspection by a specialist environmental health inspector should also be considered.

Always ensure that sealant and grout is in good condition to prevent any moisture issues occurring in the future.

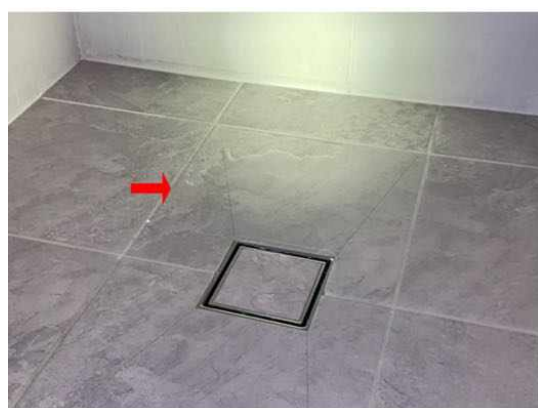
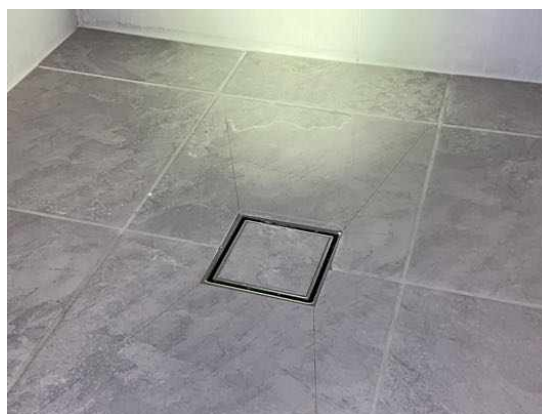
Finding 3.16

Building:	Main Building
Location:	Bathroom
Finding:	Shower base - Water pooling
Information:	Evidence of water pooling around the floor waste in the shower recess was noticed at the time of inspection. It is suspected that this excessive moisture is attributed to insufficient fall in the shower floor tiles.

This pooling is minor overall but is still considered unsatisfactory, as standard tiling practices would not permit this situation to occur. Pooling water around floor wastes can create a slip hazard in extreme cases and create conditions that are conducive to mould growth over time. Where left unmanaged, the degradation of sealant and grouting is also likely to occur, possibly necessitating further repair works.

Remedial works may involve some sections of tiling and flooring repair and replacement. A tiling contractor or bathroom specialist should be appointed to provide further advice on reparation options and to perform works as necessary.

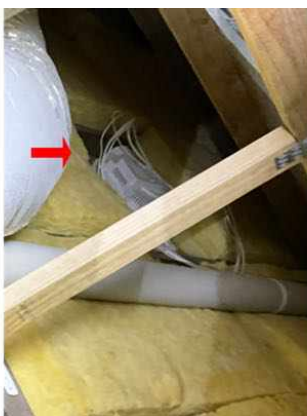
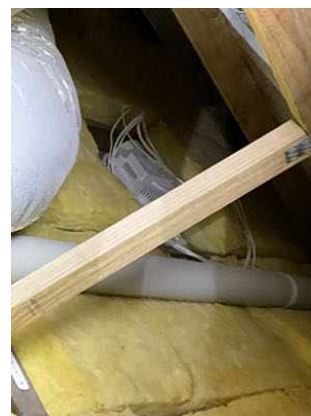
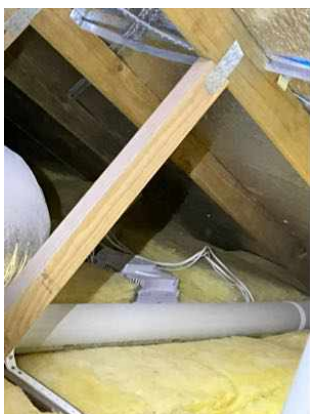
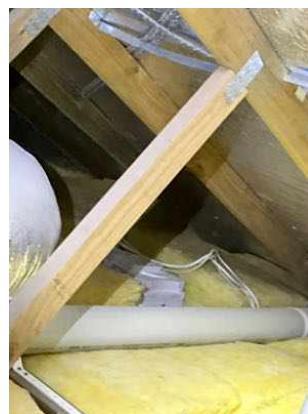
Finding 3.17

Information: The exhaust fan located within the roof void is not appropriately ducted to the external atmosphere and is currently discharging moist air directly into the roof space. This is considered a defect under AS 4349.1, as it does not meet the minimum standard of residential building performance expected under normal residential building practices.

This condition may lead to excessive condensation within the roof void, increasing the risk of mould growth, deterioration of insulation, timber decay, and overall reduced durability of building elements. It may also result in poor indoor air quality, potentially affecting occupant health.

It is recommended that the exhaust fan be modified by a licensed HVAC contractor or qualified builder, ensuring it is properly ducted to discharge externally in accordance with manufacturer specifications, the National Construction Code (NCC), and applicable Australian Standards.

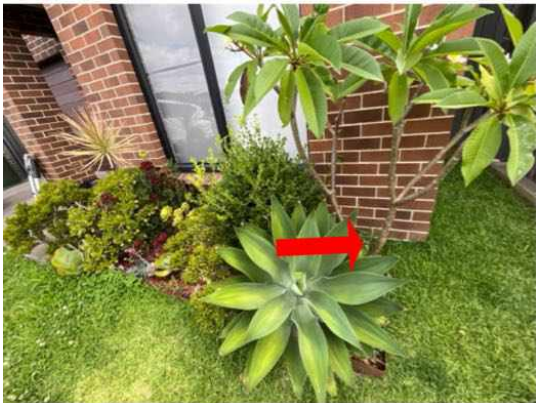
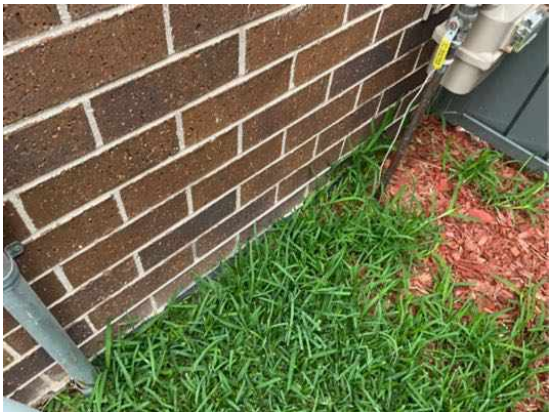
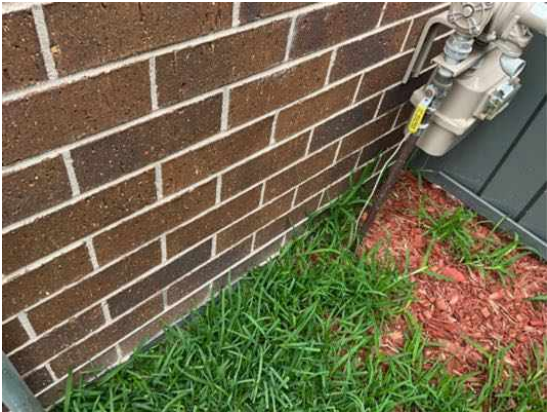
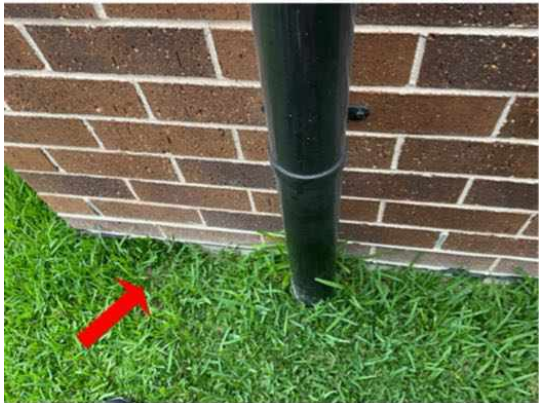
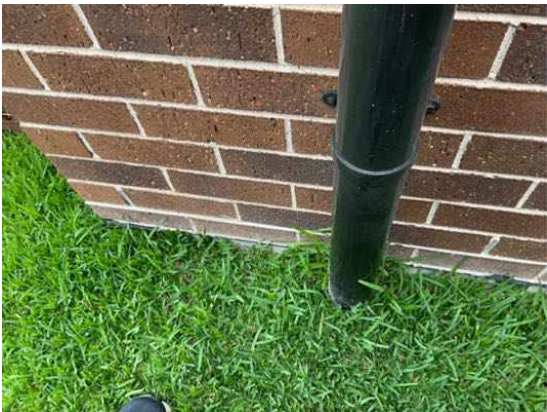
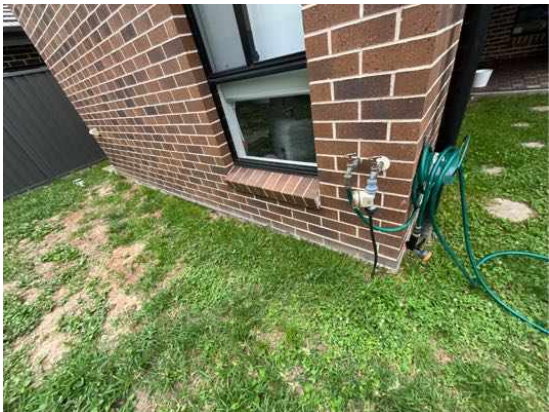
If the slab edge is not properly exposed there is a high risk of termite attack. Sometimes, in order to determine the type of slab, a suitably qualified person such as an architect or builder may be required to consult the construction plans.

Where the slab edge cannot be properly inspected, it is highly recommended that termite or timber pest inspections be carried out every 6-12 months to aid protection of the property against infestation.

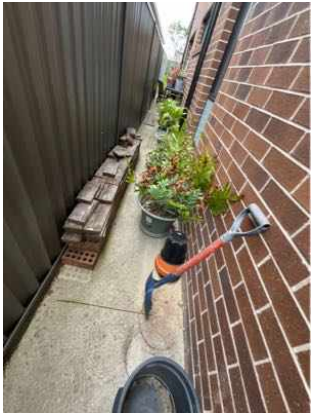
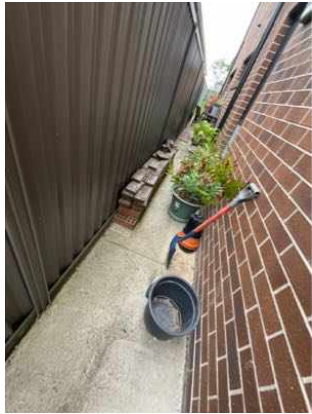
Finding 6.02

Building: Main Building
Location: All Areas
Finding: vegetation around a property can increase the risk of termite infestation
Information: The presence of vegetation around a property can increase the risk of termite infestation, as it provides a conducive environment for them. To address this, consider maintaining a clear space between the vegetation and your home. If you suspect a termite issue, it's advisable to consult with a licensed pest control professional for inspection and treatment.

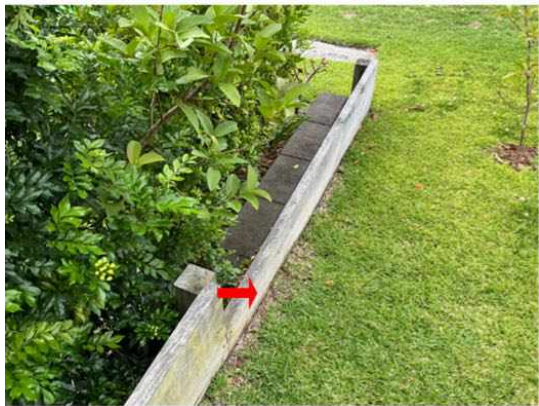
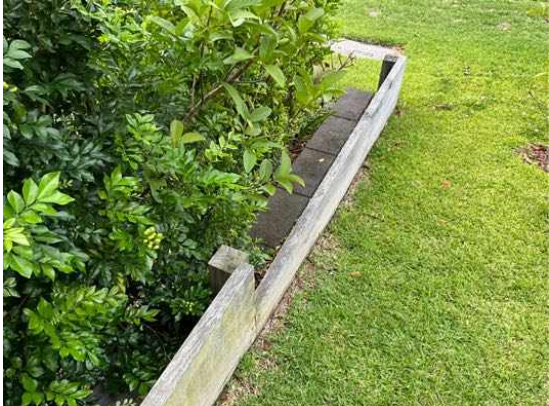
Finding 6.04

Building: Main Building
Location: All Areas
Finding: Bridging or Obstruction Conducive environment for Termites
Information: Bridging of termite barriers occurs when termites bridge (usually by building a mud tunnel) a termite barrier or inspection inspection zone or where termites have a passage, allowing them to bridge the barrier.

Where bridging has occurred full inspection is prevented and termites may enter a property in a concealed or undetected manner.

Recommended moving obstructions away from the external walls for further and future inspections.

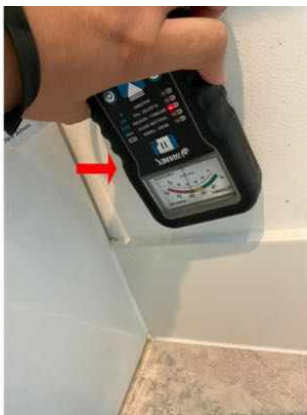
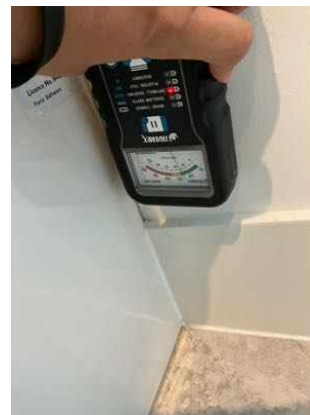
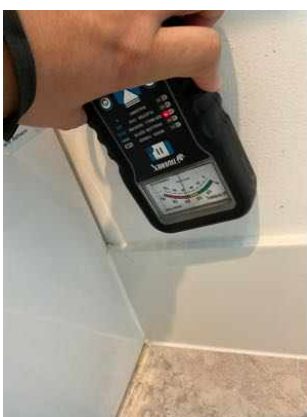
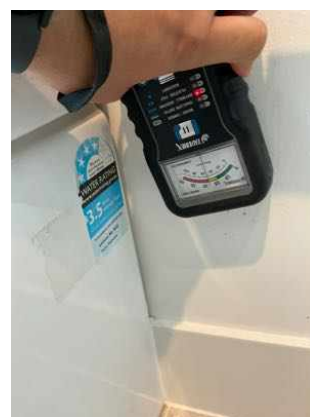
Finding 6.08

Building: Main Building
 Location: Bathroom

Finding: Excessive moisture - Conducive to Timber pest
Information: Excessive moisture can attract termites and produce conditions that promote fungal growth and wood decay.

Excessive moisture is generally caused by deteriorated inadequate or missing roof drainage leaking plumbing pipes or fixtures poorly plumbed HWS overflows or condenser units and poor site drainage.

Prior to any remedial works being performed a qualified plumber should be appointed to further inspect the property and to identify the cause of the excessive moisture. Works to remove affected building elements may then be necessary and should be performed by an appropriate tradesperson.

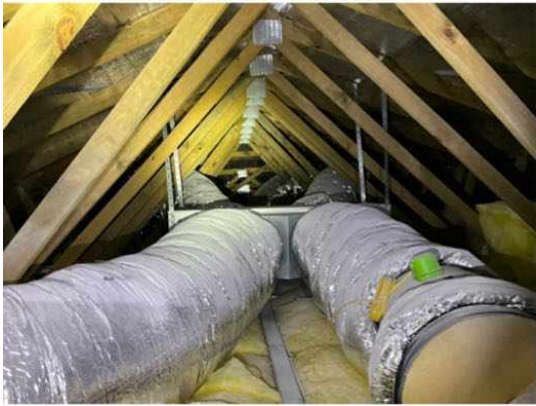
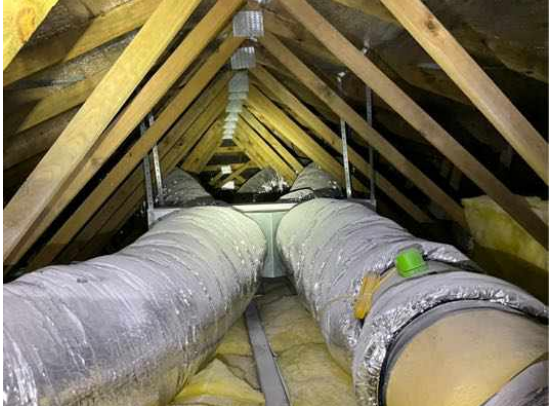
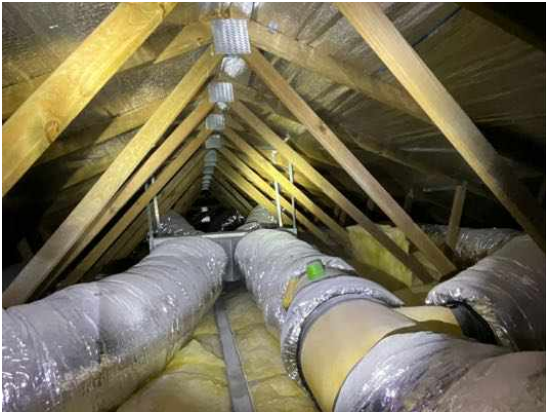
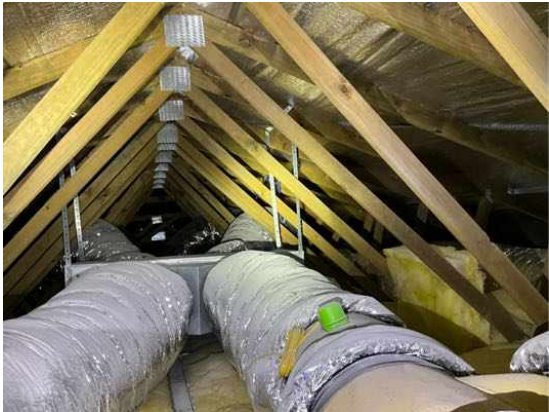
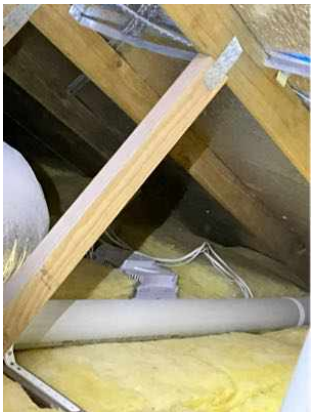
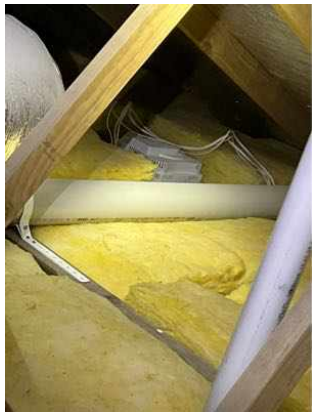
Building: Main Building
Location: All Areas
Finding: Additional Photos - Obstructions and Limitations
Information: These photographs are an indication of the obstructions and limitations which impeded full inspection of the property at the time of inspection. These obstructions can hide an array of defects and should be removed to allow full inspection to be carried out. A re-inspection is recommended once the areas are made accessible.

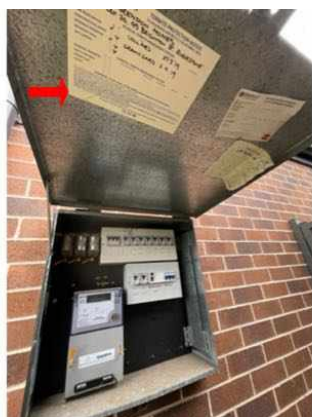
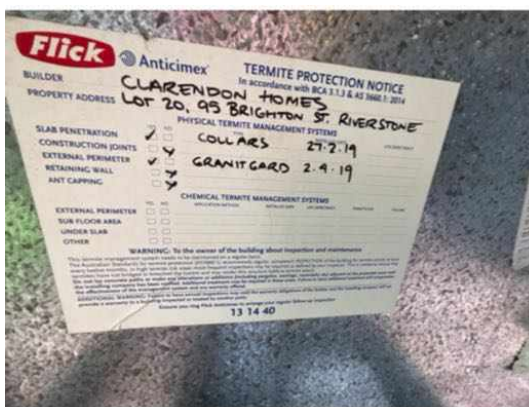
- Building: Main Building
- Location: Exterior walls - right side
- Finding: Evidence of Termite Management System - Durable notice / Legible Sticker - seek further information
- Information: The application of a pre & post-construction chemical termite barrier is highly recommended for all properties. Such barriers are highly effective in preventing termite attack on any timber building elements throughout the property.

A durable notice placed in the switchboard unit to indicate termite barriers at the time of inspection.

Client must seek further information from the vendor or real estate agent if the conditions of termite management systems were maintained as per the label or seek advise from licensed pest controller.
