Building and Timber Pest Inspection Report

Inspection Date: Wed, 4 Feb 2026

Property Address: 16/2 Charles St, Parramatta NSW 2150,
Australia

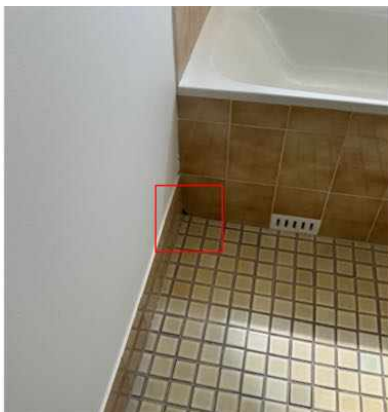
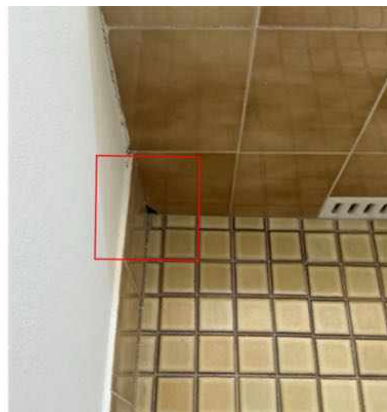
Building: Main Building
Location: Bathroom, kitchen , balcony
Finding: Tiles - Cracked or damaged (inc Hairline glaze cracking)
Information: Cracking was evident to the tiling in this area at the time of inspection. While the cracking appears to be minor, this area is frequently exposed to water, allowing potential for water penetration into adjoining sections of walls or flooring.

If left unmanaged, water penetration to these areas may lead to subsequent water damage, which is likely necessitate repair work to affected building elements.

A tiling contractor should be appointed to ensure that no further water damage occurs. The re-application of silicone and grouting throughout remaining tile work is also advised, to further protect the area against water penetration.

Where water penetration has led to water damage, appointment of a relevant tradesperson may be required to repair damaged building elements.

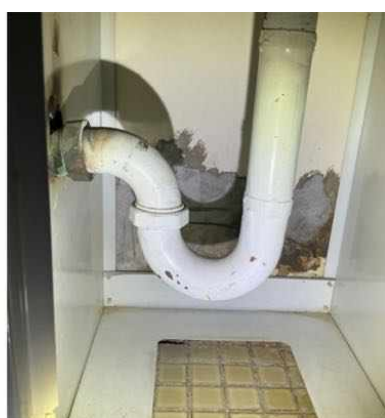
Building:	Main Building
Location:	Laundry
Finding:	Installation - substandard or incomplete (Incomplete repairs of possible moisture damage, incomplete finish)
Information:	The installation of this building element appears to have been completed to a substandard level of workmanship or is incomplete. Generally substandard repairs or installation are related to poor workmanship, the use of inappropriate materials, or a failure to complete installation to a suitable standard.

Where installation is substandard and/or incomplete, the client should contact the responsible trade to undertake rectification. Unfinished and substandard building works are likely to degrade more quickly and may create potential for secondary defects to associated building elements.

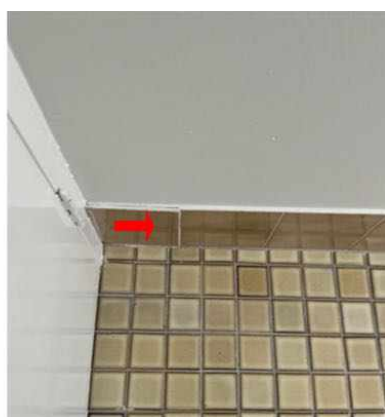
Finding 3.03

Building:	Main Building
Location:	Bathroom
Finding:	Tiles - Drummy
Information:	Drummy tiled areas were identified at the time of inspection. The term 'drummy' refers to tiles that have become detached from their fixing, despite otherwise being in relatively good condition. Such defects are generally caused by physical or moisture damage to the area. Drummy tiled areas may also be a direct result of poor

Tiled areas may swell and shrink with changes in air humidity if the area has sustained moisture damage. Any exposure to moisture is capable of causing tiled areas to become drummy and/or cracked over a prolonged period of time. Drummy tiled areas generally require removal and replacement of affected tiles, with adequate sealant and grouting.

Specialist trades are available for these types of services. A registered builder may be required to undertake works if damage is extensive or if secondary building defects have resulted. Otherwise, it is advised that a tiling contractor be appointed to perform works as necessary. Immediate action is recommended to ensure that no further damage is sustained in the affected area.

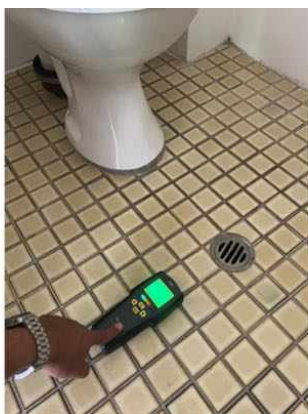
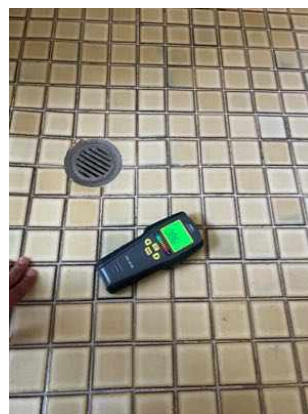
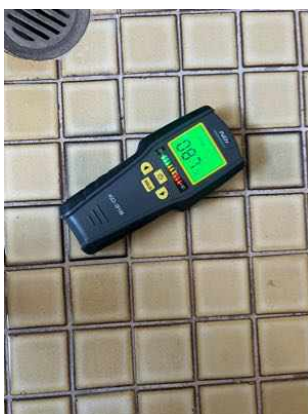
Finding 3.04

Building:	Main Building
Location:	Bathroom
Finding:	Elevated Moisture Bathroom (No visible deterioration noted)
Information:	Elevated moisture levels were detected to tiled surfaces in bathroom/shower areas. Persistent moisture ingress can lead to concealed damage, including timber rot and mould growth.

Elevated moisture readings in tiled wet areas can occur from normal shower use, age/deterioration of waterproofing membranes, plumbing leaks or moisture absorption through grout lines. While no damage was visible, elevated readings may indicate moisture retention behind tiles, which can be a conducive condition for future deterioration if not monitored.

No immediate action required. Monitor the area over time for signs of drumming, efflorescence, tile movement, or grout deterioration. If concerns arise, a licensed waterproofing specialist can perform further investigation (e.g., pressure testing, membrane assessment).

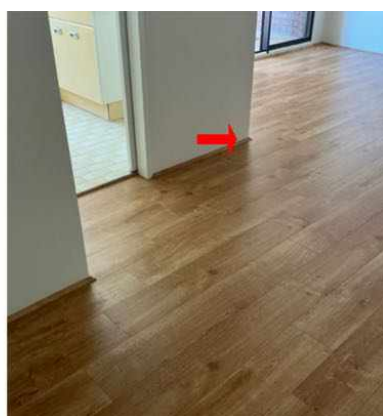
Building:	Main Building
Location:	All Internal Areas
Finding:	Flooring - Uneven
Information:	The internal flooring in this area is out of level and uneven. Uneven flooring is likely to indicate minor defects such as expected movement of the foundations of the property, but may also indicate subsidence of the associated subfloor stumps.

It is advised that the flooring be closely monitored to identify any further movement. Where flooring remains relatively unchanged for an extended period of time (i.e. several months), it is likely that this defect has been caused by expected movement of the foundations of the property.

However, where flooring is uneven further, potentially invasive inspection of the subfloor structures and stumps in this area is required. In this case, works to repair are likely to be required, and would be carried out by a registered builder specialising in re-stumping.

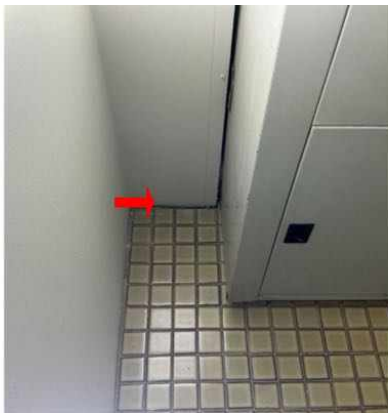
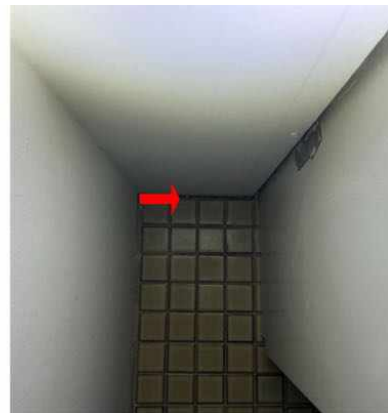
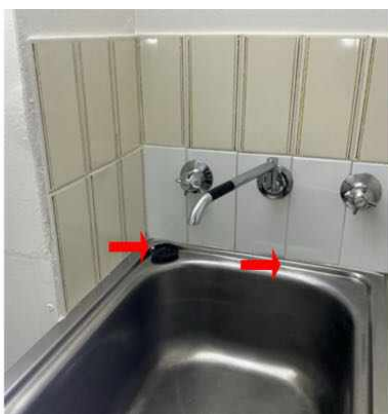
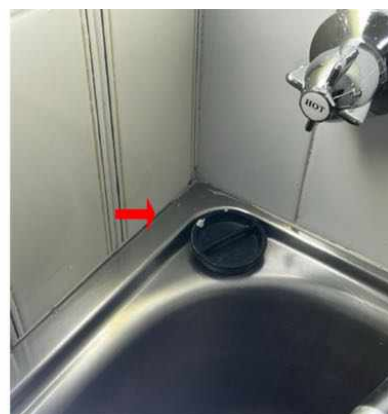
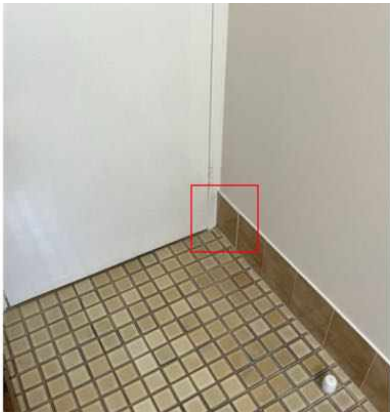
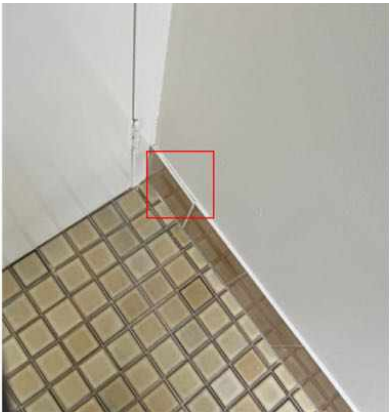
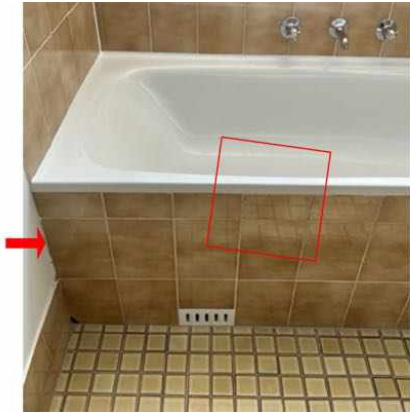
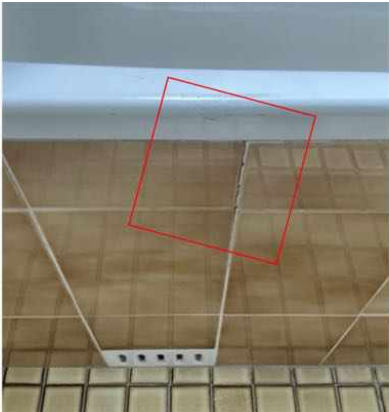
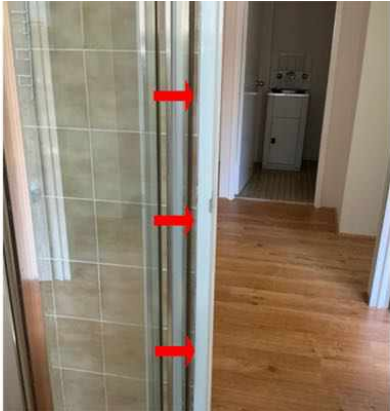
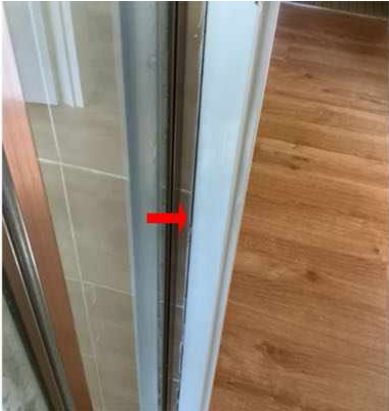
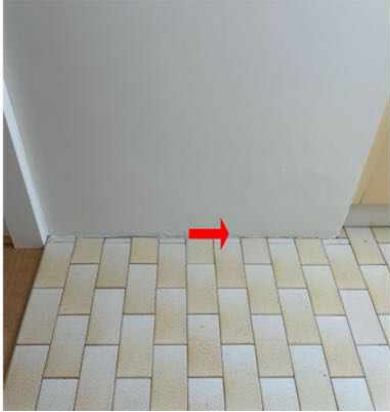
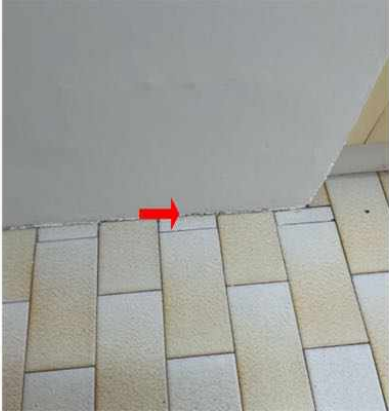
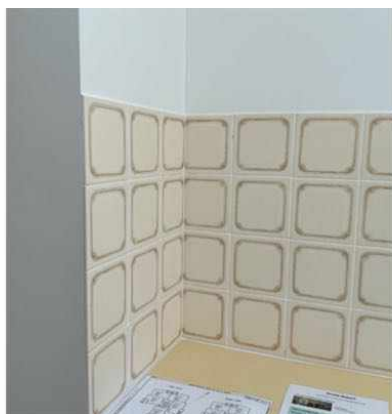
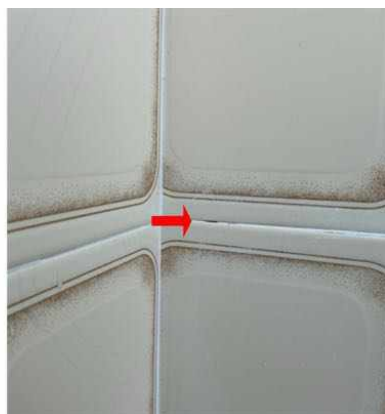
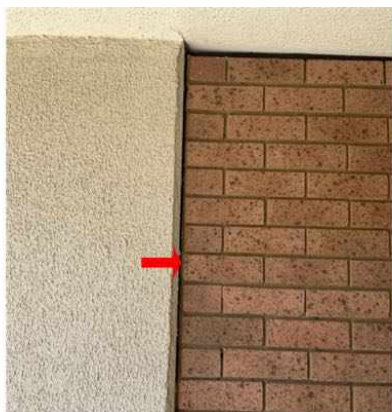
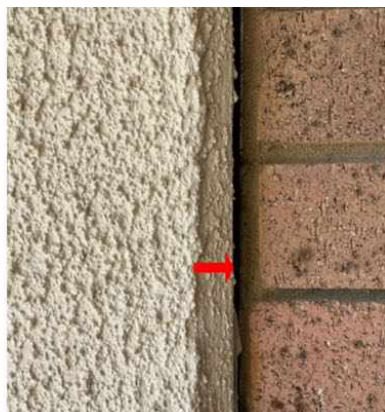
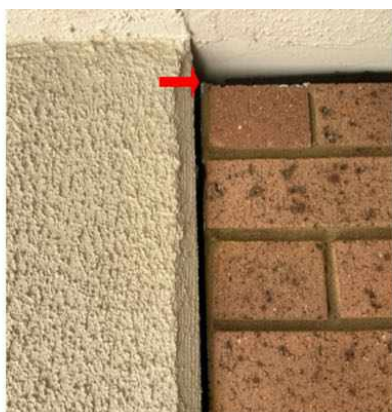
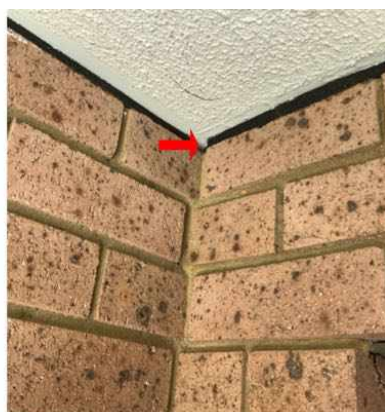
Finding 3.07

Finding: Sealant and grouting - Missing or degraded
 Information: It was noted on inspection that sealant or grout is degraded. There is also evidence of poor workmanship and excessive use of sealant. Silicone should never be used as a first line of defence against waterproofing. Further inspection by a licensed waterproofing contractor is highly recommended

Different materials and floor areas move at different rates, generally causing cracking to grout or sealant at this point. A flexible sealant is required to allow for expected expansion and contraction, while keeping the joint water tight and protective of all associated building materials.

There appears to be excessive mould to the sealant and grout which will likely require scraping out and replacement.

Flexible and mould resistant materials should be applied to affected areas to prevent any subsequent water damage that is likely to occur. Regular maintenance and replacement of damaged or missing or damaged sealant and grout is highly recommended to the wet areas, as this is a regular wear and tear defect. Sealant and grouting in areas that come into regular contact with water should be maintained for the long term care of your property.

A sealant specialist or tiling contractor should be appointed to complete these works as soon as possible

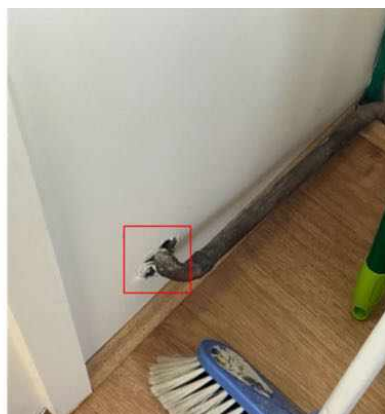
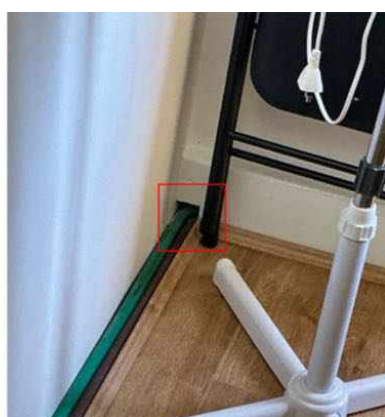
Finding 3.08

Building:	Main Building
Location:	Bedroom
Finding:	Incomplete or substandard works - Holes not sealed
Information:	The works to this area appear to be incomplete or have been completed to a substandard level.

Works that have not been completed to a satisfactory level create potential for the development of building defects and may impede on the safety and integrity of the overall structure.

It is highly recommended that the relevant trades be appointed to complete these

works and ensure the safety of the area and the longevity of all associated building elements.

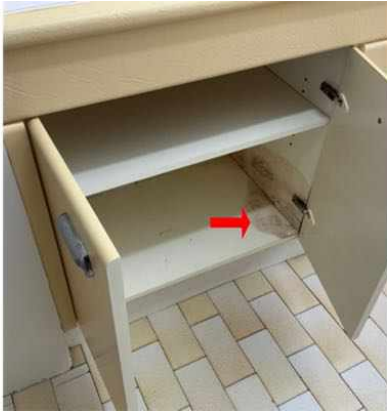
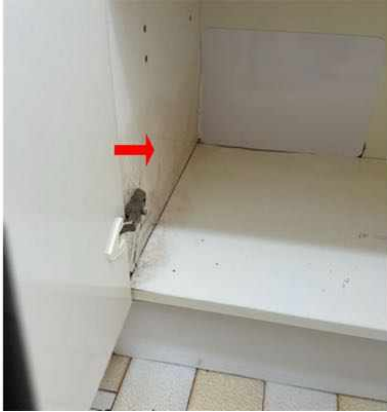
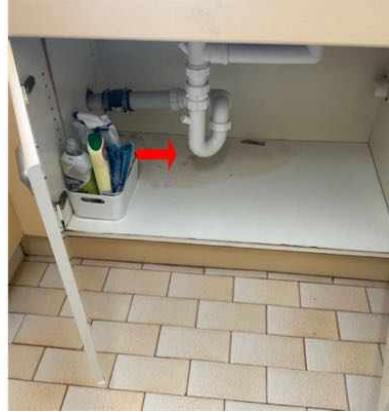
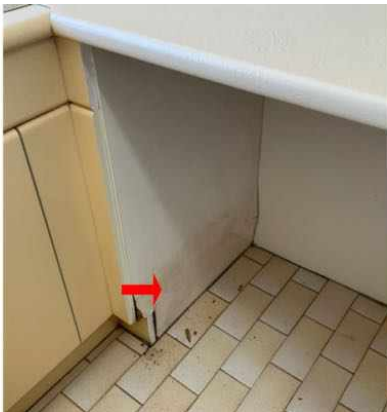
Finding 3.09

Building:	Main Building
Location:	Kitchen
Finding:	Building element - Damaged - Cabinet moisture damage
Information:	Breakage occurs generally when the building materials have either aged and decayed, or as a result of damage (accidental or deliberate).

Repair and/or replacement of broken elements is advised to ensure that additional secondary defects do not arise as a consequence. Such works are necessary, as all building elements play a key role in the operation and function of the overall structure and its performance.

A relevant tradesperson should be appointed to repair or replace the affected building element prior to any subsequent damage being caused.

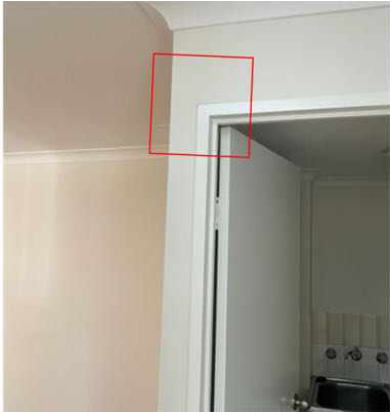
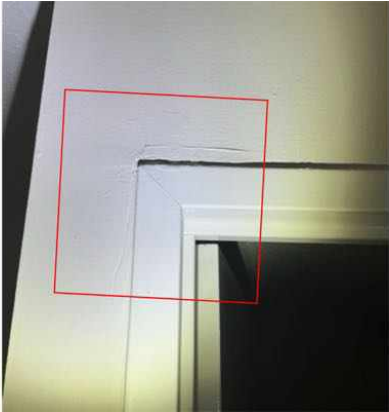
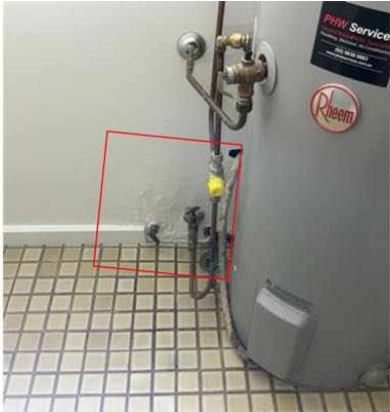
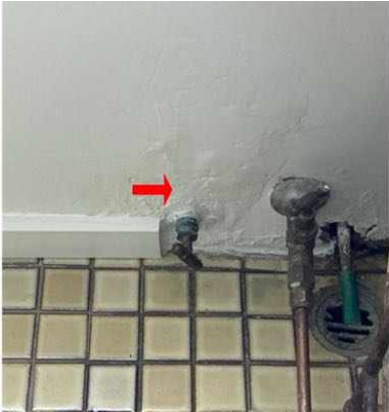
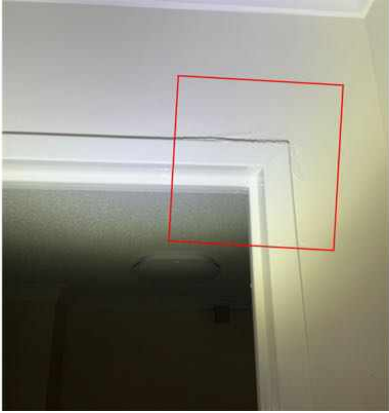
Finding 3.10

Building:	Main Building
Location:	All Internal Areas
Finding:	Paint finish and hairline cracking
Information:	The paint finish in this area was identified as being incomplete at the time of inspection including some hairline minor cracking.

Whilst incomplete or missing paint finish is generally an appearance defect, it can also lead to the development of secondary building defects over time. Incomplete areas of paint finish expose the area to moisture, potentially accelerating the deterioration of underlying building materials.

Incomplete paint finishes should be sanded back, filled, leveled and painted, as applicable. Where inadequate or missing paint protection has led to the deterioration of the associated building element, repair and/or replacement of this building element may be required.

A painting contractor should be appointed as soon as possible to perform necessary works to aid the appearance of the affected area and to ensure the area is protected against further deterioration. Alternatively, the homeowner following manufacturer instructions may perform these works.

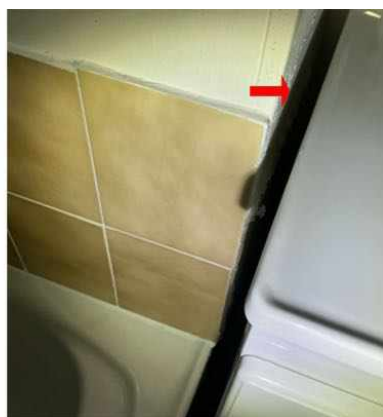
Finding 3.11

Building:	Main Building
Location:	Bathroom
Finding:	Installation - substandard or incomplete (Gap between vanity and wall)
Information:	The installation of this building element appears to have been completed to a substandard level of workmanship or is incomplete. Generally substandard repairs or installation are related to poor workmanship, the use of inappropriate materials, or a failure to complete installation to a suitable standard.

Where installation is substandard and/or incomplete, the client should contact the responsible trade to undertake rectification. Unfinished and substandard building works are likely to degrade more quickly and may create potential for secondary

defects to associated building elements.

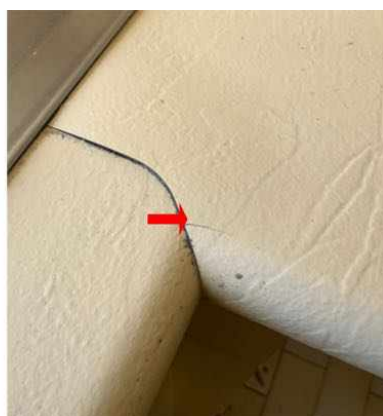
Finding 3.12

Building:	Main Building
Location:	Kitchen
Finding:	Building element - Damaged - benchtop minor crack
Information:	Breakage occurs generally when the building materials have either aged and decayed, or as a result of damage (accidental or deliberate).

Repair and/or replacement of broken elements is advised to ensure that additional secondary defects do not arise as a consequence. Such works are necessary, as all building elements play a key role in the operation and function of the overall structure and its performance.

A relevant tradesperson should be appointed to repair or replace the affected building element prior to any subsequent damage being caused.

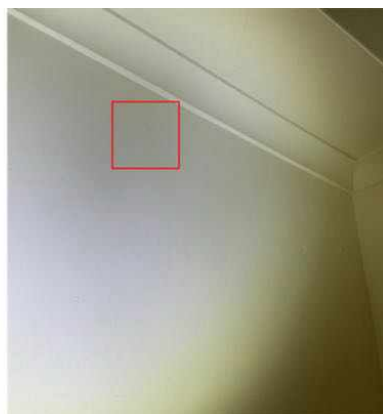
Finding 3.13

Building:	Main Building
Location:	All Internal Areas
Finding:	Wall nails - Popping to some areas

Numerous popped nails were identified in the wall sheets at the time of inspection. Nails and screws are held by the friction between them and the surface that they are applied to. Over time, the nails and screws can back out, which is often a result of general ageing and deterioration of the building structure.

If left unmanaged, the wall sheets may become loose and unstable, increasing the rate of deterioration of the wall sheeting and creating potential for the development of secondary defects.

Re-fastening of popped nails will help to maintain the stability of the internal walls and associated building elements. Such minor works will also help to improve the appearance of the affected area and secure the wall sheets. These works should be performed by a qualified carpenter or plasterer at client discretion.

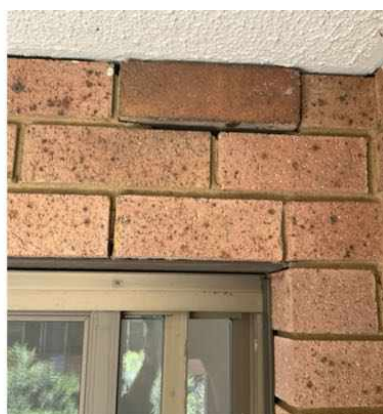
Finding 3.14

Building:	Main Building
Location:	Balcony
Finding:	Brickwork - Deteriorated mortar and loose brick
Information:	Mortar, or 'bedding', is the material which fills joins and intersections between bricks in masonry walls and structures. Sections of mortar in this brickwork were identified as having deteriorated, which is generally expected for a property of this age and condition.

Mortar may deteriorate as a result of age of building materials, minor movement of bricks, or frequent exposure to weathering. Mortar should be replaced to ensure that bricks remain in their intended location and to prevent gaps, which would allow water or moisture ingress and secondary damage as a result.

Mortar deterioration can be addressed by a bricklayer where areas of deterioration are localised and easily accessible. Alternatively, appointment of a registered builder is advised, to repoint large areas of decaying mortar. Where secondary structural defects have become evident, consultation with a structural engineer may be required.

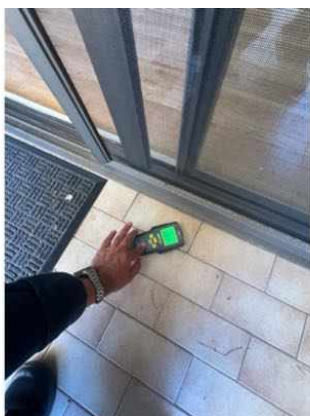
Building:	Main Building
Location:	Balcony
Finding:	Elevated moisture - No visible deterioration
Information:	Elevated moisture meter readings were recorded to the tiled floor when tested using a non-invasive (pinless) moisture meter. No visual evidence of moisture ingress, tile debonding, grout deterioration, staining, mould growth, or related moisture damage was observed at the time of inspection. Ongoing monitoring is recommended, and further investigation may be warranted should visible signs of moisture-related distress become evident.

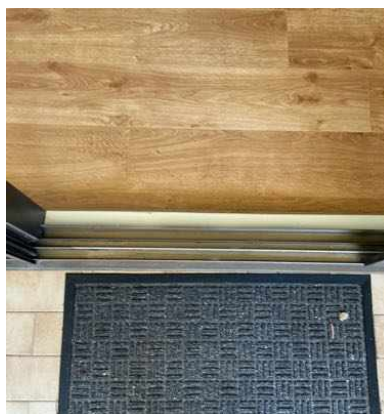
Building:	Main Building
Location:	Balcony
Finding:	Balcony Floor Level Differential
Information:	The balcony finished surface appears to be close to, or at the same level as, the internal floor. Standard construction practice requires a step-down of approximately 50 mm unless a fully engineered threshold drainage system is provided. No such drainage features were visible during inspection. This configuration increases the risk of water ingress, and confirmation of the balcony waterproofing detail through strata/building management is recommended.

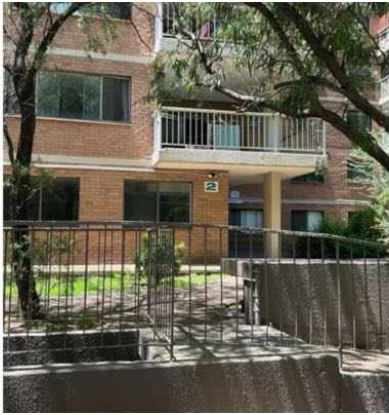
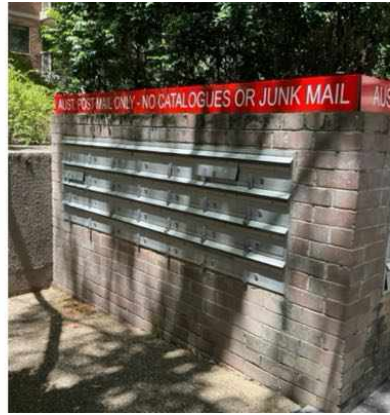
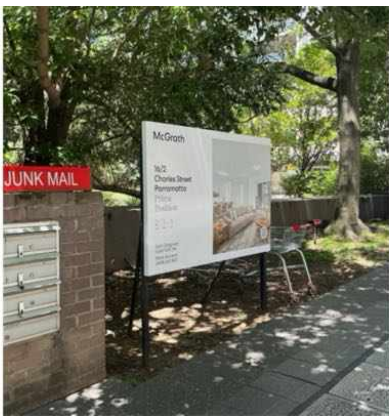
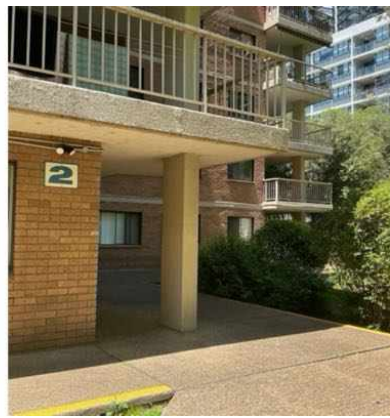
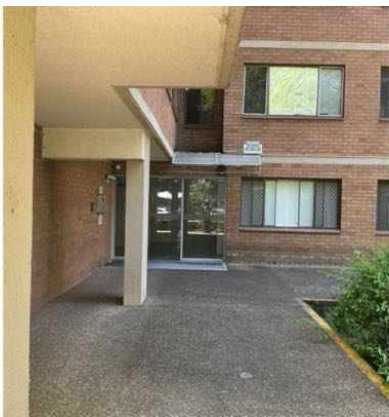
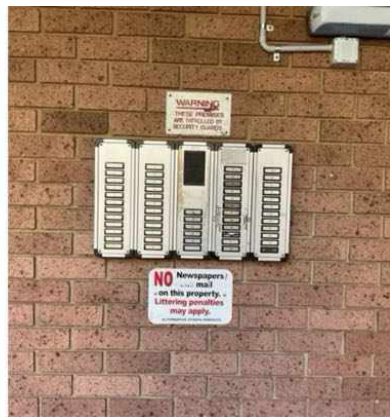
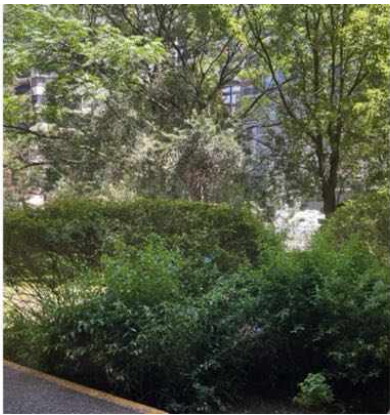
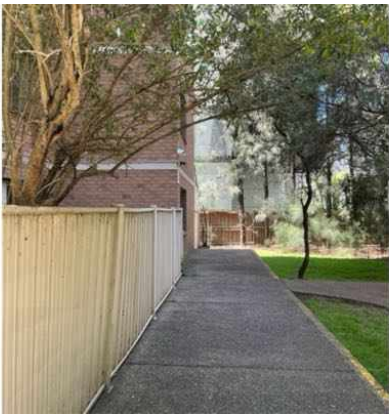
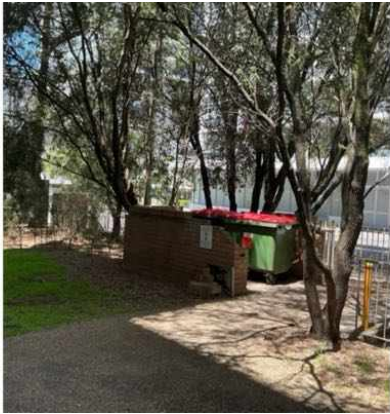
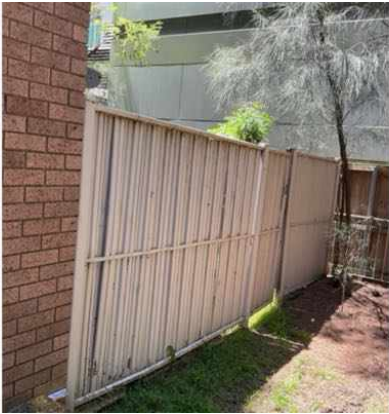
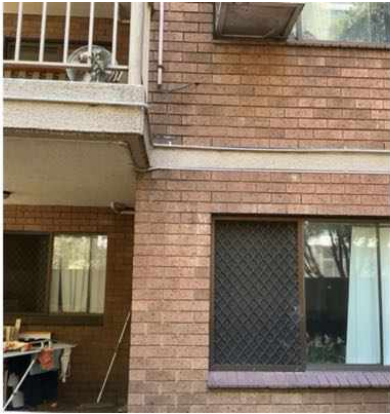
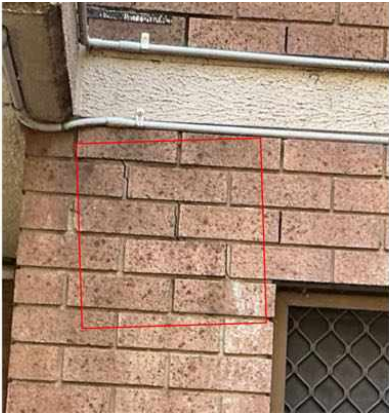
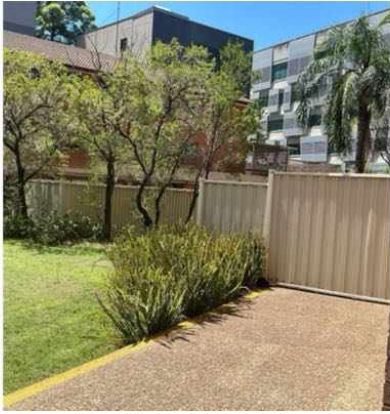
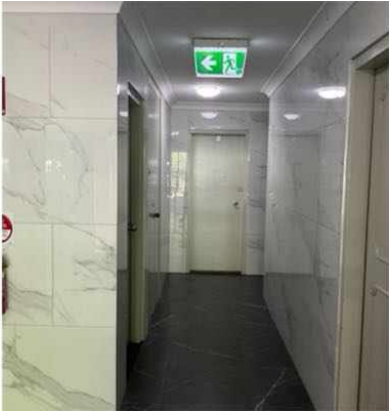
Building: Main Building
 Location: All External Areas
 Finding: Additional Photos - Obstructions and Limitations
 Information: These photographs are an indication of the obstructions and limitations which impeded full inspection of the property at the time of inspection. These obstructions

can hide an array of defects and should be removed to allow full inspection to be carried out. A re-inspection is recommended once the areas are made accessible.

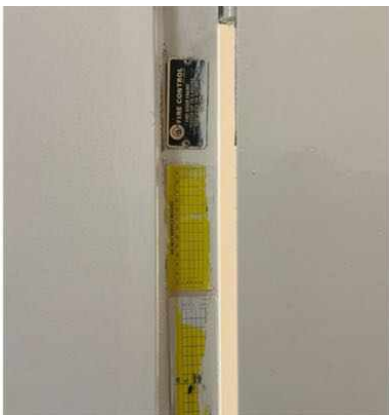
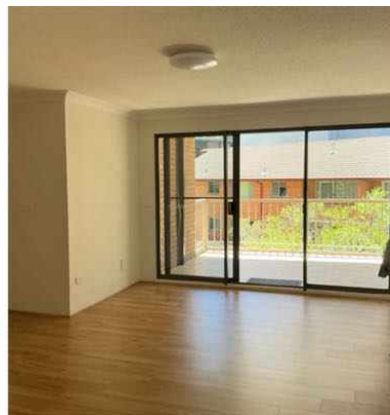
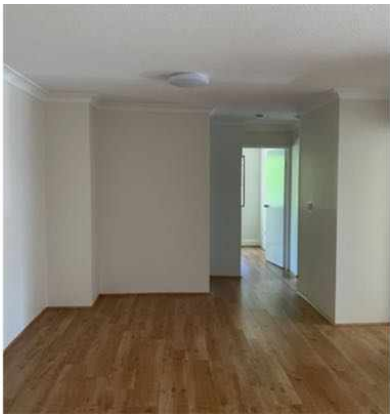
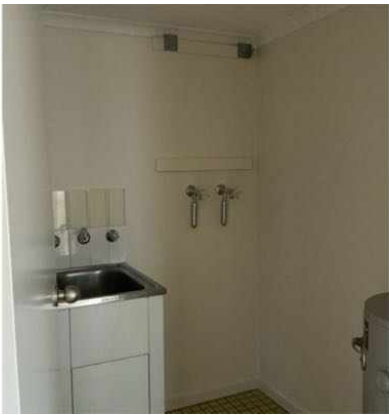
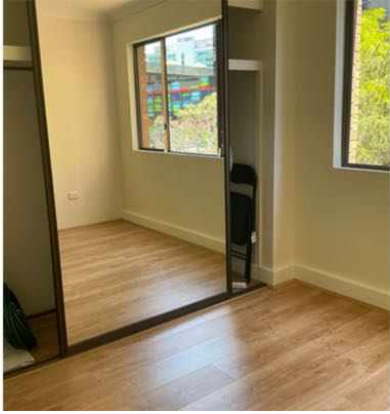
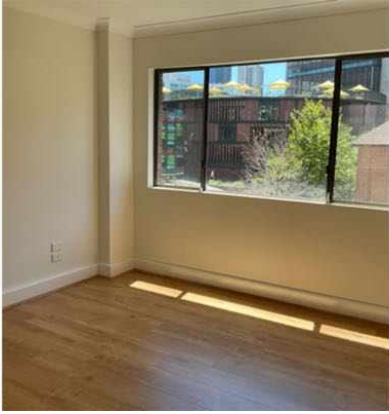
Noted Item

Building: Main Building
 Location: All Internal Areas
 Finding: Additional Photos - Obstructions and Limitations
 Information: These photographs are an indication of the obstructions and limitations which impeded full inspection of the property at the time of inspection. These obstructions can hide an array of defects and should be removed to allow full inspection to be carried out. A re-inspection is recommended once the areas are made accessible.
