Building and Timber Pest Inspection Report

Inspection Date: Fri, 23 Jan 2026

Property Address: 299 Dwyer Rd, Leppington NSW 2179,
Australia

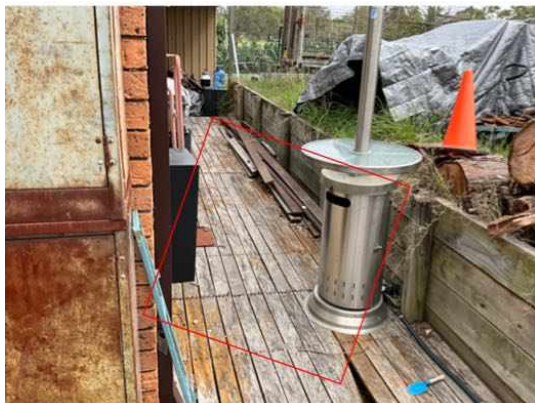
Building:	Main Building
Location:	Deck
Finding:	Flooring - Uneven
Information:	The internal flooring in this area is out of level and uneven, suspected to have been caused as a result of severe timber rot.

This creates a trip and fall hazard and severe injuries maybe caused if not addressed urgently. A licensed carpenter must be appointed immediately for rectifications.

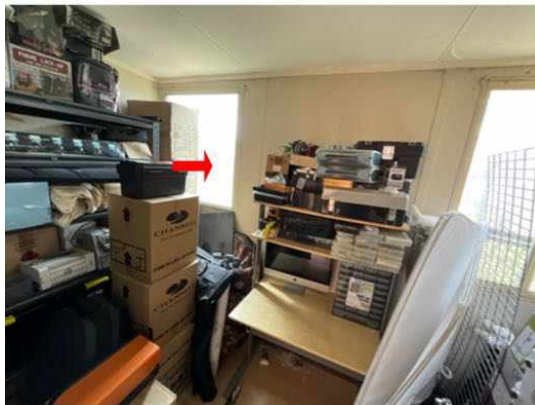
Finding 1.02

Building:	Main Building
Location:	Outbounding storage
Finding:	Window/glass - Cracked/broken
Information:	Cracks and or breakage was identified in this area at the time of inspection. Cracking or breakage is generally the result of impact damage, and is likely to develop further

The likelihood of this window pane further cracking and shattering is increased exponentially, providing a safety hazard in the area. The cracked window also impairs the weather tightness of the building, creating potential for minor water leaks.

A licensed glazier is required to repair the window as soon as possible. Depending on the extent of the cracking, replacement of the window may be required. Please be advised that any persons coming into contact with the cracked window should do so with due caution to avoid any personal injury that may ensue.

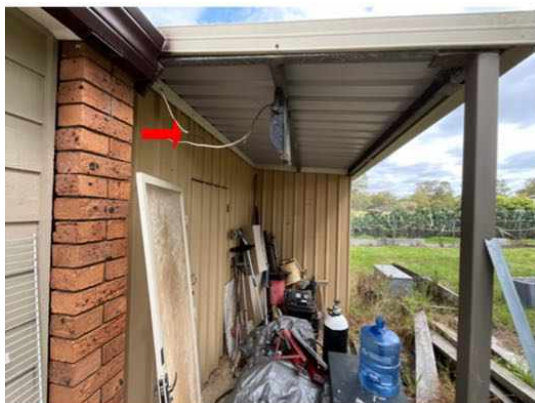
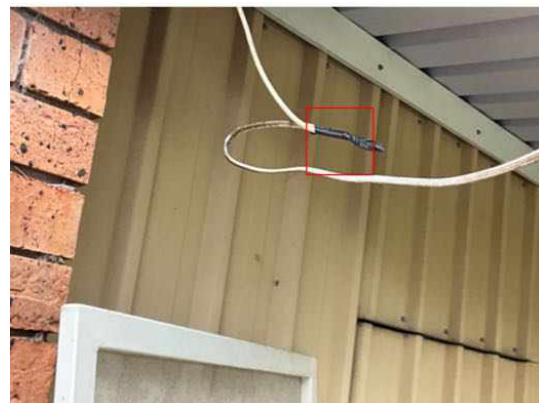
Finding 1.03

Building:	Main Building
Location:	Rear Elevation
Finding:	Electrical wiring - Exposed/Messy
Information:	Instances of exposed wiring, messy wiring, not in junction boxes or unprotected with electrical tape was identified in this area at the time of inspection.

We highly recommend that a licensed electrician be engaged to check this area and make safe all exposed wiring before any further inspections or works are carried out.

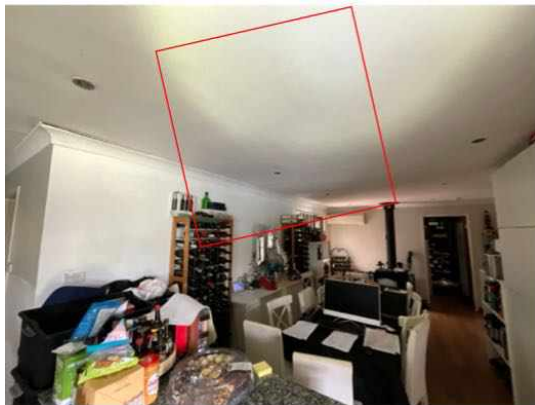
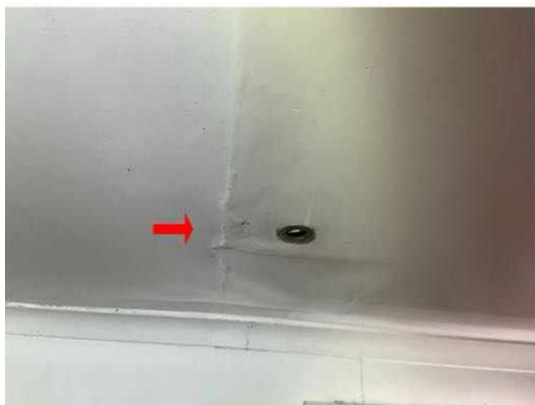
Finding 2.01

Building:	Main Building
Location:	Dining Room
Finding:	Ceiling - Water damaged
Information:	Water damage to the ceiling lining is generally an indication of excessive moisture being present in the roof void, usually via a leak to the roof covering.

Where water damage is evident to the ceiling, the primary requirement is to identify and rectify the source of the leak. A roof restoration specialist should be appointed as soon as possible to identify the leak and perform rectification works as necessary, ensuring the water damage is restricted.

Once the leak is repaired, consultation with relevant tradespeople, including plasterers and painters, is advised. Rectification works may include replacement of ceiling lining or minor repainting, depending on the extent of the damage.

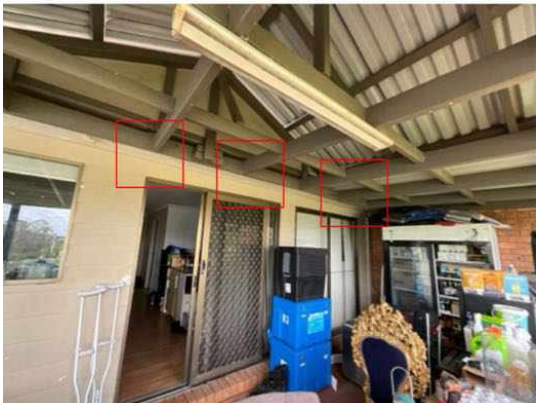
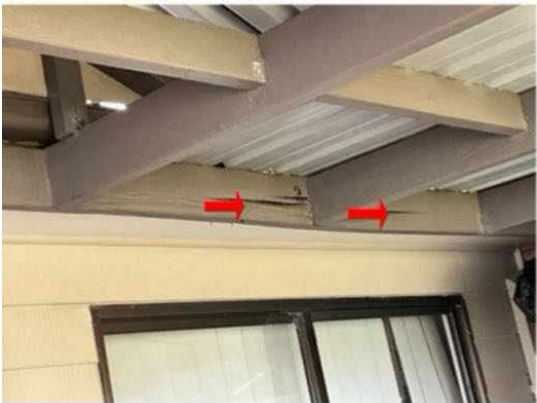
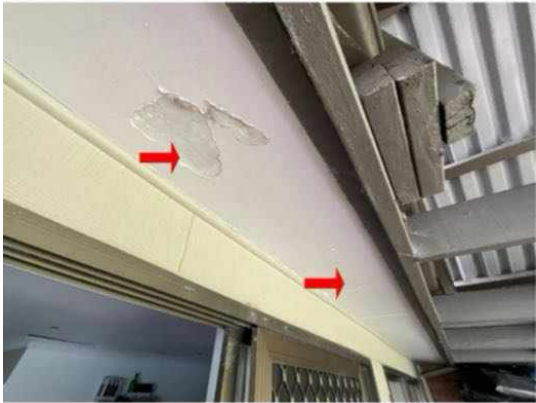
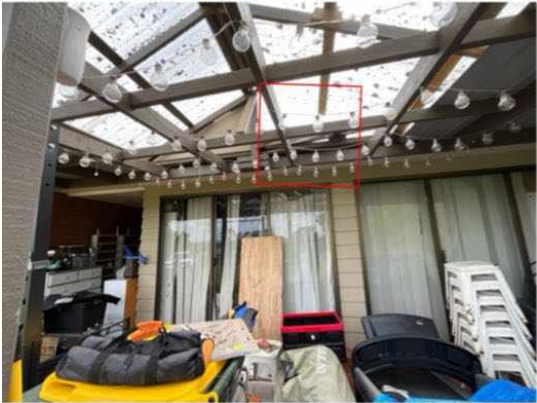
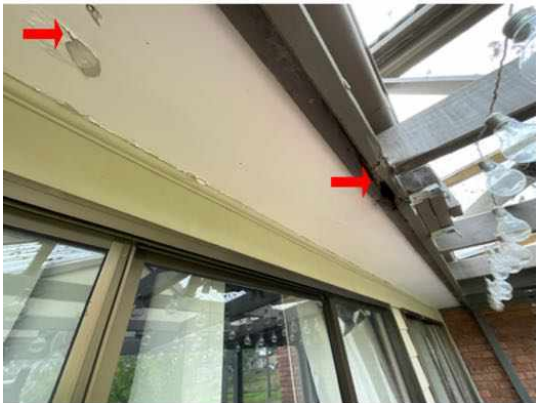
Finding 2.02

Building:	Main Building
Location:	Awnings

Finding: Water Damage

Information: Water damage is generally an indication of excessive moisture being present, usually via a leak.

Where water damage is evident, the primary requirement is to identify and rectify the source of the leak. A roofing plumber should be appointed as soon as possible to identify the leak and perform rectification works as necessary, ensuring the water damage is restricted. A licensed carpenter should then be appointed to replace all affected elements.

Once the leak is repaired, consultation with relevant tradespeople, including carpenters, plasterers and painters, is advised.

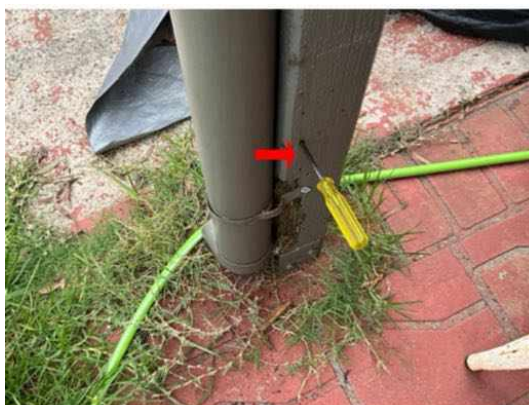
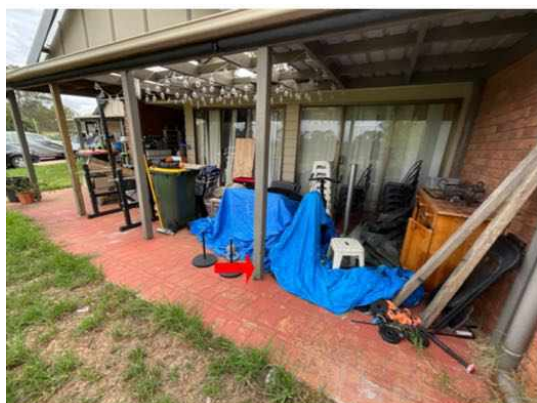
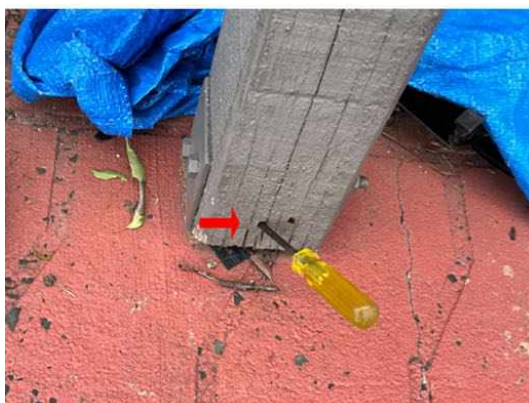
Finding 2.03

Building:	Main Building
Location:	Front awning
Finding:	Wood rot/decay
Information:	This building element shows evidence of severe wood rot. Wood rot, also known as Fungal Decay, occurs when timbers and other cellulose building materials are exposed to damp conditions on an ongoing basis. This could be the result of exposure to weathering over a prolonged period of time, or the attraction of excessive moisture from other abutting building materials.

Replacement of affected timbers is a necessary step in protecting surrounding building elements from such deterioration. A licensed carpenter is required to replace affected building materials.

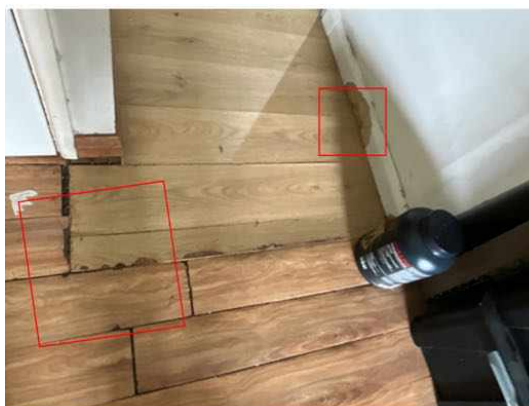
Finding 3.01

Building:	Main Building
Location:	Outside bathroom
Finding:	Water Damage

Information: Water damage is generally an indication of excessive moisture being present, usually via a leak.

Where water damage is evident, the primary requirement is to identify and rectify the source of the leak. A licensed plumber should be appointed as soon as possible to identify the leak and perform rectification works as necessary, ensuring the water damage is restricted.

Once the leak is repaired, consultation with relevant tradespeople, including carpenters, plasterers and painters, is advised.

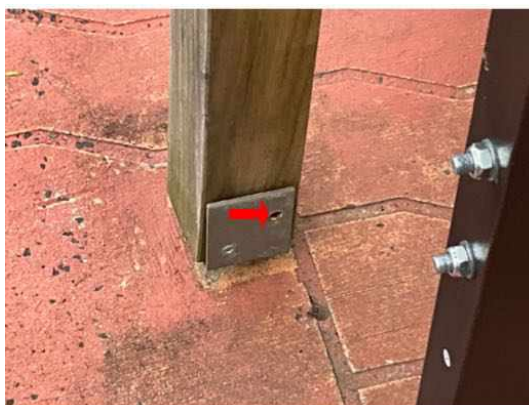
Finding 3.02

Finding: Fitting or fixture - Loose

Information: The fitting in this area is loose and requires adjustment to tighten.

If left unmanaged, the fitting may further deteriorate, causing potential for the development of other minor secondary defects.

A licensed carpenter should be appointed to perform these rectification works at discretion of the client.

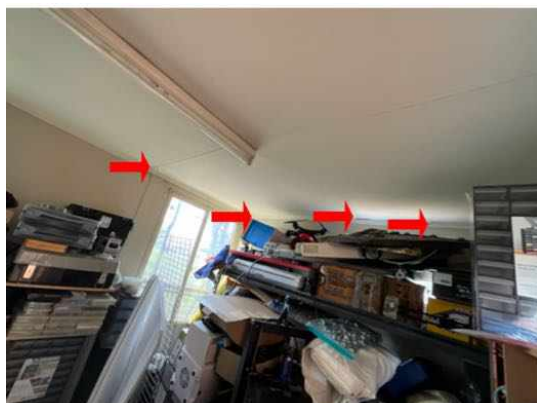
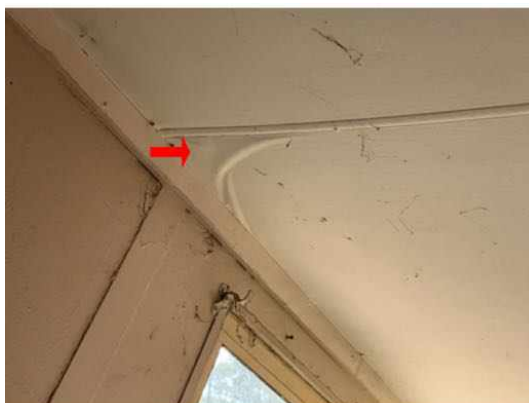
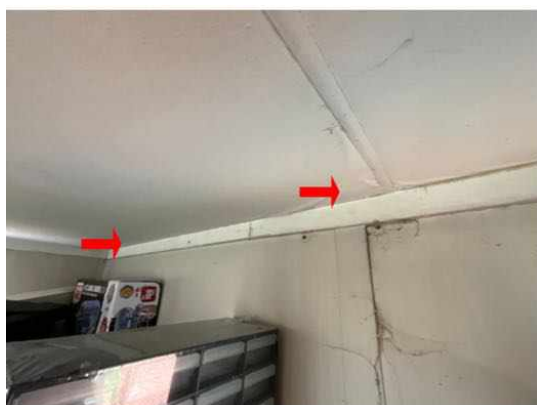
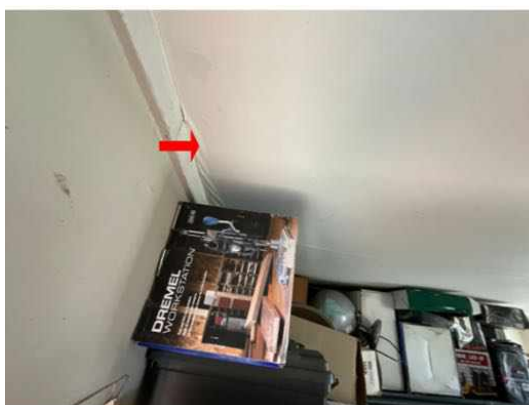
Finding 3.03

Building:	Main Building
Location:	Outbounding storage
Finding:	Building element - Swollen
Information:	Swollen building elements generally indicate that the building materials have been affected by excessive moisture over a prolonged period of time, and have swollen as a result. Excessive moisture is likely to lead to the development of secondary damage to any associated building elements, which may necessitate major repair works if prolonged.

Rectification of the cause of the water leak should be addressed prior to any remedial works to the swollen building elements. A licensed roof plumber should be appointed immediately to identify the cause of the leak and provide advice on remedial works as necessary. Repair and/or replacement of swollen building elements should be conducted as a matter of urgency by a licensed builder.

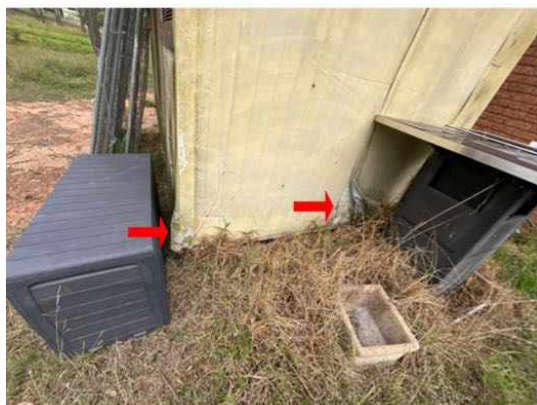
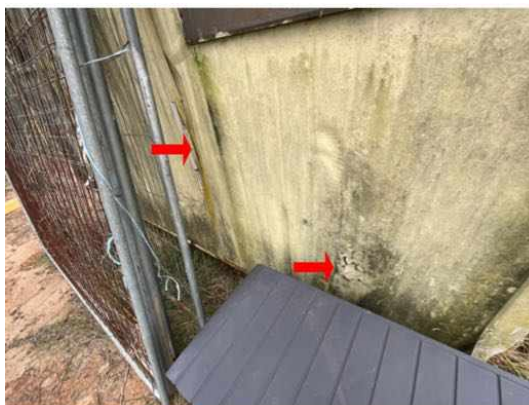
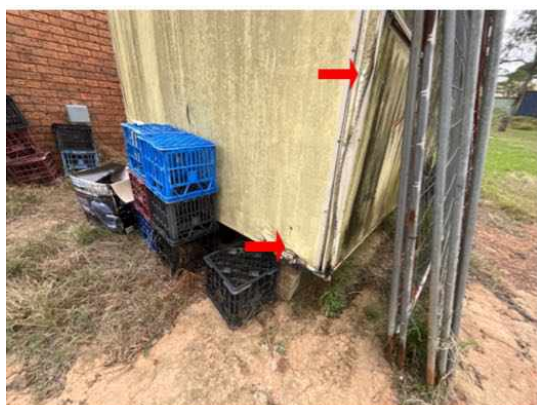
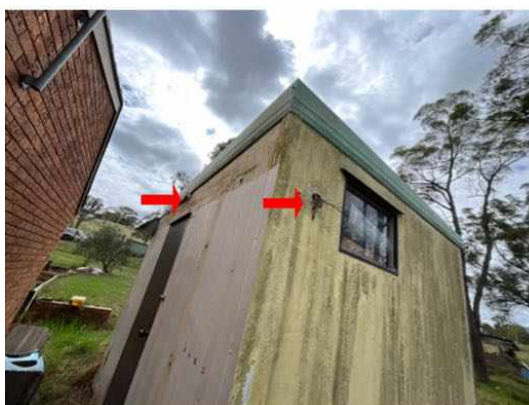
Finding 3.04

Building:	Main Building
Location:	Outbounding storage
Finding:	Building element - Damaged
Information:	Breakage occurs generally when the building materials have either aged and decayed,

or as a result of damage (accidental or deliberate).

Repair and/or replacement of broken elements is advised to ensure that additional secondary defects do not arise as a consequence. Such works are necessary, as all building elements play a key role in the operation and function of the overall structure and its performance.

A relevant tradesperson should be appointed to repair or replace the affected building element prior to any subsequent damage being caused.

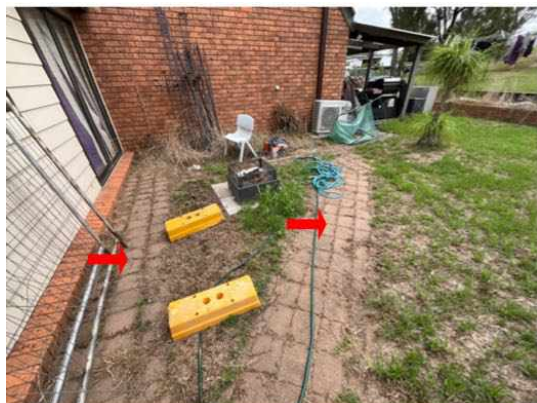
Finding 3.05

Building: Main Building
 Location: Paved areas
 Finding: Paving — Uneven
 Information:

Sections of the external paved area are uneven, which may develop into a trip hazard. It appears as though the area has been subject to rough installation, or that paving sections have lifted due to movements in the foundation.

Left unmanaged, the May develop into a safety hazard due to trip and fall.

Re-paving of the area is required to remedy this situation. Further consultation with a specialist concreter is advised.

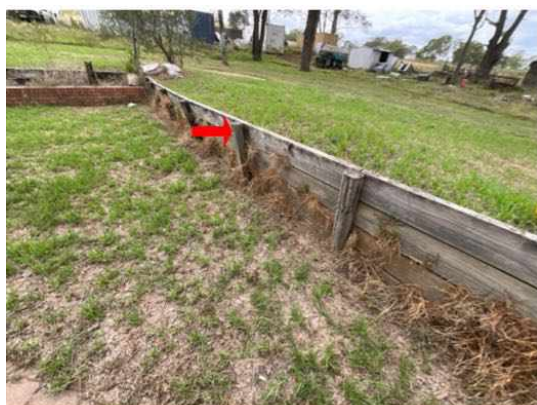
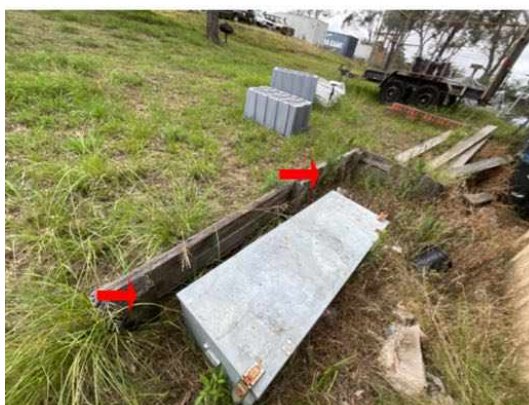
Finding 3.06

Finding: Timber retaining wall — Defective

Information: The retaining wall in this area was found to be defective at the time of inspection. Generally, defective retaining walls are caused by poor original design or material use. However, deteriorated retaining walls may also be a result of substandard construction, poor site drainage or unmanaged stormwater flows.

Where retaining walls further rot and decay, an environment is created that is conducive to termite and pest infestation.

A landscaper must be appointed for rectifications.

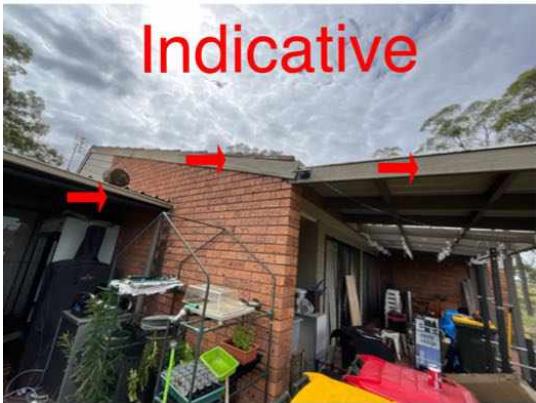
Building:	Main Building
Location:	Multiple external surfaces
Finding:	External painting deteriorated
Information:	Much of the external paintwork including but not limited to windows, fascias, guttering, veranda and other external fittings have been neglected and require attention to prepare and re-paint.

Whilst incomplete or missing paint finish is generally an appearance defect, it can also lead to the development of secondary building defects over time. Incomplete areas of paint finish expose the area to moisture, potentially accelerating the deterioration of underlying building materials.

Degraded paint finishes should be sanded back, filled, leveled and painted, as applicable. Where inadequate or missing paint protection has led to the deterioration of the associated building element, repair and/or replacement of this building element may be required.

A painting contractor should be appointed as soon as possible to perform necessary works to aid the appearance of the affected area and to ensure the area is protected against further deterioration. Alternatively, the homeowner following manufacturer instructions may perform these works.

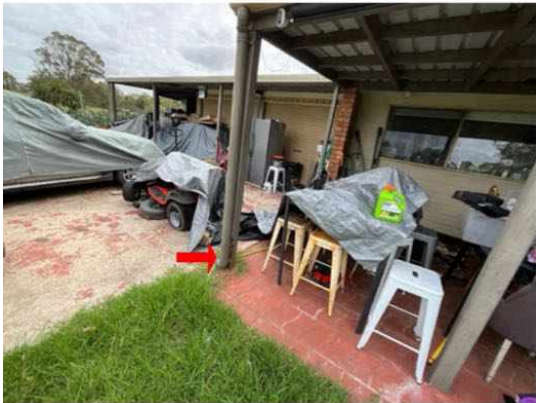
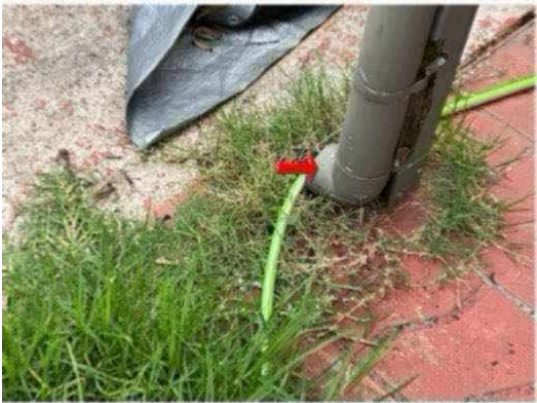
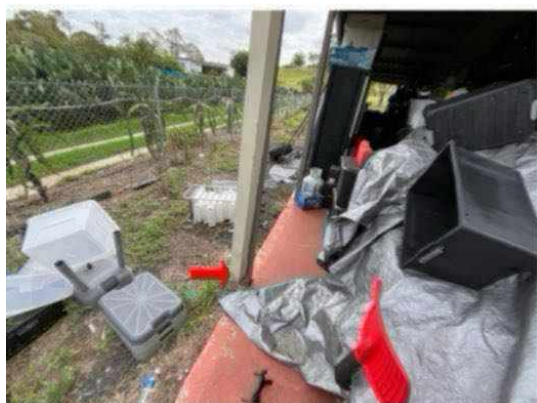
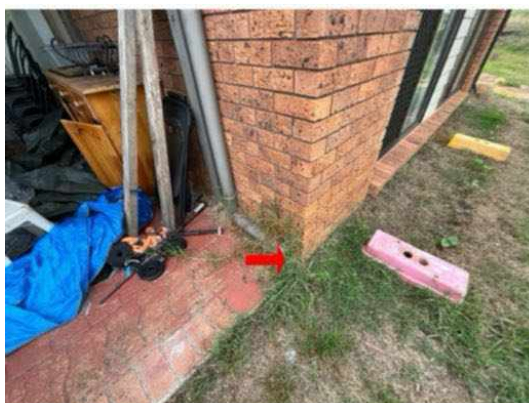
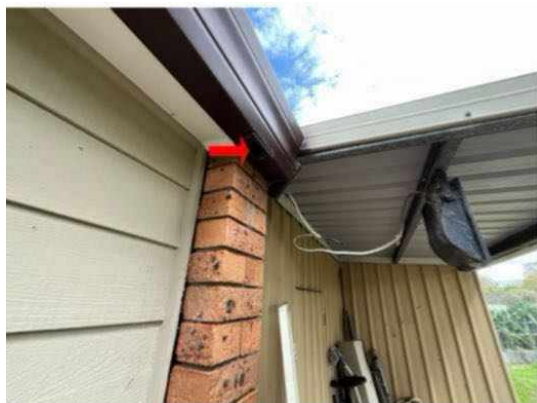
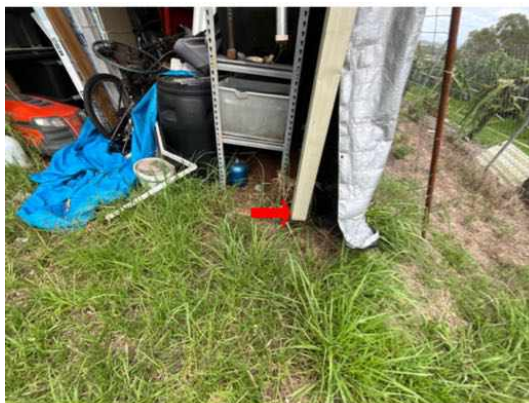
Finding 3.09

Building: Main Building
 Location: Multiple areas
 Finding: Stormwater drain - Not connected
 Information: The roof plumbing is not adequately connected to stormwater drainage on the site. This disconnection negatively impacts the functional capacity of the roof plumbing.

Where roof plumbing doesn't drain adequately, the area at the base perimeter can become excessively damp, potentially creating an environment that is susceptible to rust and corrosion of surrounding building elements, as well as attracting termites and other pests.

It is highly recommended that a plumber be appointed to further inspect the area and to install adequate drainage equipment where necessary.

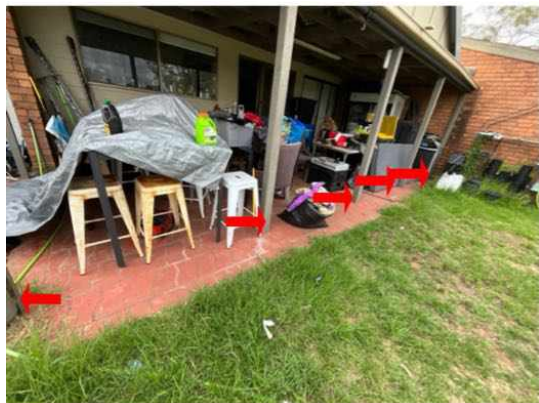
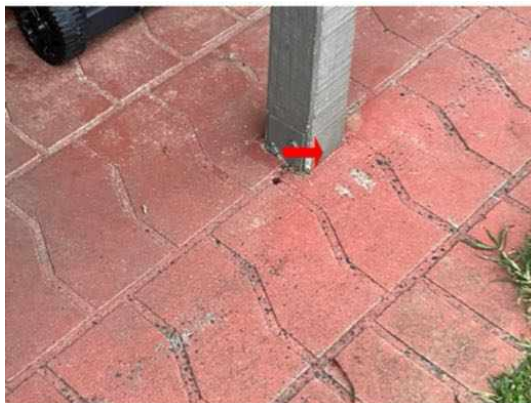
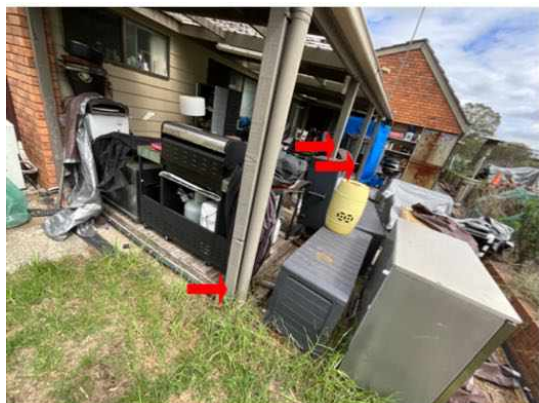
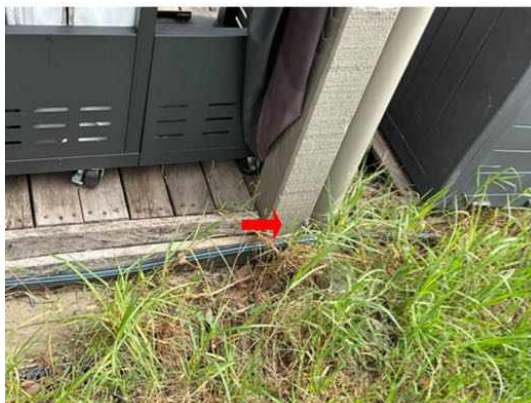
Finding 3.10

Building:	Main Building
Location:	Multiple timber posts
Finding:	Untreated or non-durable timbers in a hazardous environment
Information:	To reduce the risk of timber pest attack it is essential that timber used in a hazardous environment (e.g. in direct contact with the ground or frequently exposed to damp conditions) is of sufficient durability and/or is adequately preservative treated.

Untreated timbers in direct contact with the ground are likely to develop severe wood rot and/or fungal decay if left unattended creating attraction for subterranean termites to infest the timbers from surrounding areas.

If untreated or non-durable timbers are found to be in a hazardous environment it is highly advised that replacement of these building elements be performed as soon as possible to aid the protection of the property against termite / timber pest attack.

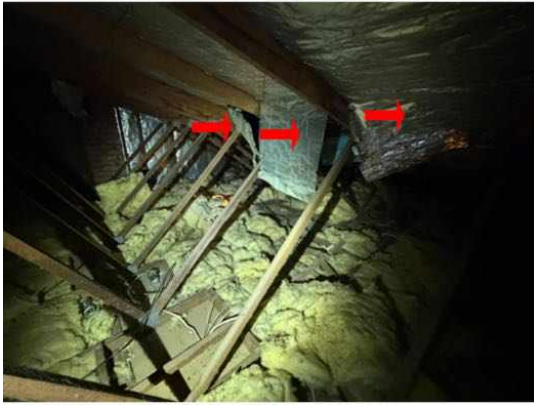
Building:	Main Building
Location:	Roof Void
Finding:	Sarking - Damaged
Information:	Sarking, a laminated aluminium foil applied to the interior of the roof covering, assists in insulating the property and acting as a vapour-barrier to the roof void and, subsequently, to the household.

Where sarking is damaged, both insulation and moisture protection of the property are inhibited. This creates a loss of energy and thus negatively impacts the energy efficiency of the property, allowing potential for moisture ingress from condensation or leaking roof tiles.

It is important to repair any holes or damaged sections of sarking to ensure that the building material is fully functional. A registered builder or qualified carpenter should be consulted to provide further advice on this defect and to perform rectification works at client discretion.

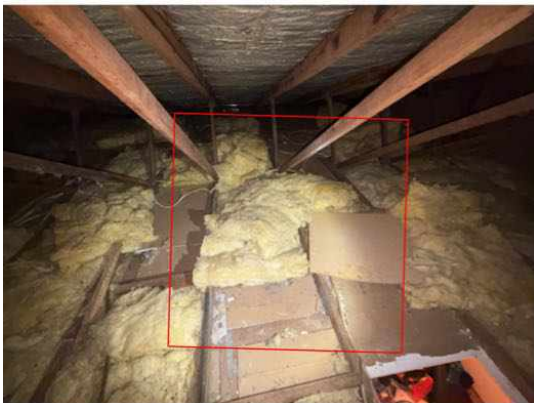
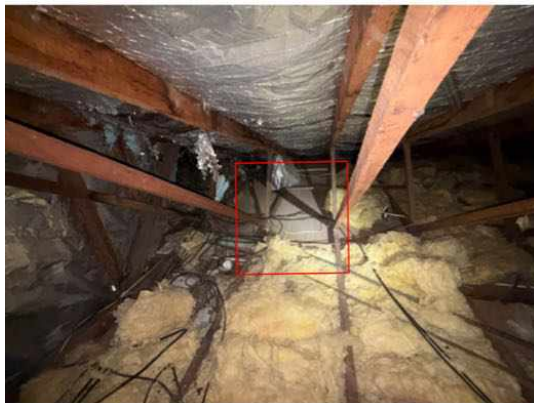
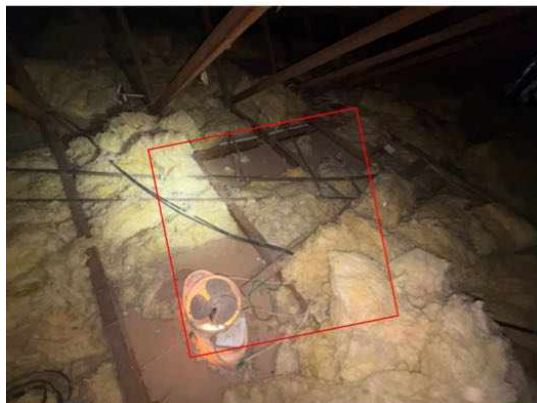
Finding 3.12

Building: Main Building
 Location: Roof Void
 Finding: Insulation - Moved
 Information:

Upon inspection of the roof void it was noted that some insulation is removed and or misplaced.

Insufficient insulation will result in a comparatively higher cost to heat and cool a property as there is a lack of Insulation (or uneven coverage of insulation) which works as a barrier to heat transfer. This helps to keep out unwanted heat in summer and preserves warmth inside your home in winter. It can also help soundproof your home from unwanted airborne noise transfer.

Installation of adequate insulation is required and should be conducted as soon as possible.

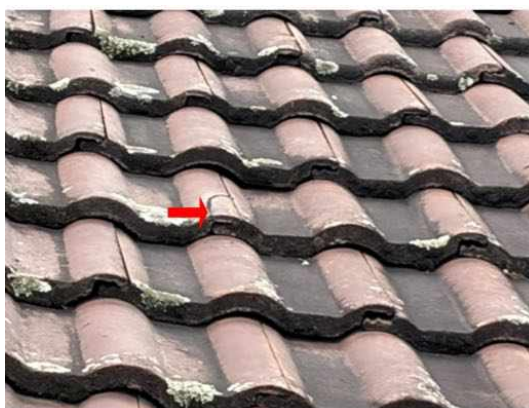
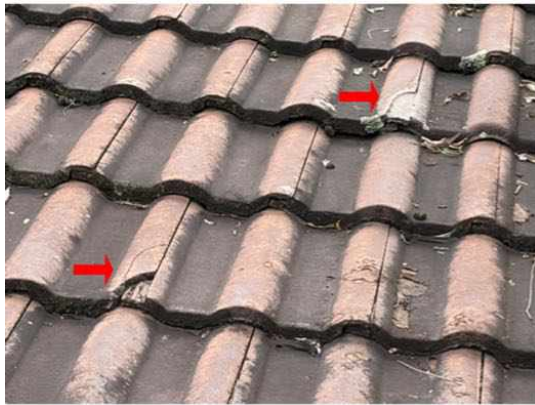
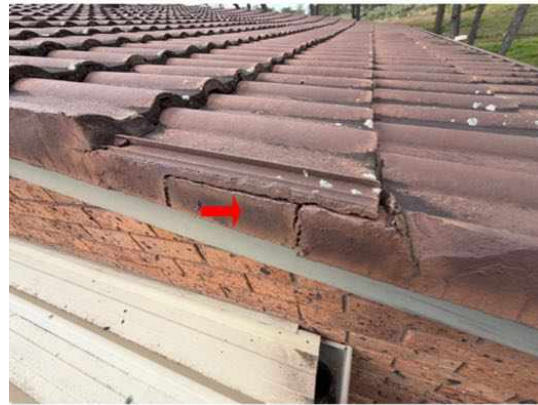
Finding 3.13

Building: Main Building
 Location: Roof Exterior
 Finding: Roof tiles - Weathered
 Information:

Upon inspection of the exterior roofing, the majority of roof tiles were considered to be in a fair condition. While weathering of the tiles is consistent with the age of the property, maintenance works are required.

Isolated areas of mortar have come loose and minor cracking is also present. Re-pointing and re-sealing the may be considered as an interim solution by the client to help preserve and extend the life span of the tiles.

Where left unmanaged, deteriorating roof tiles are likely to lead to a number of secondary defects, including minor water leaks and weather exposure to internal roofing structures.

Consultation with a licensed roofing contractor is highly advised to gain advice on cost of remedial works that may be required in the short to medium term. Remedial works are likely to increase the longevity of the exterior roofing structure.

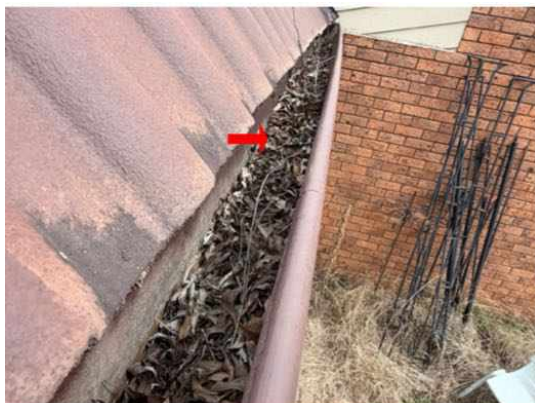
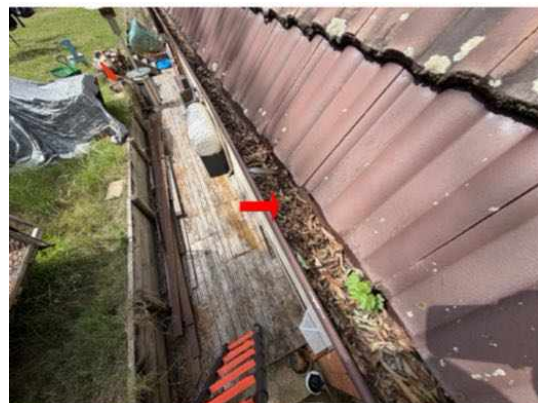
Blocked gutters are likely to lead to high levels of moisture in the affected areas. Such moisture will not only cause rust and decay of the associated building materials, but can also provide conditions that are conducive to termite and timber pest activity. Blockages in gutters should therefore be removed immediately to ensure dry conditions are maintained.

Consult a Licensed Plumber for further specific advice on remedial works that may be required. In the interim, it is highly advised that blocked gutters be removed by the homeowner or a general handyperson as a matter of urgency.

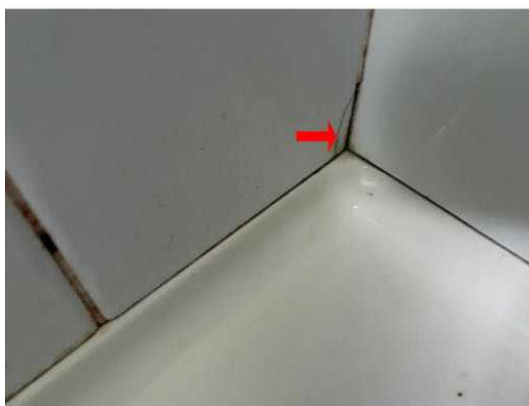
Finding 3.15

Building: Main Building
 Location: Ensuite
 Finding: Wet area tiles - Cracked or damaged
 Information: Cracking was evident to the tiling in this area at the time of inspection. While the cracking appears to be minor, this area is frequently exposed to water, allowing potential for water penetration into adjoining sections of walls or flooring.

If left unmanaged, water penetration to these areas may lead to subsequent water damage, which is likely necessitate repair work to affected building elements.

A bathroom specialist should be appointed to determine the integrity of the bathroom waterproofing membrane. If the membrane was found to be intact then relatively minor works to replace the cracked tiles should be carried out to ensure no further damage occurs. The re-application of silicone and grouting throughout remaining tile work is also advised, to further protect the area against water penetration.

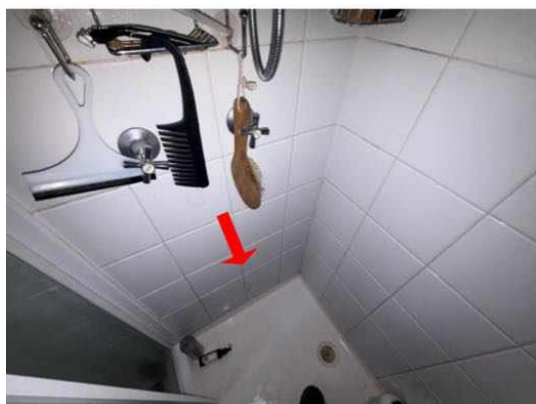
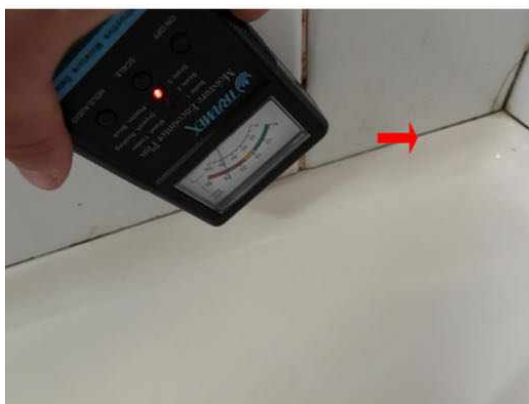
Finding 3.16

Building: Main Building
 Location: Ensuite
 Finding: Sealant and grouting - Missing or damaged
 Information:

It was noted on inspection that sealant or grout is degraded to this area.

Different materials and floor areas move at different rates, generally causing cracking to grout or sealant at this point. A flexible sealant is required to allow for expected expansion and contraction, while keeping the joint water tight and protective of all associated building materials.

Flexible and mould resistant materials should be applied to affected areas to prevent any subsequent water damage that is likely to occur. Regular maintenance and replacement of damage or missing or damaged sealant and grout is highly recommended to the wet areas, as this is a regular wear and tear defect. Sealant and grouting in areas that come into regular contact with water should be maintained for

A sealant specialist should be appointed to complete these works as soon as possible.

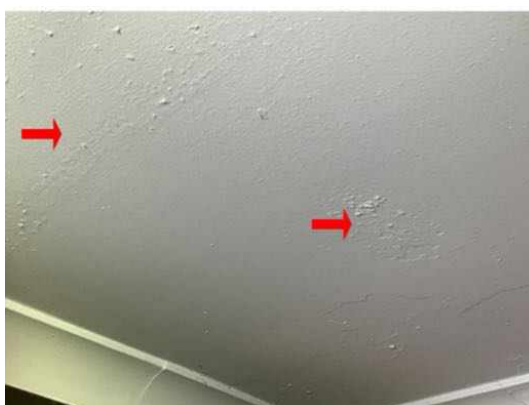
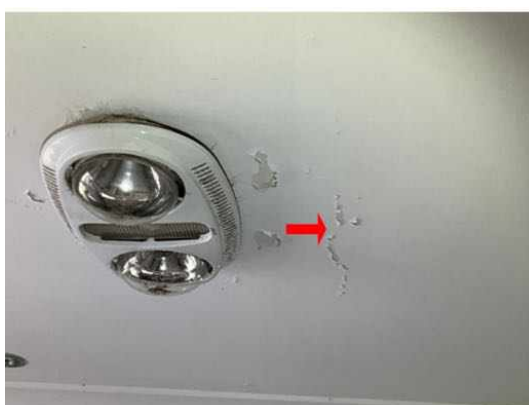
Finding: Paint cracking and peeling
Information: Cracking and ultimately flaking of paint can occur for a variety of reasons. Often these failures are due to the fact that the paint has inadequate adhesion and flexibility, both common problems with lower quality exterior flat paints.

When timber is involved, moisture intrusion results in swelling of the wood surface followed by contraction as the wood dries. The expansion and contraction cycles, can result in cracking and subsequent paint failure by flaking and peeling.

Cracking and flaking can also result when paint is applied too thinly due to overspreading (higher-than-recommended spread rate) or excessive thinning. These practices tend to diminish the paint's final film thickness, so that it is more vulnerable to cracking and flaking.

Inadequate surface preparation can also cause these failures, especially when paint is applied to bare wood or a very porous surface without first applying a primer.

A qualified painter should be appointed to rectify the problem.

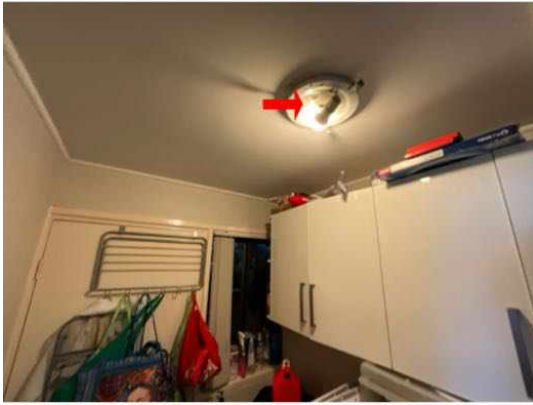
Finding 3.20

Building: Main Building
 Location: Laundry
 Finding: Light cover - Missing (Cosmetic)
 Information: The light cover in this area was found to be missing at the time of inspection. Breakage occurs generally when the building materials have aged and decayed, but may also be indicative of impact damage to the building element (accidental or deliberate). This is mainly a cosmetic defect which can be replaced by the home owner.

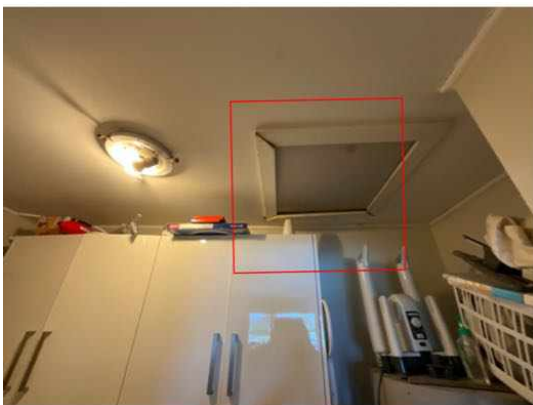
Finding 3.21

Building:	Main Building
Location:	Laundry
Finding:	Beads - Damaged
Information:	Beading acts (like cornice or skirtings) to cover the intersection or joins of building materials. It was noted at the time of inspection that beading in this area has deteriorated. This deterioration is suspected to have been caused by general ageing and frequent exposure to weather, which is expected in a building of this age and condition.

Beading is important in weatherproofing the surrounding building elements and preventing pest ingress. Furthermore, beading works to protect the joins of building materials, which are more susceptible to deterioration and decay.

Repair or replacement of the beading is advised to ensure the protection and longevity of any associated building elements. Such works may be performed by a general handyperson or qualified carpenter.

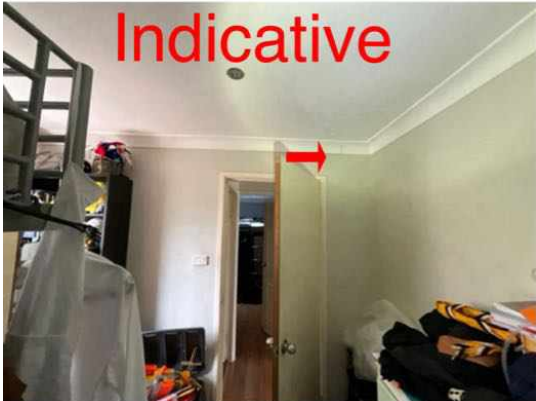
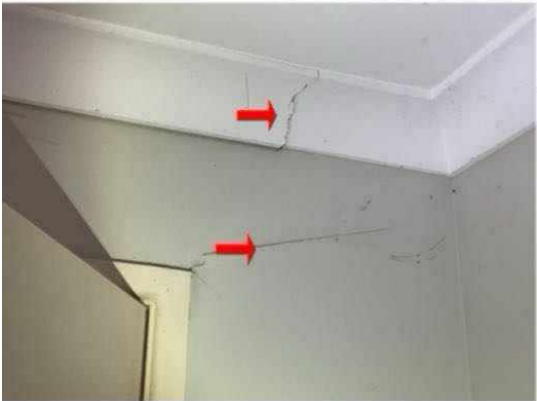
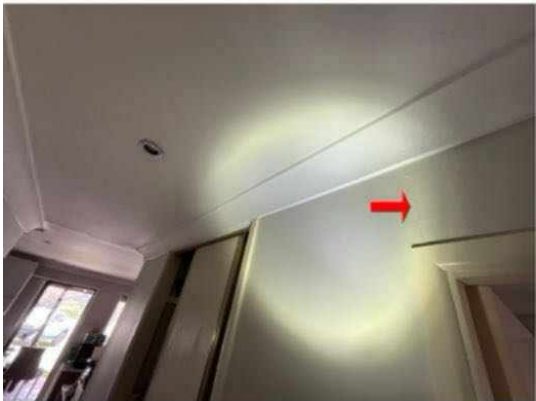
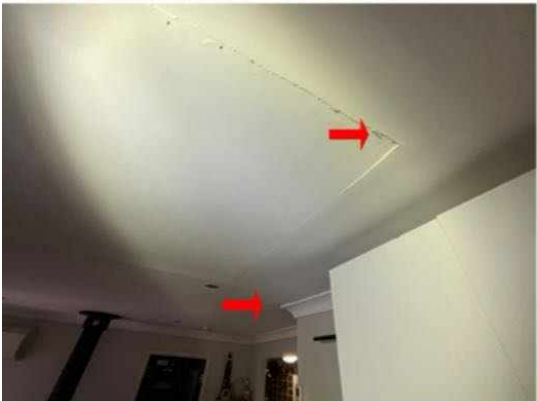
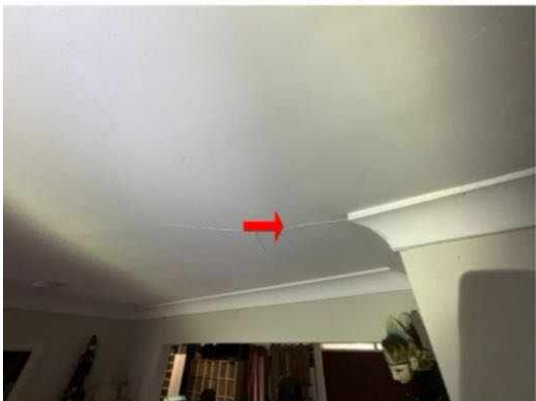
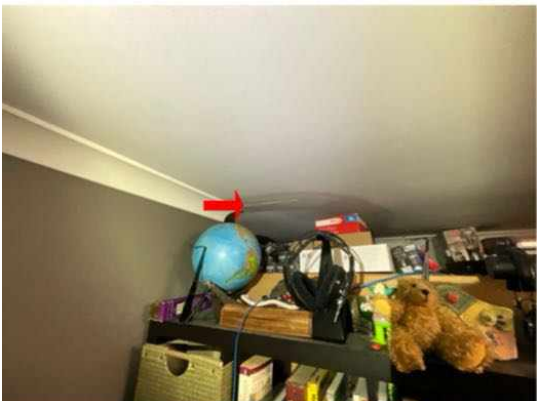
Finding 3.22

Building:	Main Building
Location:	Multiple areas

Finding: Cracking - Damage Category 1 - Fine (up to 1mm)
Information: Although fine cracks are quite noticeable, they are often only considered to be an appearance defect, and usually do not indicate any structural damage. Generally, the cause of a fine crack is indicative of a separation between building materials and finishes (e.g. paint, plaster, etc.) along joins.

Cracking of this nature can generally be repaired with minor sanding, filling and/or repainting. Such works should be performed by a qualified painter or a general handyman.

Monitoring of all cracking should be conducted frequently. Always contact a building inspector should cracks widen, lengthen, or become more numerous.

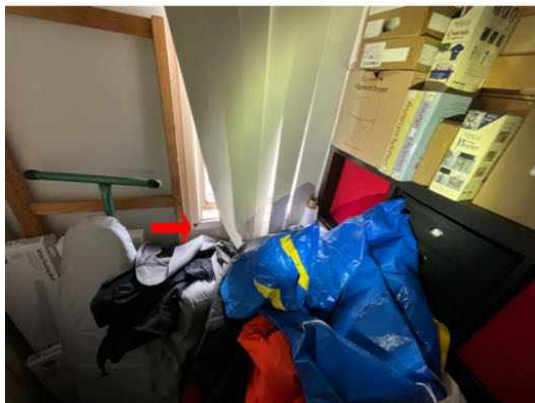
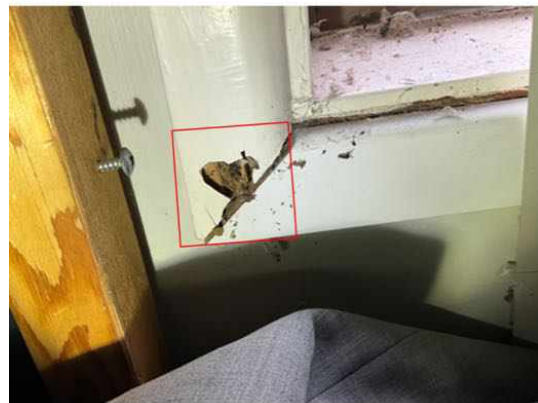
Building:	Main Building
Location:	Rear storage
Finding:	Evidence of termite damage
Information:	Despite no live termite or timber pest activity being indicated, previous termite damage was found to have affected this area or otherwise termite workings were identified at the time of inspection. This damage is considered to be inactive.

A licensed termite specialist should be appointed to provide a treatment plan compliant to the current Australian Standard, but also to carry out an invasive inspection to determine the extent of termite damages.

A licensed builder should then be appointed for repairs.

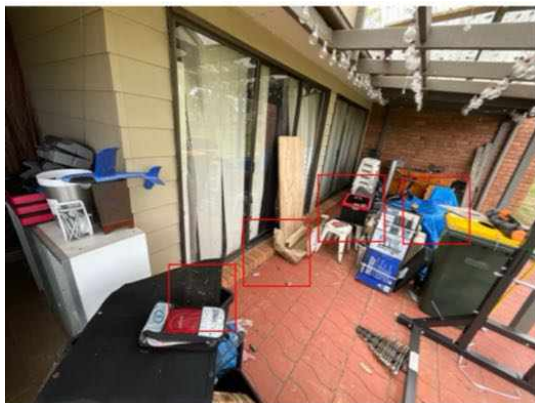
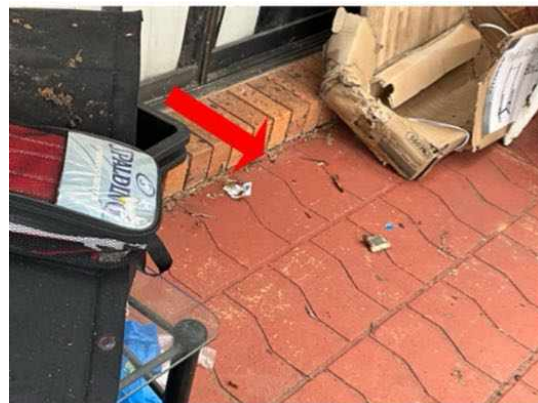
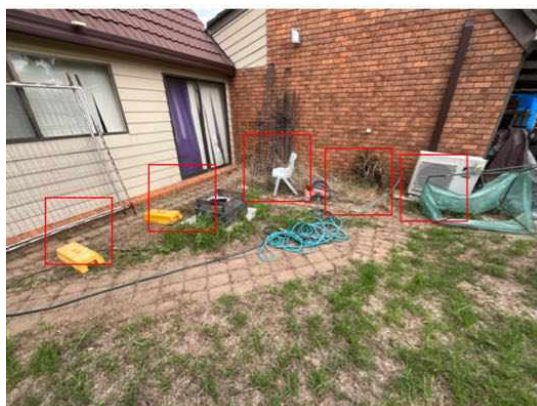
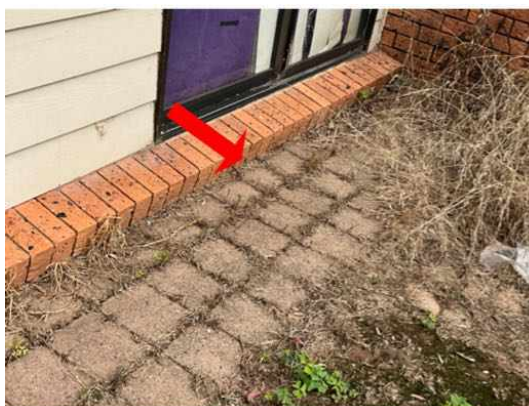
Damp proof course (DPC) is a barrier of impervious material built into a wall or pier to prevent moisture from moving to any part of the building. Where external ground levels are built up over this barrier ingress is provided for moisture from the exterior grounds into the base brickwork or other building material and allowed to rise.

Such conditions attract termites into these damp areas which is likely to lead to infestation if left untreated.

While retrospective fitting of DPC is considered to be impractical works are required in order to prevent the extraction of moisture from the external environment into exterior brickwork or wall materials. Landscaping or re-paving of external grounds may be considered by the client. Regular annual inspections are strongly advised.

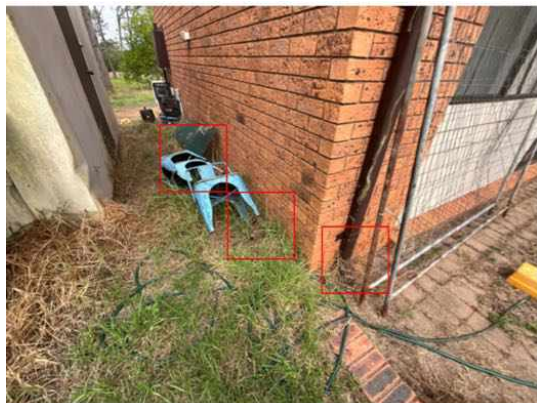
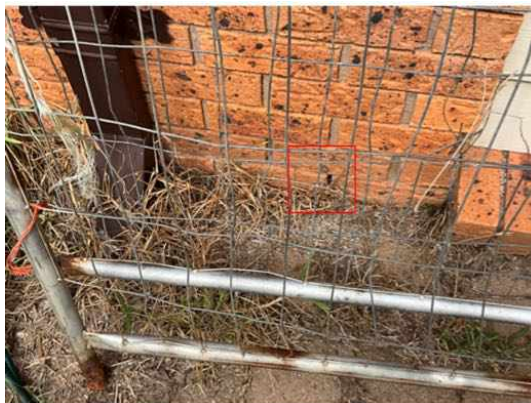
Finding 6.05

Building:	Main Building
Location:	Multiple areas
Finding:	Bridging or breaching of termite barriers - weep holes
Information:	Bridging is the spanning of a termite barrier or inspection zone so that subterranean termites are provided with passage over or around that barrier.

Weep holes in the exterior brickwork of the property are designed to allow condensation that may build up between the brickwork and subsequent timber framework to drain from within the wall hence preventing any deterioration of the timber building elements.

Additionally build-up of moisture is likely to occur if weep holes are covered further attracting termite activity to these areas.

It is highly recommended that weep holes are left exposed in all areas throughout the external property. Therefore if any termite activity leading into weep holes becomes easily detectable during frequent pest inspections.

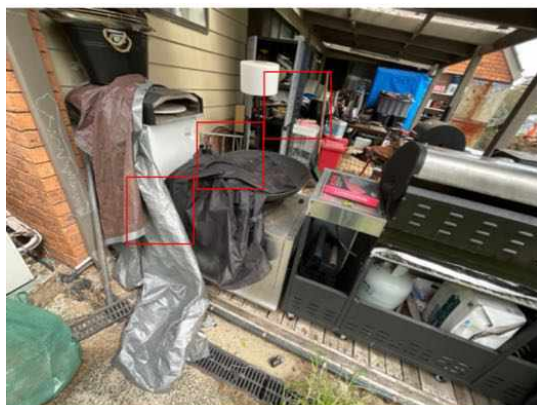
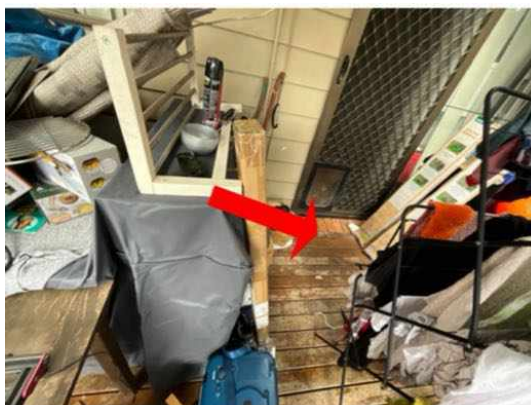
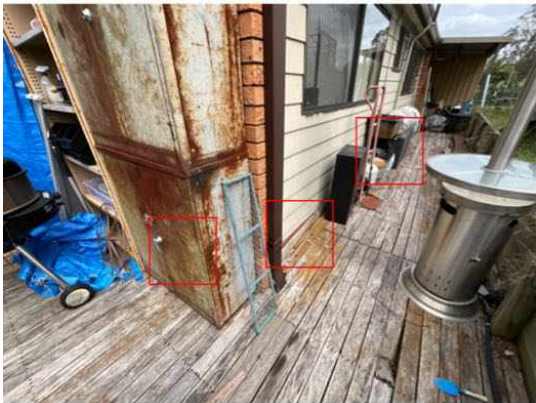
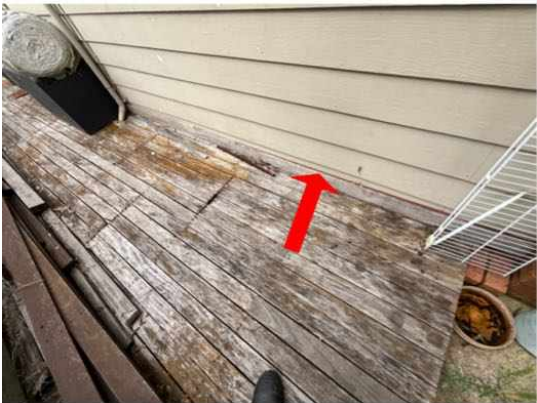
Finding 6.06

Building:	Main Building
Location:	Deck
Finding:	Bridging or breaching of termite barriers - adjacent internal flooring
Information:	Bridging is the spanning of a termite barrier or inspection zone so that subterranean termites are provided with passage over or around that barrier.

It is important for internal flooring to be raised above adjacent external ground levels. Where external ground levels are above internal flooring water pooling and subsequent internal flooding is likely to occur which may attract termite activity to the internal area.

It is highly advised that a landscaper or paver be appointed to lower external grounds that are raised above adjacent internal flooring. Alternatively if external grounds and internal flooring is level installation of a raised door sill may be appropriate in preventing any water pooling in the area.

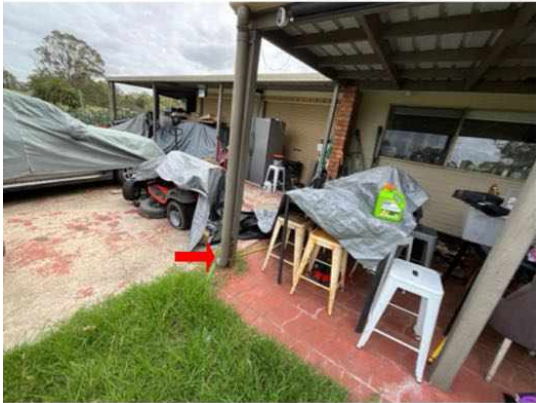
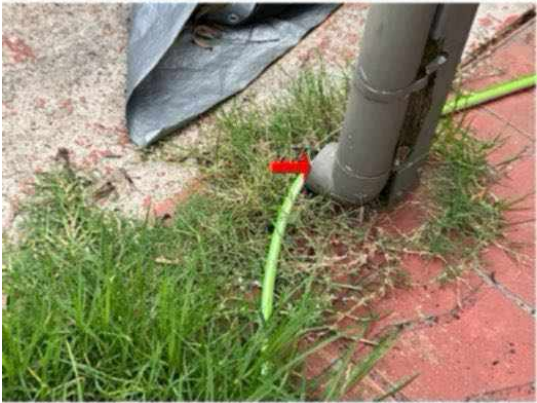
Finding 6.07

Building: Main Building
Location: Multiple areas
Finding: Stormwater drain - Not connected
Information: The roof plumbing is not adequately connected to stormwater drainage on the site. This disconnection negatively impacts the functional capacity of the roof plumbing.

Where roof plumbing doesn't drain adequately, the area at the base perimeter can become excessively damp, potentially creating an environment that is susceptible to rust and corrosion of surrounding building elements, as well as attracting termites and other pests.

It is highly recommended that a plumber be appointed to further inspect the area and to install adequate drainage equipment where necessary.
