Building and Timber Pest Inspection Report

Inspection Date: Fri, 23 Jan 2026

Property Address: 299 Dwyer Rd, Leppington NSW 2179,
Australia

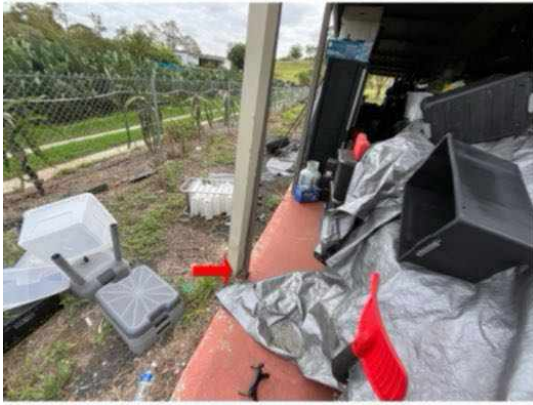
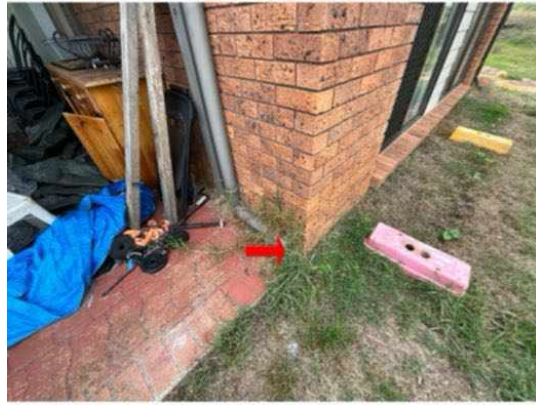
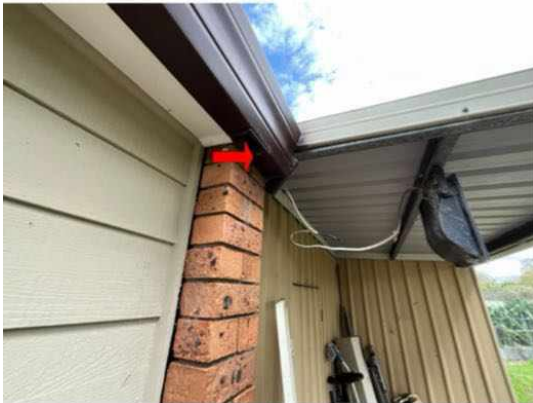
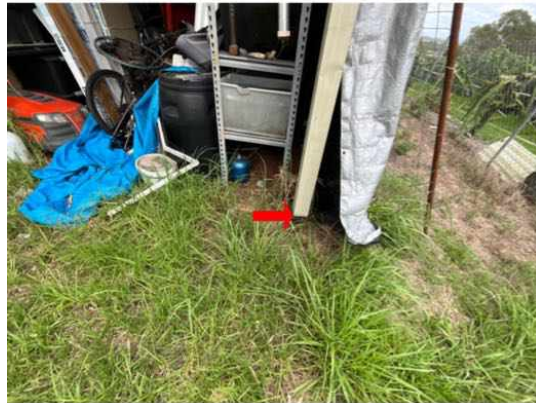
Where roof plumbing doesn't drain adequately, the area at the base perimeter can become excessively damp, potentially creating an environment that is susceptible to rust and corrosion of surrounding building elements, as well as attracting termites and other pests.

It is highly recommended that a plumber be appointed to further inspect the area and to install adequate drainage equipment where necessary.

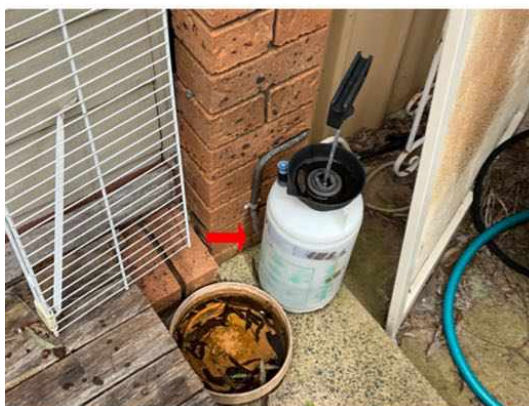
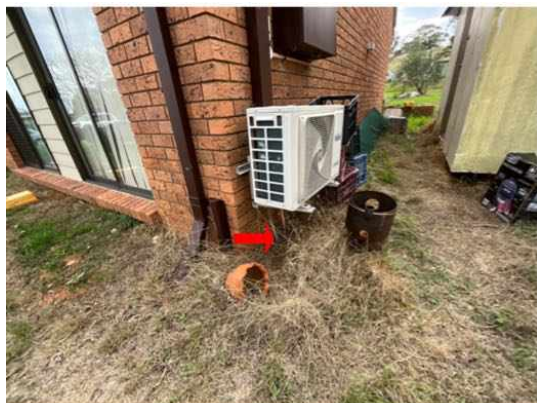
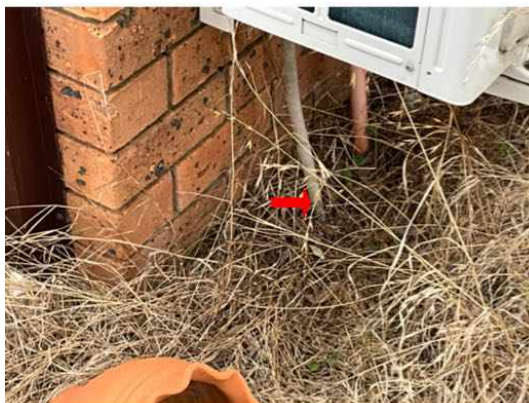
Finding 6.08

Building:	Main Building
Location:	Multiple areas
Finding:	Overflow - Not plumbed for drainage
Information:	The overflow is not plumbed or connected to suitable drainage, which can result in the surrounding area becoming excessively damp.

These damp conditions can lead to secondary defects such as rot, rust or corrosion of associated building elements, the formation of fungal decay, or even the creation of potential slip hazards. When coupled with poor site drainage, pooling of water may also attract termite activity to this area.

It is highly recommended that a licensed plumber be appointed to install adequate drainage to the overflow. These works will ensure that the area remains dry and free of any secondary defects.

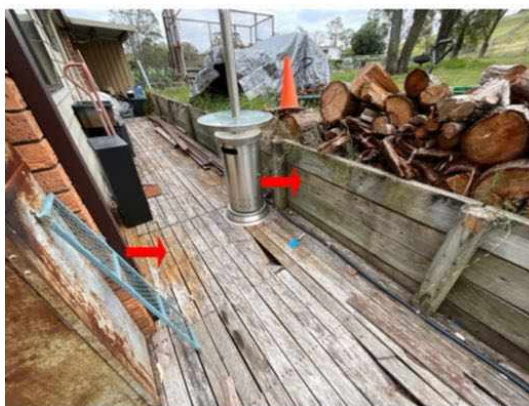
Finding 6.09

Building:	Main Building
Location:	Fencing & Landscaping
Finding:	Building materials in direct ground contact - conducive to termites
Information:	Where timber elements are in direct contact with the ground and consequently moisture or dampness they become conducive to termite activity. Whether timber is used as a building element part of a fencing structure or stored as an unused item they can provide an environment that is attractive to termite infestation.

When met with excessive moisture timber begins to decay and develop wood rot. Any timbers that are in direct contact with external grounds especially if left untreated or non-durable also provide ingress for subterranean termites into that particular element.

The removal of any such materials that may be conducive to termite activity should be removed as soon as possible to minimise the risk of termite attack.

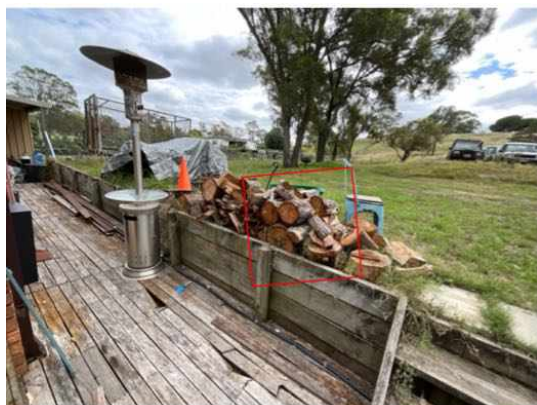
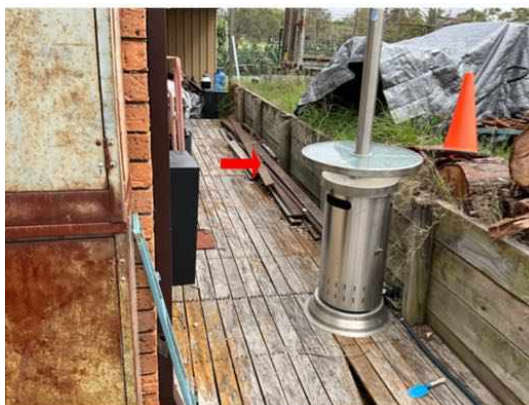
Finding 6.10

Information: The storing of timbers in the subfloor space or around the external property increases the risk of termite activity being present. As they are likely to come into contact with weather conditions or excessive moisture wood rot is likely to develop on timbers that are not treated.

It is highly recommended that any stored timbers be immediately removed from areas in which they may attract any termite / timber pest attack. Minimisation of risk / prevention of termite attack is far more adequate than dealing with the presence of termite activity.

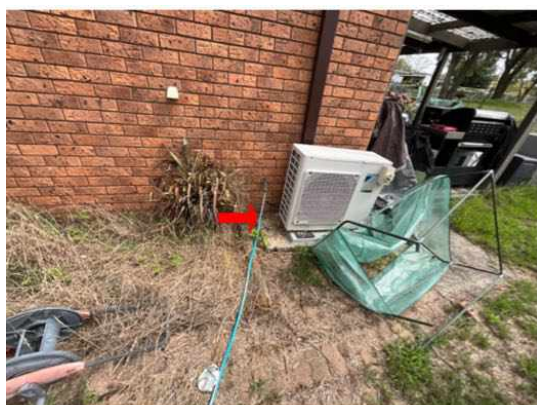
Building:	Main Building
Location:	External tap
Finding:	Tap - No drain
Information:	The external tap in this area was noted to have no drain at the time of inspection.

This keeps the surrounding surfaces damp while using the tap, which becomes conducive to termite activity.

A licensed plumber must be appointed to ensure an appropriate drain is installed.

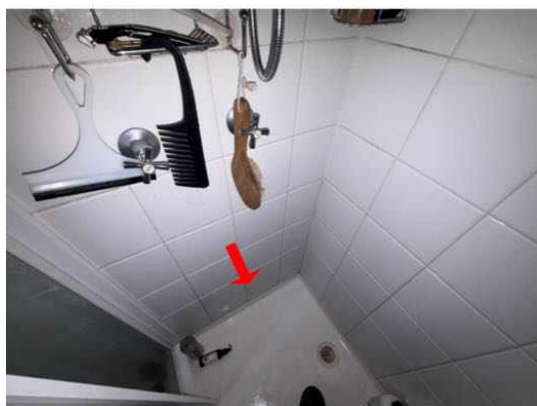
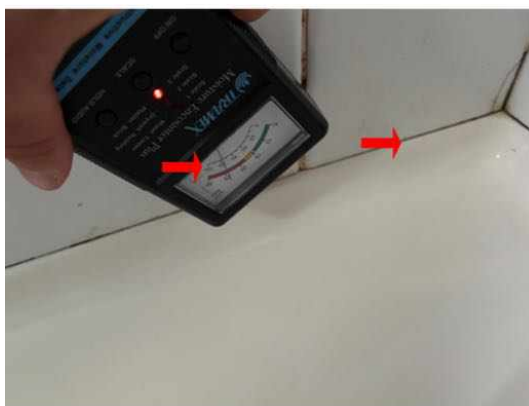
Finding 6.13

Building:	Main Building
Location:	Ensuite
Finding:	Shower damp - Sealant and grout
Information:	Damp is evident to the lower 400mm of wall to the shower alcove. This defect is quite common, and is suspected to have been caused by moisture permeating or leaching through the grouting and sealant in this area, which shows evidence of deterioration. Leaking pipes within the wall is also a possible cause however this seems unlikely in this instance as there is no moisture build up around the taps or transferring to the other side of the wall. There appears to be no sealant around the tap spindles which

Damp (or structural damp) refers to the presence of unwanted moisture in the structure of a building, either as the result of intrusion from outside, or condensation from within the structure. In the shower area, internal water leaks, degraded materials or other sources of excessive moisture are generally the cause of damp.

Unmanaged damp in the shower recess is likely to facilitate the formation and development of mould and fungi growth, decaying associated building materials and compromising their structural integrity of associated elements. It is important to address damp conditions, as the World Health Organisation notes that excess moisture leads - on almost all indoor materials - to growth of microbes such as moulds, fungi and bacteria, which subsequently emit spores and other matter into the indoor air. Exposure to these contaminants is associated with a wide range of respiratory and other health-related problems. Damp conditions also create a conducive environment for termite infestation.

Consultation with a bathroom sealant specialist is advised immediately to identify the cause of damp and to perform remedial works as required.

Always ensure that sealant and grout is in good condition to prevent any moisture issues occurring in the future.

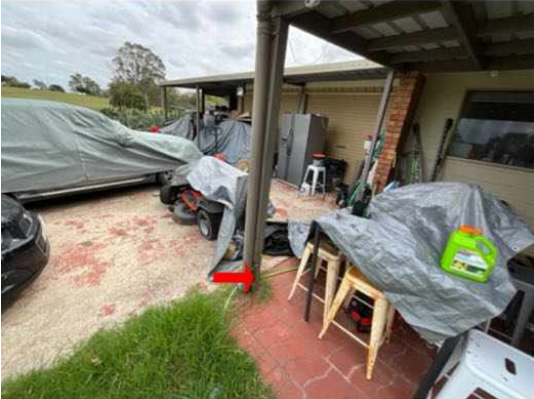
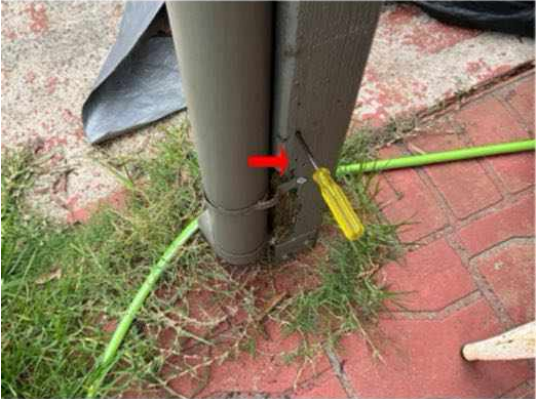
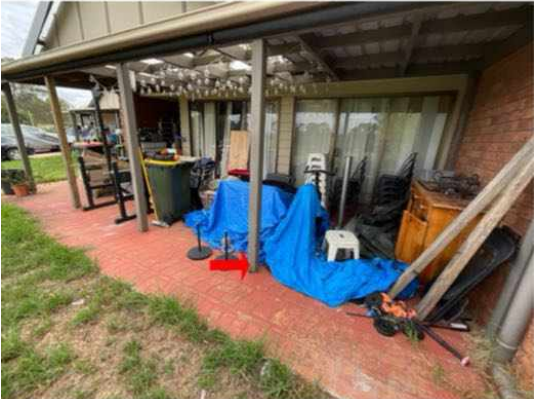
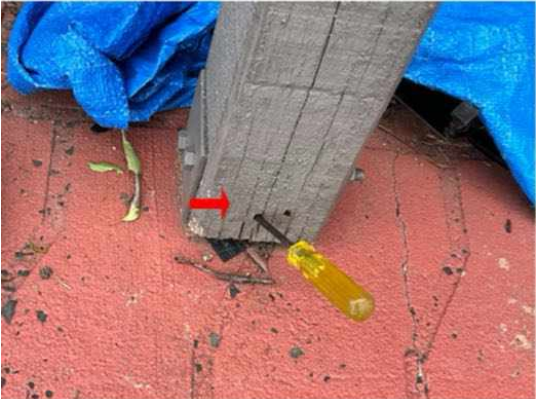
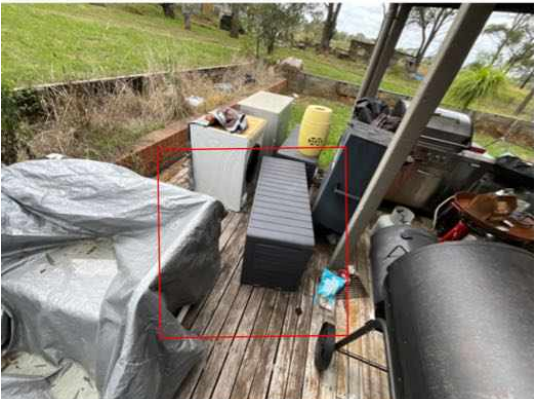
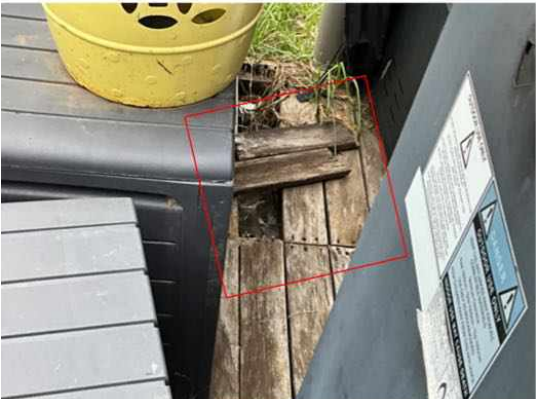
Finding 7.01

Building:	Main Building
Location:	Front awning
Finding:	Wood rot/decay
Information:	This building element shows evidence of wood rot. Wood rot, also known as Fungal Decay, occurs when timbers and other cellulose building materials are exposed to damp conditions on an ongoing basis. This could be the result of exposure to weathering over a prolonged period of time, or the attraction of excessive moisture

from other abutting building materials.

Replacement of affected timbers is a necessary step in protecting surrounding building elements from such deterioration. A licensed carpenter is required to replace affected building materials.

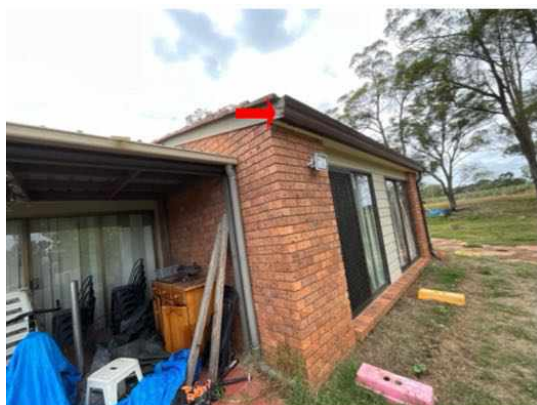
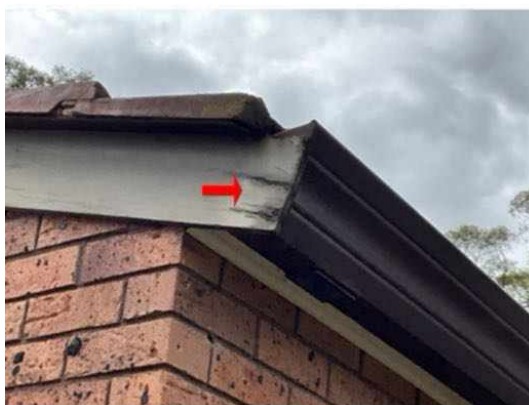
Finding 7.02

Building: Main Building
Location: Fascias
Finding: Fascias - Wood rot/decay
Information: Wood rot was found to be affecting fascias and barges in this area, evidenced by the

presence of mould on the surface in some areas. Wood rot, also known as Fungal Decay, occurs when timbers and other cellulose building materials are exposed to damp conditions on an ongoing basis.

It is likely that this wood rot has developed as a result of faults in the roof plumbing, creating excessive moisture in this areas. Otherwise frequent exposure to rain and other weather conditions also make fascias and barges susceptible to accelerated deterioration.

Early intervention and regular maintenance will prolong the useful life of these building elements. Prior to any works being performed, the cause of the moisture that has created the visible wood rot should be identified and addressed in a suitable manner.

It is advised that a roof plumber be appointed to inspect all roof plumbing and subsequently identify the cause of the wood rot. Replacement of affected fascias and barges may then be a necessary step in protecting surrounding building elements from such deterioration.

A licensed plumber may be appointed to assess the cause of excessive moisture and to provide advice on any remedial works as required. A licensed carpenter may also be required to replace affected building materials.

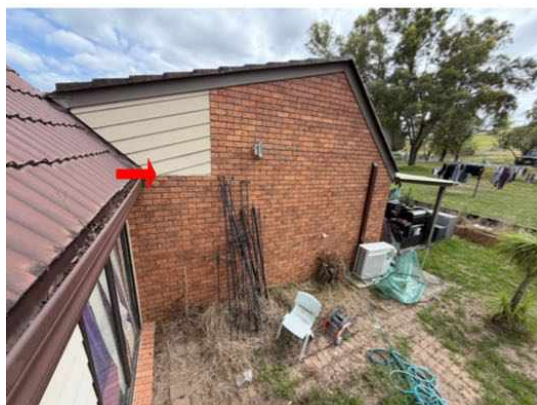
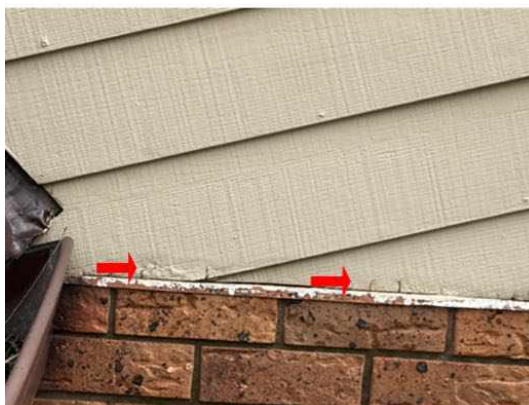
Finding 7.03

Building:	Main Building
Location:	Rear weatherboards
Finding:	Weatherboards - Rotting
Information:	The external weatherboards show signs of fungal decay (wood rot) in several sections. This wood rot is suspected to have developed over a prolonged period of time due to frequent weather exposure, which is expected in a property of this age and condition

Weatherboards are sealed and protected by paint and other sealants. When these sealants deteriorate over time, they allow water penetration to the weatherboards, causing wood rot. If left unmanaged, the wood rot is likely to develop further, possibly necessitating major repair or replacement works in the long-term future.

To maintain the condition of the external wall cladding, any severely affected weatherboards should be substituted as soon as possible with pre-treated replacements. Where weatherboards have rotted due to excessive moisture other than rain penetration, the cause of the moisture should be identified immediately by a licensed plumber. A qualified carpenter should be appointed to repair and replace rotting weatherboards.

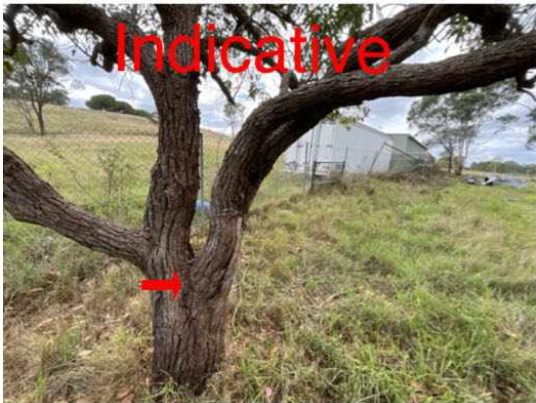
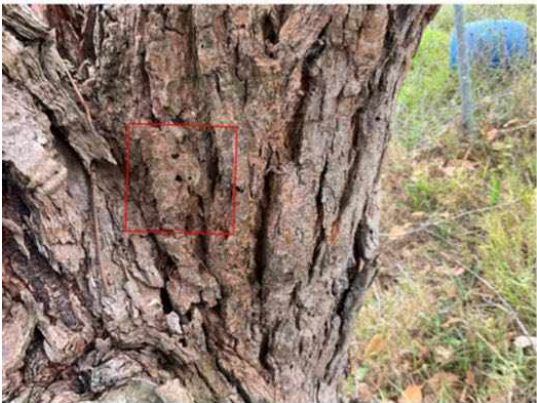
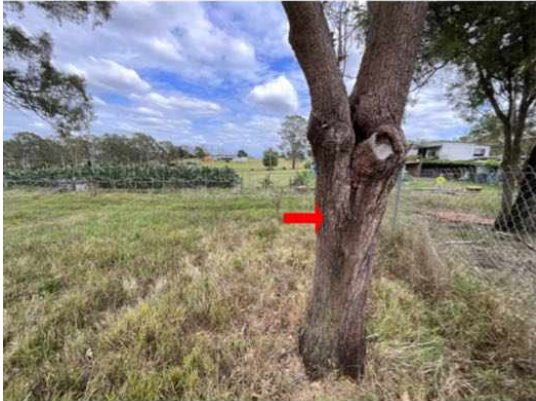
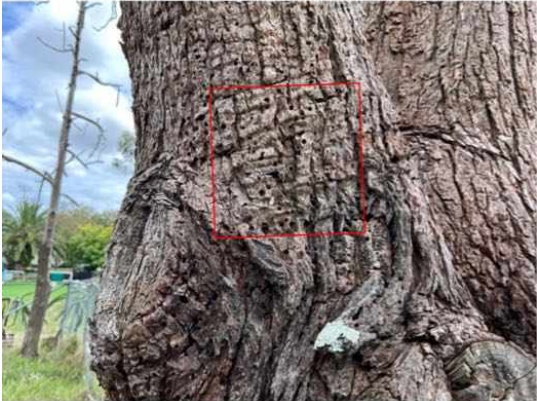
Finding 8.01

Building:	Main Building
Location:	Trees
Finding:	Evidence of wood borer activity identified
Information:	Wood borers small beetles that colonise in exposed timber elements are a common timber pest that are regularly mistaken for termites. Although wood borer activity is generally not detrimental to the affected timber they may lead to serious damage and necessitate replacement of certain building elements if left unattended.

The other commonly known borer the Anobium borer is more likely to attack floorboards and may cause severe structural damage to flooring areas.

As no live wood borer activity was identified treatment is not required at this time. Replacement of affected timbers may be considered by the client for superficial reasons.

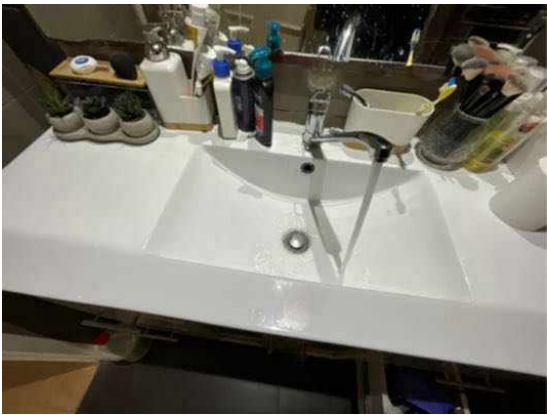
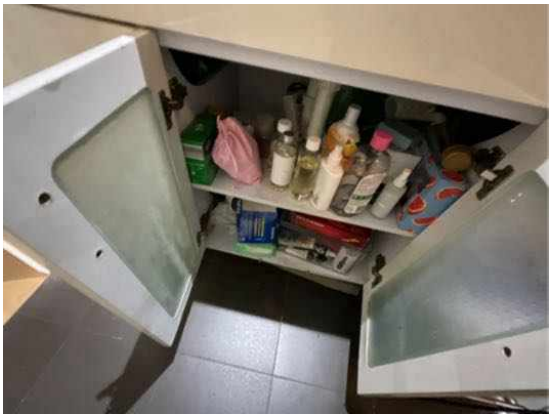
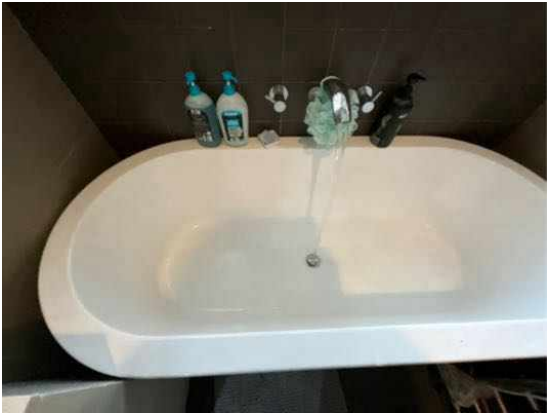
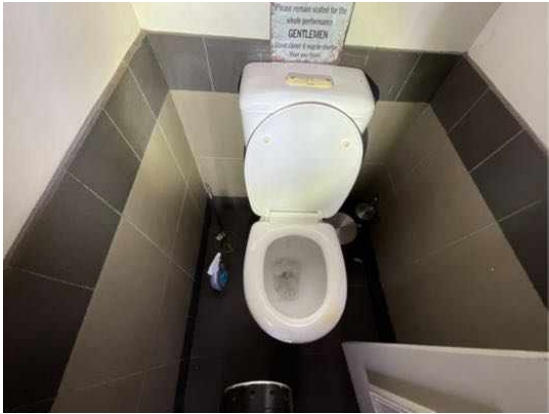
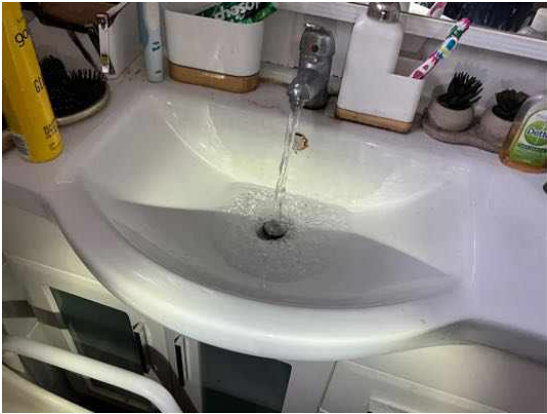
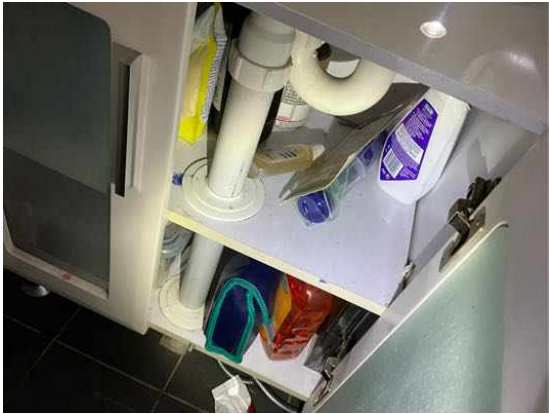
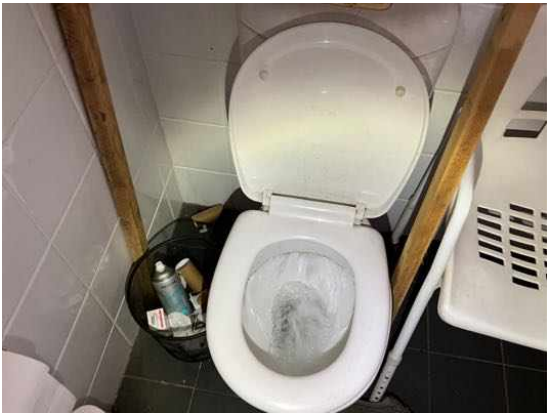
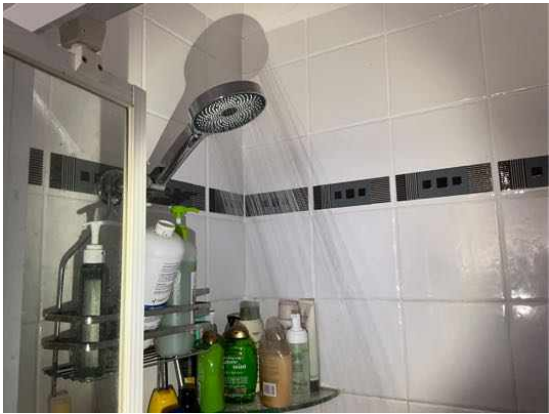
Additional photos are provided for your general reference.

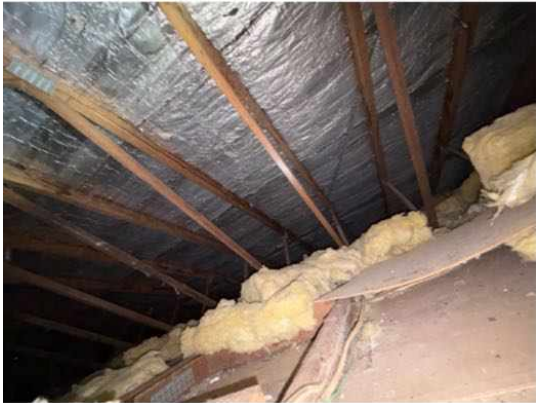
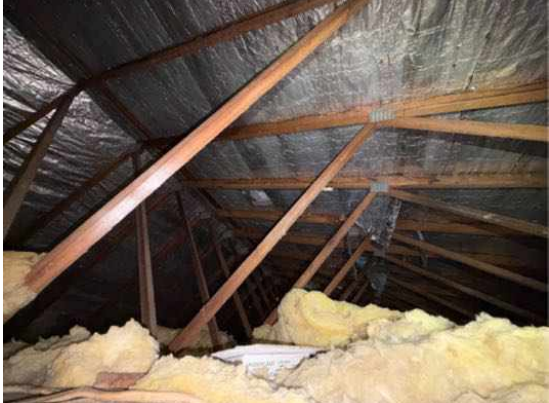
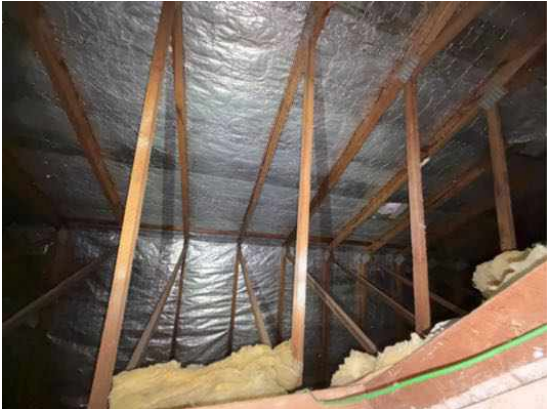
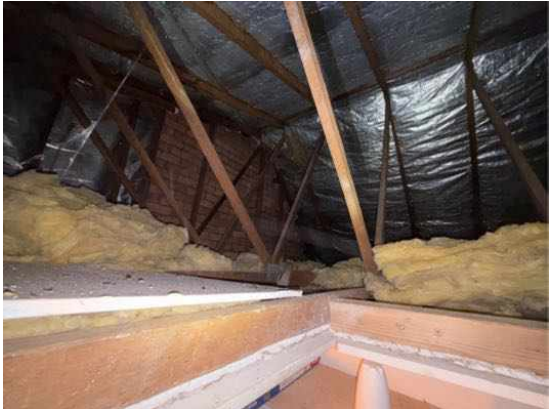
Building: Main Building
Location: Roof Void
Finding: Additional Photos
Information:

Additional photos are provided for your general reference.

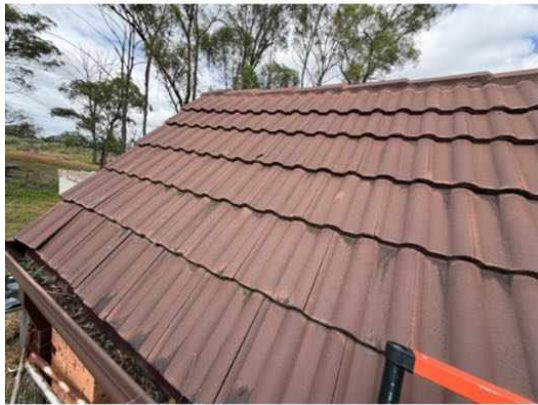
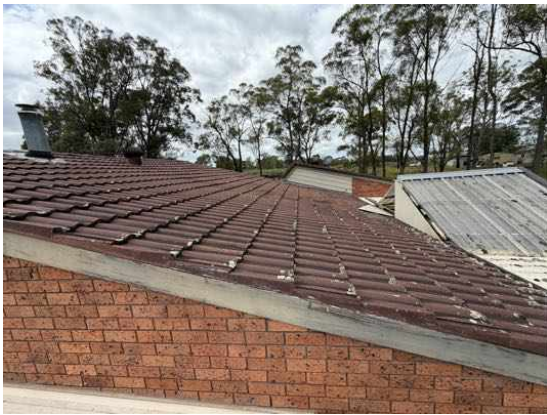
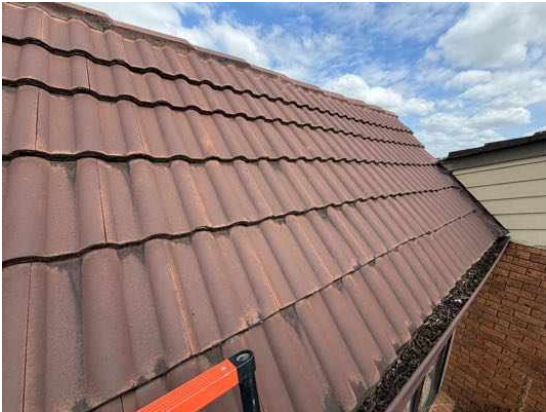
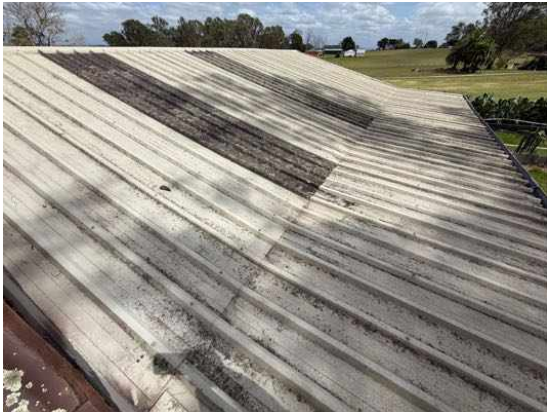
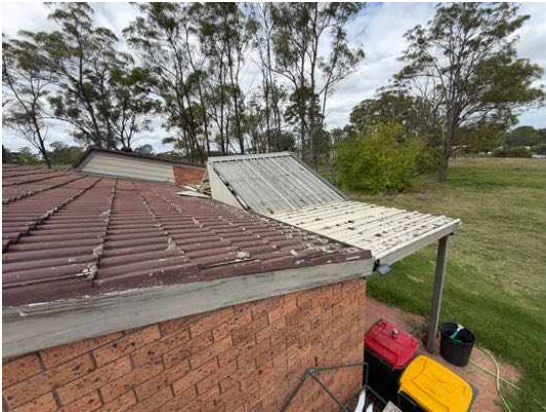
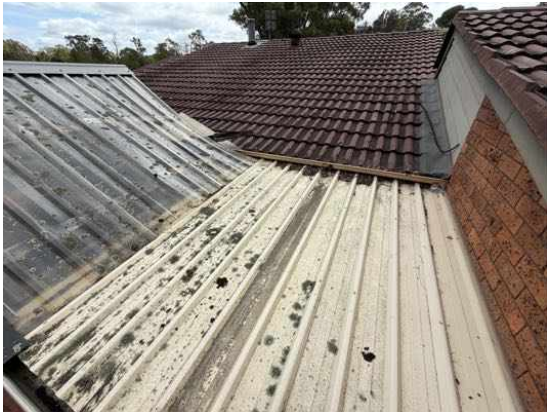
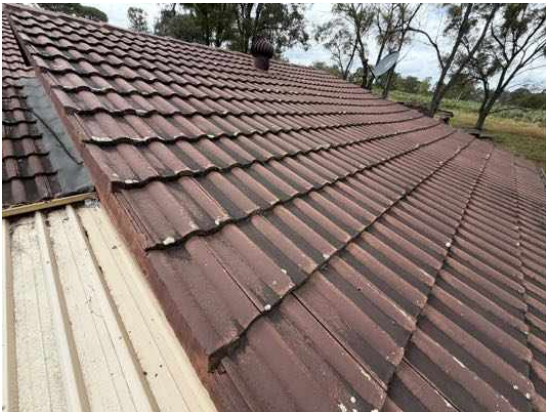
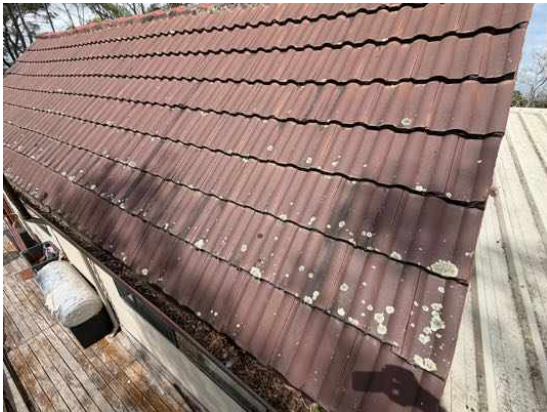
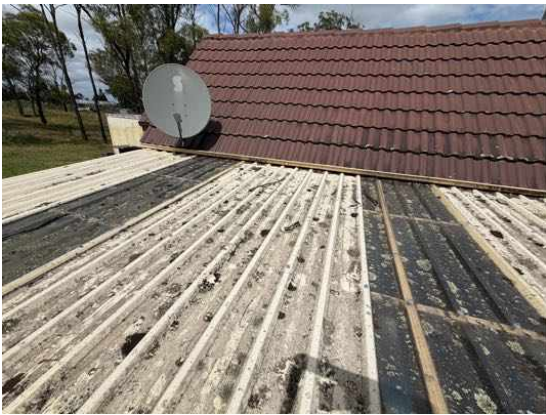
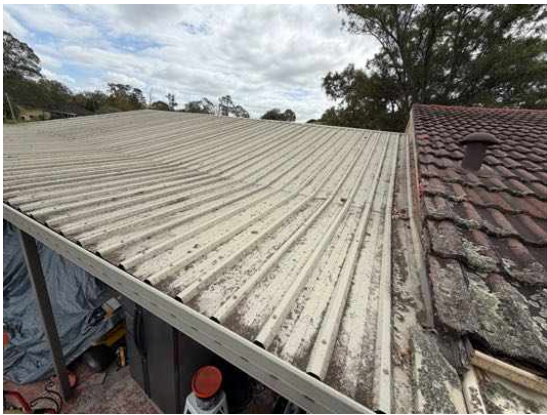
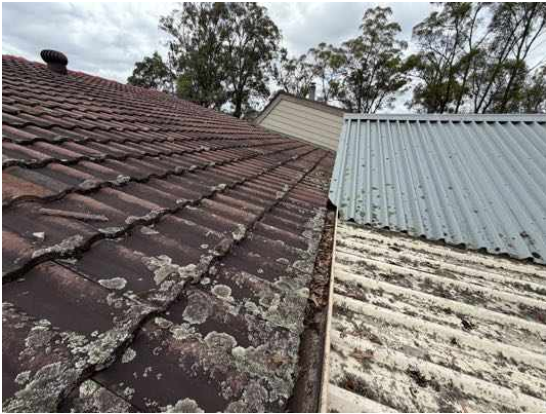
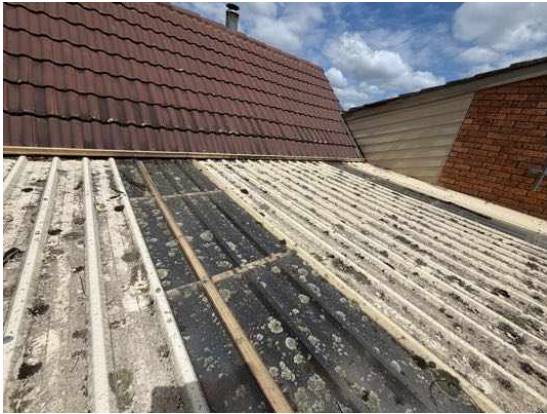
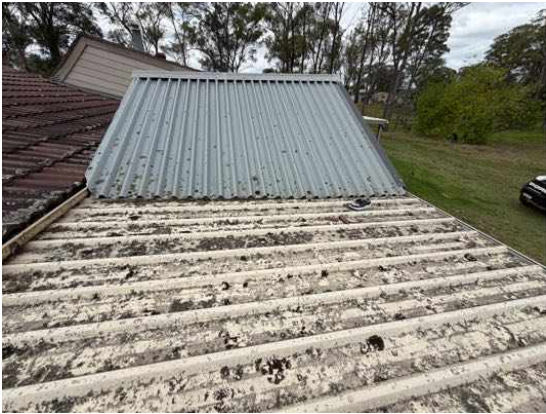
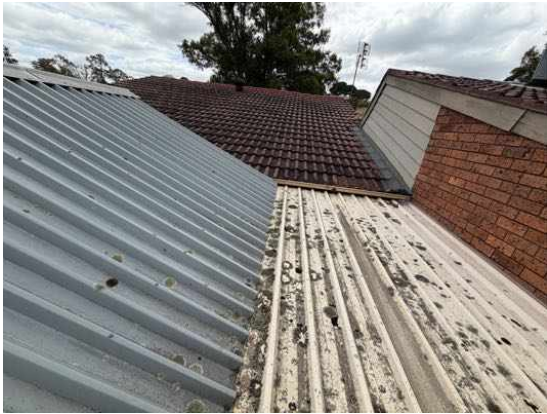
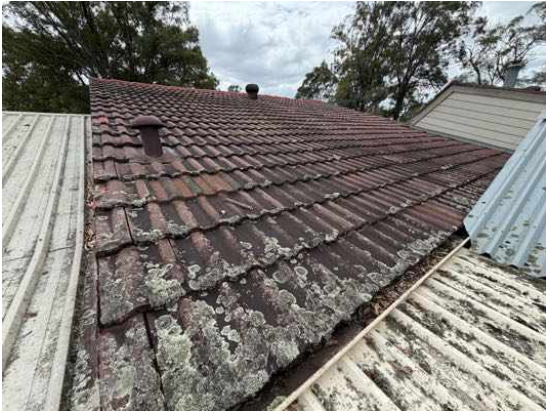
Building: Main Building
Location: Roof Exterior
Finding: Additional Photos
Information:

Additional photos are provided for your general reference.

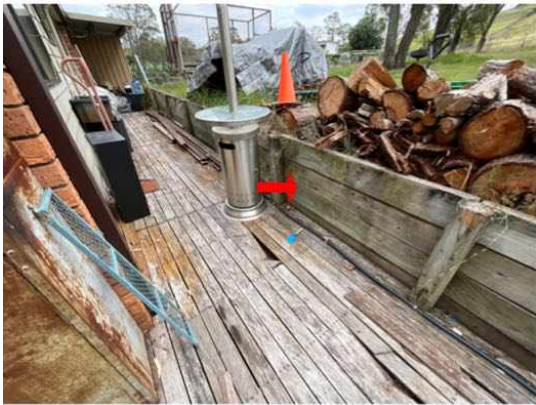
Building:	Main Building
Location:	Retaining walls
Finding:	Retaining walls
Information:	At the time of inspection the retaining walls were checked and no defects were observed other than those which May have been mentioned earlier in this report. AS4349.1-2007 requires all retaining walls in excess of 700mm to be inspected by a licensed and practicing structural engineer.

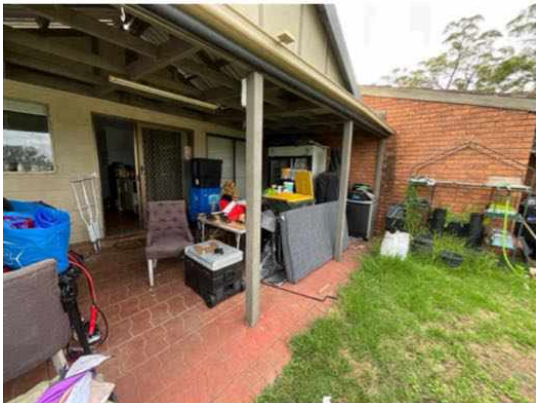
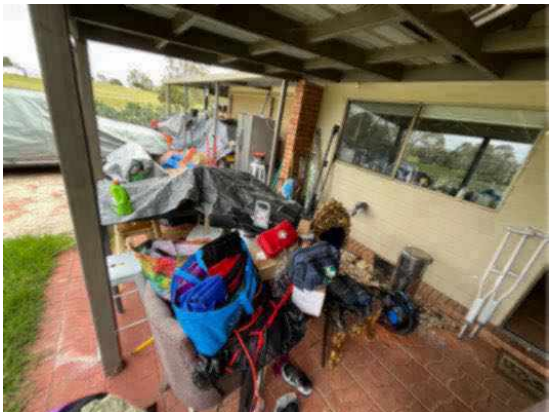
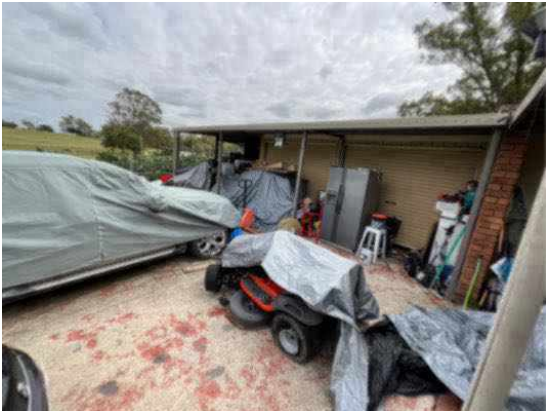
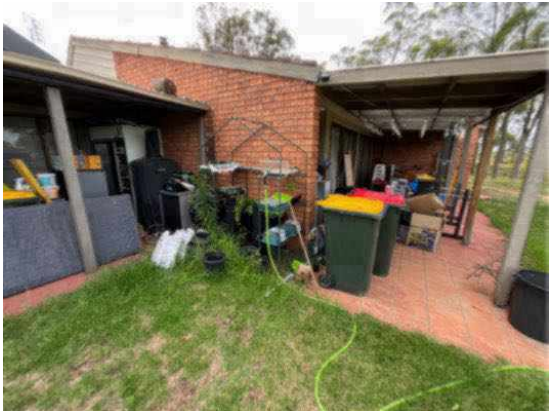
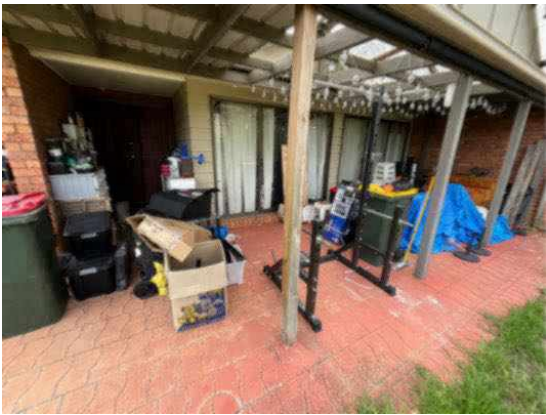
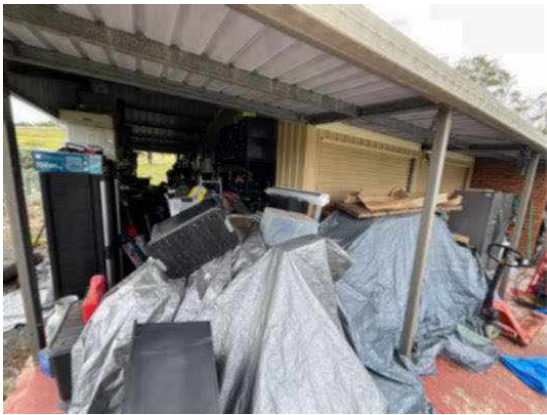
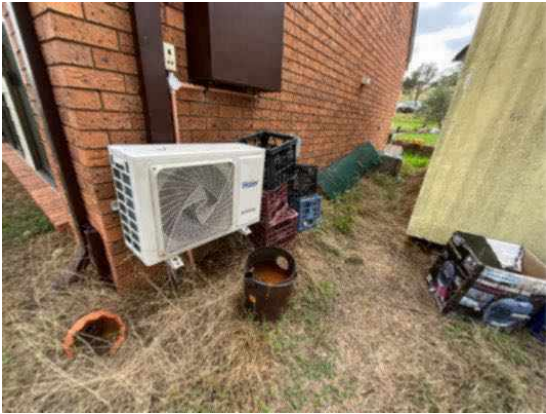
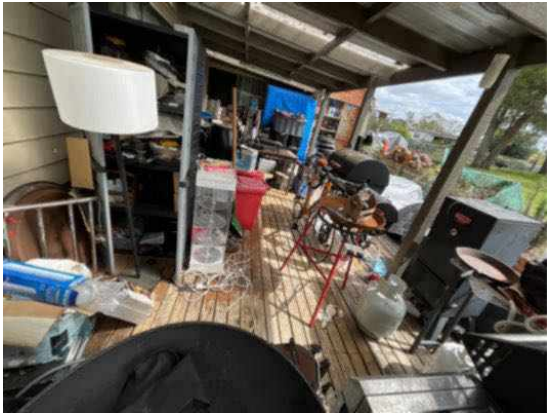
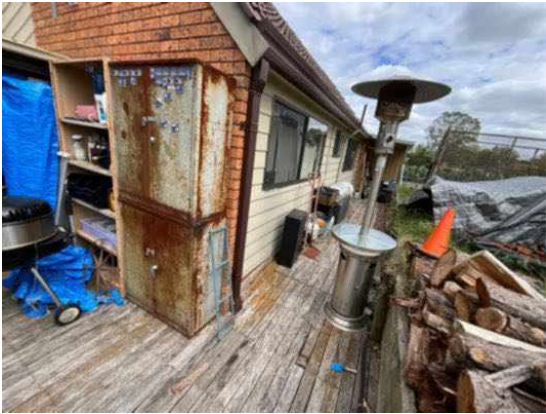
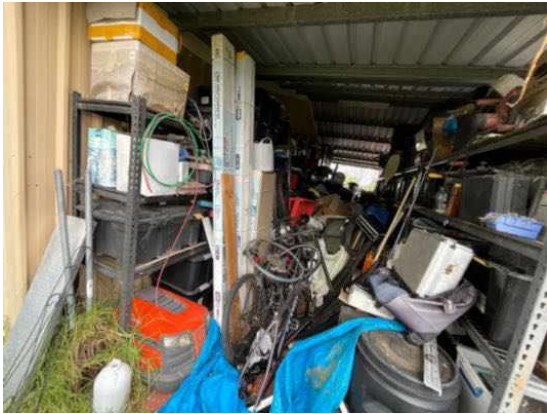
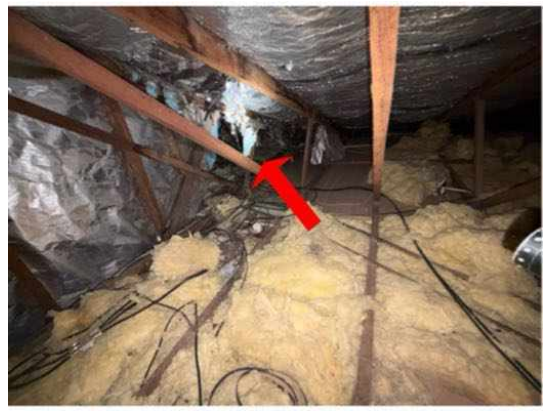
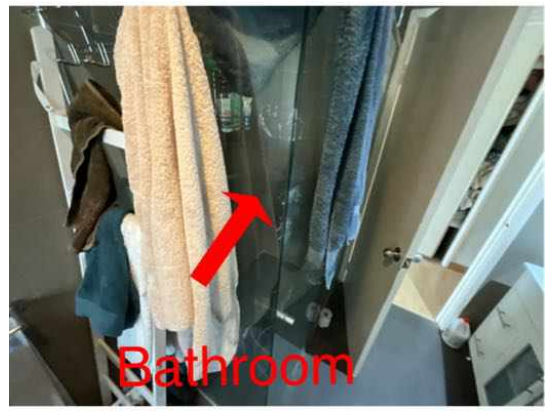
Building: Main Building
Location: All Areas
Finding: Additional Photos - Obstructions and Limitations
Information:

These photographs are an indication of the obstructions and limitations which impeded full inspection of the property at the time of inspection. These obstructions can hide an array of defects and should be removed to allow full inspection to be carried out. A re-inspection is recommended once the areas are made accessible.
