Building and Timber Pest Inspection Report

Inspection Date: Tue, 3 Mar 2026

Property Address: 1/130 Lake Entrance Rd, Oak Flats NSW
2529, Australia

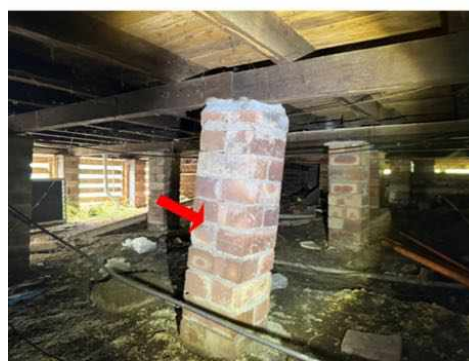
Building: Building 1
 Location: Rear wall/yard areas
 Finding: Site drainage - Inadequate
 Information: The site drainage in the rear of the property was found to be inadequate at the time of inspection, creating water damage to associated building elements.

Rainwater is entering the subfloor and combined with the water leak, has created mould, rising damp, pooling water and possibly the reason for the leaning pier.

In NSW, a major defect is a defect that can cause further damage which applies here.

It is important that water does not lie against the base of walls; surrounding paths and ground levels should be sloped to drain water away from walls. Downpipes should not discharge stormwater onto lower walls or plinths. Stormwater should be carried away by large, regularly cleaned drains. Ground levels may need to be lowered to expose a buried DPC.

Where site drainage is inadequate here, installation of an Agricultural (Aggie) Drain is required. A qualified plumber should be appointed to further inspect the property and perform any remedial works as necessary. Secondary defects are likely to occur if left unmanaged.

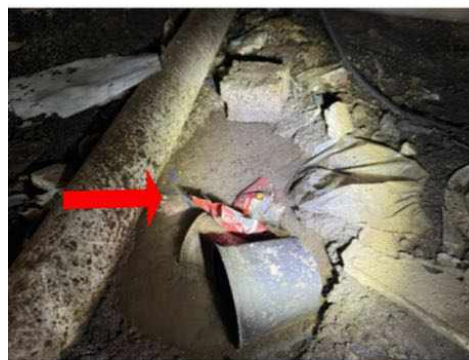
Building:	Building 1
Location:	Subfloor
Finding:	Foundations - adjacent water pooling
Information:	Water pooling near foundations and footings is a serious concern with the potential to adversely impact on the longevity of the dwelling. This house requires rear drainage and immediate repair if the water leak to stop water pooling and foundation movement.

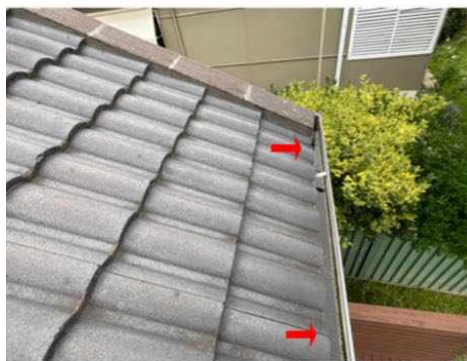
Building:	Building 1
Location:	Pictured front right gutter
Finding:	Gutter - Insufficient fall
Information:	There is an insufficient fall in the front gutter, which means that the angle of this gutter is inadequate for rainwater to drain away. This will result in pooling of water in the area, creating the potential for water damage to nearby areas. This is likely to lead to further defects if not repaired. Adjustment by a roofing contractor is required as soon as possible to prevent any damage to this area.

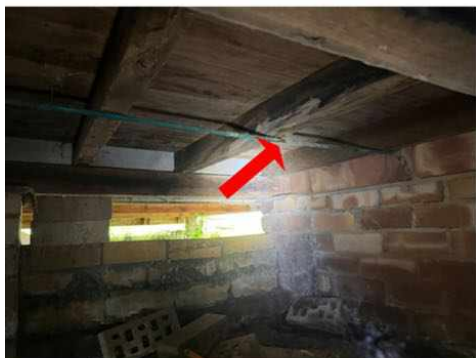
Building:	Building 1
Location:	Subfloor
Finding:	Pipework - Leaking into subfloor
Information:	Dampness to localised sections of the subfloor area was identified from a leaking pipe with a continuous spray emitting.

Dampness in this area has lead to wood rot, pooling water and general deterioration of structures within the subfloor space. Excessive moisture also creates an environment which is conducive to termite and pest infestation.

A licensed plumber should be appointed immediately to repair any pipes that may be leaking. This will ensure a dry subfloor space as well as improving the water efficiency of the property.

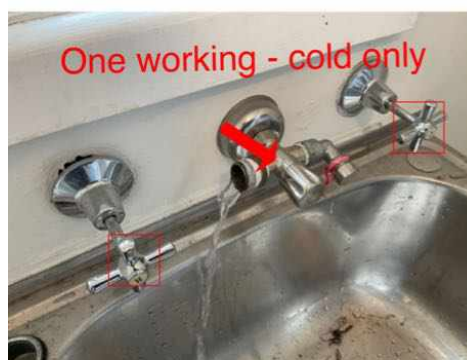
Building:	Building 1
Location:	Laundry
Finding:	Taps not working
Information:	The tap in this area appears to have not been installed correctly. This middle tap is working with cold water. The two outside laundry tub taps were not working at the time of the inspection. A qualified plumber should be appointed to re-fix these plumbing fittings.

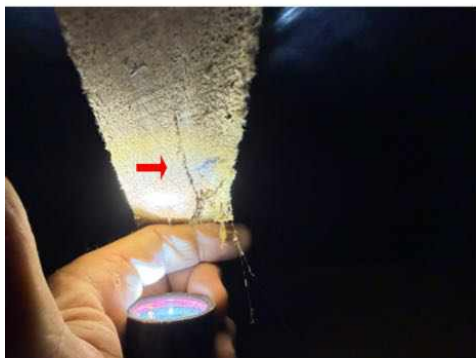
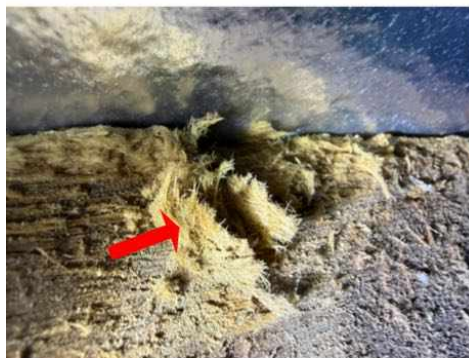
Building:	Building 1
Location:	Some Roof cavity areas
Finding:	Chemical delignification identified
Information:	Minor chemical delignification also known as wood defibration was found in the rafters and refers to the chemical breakdown of timber building elements. This breakdown of the Lignin deteriorates the wood impacting on the structural integrity and tensile strength of the affected building element.

Chemical delignification is most common near marine environments due to the high levels of salt in the air however this deterioration may also occur in other areas where timber elements are frequently exposed to damaging gases chemicals etc.

Where timber building elements have minor deterioration, these areas should be monitored and repair and / or replacement may be required in the future if the damage continues. The likely cause of the defibration should also be investigated and dealt with accordingly.

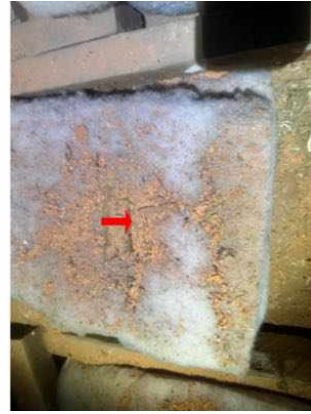
Building:	Building 1
Location:	All Roof cavity areas
Finding:	Roof tile deterioration - Fretting
Information:	Fretting has been observed in the roof void evidenced by dust from the tiles settling on the insulation. This condition indicates premature deterioration of the tiles, which may be caused by poor-quality or unsuitable tiles, excessive moisture exposure, inadequate sealing, or general wear over time. This appears to be very minor at the time of the inspection.

This should be checked every 2 years and if the tile fretting worsens, a qualified tiler or building contractor should be engaged to assess the affected areas and carry out appropriate remedial works, which may include sealing, surface treatment, or replacement of the deteriorated tiles, and investigation of any underlying moisture issues.

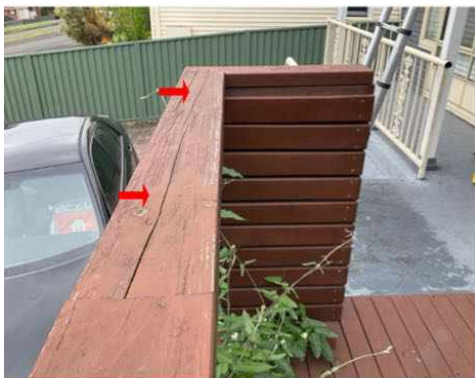
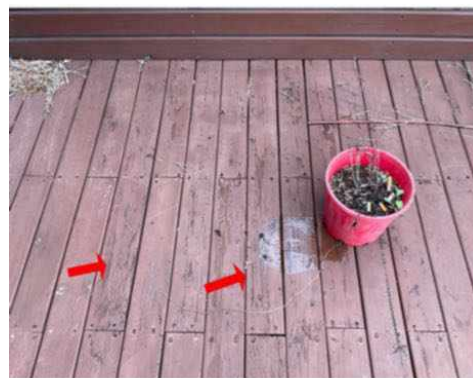
Building: Building 1
 Location: Pictured external areas
 Finding: Building elements - Damaged
 Information: Evidence of minor damaged areas was identified at the time of the inspection. These include -

1. Some front and rear decking areas show weathering and minor split timbers.
2. The shower door is not fitted to the shower.
3. The shower head sprays water near the toilet.

A carpenter would be the trade responsible for rectification of these areas when convenient.

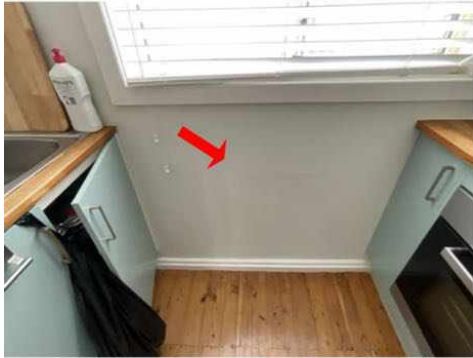
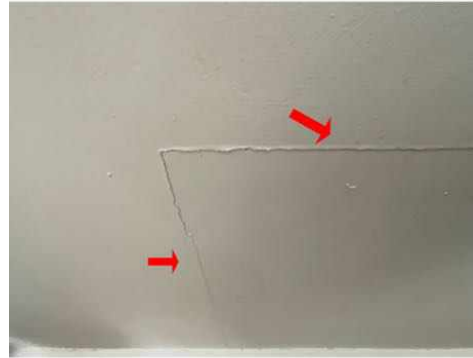
Building:	Building 1
Location:	Kitchen
Finding:	Cracking - Damage Category 1 - Fine (up to 1mm)
Information:	Although fine cracks are quite noticeable, they are often only considered to be an appearance defect, and usually do not indicate any structural damage. Generally, the cause of a fine crack is indicative of a separation between building materials and finishes (e.g. paint, plaster, etc.) along joints.

Cracking of this nature can generally be repaired with minor sanding, filling and/or repainting. Such works should be performed by a qualified painter or a general handyman.

Monitoring of all cracking should be conducted frequently. Always contact a building inspector should cracks widen, lengthen, or become more numerous.

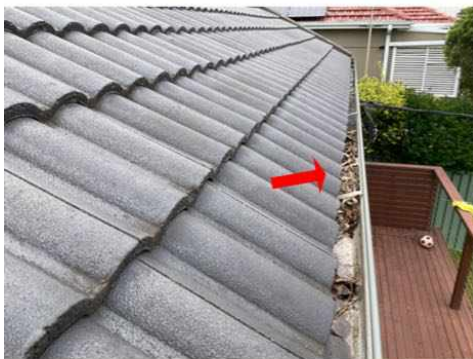
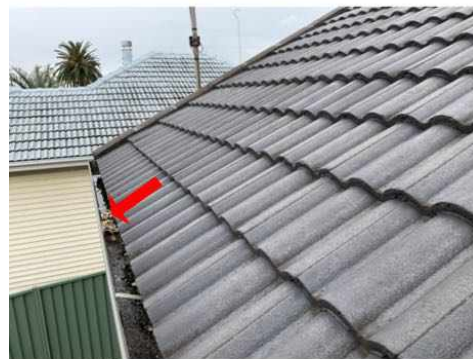
Building: Building 1
 Location: Roof exterior
 Finding: Gutters - Full and blocked
 Information: The guttering on around the roof was found to be blocked at the time of the inspection. Roof plumbing structures, such as guttering and downpipes, should be free of all debris to prevent blockages. Blockages of the guttering and downpipes will lead to pooling and accumulated water overflows, which is likely to subsequently flood eaves and exterior walls.

Blocked gutters are likely to lead to high levels of moisture in the affected areas which can cause rust and decay of the gutters and downpipes and wood rot to adjoining timber areas. Blockages in gutters should therefore be removed immediately to ensure dry conditions are maintained.

It is highly advised that gutters be cleaned by the homeowner or a general handyperson as a matter of urgency.

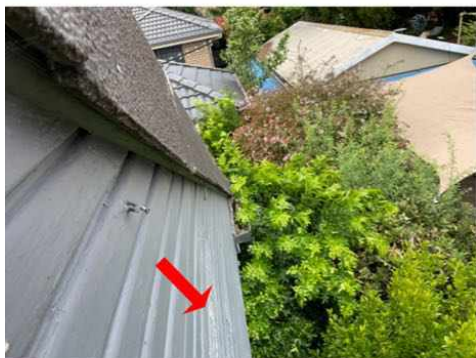
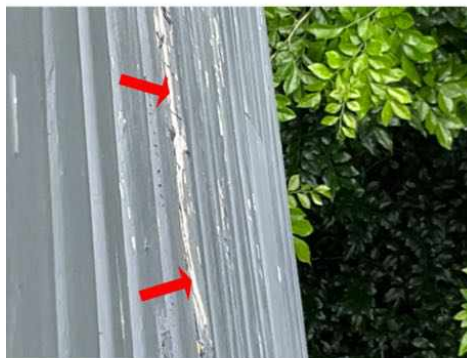
Building:	Building 1
Location:	Pictured right wall and bathroom
Finding:	Wood rot
Information:	The building shows evidence of wood rot. Wood rot, also known as Fungal Decay, occurs when timbers and other cellulose building materials are exposed to damp conditions on an ongoing basis. This could be the result of exposure to weathering over a prolonged period of time, or the attraction of excessive moisture from other abutting building materials.

Early intervention and regular maintenance, particularly of exterior timbers, will prolong the useful life of these building elements. Prior to any works being performed, the cause of the moisture that has created the visible wood rot should be identified and addressed in a suitable manner. Replacement of affected timbers may then be a necessary step in protecting surrounding building elements from such deterioration.

A qualified carpenter or registered builder may also be required to replace affected building materials.

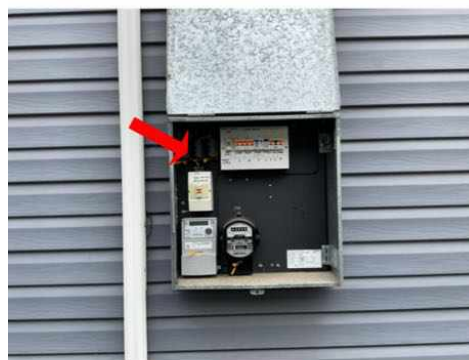
Building:	Building 1
Location:	Meter Box
Finding:	Termite Management System - no evidence of a chemical installation
Information:	The application of a post-construction chemical termite barrier is highly recommended for all properties. Such barriers are highly effective in preventing termite attack on any timber building elements throughout the property.

The client may consider gaining further advice from a pest controller as to the costs and procedures involved with a 'chemical' application. It is recommended that obtaining such advice be a short-term priority.

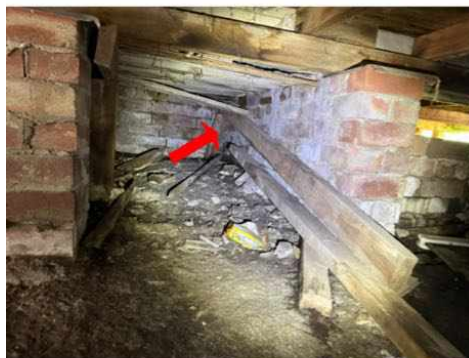
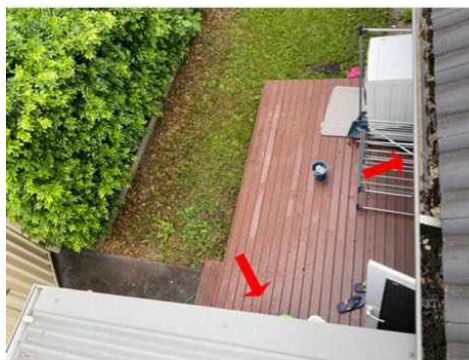
Building:	Building 1
Location:	Yard - front
Finding:	Bridging - Vegetation and decking
Information:	Where vegetation and decking obstructs inspection of building elements, also known as bridging as it provides a bridging point for the access of termites, full inspection can not be achieved. Consequently moisture or dampness may be present and the areas becomes conducive to termite activity. Plants and decks against or very close to buildings provide cover, shade and can provide an environment that is attractive to termite infestation.

The removal and replanting of plant species that do not provide "cover" or cutting back of existing vegetation and leaving a small gap between decking and the building walls will assist greatly in preventing Bridging from occurring.

The removal of any such stored building or plant materials that may be conducive to termite activity should be carried out as soon as possible and arrange re inspection to minimize the risk of termite attack.

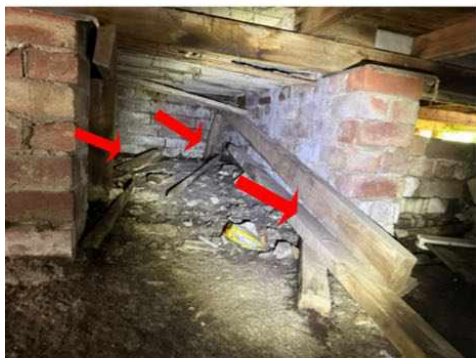
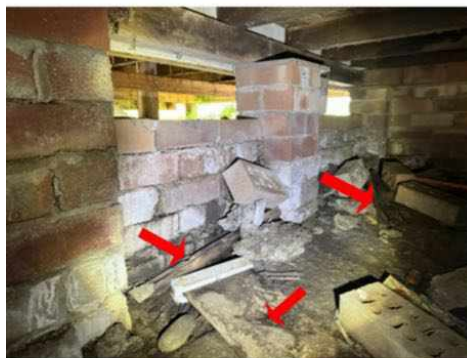
Building:	Building 1
Location:	Subfloor
Finding:	Timber in contact with the ground
Information:	Any timbers in direct ground contact provide opportunity for concealed termite entry and are likely to be subject to premature rot and decay as the soil retains moisture or damp conditions against the timbers.

Removal of all waste timber that is in direct contact with ground is highly advised. This timber is promoting mould and wood rot and is very attractive to termites.

Frequent pest inspections are advised to readily identify any termite activity in these areas.

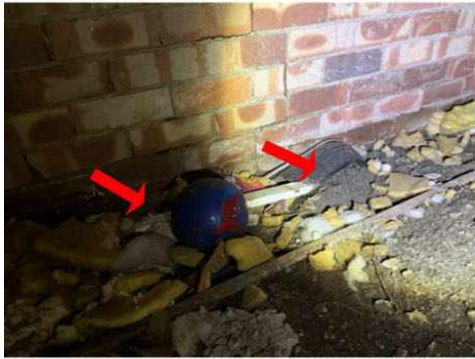
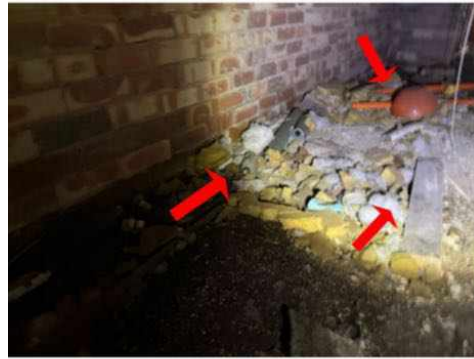
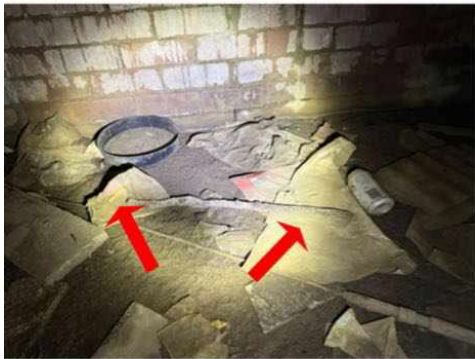
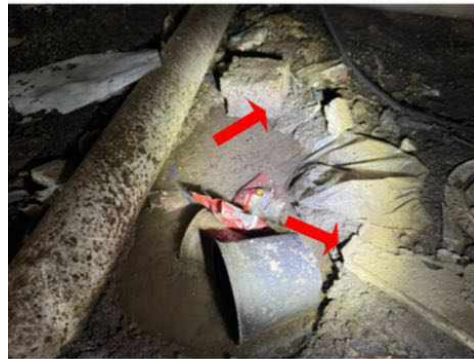
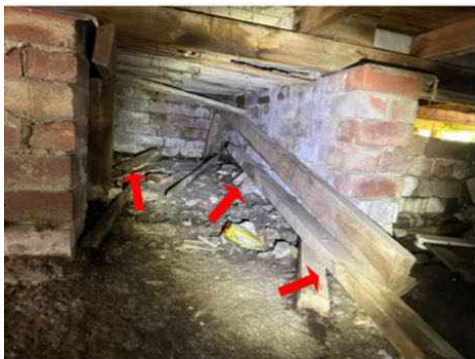
Information: An array of debris was found in the subfloor area at the time of inspection. Debris in this area restricts subfloor ventilation and creates potential for concealed pest entry. Stored timbers and other materials may also make the area susceptible to termite activity and wood rot.

A clear and empty subfloor will be better ventilated and easier to maintain in a dry condition. The removal of any timber debris is vital in minimising the risk of termite or wood borer activity.

Debris in the subfloor should be removed as soon as possible. Depending on the location and amount of debris and stored items, the homeowner may elect to undertake this task. Alternatively there are a large number of rubbish removal subcontractors that could undertake these works.

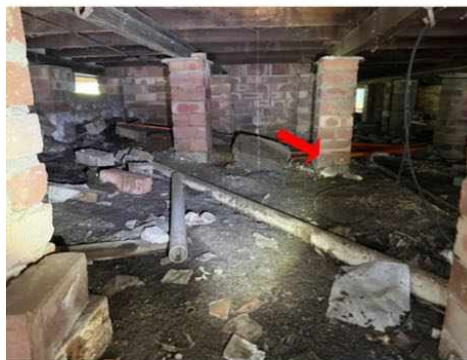
Building:	Building 1
Location:	Subfloor
Finding:	Damp - Rising
Information:	Rising damp describes the upward movement of water in low sections of building elements (e.g. walls) by capillary action - the movement of water through porous materials such as bricks, sandstone or mortar.

Rising damp is generally managed by the installation of a damp proof course during construction. A Damp Proof Course (DPC) is an impermeable barrier at the base of the wall above ground level. However, many 19th Century buildings have no damp course installed, or the materials have failed. The DPC may have been omitted as a

consequence of poor workmanship, or it may have been bridged where materials built up against the side of the house allow moisture ingress above the DPC level.

The first step in addressing rising damp is to diagnose the cause. The identified cause should be addressed first before addressing the appearance and other defects which have resulted from the rising damp. If the original cause is not resolved, further cases of damp are likely to ensue, resulting in secondary defects.

Consultation with a qualified plumber is advised immediately to identify the cause of the damp and perform remedial works as required.

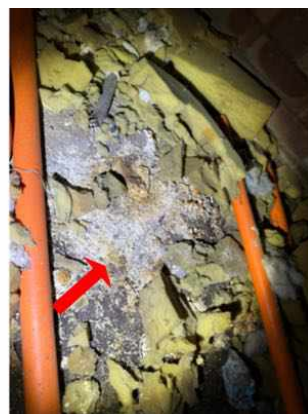
Building:	Building 1
Location:	Subfloor
Finding:	Mould - Present in subfloor
Information:	Where evidence of mould growth was noted, there may be environmental, biological or health issues associated with the report. A specialist inspection by a suitably qualified environmental health inspector is warranted, where mould is extensive or where any

Subfloor mould is generally caused by moisture ingress, lack of external drainage, lack of adequate ventilation and subfloor debris present. These issues need rectification

Generally, the client is advised to ensure that the general environment is free of moisture and humidity to aid in the prevention of mould formation and development.

to stop mould development. Any mould found during the inspection should be cleaned immediately by a cleaning contractor or the homeowner as applicable.

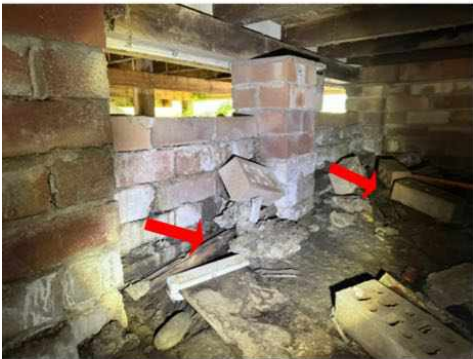
Note - See ALL wood rot photos, all these show fungal decay.

In this case, the affected timber element is in a decaying state and will need replacement by a carpenter or licensed builder.

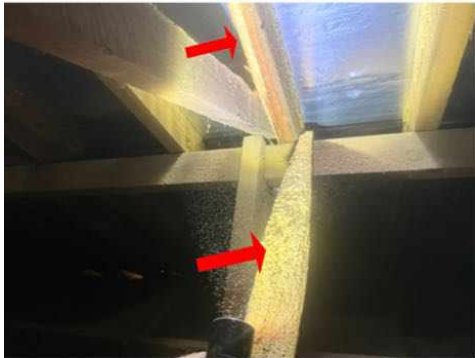
The other commonly known borer the Anobium borer is more likely to attack floorboards and may cause severe structural damage to flooring areas.

As no live wood borer activity was identified treatment is not required at this time. As the borer has only damaged 20% of this rafter treatment is not required at this time.

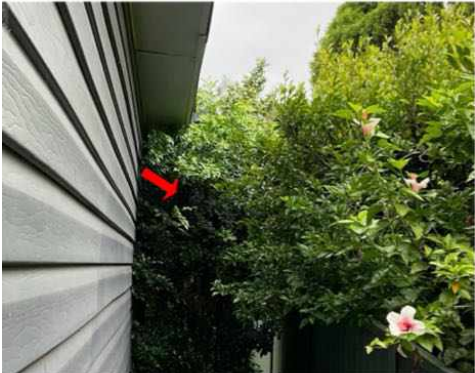
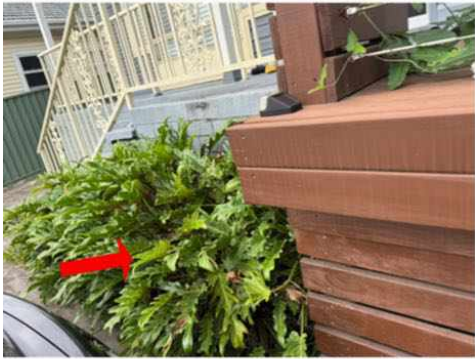
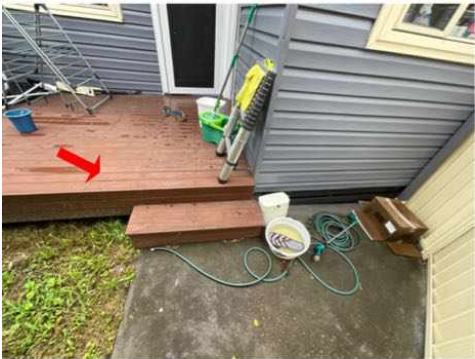
Building: Building 1
 Location: All External Areas
 Finding: Additional Photos - Obstructions and Limitations of EXTERNAL AREAS
 Information: These photographs are an indication of the obstructions and limitations which impeded full inspection of external areas at the time of inspection. These obstructions can hide an array of defects and should be removed to allow full inspection to be carried out. A re-inspection is recommended once the areas are made accessible.

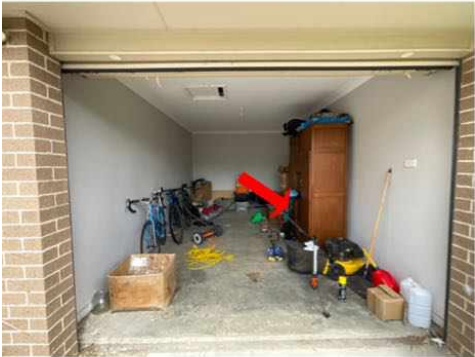
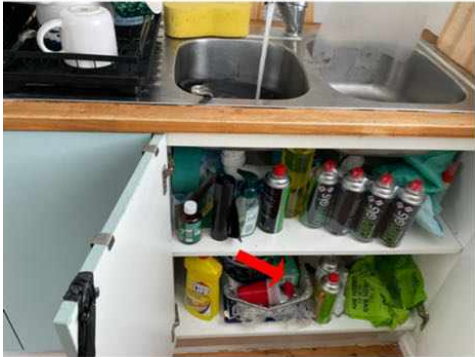
Building: Building 1
Location: All Internal Areas
Finding: Additional Photos - Obstructions and Limitations of INTERNAL AREAS
Information: These photographs are an indication of the obstructions and limitations which impeded full inspection of Internal areas at the time of inspection. These obstructions can hide an array of defects and should be removed to allow full inspection to be carried out. A re-inspection is recommended once the areas are made accessible.

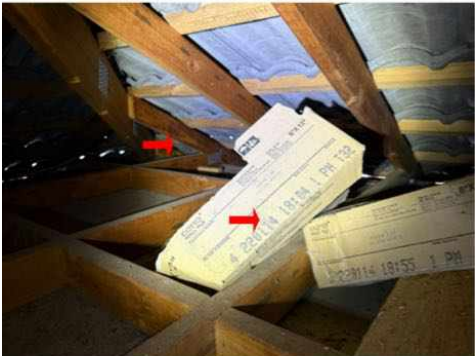
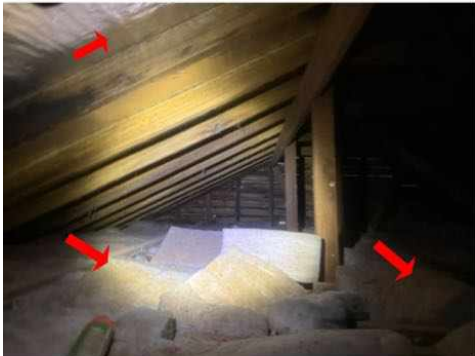
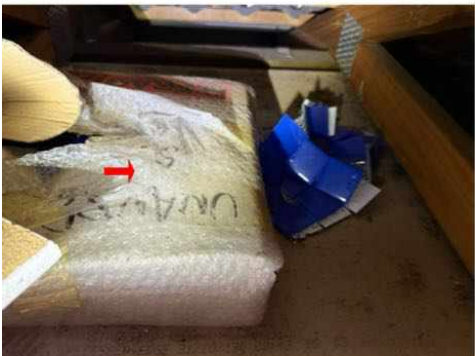
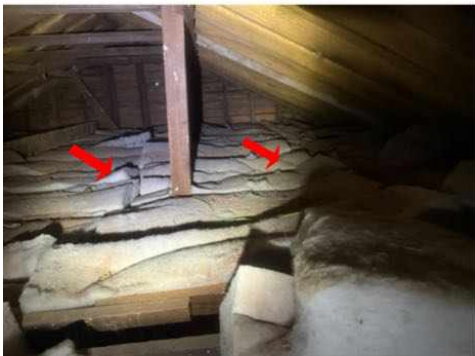
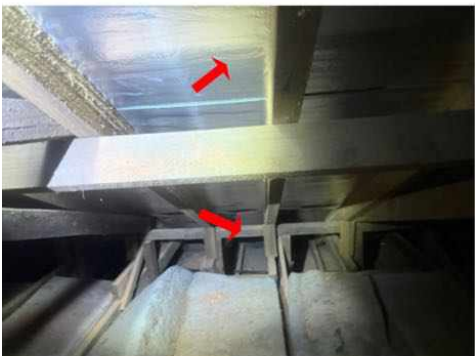
Building: Building 1
 Location: All Roof cavity areas
 Finding: Additional Photos - Obstructions and Limitations of the ROOF CAVITY
 Information: These photographs are an indication of the obstructions and limitations which impeded full inspection of roof cavity areas at the time of inspection. These obstructions can hide an array of defects and should be removed to allow full inspection to be carried out if applicable. A re-inspection is recommended once the areas are made accessible.

The inspection was also limited to areas with an allowable crawl space of 600mm x 600mm, in particular towards the external walls where the roof line diminishes, these

areas were not accessible.

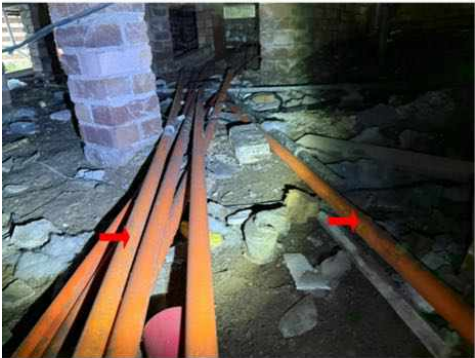
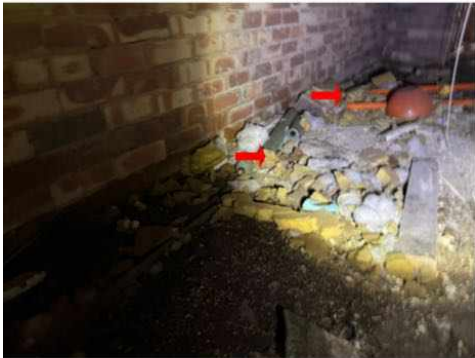
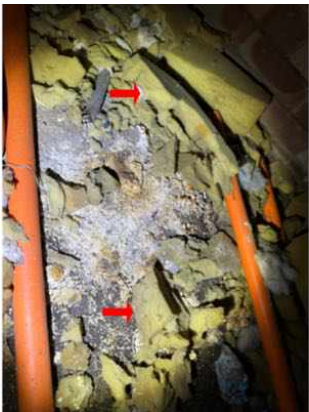
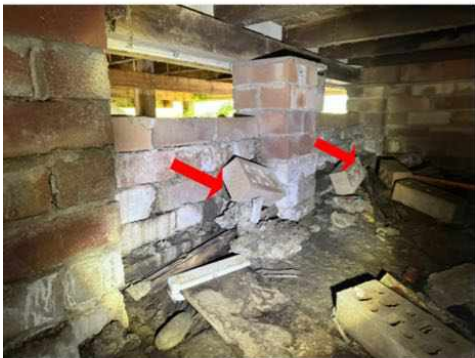
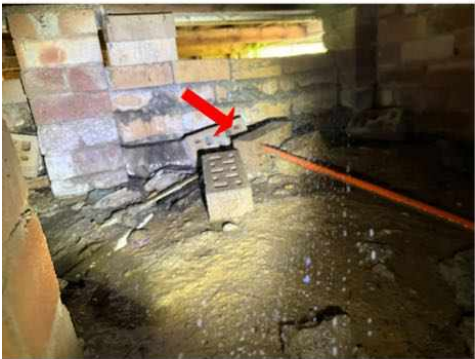
Building: Building 1
Location: All Subfloor Areas
Finding: Additional Photos - Obstructions and Limitations of SUBFLOOR AREAS
Information: These photographs are an indication of the obstructions and limitations which impeded full inspection of subfloor areas at the time of inspection. These obstructions can hide an array of defects and should be removed to allow full inspection to be carried out. A re-inspection is recommended once the areas are made accessible.

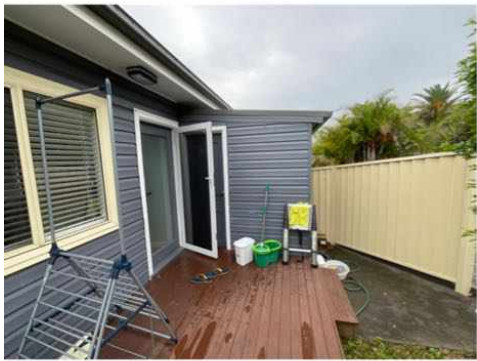
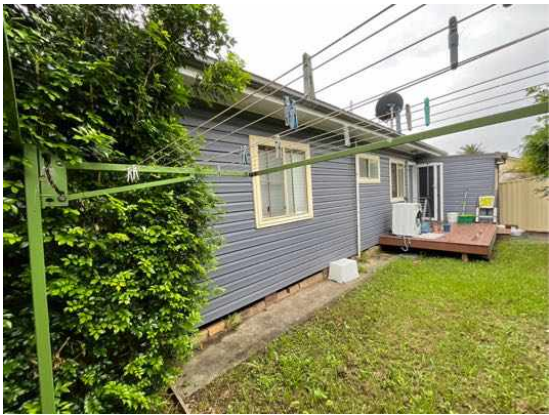
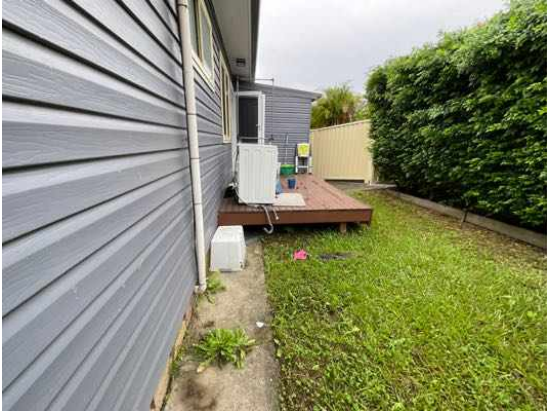
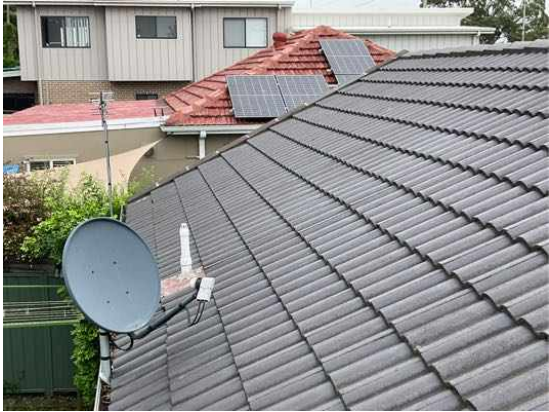
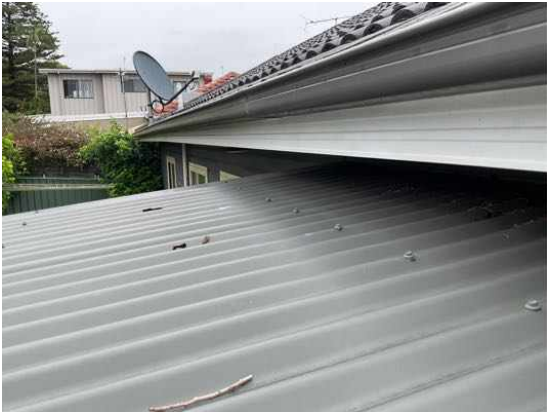
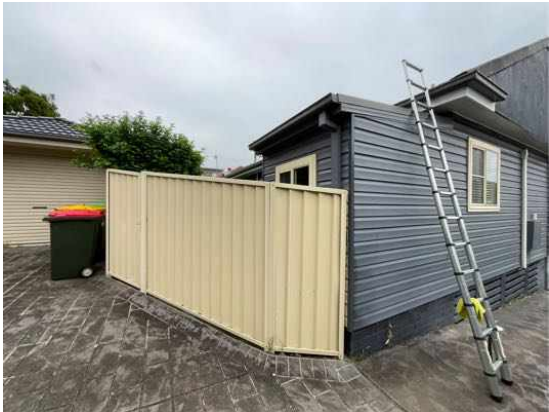
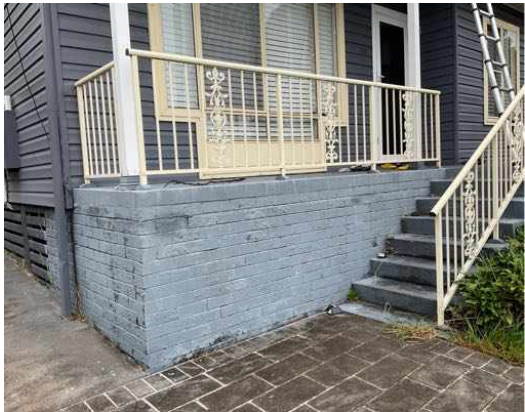
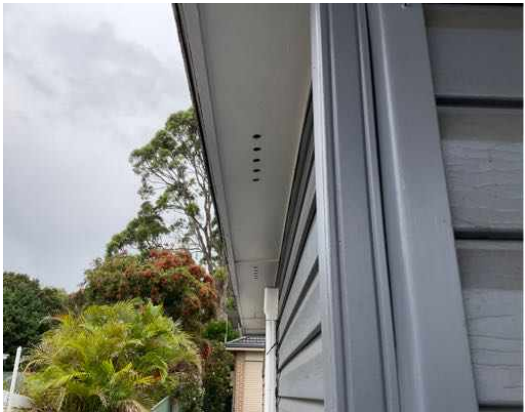
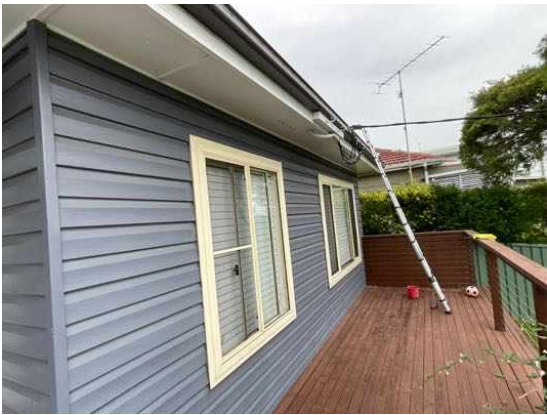
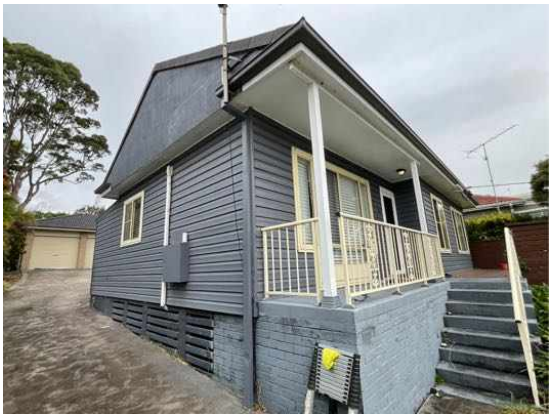
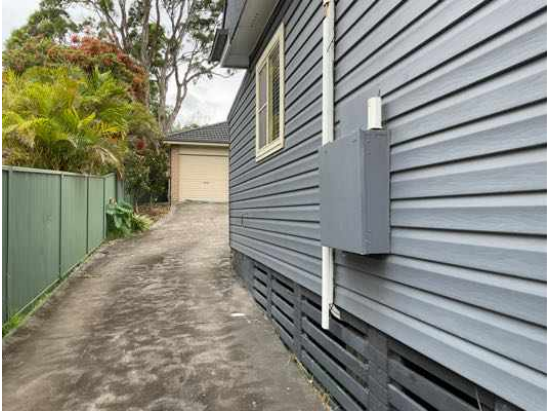
Building: Building 1
Location: All External Areas
Finding: Additional Photos
Information: Additional photos are provided for your general reference

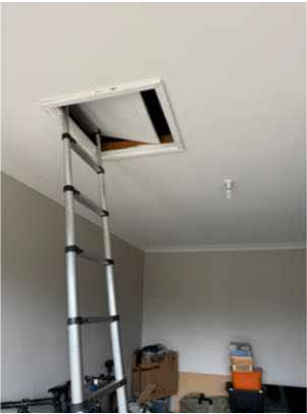
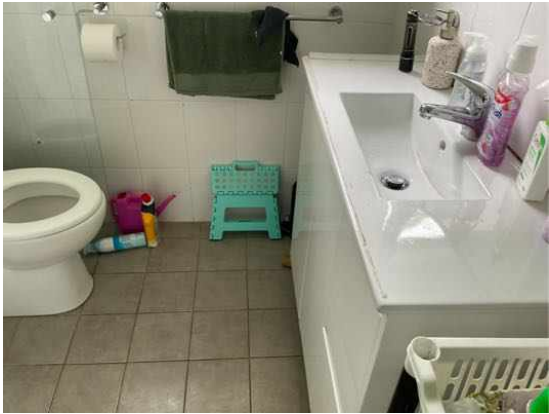
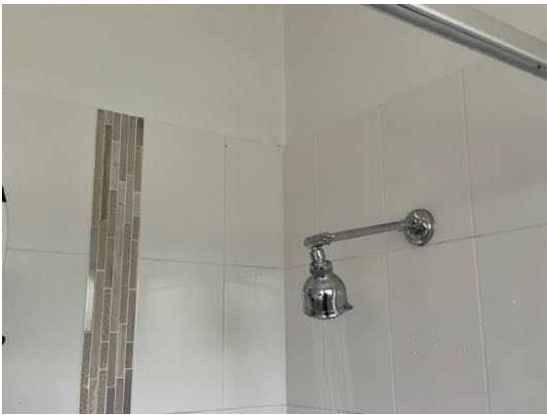
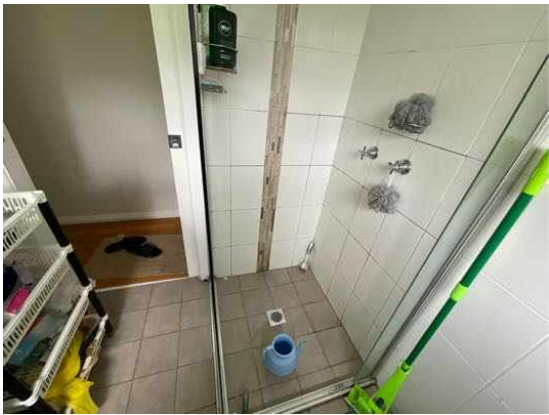
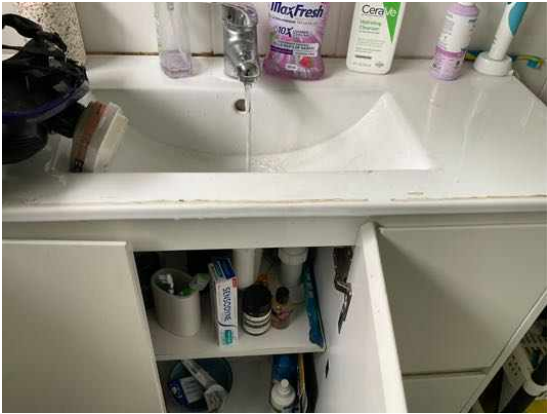
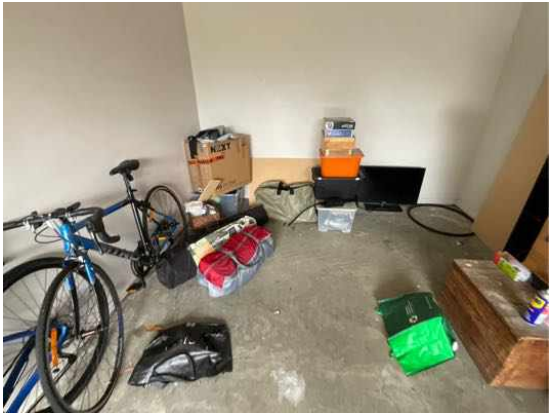
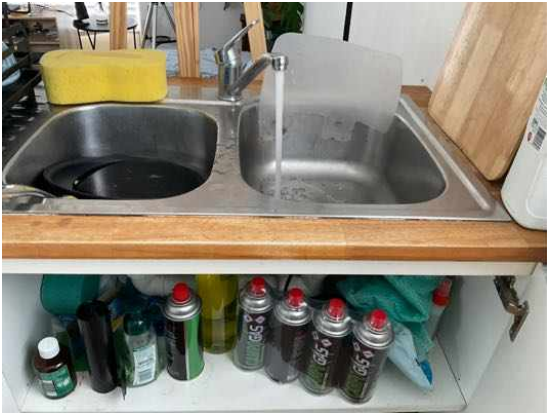
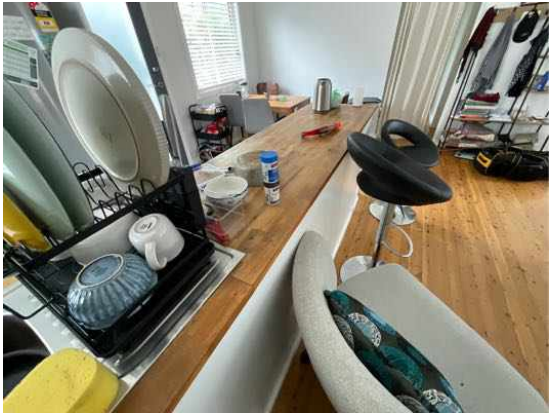
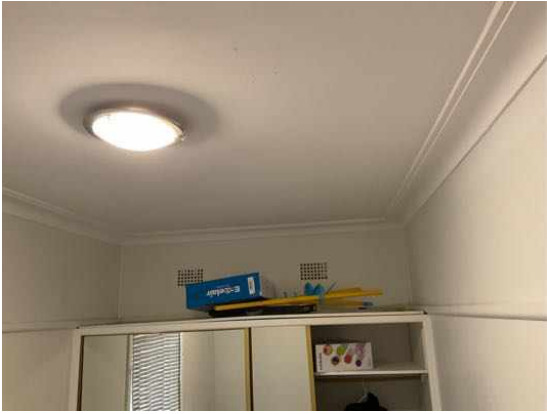
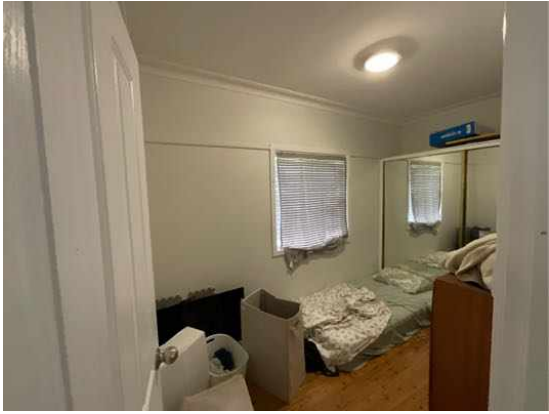
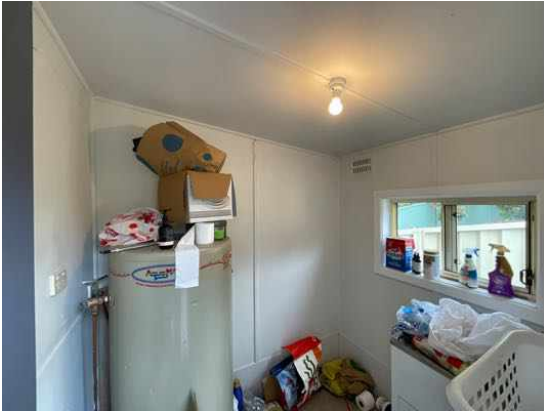
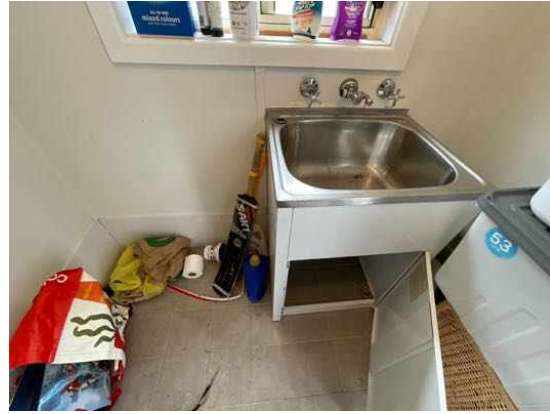
Building: Building 1
Location: All Internal Areas
Finding: Additional Photos
Information: Additional photos are provided for your general reference

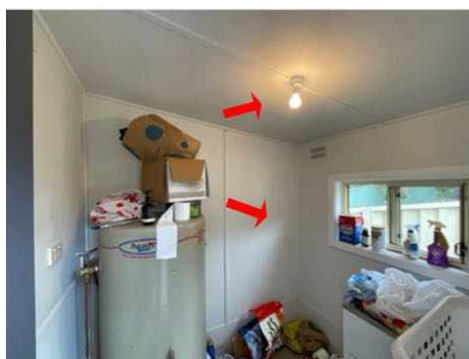
Building:	Building 1
Location:	Roof exterior
Finding:	Asbestos - Suspected ACM Identified on Site
Information:	Reporting on Asbestos is outside the Scope of this Report. This suspected defect is highlighted as a caution only. We suspect, based on our experience in the building industry, that there is a higher risk of the identified building element containing asbestos.

As Asbestos Reporting is outside the scope of this report, we advise that you consider a separate Asbestos Inspection and Condition Audit, which can include the taking of samples for definitive confirmation of the presence of Asbestos.

In the interim, the client is advised to act with caution, especially when considering any damage to building materials general wear and tear renovations extensions demolition and general maintenance activities due to the suspected presence of Asbestos.
