Building and Timber Pest Inspection Report

Inspection Date: Tue, 27 Jan 2026

Property Address: 87 Hastings St, The Ponds NSW 2769,
Australia

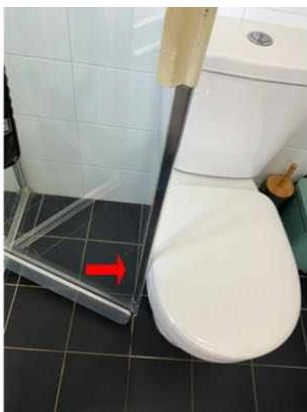
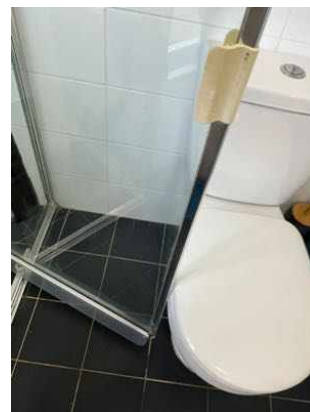
Building:	Main Building
Location:	Bathroom
Finding:	Shower screen - Hitting toilet
Information:	A safety hazard was identified in the bathroom of the property. The issue pertains to the shower screen, which, when fully opened, makes contact with the adjacent toilet. This situation poses an immediate risk to the safety and well-being of occupants due to the potential for accidents and injuries.

Collision between the shower screen and the toilet can cause injury to individuals using the bathroom, particularly if the shower screen shatters upon impact. The repeated contact between the shower screen and the toilet can also result in damage to both fixtures, leading to costly repairs or replacements.

This is to be addressed prior to handover.

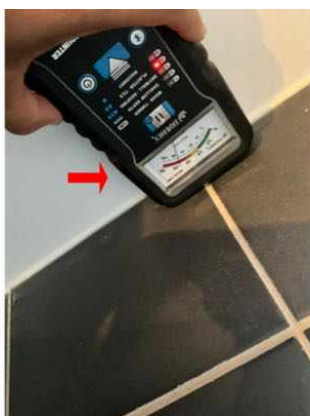
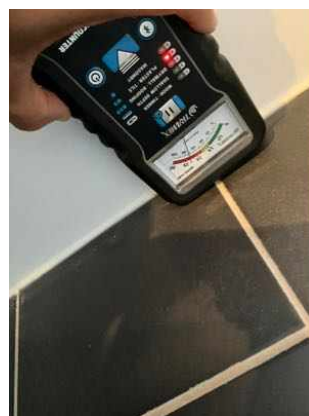
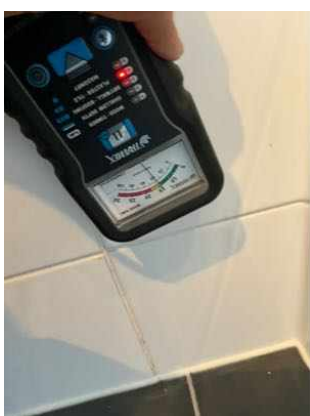
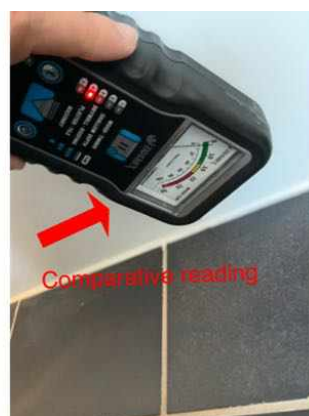
Damp is evident to the lower 300mm of wall to the shower alcove. This defect is quite common, and is suspected to have been caused by moisture permeating through the grouting in this area, which shows evidence of deterioration. Leaking pipes within the adjoining wall is also a possible cause.

Damp (or structural damp) refers to the presence of unwanted moisture in the structure of a building, either as the result of intrusion from outside, or condensation from within the structure. In the shower area, internal water leaks or other sources of

excessive moisture are generally the cause of damp.

Unmanaged damp in the shower recess is likely to facilitate the formation and development of mould and fungi growth, decaying associated building materials and compromising their structural integrity. It is important to address damp conditions, as the World Health Organisation notes that excess moisture leads - on almost all indoor materials - to growth of microbes such as moulds, fungi and bacteria, which subsequently emit spores and other matter into the indoor air. Exposure to these contaminants is associated with a wide range of respiratory and other health-related problems.

Consultation with a qualified plumber or bathroom specialist is advised immediately to identify the cause of damp and to perform remedial works as required. Where excessive mould growth is present, further inspection by a specialist environmental health inspector should also be considered.

Always ensure that sealant and grout is in good condition to prevent any moisture issues occurring in the future.

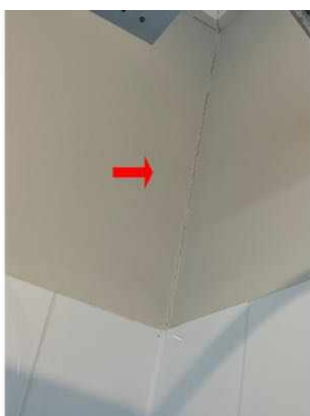
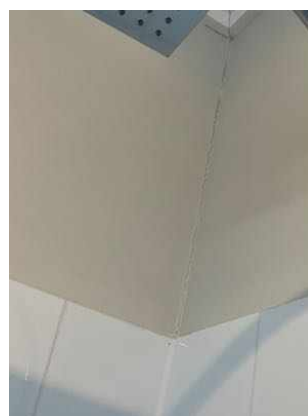
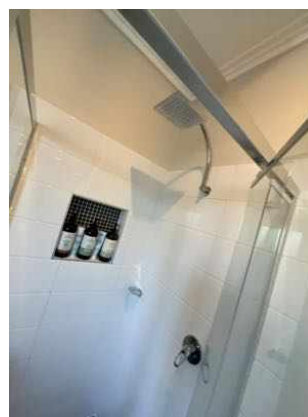
Finding 3.06

Building: Main Building
Location: Ensuite - Master

Finding: Gyprock - Crack (Fine)
 Information: Fine cracks have appeared in the gyprock , suggesting potential issues with settling or structural movement.

The fine cracks in the gyprock ceiling pose a risk of further widening, compromising the aesthetic appeal of the space, and potentially indicating underlying structural problems.

A skilled plasterer or a contractor specializing in drywall repairs should assess the extent of the cracks and address them promptly. Identifying and fixing the root cause of the issue, whether related to settling or structural concerns, is essential to prevent further damage and maintain the integrity of the ceiling.

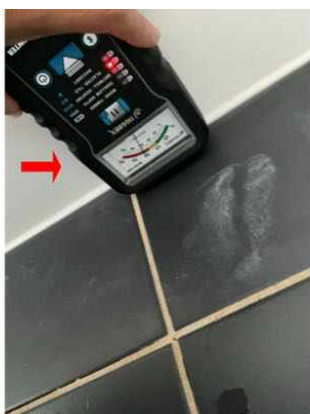
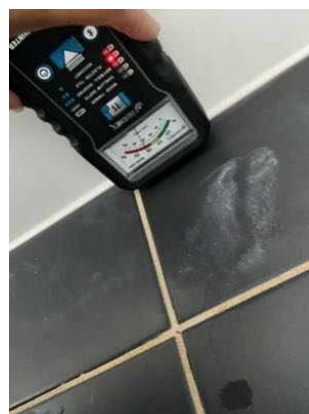
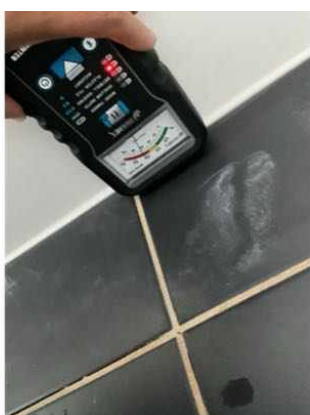
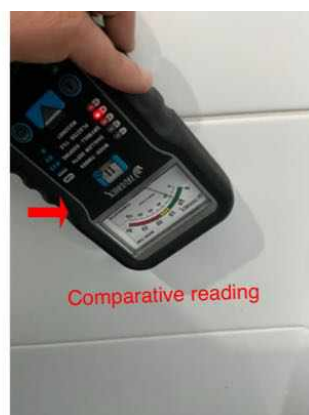
Finding 3.07

Building: Main Building
 Location: Bathroom
 Finding: Shower - Damp
 Information: Damp is evident to the lower 300mm of wall to the shower alcove. This defect is quite common, and is suspected to have been caused by moisture permeating through the grouting in this area, which shows evidence of deterioration. Leaking pipes within the adjoining wall is also a possible cause.

Damp (or structural damp) refers to the presence of unwanted moisture in the structure of a building, either as the result of intrusion from outside, or condensation from within the structure. In the shower area, internal water leaks or other sources of excessive moisture are generally the cause of damp.

Unmanaged damp in the shower recess is likely to facilitate the formation and development of mould and fungi growth, decaying associated building materials and compromising their structural integrity. It is important to address damp conditions, as the World Health Organisation notes that excess moisture leads - on almost all indoor materials - to growth of microbes such as moulds, fungi and bacteria, which subsequently emit spores and other matter into the indoor air. Exposure to these contaminants is associated with a wide range of respiratory and other health-related problems.

Consultation with a qualified plumber or bathroom specialist is advised immediately to identify the cause of damp and to perform remedial works as required. Where excessive mould growth is present, further inspection by a specialist environmental health inspector should also be considered.

Always ensure that sealant and grout is in good condition to prevent any moisture issues occurring in the future.

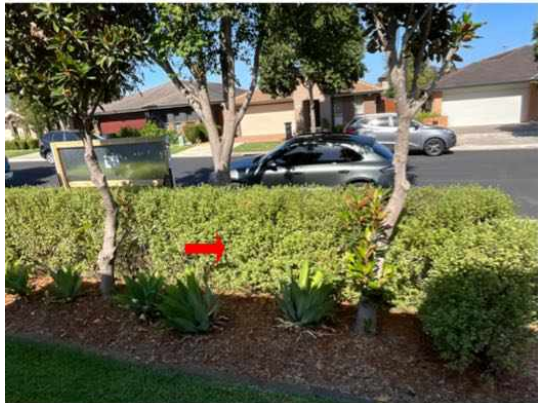
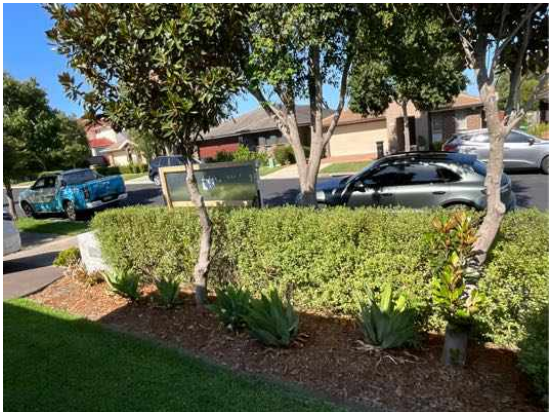
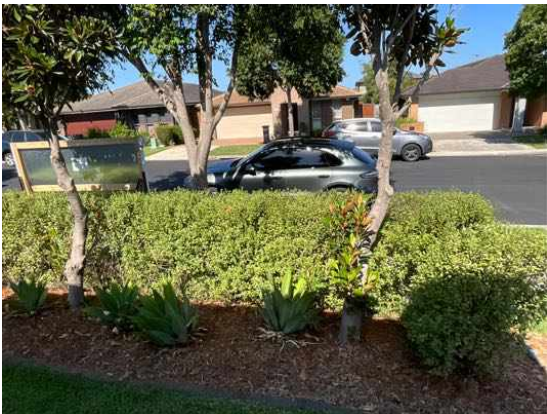
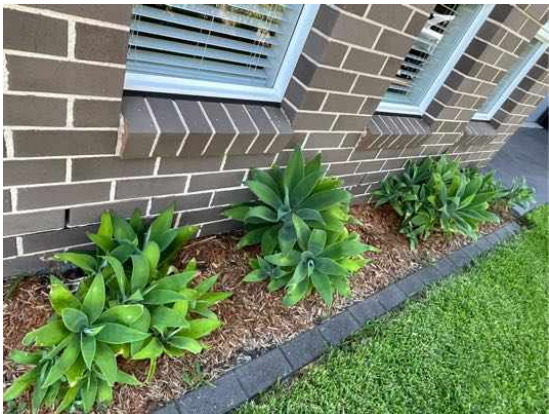
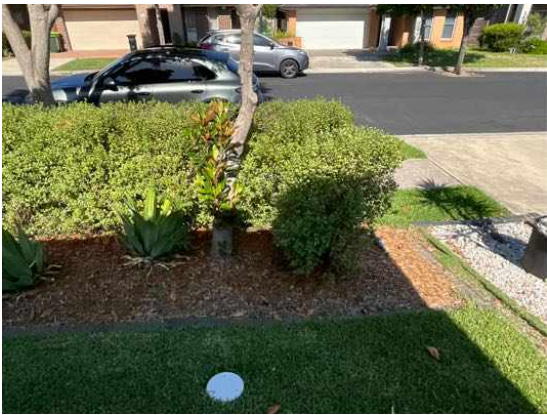
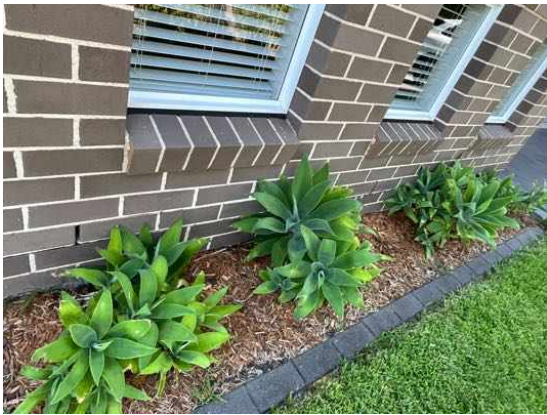
Finding 6.02

Building: Main Building
Location: All Areas
Finding: vegetation around a property can increase the risk of termite infestation
Information: The presence of vegetation around a property can increase the risk of termite infestation, as it provides a conducive environment for them. To address this, consider maintaining a clear space between the vegetation and your home. If you suspect a termite issue, it's advisable to consult with a licensed pest control professional for inspection and treatment.

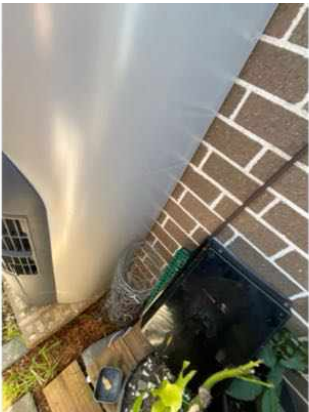
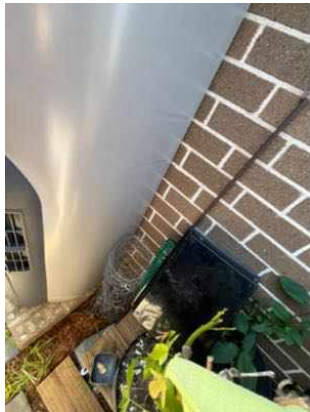
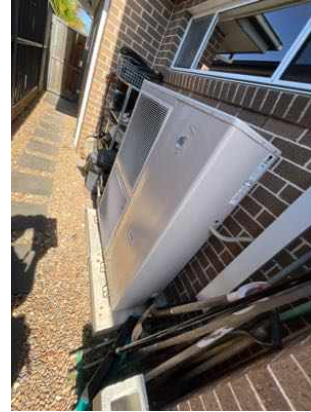
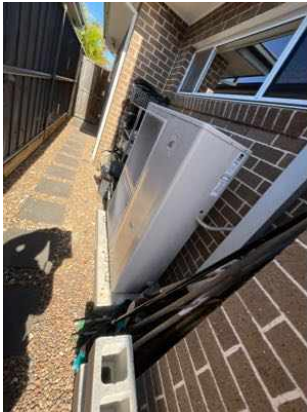
Finding 6.03

Building: Main Building
Location: All Areas
Finding: Bridging or Obstruction Conducive environment for Termites
Information: Bridging of termite barriers occurs when termites bridge (usually by building a mud tunnel) a termite barrier or inspection inspection zone or where termites have a passage, allowing them to bridge the barrier.

Where bridging has occurred full inspection is prevented and termites may enter a property in a concealed or undetected manner.

Recommended moving obstructions away from the external walls for further and future inspections.

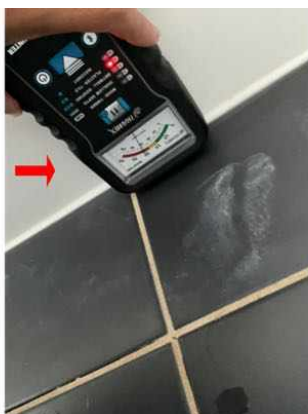
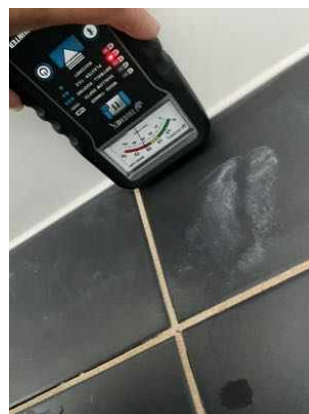
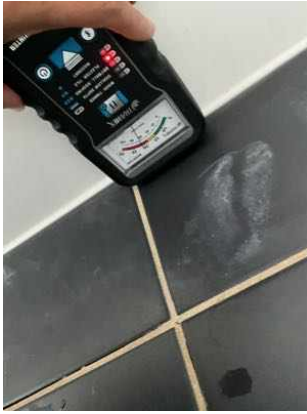
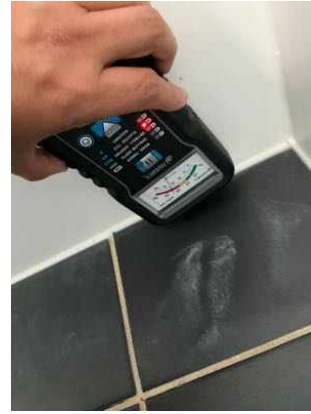
Finding 6.06

Building:	Main Building
Location:	Bathroom
Finding:	Excessive moisture - Conducive to Timber pest
Information:	Excessive moisture can attract termites and produce conditions that promote fungal growth and wood decay.

If mould growth has been found there may be environmental biological or health issues involved. In these cases an appropriately qualified inspector should also be contacted.

Prior to any remedial works being performed a qualified plumber should be appointed to further inspect the property and to identify the cause of the excessive moisture. Works to remove affected building elements may then be necessary and should be performed by an appropriate tradesperson.

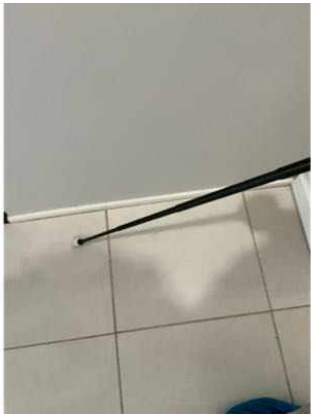
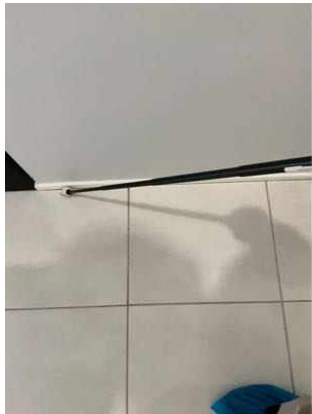
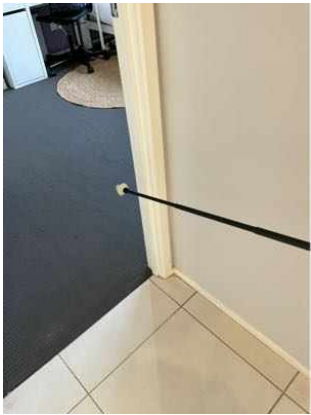
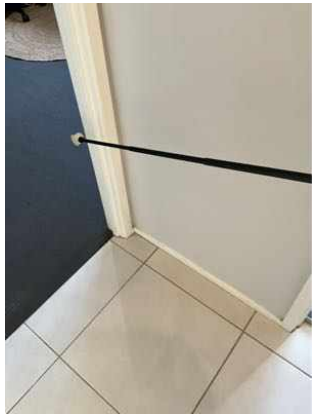
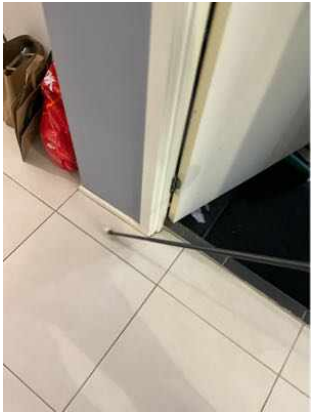
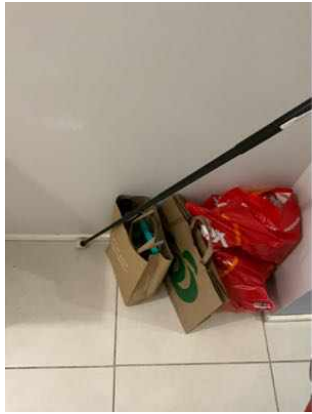
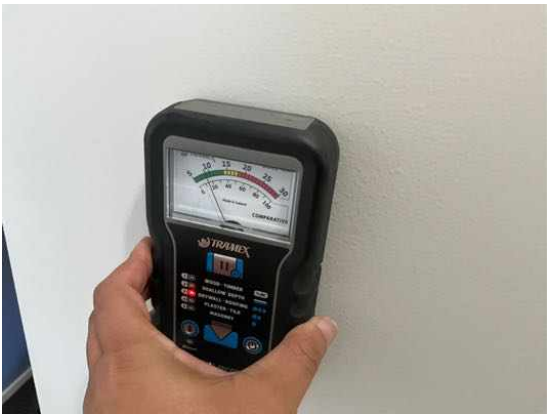
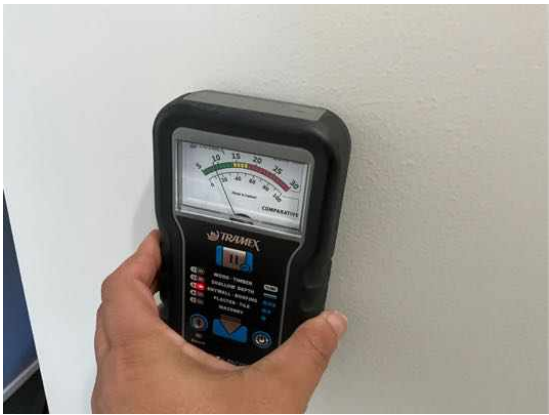
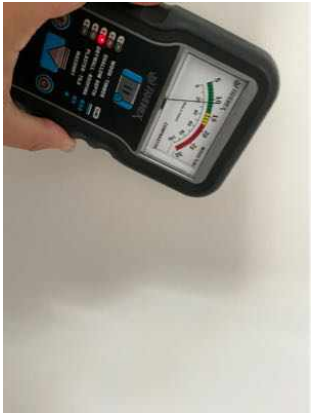
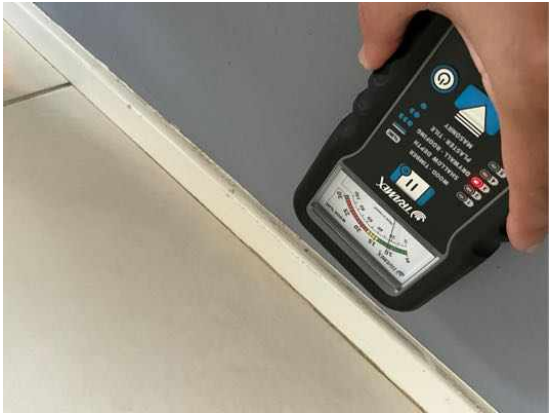
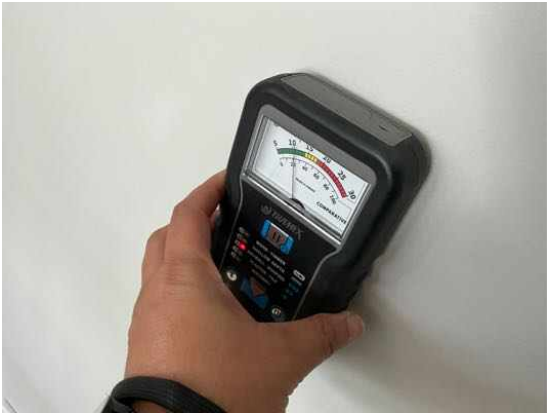
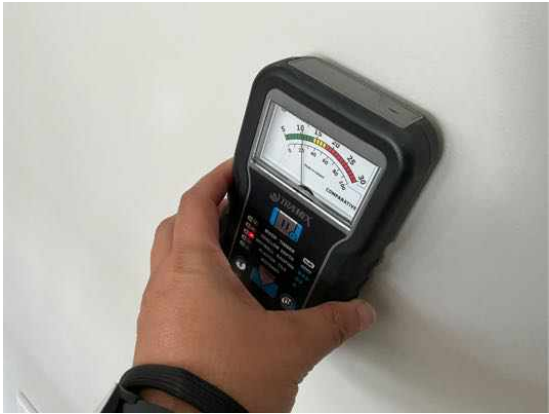
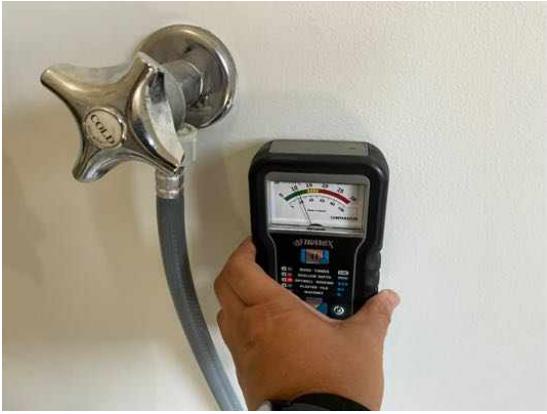
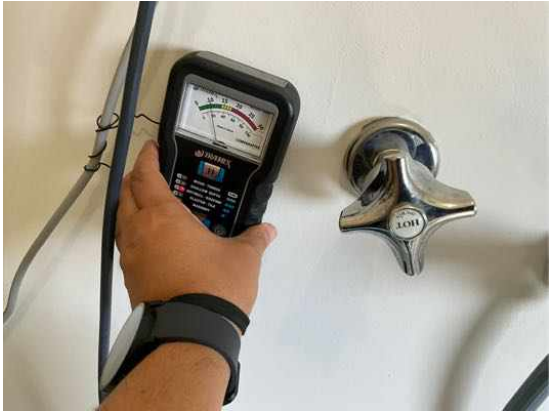
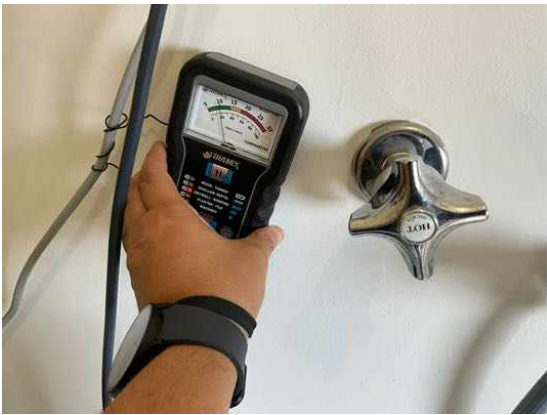
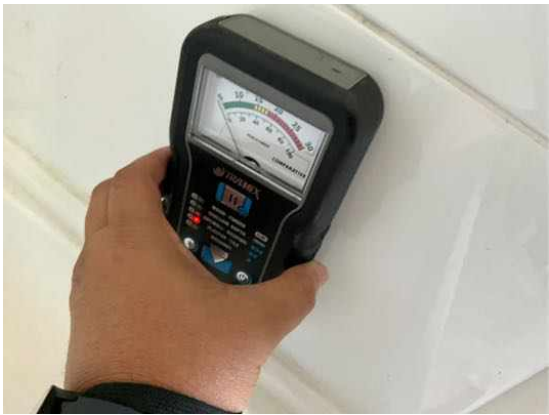
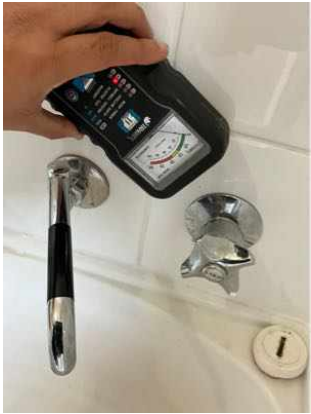
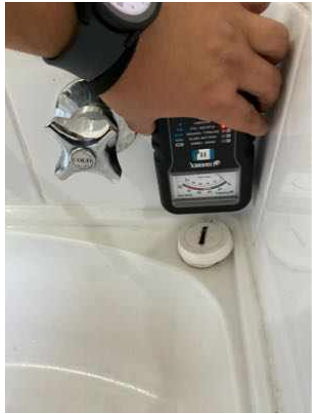
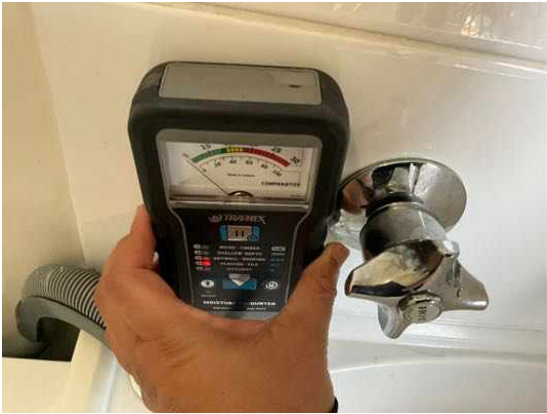
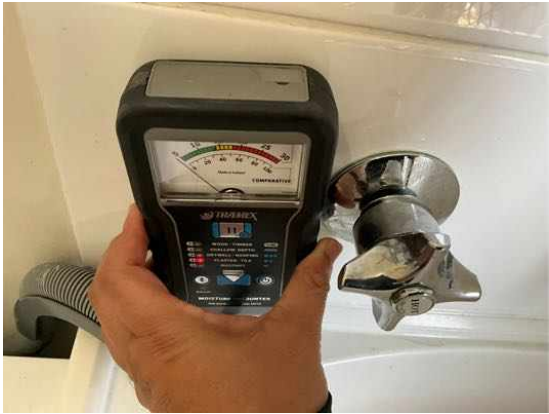
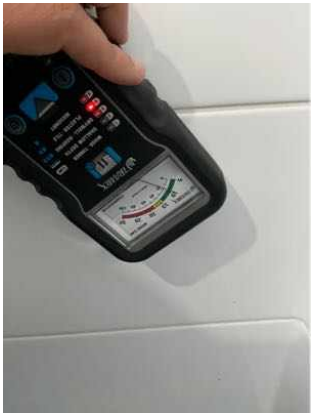
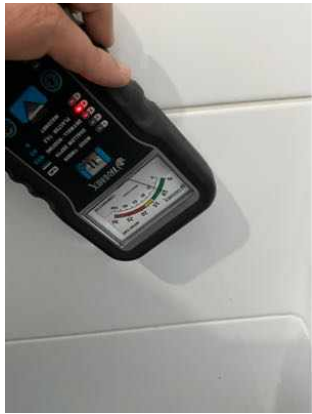
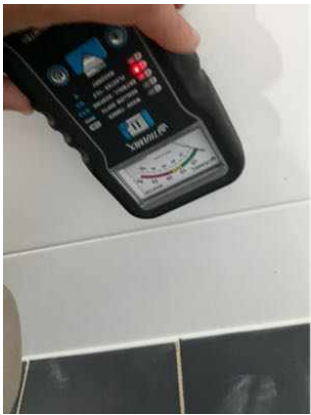
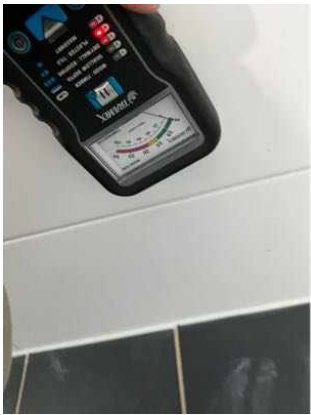
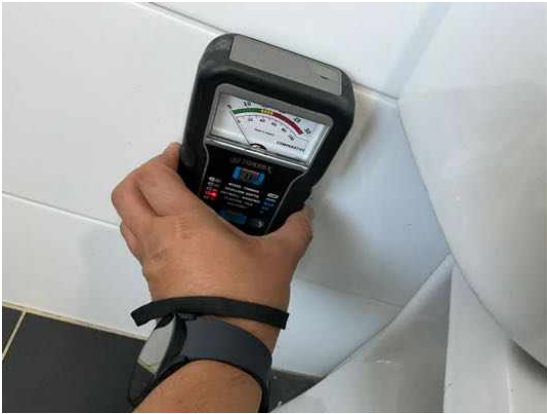
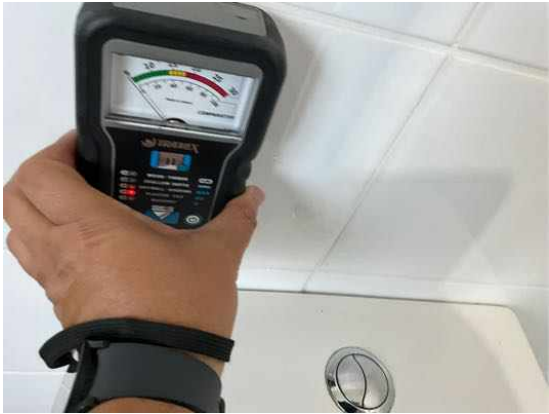
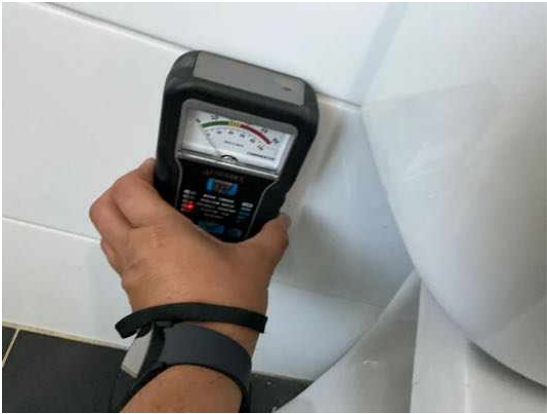
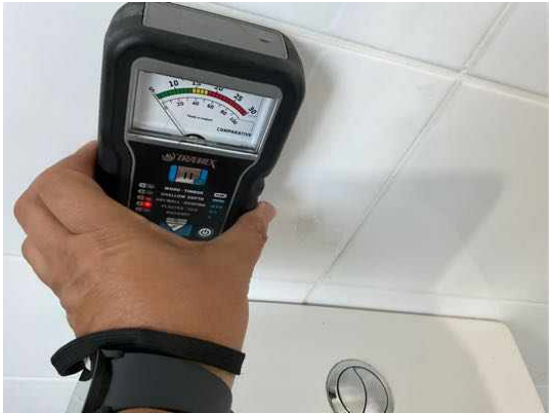
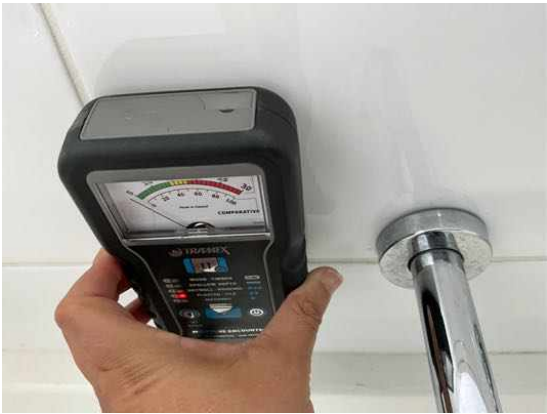
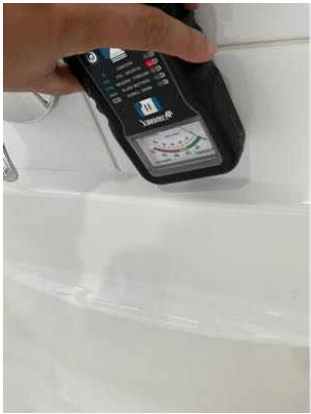
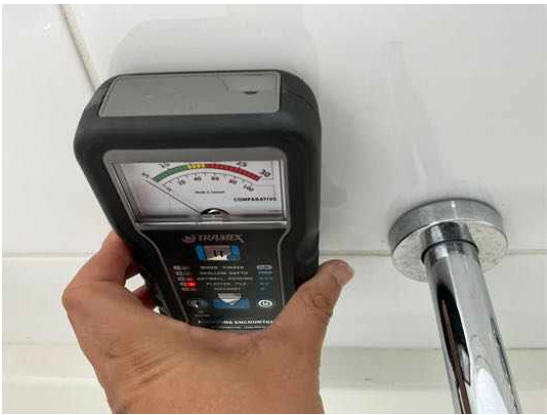
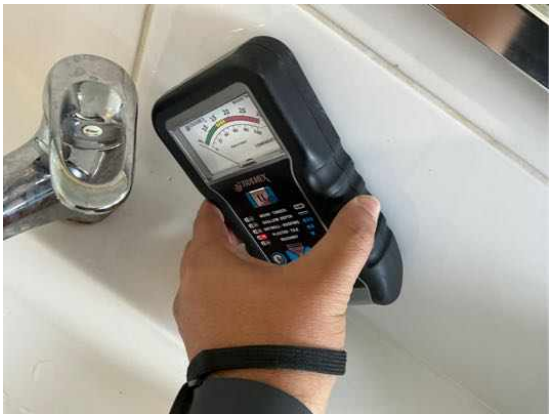
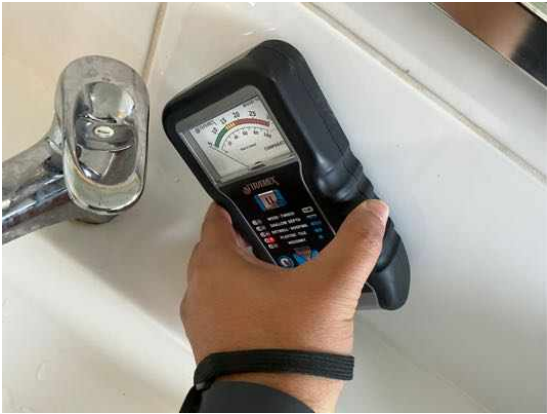
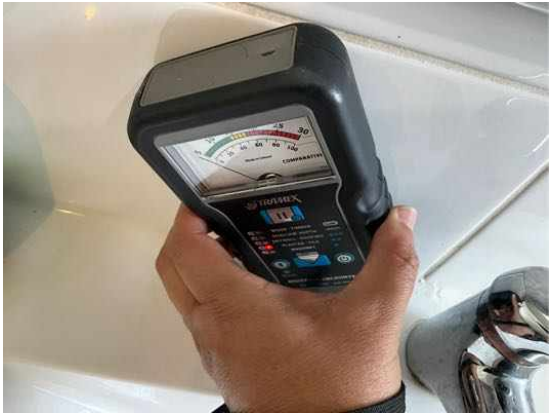
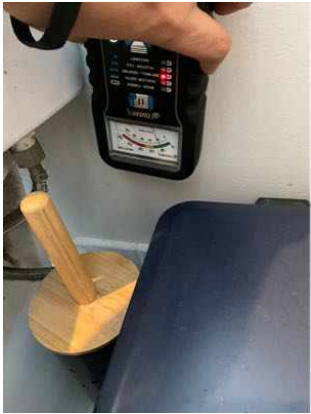
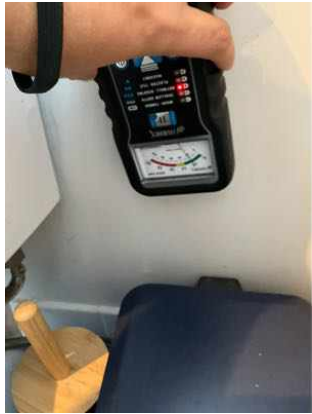
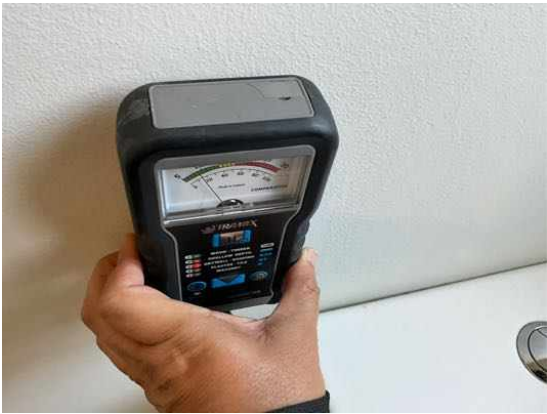
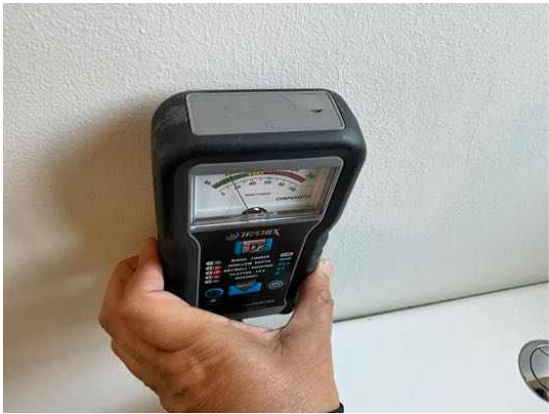
Building: Main Building
Location: All Areas
Finding: Additional Photos
Information: Additional photos are provided for your general reference

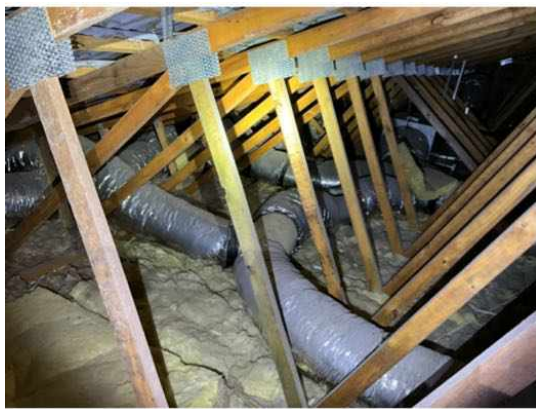
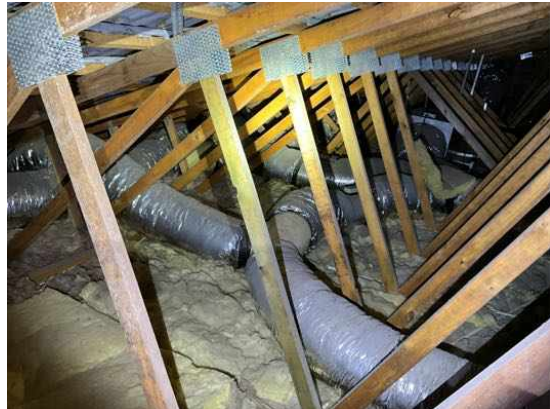
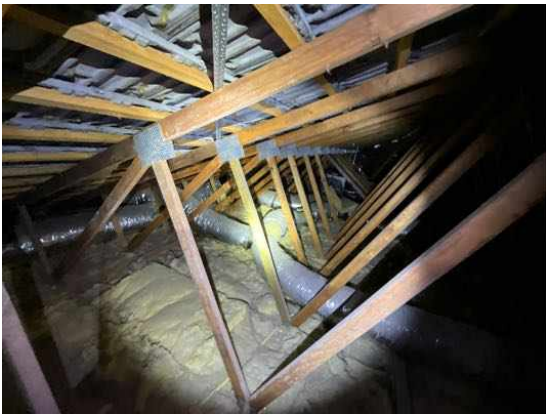
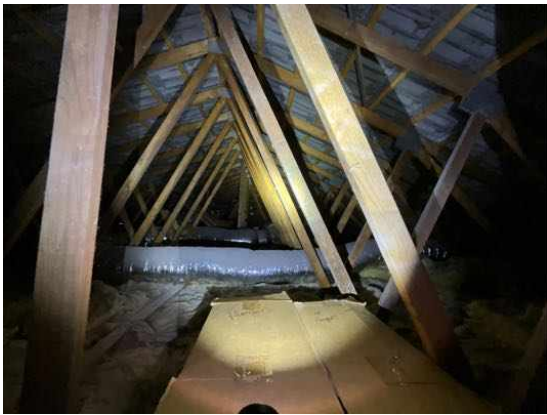
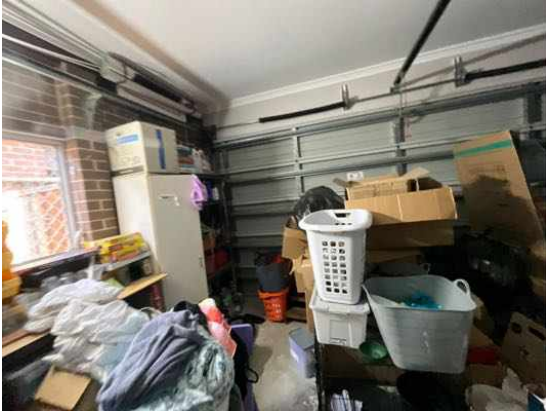
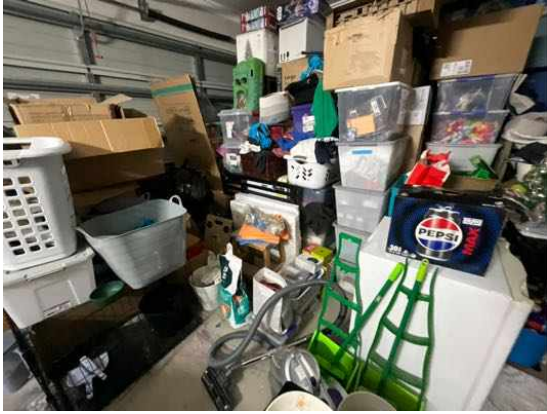
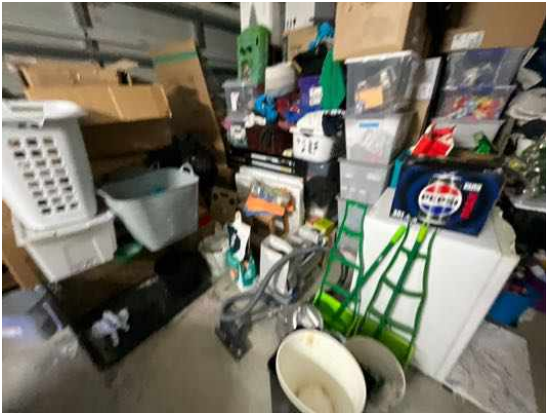
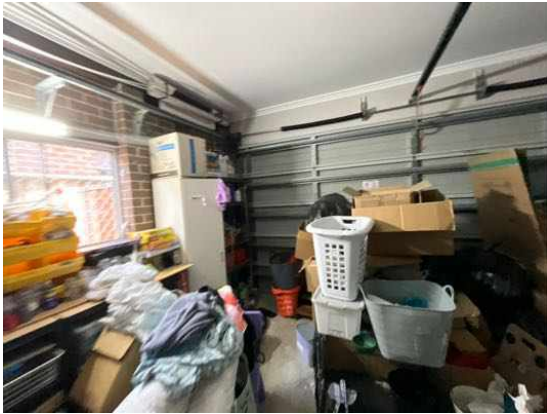
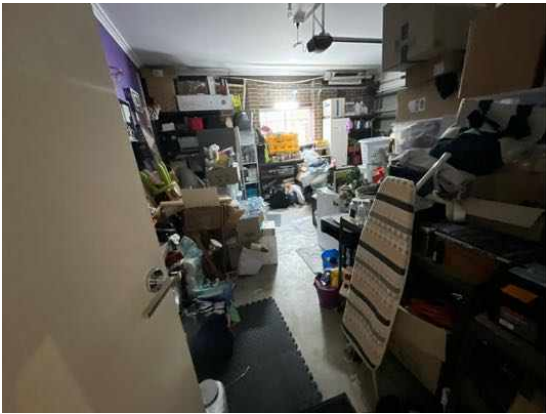
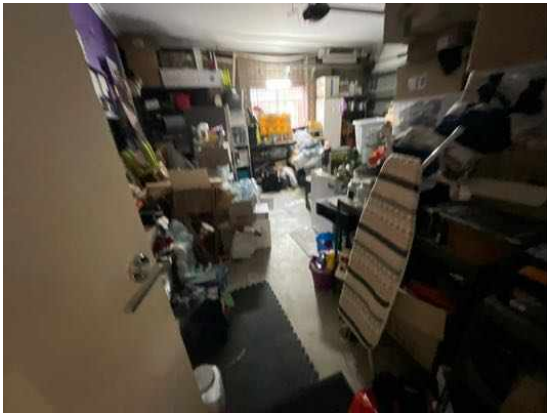
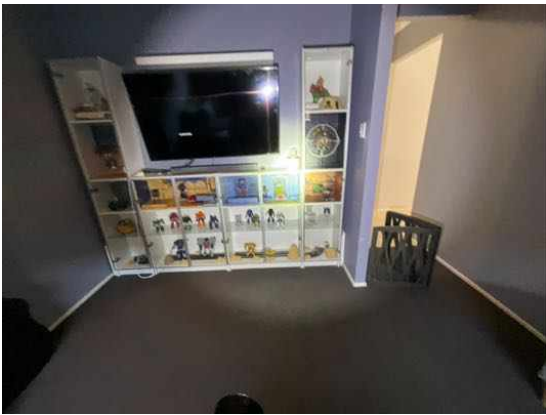
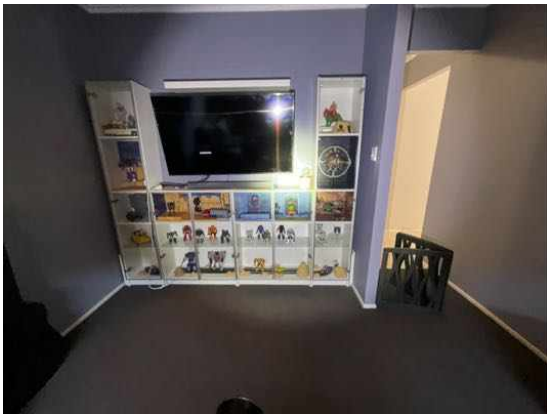
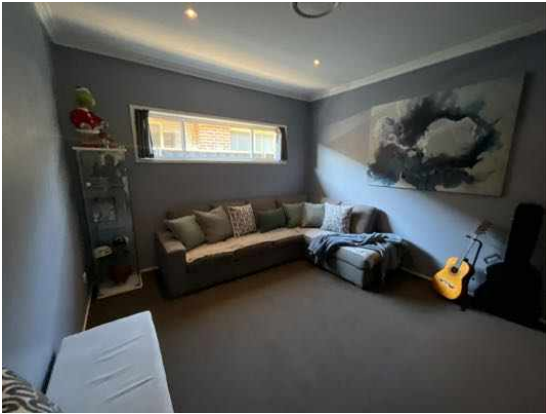
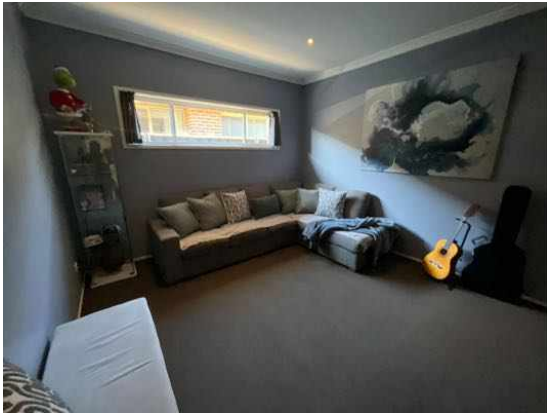
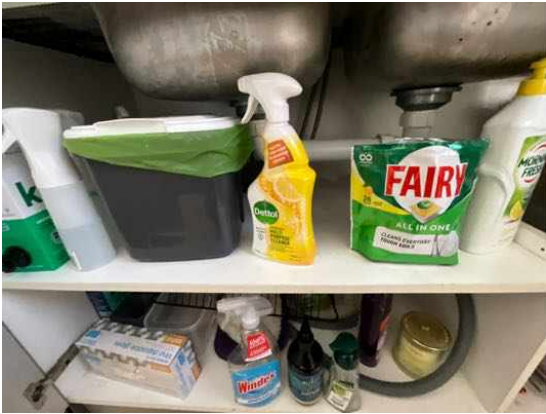
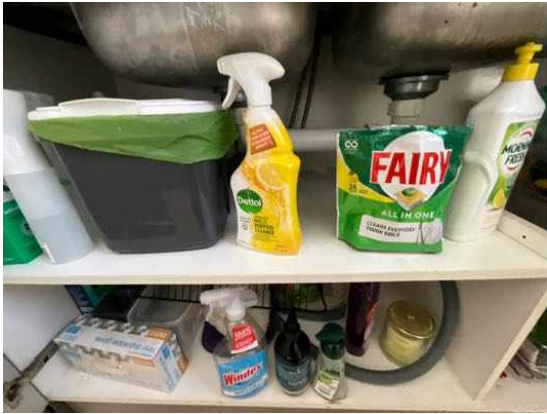
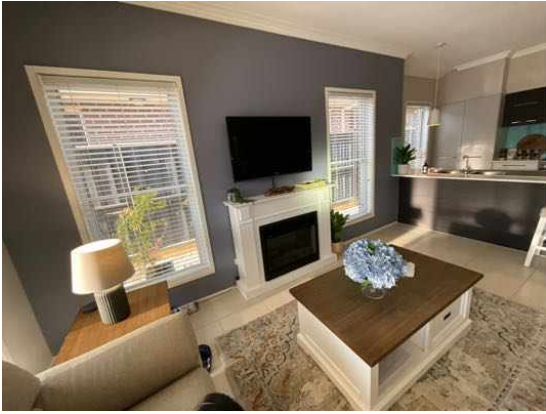
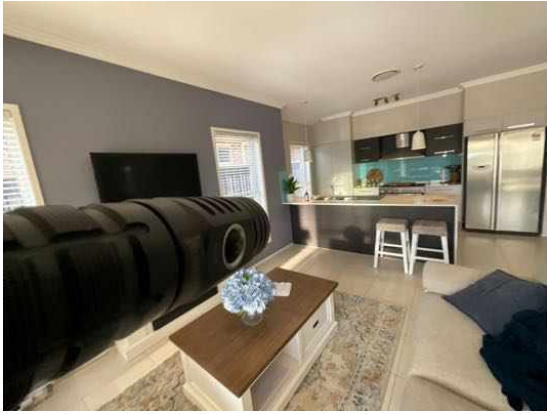
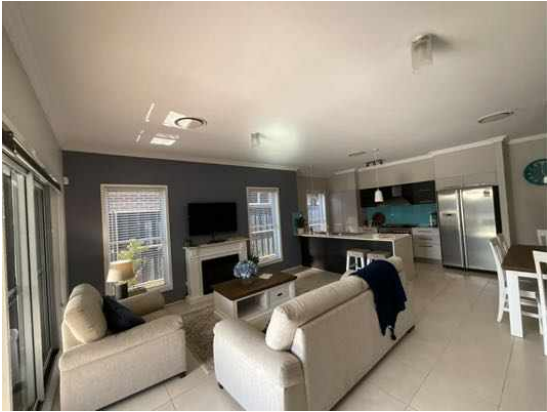
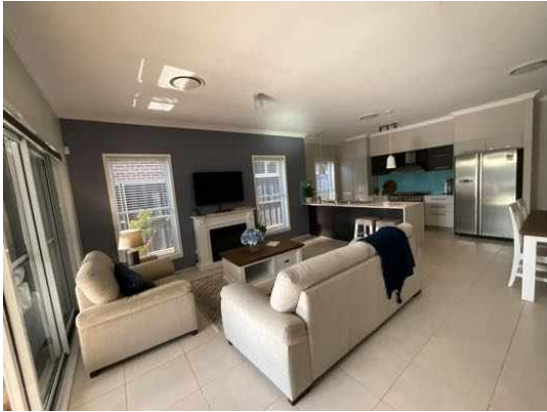
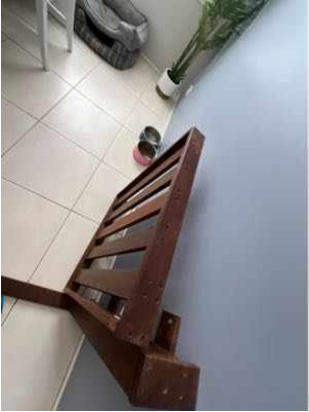
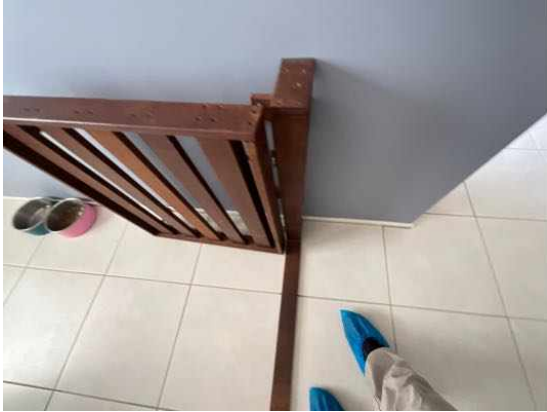
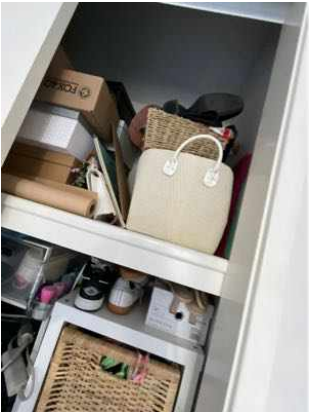
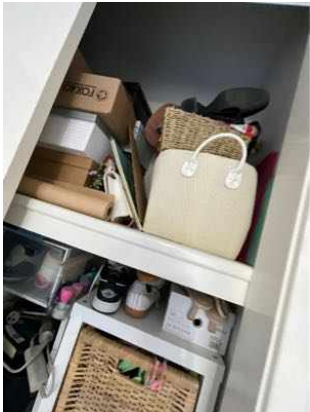
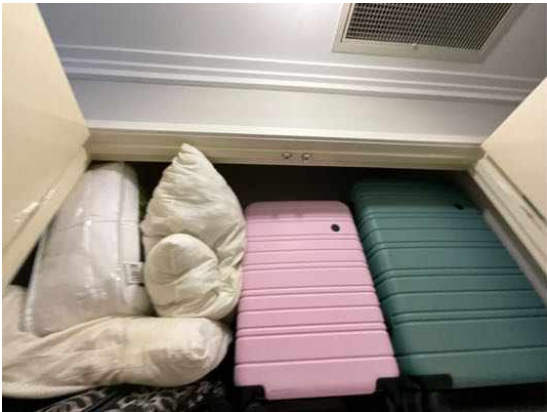
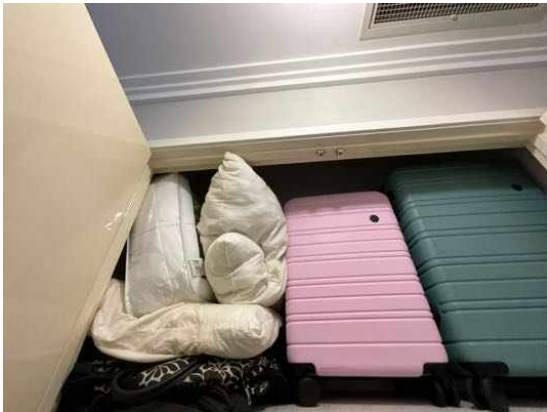
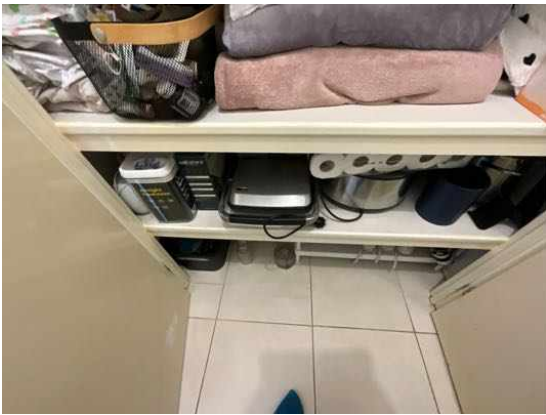
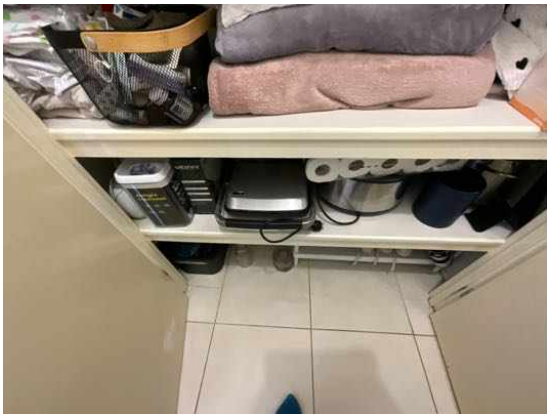
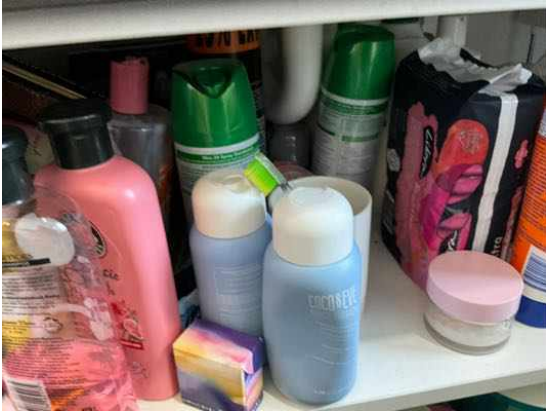
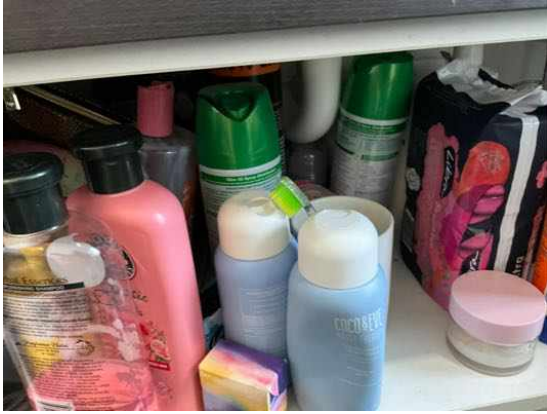
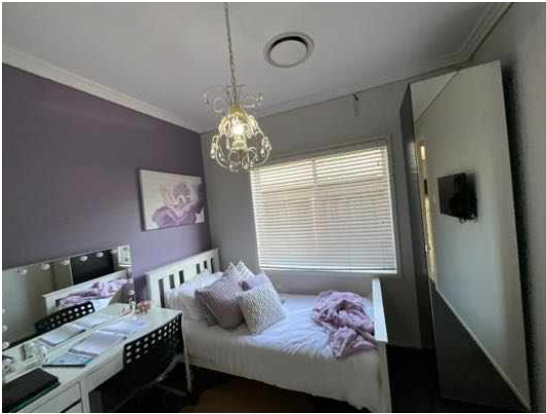
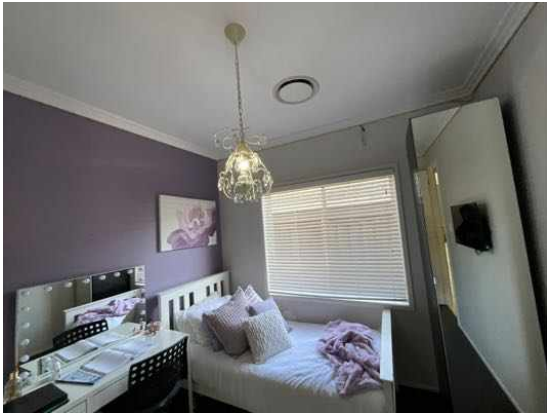
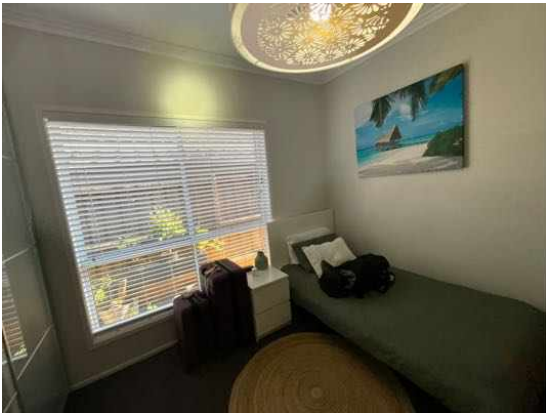
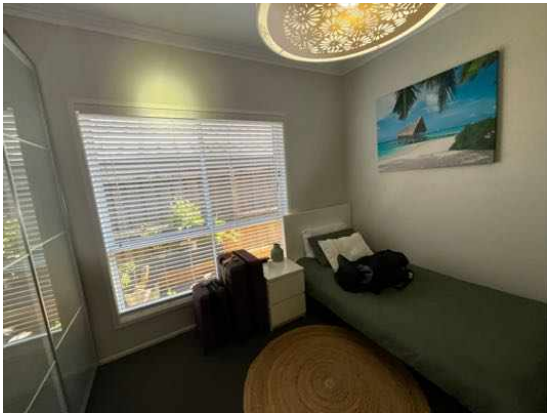
Building: Main Building
Location: All Areas
Finding: Additional Photos - Obstructions and Limitations
Information: These photographs are an indication of the obstructions and limitations which impeded full inspection of the property at the time of inspection. These obstructions can hide an array of defects and should be removed to allow full inspection to be carried out. A re-inspection is recommended once the areas are made accessible.
