Building and Timber Pest Inspection Report

Inspection Date: Tue, 27 Jan 2026

Property Address: 87 Hastings St, The Ponds NSW 2769,
Australia

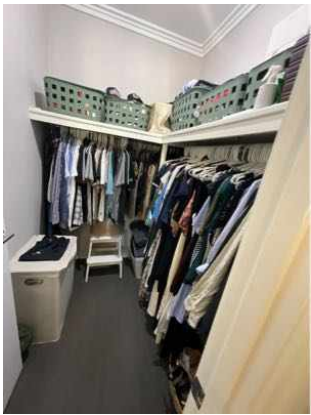
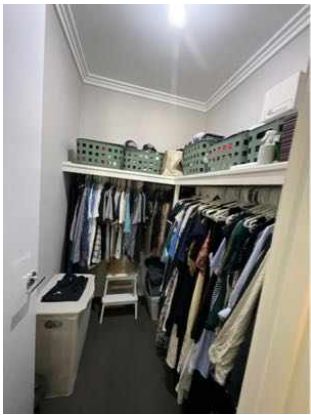
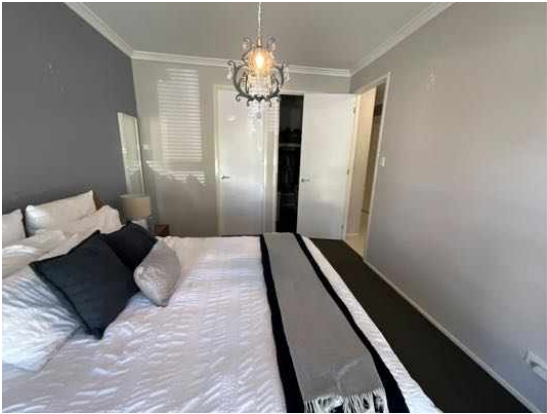
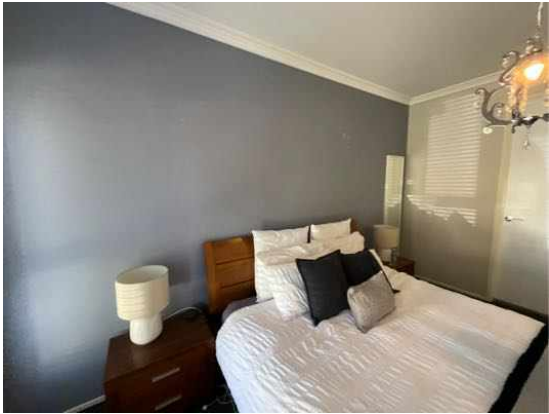
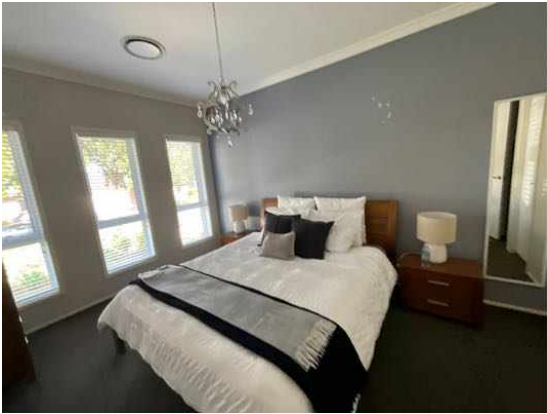
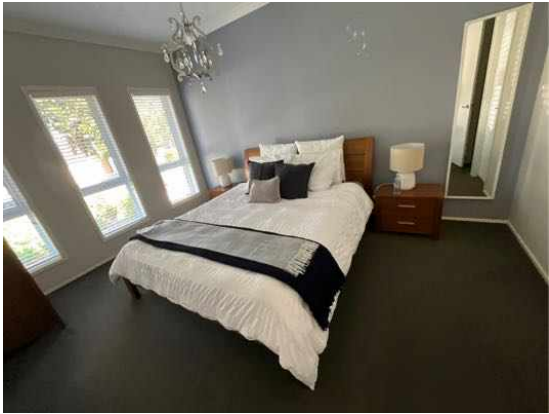
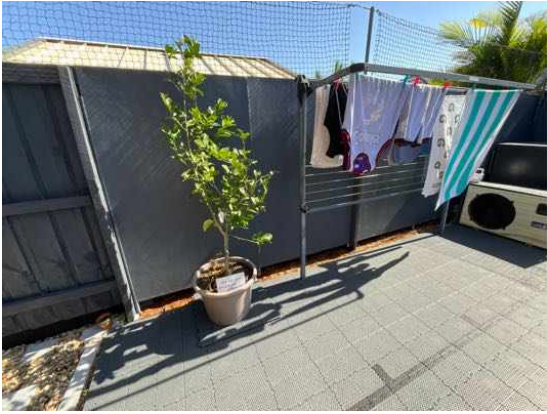
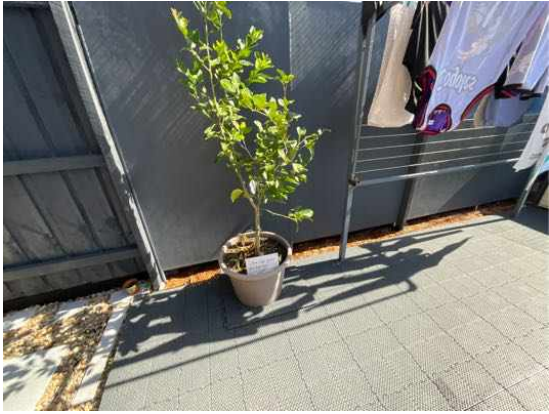
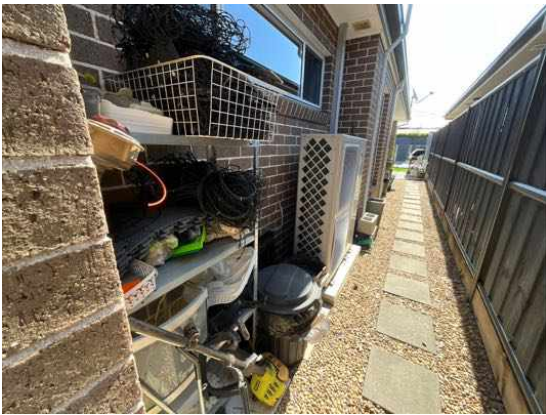
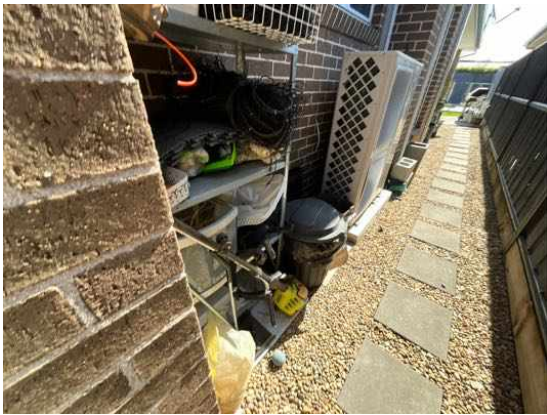
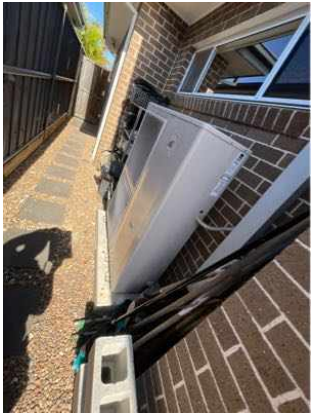
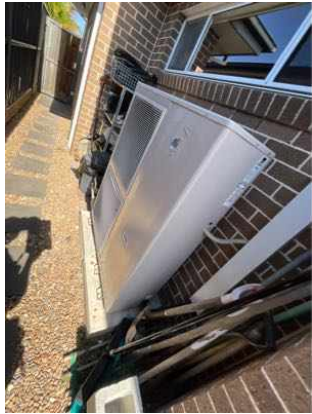
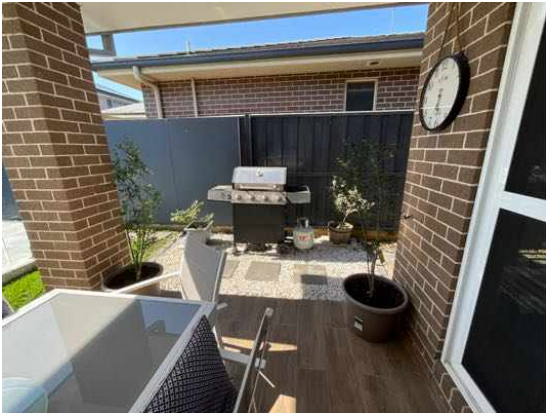
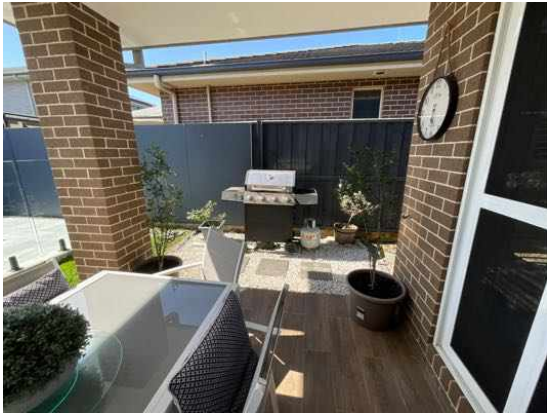
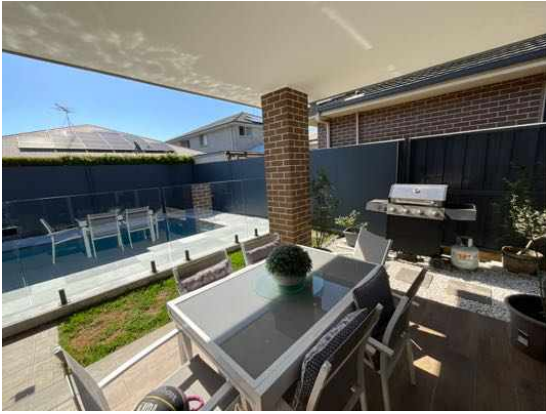
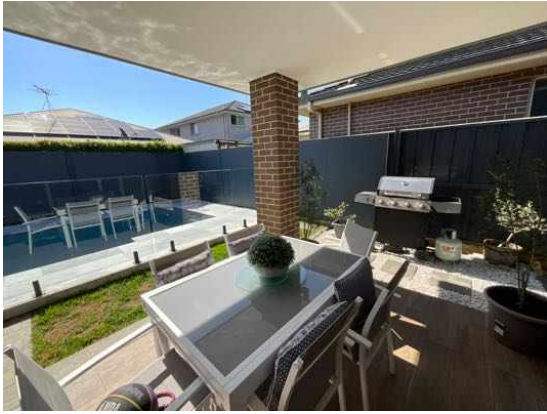
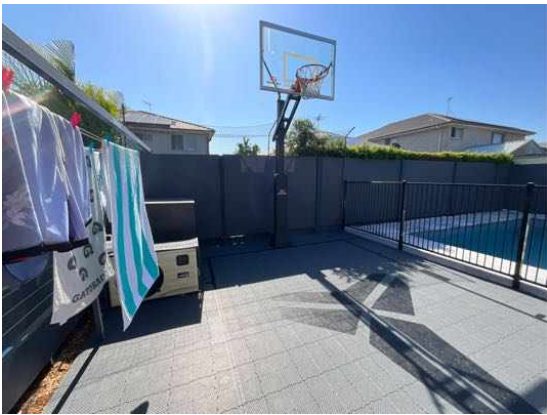
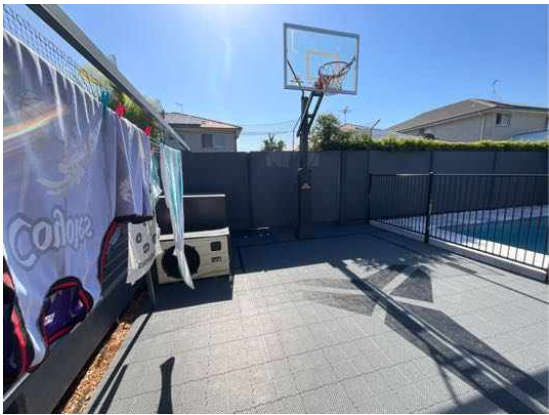
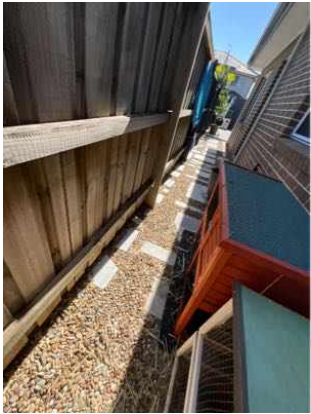
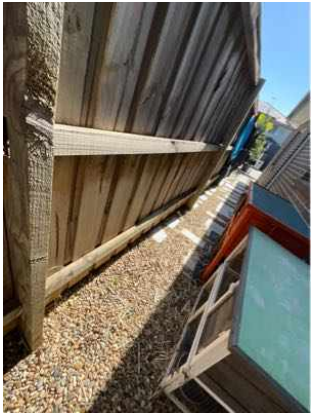
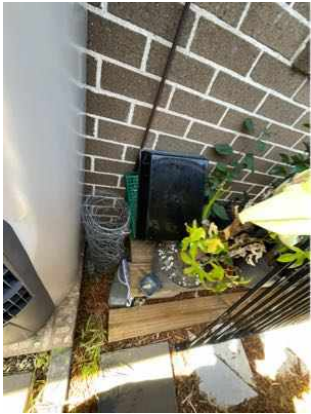
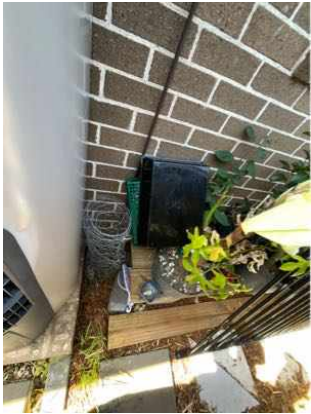
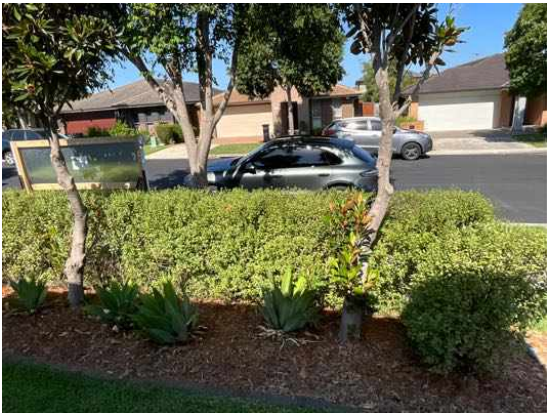
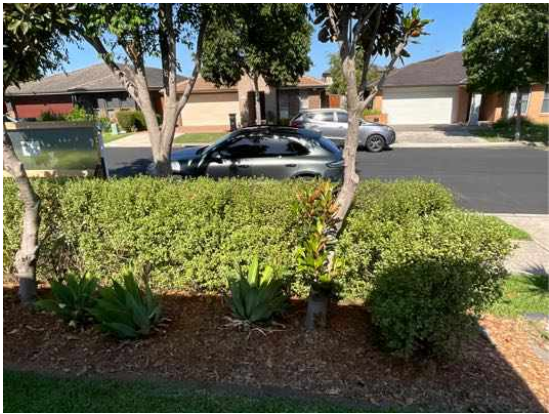
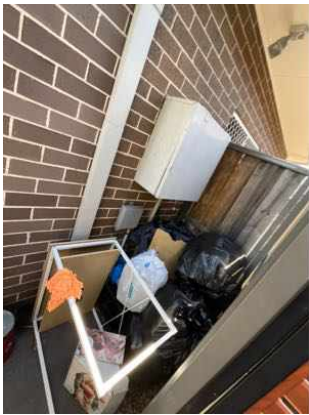
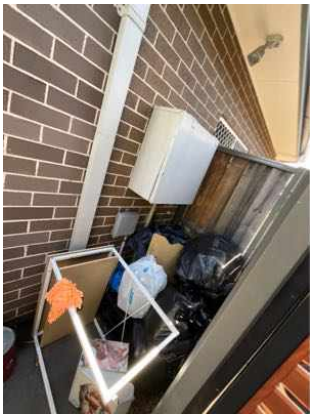
Building: Main Building
Location: All Areas
Finding: Additional Photos - Obstructions and Limitations
Information: These photographs are an indication of the obstructions and limitations which impeded full inspection of the property at the time of inspection. These obstructions can hide an array of defects and should be removed to allow full inspection to be carried out. A re-inspection is recommended once the areas are made accessible.

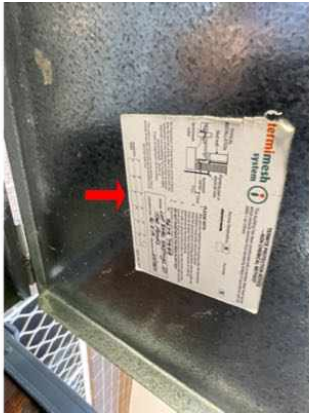
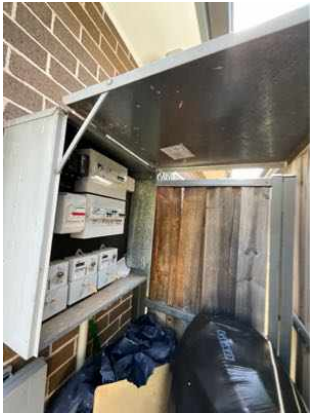
- Building: Main Building
- Location: Exterior walls - right side
- Finding: Evidence of Termite Management System - Durable notice / Legible Sticker - seek further information
- Information: The application of a pre & post-construction chemical termite barrier is highly recommended for all properties. Such barriers are highly effective in preventing termite attack on any timber building elements throughout the property.

A durable notice placed in the switchboard unit to indicate termite barriers at the time of inspection.

Client must seek further information from the vendor or real estate agent if the conditions of termite management systems were maintained as per the label or seek advise from licensed pest controller.
