# Building and Timber Pest Inspection Report

Inspection Date: Fri, 30 Jan 2026

Property Address: 8002B Vista Dr, Benowa QLD 4217,  
Australia

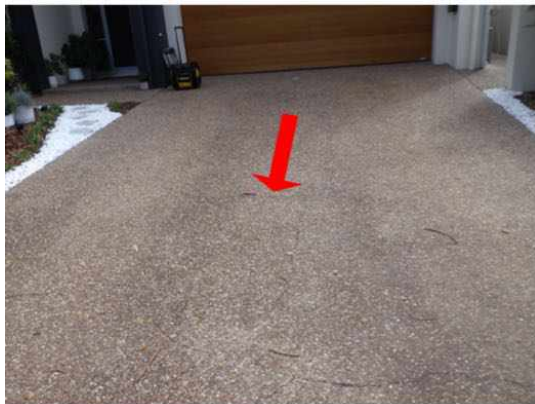
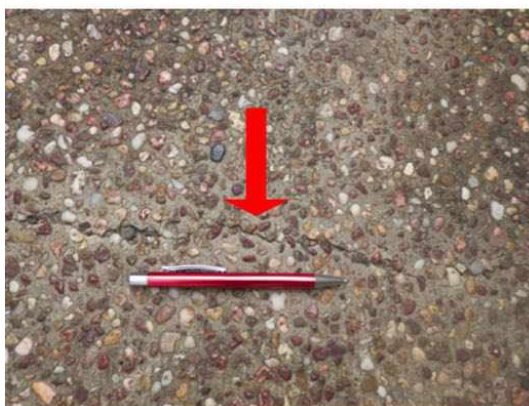
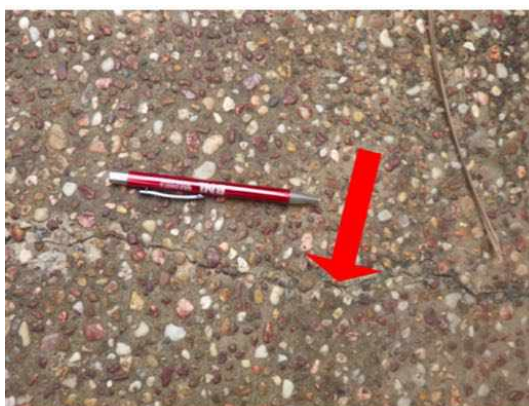
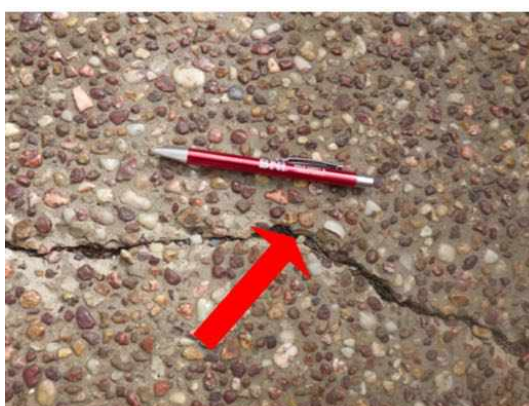
Building: Main Building  
Location: Driveway > Ground Level  
Finding: Cracking in concrete slab - Category 1  
Information: Cracking coded as Category 1 was identified in the driveway and footpaths concrete slabs. A Category 1 crack is described as a fine but noticeable crack, with the slab at an otherwise reasonable level.

To be considered Category 1, the approximate width of the crack is less than 1.0mm, or a less than 10mm change in offset when a 3m straight edge is placed over the defect.

Category 1 cracks should be monitored for a period of 12 months. At the end of the monitoring period, identified cracks that are rated greater than Category 2 are considered defects, and require rectification.

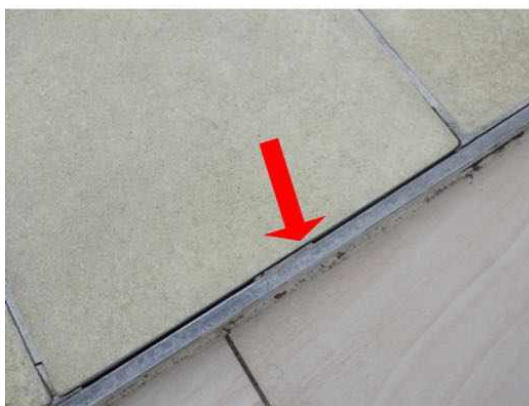
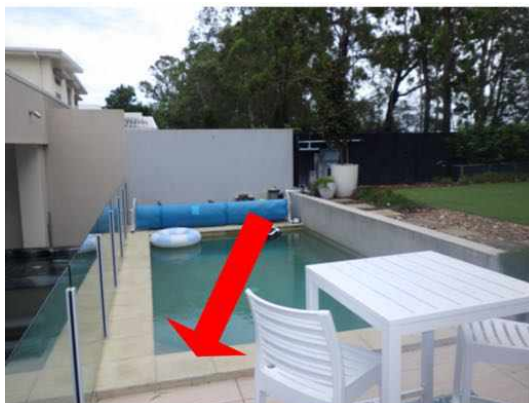
### Finding 3.02

Building:	Main Building
Location:	Pool Area > Front Left
Finding:	Sealant and grouting
Information:	It was noted on inspection that sealant or grout has deteriorated to the pool area coping tiles on the front left side. Grout is used to protect gaps and crevices in building materials to ensure that they are water-tight and prevent water penetration to associated structures.

A sealant specialist or tiling contractor should be appointed to complete repair work.

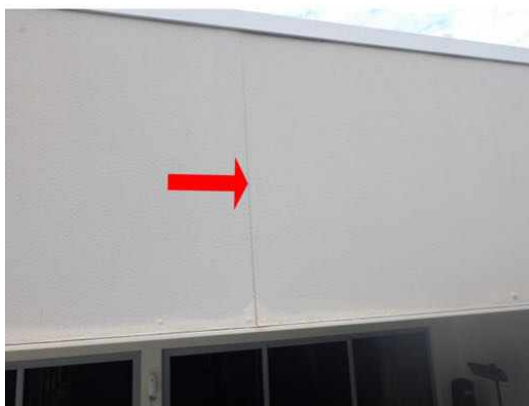
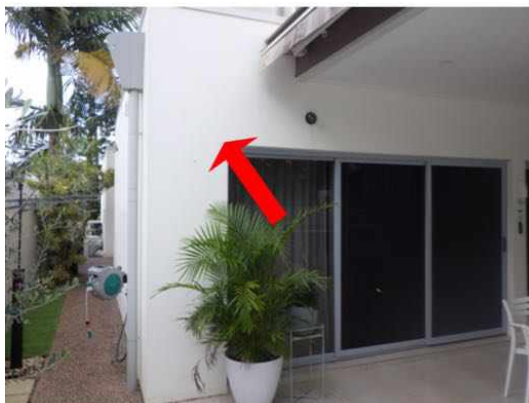
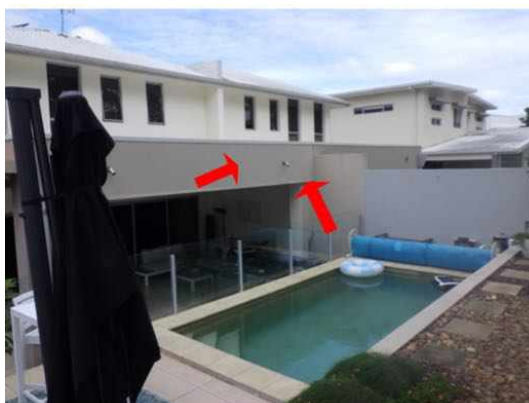
### Finding 3.03

Building:	Main Building
Location:	Exterior walls - rear > Rear
Finding:	Cracking - Walls
Information:	There is minor cracking to areas of the exterior wall cladding or render at the rear of the building (as per example photos). The cracking appears to be concentrated at the vertical joints of the wall sheeting and is generally minor in nature. It is assumed the cracking is the result of normal building movement or substandard workmanship at the time of construction.

A licensed solid plasterer or qualified painter could be consulted regarding rectification options.

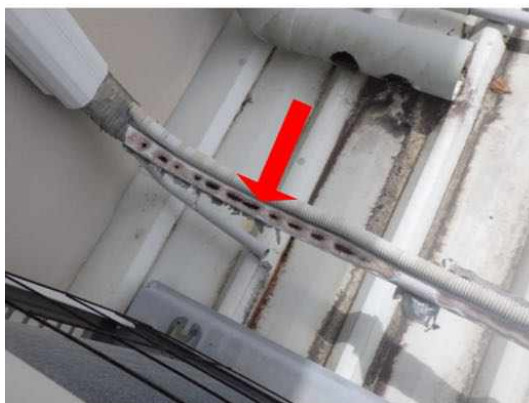
### Finding 3.04

Building:	Main Building
Location:	Exterior walls - right side > Centre Right
Finding:	Pipework - Insulation deteriorated
Information:	At the time of inspection sections of the air conditioning unit pipe work insulation showed evidence of damage and deterioration. It is suspected that this deterioration has developed as a result of excessive exposure to weather, including UV exposure in daylight. Deteriorated insulation reduces the effectiveness of the material in helping to maintain the desired temperature and work most efficiently.

If left in an exposed position, it is likely that the deterioration will continue and worsen over time, potentially resulting in secondary building defects as well as a further loss in

insulating properties.

Some areas of replacement of pipe insulation is likely to be required. Further preventative measures to remove or protect the material from future exposure are also advisable. Consultation with a licensed air conditioning installer is advised to gain quotes for the repair and/or replacement of deteriorated insulation.

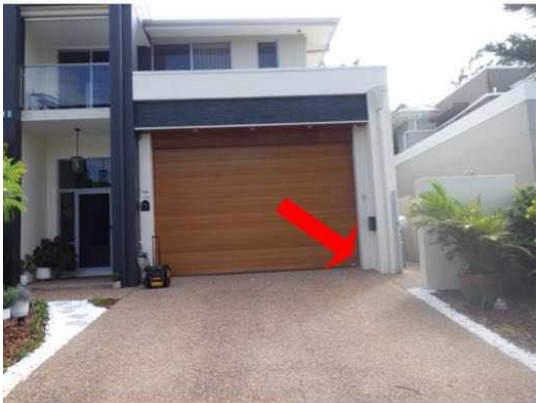
Building:	Main Building
Location:	Garage > Front Right
Finding:	Garage door - dent
Information:	The garage door has a minor dent likely to have resulted from impact damage be it accidental or deliberate impact at sometime.

Repair and/or replacement of the garage door panel would improve the condition of the garage door but certainly not an urgent item

A qualified sectional door installer or supplier could be engaged to check out the operation and overall condition of the door to determine if repair is an option otherwise replacement of the bottom panel may need to be considered.

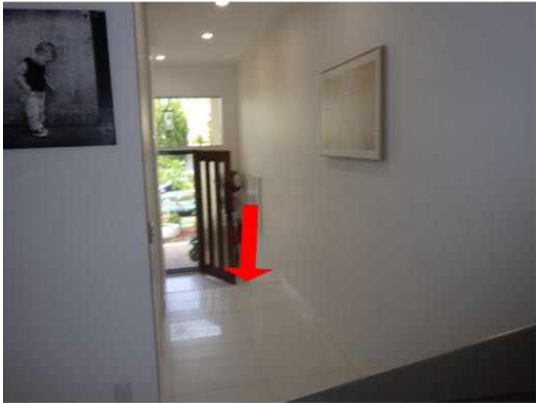
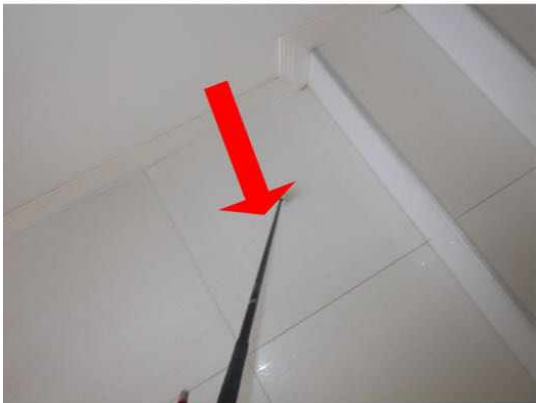
**Finding 3.06**

Building: Main Building  
Location: Entry > Centre Left  
Finding: Tile - Drummy  
Information:

A drummy tile to the entry area floor was identified at the time of inspection. The term 'drummy' refers to tiles that have become detached from their fixing, despite otherwise being in relatively good condition. Such defects are generally caused by physical or moisture damage to the area. Drummy tiled areas may also be a direct result of poor workmanship during the construction process.

A tiling contractor could be appointed to undertake repair works if necessary.

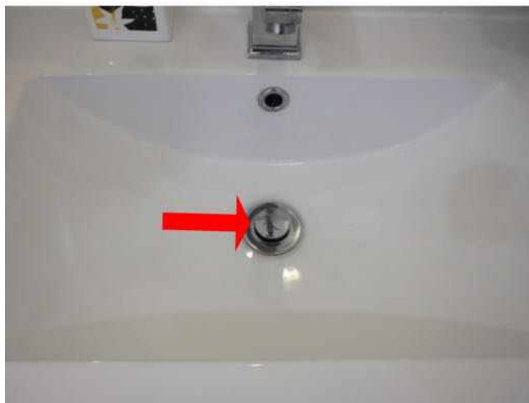
### Finding 3.07

Building:	Main Building
Location:	Powder Room > Centre
Finding:	Basin - Pop up waste stiff.
Information:	The powder room basin pop up waste was stiff to operate at the time of inspection. It is advised that maintenance is carried out on the waste so as it functions as intended.  A handyman could be appointed to perform any remedial works where required.

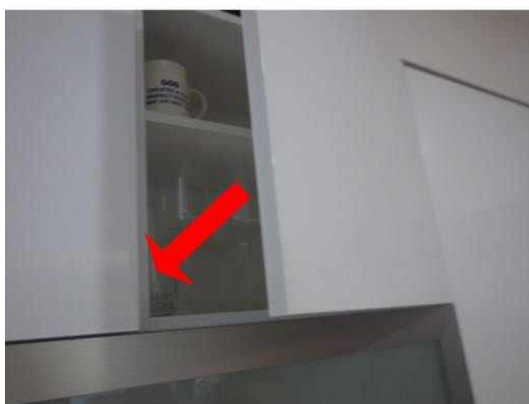
### Finding 3.08

Building:	Main Building
Location:	Kitchen > Centre Left
Finding:	Magnetic Catch
Information:	At the time of inspection the magnetic push catch to the left side overhead cupboard door was missing.  A general handyman could be engaged to replace the magnetic push catch at the clients discretion.

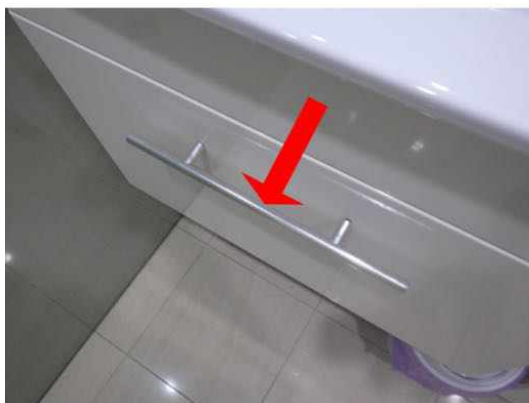
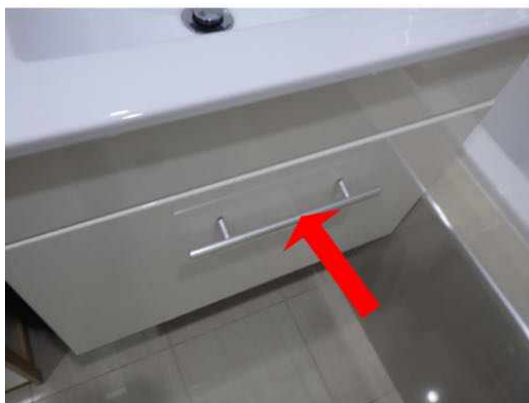
### Finding 3.09

Building: Main Building  
 Location: Bathroom > Centre  
 Finding: Handles - Loose  
 Information: The bathroom cabinetry drawer handles were found to be loose at the time of inspection. Breakage occurs generally when the building materials have aged and decayed.

Repair of the loose drawer handles is advised to improve the operational state of the cabinetry.

A general handyman could be appointed to re-tighten the drawer handles at the client's discretion.

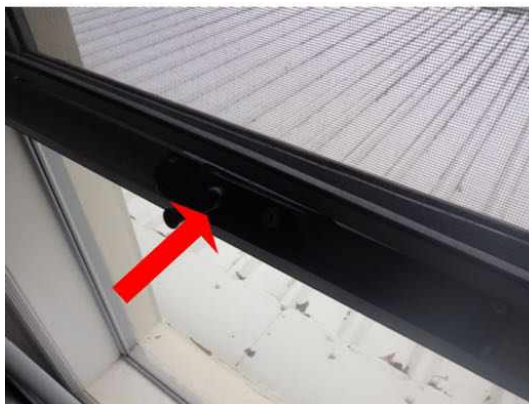
### Finding 3.10

Building: Main Building  
 Location: Bedroom 3 > Centre Left  
 Finding: Window - Broken handle  
 Information: The window winder handle to the bedroom 3 left side awning window was found to be broken or not functioning normally at the time of inspection. Breakage occurs generally when the building materials have aged and decayed.

Repair of the broken window winder handle is advised to improve the operational state

of the associated window.

An aluminium window service agent could be appointed to repair/replace the window winder handle at the client's discretion.

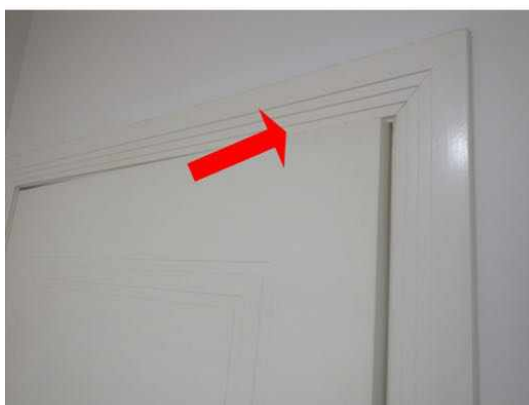
### Finding 3.11

Building: Main Building  
 Location: Bedroom 2 > Front  
 Finding: Door - Binding/Jamming  
 Information: Binding and/or jamming of the bedroom 2 door on the top of door frame was evident during standard operation. This defect inhibits the functionality of affected door as well as creating potential for secondary defects to associated building elements, such as damage to the door framing.

A door that binds to the associated door frame may have several causes, such as poor installation of the door or deteriorated hinges.

A qualified carpenter or general handyperson could be appointed to perform minor rectification works at client discretion.

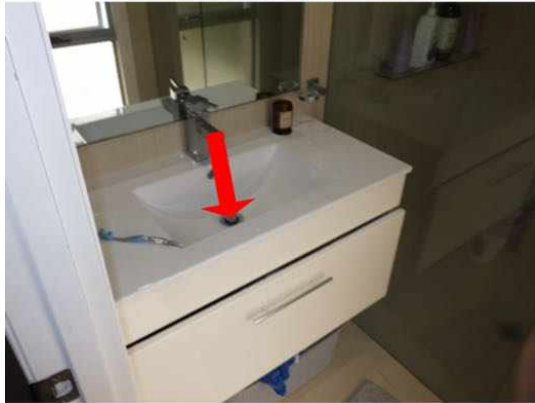
Building: Main Building  
 Location: Ensuite - Bed 2 > Front Left  
 Finding: Basin - Pop up waste stiff.  
 Information: The bedroom 2 ensuite basin pop up waste was stiff to operate at the time of inspection. It is advised that maintenance is carried out on the waste so as it functions as intended.

A handyman could be appointed to perform any remedial works where required.

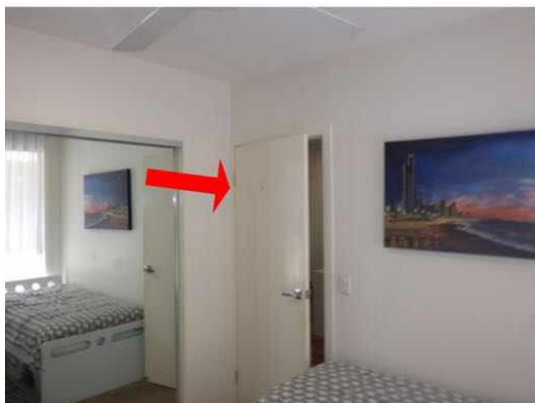
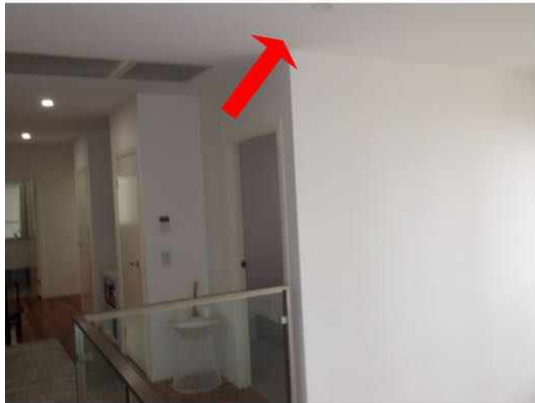
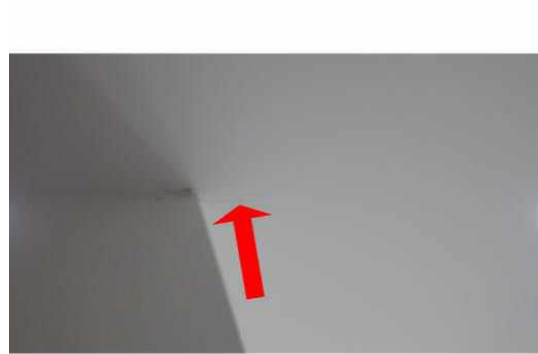
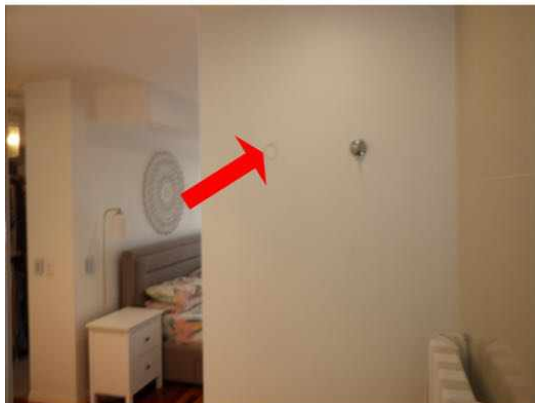
### Finding 3.13

Building: Main Building  
 Location: Internal Areas > Existing  
 Finding: Wear and Tear  
 Information: At the time of inspection the building interior showed signs of minor cracking and/or scuffing to walls, ceilings and timber trims (as per example photos).

The level of damage appears consistent with general deterioration and/or wear and tear.

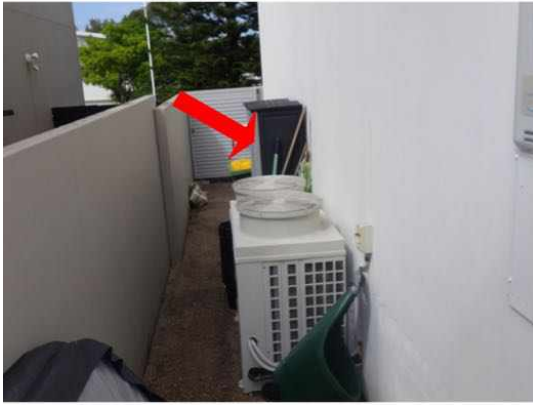
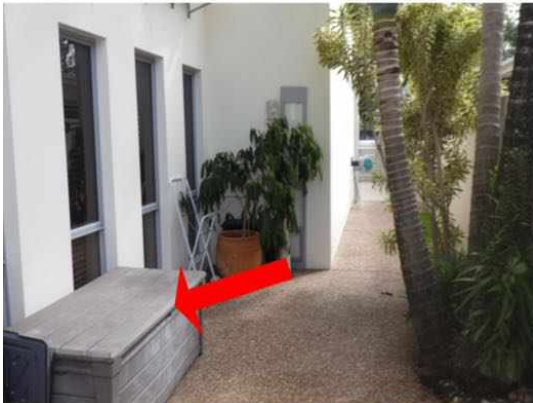
The storing of items around the exterior of the property increases the risk of termite activity being present.

It is highly recommended that any stored items be immediately moved away from external wall areas in which they may conceal or attract any termite / timber pest attack. Minimisation of risk / prevention of termite attack is far more adequate than dealing with the presence of termite activity.

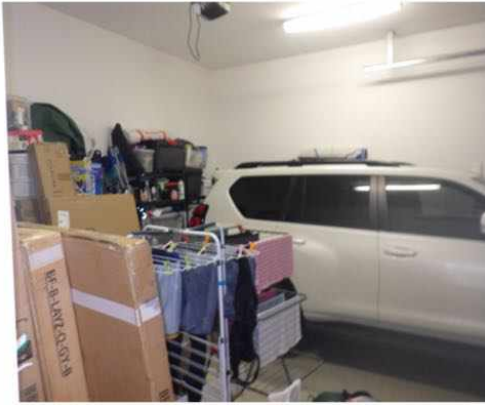
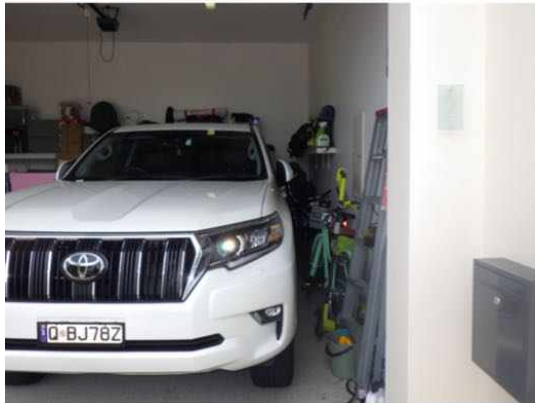
### Finding 6.02

These stored items severely limit full inspection of the area and may conceal timber termite pest and or vermin activity.

It is highly recommended the items are removed to allow for complete inspection of the area.

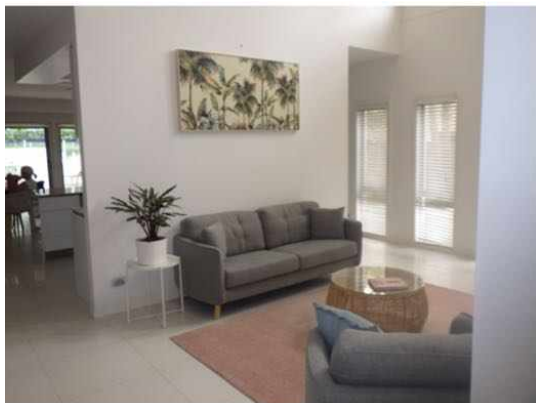
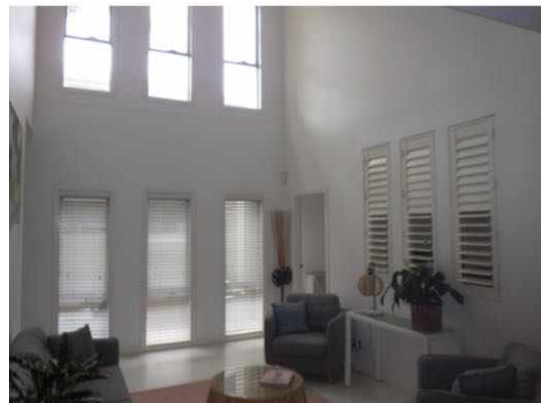
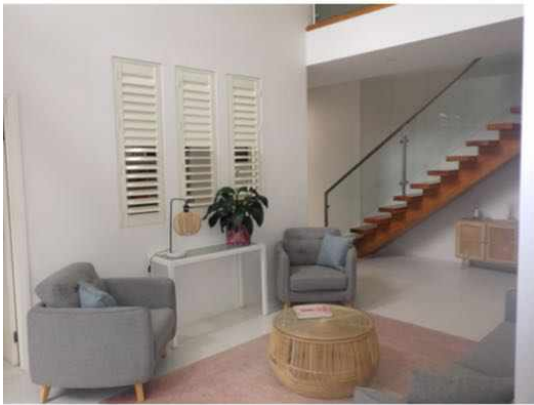
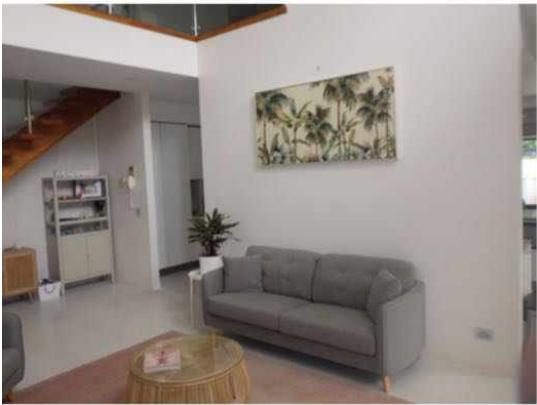
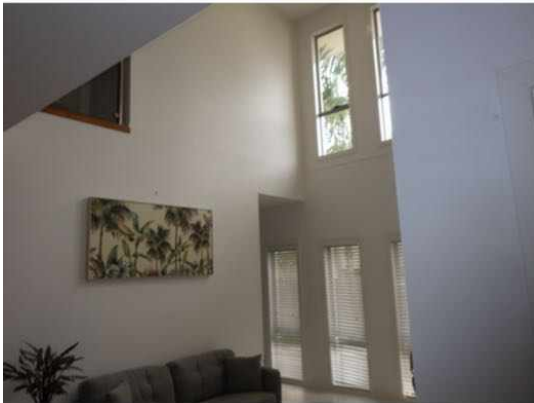
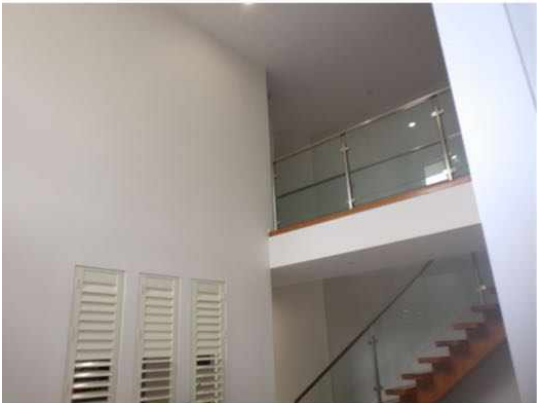
Building: Main Building  
Location: Lounge Room > Existing  
Finding: No obvious defect  
Information: No obvious defects found at the time of inspection.

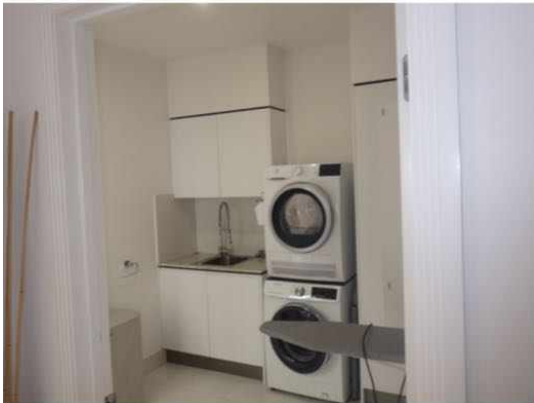
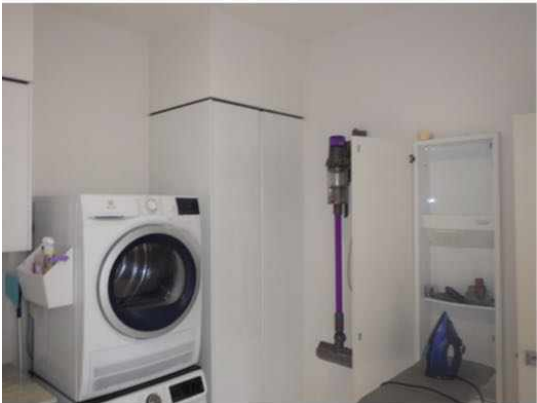
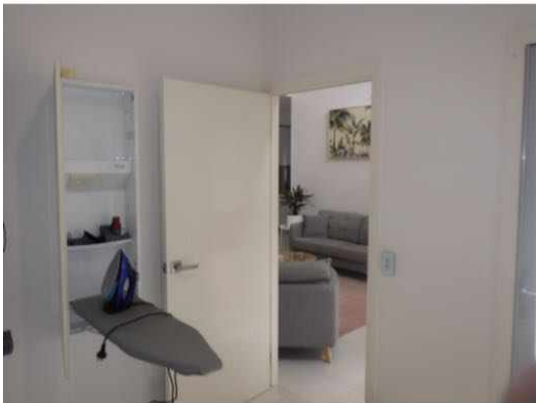
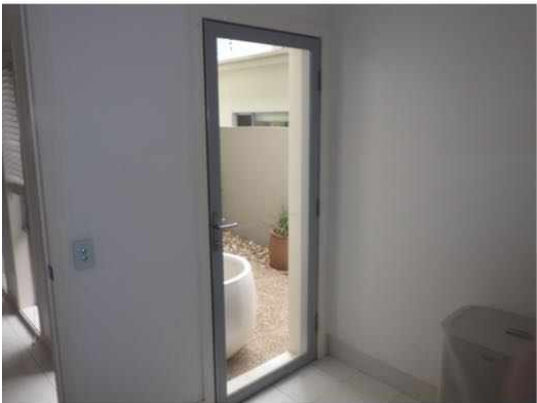
Building: Main Building  
Location: Laundry > Existing  
Finding: No obvious defect  
Information: No obvious defects found at the time of inspection.

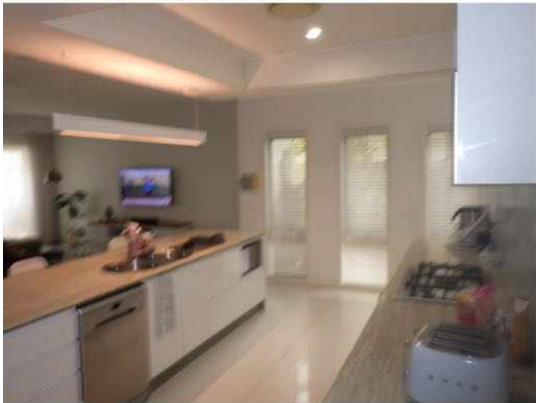
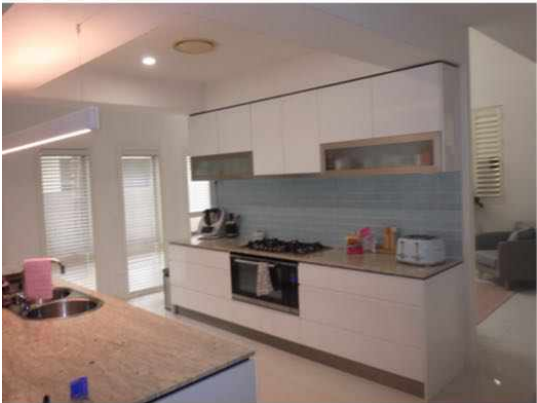
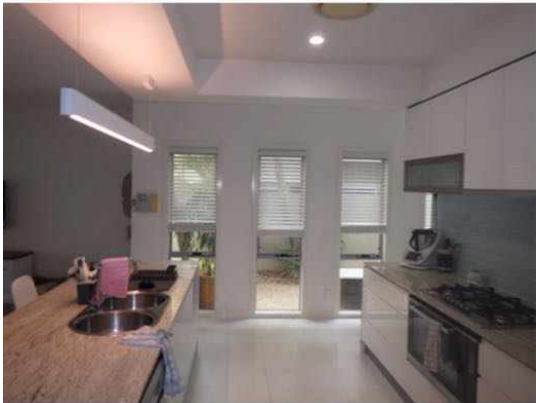
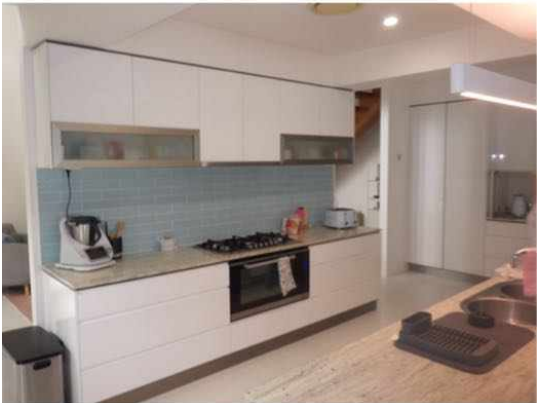
Building: Main Building  
 Location: Kitchen > Existing  
 Finding: No obvious defect  
 Information: No obvious defects found at the time of inspection.

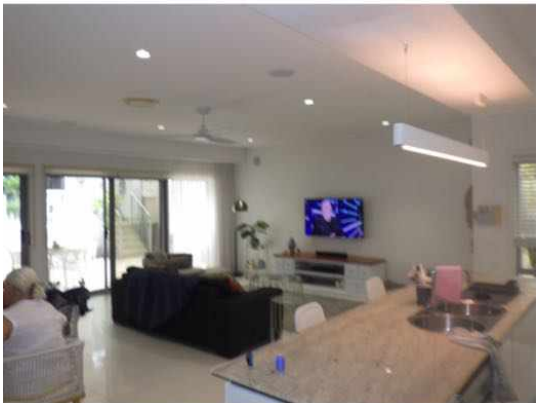
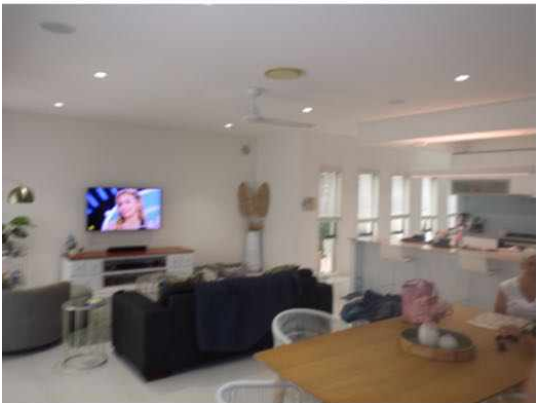
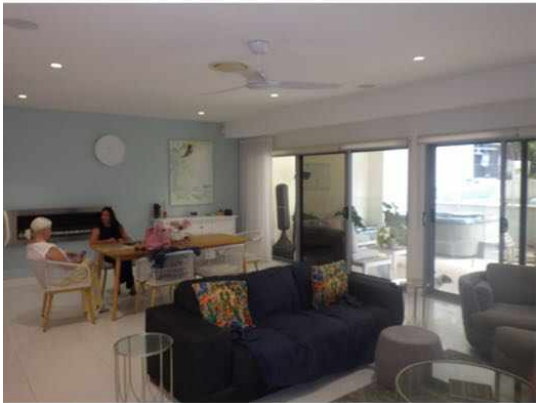
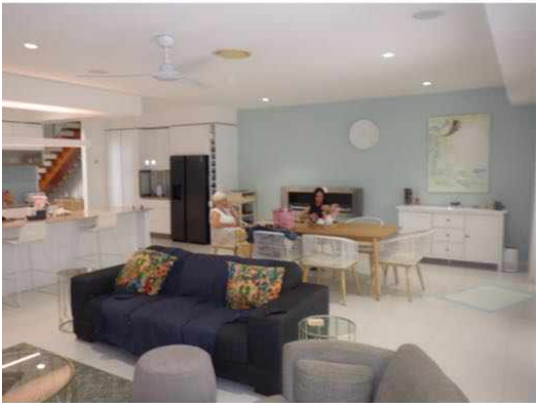
Building: Main Building  
 Location: Living/Dining Room > Existing  
 Finding: No obvious defect

Information: No obvious defects found at the time of inspection.

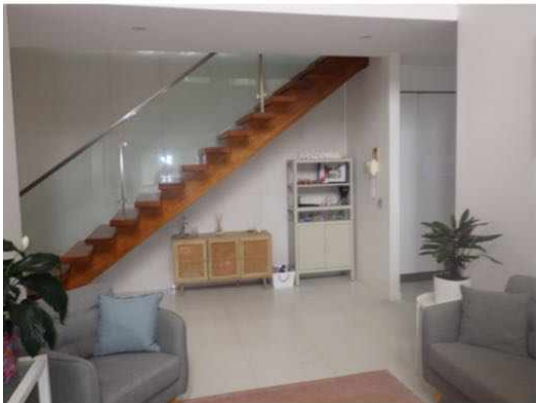
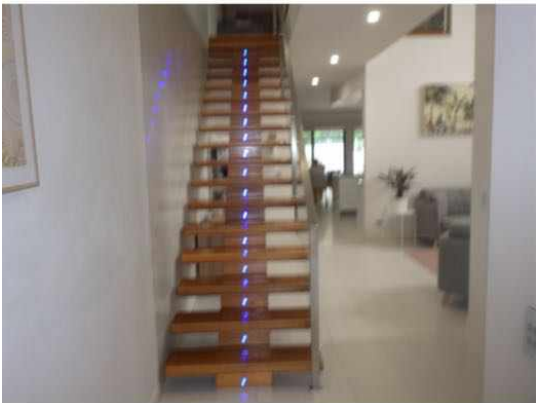
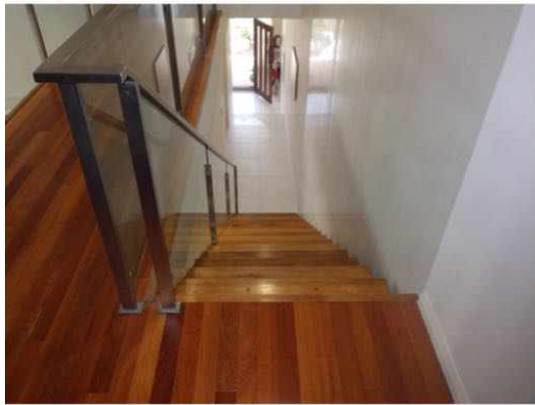
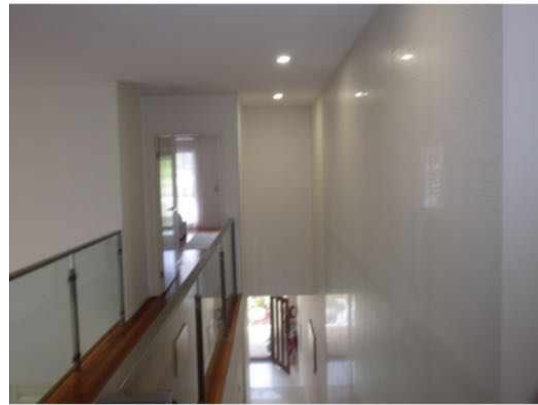
Building: Main Building  
Location: Stairs - Internal > Existing  
Finding: No obvious defect  
Information: No obvious defects found at the time of inspection.

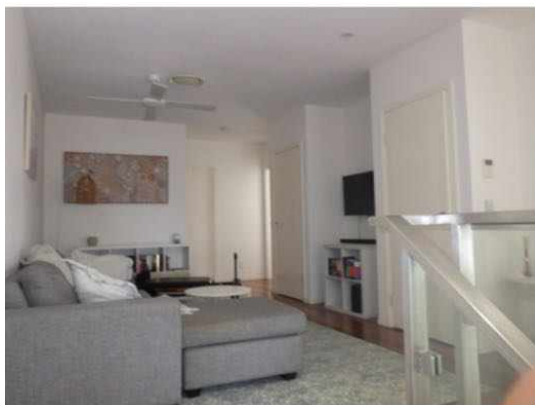
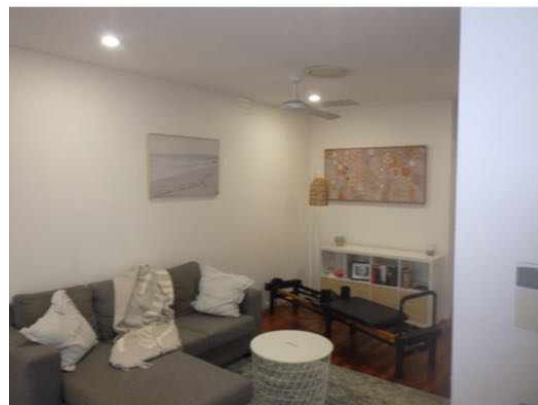
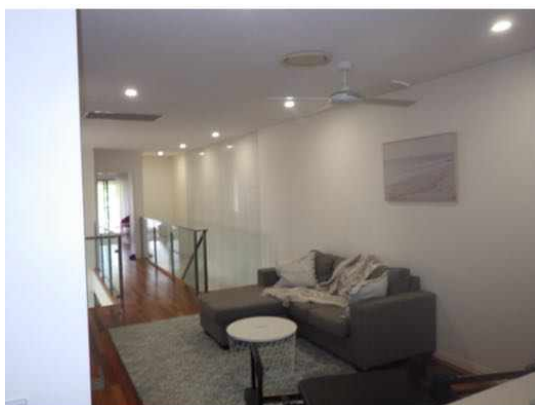
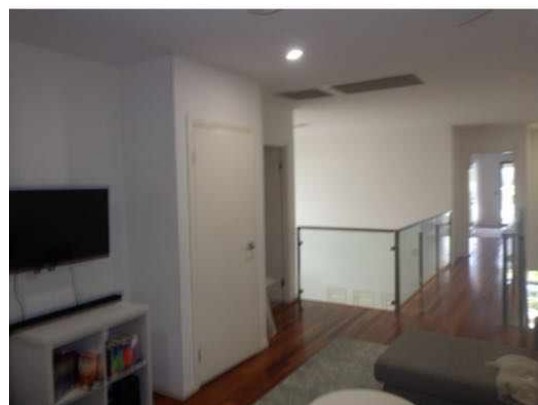
Building: Main Building  
Location: Rumpus Room > Existing  
Finding: No obvious defect  
Information: No obvious defects found at the time of inspection.

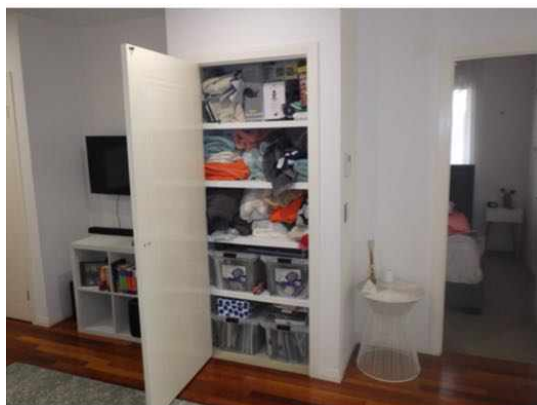
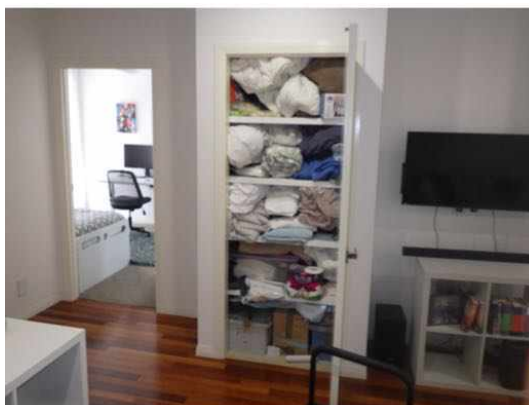
Building: Main Building  
Location: Storage Cupboards > Existing  
Finding: No obvious defect

Information: No obvious defects found at the time of inspection.

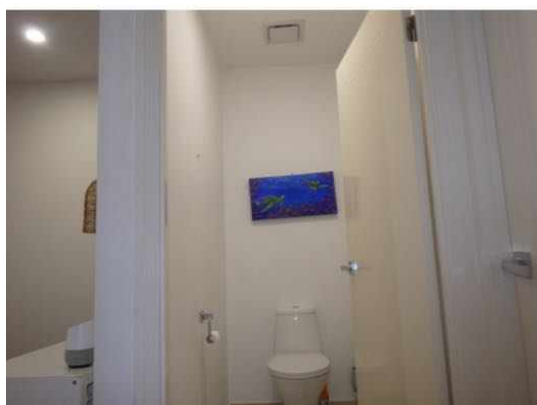
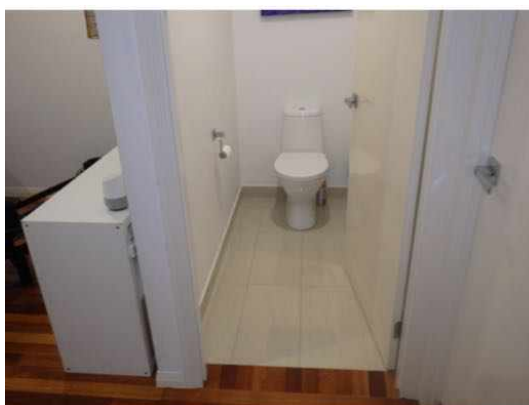
Building: Main Building  
 Location: Toilet (WC) - 2 > Existing  
 Finding: No obvious defect  
 Information: No obvious defects found at the time of inspection.

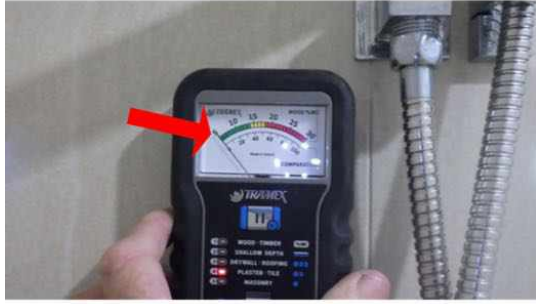
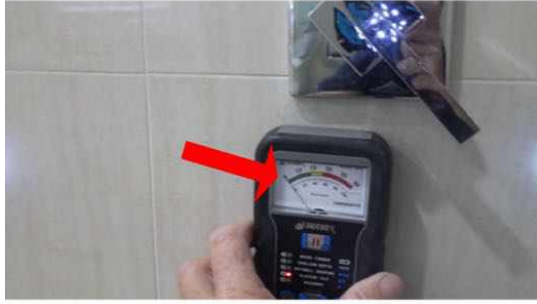
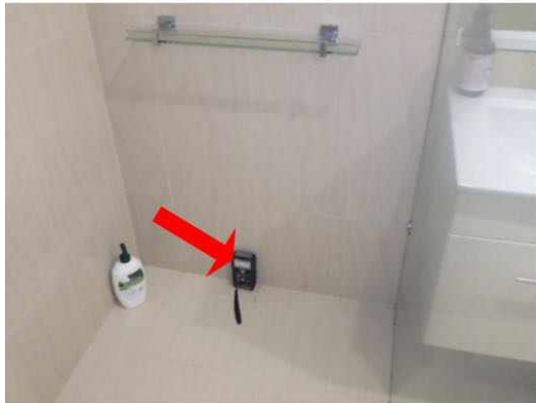
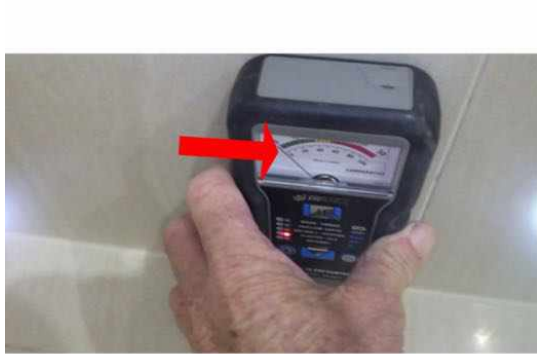
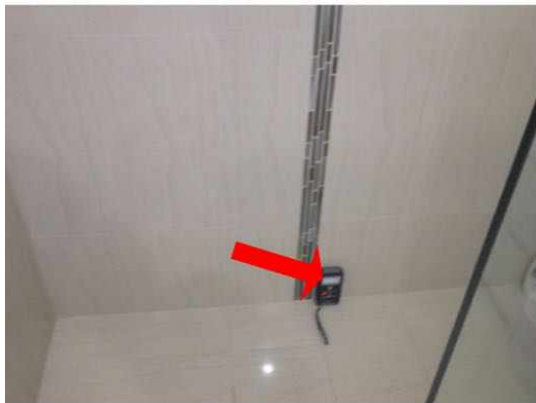
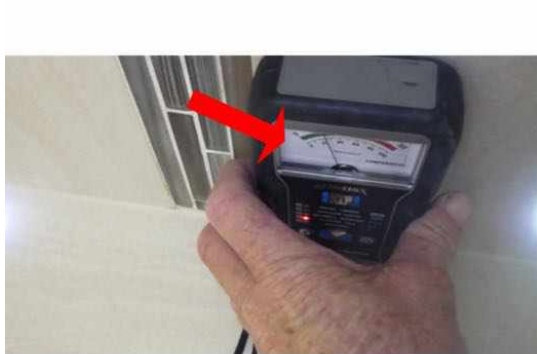
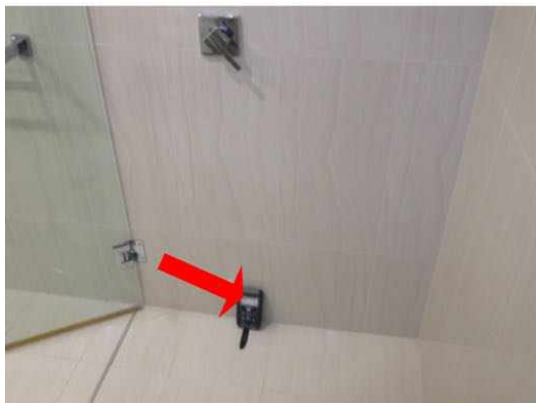
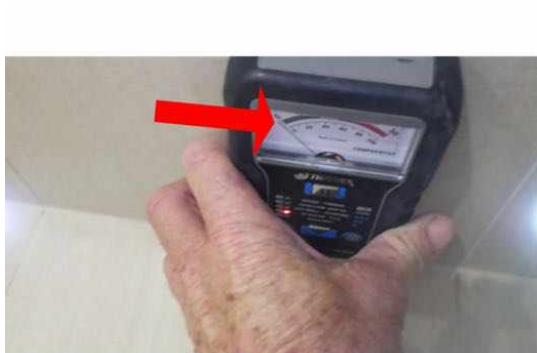
Building: Main Building  
 Location: Bathroom > Centre Left  
 Finding: Moisture Level Readings  
 Information: At the time of inspection the bathroom shower cubicle areas checked with the Tramex Moisture Meter returned low - normal moisture level readings.

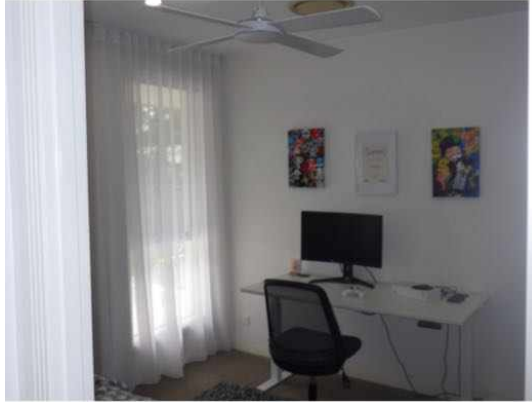
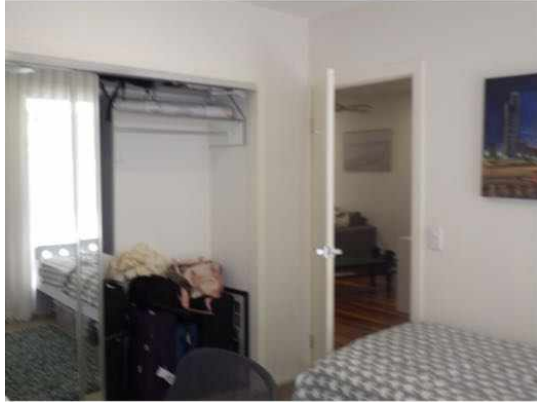
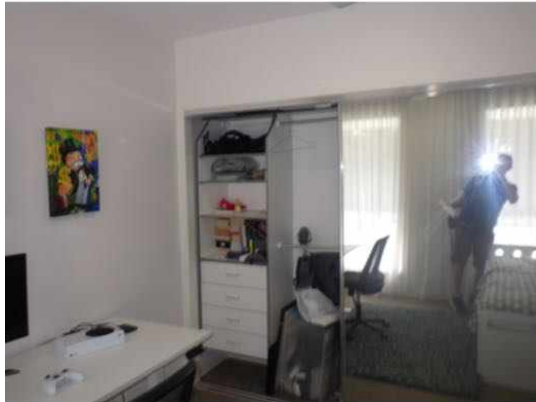
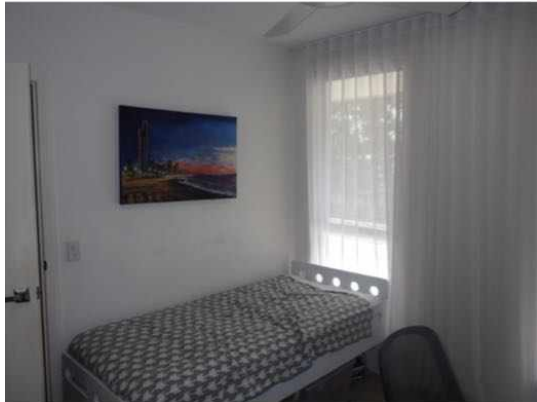
Building: Main Building  
Location: Bedroom 3 > Existing  
Finding: Additional Photos  
Information: Additional photos are provided for your general reference

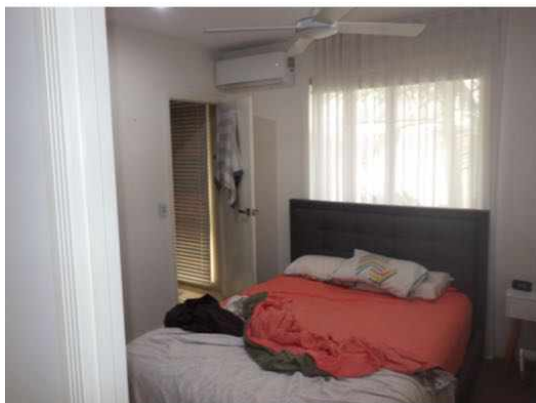
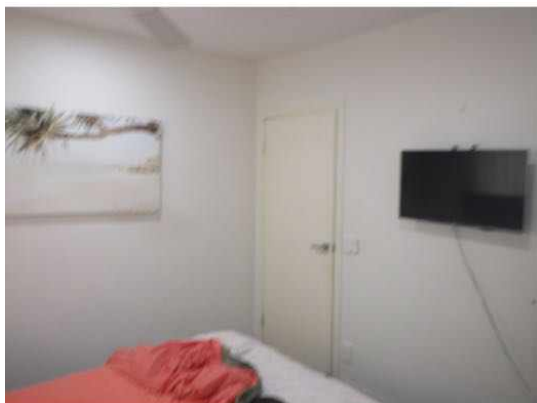
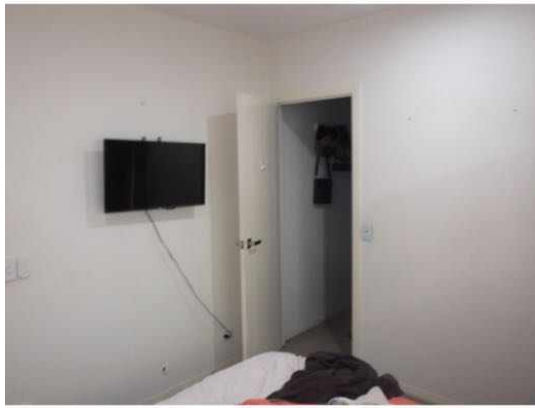
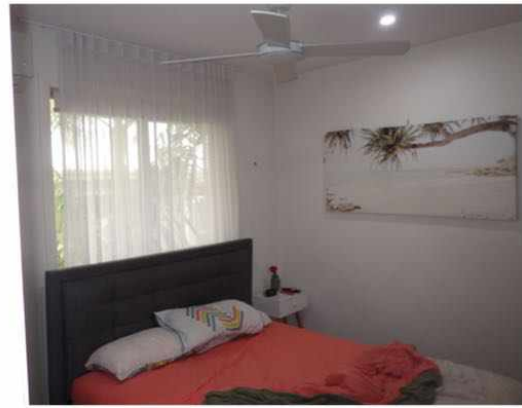
Building: Main Building  
Location: Bedroom 2 > Existing  
Finding: Additional Photos  
Information: Additional photos are provided for your general reference

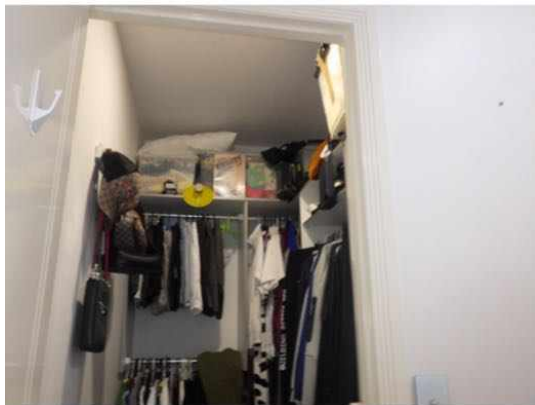
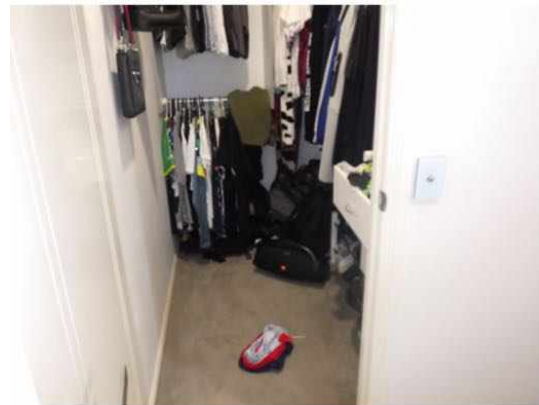
Building: Main Building  
Location: Bedroom 2 - Robe > Existing  
Finding: No obvious defect  
Information: No obvious defects found at the time of inspection.

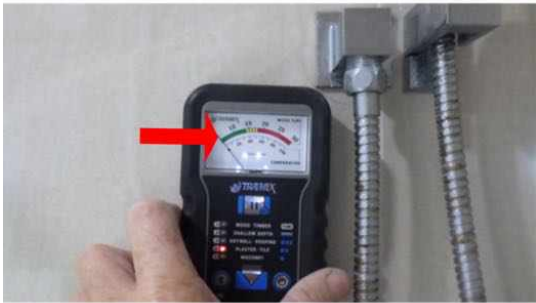
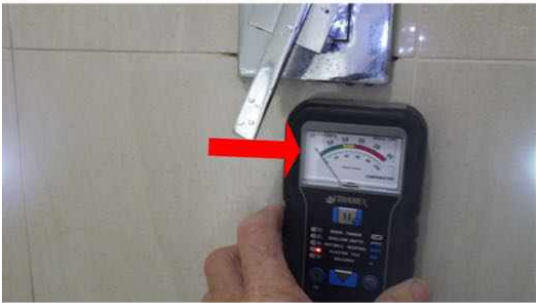
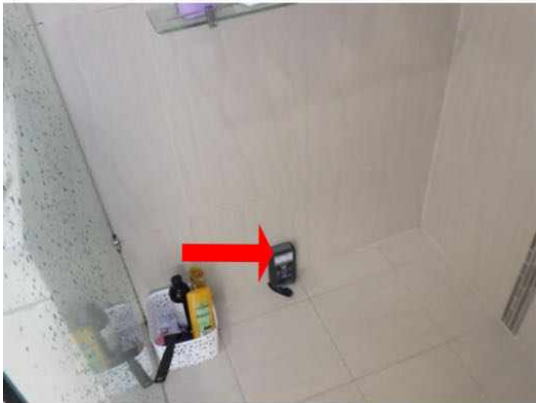
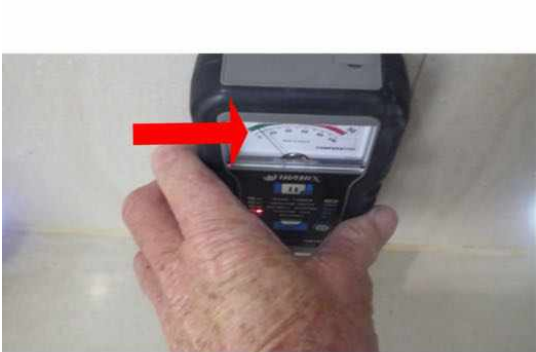
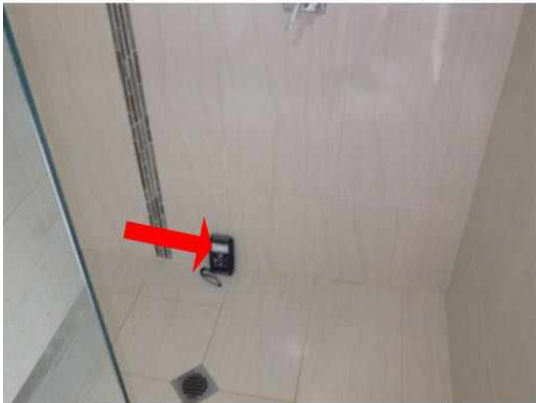
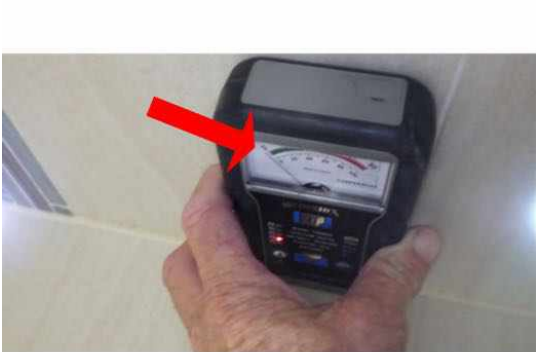
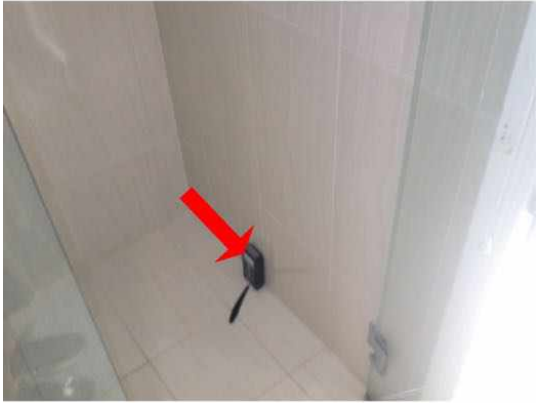
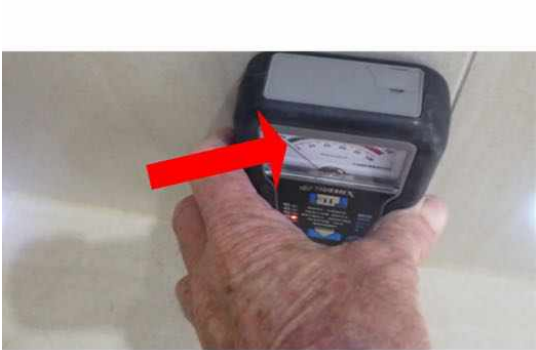
Building: Main Building  
Location: Ensuite - Bed 2 > Rear  
Finding: Moisture Level Readings  
Information: At the time of inspection the bedroom 2 ensuite shower cubicle areas checked with the Tramex Moisture Meter returned low - normal moisture level readings.

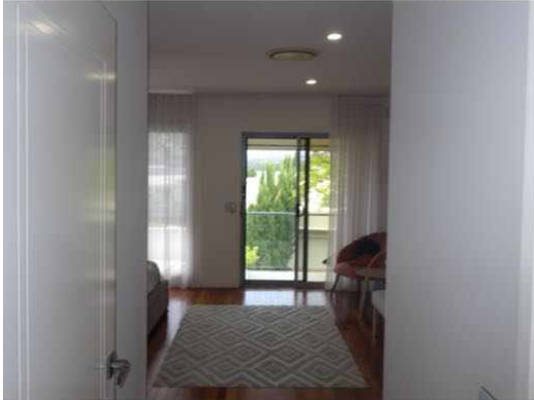
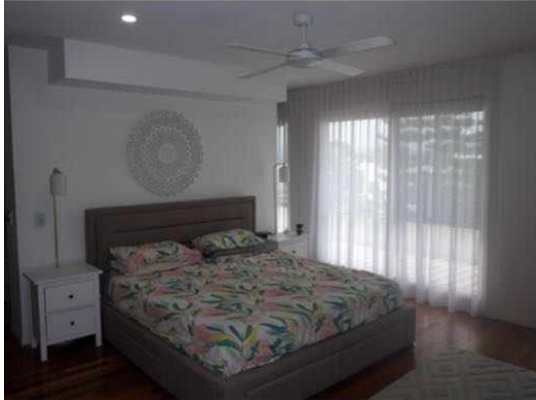
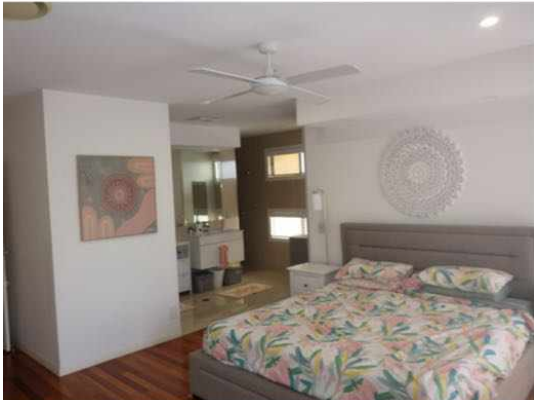
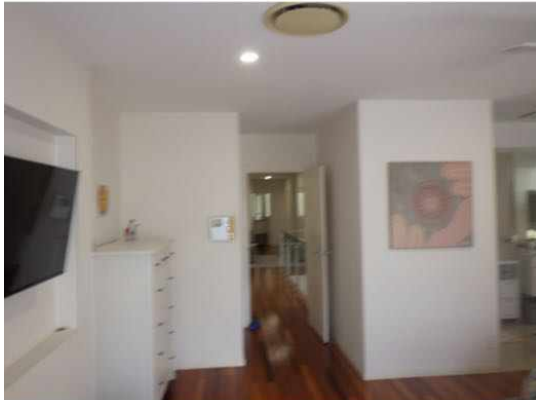
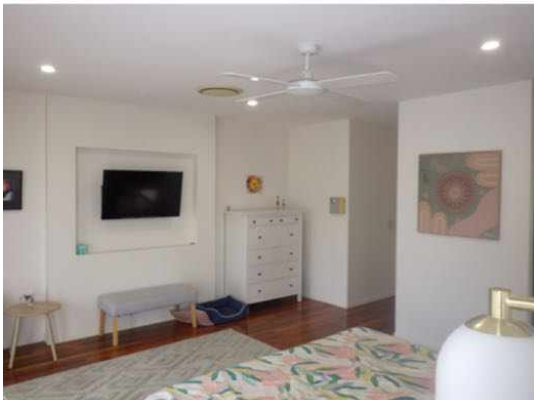
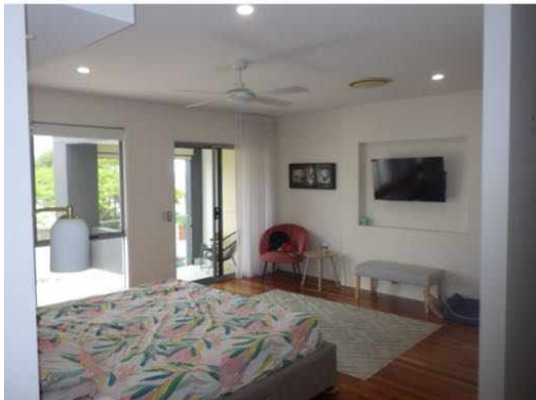
Building: Main Building  
Location: Bedroom - Master > Existing  
Finding: No obvious defect  
Information: No obvious defects found at the time of inspection.

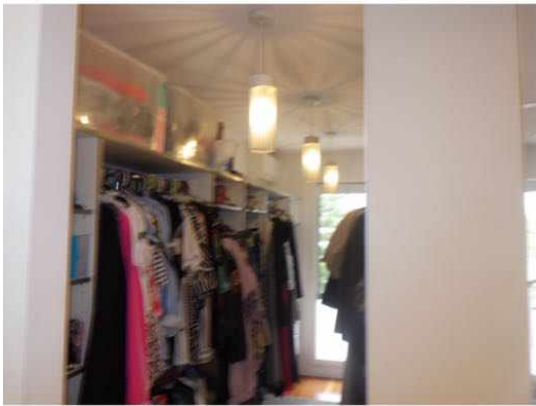
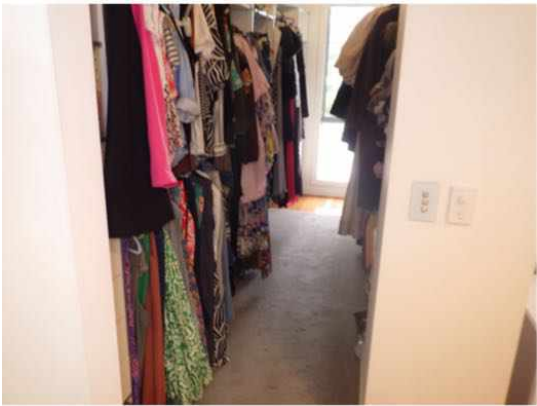
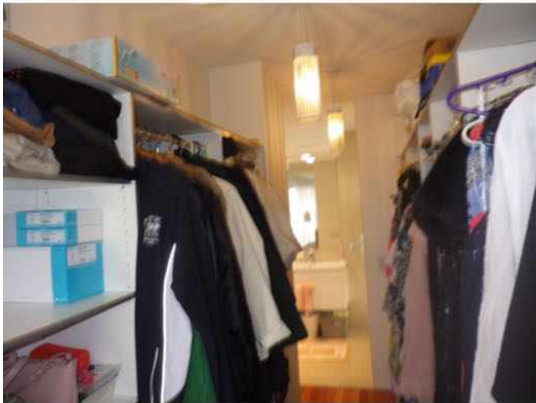
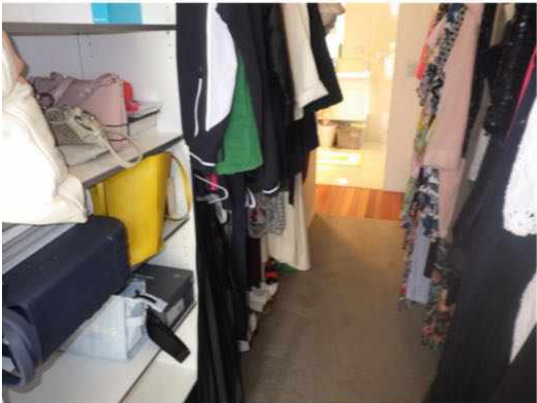
Building: Main Building  
Location: Walk-In Robe - Master > Existing  
Finding: No obvious defect  
Information: No obvious defects found at the time of inspection.
