# Building and Timber Pest Inspection Report

Inspection Date: Fri, 30 Jan 2026

Property Address: 8002B Vista Dr, Benowa QLD 4217,  
Australia

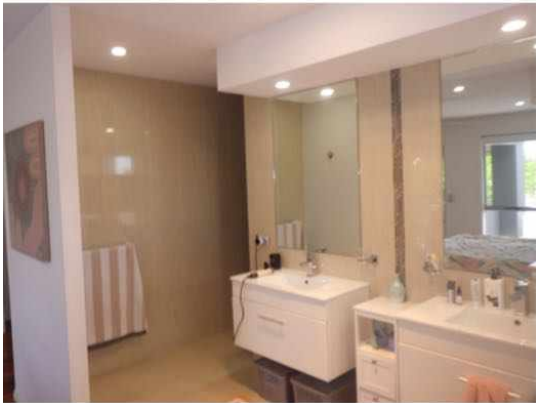
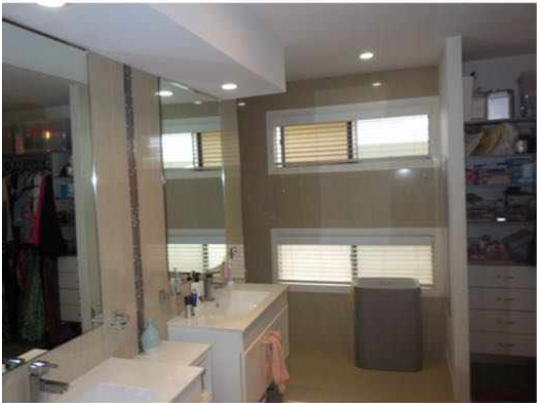
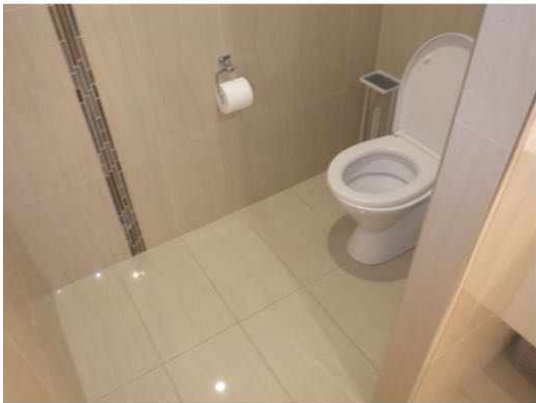
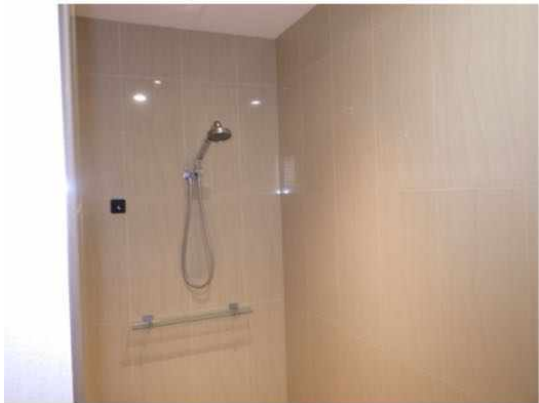
Building: Main Building  
Location: Ensuite - Master > Existing  
Finding: No obvious defect  
Information: No obvious defects found at the time of inspection.

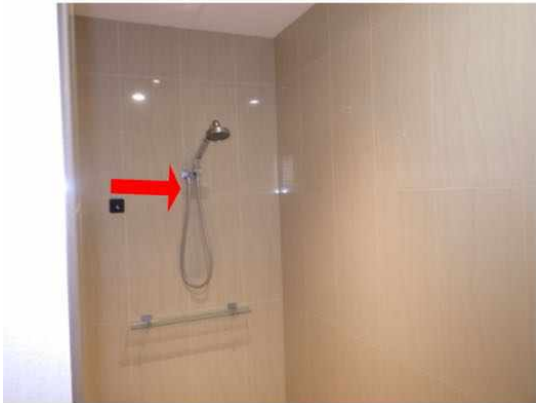
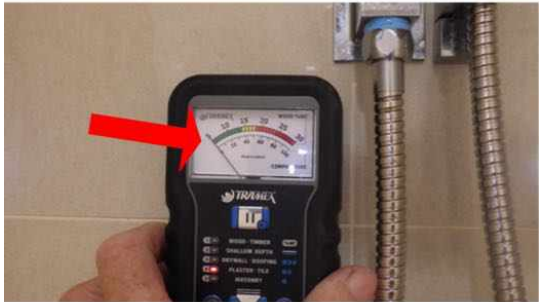
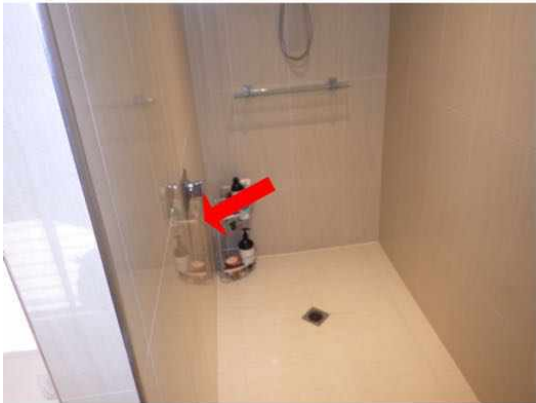
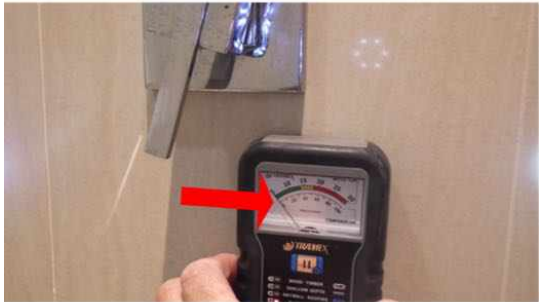
Building: Main Building  
Location: Ensuite - Master > Rear Right  
Finding: Moisture Level Readings  
Information: At the time of inspection the main bedroom ensuite shower cubicle areas checked with the Tramex Moisture Meter returned low - normal moisture level readings.

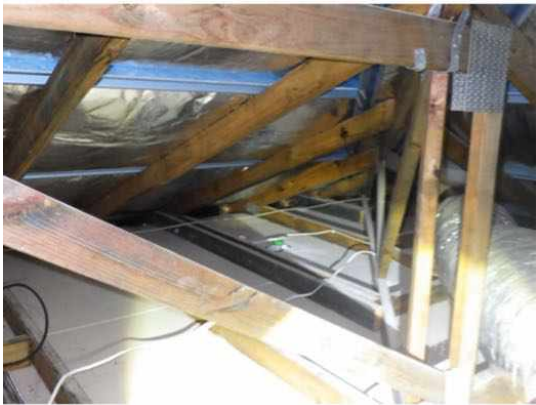
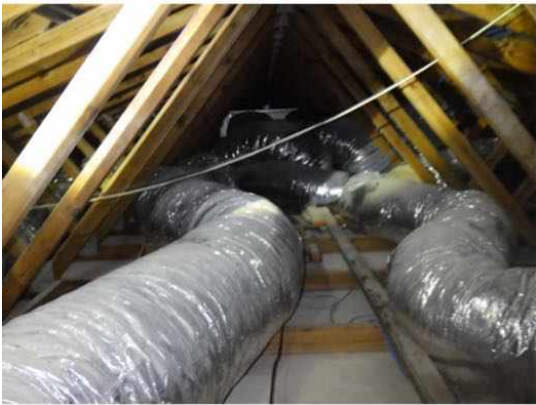
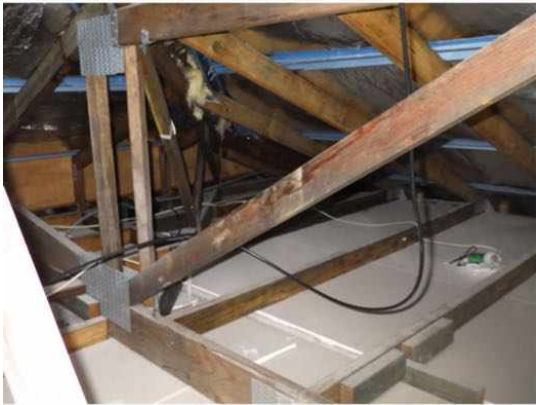
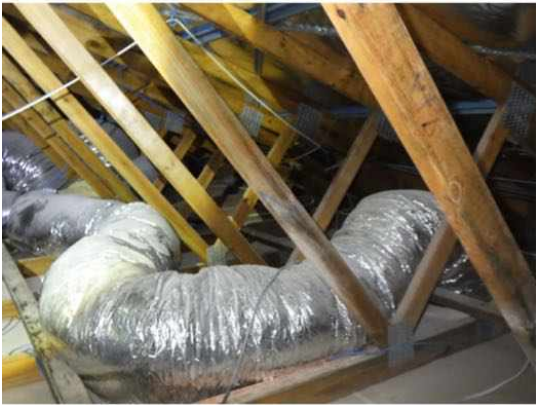
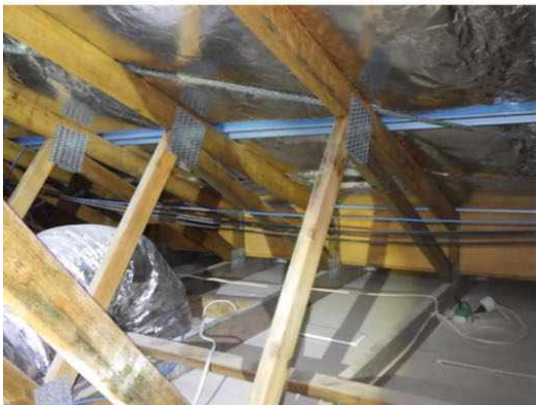
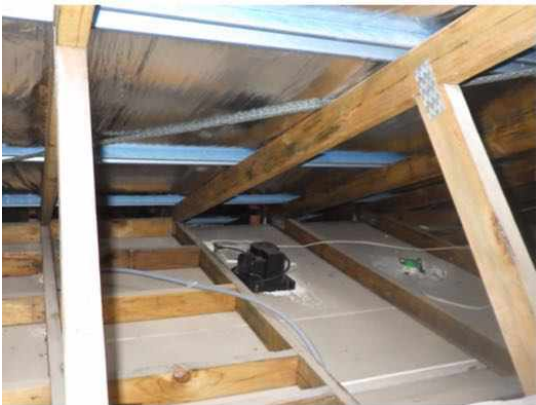
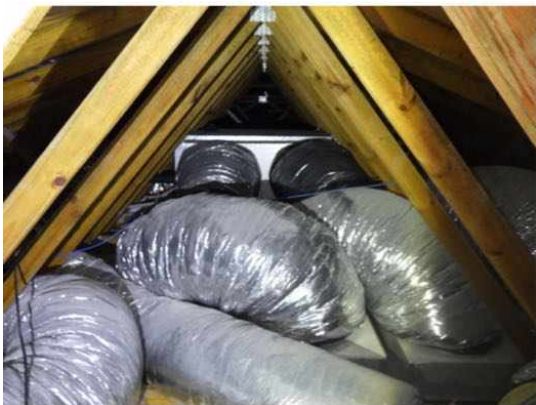
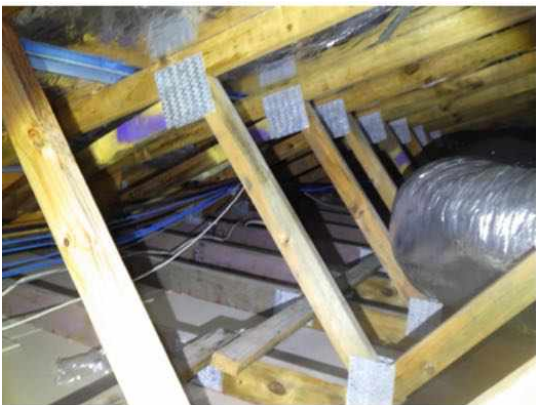
Building: Main Building  
Location: Attic > Existing  
Finding: Additional Photos  
Information: Additional photos are provided for your general reference

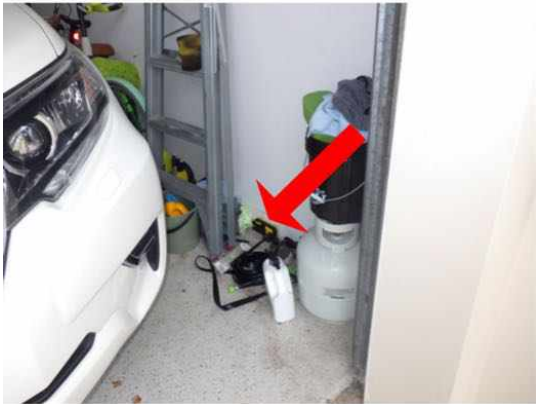
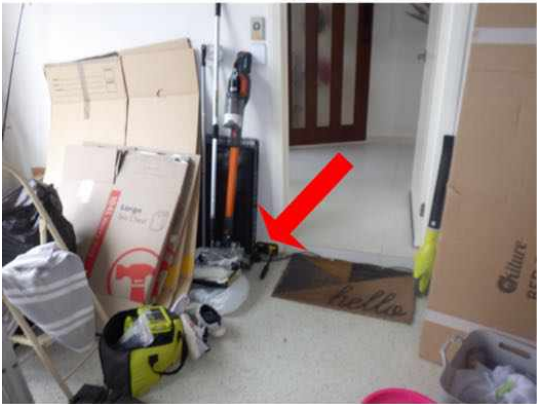
Building: Main Building  
Location: Internal Areas > Existing  
Finding: Termitracker  
Information: The termitracker was positioned randomly to internal wall, timber skirting and window frame areas checking for signs of termite activity.

No activity was recorded at the time of inspection.

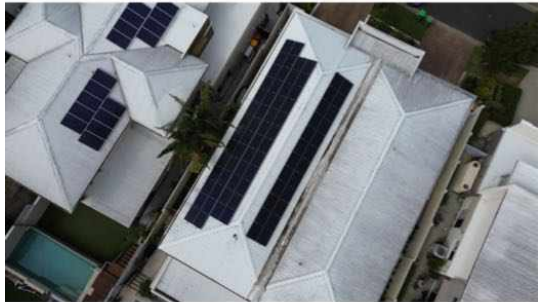
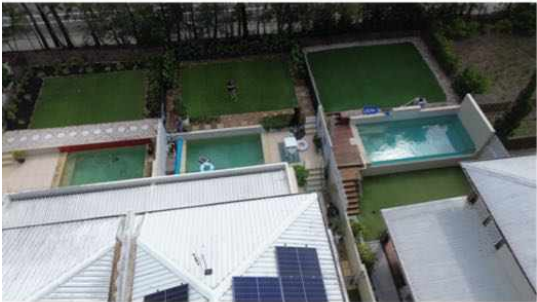
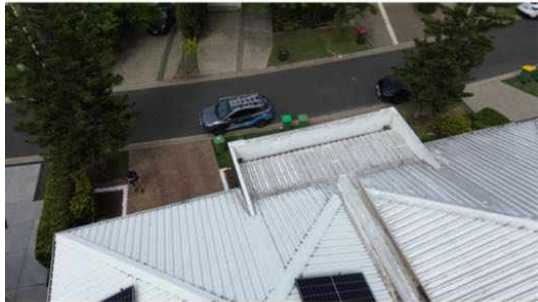
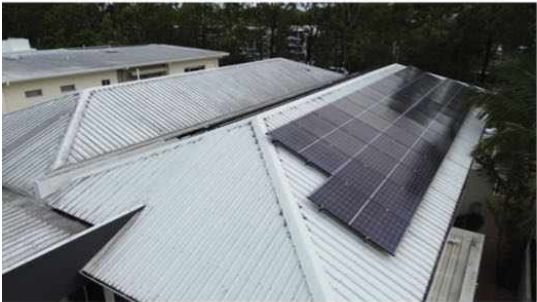
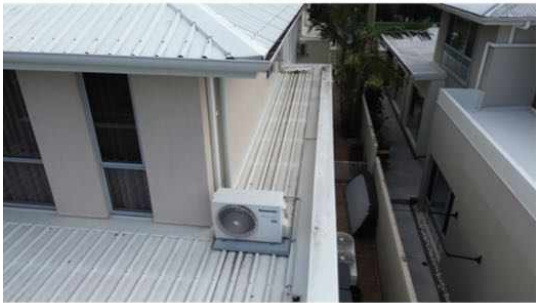
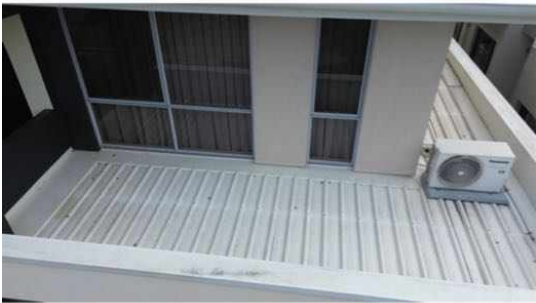
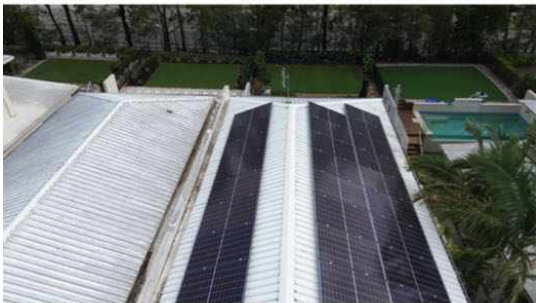
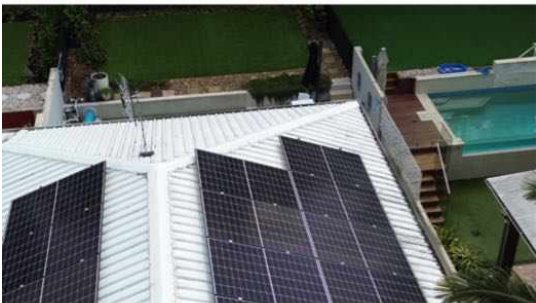
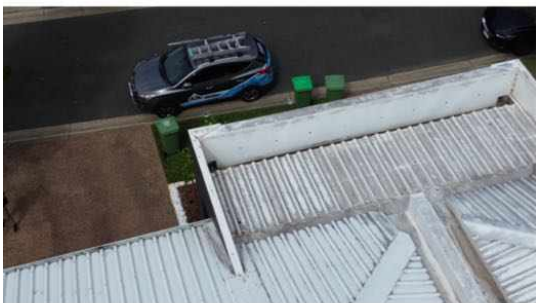
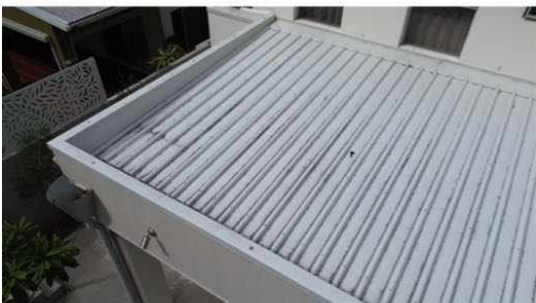
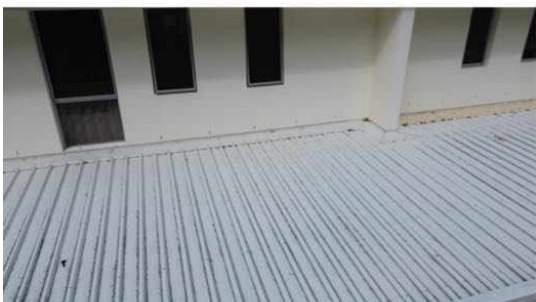
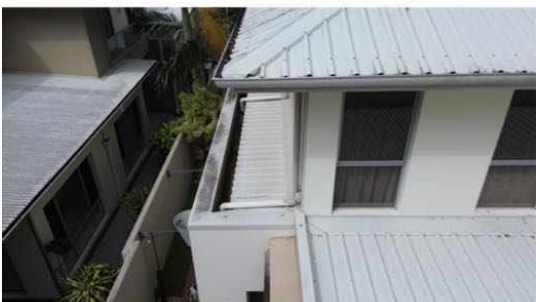
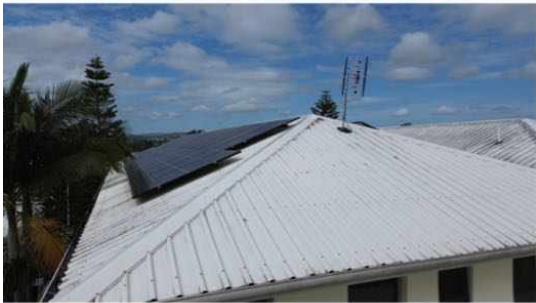
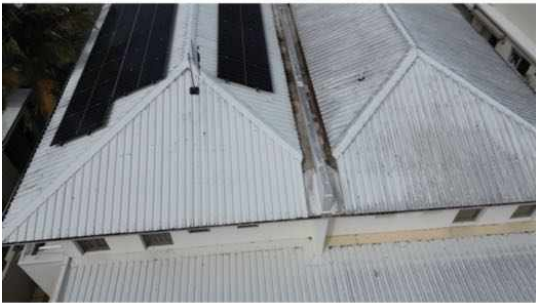
Building: Main Building  
Location: Roof Exterior > Existing  
Finding: Roof Photos  
Information: Roof area photos were taken with the DJI Mini 3 Drone flown over the roof at the time of inspection.

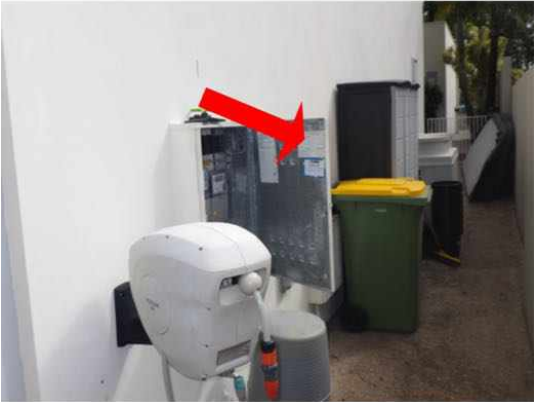
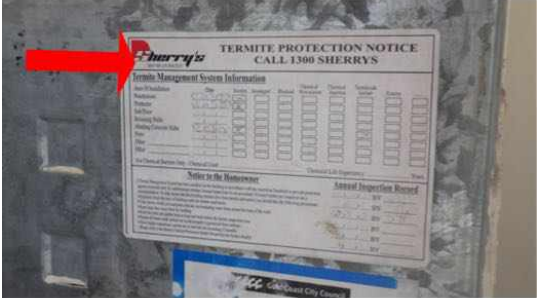
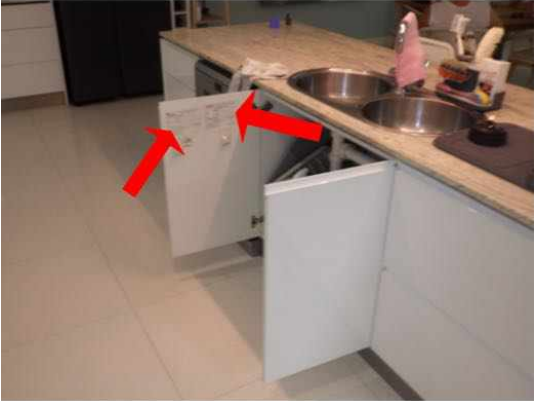
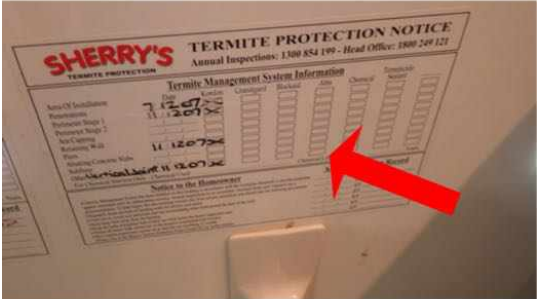
In this instance evidence of a previously installed physical barrier was observed, along with a durable notice inside the electrical meter box and the kitchen area under sink cabinetry. This system requires regular annual inspections.

No evidence of regular or annual inspections was found.
