# Building and Timber Pest Inspection Report

Inspection Date: Wed, 21 Jan 2026

Property Address: 9/12 Edward St, Caboolture QLD 4510,  
Australia

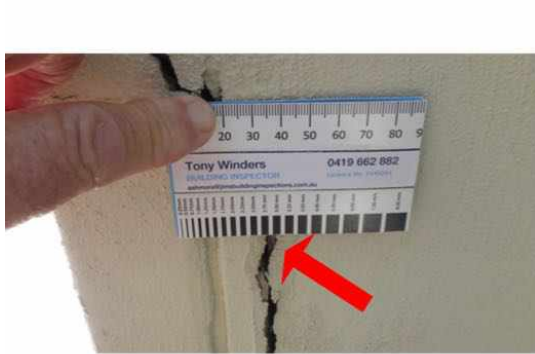
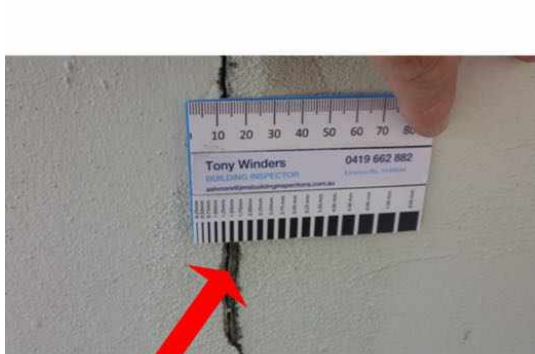
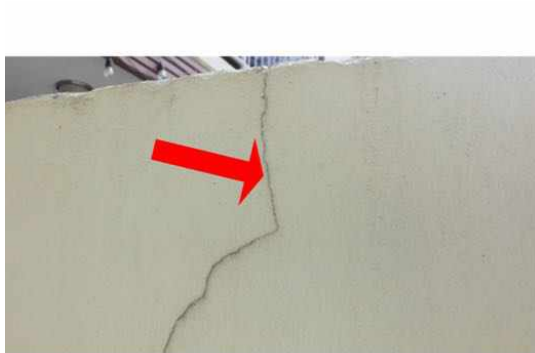
Building: Main Building  
Location: Exterior walls > Existing  
Finding: Cracks to external rendered surfaces  
Information: At the time of inspection it was observed that cracking or damage to external wall rendered surfaces of the building has occurred (as per example photos). The degree of damage appears to fall within Category 2, described as noticeable cracks which are easily filled. Such cracking may cause doors and/or windows to stick slightly, and are generally less than 5mm in width.

Damage of category 2, is generally required to be monitored for a period of 12 months, after which time a crack rated above Category 2 is considered a defect that requires rectification. Always contact your building inspector should cracks widen, lengthen, or become more numerous.

Note - External wall areas maintenance or repairs will likely be the responsibility of the buildings body corporate managers.

It is advised the client request a BCMM form 33 or 34 from the buildings body corporate managers.

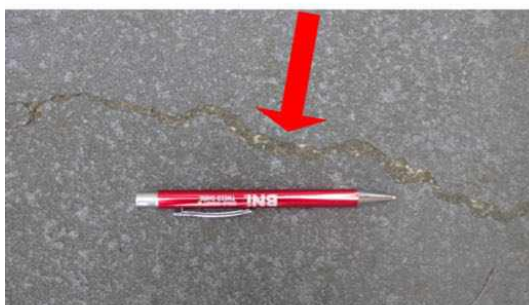
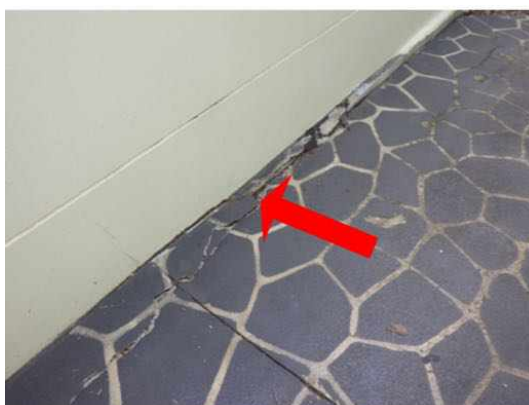
Finding 3.02

Building: Main Building  
 Location: Footpath > Ground Level  
 Finding: Cracking in concrete slab - Category 1  
 Information: Cracking and or movement coded as Category 1 - 2 was identified in the footpaths concrete slabs (as per example photos). A Category 1 crack is described as a fine but noticeable crack, with the slab at an otherwise reasonable level.

To be considered Category 1, the approximate width of the crack is less than 1.0mm, or a less than 10mm change in offset when a 3m straight edge is placed over the defect.

Category 1 cracks should be monitored for a period of 12 months. At the end of the monitoring period, identified cracks that are rated greater than Category 2 are considered defects, and require rectification.

Note - External area maintenance is generally the responsibility of the buildings body corporate managers.

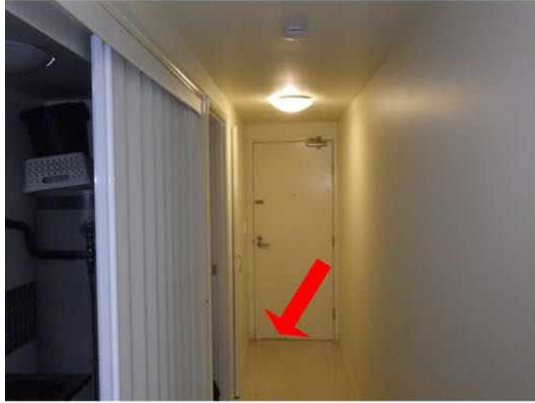
**Finding 3.03**

Building: Main Building  
 Location: Entry > Front  
 Finding: Damaged Door

Information: The entry door has suffered minor damage to the bottom edge.

Damage occurs generally when the building materials have aged and decayed, but may be the result of exposure to moisture.

A qualified painter or general handyman could be appointed to repair the door at the clients discretion.

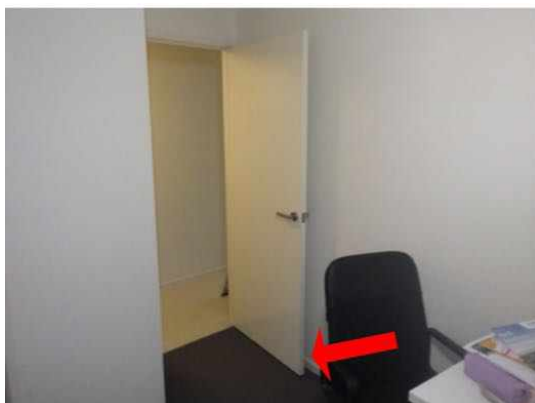
### Finding 3.04

Finding: Door stop - Missing

Information: The bedroom 2 door stop is missing or is inadequate to stop the door handle from damaging the wall.

Re-installation or replacement of the door stop is advised to prevent any subsequent damage to the wall linings or associated structures.

A general handyman may be appointed to perform these works at client discretion.

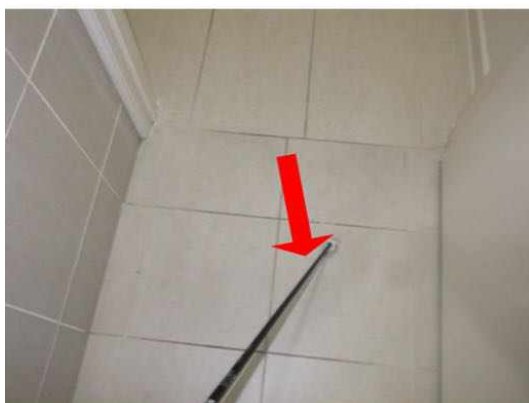
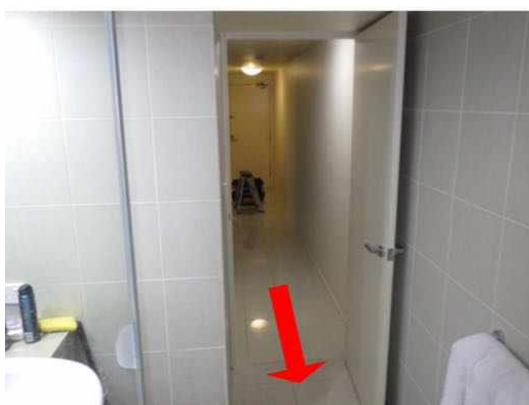
### Finding 3.05

Location: Bathroom > Front  
 Finding: Tiles - Drummy  
 Information: Drummy tiled areas were identified in the bathroom area floor at the time of inspection. The term 'drummy' refers to tiles that despite being in relatively good condition have a hollow sound when tapped on and may be inclined to crack from heavy impact whether accidental or deliberate. Drummy tiled areas may be a direct result of poor workmanship during the construction process.

A tiling contractor could be appointed to perform works if necessary.

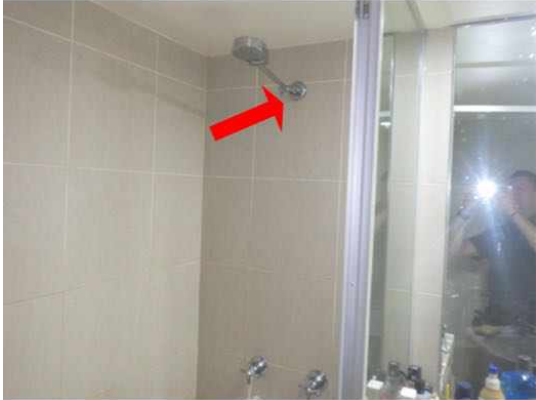
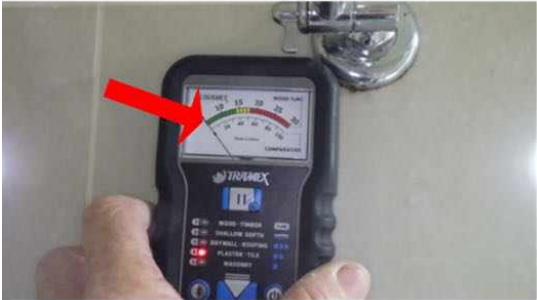
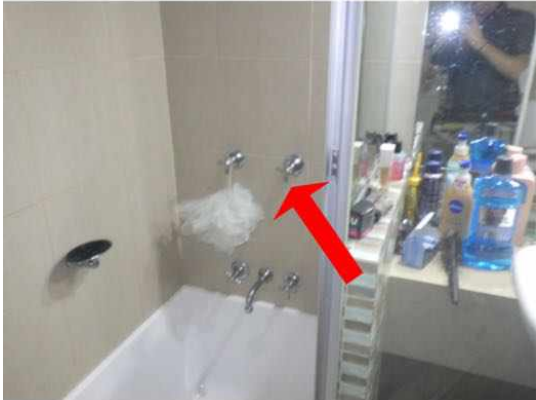
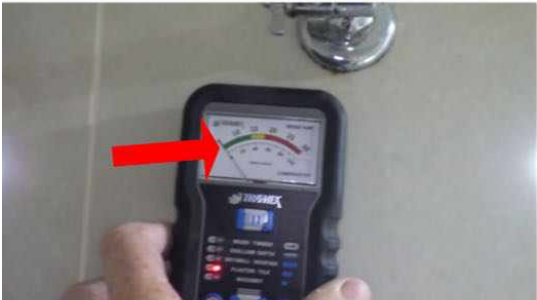
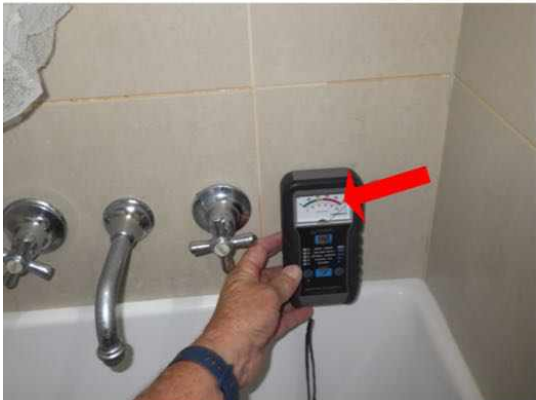
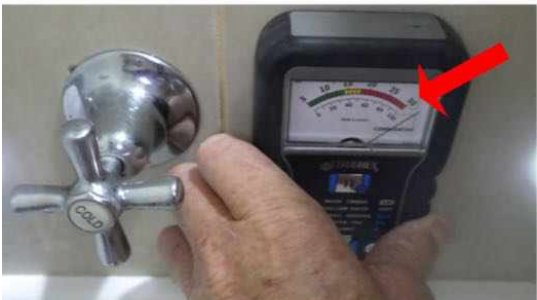
### Finding 3.06

Building: Main Building  
 Location: Bathroom > Rear Right  
 Finding: Shower - Monitor  
 Information: Mid range - elevated moisture level readings were recorded to the lower 200mm of wall to the bathroom shower alcove at the time of inspection. There was no elevated moisture level readings around the tap area, and no elevated readings transferring to the other side of the wall in the areas where moisture readings were able to be obtained. Both sealant and grout appear in good condition at present.

This defect is quite common, and is suspected to have been caused by moisture permeating or leaching through the grouting and perhaps gaps in the sealant.

Monitoring the area is advised and if any visual signs of excessive moisture appear (peeling paint, mould) then consultation with a qualified plumber or bathroom specialist would be advised to identify the cause of damp and to perform remedial works as required.

Always ensure that sealant and grout is in good condition to prevent any moisture issues occurring in the future.

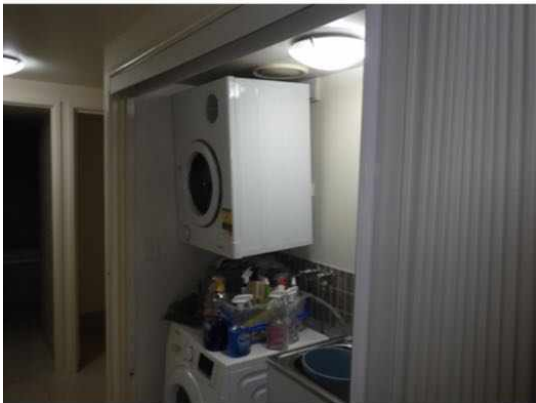
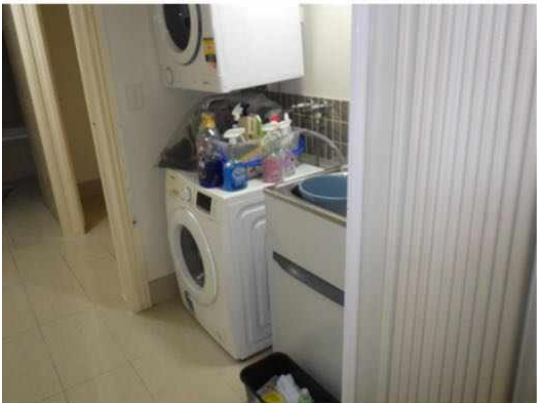
Building: Main Building  
 Location: Storage Cupboards  
 Finding: No obvious defect  
 Information: No obvious defects found at the time of inspection.

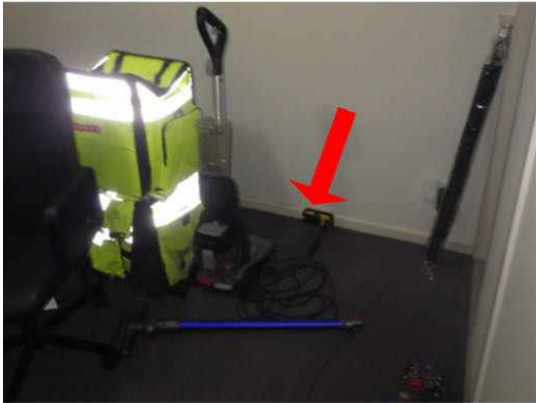
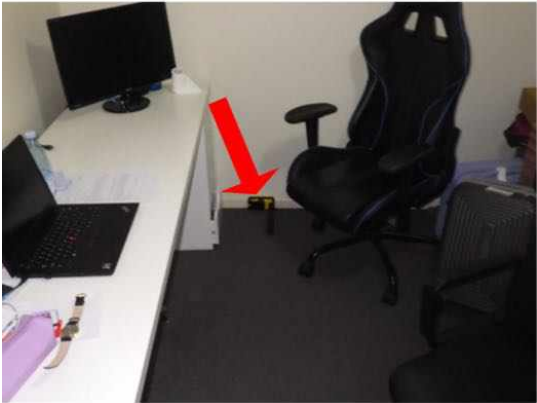
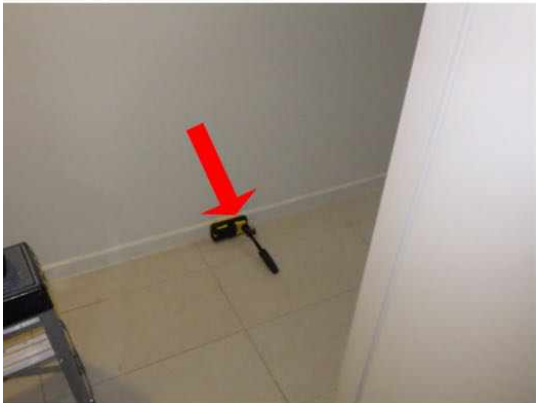
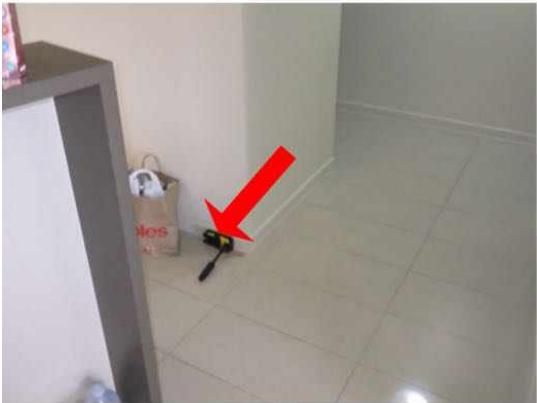
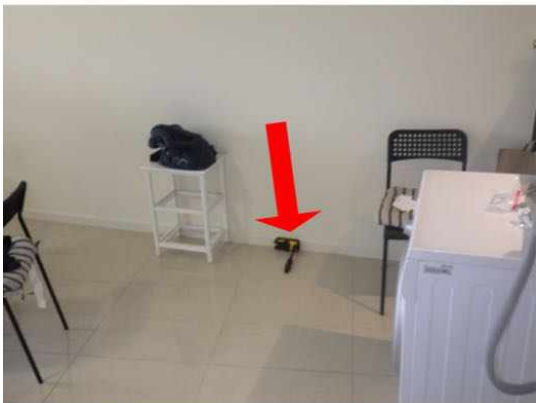
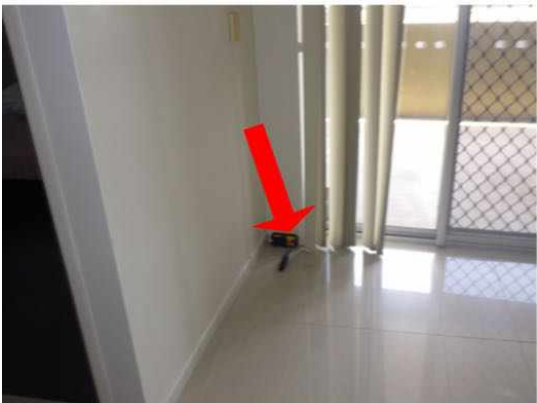
Location: Internal Areas  
Finding: Termitracker  
Information: The termitracker was positioned randomly to internal wall, timber skirting and window frame areas checking for signs of termite activity.

No activity was recorded at the time of inspection.

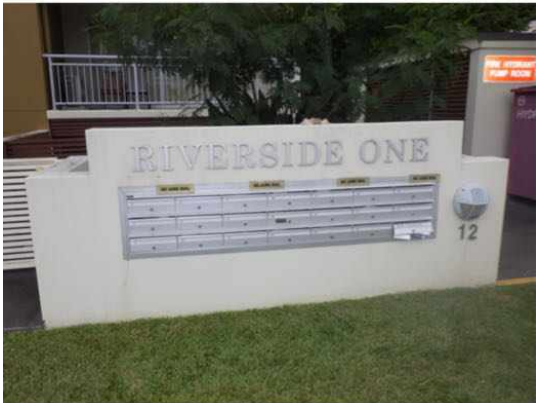
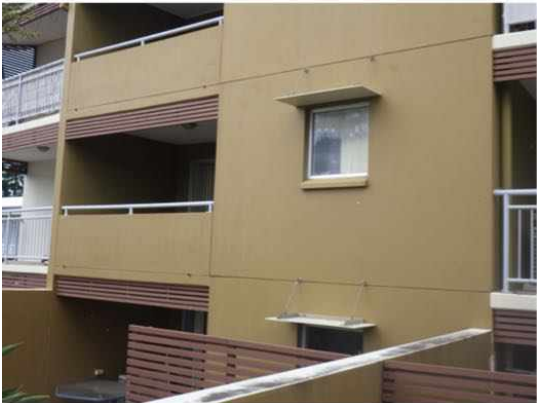
Building: Main Building  
Location: External Areas  
Finding: Additional Photos  
Information: Additional photos are provided for your general reference
