Building Inspection Report

Inspection Date: Thu, 12 Mar 2026

Property Address: 22 Crozier Terrace, Oaklands Park SA 5046,
Australia

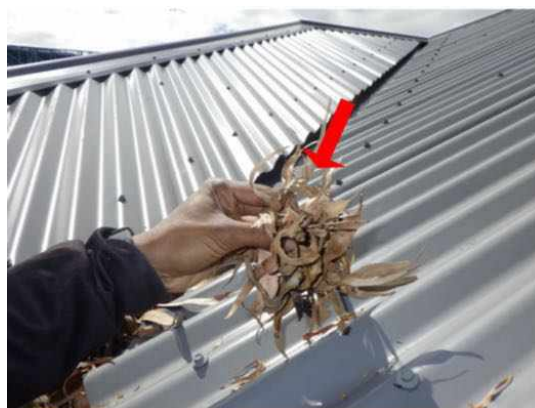
Defects 2.01

Blocked gutters are likely to lead to high levels of moisture in the affected areas. Such moisture will not only cause rust and decay of the associated building materials, but can also provide conditions that are conducive to termite and timber pest activity. Blockages in gutters should therefore be removed immediately to ensure dry conditions are maintained.

Consult a Licensed Plumber for further specific advice on remedial works that may be required. In the interim, it is highly advised that blocked gutters be removed by the homeowner or a general handyperson as a matter of urgency.

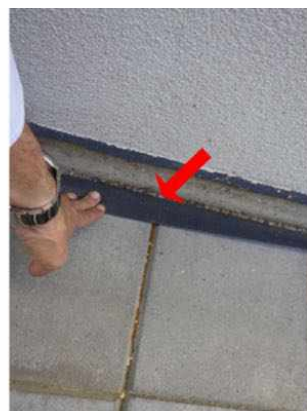
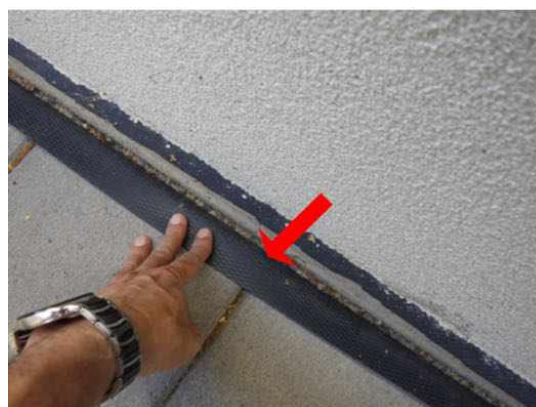
Defects 3.01

If the slab edge is not properly exposed there is a high risk of termite attack. Sometimes, in order to determine the type of slab, a suitably qualified person such as an architect or builder may be required to consult the construction plans.

Where the slab edge cannot be properly inspected, it is highly recommended that termite or timber pest inspections be carried out every 6-12 months to aid protection of the property against infestation.

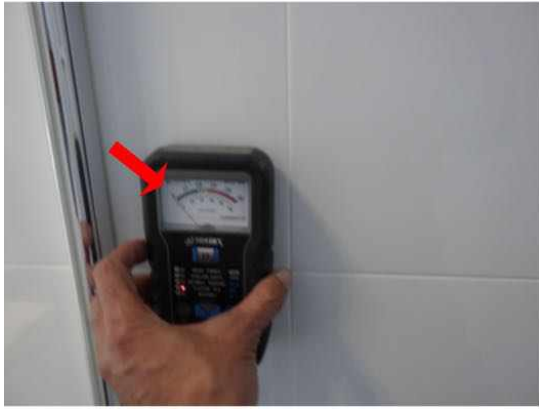
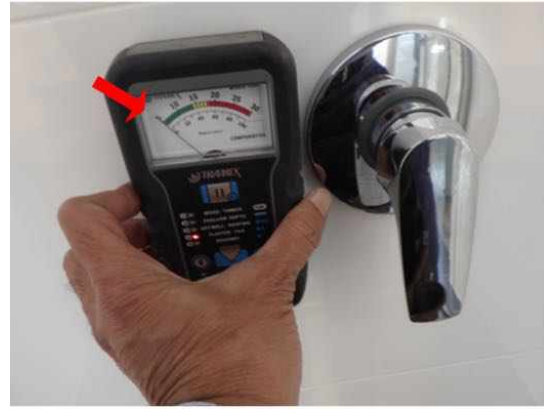
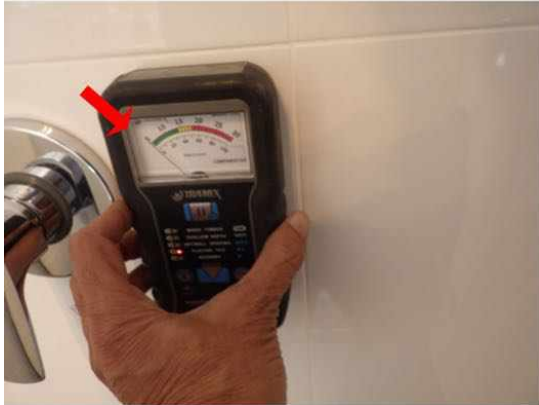
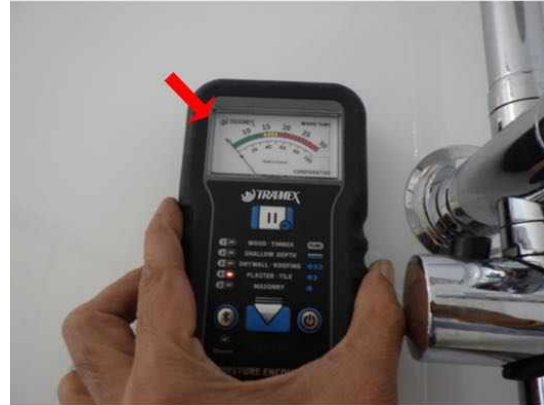
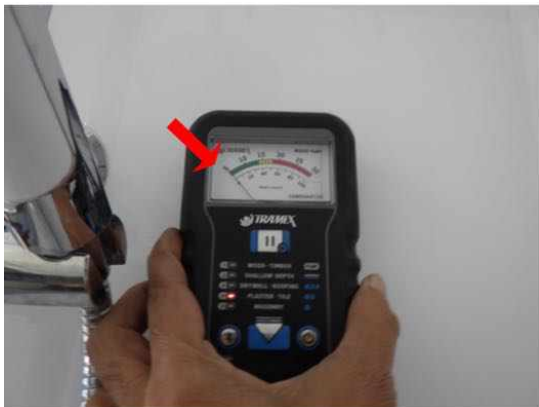
Damp (or structural damp) refers to the presence of unwanted moisture in the structure of a building, either as the result of intrusion from outside, or condensation

from within the structure. In the shower area, internal water leaks or other sources of excessive moisture are generally the cause of damp.

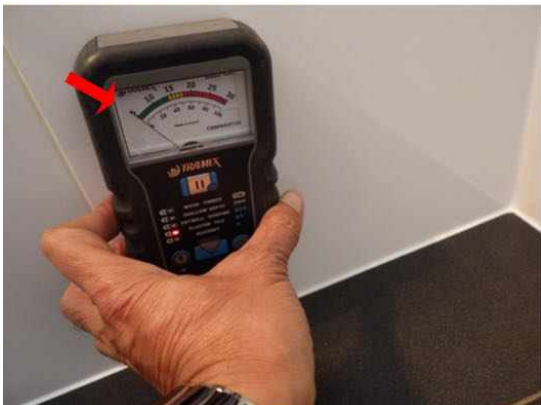
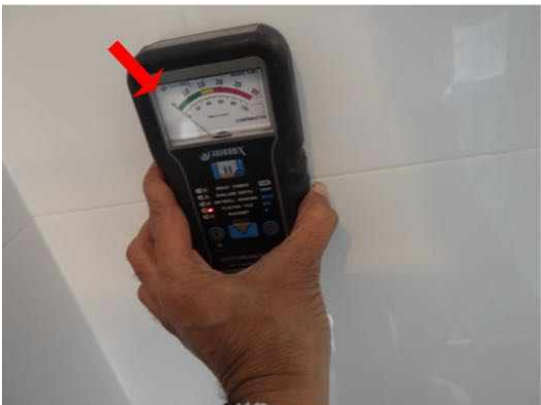
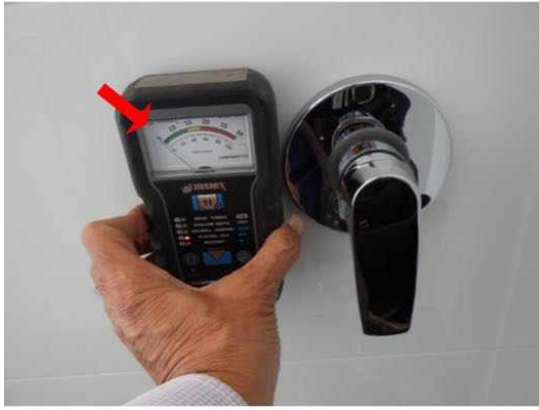
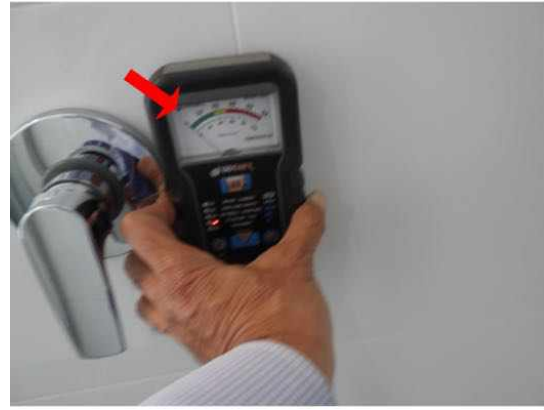
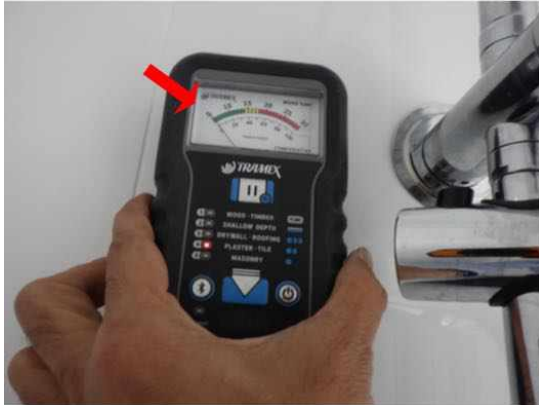
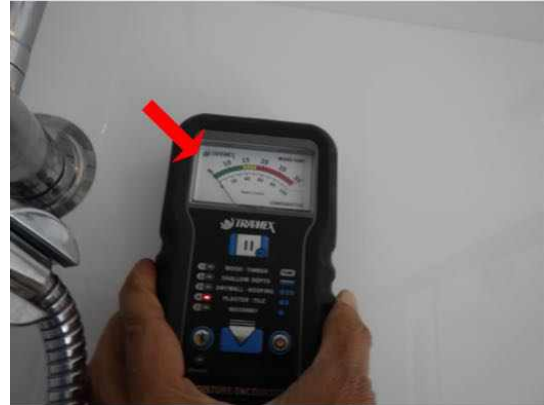
Building: Building 1
 Location: Bathroom 2
 Finding: Shower Alcove - No Damp
 Information: At the time of inspection it was noticed that damp is not evident to the shower alcove.

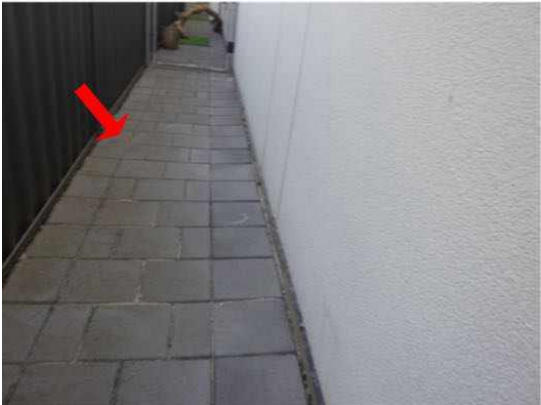
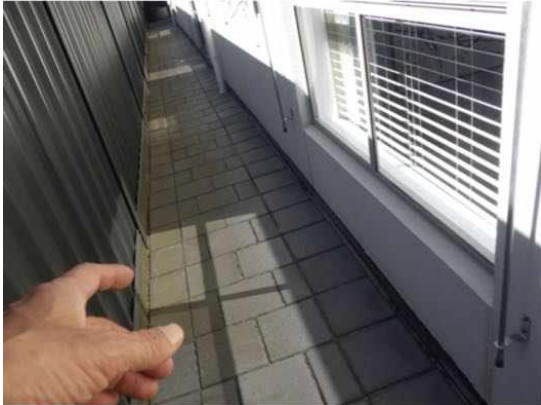
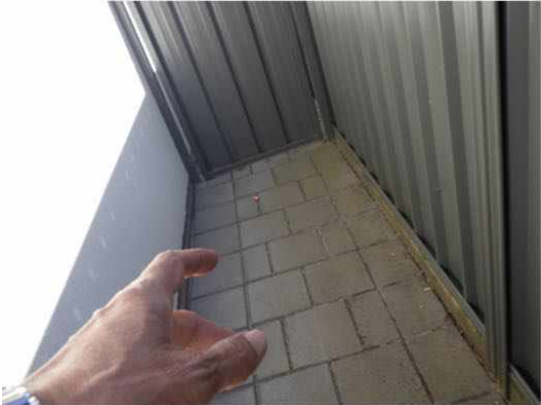
Building: Building 1
 Location: All External Areas
 Finding: Water pooling - against property
 Information: Water appears to be pooling against the house. It is suspected that this is a result of poor site drainage but may also be due to excessive moisture from an unidentified source.

Where water is pooling against the house water damage to the external wall cladding is imminent.

Such water pooling also increases the risk of termite activity and the development of fungal decay in the area.

Consult a Licensed Plumber regarding the cost of potential site drainage rectification works.

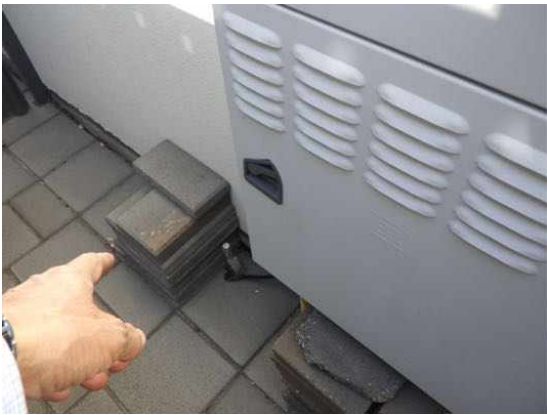
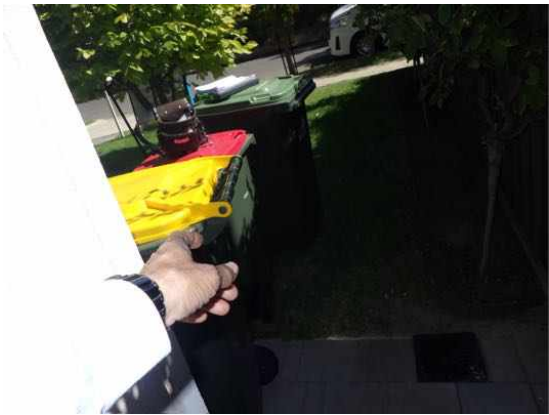
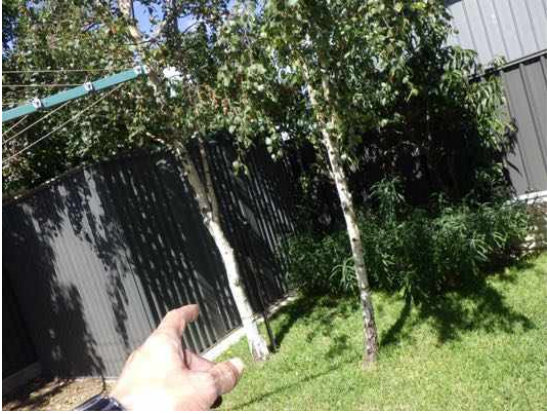
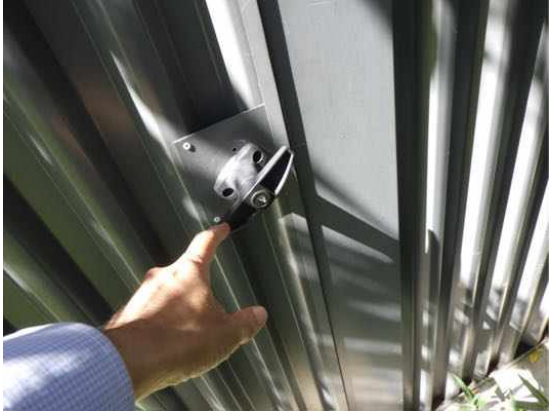
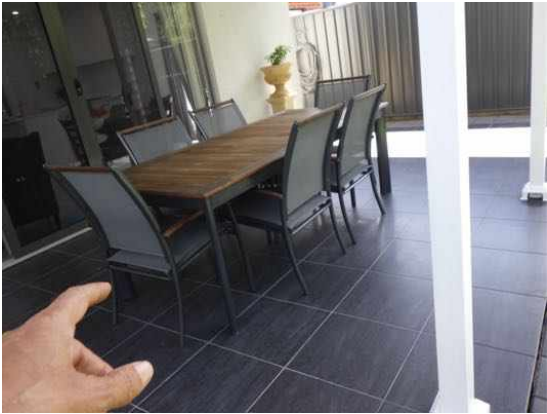
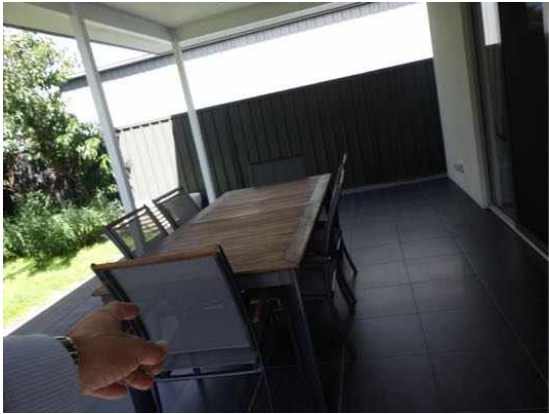
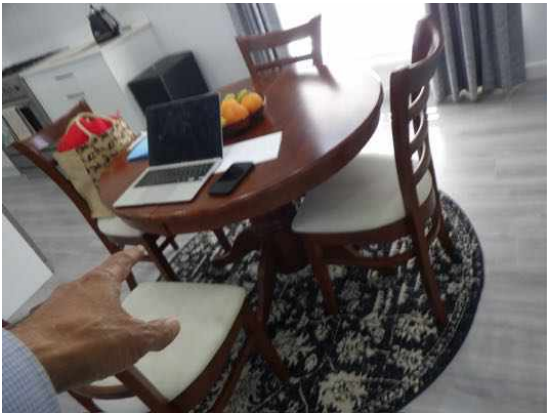
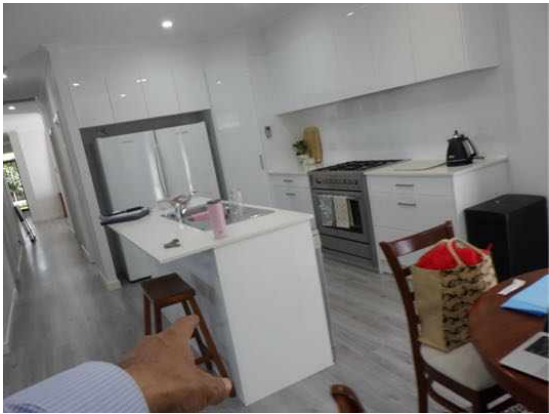
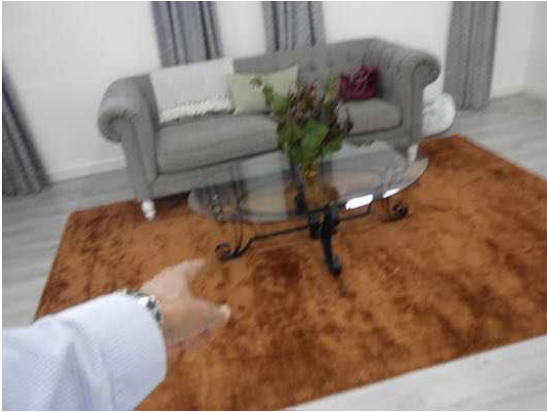
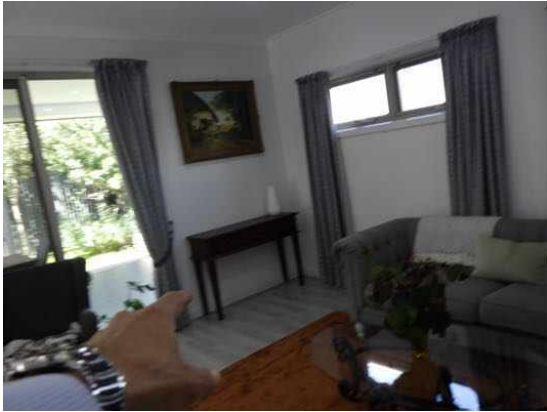
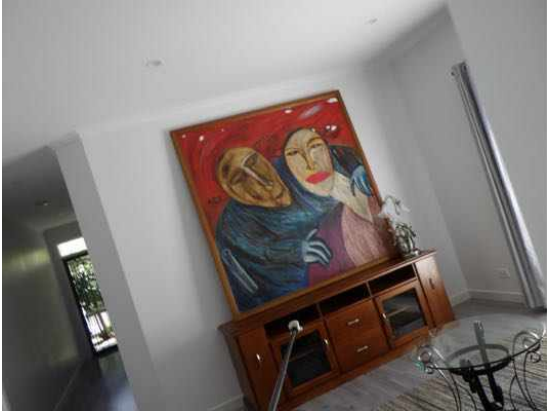
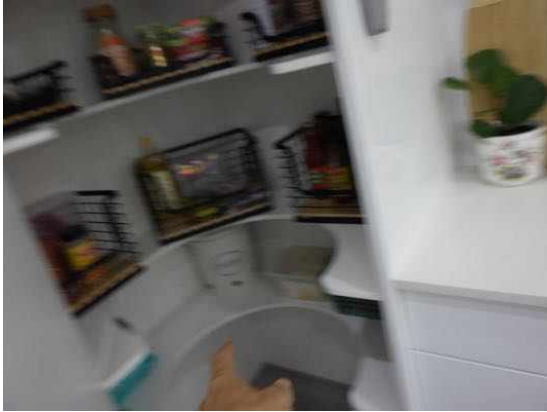
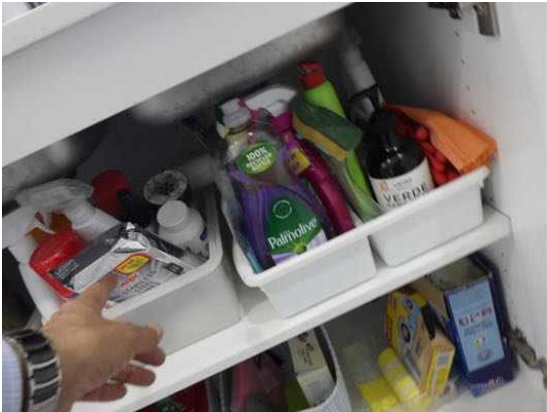
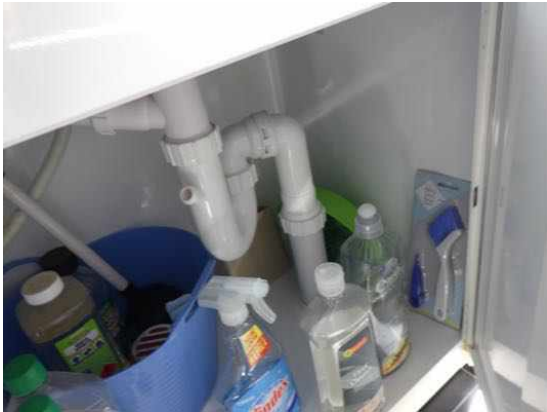
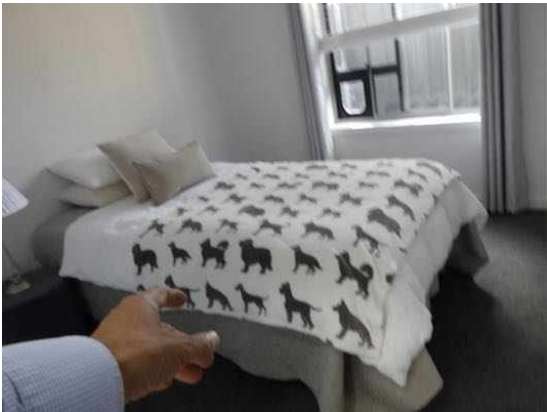
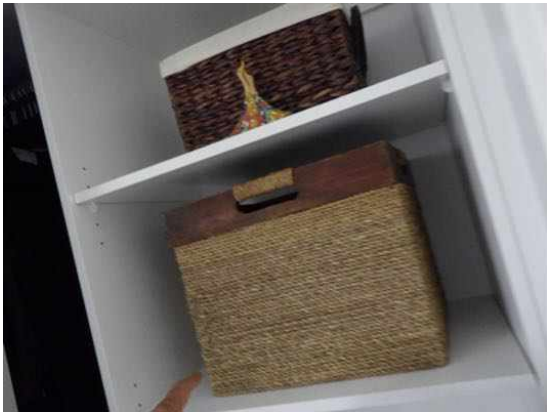
Building: Building 1
Location: All Areas
Finding: Additional Photos - Obstructions and Limitations
Information: These photographs are an indication of the obstructions and limitations which impeded full inspection of the property at the time of inspection. These obstructions can hide an array of defects and should be removed to allow full inspection to be carried out. A re-inspection is recommended once the areas are made accessible.
