Building and Timber Pest Inspection Report

Inspection Date: Fri, 27 Mar 2026

Property Address: 3/159 Northern Rd, Heidelberg Heights VIC
3081, Australia

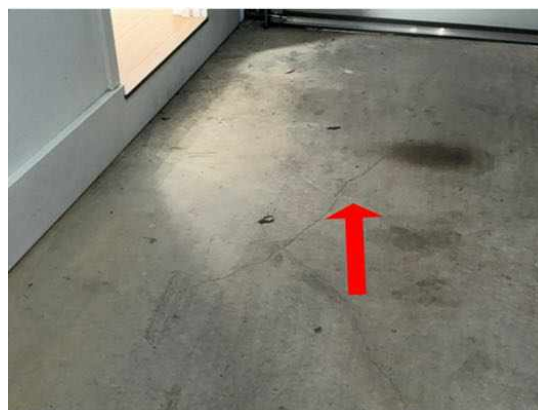
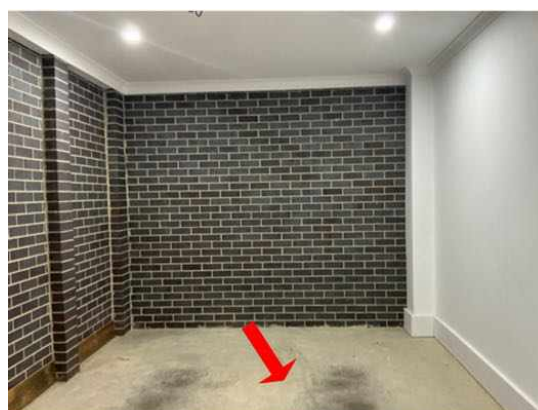
Building:	Main Building
Location:	Garage
Finding:	Crack in concrete slab - Category 1
Information:	A crack coded as Category 1 was identified in the slab. A Category 1 crack is

described as a fine but noticeable crack, with the slab at an otherwise reasonable level.

To be considered Category 1, the approximate width of the crack is less than 1.0mm, or a less than 10mm change in offset when a 3m straight edge is placed over the defect.

Category 1 cracks should be monitored for a period of 12 months. At the end of the monitoring period, identified cracks that are rated greater than Category 2 are considered defects, and require rectification.

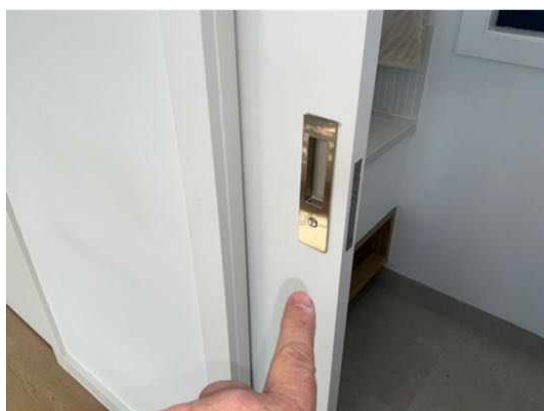
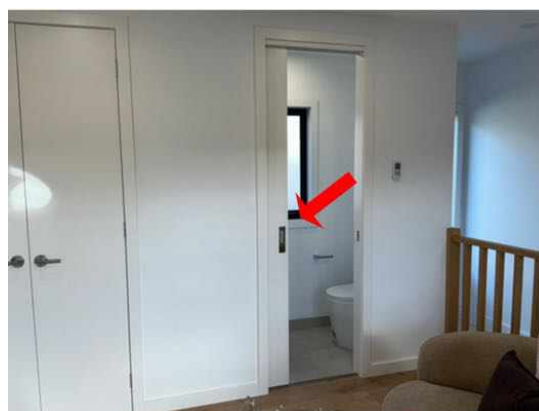
Building: Main Building
 Location: Powder Room
 Finding: Door handle loose
 Information: The door handle was found to be loose.

Unattended to the handle could fall off and make the door inoperative.

A carpenter/handy man should be appointed immediately to review and adjust at the owners discretion.

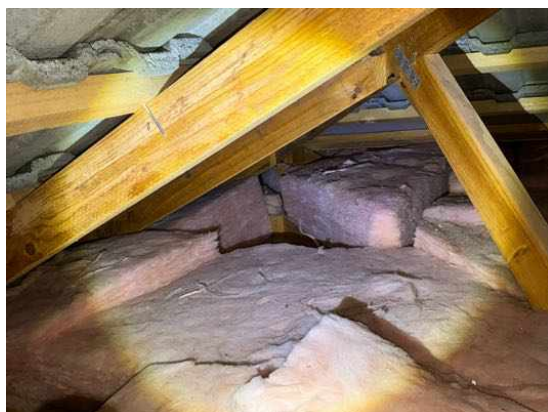
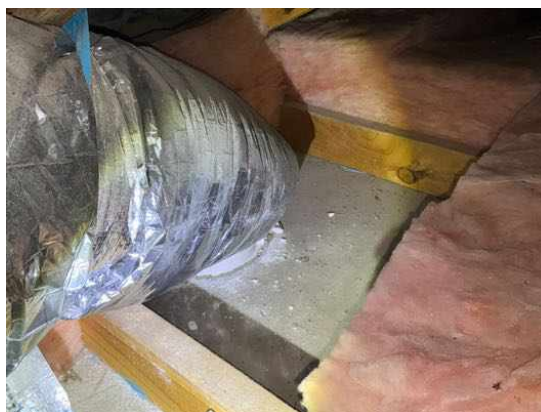
Building:	Main Building
Location:	Roof Void
Finding:	Insulation - Missing-disturbed
Information:	Upon inspection of the roof void it was noted that insulation is not present or disturbed.

Insufficient insulation will result in a comparatively higher cost to heat and cool a property as there is a lack of Insulation (or uneven coverage of insulation) which works as a barrier to heat transfer. This helps to keep out unwanted heat in summer and preserves warmth inside your home in winter. It can also help soundproof your home from unwanted airborne noise transfer.

Where insulation is absent, the area does not meet current Australian Standards. Installation of adequate insulation is required and should be conducted as soon as possible.

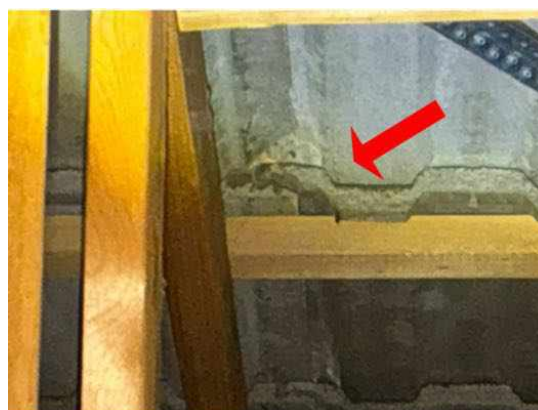
Finding 3.09

It is noted that this repair was made at the time of construction and the builder should rework as part of his warranty obligations

. A roofing contractor or general handyman may be appointed to perform these works at client discretion.

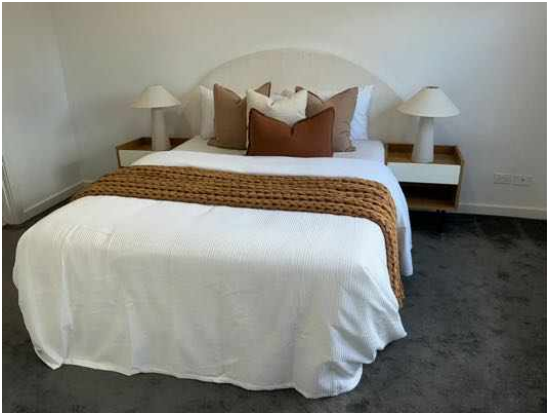
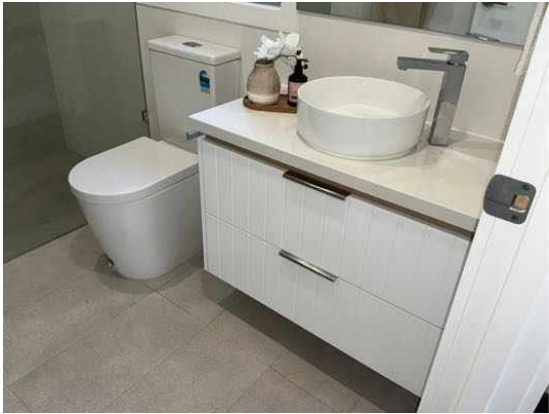
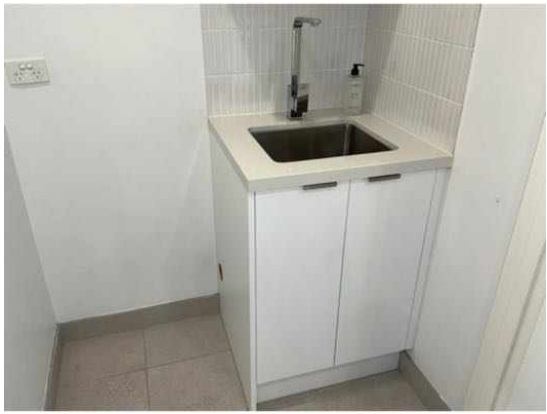
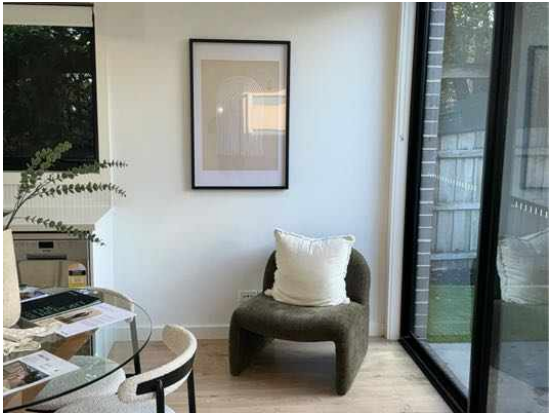
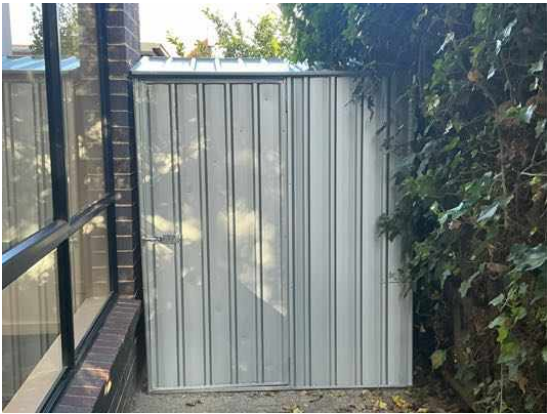
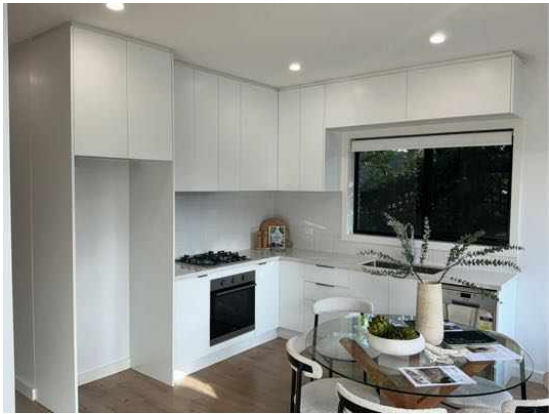
Building: Main Building
Location: All Areas
Finding: Additional Photos - Obstructions and Limitations
Information: These photographs are an indication of the obstructions and limitations which impeded full inspection of the property at the time of inspection. These obstructions can hide an array of defects and should be removed to allow full inspection to be carried out. A re-inspection is recommended once the areas are made accessible.

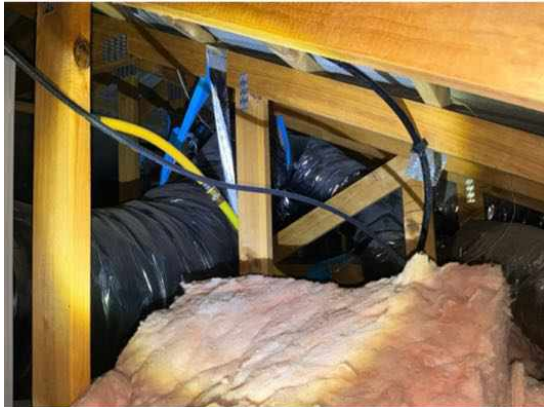
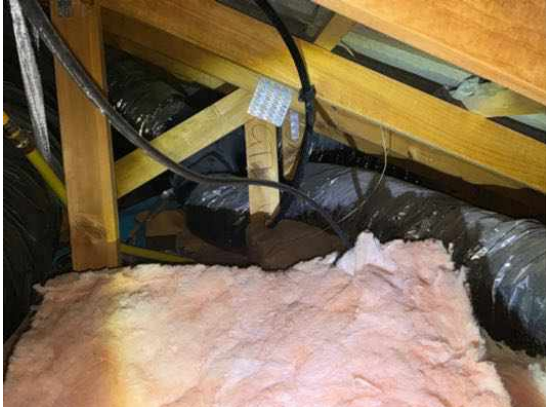
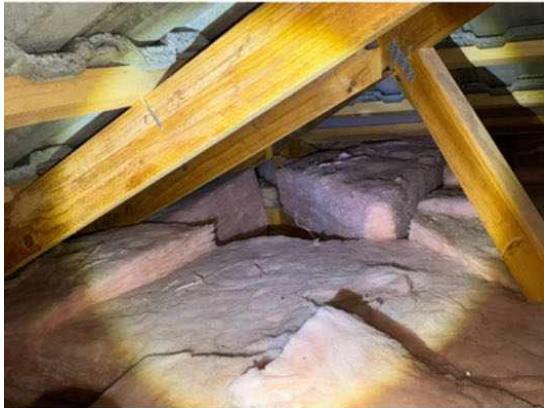
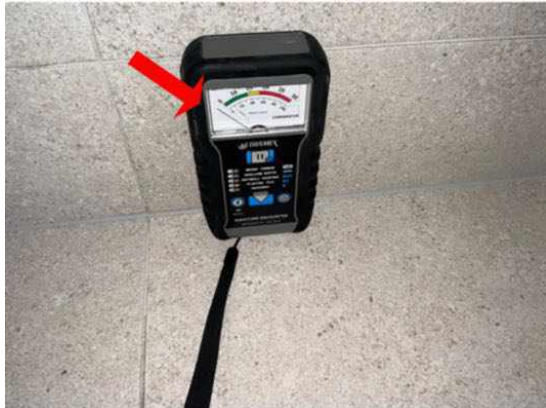
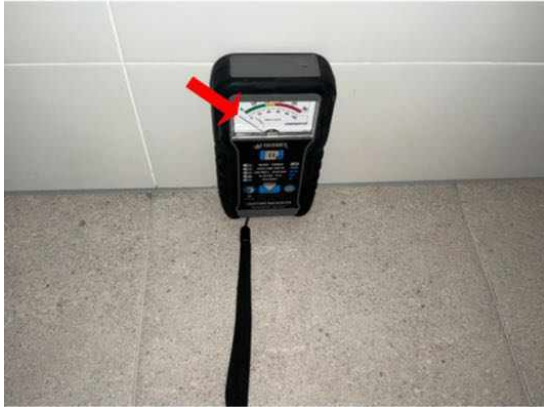
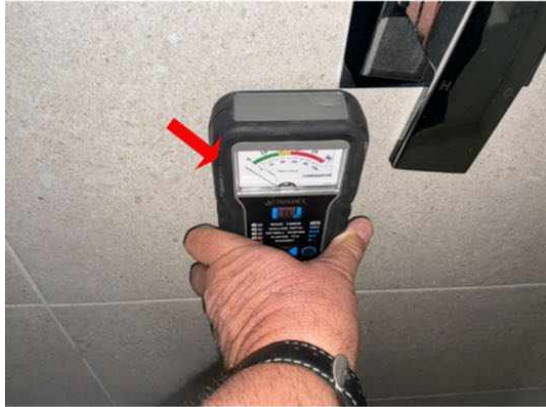
Building: Main Building
Location: All Areas
Finding: Additional Photos
Information: Additional photos are provided for your general reference
