Building and Timber Pest Inspection Report

Inspection Date: Tue, 10 Feb 2026

Property Address: 48 Carlisle St, Ethelton SA 5015, Australia

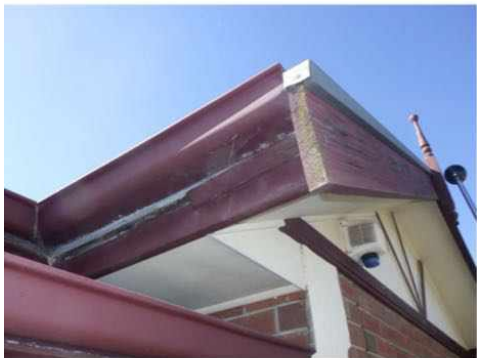
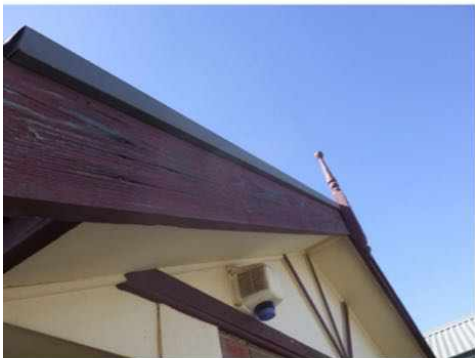
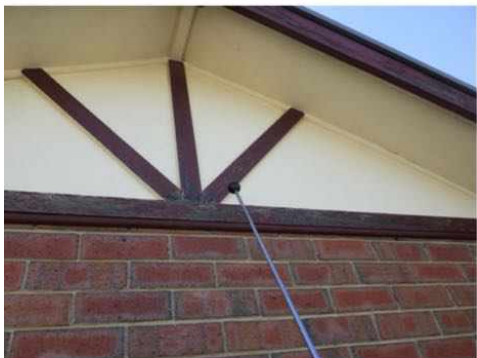
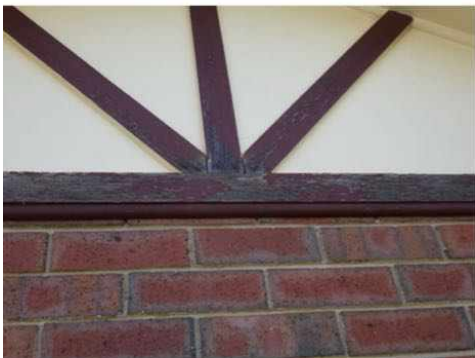
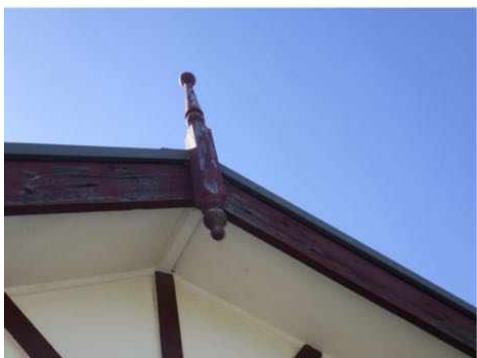
Building:	Building 1
Location:	All External Areas
Finding:	External painting deteriorated
Information:	Much of the external paintwork including but not limited to exterior fascia timbers, and other elements, have been neglected and require attention to prepare and re-paint.

Whilst incomplete or missing paint finish is generally an appearance defect, it can also lead to the development of secondary building defects over time. Incomplete areas of paint finish expose the area to moisture, potentially accelerating the deterioration of underlying building materials.

Degraded paint finishes should be sanded back, filled, leveled and painted, as applicable. Rust to steel beams should be ground out and treated.

A painting contractor should be appointed as soon as possible to perform necessary works to aid the appearance of the affected area and to ensure the area is protected against further deterioration. Alternatively, the homeowner following manufacturer instructions may perform these works.

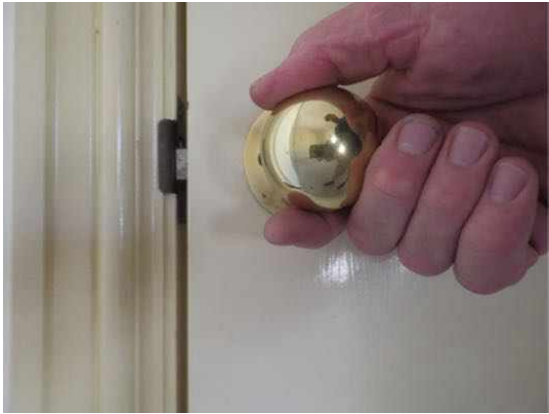
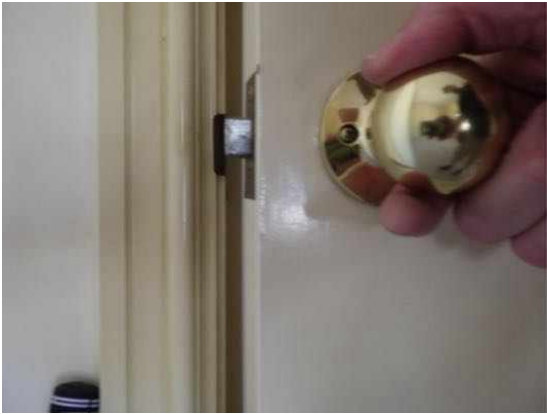
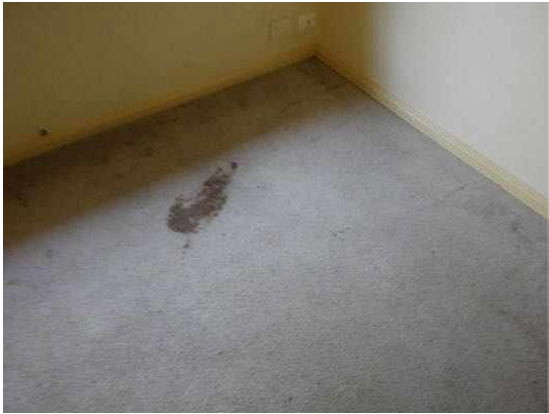
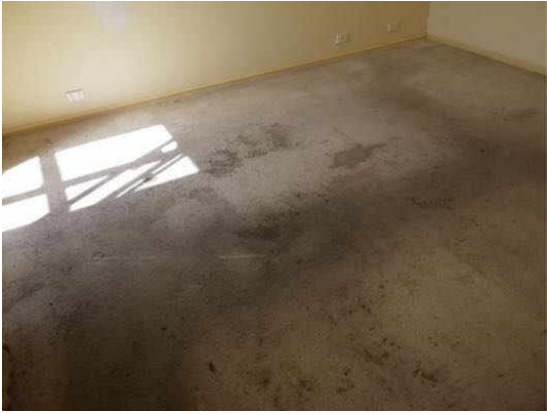
Building: Building 1
 Location: All Areas
 Finding: Minor defects present
 Information: There were several age and maintenance related defects evident to the dwelling at the

- Damage to front porch tiling
- Damage to front porch post
- Physical Damage to garage wall
- Bed 1 door not striking
- Carpet deteriorated throughout.

Appropriate licensed trades people could be appointed to make repairs at the discretion of the client.

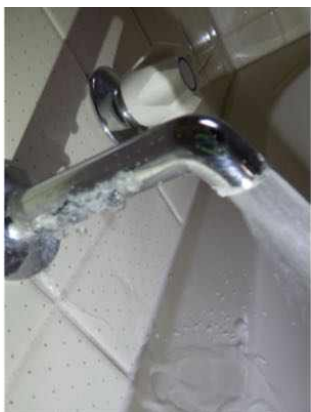
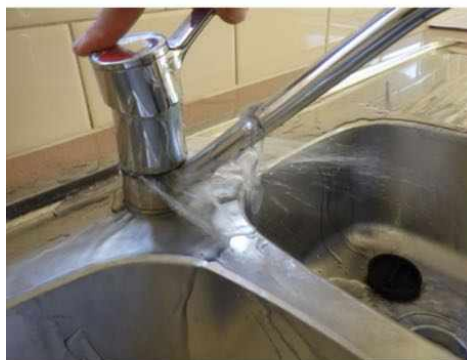
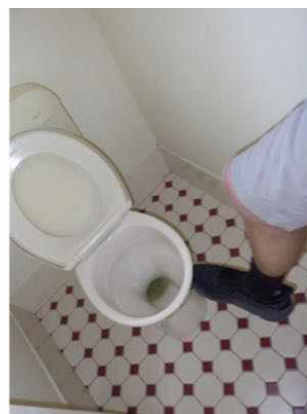
Finding 3.06

Building: Building 1
Location: Roof Void
Finding: Plumbing issues.
Information: All plumbing should to be maintained in good order.

- Leak to bath spout
- Leaking to kitchen mixer
- Loose toilet pan

It is highly recommended that the client makes contact with a licensed plumber to make required investigations and adjustments prior to any further secondary defects being created.

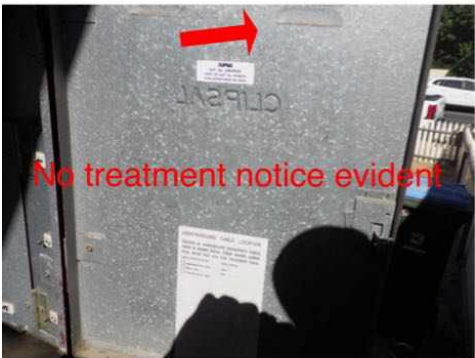
At the time of inspection, it appeared as though no termite management system has been installed, with no evidence to suggest preventative works taking place.

The client may consider gaining further advice from a pest controller as to the costs and procedures involved with this application. It is recommended that obtaining such advice be a short-term priority.

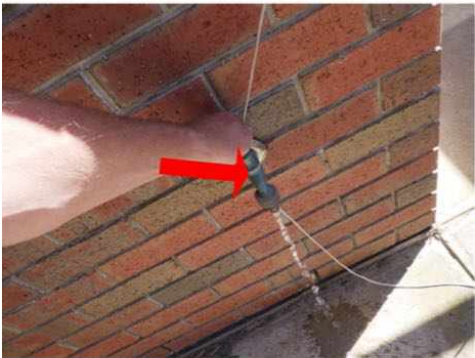
Finding 6.04

Building: Building 1
Location: Yard - Back
Finding: Air conditioner and or external tap - No drainage
Information: Moisture around the perimeter of the building should be minimised to ensure that the area is kept dry and stable which in turn reduces the risk of water damage and termite infestation.

There appears to be no drainage points set up to the air conditioning unit, and or the external tap. While this is not a legal requirement it is recommended to reduce the risk of moisture related issues and the creation of an environment conducive to termite activity.

It is recommended that a licensed plumber be appointed to set up drainage in order to prevent such an environment from being created.

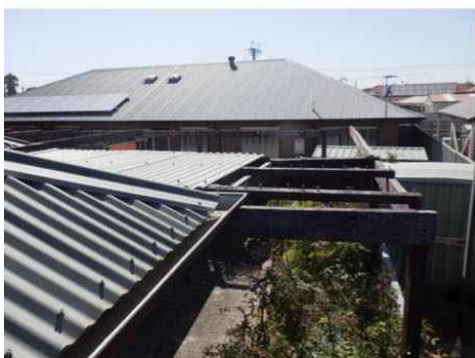
Early intervention and regular maintenance will prolong the useful life of these building elements.

Replacement will likely be required and could be carried out by a licensed carpenter at the discretion of the client.

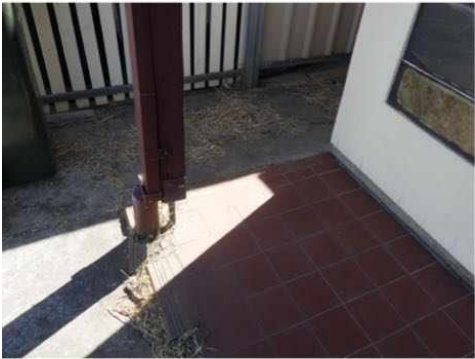
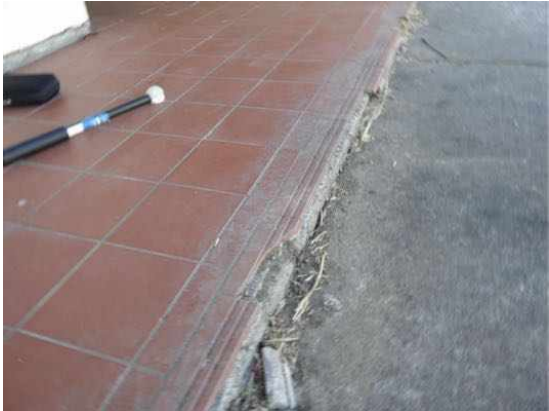
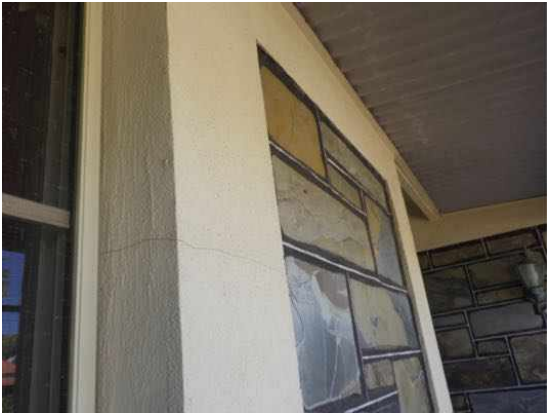
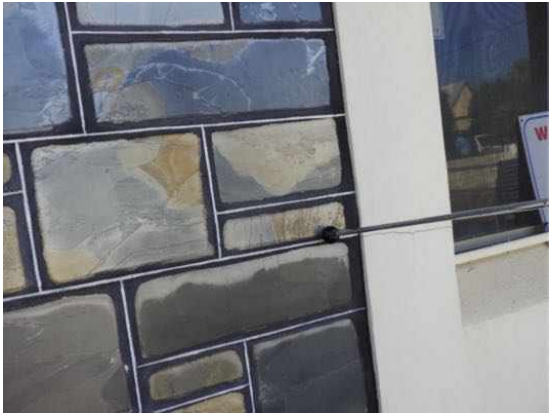
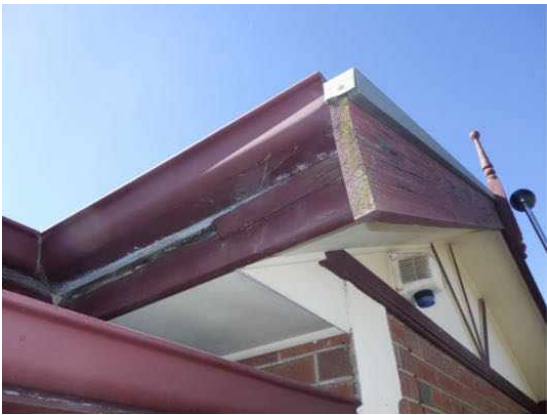
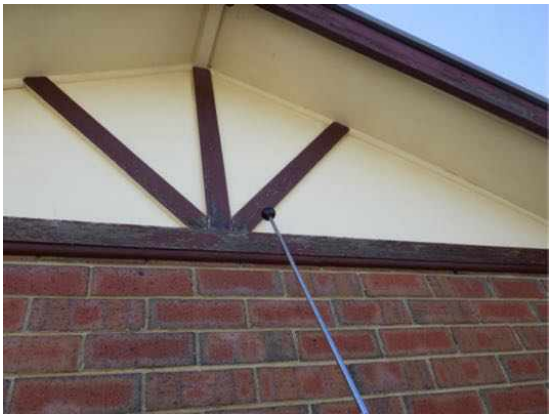
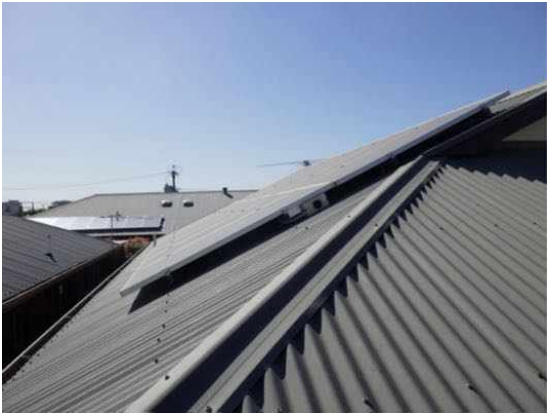
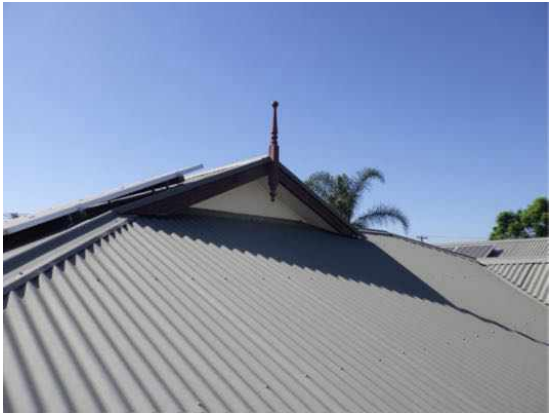
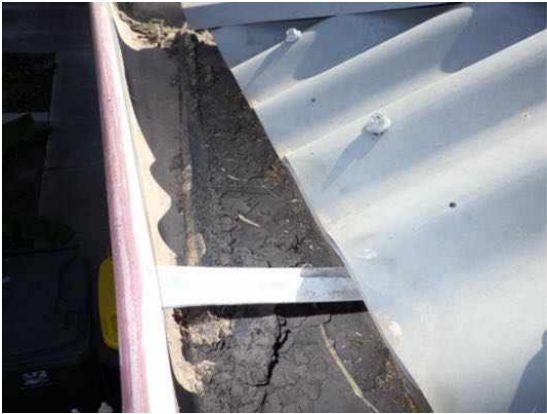
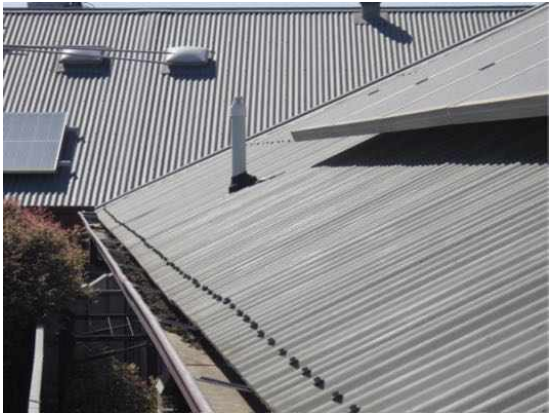
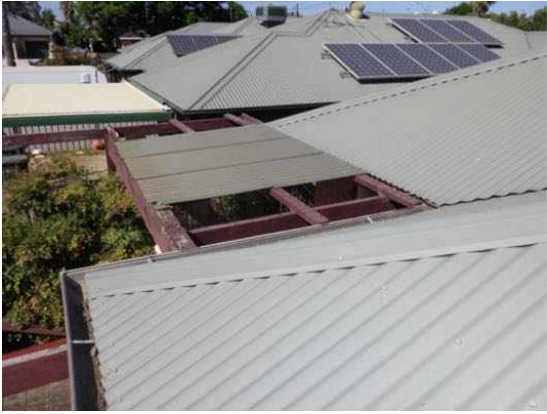
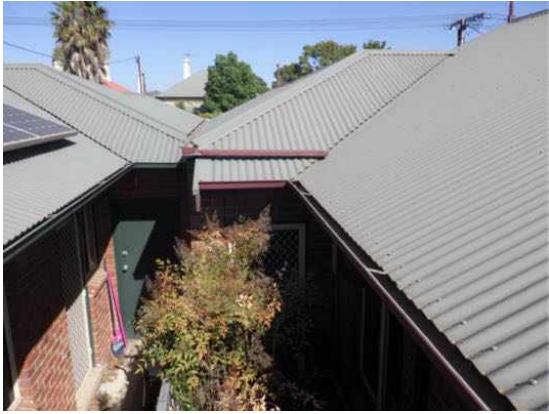
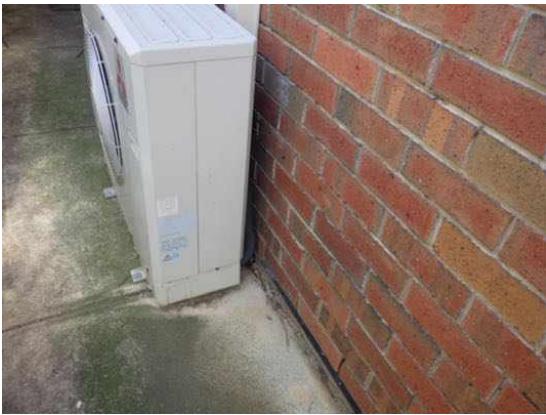
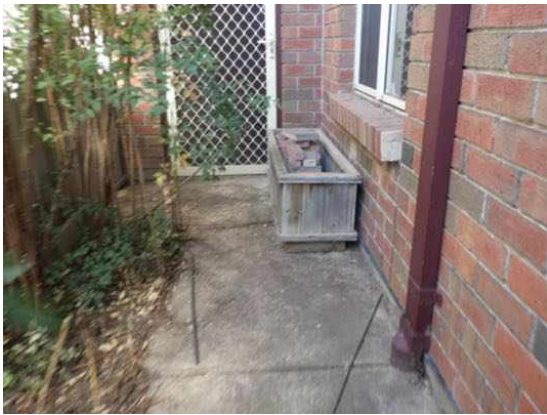
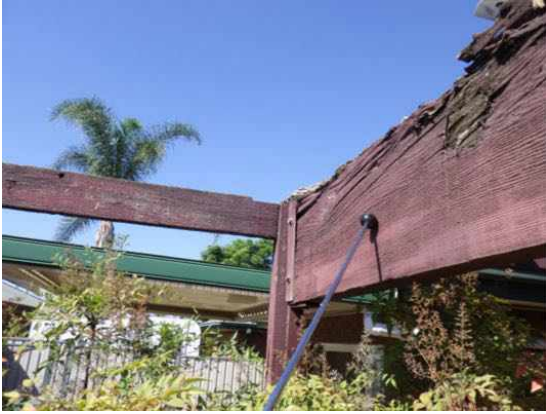
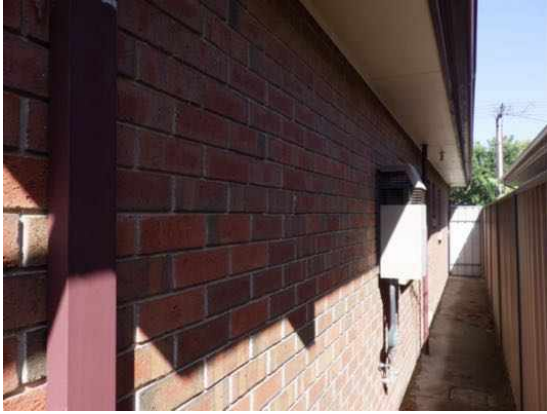
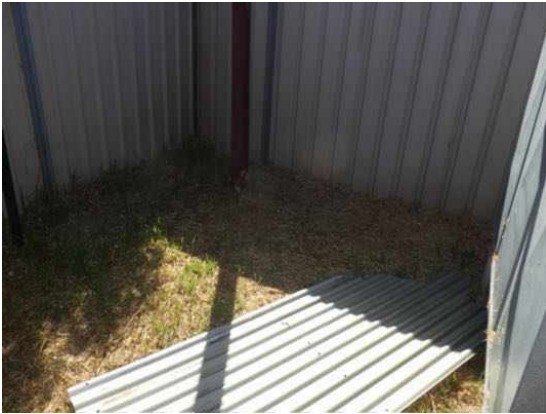
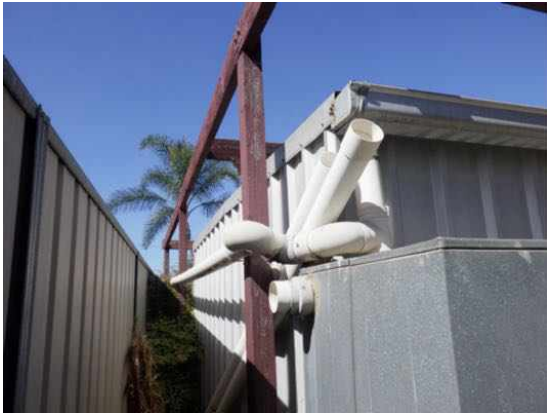
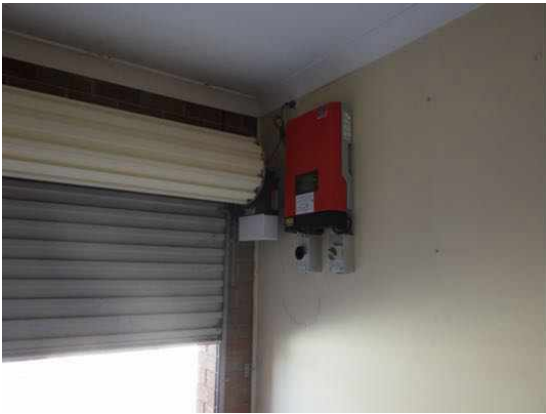
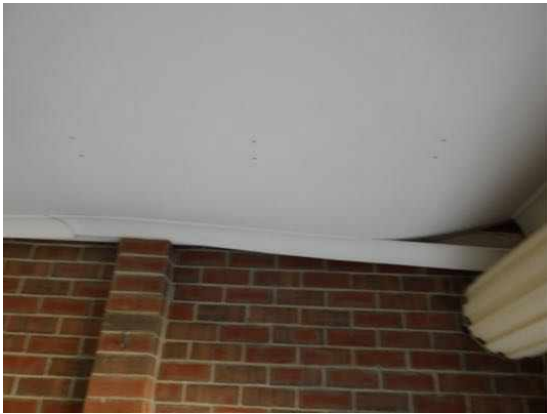
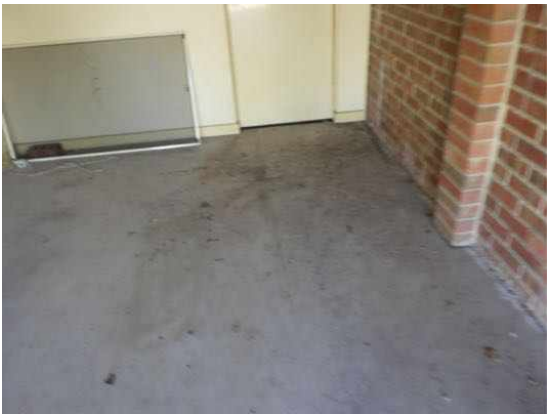
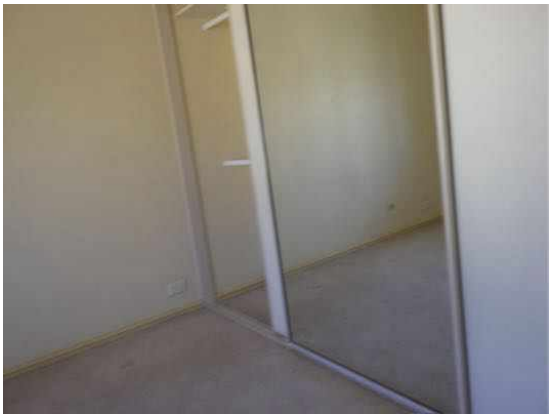
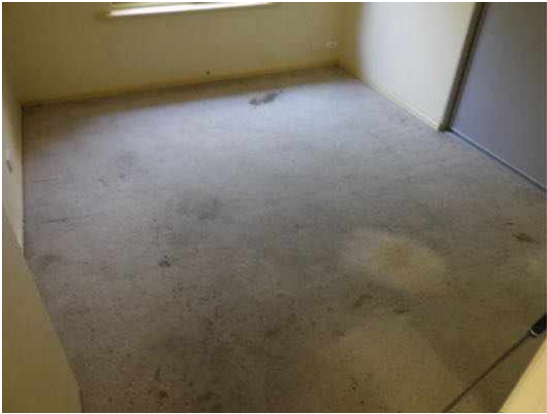
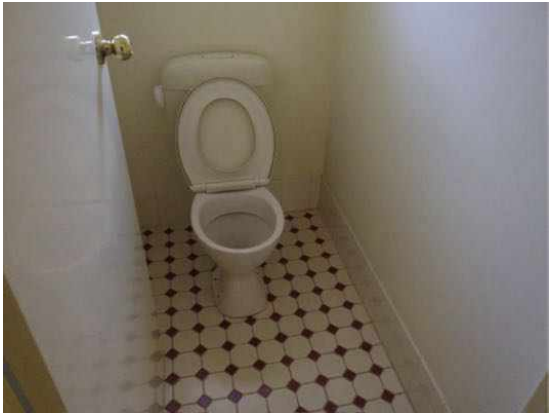
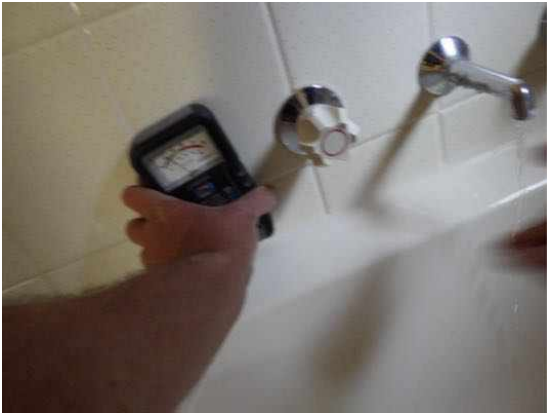
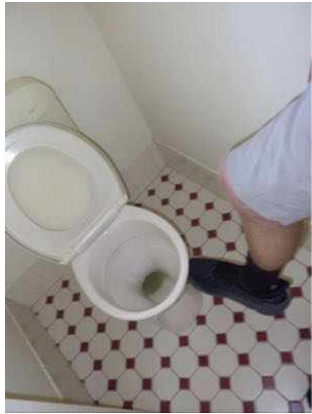
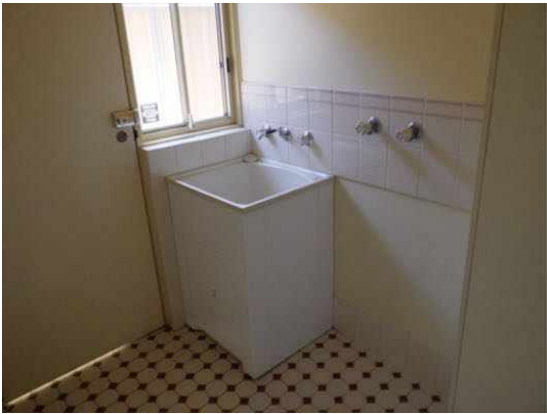
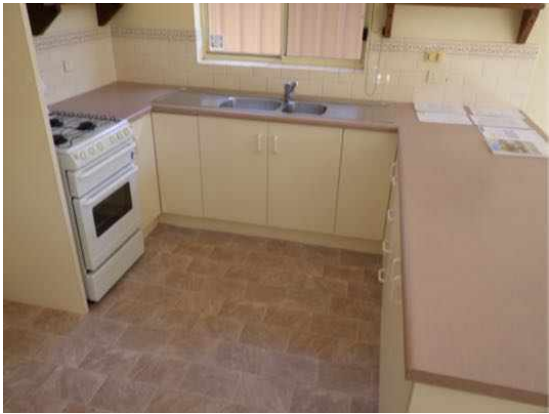
Building: Building 1
Location: All Areas
Finding: Additional Photos - Obstructions and Limitations
Information:

These photographs are an indication of the obstructions and limitations which impeded full inspection of the property at the time of inspection. These obstructions can hide an array of defects and should be removed to allow full inspection to be carried out.
