Building and Timber Pest Inspection Report

Inspection Date: Thu, 15 Jan 2026

Property Address: 4/40 New Line Rd, West Pennant Hills NSW
2125, Australia

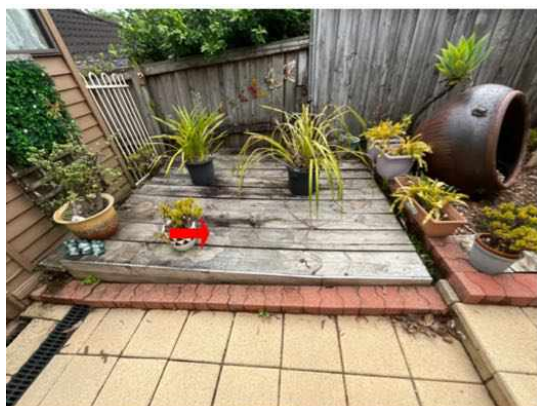
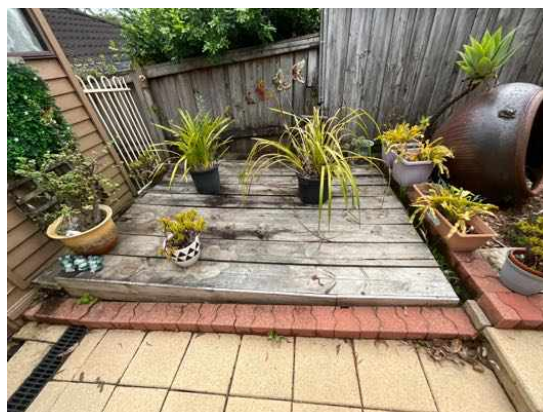
External timber structures are also constantly exposed to weather deteriorates in an exhilarate manner, ongoing assessments are required.

It is highly recommended that a structural engineer further, assess the external timber balcony or a deck to inform the client of its load capacity.

Regular maintenance inspections by competent practitioners is needed.

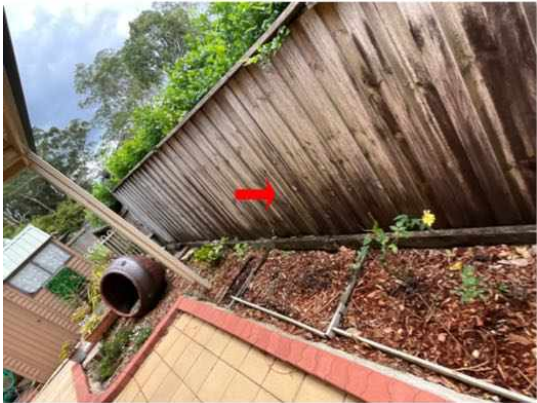
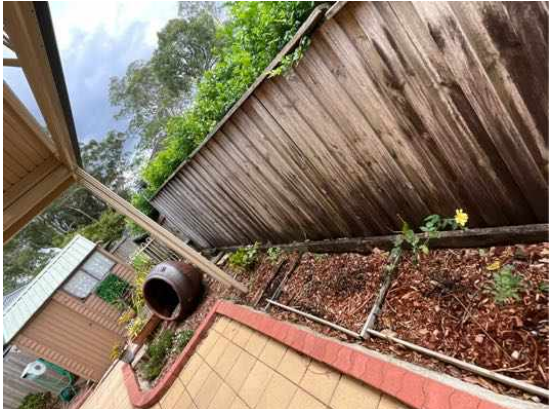
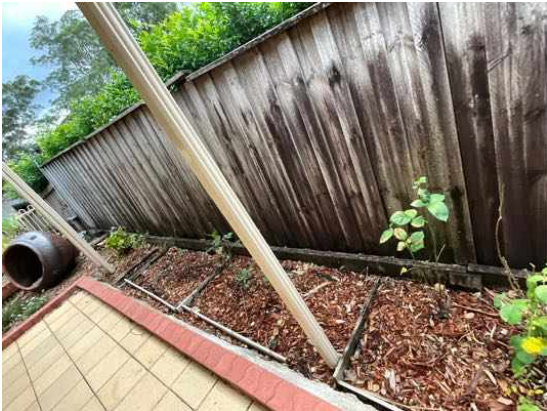
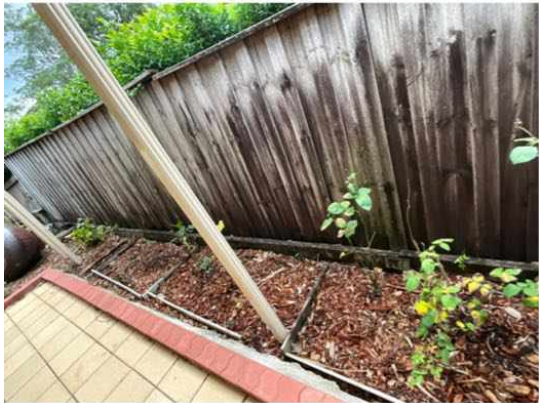
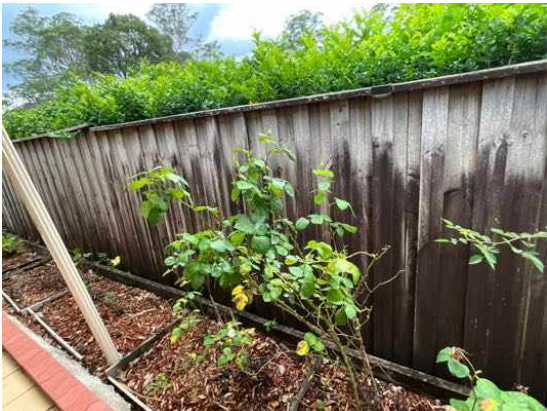
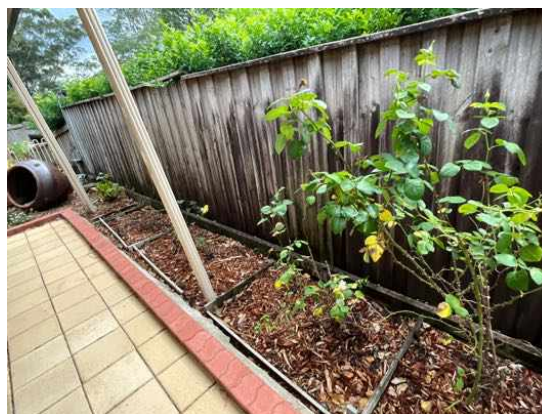
Finding 2.01

The leaning fence poses a risk of collapse, potential property damage, and a security breach, diminishing its effectiveness as a barrier.

A skilled fencing contractor or handyman is needed to assess and rectify the leaning fence. Timely repair is crucial to restore the fence's stability and prevent further damage or safety hazards.

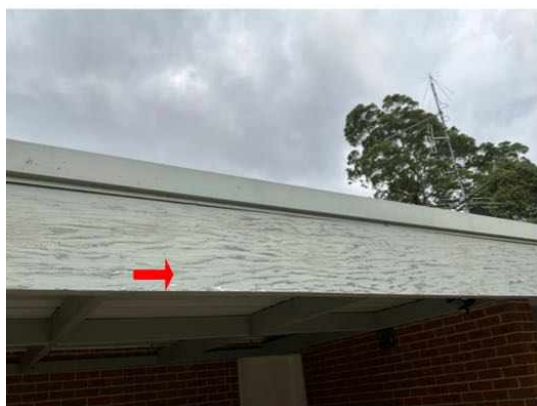
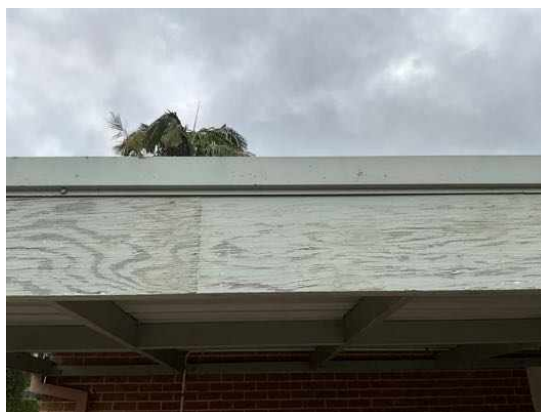
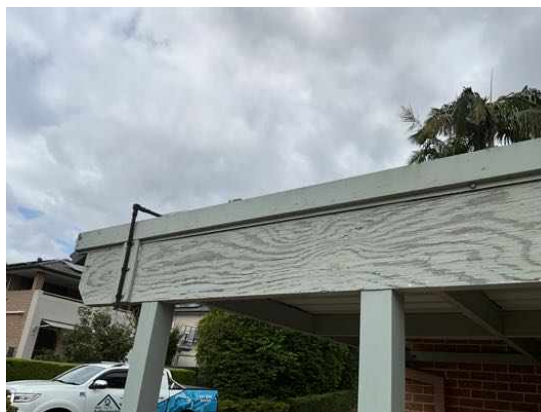
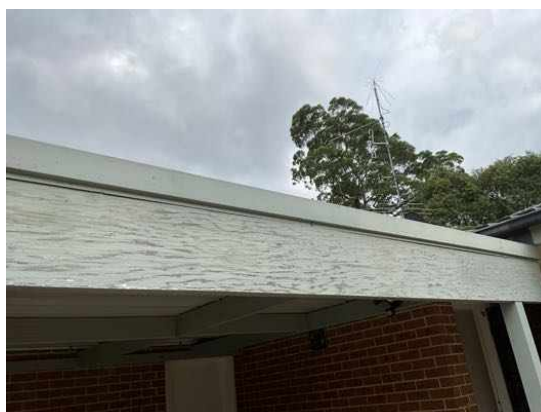
Finding 3.01

Building:	Main Building
Location:	All Areas
Finding:	Timber - exposed to weather
Information:	External timbers that are frequently exposed to harsh weather conditions require adequate protection in order to maintain their condition. Where timbers have not been painted or treated adequately, general deterioration is likely to occur at an accelerated rate.

If left unattended, replacement of these timbers is likely to be necessary in the short-term future. Adequate treatment of these timbers is required as soon as possible by a painting contractor or general handyman.

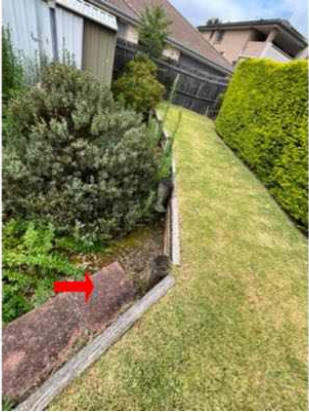
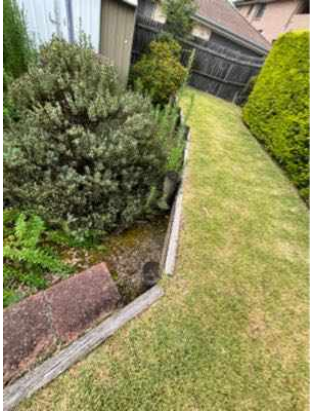
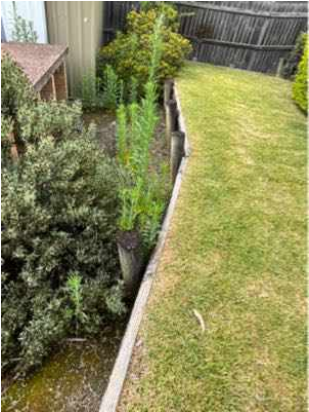
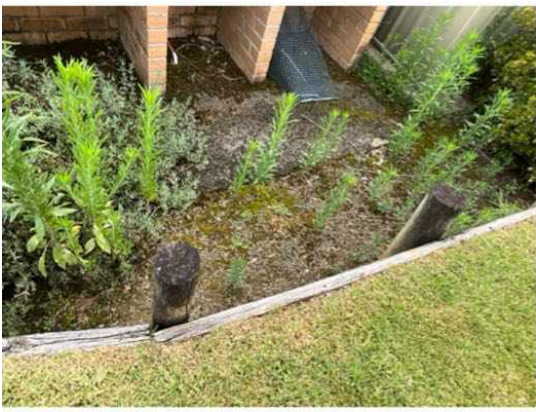
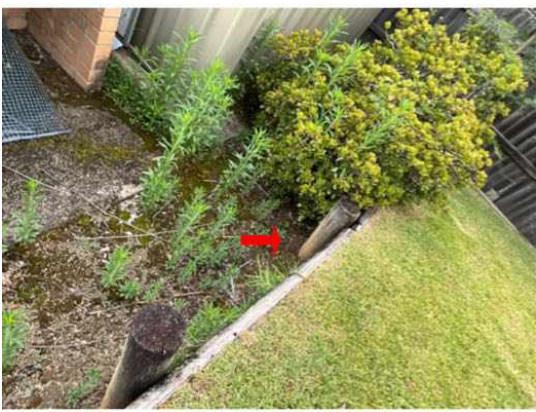
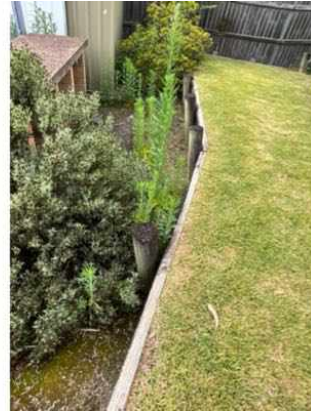
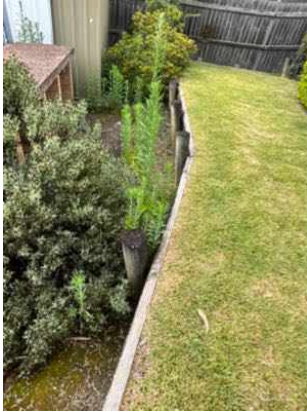
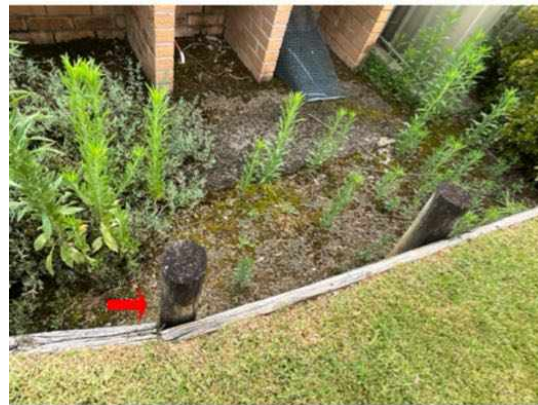
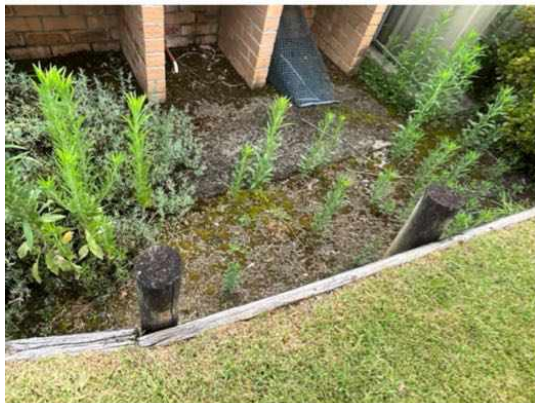
Finding 3.02

Finding: Retaining wall - Defective

Information: The retaining wall in this area was found to be defective at the time of inspection. Generally, defective retaining walls are caused by poor original design or material use. However, deteriorated retaining walls may also be a result of substandard construction, poor site drainage or unmanaged stormwater flows.

If left unmanaged, the retaining wall may become a safety hazard if it continues to destabilise. Where retaining walls further rot and decay, an environment is created that is conducive to termite and pest infestation.

Significant repair and replacement should be expected. Where retaining walls are considered structural walls, a structural engineer / surveyor should be consulted regarding required remedial works. Otherwise, a landscaper or retaining wall installer may be appointed to repair or replace the wall, at the discretion of the client.

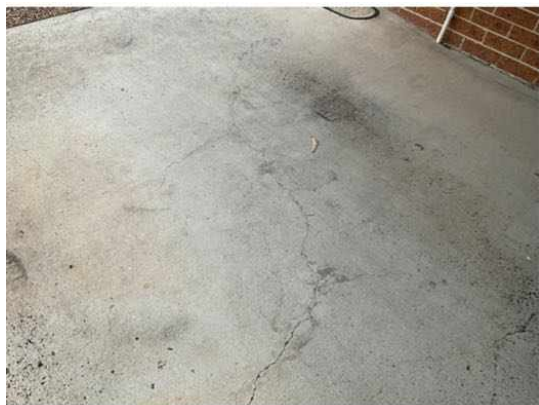
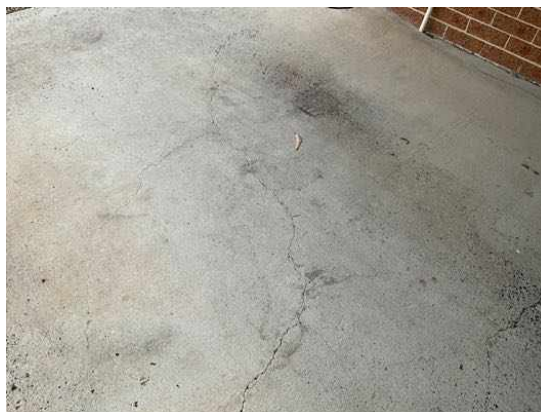
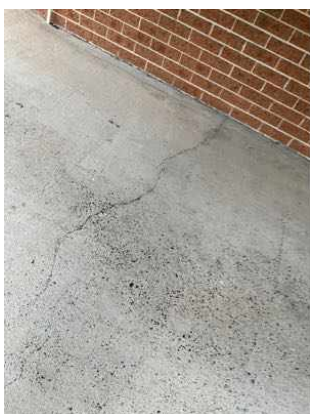
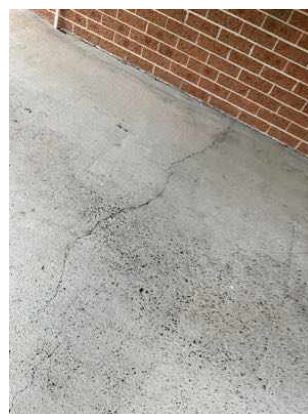
Finding 3.03

Building:	Main Building
Location:	All Areas
Finding:	Crack in concrete slab - Category 0
Information:	A crack coded as Category 0 was identified in the slab. A Category 0 crack is described as a hairline crack, representing insignificant movement of slab from level.

The approximate width of the crack to be considered Category 0 is 0.3mm, or change in offset of less than 8mm when a 3m straight edge is placed over the defect.

No rectification is required at this time. However, all cracking should be monitored over a 12 month period to identify any further damage in the area.

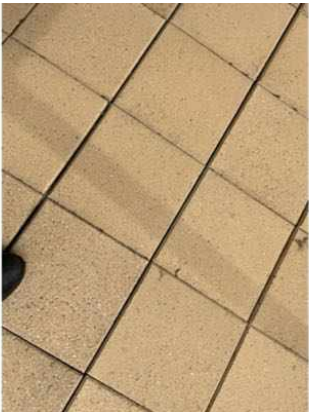
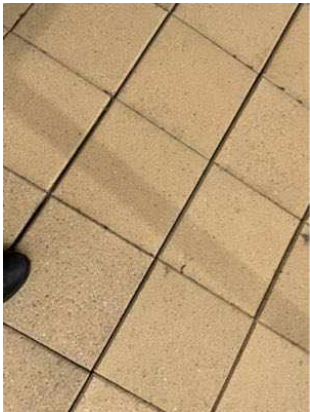
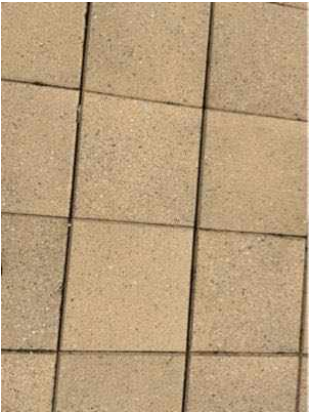
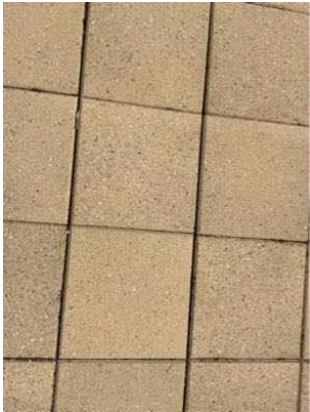
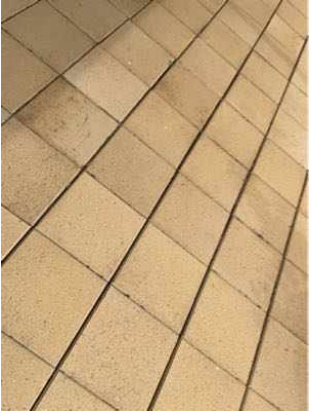
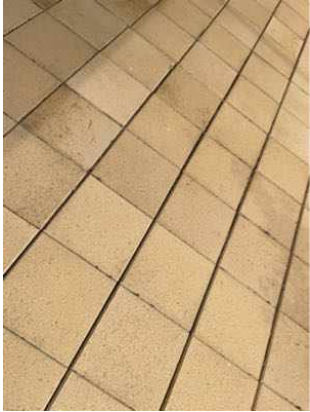
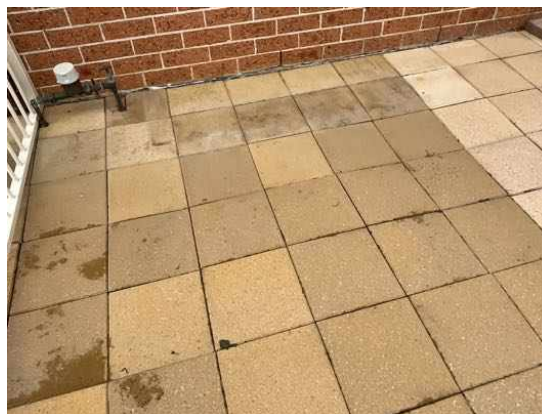
Finding 3.04

Building:	Main Building
Location:	Yard - Side
Finding:	Pavers uneven and displaced
Information:	Cracked, uneven, and displaced pavers were observed. Several pavers appear loose, misaligned, or deteriorated.

The uneven surface poses a significant trip hazard for pedestrians and may impact the usability of the driveway. Displacement and cracking can worsen over time due to vehicle traffic, poor subbase compaction, or water ingress. Wall cracking may lead to moisture entry or structural wear if left untreated.

- A qualified paving contractor should be engaged to lift, relevel, and relay the affected pavers with proper bedding and compaction.
- A licensed builder or bricklayer should repair and seal the masonry wall crack around the pipe to prevent further water ingress and deterioration.

- Drainage should also be checked to ensure water is not contributing to the issue.

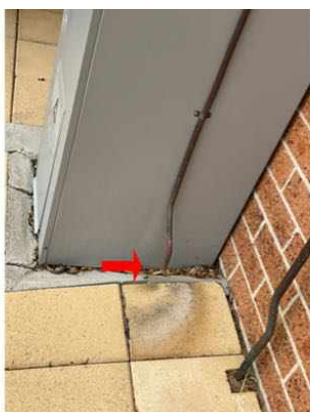
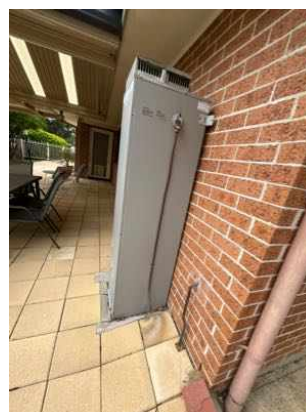
Finding 3.05

Building:	Main Building
Location:	Exterior walls - right side
Finding:	HWS Overflow - Not Connected
Information:	The Hot Water System (HWS) overflow was found to be disconnected from storm water drainage and is creating excessive moisture in the surrounding area.

These damp conditions can lead to secondary defects such as rot, rust or corrosion of associated building elements, the formation of fungal decay, or even the creation of potential slip hazards. When coupled with poor site drainage, pooling of water may also attract termite activity to this area.

It is highly recommended that a licensed plumber be appointed to connect the HWS overflow in order to prevent such an environment from being created. These minor works should be carried out as soon as possible.

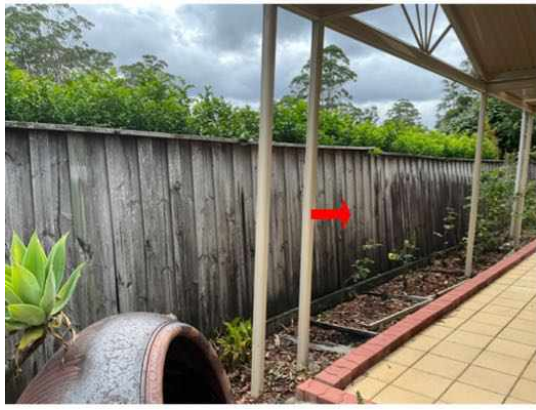
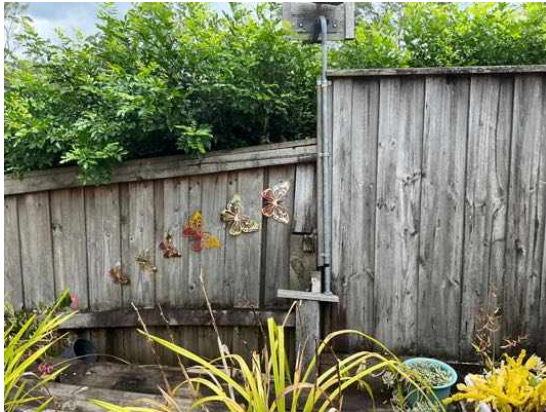
Finding 3.06

Building:	Main Building
Location:	Fencing
Finding:	Detoriated fence

Information: The fence along the property boundary has deteriorated significantly, showing signs of rot, rust, and structural weakness. Several sections are leaning or have become detached, compromising the integrity of the fence and its ability to perform its intended function.

The deteriorated fence poses multiple risks:

1. **Safety Hazard:** The unstable fence may collapse, posing a risk of injury to residents, visitors, and passersby.
2. **Security Concern:** The compromised fence may allow unauthorized access to the property, increasing the risk of theft, vandalism, or trespassing.
3. **Property Damage:** Falling sections of the fence could damage nearby structures, plants, or other property features.
4. **Legal Liability:** If the fence were to fail and cause injury or damage to neighboring properties, the property owner may be held liable.

- **Licensed Fencing Contractor:** A professional fencing contractor should be hired to assess the extent of the damage and either repair or replace the deteriorated sections.
- **Handyman Services:** For minor repairs, a qualified handyman could be engaged to reinforce or repair specific sections of the fence.
- **Landscaper (if the fence is part of a larger garden feature):** If the fence is integrated into the landscape design, a landscaper with experience in fencing could be involved in the repair or replacement process.

It's important to ensure that whoever is hired is experienced and qualified to ensure the fence is restored to a safe and functional condition, compliant with local regulations.

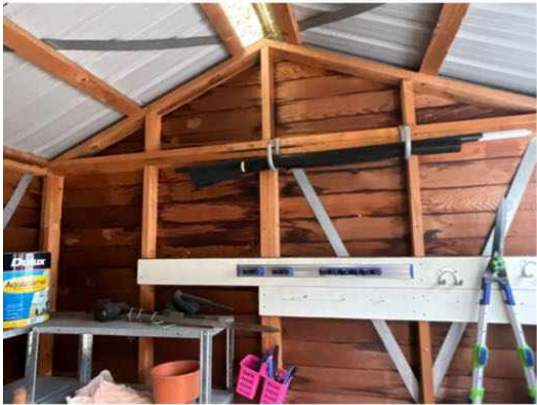
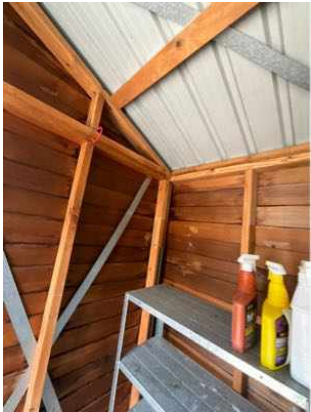
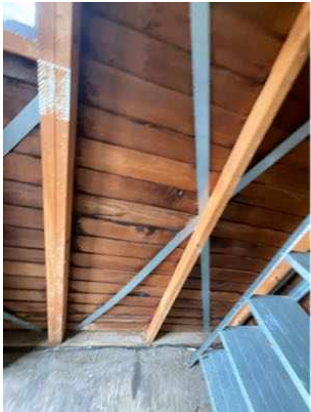
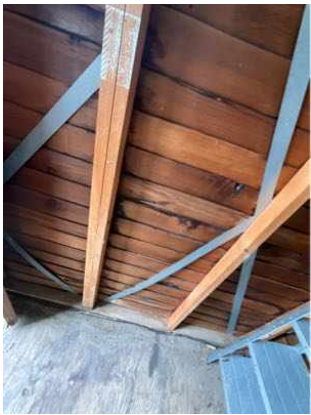
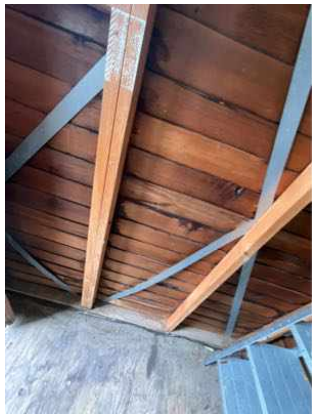
Building:	Main Building
Location:	Shed
Finding:	Shed - detached shed structure significant deterioration
Information:	The detached shed structure exhibits signs of significant deterioration, including weathered and rotting external cladding, uneven and damaged ceiling linings, and general structural instability. These conditions indicate the structure is not fit for safe use or occupation in its current state.
Risk:	
	High – Structural instability poses a safety hazard, with potential for partial collapse,

injury, or failure during adverse weather conditions.

Engage a licensed builder or structural engineer to conduct a full assessment of the shed's condition and advise on required repairs or reconstruction. Demolition and rebuild may be more cost-effective depending on the severity of structural issues.

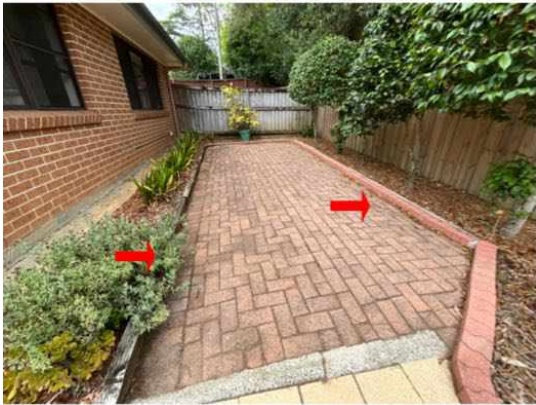
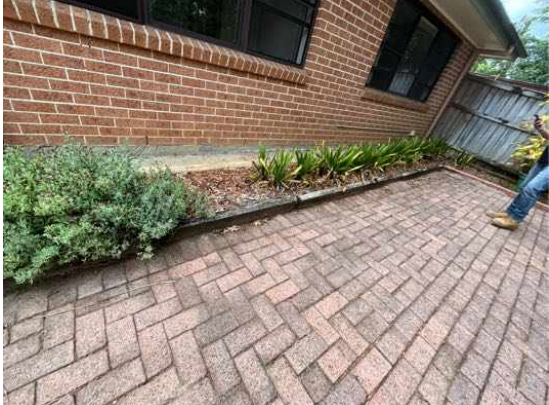
Finding 3.08

Building: Main Building
Location: Yard - Back
Finding: Water pooling - poor surface drainage
Information: Surface drainage

Surface water drainage is defective if it is not in accordance with the requirements of the Building Code of Australia.

Such water pooling also increases the risk of termite activity and the development of fungal decay in the area.

Consult a Licensed Plumber regarding the cost of potential site drainage rectification works.

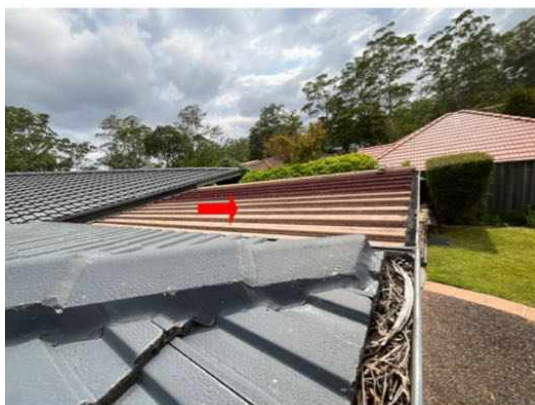
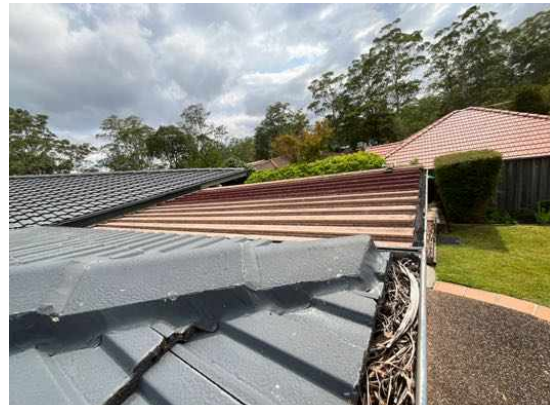
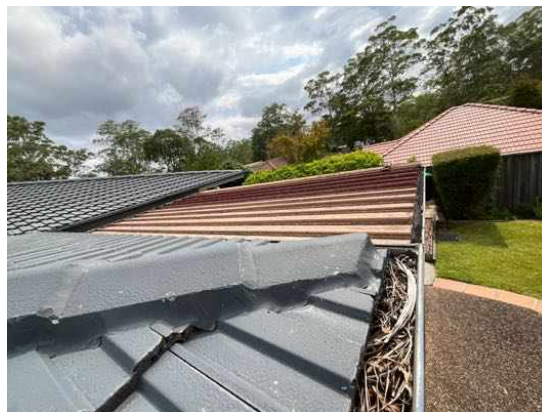
Finding 3.09

Building: Main Building
 Location: Roof Exterior
 Finding: Roof Weathered - metal roof sheeting
 Information: The roof sheeting shows visible weathering, surface oxidation, and deterioration of fastener washers. Some sheet overlaps appear uneven and may not provide adequate weatherproofing at joints near the dormer. The sealant and flashing junctions also show signs of age and deterioration.

Prolonged weather exposure and rusting can lead to corrosion, potential roof leaks, and reduced lifespan of the sheeting. Deteriorated fasteners may allow water ingress, particularly around joints and penetrations.

Engage a licensed roofing contractor to inspect and maintain the affected areas. Replace rusted screws and washers, resecure loose or uneven sheets, and apply protective roof coating or repainting as required. Check flashings and sealants to ensure watertightness.

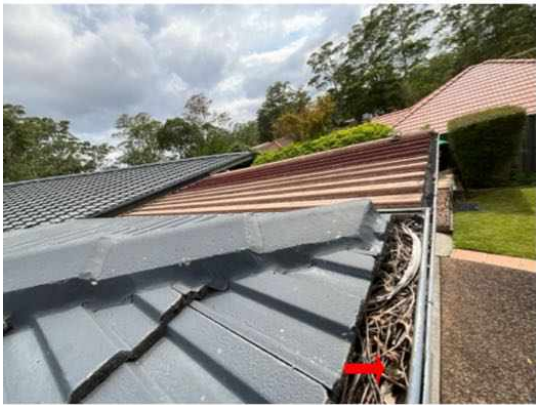
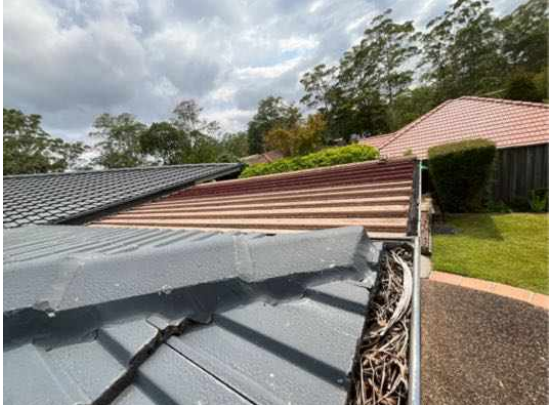
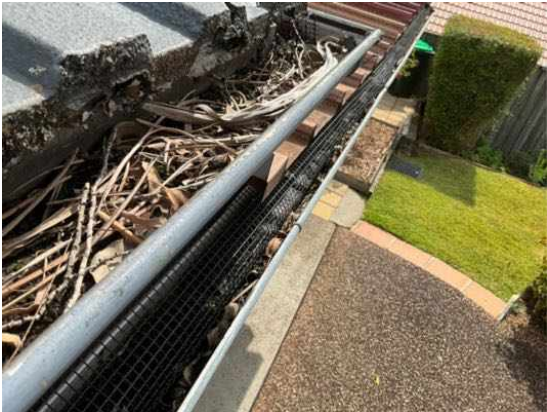
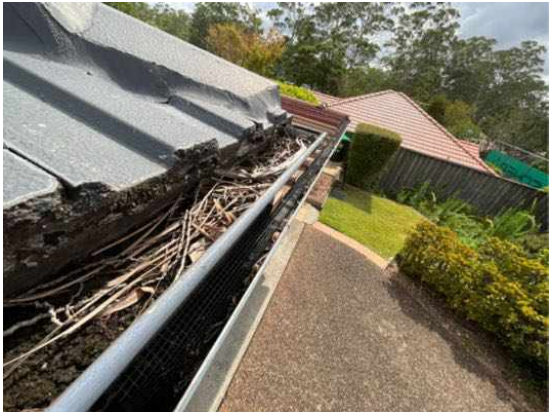
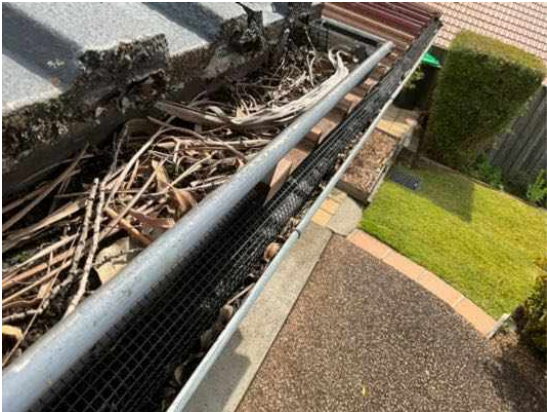
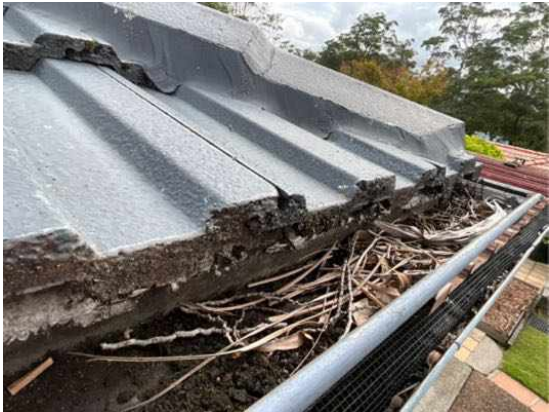
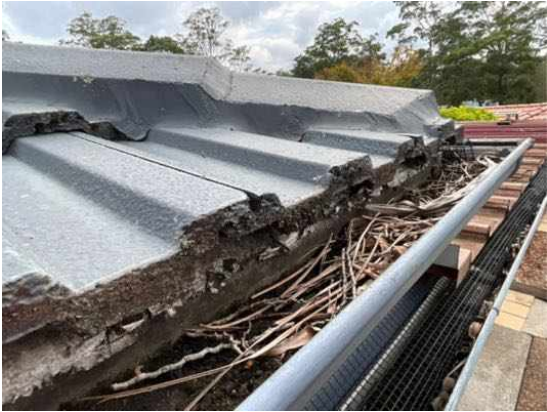
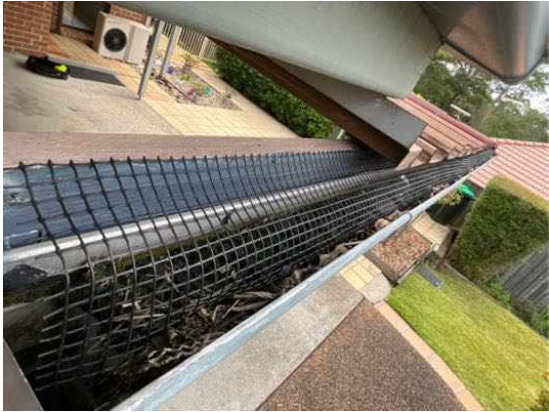
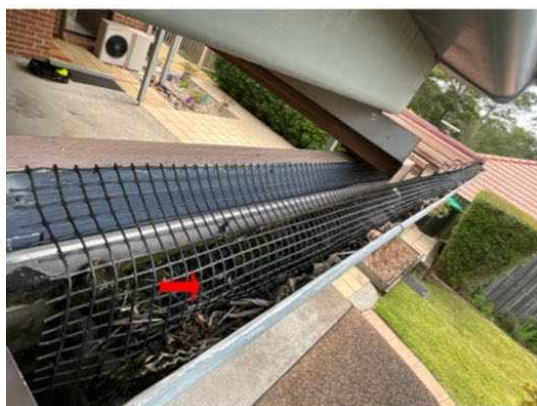
Finding 3.10

Building:	Main Building
Location:	Roof Exterior
Finding:	Blocked gutters - organic debris
Information:	The roof gutter system was observed to be blocked with organic debris and moss growth, as evident in the provided images.

- Water ingress into the eaves or walls,
- Timber rot or deterioration of fascia and soffits,
- Accelerated moss and algae growth, promoting further blockages,
- Potential foundation issues if water pools near the base of the structure.

A licensed roofing contractor or qualified gutter cleaning service should be engaged to remove the debris and inspect the system for any further issues.

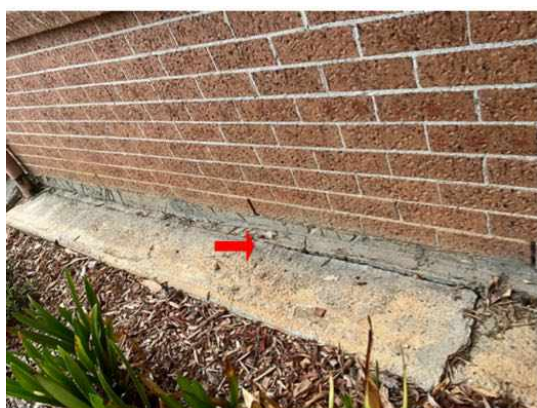
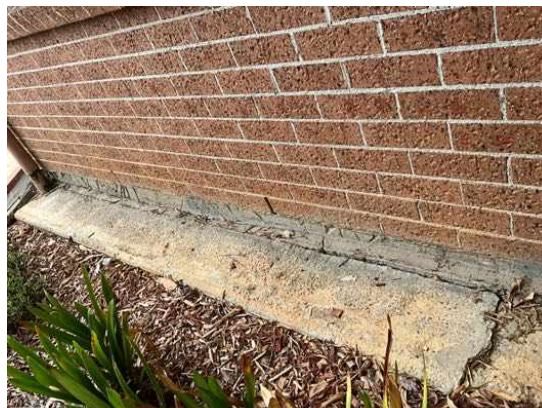
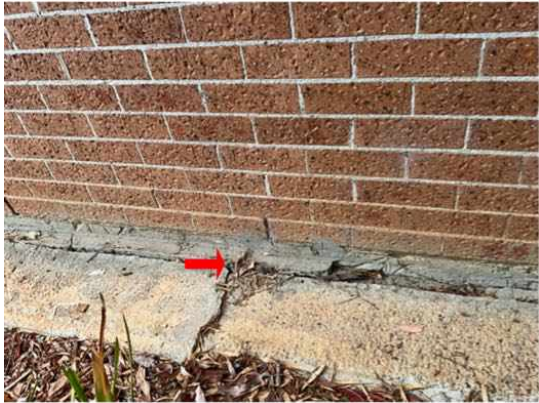
Finding 3.11

Building:	Main Building
Location:	Exterior walls - rear
Finding:	Mortar - damage and deterioration
Information:	The mortar joints in the brickwork and concrete structures, exhibit signs of damage and deterioration. The mortar has visibly cracked, crumbled, and eroded in sections, leading to weakened structural integrity of the affected areas.

If left unaddressed, the deterioration of mortar can allow moisture ingress, leading to potential water damage, mold growth, or further weakening of the wall's structure. Over time, this could lead to more significant structural issues such as cracking in the masonry or even partial collapse, presenting safety hazards.

A qualified bricklayer or masonry specialist should be engaged to perform repointing of the damaged mortar joints. The process involves removing the deteriorated mortar and replacing it with fresh mortar to restore the integrity of the structure. The affected concrete areas should also be repaired, possibly with a concrete repair specialist to ensure proper sealing and protection against further weathering and water infiltration.

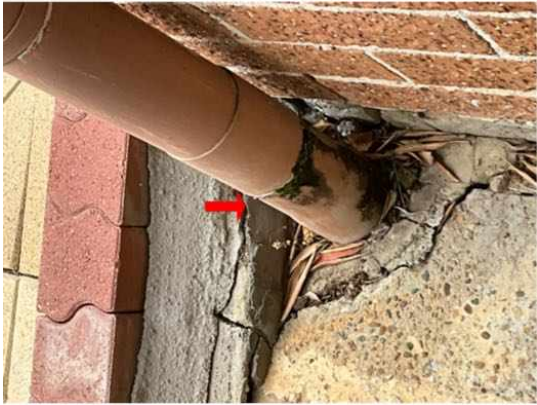
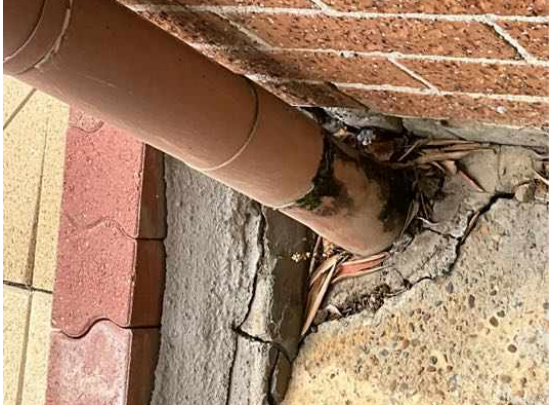
Finding 3.12

Building: Main Building
Location: Exterior walls - rear
Finding: Downpipe leakage
Information: The downpipes in the drainage system exhibit leaking water.

The leaking downpipes pose a risk of water damage to the building’s foundation, exterior walls, and surrounding landscape. Prolonged exposure to moisture can lead to structural deterioration, mold growth, and compromised drainage.

A qualified plumber or roofing specialist should inspect and replace the leaking downpipes. Repair or replacement may involve fixing the areas, applying protective

coatings, or installing new downpipes to ensure proper drainage and prevent further water damage. Early intervention is crucial to avoid escalating issues.

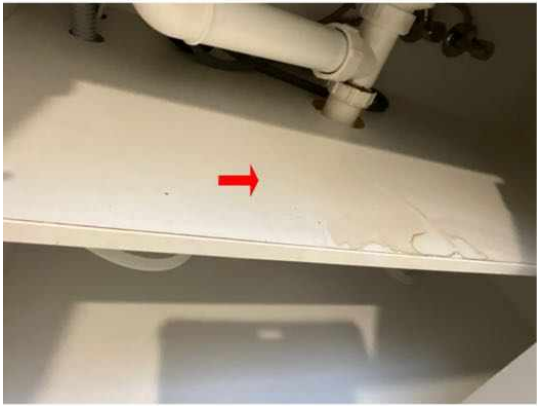
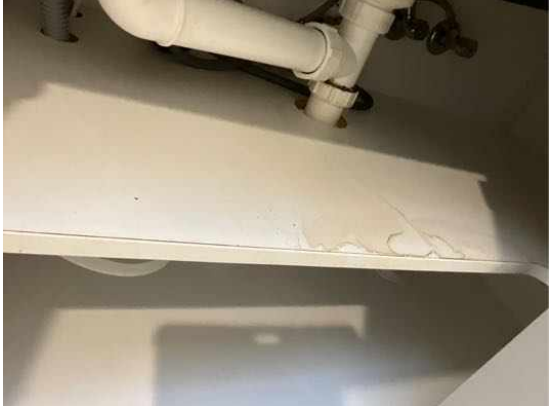
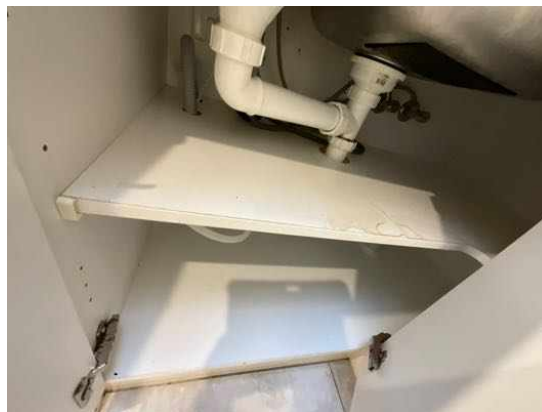
Finding 3.13

Building: Main Building
Location: Kitchen
Finding: Water Stains in Vanity
Information: "Water stains observed in the vanity area, compromising its appearance and potentially causing damage."

Continued water exposure may lead to material damage, mold growth, and diminished aesthetic appeal.

A licensed plumber or maintenance professional should assess and fix any leaks contributing to the water stains, while a cleaning or restoration service may be needed to address the visible stains and prevent further damage.

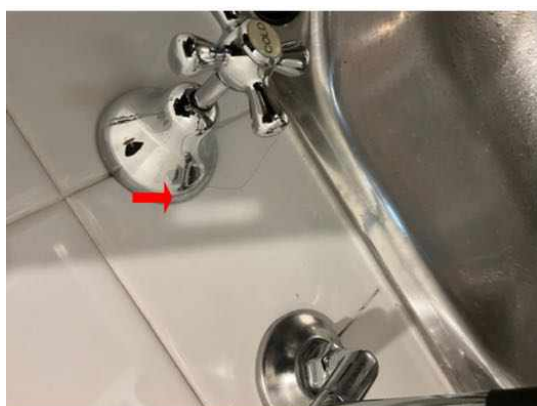
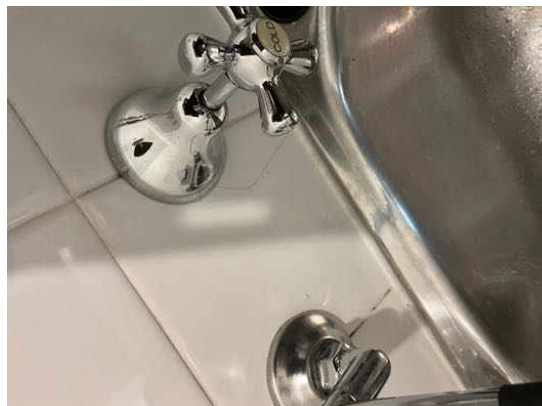
Finding 3.14

Finding: Tiles - Cracked or damaged

Information: Cracking was evident to the tiling in this area at the time of inspection. While the cracking appears to be minor, this area is frequently exposed to water, allowing potential for water penetration into adjoining sections of walls or flooring.

If left unmanaged, water penetration to these areas may lead to subsequent water damage, which is likely necessitate repair work to affected building elements.

A tiling contractor should be appointed to ensure that no further water damage occurs. The re-application of silicone and grouting throughout remaining tile work is also advised, to further protect the area against water penetration.

Where water penetration has led to water damage, appointment of a relevant tradesperson may be required to repair damaged building elements.

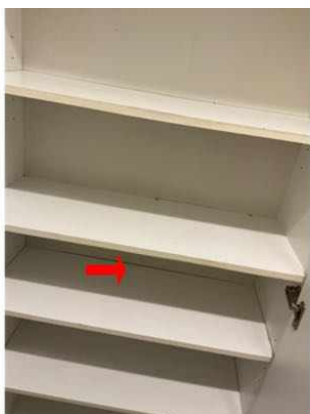
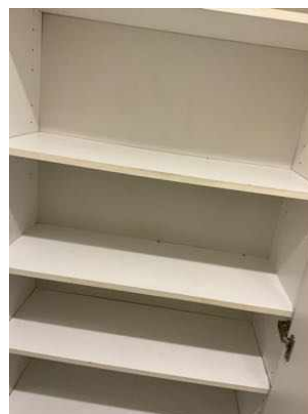
Finding 3.15

Finding: Cabinetry noticeable signs of aging and wear and tear

Information: “The cabinetry within the property is exhibiting noticeable signs of aging and wear and tear, manifesting as surface scratches, faded finishes, and worn edges. This degradation not only compromises the aesthetic quality of the cabinetry but also raises concerns about long-term durability and functionality.”

- Engage a professional cabinetry specialist or carpenter to assess the extent of wear and recommend refinishing or refacing options.
- This may involve repairing scratches, applying new finishes, or replacing worn-out components to restore the cabinetry’s appearance.

- In cases of severe wear, consider upgrading specific components or replacing the cabinetry to ensure long-term durability and aesthetic satisfaction.

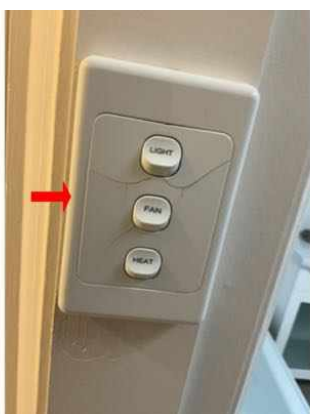
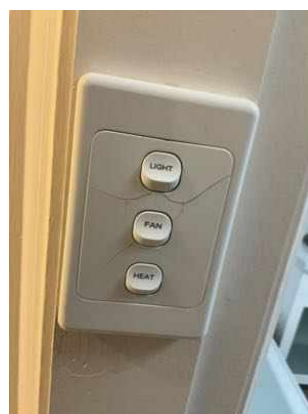
Finding 3.16

Finding: Light fitting - Damaged

Information: The light fitting in this area was found to be damaged at the time of inspection. Damage occurs generally when the building materials have aged and decayed, but may also be indicative of impact damage to the building element (accidental or deliberate).

Left unmanaged, the fitting is unlikely to cause further damage to surrounding building elements. However, the broken light fitting may expose electrical works, and may create a minor safety hazard if there is potential contact with persons in the area.

Repair and/or replacement of the damaged fitting is advised. A Licensed electrician should be appointed to repair/replace the light fitting at the client's discretion.

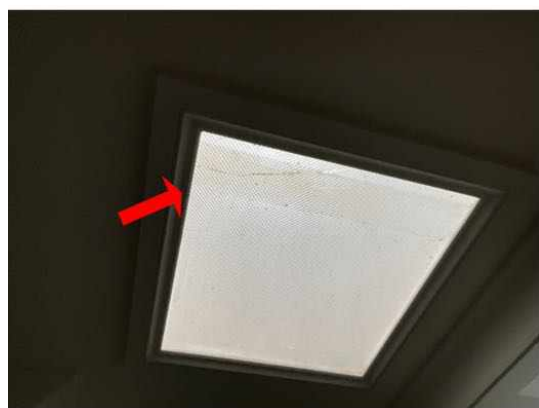
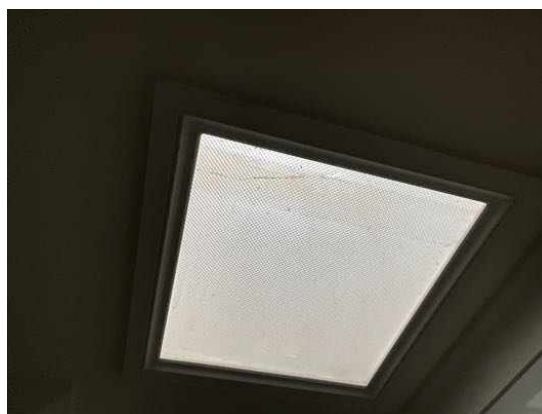
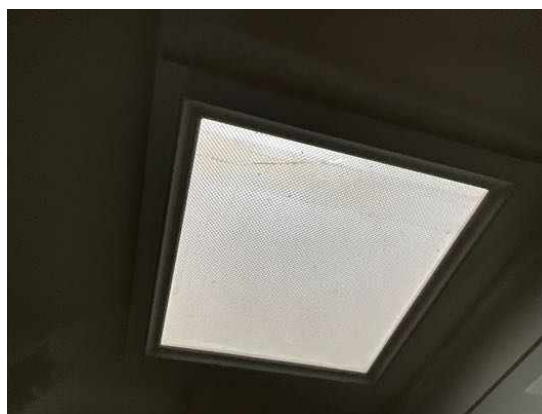
Finding 3.17

Finding: Skylight damaged

Information: Skylight or natural light diffuser in the roof space appears to be cracked..

- Water Ingress: A damaged or unsealed sunlit can allow rainwater to enter the roof cavity, causing damage to insulation, ceiling linings, or timber framing.
- Pest Entry: Gaps or cracks may provide access points for insects or rodents.
- Thermal Inefficiency: Unsealed areas can compromise insulation performance and contribute to energy loss.
- Structural Degradation: Ongoing water ingress can lead to rot, mould growth, or degradation of framing timbers over time.

- Roof Plumber or Licensed Roofing Contractor – To inspect the skylight , reseal or replace it as needed, and ensure proper waterproofing and flashing are in place in accordance with NCC and relevant Australian Standards.

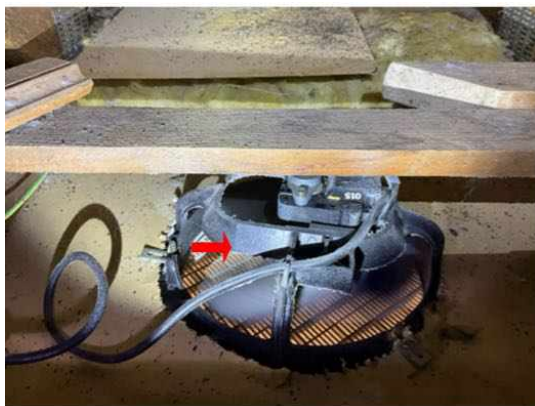
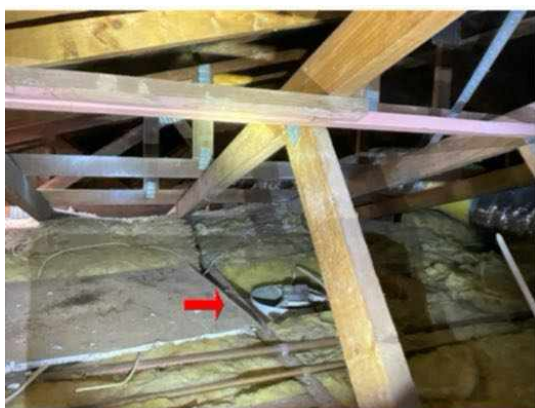
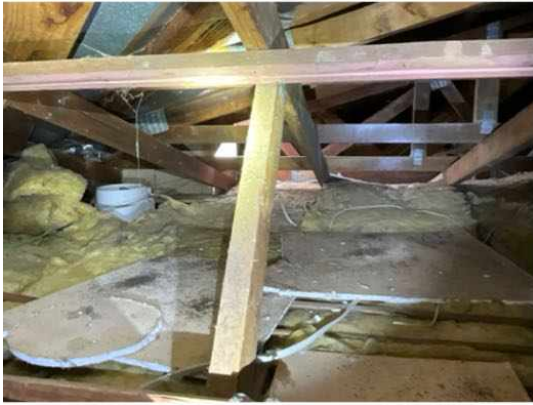
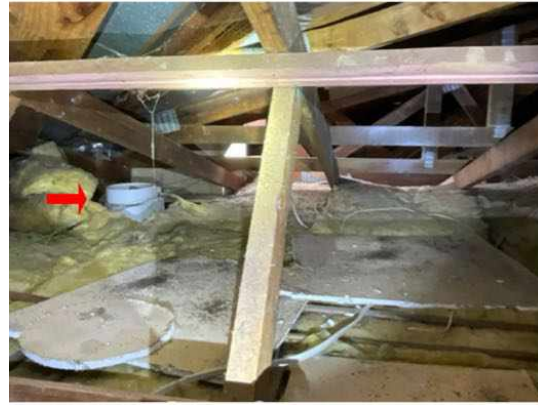
Finding 3.18

Building:	Main Building
Location:	Roof Void
Finding:	Exhaust fan not vented out

Information: The exhaust fan located within the roof void is not appropriately ducted to the external atmosphere and is currently discharging moist air directly into the roof space. This is considered a defect under AS 4349.1, as it does not meet the minimum standard of residential building performance expected under normal residential building practices.

This condition may lead to excessive condensation within the roof void, increasing the risk of mould growth, deterioration of insulation, timber decay, and overall reduced durability of building elements. It may also result in poor indoor air quality, potentially affecting occupant health.

It is recommended that the exhaust fan be modified by a licensed HVAC contractor or qualified builder, ensuring it is properly ducted to discharge externally in accordance with manufacturer specifications, the National Construction Code (NCC), and applicable Australian Standards.

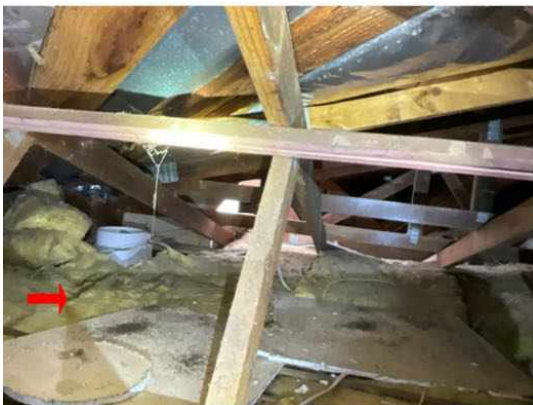
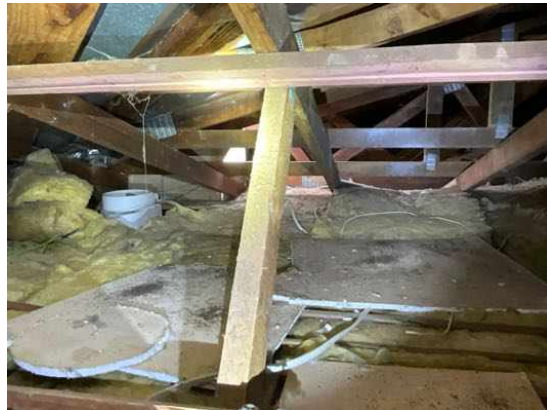
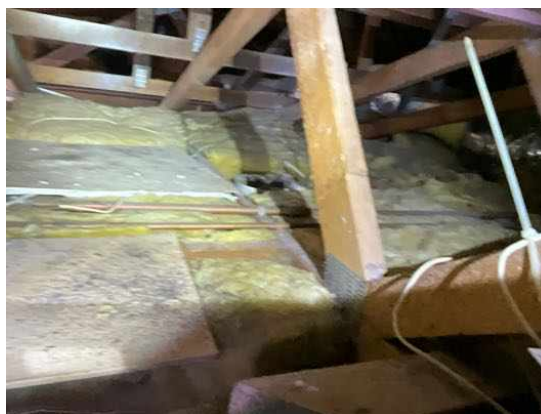
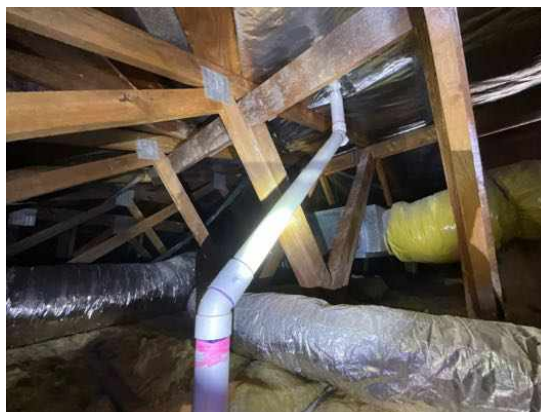
Information: Sections of insulation in the roof void have been poorly installed or moved from their original position and are covering down light fittings. While the down lights have been fitted with appropriate protective covers, the presence of this insulation creates a potential fire hazard.

Any insulation within the vicinity of down light fixtures should be moved and re-applied to more appropriate sections of the roof void, thus ensuring the area is fire-safe. An insulation contractor should be appointed as soon as possible to perform any necessary works as required.

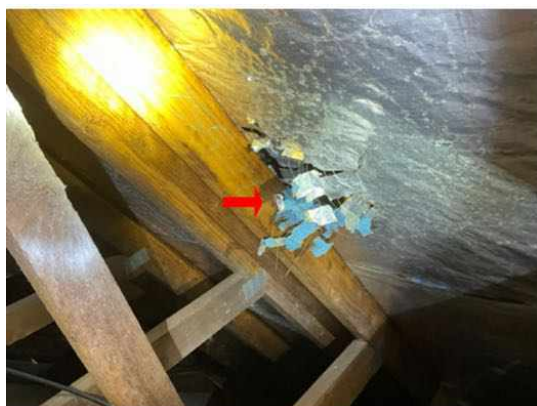
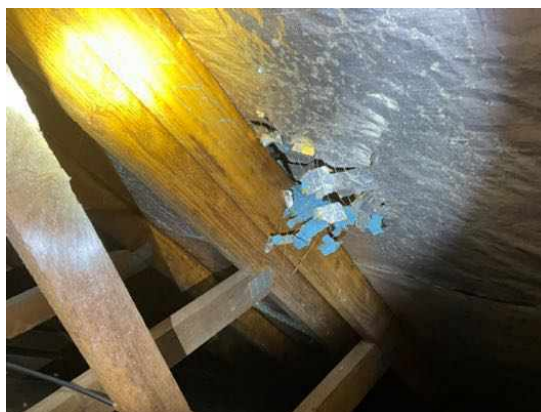
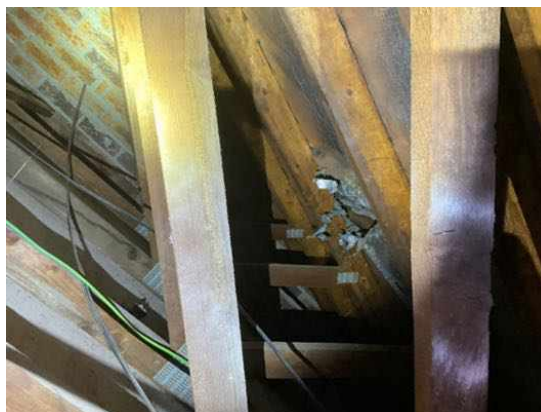
Finding 3.20

Building:	Main Building
Location:	Roof Void garage
Finding:	Sarking - Damaged
Information:	Sarking, a laminated aluminium foil applied to the interior of the roof covering, assists in insulating the property and acting as a vapour-barrier to the roof void and, subsequently, to the household.

Where sarking is damaged, both insulation and moisture protection of the property are inhibited. This creates a loss of energy and thus negatively impacts the energy efficiency of the property, allowing potential for moisture ingress from condensation or leaking roof tiles.

It is important to repair any holes or damaged sections of sarking to ensure that the building material is fully functional. A registered builder or qualified carpenter should be consulted to provide further advice on this defect and to perform rectification works at client discretion.

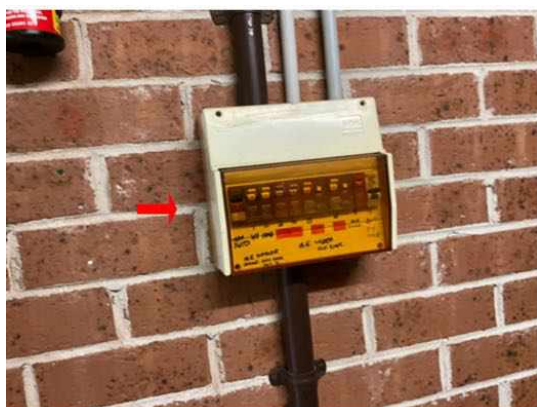
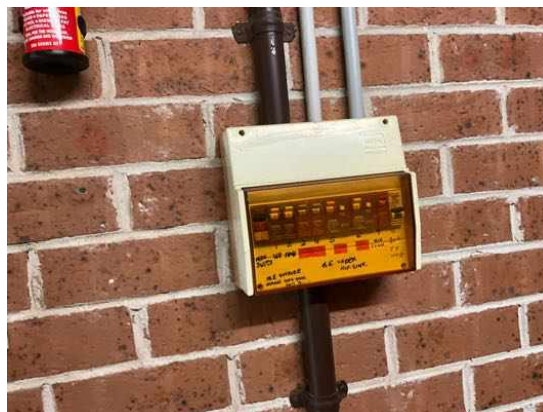
Building: Main Building
 Location: Garage
 Finding: No Evidence of Termite Management System - Durable notice / Legible Sticker
 Information: The application of a pre & post-construction chemical termite barrier is highly recommended for all properties. Such barriers are highly effective in preventing termite attack on any timber building elements throughout the property.

Client must seek further information from the vendor or real estate agent if the

conditions of termite management systems were maintained.

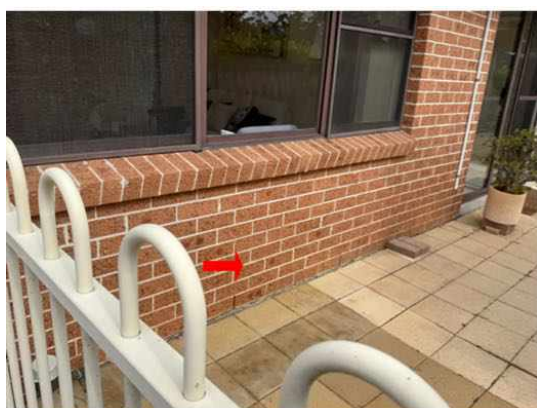
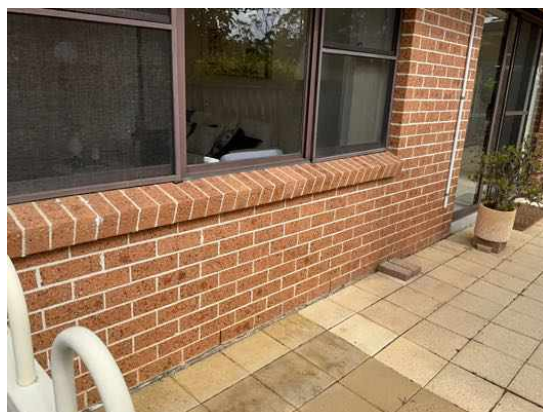
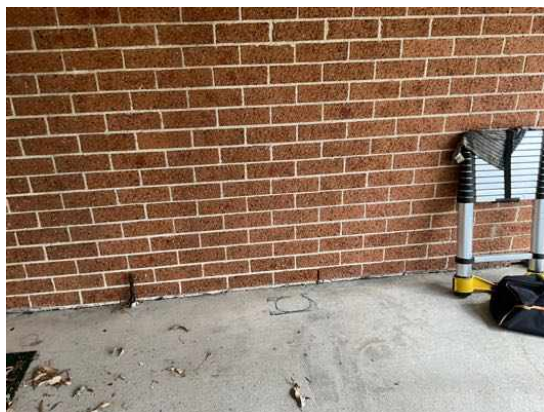
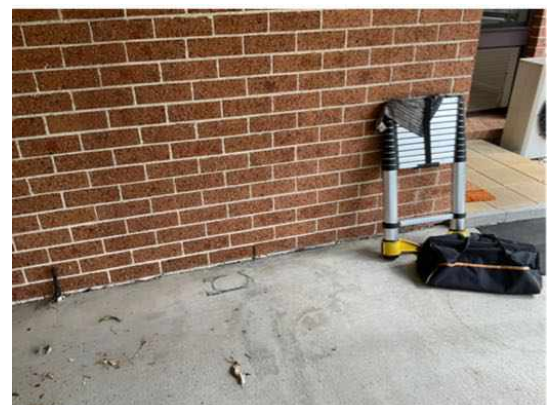
Finding 6.02

Building: Main Building
 Location: All Areas
 Finding: Slab Edge - Exposure
 Information: An inspection zone of at least 75mm in relation to the exposed slab edge, between the bottom brick and the perimeter pavement, is required. This inspection zone should be maintained in order to force termites into the open where they can be detected more readily during regular inspections. The slab edge should not be concealed by anything that may prevent inspection of the area, including render, landscaping, soil, turf, paving, concrete cladding or other structures.

If the slab edge is not properly exposed there is a high risk of termite attack. Sometimes, in order to determine the type of slab, a suitably qualified person such as an architect or builder may be required to consult the construction plans.

Where the slab edge cannot be properly inspected, it is highly recommended that termite or timber pest inspections be carried out every 6-12 months to aid protection of the property against infestation.
