Building and Timber Pest Inspection Report

Inspection Date: Thu, 15 Jan 2026

Property Address: 4/40 New Line Rd, West Pennant Hills NSW
2125, Australia

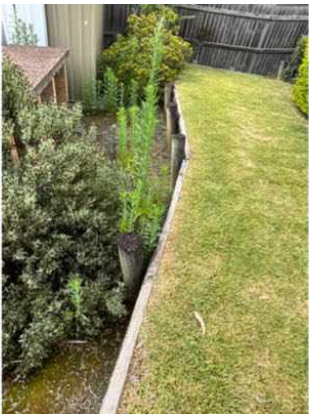
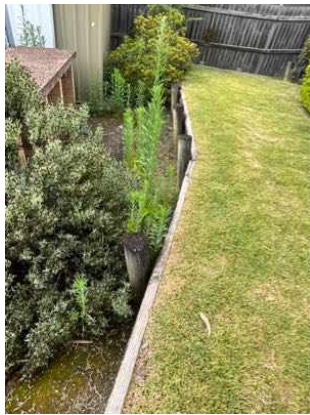
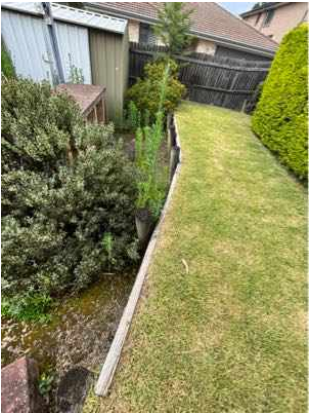
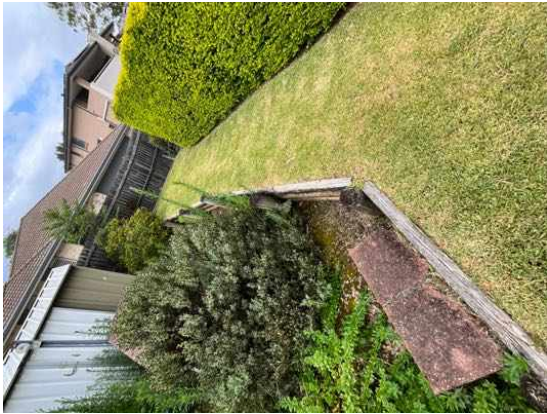
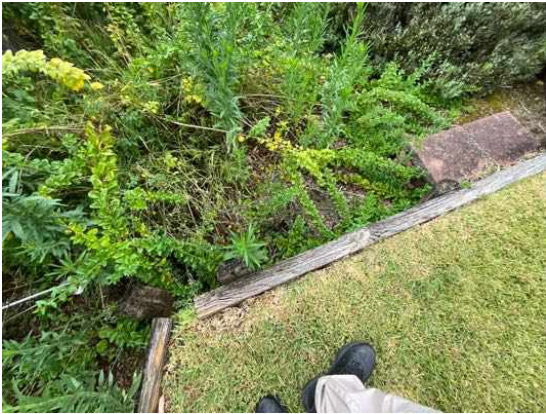
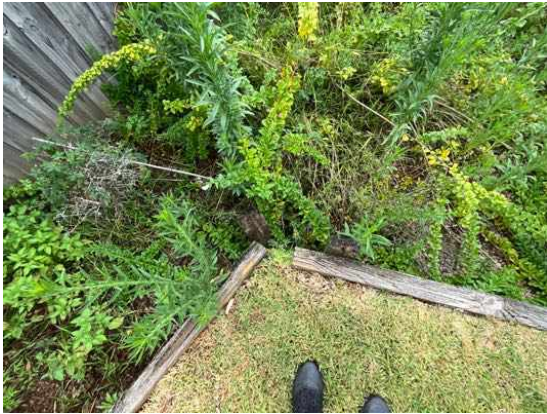
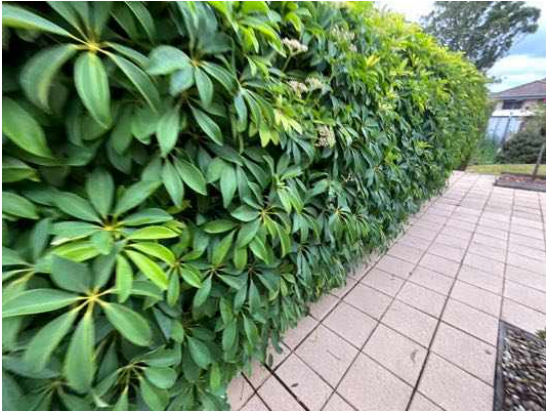
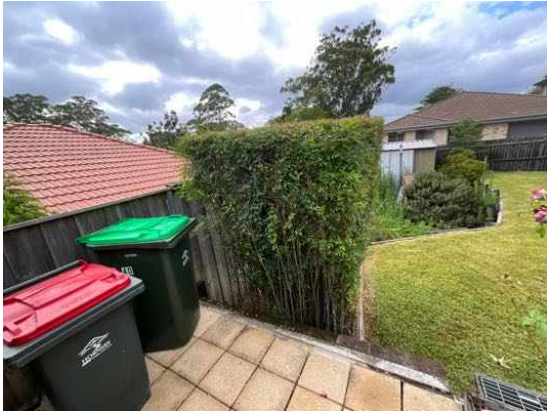
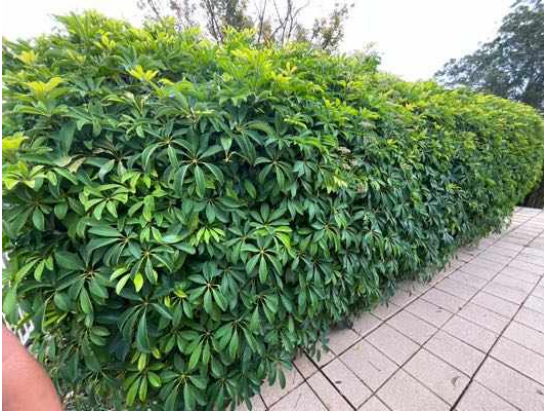
Finding 6.03

Building:	Main Building
Location:	All Areas
Finding:	Dense vegetation around a property can increase the risk of termite infestation
Information:	The presence of dense vegetation around a property can increase the risk of termite infestation, as it provides a conducive environment for them. To address this, consider maintaining a clear space between the vegetation and your home. If you suspect a termite issue, it's advisable to consult with a licensed pest control professional for inspection and treatment.

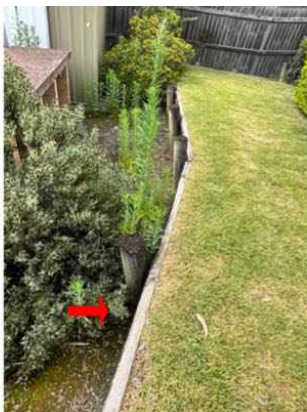
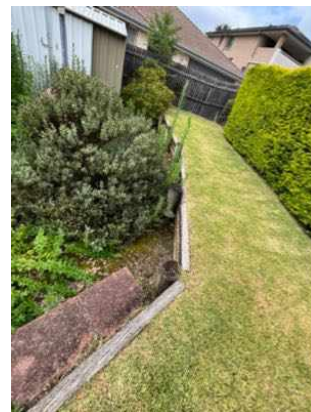
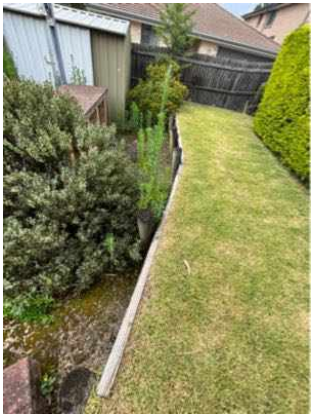
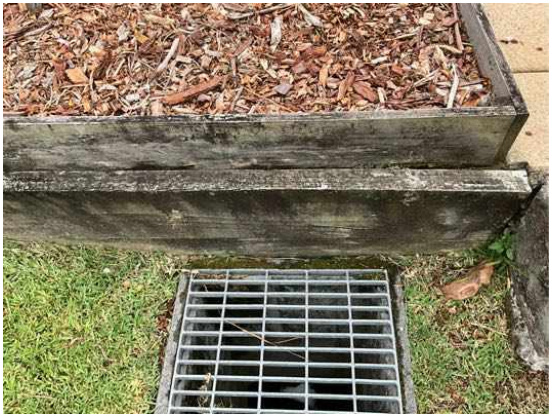
Finding 6.04

Building:	Main Building
Location:	All Areas
Finding:	Timber on ground / conducive conditions to termite damage
Information:	Timber on the ground is indeed conducive to termite damage. Termites are known to thrive in moist environments, and wood in contact with soil or moisture is more susceptible to infestation.

To prevent this, it's important to keep timber elevated and away from direct ground contact. Regular inspections and proper termite control measures are also essential to protect your wooden structures from termite damage.

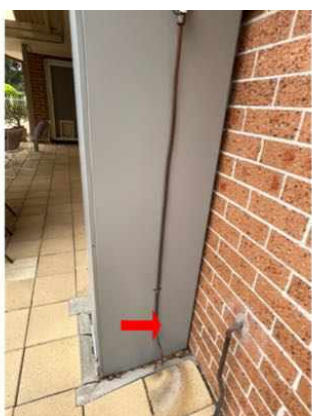
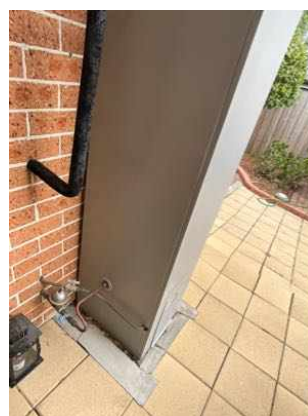
Finding 6.05

Building:	Main Building
Location:	All Areas
Finding:	Bridging or Obstruction Conducive environment for Termites
Information:	Bridging of termite barriers occurs when termites bridge (usually by building a mud tunnel) a termite barrier or inspection inspection zone or where termites have a passage, allowing them to bridge the barrier.

Where bridging has occurred full inspection is prevented and termites may enter a property in a concealed or undetected manner.

Recommended moving obstructions away from the external walls for further and future inspections.

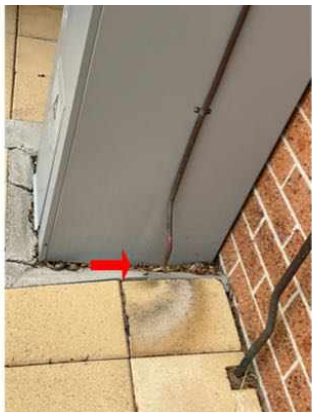
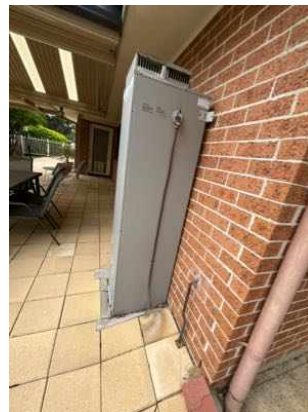
Finding 6.06

Building:	Main Building
Location:	Exterior walls - right side
Finding:	HWS not connected - conducive conditions for timber pest attacks
Information:	The hot water system (HWS) is not connected, leaving exposed pipes and creating conducive conditions for timber pest attacks.

Risk of Timber Pest Attack: The risk of timber pest attack is heightened when the hot water system is not connected. Exposed pipes provide easy access points for timber pests like termites and ants to infiltrate the building structure. These pests are attracted to moisture, and the absence of flowing water through the system can lead to moisture buildup, creating an ideal environment for pests to thrive and cause damage to timber components within the building.

A licensed plumber or qualified plumbing technician should be engaged to reconnect the hot water system. They will assess the existing plumbing infrastructure, determine the appropriate connection points, and ensure proper installation and functionality of

the HWS. Additionally, they may inspect for any signs of timber pest activity and recommend preventive measures, such as installing physical barriers or implementing moisture control measures, to deter pest infestations and protect the building from damage. Regular maintenance and inspections by homeowners or property managers are also essential to detect and address potential issues before they escalate.

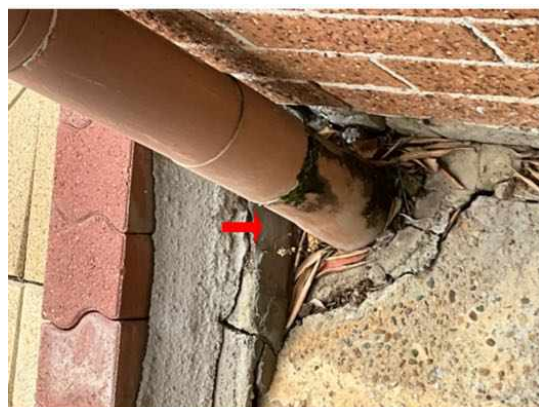
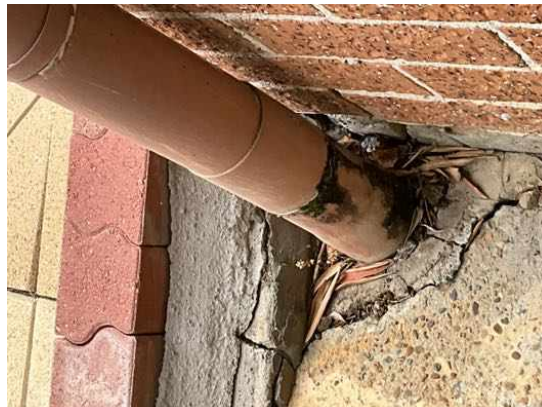
Finding 6.07

Building:	Main Building
Location:	Exterior walls - rear
Finding:	Downpipes Rusty / leaking - Conductive conditions for Timber pest
Information:	Rusty / leaking downpipes can indeed pose a risk for attracting termites, as they provide a source of moisture near a building's foundation. Termites are attracted to moisture and wood, so it's important to address this issue to prevent potential infestations. Connecting downpipes to the stormwater system or ensuring proper drainage away from the building can help mitigate this a licensed plumber is the most qualified professional to handle plumbing-related tasks, including connecting downpipes to the stormwater system. They have the necessary expertise and tools to ensure proper installation.

Please remember that proper installation is essential to ensure effective drainage and prevent future issues, so it's often best to hire a qualified professional, especially for complex or extensive downpipe installations.

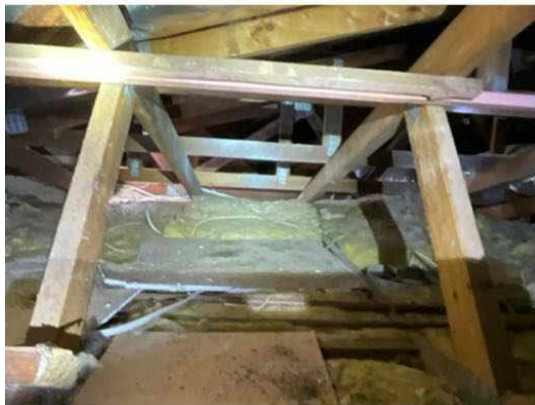
Finding 6.08

Building:	Main Building
Location:	Roof Void
Finding:	Roof void exhibits conspicuous signs of excessive moisture
Information:	The roof void exhibits conspicuous signs of excessive moisture, evident through water staining within the sarking material.

Risk in Terms of Timber Pest: The excessive moisture within the roof void poses a significant risk for timber pests such as termites, as it creates an ideal environment for infestation and proliferation. The damp conditions promote wood decay, making the structure susceptible to damage by these pests.

A qualified roofing contractor and a professional pest control service specialized in timber pest management should be engaged to rectify the issue. They can assess the extent of moisture damage, address any underlying structural issues, and implement effective solutions to mitigate the risk of timber pest infestation.

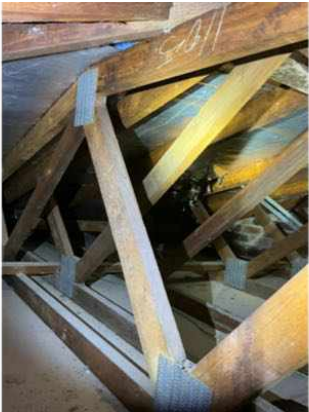
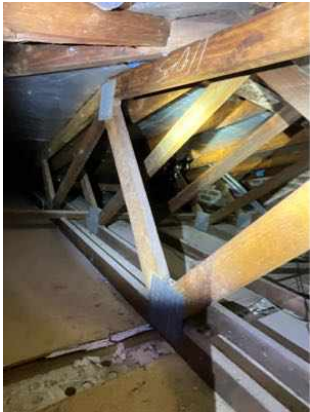
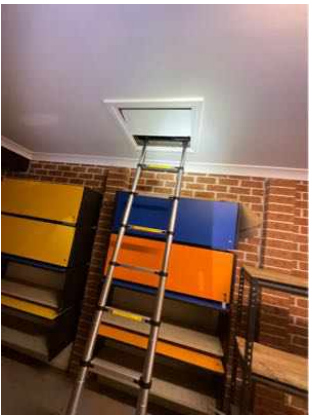
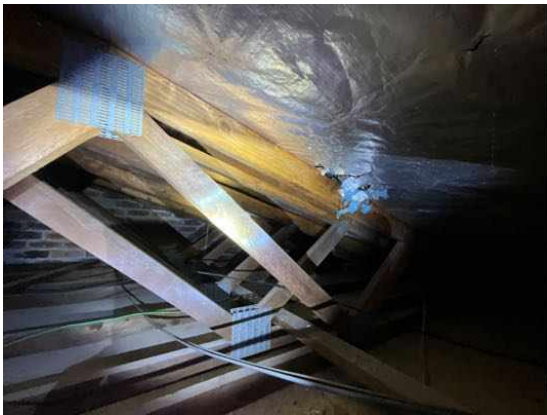
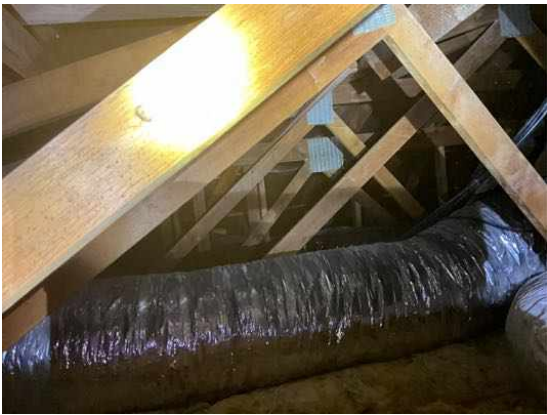
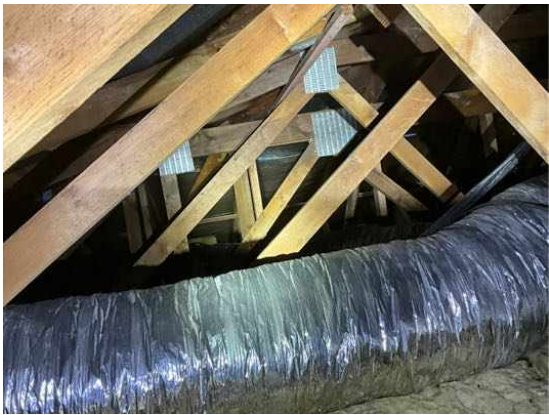
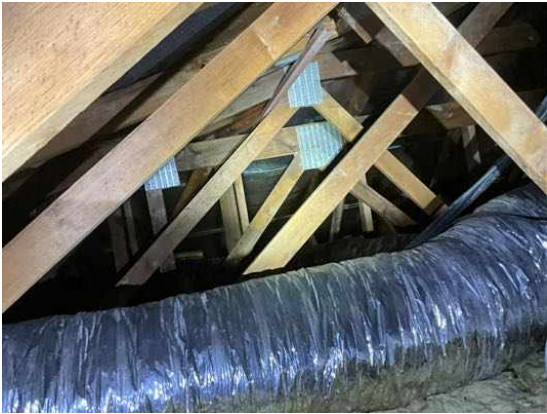
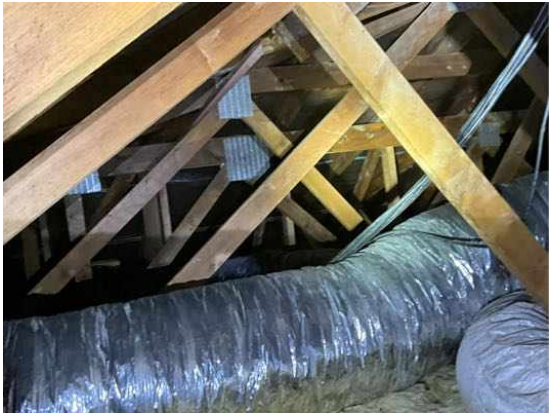
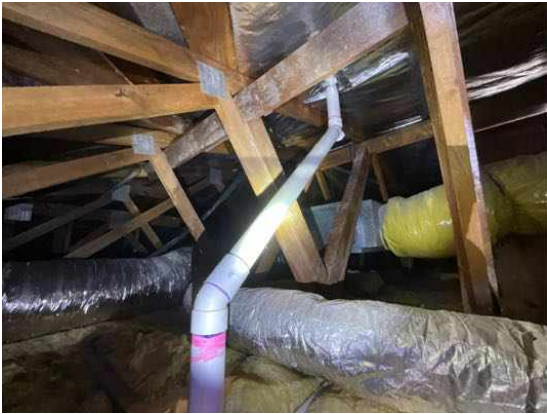
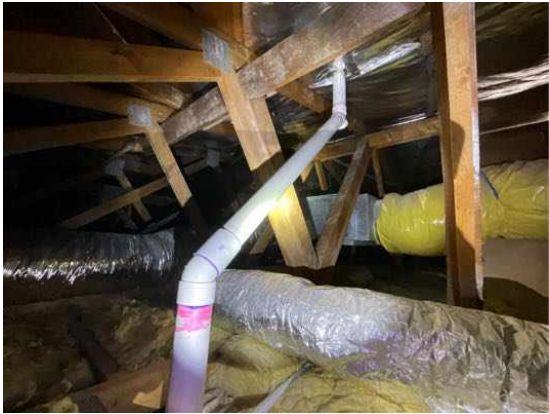
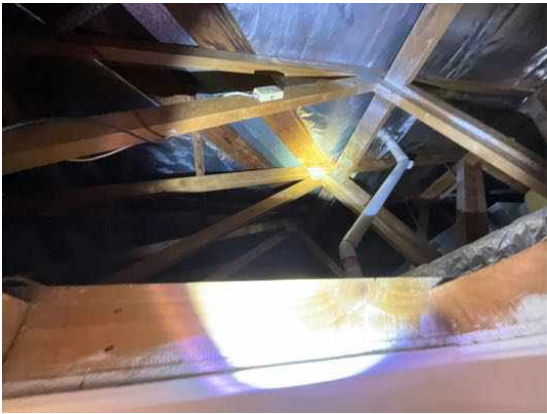
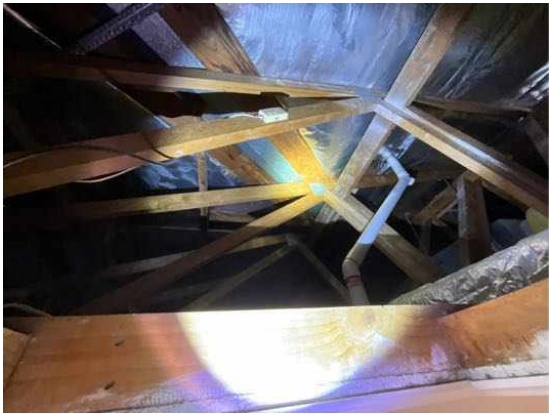
Building: Main Building
Location: All Areas
Finding: Additional Photos - Obstructions and Limitations
Information: These photographs are an indication of the obstructions and limitations which impeded full inspection of the property at the time of inspection. These obstructions can hide an array of defects and should be removed to allow full inspection to be carried out. A re-inspection is recommended once the areas are made accessible.
