Building and Timber Pest Inspection Report

Inspection Date: Thu, 26 Feb 2026

Property Address: 2/74 Linda St, Coburg VIC 3058, Australia

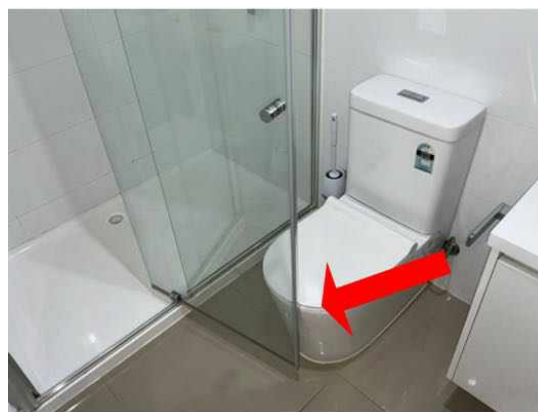
Building:	Main Building
Location:	Ensuite
Finding:	Shower screen door catching and binding
Information:	The shower screen door was found to be hitting the toilet when being opened. This would be considered a safety hazard as the glass could shatter if opened too hard. It is recommended that a shower screen installer or handyman attend to the shower screen door to adjust and fit a protective door cushion.

This should be done immediately

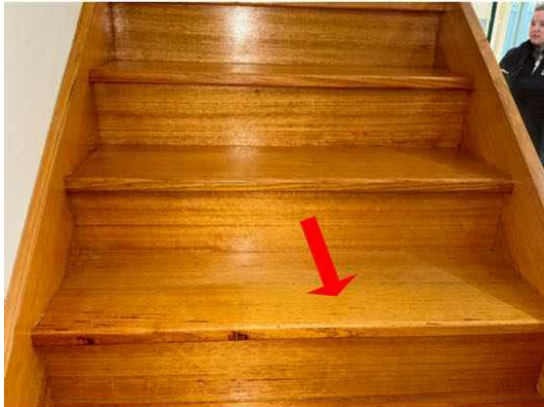
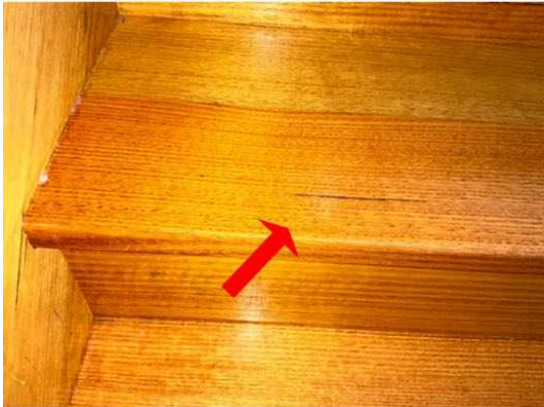
Finding 1.02

Building:	Main Building
Location:	Stairs - Internal
Finding:	Stairs slippery finish
Information:	It was observed that the polished timber stairs were finished in a coating that has no slip index rating and appears to be quite smooth

Polished timber stairs should be finished in an appropriate non-slip coating with a rough surface finish. Alternatively the stairs should be fitted with non-slip nosing to the treads or a non-slip tape to the stair treads

A general handyman or painting contractor should review as soon as possible.

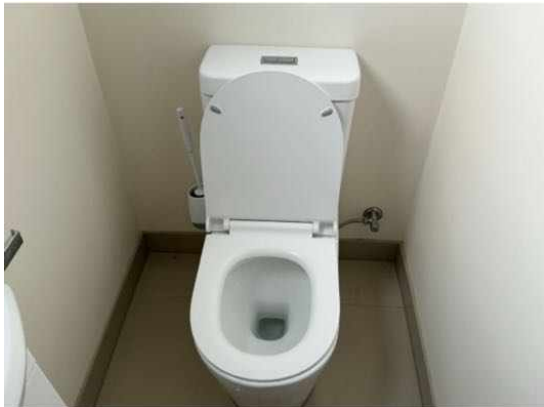
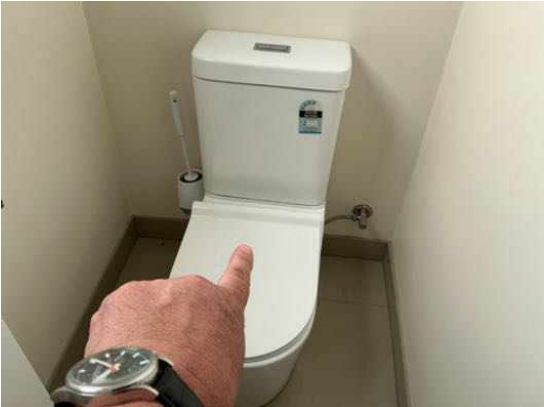
Finding 1.03

Building: Main Building
Location: All Bathrooms
Finding: Toilet seat loose
Information: It was observed that the toilet seats are loose and unstable.

Loose seats can cause fall injury to persons while in use and lead to serious injury

A licensed sanitary plumber should be engaged to review prior to use

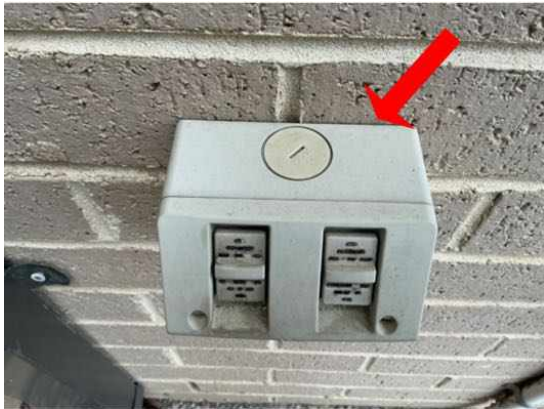
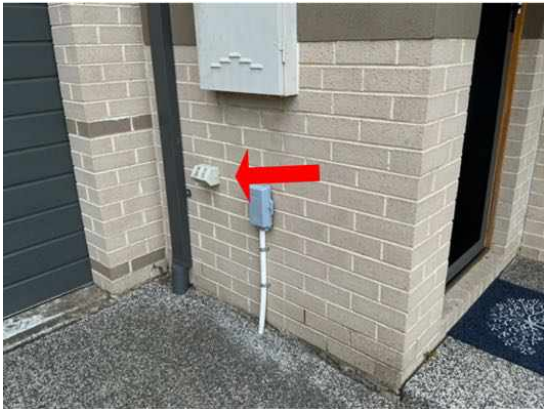
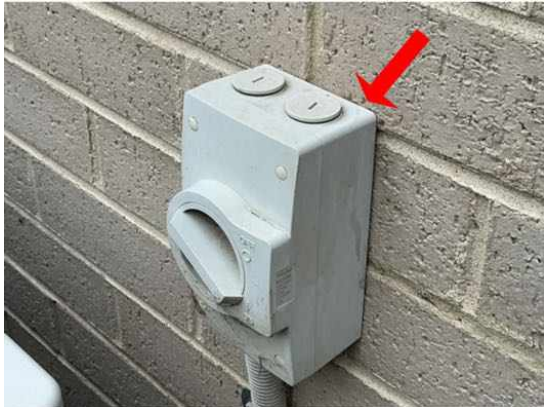
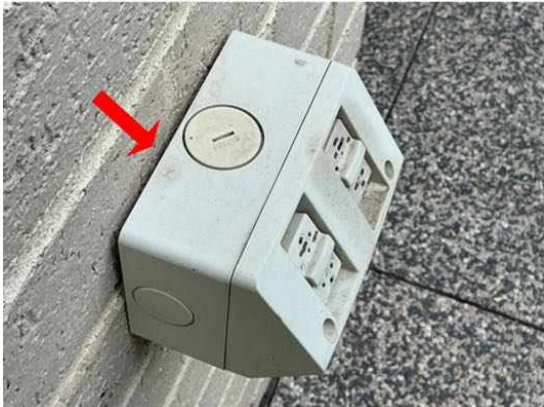
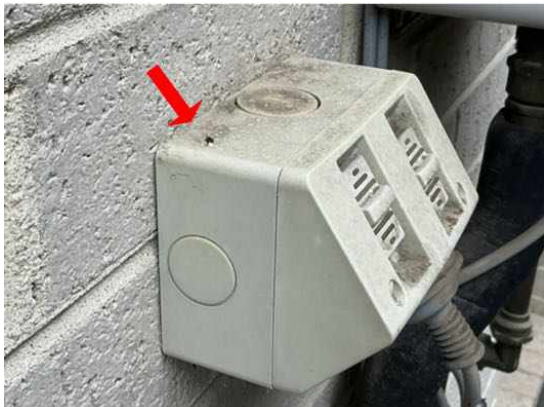
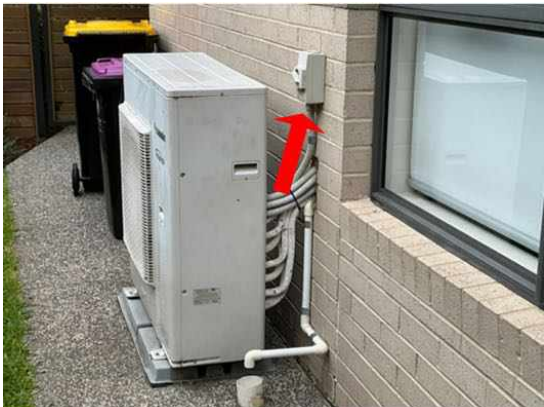
Finding 1.04

Building:	Main Building
Location:	All External Areas
Finding:	External power point not sealed
Information:	It was observed that several external power points to external wall are not adequately sealed from moisture ingress.

AS 3000 states all external electrical Power points should be sealed against possible moisture and water ingress

Moisture inside a fitting can caused earth leakage,power cut out and could cause injury to persons

All external power points are to be sealed (generally at the top) to prevent moisture ingress to the fitting.

A licensed electrician should review immediatly

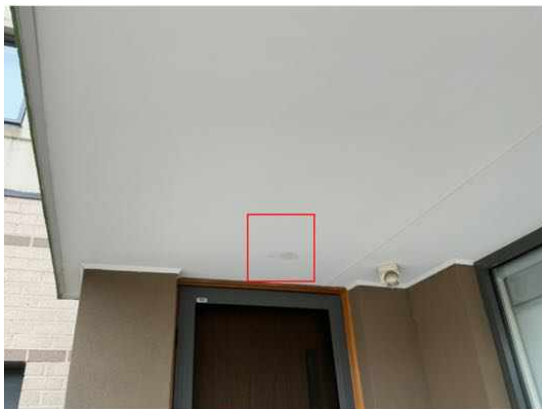
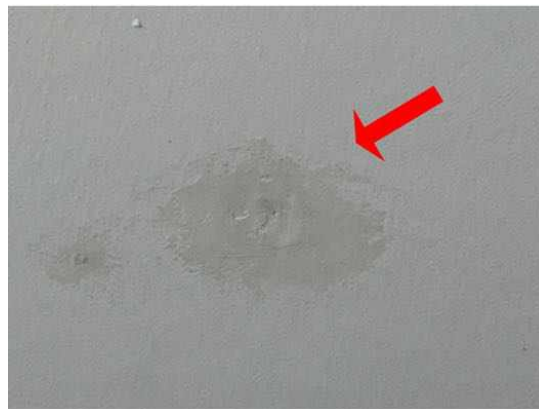
Building: Main Building
Location: Porch
Finding: Poor quality repair work

Information: It was observed at the time of the inspection that a repair has been undertaken to the ceiling in the porch area. The repair is demonstrating poor workmanship and appears to be incomplete.

Although anaesthetic defect it detracts from the overall appearance of the building.

The owners should engage a general handyman to review at their discretion

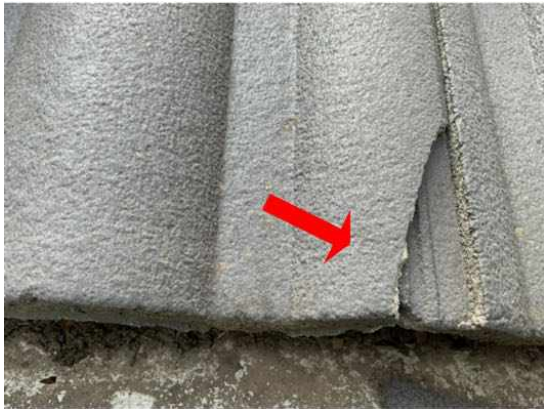
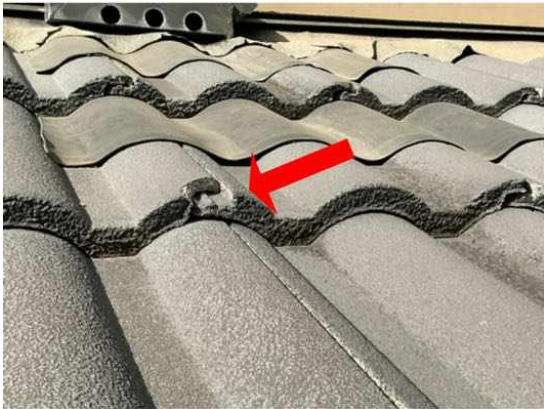
Finding 3.02

Finding: Roof tiles - Broken

Information: Upon inspection of the exterior roof covering, broken roofing tiles were identified. Broken and friable roof tiles are generally the result of ageing and weathering of what is essentially a porous material.

If left to further deteriorate, broken and brittle roof tiles are likely to lead to water penetration via the roof into the ceiling space, causing secondary damage to ceiling linings, insulation and roof structures. Broken roof tiles are also likely to detract from the effectiveness of the roof drainage system, creating potential for secondary damage to the exterior roof covering and roof plumbing.

Replacement of broken tiles is required and should be performed by a roofing contractor as soon as possible.

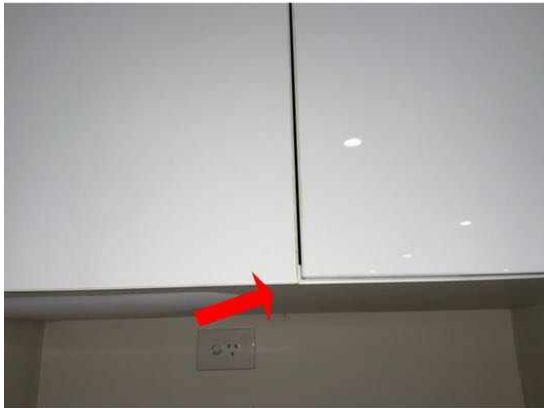
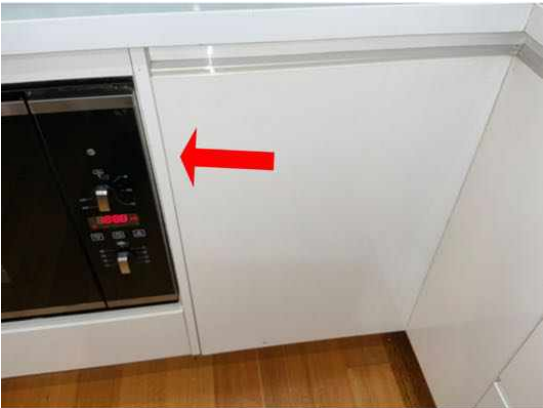
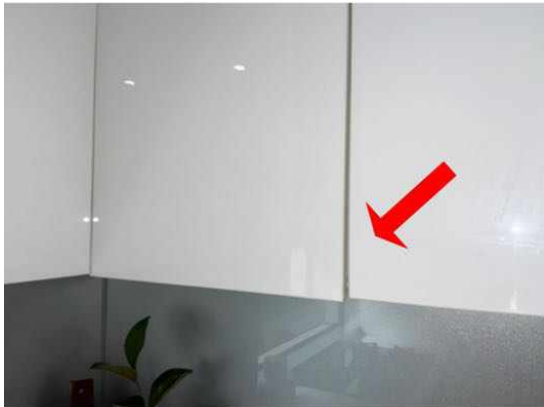
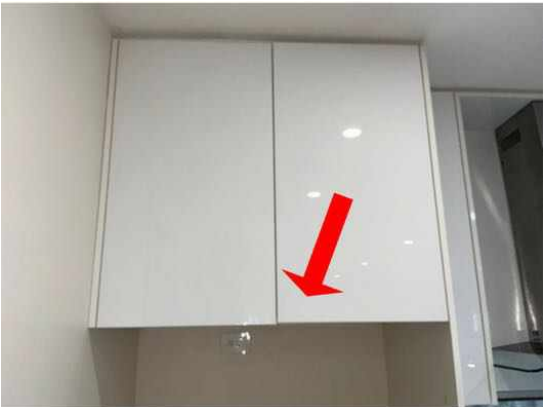
Building: Main Building
Location: Kitchen
Finding: Cabinet doors require adjustment
Information: It was noted that many cabinet doors to the kitchen had become loose overtime and has caused the doors to bind and become difficult to open.

Doors which catch and bind can damage laminated surfaces and allow water ingress into cabinetry elements. This can cause swelling of the chipboard substrate and premature deterioration of the structure of the cabinet.

A qualified cabinet maker should review at the owners discretion.

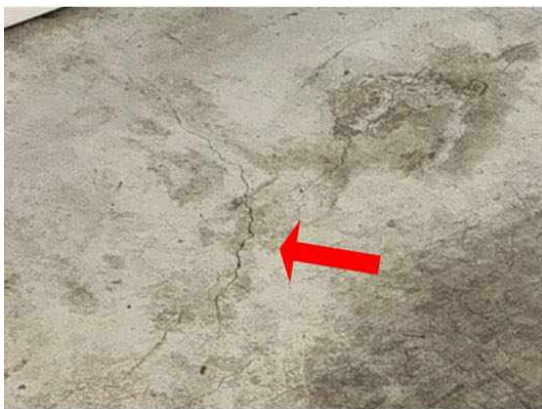
Finding 3.05

Building:	Main Building
Location:	Garage
Finding:	Cracking - Damage Category 1 - Fine (up to 1mm)
Information:	Although fine cracks are quite noticeable, they are often only considered to be an appearance defect, and usually do not indicate any structural damage. Generally, the cause of a fine crack is indicative of a separation between building materials and finishes (e.g. paint, plaster, etc.) along joins.

Cracking of this nature can generally be repaired with minor sanding, filling and/or repainting. Such works should be performed by a qualified painter or a general handyman.

Monitoring of all cracking should be conducted frequently. Always contact a building inspector should cracks widen, lengthen, or become more numerous.

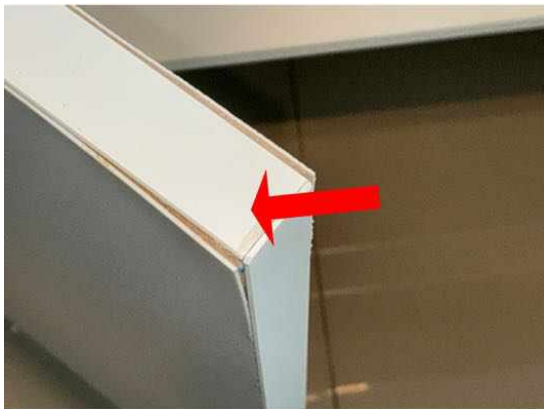
Finding 3.06

Building:	Main Building
Location:	Bathroom
Finding:	Malaine deteriorated
Information:	It was observed that the white malamine surface to the ensuite vanity cabinet doors was deteriorated and water damaged

The white melamine coating is required to prevent the ingress of moisture into the kitchen cabinets substrate. damaged Malaine on cabinets and is also an aesthetic defect which detracts from the overall appeal of the building.

A qualified cabinet maker should be engaged to review at their owners discretion

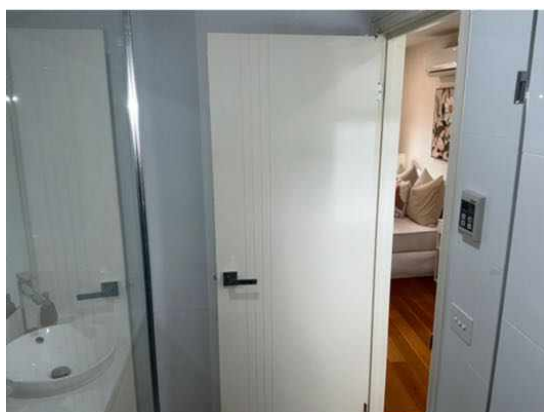
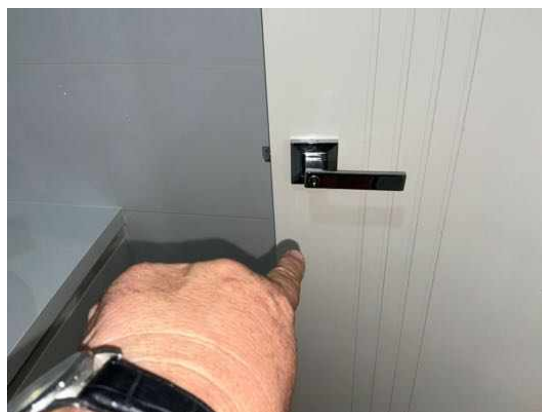
Building: Main Building
 Location: Ensuite
 Finding: Doors rattling
 Information: It was observed that ensuite door is rattling when closed at the latch.

Unadjusted, the rattling should can be noisy and irritating. Door movement also can cause cracking paintwork to the door frame and architraves.

A qualified carpenter or handyman should be engaged to adjust at the owners

convenience

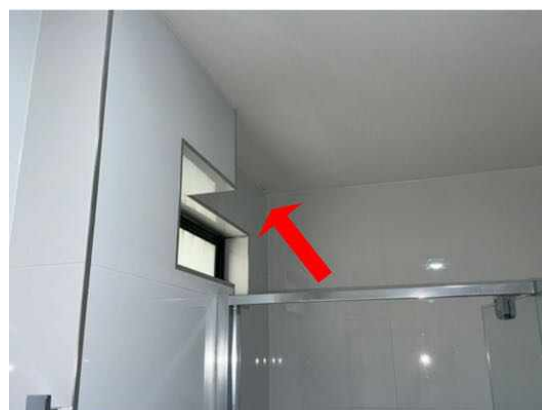
Finding 3.09

Finding: Water leak - Inactive

Information: Water leaks generally occur when a particular area of the property is not weather- or water-tight. While the damage in this area appears to be from an old inactive water leak, the area should be monitored frequently for the recurrence of any dampness.

Repair and / or replacement of previously affected building elements is at client discretion. Consider a further invasive inspection: removal of obstructions around the damaged area may reveal further damage which has been concealed. A more significant or major defect may be identified at this time.

Where recurrence of an active water leak is identified, a qualified plumber should be appointed immediately to rectify the leak and advise on any further preventative works as necessary.

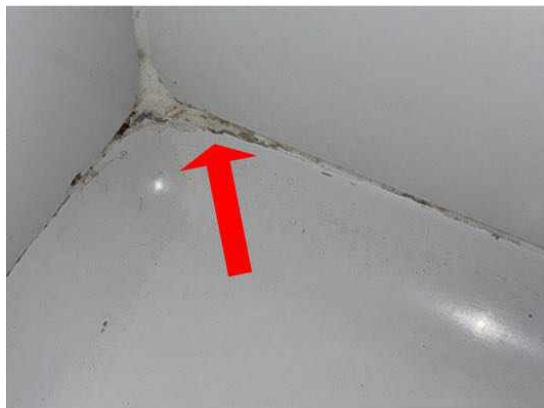
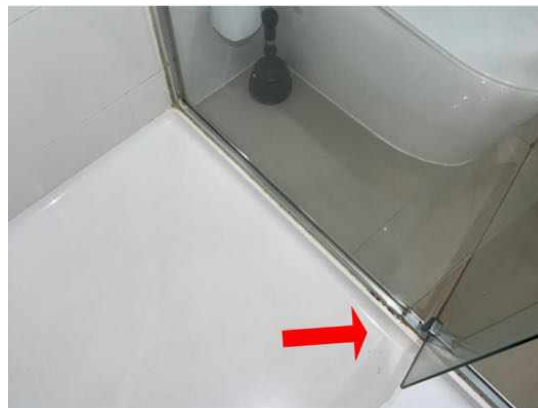
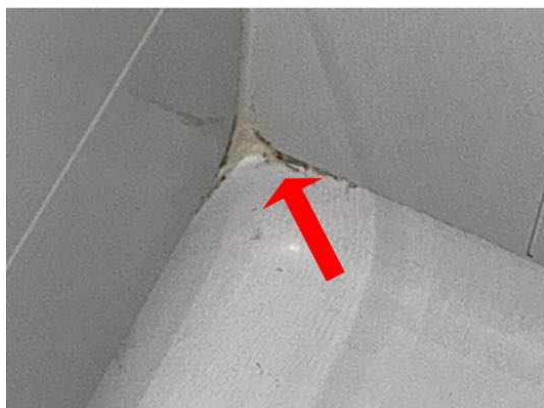
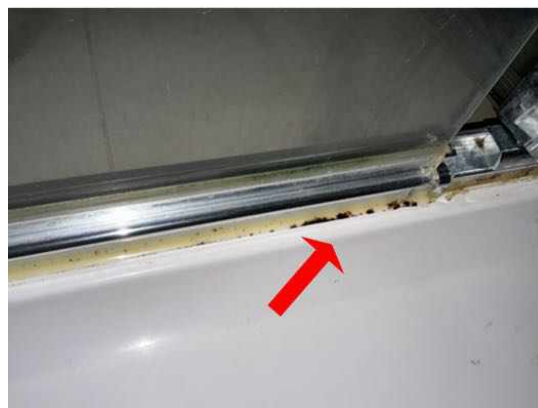
Finding 3.10

Location: Ensuite
 Finding: Minor mould
 Information: It was observed that a small amount of mould was present in the sealant at the bottom of the shower closet. This is minor in nature and requires a through clean prior to use of the shower

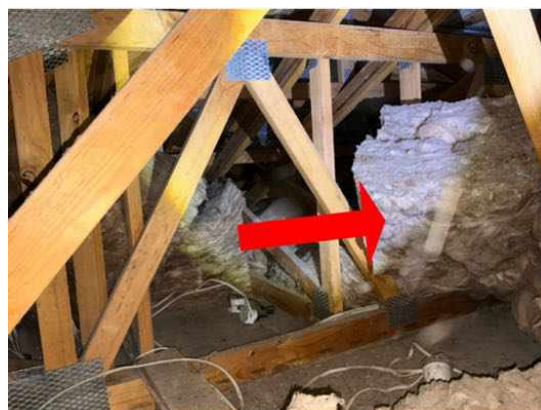
Finding 3.11

Building: Main Building
 Location: Roof Void
 Finding: Insulation - Missing-disturbed
 Information: Upon inspection of the roof void it was noted that insulation is not present or disturbed.

Insufficient insulation will result in a comparatively higher cost to heat and cool a property as there is a lack of Insulation (or uneven coverage of insulation) which works as a barrier to heat transfer. This helps to keep out unwanted heat in summer and preserves warmth inside your home in winter. It can also help soundproof your home from unwanted airborne noise transfer.

Where insulation is absent, the area does not meet current Australian Standards. Installation of adequate insulation is required and should be conducted as soon as possible.

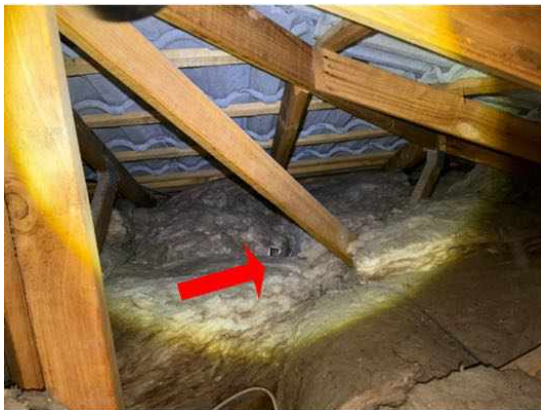
Building: Main Building
 Location: Roof Void
 Finding: Exhaust fan/fans not ducted
 Information: Exhaust fans should from the fan to the outside atmosphere. This is to prevent condensation, unwanted smells and the build up of moisture in the roof void.

A licenced plumber or licensed electrician should review as soon as possible.

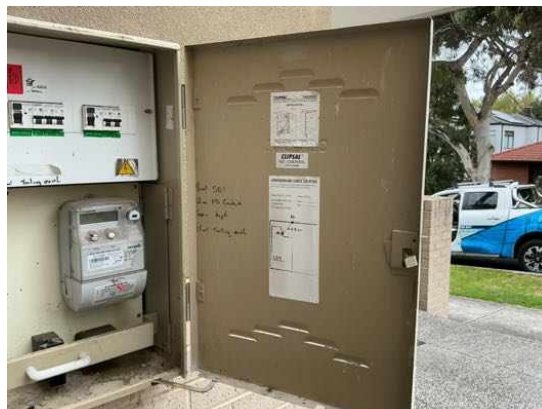
Building:	Main Building
Location:	Meter Box
Finding:	Termite Management System - no evidence of a chemical installation
Information:	The application of a post-construction chemical termite barrier is highly recommended for all properties, particularly if live termite activity has been found on the site previously. Such barriers are highly effective in preventing termite attack on any timber building elements throughout the property.

A durable notice should be placed in the switchboard unit to indicate current termite barriers. At the time of inspection, it appeared as though no termite management system has been installed, with no evidence to suggest preventative works taking place.

The client may consider gaining further advice from a pest controller as to the costs and procedures involved with this application. It is recommended that obtaining such advice be a short-term priority.

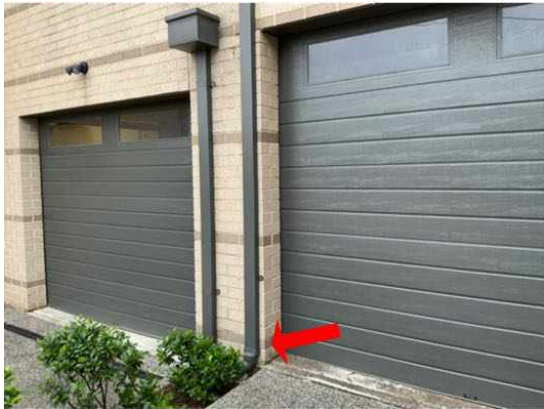
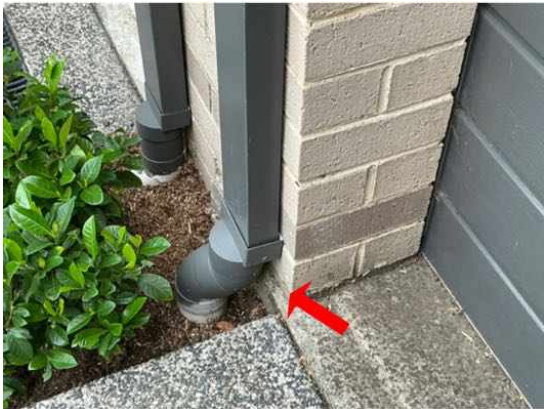
Finding 6.02

Building:	Main Building
Location:	All External Areas
Finding:	Bridging of termite barrier
Information:	Bridging of termite barriers occurs when termites bridge (usually by building a mud tunnel) a termite barrier or inspection zone or where termites have a passage allowing them to bridge the barrier.

Generally this takes the form of finished ground levels external paving or concrete being retrospectively installed above the damp course level the adjacent internal floor level or weep and ventilation holes.

Where bridging has occurred full inspection is prevented and termites may enter a property in a concealed or undetectable manner.

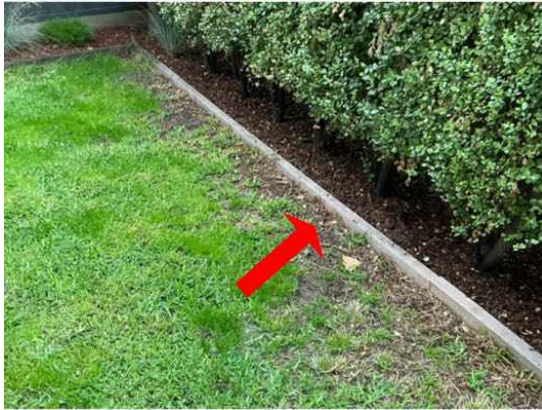
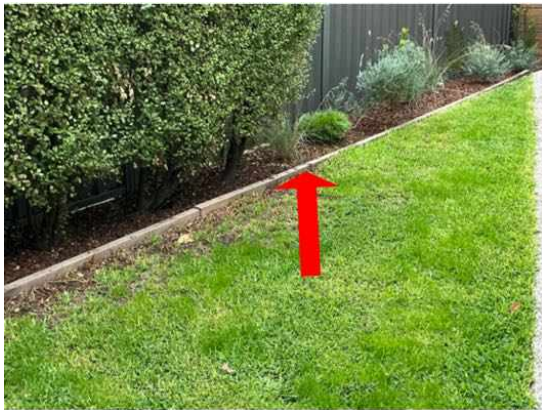
Building:	Main Building
Location:	All External Areas
Finding:	Untreated or non-durable timbers in a hazardous environment
Information:	To reduce the risk of timber pest attack it is essential that timber used in a hazardous environment (e.g. in direct contact with the ground or frequently exposed to damp conditions) is of sufficient durability and/or is adequately preservative treated.

Untreated timbers in direct contact with the ground are likely to develop severe wood rot and/or fungal decay if left unattended creating attraction for subterranean termites to infest the timbers from surrounding areas.

If untreated or non-durable timbers are found to be in a hazardous environment it is highly advised that replacement of these building elements be performed as soon as possible to aid the protection of the property against termite / timber pest attack.

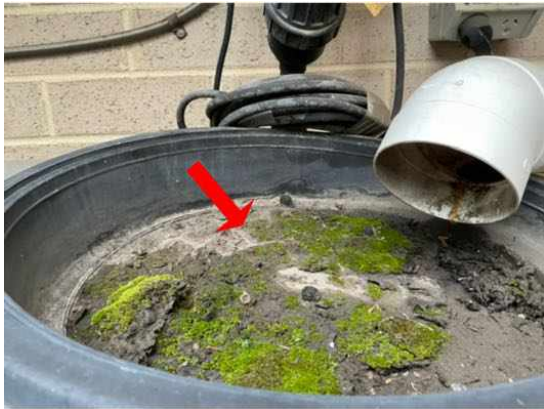
Finding 6.05

Building: Main Building
Location: Exterior walls - left side- water tank
Finding: Water tank strainer blocked
Information: It was noted at the time of the inspection that the strainer to the water tank was blocked with debris. This can cause overflow and enable excessive moisture and water to overflow the tank.

Excessive moisture from the overflow can be conducive to termite activity.

The owners or a general handyman should be engaged to clean the strainer as soon as possible

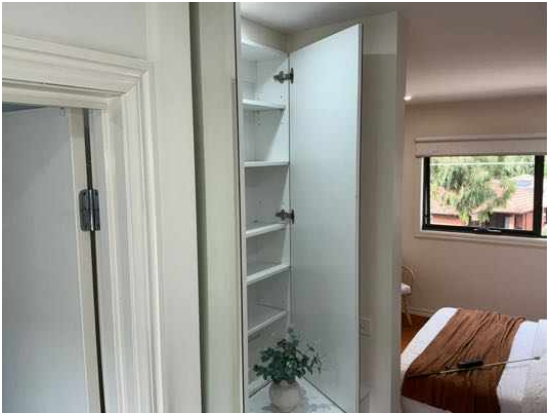
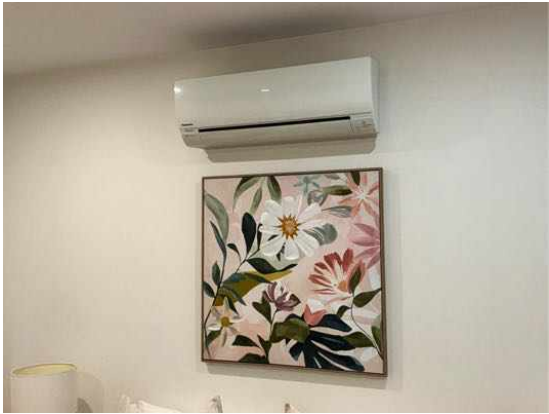
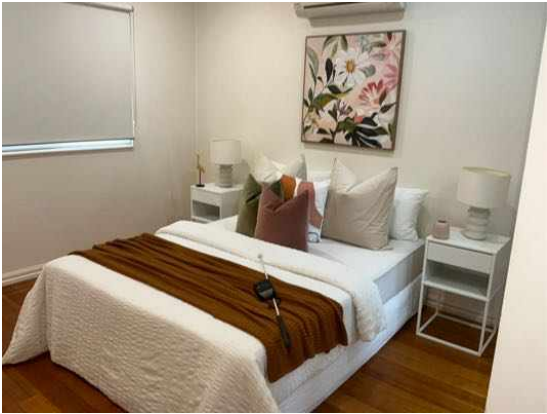
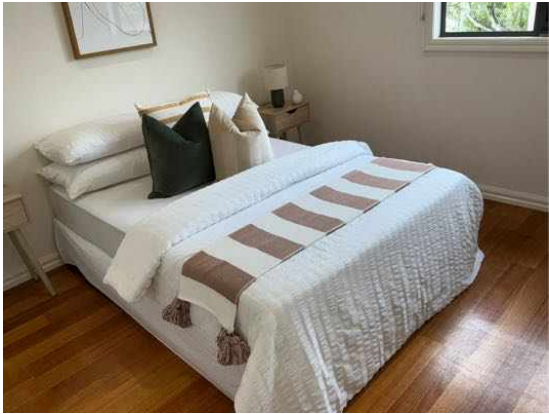
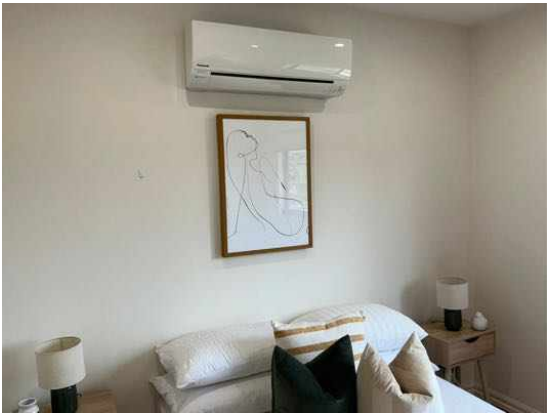
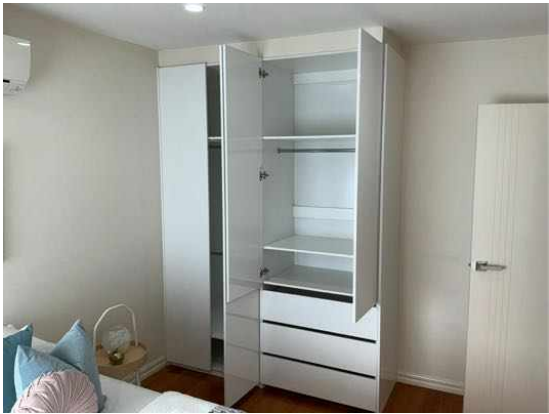
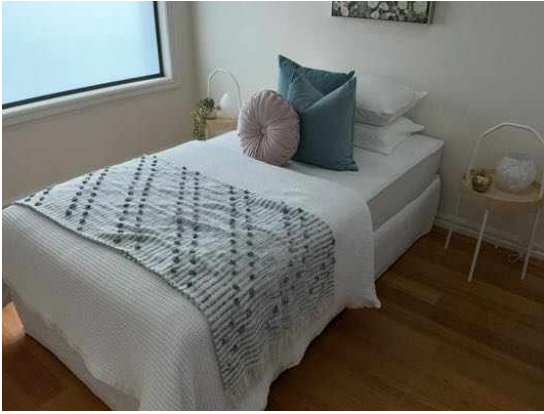
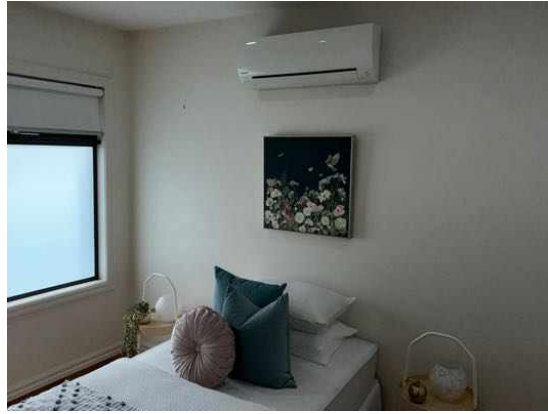
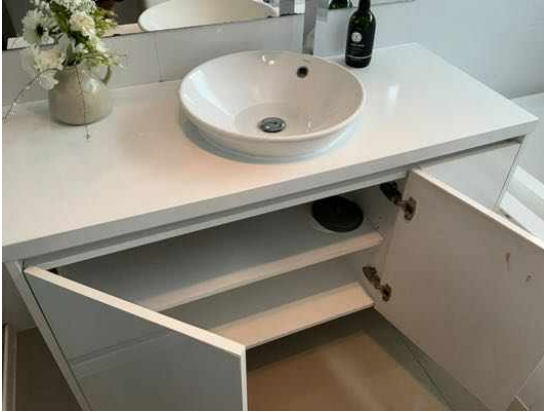
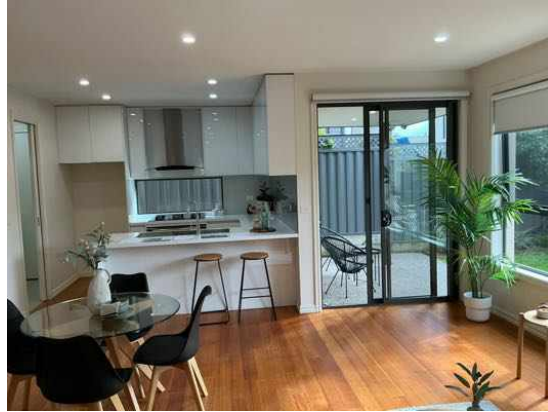
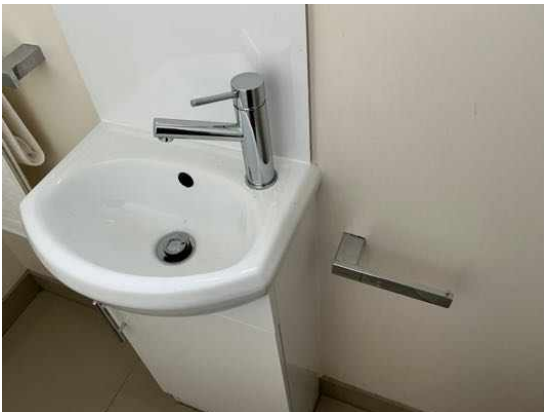
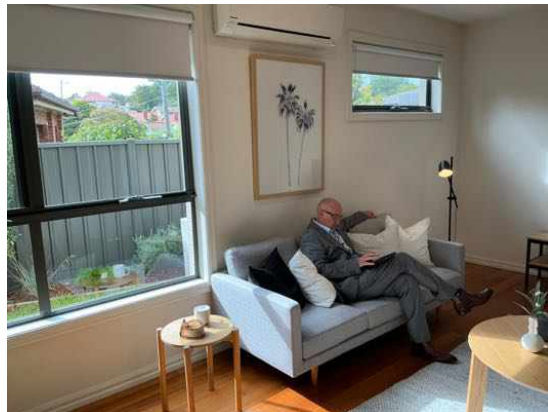
Building: Main Building
Location: All Areas
Finding: Additional Photos - Obstructions and Limitations
Information: These photographs are an indication of the obstructions and limitations which impeded full inspection of the property at the time of inspection. These obstructions can hide an array of defects and should be removed to allow full inspection to be carried out. A re-inspection is recommended once the areas are made accessible.

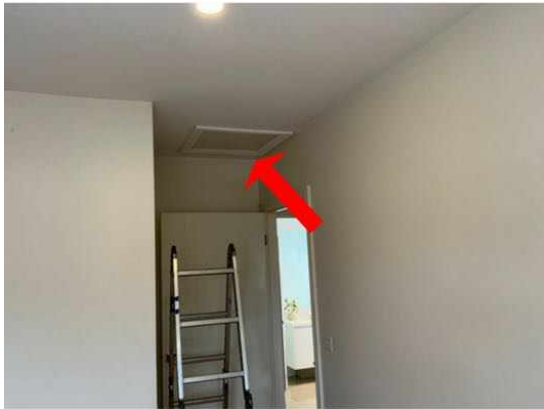
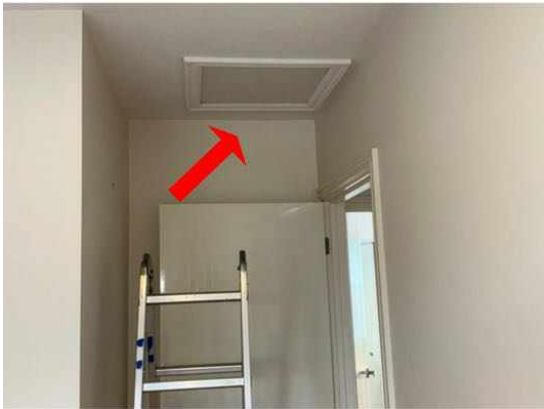
Building: Main Building
 Location: Bedroom - Master
 Finding: Manhole / limited roof space access
 Information: Due to the position of the manhole and the low roof pitch ,only a limited inspection of the roof space was possible. This was taken from the top of the ladder and a further invasive inspection is advised.
