Building Inspection Report

Inspection Date: Wed, 11 Mar 2026

Property Address: 18 Ravenhall St, Braybrook VIC 3019,
Australia

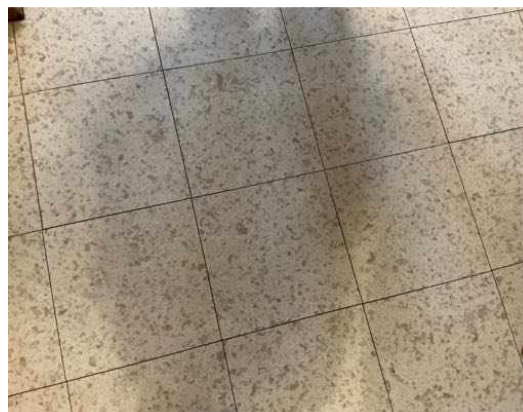
Defects 1.04

Building:	Main Building
Location:	Kitchen
Finding:	Asbestos - Suspected ACM Identified on Site
Information:	Reporting on Asbestos is outside the Scope of this Report. This suspected defect is highlighted as a caution only. We suspect, based on our experience in the building

As Asbestos Reporting is outside the scope of this report, we advise that you consider a separate Asbestos Inspection and Condition Audit, which can include the taking of samples for definitive confirmation of the presence of Asbestos.

In the interim, the client is advised to act with caution, especially when considering any damage to building materials general wear and tear renovations extensions demolition and general maintenance activities due to the suspected presence of Asbestos.

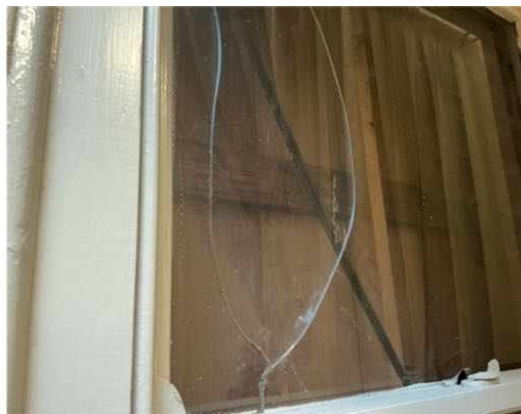
Defects 1.05

Building:	Main Building
Location:	All Areas
Finding:	Window - Cracked
Information:	Cracks were identified in the window in this area. Cracking in windows is generally the result of impact damage, and is likely to develop further when left unmanaged.

The likelihood of this windowpane further cracking and shattering is increased exponentially, providing a safety hazard in the area. The cracked window also impairs the weather tightness of the building, creating potential for minor water leaks.

A qualified glazier is required to repair the window as soon as possible. Depending on the extent of the cracking, replacement of the window may be required. Please be advised that any persons coming into contact with the cracked window should do so with due caution to avoid any personal injury that may ensue.

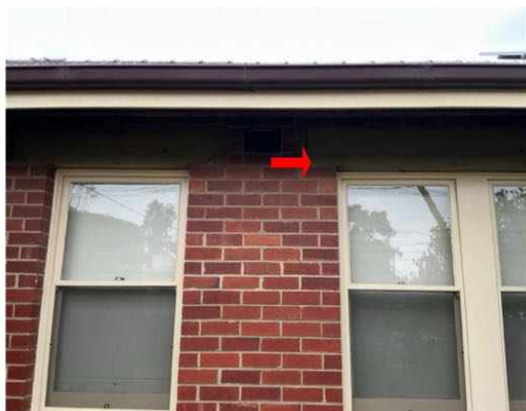
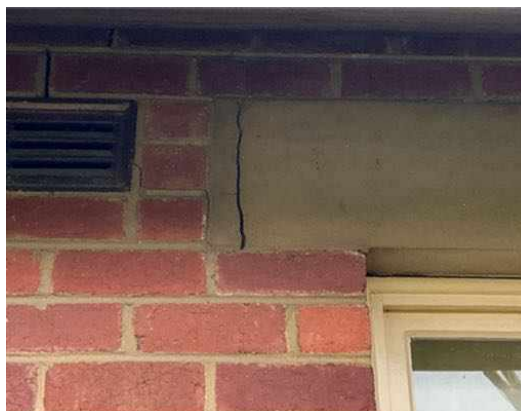
Defects 2.04

Building:	Main Building
Location:	All Areas
Finding:	Brickwork - Cracking [Extensive repairs required]
Information:	Major cracking is evident to the brickwork in this area. When managing this degree of cracking, major extensive repair work is generally required. Such work is likely to involve replacement of sections of affected brickwork.

Structural issues are generally the underlying cause of such cracking. It is suspected that this damage has been created due to movement of key structural elements or general subsidence of associated footings.

A structural engineer and bricklayer should be appointed immediately to inspect the structural integrity of the affected brickwork and to assess the safety of the associated structures. The engineer can also nominate a scope of works required for rectification.

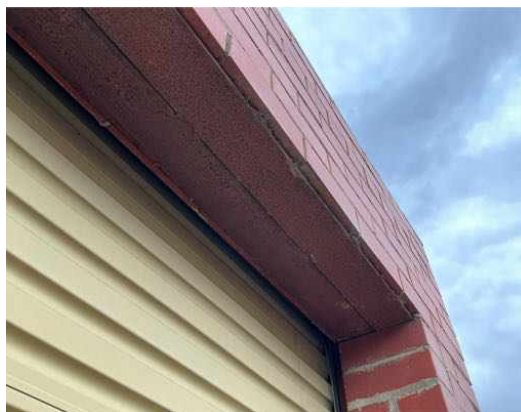
Defects 3.02

Building:	Garage
Location:	All Areas
Finding:	Lintels - Rusted or corroded
Information:	This building element shows evidence of rusting and corrosion, which is likely to have developed as a result of excessive exposure to moisture and or inadequate coatings.

As surface rust provides no protection to the underlying iron, the deteriorating

condition is likely to worsen if not addressed in the short-term future.

Where possible, the use of galvanized (treated) metals or aluminium coated metals aid in rust prevention, as does regular general maintenance. Rust formation can be controlled with coatings, such as paint, that isolate the iron from the environment.

Rusting and corrosion should be managed by ideally removing or limiting the affected surface from exposure to moisture. A registered builder may be appointed to replace any building elements that have been severely affected by rust or water damage.

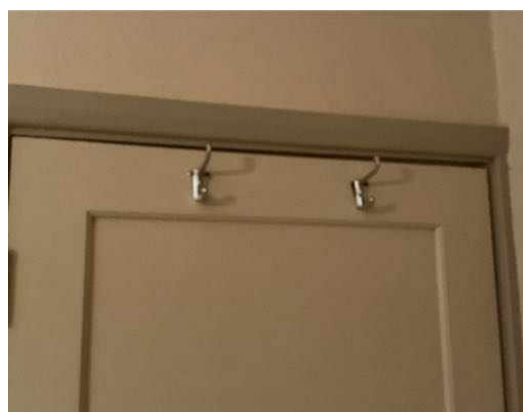
Defects 3.06

Building:	Main Building
Location:	All Areas
Finding:	Door - Gap
Information:	<p>A significant gap was identified between the door and door frame in this area. Where large gaps to the head or foot of door frames appear, it may indicative of a variety of defects, ranging from uneven framework, sagging hinges or uneven flooring.</p> <p>A gap to the head of the door may also indicate movement of the foundation of the property, which is a common occurrence and does not indicate structural damage.</p> <p>A qualified carpenter should be appointed to perform remedial works to restore the door to a fully operational level.</p>

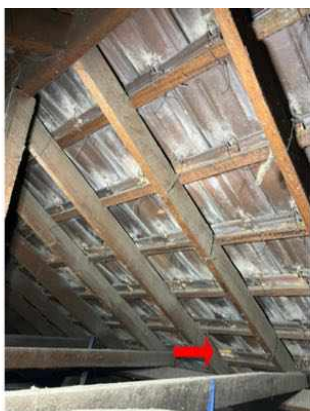
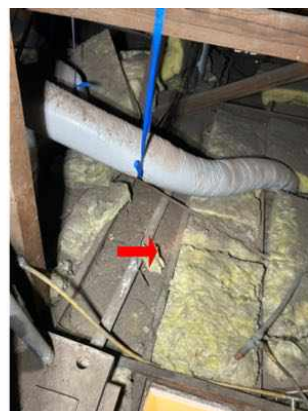
Where left unmanaged, deteriorating roof tiles are likely to lead to a number of secondary defects, including minor water leaks and weather exposure to internal roofing structures.

Consultation with a roofing contractor is highly advised to gain advice on cost of remedial works that may be required in the short to medium term. Remedial works are likely to increase the longevity of the exterior roofing

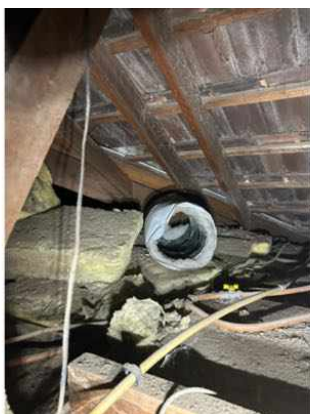
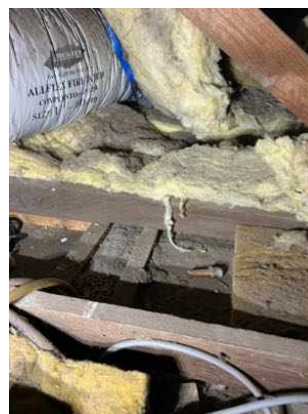
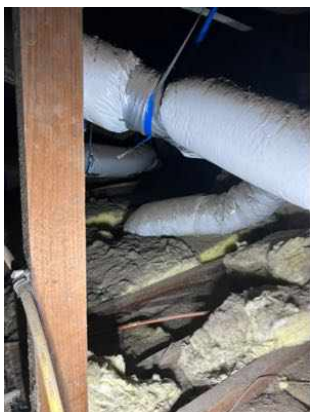
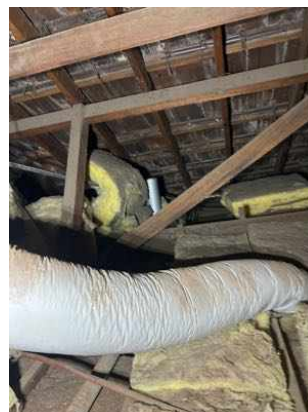
Defects 3.09

Building:	Main Building
Location:	All Areas
Finding:	Insulation - Inadequate
Information:	Upon inspection of the roof void it was noted that there is a lack of adequate insulation.

The level of insulation in the property does not meet current Australian Standards. Installation of adequate insulation is required and should be conducted as soon as possible.

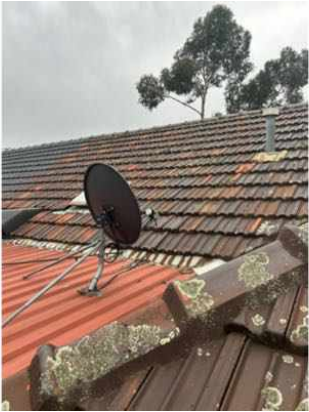
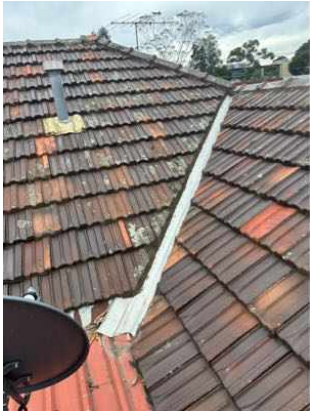
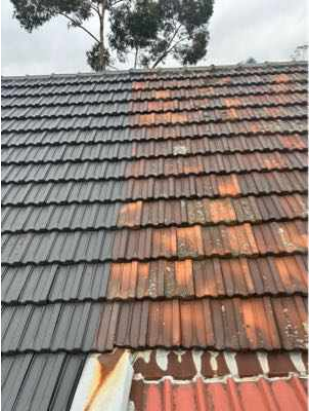
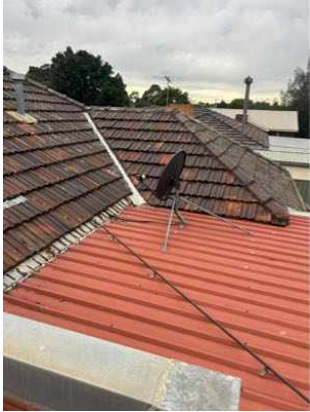
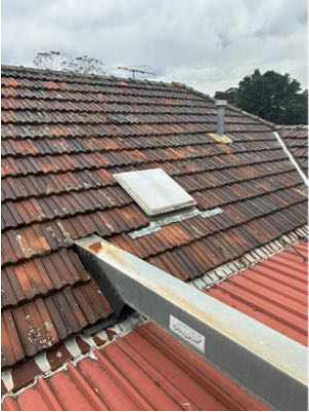
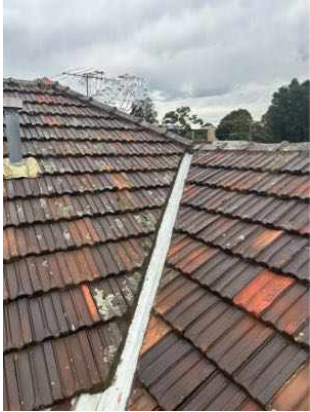
Defects 3.10

Building:	Main Building
Location:	All Areas
Finding:	Roof tiles - Weathered
Information:	Upon inspection of the exterior roofing, the majority of roof tiles were considered to be in a fair condition. While weathering of the tiles is consistent with the age of the property, maintenance works are required.

Where left unmanaged, deteriorating roof tiles are likely to lead to a number of secondary defects, including minor water leaks and weather exposure to internal roofing structures.

Consultation with a roofing contractor is highly advised to gain advice on cost of remedial works that may be required in the short to medium term. Remedial works are likely to increase the longevity of the exterior roofing structure.

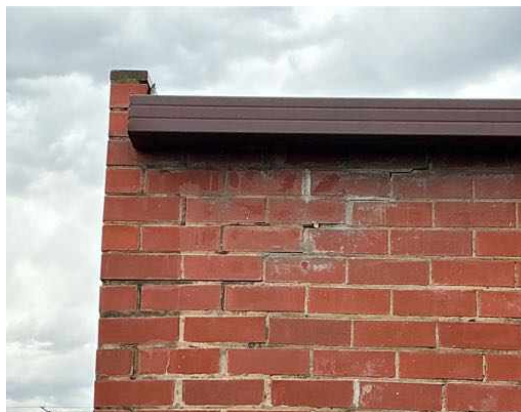
Noted Item

Building: Garage
 Location: All Areas
 Finding: Brickwork - Step cracking
 Information: Step cracking was identified to the brickwork in this area at the time of inspection. Step cracking, which is similar to other forms of cracking, has a variety of possible causes. However, the most common is the subsidence of adjacent footings.

Step cracking is a relatively common defect, and is most likely to occur adjacent to windows, doors and other openings. Mortar failure in the gaps between affected bricks indicates the stresses and tensions affecting the wall.

Where step cracking is extensive or severe, the client is advised to consult a structural engineer. Minor step cracking can be used as a warning sign to address factors causing stress to the wall, which can include the effect of surrounding trees, water leaks, soil erosion, or even the presence of reactive soils in the surrounding area.
