Building and Timber Pest Inspection Report

Inspection Date: Mon, 9 Mar 2026

Property Address: 7 Louise St, Dapto NSW 2530, Australia

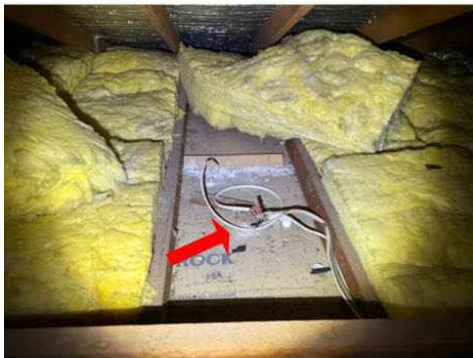
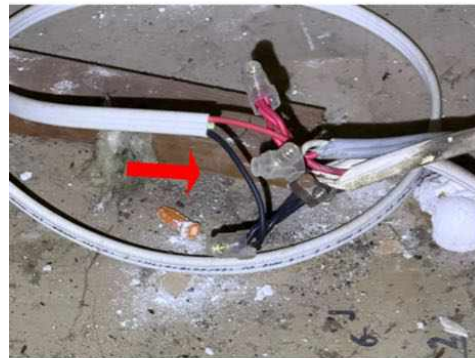
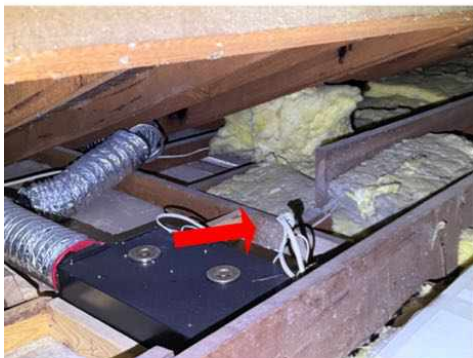
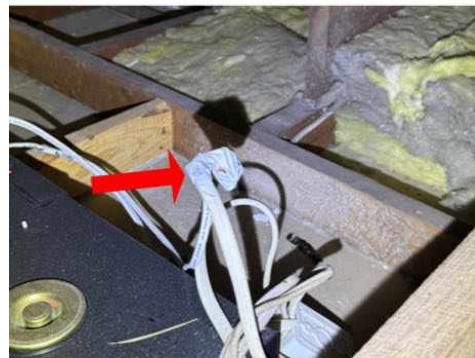
Building:	Building 1
Location:	Roof Cavity (rear middle and right)
Finding:	Electrical cables missing a junction boxes
Information:	Two electrical fittings in the roof was found to be missing a junction boxes at the time of inspection.

These missing fittings and loose cables does expose electrical works, and may create a safety hazard if there is potential contact with persons in the area.

A Licensed electrician should be appointed to rectify these areas immediately.

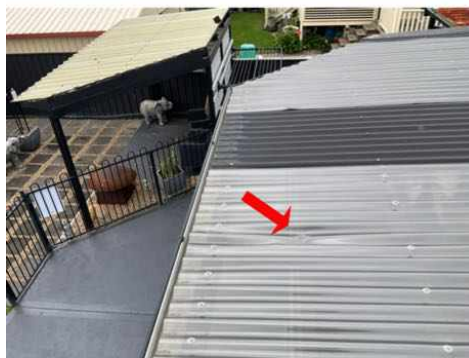
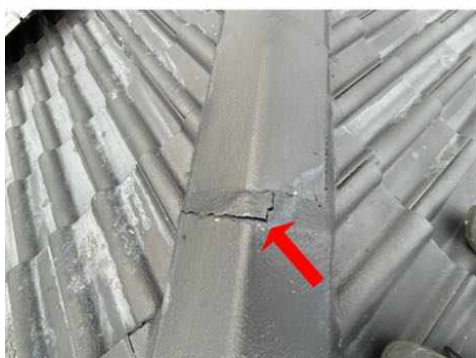
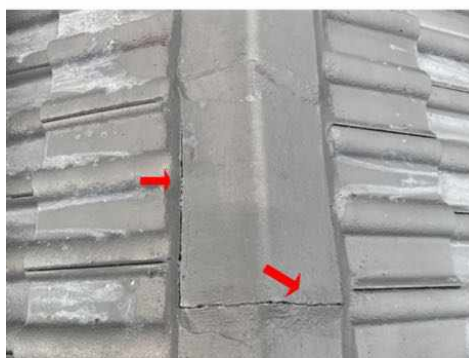
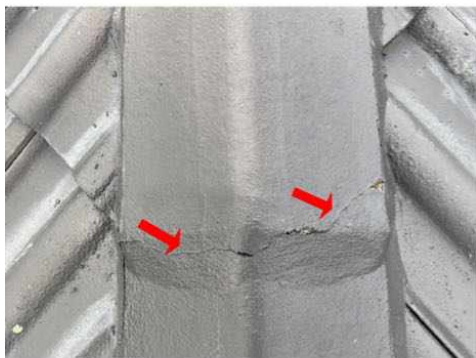
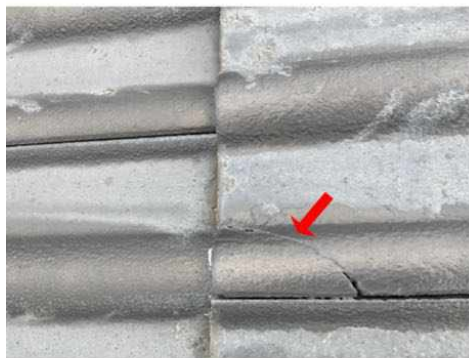
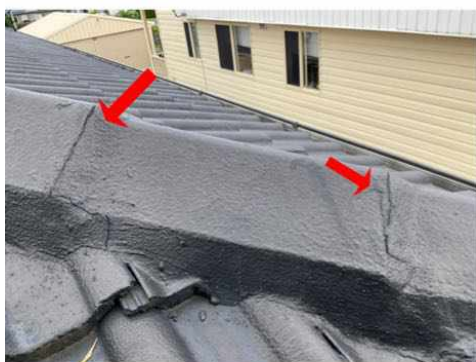
Building:	Building 1
Location:	Roof Exterior
Finding:	Roof tiles - Weathered
Information:	Upon inspection of the exterior roofing, the majority of roof areas were considered to be in good condition. While weathering of the tiles is consistent with the age of the property, maintenance works are required in these pictured areas.

Isolated areas of mortar have come loose and minor cracking is also present. Re-pointing and re-sealing the may be considered as an interim solution by the client to help preserve and extend the life span of the tiles.

Where left unmanaged, deteriorating roof tiles are likely to lead to a number of secondary defects, including minor water leaks and weather exposure to internal roofing structures.

Consultation with a roofing contractor is highly advised to gain advice on cost of remedial works that may be required in the short to medium term. Remedial works are likely to increase the longevity of the exterior roofing structure.

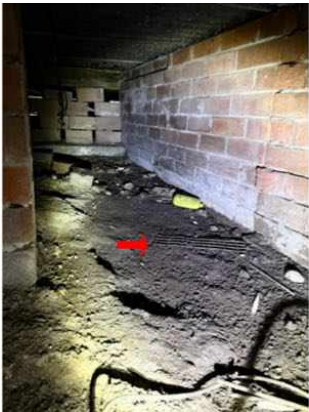
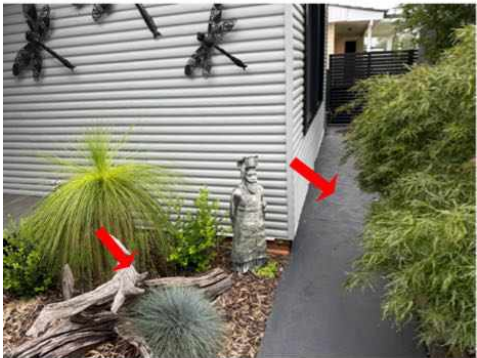
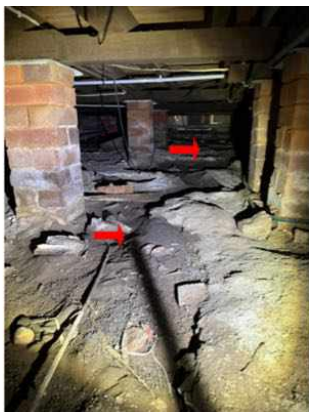
Building: Building 1
Location: Front wall areas
Finding: Site drainage - Inadequate
Information: The site drainage in the front area was found to be inadequate at the time of inspection, creating potential for subsequent water damage to associated building elements.

It is highly recommended to install front drainage to stop water entering subfloor areas creating rising damp, mould and other defects.

Where site drainage is inadequate, installation of an Agricultural (Aggie) Drain may be required. A qualified plumber should be appointed to further inspect the property and perform any remedial works as necessary. Secondary defects are likely to occur if left unmanaged.

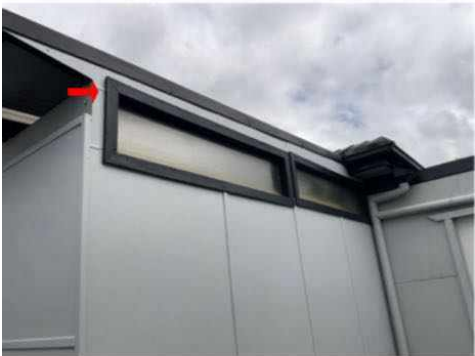
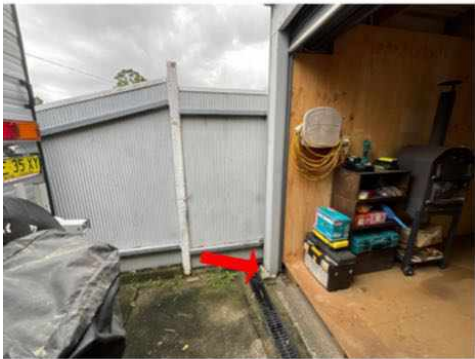
Finding 3.04

Building:	Building 1
Location:	Pictured areas
Finding:	Wood rot
Information:	The building shows evidence of small areas of wood rot. Wood rot, also known as Fungal Decay, occurs when timbers and other cellulose building materials are exposed to damp conditions on an ongoing basis. This could be the result of exposure to weathering over a prolonged period of time, or the attraction of excessive moisture from other abutting building materials.

Early intervention and regular maintenance, particularly of exterior timbers, will prolong the useful life of these building elements. Prior to any works being performed, the cause of the moisture that has created the visible wood rot should be identified and addressed in a suitable manner. Replacement of affected timbers may then be a necessary step in protecting surrounding building elements from such deterioration.

A qualified carpenter or registered builder may also be required to replace affected building materials.

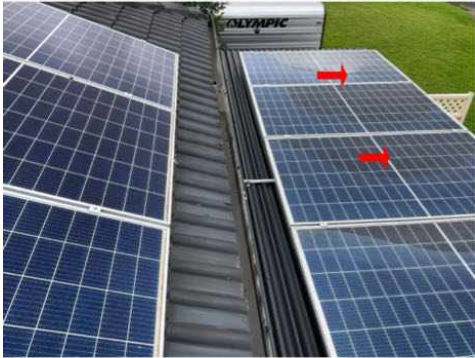
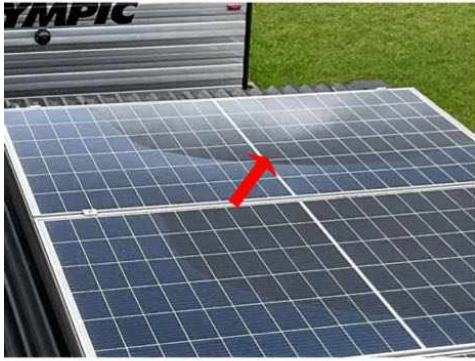
Finding 3.05

Building: Building 1
Location: Pictured areas
Finding: Solar panels - water pooling
Information: Water pooling was observed on the left-side solar panels, indicating possible incorrect installation or inadequate panel pitch, which may reduce efficiency and lead to premature deterioration. Inspection by a licensed solar installer is recommended.

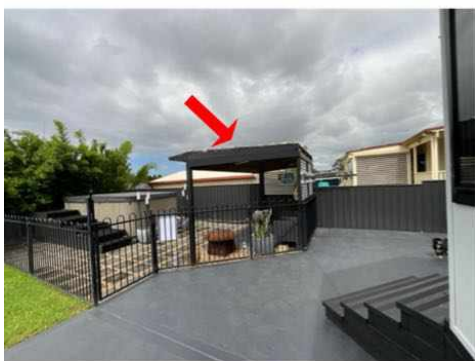
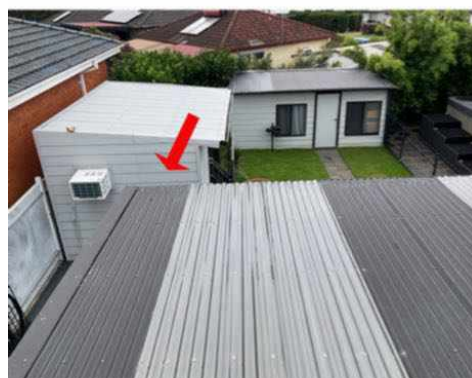
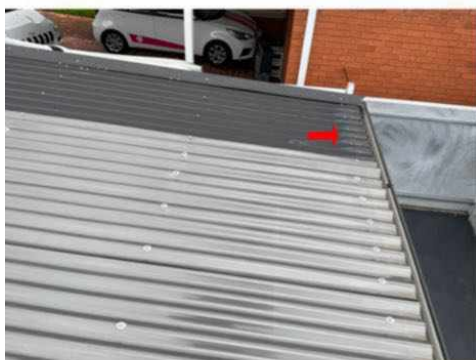
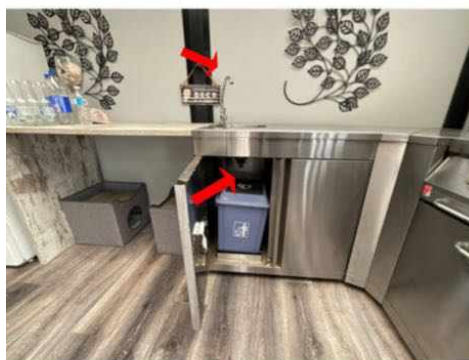
Finding 3.06

Building: Building 1
 Location: Pictured external areas
 Finding: Building elements - loose/damaged/ not working
 Information: Evidence of minor missing or damaged areas was identified at the time of the inspection. These include -

1. The small pergola requires cross bracing to stop minor movement.
2. A small amount if water is pooling on the left rear gutter requiring adjustment by a roof plumber or handy person.
3. The rear bbq sink and tap is not plumbed for use and one fluorescent light and one rangehood light was not working.

A carpenter would be the trade responsible for rectification of these areas when convenient.

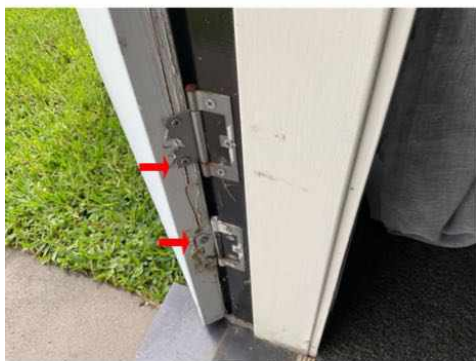
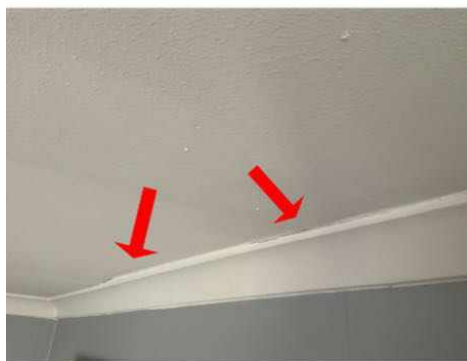
Note - some areas were obstructed by a bed and cupboards filling up the ends and some middle walls.

A carpenter would be the trade responsible for rectification of these areas when convenient.

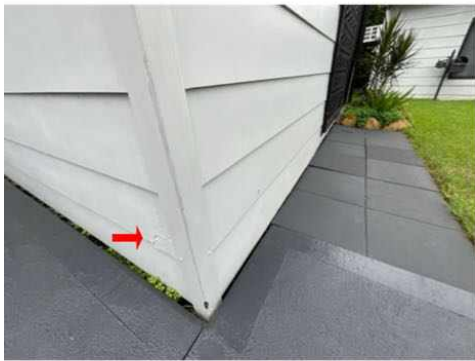
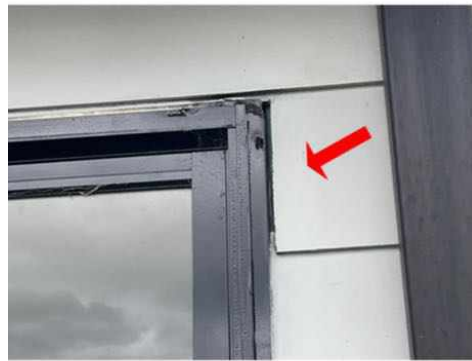
Finding 3.12

Building: Building 3
 Location: Pictured rear room area
 Finding: Building elements damaged
 Information: Evidence of minor damaged areas was identified to building 3 at the time of the inspection. These include -

Some areas were blocked by stored boxes and furniture.

A carpenter and plasterer would be the trade responsible for rectification of these areas when convenient.

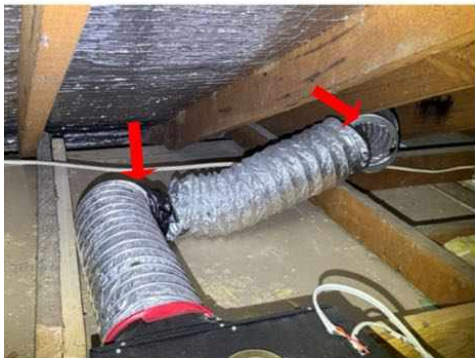
Building:	Building 1
Location:	Roof Void
Finding:	Exhaust ducting - Damaged
Information:	The exhaust ducting above the bathroom was found to be disconnected in the roof cavity. This will mean the exhaust is not functioning effectively.

It is highly recommended that a handy person or A/c installer be appointed to reconnect the ducting in order to prevent a loss of air into the roof void.

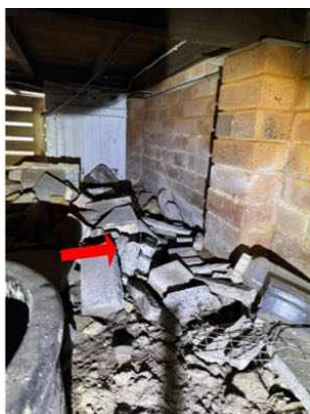
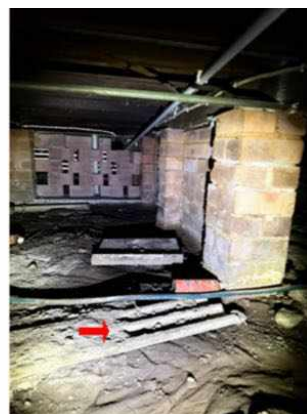
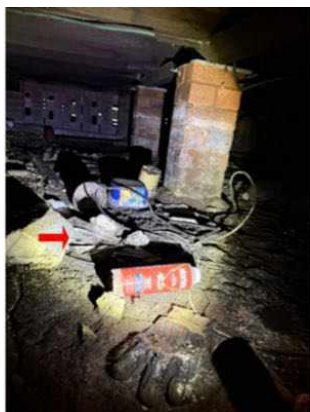
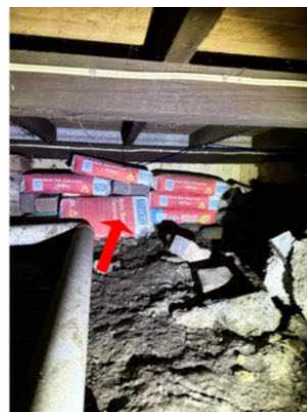
Finding 6.04

Building:	Building 1
Location:	All Subfloor Areas
Finding:	Subfloor - Debris
Information:	An array of debris was found in the subfloor area at the time of inspection. Debris in this area restricts subfloor ventilation and creates potential for concealed pest entry. Stored timbers and other materials may also make the area susceptible to termite activity and wood rot.

A clear and empty subfloor will be better ventilated and easier to maintain in a dry condition. The removal of ALL timber and subfloor debris is vital in minimising the risk of termite or wood borer activity.

Debris in the subfloor should be removed as soon as possible. Depending on the location and amount of debris and stored items, the homeowner may elect to undertake this task. Alternatively there are a large number of rubbish removal subcontractors that could undertake these works.

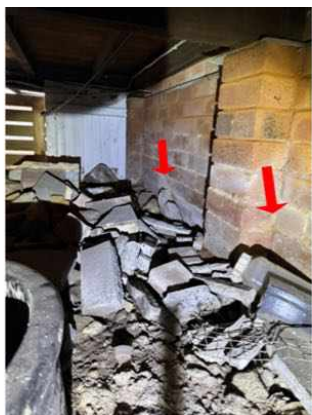
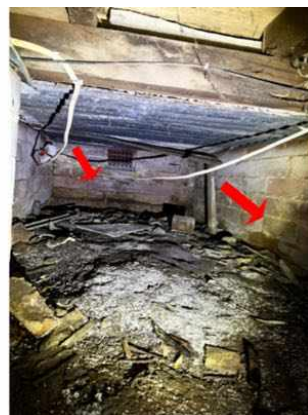
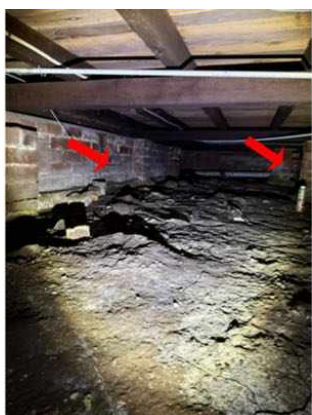
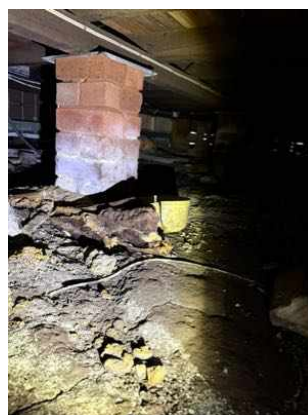
Finding 6.05

Building:	Building 1
Location:	All Subfloor Areas
Finding:	Damp - Rising and subfloor mould in the Goulburn area
Information:	Rising damp describes the upward movement of water in low sections of building elements (e.g. walls) by capillary action - the movement of water through porous materials such as bricks, sandstone or mortar. This is commonly found in the Goulburn area.

Subfloor mould is generally caused by moisture ingress, lack of external drainage, lack of adequate ventilation and subfloor debris present. These issues need rectification to stop mould development.

Consultation with a qualified plumber is advised immediately to identify the cause of the damp and mould and perform remedial drainage works as required.

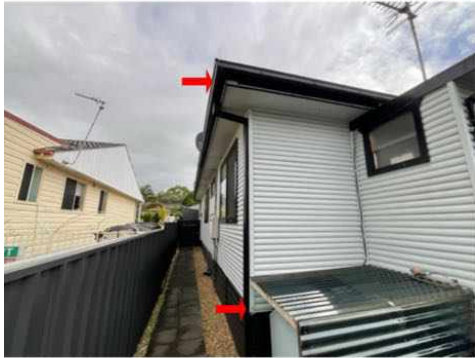
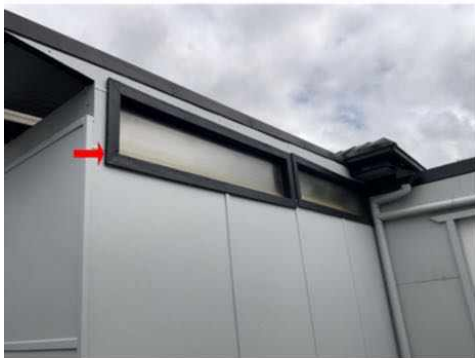
Building:	Building 1
Location:	Areas pictured in the wood rot defect
Finding:	Fungal decay - present (localised)
Information:	Fungal decay also known as wood decay or wood rot generally refers to the deterioration of timber elements when in contact with excessive levels of moisture for a prolonged period of time.

In this case, these small areas of the affected timber fascia, barge board and other small areas are in a decaying state and will need bogging up or replacement by a carpenter or licensed builder.

Note - See ALL wood rot photos in building defects above, all these show fungal decay.

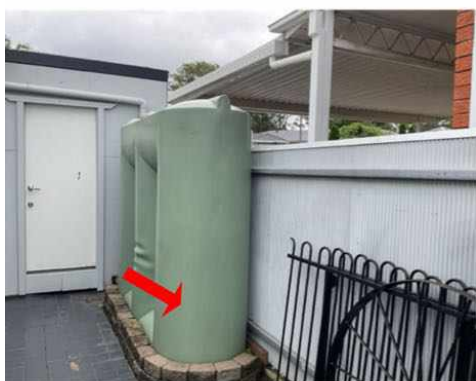
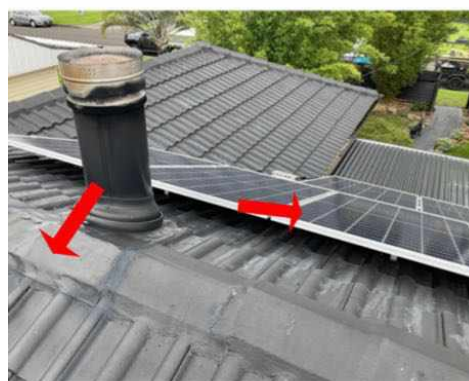
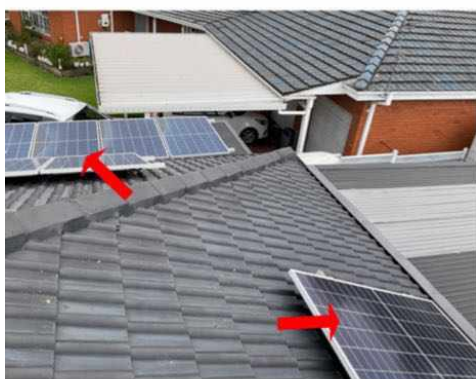
Building: Building 1
 Location: All External Areas
 Finding: Additional Photos - Obstructions and Limitations of EXTERNAL AREAS
 Information: These photographs are an indication of the obstructions and limitations which impeded full inspection of external areas at the time of inspection. These obstructions can hide an array of defects and should be removed to allow full inspection to be carried out. A re-inspection is recommended once the areas are made accessible.

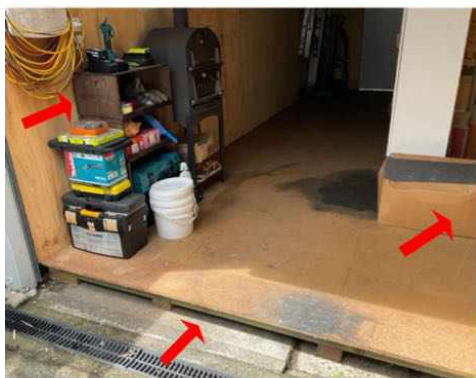
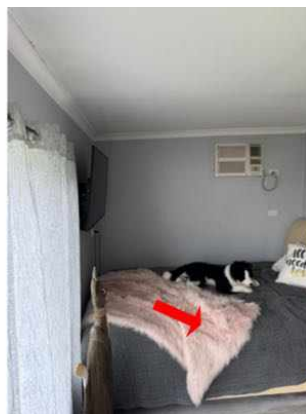
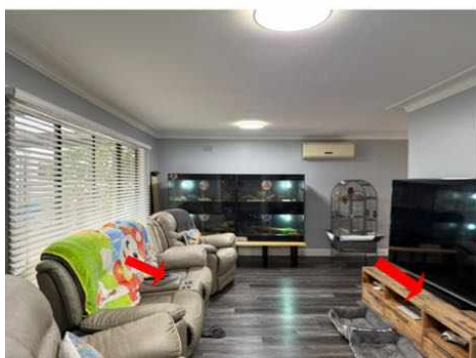
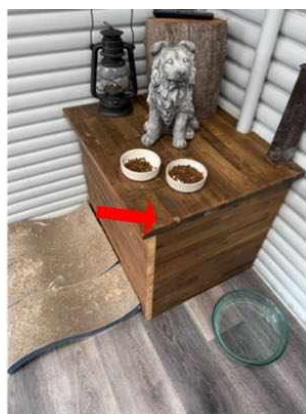
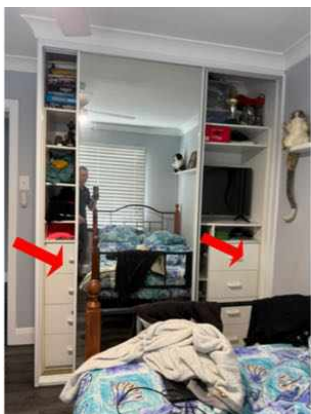
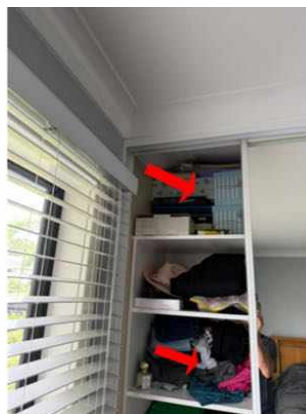
Building: Building 1
 Location: All Internal Areas
 Finding: Additional Photos - Obstructions and Limitations of INTERNAL AREAS
 Information: These photographs are an indication of the obstructions and limitations which impeded full inspection of Internal areas at the time of inspection. These obstructions can hide an array of defects and should be removed to allow full inspection to be

carried out. A re-inspection is recommended once the areas are made accessible.

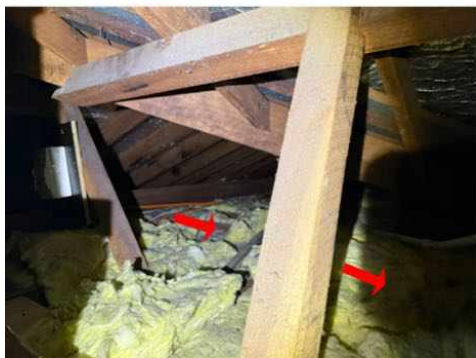
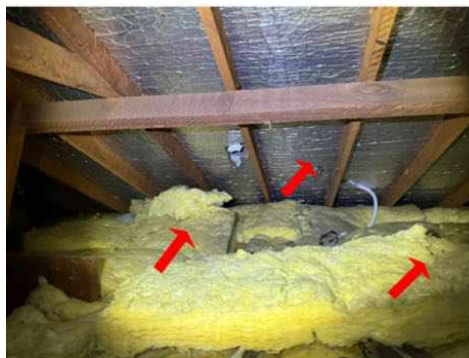
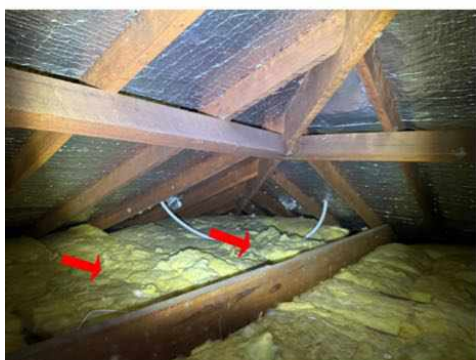
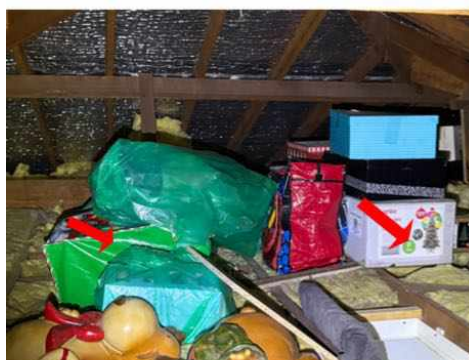
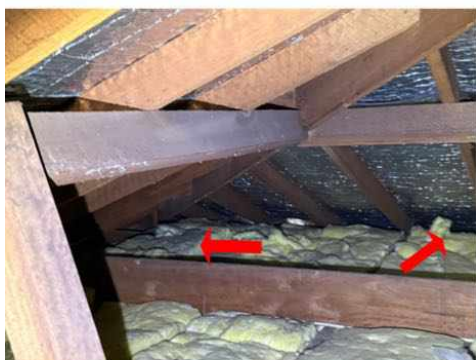
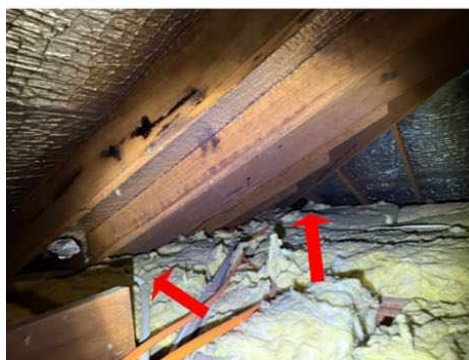
Building: Building 1
 Location: All Roof cavity areas
 Finding: Additional Photos - Obstructions and Limitations of the ROOF CAVITY
 Information: These photographs are an indication of the obstructions and limitations which impeded full inspection of roof cavity areas at the time of inspection. These obstructions can hide an array of defects and should be removed to allow full inspection to be carried out if applicable. A re-inspection is recommended once the areas are made accessible.

The inspection was also limited to areas with an allowable crawl space of 600mm x 600mm, in particular towards the external walls where the roof line diminishes, these areas were not accessible.

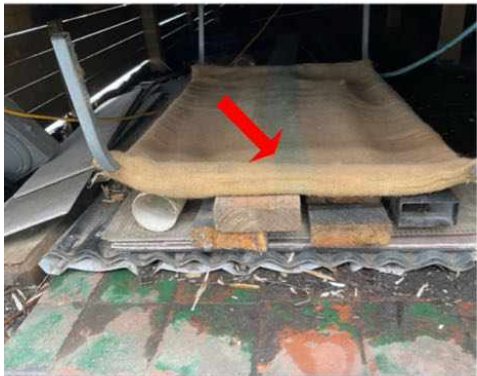
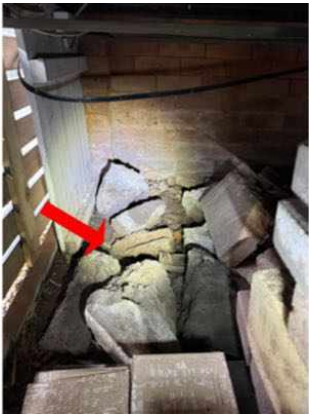
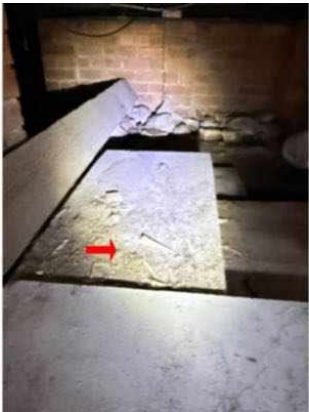
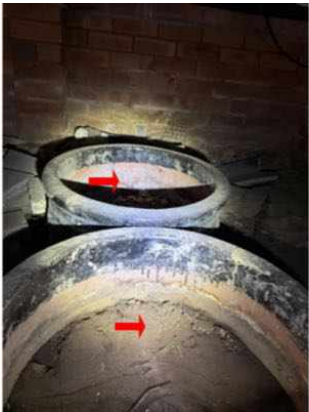
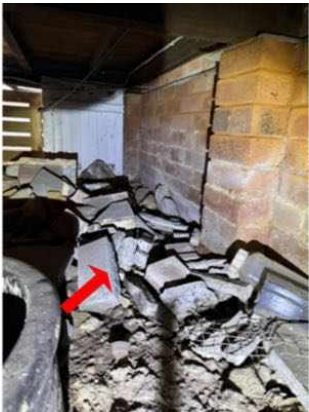
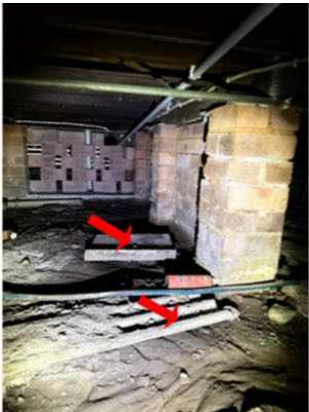
Building:	Building 1
Location:	All Subfloor Areas
Finding:	Additional Photos - Obstructions and Limitations of SUBFLOOR AREAS
Information:	These photographs are an indication of the obstructions and limitations which impeded full inspection of subfloor areas at the time of inspection. These obstructions can hide an array of defects and should be removed to allow full inspection to be

carried out. A re-inspection is recommended once the areas are made accessible.

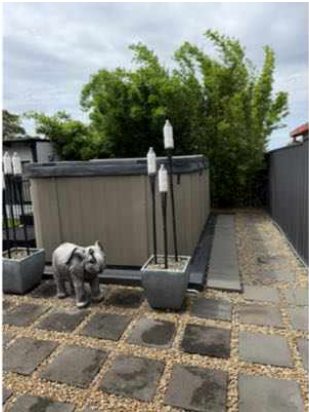
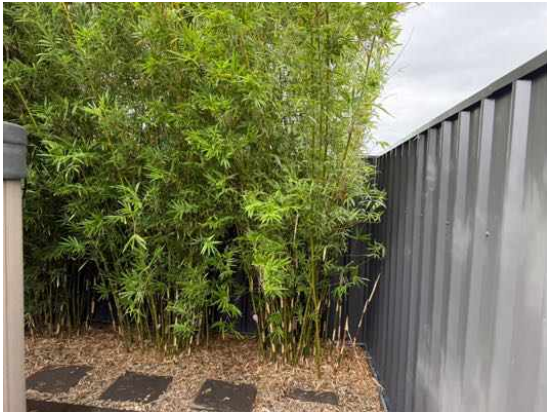
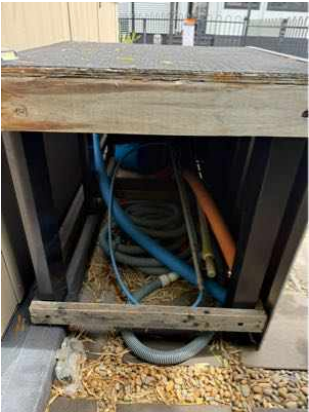
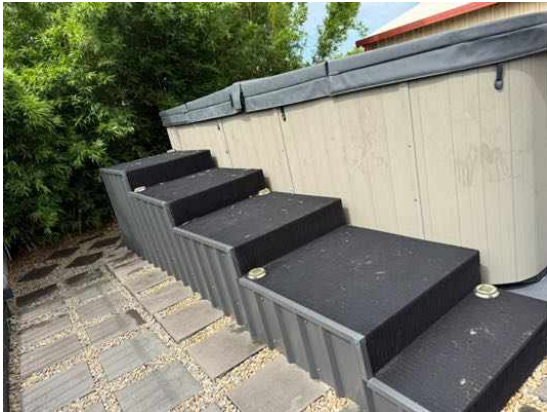
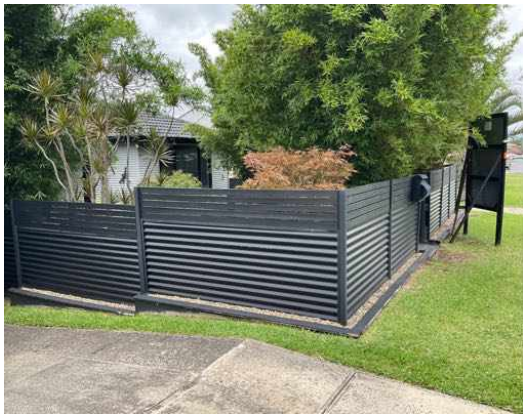
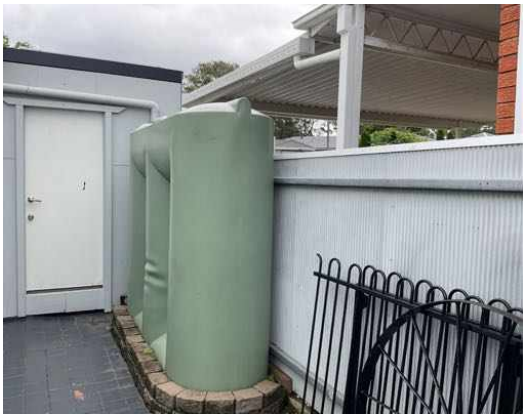
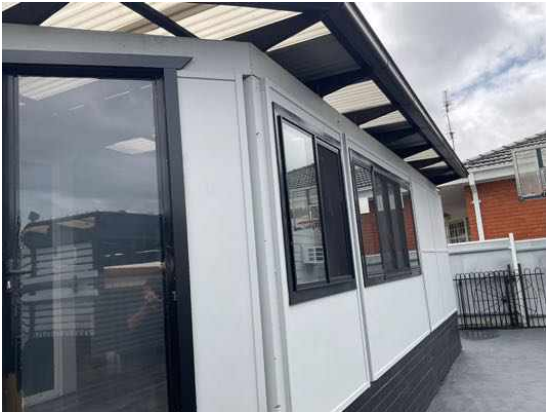
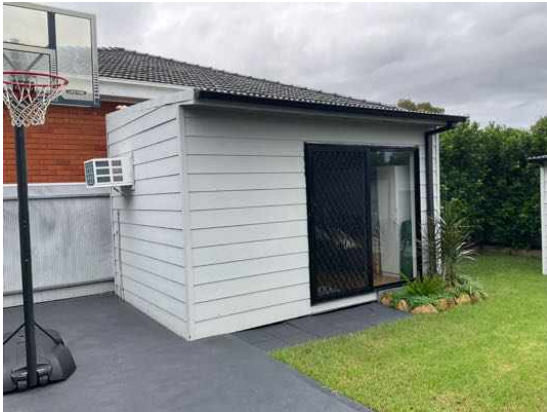
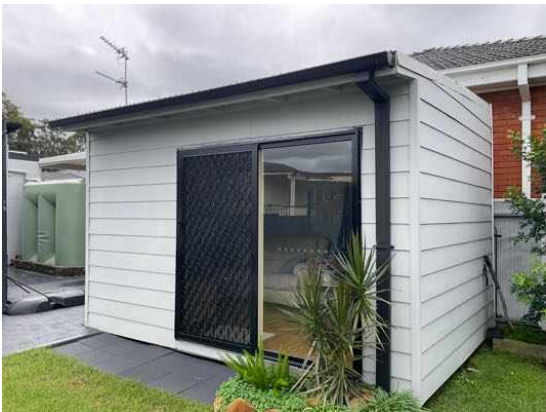
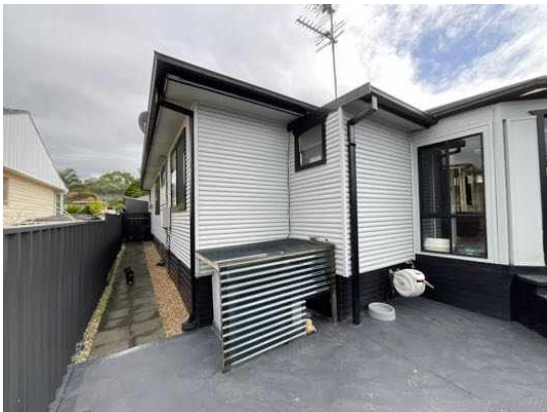
Building: Building 1
Location: All External Areas
Finding: Additional Photos
Information: Additional photos are provided for your general reference

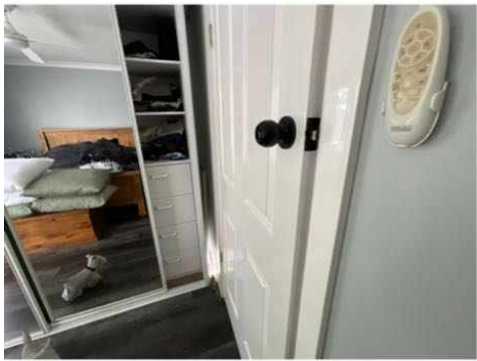
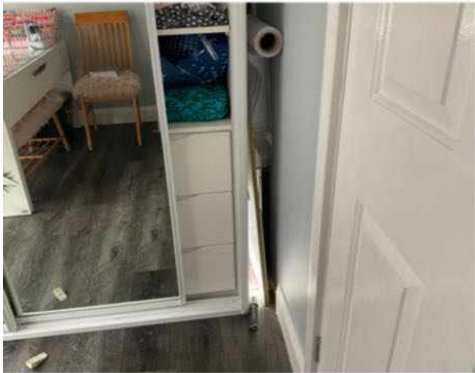
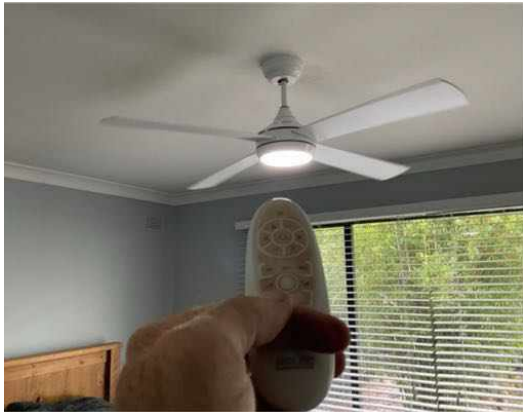
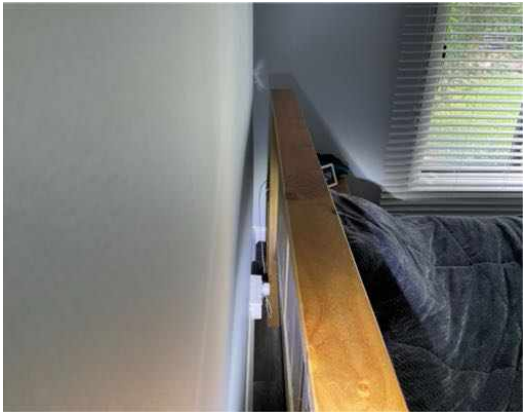
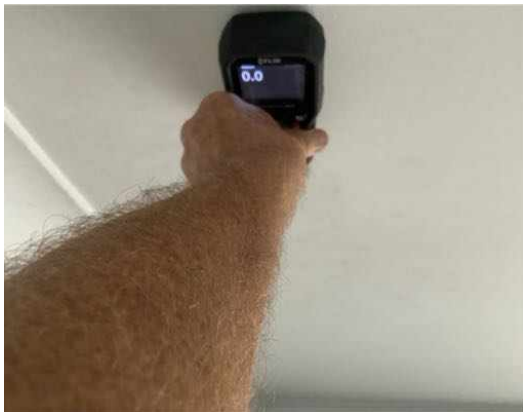
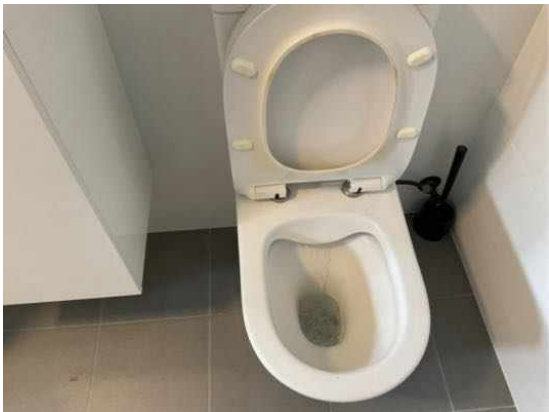
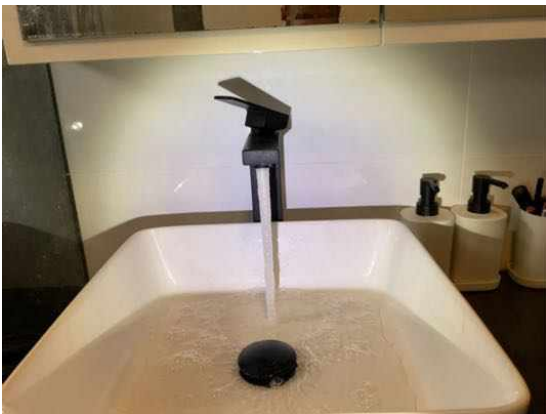
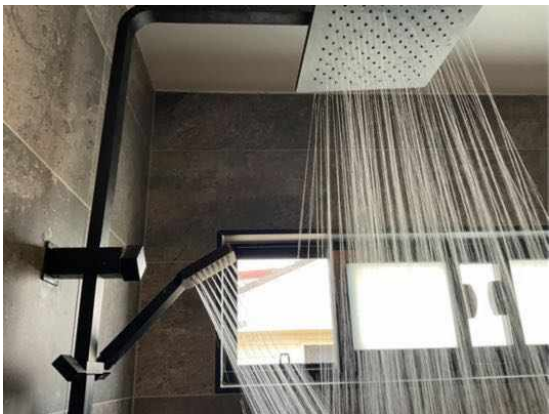
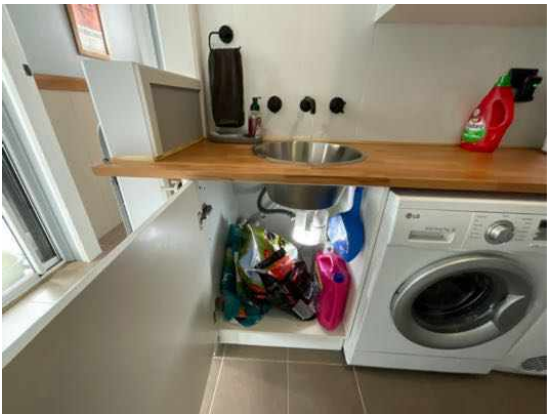
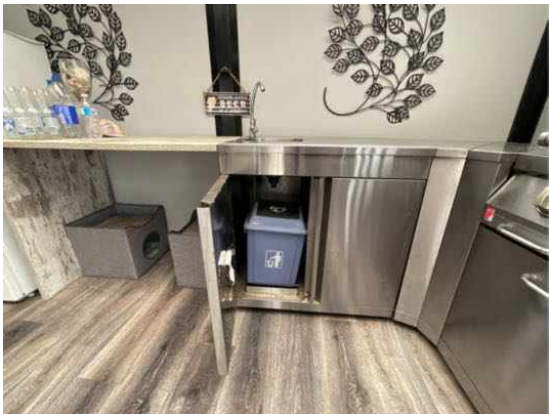
Building: Building 1
Location: All Internal Areas
Finding: Additional Photos
Information: Additional photos are provided for your general reference

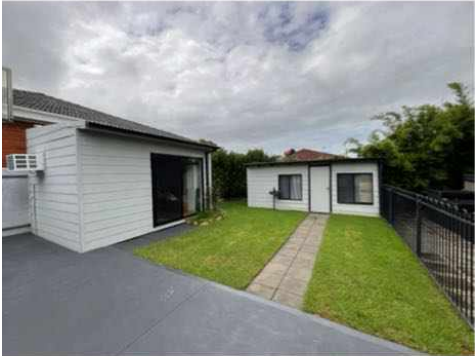
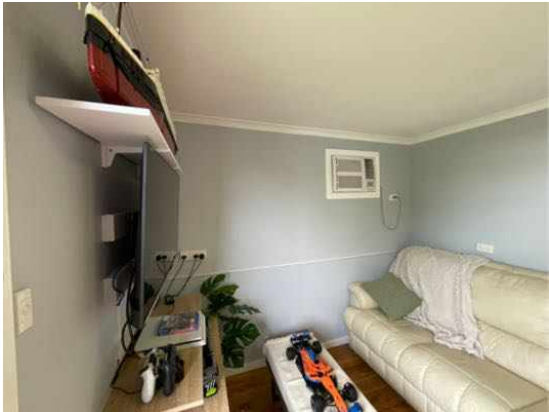
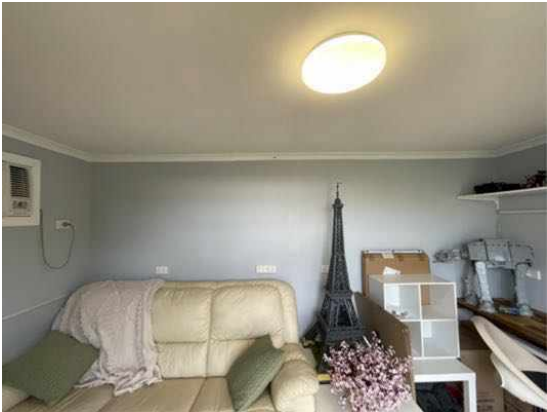
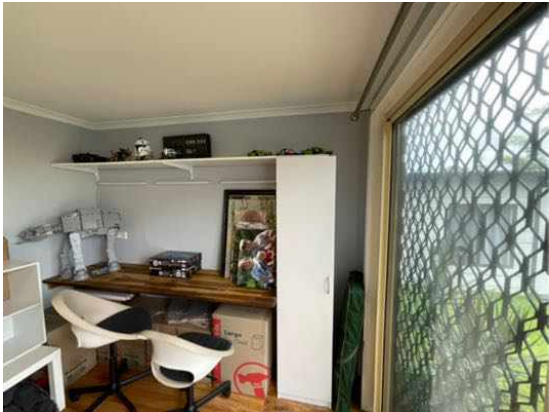
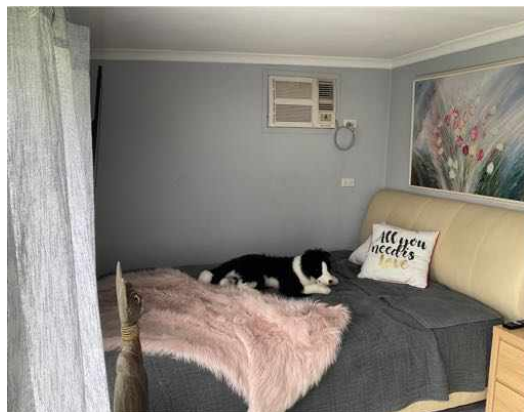
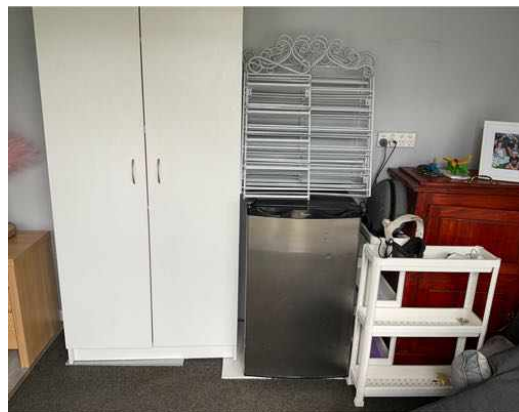
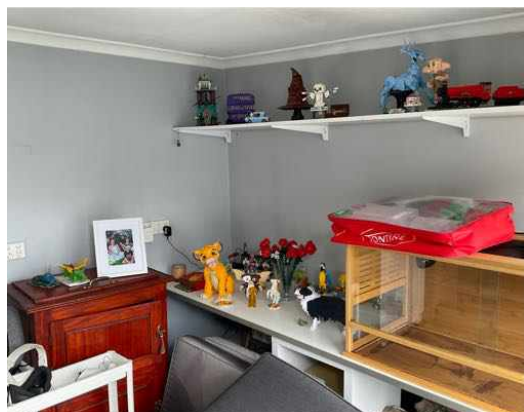
Building: Building 3
Location: Both rear buildings
Finding: Additional Photos
Information: Additional photos are provided for your general reference

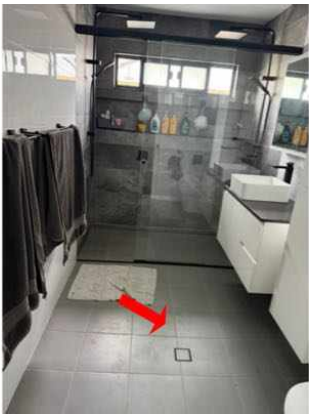
Building: Building 1
 Location: Bathrooms and laundry
 Finding: Waterproofing membranes - Information Only
 Information: Internal Water Proofing Membranes, are crucial in preventing water ingress into the property is important to know that the Membrane System used is to Australian Standards and has been installed correctly.

With older property's where this information is unavailable all wet areas should be monitored. If any leaks, water staining, peeling or bubbling of the paint become evident to any adjacent walls or ceilings below a licensed builder or waterproofing specialist is recommended to investigate further.

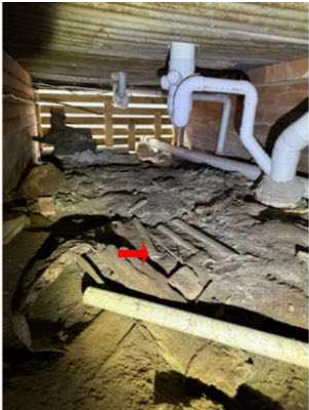
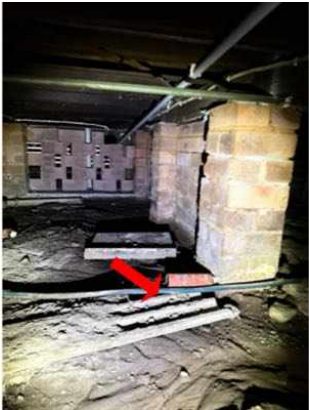
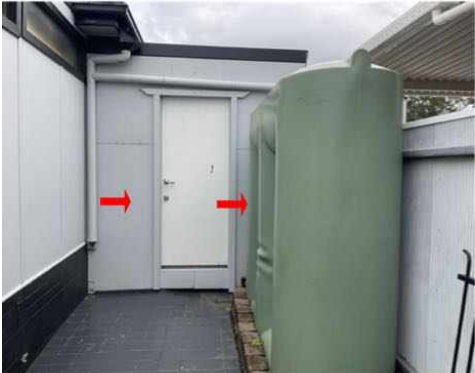
Building: Building 1
Location: All Subfloor Areas
Finding: Asbestos - Suspected ACM Identified on Site
Information: Reporting on Asbestos is outside the Scope of this Report. This suspected defect is highlighted as a caution only. We suspect, based on our experience in the building industry, that there is a higher risk of the identified building element containing asbestos.

As Asbestos Reporting is outside the scope of this report, we advise that you consider a separate Asbestos Inspection and Condition Audit, which can include the taking of samples for definitive confirmation of the presence of Asbestos.

In the interim, the client is advised to act with caution, especially when considering any damage to building materials general wear and tear renovations extensions demolition and general maintenance activities due to the suspected presence of Asbestos.
