# Building and Timber Pest Inspection Report

Inspection Date: Wed, 28 Jan 2026

Property Address: 12 Oxford Cl, Sippy Downs QLD 4556,  
Australia

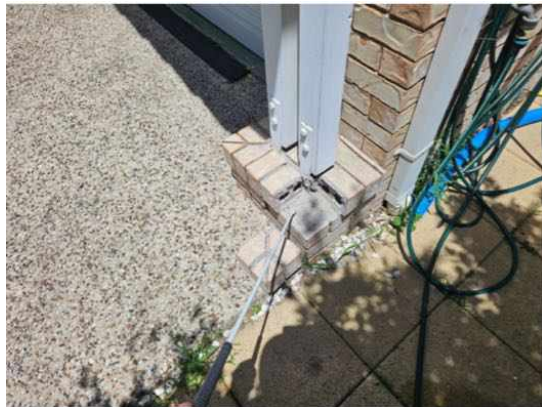
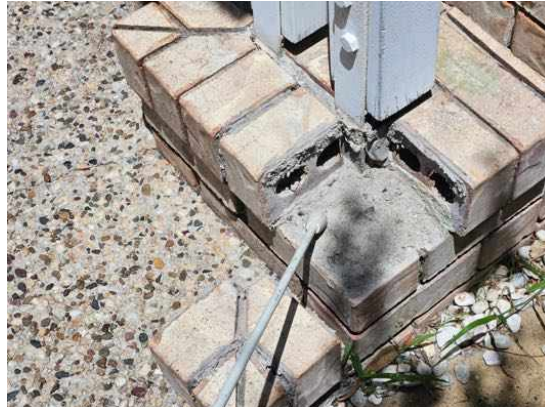
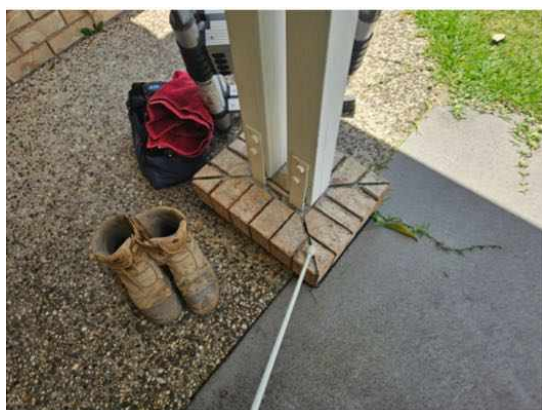
Building: Main Building  
Location: As shown  
Finding: Brickwork - cracking  
Information: Cracking was identified to the brickwork bases of the front posts at the time of inspection. Cracking of this nature can usually be attributed to movement or minor expansion of the underlying concrete over time.

The repairs are generally easily resolved.

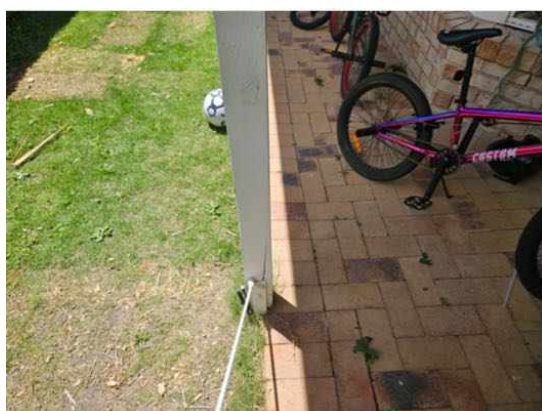
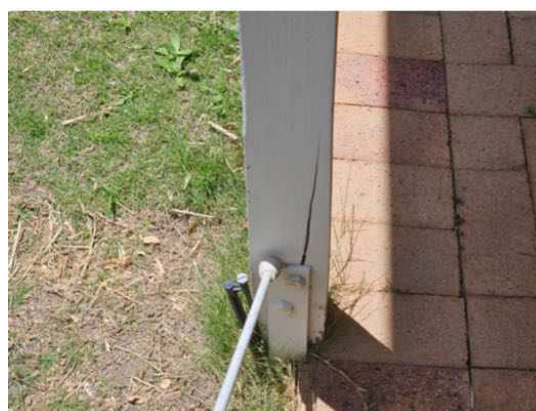
### Finding 3.02

Building:	Main Building
Location:	Pergola
Finding:	Verandah post - splitting
Information:	On the day of inspection the pergola was inspected and it was noted that one of the verandah posts are splitting at the base.

Being at the base of the post, this split, which is approximately 200mm in length, will compromise the bolted fixings ability to secure the posts in position.

It advise that a licensed builder or licensed carpenter be engaged to replace the post with new timber.

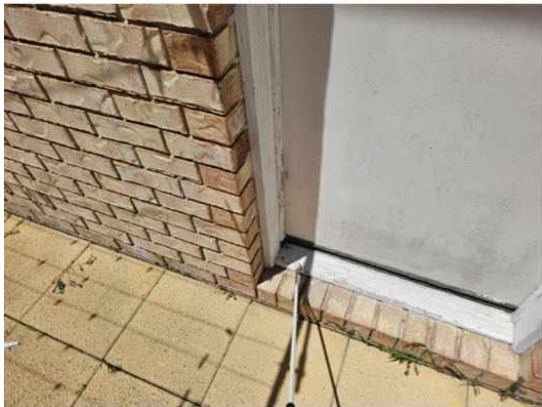
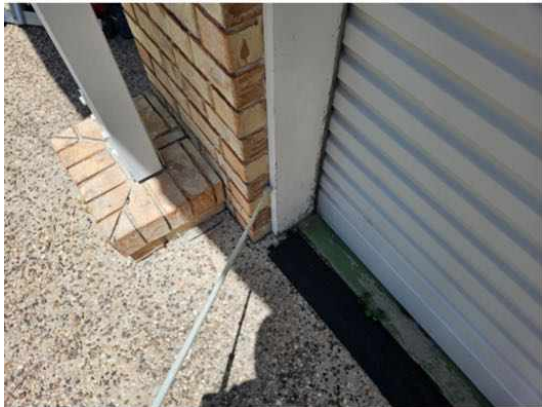
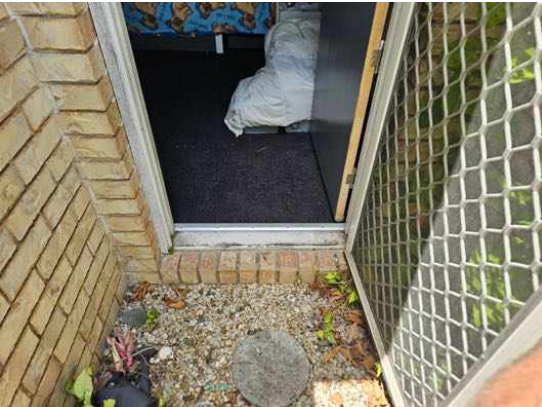
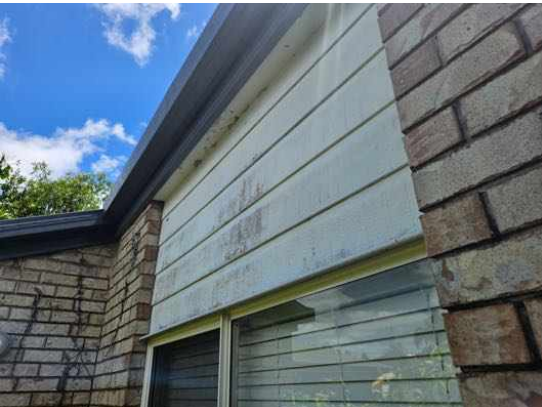
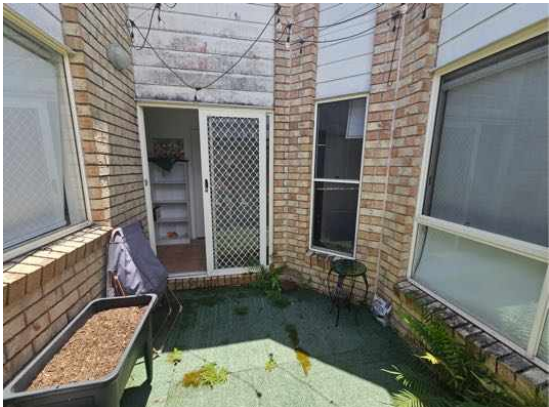
### Finding 3.03

Building:	Main Building
Location:	As shown
Finding:	External painting deteriorated - minor
Information:	The external paintwork of the walls and joinery as shown will require attention to prepare and re-paint in the short term.

A painting contractor could be appointed to perform necessary works to aid the appearance of the affected area and to ensure the area is protected against further deterioration.

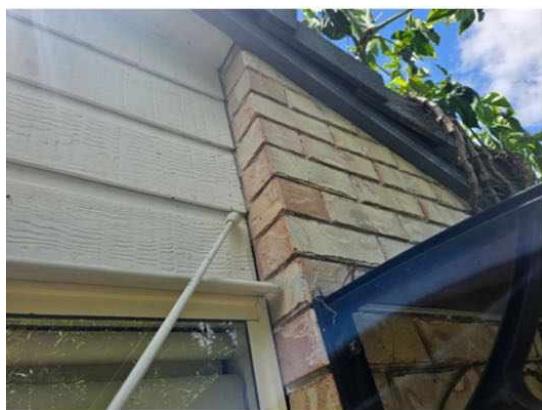
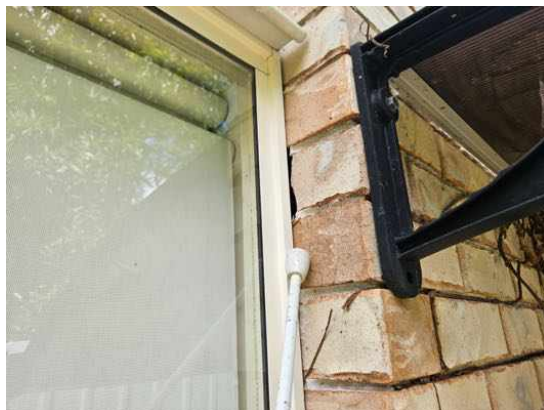
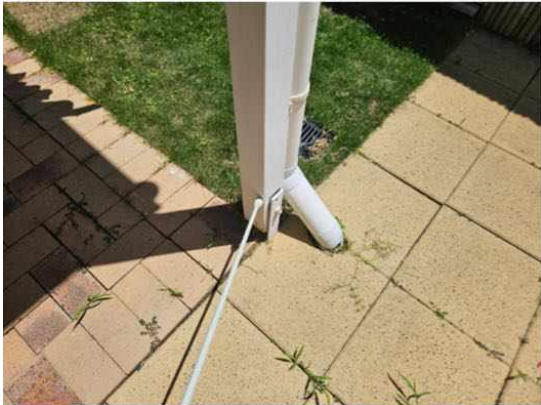
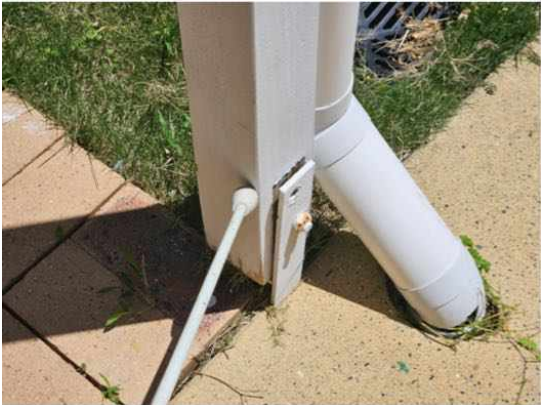
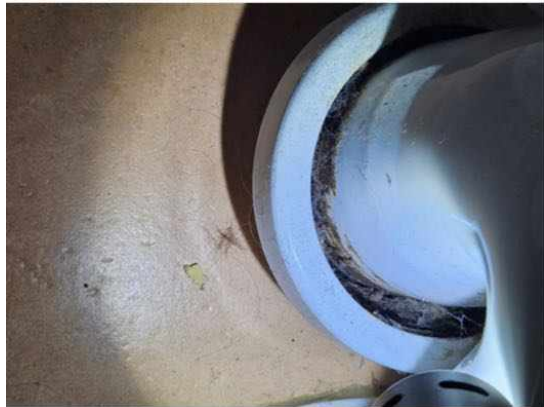
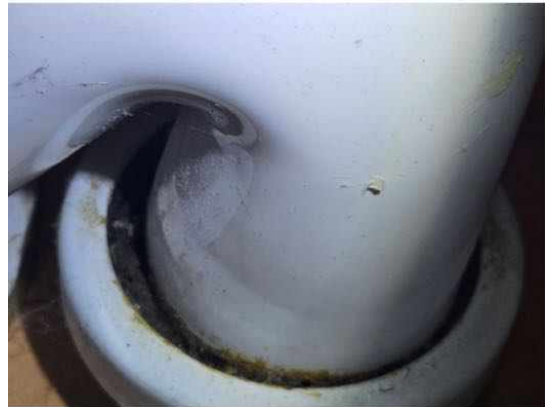
### Finding 3.04

Building:	Main Building
Location:	All Areas
Finding:	Miscellaneous minor defects
Information:	Below are listed the miscellaneous minor defects identified on the day of inspection.

1. Gap at weatherboard / brick on rear gable.
2. Rusted bolt to be replaced on pergola post.
3. Right side gate binds.
4. Beading broken on garage eave.
5. WC, toilet pan seal deteriorated.
6. Master-bedroom and kitchen windows require servicing.

These minor defects should be attended to in the short term to prevent further deterioration.

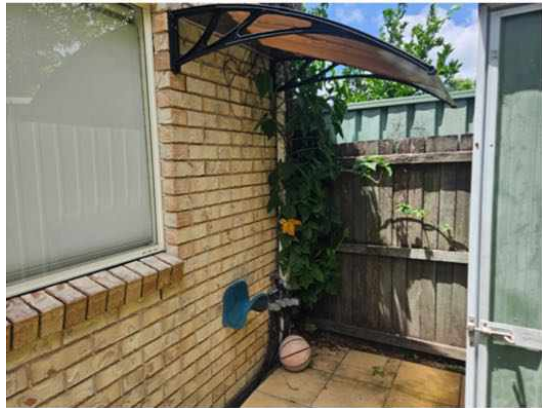
Building: Main Building  
Location: As shown  
Finding: Garden - growing against house.  
Information: It was noted on the day of inspection that the plants, in particular an invasive vine, were growing against the building. This can be at risk of creating an environment for timber pests and vermin to enter the building.

It is recommended that the foliage be cut back to give a clear inspection zone against the building.

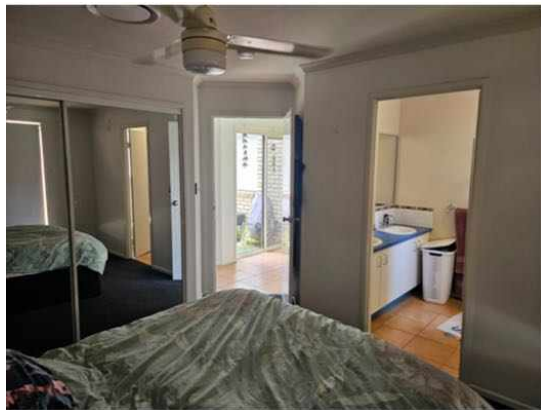
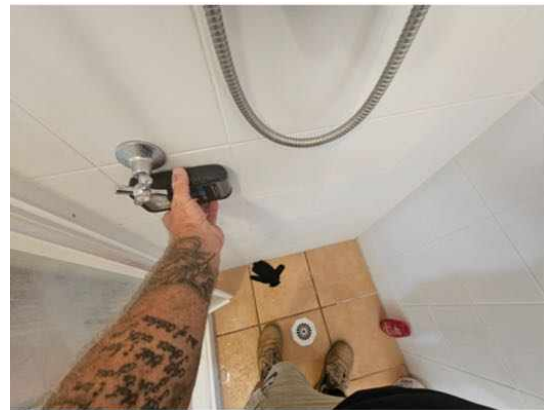
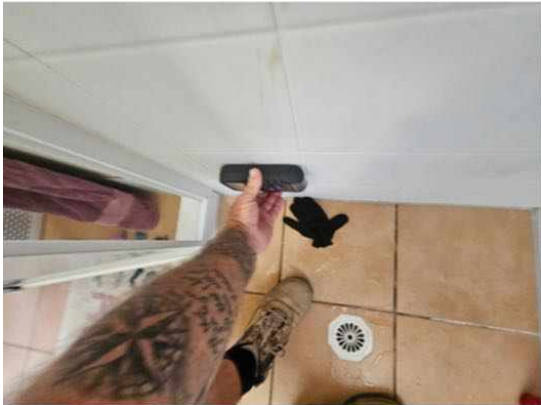
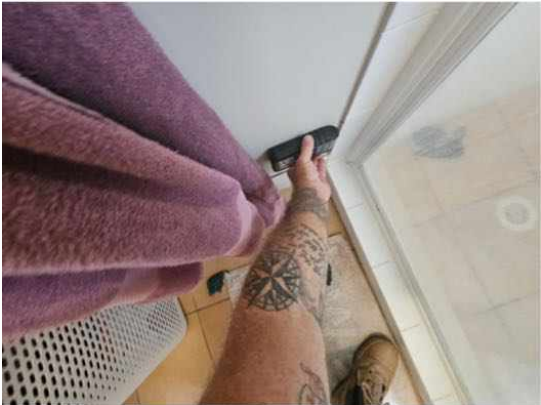
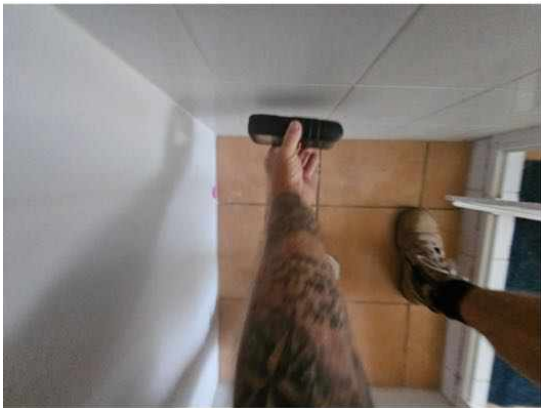
Building: Main Building  
Location: Bathroom, ensuite, laundry  
Finding: No moisture detected in bathroom / ensuite / laundry  
Information: On the day of inspection the showers in the bathroom/s and ensuite, and wall of the laundry are measure for moisture using a "Tramex" moisture meter. During this inspection no moisture was detected in these areas and the tiled / sheeted surfaces appear to be in good order.

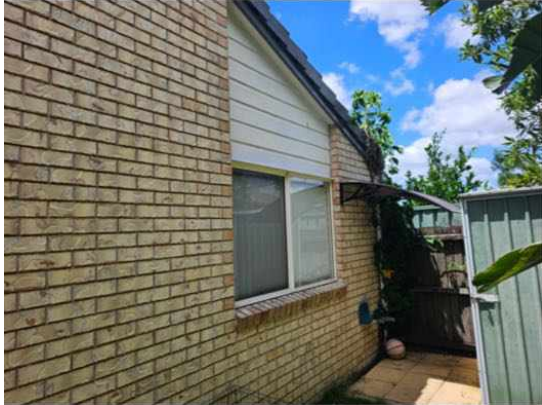
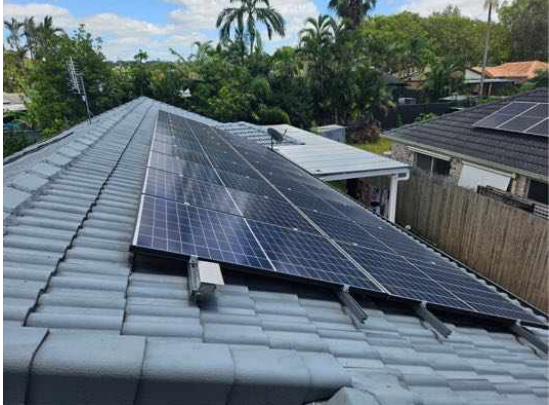
Building: Main Building  
Location: All Areas  
Finding: Additional Photos - Obstructions and Limitations  
Information: These photographs are an indication of the obstructions and limitations which impeded full inspection of the property at the time of inspection. These obstructions can prevent full inspections of the areas shown.

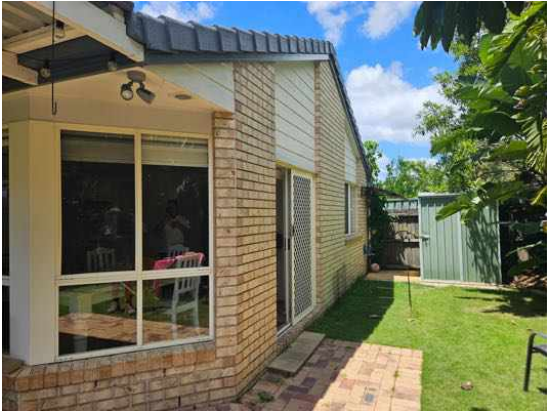
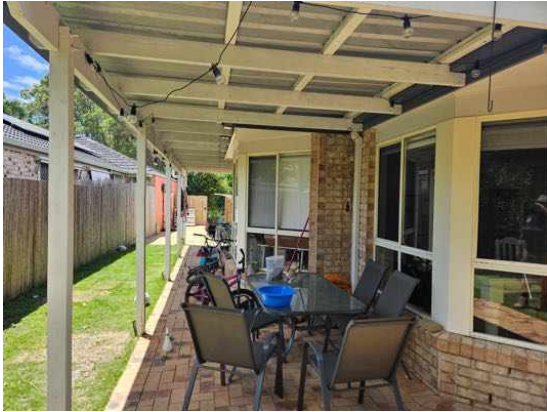
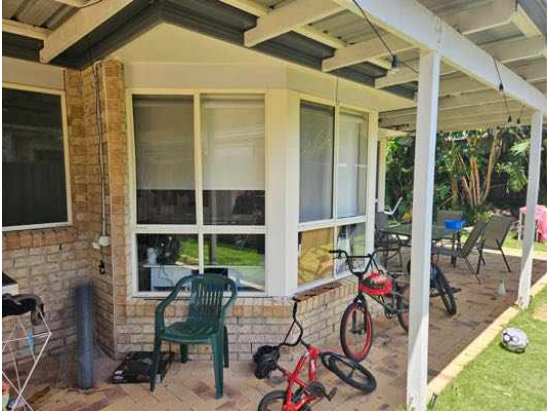
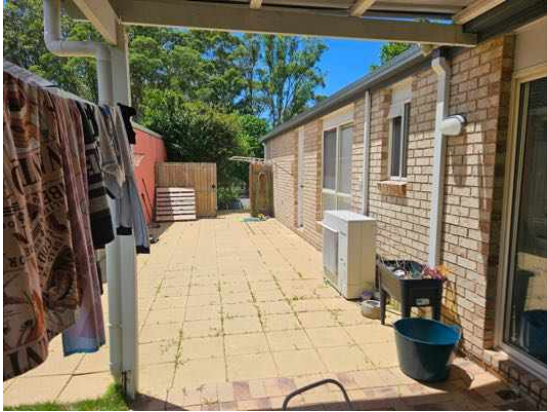
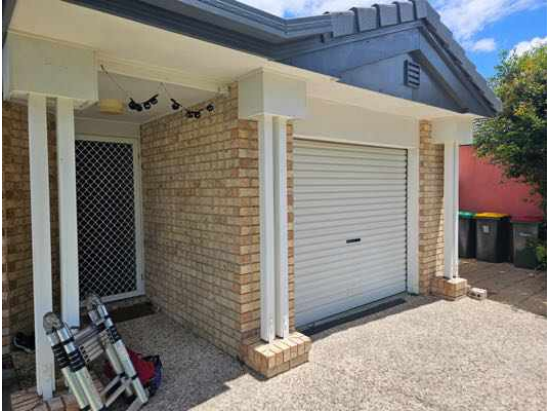
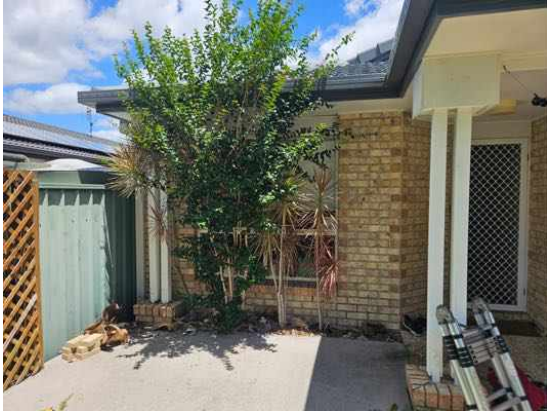
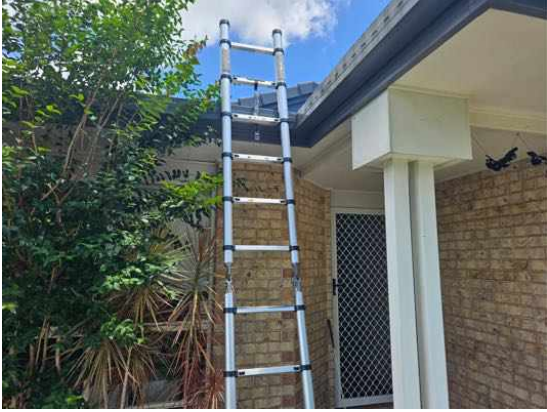
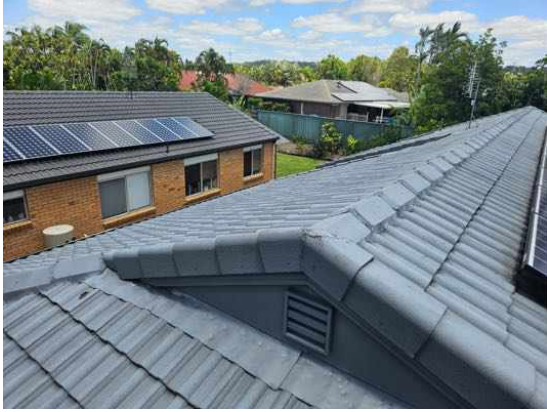
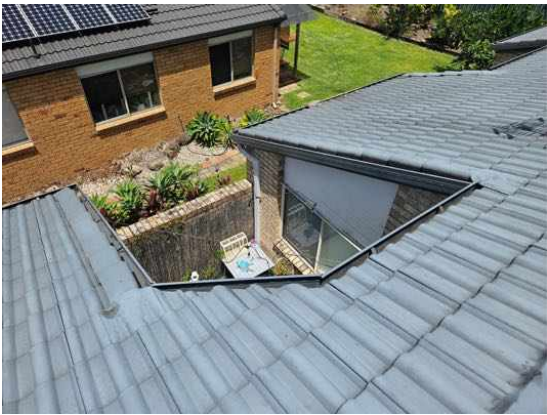
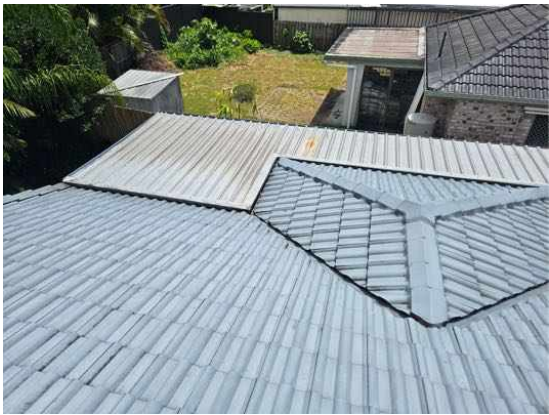
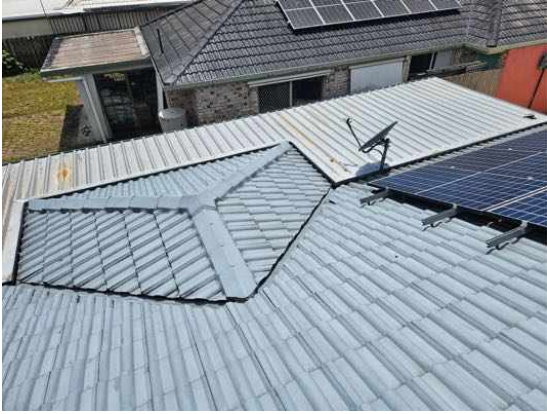
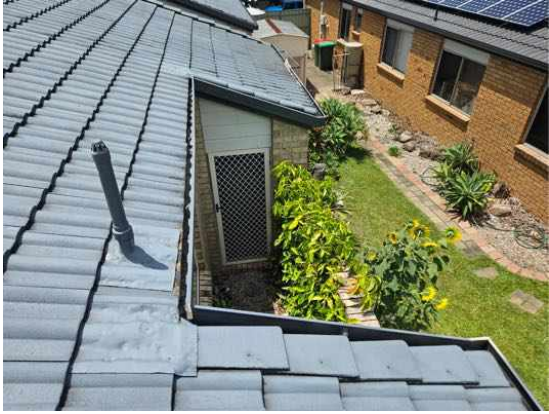
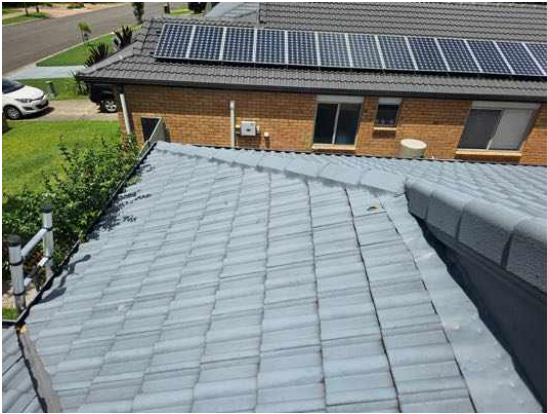
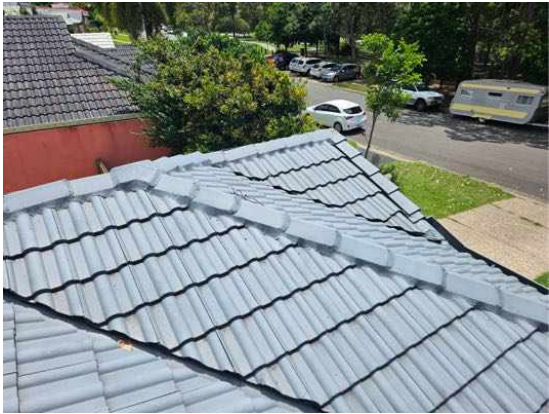
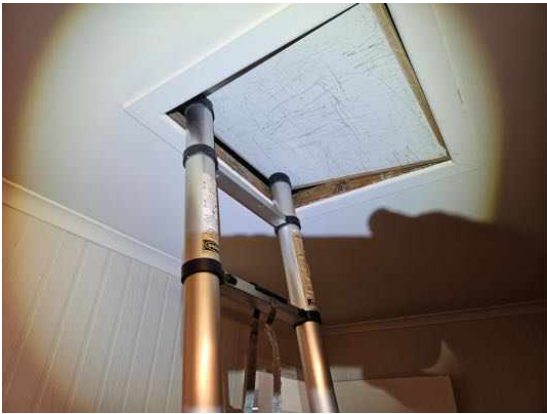
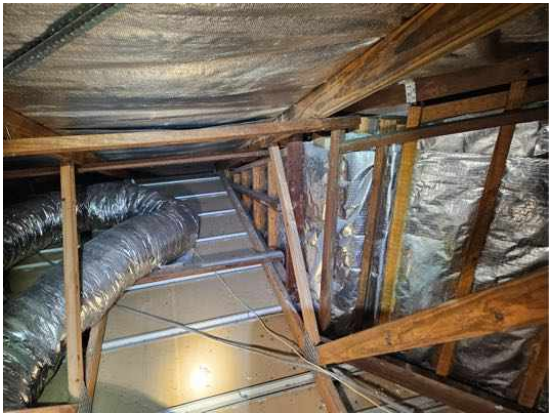
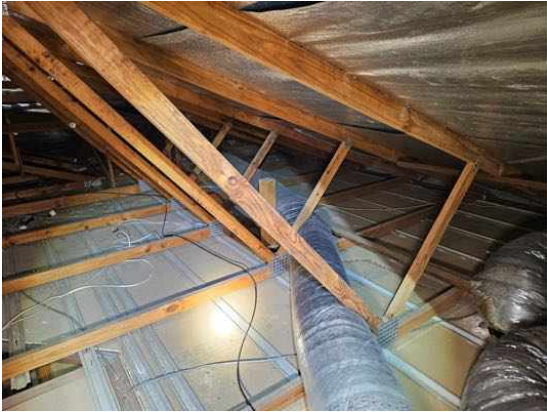
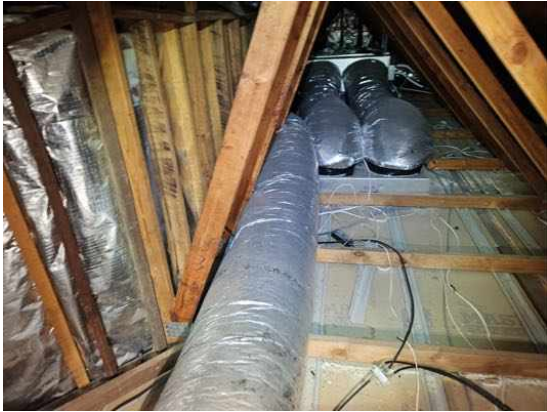
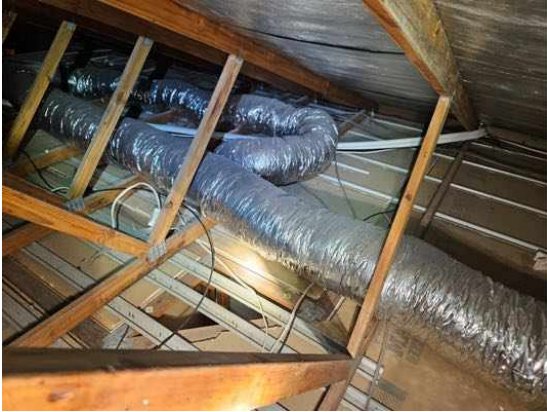
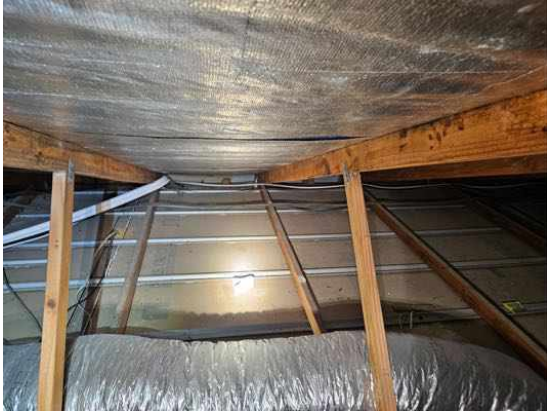
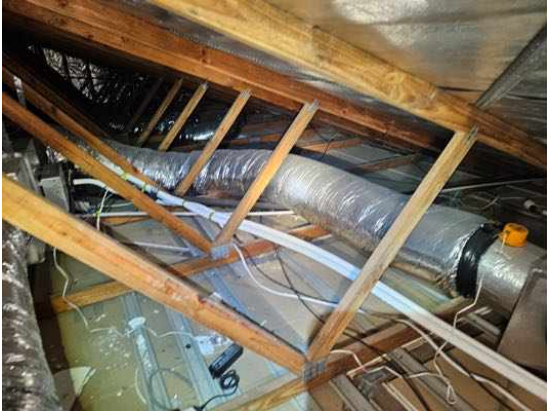
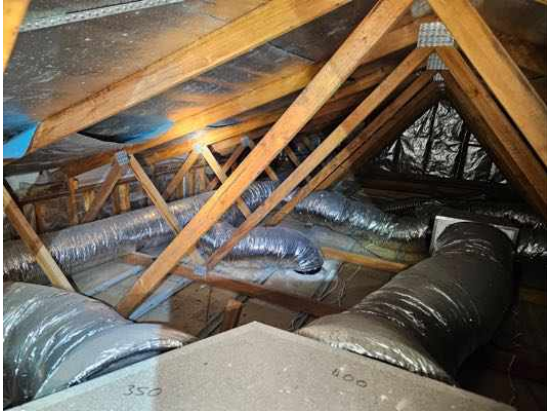
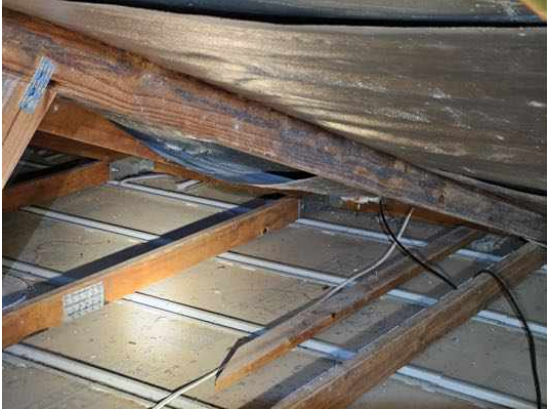
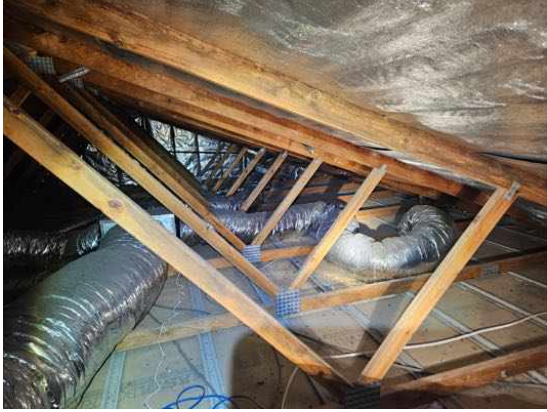
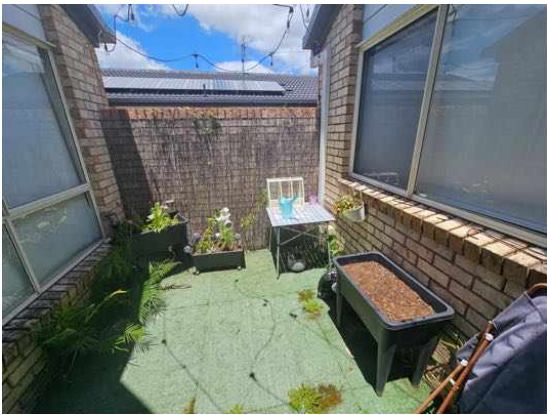
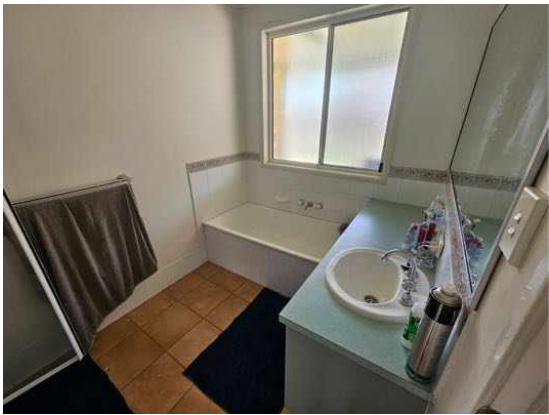
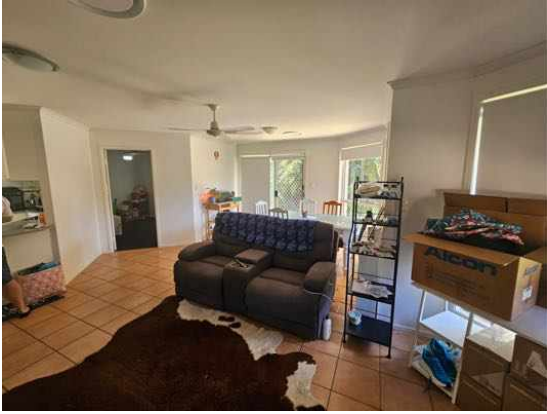
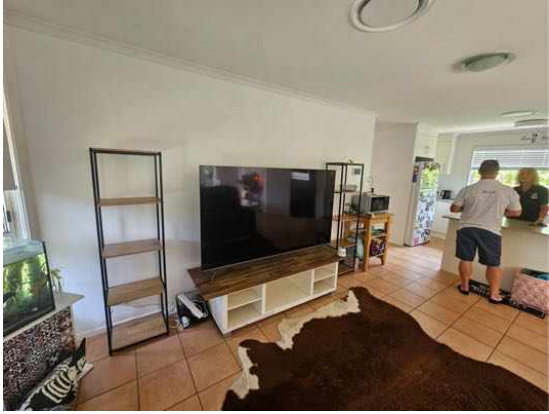
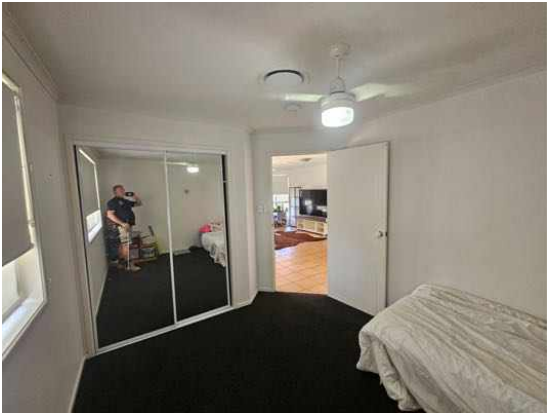
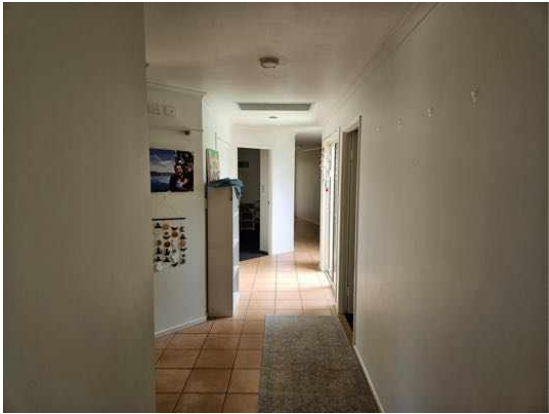
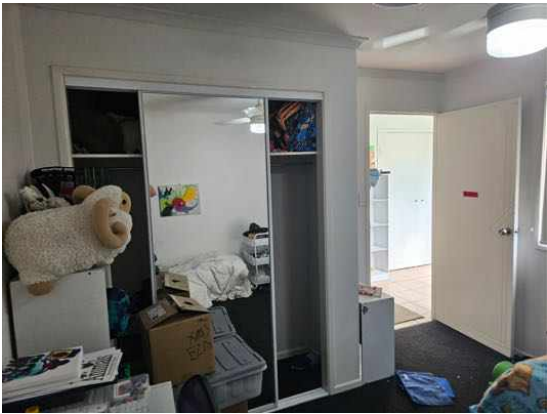
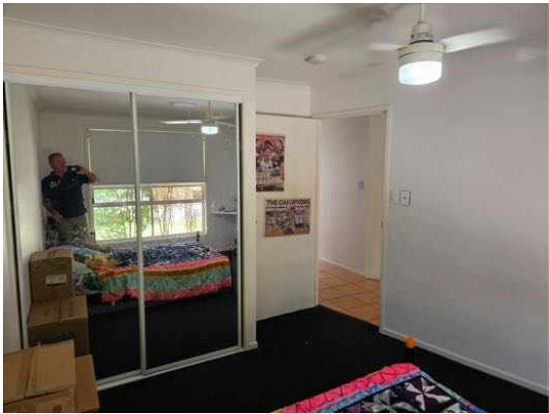
Building: Main Building  
Location: All Areas  
Finding: Additional Photos for client reference  
Information: Additional photos are provided for your general reference.

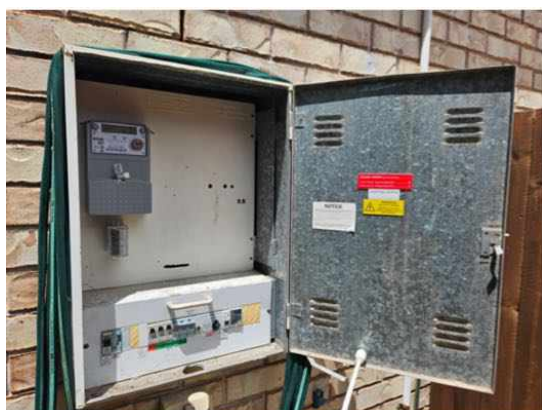
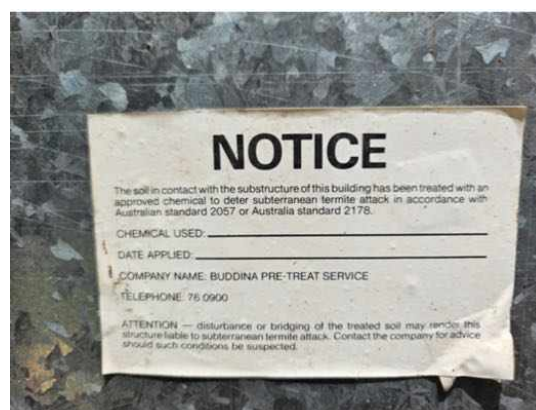
The building previously employed a chemical underslab spray barrier applied at construction. There was no other evidence available on the day to show an existing post construction barrier. It is strongly recommended that a barrier system be implemented.

In order for a barrier system to be effective, the property must have regular inspections at intervals of not greater than 12 months. Depending on the risk profile attributed to the property, these inspections may be recommended at lesser time periods.
